#### 5.4 West Elevation

## 6. Interior

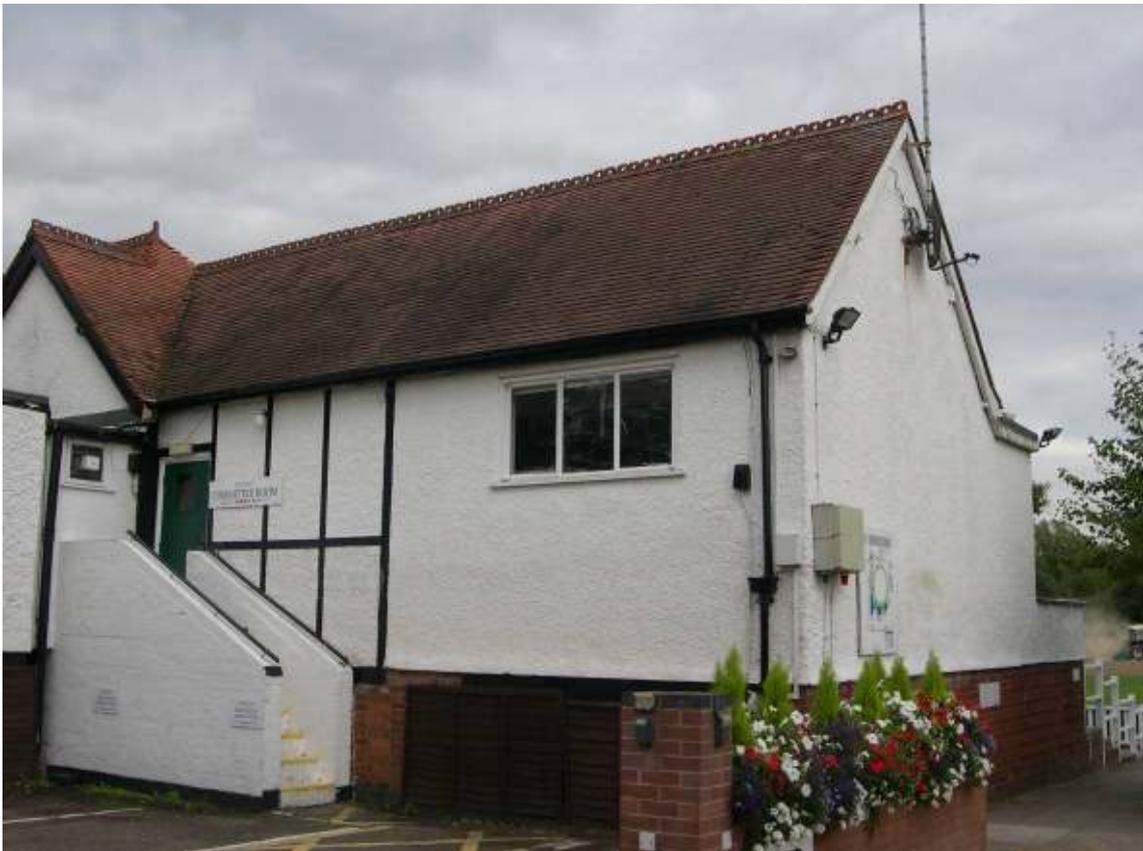
**Plate 12: West Elevation, Southern End**

The rear (western) wall of the committee room clearly displays the phases of construction present in the building. To the north, the wall features visible timber framing, painted black against the white rendered wall, echoing the styling of the original part of the building. This section belongs to the pre-1928 extension visible in the historic photographs above. A door at the northern end of this extension opens onto an external flight of brick steps leading south to ground level.

The committee room continues southward from the timber-framed part of the wall, marked by a subtle change in roofing tile colour. A three-paned window is present close to eaves level in this most recent addition.

Below the floor level of the committee room it is apparent that the western wall of the building is supported on brick piers obscured by modern fence panels to the south and by a brick-built staircase to the north providing access to the committee room area. At the southern end of this wall, cast-iron rainwater goods are fitted.

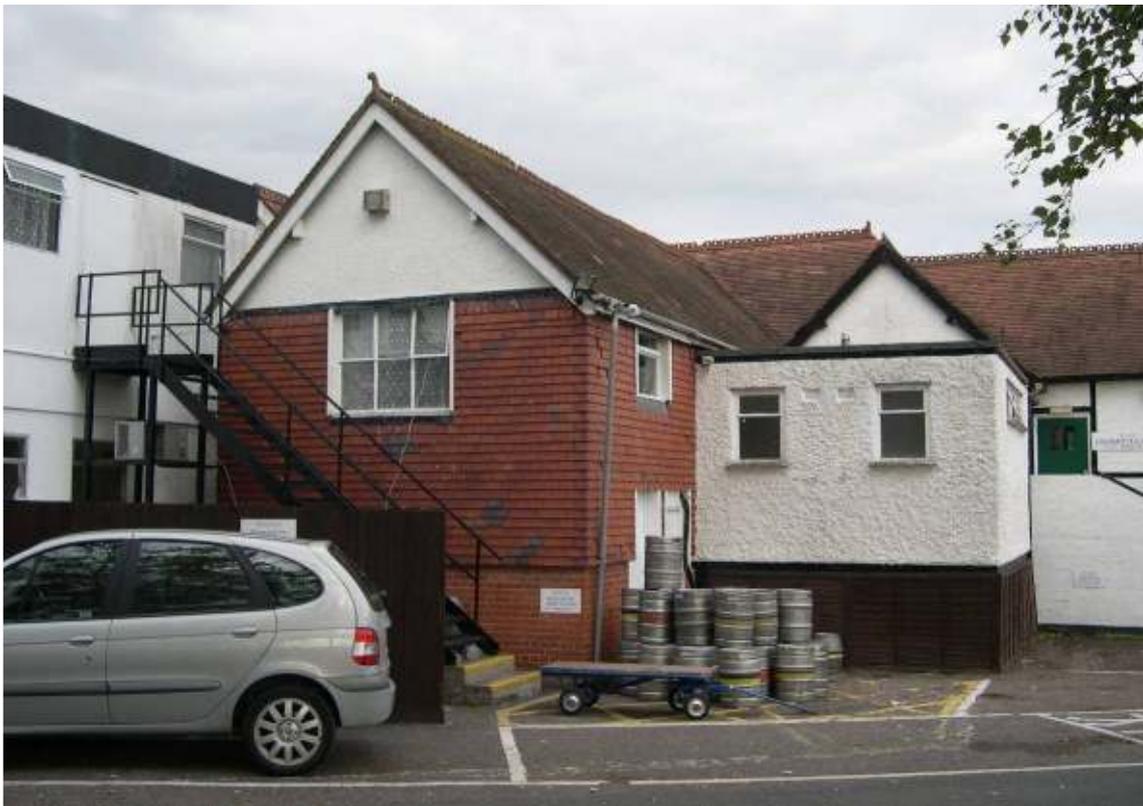
**Plate 13: West Elevation, Centre**

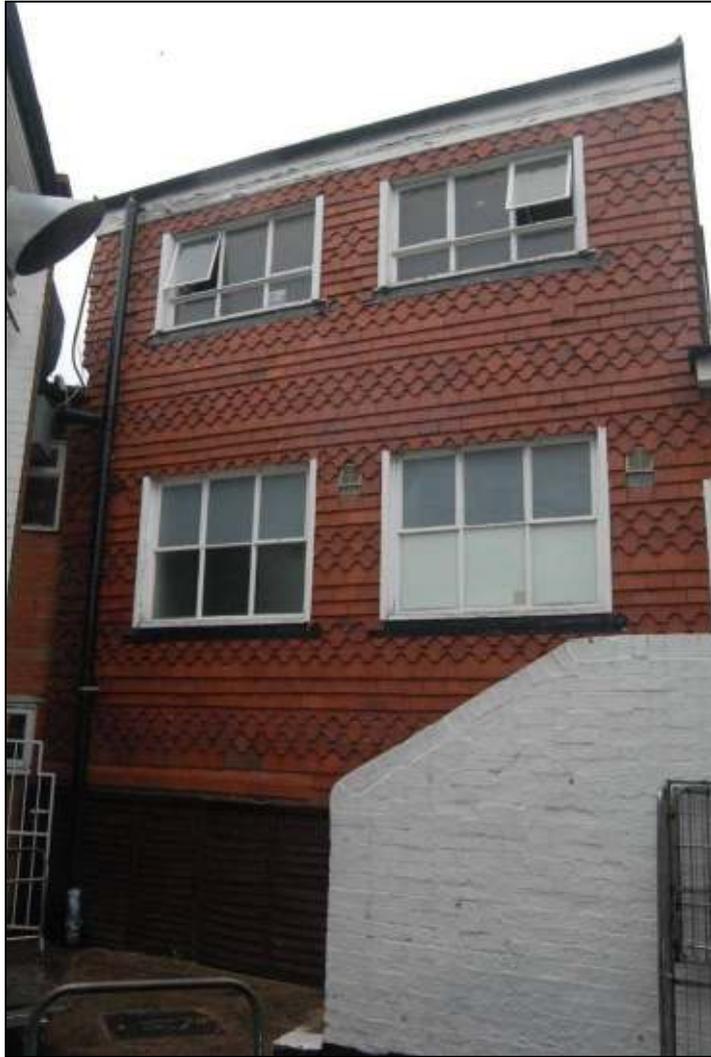
The northernmost part of the pavilion is comprised, on the western side, of a two-storey extension containing a shower room on the ground floor and a changing room above. This part of the building is again raised on brick piers hidden by timber fencing. The entire height of the western wall above the piers is clad in hung tiles in the same pattern as to the south.

Four windows are present on this wall, two per storey, each in 3x2 configuration. The upper corner panes of each window are top-hung casements.

**Plate 14: Western Elevation, Northern End**

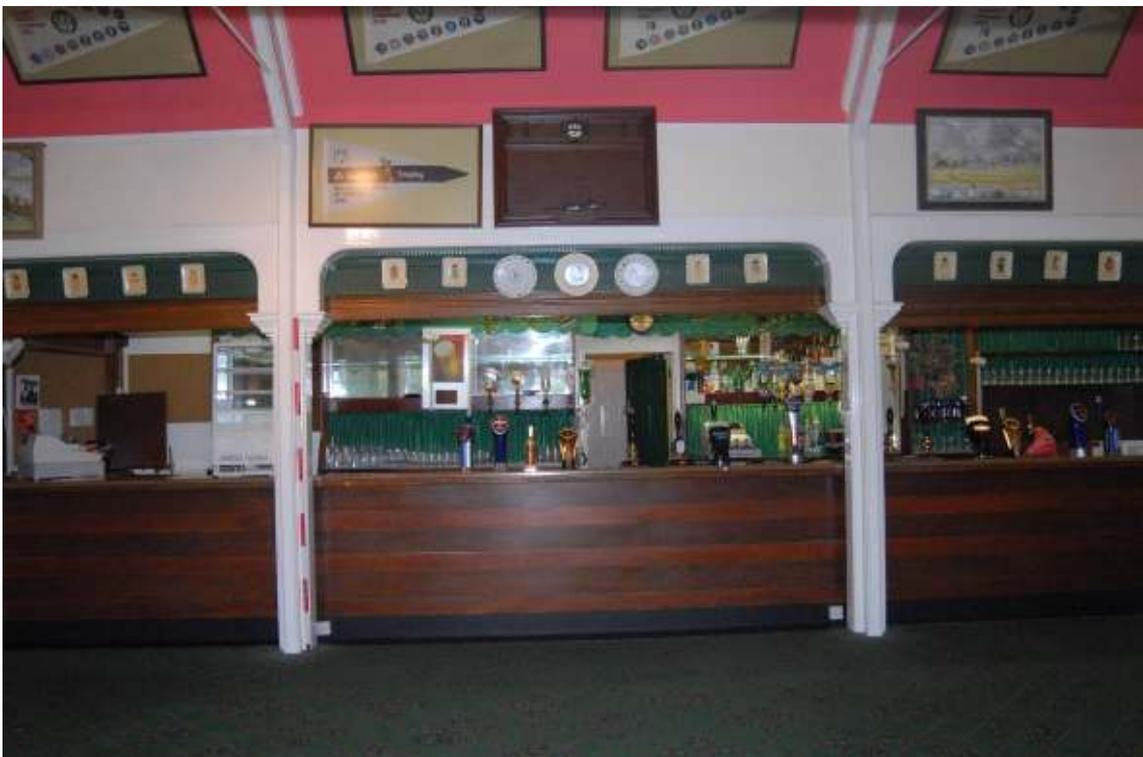
**Plate 18: The Bar.** The pillars indicate the location of the original western pavilion wall.

The main area of the pavilion is occupied by the members' bar. The bar, entered from the terracing facing the pitch via modern glass doors area, is open-plan with visible trusses of timber reinforced with steel bars throughout its length. A row of posts along the front of the counter and the corresponding row further to the east demarcate the extent of the original building, prior to its numerous extensions.

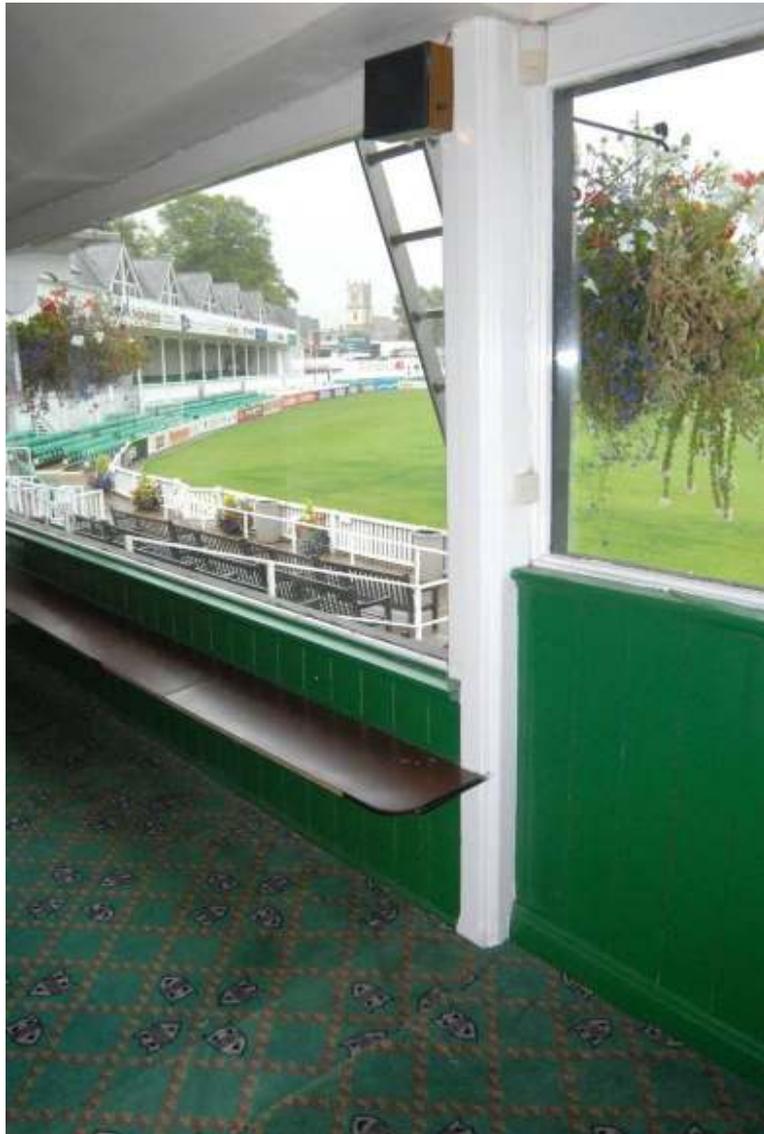
**Plate 27: Post marking location of original wall between central and southern areas, members' pavilion**

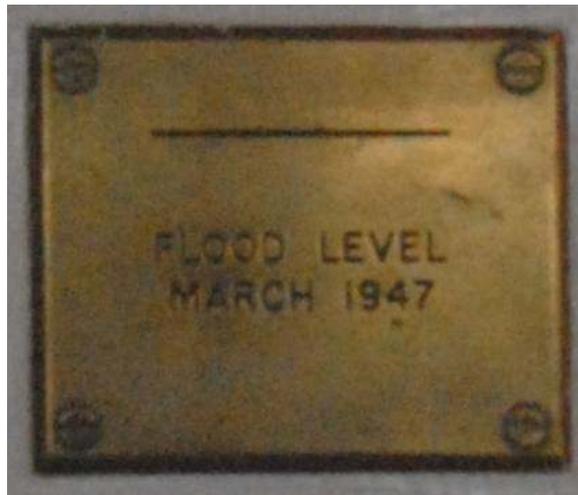
Plaques affixed to the western pillar of the southernmost truss indicate the levels of flood water in particularly wet years.

**Plate 32: Flood level plaque, 1947, situated c. 1m from the floor of the bar**

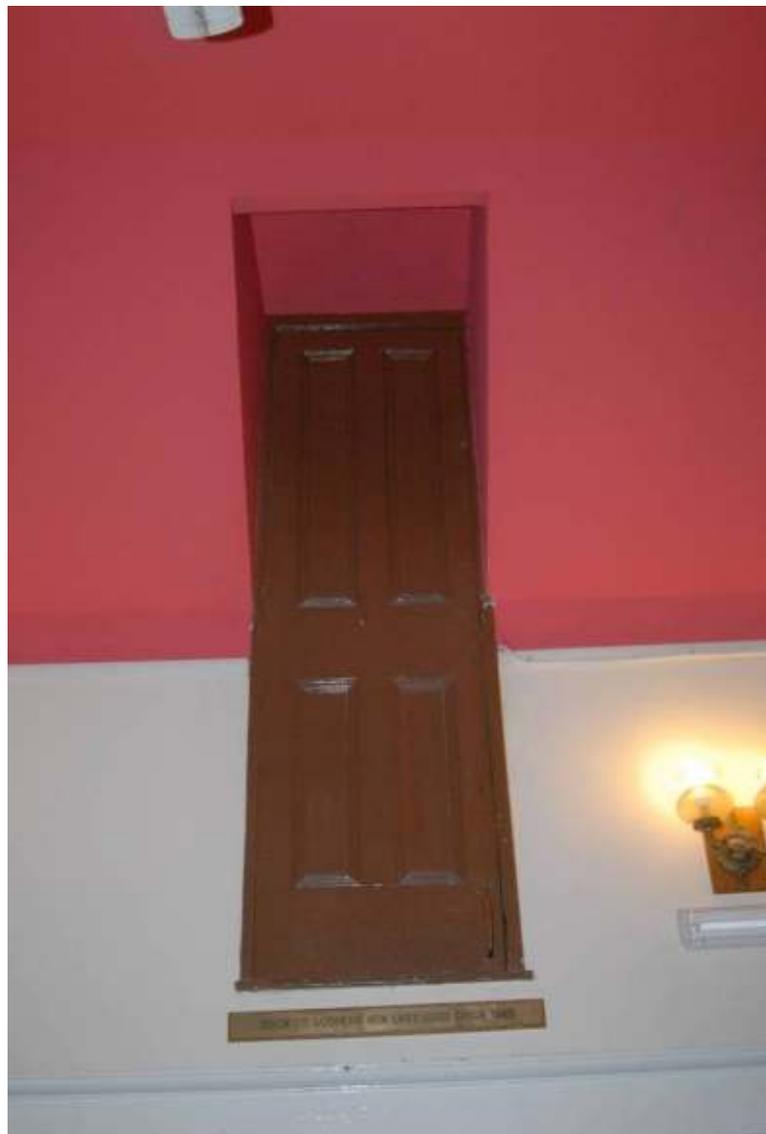
Access to the clock tower is via a door located in the original eastern wall of the building, above the modern glass doors from the pitch. A plaque is fixed to the wall below the door stating 'DOOR TO SCORERS BOX LAST USED CIRCA 1950'

**Plate 35: Door to clock tower / scorers' box**

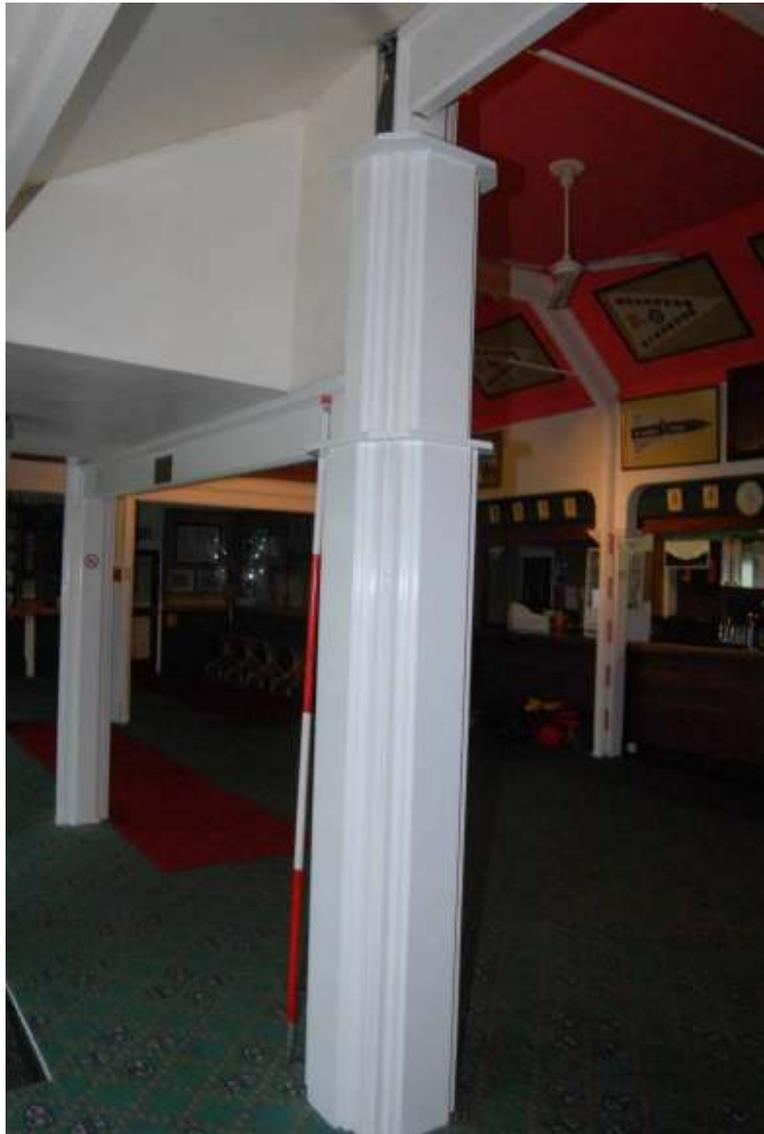
**Plate 36: Detail of pillar from original north wall, originally forming northern side of entrance to pavilion**

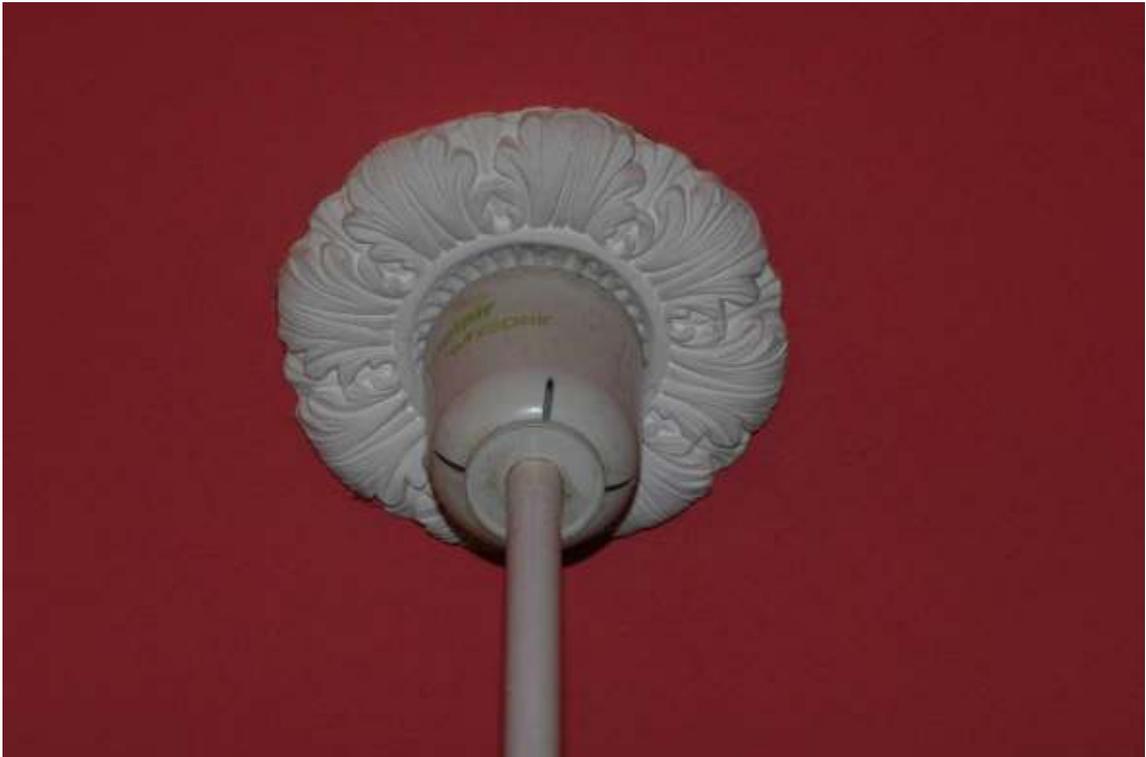
The ceiling of the bar area follows the pitch of the roof to tiebeam level before running horizontally across the building. Ceiling fans are fitted to the bar area in locations presumed to have originally been fitted with lights, owing to the elaborate yet small moulded plaster ceiling roses present.

**Plate 38: Ceiling rose, members' bar**

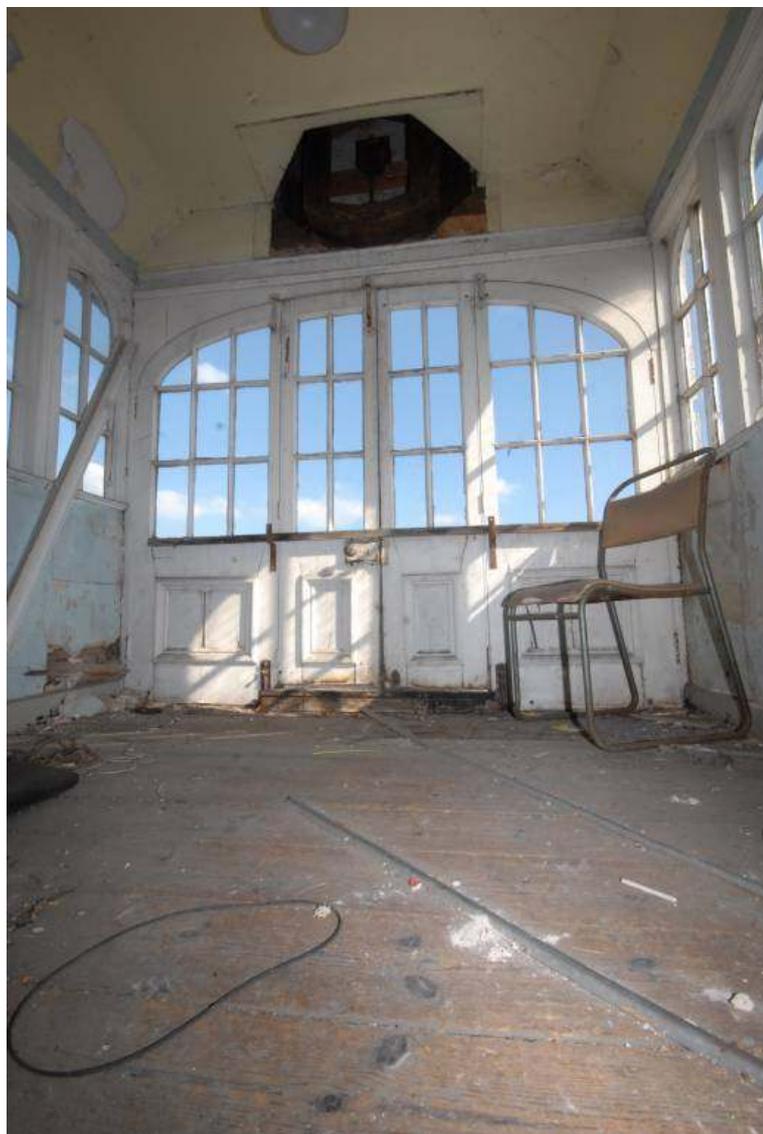
The north and south walls of the scorers' box feature windows over lath and plaster, whereas doors originally opening onto the balcony dominate the eastern wall. The interior is somewhat dilapidated. Blue paint is peeling from the walls and yellow from the ceiling. A small amount of plaster has become detached to the

northeast. The woodwork making up the remainder of the room is painted white. The central double doors form the primary opening, although the remainder of the wall is made up of secondary doors enabling the entire face of the room to be opened. A steel bar, presumably fitted when the balcony was removed, prevents accidental opening of the doors.

**Plate 47: Interior of clock tower / scorers' box**

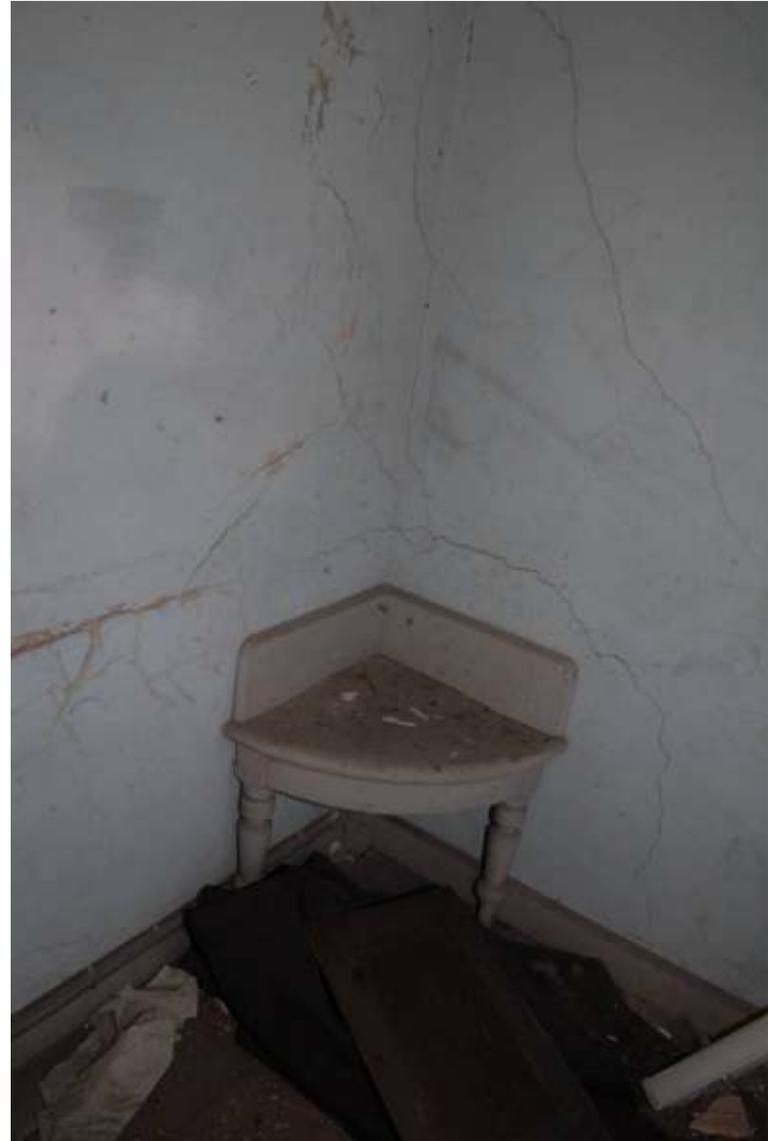
The northwest corner of the room features a small built-in stool. The western wall is plain excepting the door leading into the members' bar. The door opening is surrounded with a timber frame.

**Plate 51: Fitted seat, northwest corner of scorers' box**
