Worcestershire County Cricket Club
Individual Phased Plans (1 of 2) @ 1:500
This image © The Historic Environment Consultancy 2008

Worcestershire County Cricket Club, Main Pavilion

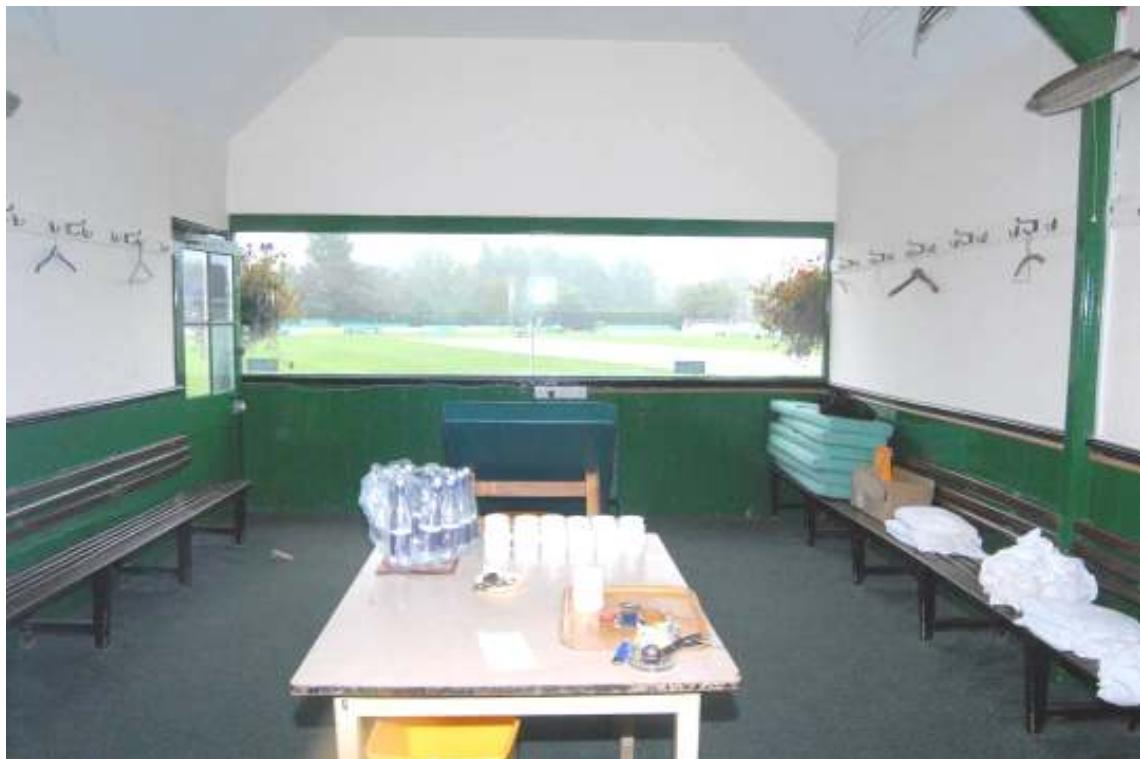
The door leading to the pitch is not in its original location. The door was once situated in the southern wall of the room, east of the truss. The original access to this room, shown on the architect's plan, was via a flight of steps into the main part of the pavilion, now the bar. Also differing from the original plan, a wall which once ran north-south toward the west end of the changing room is absent. This wall originally divided the room into a changing room (east) and a kitchen (west), the latter having a door leading into the bar area.

Plate 60: The visitors' changing room showing the current door location. The original door would have been located closer to the green pillar on the opposite side.

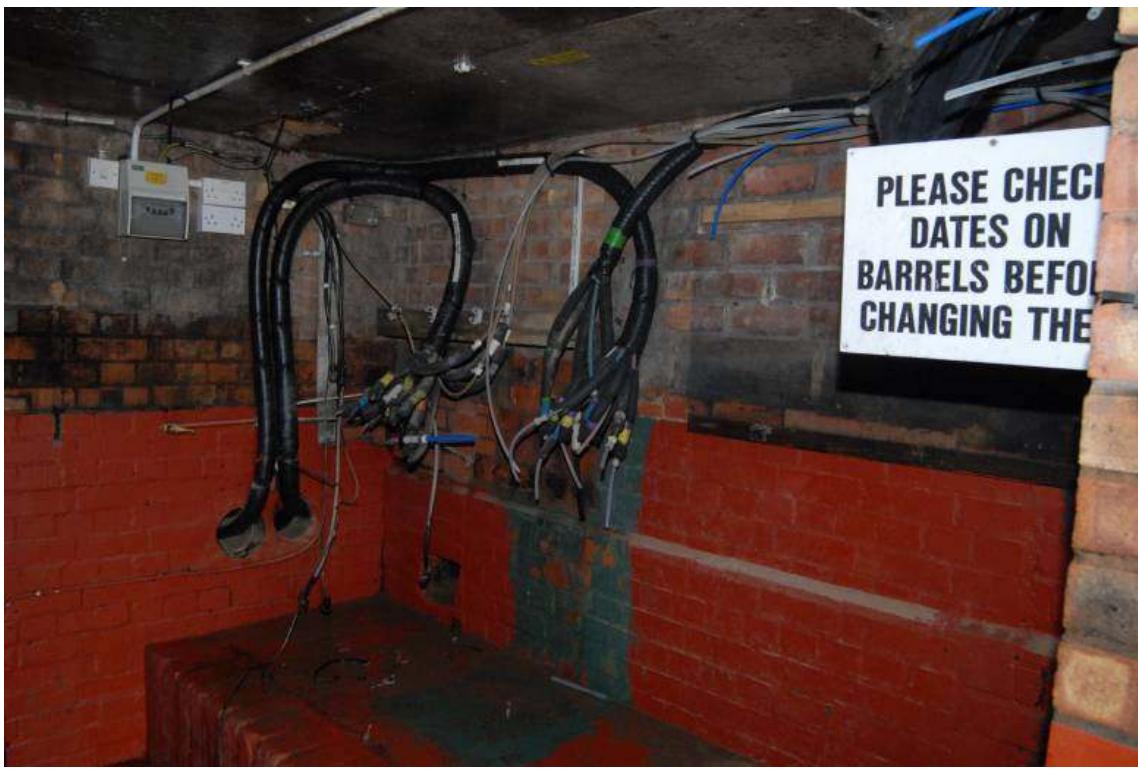
Plate 80: Northeast aspect, beer store, showing beer delivery pipes and blocked loophole

The eastern wall is clearly made from larger bricks and is the original western wall of this extension prior to the construction of the beer store and office above. Visible in the brickwork of the eastern wall (see Plate 80), a patch of concrete seven courses down from ceiling height marks the location of a now blocked gun / rifle loophole from the Second World War conversion of the current gentlemen's lavatory into a defended building.

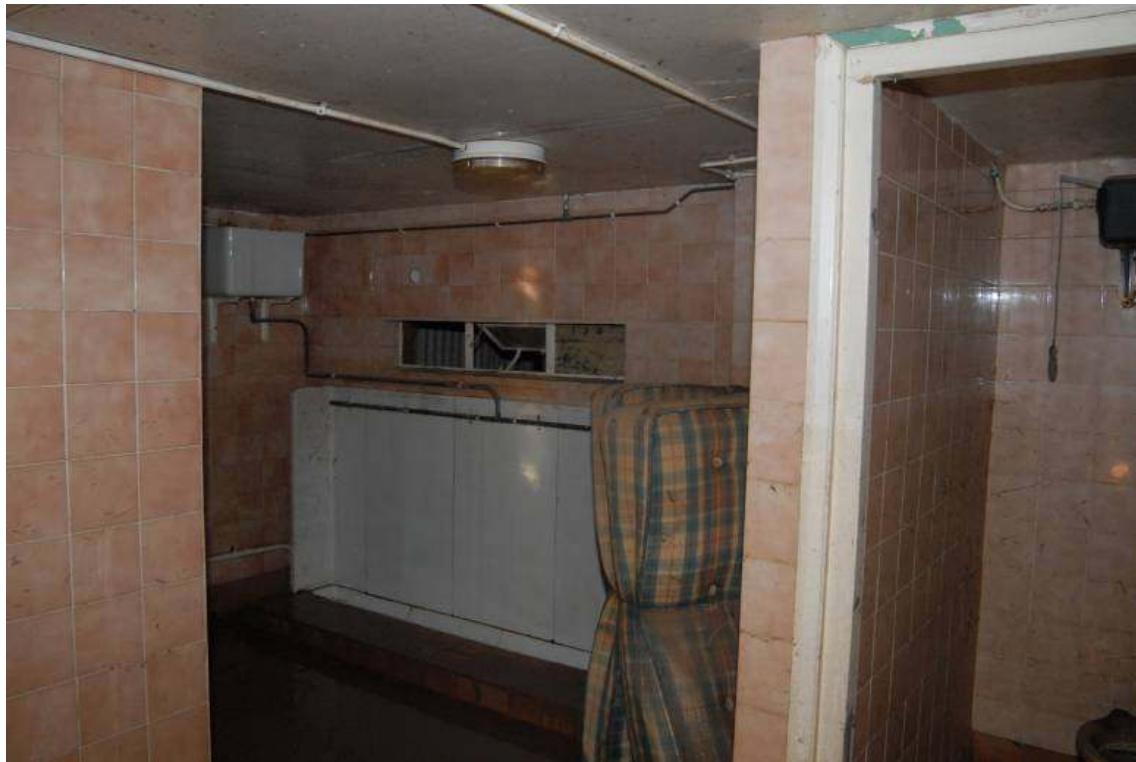
Plate 82: Northeast aspect, lavatories, showing possible loophole window

Worthy of note is the long window above the urinal, opening into the void beneath the pavilion. It is important to note that this part of the building was constructed a number of years after the construction of the original pavilion structure and therefore this window was never installed with the intention of admitting light. The long thin nature of this window, currently occupied by three top-hung casement windows, indicates its provenance as a rifle / machine gun loophole from the Second World War adaptation as a defended building.

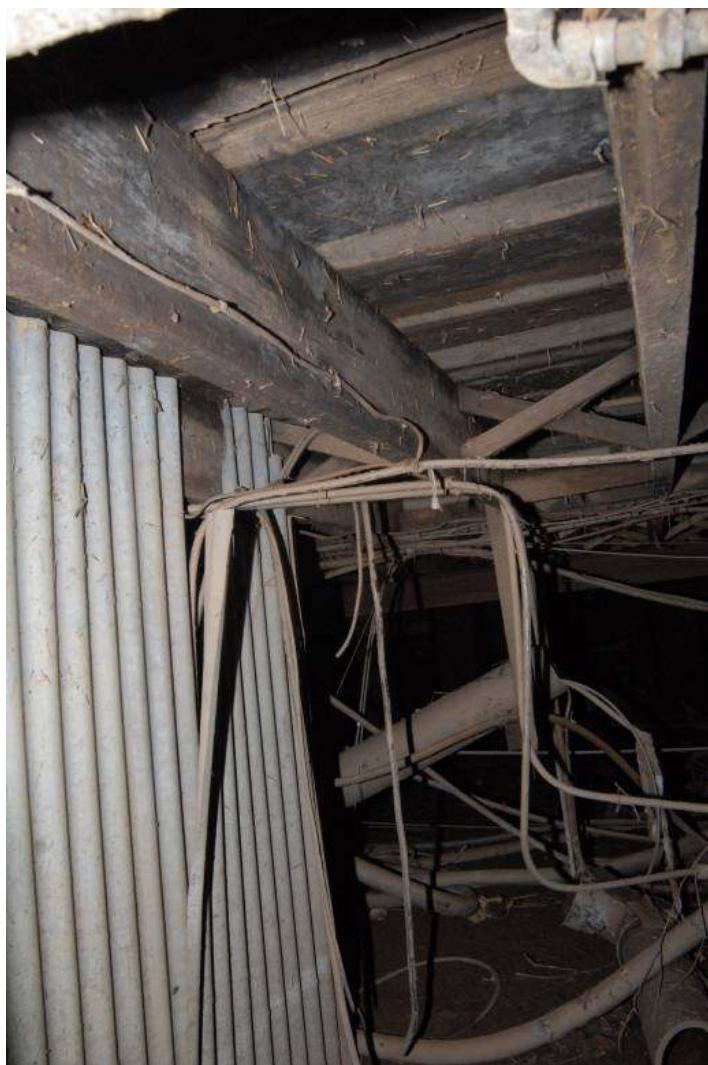
Plate 84: Area beneath original pavilion, observed through window / loophole from gents' lavatory

Examination of the area beyond the window / loophole suggests that the storeroom beneath the pavilion may not have been constructed as per the architect's plan and may have been made, instead, from corrugated iron, the remains of which are visible fixed to the timbers instead. Access to this area was not considered practical and safe for any further investigation.

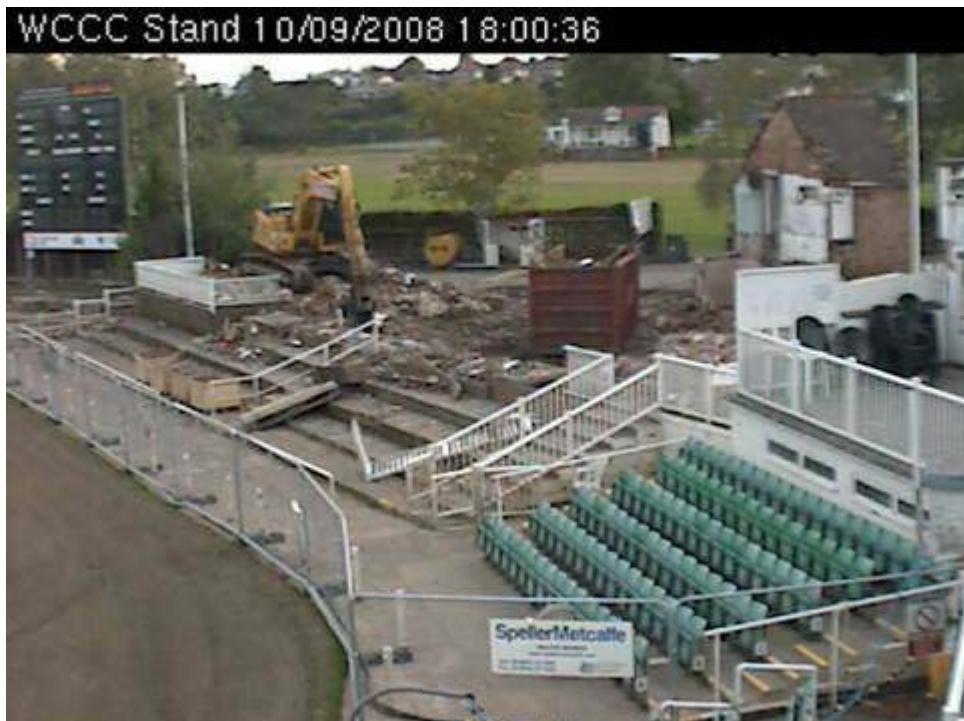
Plate 91: Image captured from demolition monitoring webcam

Visible to the right of Plate 91, the remaining part of the pavilion is the most recent addition to the storeroom / kitchen / office extension. The door from the kitchen to the office is apparent, as is the white painted western wall of the kitchen. It is clear from this image that the part of the building housing the beer store and office was added separately.
