## BUILDING RECORDING

Mac's Café  
Bath Road  
Padworth  
Berkshire

*Colin Lacey BA MSc PIFA*  
24/07/2008

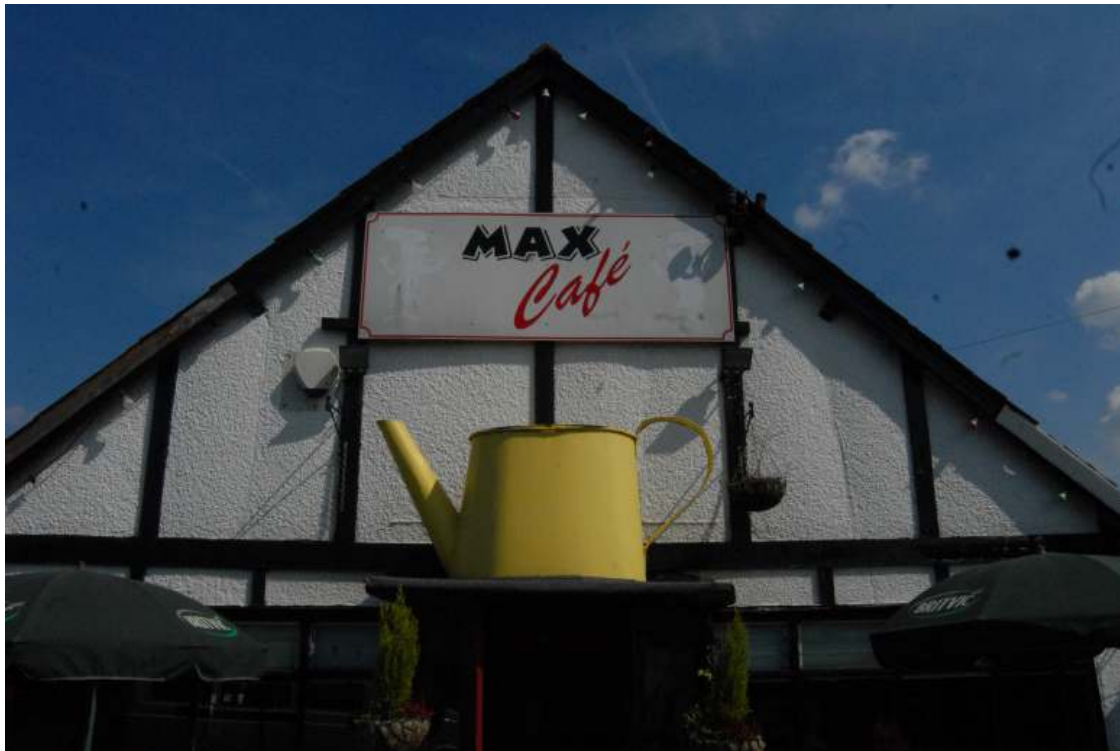
Plate 1: Detail of apex, sign and large teapot

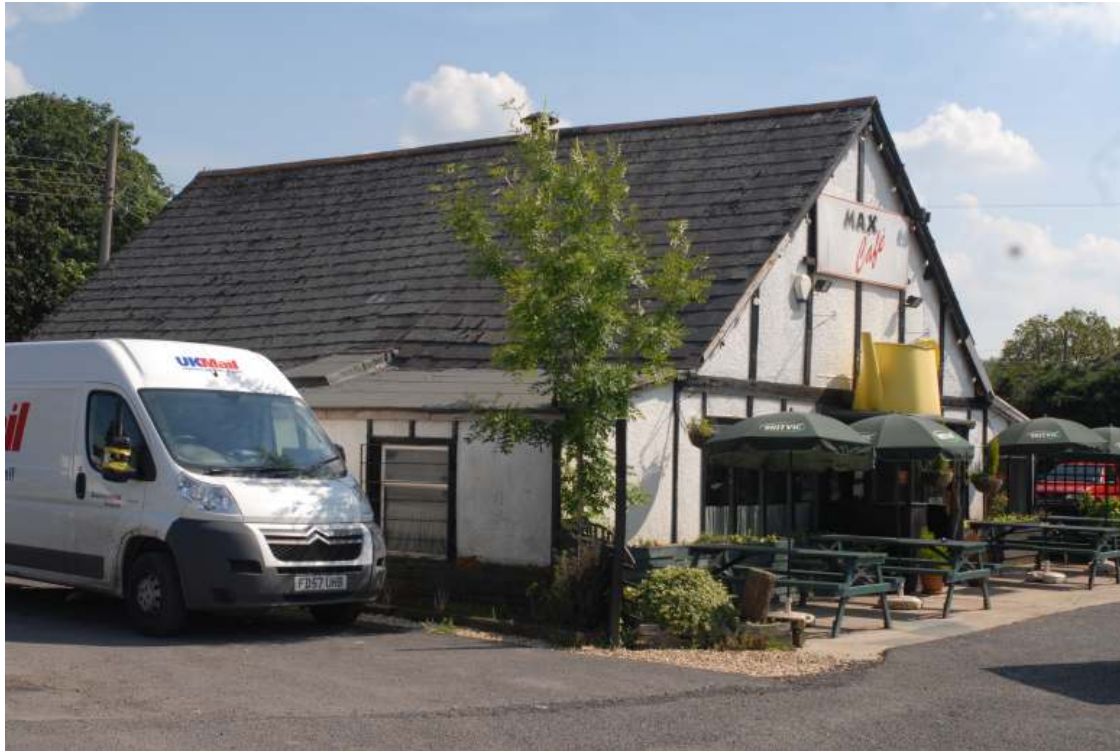
**Plate 2: Northern aspect, Mac's Café**

The walls of the original building and of the northwest extensions are largely pebbledashed and painted white with a black lower section. This is not apparent on the front elevation owing to the presence of raised flowerbeds obscuring this part of the wall.

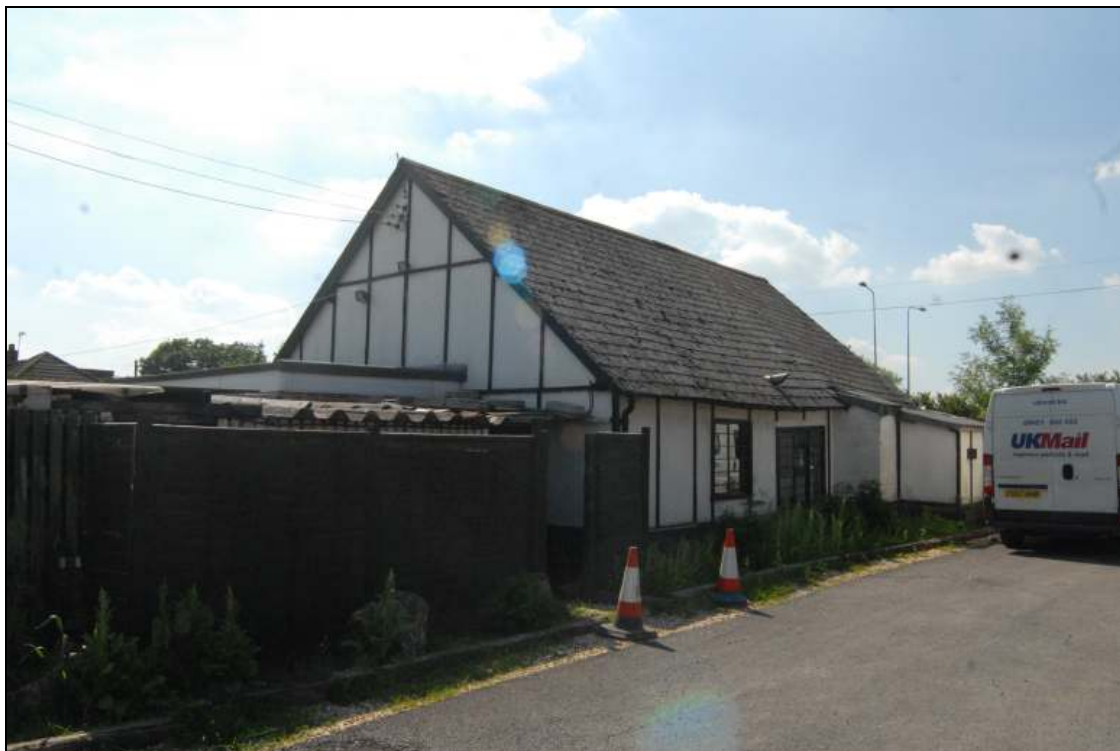
**Plate 3: Eastern aspect, Mac's Café**

Mock Tudor timbers are located across the walls of the building, painted black to contrast against the white of the walls. These timbers appear to be decorative.

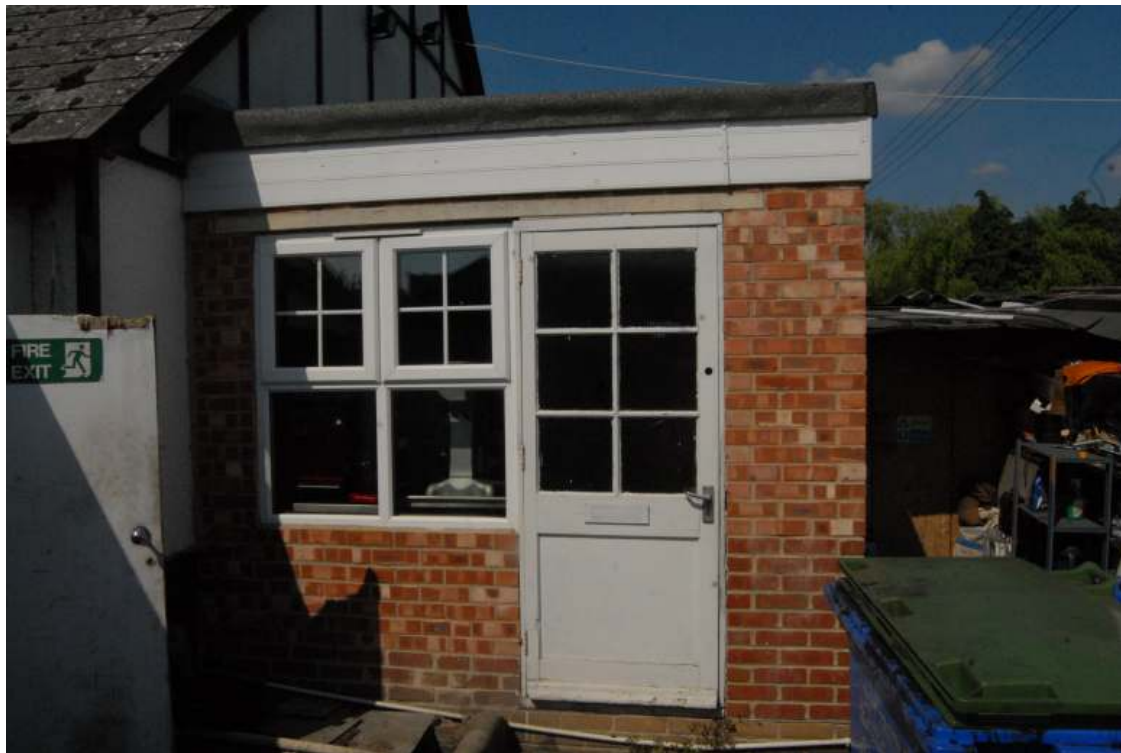
Immediately to the south, a recent brick extension is situated. This houses a storeroom and features a window central to its southeast wall, with a door alongside a window to the southwest, opening into a small fenced-off yard area. The yard is bordered by the café to the northwest, the lavatory block to the northeast, a static caravan to the southeast and a fence and gate to the southwest.

**Plate 4: Southwest aspect, recent extension**

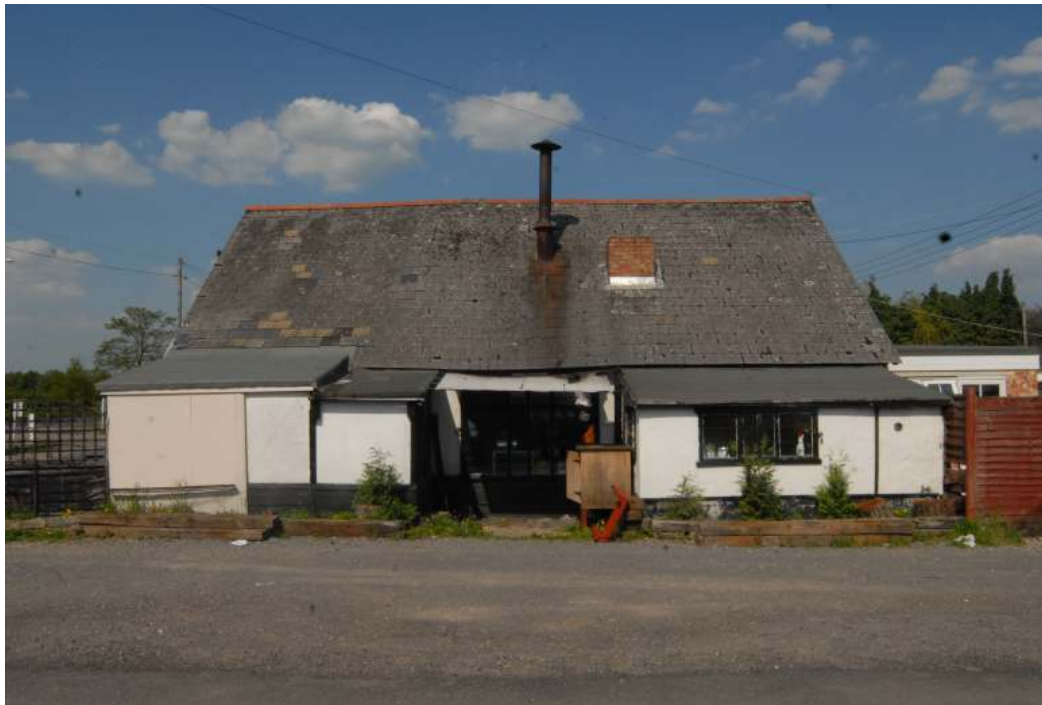
**Figure 3: Southwest elevation**

The southwest front extension was constructed in at least two phases with the felted roofline of the southern section being lower than that of the northern. It is considered that this southern part with its plain rendered walls is a later addition. The northern part of the original extension is clad in timber sheeting although the remainder is pebbledashed.

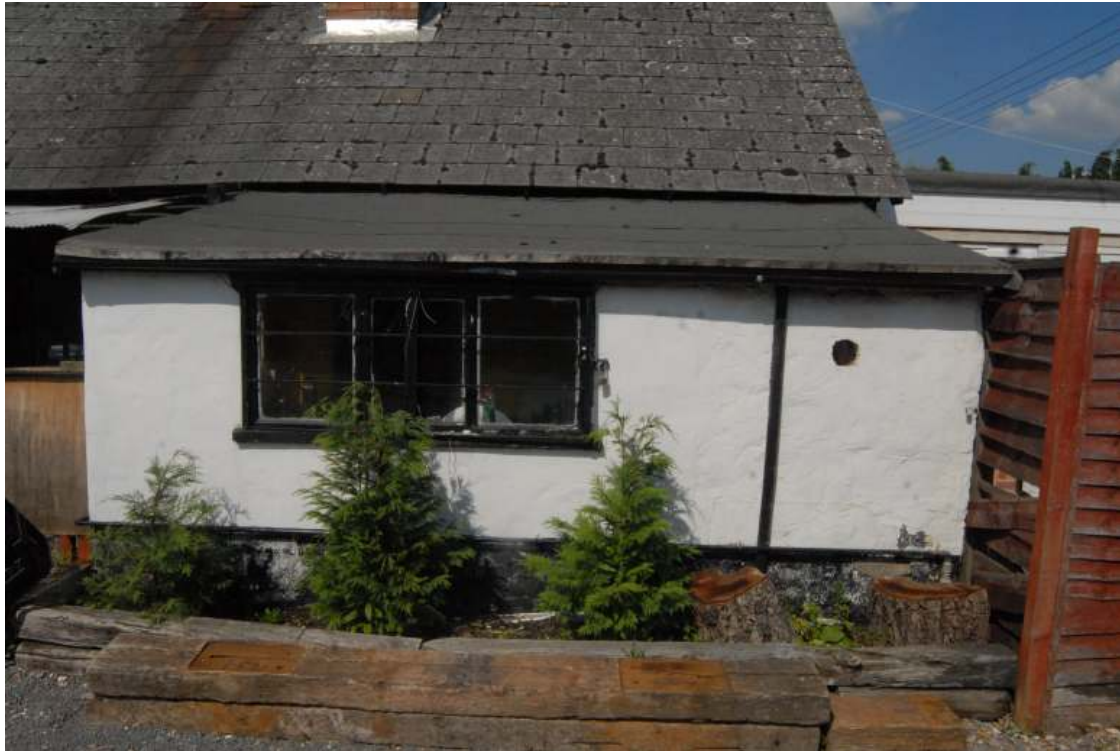
**Plate 6: Southwest aspect, southeast extension**

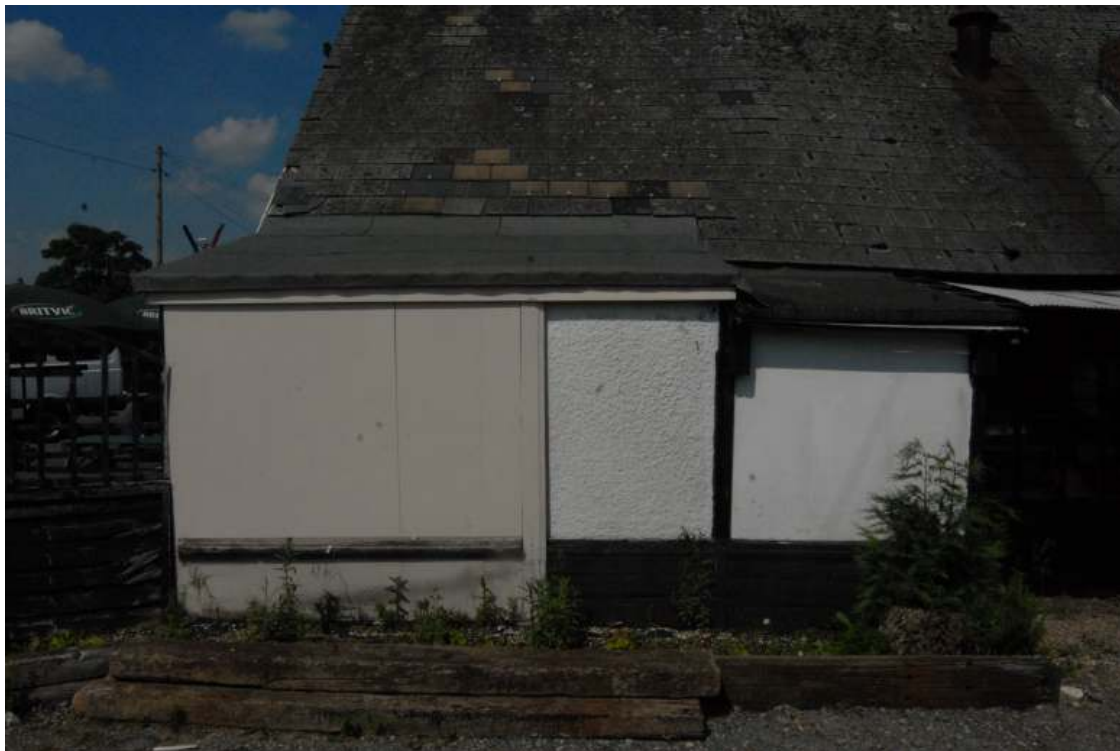
**Plate 7: Southwest front extension**

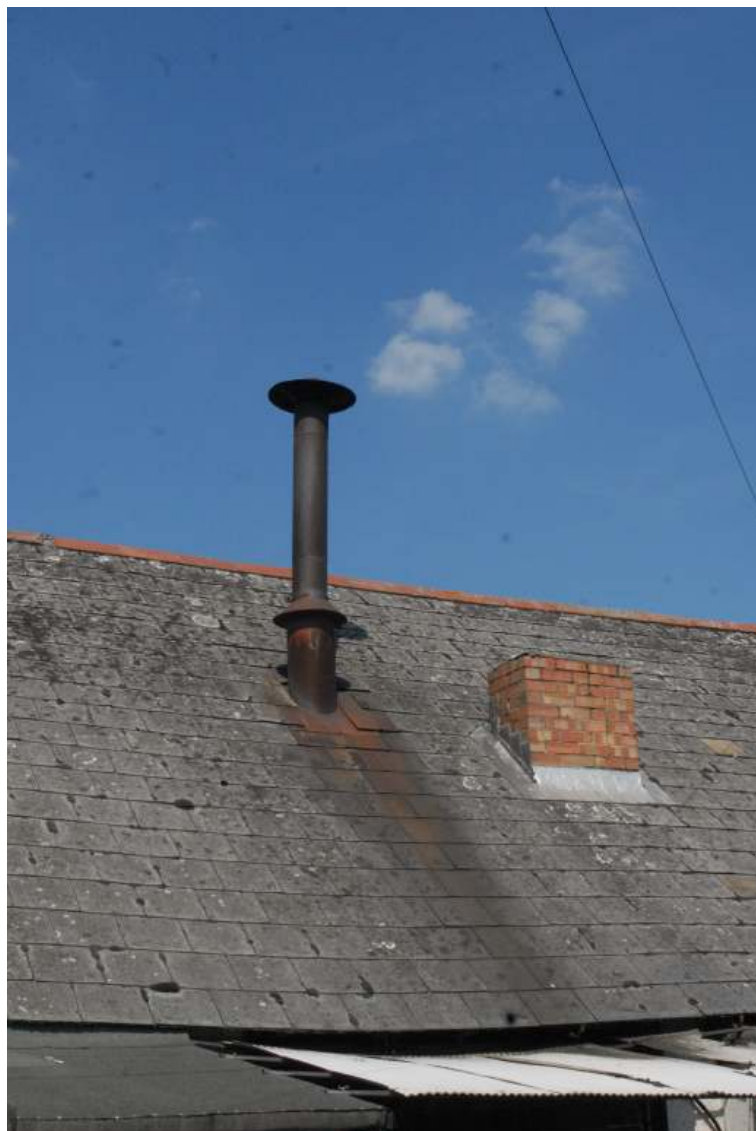
The southwest roof pitch is punctuated by two chimneys, one of brick, the second a steel flue with rain cowl.

**Plate 8: Chimneys, southwest roof**

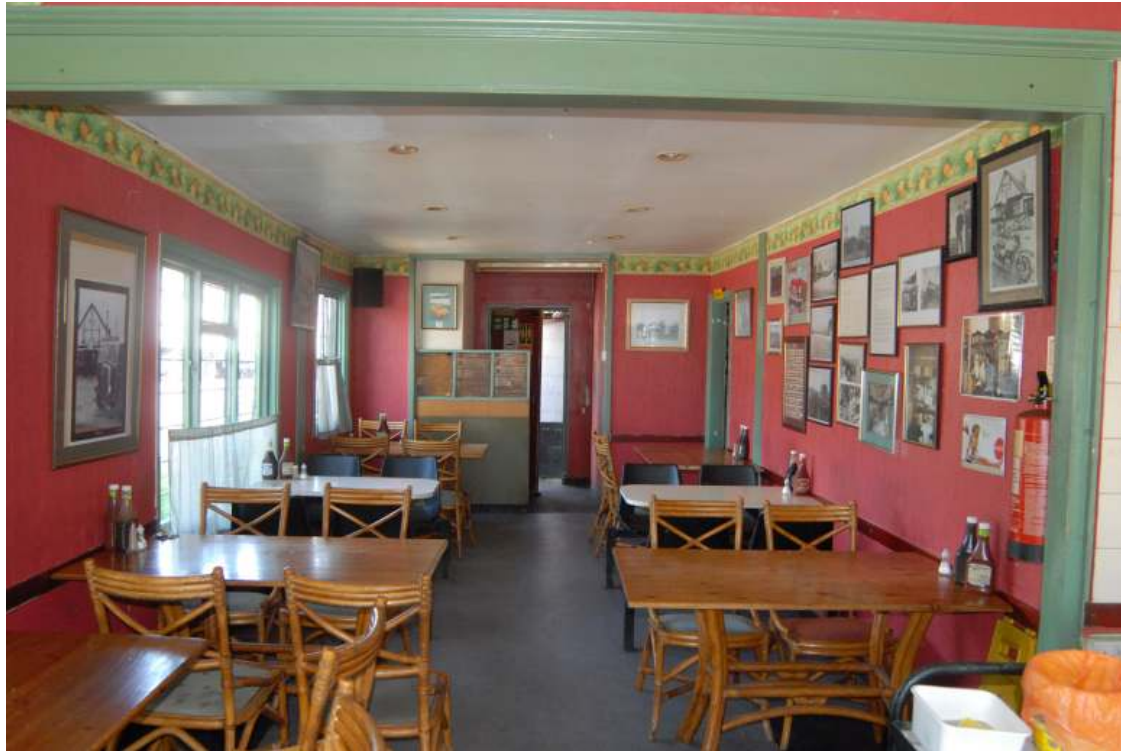
**Plate 11: Northeast wing, dining area**

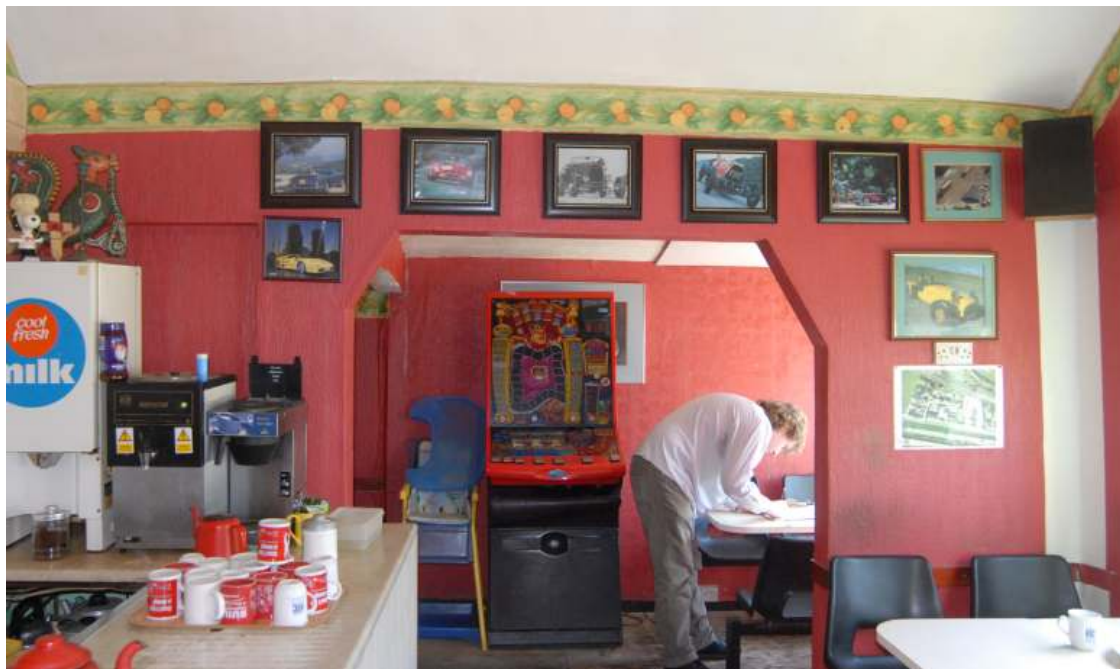
Access to the southwest extension of the dining area is via an irregular angled archway through the original southwest wall of the building (see Plate 14). Southeast of the opening, a blocked doorway is visible originally leading to the area occupied by the part of the southwest extension with the lower ceiling.

**Plate 14: View into southwest extension**

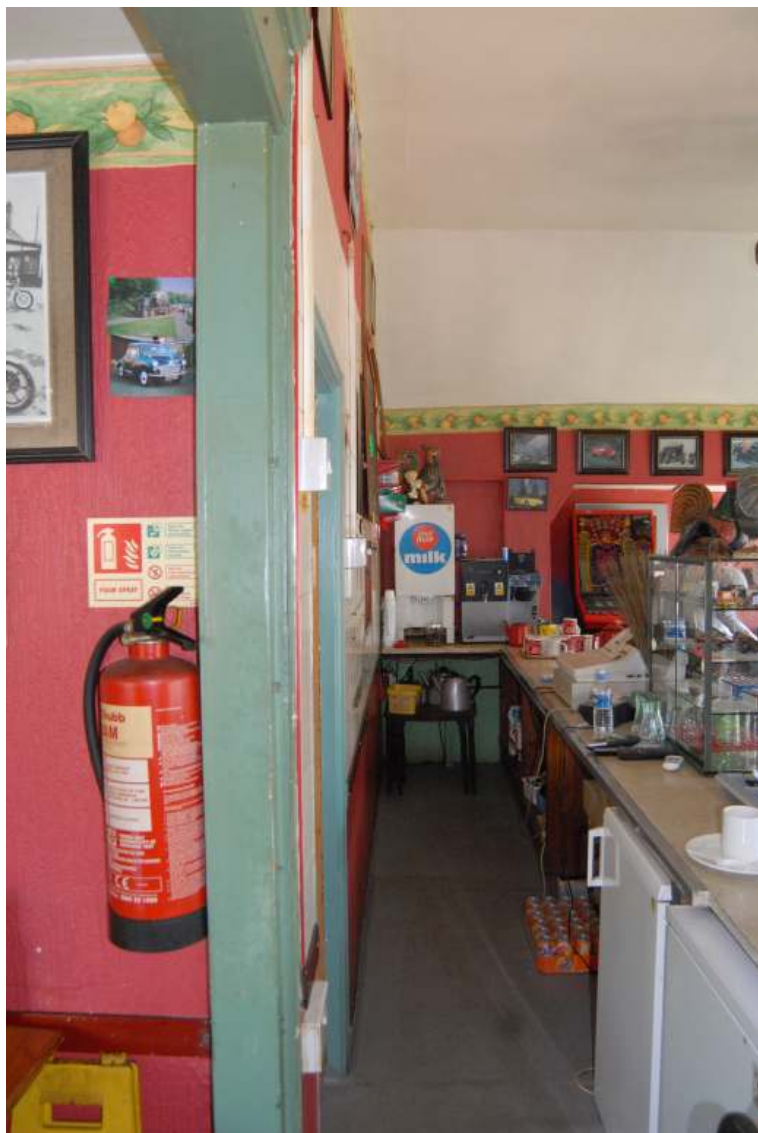
**Plate 15: View behind counter, blocked doorway visible behind milk cooler**

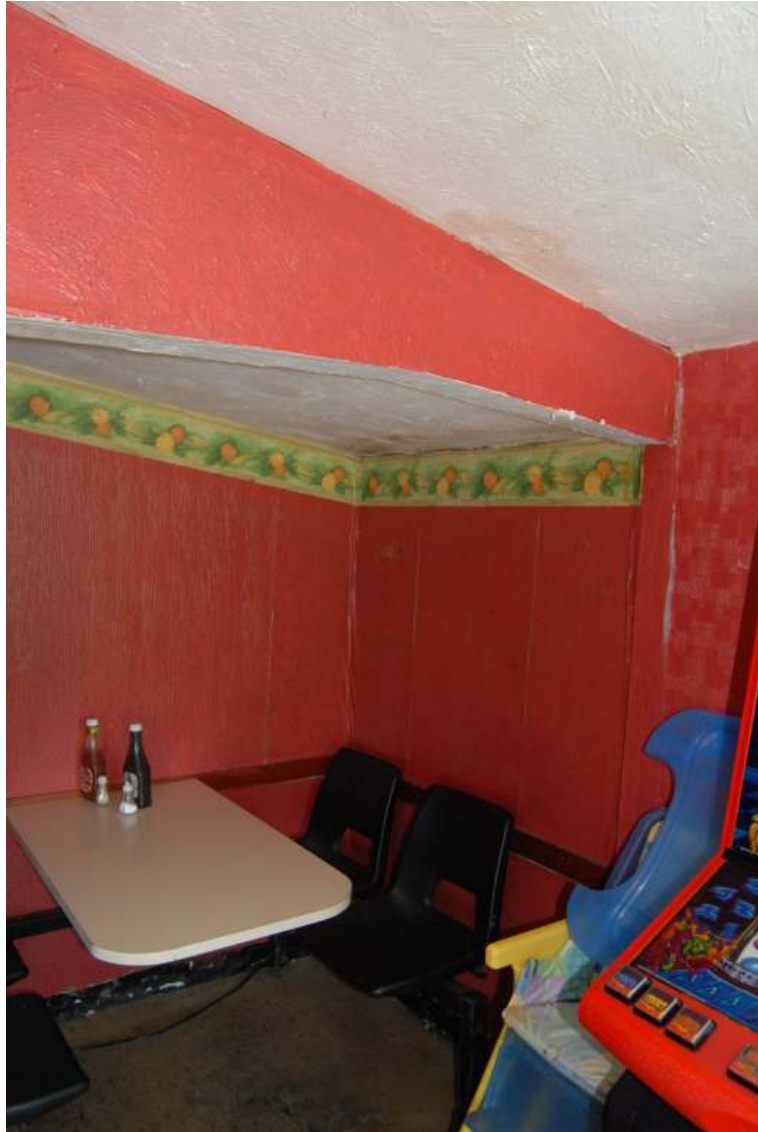
**Plate 17: Beam in ceiling of southwest extension, highlighting differing ceiling heights**

The difference in ceiling heights in this extension is clear, demarcated by the presence of an irregularly shaped beam running across the room where the original rear wall once stood.

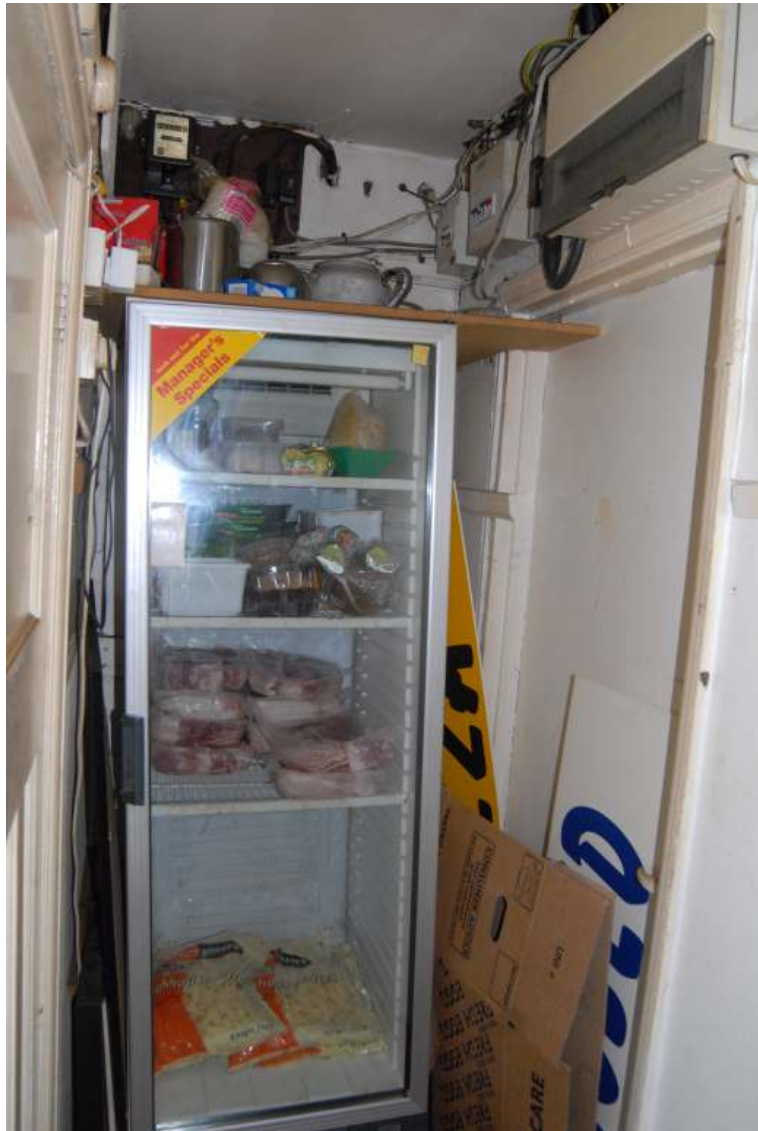
A doorway towards the southeast end of the southwest wall of the dining area leads into a short northwest-southeast corridor. To the southeast of this corridor, a door leads from the right into a further storage cupboard, opposite which, a blocked doorway once led into the kitchen. Adjacent to the blocked doorway and opposite the opening to the dining area a further opening gives access to the rear preparation area of the kitchen. It is believed that this opening is a more recent construction owing to the lack of doorframe and that the layout of this corridor area was clearly altered in order to give more storage space at its southeast end.

Plate 19: View southeast into corridor area with blocked door to right

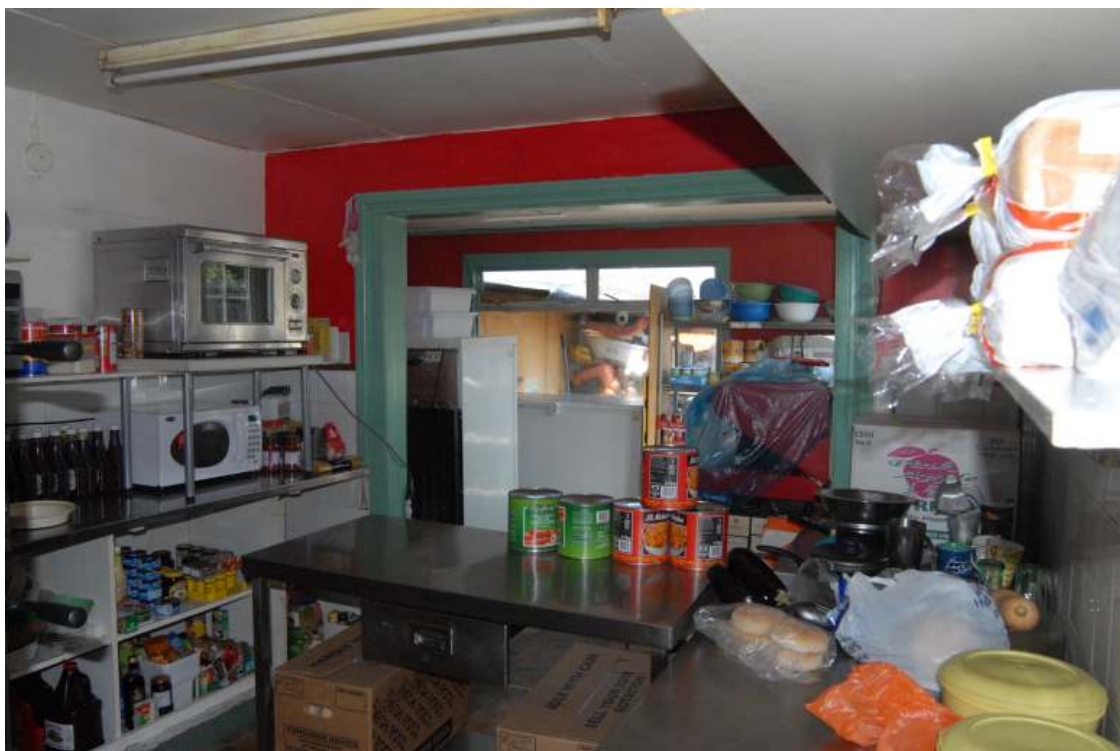
**Plate 22: Rear kitchen preparation area**

The rear kitchen area was used for storage and food preparation. The chimneybreast and a built-in cupboard to the northeast dominated the northwest wall. Shelves are fitted around the walls, the northeast and

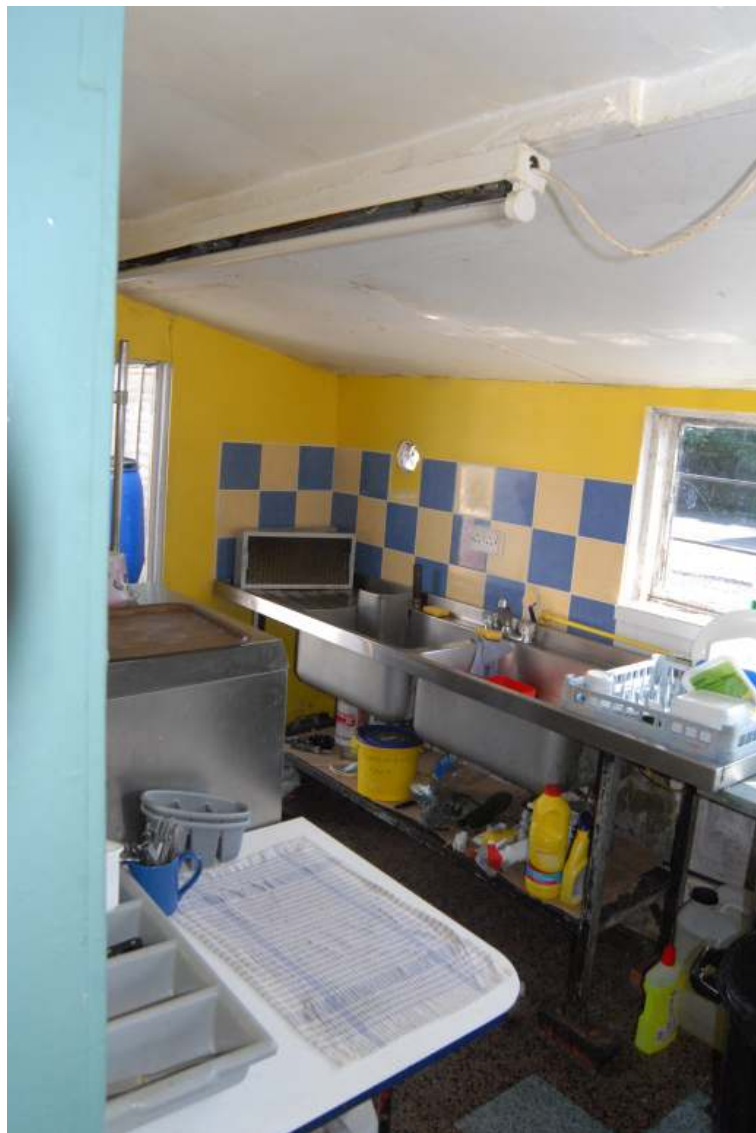
**Plate 23: Southern aspect, kitchen lean-to extension**

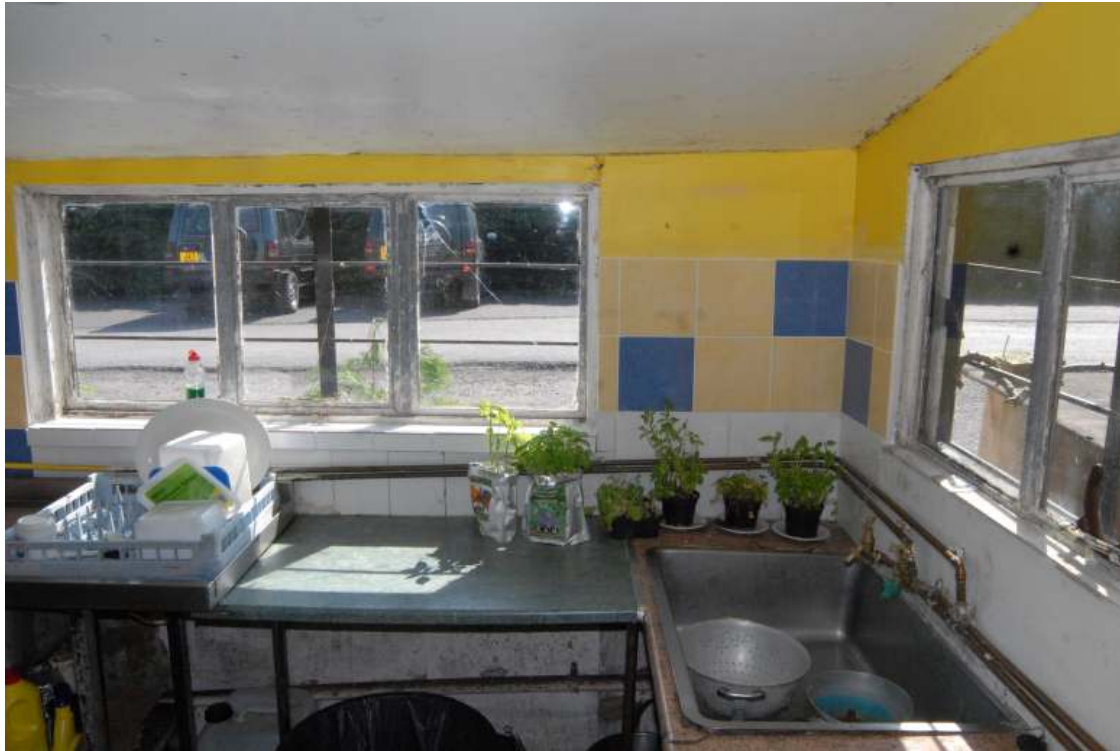
**Plate 24: Southwest aspect, kitchen lean-to extension**

The final extension, attached to the southwest side of the rear kitchen preparation area, is a similar lean-to structure to those found in the dining area. The ceiling slopes to the southwest following the line of the roof above. The walls are partially tiled. Yellow paint adorns the remainder of the walls, whereas the ceiling is white. Dilapidated windows are located in the walls to the southwest and northwest. A door is situated in the southeast wall.
