Building Recording of
61-63 Great Eastern Street
Shoreditch
London
EC2A 3HS
National Grid Reference: TQ 331 823
Planning Reference Number: 2012/0506

Document Reference Number 2014/1146
Version 1

Building Recording of: 61-63 Great Eastern Street
Dr Peter Wardle and Colin Lacey
14/05/2014

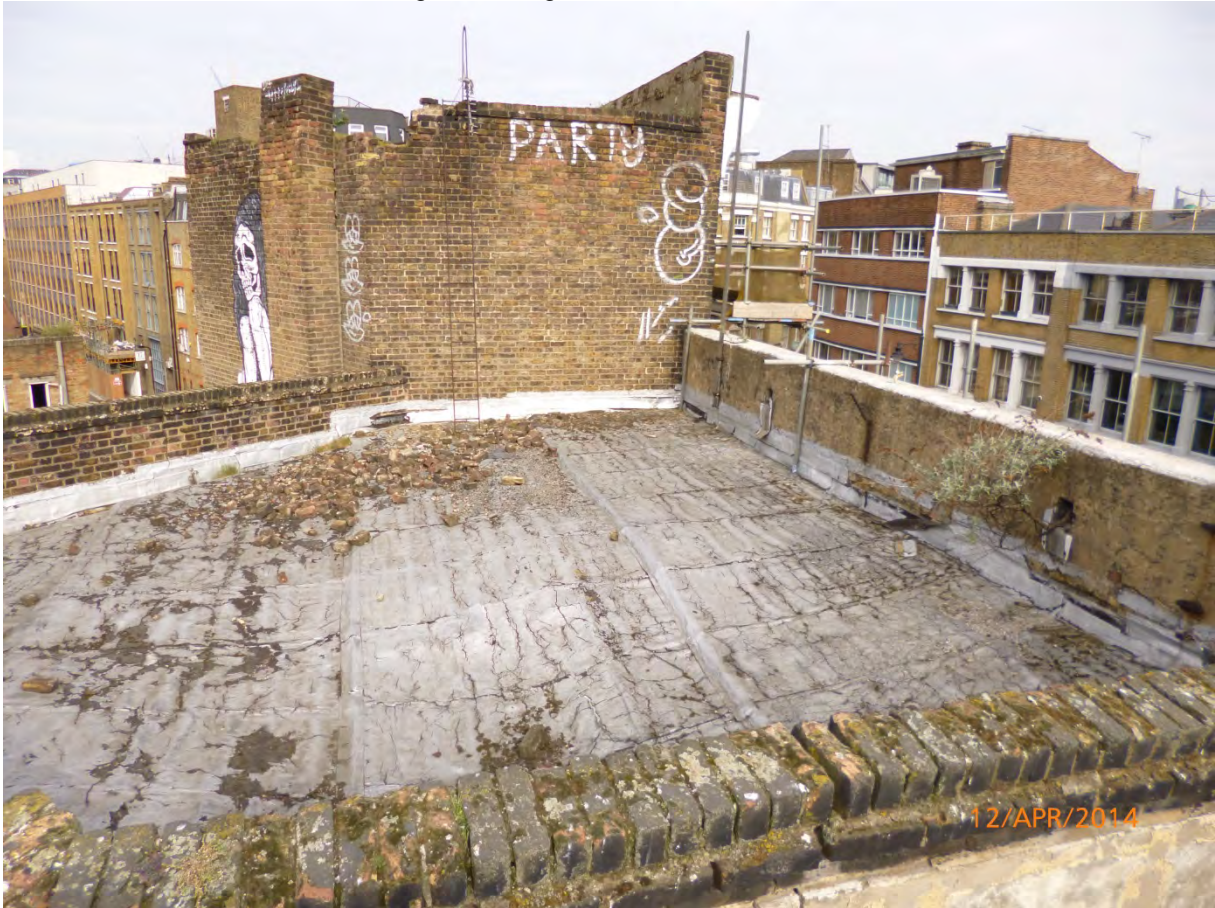
Plate 19: Roof over 61 Great Eastern Street

The deterioration in the roof surface and parapet walls is clear from the above photograph.

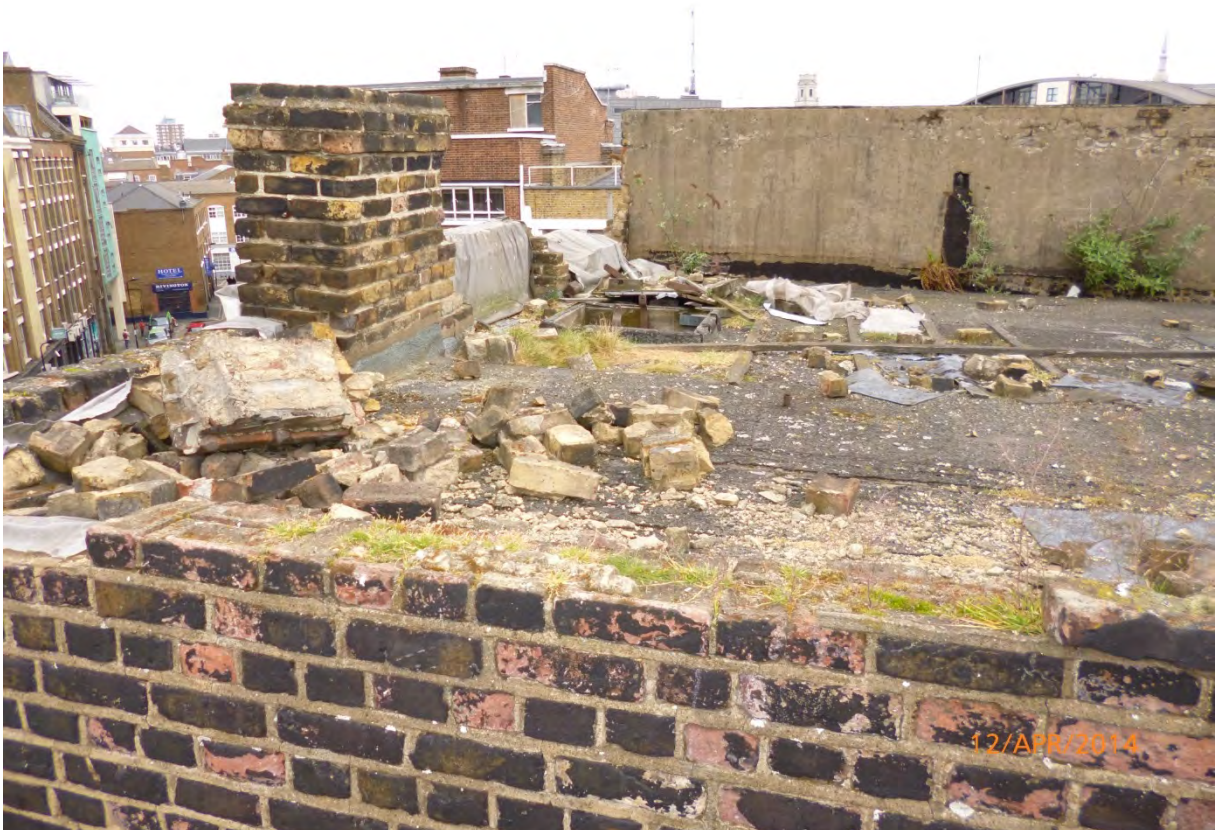
Plate 20: Structural damage to the roof of 63 Great Eastern Street

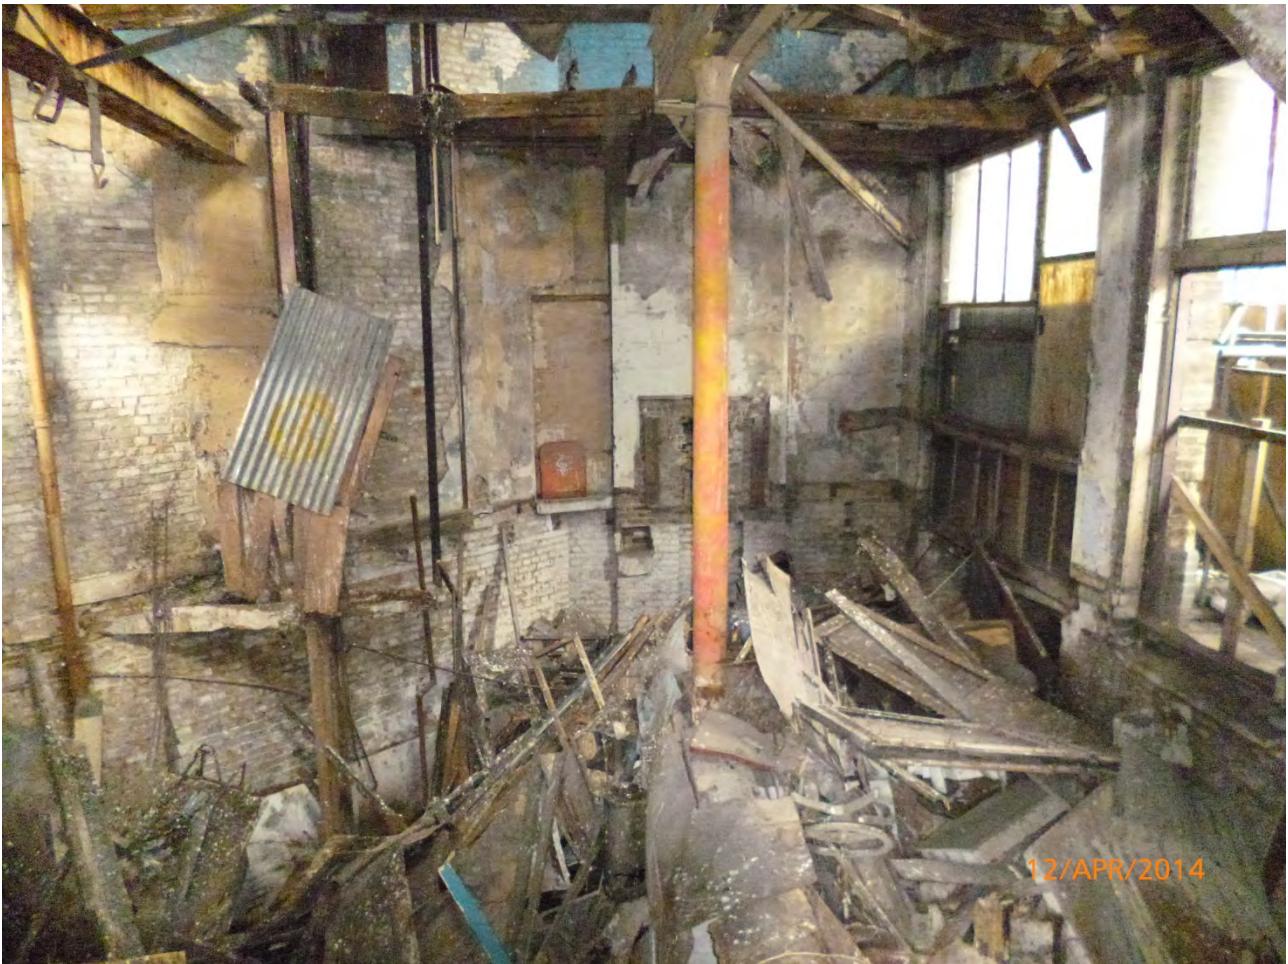
Plate 31: General view, ground floor and basement

It can be seen in the above photograph the ground floor has entirely collapsed into the basement. It is also evident that a large part of the first floor has also collapsed. The reverse of the shop frontage is visible to the left of the image and a cast iron pillar is present, installed to support the first floor. This is standing on a wall in the basement.

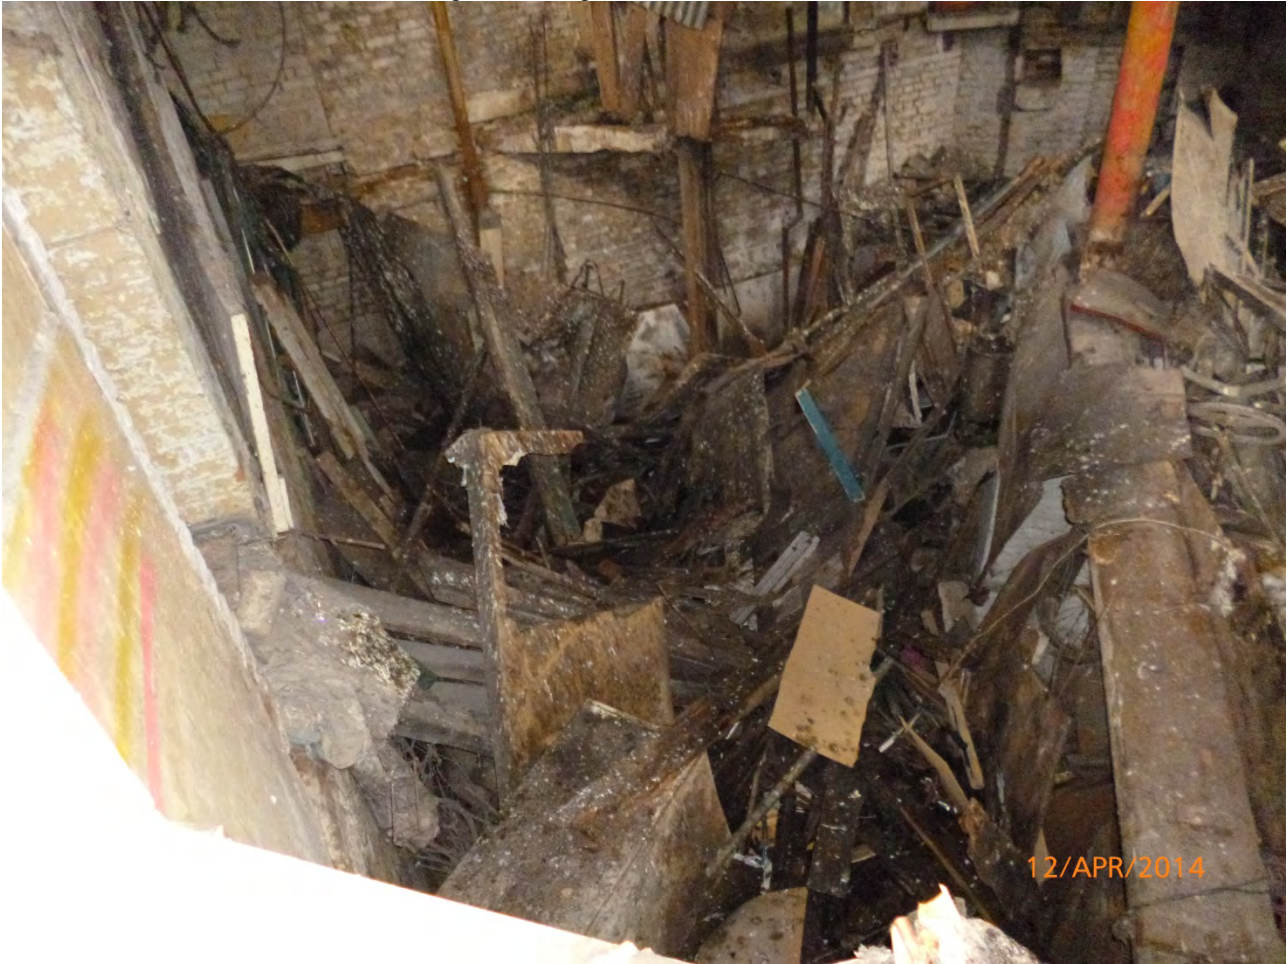
Plate 32: View into basement showing debris

Two possible walls are visible in the above photograph, originally supporting the ground floor. These are surrounded by the debris of the upper floors.

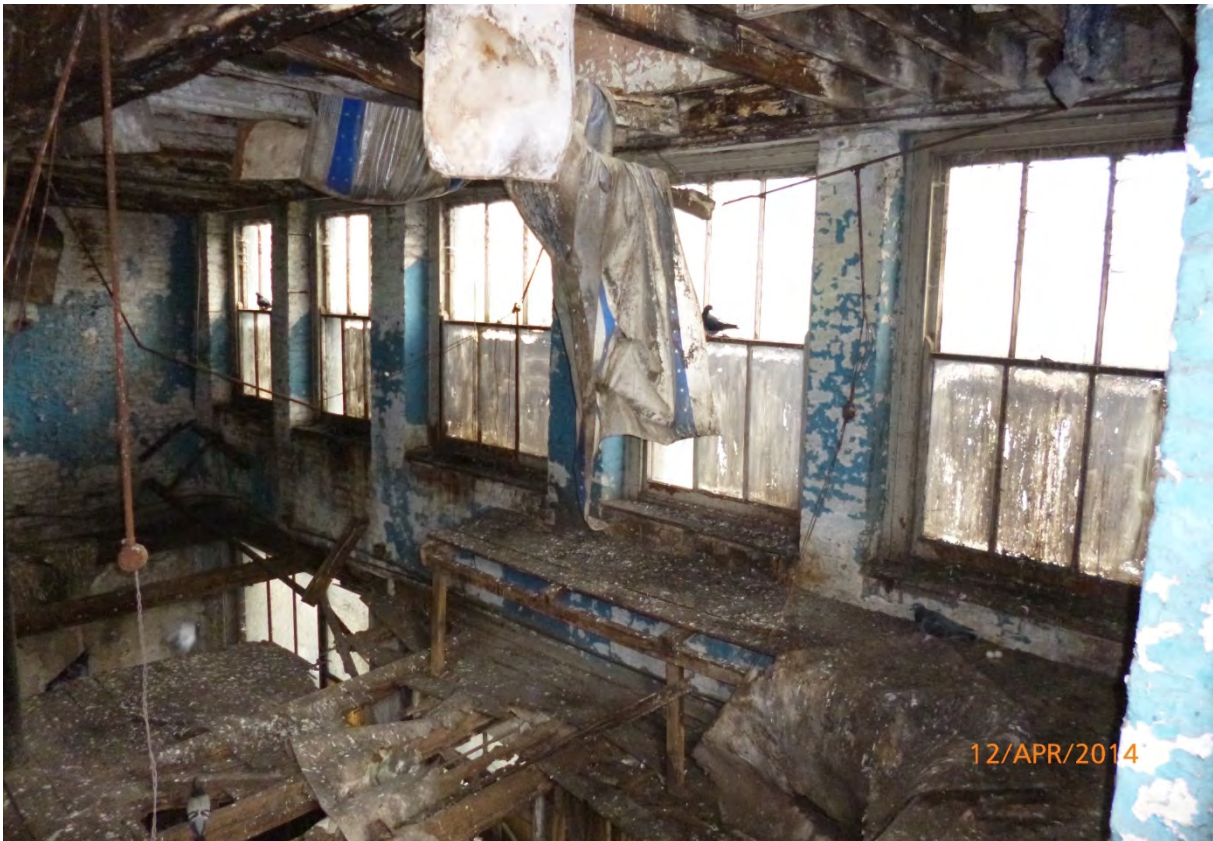
Plate 33: View towards frontage, first floor

The walls of the first floor have traces of blue paint. The floor is largely absent, having fallen away. Horned sash windows with three-paned sashes are present

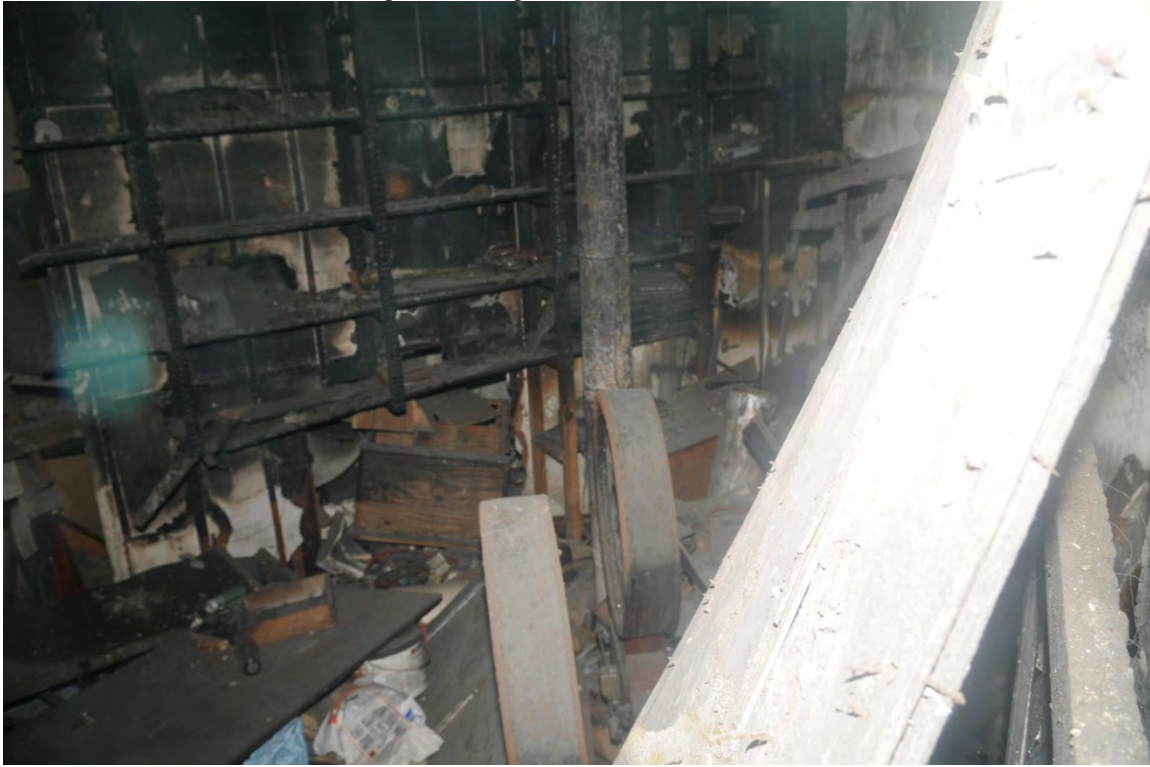
Plate 44: Store room

The above photograph is considered to depict a store room towards the southern end of the building. It has been extensively damaged by fire. Fire / smoke damage is also apparent in the northwest room, illustrated in photographs below.

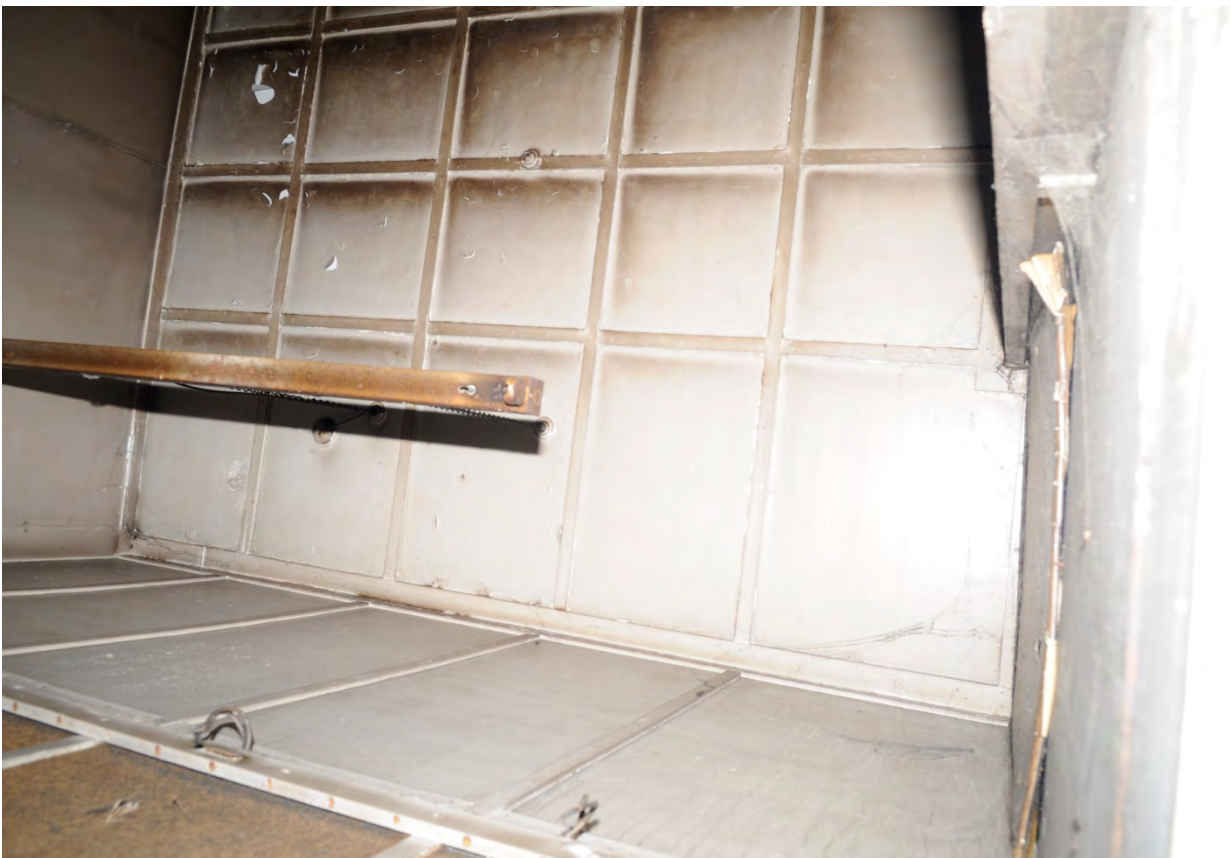
Plate 47: Detail of ceiling, northwest room, showing smoke damage
The ceiling in this part of the room appears to be a 20th century suspended ceiling.

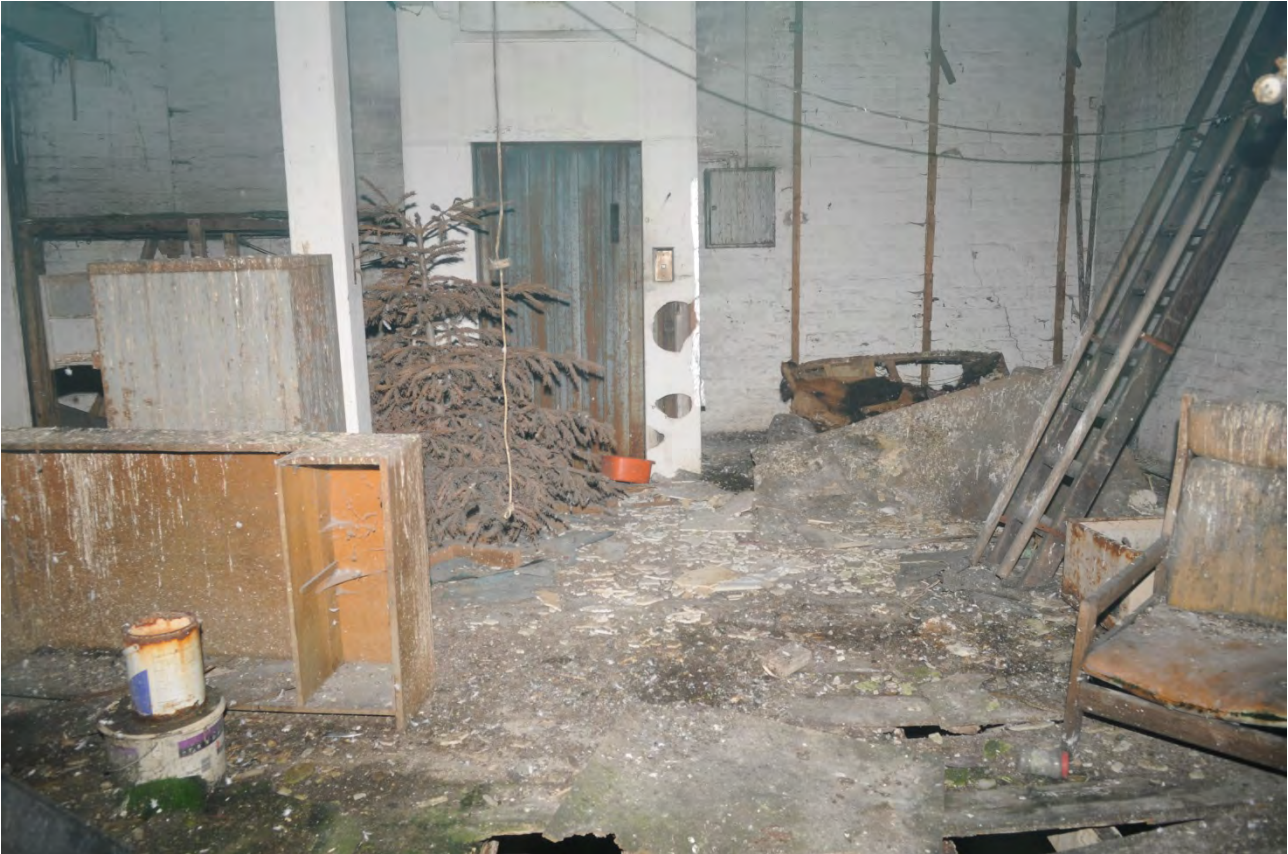
**Plate 56: General view, third floor**

The lift is visible to the centre of the image. A substantial post is noted in front of the lift, supporting a north-south ceiling beam mentioned in the structural appraisal. The structural appraisal mentions two main beams spanning the east and west walls, supported centrally by a wooden post. The ends of these beams are supported on stone corbels projecting from the walls. The walls are noted as moving outwards at this time, resulting in the beams being out of alignment with the corbels. The timber posts were also cracked. Above these, three secondary timber beams were noted, running north-south. These were supported on stone corbels and again, the movement of the walls had resulted in 'less than minimum bearing for the secondary beams'. It is noted that this movement of walls is a consequence of there being no bond between the brickwork of the walls at the corners.

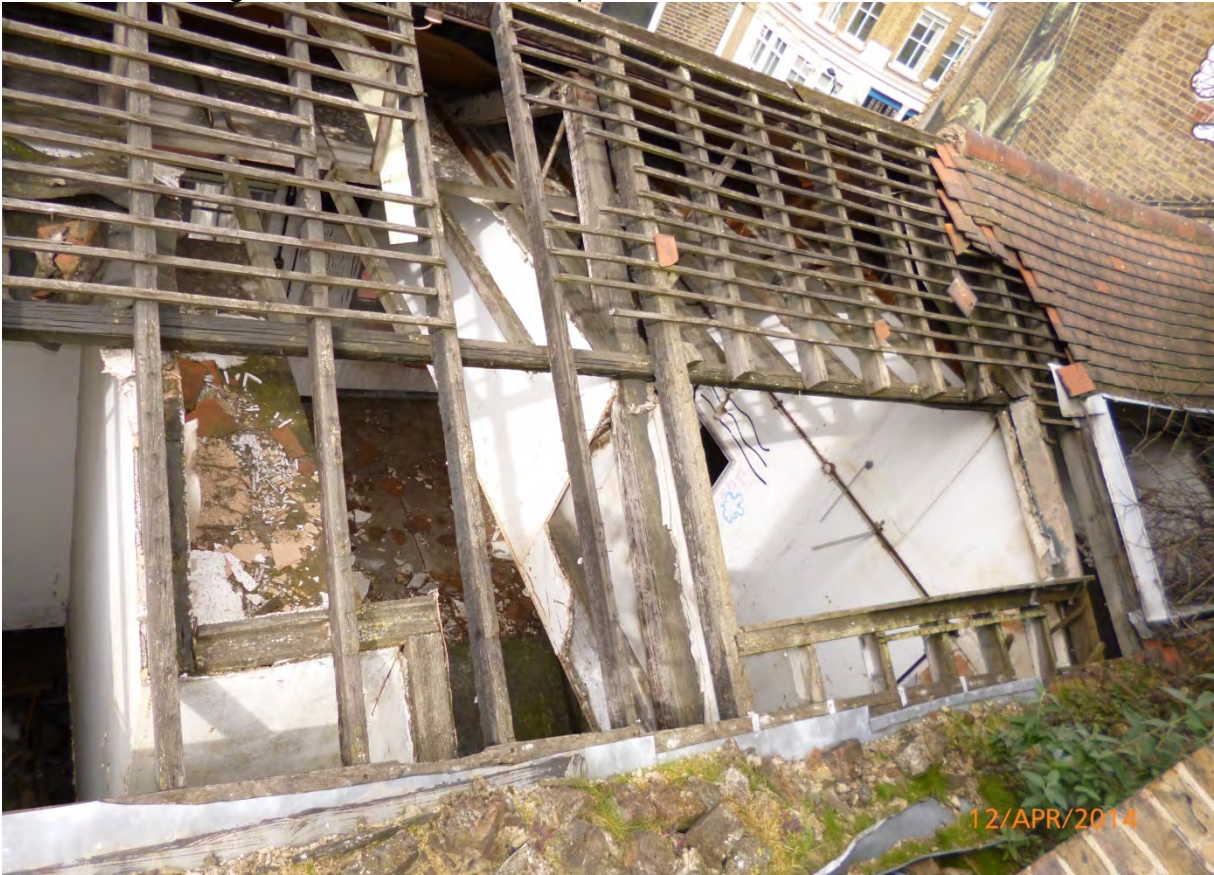
Plate 65: Absent roof covering, building to rear
