Heritage Statement:  
Buildings at Lostock Hall Farm  
Bolton  
Greater Manchester  
BL6 4BS

22<sup>nd</sup> October 2015  
Document Reference Number 2013/1282  
Version 1

This Heritage Statement should be read in conjunction with the building recording report, Historic Environment Consultancy ref. 2015/1280.

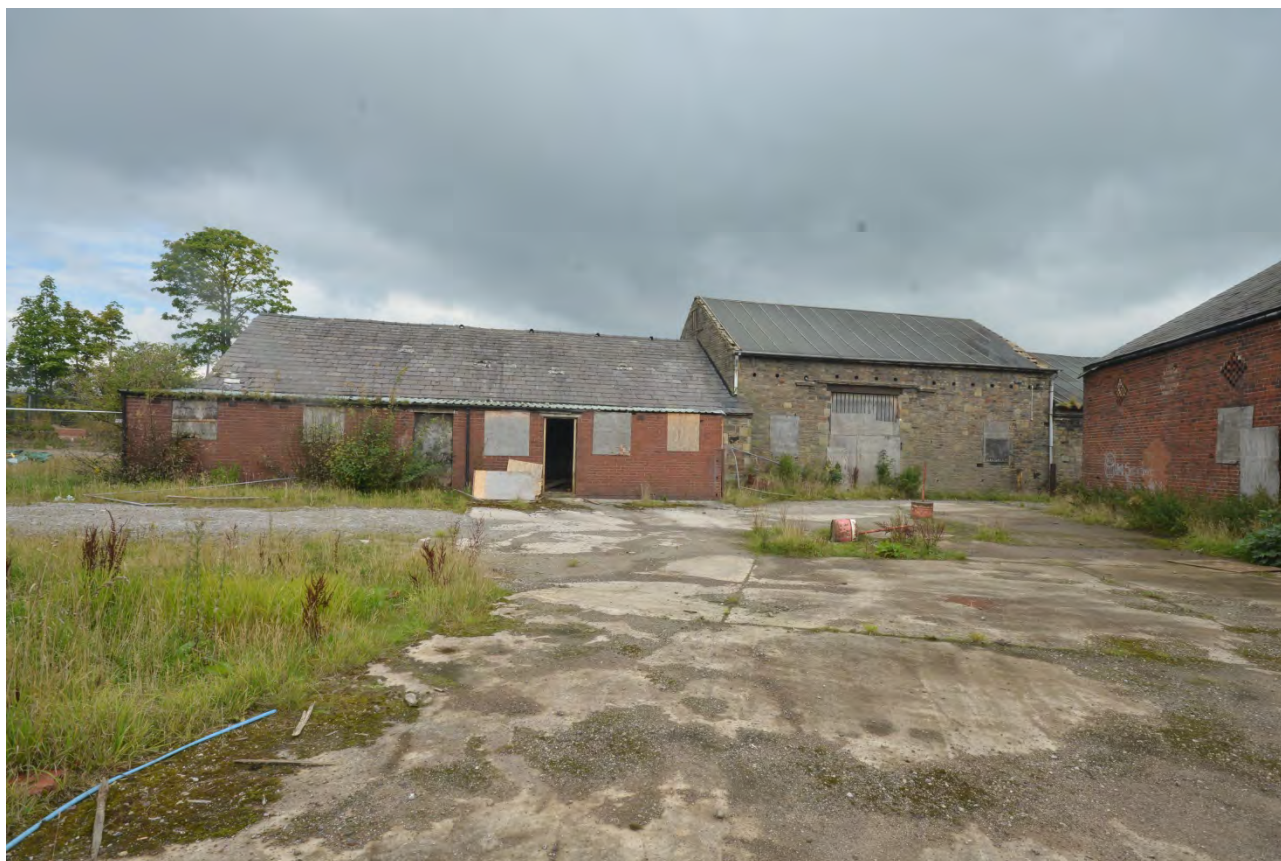
**Plate 1: Western part, building 1**

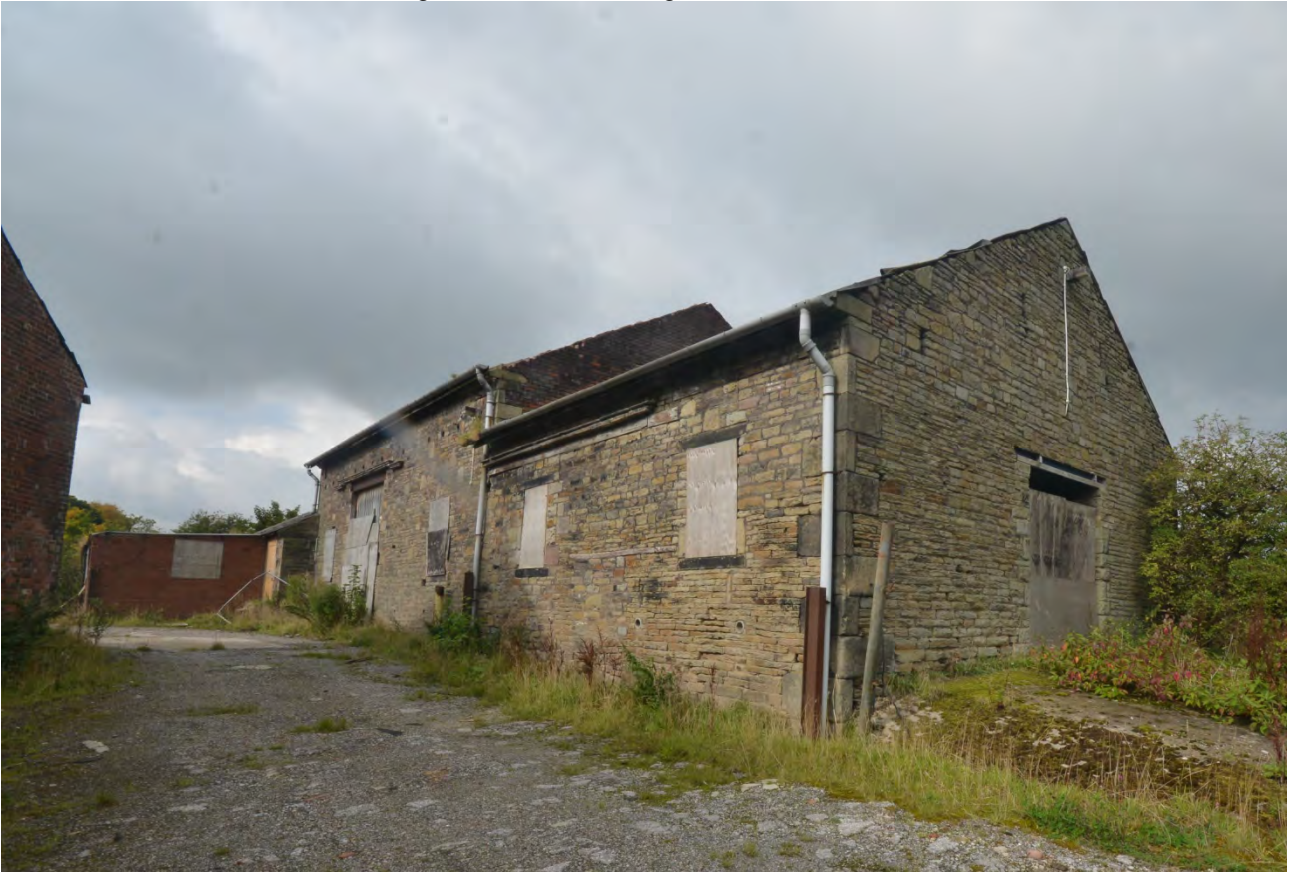
**Plate 2: Southwest aspect, building 1**

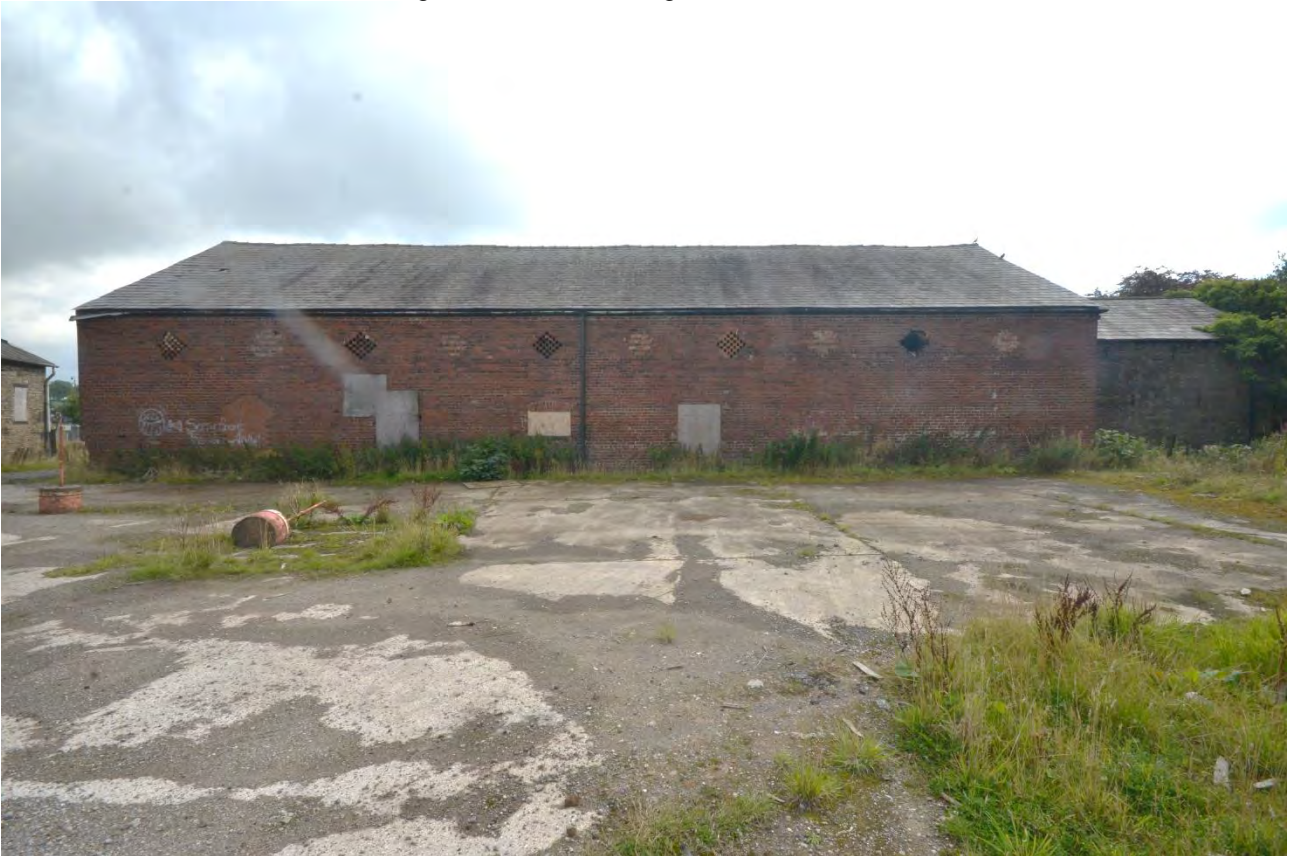
**Plate 3: West aspect, building 2**

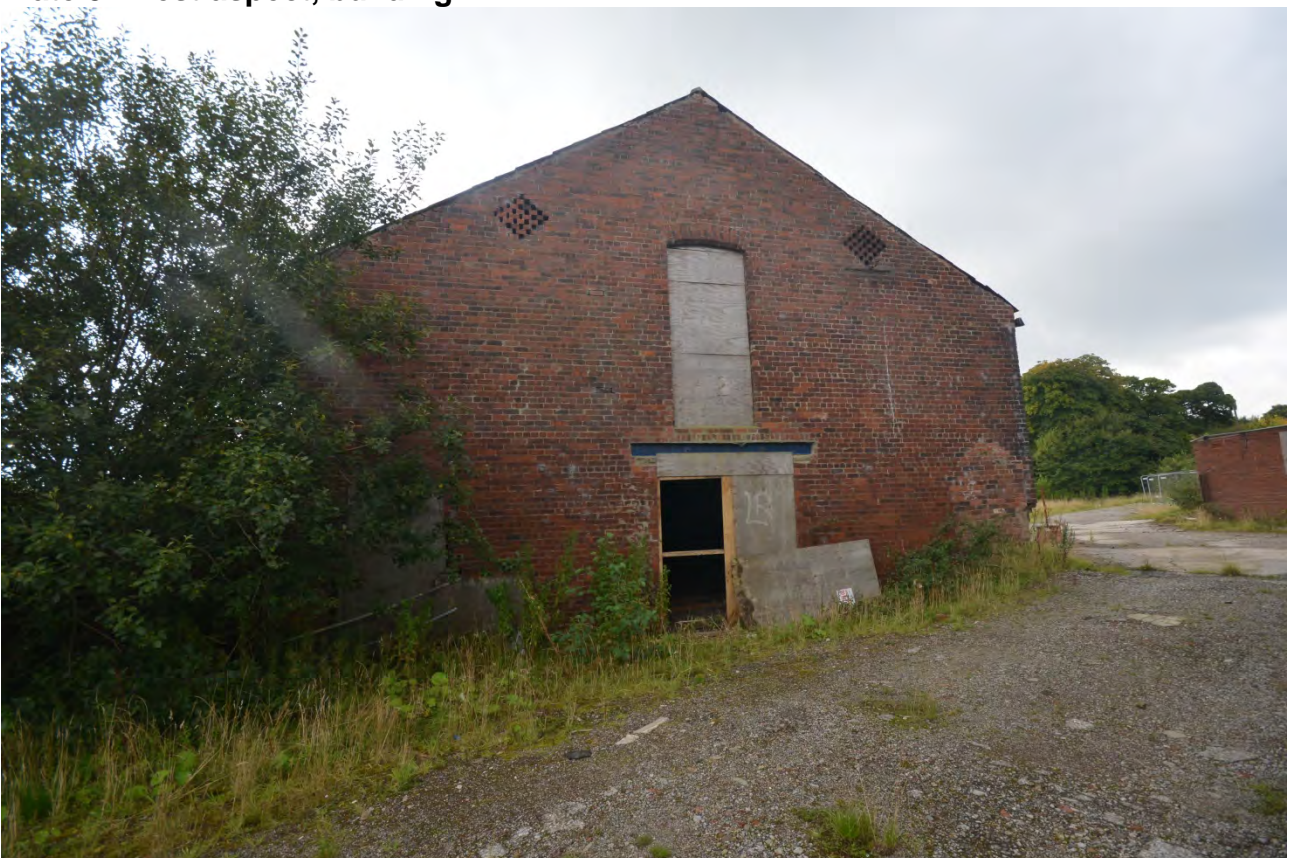
**Plate 4: North aspect, building 2**

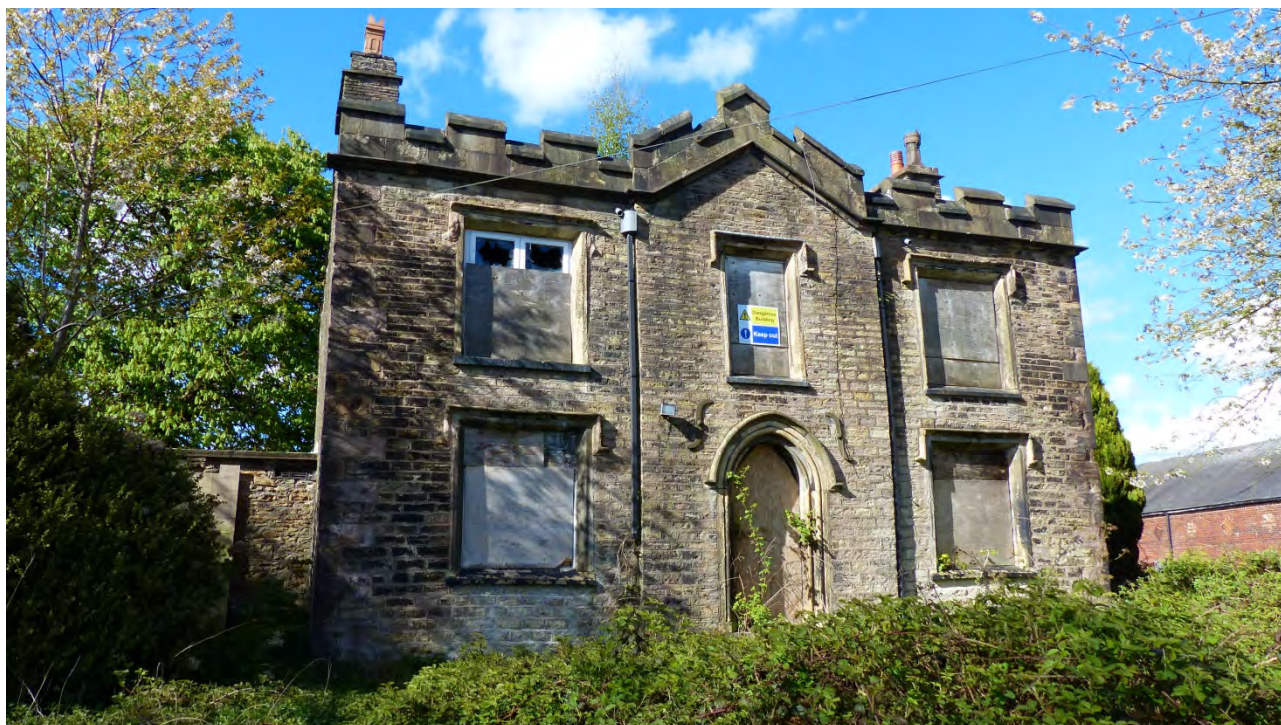
Plate 5: South elevation, building 3

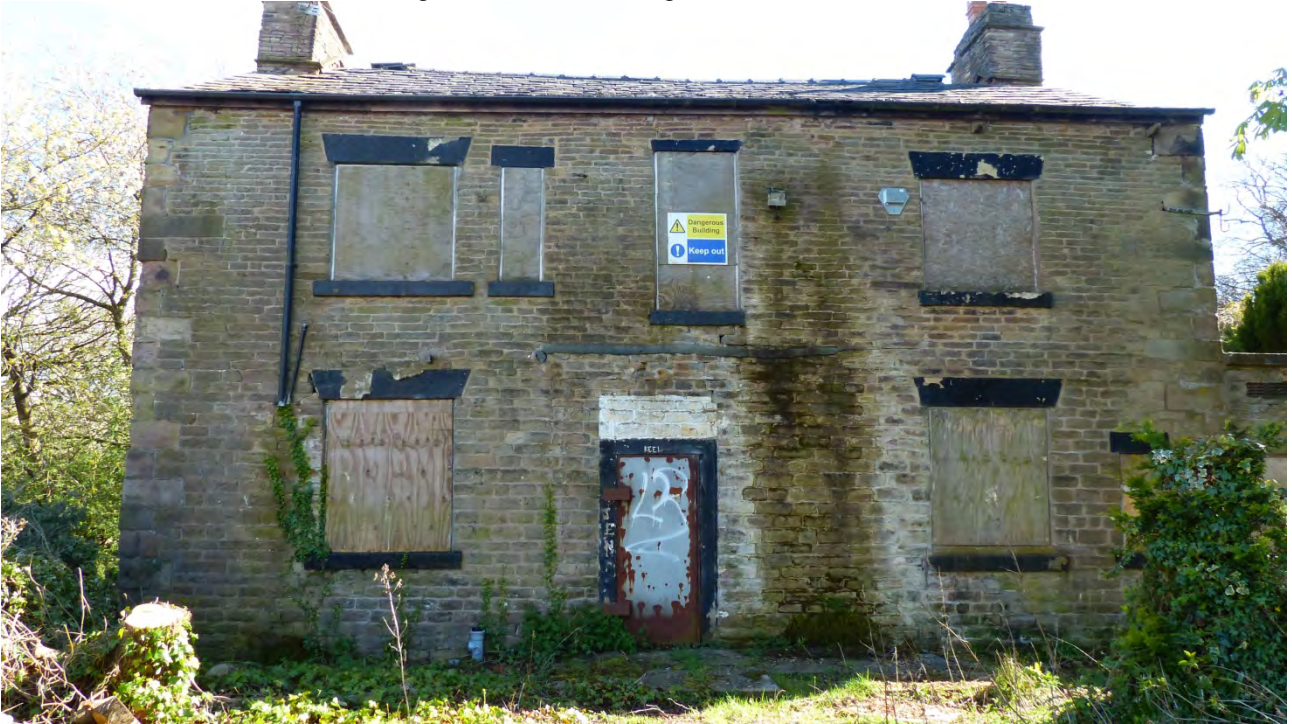
Plate 6: North elevation, building 3
