Level 3  
Building Recording of  
**5 Ravey Street**  
Shoreditch  
London  
EC2A 3HS  
National Grid Reference: TQ 331 823  
Planning Reference Number: 2012/0506

Dr Peter Wardle & Colin Lacey  
28/11/2013

Document Reference Number 2013/1147  
Version 0.5

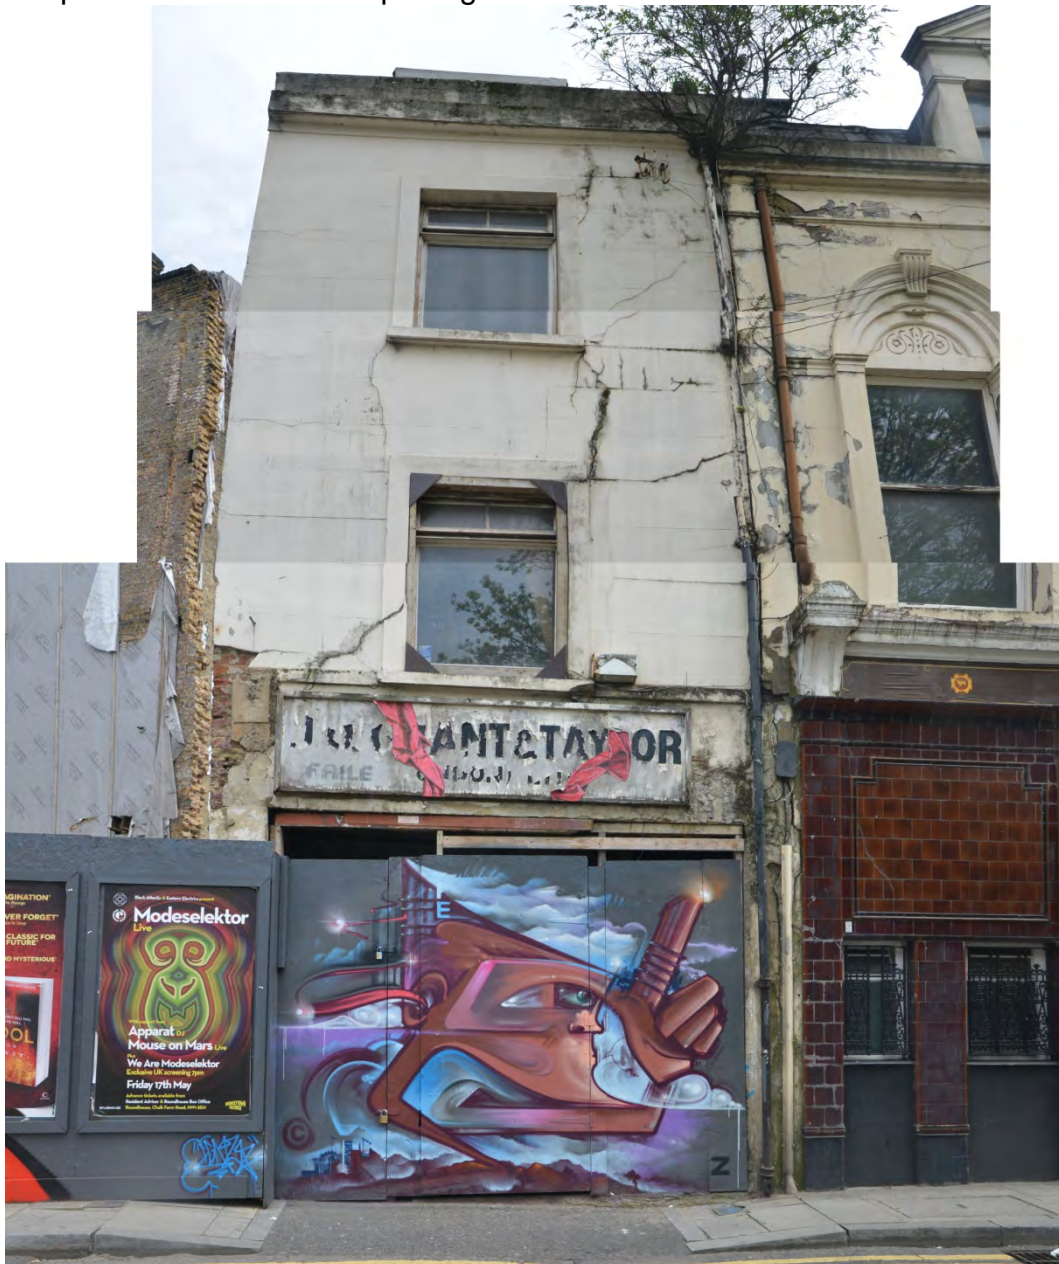
The façade of the building is rendered with a plain parapet at its head. There is one window per floor, each comprising an opening light over a single pane. A plain stucco surround is present around each opening.

**Plate 4: Front (west) elevation, composite image**

The hoarding conceals any remainder of the gates and doors visible in the 2009 image above. An advertising hoarding is present for the business previously occupying the building.

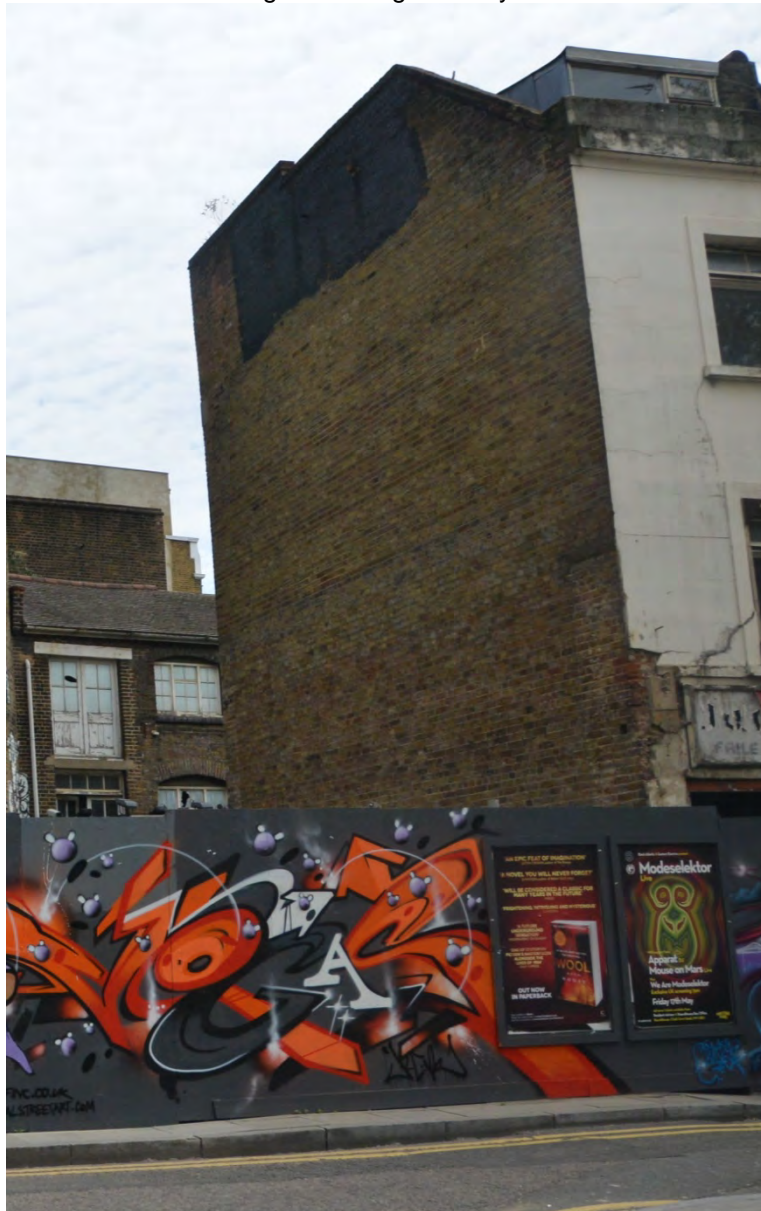
**Plate 7: North aspect**  
The northern wall is plain yellow/red brick.

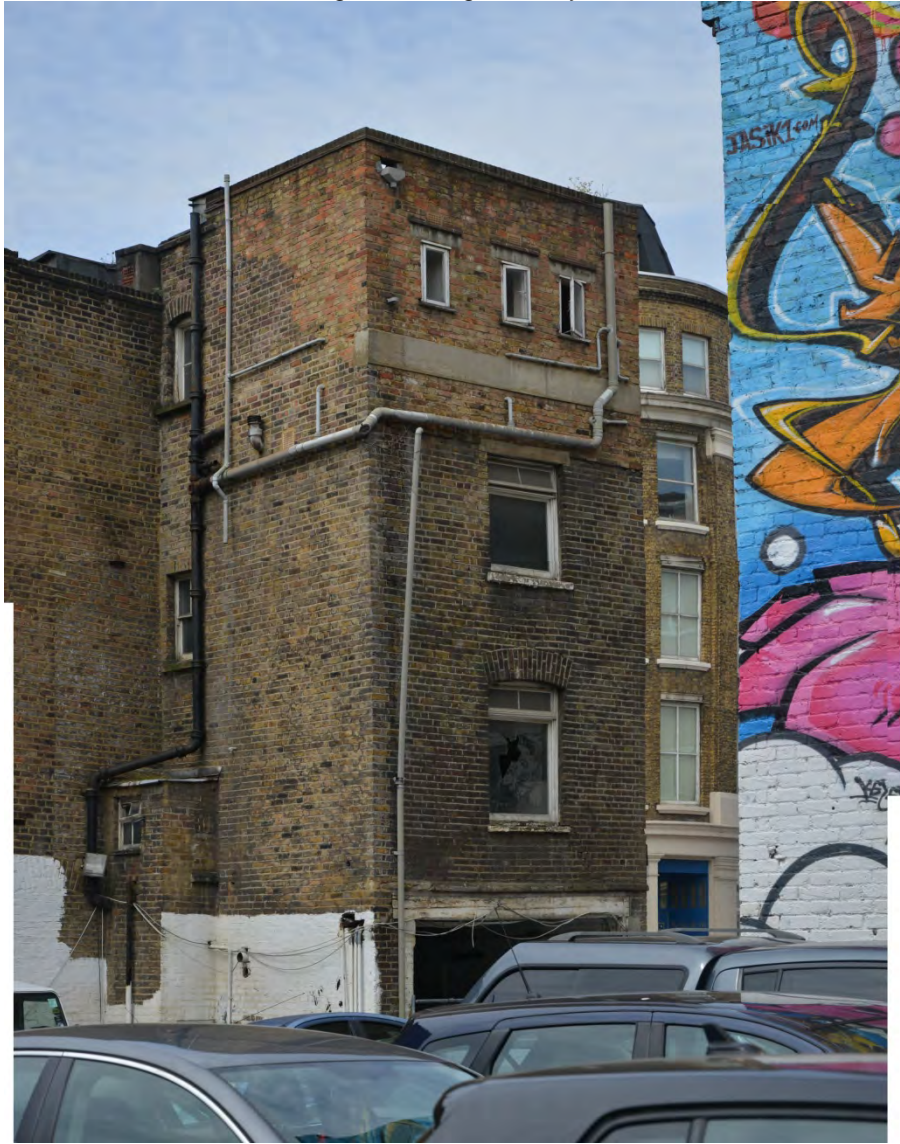
**Plate 8: Rear elevation, composite image**

The rear of the building is again of plain red/yellow brickwork. The upper part of the wall has been rebuilt in a paler brick with a large concrete lintel. This may have occurred as a result of Second World War bomb damage.

At third floor level, three side-hung casement windows are present. These are thought to date from the rebuilding. At first and second floor level, large single-paned windows with lights over are located, one per storey. The lower window has a cambered brick lintel and it is thought that the upper window would have originally followed suit, however the rebuilt section begins at the head of this opening and a straight concrete lintel has been installed.

At ground floor level, the opening of the through-passage is noted. This was secured at the time of survey.

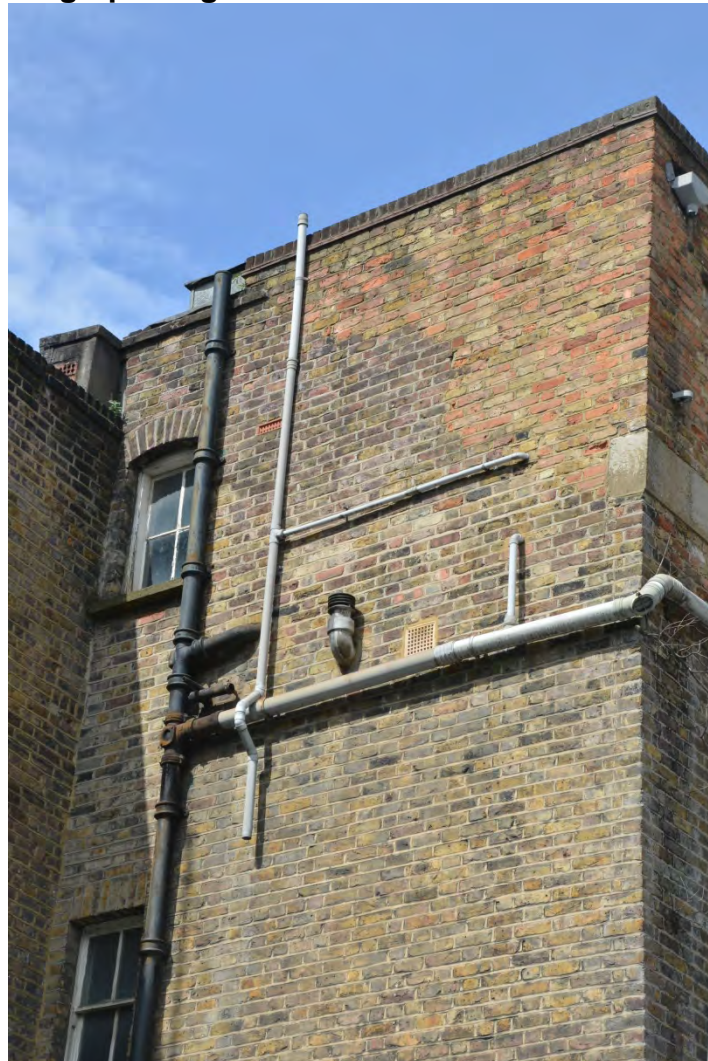
The building joins the Griffin Public House to the south, but does have a small section of its own southern wall where it protrudes from the line of the southern building. A recessed section of wall at the apex between the two buildings marks the stairwell within 5 Ravey Street. This features windows to each floor. The upper window has a cambered brick lintel and comprises a four-paned casement. The window below has a straight brick lintel and comprises a sash.

**Plate 10: Detail of south elevation**

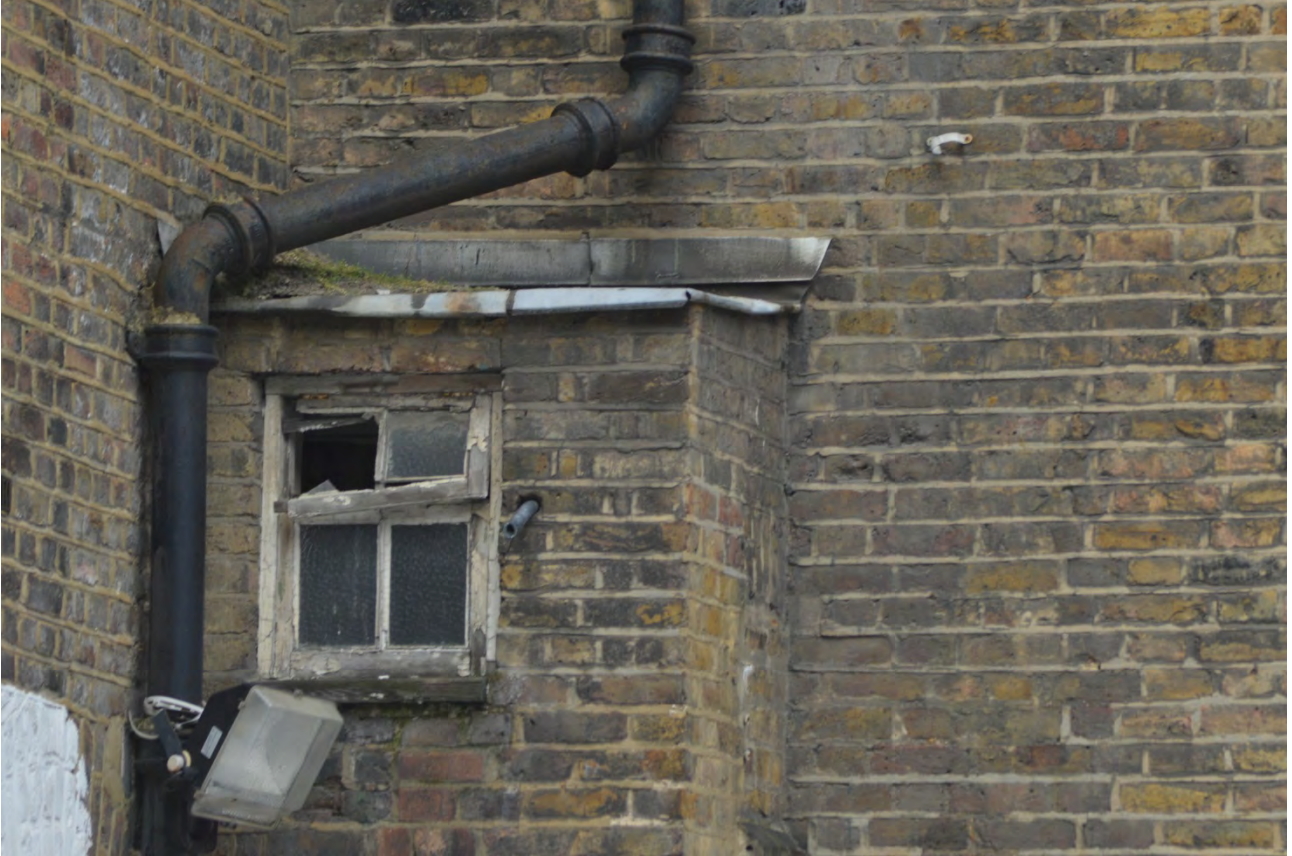
At ground floor level, a small projecting section below the stairwell contains a lavatory. This is flat-roofed and features a timber framed window with opening light.

**Plate 11: Detail of projecting lavatory section**

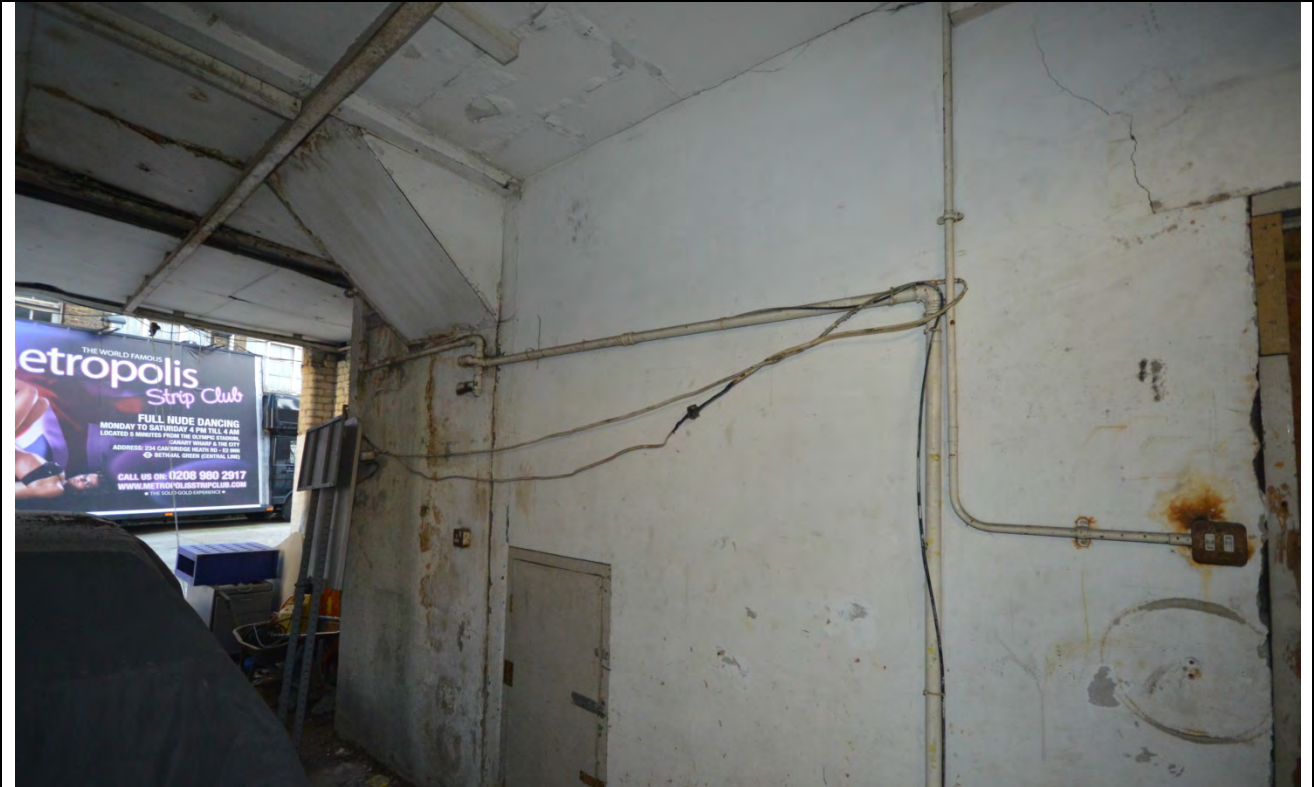
Plate 14: Door to store room

Current Function	Store room
Original Function	
Phase	
Plan Form	Unaltered
Windows	None
Historic Features	
Comments/Description	Area inaccessible at time of recording

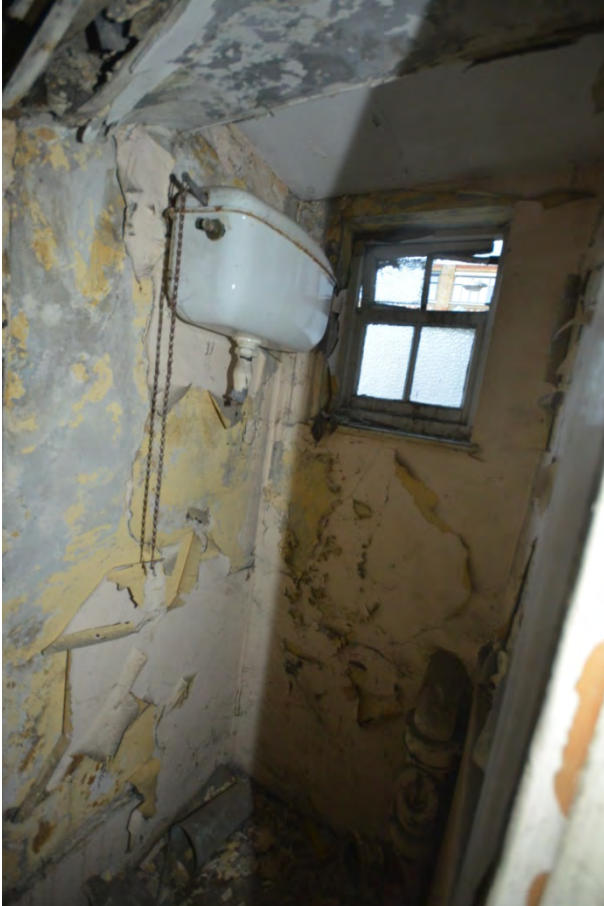
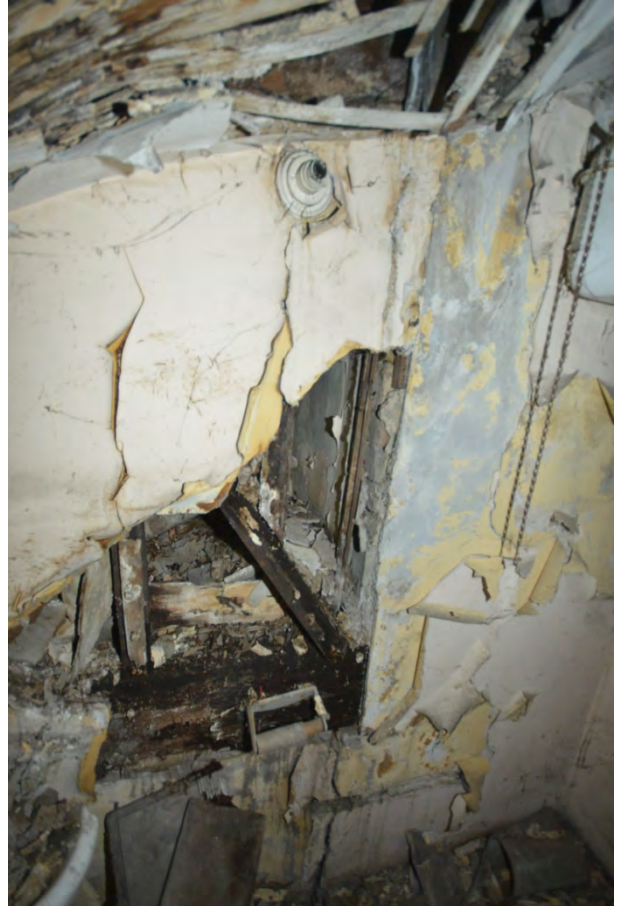
Current Function	Lavatory
Original Function	
Phase	
Plan Form	
Windows	4 pane timber framed casement
Historic Features	Early 20th century high level cistern, degraded ceiling revealing laths
Comments/Description

Plate 15: General views, lavatory

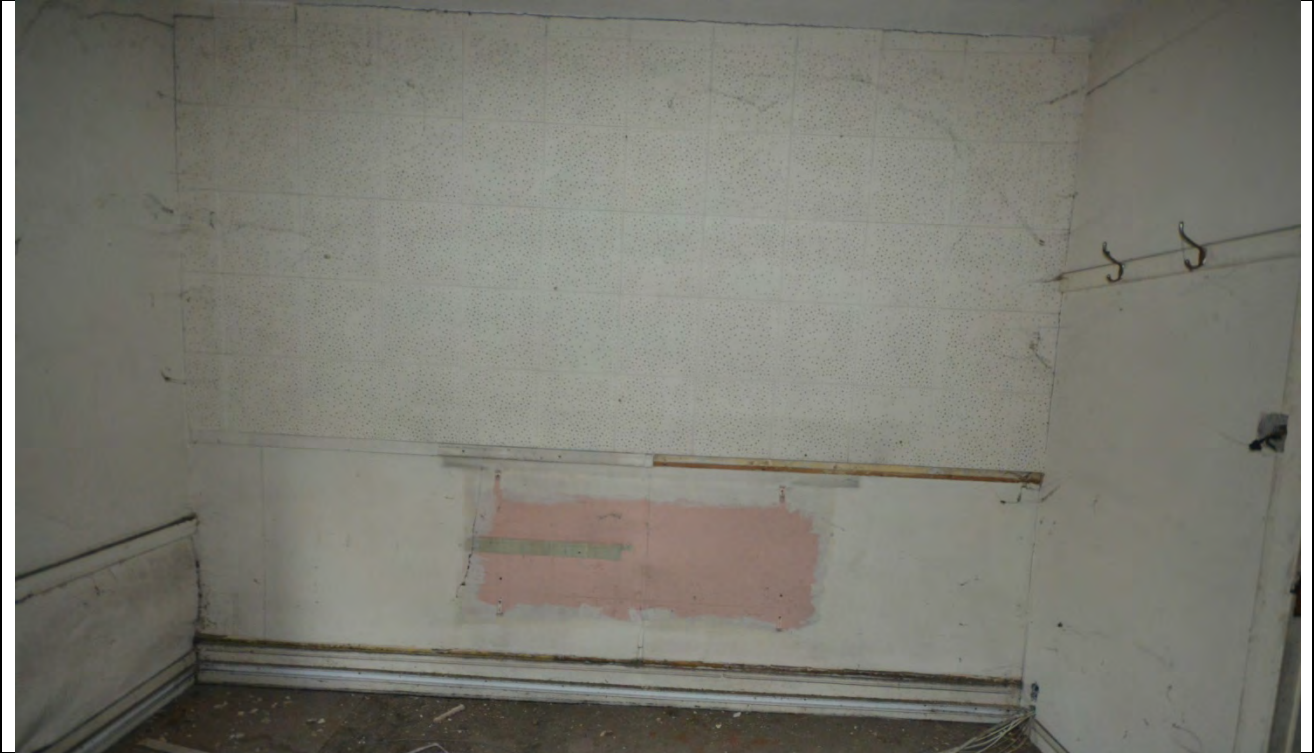
**Plate 18: First Floor Room 2 Looking North**

Current Function	Vacant
Original Function	
Phase	
Plan Form	
Windows	Modern single pane with lights over
Historic Features	Blocked fireplace, 19th / 20th century panelling over staircase

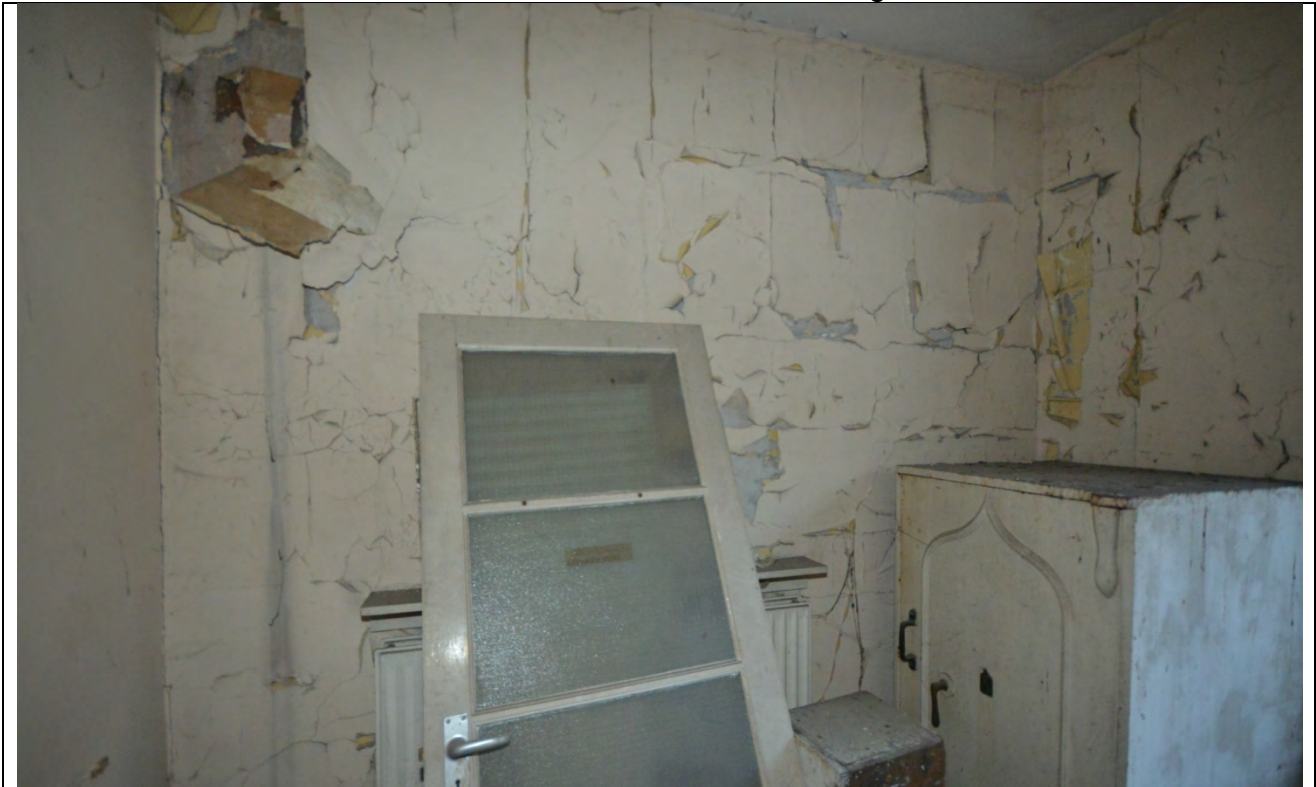
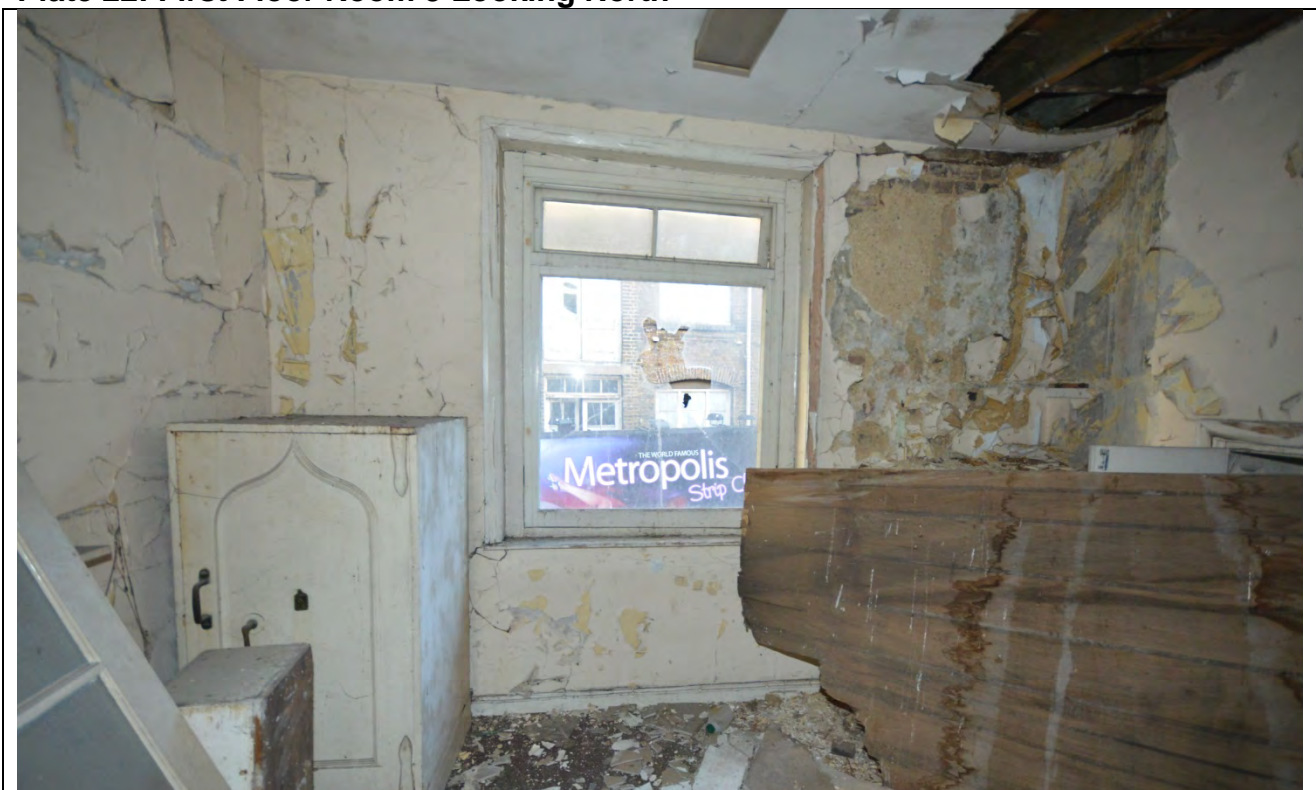
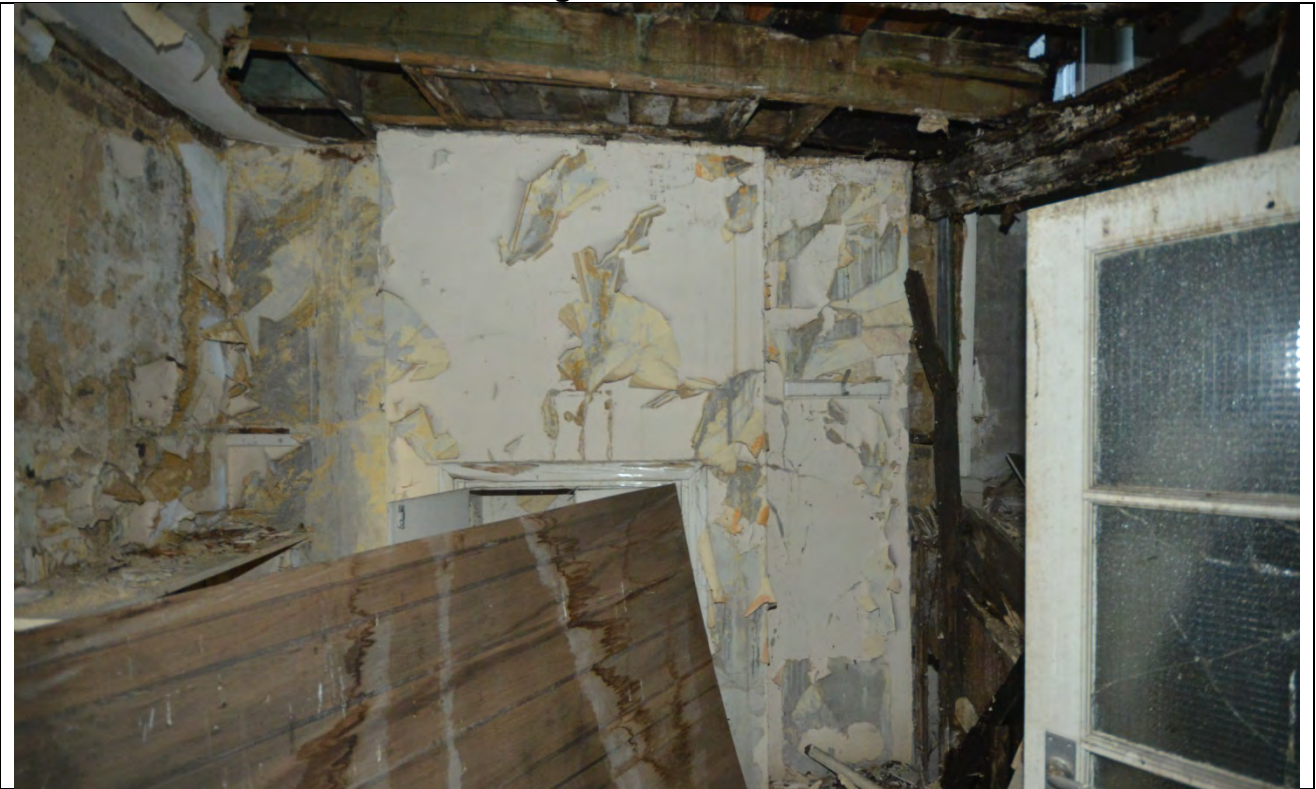
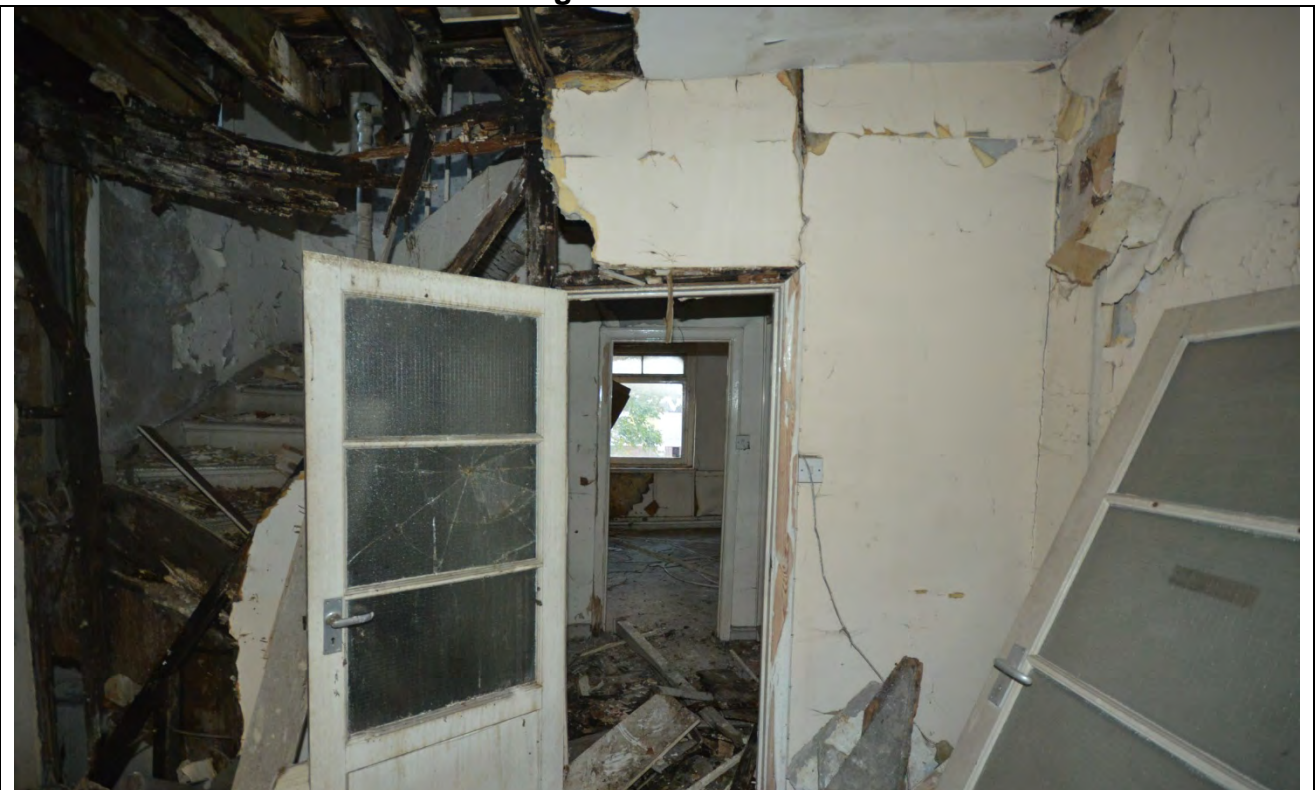
Current Function	Vacant
Original Function	
Phase	
Plan Form	
Windows	Modern single pane with lights over
Historic Features	
Comments/Description	Cupboard constructed over former fireplace, large safe in corner of room possibly contributing to deterioration / weakening of historic structure

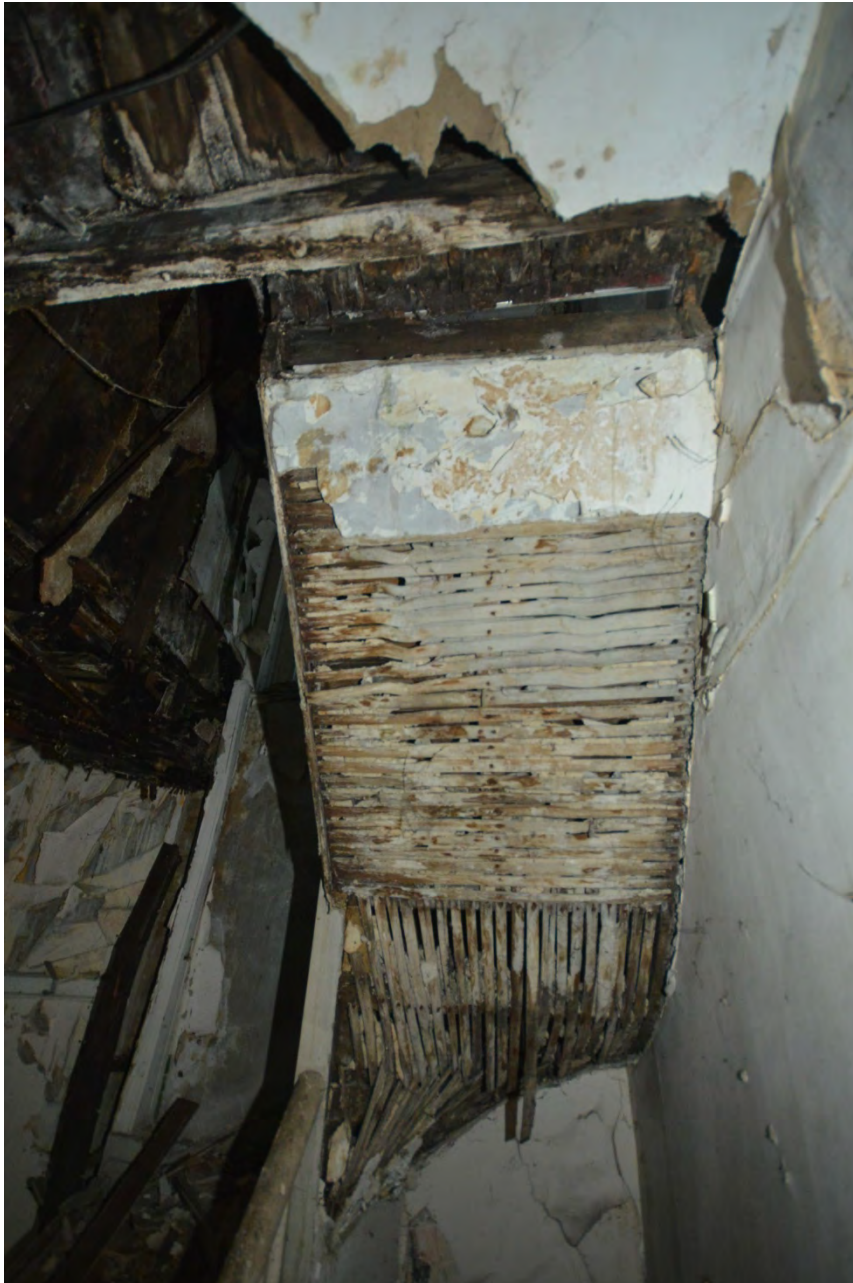
Current Function	Stairs / Landing
Original Function	
Phase	
Plan Form	
Windows	None
Historic Features	19th century balustrade, exposed laths
Comments/Description

**Plate 26: Underside of staircase to second floor**

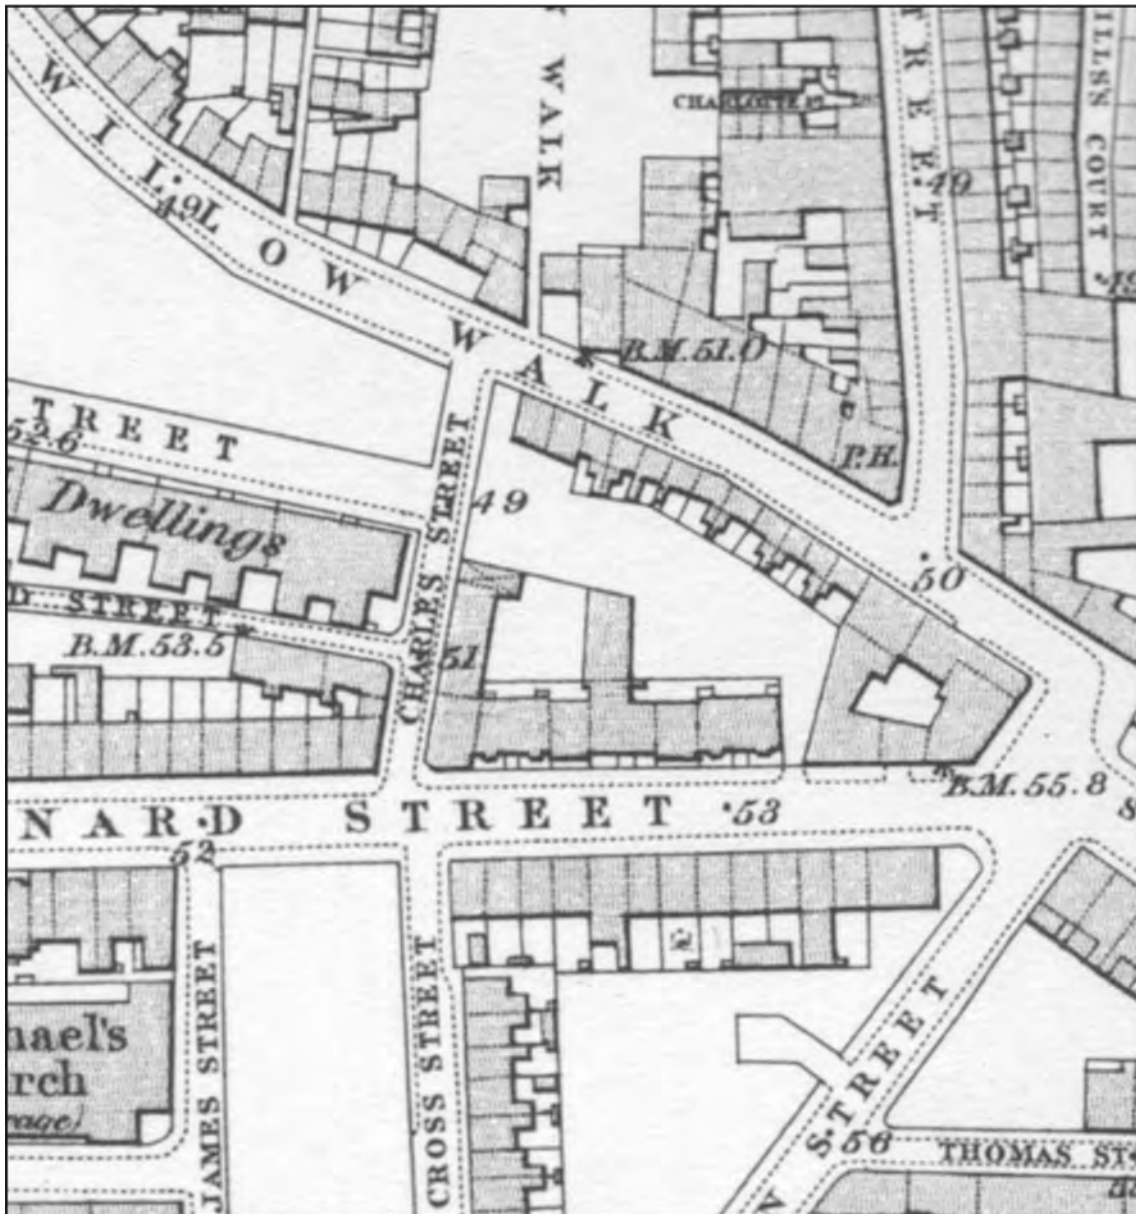
**Figure 5: 1872 Ordnance Survey plan**

The Griffin Public House and 5 Ravey Street have both been constructed. The northern wall of The Griffin is in a somewhat uncertain location, appearing to intrude into the footprint of no. 5.

The eastern wall of the public house is depicted as being parallel to Charles Street (Ravey Street) rather than reflecting its true form, tapering to the north.

It is considered likely that this discrepancy is due to the surveyor not being able to access the rear of the building when composing the map, and projecting a straight line from the visible roof line of the frontage.

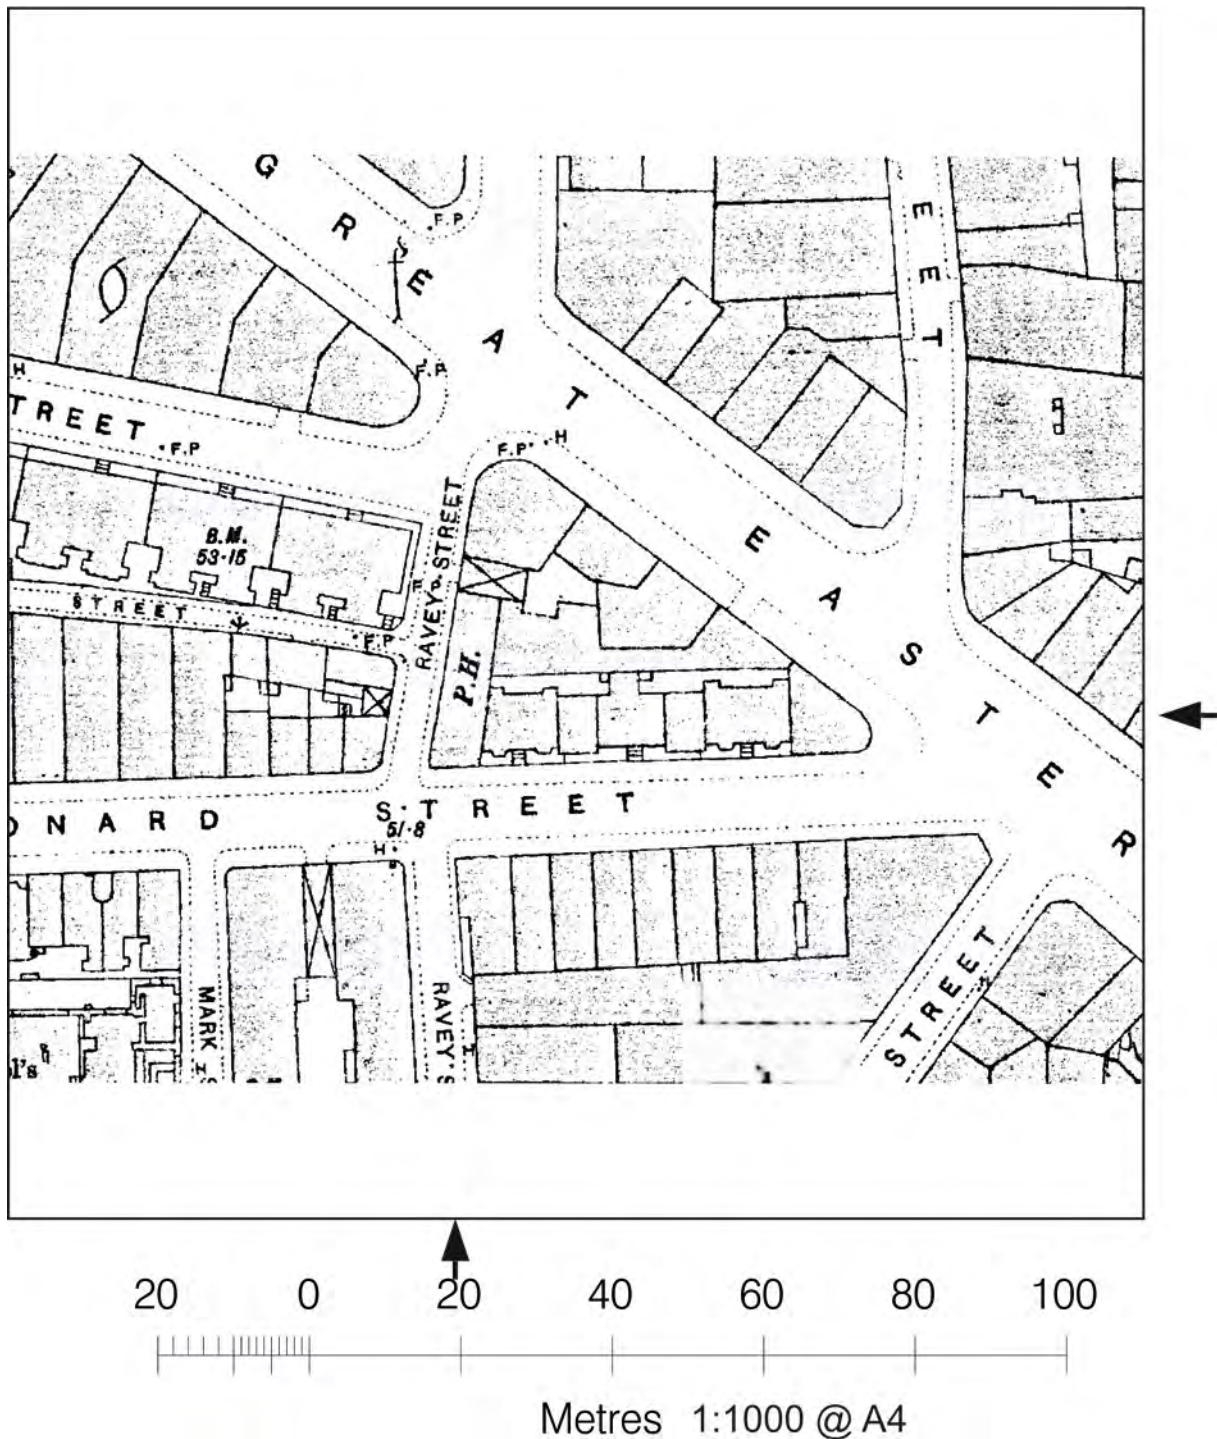
**Figure 7: 1913 Ordnance Survey**

The buildings are shown in their current form. The party wall between The Griffin and 5 Ravey Street appears further south than in the former map - more akin to its current position.

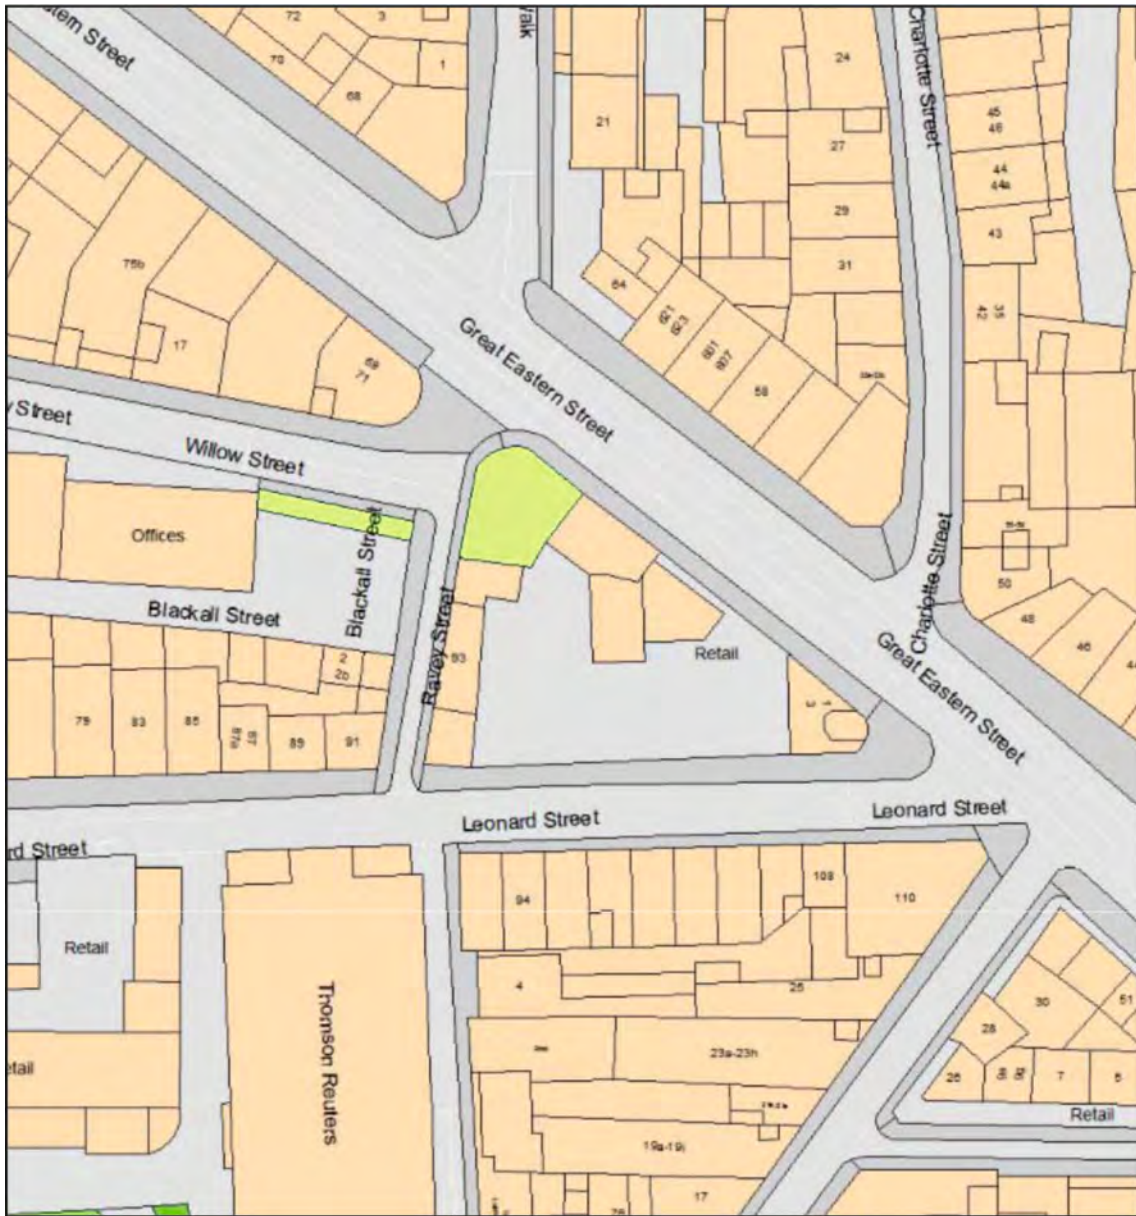
**Figure 13: Modern Ordnance Survey**

The building has its current footprint.

The southern boundary of the building is located somewhat further south than its actual location, making the building 'L'-shaped. This is not the case, and therefore the accuracy of the southern wall as depicted by the Ordnance Survey cannot be relied upon.
