Heritage Statement:

Ground Floor – The Bar  
The Griffin  
93, Leonard St  
Shoreditch  
London  
EC2A 4RD

Document Reference Number 2015/1254  
Version 0.5

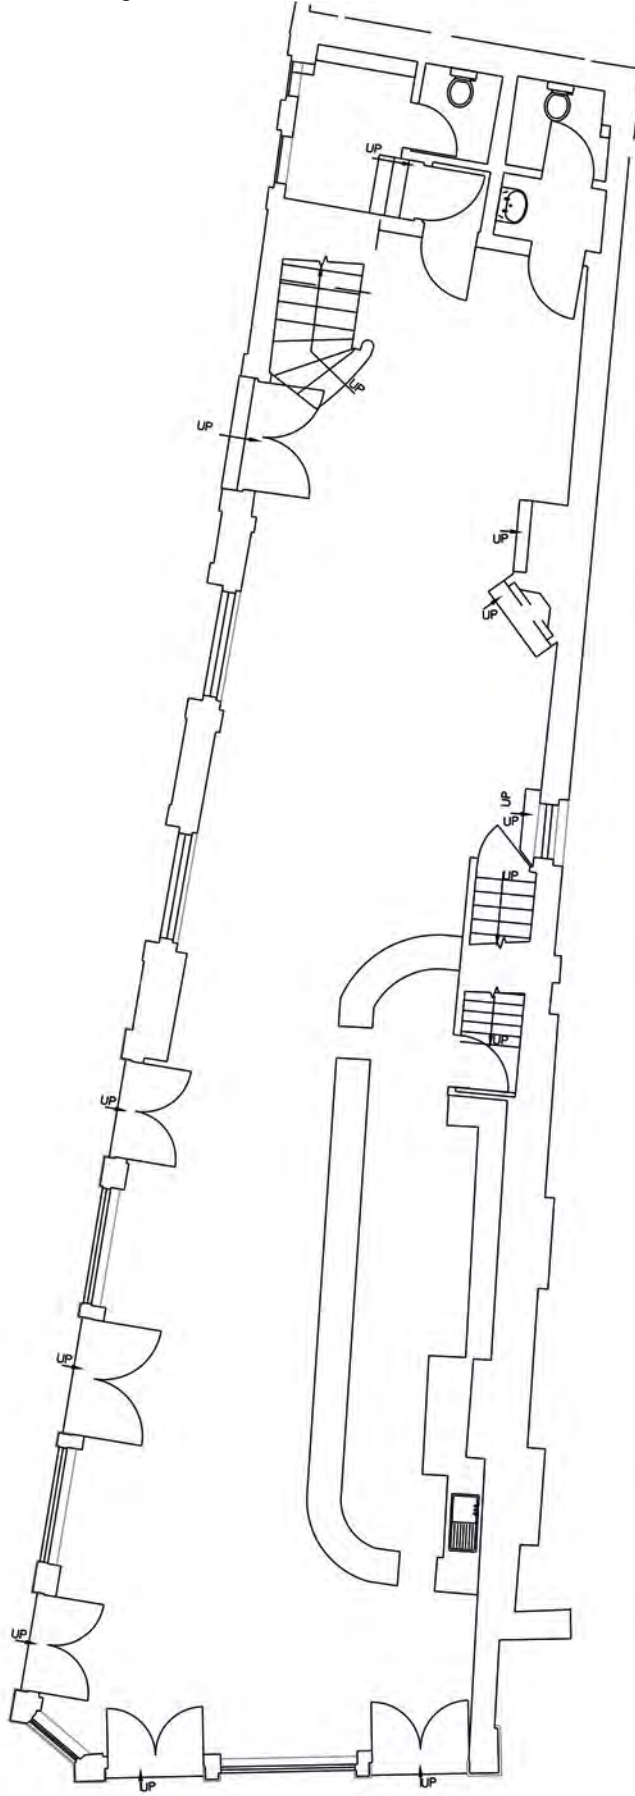
**Figure 3: The ground floor, 1:100 @ A4**

The layout of the ground floor of the building is shown in the following plan:

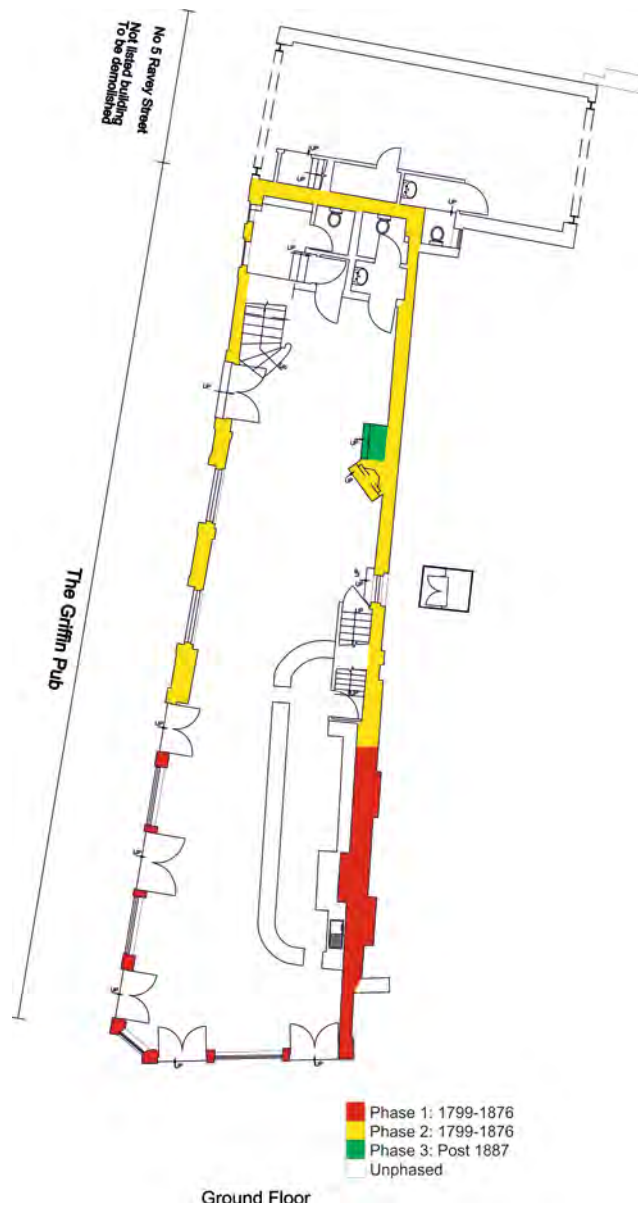
Figure 4: Phase Plan, Ground Floor, 1:200 @ A4

Phase	Date	Description	How Dated
1 Original	1799-1872	The frontage of the building	Change in floor levels of upper floors, difference noted in style of west wall, present on 1872 OS
2	1874-1894	The northern part of the building	Change in floor levels of upper floors, difference noted in style of west wall, present on 1872 OS
3	Post 1887	Dumb waiter, internal partition walls	Fabric, departing from historic layout, invention of dumb waiter, patented 1887

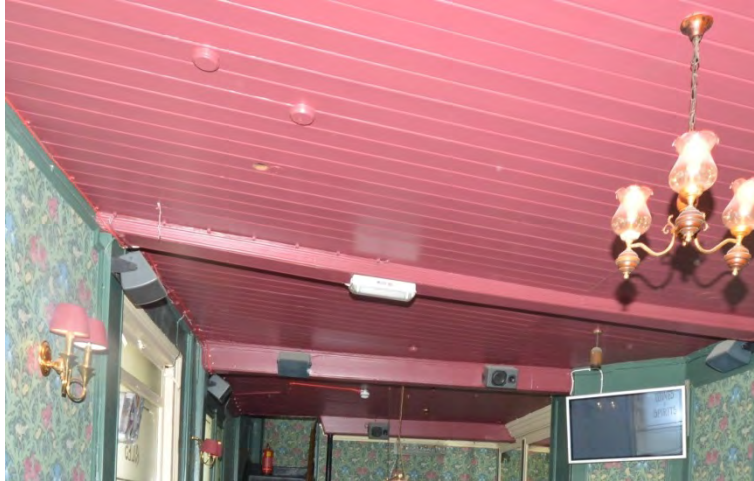
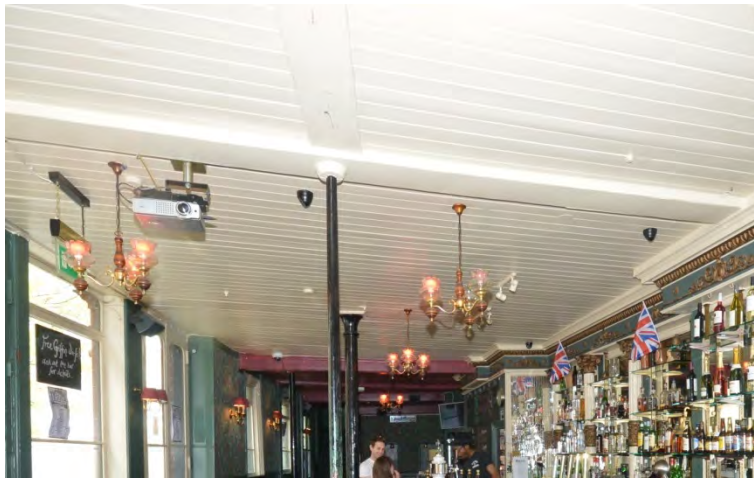
**Plate 3: Ceiling, north end**

**Plate 4: Ceiling, south end**

The ceiling is panelled with tongue and groove planks. This is not a historic ceiling form.

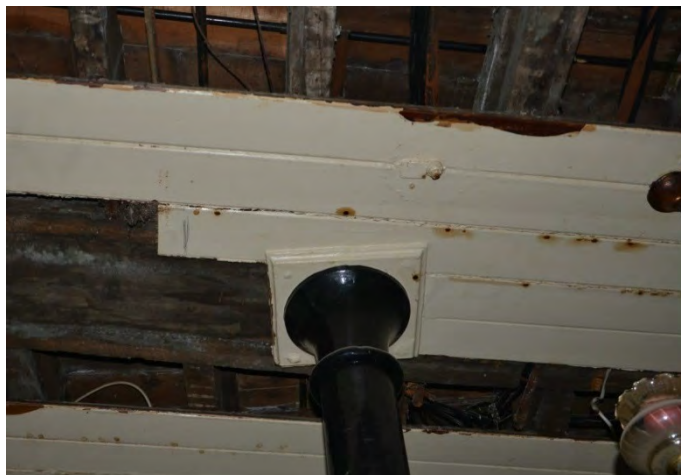
Investigative works have revealed scars from a former lath and plaster ceiling.

**Plate 5: Lath & plaster marks revealed beneath tongue and groove**

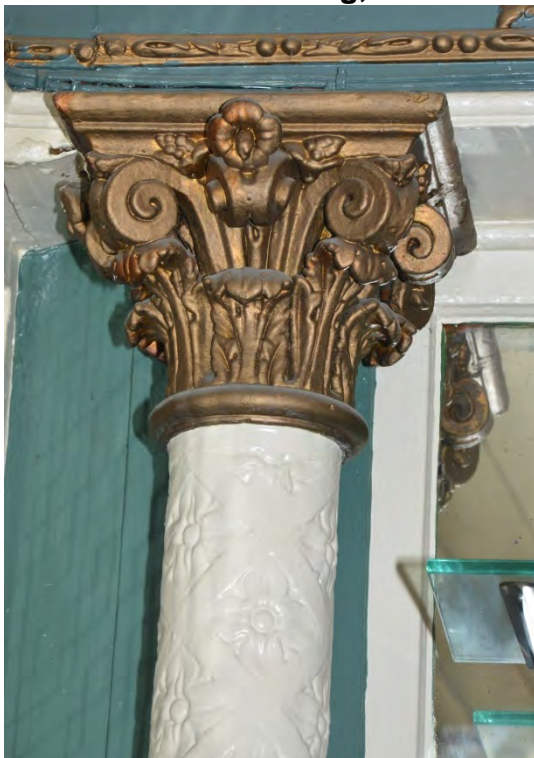
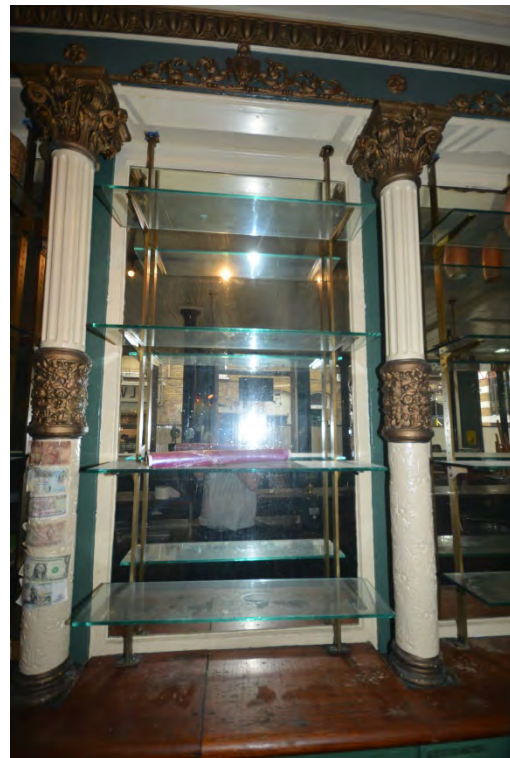
Plate 8: Detail of columns

The eastern wall features a moulded cornice and frieze with further decorative mouldings and columns. These run from the enclosure of the cellar staircase south to the southern wall of the building.

A chimneybreast to a former fireplace is present towards the southern end of the bar area. Mouldings surround this suggesting it predates the installation of the mouldings. It is noted that the moulded column south of the chimneybreast differs from those to the north which suggests it may be a more recent insertion.

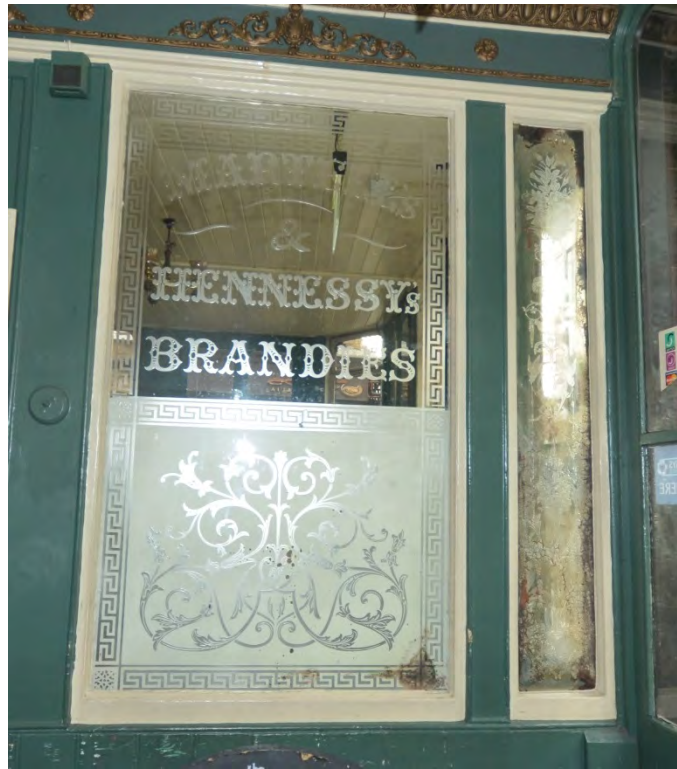
**Plate 10: Etched glass mirror, southern end of east wall advertising Martell's & Hennessy's Brandies**

Both Martell and Hennessy were established in the 18<sup>th</sup> century and therefore predate The Griffin. The mirrors are considered to date from a period following the First World War when Hennessy and Martell merged for a brief period.

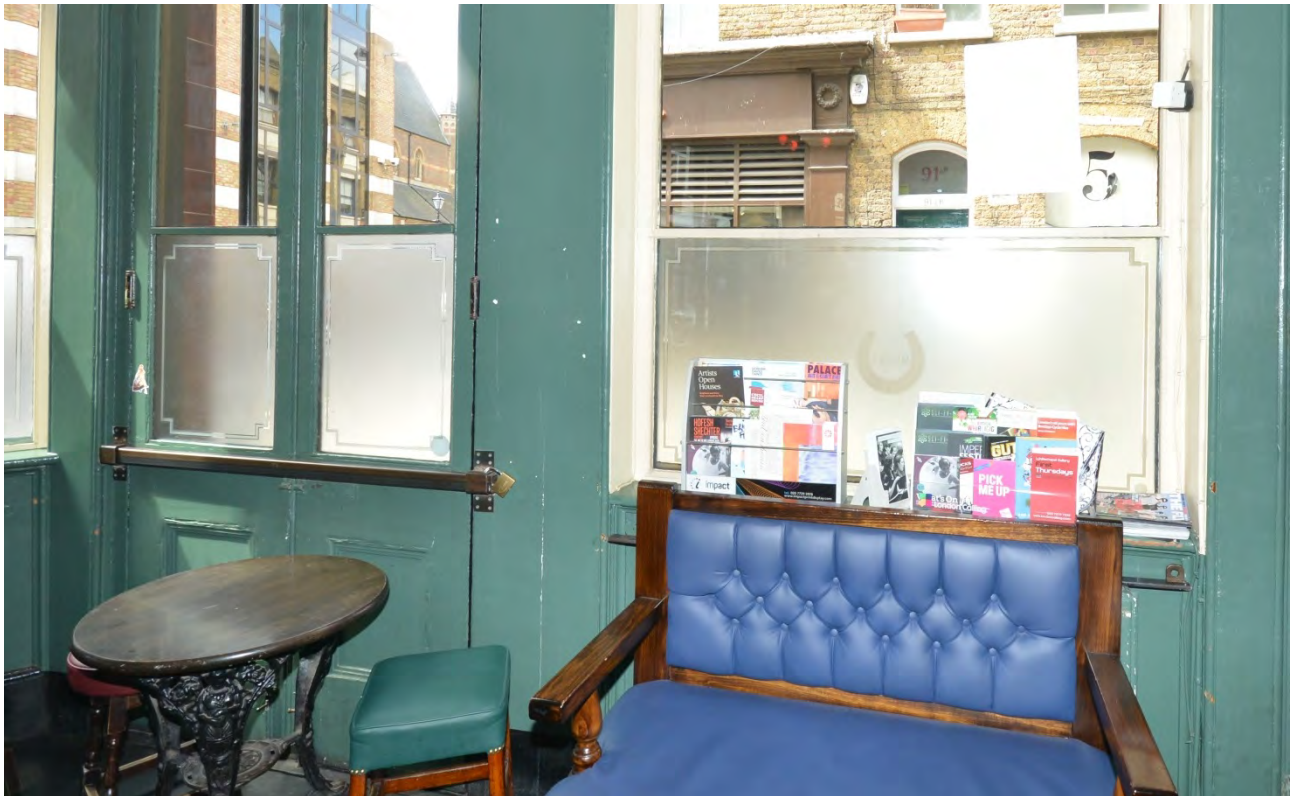
**Plate 13: Windows, western elevation, etched with Meux's logo** Meux's Brewery Company Ltd was established in 1878 from the former company, Meux & Co. In 1956, Meux's merged with Friary, Holroyd and Healy to form Friary Meux.

The frosted windows with the Meux's logo must therefore date from the period between 1878 and 1956. As The Griffin was built in 1889, these may be original windows, although are equally likely to be later additions.

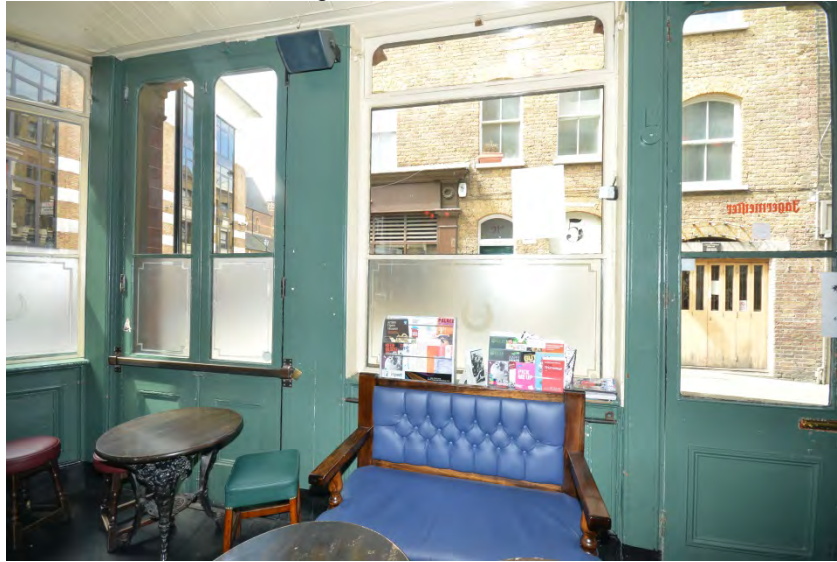
**Plate 16: Windows and doors, southern end of western wall**

The windows and doors at the southern end of the building are stylistically similar, with rounded upper corners. They are considered likely to be contemporary in date.

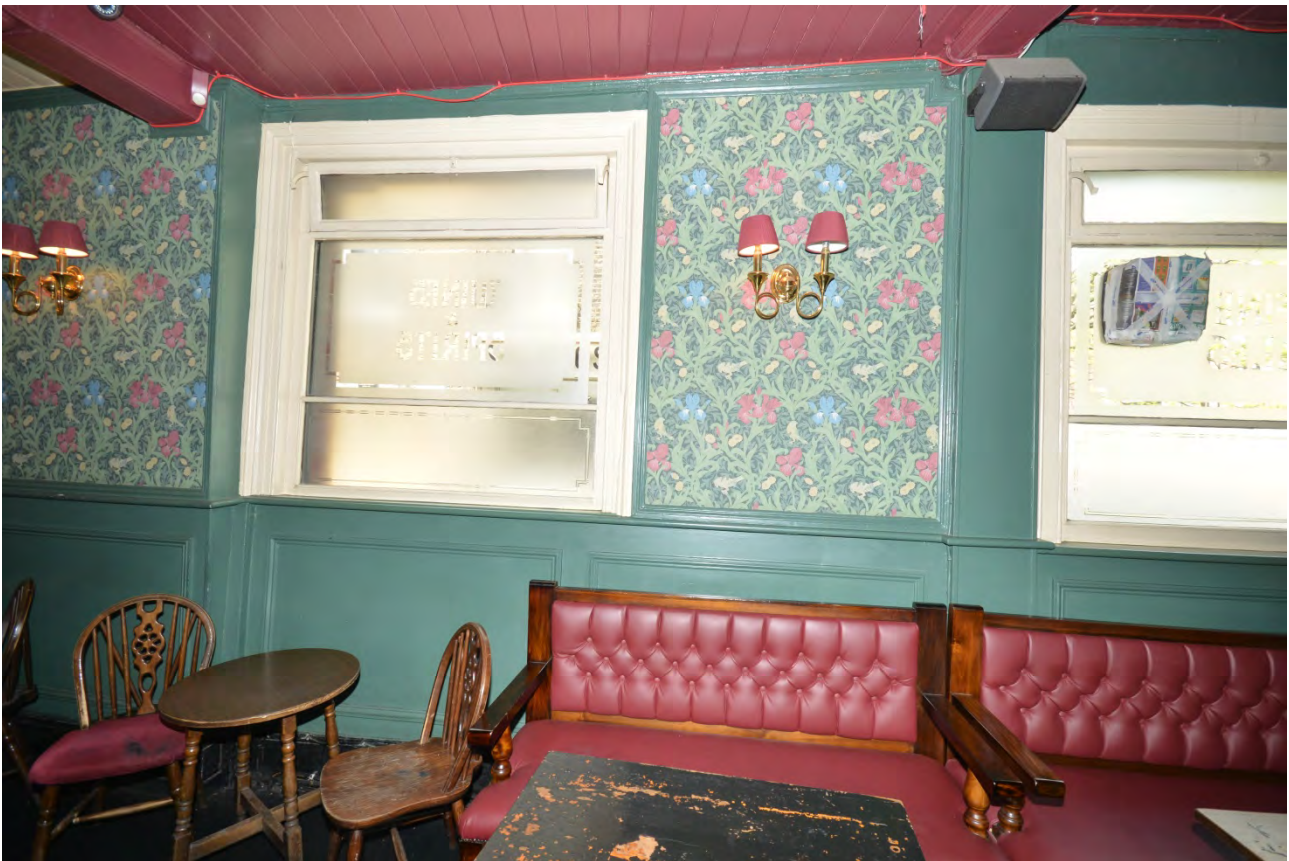
**Plate 17: Windows, northern part of western elevation**

The windows to the north of the building are clearly different, with square heads and horizontal glazing bars. These are considered to be more recent than those to the south. They may be original to this phase of the building. The etching on the glass gives no indication as to date.

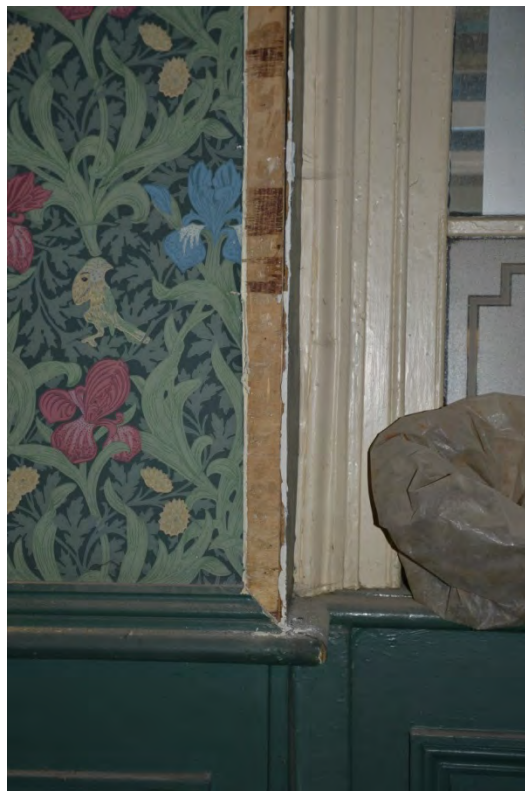
That to the west is, however, known to be modern in construction in one area at least, where recent works have shown it to be formed of modern plywood, boxing in services from the upper floors. It is unknown, therefore, how much, if any, of the panelling to the west is historic as modern decorative finishes obscure any historic detail.

**Plate 21: Modern plywood revealed during recent works**

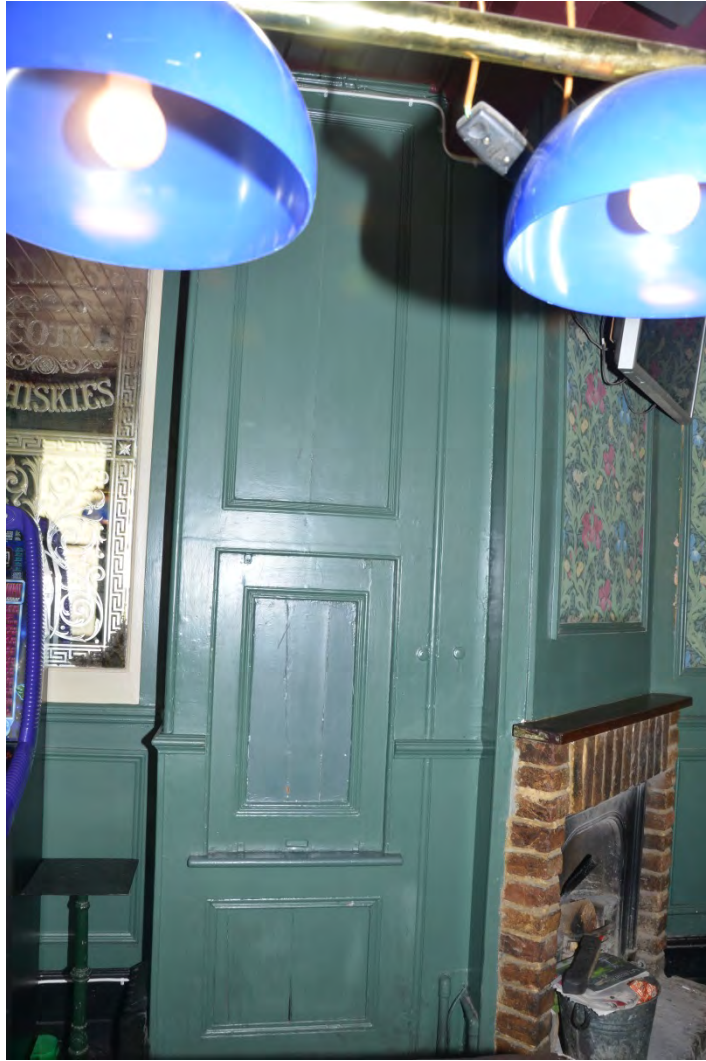
**Plate 22: Panelled enclosure for the dumb waiter**

The dumb waiter and its panelled enclosure is considered to be contemporary with the second phase of the building and the installation of mouldings and panelling to the southeast, c. post 1872.

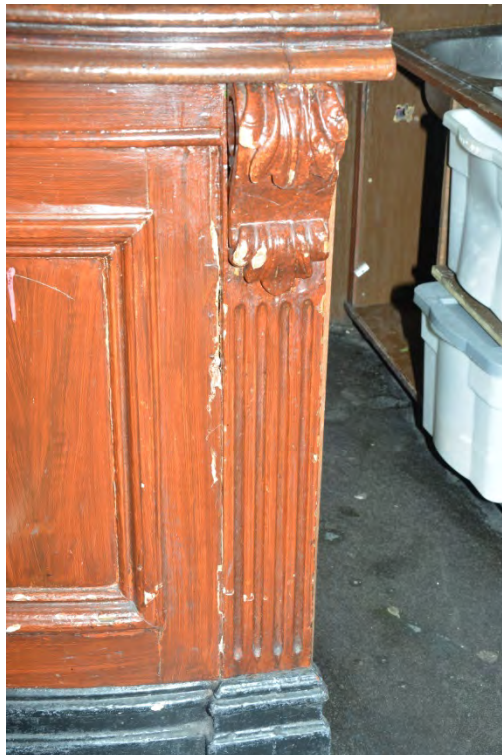
**Plate 28: Detail of moulding, bar counter**

The majority, if not all, of the bar was replaced following a 2003 planning application. It is therefore not a historic feature.

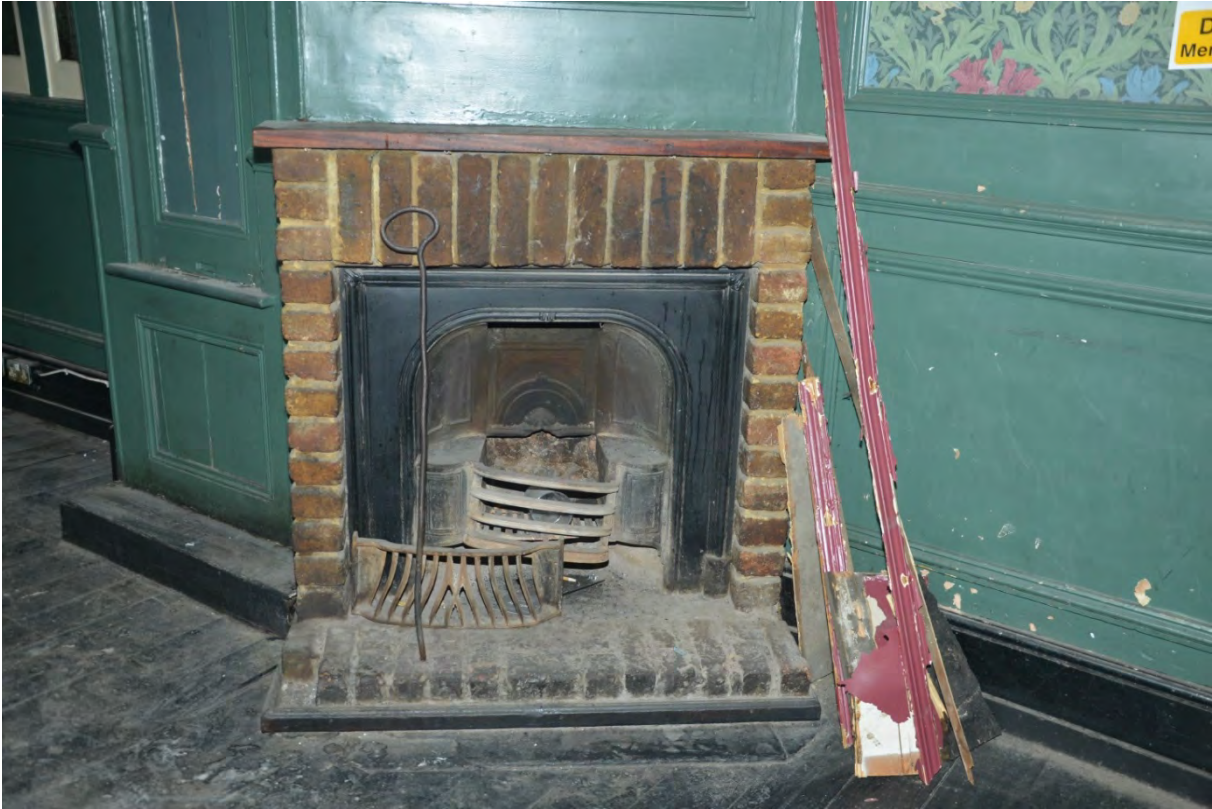
**Plate 29: Fireplace, eastern wall**

The fireplace to the north of the bar counter, against the eastern wall, comprises a mid-late 19<sup>th</sup> century cast iron insert with early-mid 20<sup>th</sup> century brick surround.

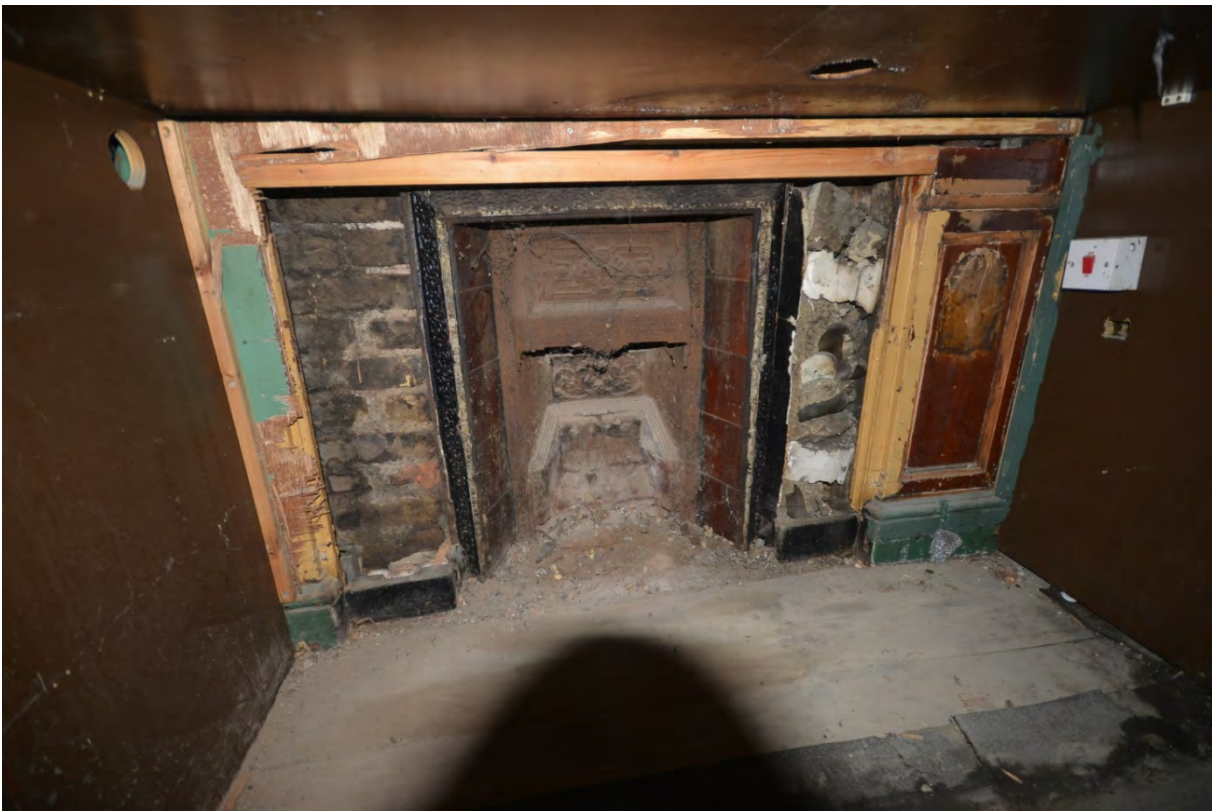
**Plate 30: Fireplace revealed during strip of back bar area**

The fireplace depicted above was revealed during stripping of the back bar area towards the southern end of the servery. This form of fireplace is common to the late 19<sup>th</sup> – early 20<sup>th</sup> centuries.

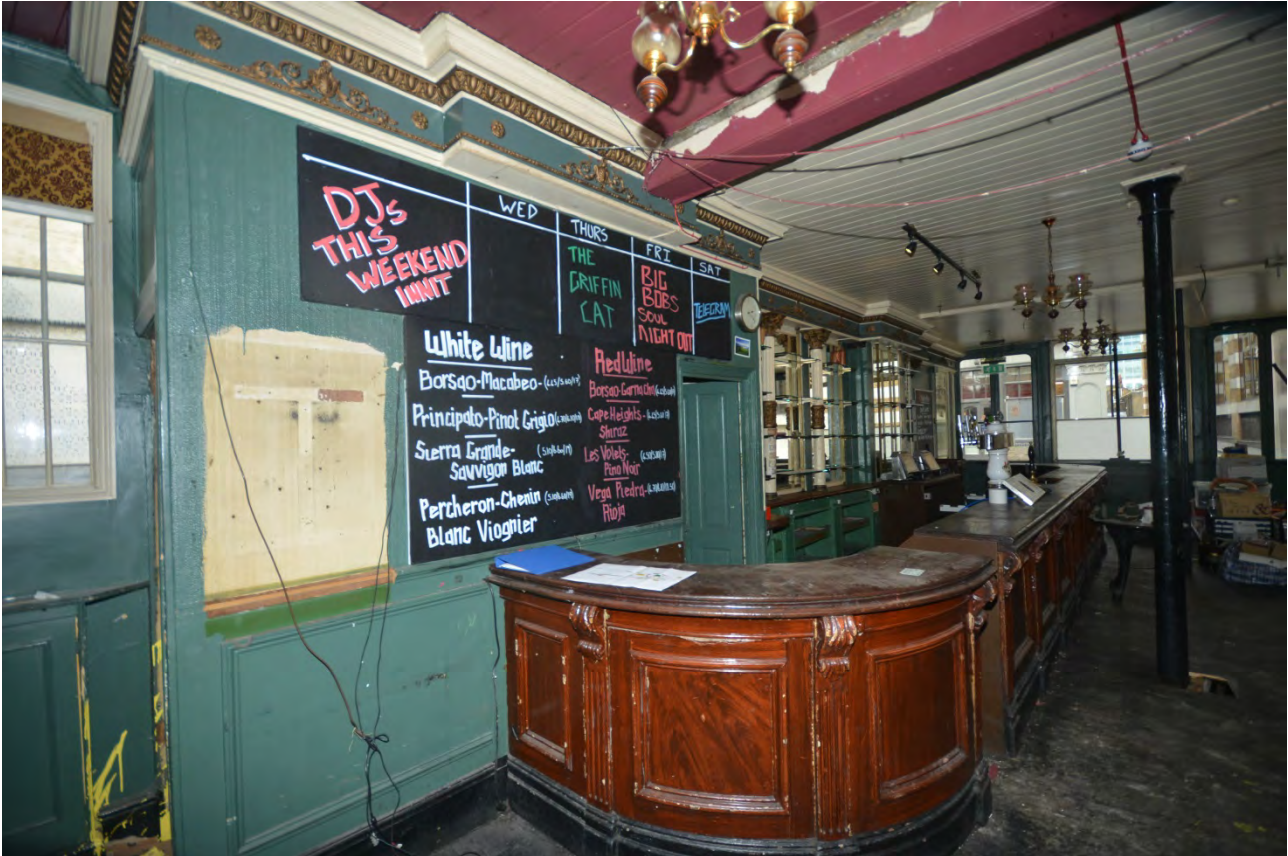
**Plate 31: North end of bar to be removed**

The northern, curved, end of the bar counter is to be removed and replaced with an open kitchen / food preparation area in the same shape as the original bar, further to the north.

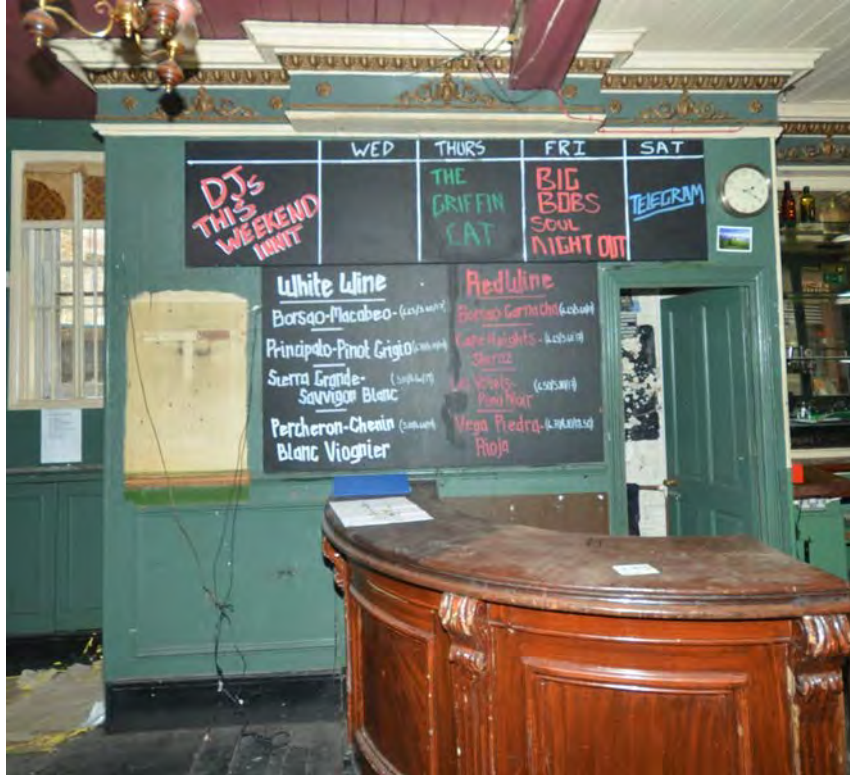
**Plate 32: The left hand half of this partition wall is to be removed**

An original partition wall formerly concealing a staircase to the first floor, now converted (with consent) into a store is to be opened to allow for the installation of food preparation equipment. The current door to the store, located in its northern wall, is to be blocked. The staircase to the south, leading down into the cellar, is to be retained, as is the moulded frieze and cornice.

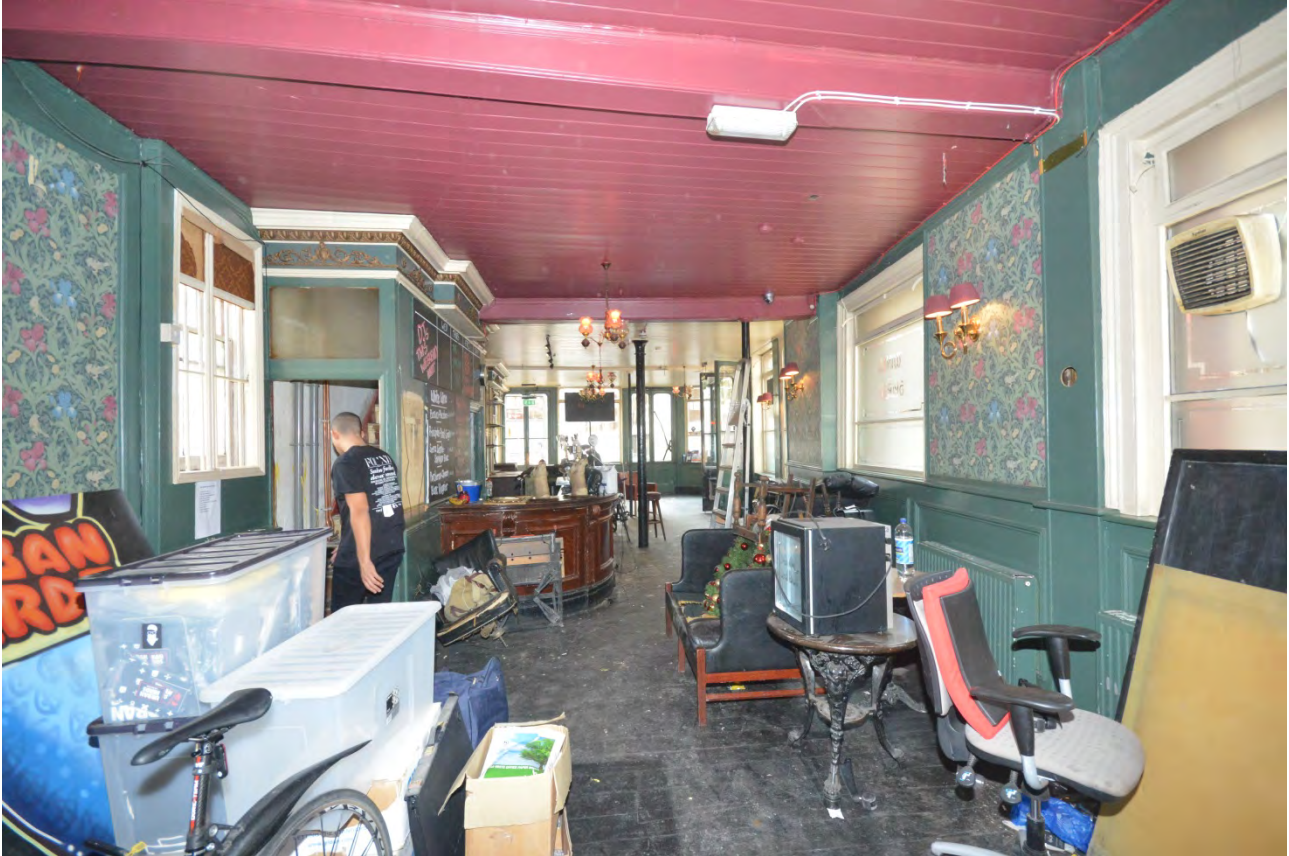
Works to the ceiling may incur damage / alteration to early timber panelling

**Plate 34: Timber panelled ceiling**

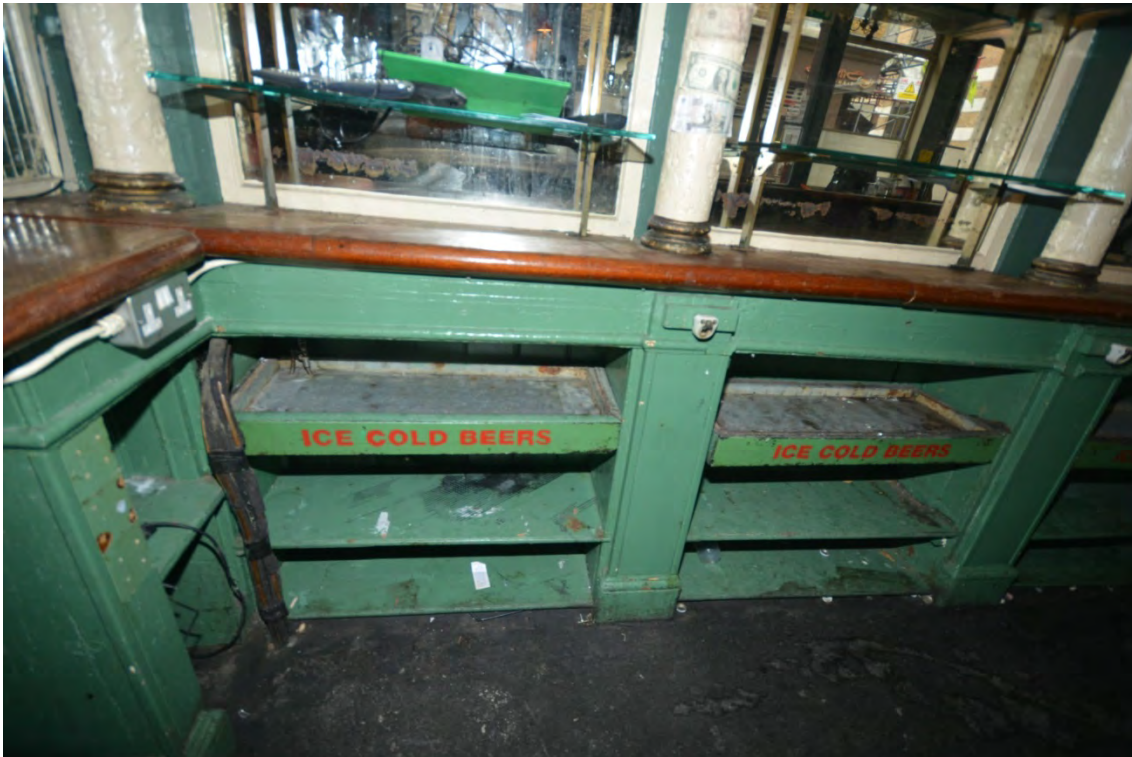
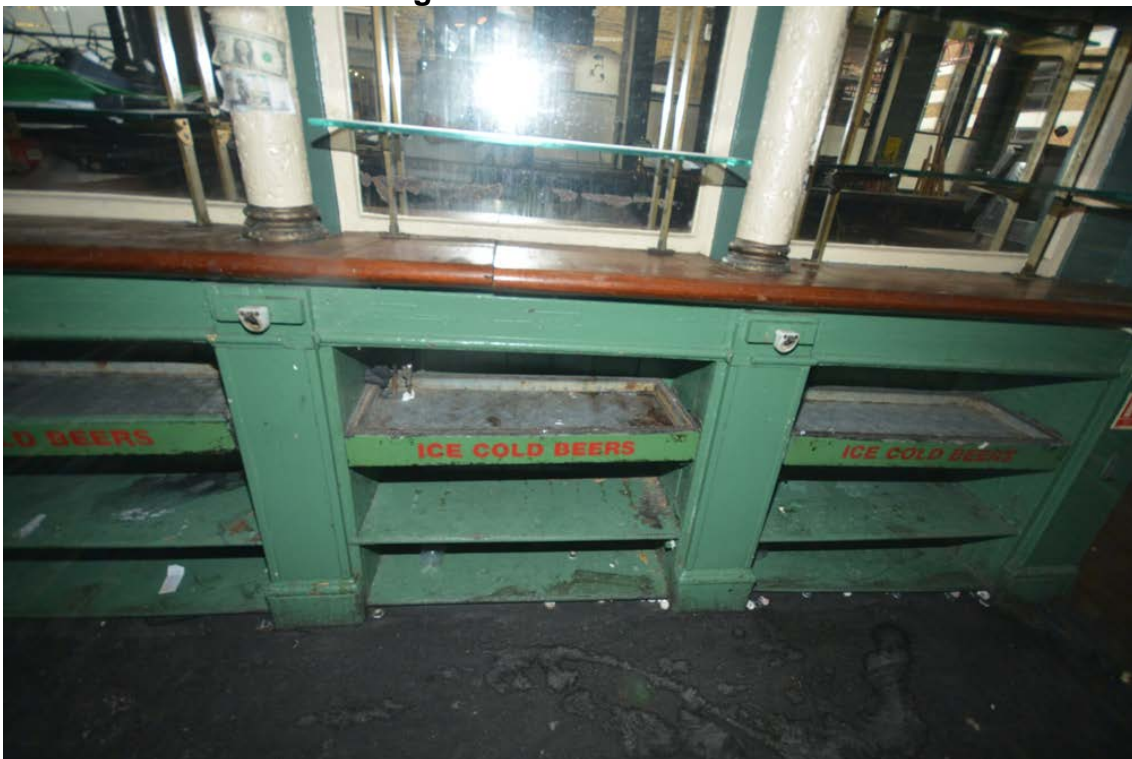
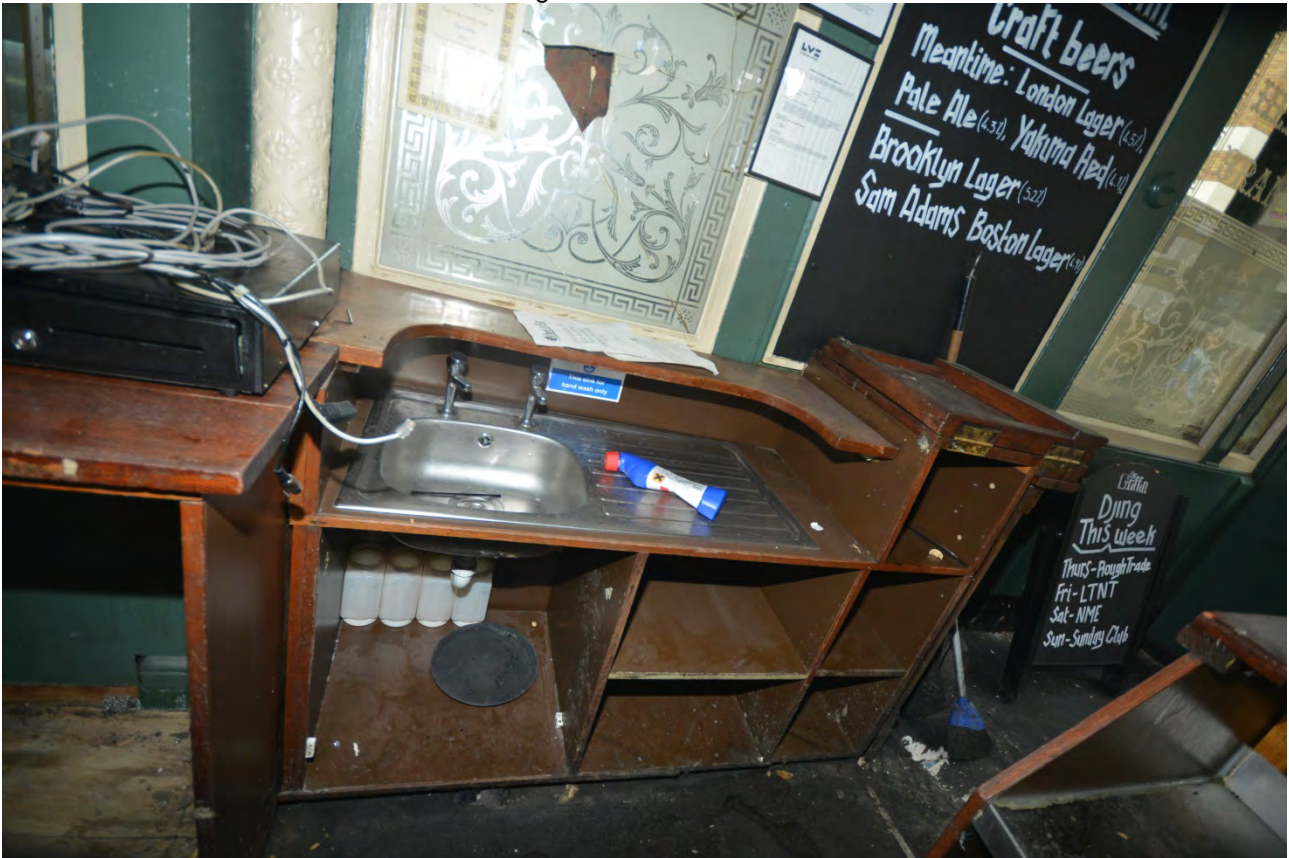
Plate 35: Detail of back bar fittings to be removed

Plate 36: Detail of back bar fittings to be removed

**Plate 37: Detail of back bar shelving to be removed**

The existing modern bar fittings are to be removed. A new mahogany lacquered bar top is to be added with display fridges and shelving below.

Whilst the overall form of the back bar is to be retained, the shelves are to be replaced with glass-fronted refrigerators, affecting the historic visual appearance of the back bar.

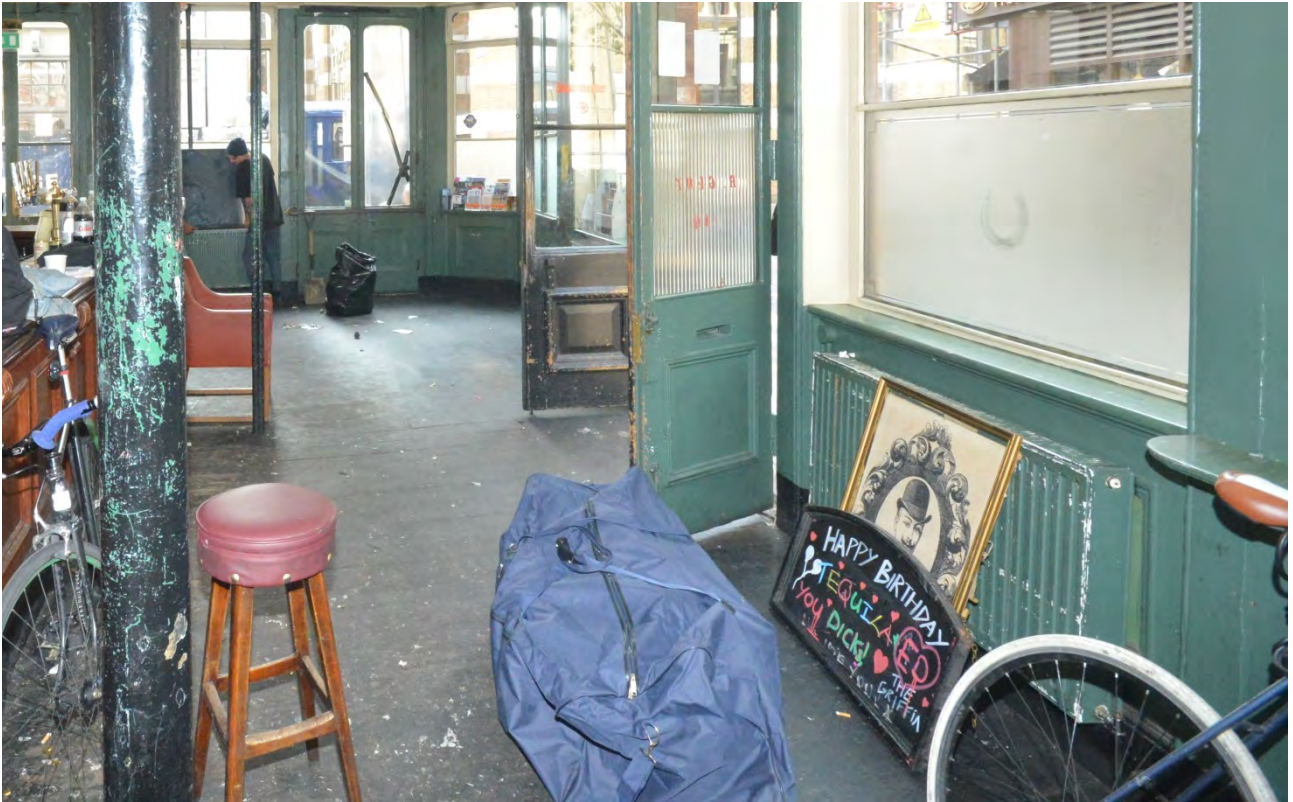
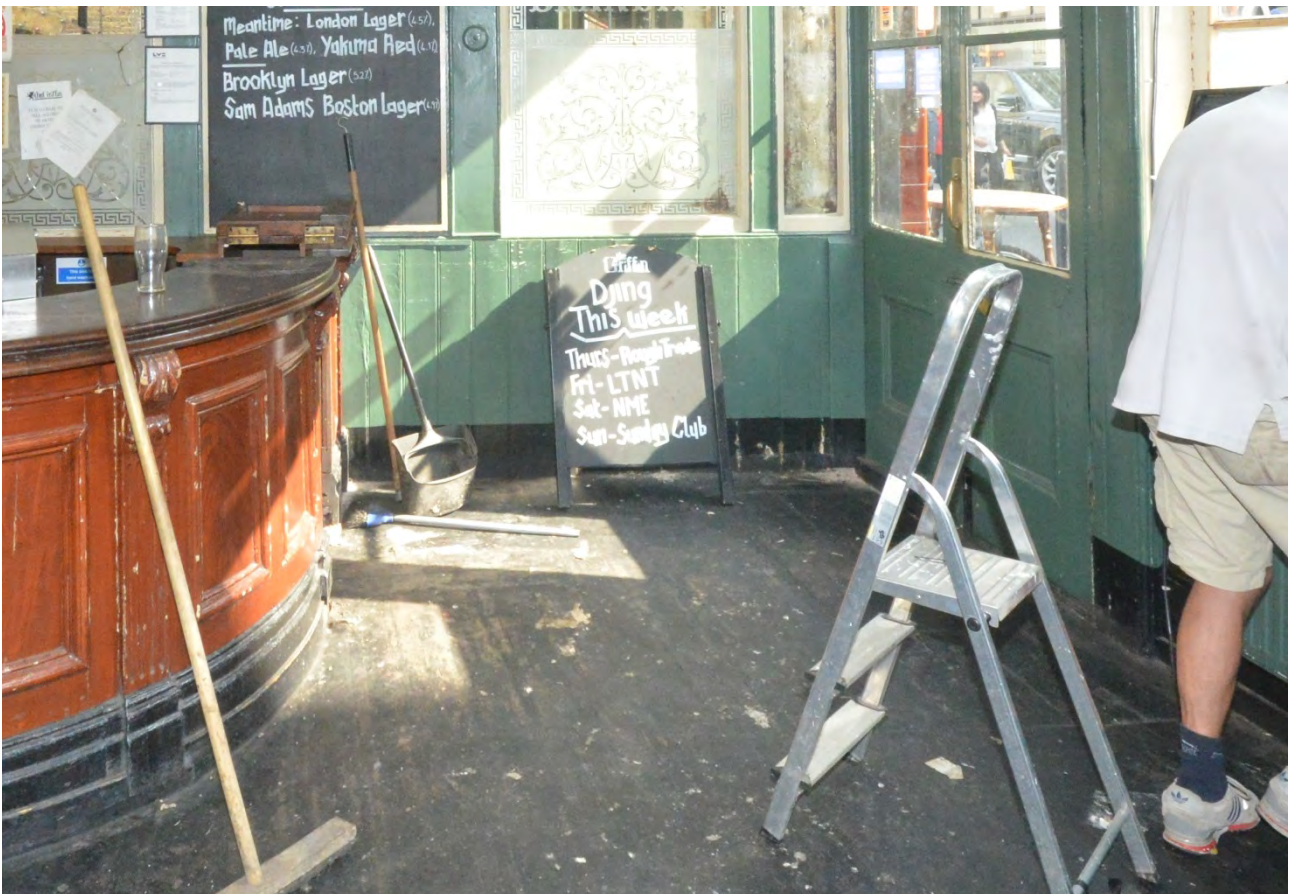
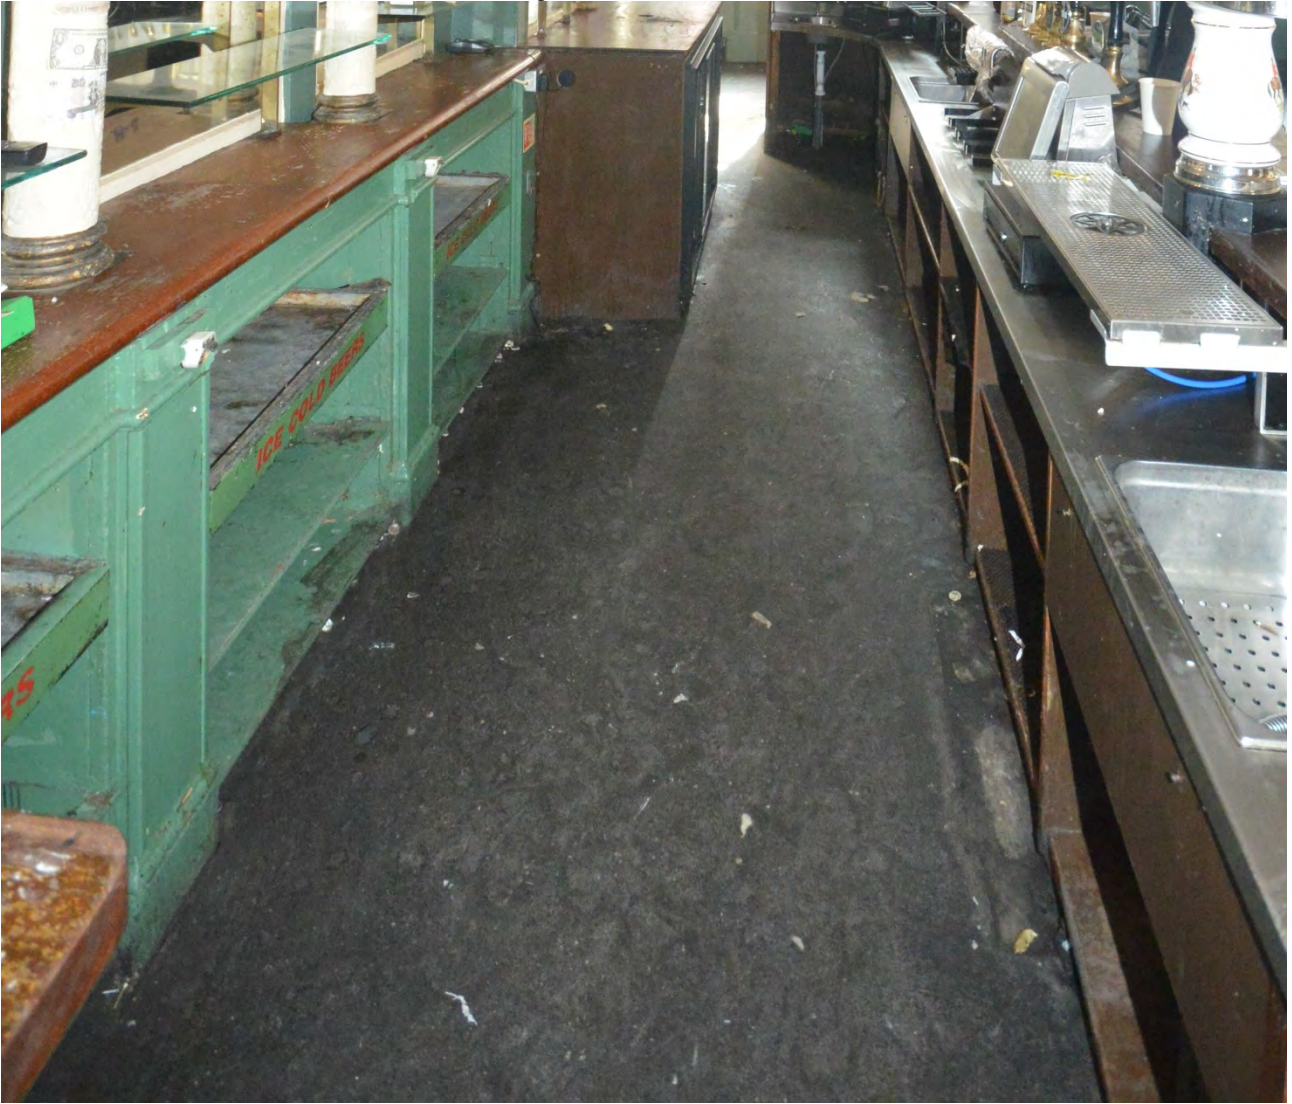
Plate 38: Flooring to be replaced

Plate 39: Flooring to be replaced

**Plate 40: Flooring to be replaced**

Replace existing flooring with 'smoked oak' flooring.

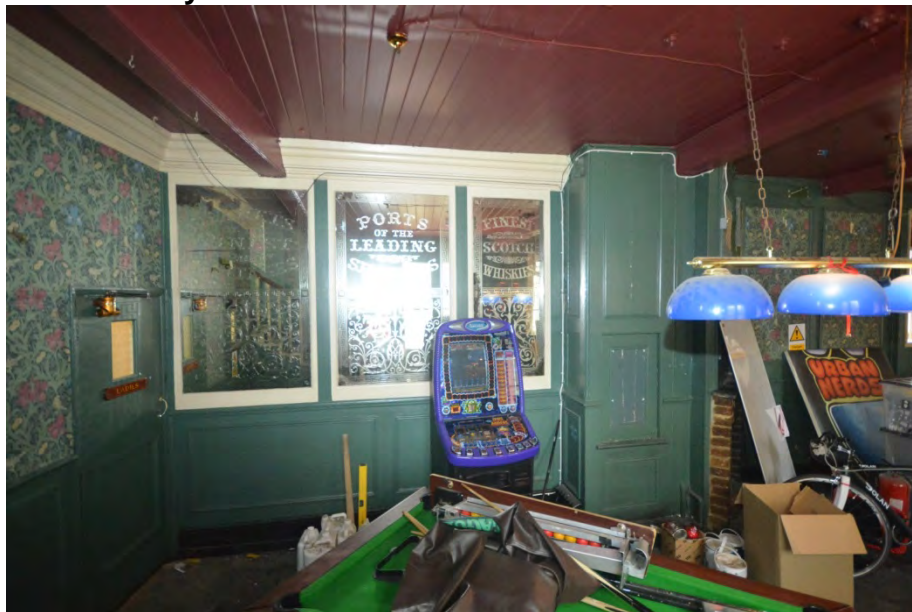
**Plate 42: Ducting to span ceiling in this location**

Install ventilation duct from proposed open kitchen area to duct in ladies' lavatory, including false ceiling in lavatory.

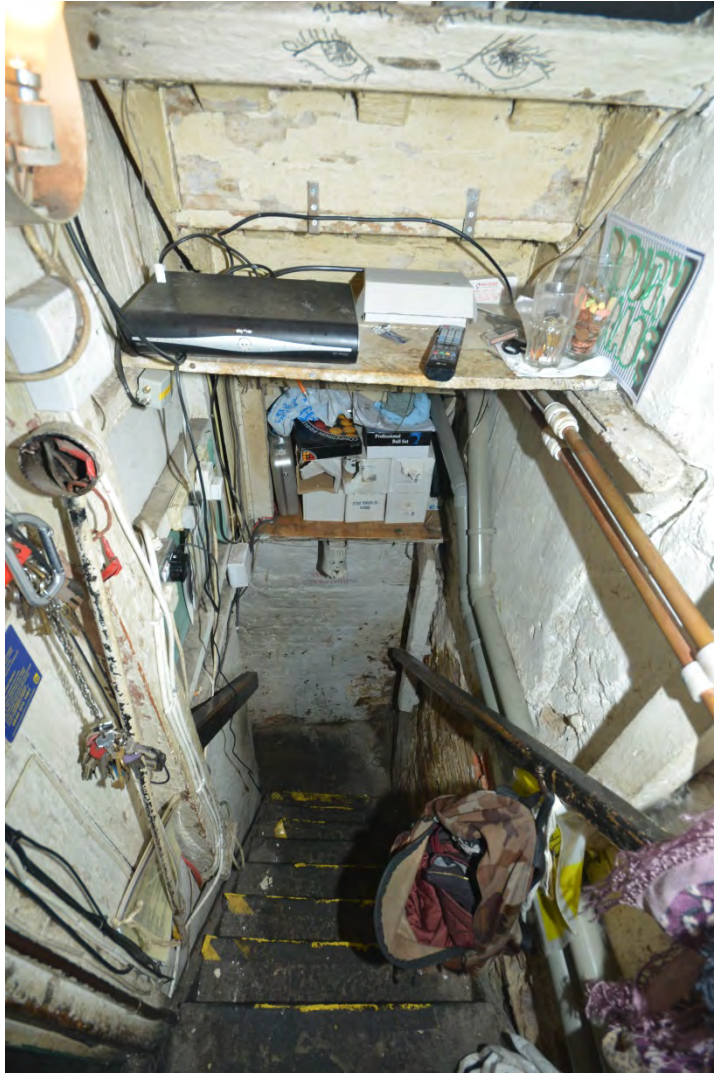
**Plate 44: The wall to the right of the photograph is to be investigated**

The condition of the stair wall is to be investigated and made good before decorating.
