Heritage Statement:

Ground Floor – The Bar  
The Griffin  
93, Leonard St  
Shoreditch  
London  
EC2A 4RD

Document Reference Number 2015/1254  
Version 0.5

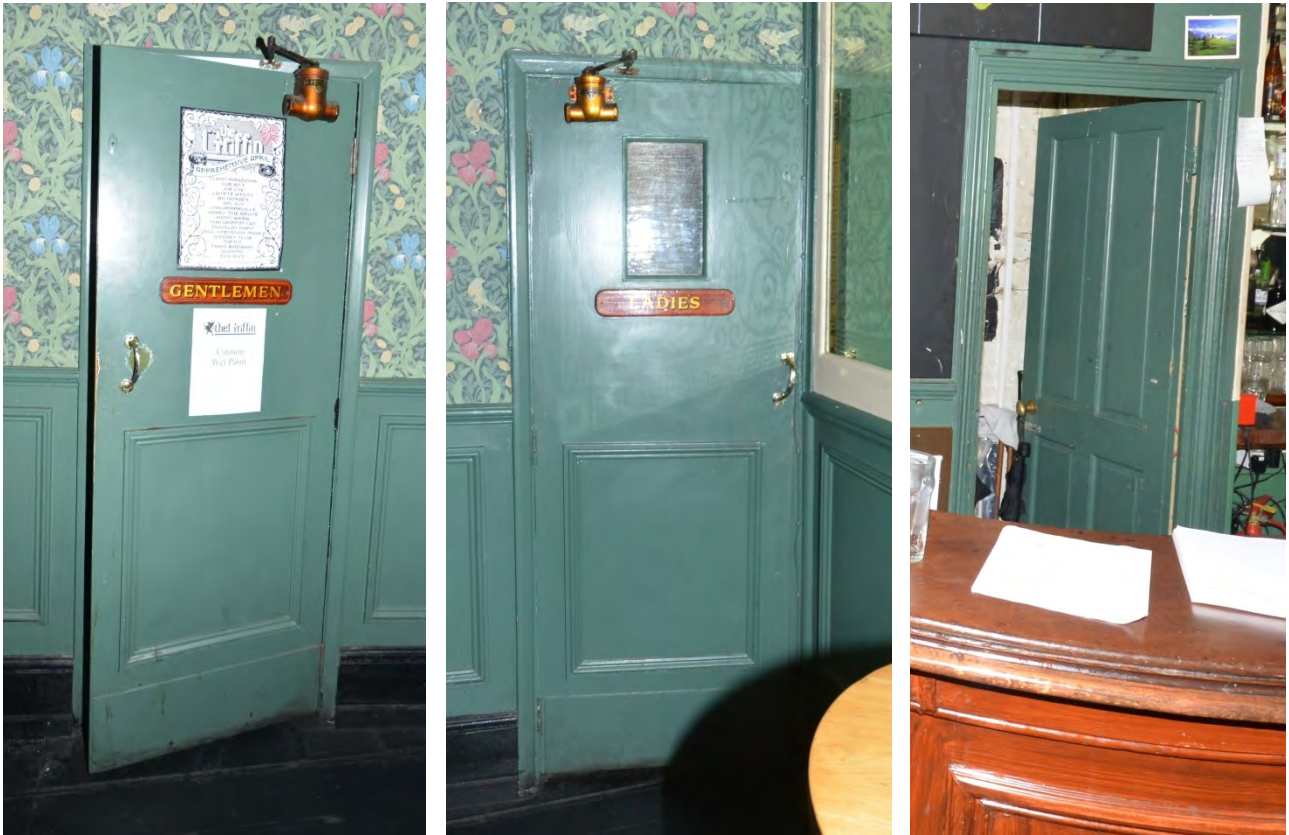
**Plate 45: Doors to be replaced**

The doors to the lavatories are modern and not in keeping with the décor of the bar area. The replacements will be more fitting.

The door to the staircase is an older four-panelled example. The replacement door will be similarly styled.

To replace the doors from the bar area to the ladies' and gents' lavatories and the staircase to the basement.

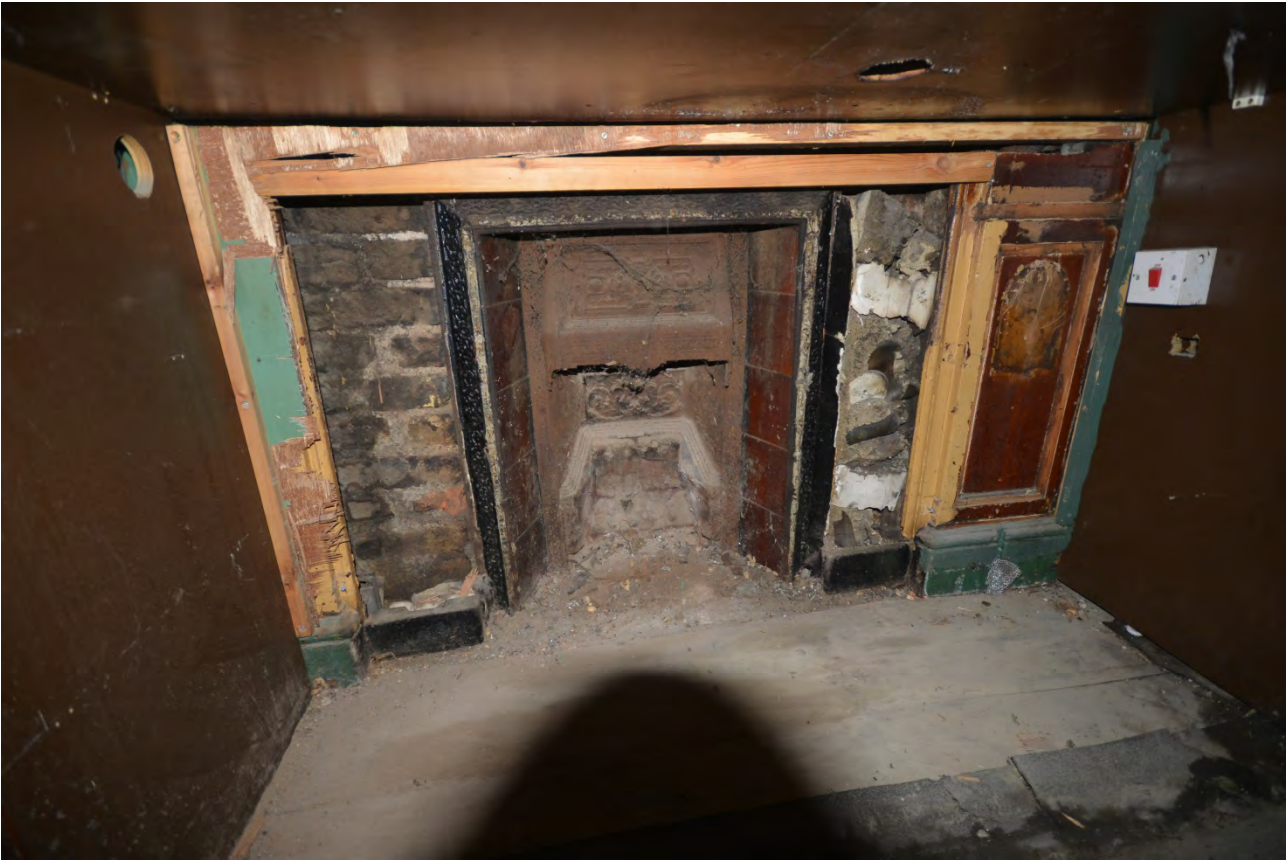
**Plate 50: Fireplace revealed during strip of back bar area**

A section of original panelling and skirting is visible to the right of the fireplace, which itself features a cast iron tiled insert with plain tiles. The fire basket is missing. This form of fireplace is common to the late 19<sup>th</sup> – early 20<sup>th</sup> centuries.

Bare brick to the left and bottles and general refuse bonded in mortar to the right indicates the location of a former fire surround and mantle shelf, considered to have been removed when the fireplace was boarded over. The presence of general refuse forming the wall to the right may indicate the opening was once larger and has been reduced in size using whatever materials were to hand in order to accommodate the insert now present.

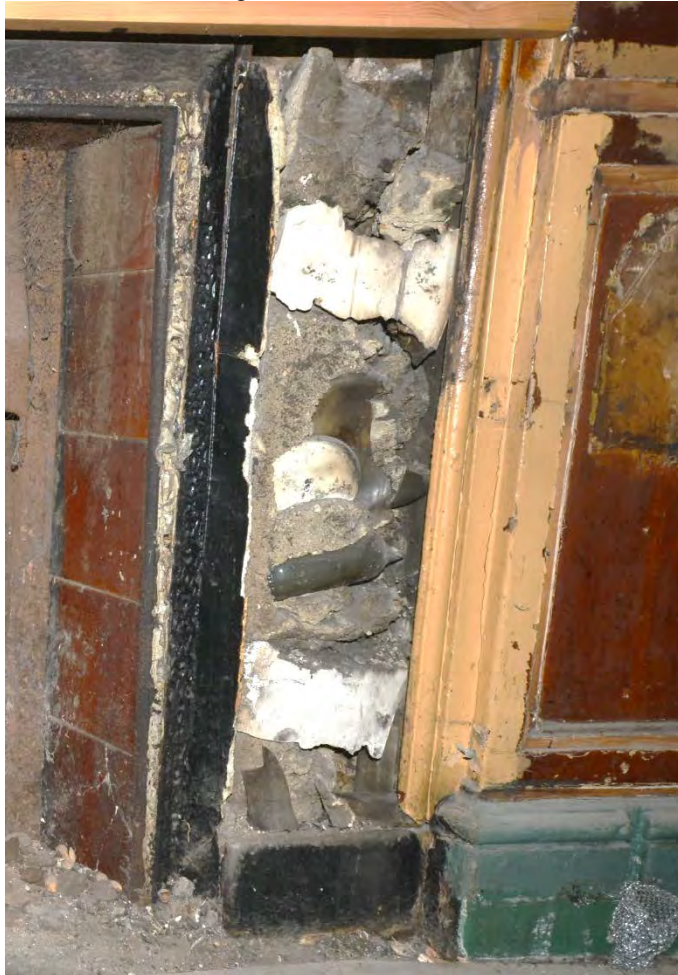
**Plate 51: Detail of bottles and refuse forming right hand wall of fireplace**

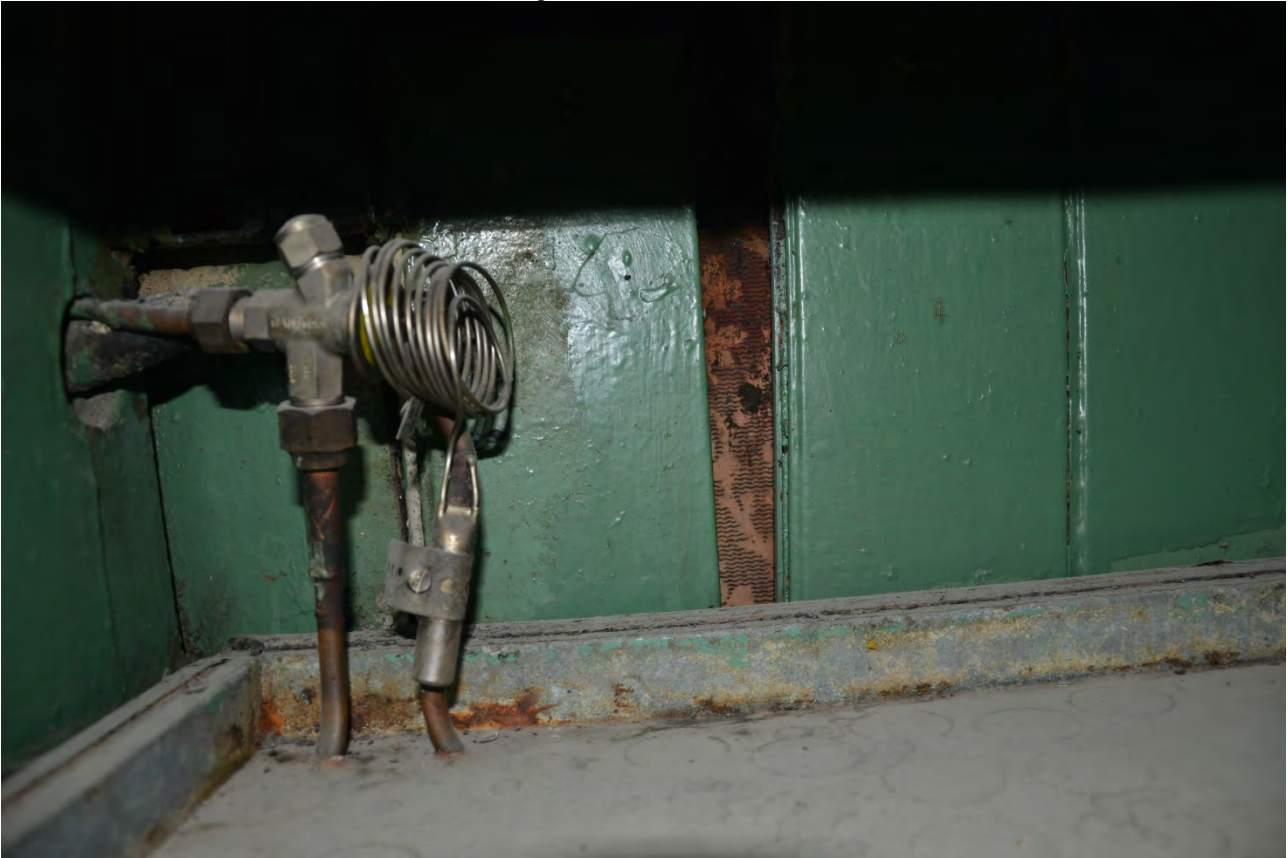
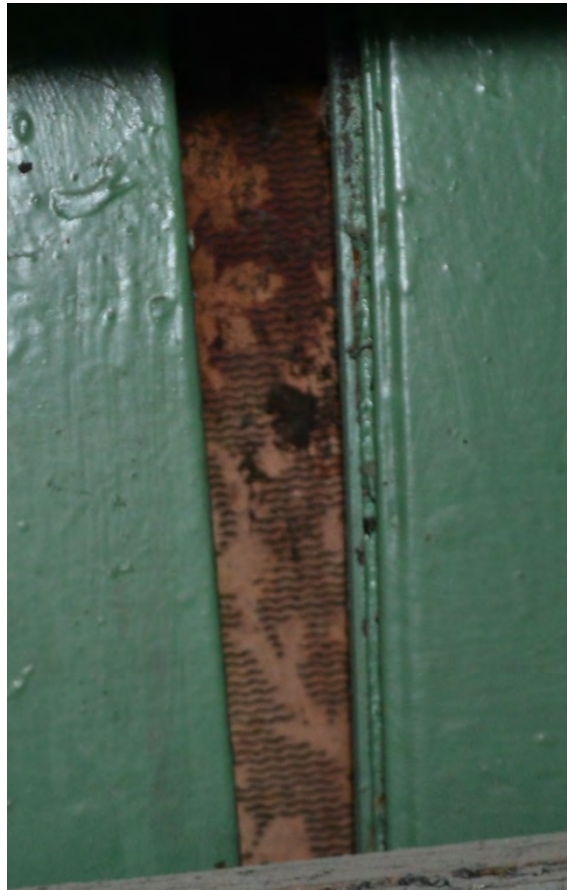
**Plate 53: Early wallpaper revealed on eastern wall**

To the north of the fireplace, a gap in tongue and groove panelling at the rear of the under-counter shelving has revealed historic wallpaper with a floral motif of an uncertain date. It is clear, in this area at least, the tongue and groove panelling cannot be original.

**Plate 54: Detail of wallpaper pattern**

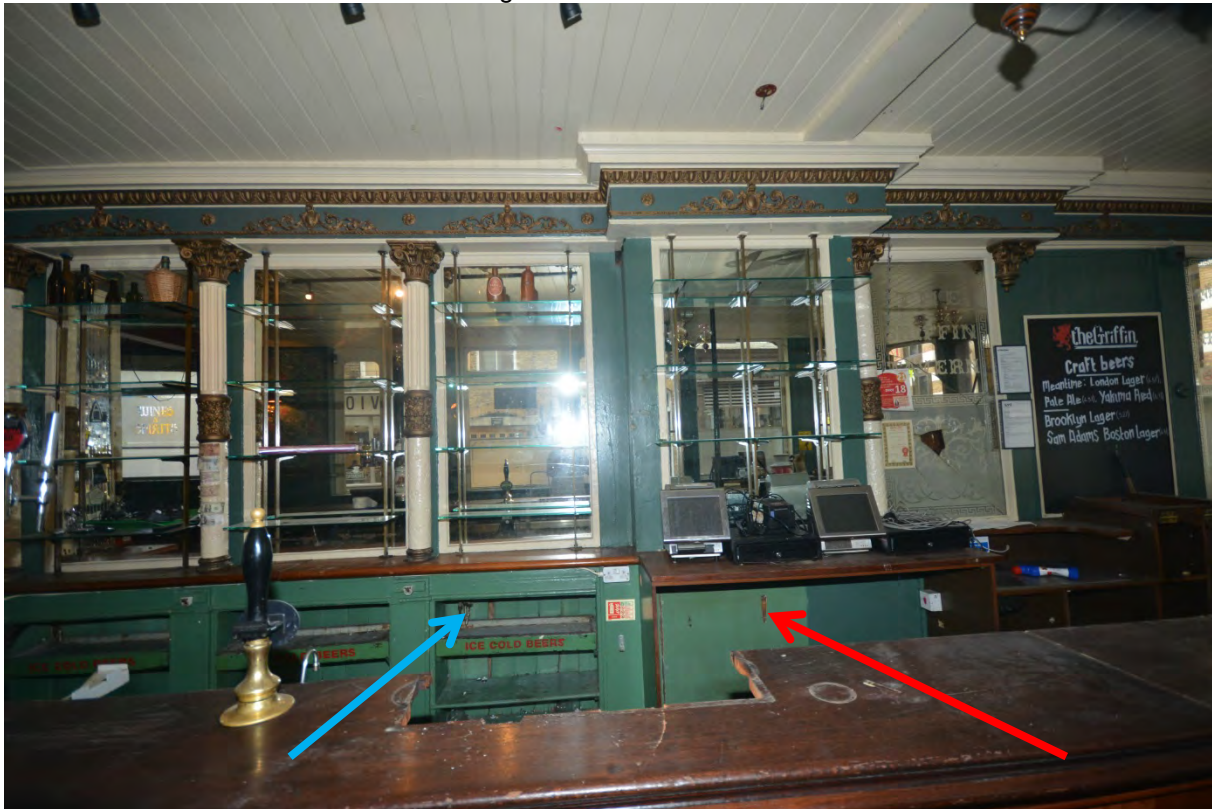
**Plate 55: Location of fireplace (arrowed red) and wallpaper (arrowed blue)**  
The above photograph clearly shows the chimneybreast leading up from the fireplace.

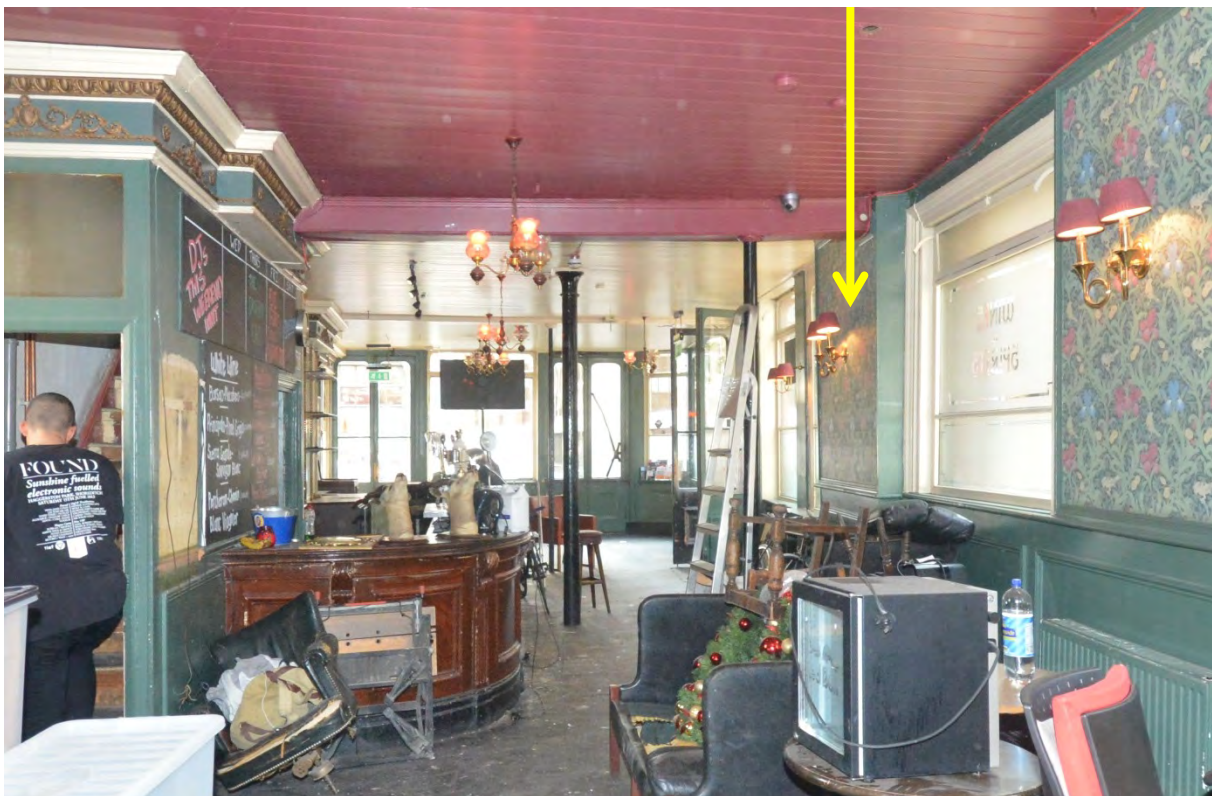
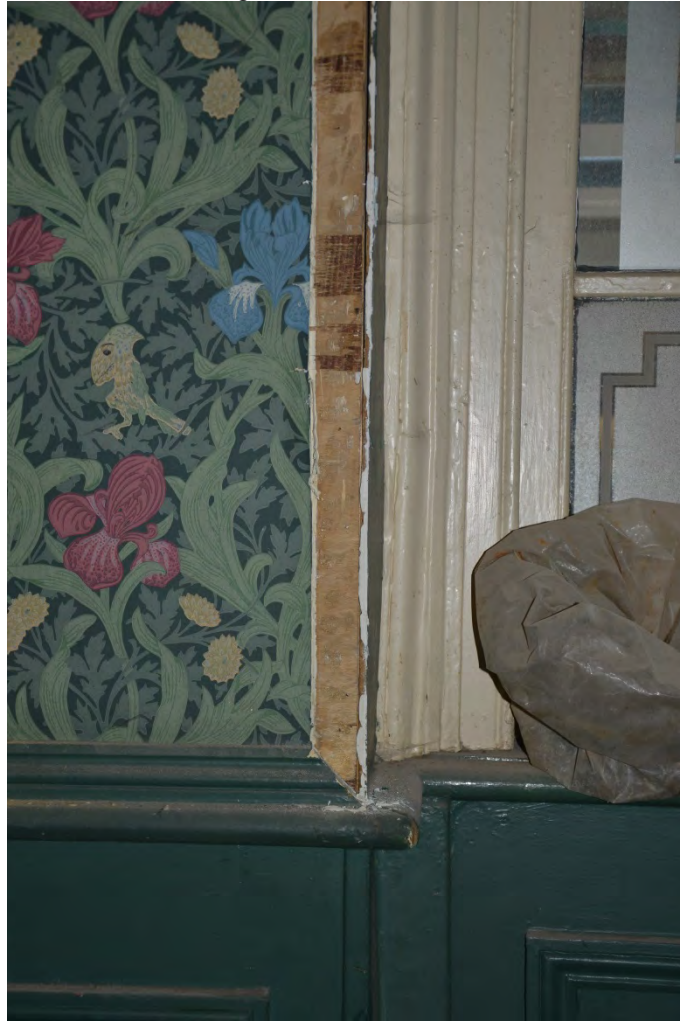
To the west of the building opposite the northern end of the bar counter, a section of wall has been revealed to be of modern plywood construction, boxing in a soil pipe which runs from the upper floors.

**Plate 56: Location of plywood boxing (arrowed)**

**Plate 57: Plywood boxing in of soil pipe**

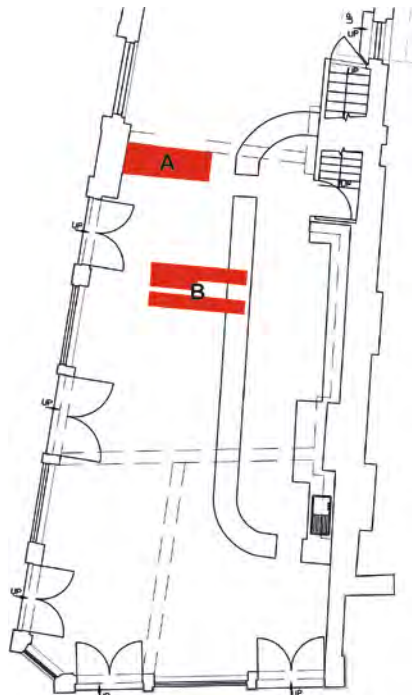
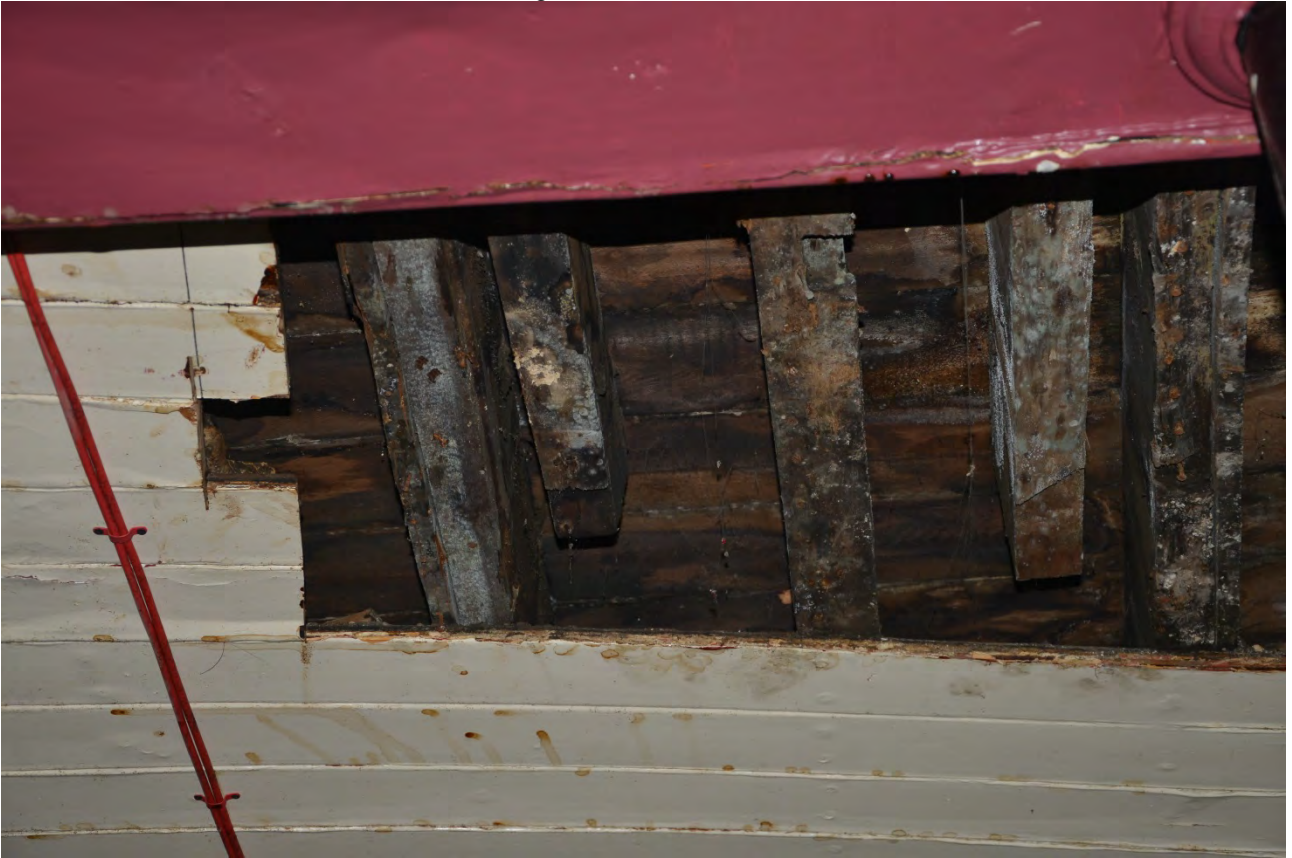
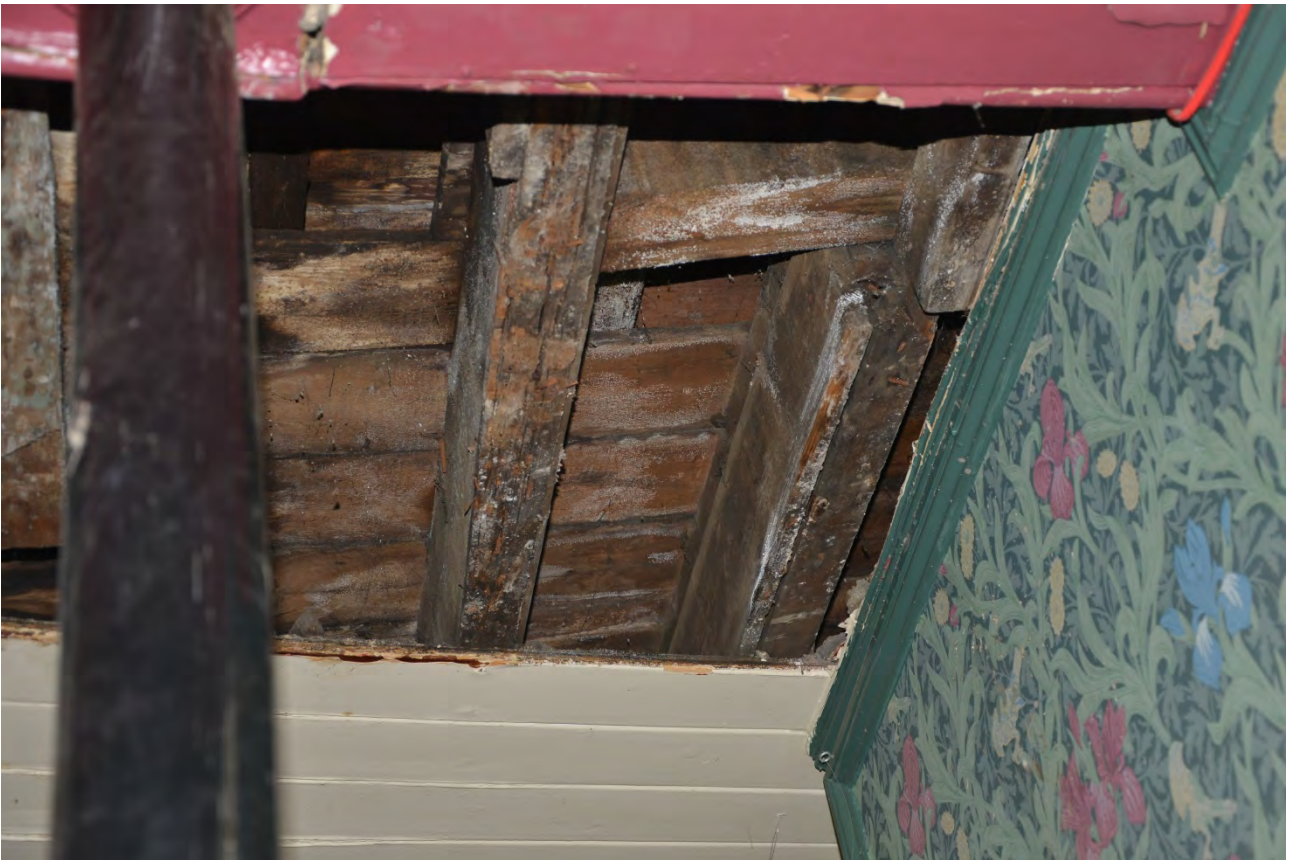
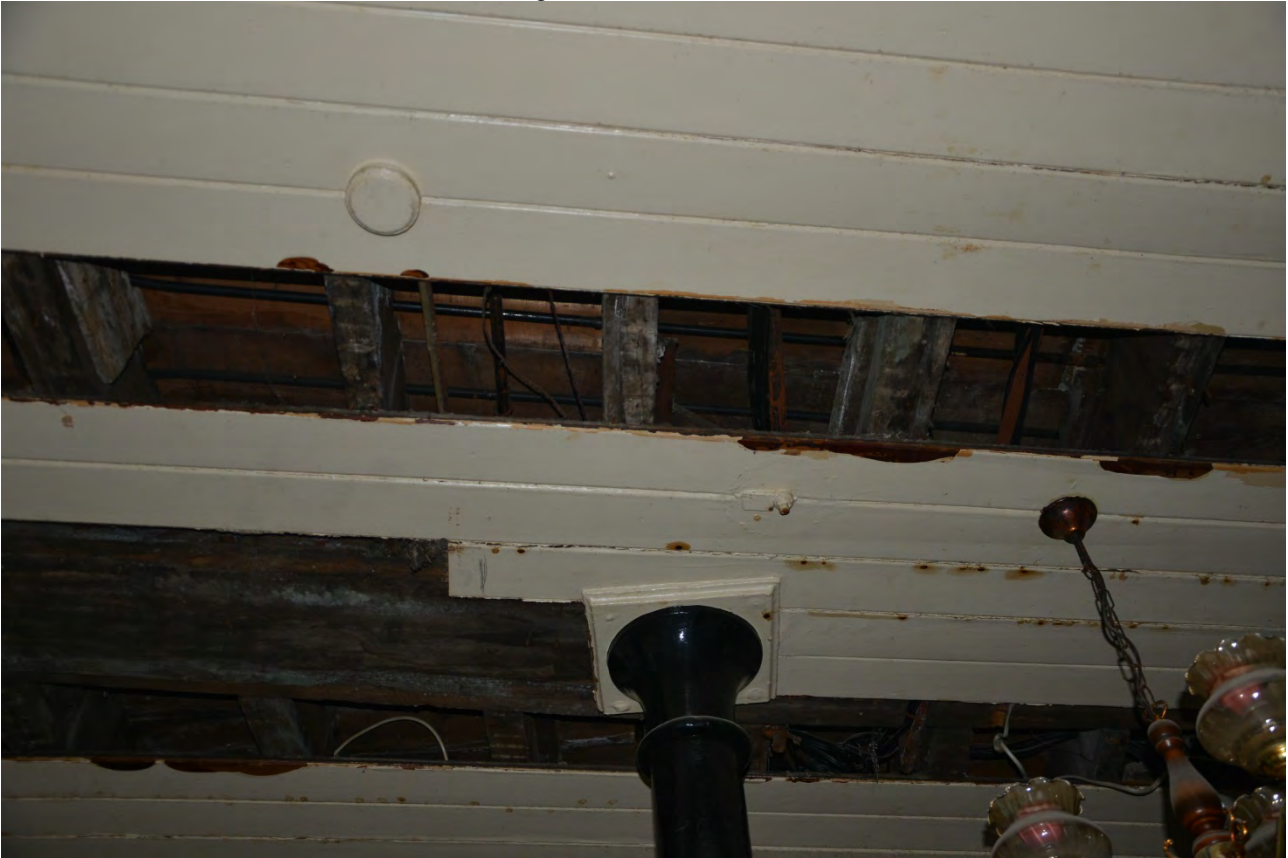
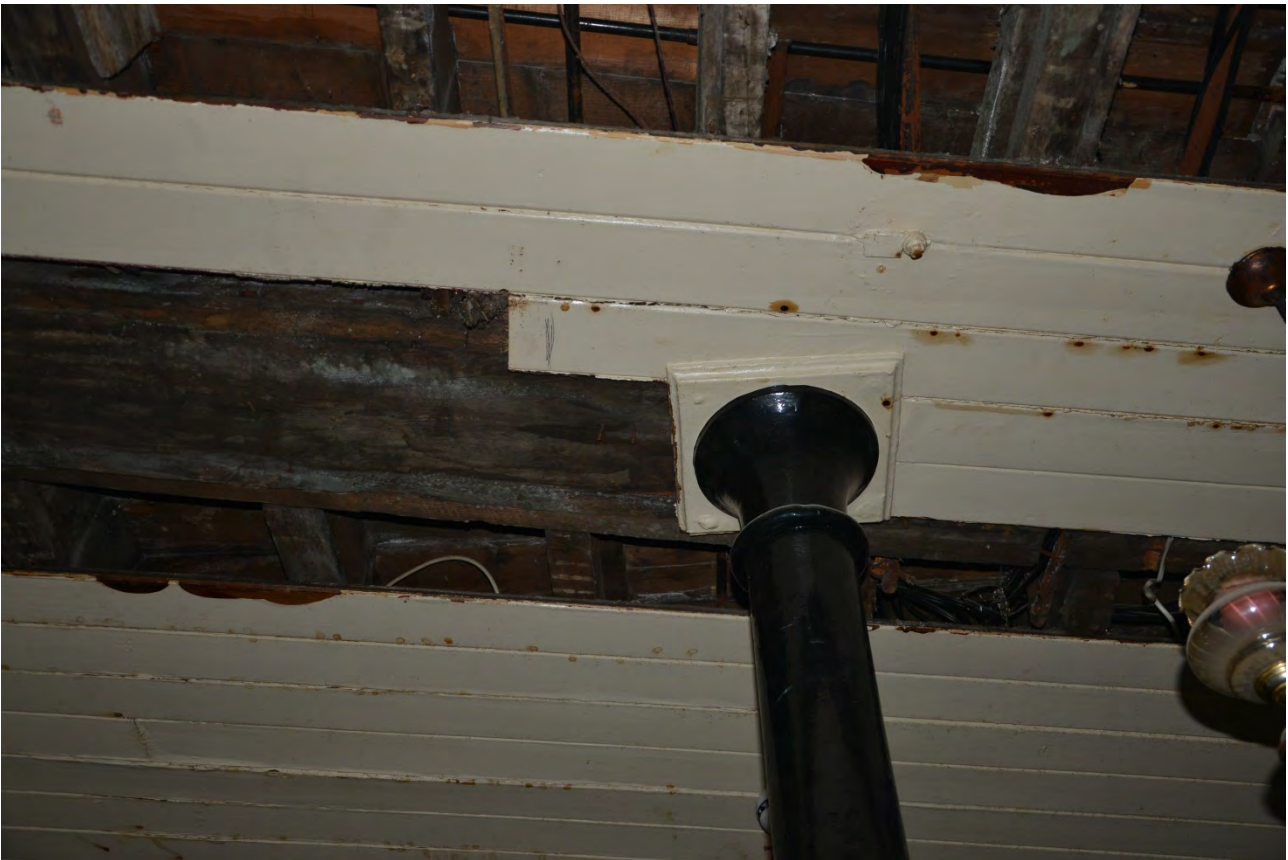
Exploratory works to the ceiling of the building have exposed timbers supporting the first floor. These are all machine-sawn and are in varying states of integrity.

**Figure 5: Location of investigative works in ceiling (not to scale)**

**Plate 58: Exposed ceiling / first floor timbers, area A**

**Plate 60: Exposed ceiling / first floor timbers, area B**
