Heritage Statement on  
**The Springs Hotel**  
Wallingford Road  
North Stoke  
Oxfordshire  
OX10 6BE  
National Grid Reference: SU813 863

Document Reference Number 2013/1168  
Version 0.6

Heritage Statement: The Springs Hotel  
Dr Peter Wardle and Colin Lacey  
18/10/2013

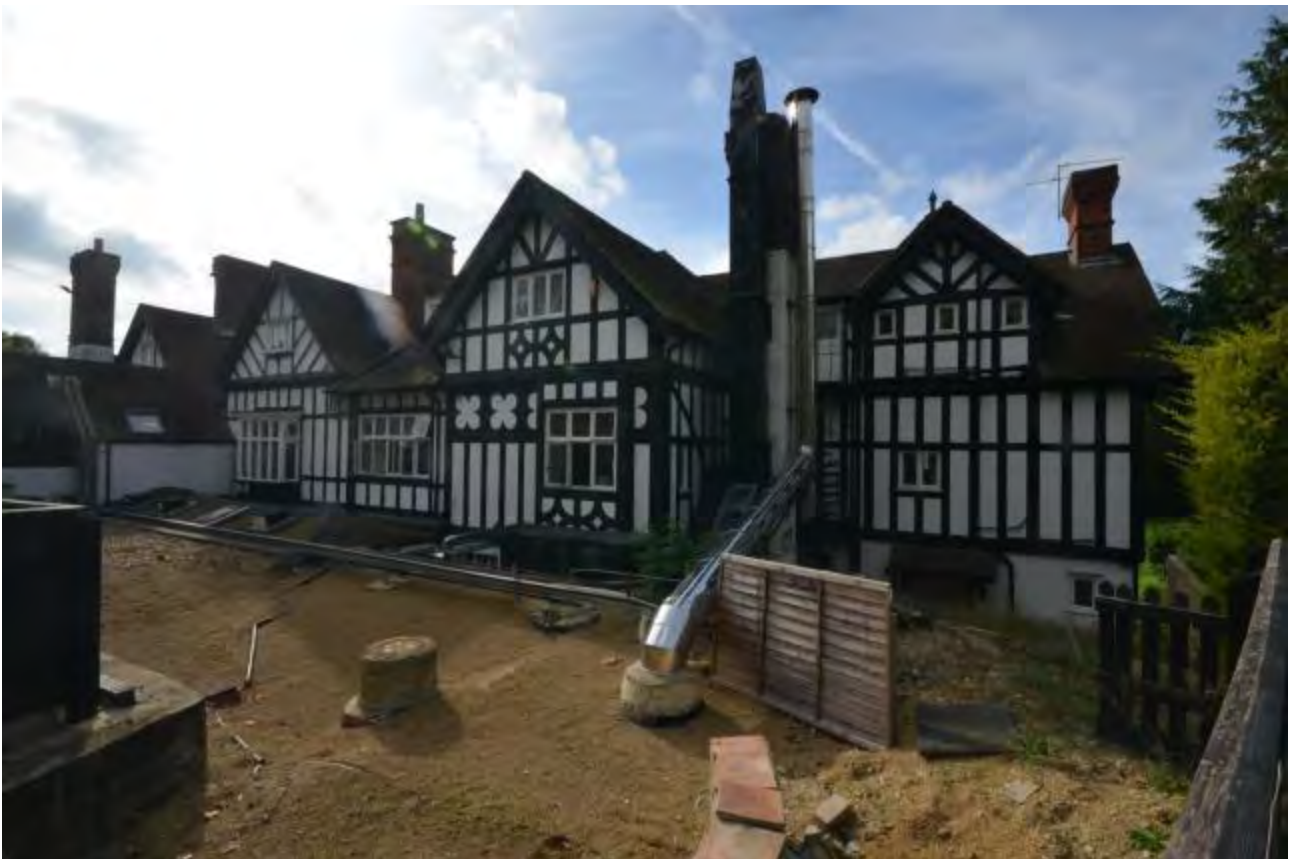
Plate 12 Front Elevation The Springs

The Springs Hotel itself detracts from the aesthetic character of the area by virtue of the presence of for example extraction flues and other paraphernalia.

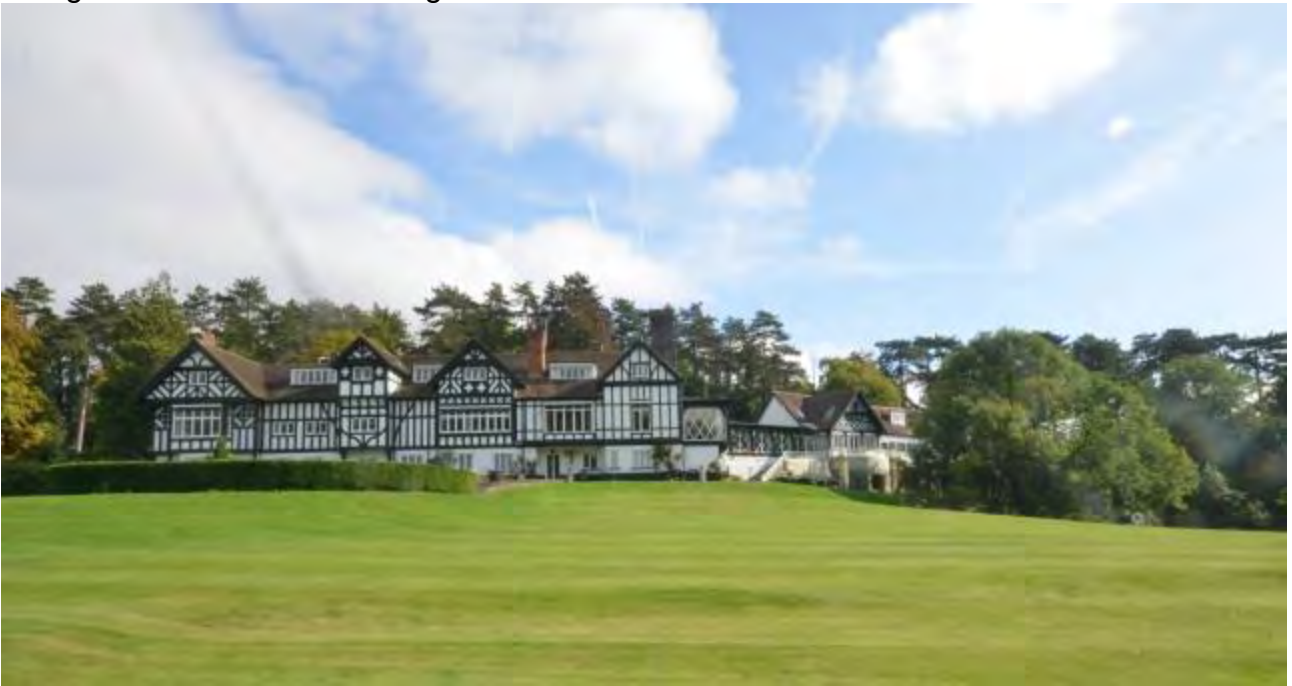
Plate 14 The Springs Hotel rear elevation

The building is a late Victorian Villa located at some distance from the settlement of North Stoke in what at the time was open countryside. It is not listed and is not on the local list of buildings. It is now used as a hotel and has been greatly altered on numerous occasions. The grounds are not on the register of Parklands and Gardens.

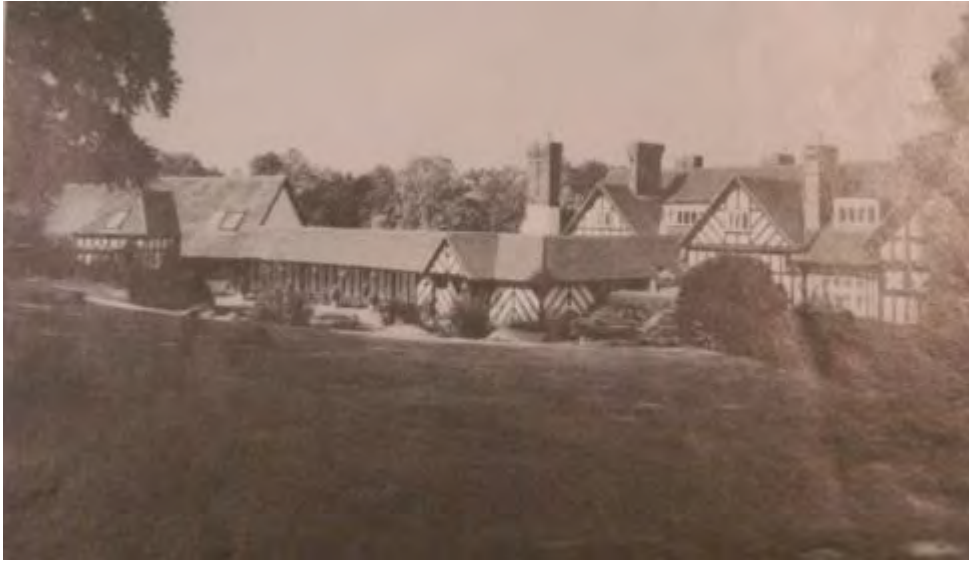
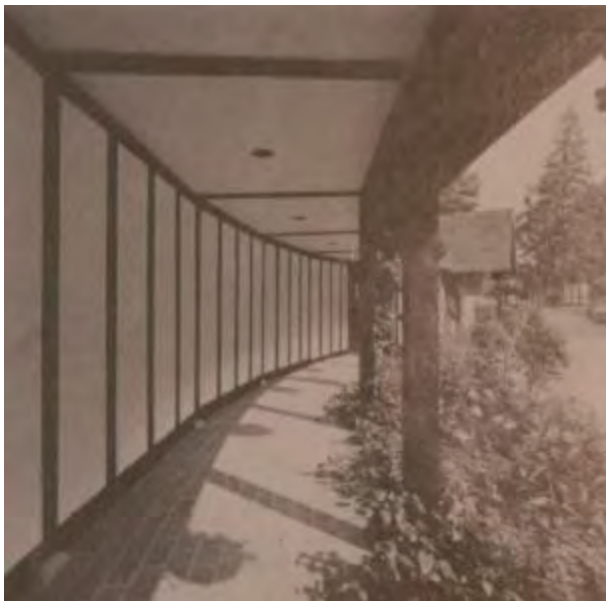
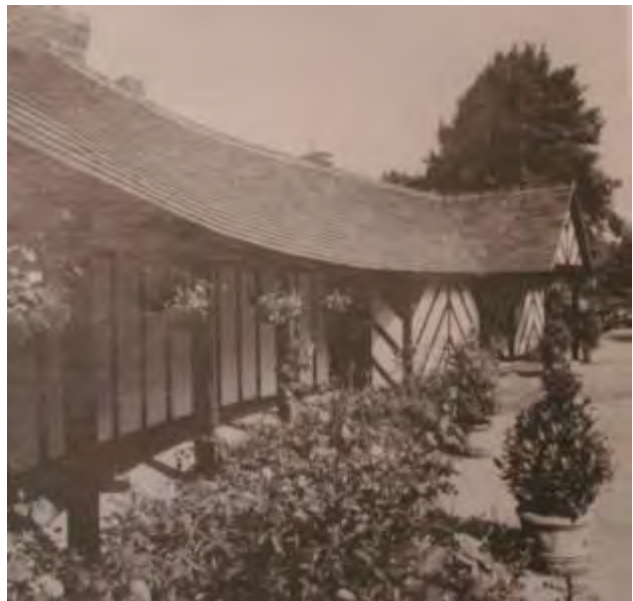
Plate 16: Architect's Journal, 1983

The curved walkway is located to the south of the current entrance and has subsequently been enclosed by glazing.

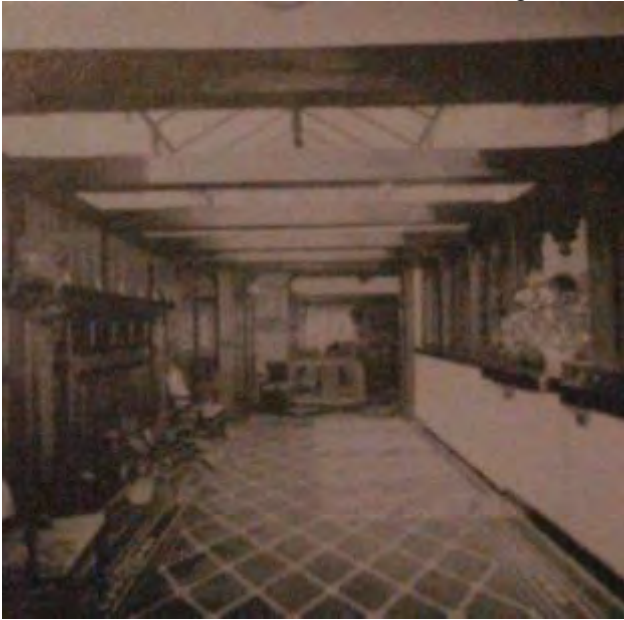
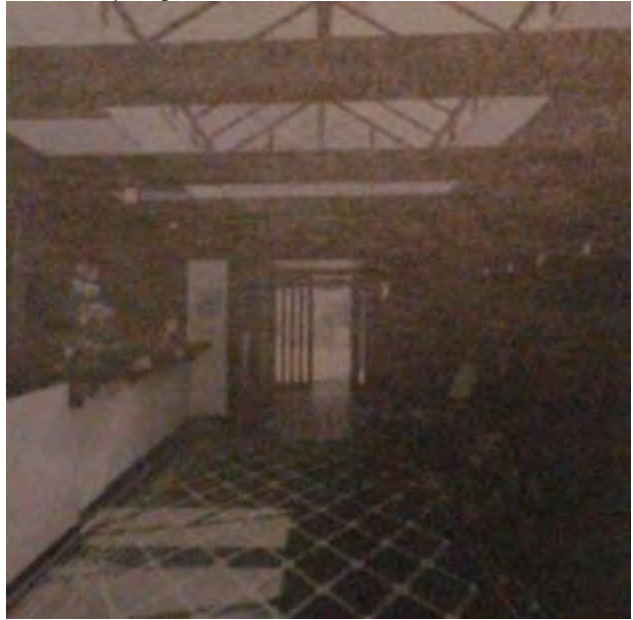
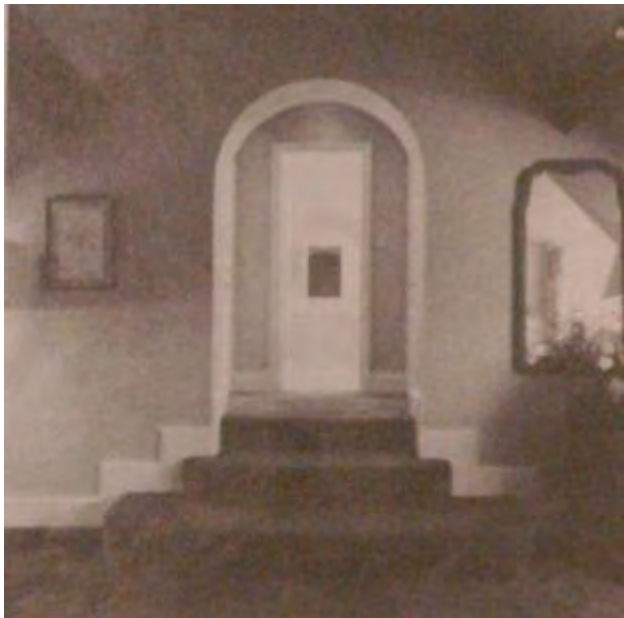
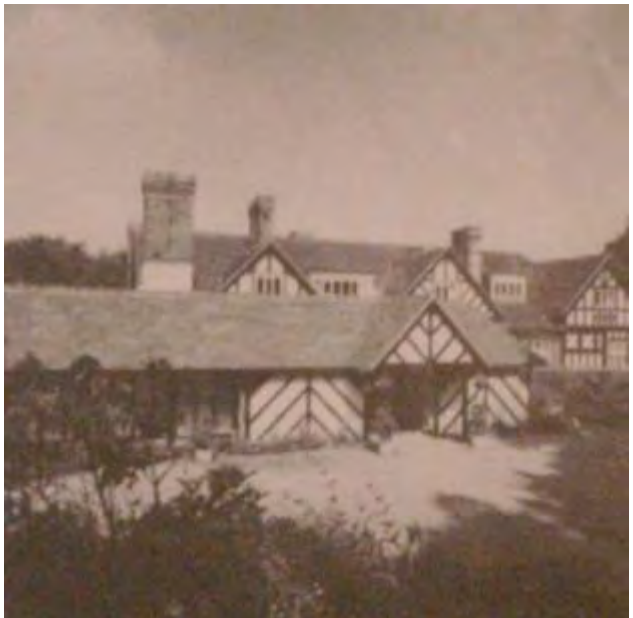
Plate 17: Architect's Journal, 1983

The images above show the new entrance / reception area and an arched doorway

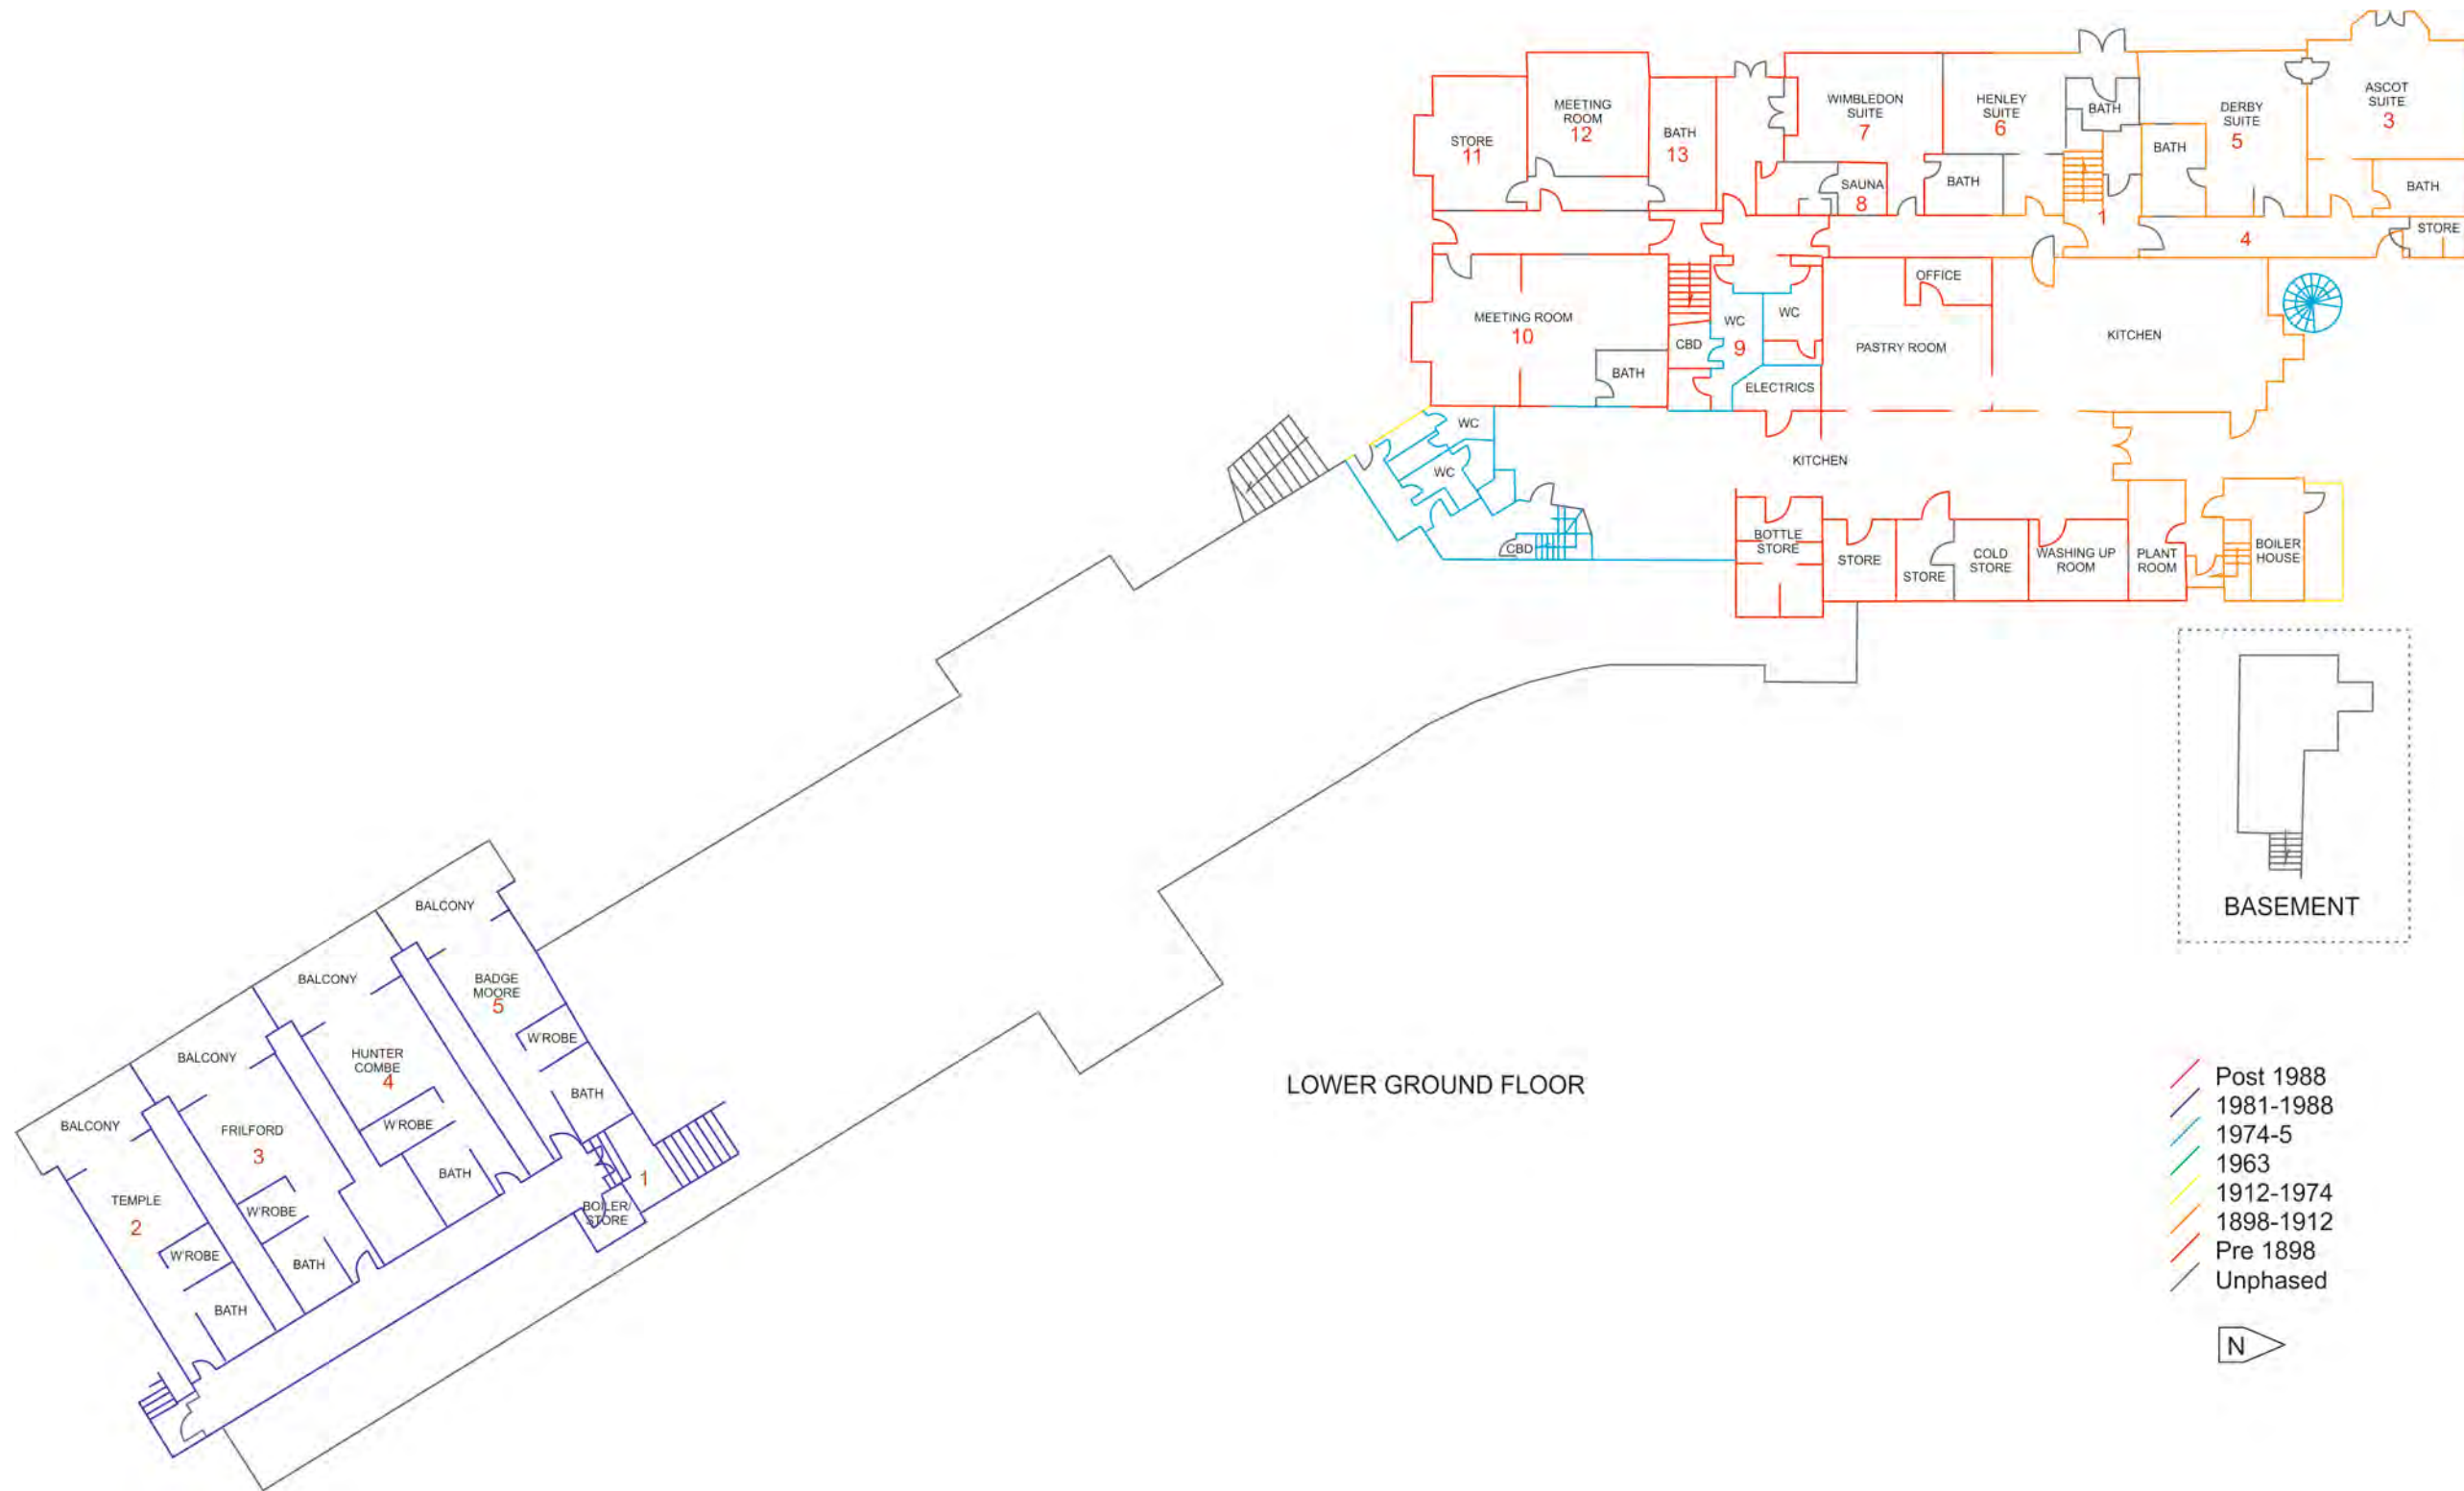
Figure 5 Phase Plan: Lower Ground Floor, 1:250 @ A3

Since the 1988 planning application was submitted, the door at the southern end of the lakeside wing axial corridor has been installed. This differs from the layout shown in the plans of the 1988 application concerning this part of the building.

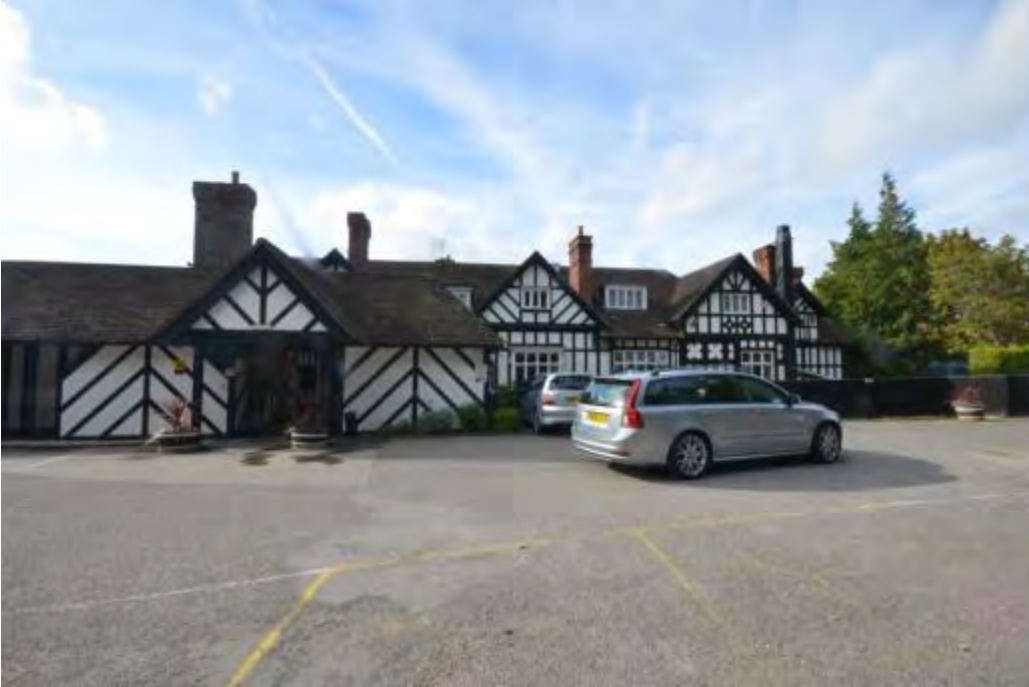
Plate 3: Northern part, front (east) elevation

The vast majority of the building, from all phases, is ornamented with mock Tudor timbers with rendered infill. The main entrance to the hotel is located to the left of the image, marked by the leftmost gable end. This was added in 1981. Whilst the majority of this elevation is decorated with mock timber framing, the degree of elaboration is somewhat less than that to the west, suggesting that although the east is now the front of the building, it was originally intended to be approached from the west.

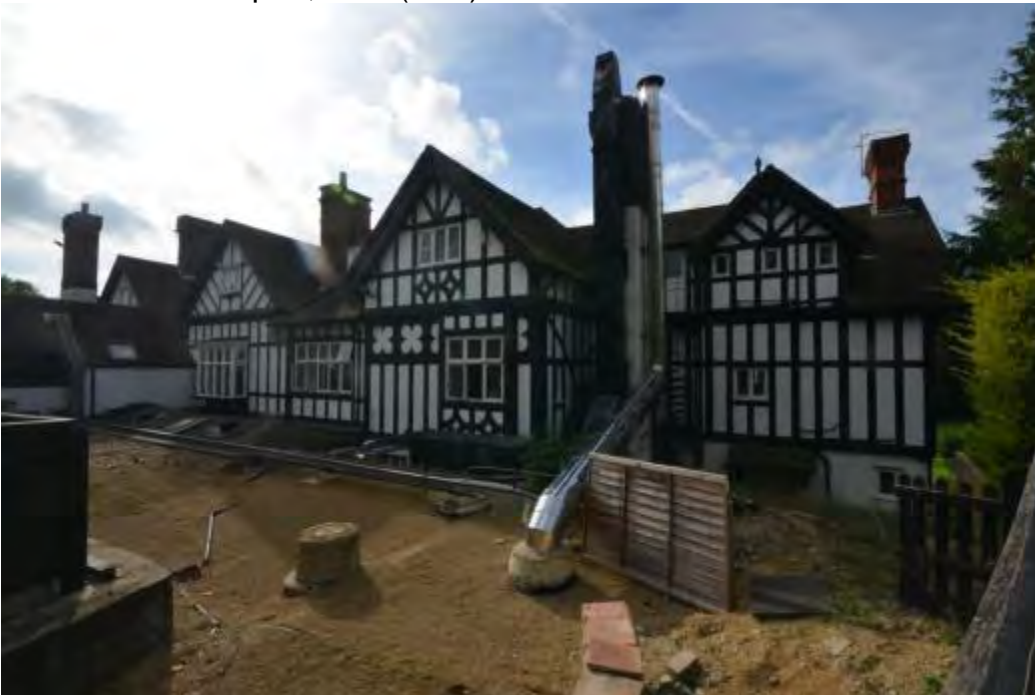
Plate 4: Detail of northern part, east elevation

The foreground of the above photograph is the roof over the lower ground floor kitchen. A large extraction duct is present running from the lower ground floor roof to a chimney on the main part of the building. The two gables to the left of the above photograph mark the extent of the original part of the building. The windows on this elevation, and throughout the building in general, vary with the phase of construction, with some being modern replacements.

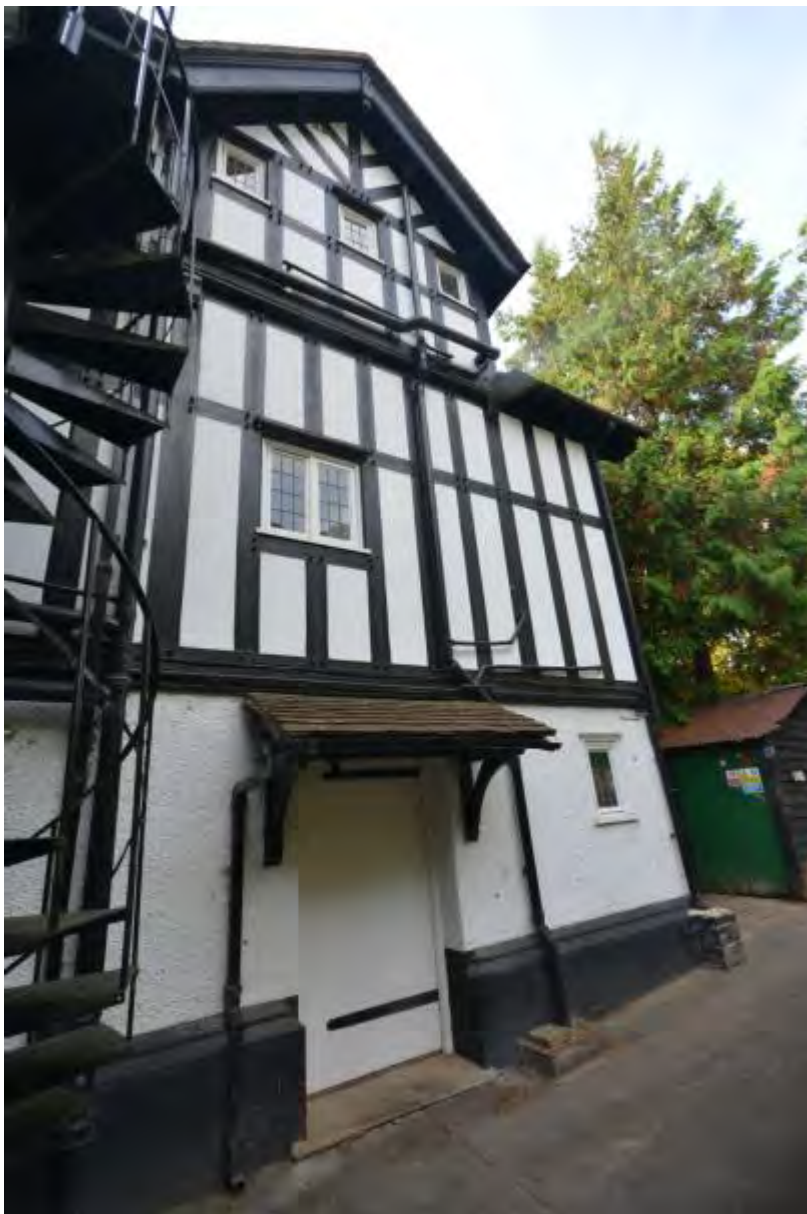
Plate 5: Northernmost gable, east elevation  
The above photograph is taken from lower ground floor level. A spiral fire escape staircase is visible to the left of the image, serving the ground and first floors of the northern part of the building.

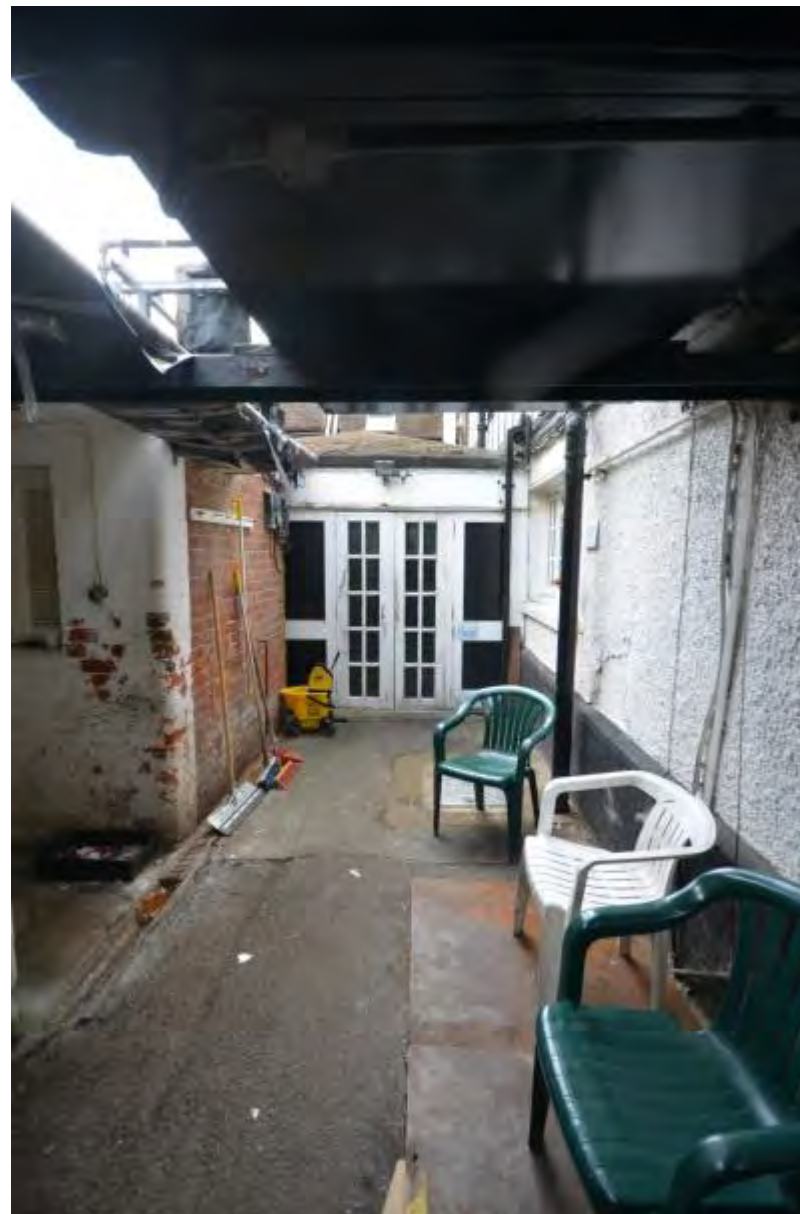
Plate 6: View south to kitchen doors, northern part of east side  
The above image is taken at lower ground floor level and shows the double doors into the kitchen area.

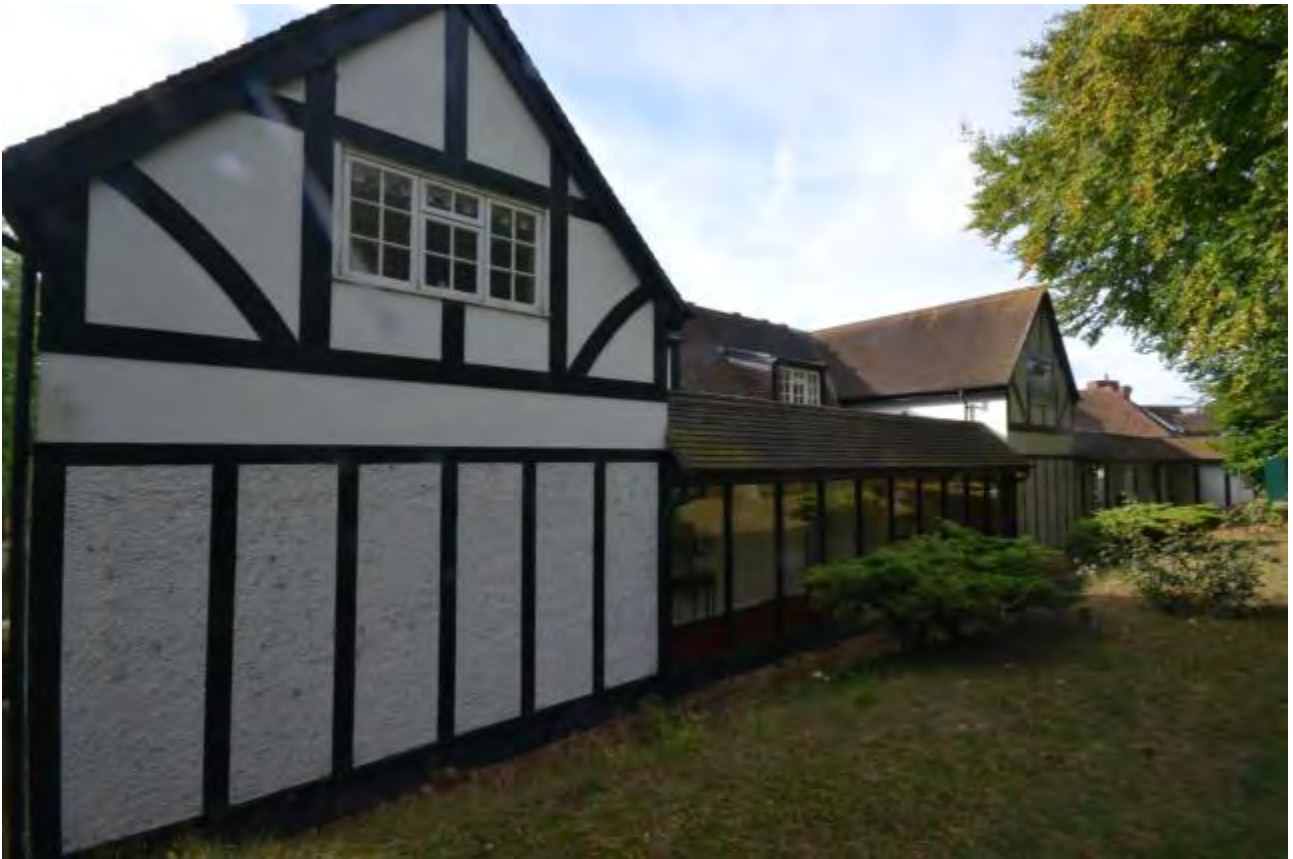
Plate 10: East elevation, Lakeside wing

A modern glazed walkway is present between gables on the eastern side of the Lakeside wing.

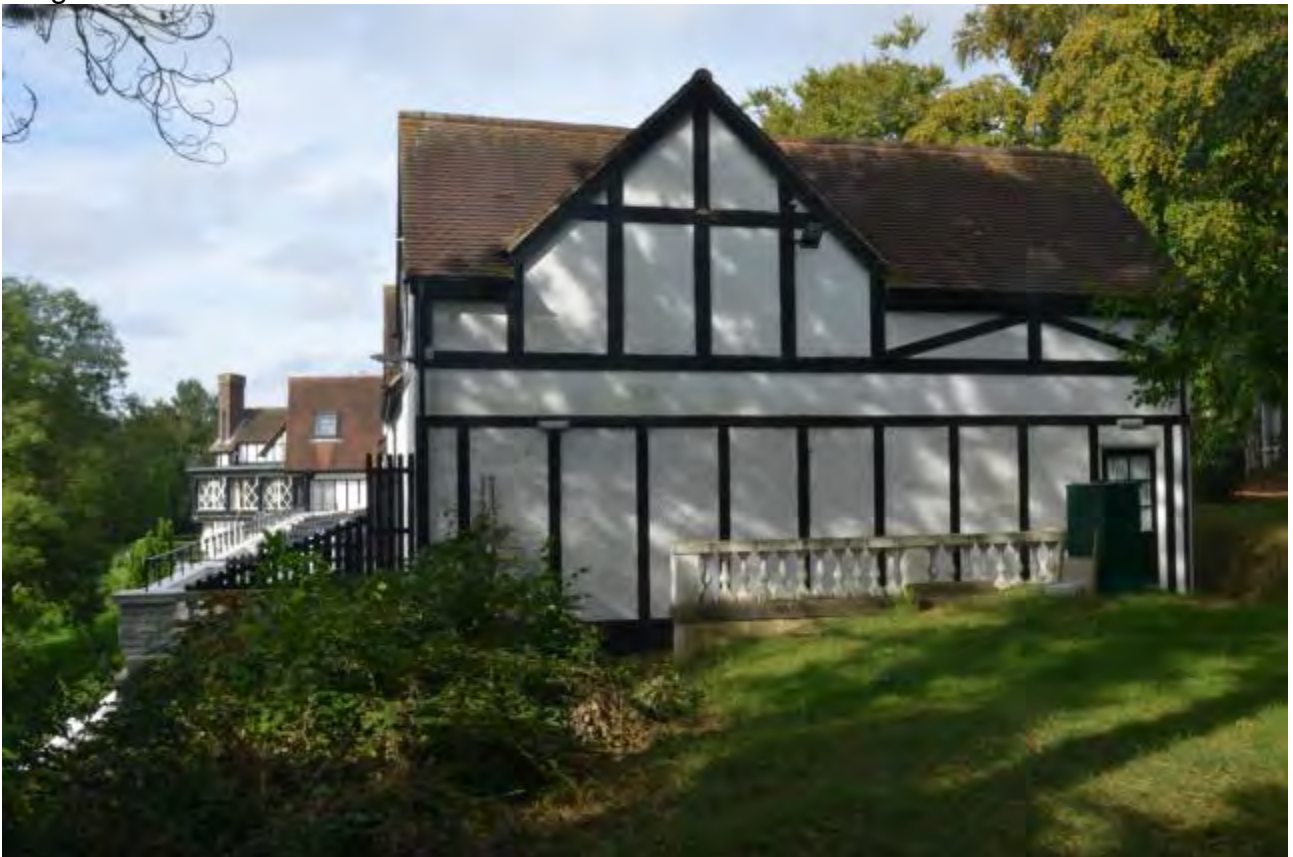
Plate 9: South elevation, Lakeside wing

The southern part of the Lakeside wing was added in 1984 and stylistically matches the mock timber framing seen on the remainder of the building, however without the same level of ornamentation as parts to the north.

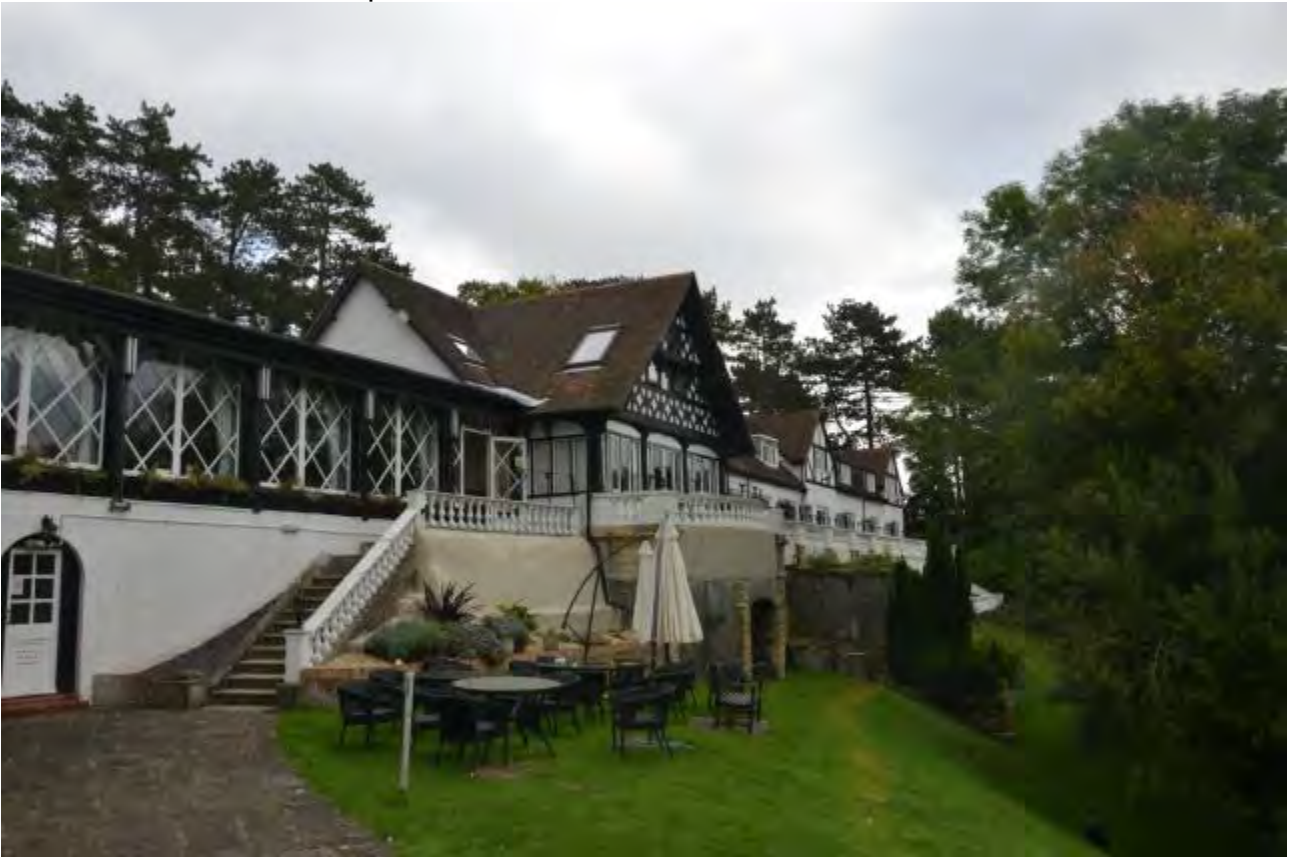
Plate 11: West aspect, Lakeside wing

The elaborate timber decoration noted in the gable depicted above provides a stylistic link to the earlier parts of the building further north.

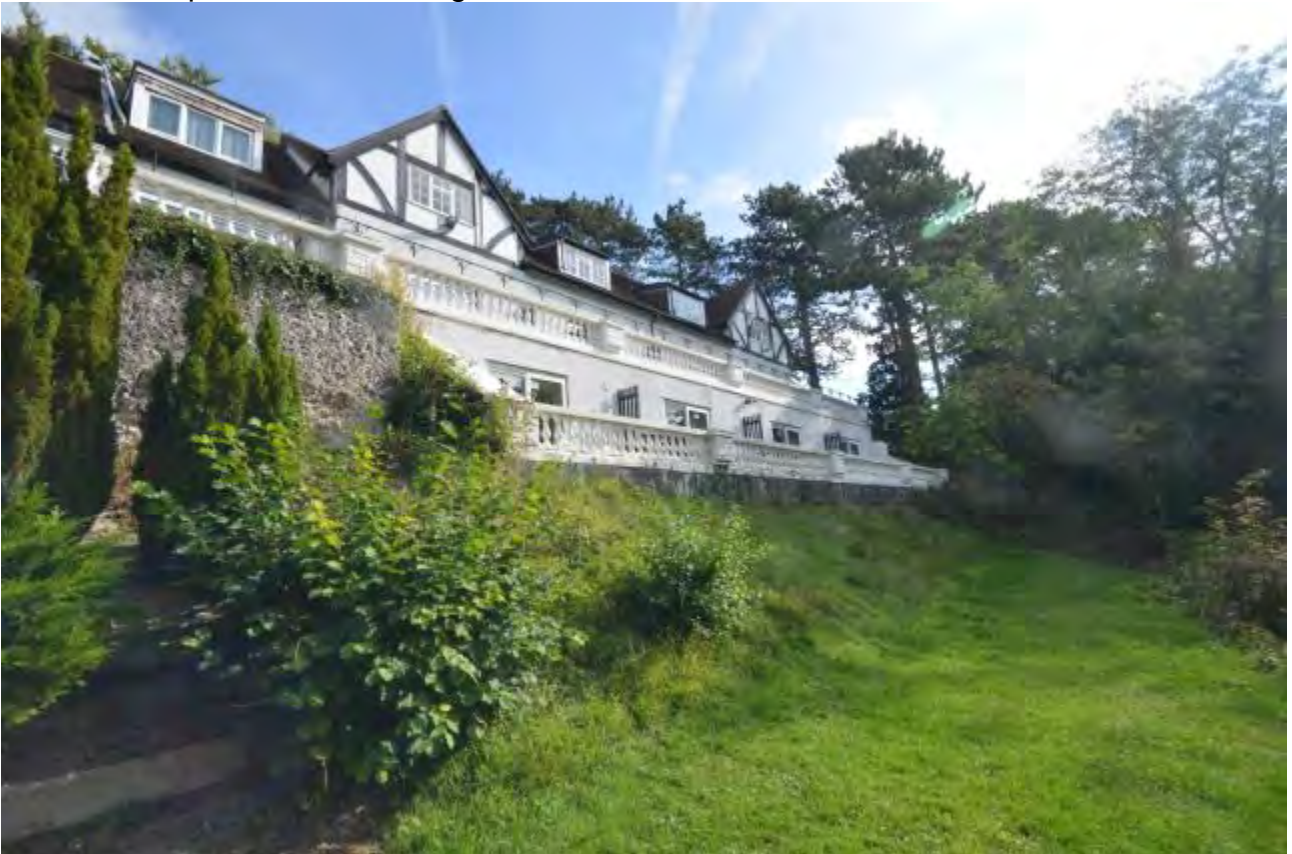
Plate 12: West aspect, Lakeside wing

This photograph shows the balustrade for the terraced balconies of the ground and lower ground floor rooms. The rooms at lower ground floor level were converted to their current form in 1988, and those at ground floor level date from 1984.

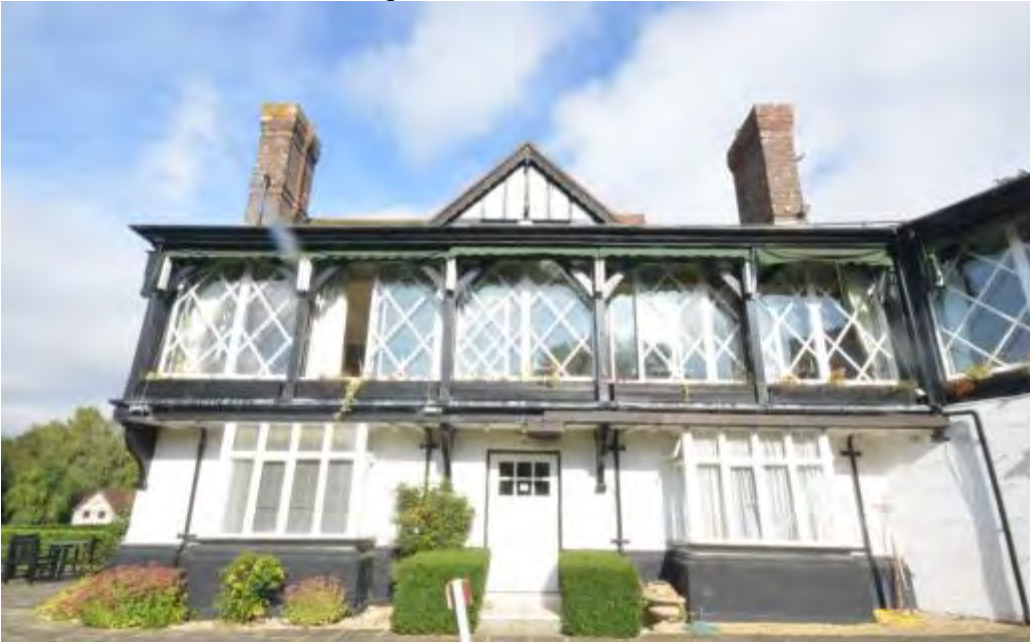
Plate 13: Southern aspect, north wing

The enclosed balcony forms part of the restaurant. To the right of the photograph, the northern end of the Lakeside wing is visible. This is the original southern elevation of the house, prior to any extension. A pair of gables flanks a single door at lower ground level, whilst the balcony projects from the ground floor above. Curved brackets either side of the door support the balcony and may be relics of a porch or canopy over the door prior to the construction of the balcony itself.

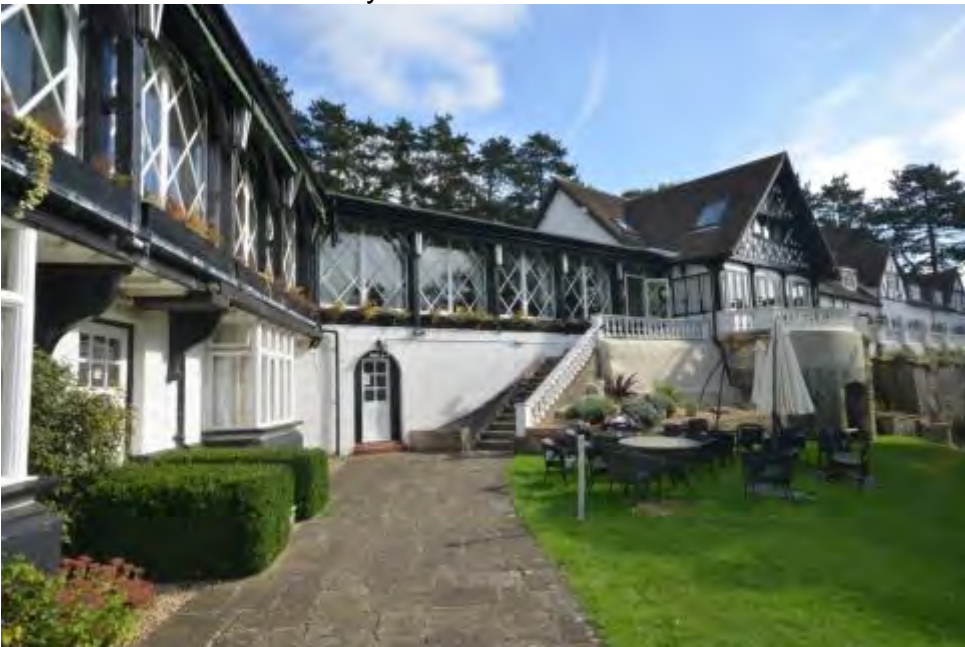
Plate 13: West elevation where north wing (left) joins Lakeside wing (right)

The enclosed balcony containing the restaurant was constructed as the 'Winter Garden' following purchase of the house by Sir John Wormald in 1912. This continues along bridging the gap between the northern and Lakeside wings. A flight of steps gives access to the garden from its southern end. To the right, a balcony is present at ground floor level, with a recessed seat accessed from the garden below.

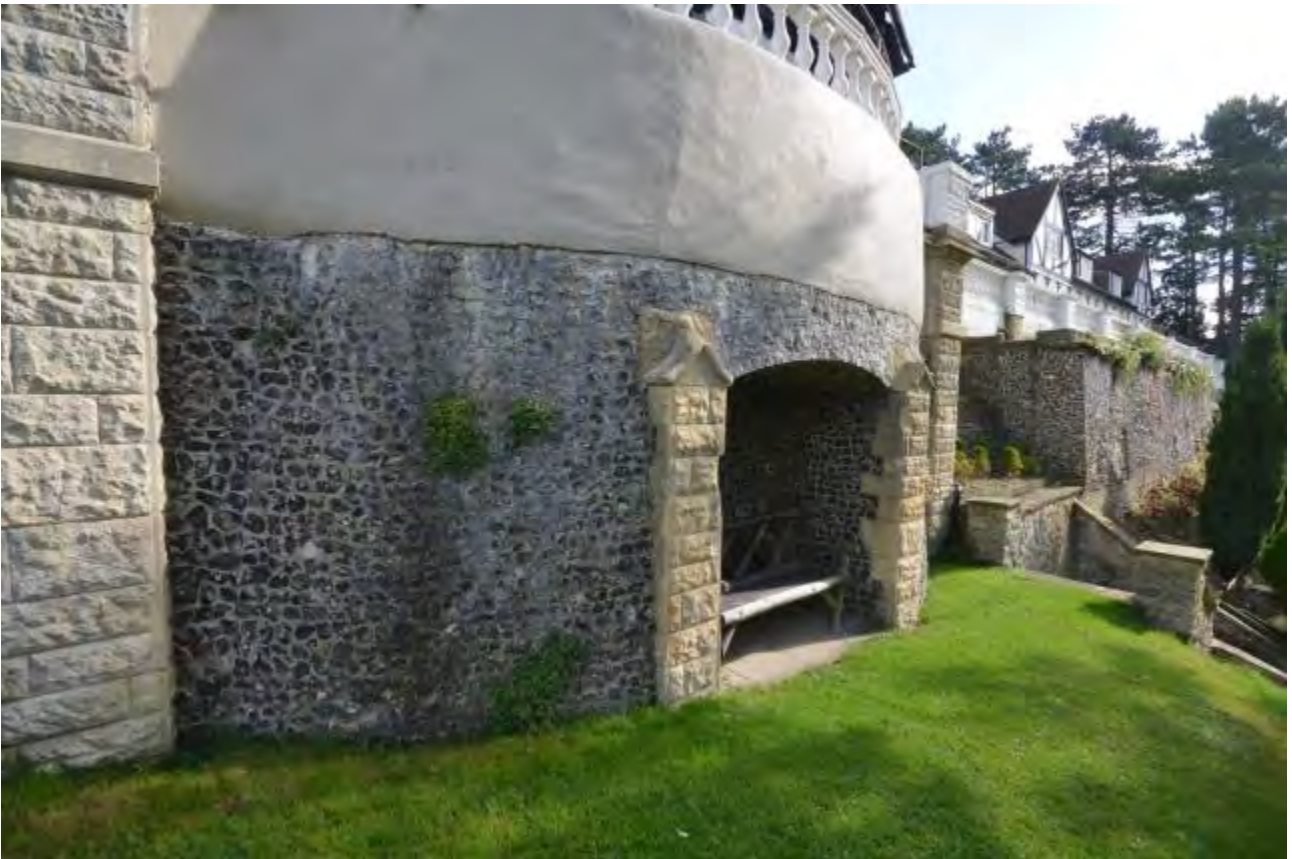
Plate 13: Detail of recessed seat in flint wall with stone piers, west elevation, Lakeside wing

The retaining wall of the Lakeside wing is largely faced in coursed dressed flint. Steps account for the change in level, giving access from the balconies / terraces above to the gardens below.

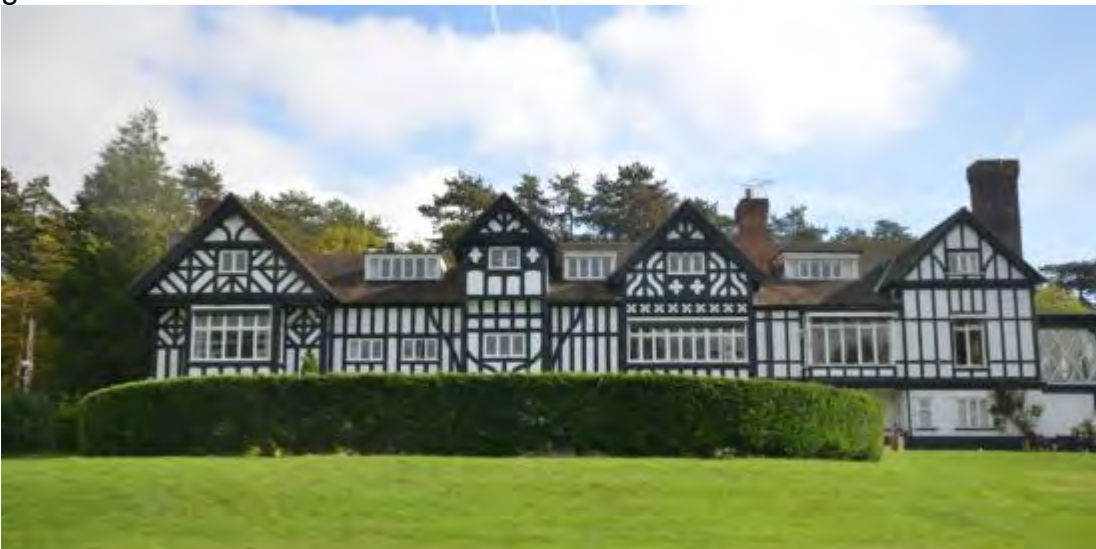
Plate 14: West elevation, north wing

The rear of the north wing of the building exhibits a number of styles of mock timber framing across its span. A number of substantial chimneystacks are visible.

The original part of the building is the area of the two gables to the right of the above photograph. The differing style of the false timbering on these two gables indicates the building was initially intended to appear as a multi-phase structure – an impression perpetuated in the external appearance of all subsequent extensions.

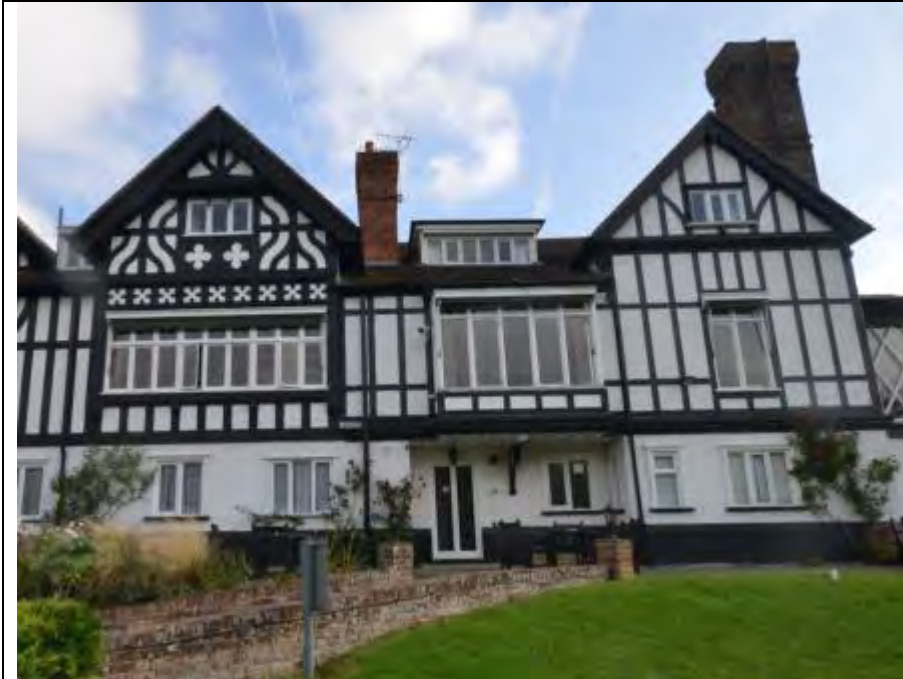
Plate 15: Western aspect, original part of The Springs

An off-centre projecting bay is present in the original part of the building at ground floor level. A dormer window is located above, whilst at lower ground level, the wall line is set back, with a curved brace supporting the bay above. The lower ground floor at the rear of the building has no timbering, and is formed of a plain roughcast wall, painted black over its lower part, white above.

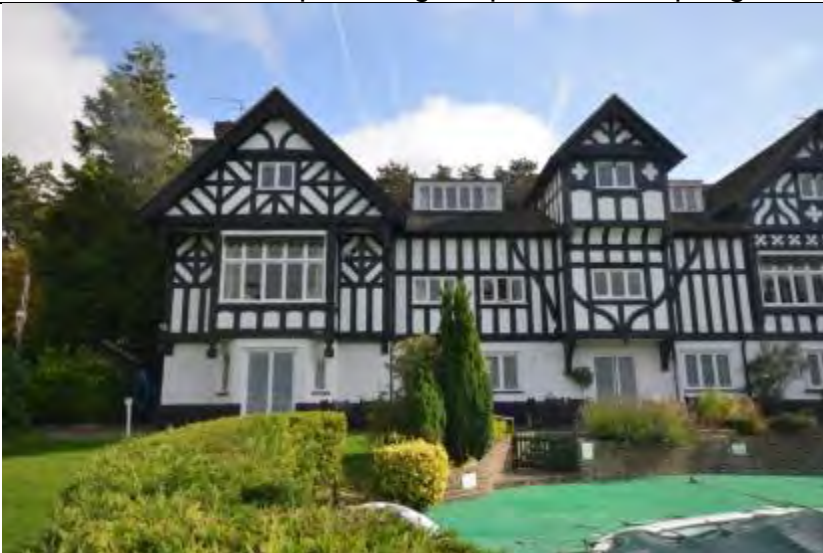
Plate 17: North end of west elevation

A jettied gable is present to the north of the original part of the building. This features two jetties, one between lower ground and ground, the second between ground and first floor. The northernmost gable has a hexagonal bay at ground floor level which changes to a rectangular bay at first floor level. The gable itself is slightly jettied.

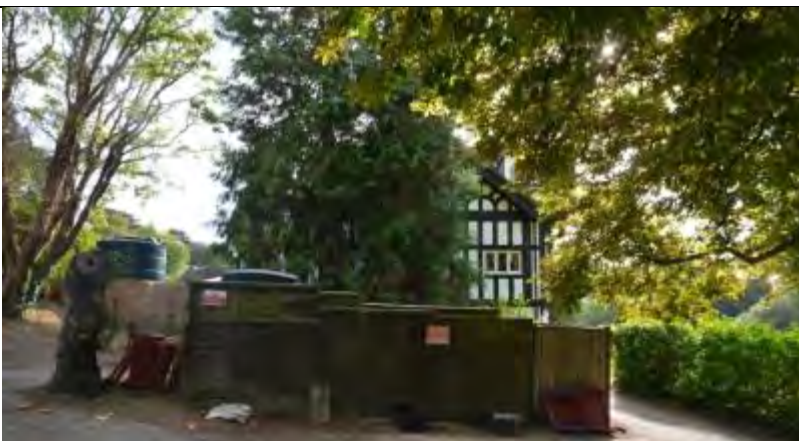
Plate 16: North aspect, north wing

The northern aspect of the north wing is largely obscured by vegetation however it is clear the mock timbering continues onto this elevation.
