Heritage Statement on  
**The Springs Hotel**  
Wallingford Road  
North Stoke  
Oxfordshire  
OX10 6BE  
National Grid Reference: SU813 863

Document Reference Number 2013/1168  
Version 0.6

Heritage Statement: The Springs Hotel  
Dr Peter Wardle and Colin Lacey  
18/10/2013

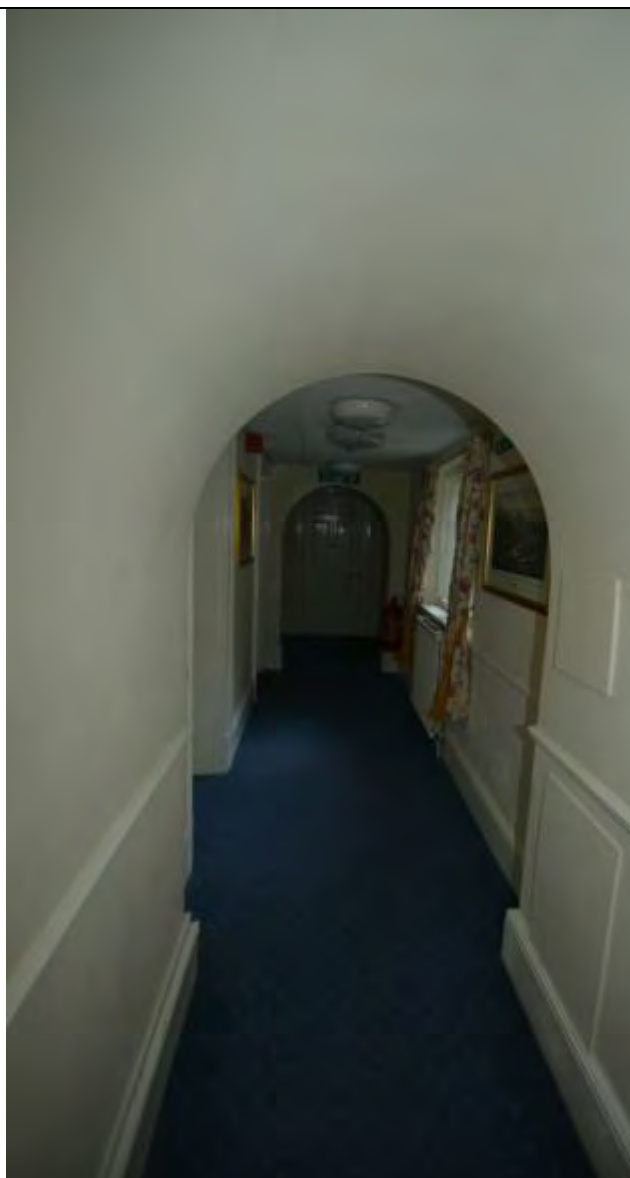
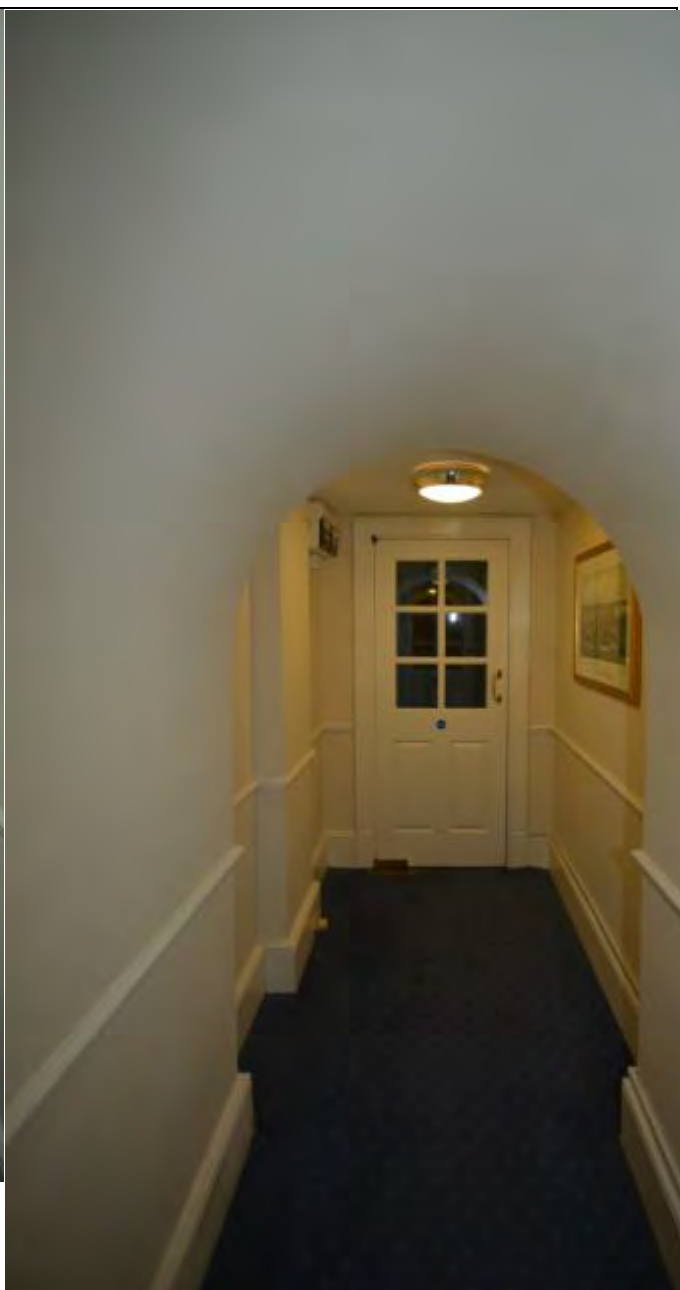
Room Name	
Current Function	Corridor
Original Function	Corridor
Phase	1898-1912
Plan Form	
Windows	None
Historic Features	Dado
Comments/Description

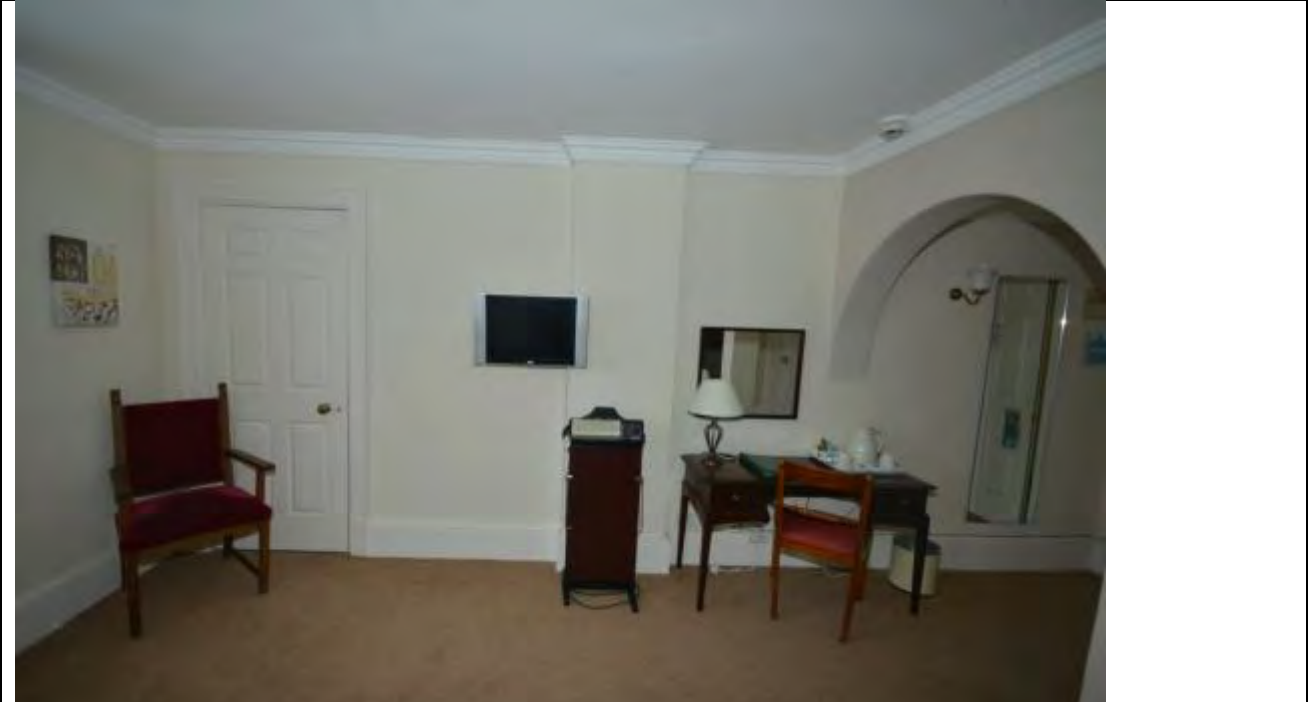
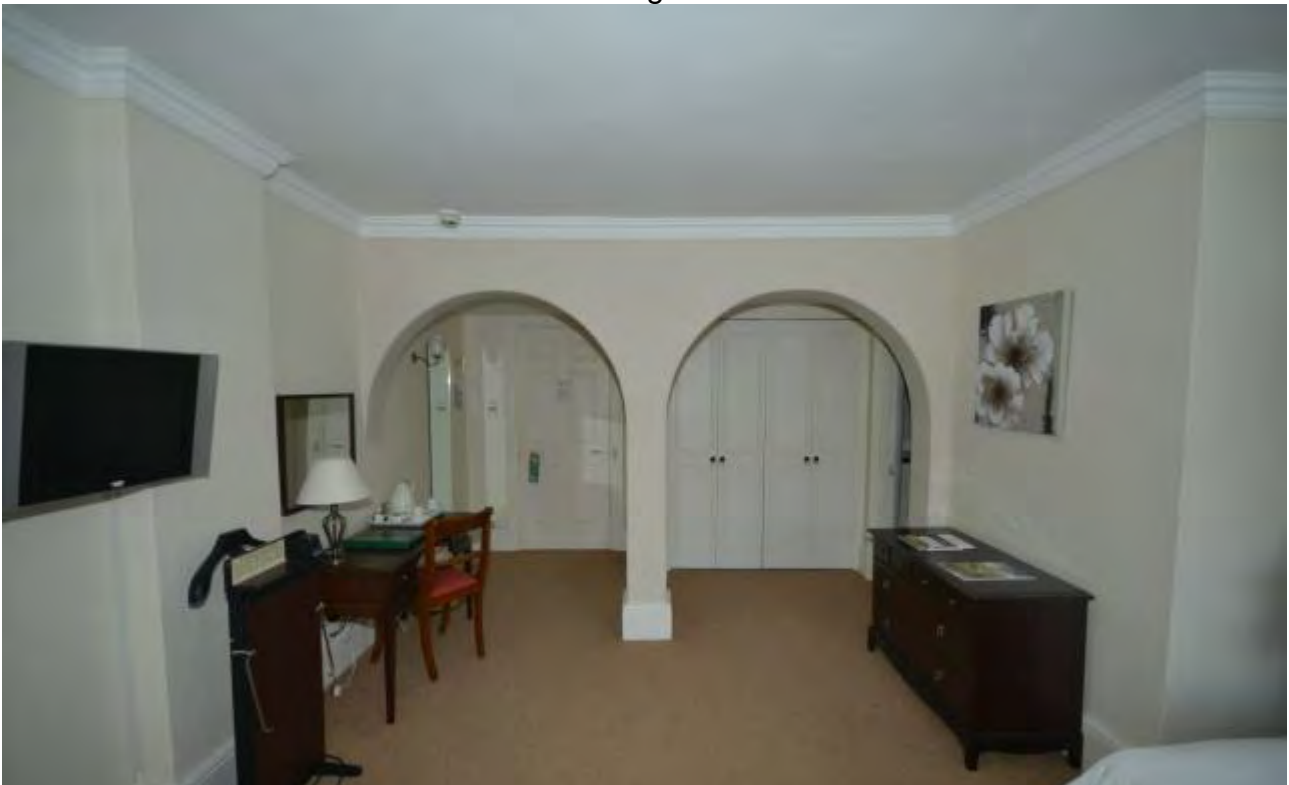
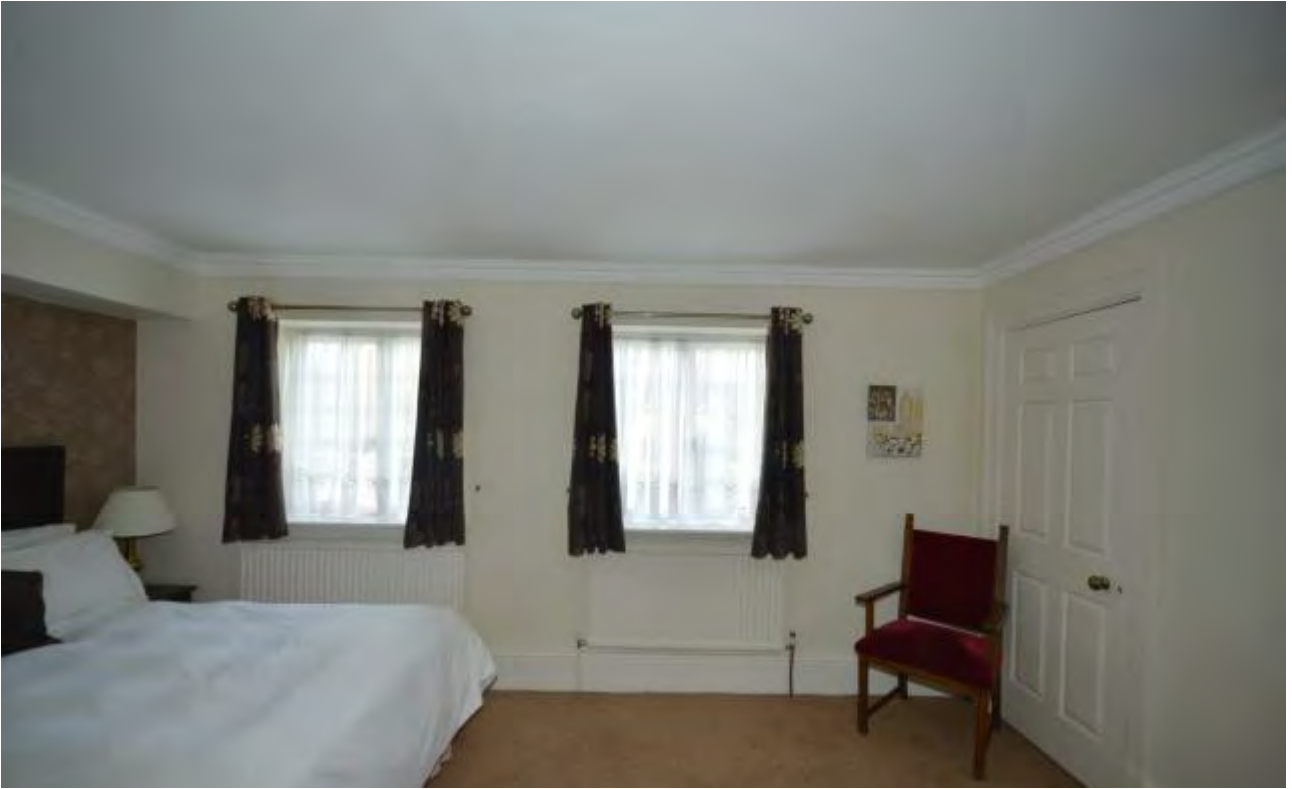
Room Name	Derby
Current Function	Bedroom
Original Function	
Phase	1898-1912
Plan Form	
Windows	Multi-paned leaded side-hung casements
Historic Features	Cornice
Comments/Description	Arches are considered likely to be a later addition

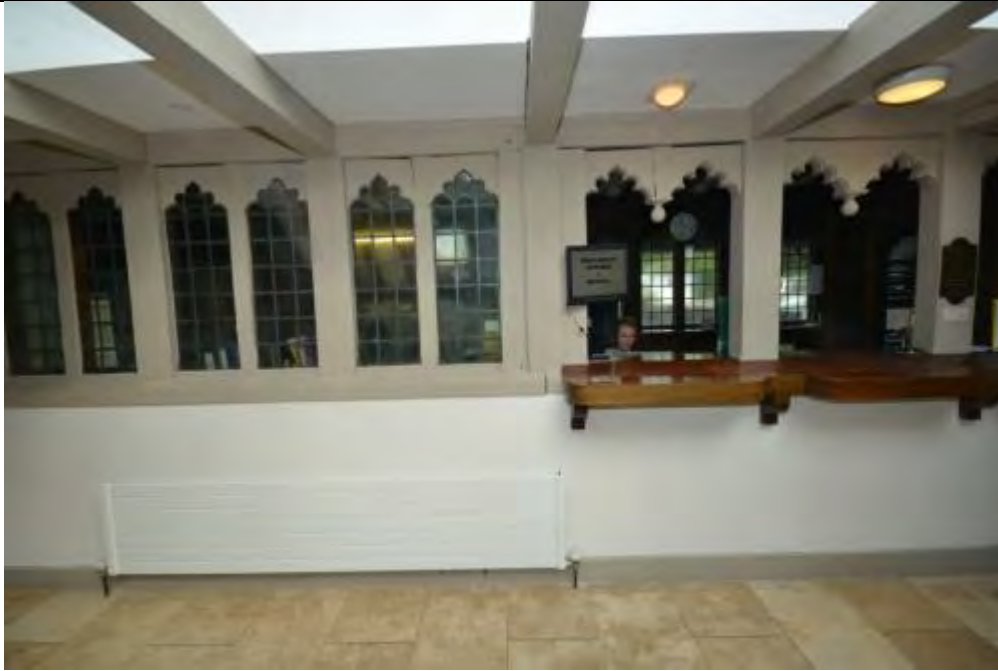
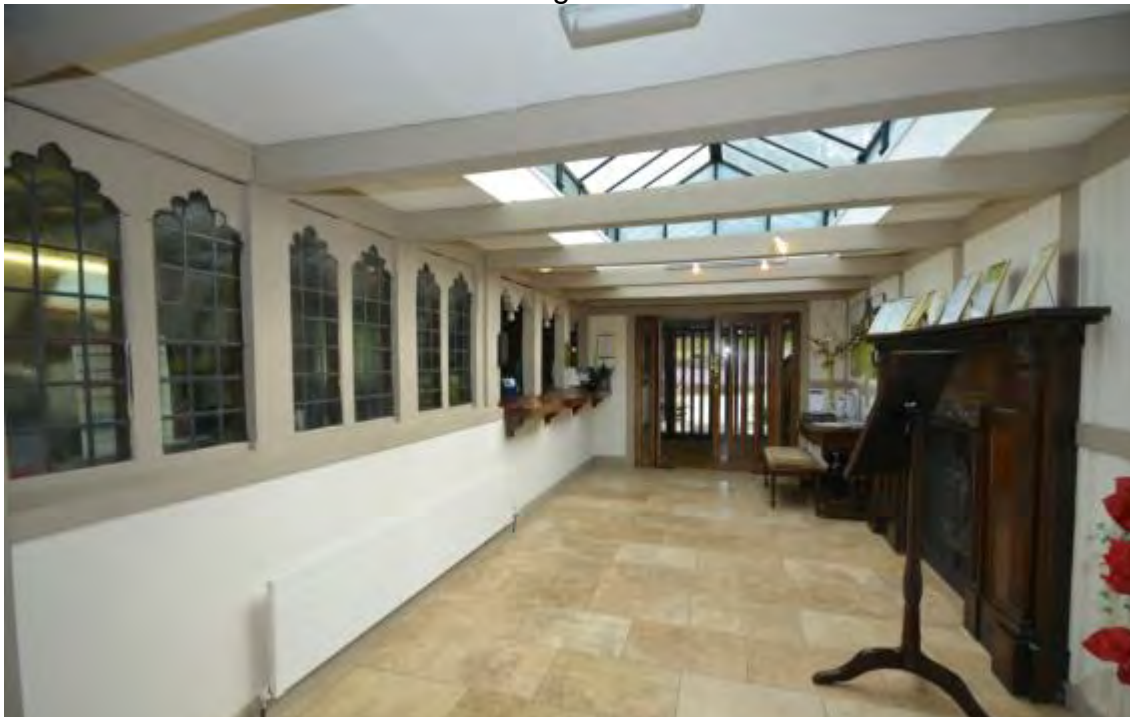
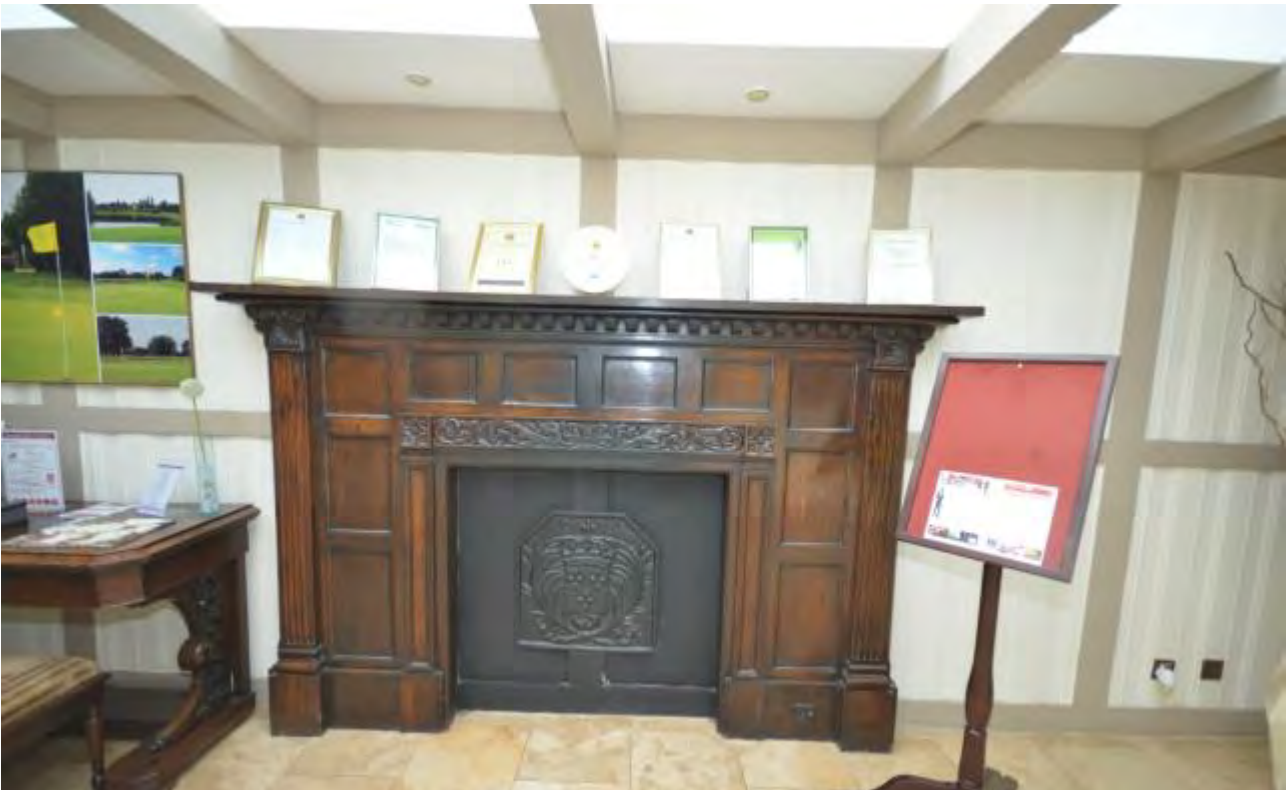
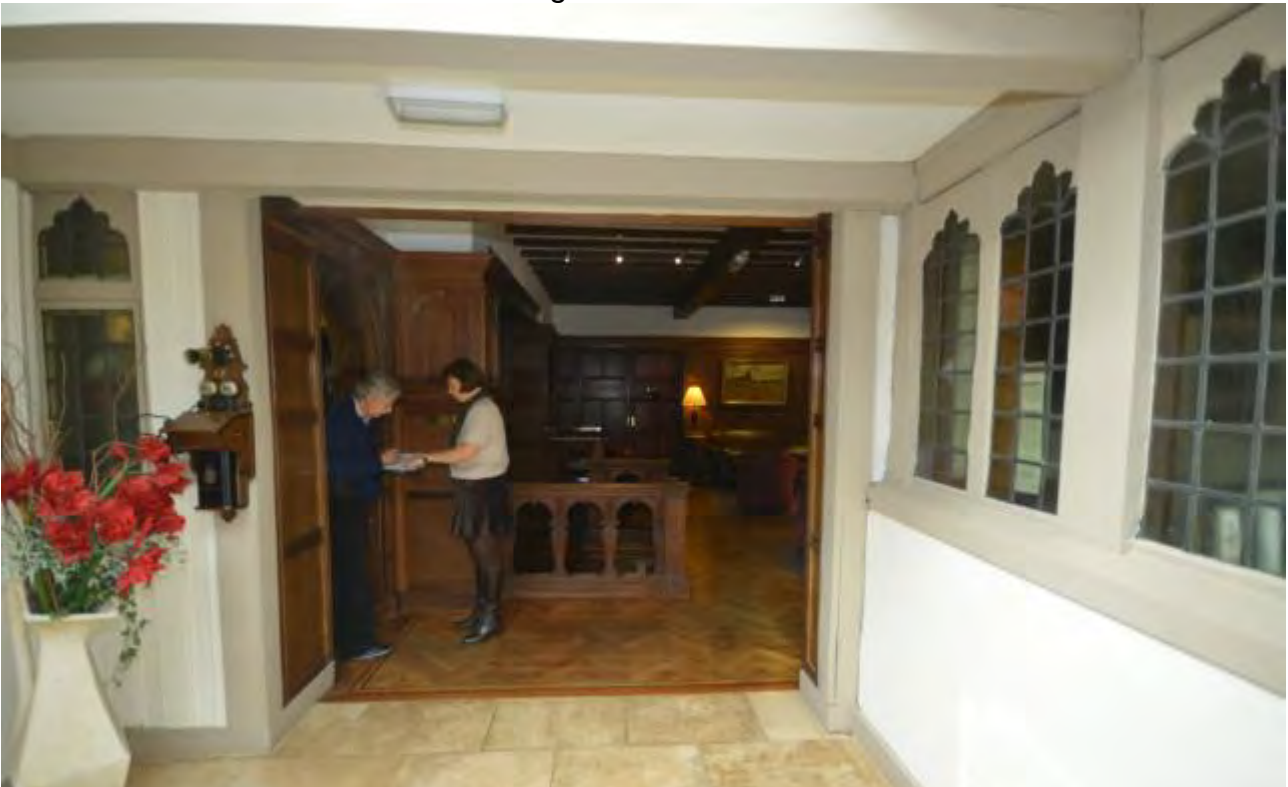
Room Name	
Current Function	Reception
Original Function	Reception
Phase	1981
Plan Form	Unaltered
Windows	Roof light, leaded windows to offices
Historic Features	None
Comments/Description	Historic fireplace fitted to modern construction

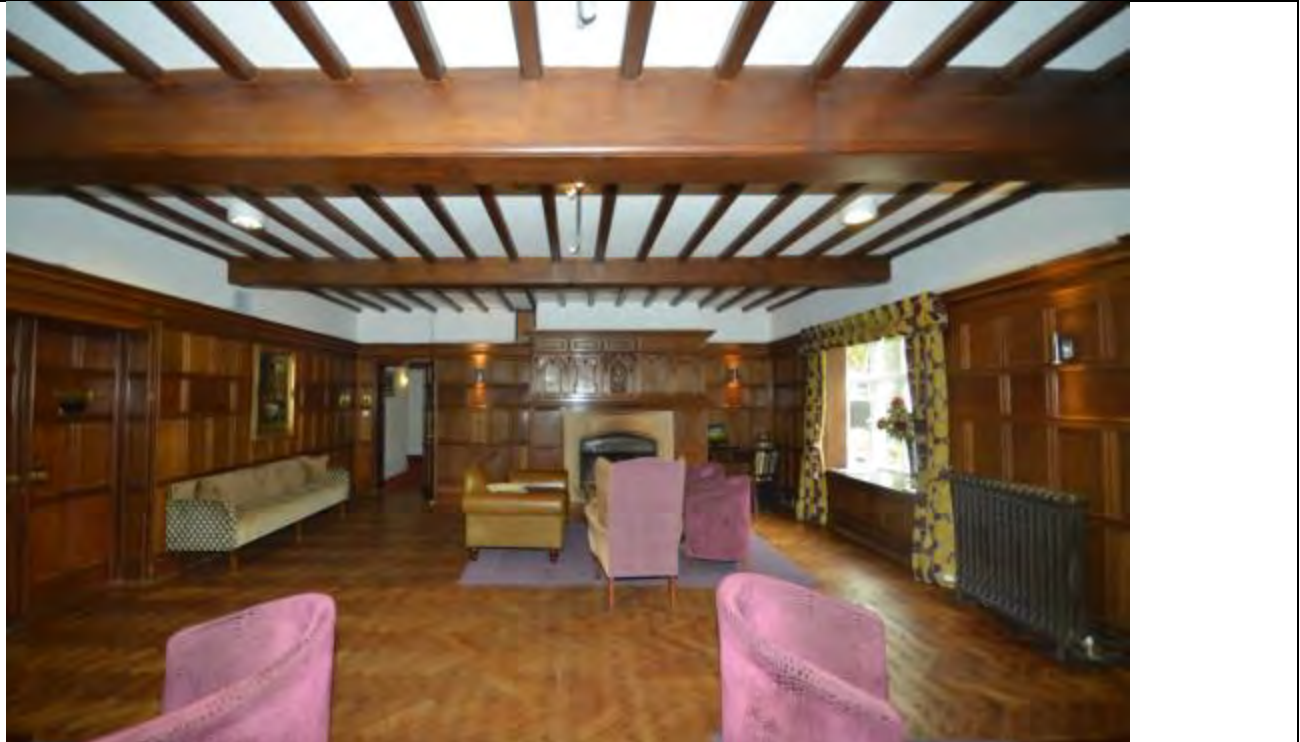
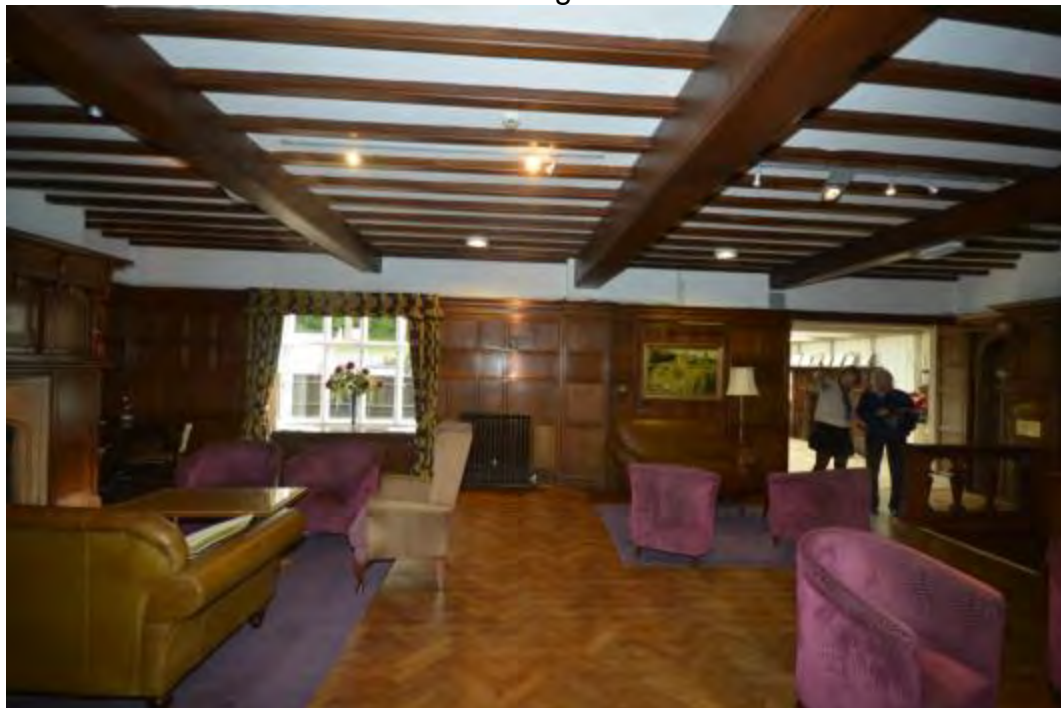
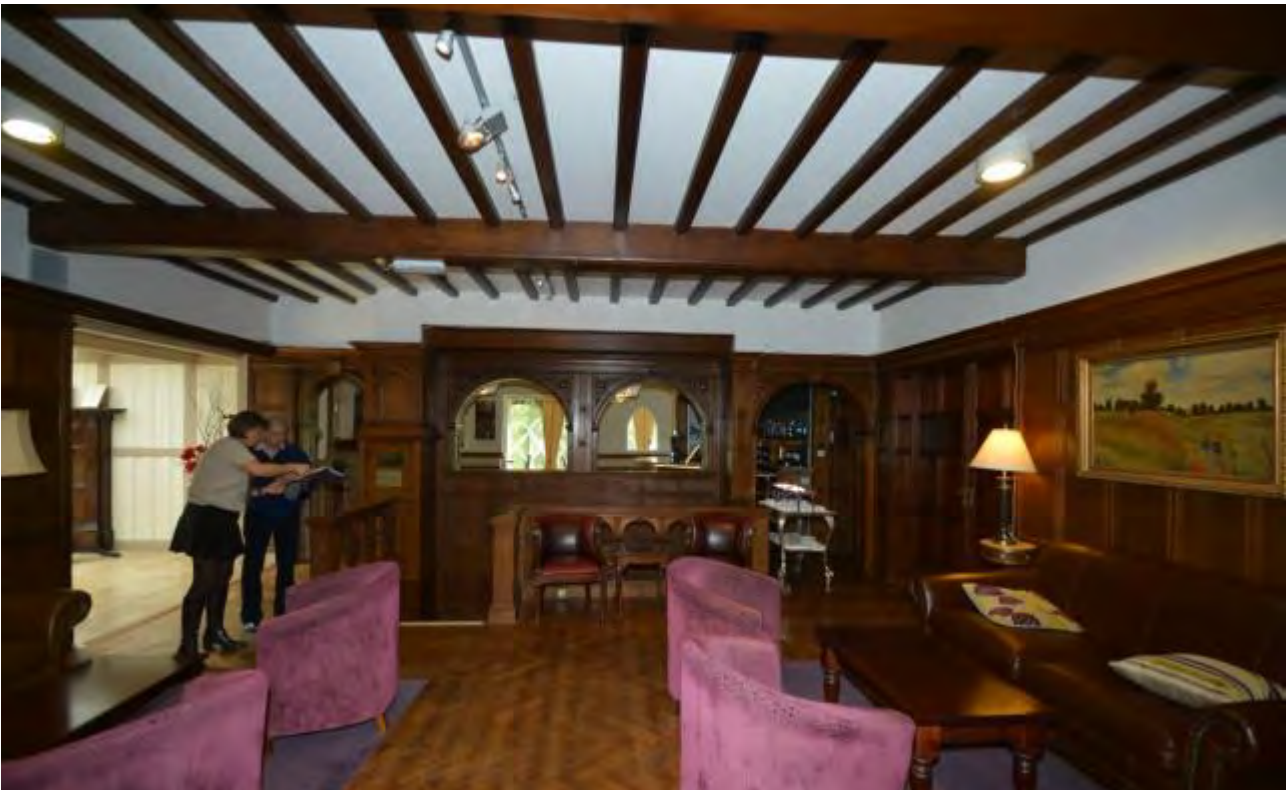
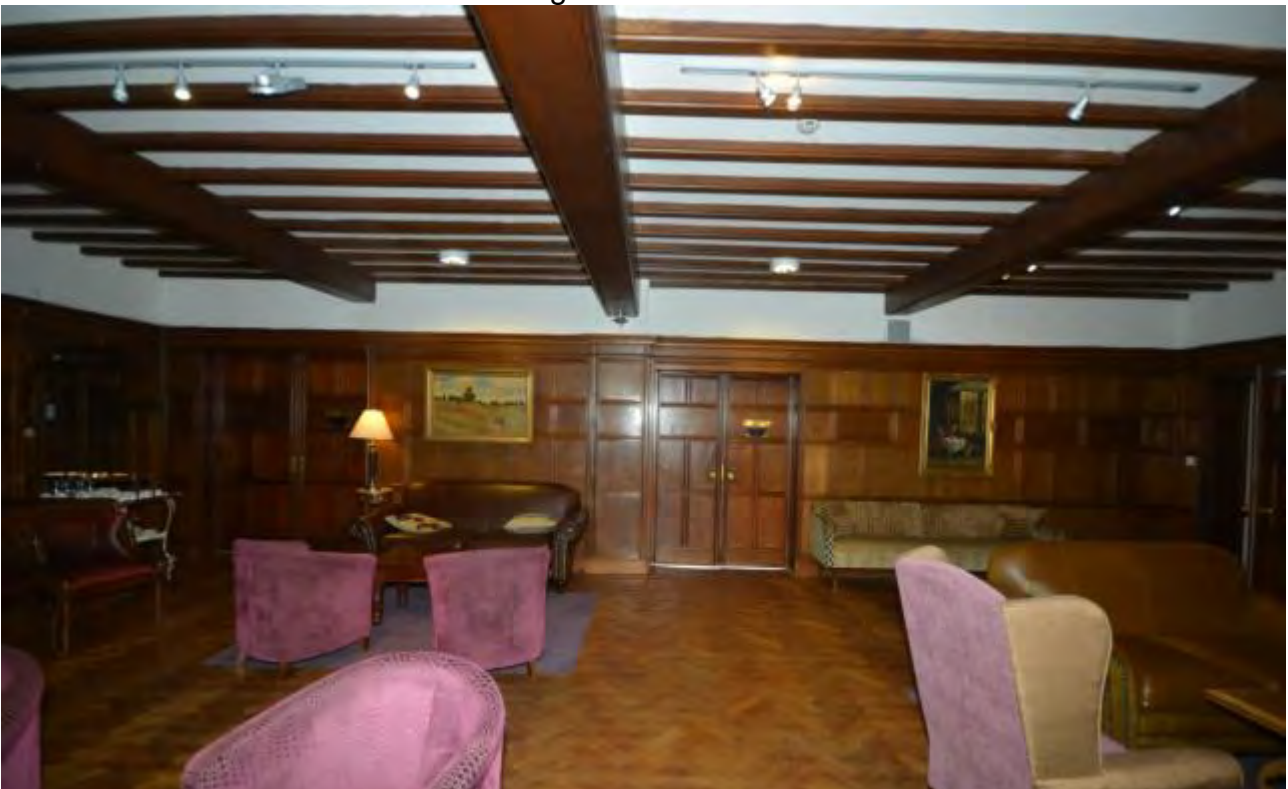
Room Name	
Current Function	Lounge
Original Function	
Phase	Pre 1898
Plan Form	Unaltered
Windows	Single-paned casements
Historic Features	Panelled walls, stone fireplace with panelled surround, machine-sawn timbers spanning ceiling, panelled doors

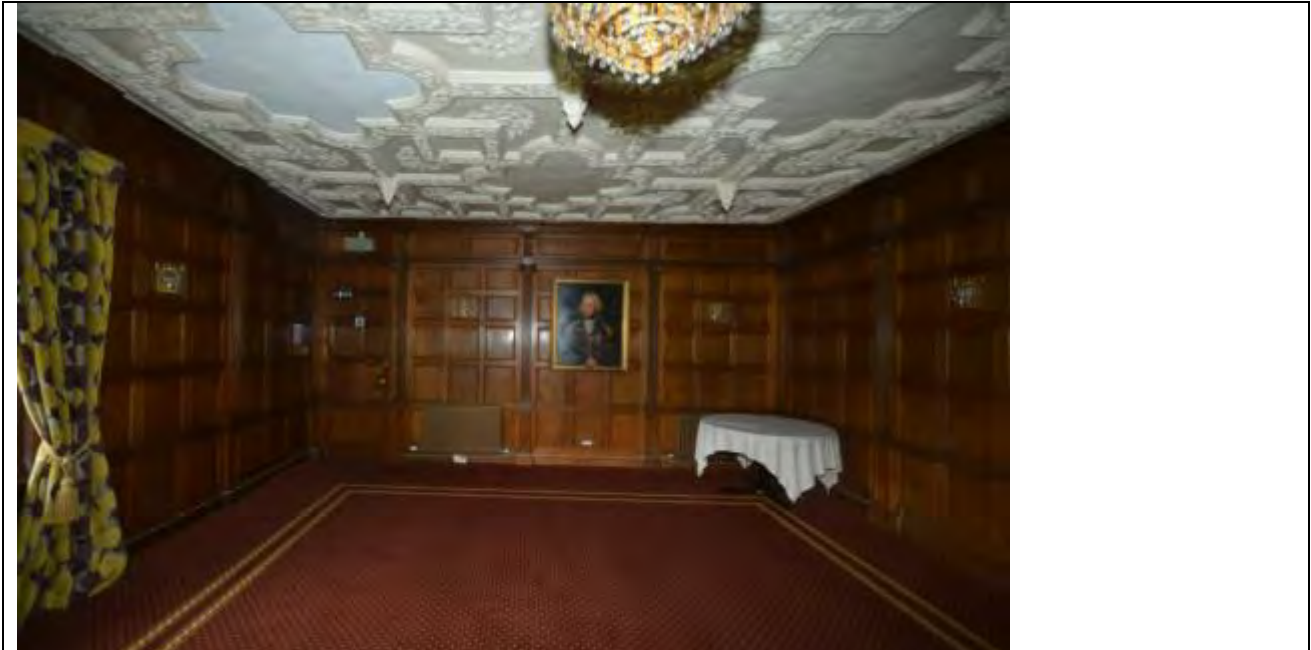
Plate 74: Ground Floor Room 3 Looking North

Room Name	Lord Nelson
Current Function	Function room
Original Function	Dining room, c. 1912
Phase	North - 1898-1912, South - pre 1898
Plan Form	Extended to North
Windows	Leaded multi-paned casements
Historic Features	Panelling, ornate moulded plaster ceiling, stone fireplace with panelled surround
Comments/Description	Ceiling is a copy of that from the Scottish hunting lodge of King James I, installed by Sir John Wormald, owner of the house from 1912..

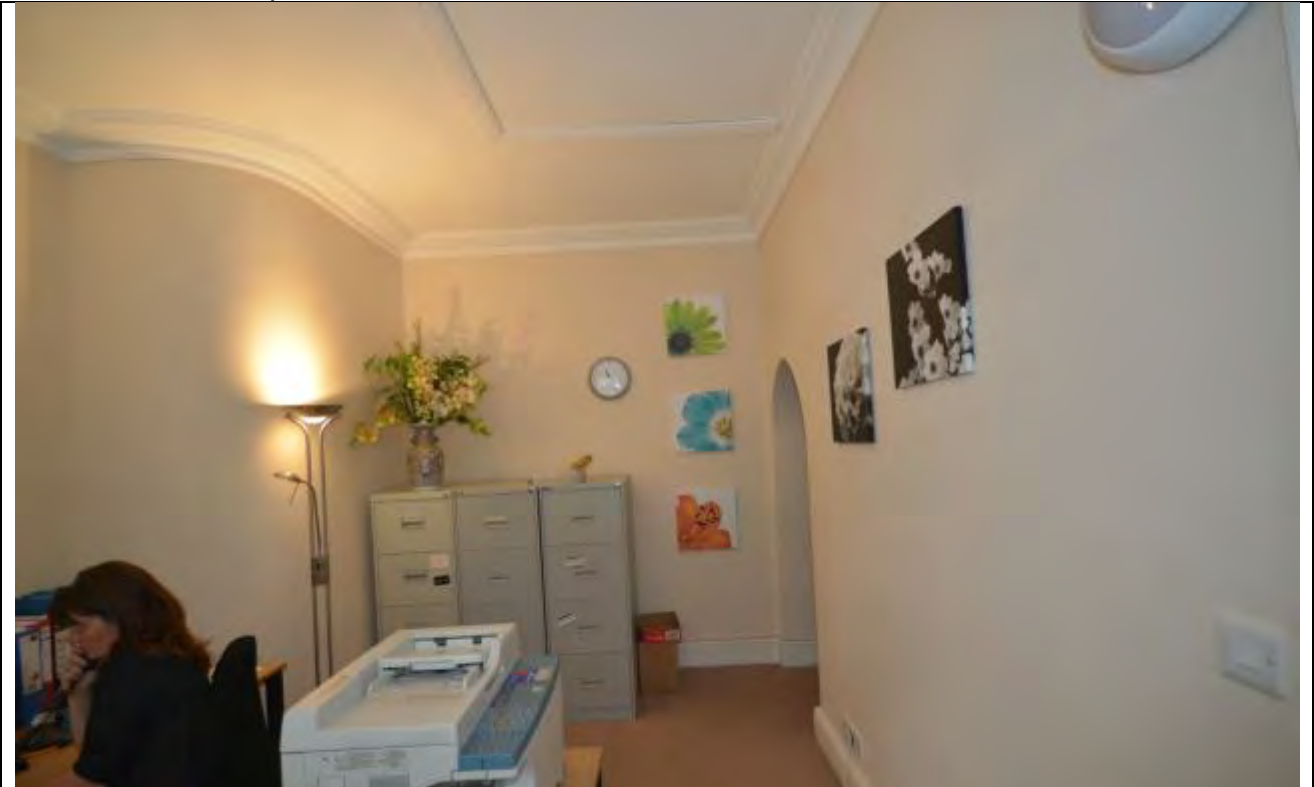
Plate 79: Ground Floor Room 4 Looking East

Room Name	Woodcote Suite
Current Function	Office
Original Function	
Phase	1898-1912
Plan Form	Southwest corner truncated for electrical cupboard
Windows	
Historic Features	
Comments/Description	Former en-suite bedroom, now used as office

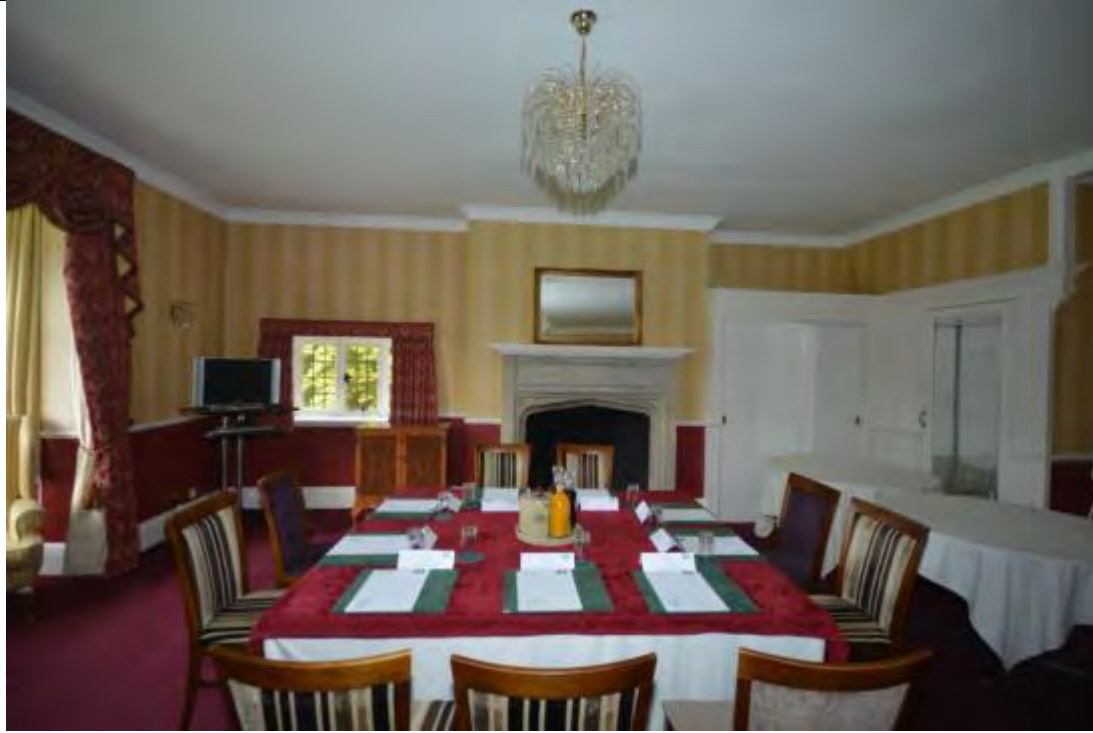
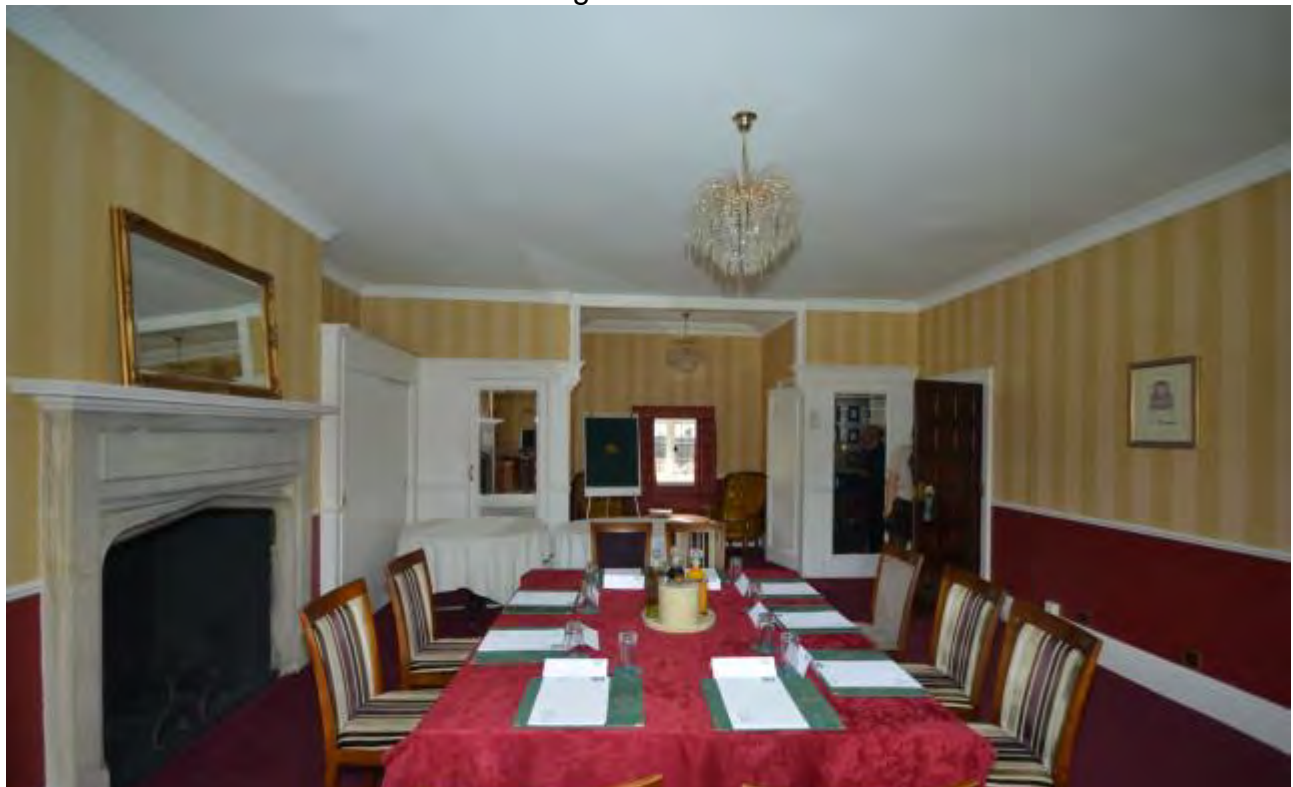
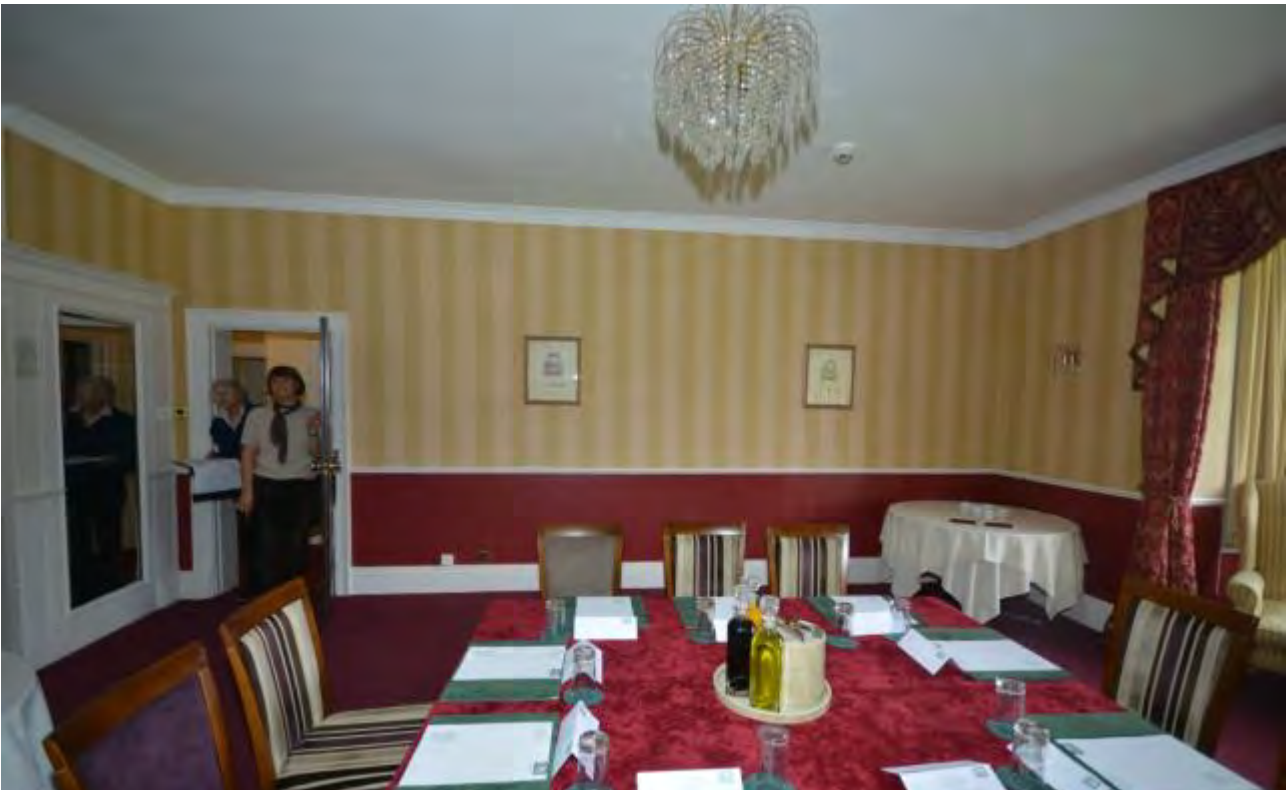
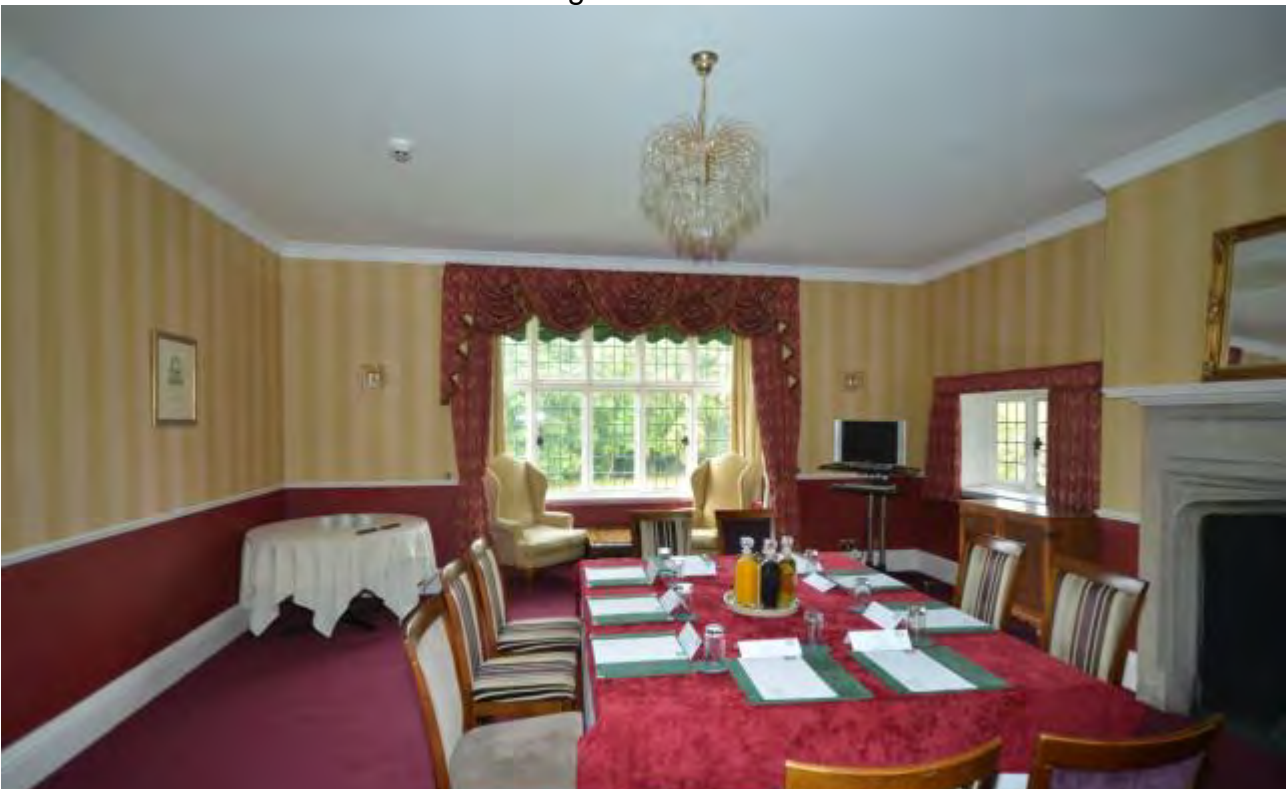
Room Name	Royal Suite
Current Function	Function room
Original Function	
Phase	1898-1912
Plan Form	Bathroom and WC added to east corners
Windows	Bay to W, multi-paned leaded casements
Historic Features	Stone fireplace, cornicing, dado
Comments/Description

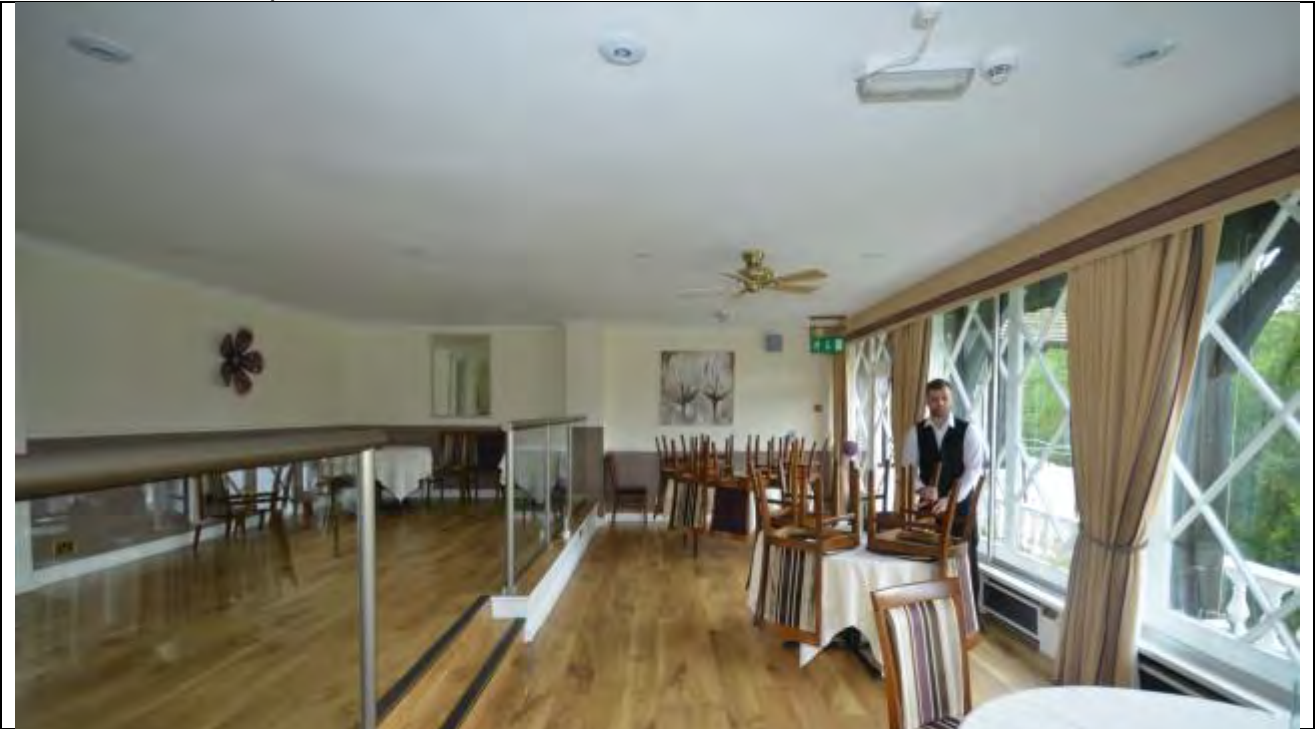
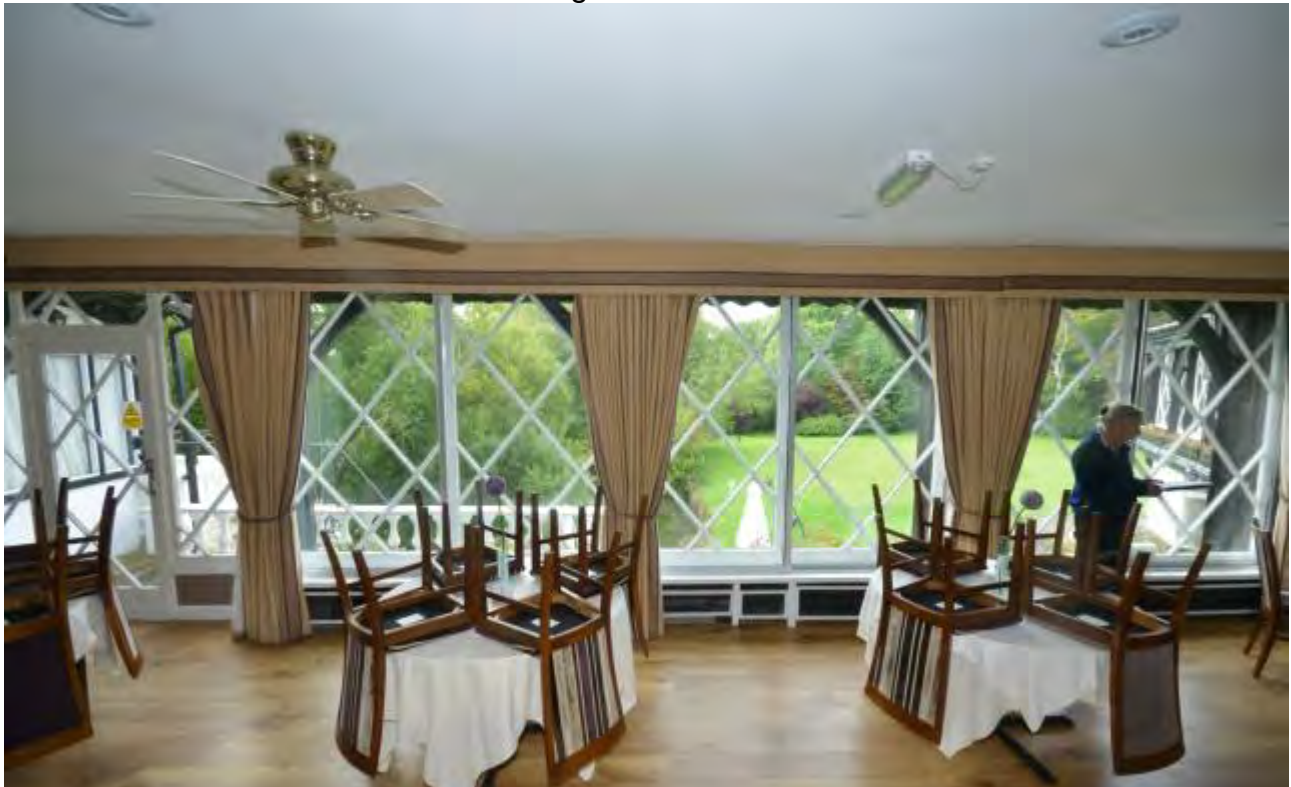
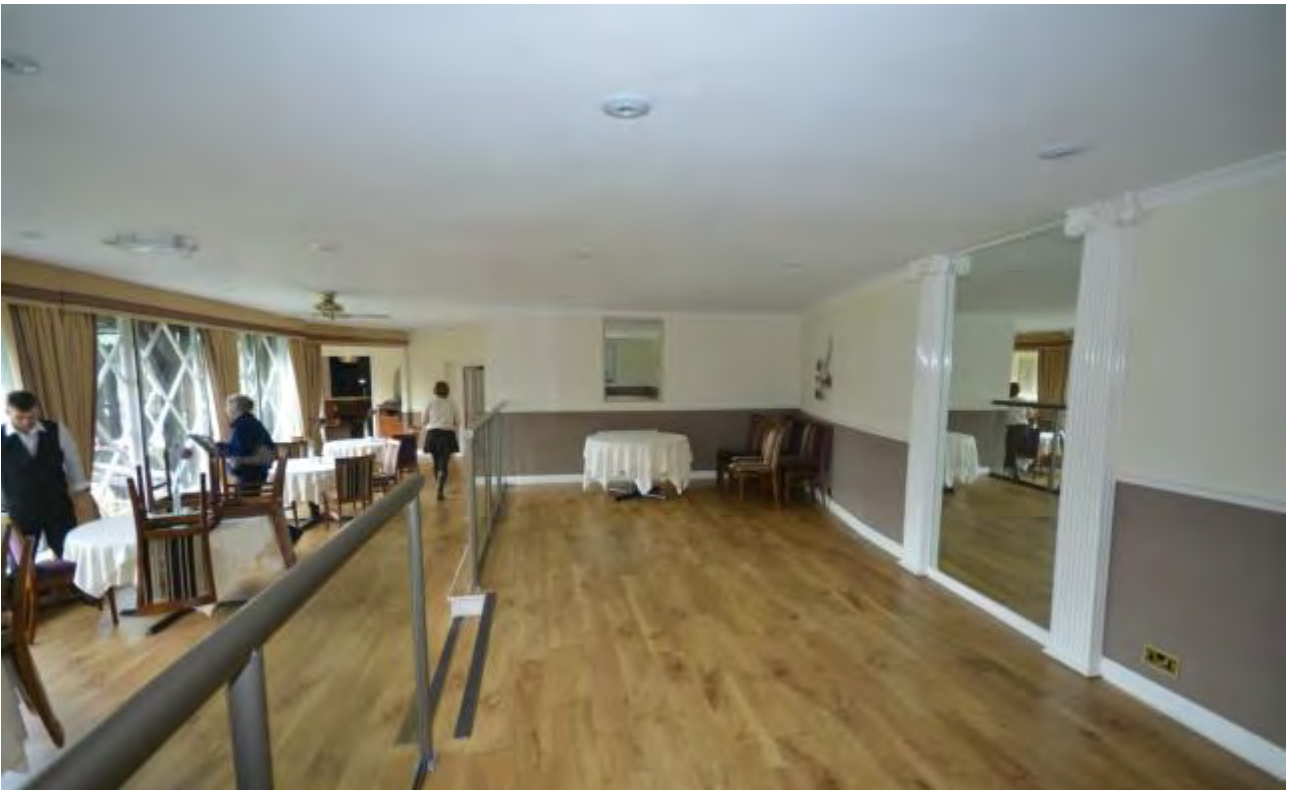
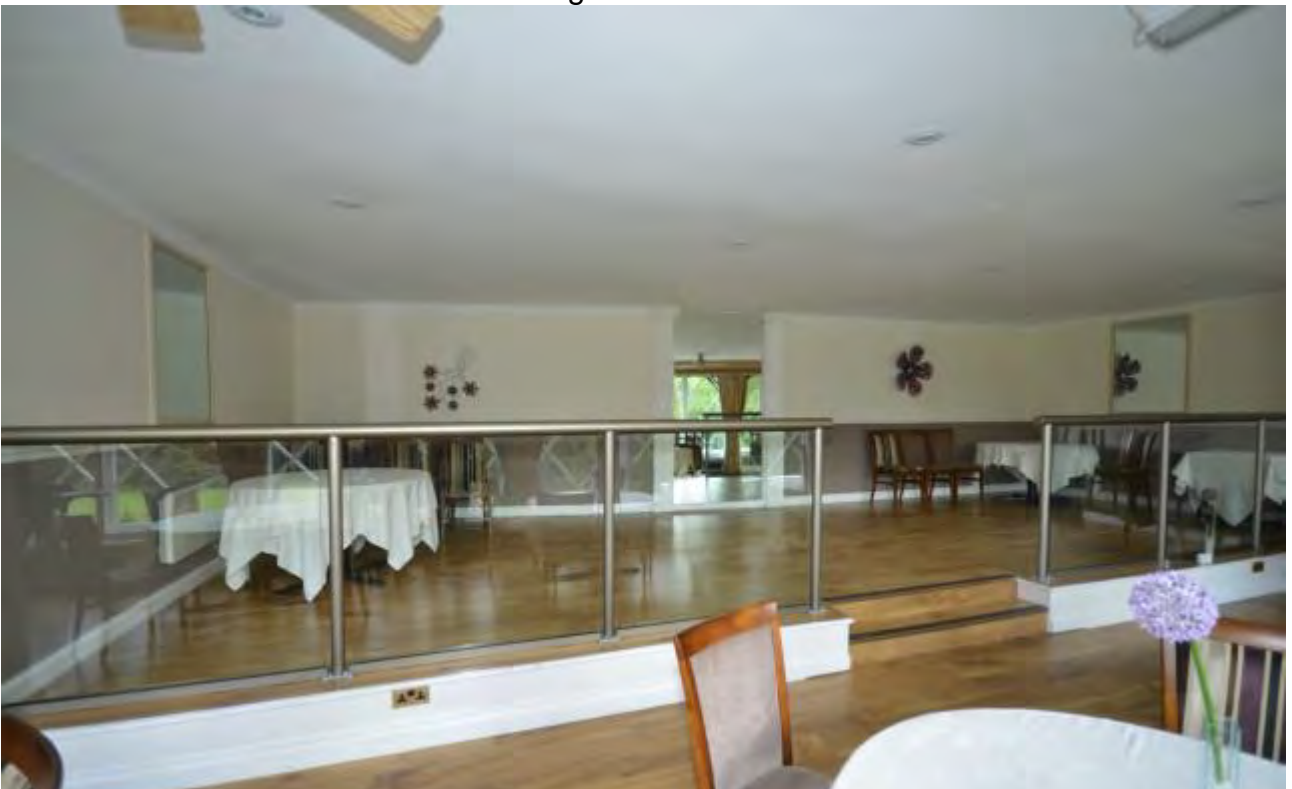
Room Name	Restaurant
Current Function	West - winter garden
Original Function	West - 1912-1974, East - 1981
Phase	West - 1912-1974, East - 1981
Plan Form	Extended to East in 1981
Windows	Modern
Historic Features	None
Comments/Description
