Heritage Statement on  
**The Springs Hotel**  
Wallingford Road  
North Stoke  
Oxfordshire  
OX10 6BE  
National Grid Reference: SU813 863

Document Reference Number 2013/1168  
Version 0.6

Heritage Statement: The Springs Hotel  
Dr Peter Wardle and Colin Lacey  
18/10/2013

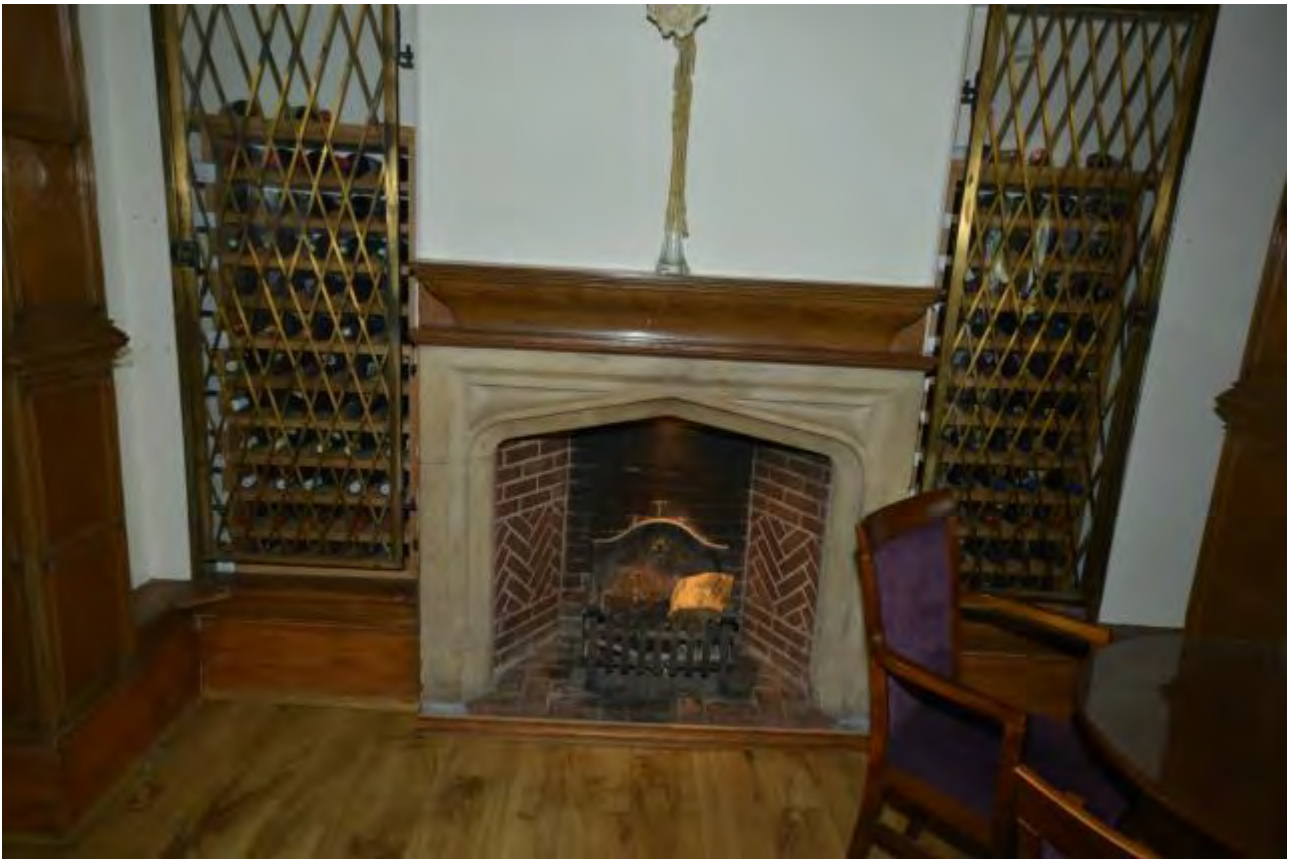
Plate 106: Detail of fireplace

Room Name	Cocktail Bar
Current Function	Bar
Original Function	
Phase	Pre 1898
Plan Form	Altered
Windows	Stained glass internal window to still room (12)
Historic Features	Cornice, ceiling mouldings, stone fireplace in oak panelled alcove with carved mouldings

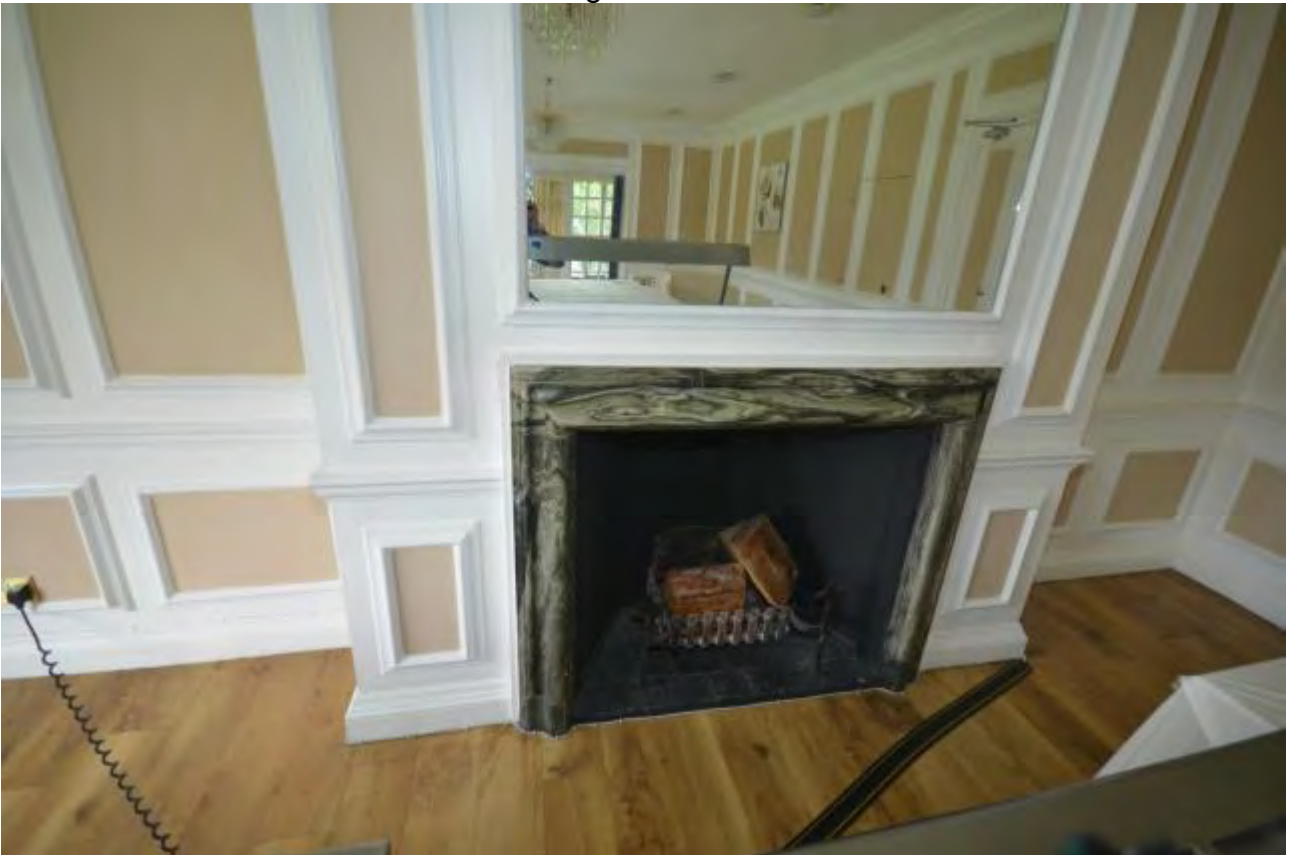
Plate 112: Detail of fireplace

Room Name	Green Room
Current Function	Function Room
Original Function	
Phase	Pre 1898
Plan Form	
Windows	Bay to W, single-paned casements
Historic Features	Cornice, stucco wall panelling, 19 <sup>th</sup> century marble fireplace

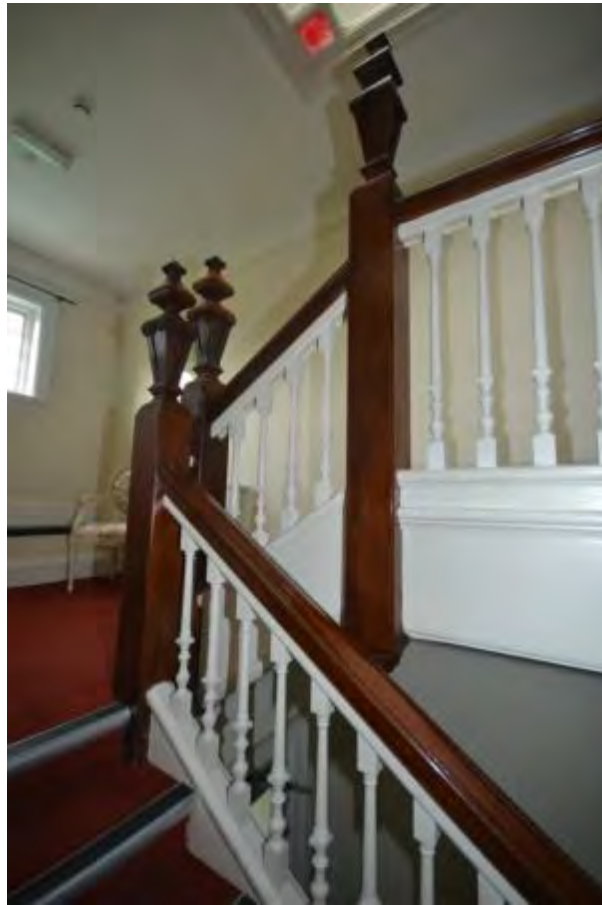
Plate 115: Detail of balustrade

Room Name	Staircase
Current Function	Staircase
Original Function	Staircase
Phase	1898-1912
Plan Form	Door and partition wall added at head of staircase
Windows	Stained glass roof light, plain casement
Historic Features	turned balusters, elaborate 19th century newell post, small pendants
Comments/Description

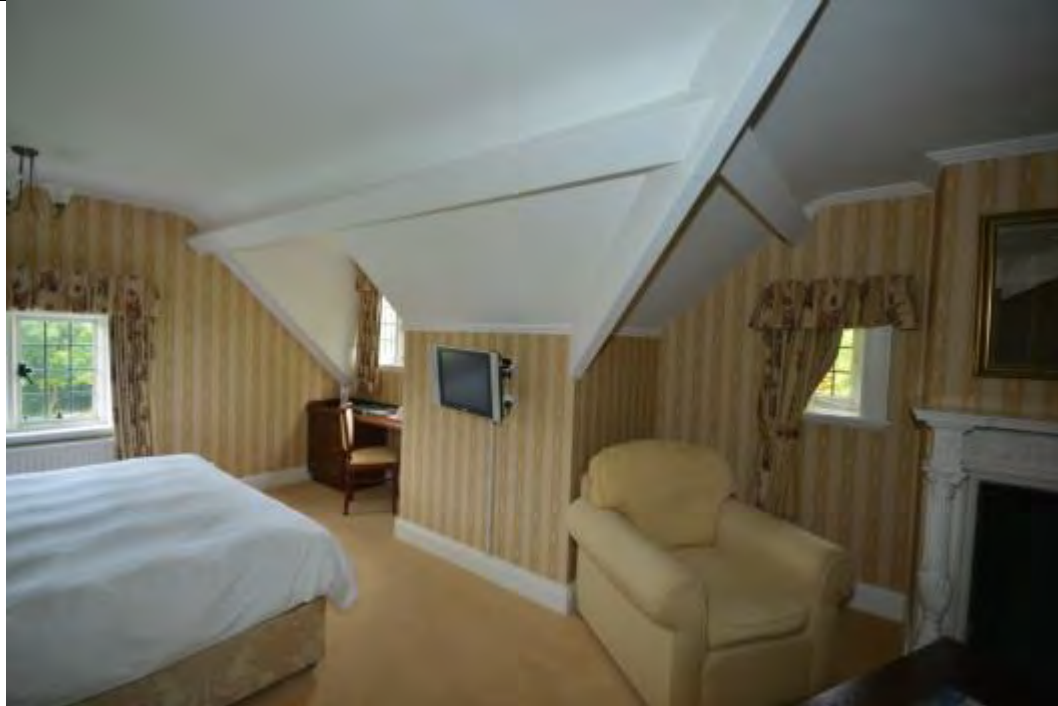
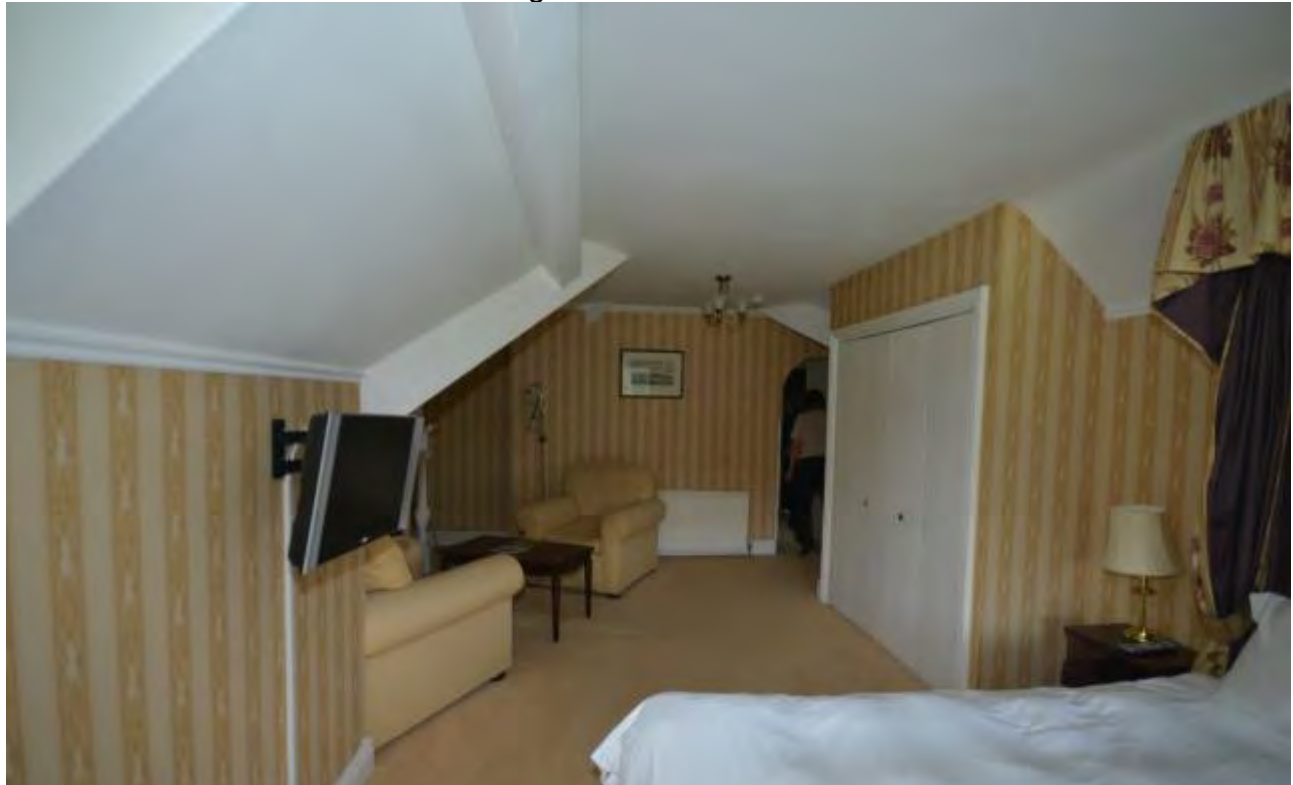
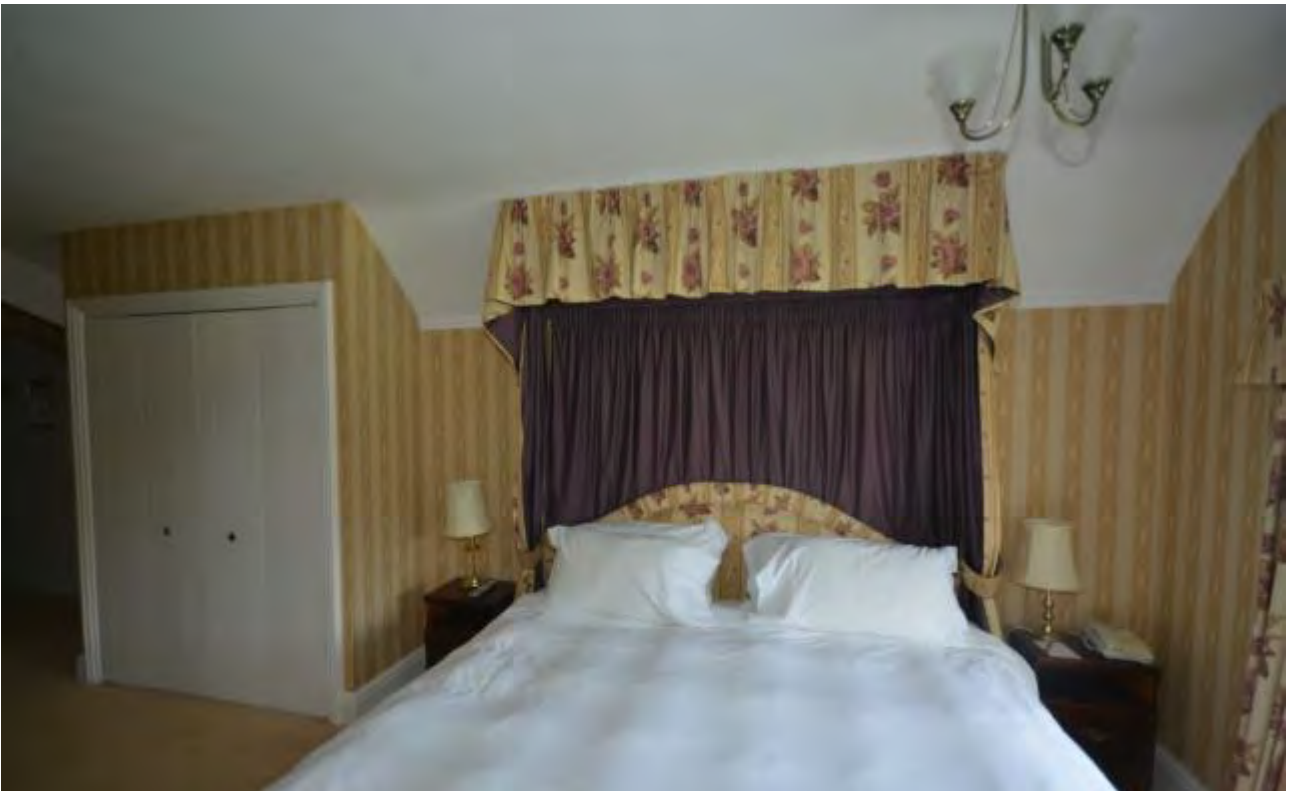
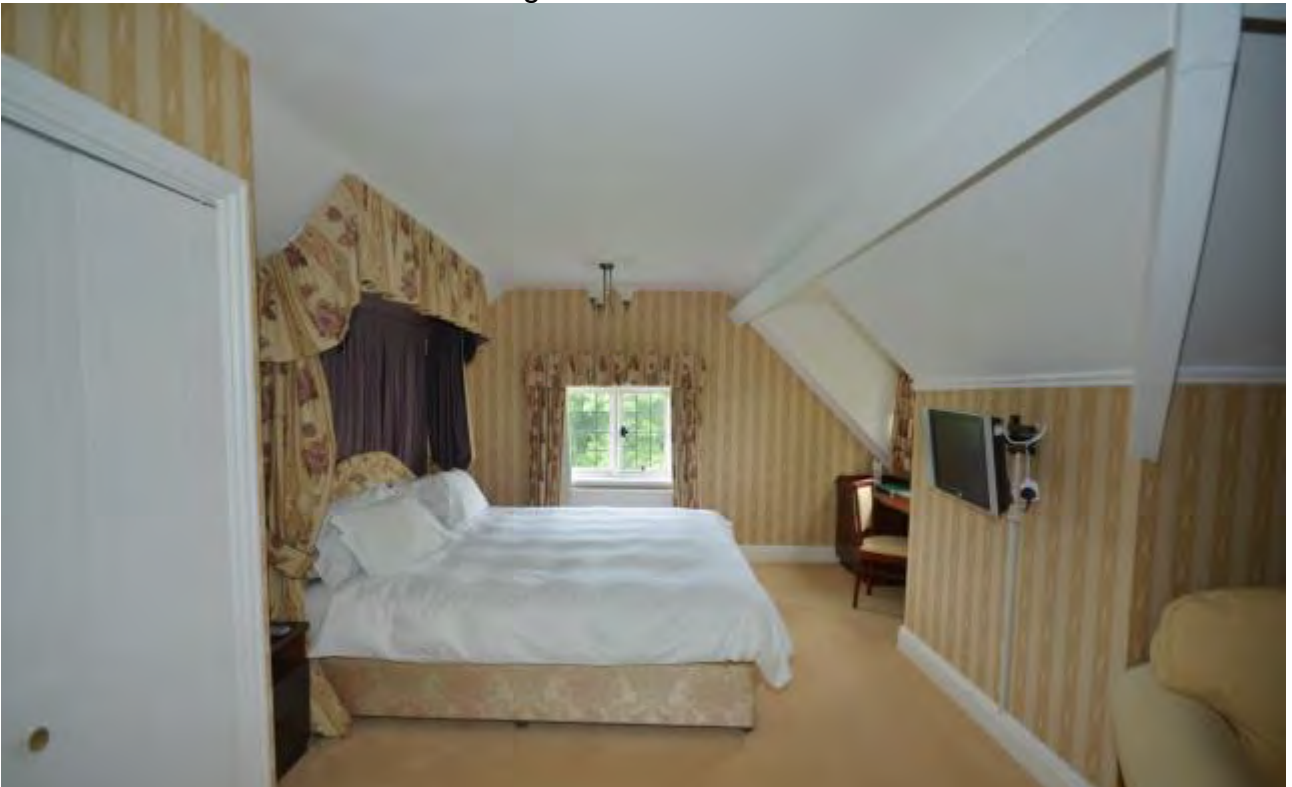
Room Name	Bishop
Current Function	Bedroom
Original Function	Bedroom
Phase	1898-1913
Plan Form	
Windows	Multi-paned leaded casements
Historic Features	Elaborate moulded fireplace
Comments/Description

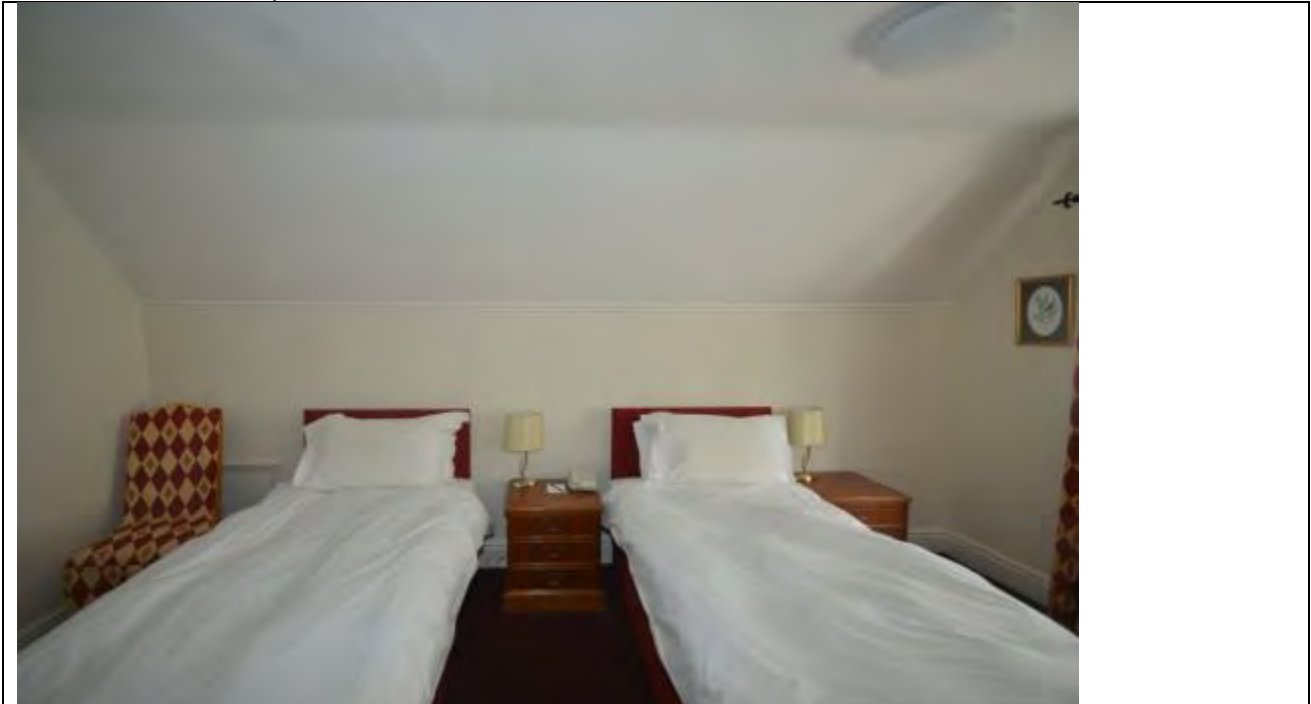
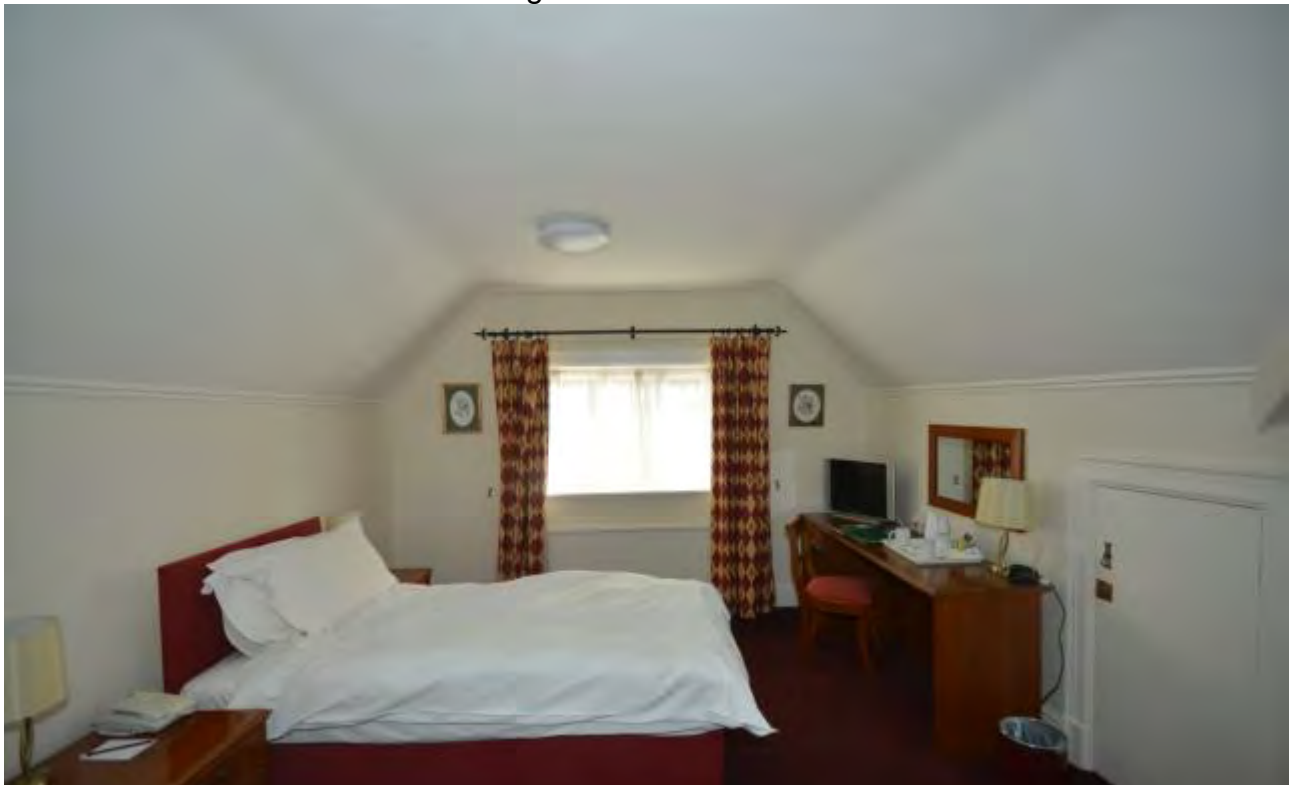
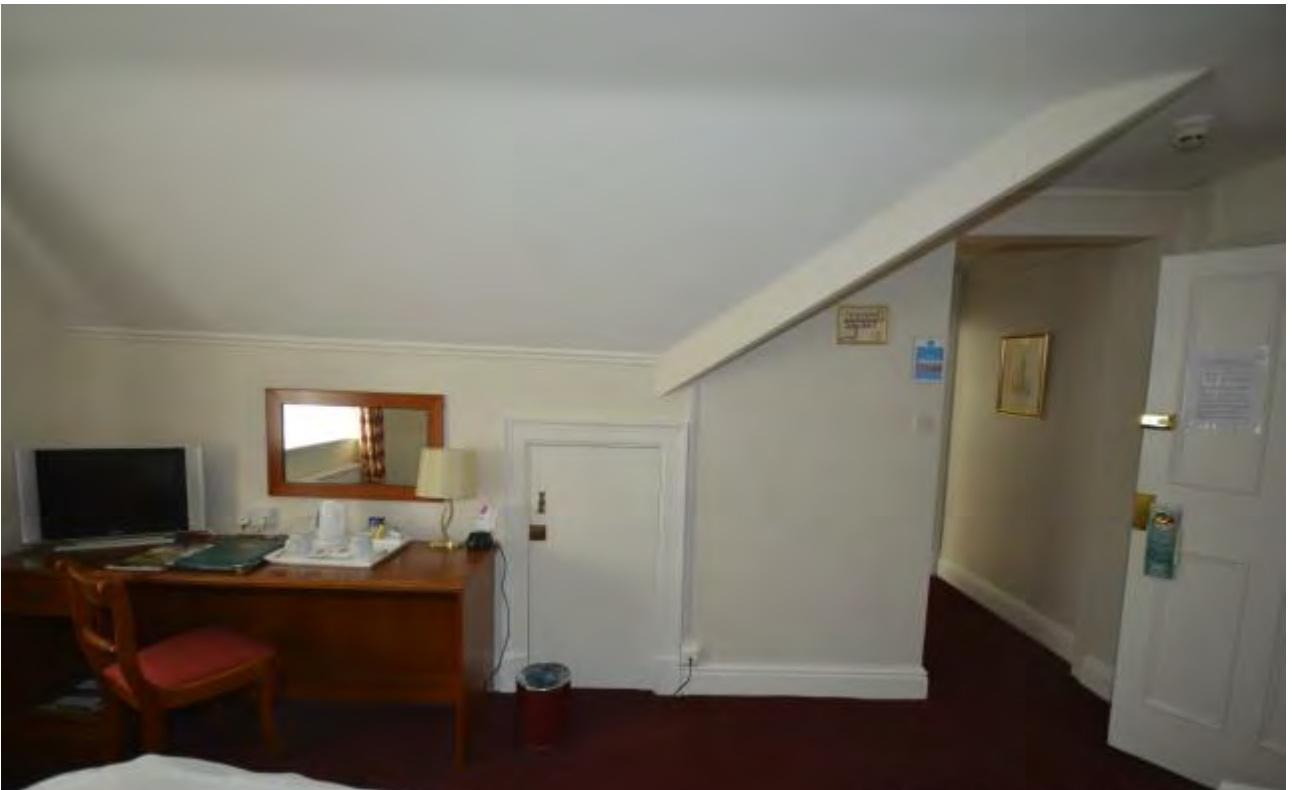
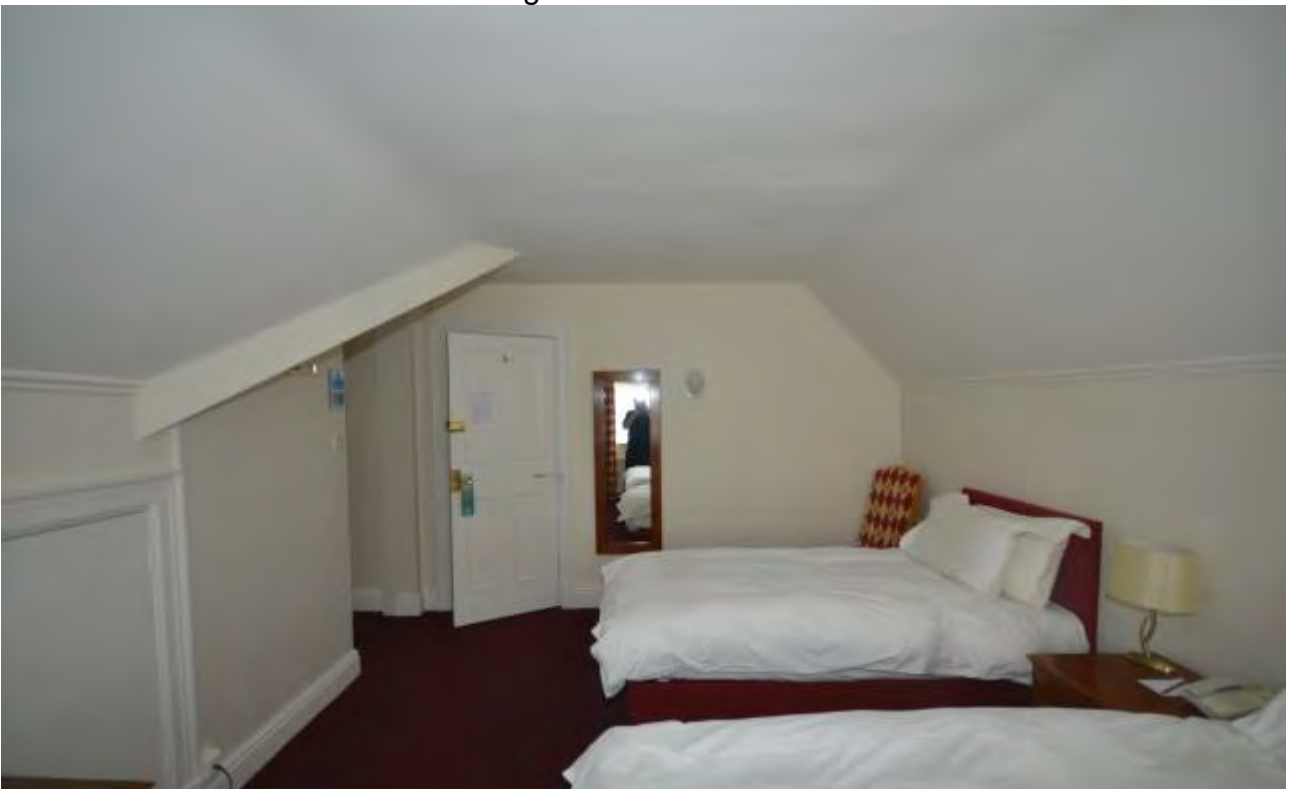
Room Name	Edwardian
Current Function	Bedroom
Original Function	Bedroom
Phase	1898-1914
Plan Form	
Windows	Modern casements
Historic Features	Plain moulded fire surround
Comments/Description

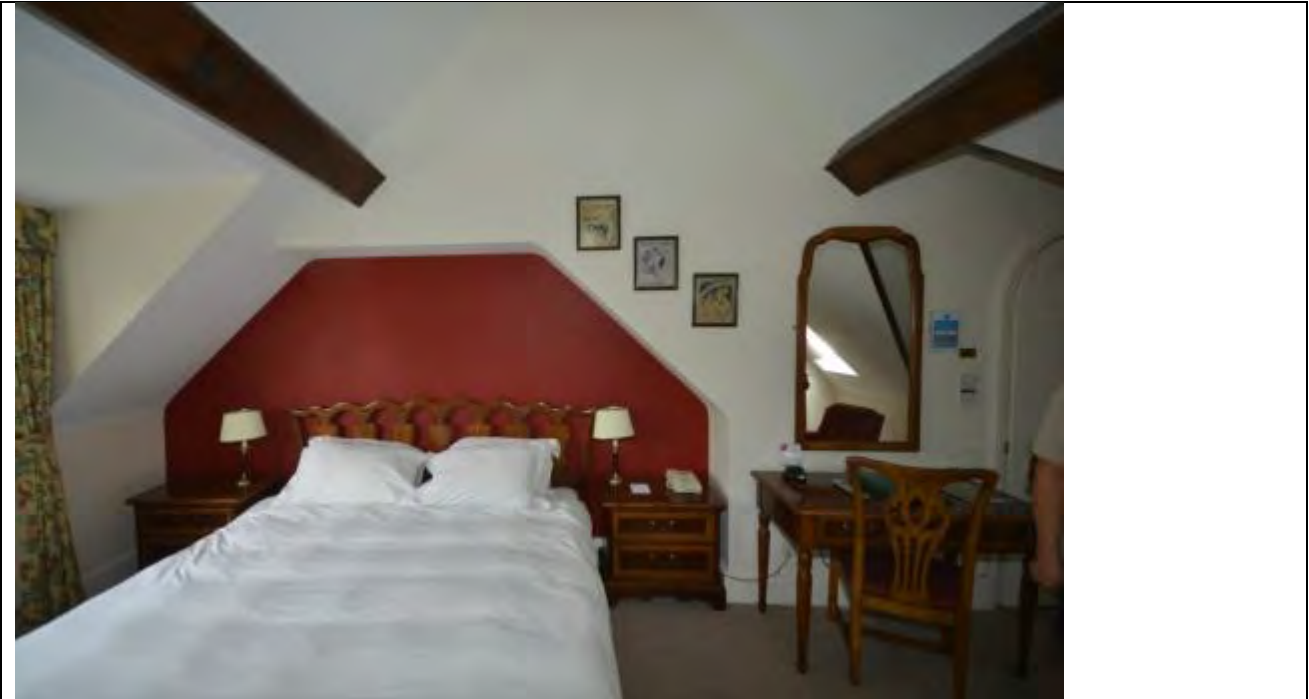
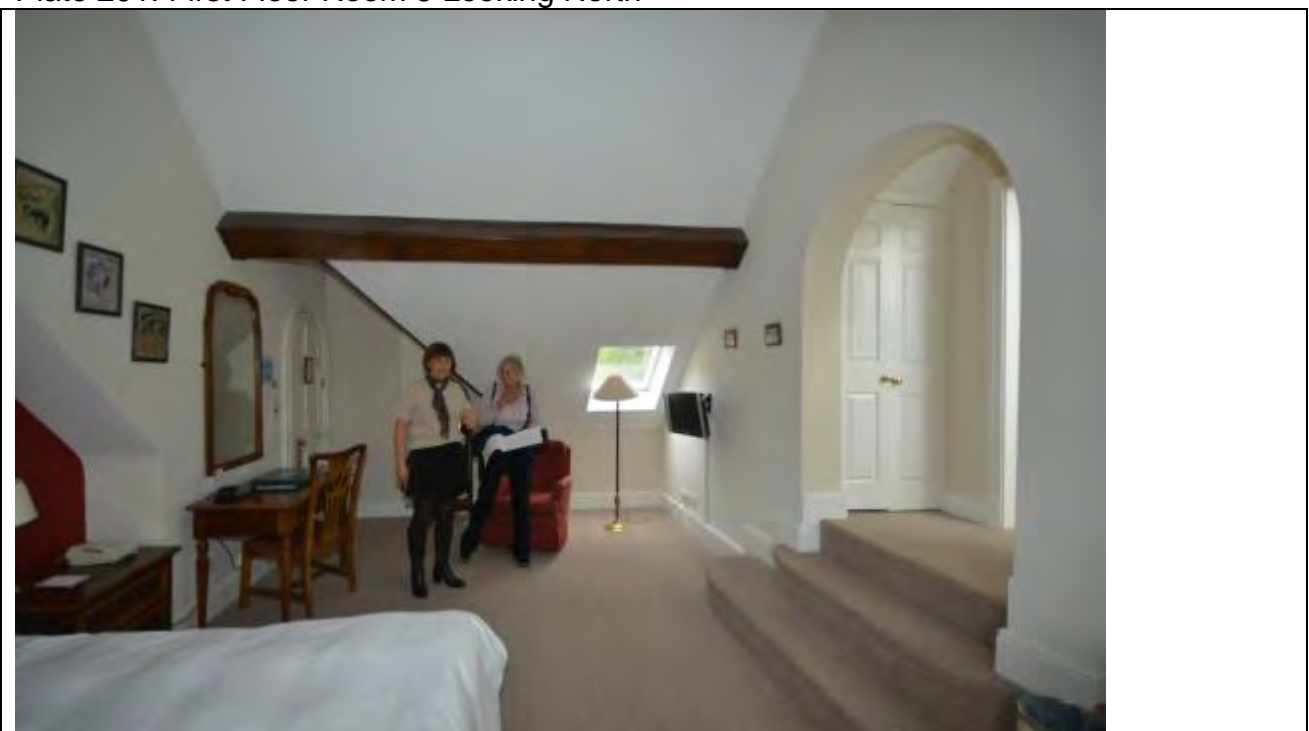
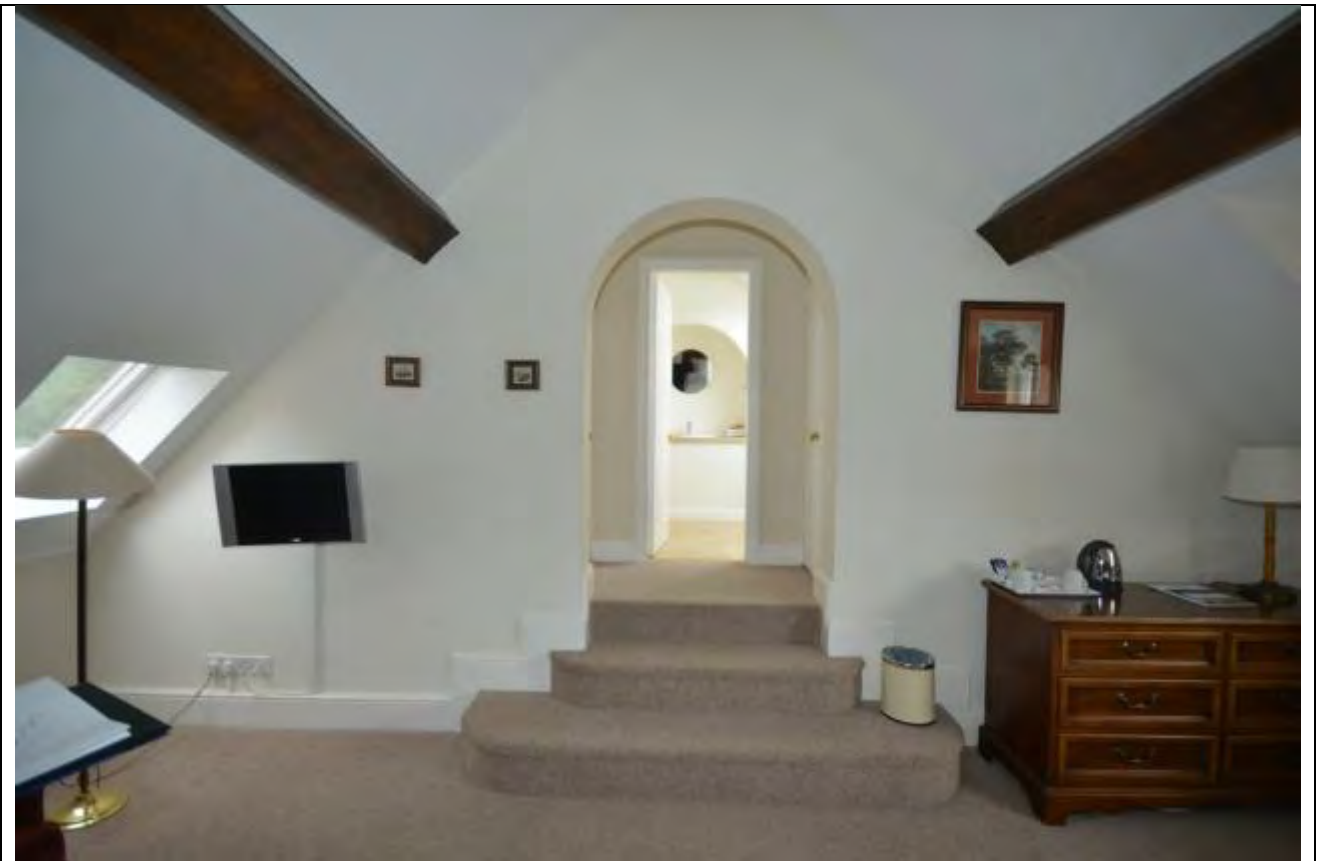
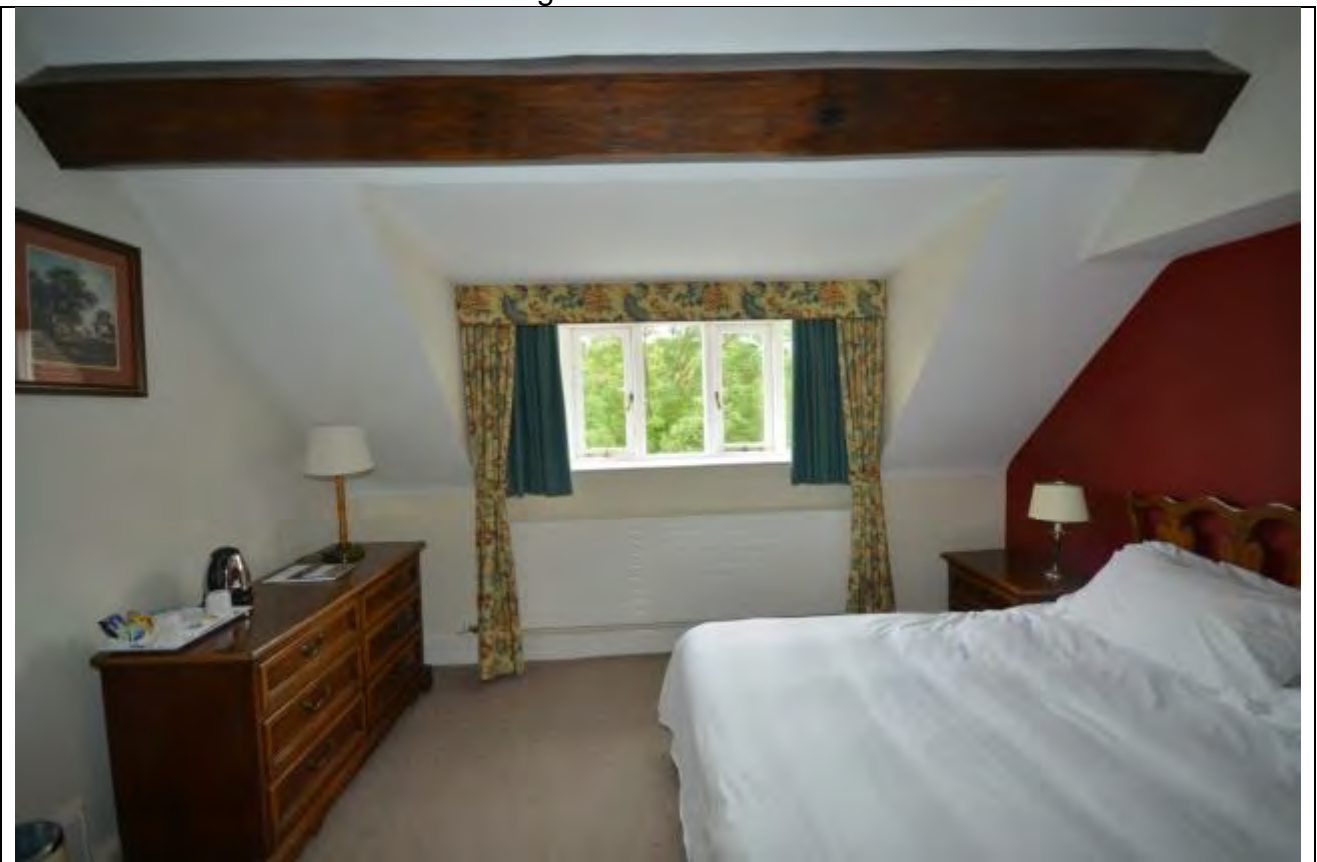
Room Name	Presidential
Current Function	Bedroom
Original Function	
Phase	Unphased
Plan Form	
Windows	Wooden casements, Velux-style roof lights
Historic Features	Exposed machine-sawn purlins
Comments/Description	This suite is located above parts of the building of pre-1898, 1912-1974 and c. 1981 date. It is unclear as to when the room was created in its current form.

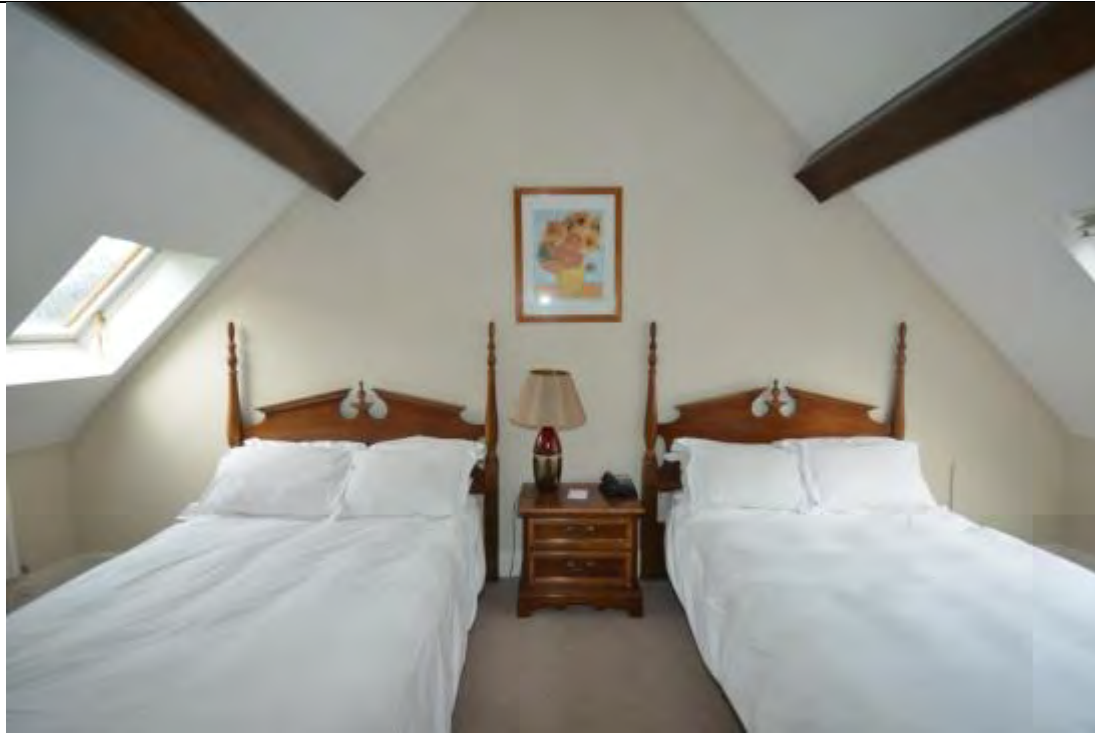
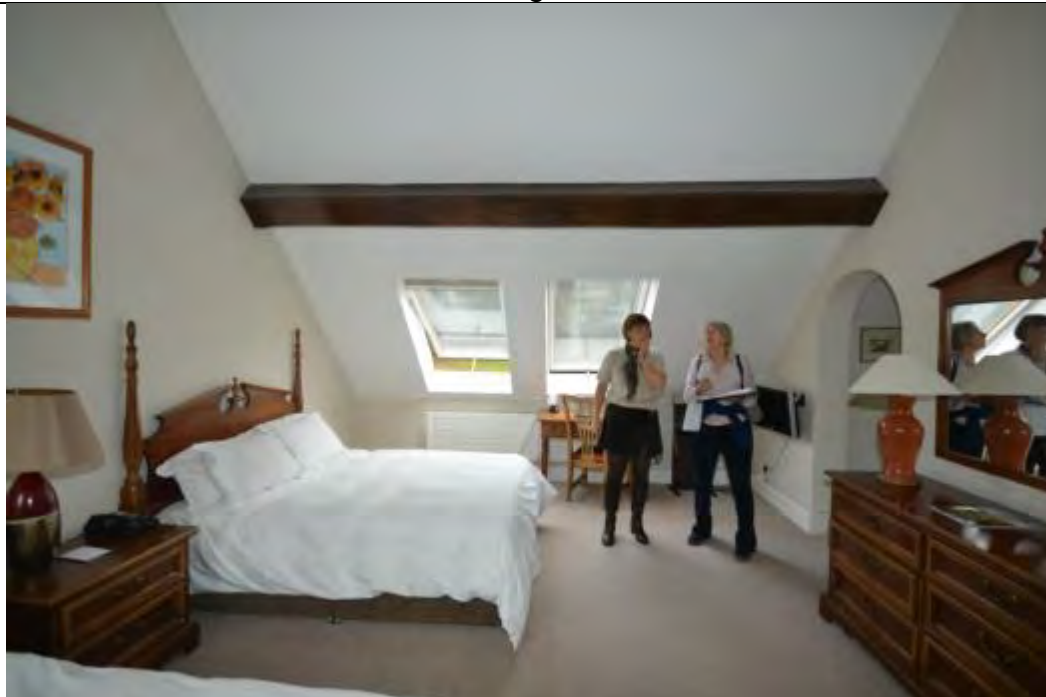
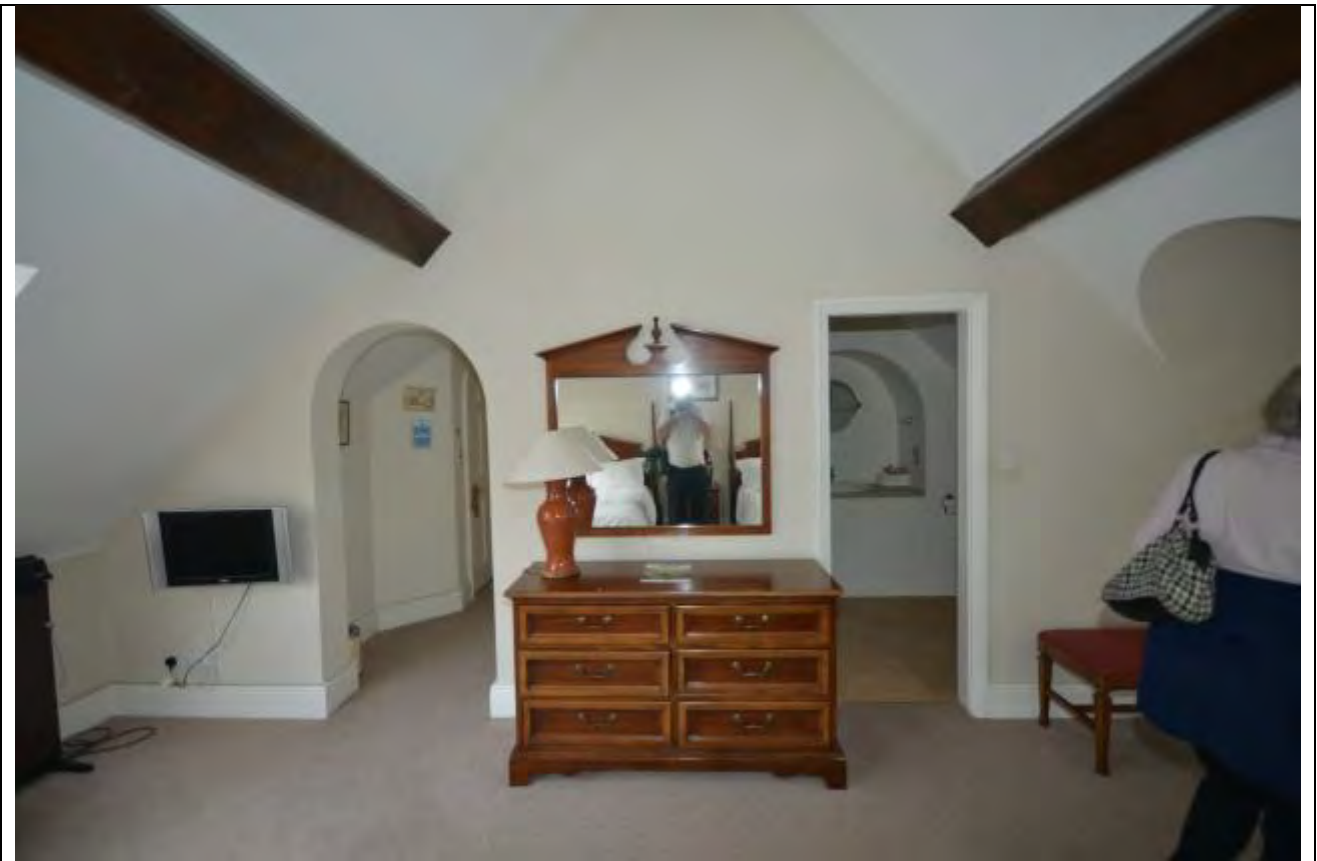
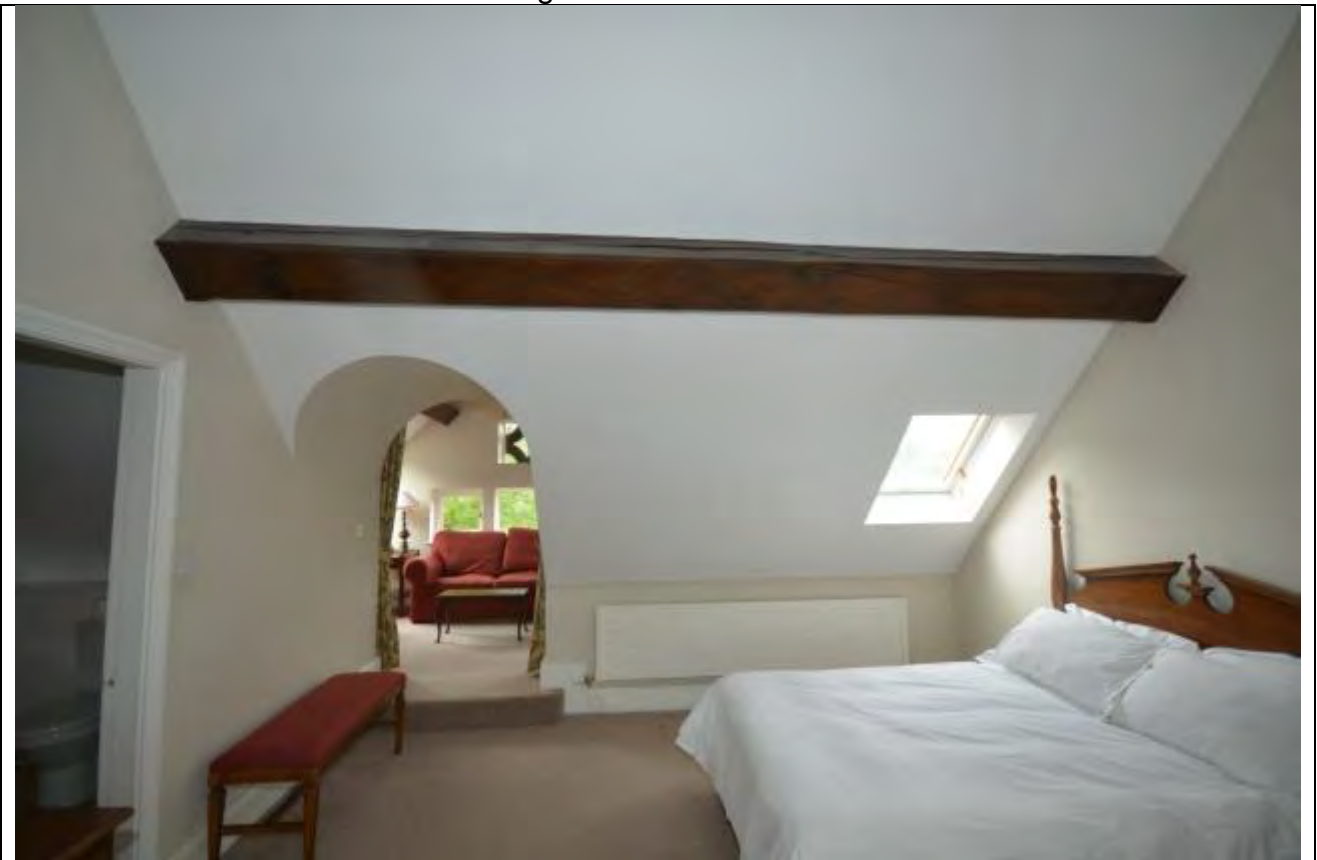
Room Name	Diplomat
Current Function	Suite – bedroom, sitting room, bathroom
Original Function	
Phase	Unphased
Plan Form	
Windows	Velux style roof lights
Historic Features	Exposed machine-sawn purlins
Comments/Description	This suite is located above parts of the building of pre-1898, 1912-1974 and c. 1981 date. It is unclear as to when the room was created in its current form.

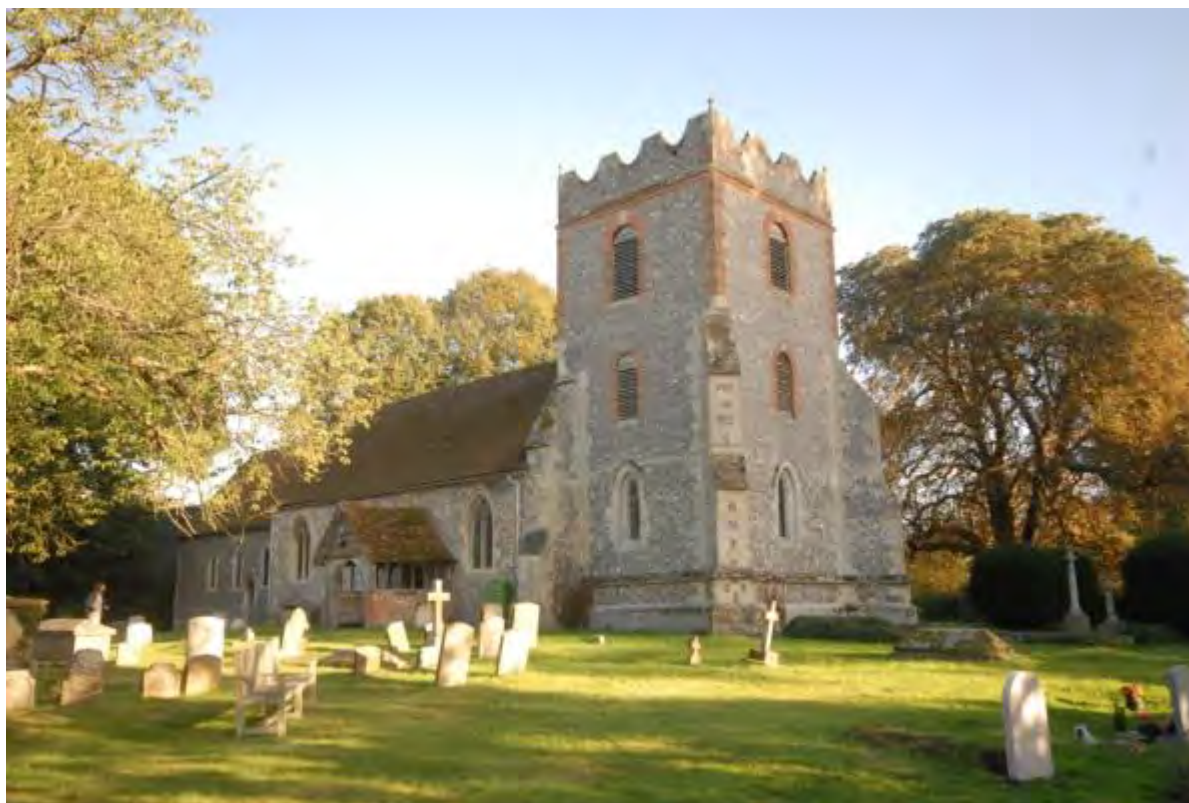
Plate 212 The Church of St Mary 2007

Flint with stone dressings; red brick dressing to top of tower; plain tile roof. Nave, chancel and west tower. Porch to right of centre: brick base; 2-centre wooden arch to front; original studded door to church in stone 2-centred archway with damaged hood mould and damaged carved end stops. Three 2-light Y-tracery windows to nave. 3 pointed lancets to chancel. Single trefoil topped lancet to chancel. 2-centred arched doorway to chancel with moulded hood. Tower to right; pointed lancet with hood mould with end stops to first stage. C18 round-headed openings with brick dressings to second stage. C18 round-headed louvred opening with brick dressings to third stage. Shaped brick cornice; shaped parapet to roof with stone ball finials to corners. Rear: Blocked 2-centre arched doorway to left of centre with hood mould. Three 2-light Y-tracery windows to nave. 3 pointed lancets and rectangular window to chancel. Carved head and hands holding stone sun dial above blocked door. Left return: 3-light probably C19 plate tracery window.

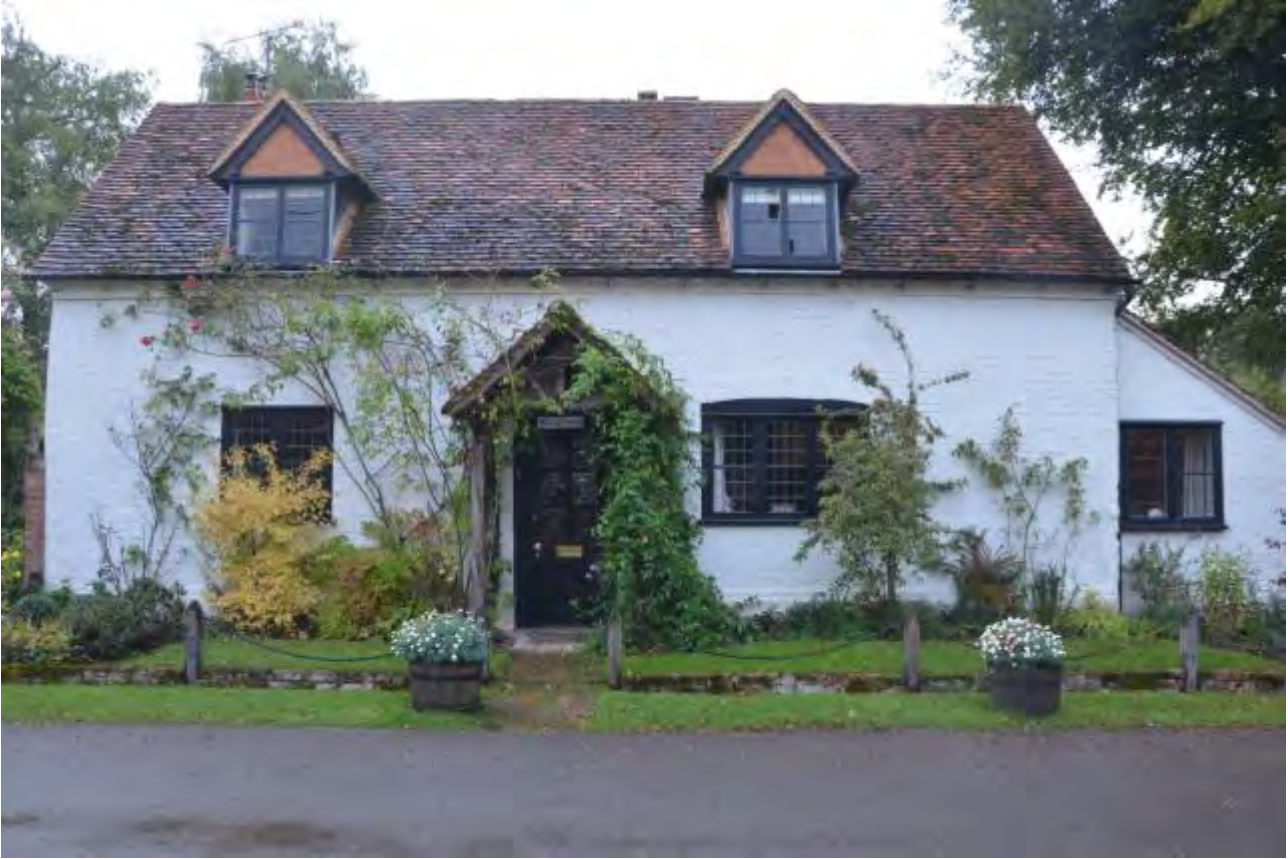
### Plate 214 Kimberley Cottage

Cottage. Probably mid C18. Painted brick; plain tile roof; brick stack to rear. Two-unit plan. Single storey and attic; 2-window range. C20 door to centre with open rustic timber frame porch with gabled plain tile roof. 2-light wood leaded casement with segmental brick head to left. 3-light wood leaded casement with segmental head to right. Dentil cornice to eaves. 2 gabled dormers Queen post roof truss to right return. Interior not inspected. Lean-to extension to right return. Included as a complete example. Listing NGR: SU6099486272

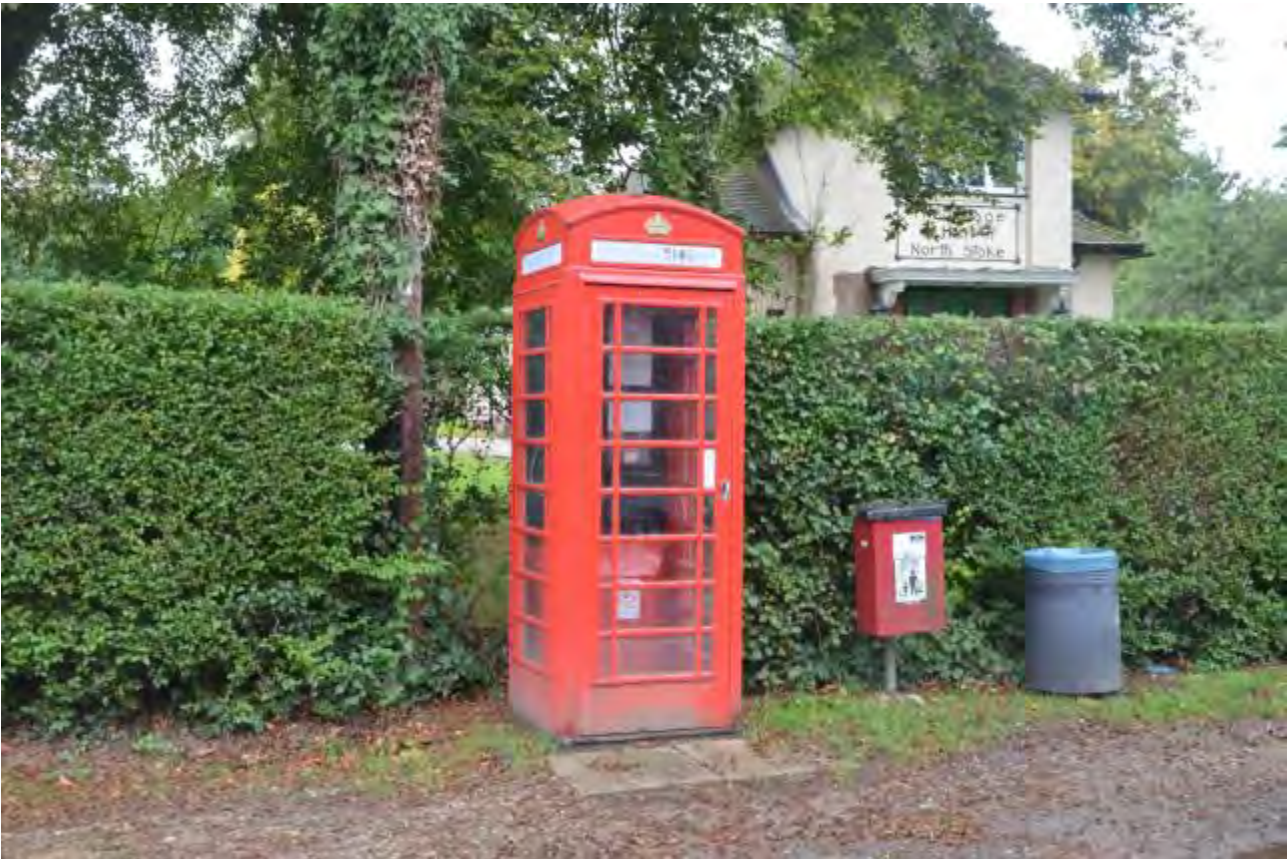
Plate 215 Telephone Kiosk  
2/139 K6 Telephone Kiosk

Telephone kiosk. Type K6. Designed 1935 by Sir Giles Gilbert Scott. Made by various contractors. Cast iron. Square kiosk with domed roof. Unperforated crowns to top panels and margin glazing to windows and door. Listing NGR: SU6099886287
