Heritage Statement on  
**The Springs Hotel**  
Wallingford Road  
North Stoke  
Oxfordshire  
OX10 6BE  
National Grid Reference: SU813 863

Document Reference Number 2013/1168  
Version 0.6

Heritage Statement: The Springs Hotel  
Dr Peter Wardle and Colin Lacey  
18/10/2013

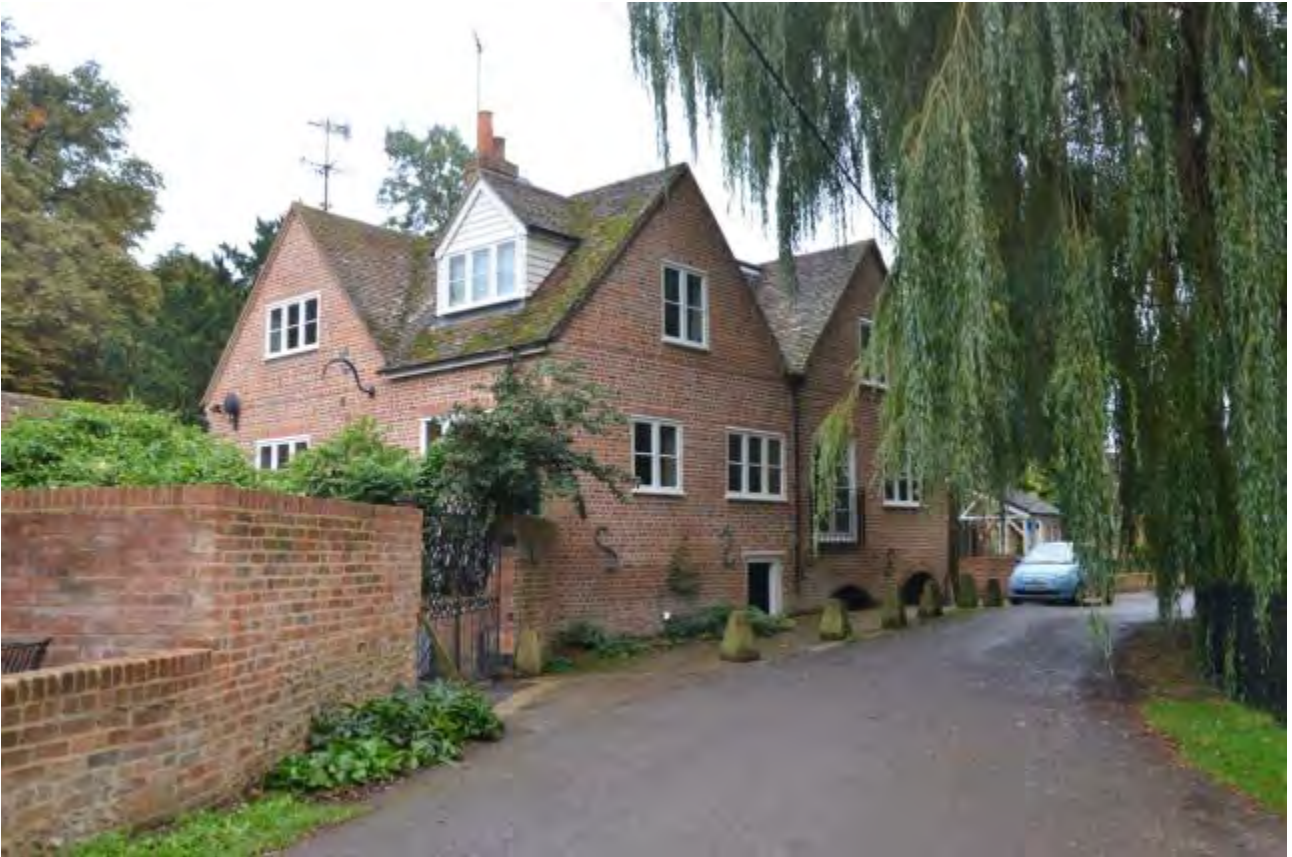
Plate 217 The Mill House  
CROWMARSH THE STREET SU68NW (East side) North Stoke 2/39 The Mill House

House. C17 with probably late C18 front and C19 extensions. Red brick with flared headers; plain tile roof; brick stacks. Probably baffle-entry plan. 2 storeys; 3-window range. Central C20 glazed door with overlight. Tripartite sashes to left and right. Brick band between ground and first floor. Three 4-pane sashes to first floor. Dentil cornice to eaves. Central ridge stack; end stack to right. Right hand return: irregular fenestration, mainly of 12-pane unhorned sashes. Subsidiary C19 extension to left with 6-panel part-glazed door with single light window to left under catslide roof. Interior not inspected.

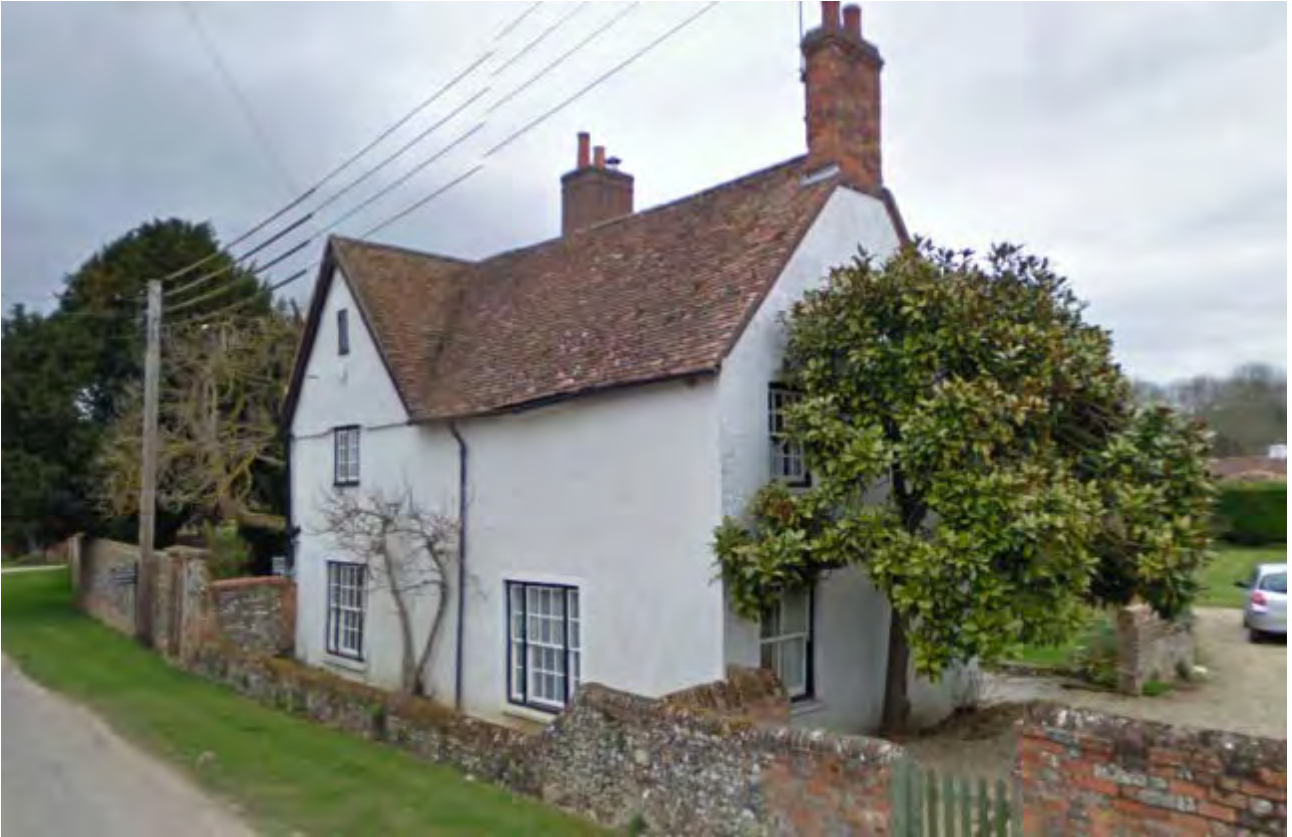
**Plate 218 The Old Farm House (Google Street View)**

Farmhouse, now house. Probably late C17 with C20 alterations. Coursed knapped flint with brick dressings; plain tile roof; brick stack. 2 storeys; 3-window range. 6-panel part-glazed door to right. C20 cross windows to original openings on ground floor. Brick flat band between ground and first floor. Original leaded cross window to first floor left. Original casement to first floor right. C20 cross window to centre. Dentil cornice to eaves. Half hipped roof. Ridge stack to right. Interior not inspected. Roughcast 2-storey wing to right. Single-storey wing to left.
