CONSERVATION STATEMENT

Arbery's
11-12 Market Place
Wantage
Oxfordshire

Planning Reference: WAN/16246/33-LB

**Conservation Statement
for
Arbery's, 11-12 Market Place, Wantage, Oxfordshire**

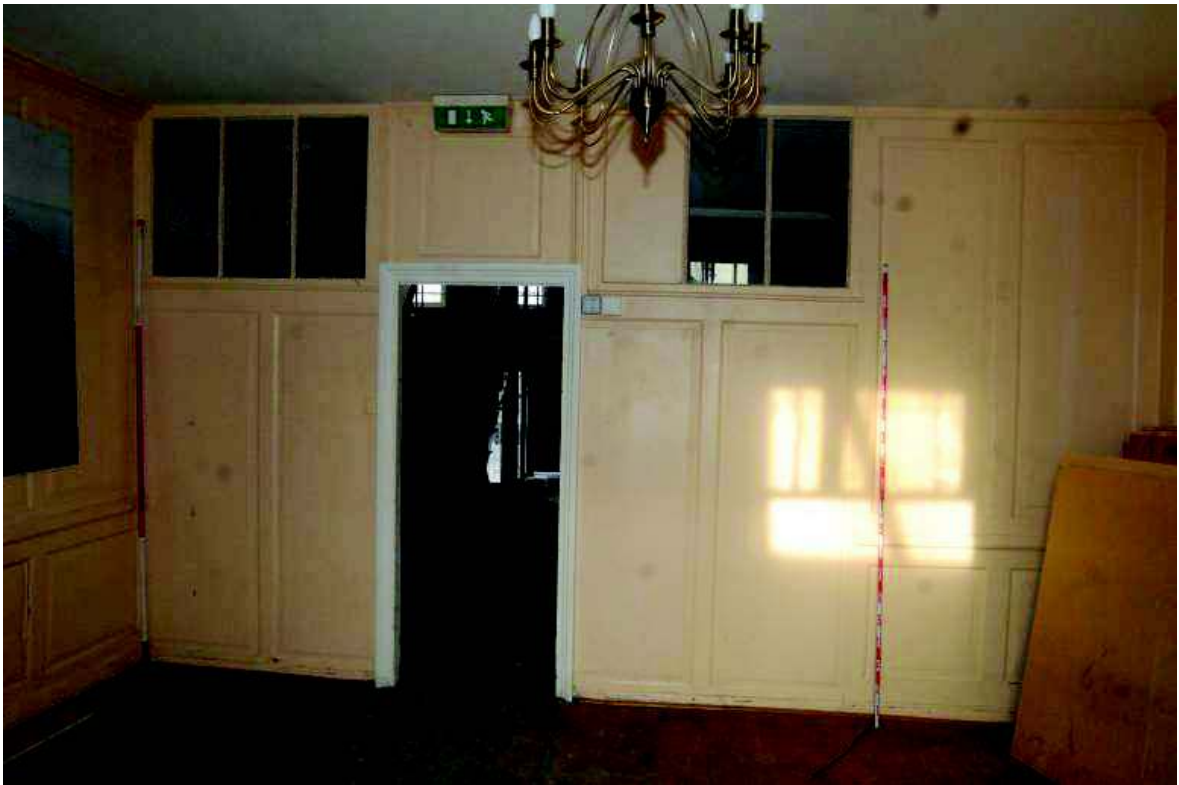
Plate 2: Northern elevation, panellled room

The northern wall also has skirting but no cornice. The doorframe is of timber and is moulded in a 19th century style. Above the door, a square panel is located. West of the door, three vertical glazed lights are located above a round moulding at a height of 1.9m. Below these, two panels run the remaining length of the wall. No dado is present. This pattern is mirrored on the eastern side of the door, although here the glass in the westernmost light has been painted on its southern side, obscuring the view of a structural timber post located immediately to the north. These panels, the door and its associated over-panel, and the panels to the west of the doorway make up the 'secondary panels' noted in the Rhodes & Steane report.

The remaining part of the northern wall, east of the 'secondary panels', follows the established 'primary panelling' pattern of skirting, dado, dado rail, rectangular panel, although has no cornice. This pattern of panels is repeated twice before the corner of the room is encountered.

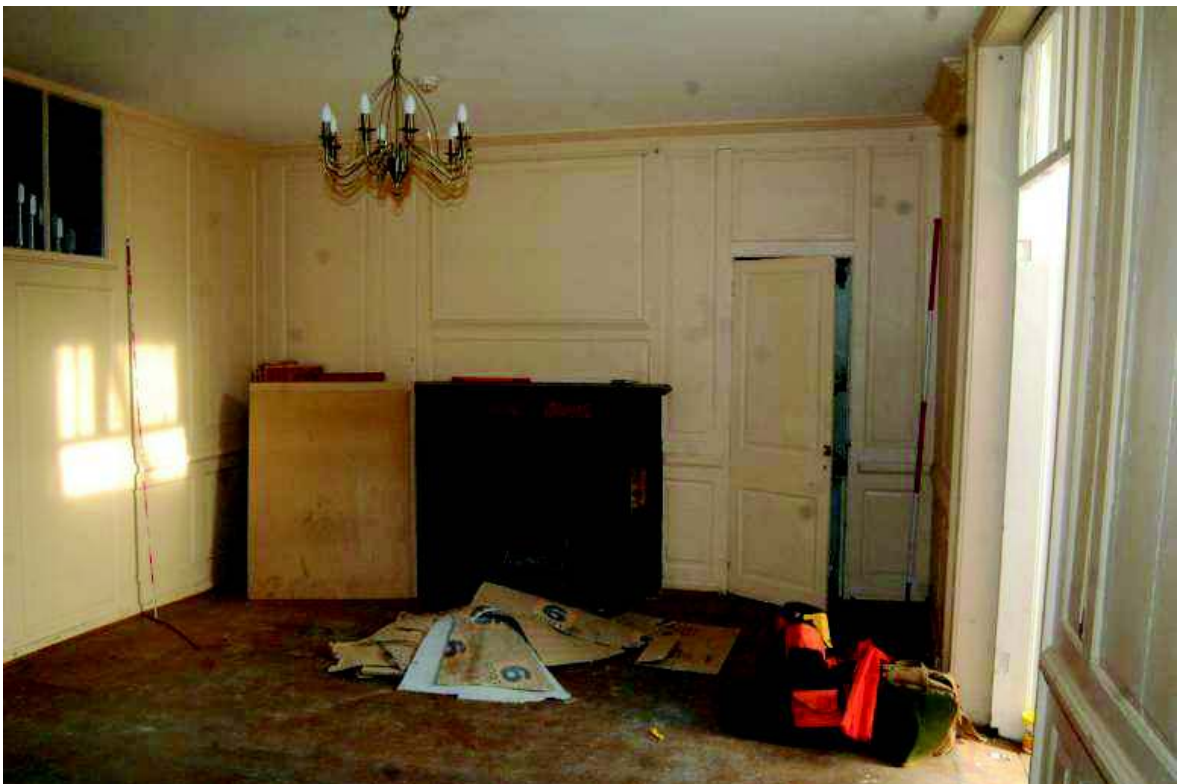
Plate 3: Eastern elevation, panellled room

The eastern wall begins at the northern end with a full-sized panel, followed by a far narrower example. South of this, a Victorian fireplace with cast iron grate is fitted, over which a large rectangular panel fills the space between the mantle shelf and coving. South of the fireplace, a further narrow panel is located followed by a 1.9m tall door into a cupboard formed by the alcove left beside the chimneybreast. The cupboard door, hinged on its northern side, has panels mirroring those on the wall either side, minus dado rail, and is secured with a modern catch on its southern side. A further panel is situated above the door. South of the door, a narrow panel of the established form completes the eastern elevation.

- The cornice along the top of the eastern wall is continuous and there are no indications of breaks at the northern side of the chimneybreast suggesting the panelling was not installed on this wall until the staircase had been altered in the 19th century.

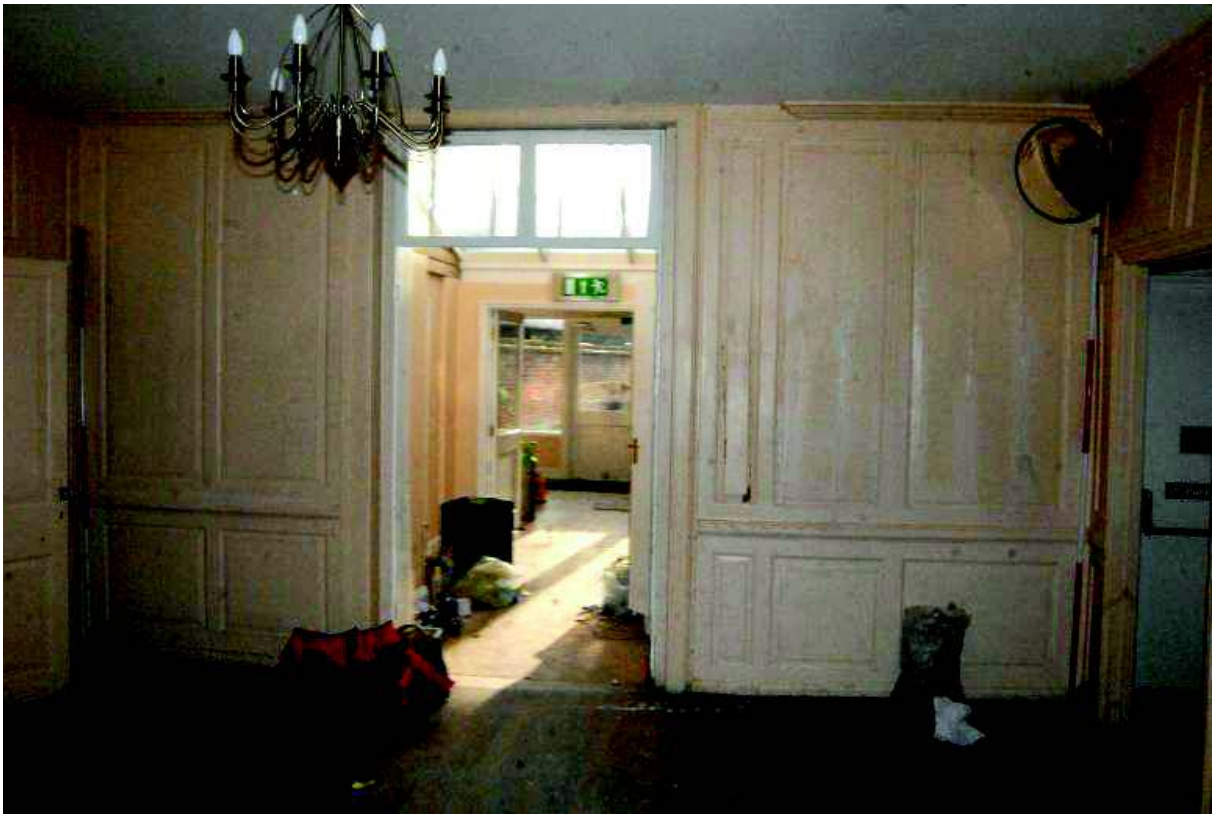
Plate 4: Southern elevation, panelled room

The southern wall features a central opening to which double doors were fitted, leading into what was originally a conservatory area. The doors are now absent although the locations of previous butt hinges are still very much apparent. A top-hung window is located at the top of the opening, again fitted with a pair of butt hinges on its upper face. The window is held from swinging by a pair of sliding bolts. In its lower face, the window frame has a pair of central holes into which further bolts could be slid to retain the doors in a closed position. The window has a pair of single pane lights.

It is apparent that the frame present is somewhat smaller than the original opening in this wall, owing to the cornice on each side ending a short distance from the opening. Noticeable joins are also present in the skirting at corresponding points.

There are two regular sized panels east of the opening, whereas to the west, three vastly disproportionate panels are found - immediately west of the opening, a very narrow panel has been installed to fill the space created by narrowing the door opening. A regular sized panel and finally a wider example follow this. It is of note that a new narrow panel had been fabricated to cover the gap left west of the door opening, whereas to the east, the panels appear to have both been altered to provide an even spacing.

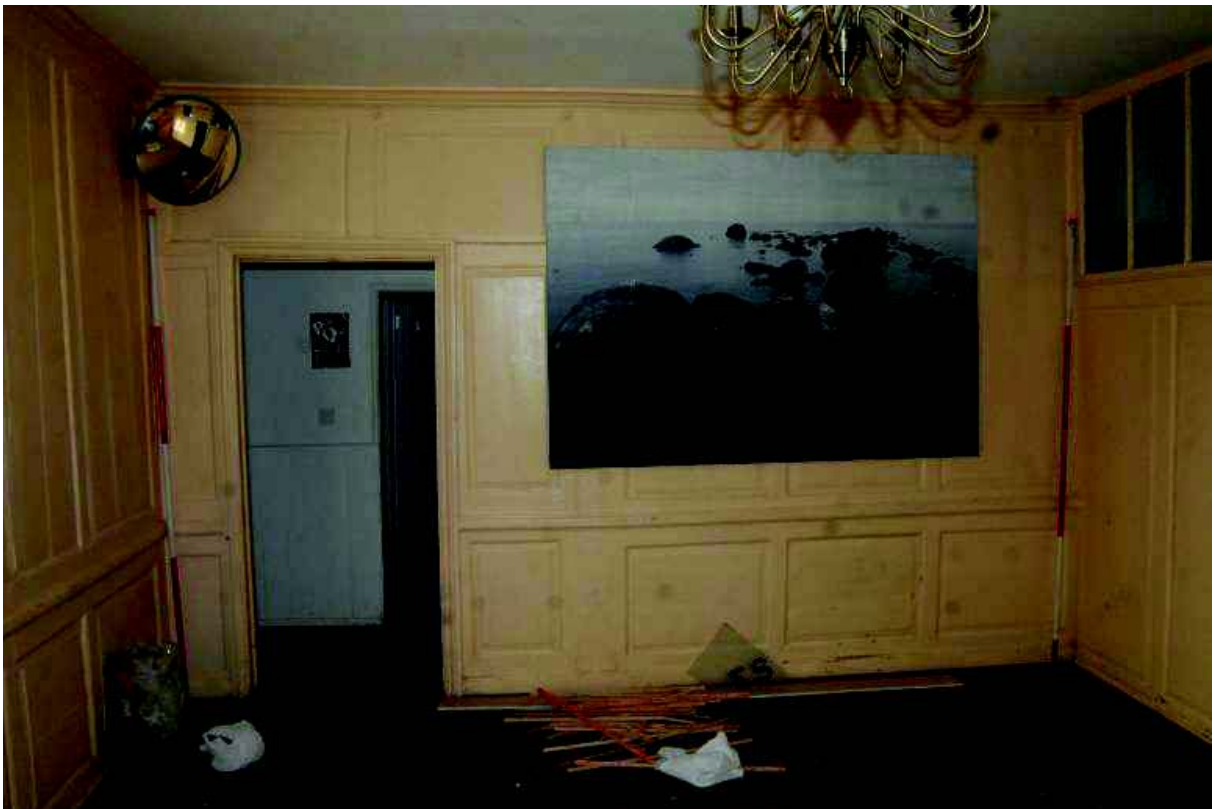
Plate 5: Western elevation, panelled room

At the southern end of the western wall, a further door opening is present leading to lavatories, a fire exit and stairs to the cellar. Again, no door is present. North of this, a slightly narrower than usual panel is located, followed by three more regular sized panels. The western wall is bowed slightly at the level of the dado rail.

In the southwest corner, a modern convex mirror is present. Also present around the head of the walls are hooks from which picture hanging rods were suspended.

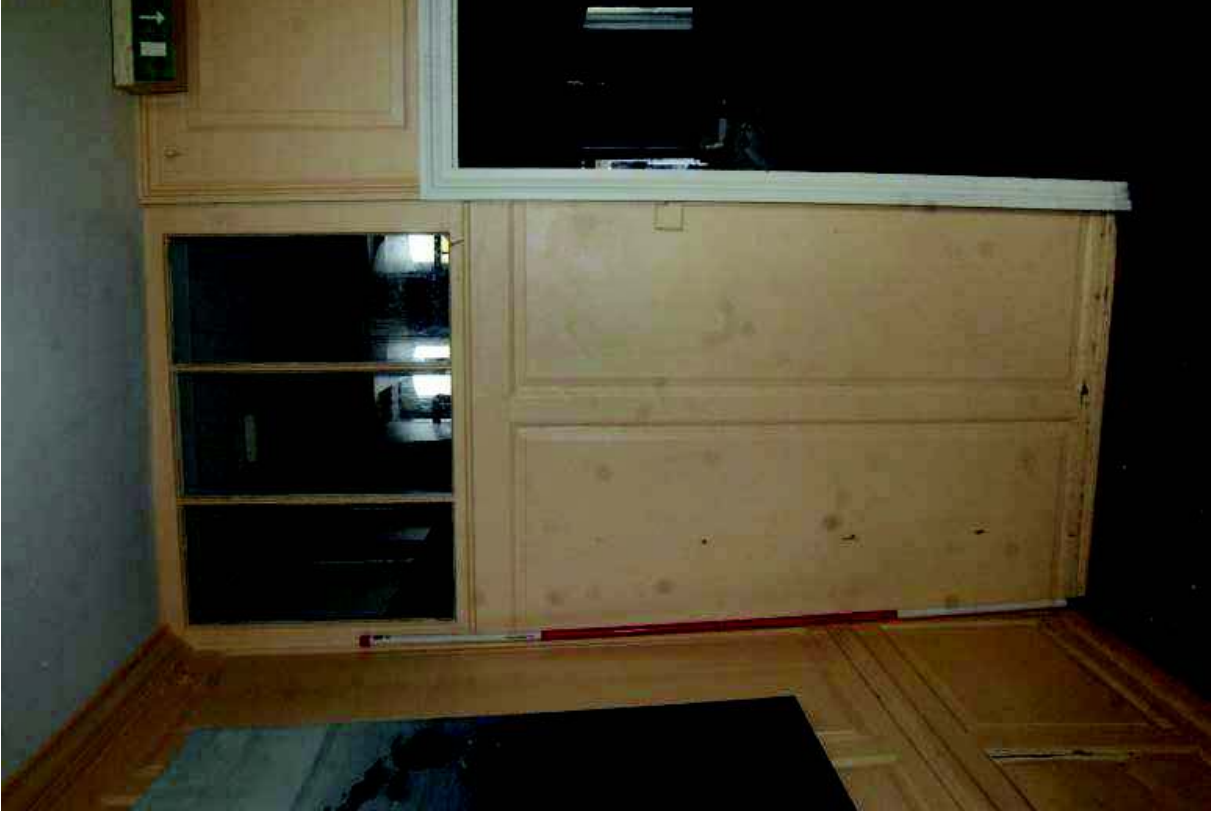
Plate 6: 'Secondary panelling' west of doorway

The areas of 'secondary panelling' have a plain reverse, with the moulding of the door frame continuing, whereas the reverse of the 'primary panelling' is distinctly different, being divided into a pair vertical plain panels running from floor to ceiling matching the spacing of the internal panelling.

It is clear that the 'secondary panelling' is a later addition to the room, likely to have been installed to narrow a much wider opening. A precise date is at present unknown, although it is thought to be an early 20th century addition.

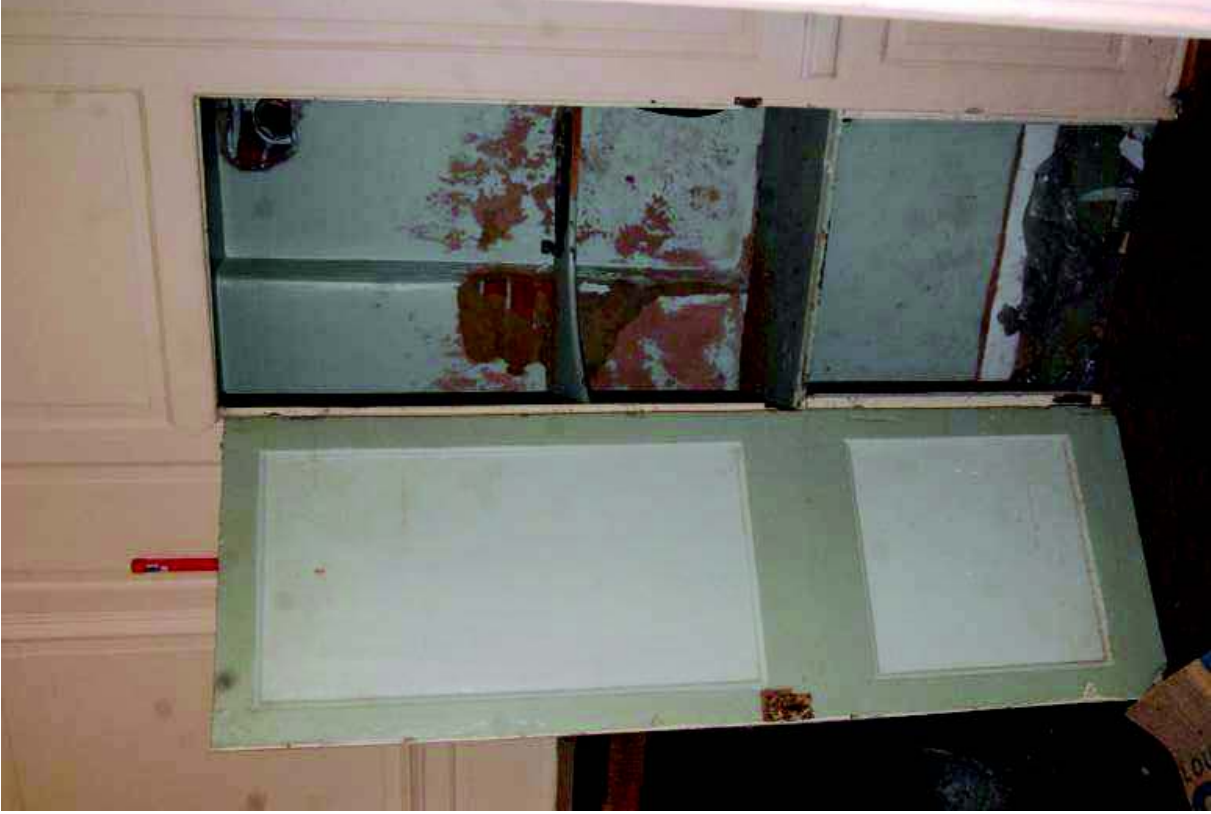
Plate 8: Cupboard, northeast aspect

The interior of the cupboard in the southeast corner of the room is painted in a pale green-blue colour. Two shelves are fitted, the lower straight-edged, located c. 0.75m above the ground. The upper shelf, situated at c. 1.25m from the ground, is a curved L-shape, running along the northern and eastern walls of the cupboard.

Above the level of the lower shelf, a recess is present in the eastern wall of the cupboard. The outer corner of this recess features a rounded edge and a damaged finish indicates this wall is constructed of red brick in a lime mortar matrix, which has been rendered before painting. This recess is thought to represent a blocked window.

- The cupboard in the southeast corner has a rendered, painted wall behind with skirting and a possible blocked window. It is unusual for the interior of a cupboard to have skirting and a blocked window, suggesting the room was in use for some time before the panelling was fitted.

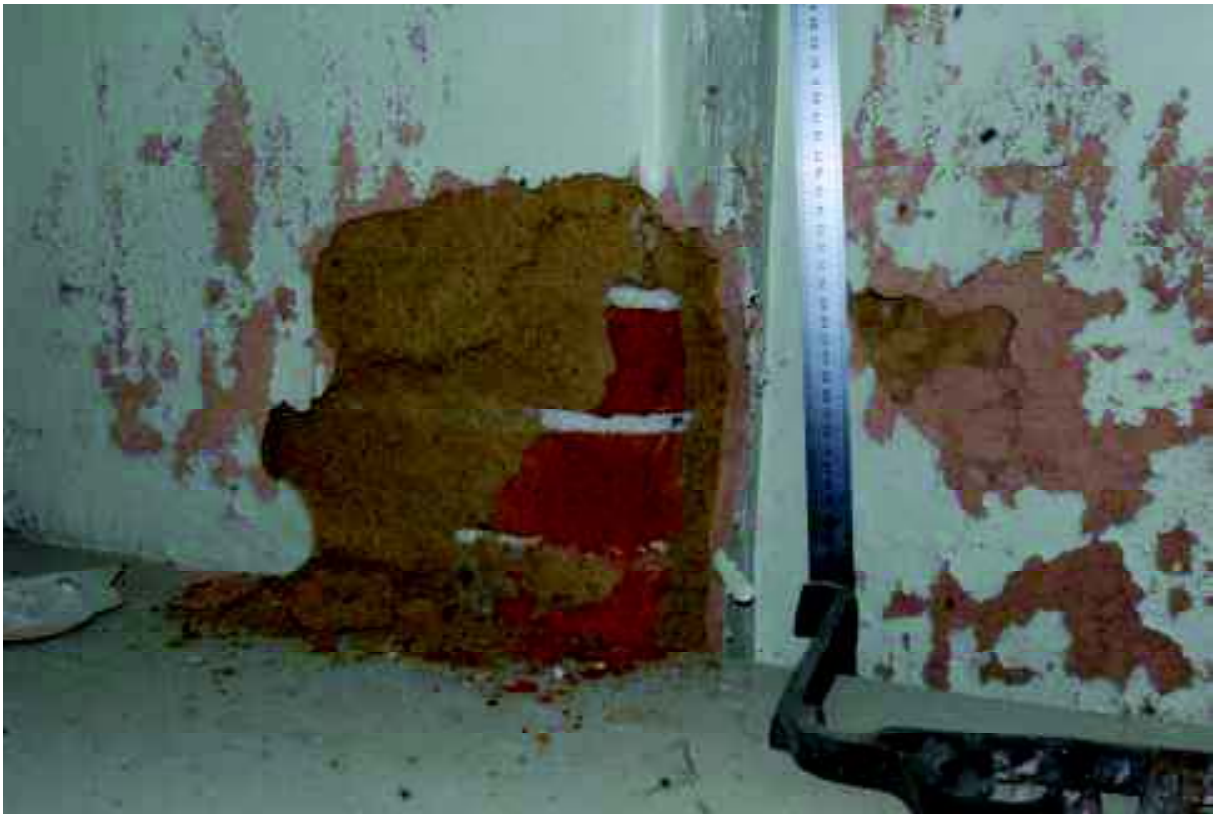
Plate 10: Detail of exposed brickwork, cupboard

Above the top shelf on the recessed part of the wall, a modern rectangular aperture is located cut roughly through the wall. Two ventilation ducts are present within. Again, in the aperture, bricks are visible. These bricks, like those mentioned above do not appear to be hand-made, therefore a Victorian or later date must be attributed to this wall. The wall blocking the window is of double thickness at this point.

- The presence of machine-made bricks in the rear wall of the cupboard suggests this wall was built in the 19th century. It is considered logical that the panelling was fitted after the construction of the wall, rather than the other way around.

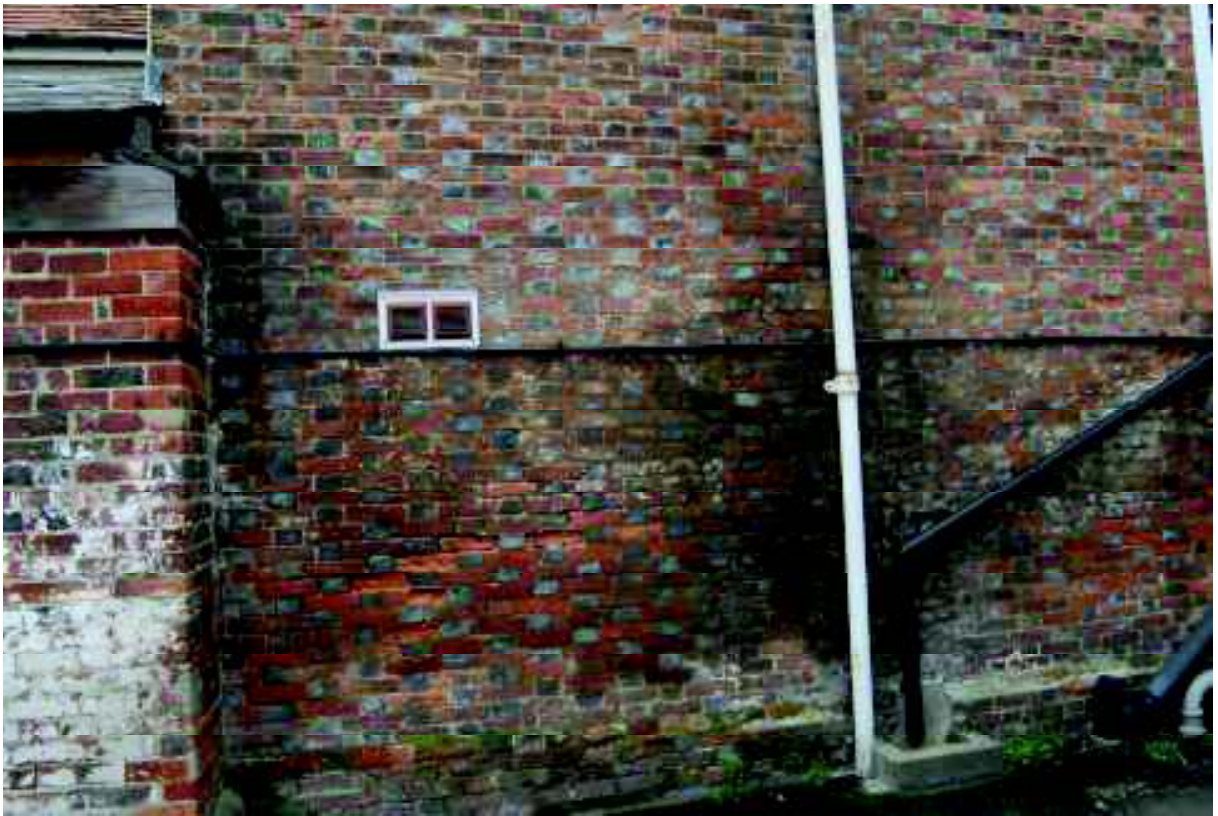
Plate 12: Reverse of wall showing area of blocked window (surrounding air vents)

Externally, there are no traces of the blocked window. The wall is constructed of Victorian or later bricks laid in Flemish bond with decorative vitrified headers. It is thought that this wall was re-skinned in the Victorian period, possibly coinciding with the blocking of the window.

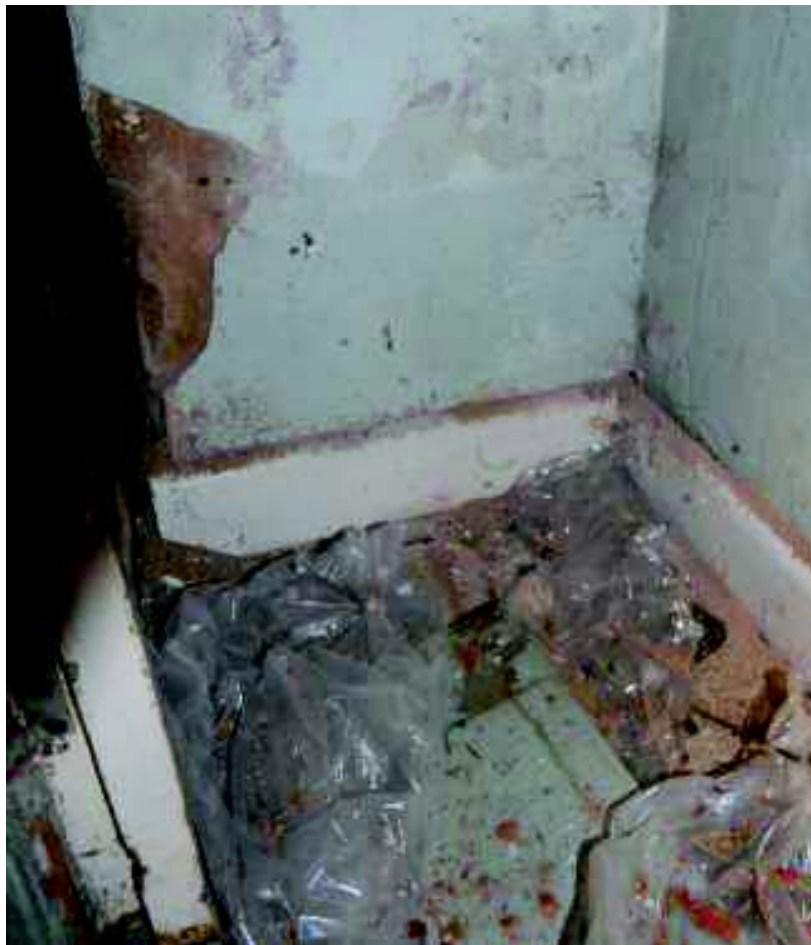
Plate 13: Detail of skirting, cupboard

It is also noted that at the foot of the wall in the cupboard, a very plain painted skirting board is apparent along the base of the wall. This is considered again to have a Victorian or later date.

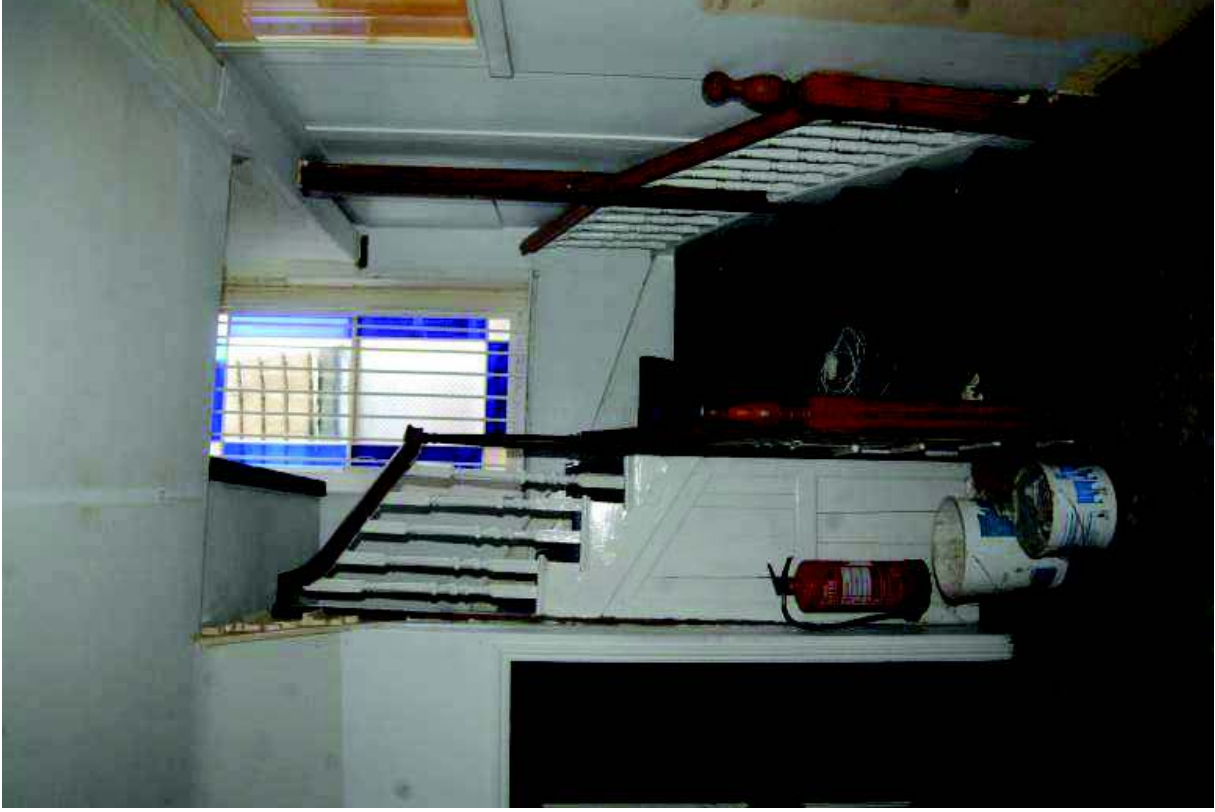
Plate 19: Eastern aspect, staircase

The staircase present in the room to the north of the panelled room is now a redundant feature. Previously it gave access to the first floor at this point, although following the conversion of upper floor rooms into separate flats, this access has been blocked at ceiling level. The staircase, however, has been preserved in-situ.

The treads and risers of the staircase are carpeted in modern carpet. The balusters are painted in white gloss, whereas the handrails and newels are plain wood.

Beneath the staircase, a further flight of steps leads down to the cellar. This is accessed via a door beneath the first floor landing and is separated from the ground floor room by timber panelling.

The staircase takes a winder form and is constructed in two phases. The original phase of construction, the upper part, features brackets in a late 18th-early 19th century style usually attributed to open-string staircases. It is possible that this staircase was originally open-strung and the underside was subsequently panelled in order to enclose the cellar stairs. The balusters of the original phase are stylistically dated to the 18th century.

- The panelling is of pine, a timber that was not widely used during the 18th century.
- The staircase could not have followed its original route whilst the room was panelled. The foot of the staircase would have ended at the chimneybreast in the panelled room and the gap behind the panelling is not considered to be large enough to accommodate the full width of the staircase at this point.

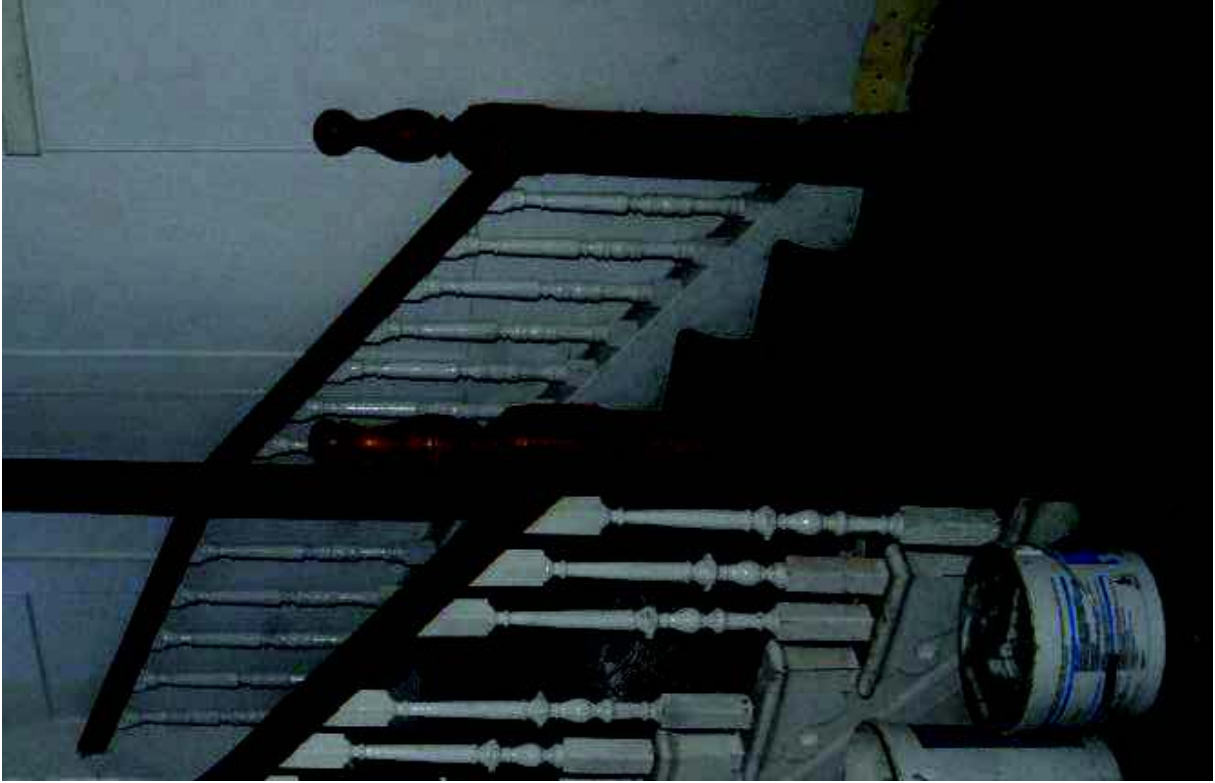
Plate 21: Detail of later part of staircase

The second phase of staircase construction is marked by a change in the style of the balusters to a Victorian style, and a change in the material used for the handrail from a darker hardwood to a much paler timber. The newel posts at the foot of the staircase are also stylistically late 19th century.

It appears that the ninety-degree bend in the staircase was installed in the 19th century and it is suggested that the original form was a straight flight of steps terminating in the panelled room.
