Heritage Statement:
Claughton Centre
Blowers Green Rd
Dudley
West Midlands
DY2 8UD
National Grid Reference: SO939897

Dr Peter Wardle & Colin Lacey

17/12/2014
Document Reference Number 2013/1192
Version 0.7

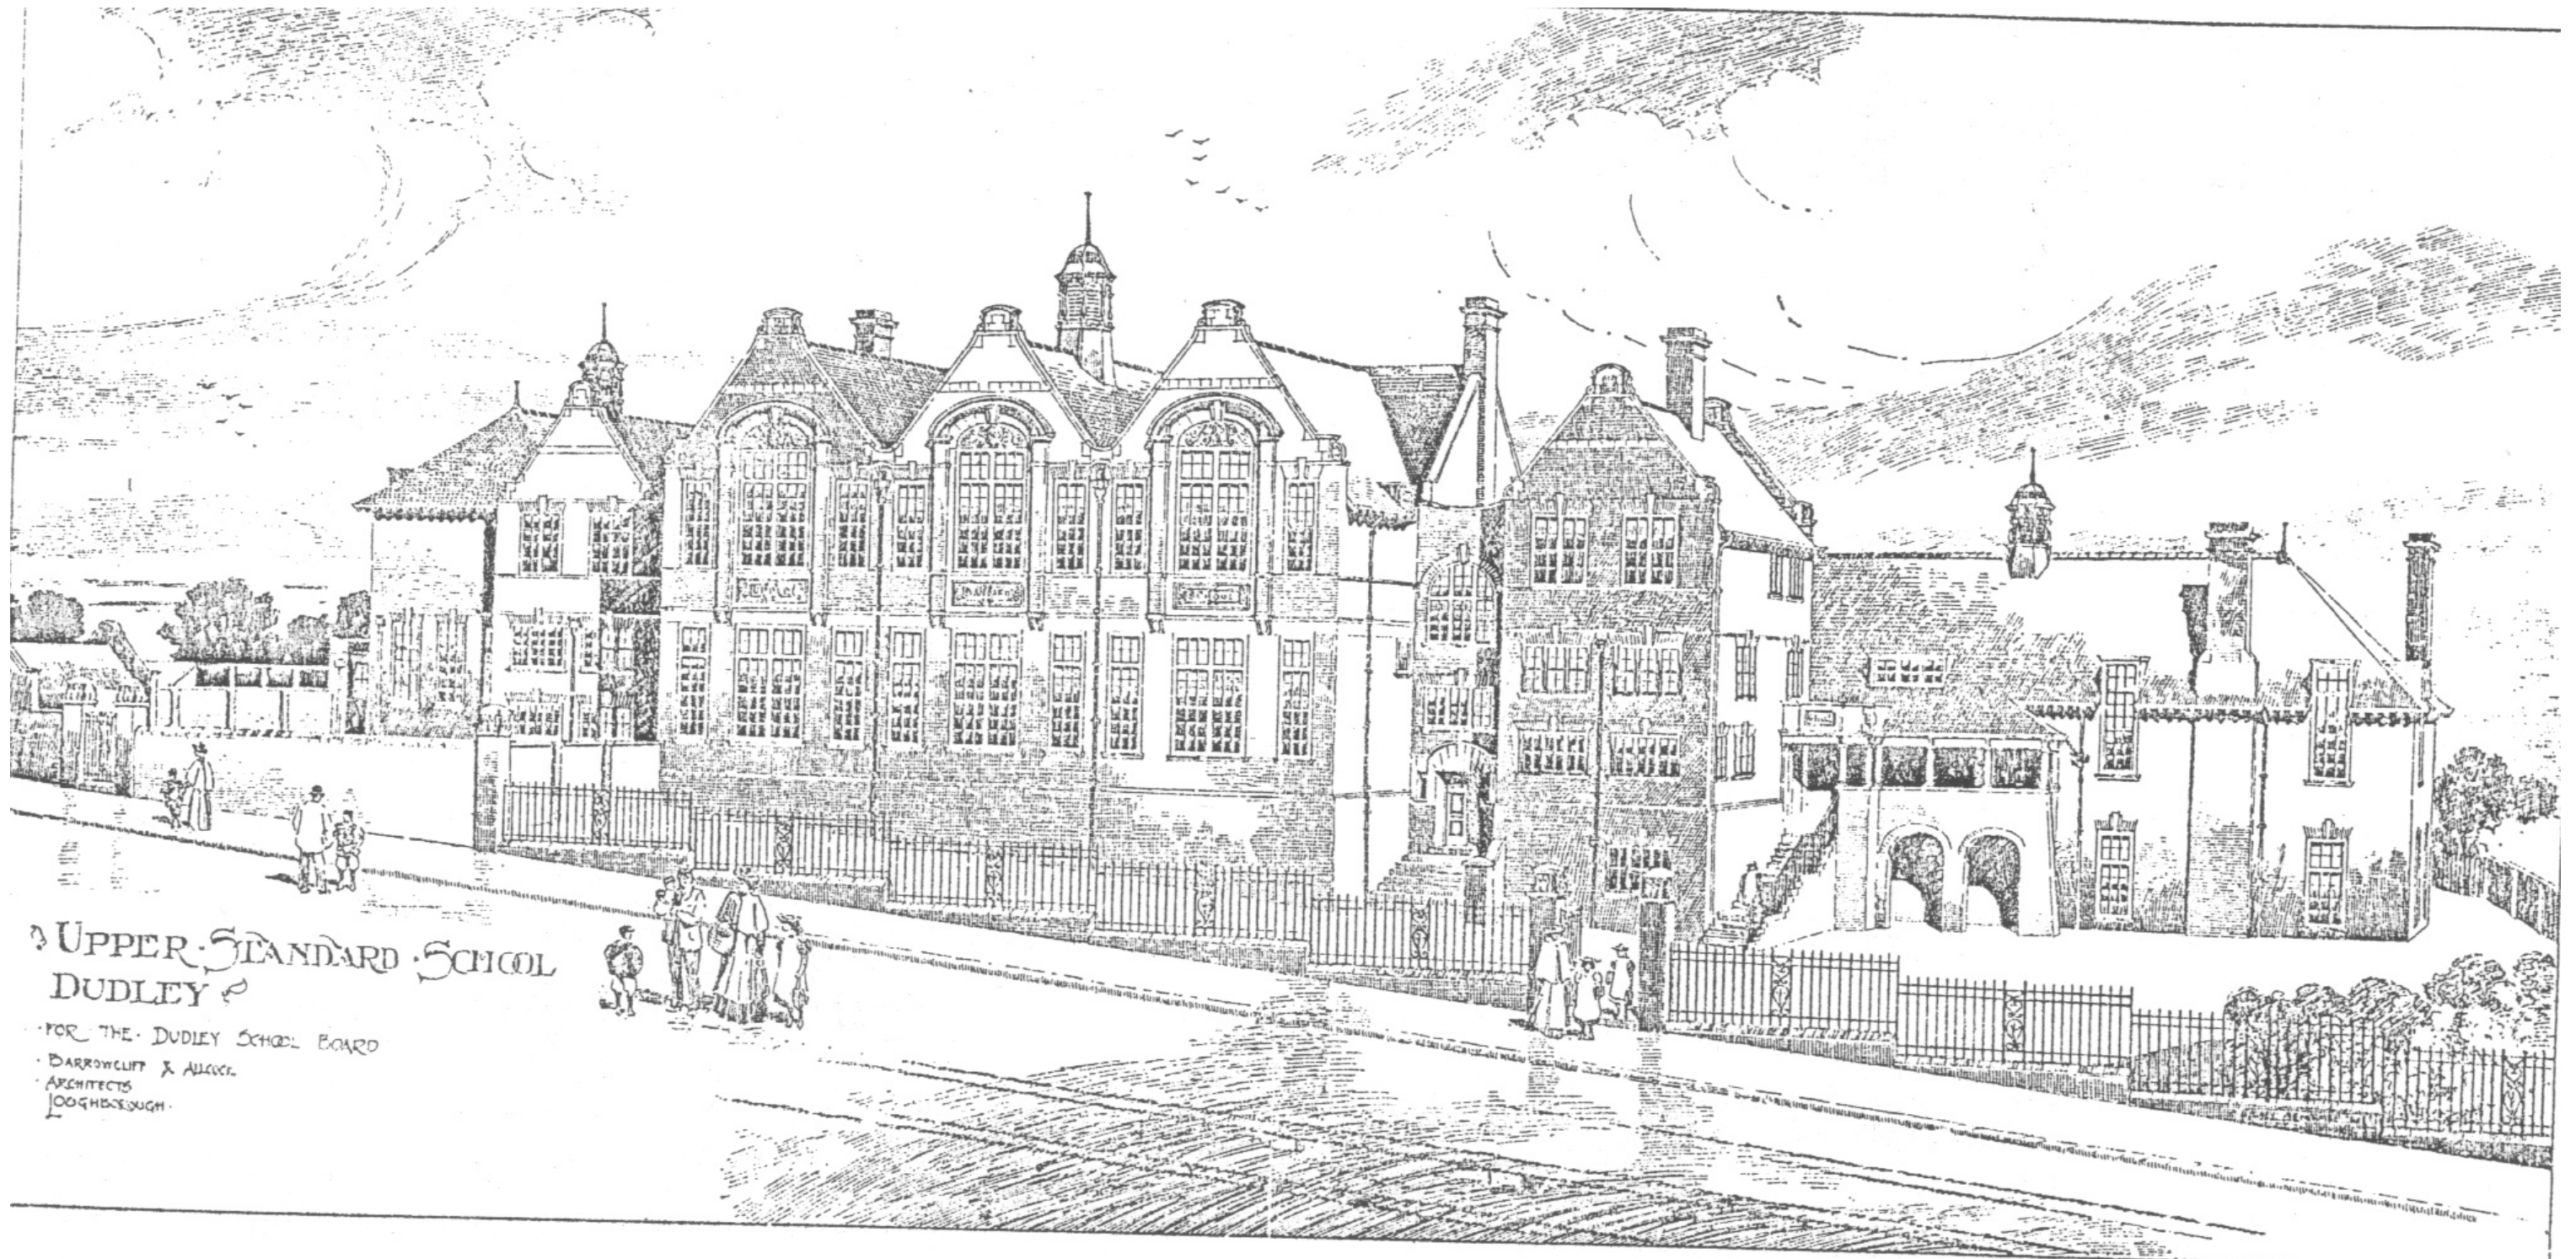
UPPER STANDARD SCHOOL
DUDLEY

FOR THE DUDLEY SCHOOL BOARD
DARROWCLIFF & ALCOCK
ARCHITECTS
LONDON

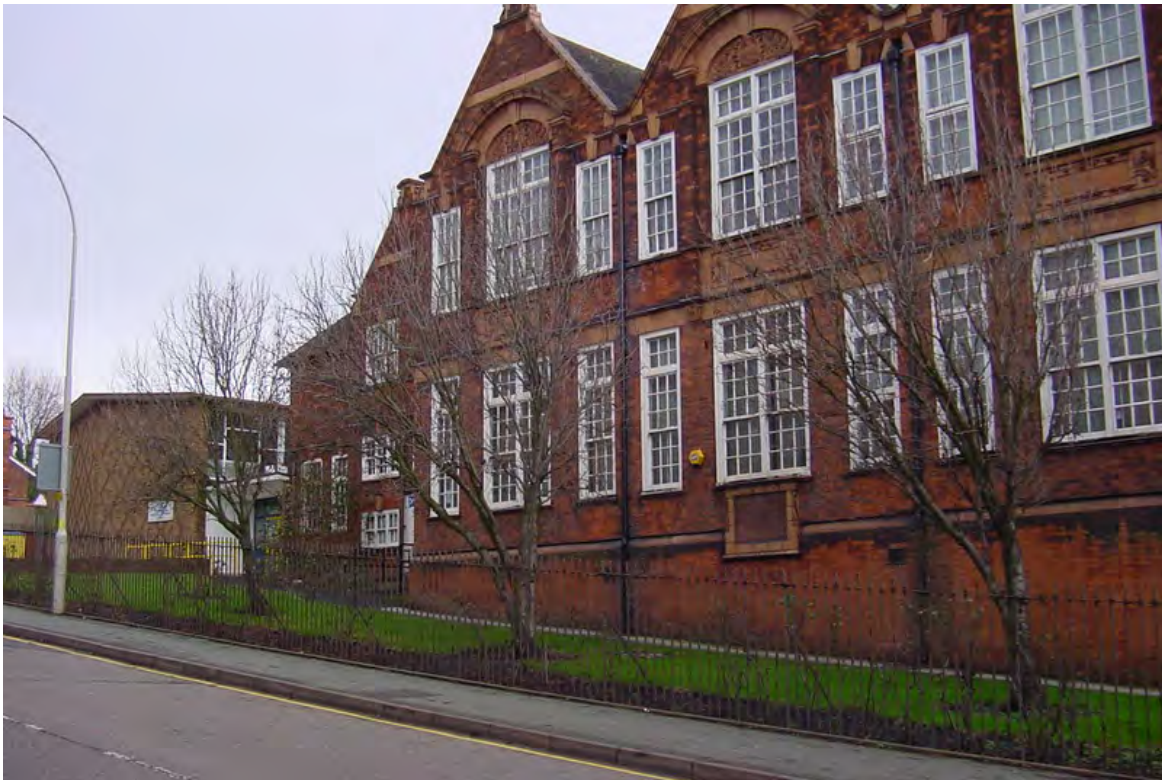
Plate 2: The facade in 2003/4

A number of photographs of the exterior of the school and of its grounds were taken in late 2003 / early 2004 by a Rob Stockton, a former pupil. They were posted to *claughton.org.uk* – a website set up as a memorial to the school and a place for former pupils to share memories. The website is now defunct although it was archived by the Internet Archive and is available online at *archive.org*. Two of the photographs are included here and others can be found in an appendix at the end of this report.

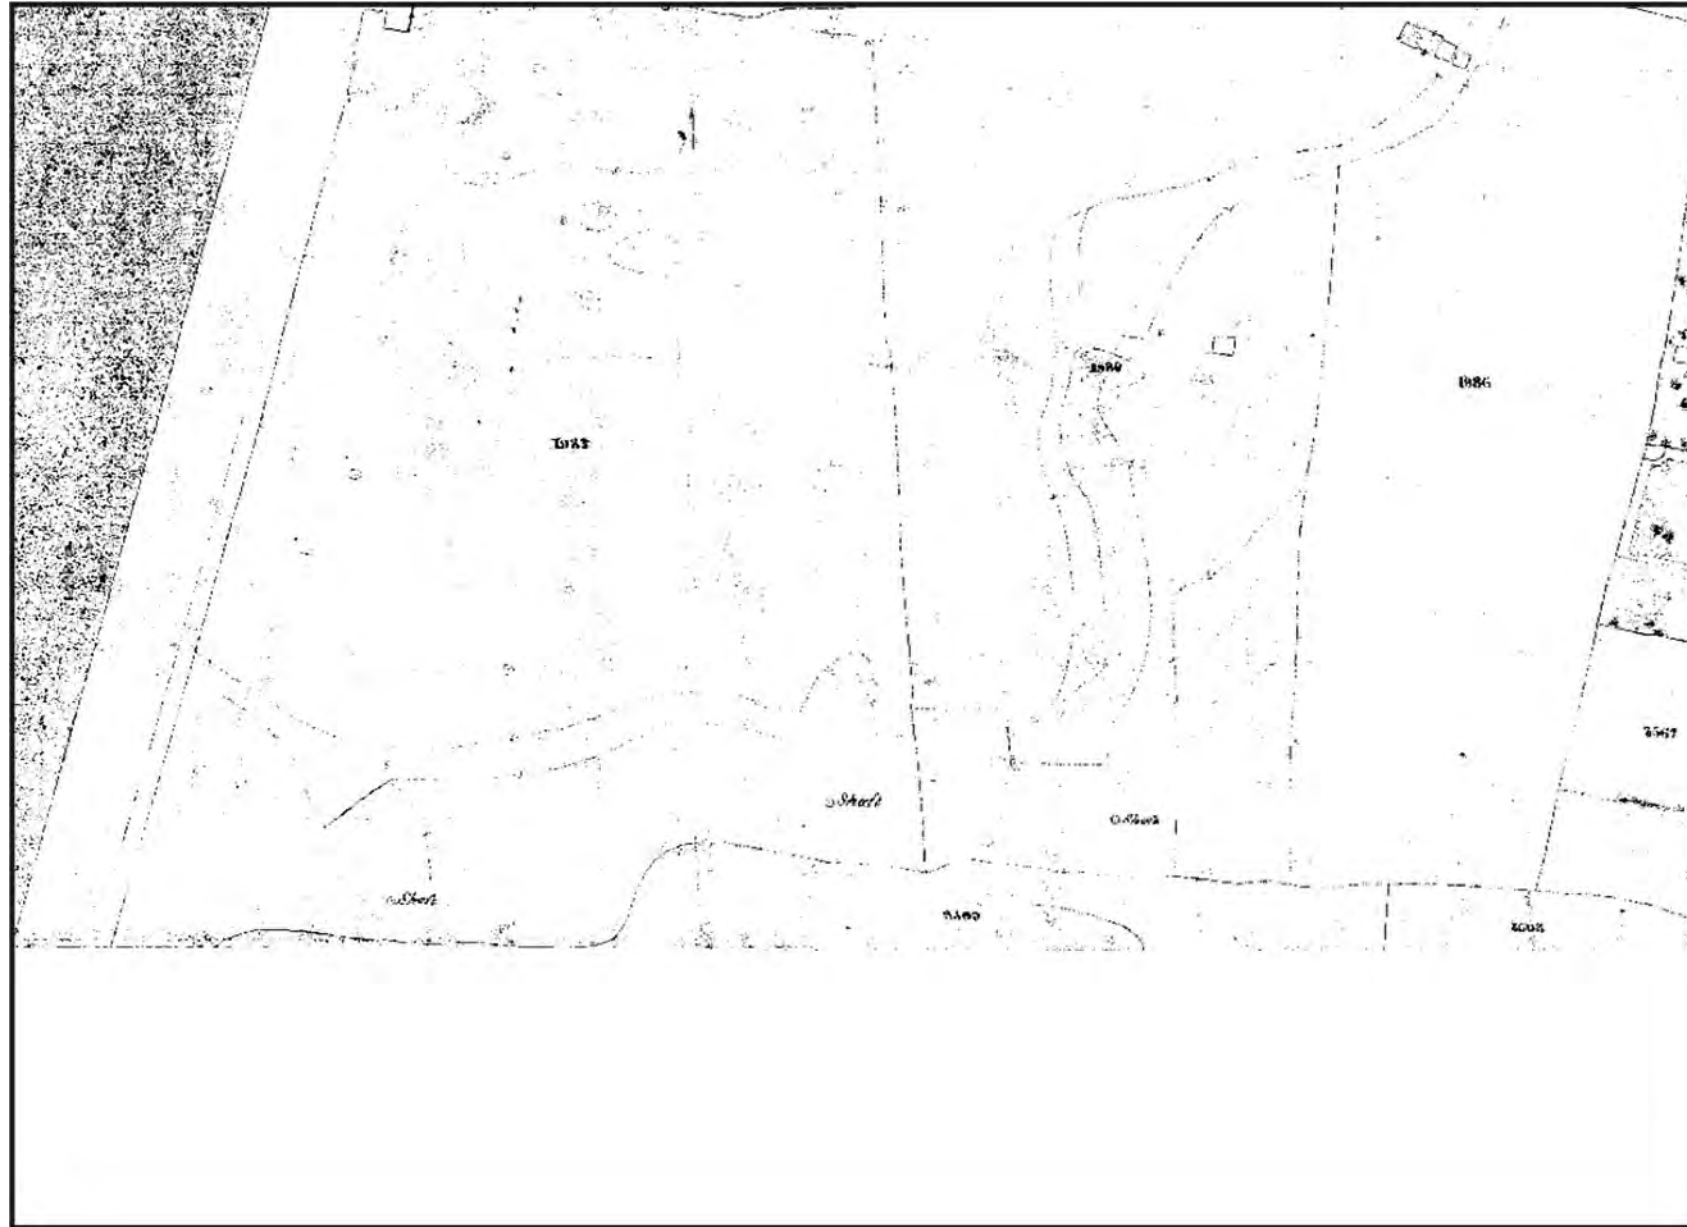
Figure 15: Roper's 1855 map, 1:1000 @ A3

The area of the site is open ground. Mine shafts are present.

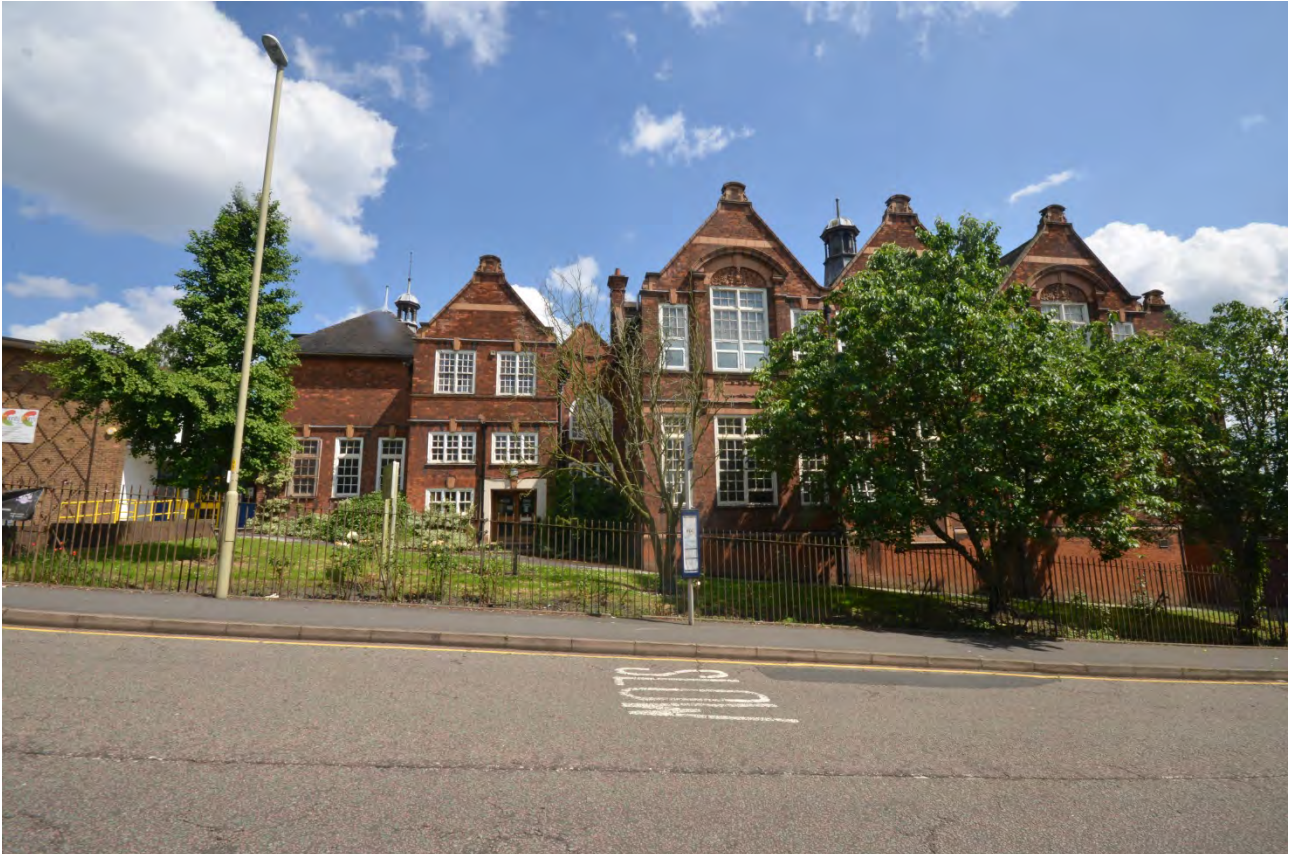
Plate 15: The Front (West Elevation)

The northern end of the façade has a mid-to-late 20th century entrance taking the form of a single-storey flat roofed passageway with glass doors to the frontage. To the south of this, a two-storey red brick structure is present with a hipped roof of red tile. The apex of the roof at the western end features a tall ornamental lead finial. To the rear of this, an ornamental cupola vent can be seen. This is one of three noted across the building.

This part of the building features three large multi-paned windows at ground floor level and none at first floor level. A string course projects from the walls above the windows, linking a moulded ceramic keystone above each window.

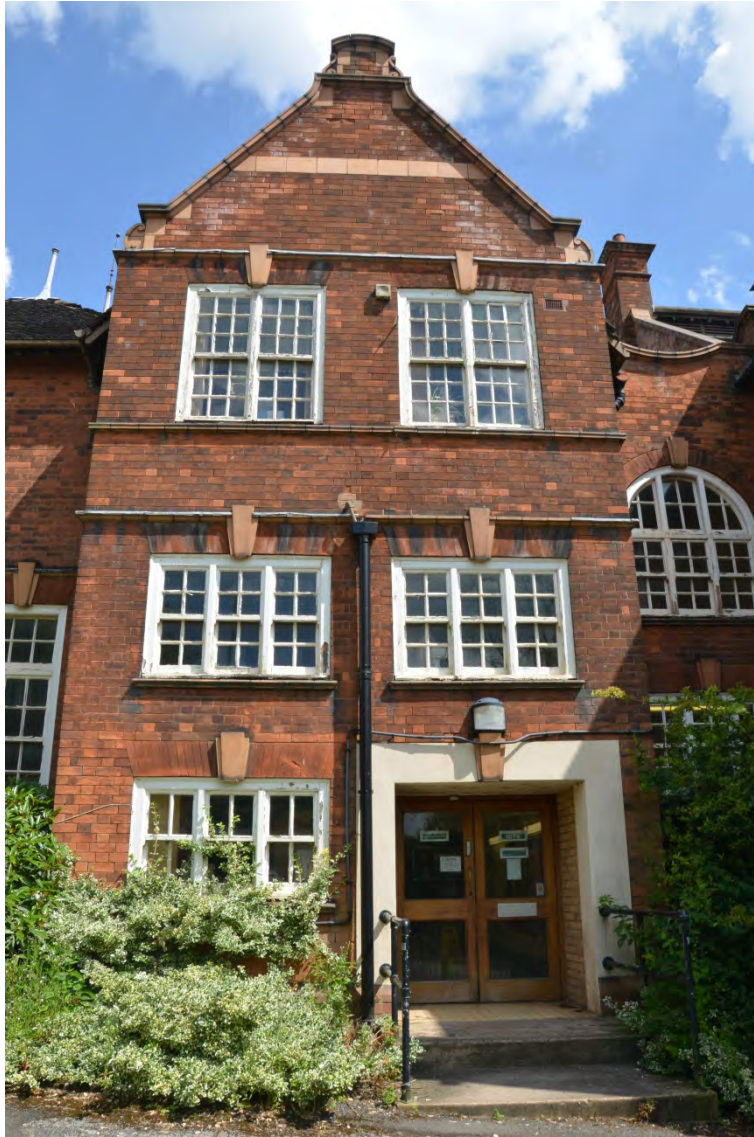
Plate 18: Northern gable

Windows are sashes with straight brick lintels featuring ceramic moulded keystones. The door is considered to be a late 20th century replacement.

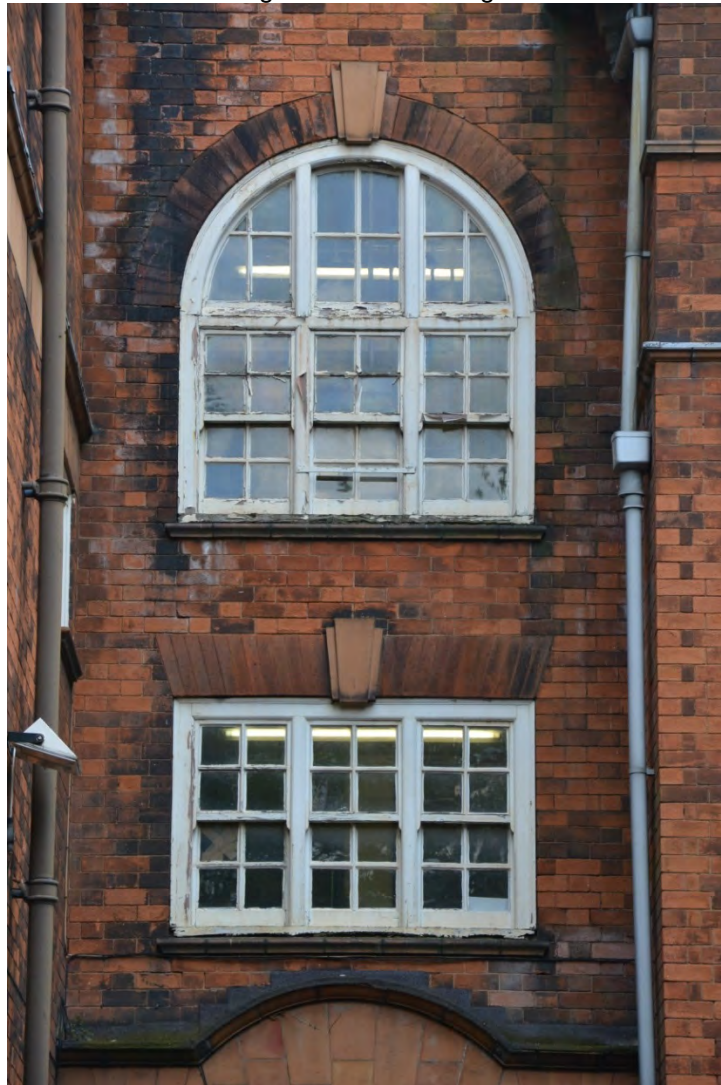
Staircases are located at either end of the building, between the outer coped gables and the central three central gables. Their location is noted externally by the presence of arched windows.

Plate 19: Staircase windows, southern part, west elevation

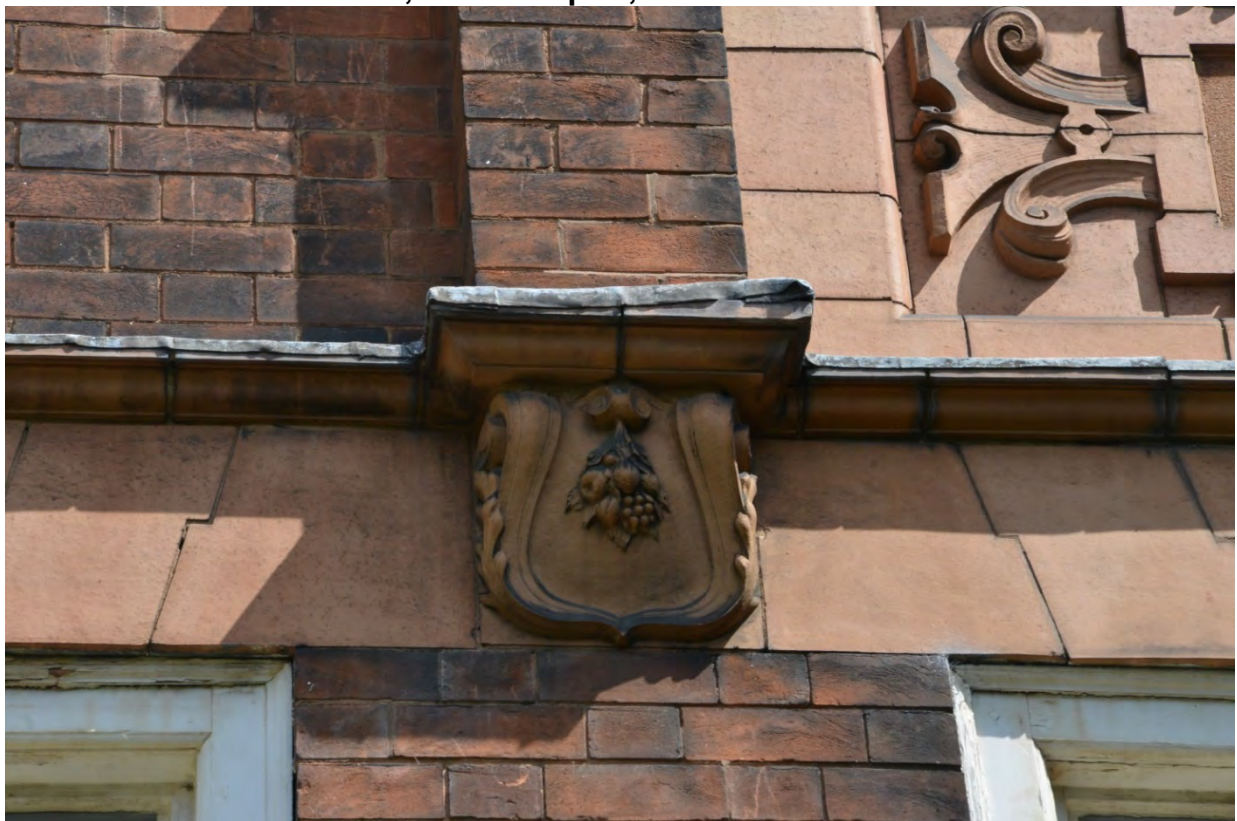
Plate 20: Detail of ceramic mouldings, central gables

The façade to the south of this section consists of five coped gables with mouldings and decorative courses of plain flat terracotta.

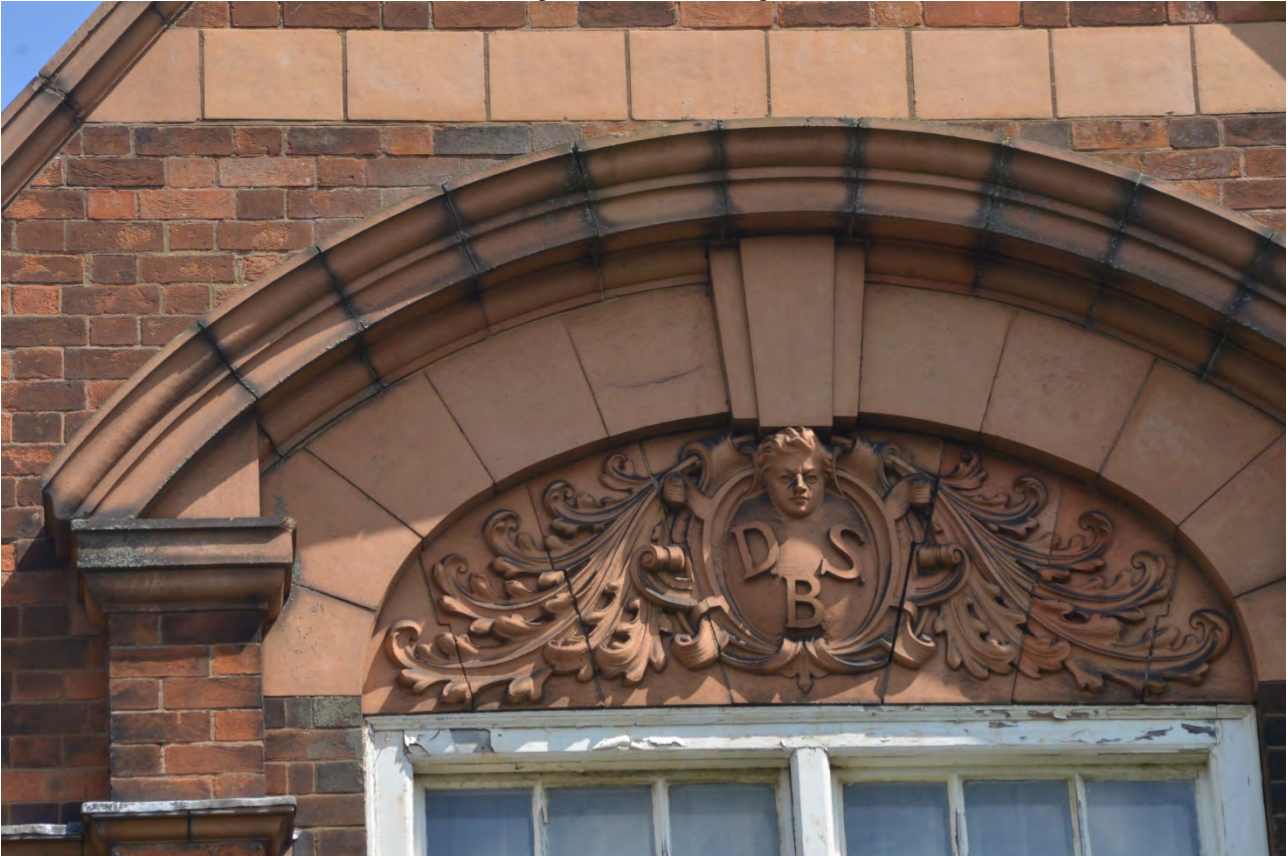
Plate 23: Detail of moulding at head of Coped gable

Similar mouldings are noted at the head of each of the three projecting gables, the central example bearing the date 1903, with the outer pair bearing the initials 'DSB', considered to refer to Dudley School Board.

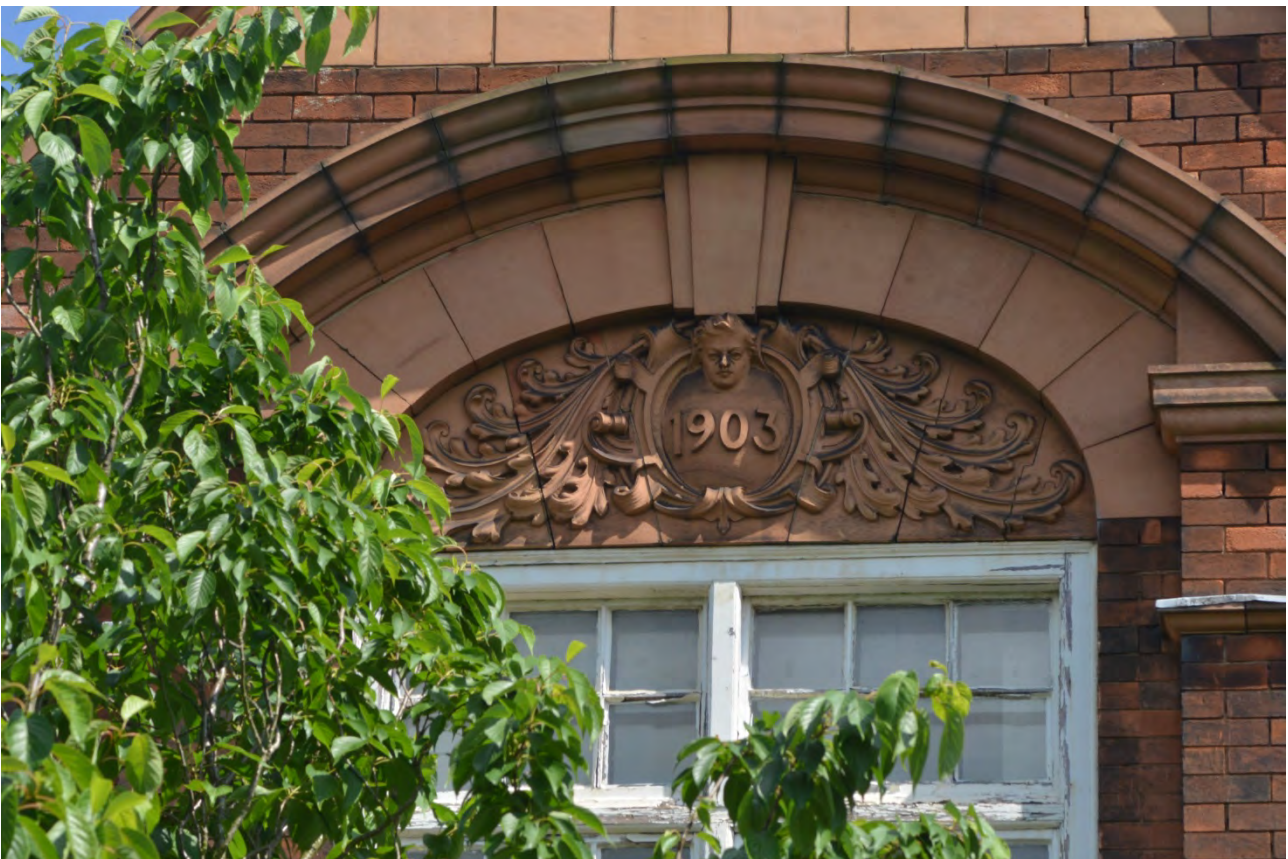
Plate 24: Detail of dated moulding at head of central gable

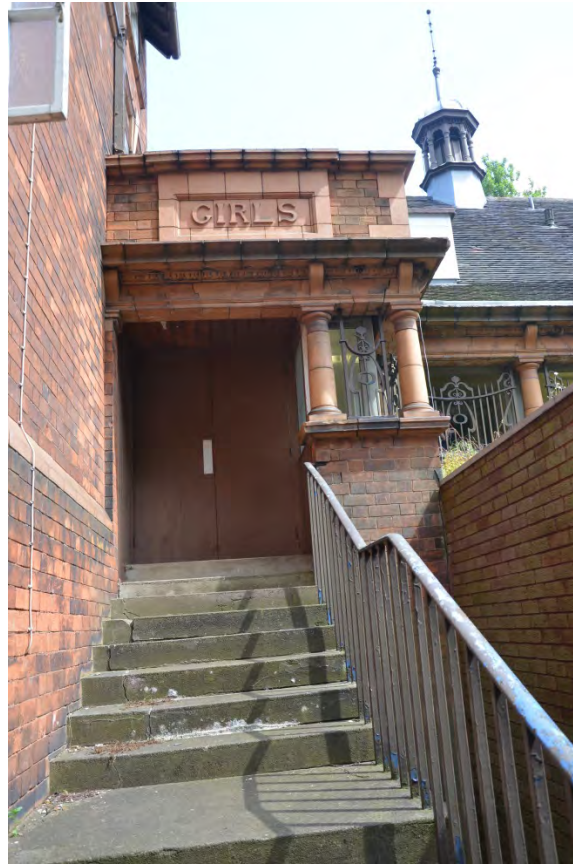
Accessed via a staircase to the south, the former girls' entrance is noted. A ceramic plaque located on a parapet over the door indicates its former purpose. Beside the door, ceramic pilasters are present flanking a window. Egg-and-dart moulding is present below the plaque, set above a jointed ceramic lintel.

Plate 25: Girls' entrance

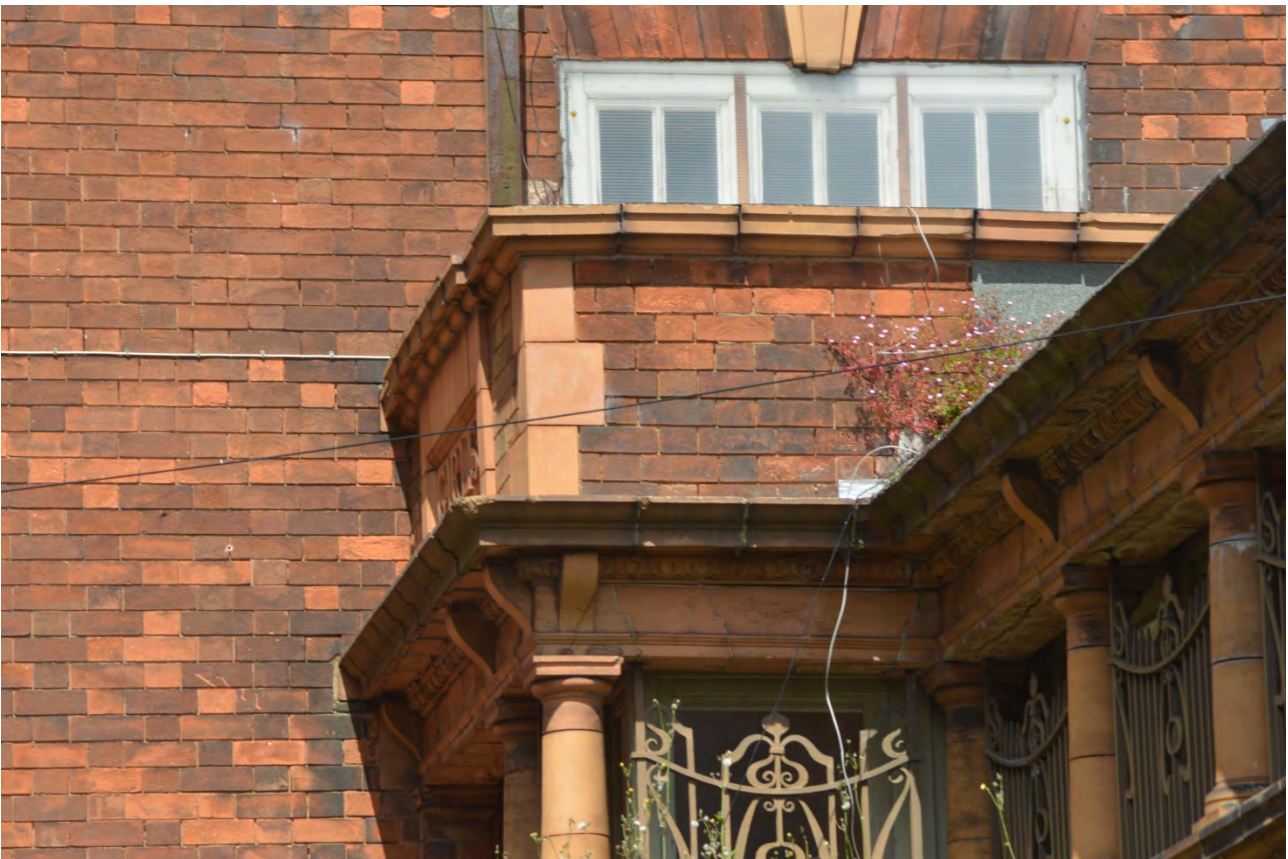
Plate 27: Detail of parapet and pilasters over girls' entrance

The pilasters are repeated to the south across the southern wing of the building, where the windows are fitted with ornate iron grilles. The grilles are thought to date from the later insertion of the ground floor extension, inserted so as to prevent the building from being broken into by people climbing on the flat roof of the extension.

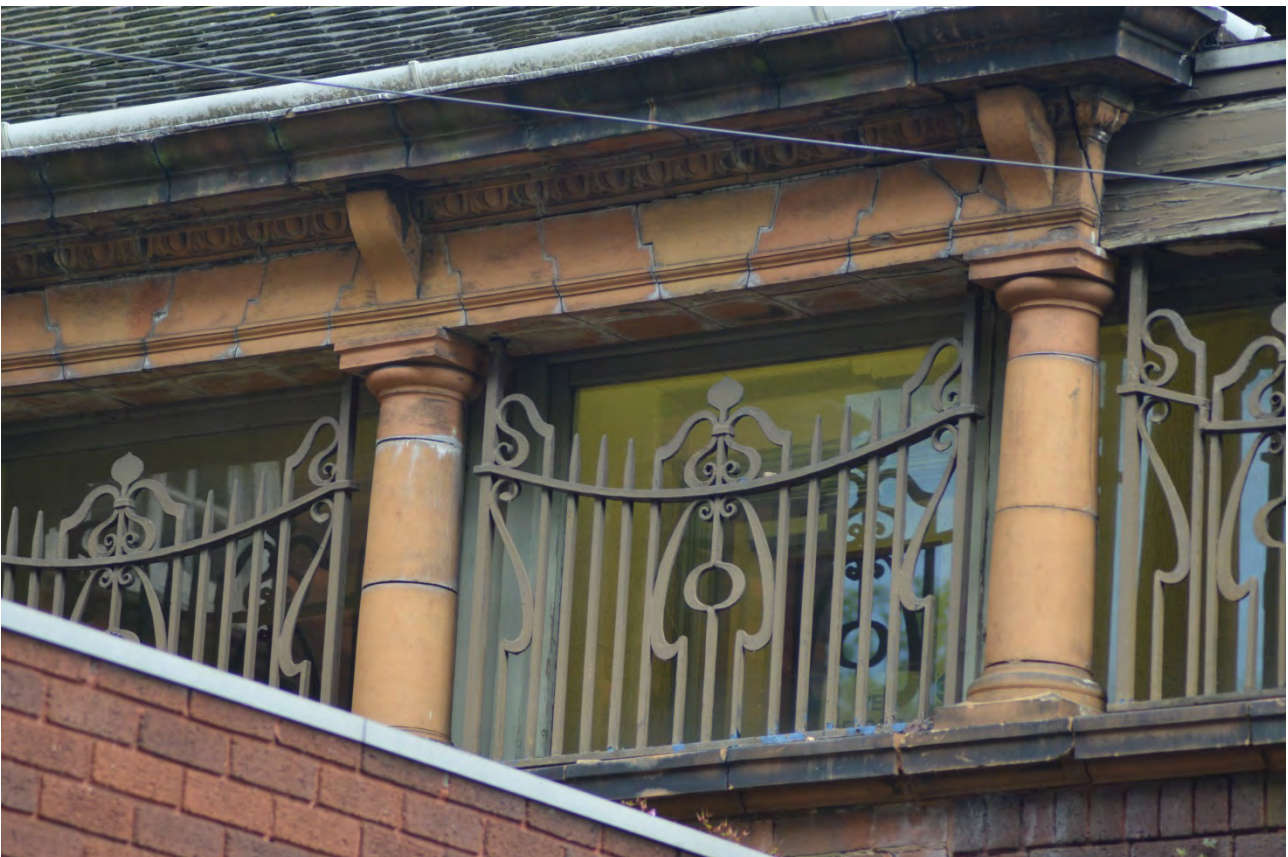
Plate 28: Detail of iron grilles

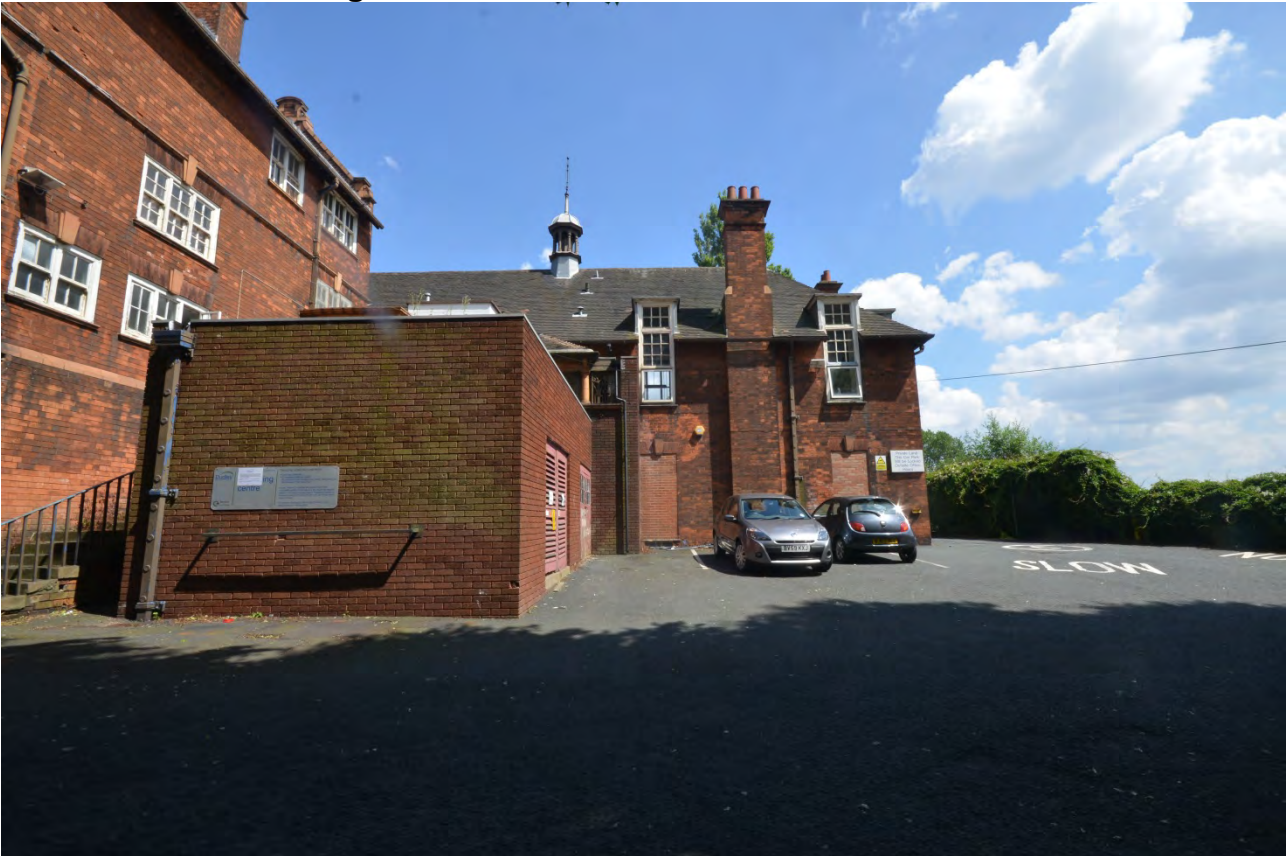
Plate 29: West elevation, showing modern extension building to south

A substantial brick chimneybreast is present to the south of the west elevation.

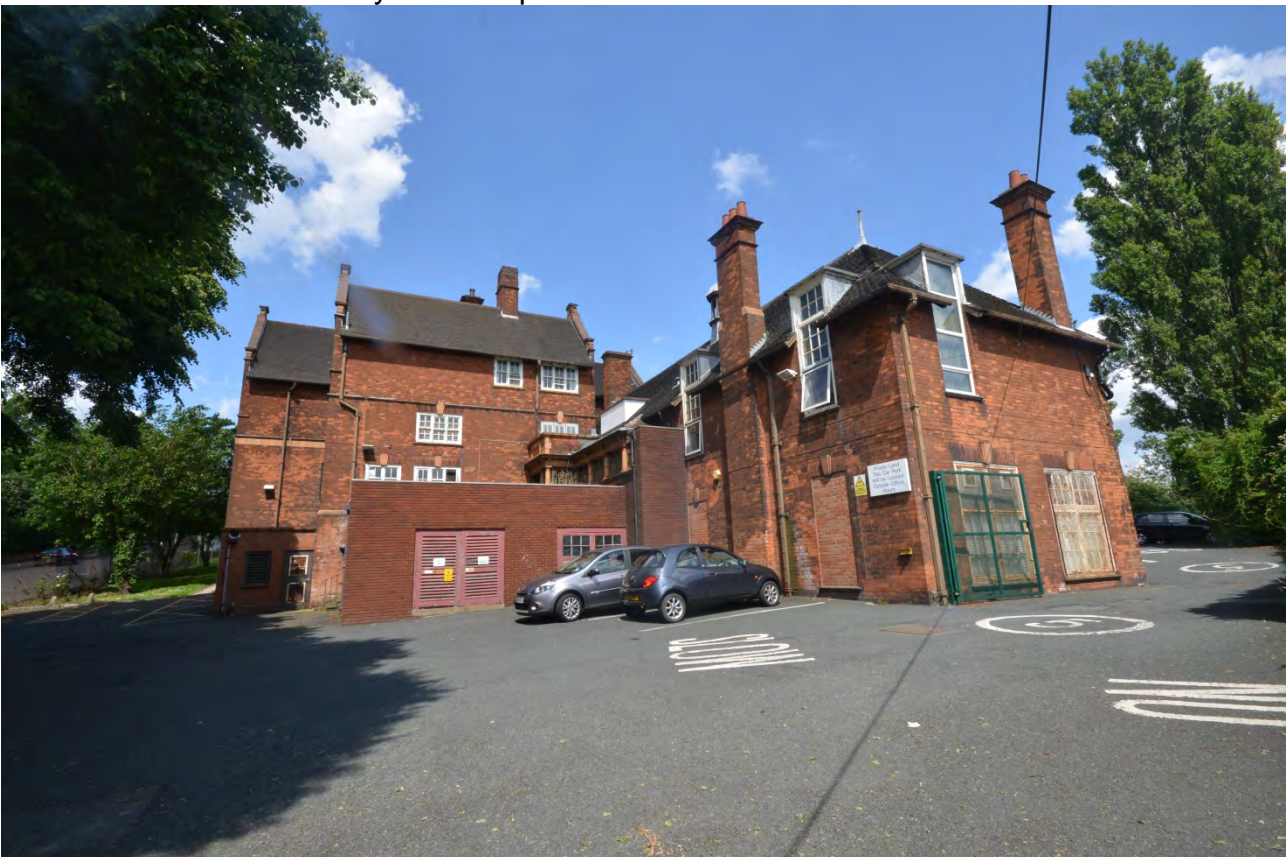
Plate 30: Southwest aspect

The layout of windows to the south is dictated by the internal room layout rather than by any notion to symmetry.

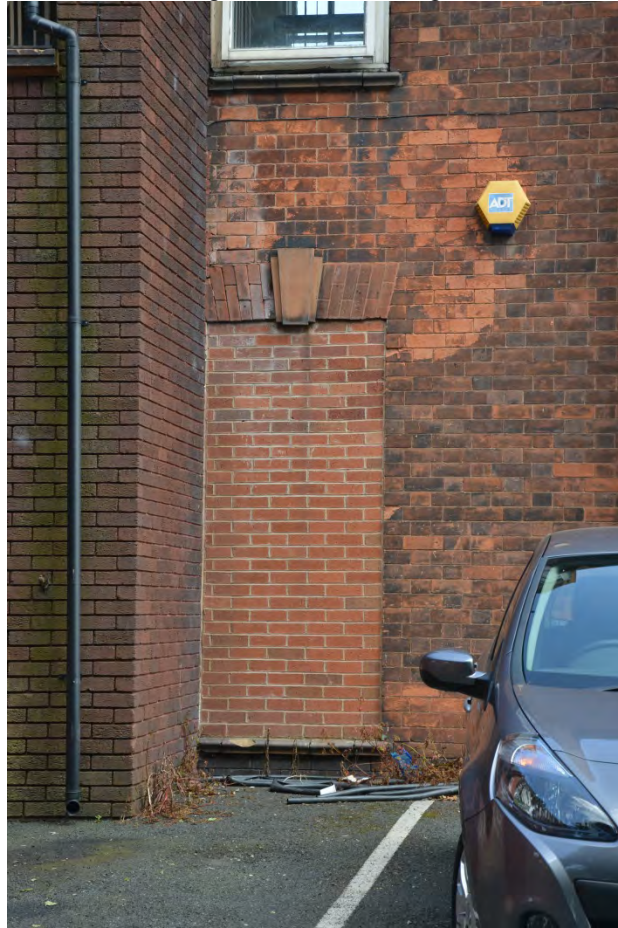
Plate 31: Detail of blocked window, west elevation, southern wing

Two blocked openings are noted at ground floor level on the western face of the southern wing. Whilst their height suggests these were doors, the projecting ceramic moulded sill below each is considered somewhat fragile in comparison to the substantial doorsteps / thresholds noted elsewhere on the building and it is therefore suggested that these were full-height windows.

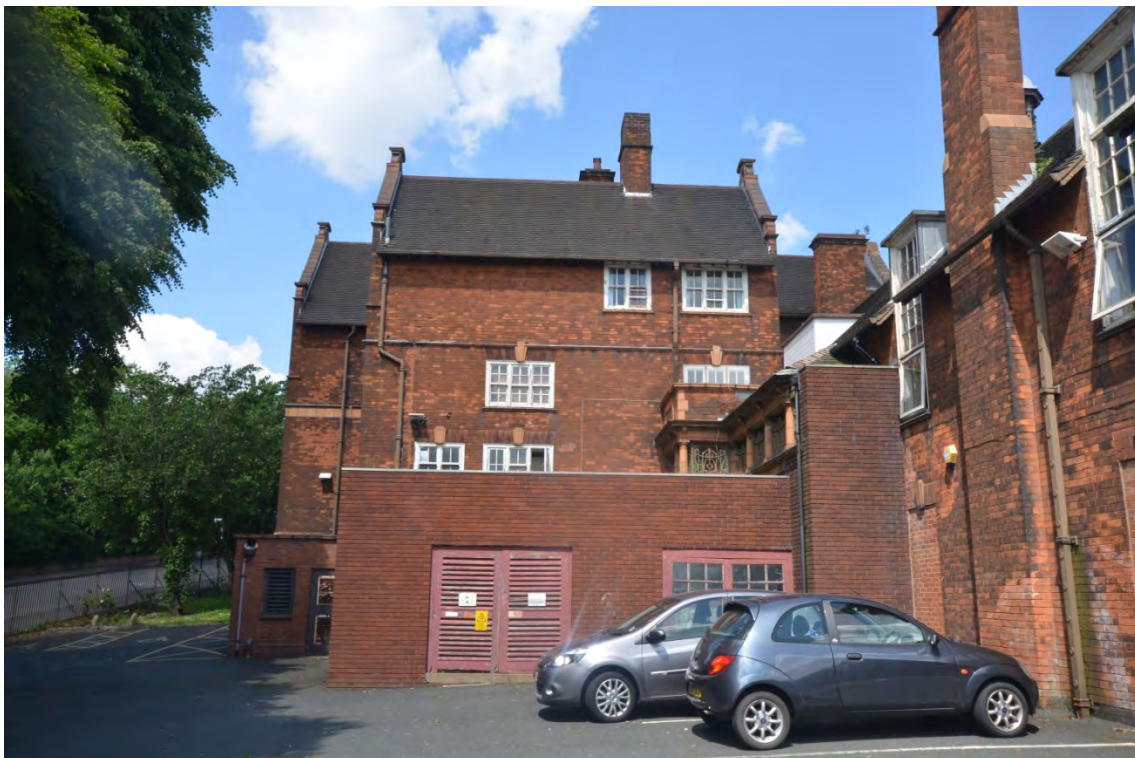
Plate 32: South elevation, western part of building

The southern side of the building is clearly plainer than the western facade although moulded ceramic keystones are present in each brick window lintel.

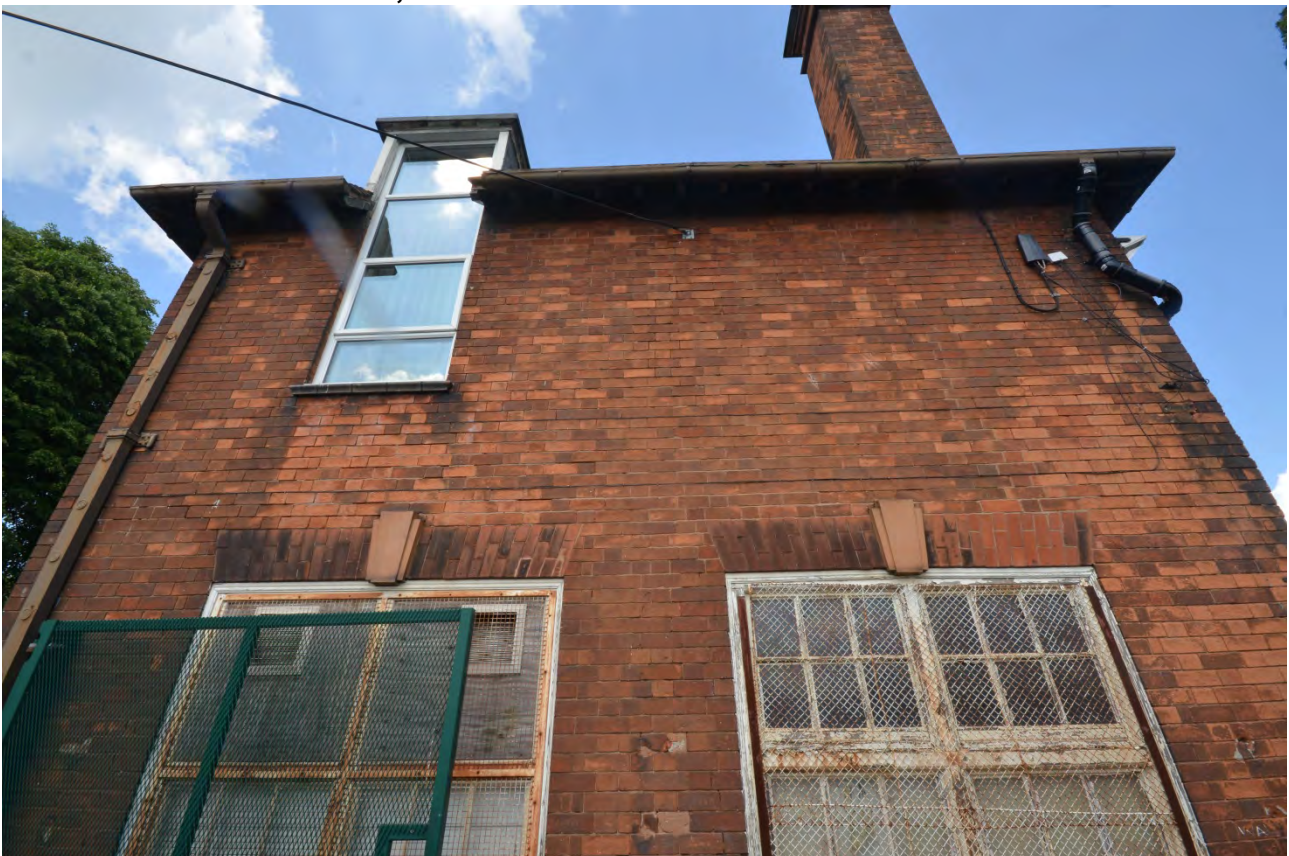
Plate 34: South elevation, southern wing

The south elevation features a four vertical-paned dormer window at first floor level which extends down into the wall. Large ground floor windows with iron frames are present.

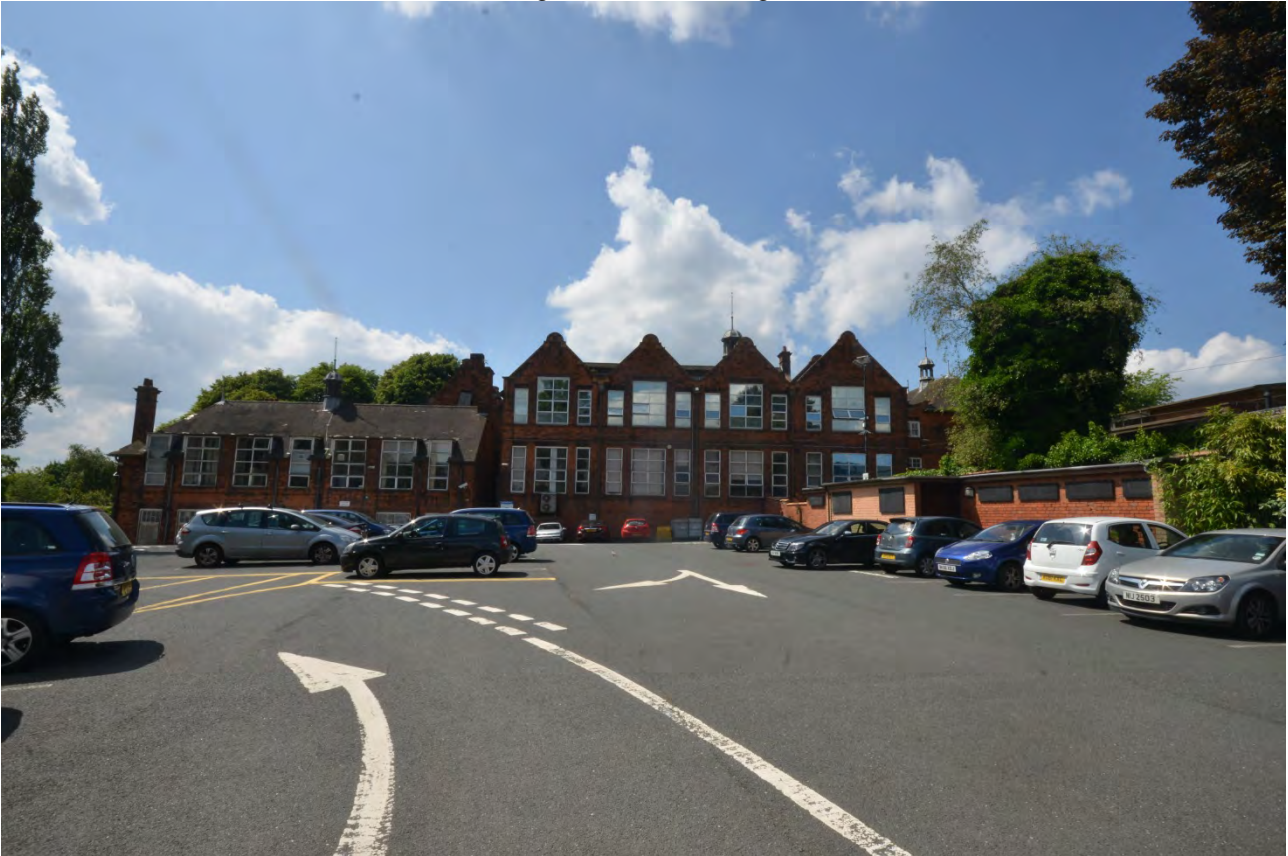
Plate 37: East elevation

The east elevation is the rear of the building. The architectural style is clearly more functional than the frontage.

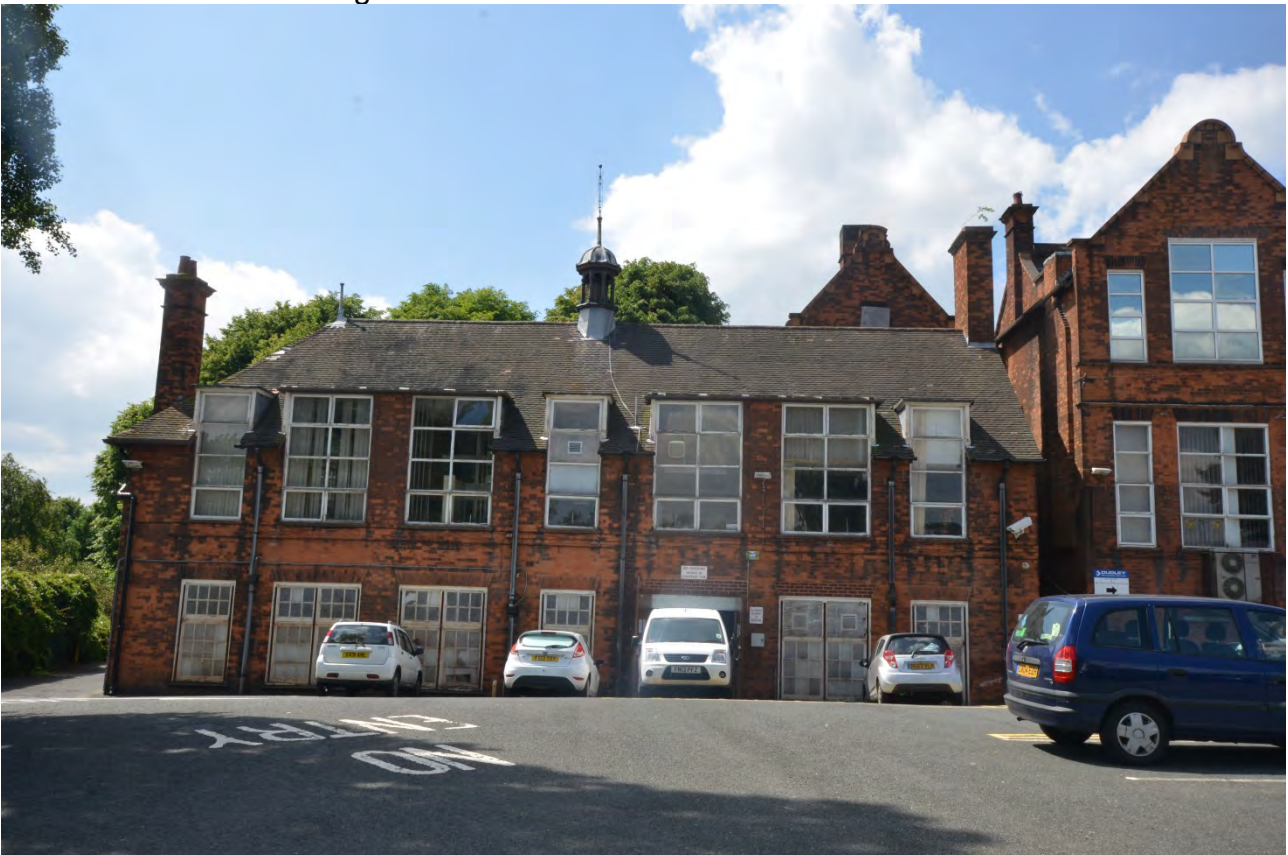
Plate 38: East elevation, south wing

All first floor windows are dormers extending down into the wall below, similar to that noted on the southern wall. Ground floor windows are also similar in style to those on the south elevation.
