Heritage Statement:
Claughton Centre
Blowers Green Rd
Dudley
West Midlands
DY2 8UD
National Grid Reference: SO939897

Dr Peter Wardle & Colin Lacey

17/12/2014
Document Reference Number 2013/1192
Version 0.7

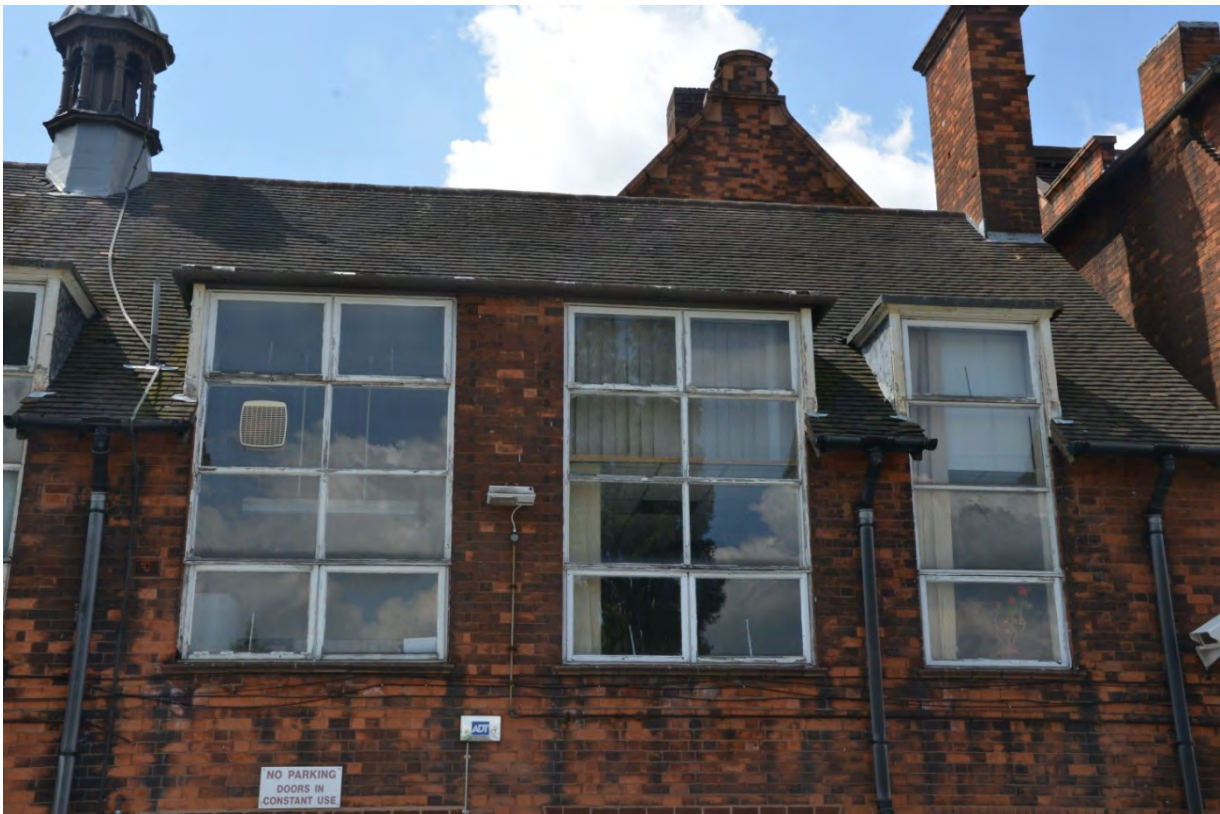
All first floor windows are dormers extending down into the wall below, similar to that noted on the southern wall. Ground floor windows are also similar in style to those on the south elevation.

Plate 39: Detail of first floor windows, east wall, southern wing

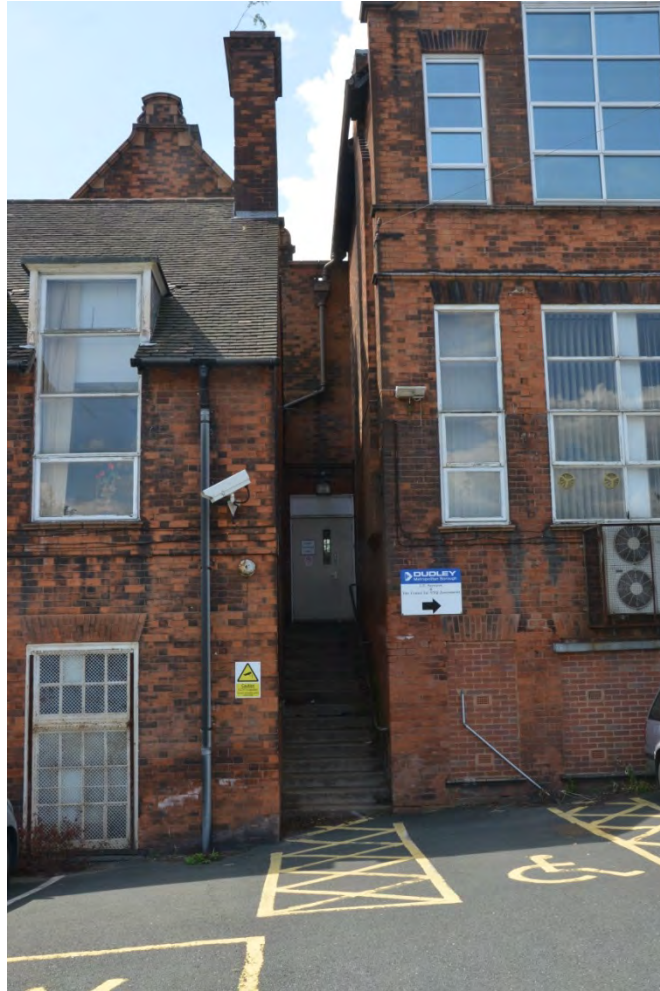
Plate 41: Detail of alleyway

A narrow alleyway marks the division between the south wing and the main part of the building. This leads to a fire escape.

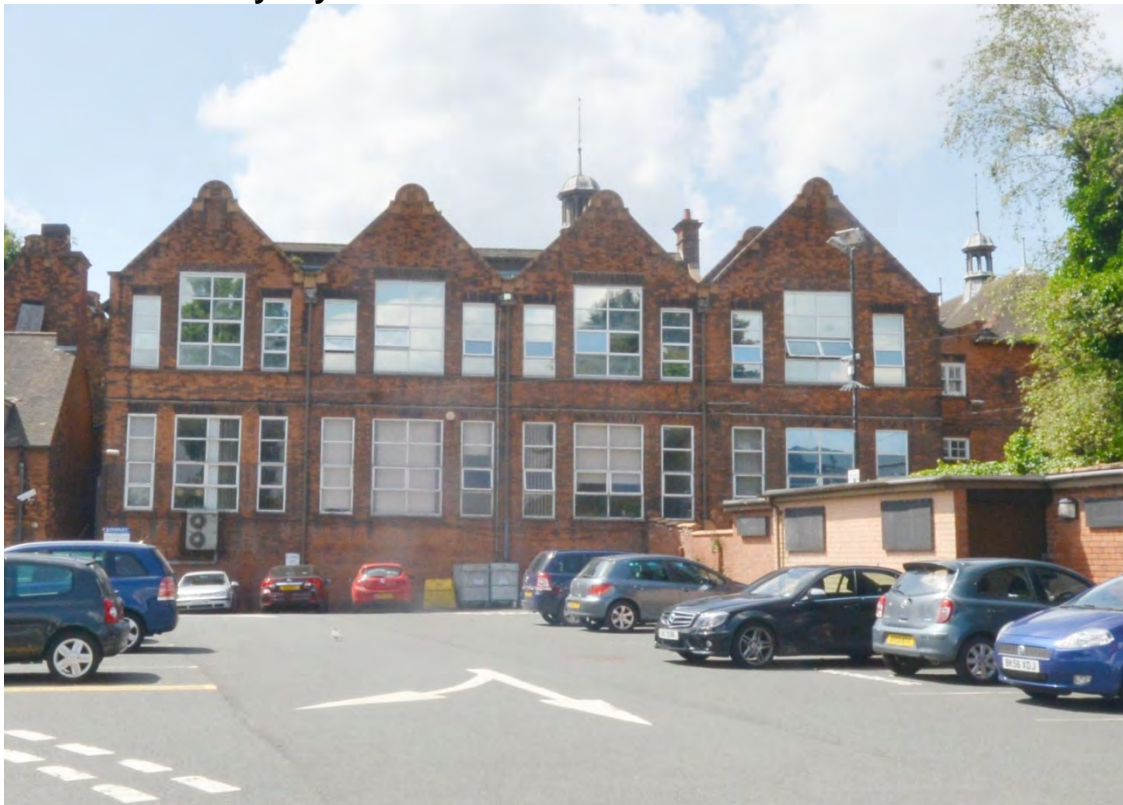
Plate 42: East elevation, main part of building

The reverse of the four gables noted on the western elevation are present to the east. That to the right is wider than those to the east, corresponding with the left hand gable noted to the front.

The gables are coped, although they are not as elaborately ornamented as those to the front.

There is a recurring pattern of windows across this part of the building. Each gable features a large central window at first floor level, flanked by a pair of narrow windows of a lesser height. Below, ground floor windows are all equal heights although they follow the widths and spacing of the windows above. All windows are iron-framed, with large rectangular panes of glass, some of which are horizontally pivoted opening lights. The windows have plain brick lintels. The rear of the building is otherwise plain.

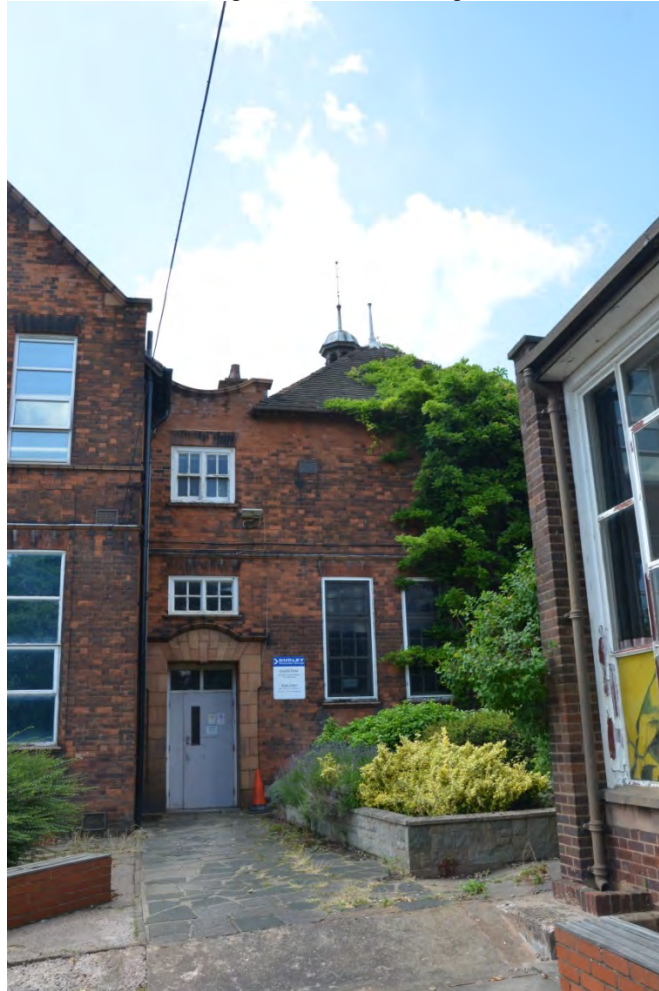
Plate 44: East elevation, section to north of main building

At the northern end of this section of the building, a lower red brick section is located. This features a short length of parapet at its head with a sweeping curve joining the gable wall with a hipped tiled roof to the north.

A pair of sash windows can be seen at first floor level on this section, with a pair of fixed lights below. These have straight brick lintels.

Below, a door gives access to the reception area of the building. This has an ornamental surround of moulded ceramic / terracotta. A pair of larger multi-paned windows are located to the north of the doorway at ground floor level, however these are obscured by security grilles and vegetation.

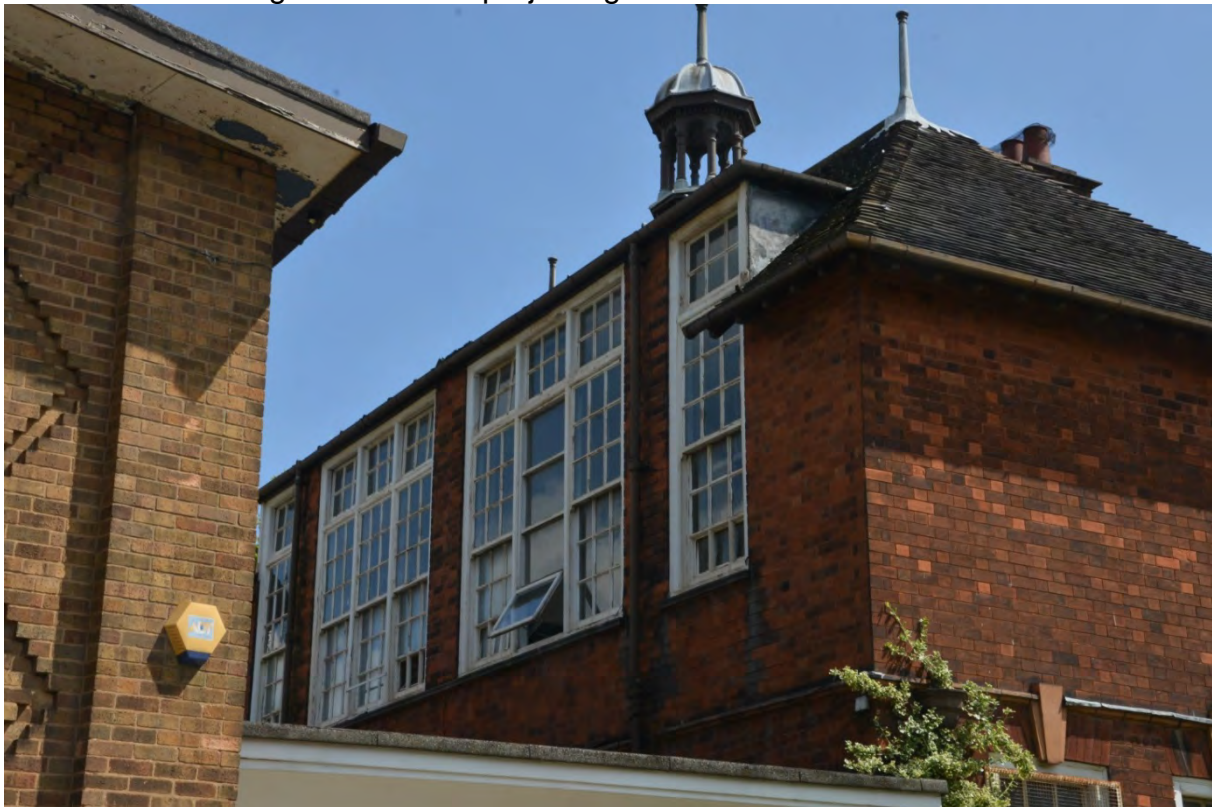
Plate 45: Detail of first floor windows, north elevation

The northern elevation of the building is obscured by extensions at ground level. Above, it is apparent that the pattern of windows follows that of the northern end of the building, with tall windows extending into dormers projecting from the roofline.

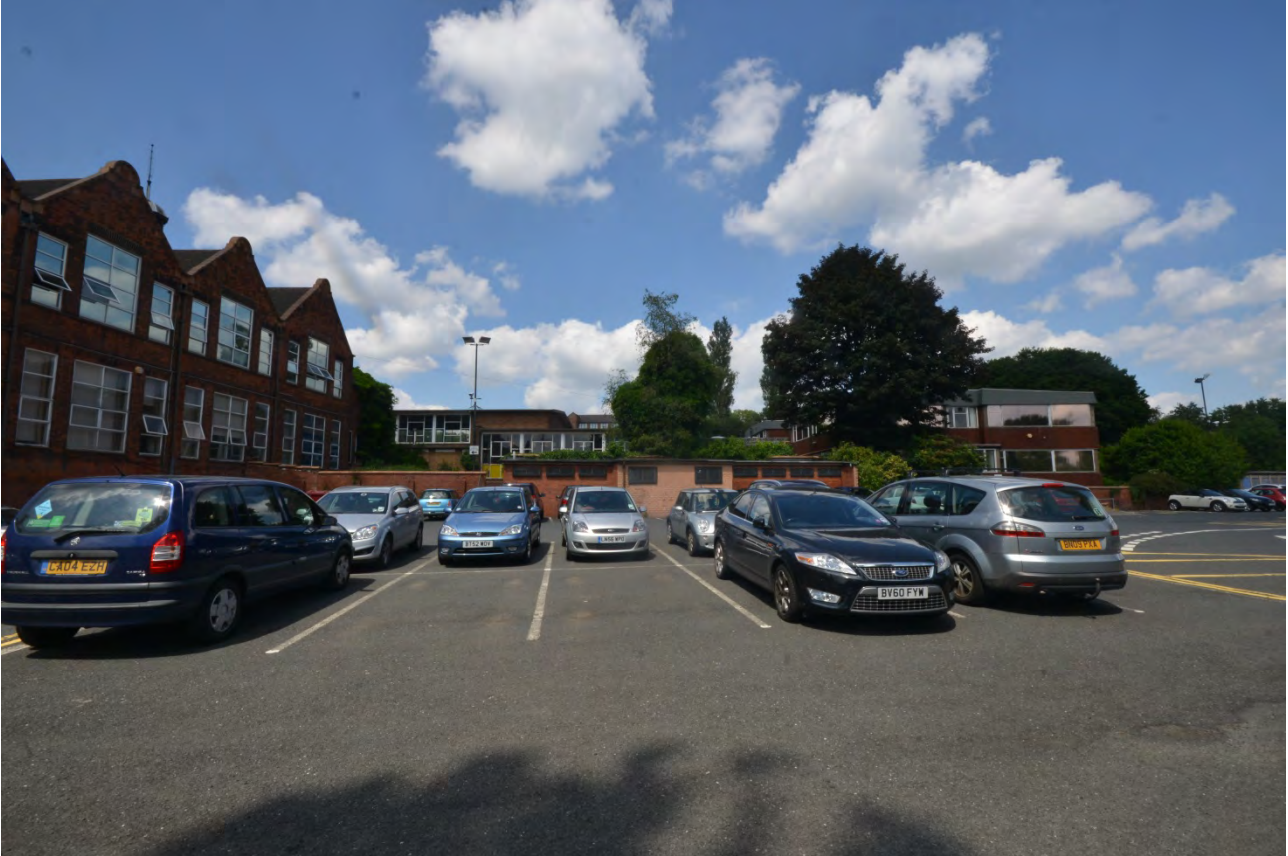
Plate 46 View north to modern extensions

At the northern end of the building, a number of extensions are present, forming a wing to which runs to the east. These are modern in construction and are depicted below.

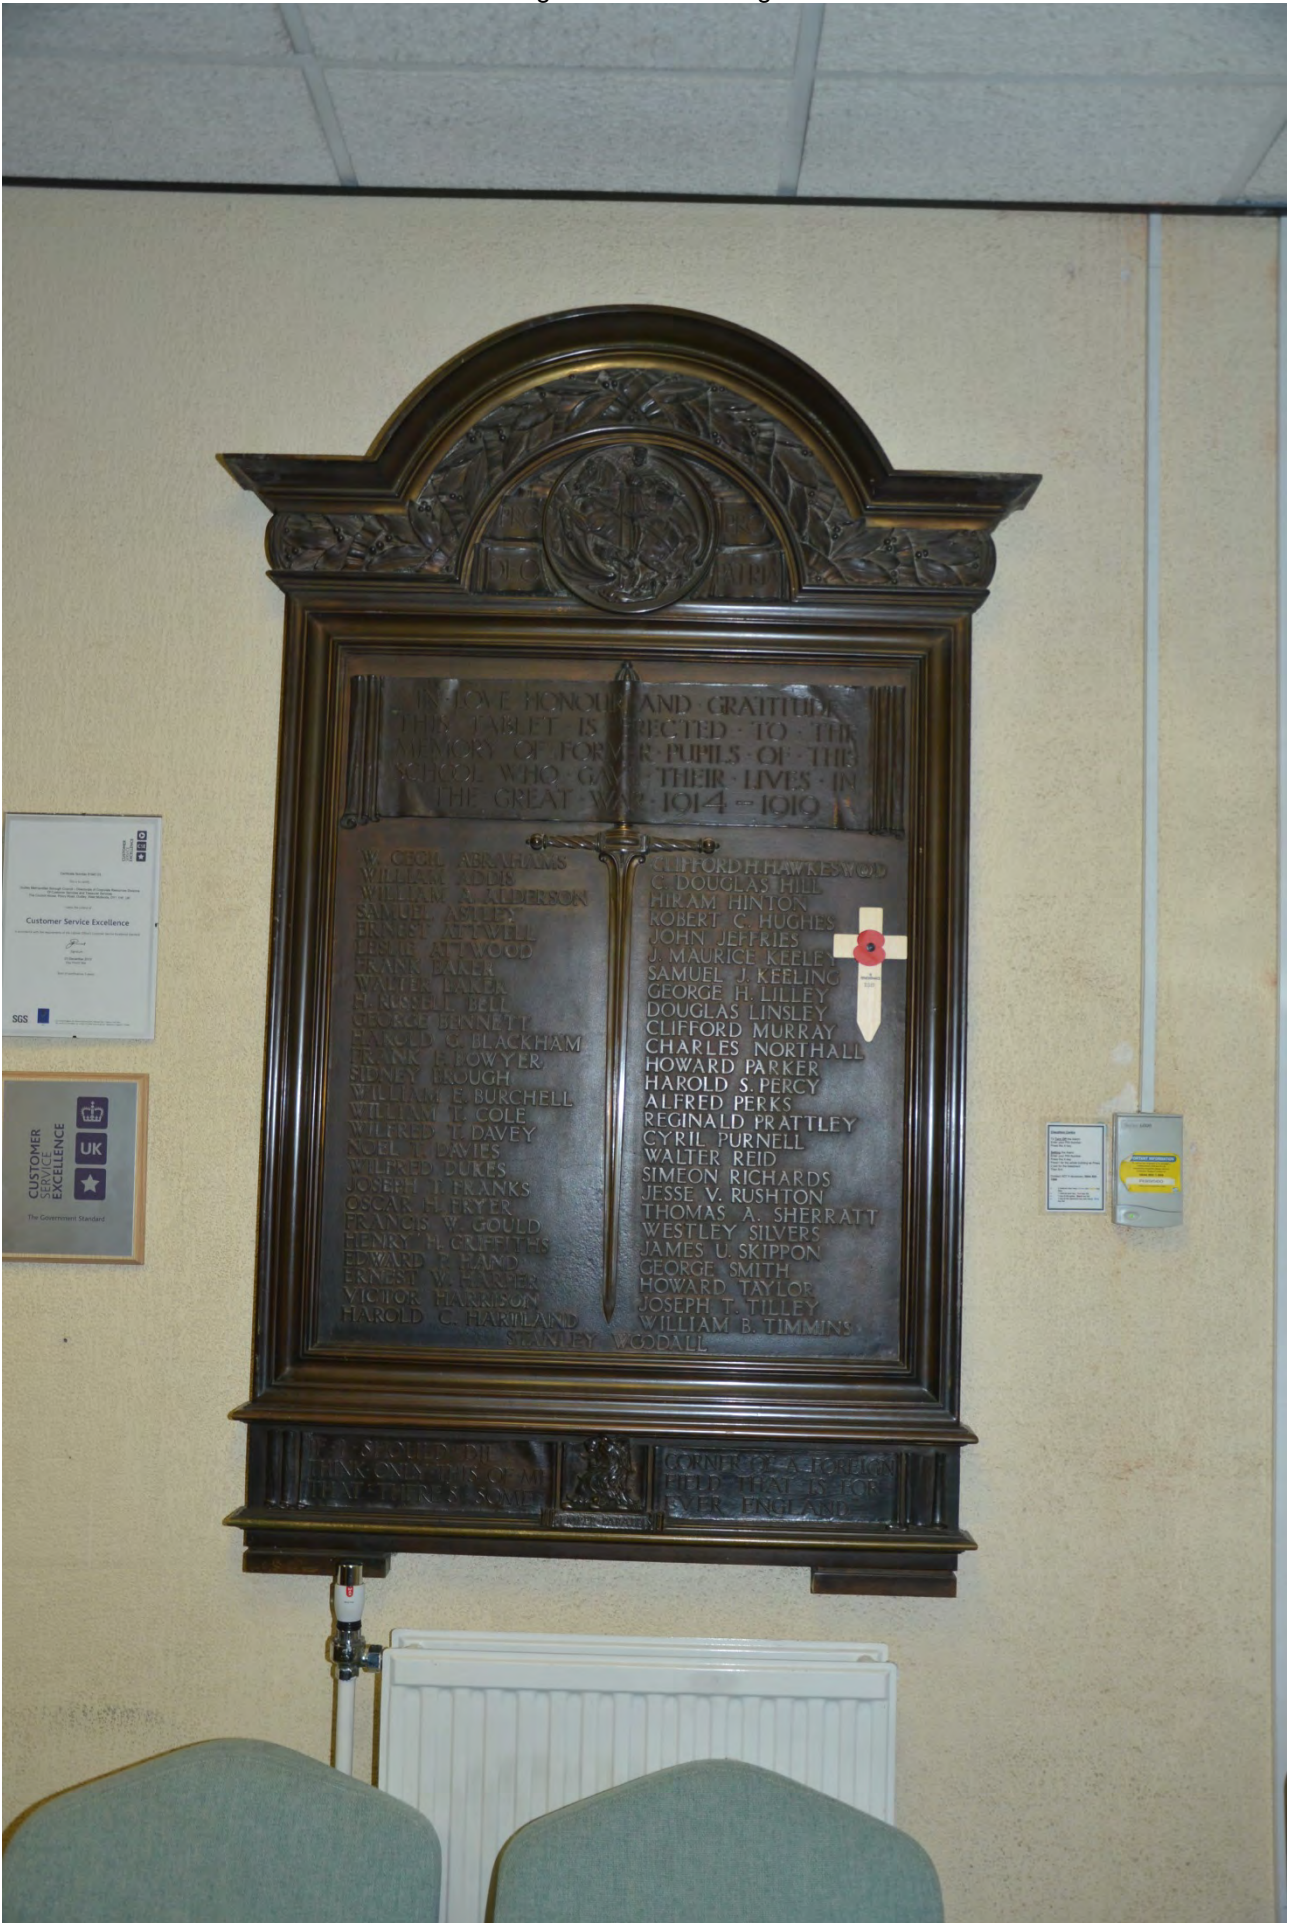
Plate 56 War Memorial Plaque

Current Function	Hallway
Original Function	Hallway
Phase	1
Plan Form	Altered
Comments/Description	Room 2 is home to a war memorial plaque commemorating former pupils of the school lost in World War 1.

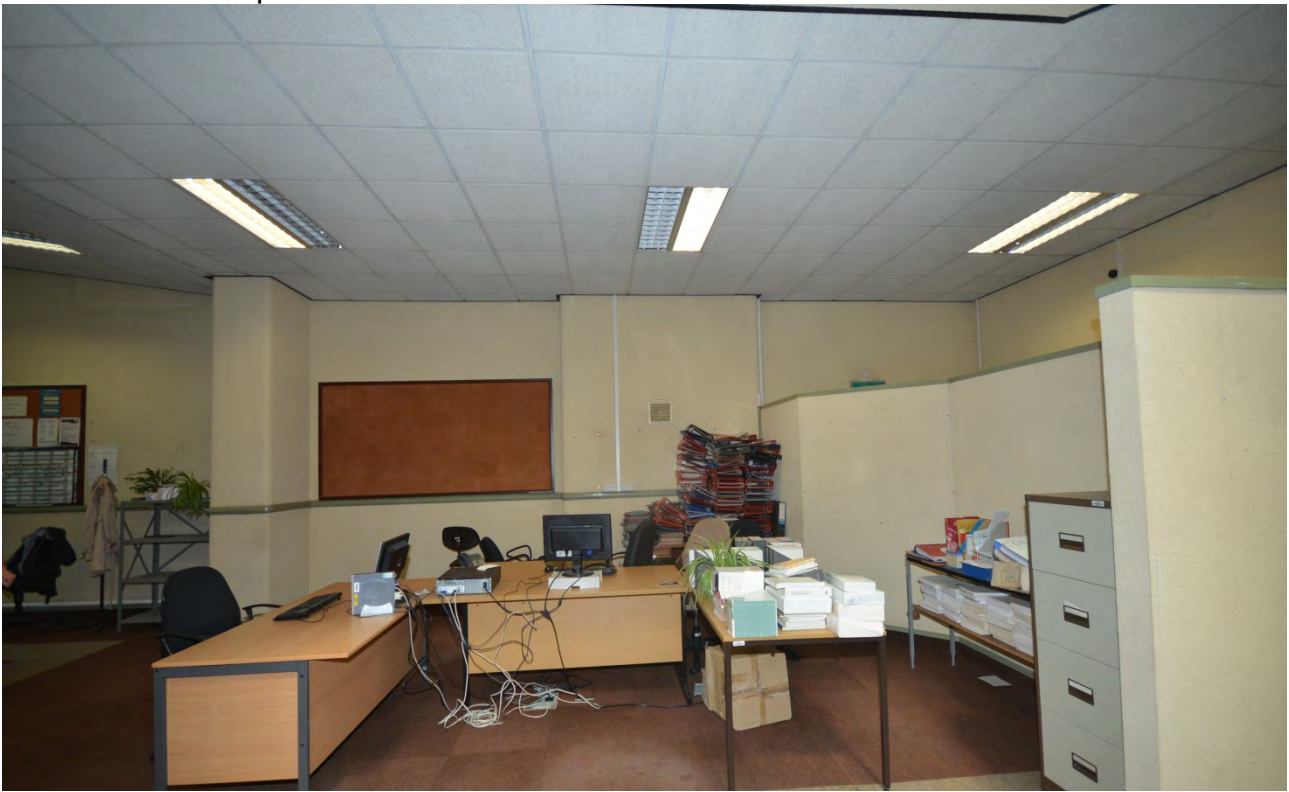
Plate 82: Ground Floor Room 13 Looking North

Current Function	Open plan office
Original Function	Hall
Phase	1&4
Plan Form	Altered
Comments/Description	Glazed lantern to first floor

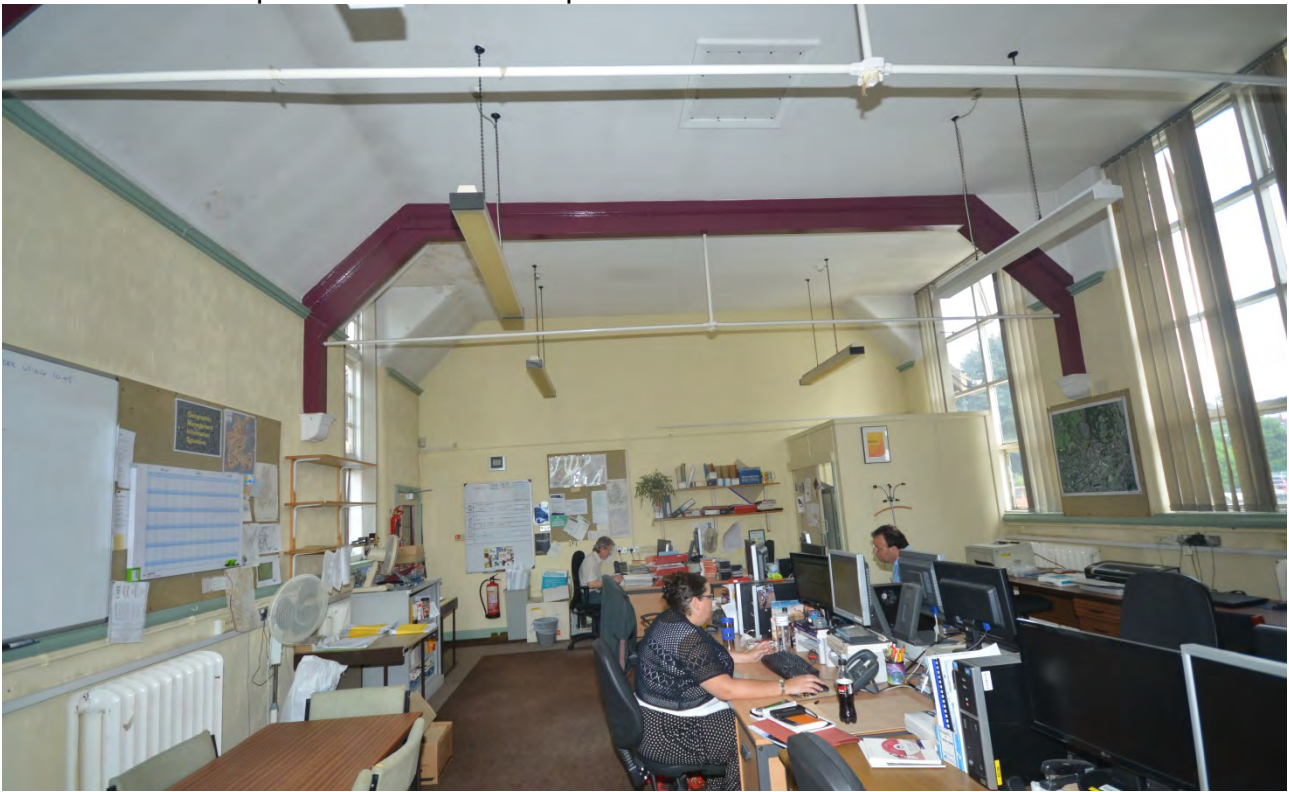
Plate 118: Ground Floor Room 26 Looking North

Current Function	Office
Original Function	Cookery room
Phase	1
Plan Form	Altered
Comments/Description	Exposed roof trusses

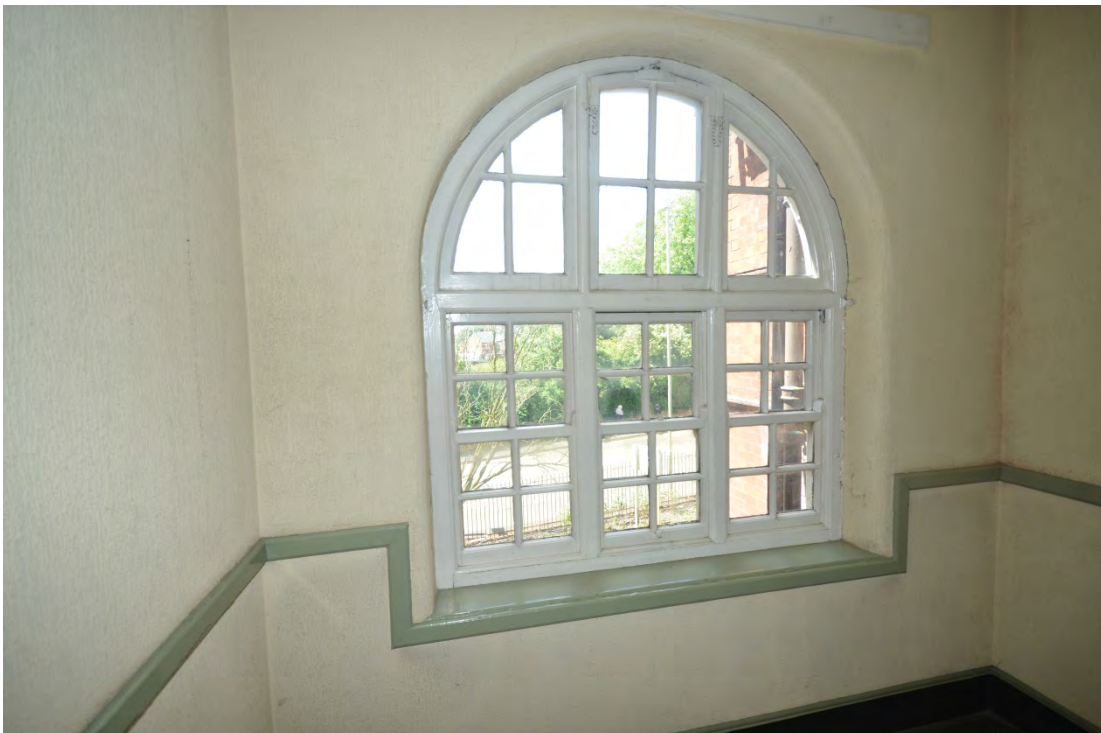
Plate 151: Arched window, staircase

Staircases are located at either end of the building, between the outer coped gables and the central three central gables. Their location is noted externally by the presence of arched windows.

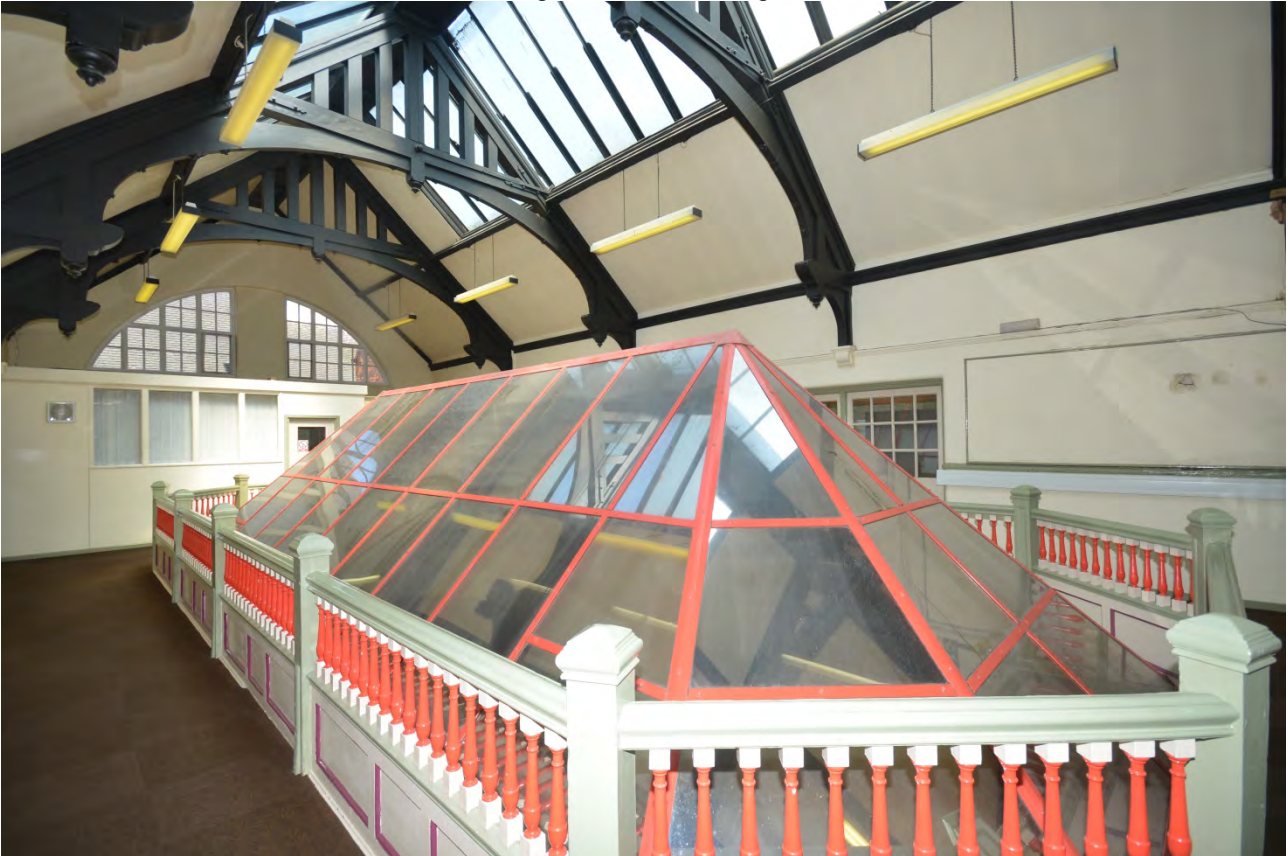
Plate 154: General view of lantern

Current Function	Atrium
Original Function	Atrium
Phase	1
Plan Form	Altered
Comments/Description	Glazed lantern to ground floor, ornate roof trusses with glazed apex to roof

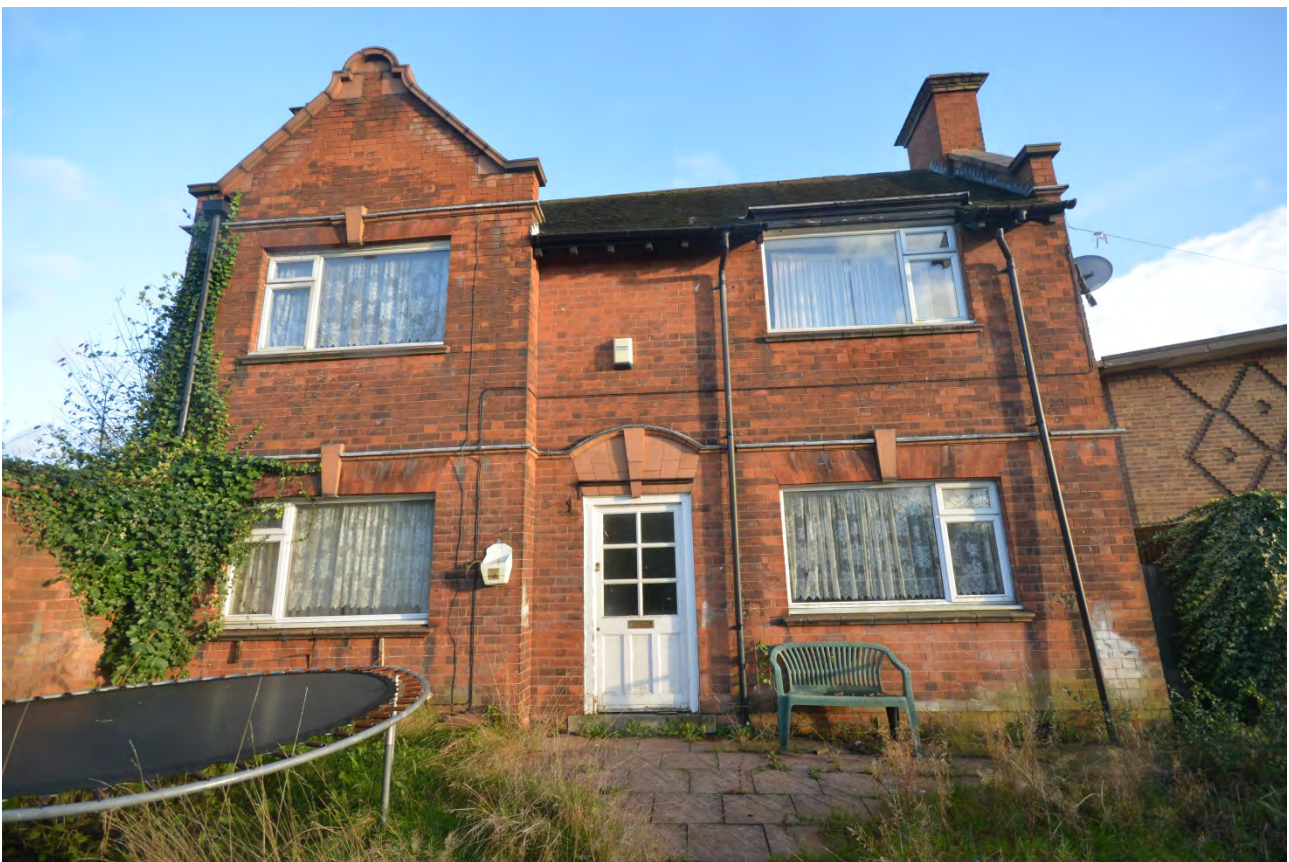
Plate 201: West (front) elevation

The building is constructed of machine-made red brick in a lime mortar matrix, in a similar style to the adjacent Claughton Centre. The bricks are arranged in Flemish bond. Across the façade of the building are examples of ceramic moulded string courses and brick lintels with projecting ceramic keystones, echoing the decoration of the Claughton Centre itself.

The northern end of the building projects slightly and has a coped gable with terracotta mouldings. The roof is of plain red tiles.

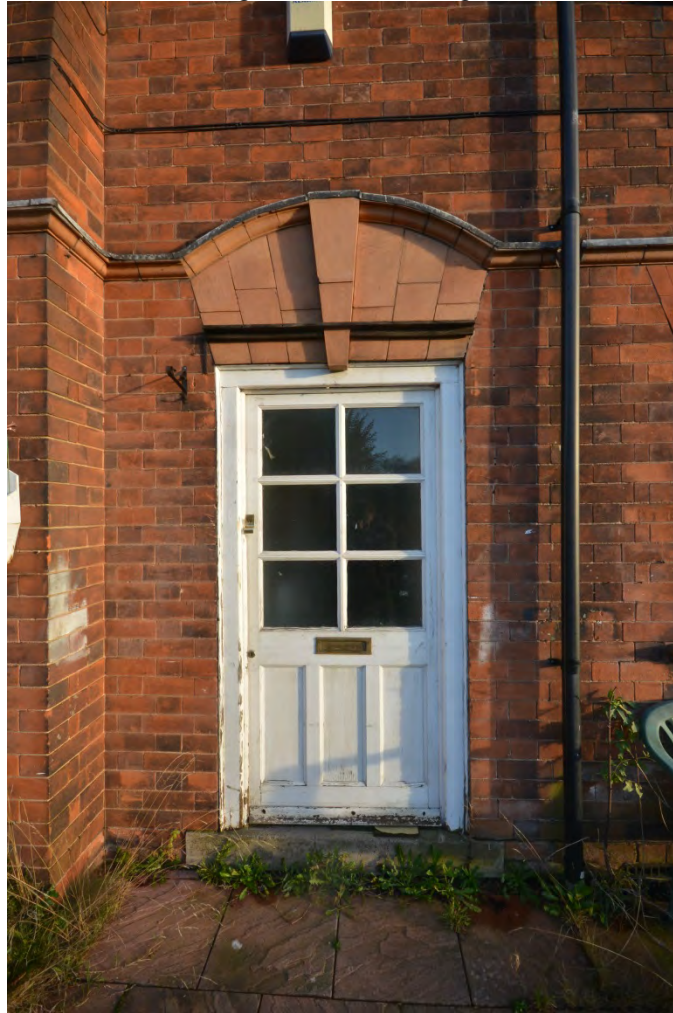
Plate 202: Detail of front door
The front door is a modern timber replacement.

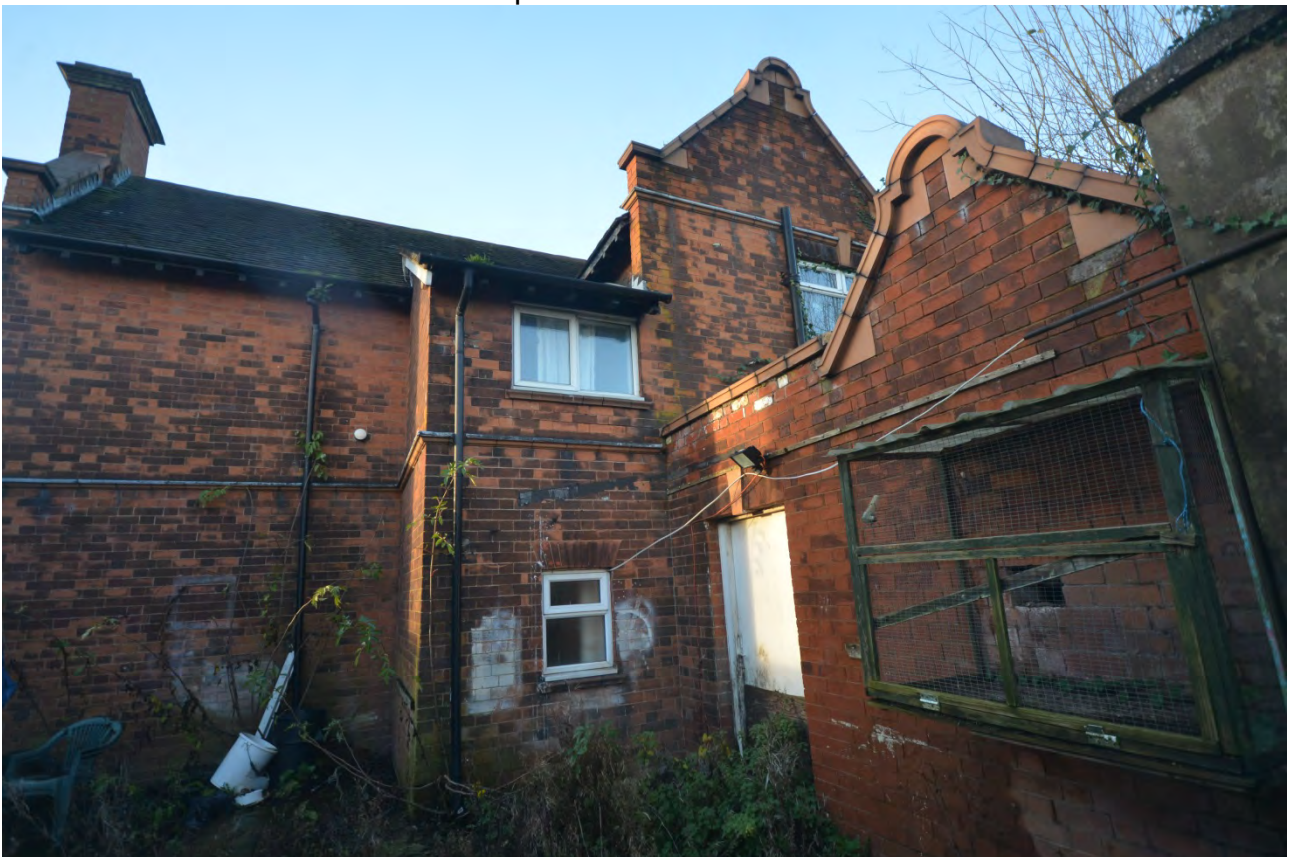
Plate 203: Rear elevation

The coped gable is mirrored on the rear of the building.

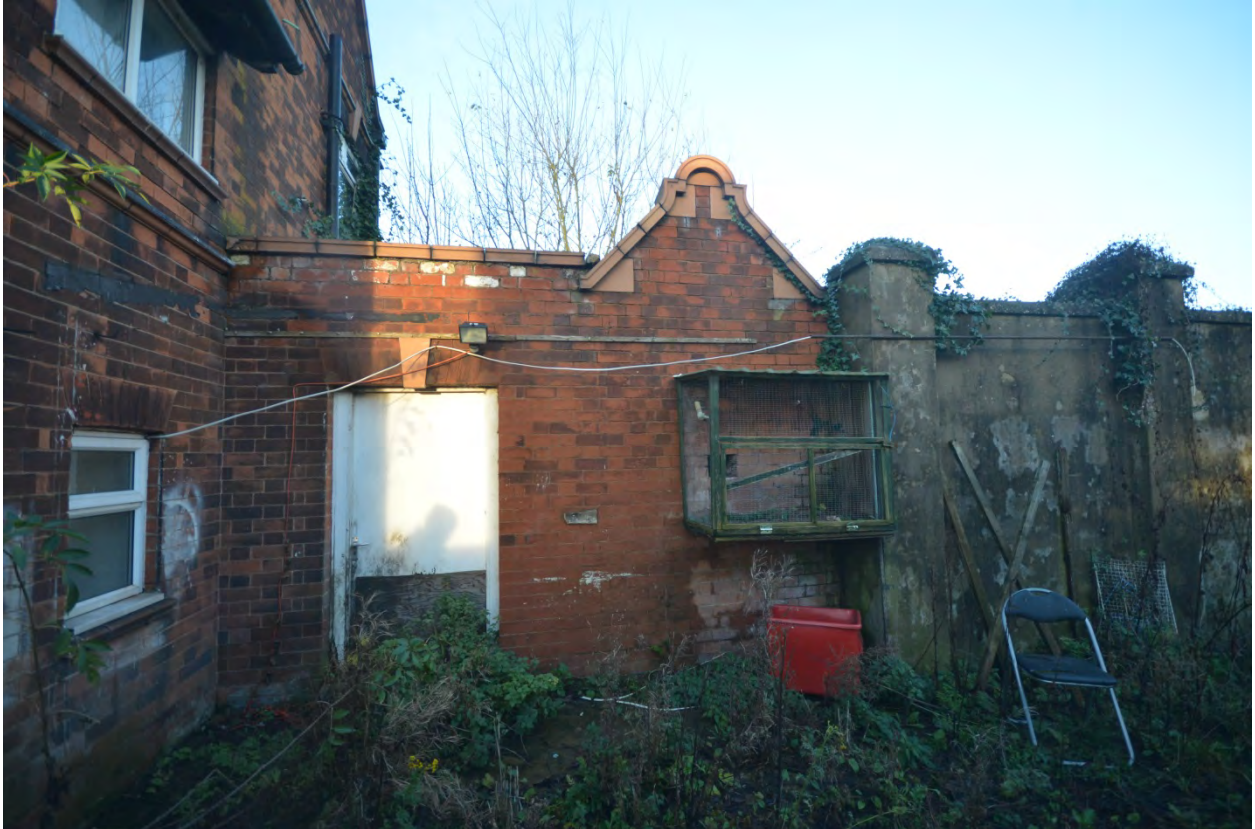
Plate 204: South elevation, outbuilding to rear of house

An outbuilding is present to the rear of the house. This has a smaller coped gable. The outbuilding was not accessible at the time of recording.

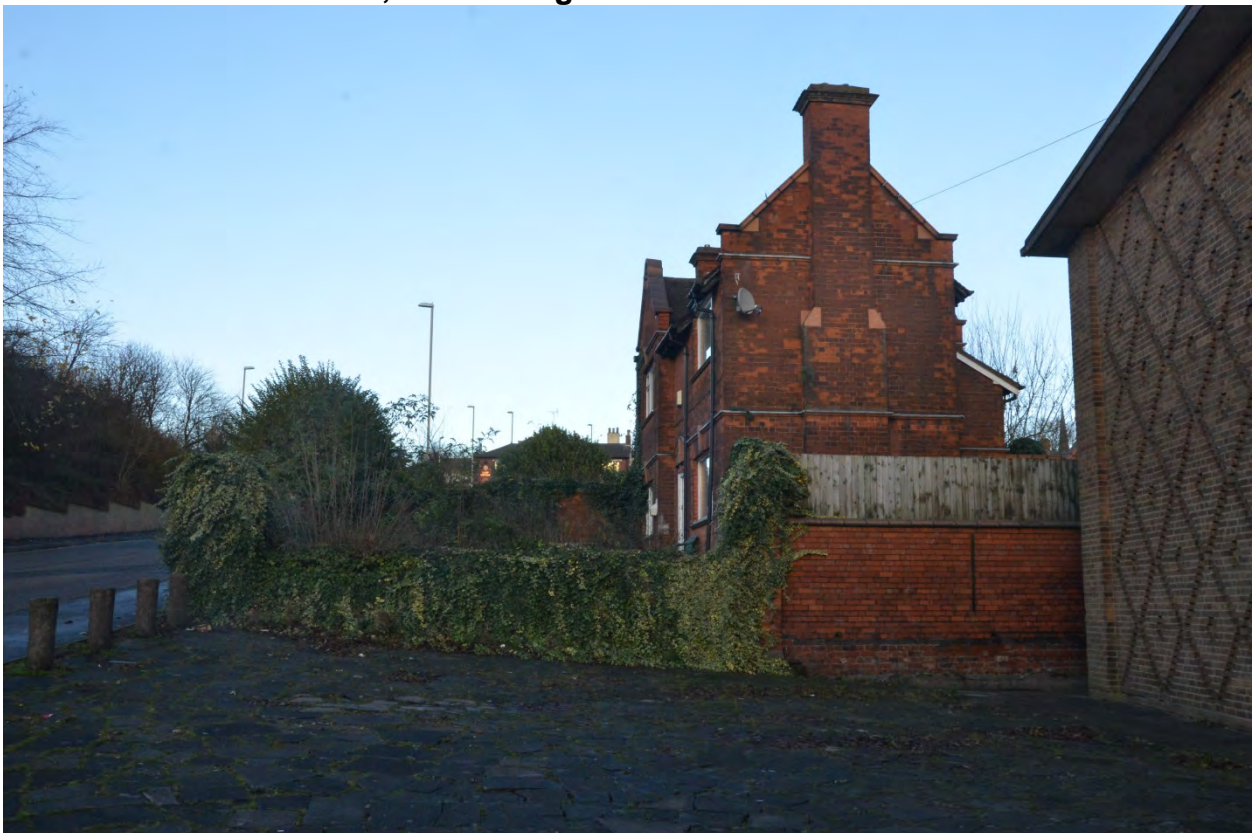
Plate 205: South elevation, house

The southern elevation is dominated by a substantial chimneybreast with ornate moulded chimneystack at its head.

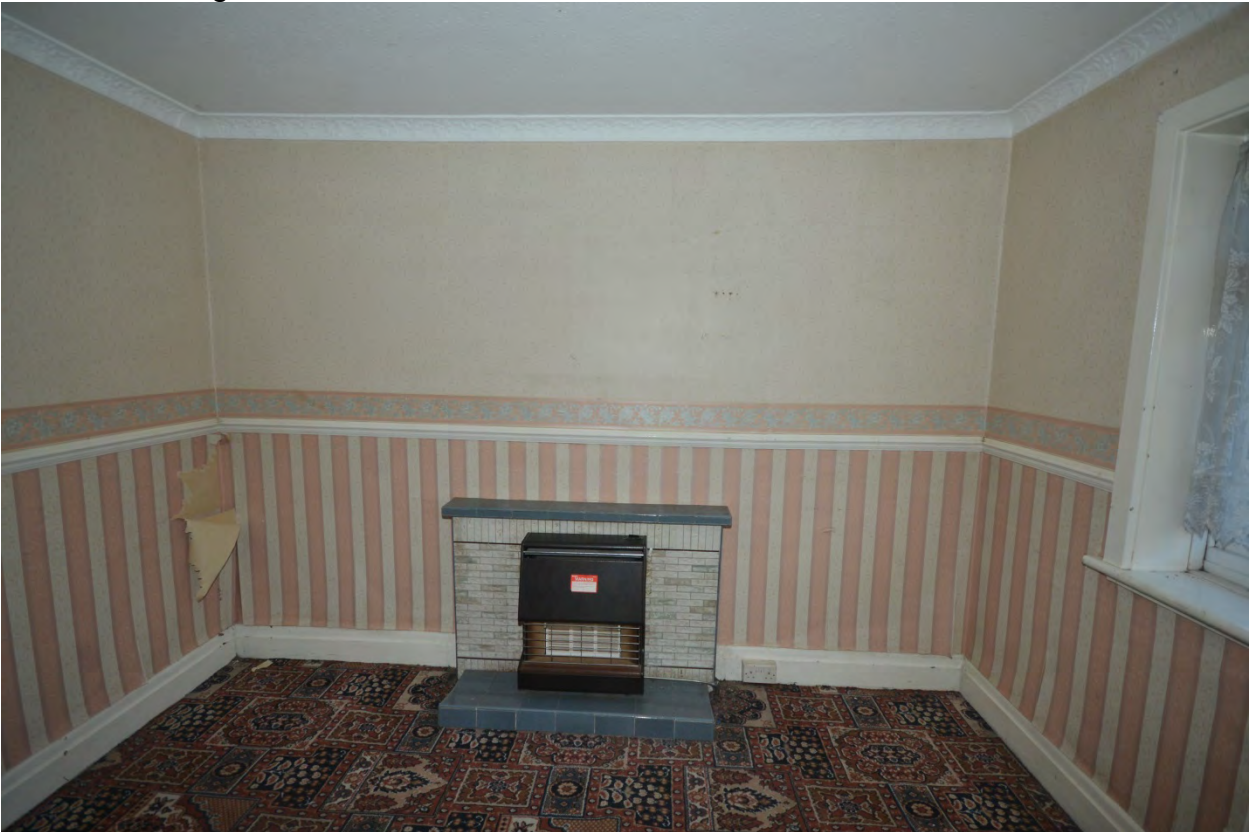
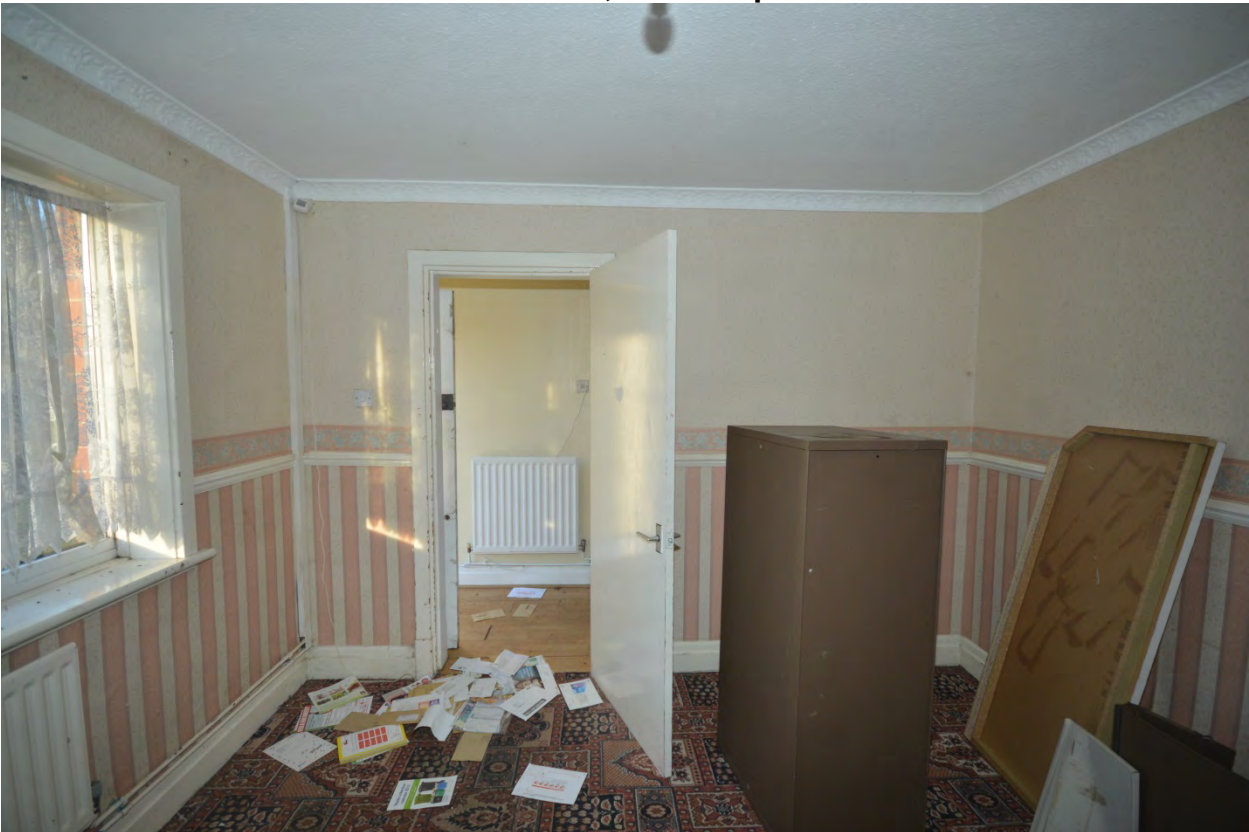
South of the front door, a room is present with window opening to the west. It has modern skirting and a modern dado. At its southern end, a 20th century fireplace is present, fitted with a modern gas fire.

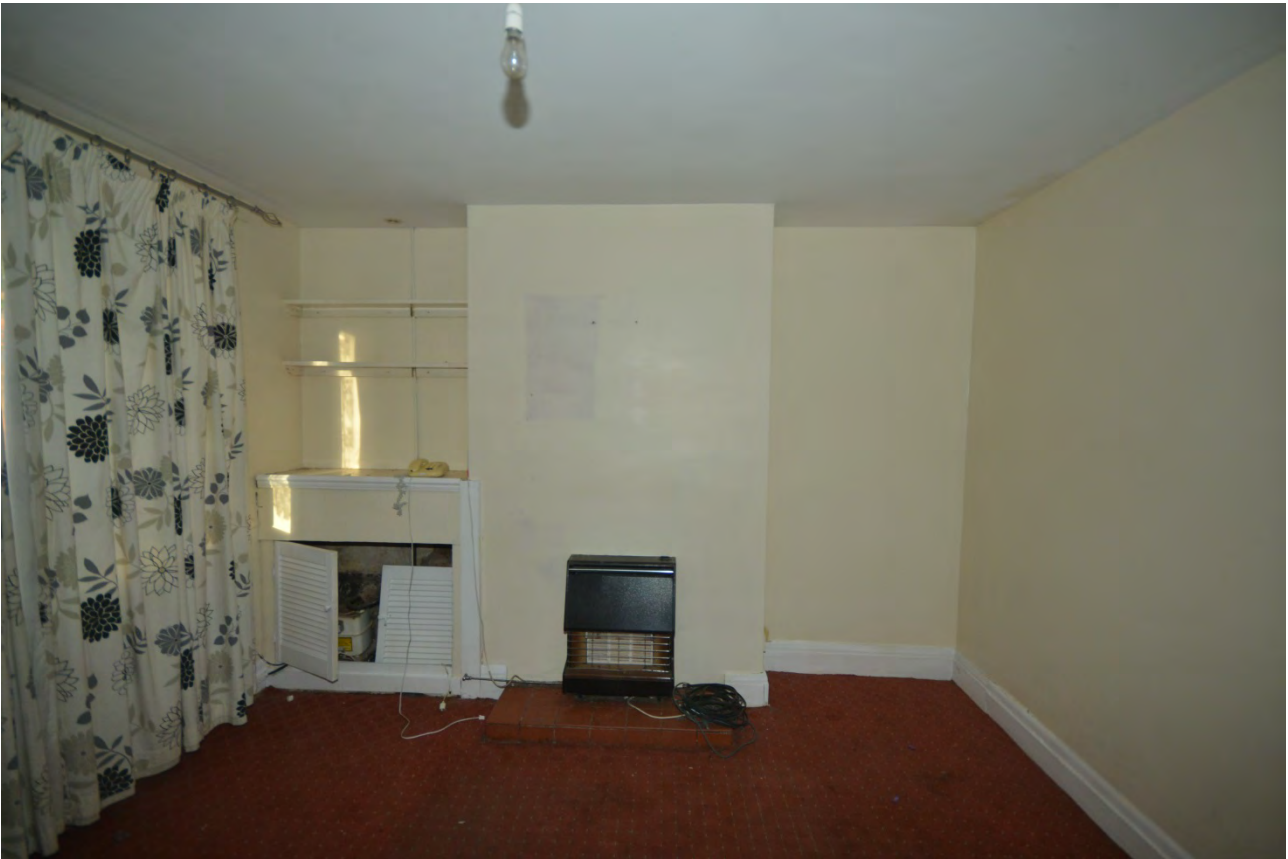
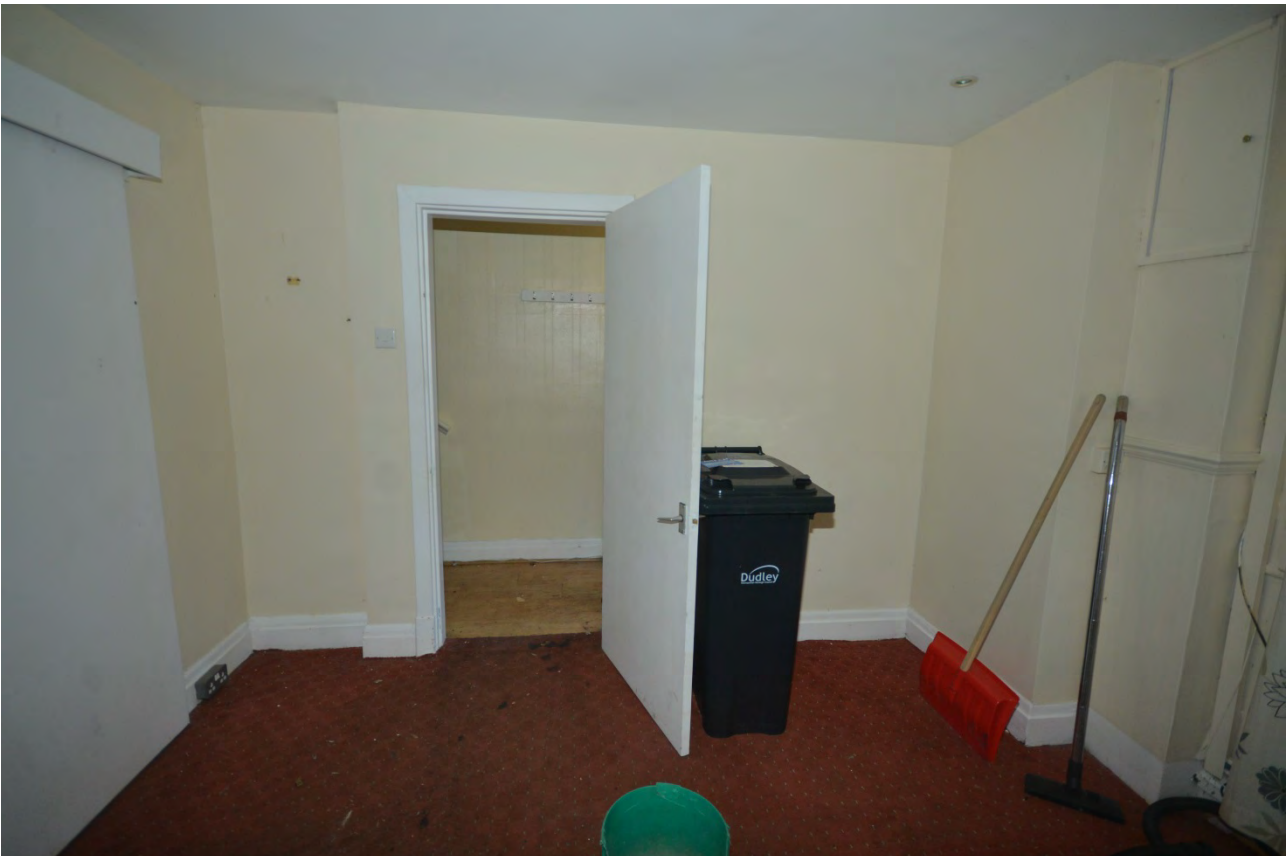
The northern room to the west of the building is fitted with modern skirting and a modern sliding door to the east. Again, a modern gas fire is fitted, although there is no fire surround. A built-in cupboard and shelves are located to the west of the chimneybreast.
