Heritage Statement:
Claughton Centre
Blowers Green Rd
Dudley
West Midlands
DY2 8UD
National Grid Reference: SO939897

Dr Peter Wardle & Colin Lacey

17/12/2014
Document Reference Number 2013/1192
Version 0.7

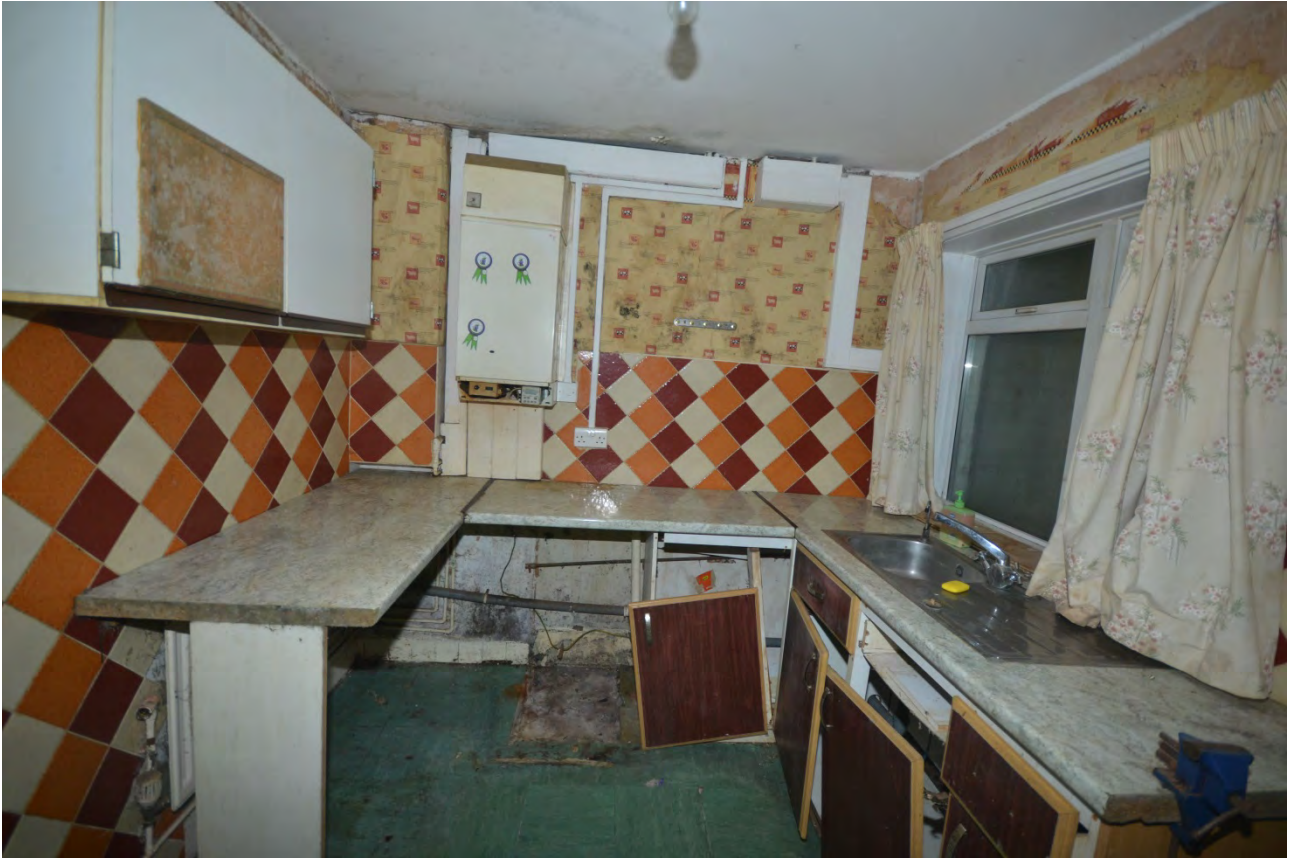
The kitchen is located to the northeast of the ground floor. It is fitted with dilapidated 20th century kitchen units. There are no historic features present.

Plate 210: North aspect, kitchen

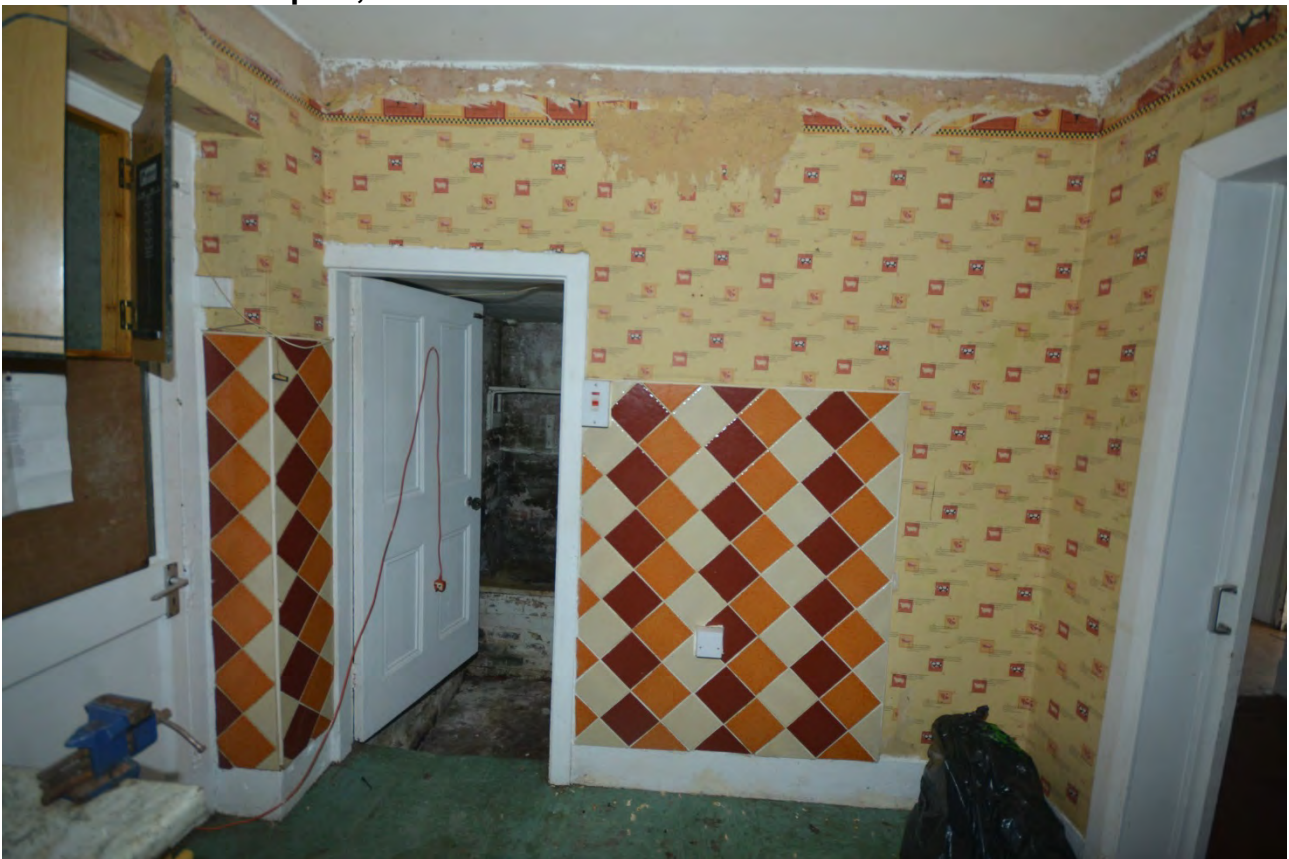
Plate 211: South aspect, kitchen

The kitchen has doors to the northwest room, the rear garden and a pantry to the southeast, all visible in the photograph above.

The door to the pantry is an original four-panelled example whereas the others are modern.

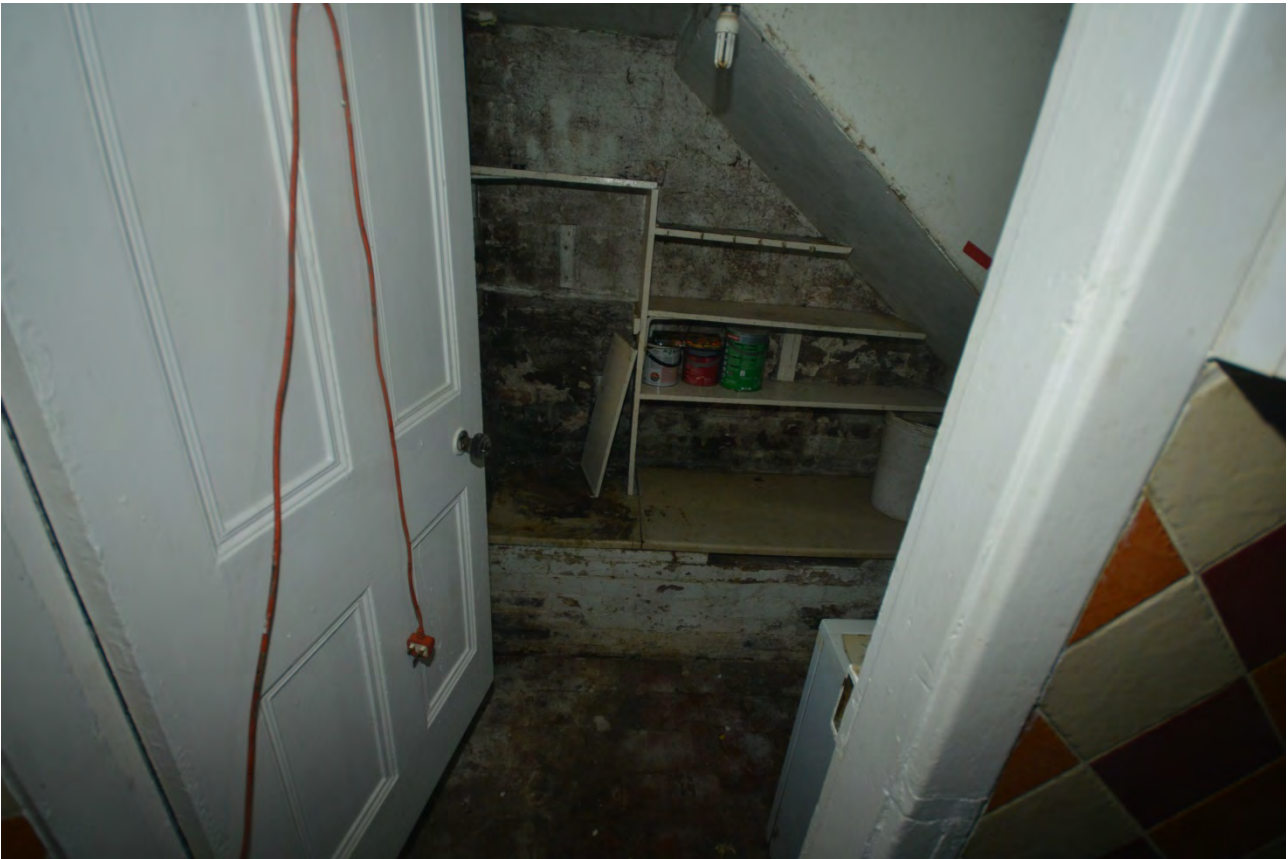
Plate 212: View into pantry

The pantry is located beneath the stairs to the first floor. It has a single window to the east and fitted shelves.

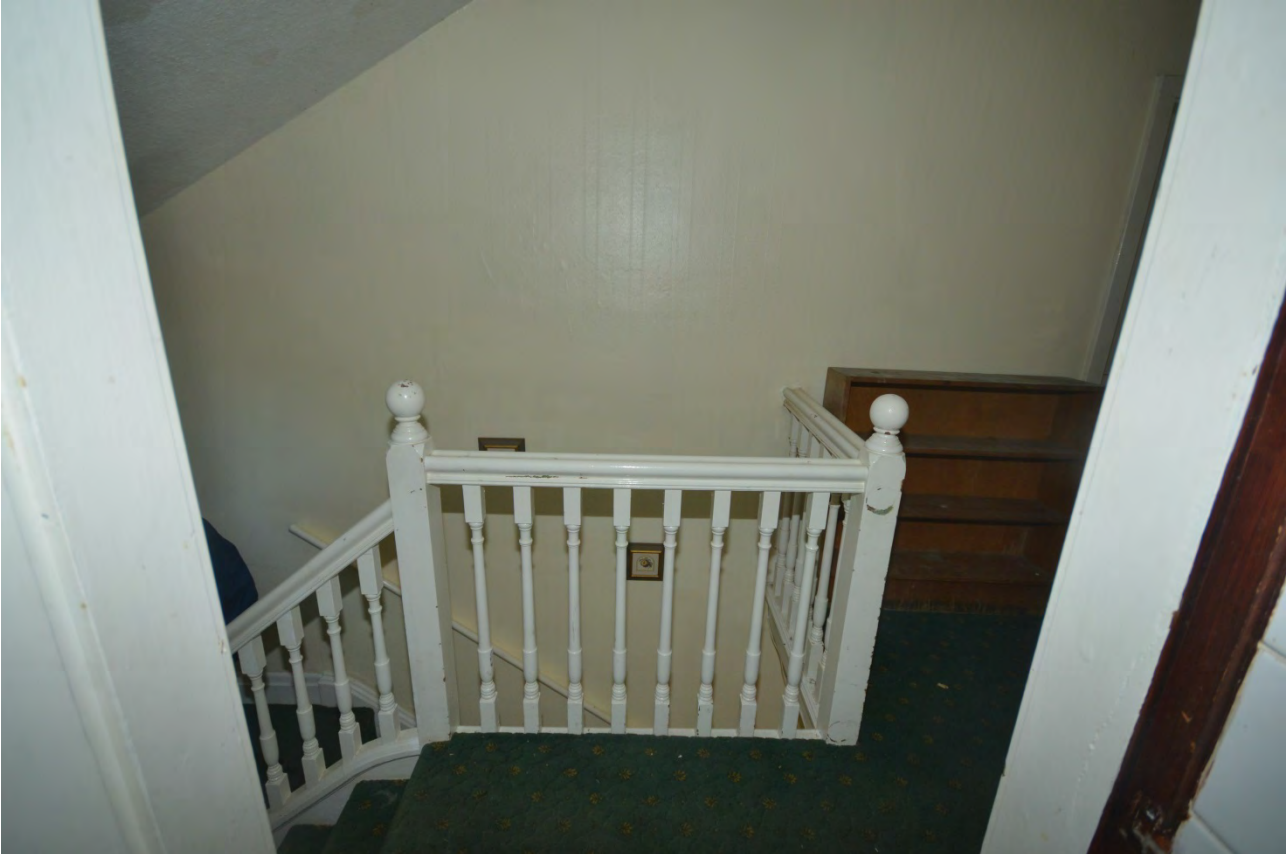
Plate 214: Detail of balustrade

The staircase to the first floor features a balustrade with simple turned ballusters and ball finials in a 19th century style.

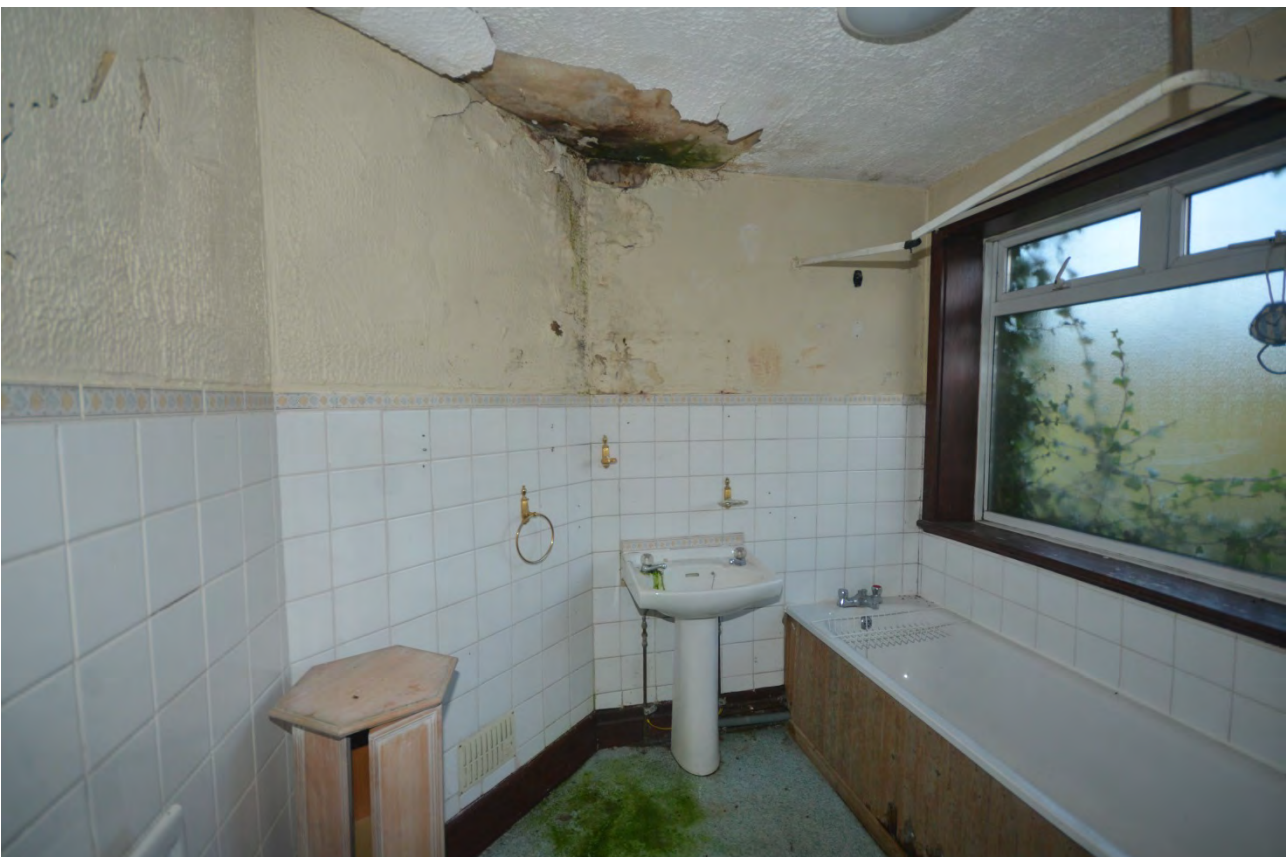
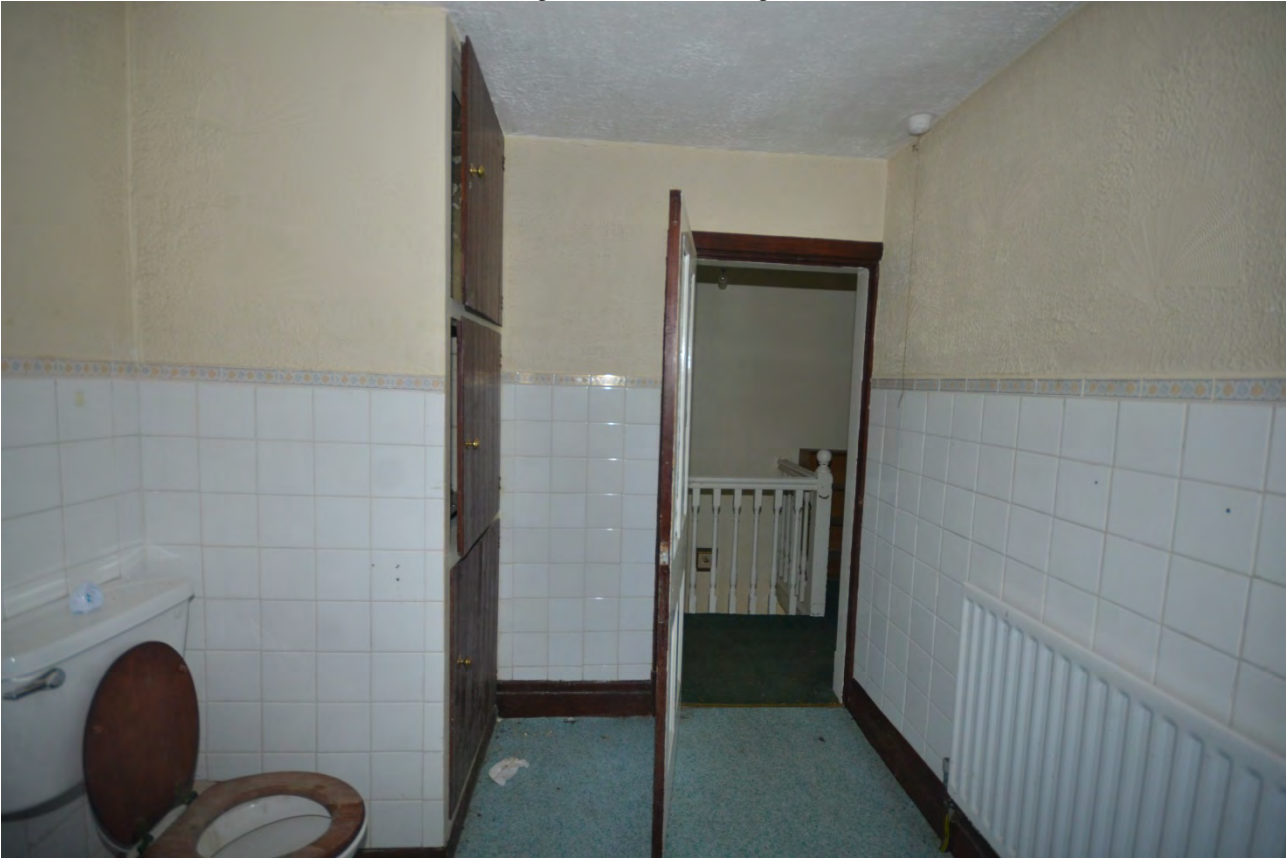
The bathroom is located to the northeast of the first floor. It has an angled northwest corner reflecting the location of a chimneybreast. There are no historic elements.

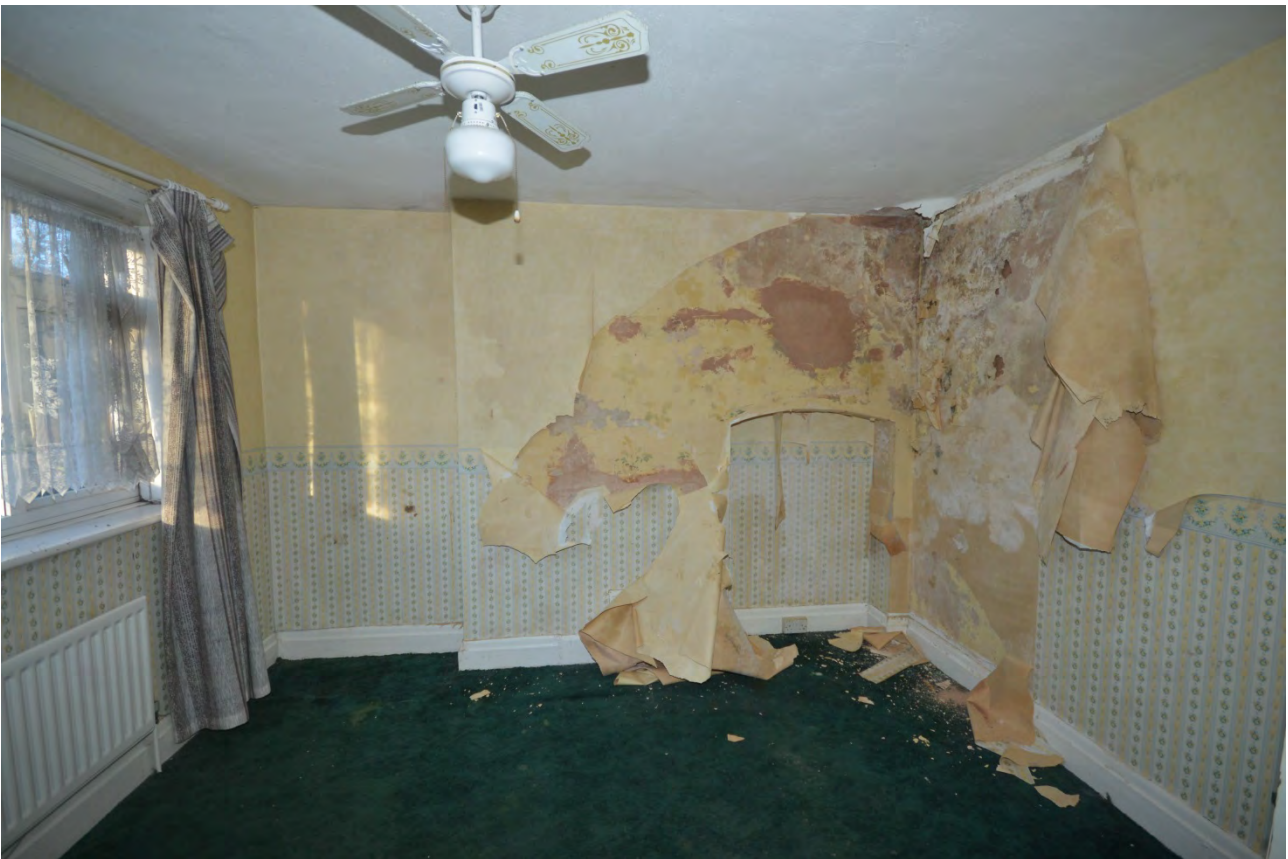
The northwest bedroom features a blocked chimneybreast in its northern wall with an arched recess to the west.

Plate 219: North aspect, northwest bedroom

The skirting spans the chimneybreast where a fireplace would have been located. It is therefore considered not to be an original feature.

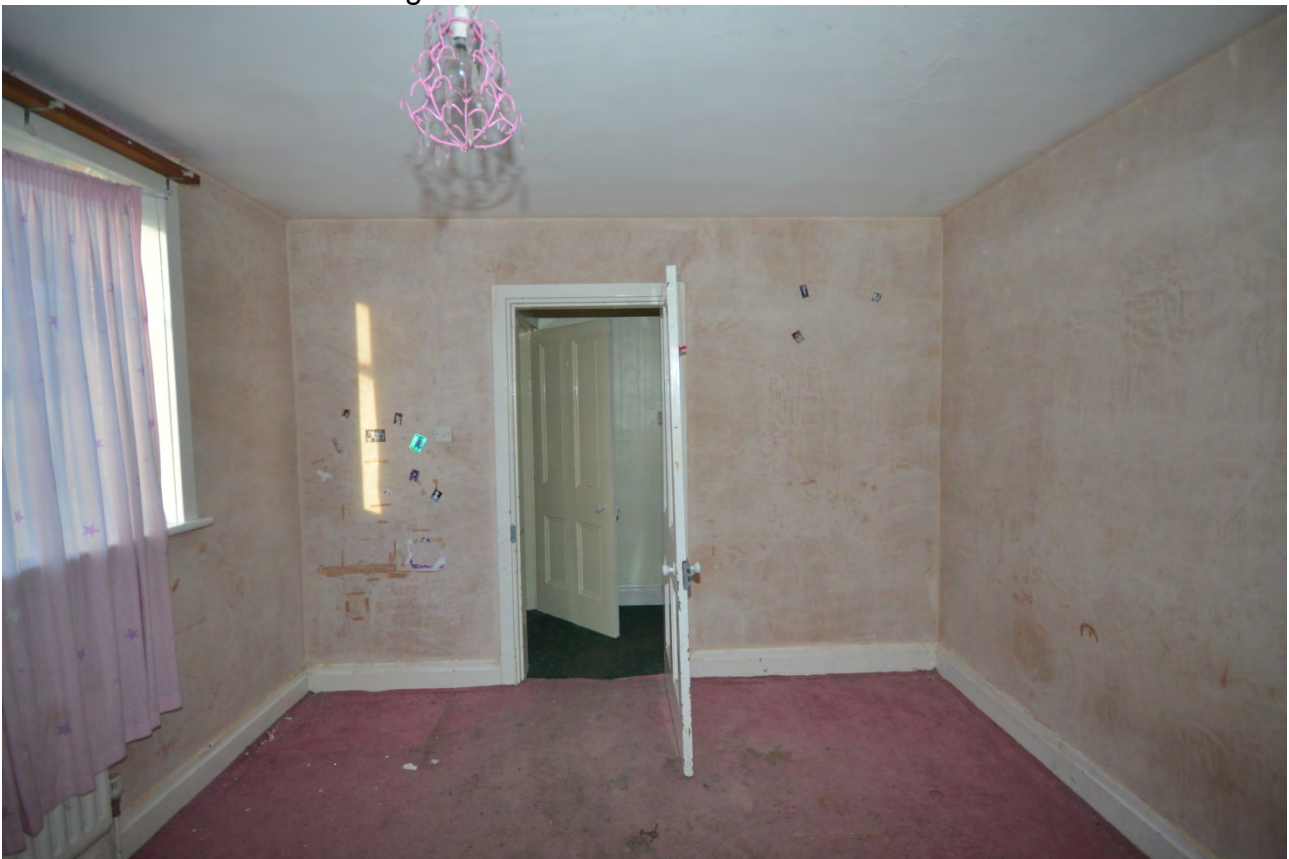
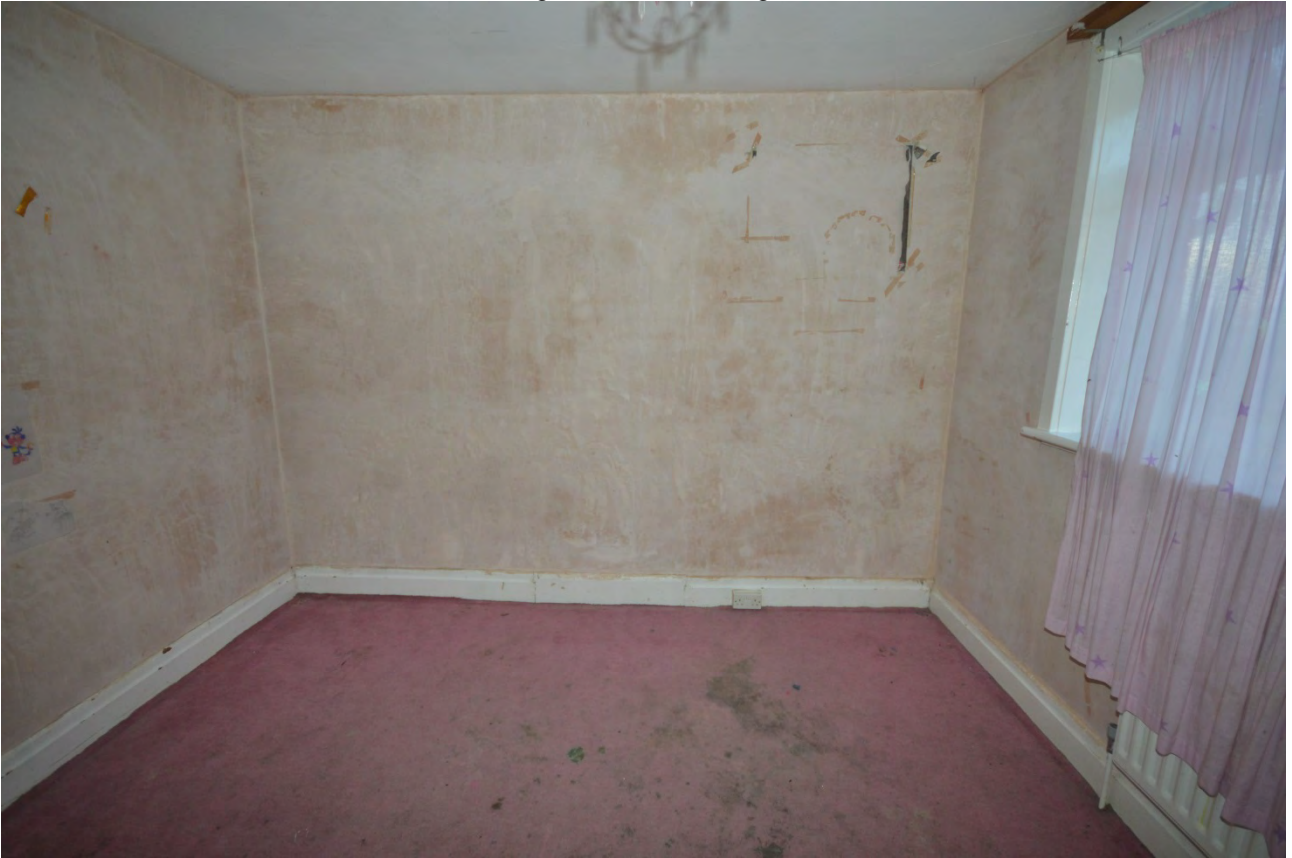
The southwest bedroom is again devoid of historic features.

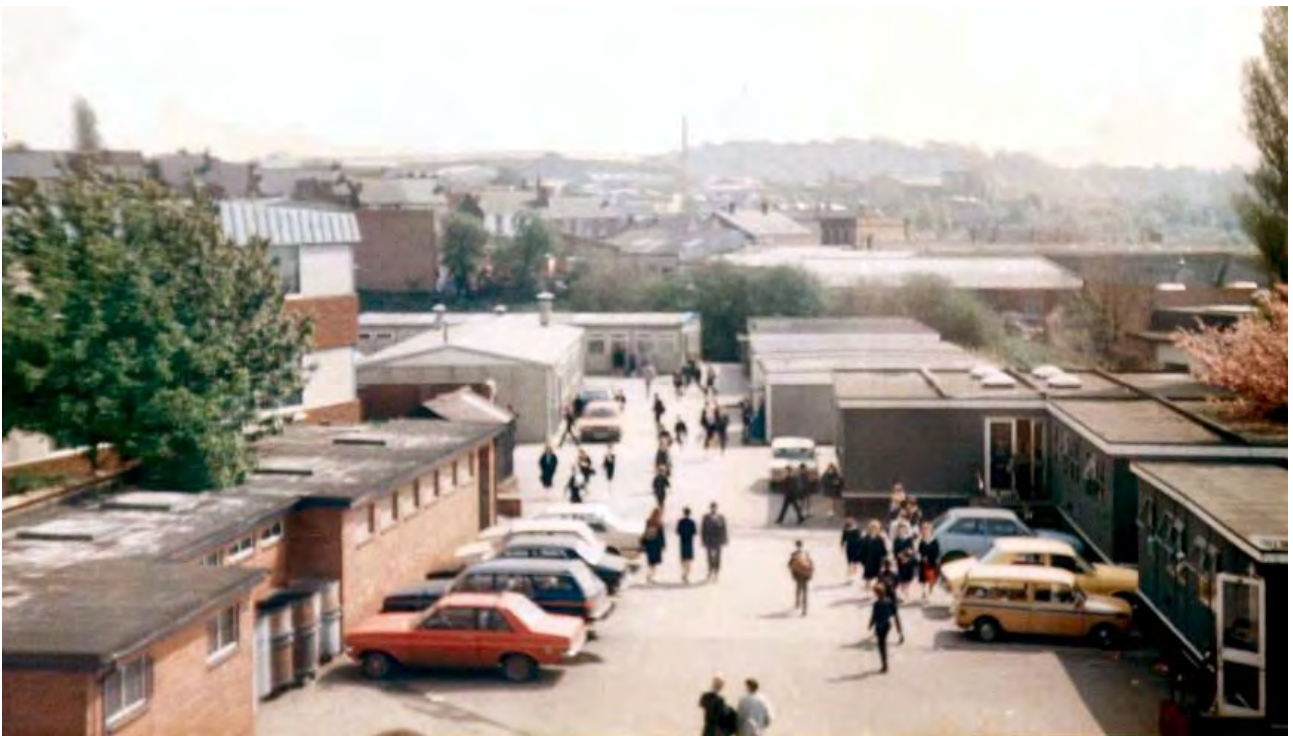
The final photograph is undated but shows the area to the east of the building in the 1970s/80s.
