CONSERVATION STATEMENT

GARAGE AT CHURCH FARM BARNES
KNIGHTON ON TEME
TENBURY WELLS
WORCESTERSHIRE

*An Archaeological Assessment of the development known as:
Garage at Church Farm Barns
Knighton on Teme
Tenbury Wells
Worcestershire*

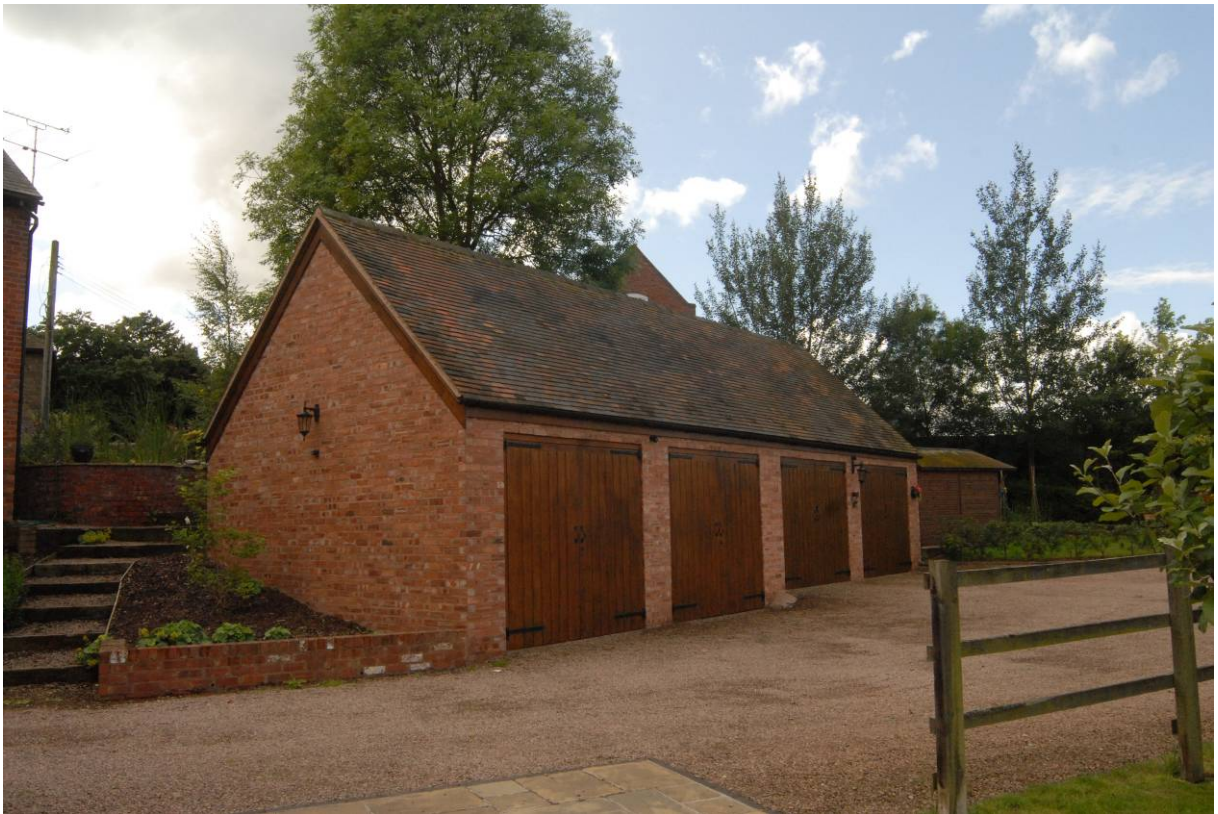
Plate 1: Garages north of Church Farm House

3.4 *Garage North of Church Farm House*

A modern brick-built garage constructed during the 2000 redevelopment works. The building is located on the footprint of a two storey steel framed barn clad in corrugated iron, dating from the early part of the 20th century, which was demolished during the redevelopment.

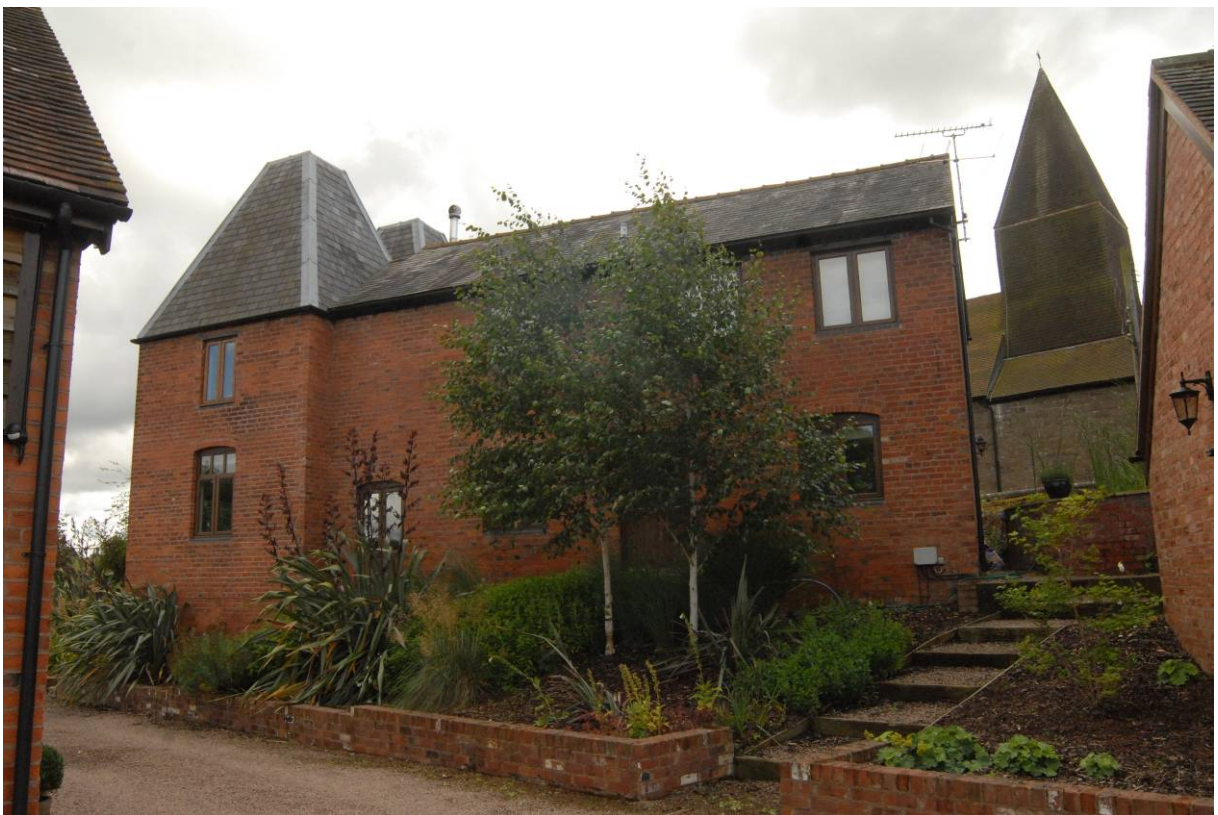
Plate 2: Northern elevation, The Hop Kiln

The hop kiln building is of red brick with a slate roof built in the vernacular style. The building is T-shaped in plan, the building running east-west, with a cross-piece at the eastern end. This cross piece housed a pair of kilns, evidential from the form of the roof at this point.

The western part of the building housed the cooling floors and storage for pockets (sacks) of dried hops below, also doubling as stabling for livestock and as a cart shed.

The hop kiln was converted into a residential property known as 'The Hop Kiln' in 2000.

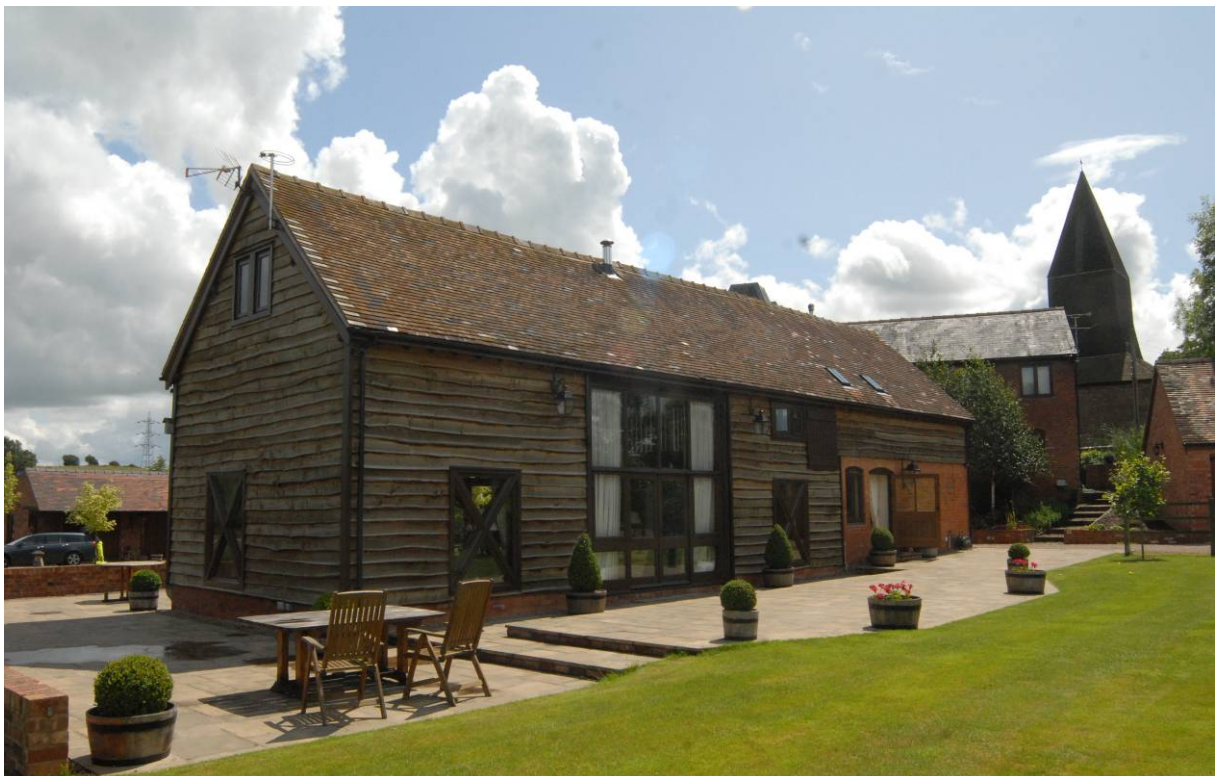
Plate 3: Northwest aspect, Church Barn

A north-south oriented range. The southern part was originally a stable with hayloft over. The ground floor of this part is of brick with weatherboarded timber frame over. The northern part was a threshing barn of weatherboarded timber frame on a brick plinth. The roof is of plain tiles.

Graffiti on the wall of the hayloft states that the building was built in 1894, and further inscriptions cover the lives of some of the occupants of the farm in the late 19th - early 20th century.

The building was converted into a residential property known as 'Church Barn' in 2000 and is the building to which the garage relates.

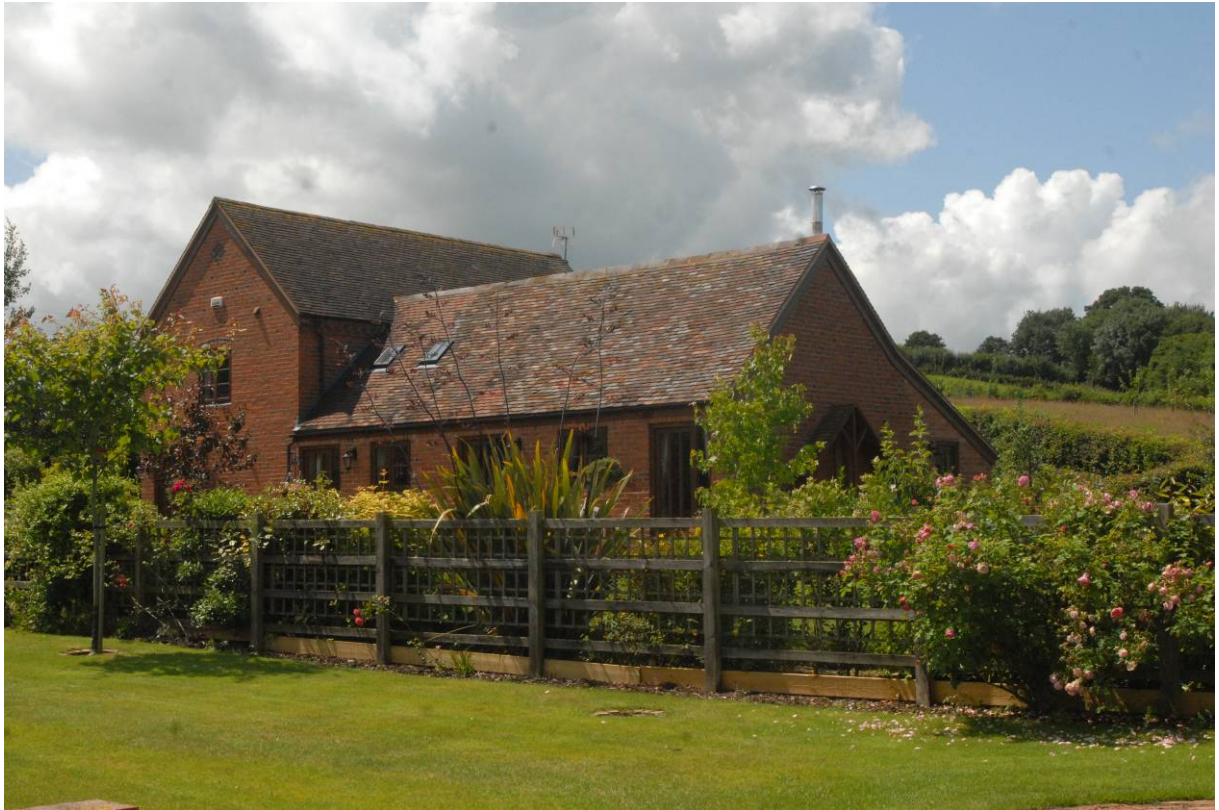
Plate 4: Finchall Barn, viewed from the east

The structure of the western barn comprises multiple phases of building. The earliest phase features two storeys of two unequal bays, originally a stable and tack room from the early 19th century. A former two-storey extension to the west of the building is apparent on historic maps. Evidence of this was observed during building recording in 2000 (Stone & Tavener).

The second phase, a single storey brick range running north at right angles to the primary phase. There is strong evidence that this range was built at the same time as the primary phase although technically it butts against it, making it technically later in date.

In the 20th century, the building was adapted as a drying room, with metal flues and extractor fans installed. Also at this point, a breeze block outshut was added to the western part of the building.

The building is of red brick construction with a plain tiled roof.

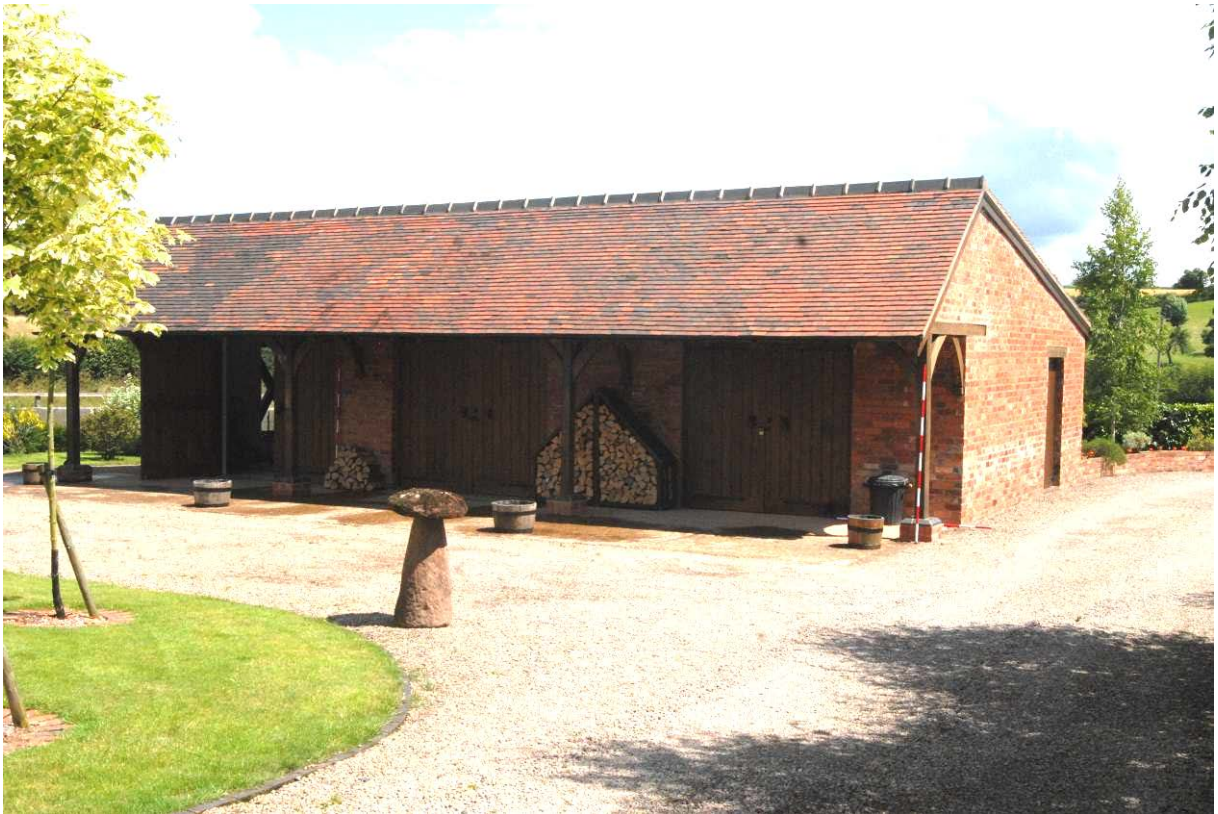
Plate 5: The Garage, western elevation

Described in the 2000 building recording (Stone & Tavener) as a 'breeze block and timber clad machinery shed', this building is clearly of late 20th century origin. The original roof was of corrugated sheet. The building was a direct contrast to the style and appearance of other buildings located at Church Farm. Evidence from historic maps (see below) proves that the building was constructed after 1973.

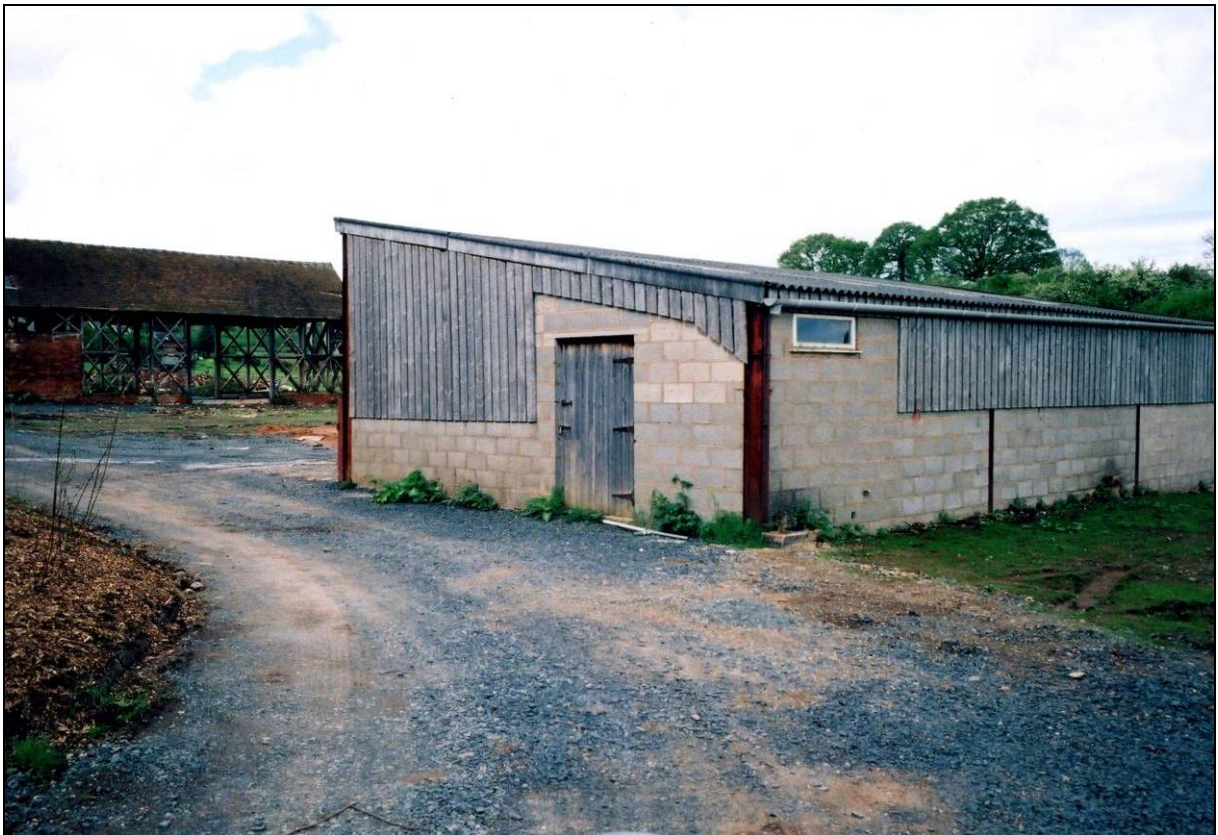
Plate 6: Shed / garage viewed from southeast, prior to reordering

The garage in its original form, constructed from modern pre-cast concrete blocks with timber over, stood out as a detractor from the visual appearance of the surrounding buildings which were all constructed of red brick with tiled or slated roofs.

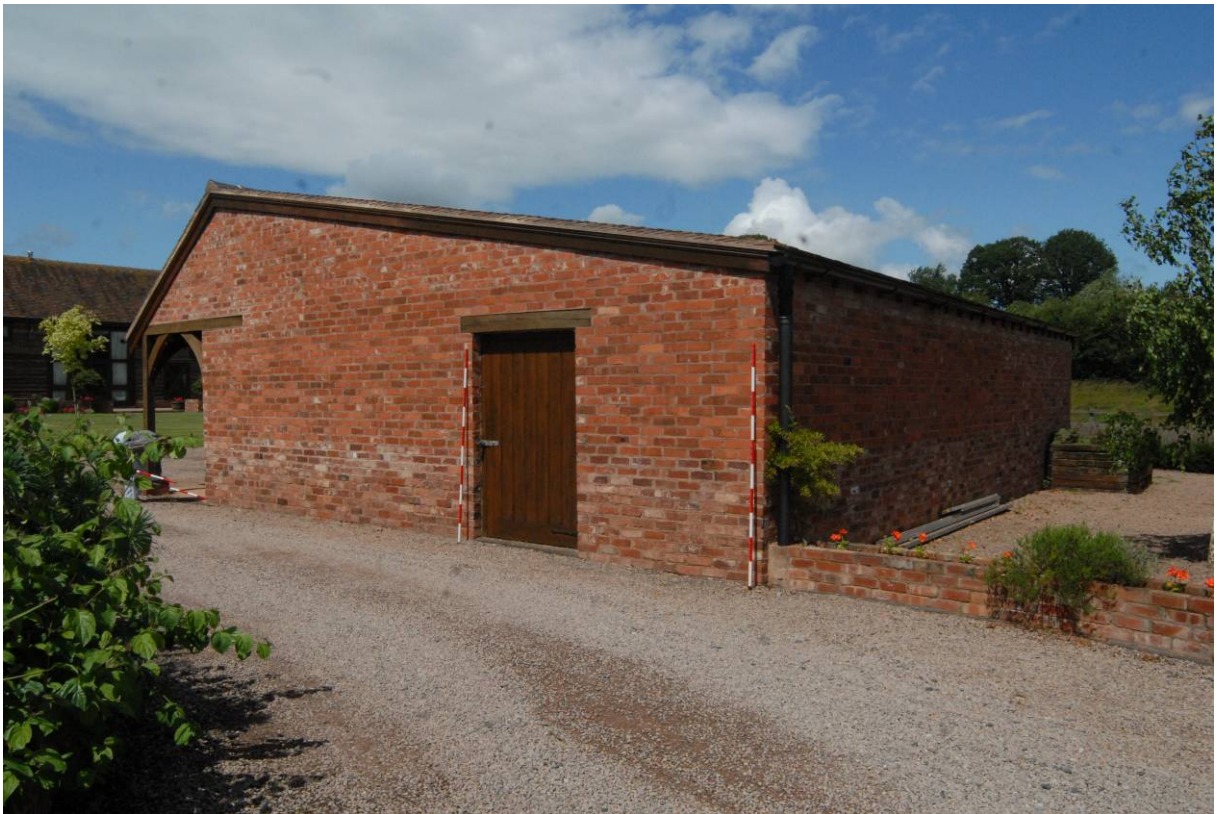
Plate 9: Southern elevation, garage, before and after modification

It is clear from the photographs above that the modifications carried out to the garage building are sympathetic to the surrounding historic setting and that the building no longer detracts from the overall appearance of the other structures in the immediate area.

Conversion of existing agricultural outbuilding to domestic garage. Cladding of original modern structure with brick, re roofing structure and extension of roof to west, forming overhang. Fitting of new timber doors. All work carried out to be in keeping with neighbouring buildings.
