Appendix 2 Level 3 Building Recording of
The Canteen Building

Blue Bird Park
Bromsgrove Road
Hunnington
Worcestershire
B62 0JW

Document Reference Number 2023/1681

Dr Peter Wardle & Colin Lacey

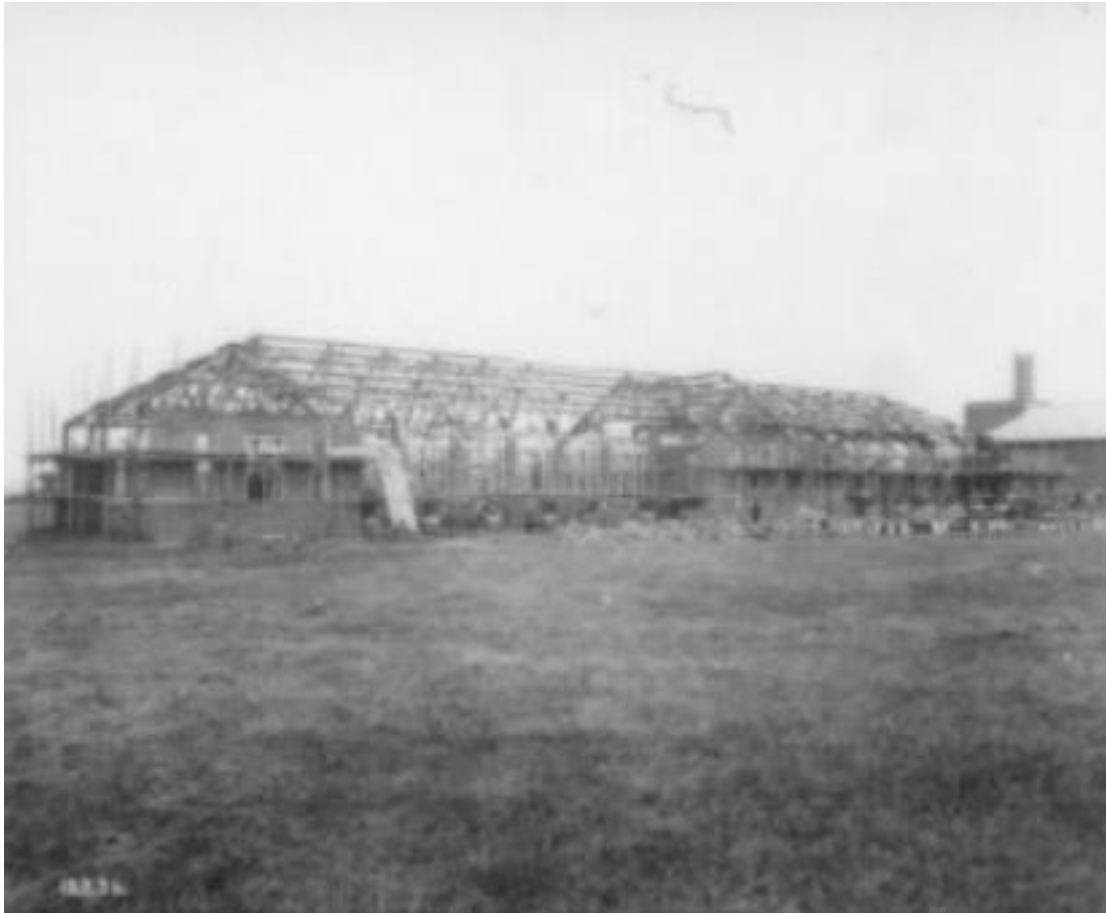
Plate 6: The canteen under construction (Blue Bird Album, Romsley & Hunnington History Society)

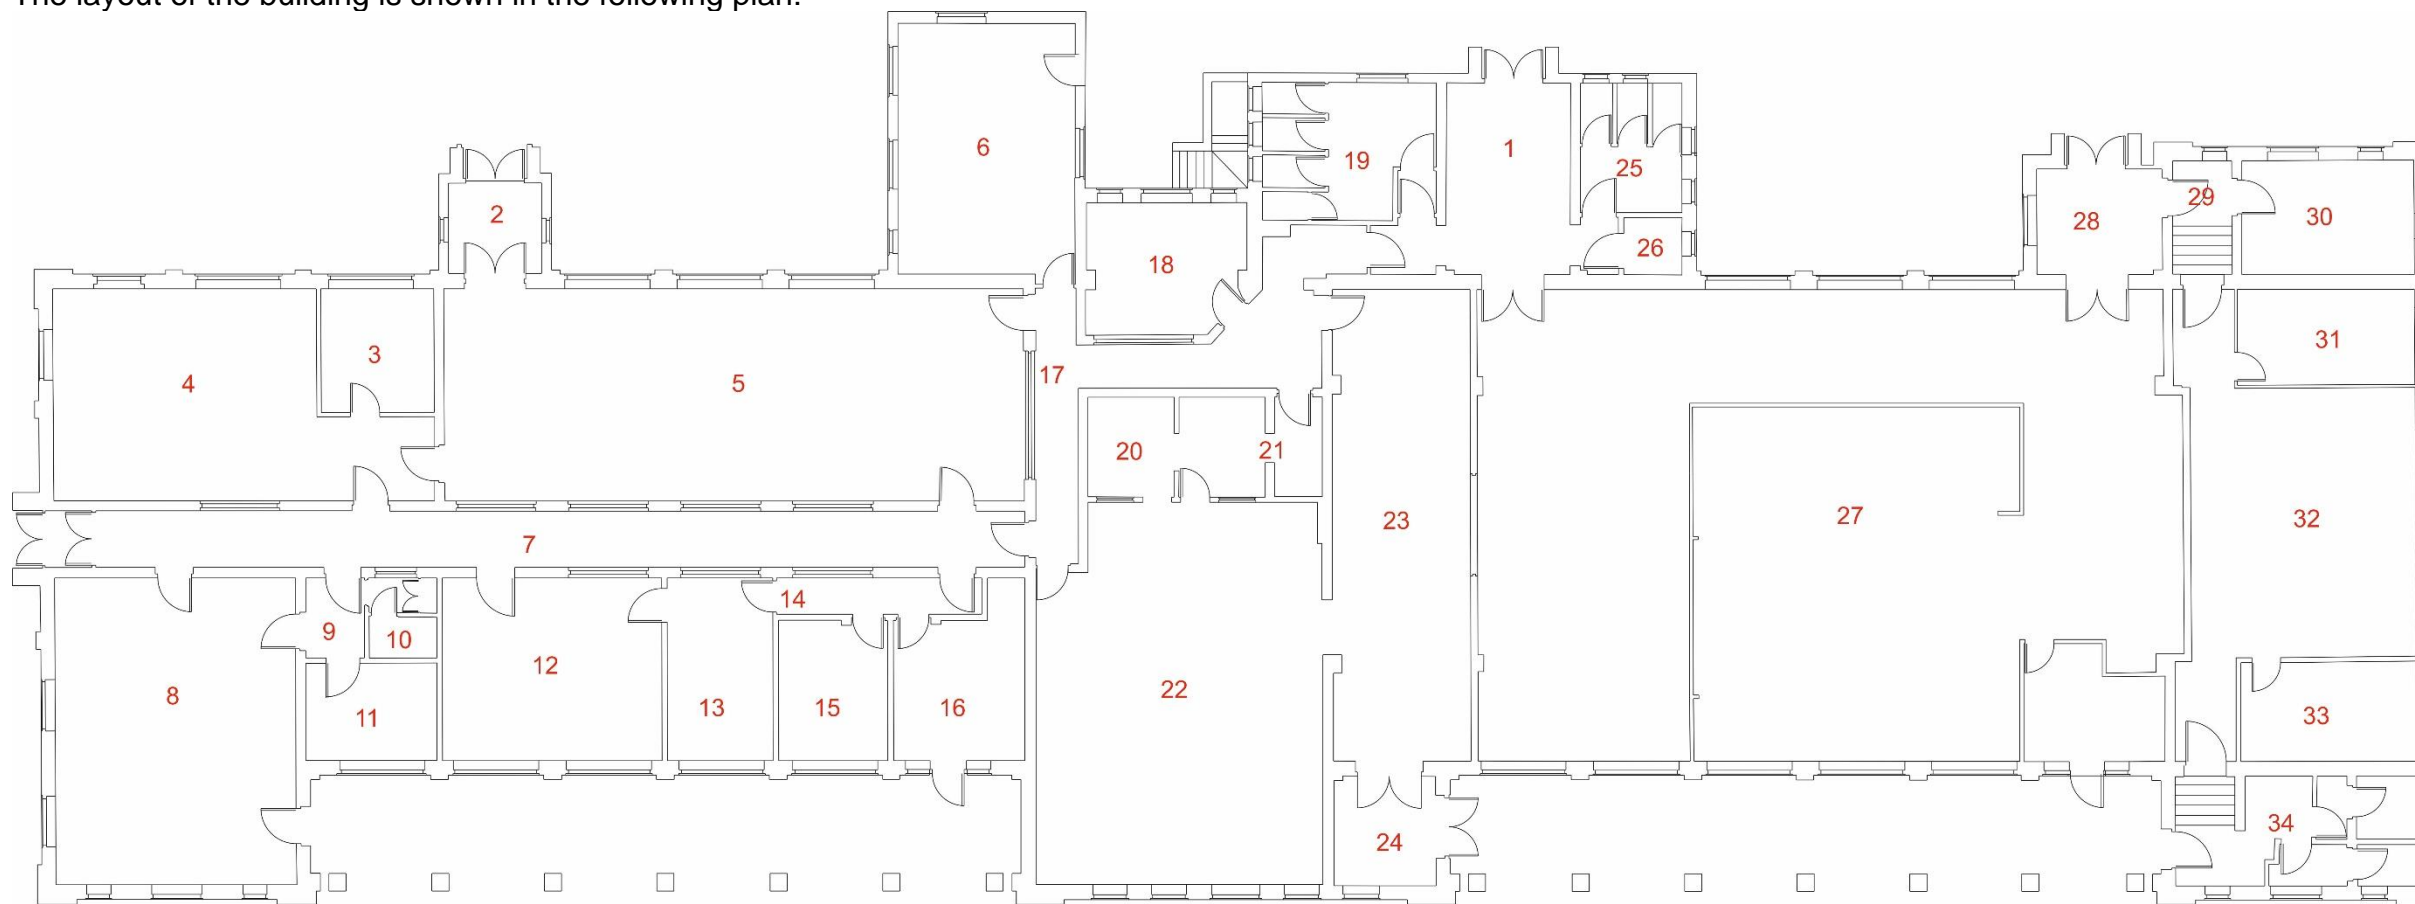
Figure 3: The layout of the Canteen building, 1:200 @ A3

The layout of the building is shown in the following plan:

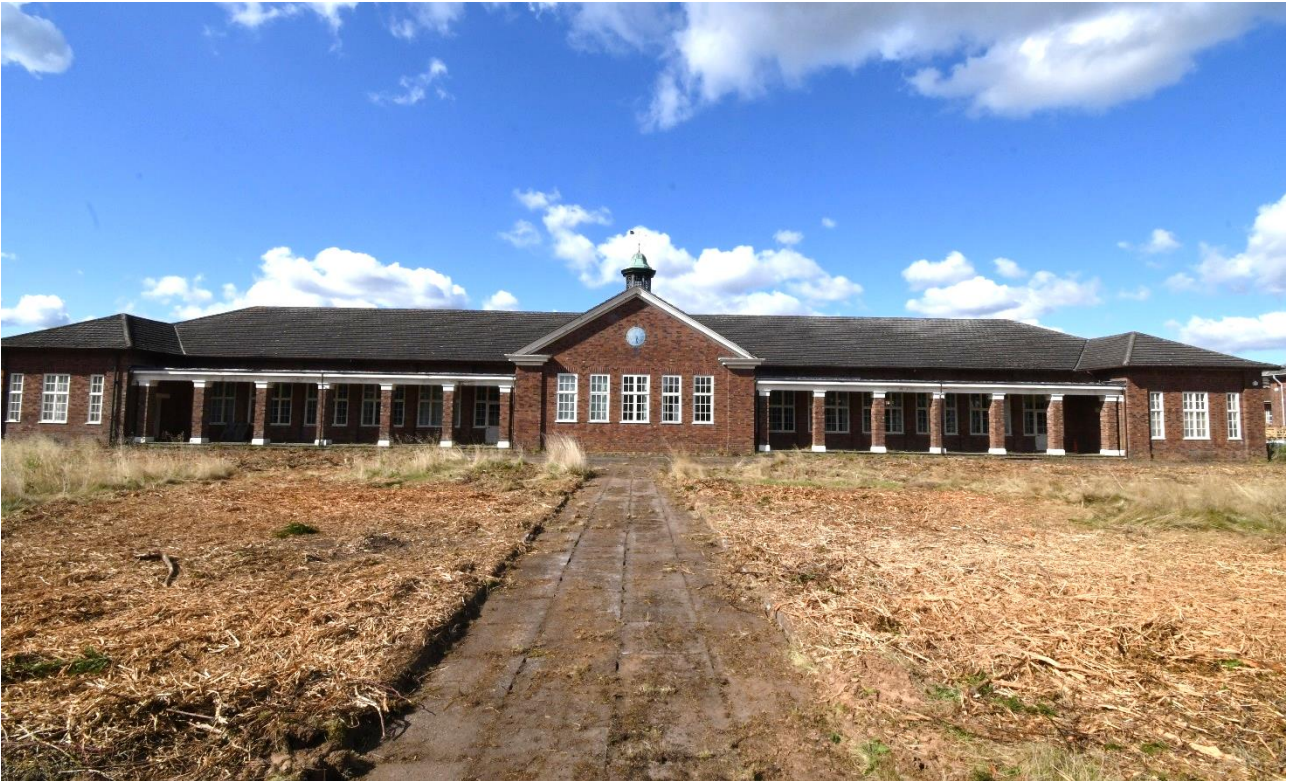
Plate 10: Front (southeast) elevation

The front of the building faces southeast and consists of three projecting bays, one at either end of the building, each with three windows, and a central bay with five windows.

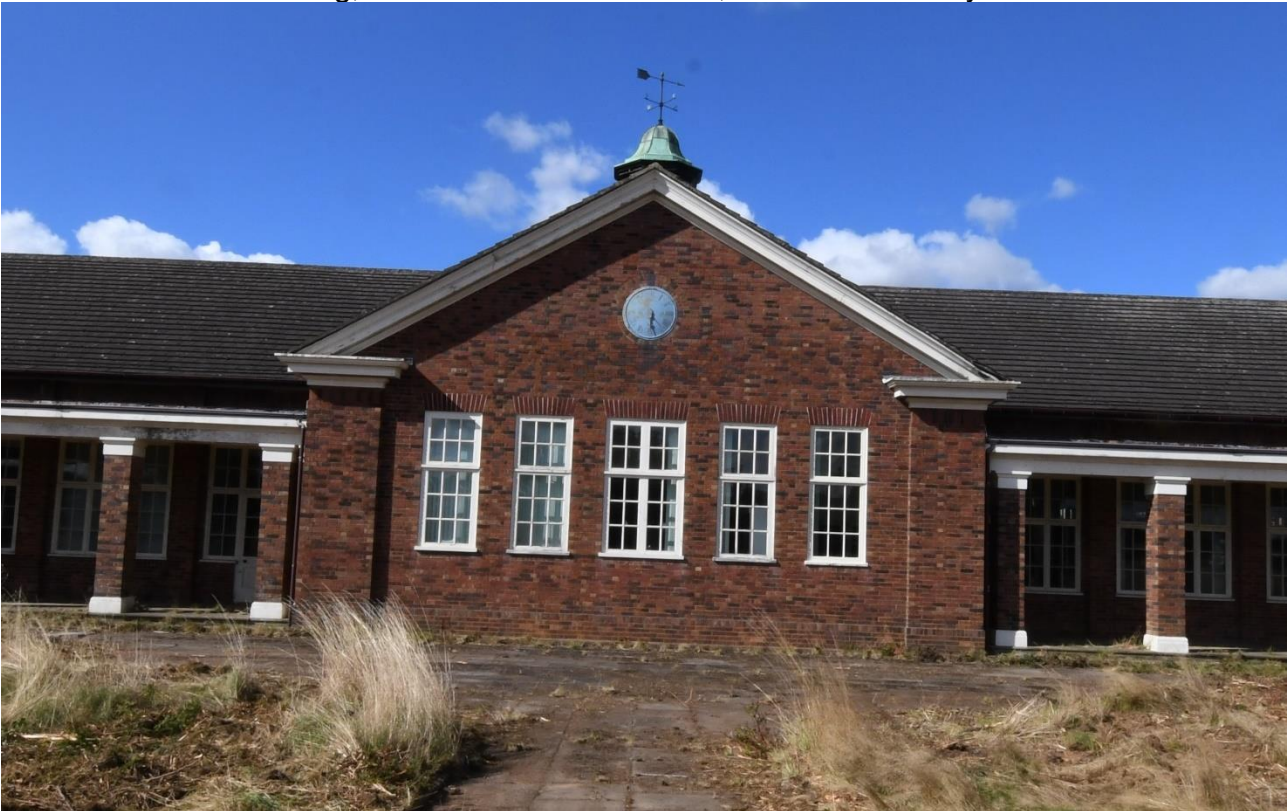
Plate 13: Detail of central bay

The central bay is further detailed with brick pilasters supporting a fully segmented pediment set into the gable. Central to the gable, a clock is located.

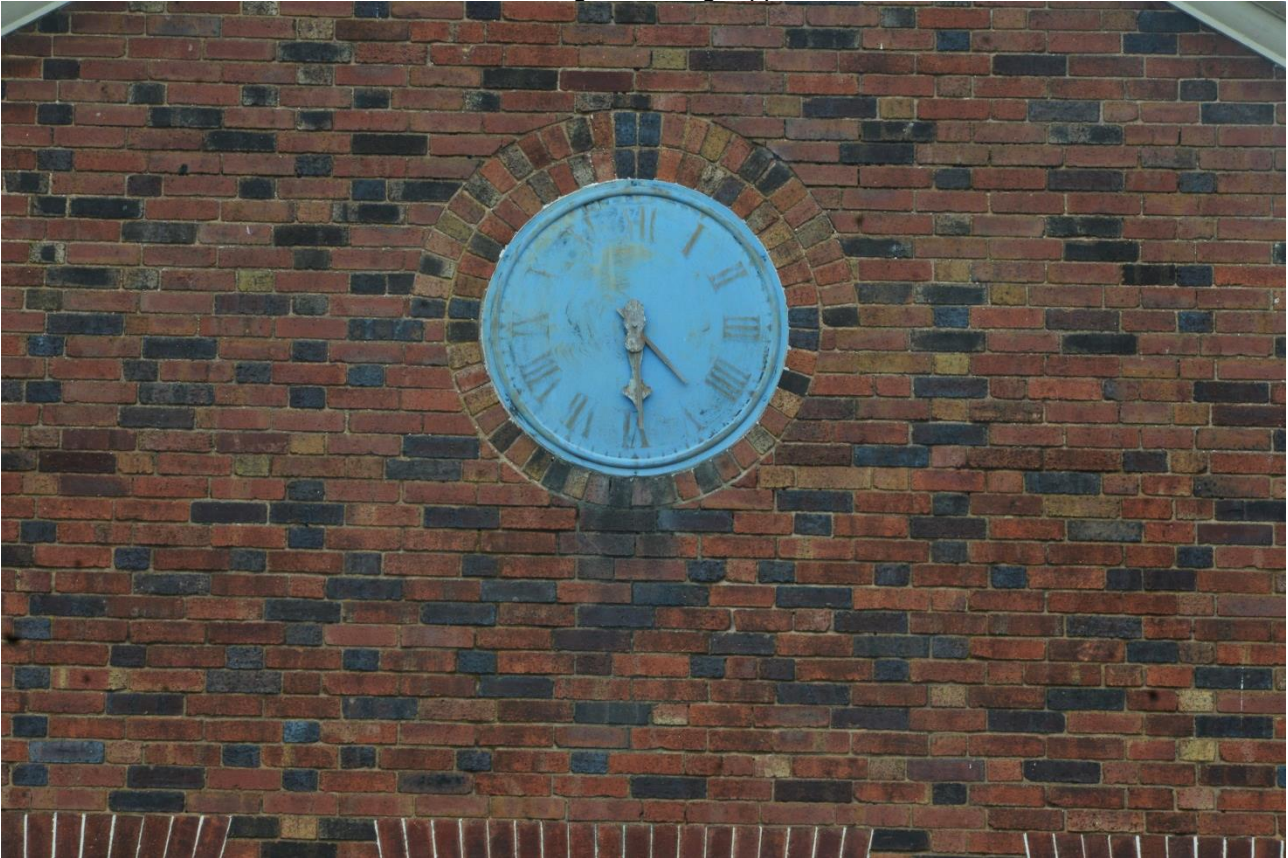
Plate 14: Detail of clock

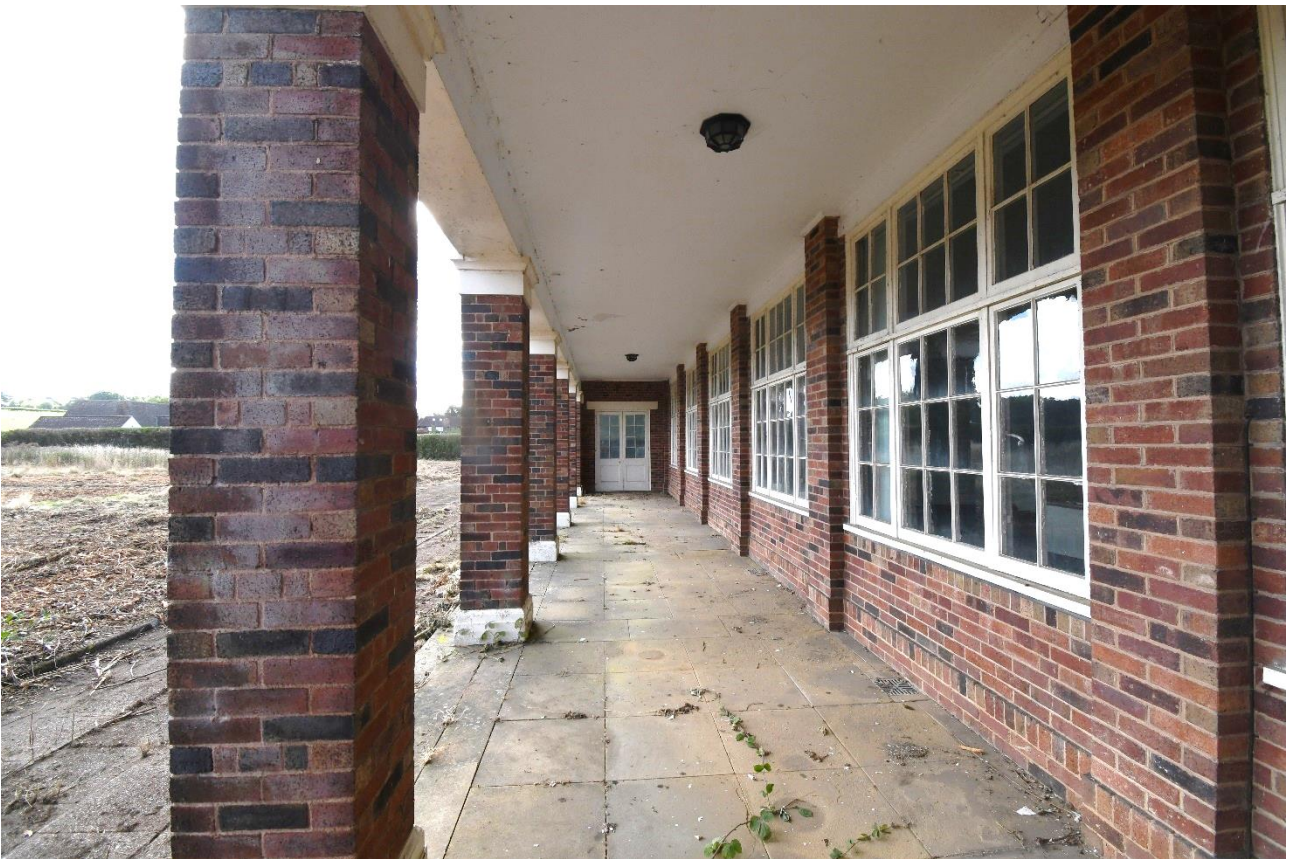
A loggia / veranda is present to each side of the central bay, detailed with brick and stone pillars, and a further six windows.

Plate 16: View to southwest along northeast veranda

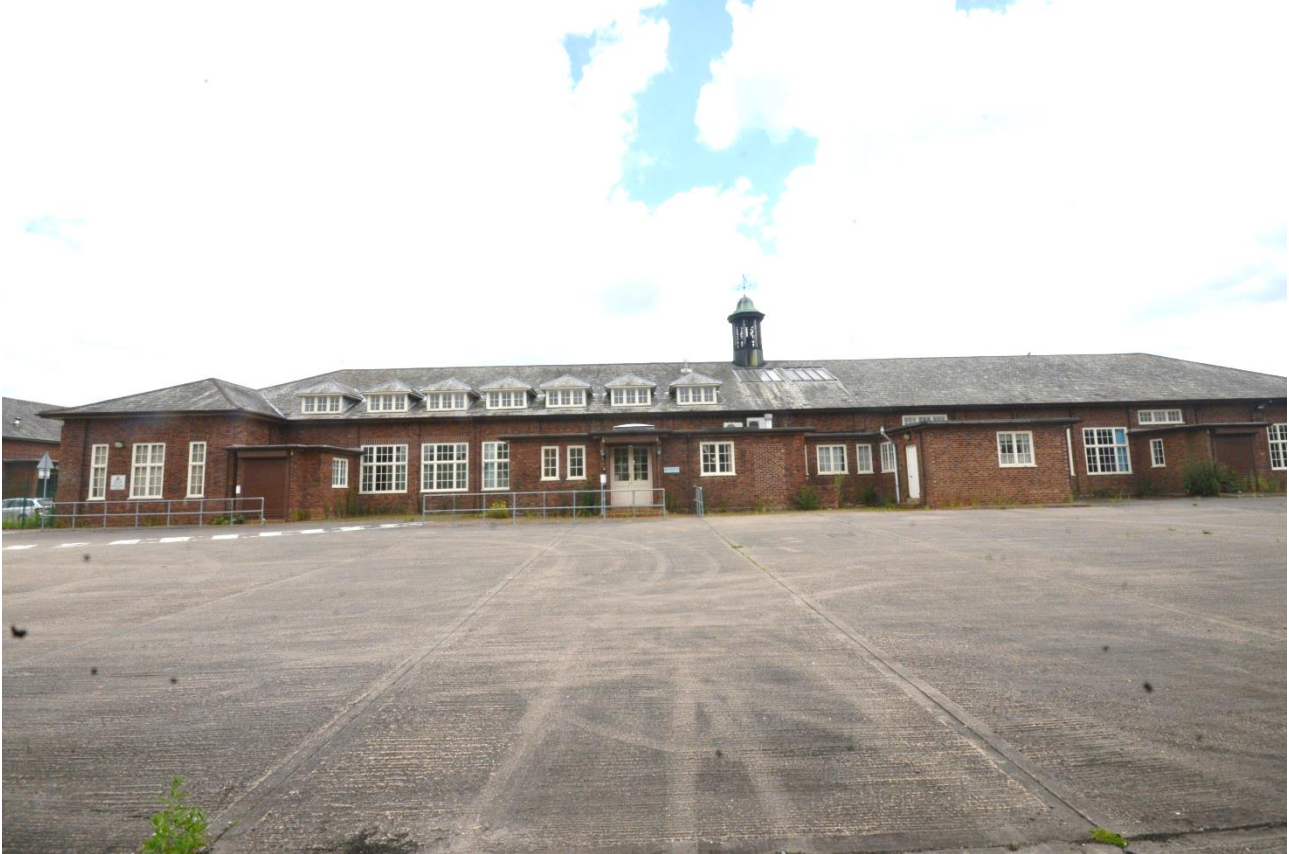
Plate 18: Rear elevation

The rear of the Canteen building has a further projecting bay on the corner closest to the Administration Building, with a hipped roof and three windows. A projecting doorway, with modern roller shutter, abuts this projecting bay, whilst central to the façade is a further low-level addition, providing the main entrance to the building.

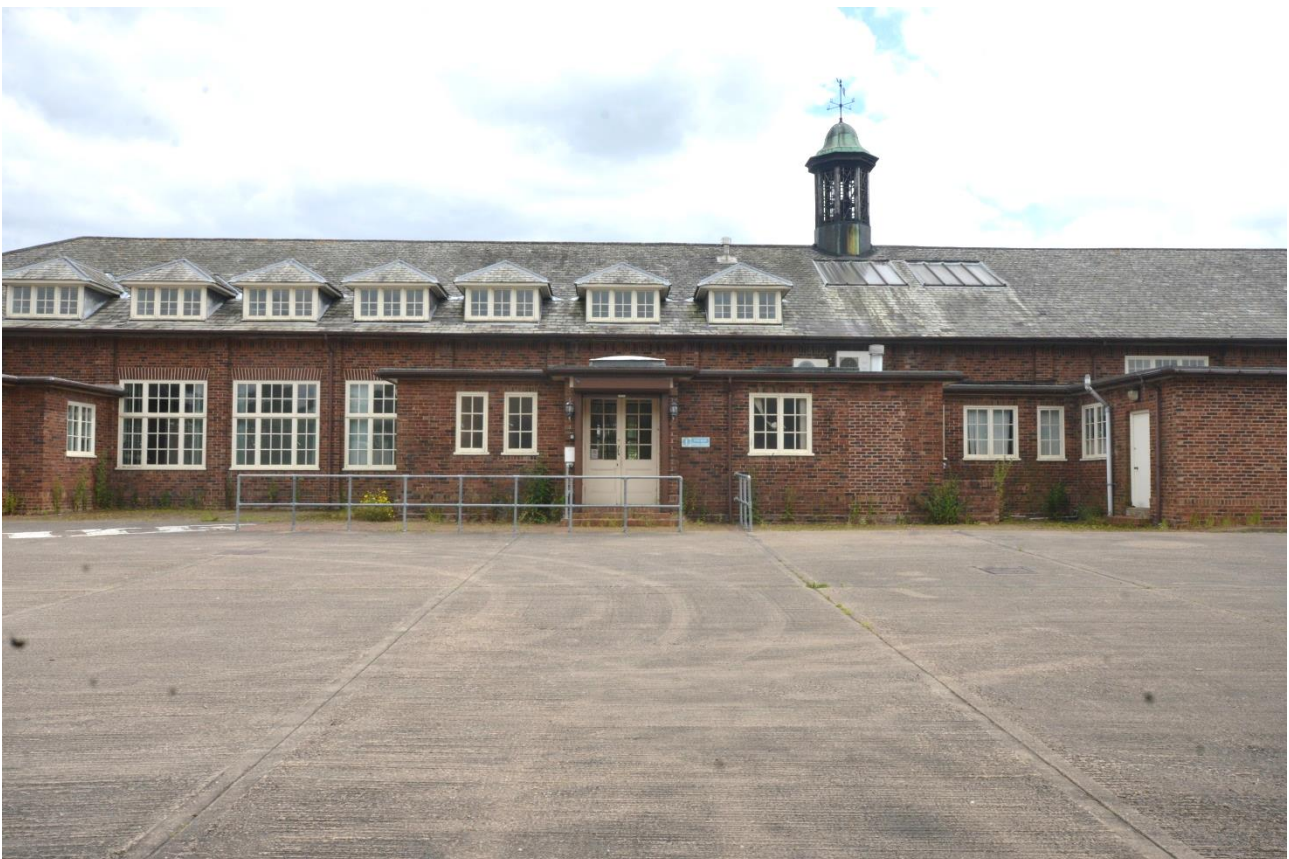
Plate 19: The main entrance, with dormers and roof light

A further projecting doorway sits on the other side of the central projection. The northern end of the rear elevation has three large windows, set between raised brick pilasters, whilst five dormer windows and a rooflight pierce the roof. The southern half of this façade is pierced by a further six windows again set between raised brick pilasters.

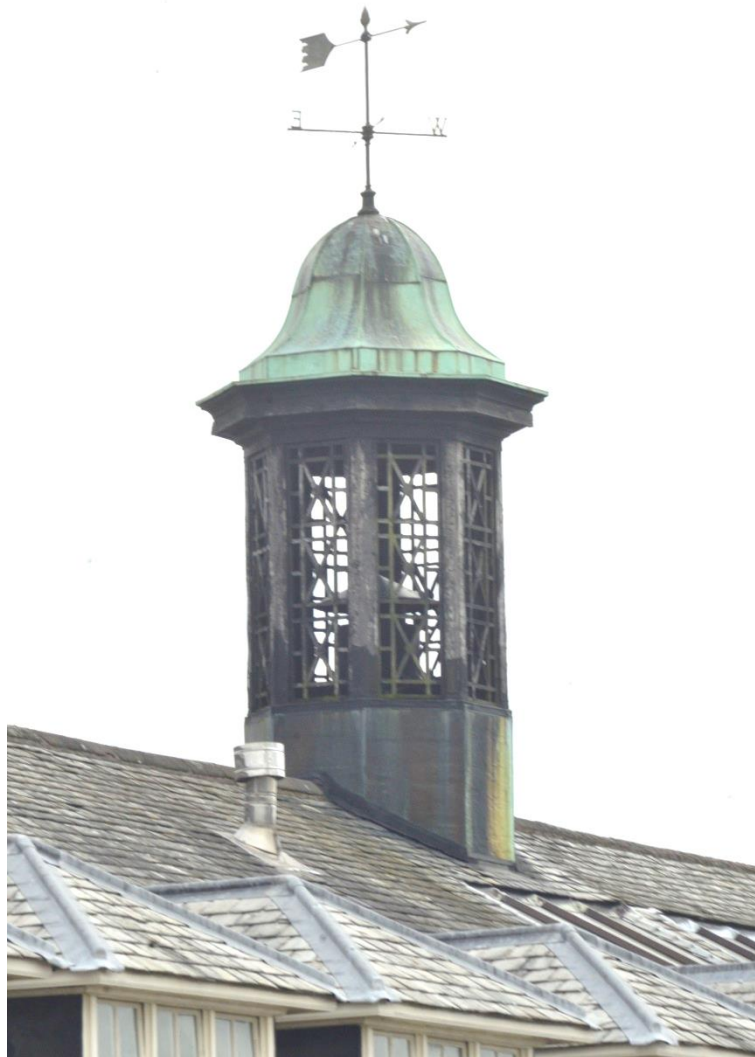
Plate 20: Detail of cupola

A decorative cupola, with fretted sides and a copper dome sits central to the roof, which is covered in slate to the sides and rear slopes and a modern red-brown tile to the front.

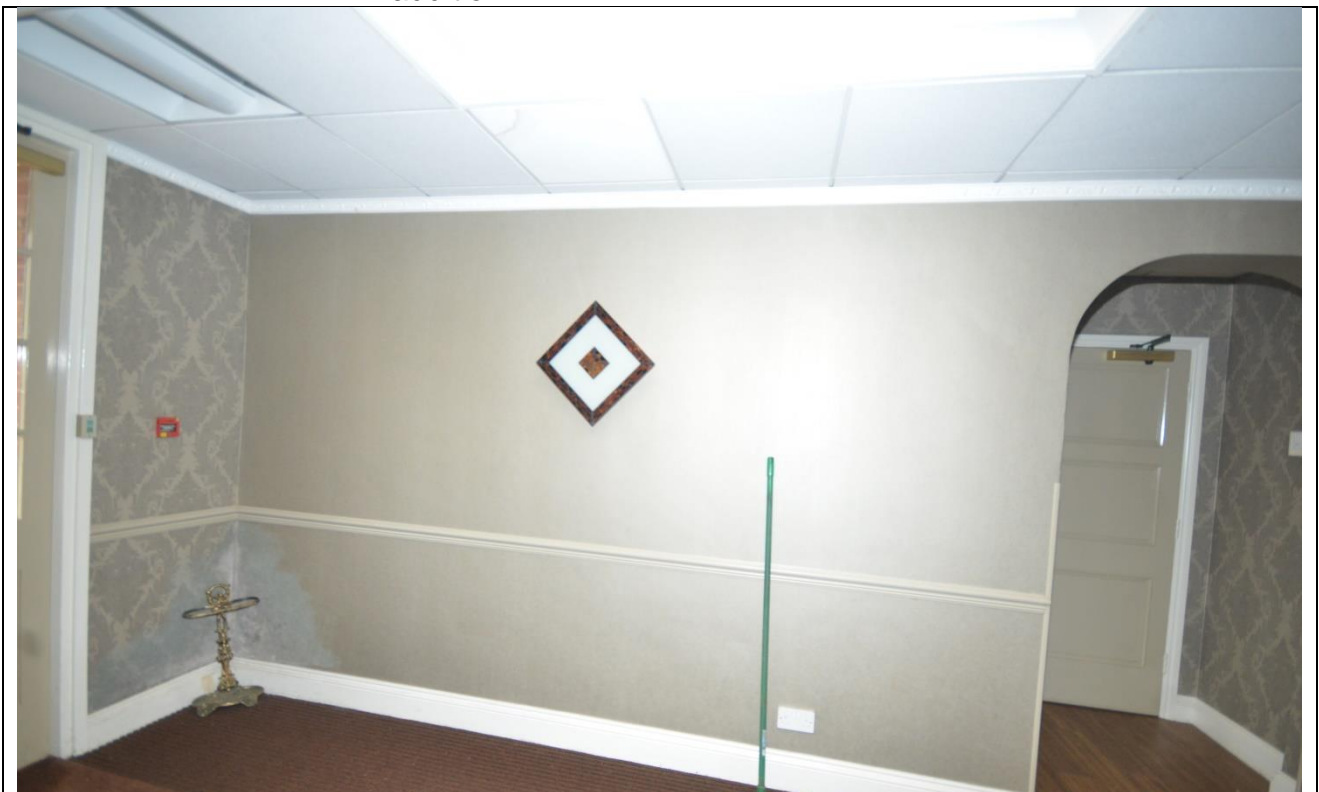
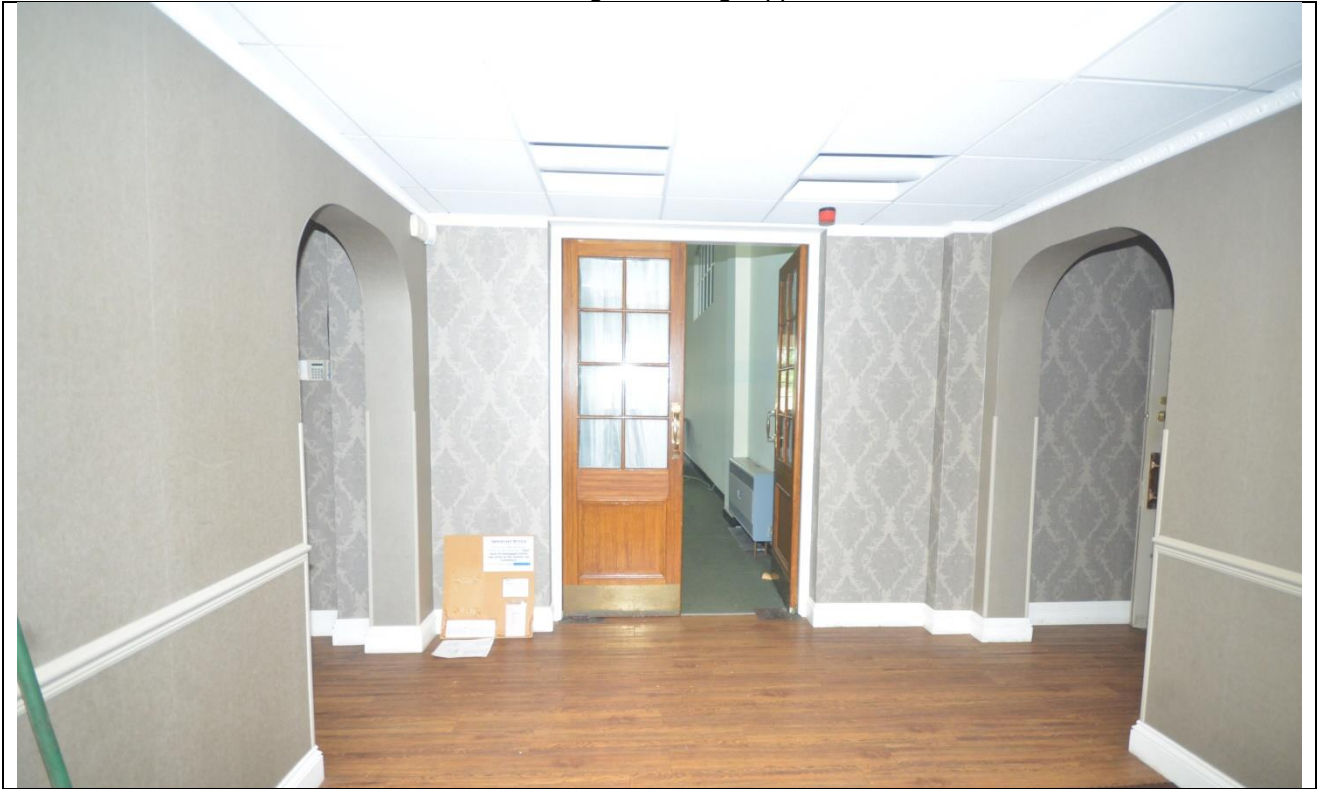
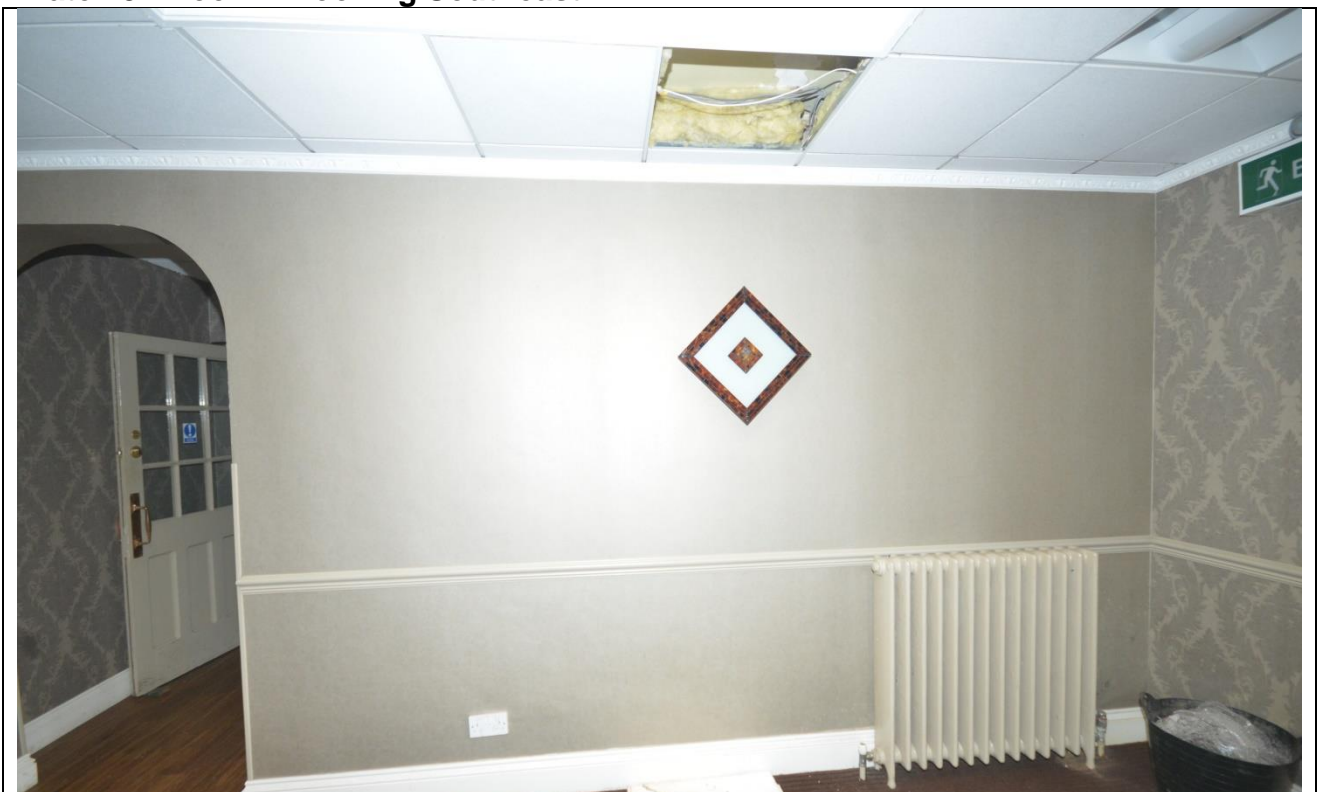
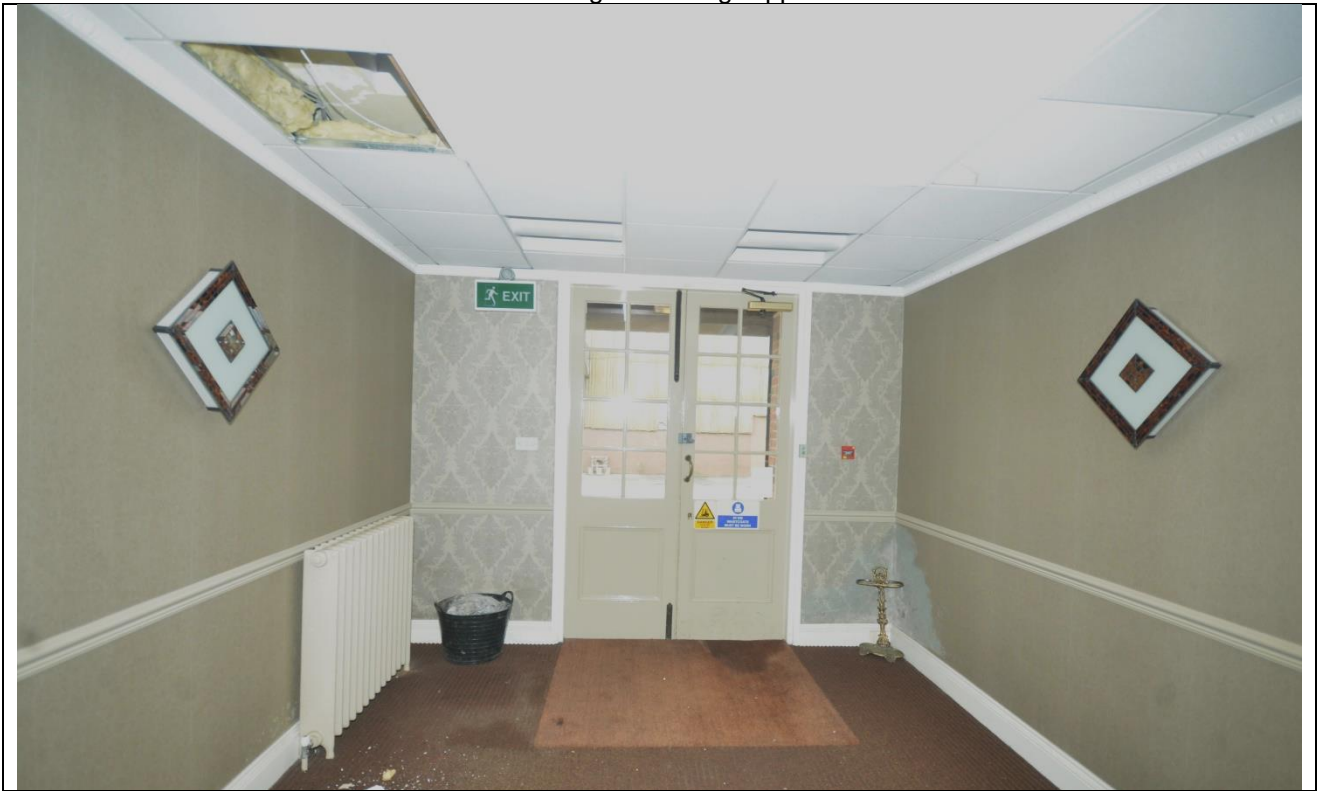
| Comments/Description | The entrance hall to the canteen building has a carpeted floor and an ornamental diamond-shaped light on the northeast and southwest walls. A modern suspended ceiling is present. Historic England suggests this part of the building is a later addition. |

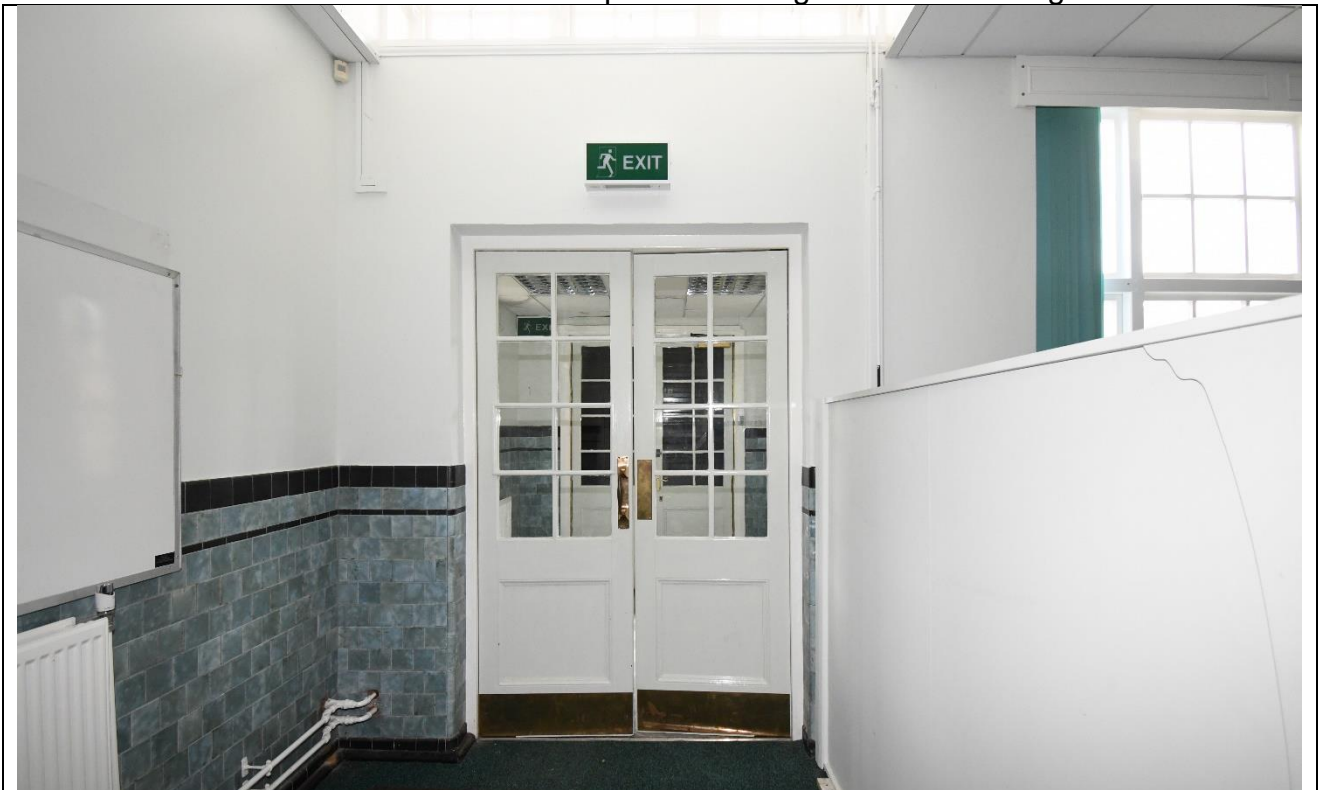
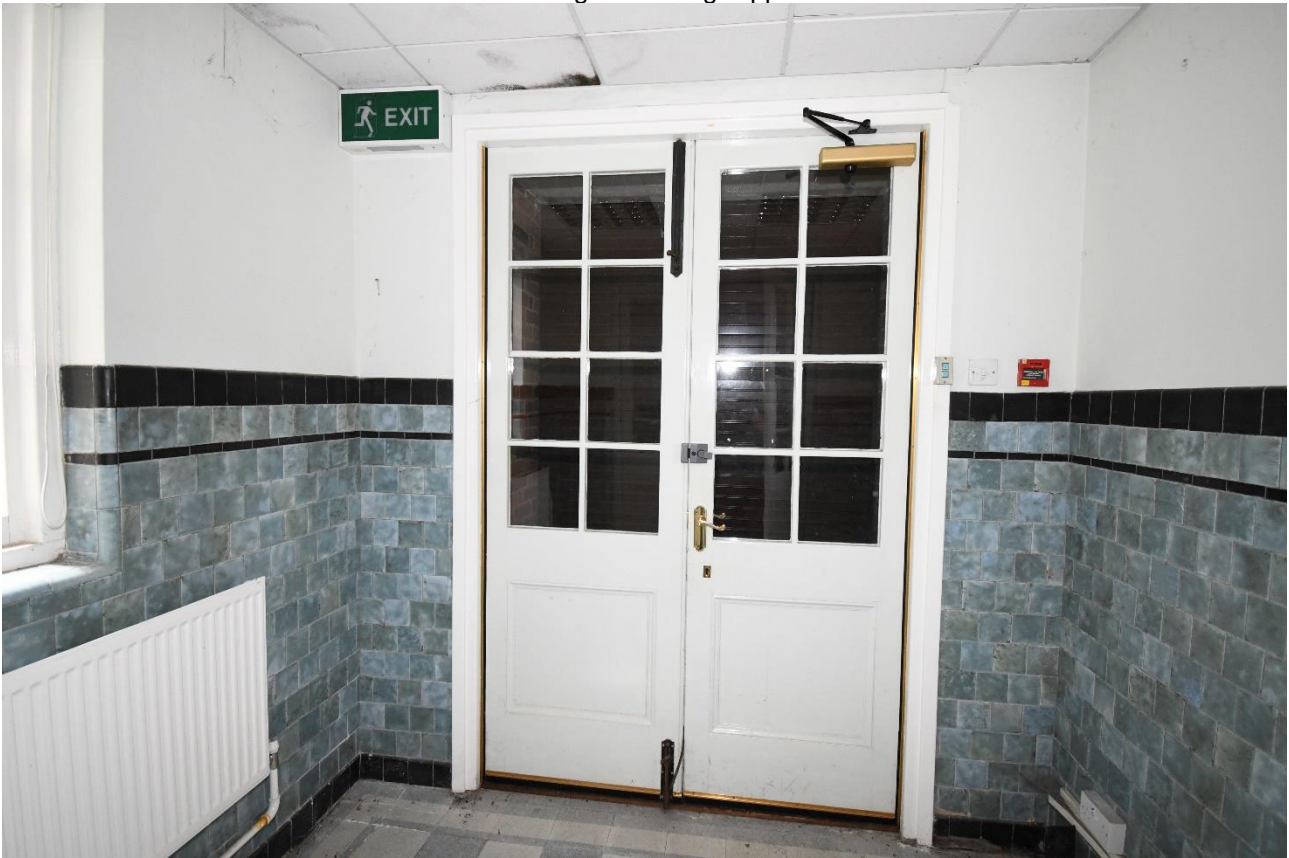
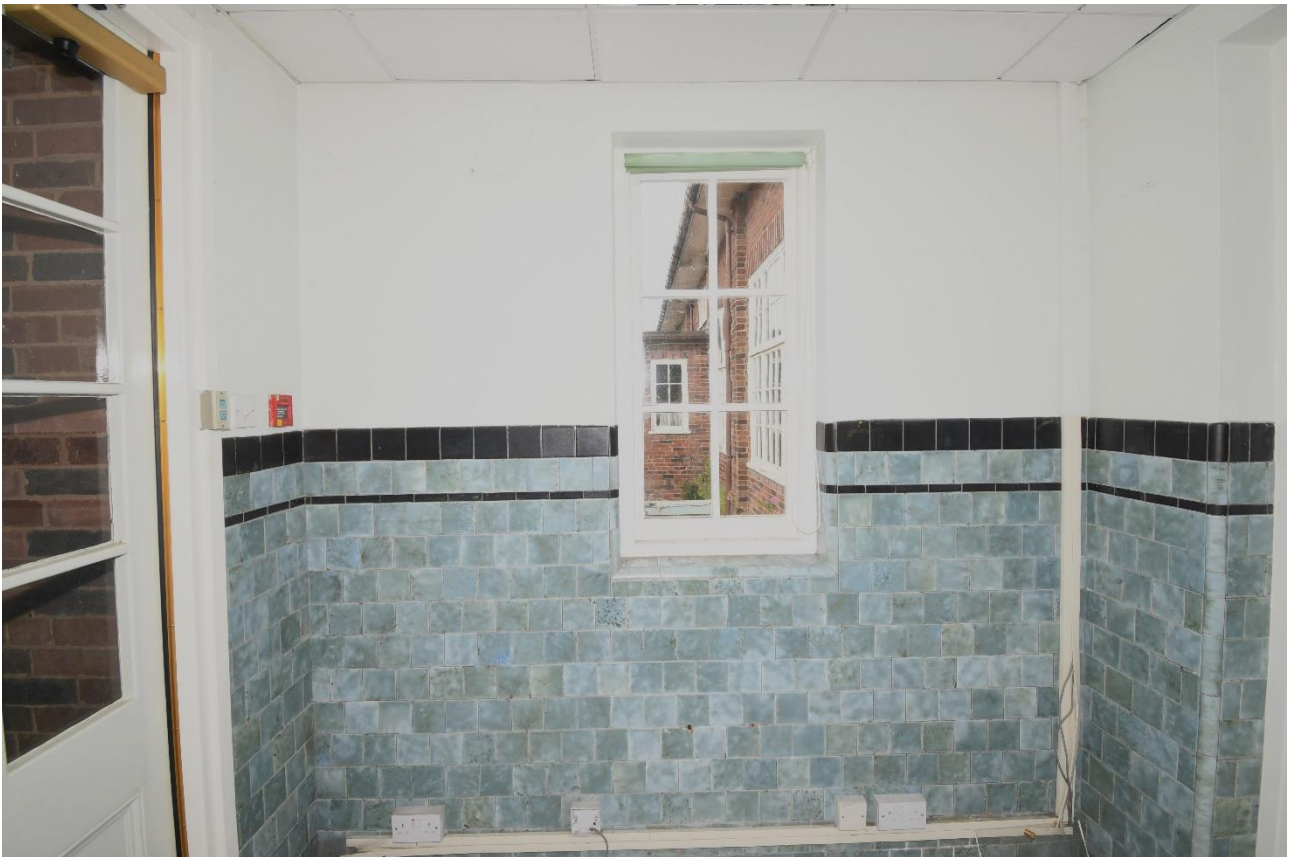
| Comments/Description | The room was not accessible at the time of the visit and is described from what could be seen through the door into room 5. A recent suspended ceiling obscures the original. |

Plate 31: Doors into room 2 from room 5

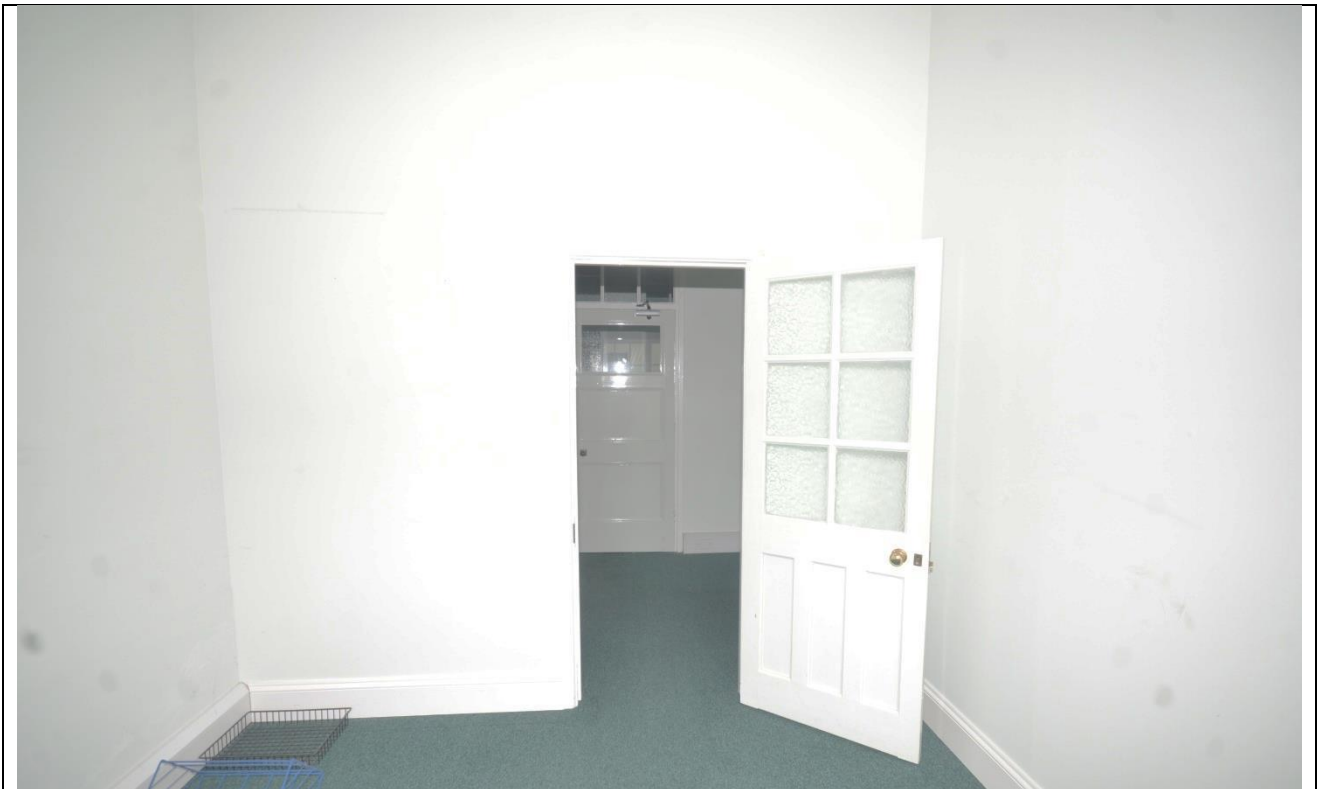
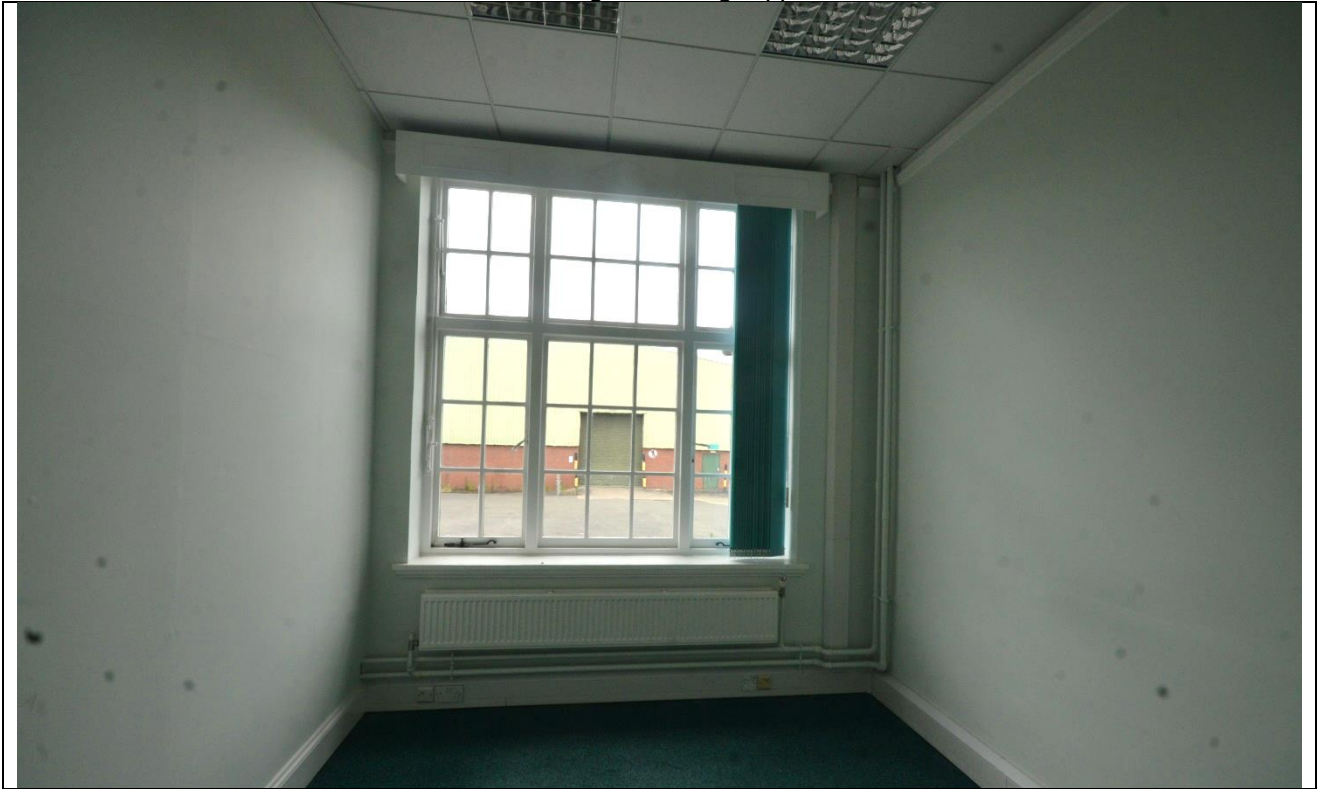
| Comments/Description | A small square room with no discernible features. A recent suspended ceiling obscures the original. |
