Appendix 2 Level 3 Building Recording of
The Canteen Building

Blue Bird Park
Bromsgrove Road
Hunnington
Worcestershire
B62 0JW

Document Reference Number 2023/1681

Dr Peter Wardle & Colin Lacey

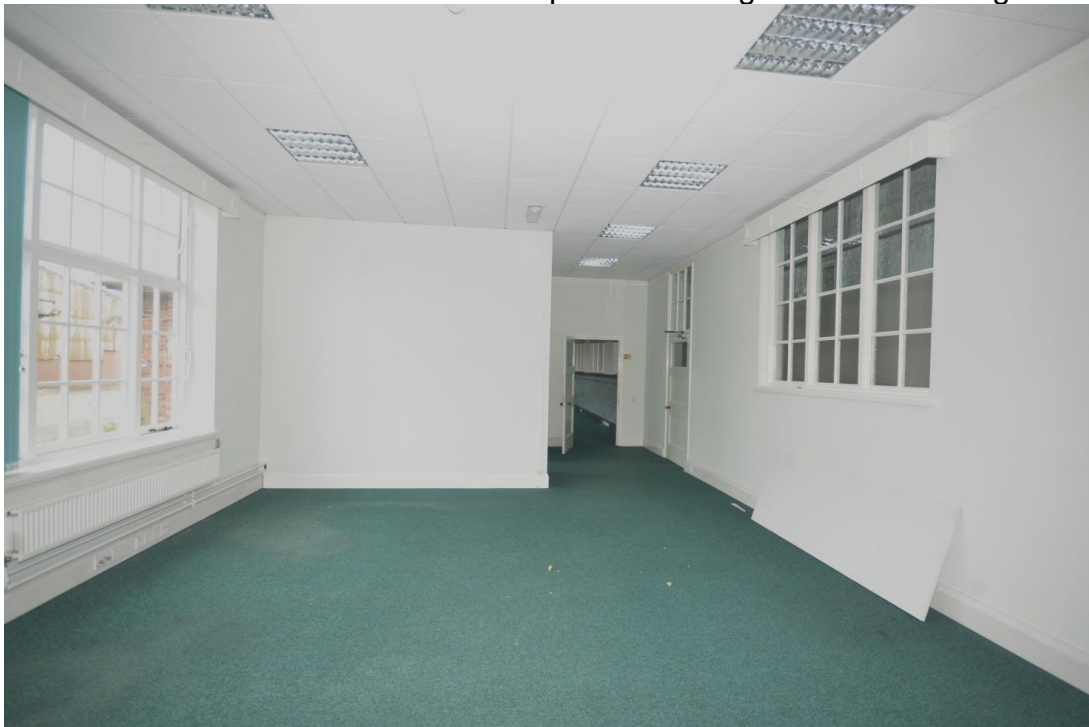
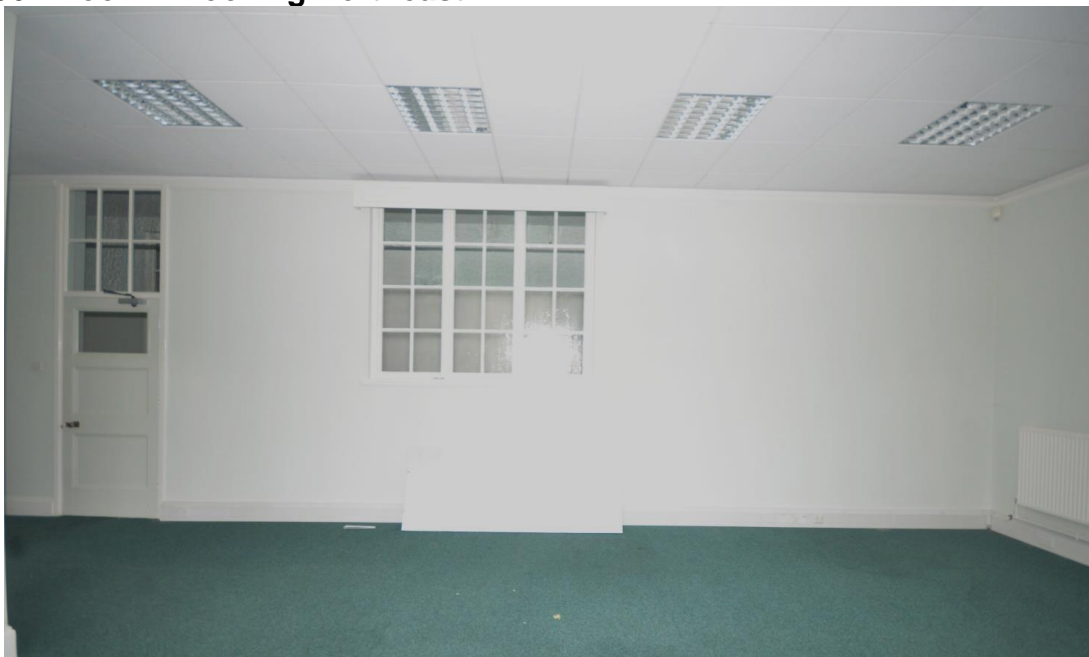
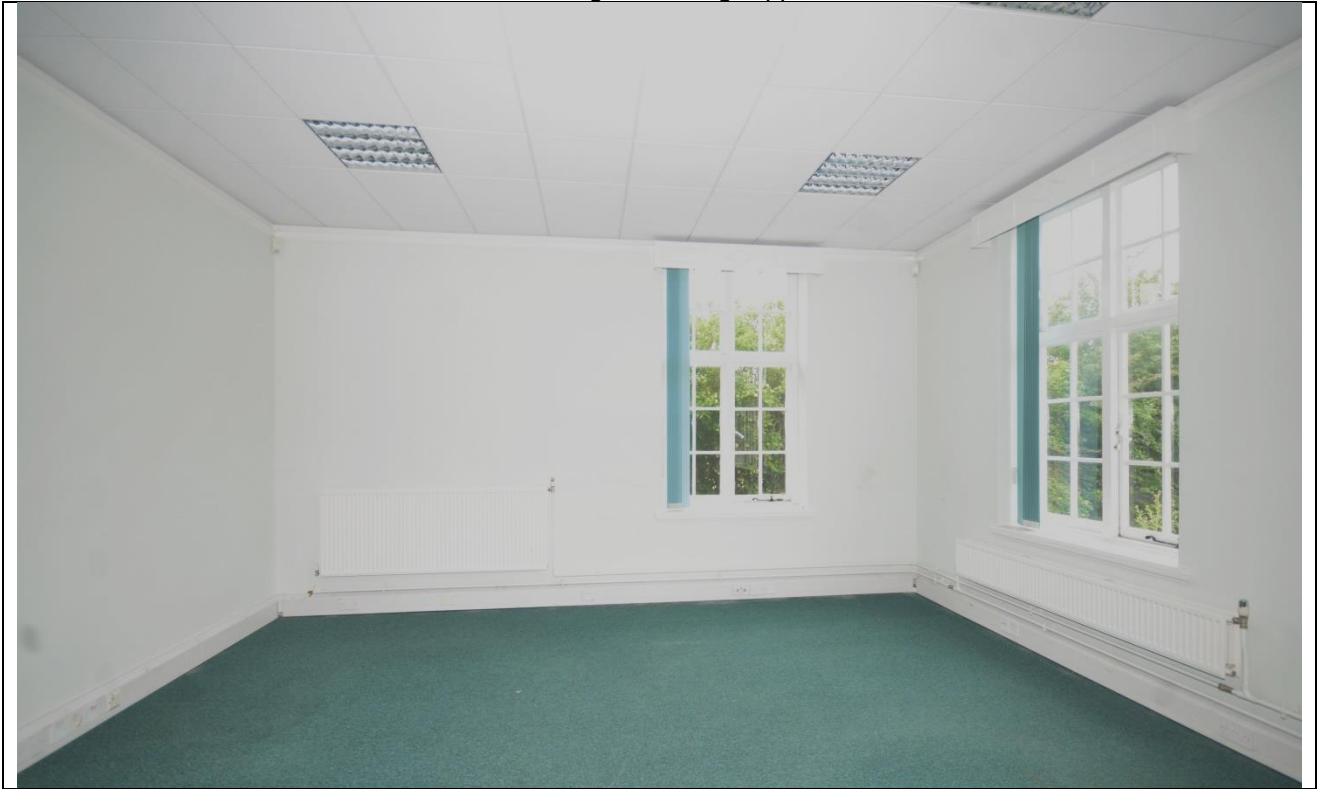
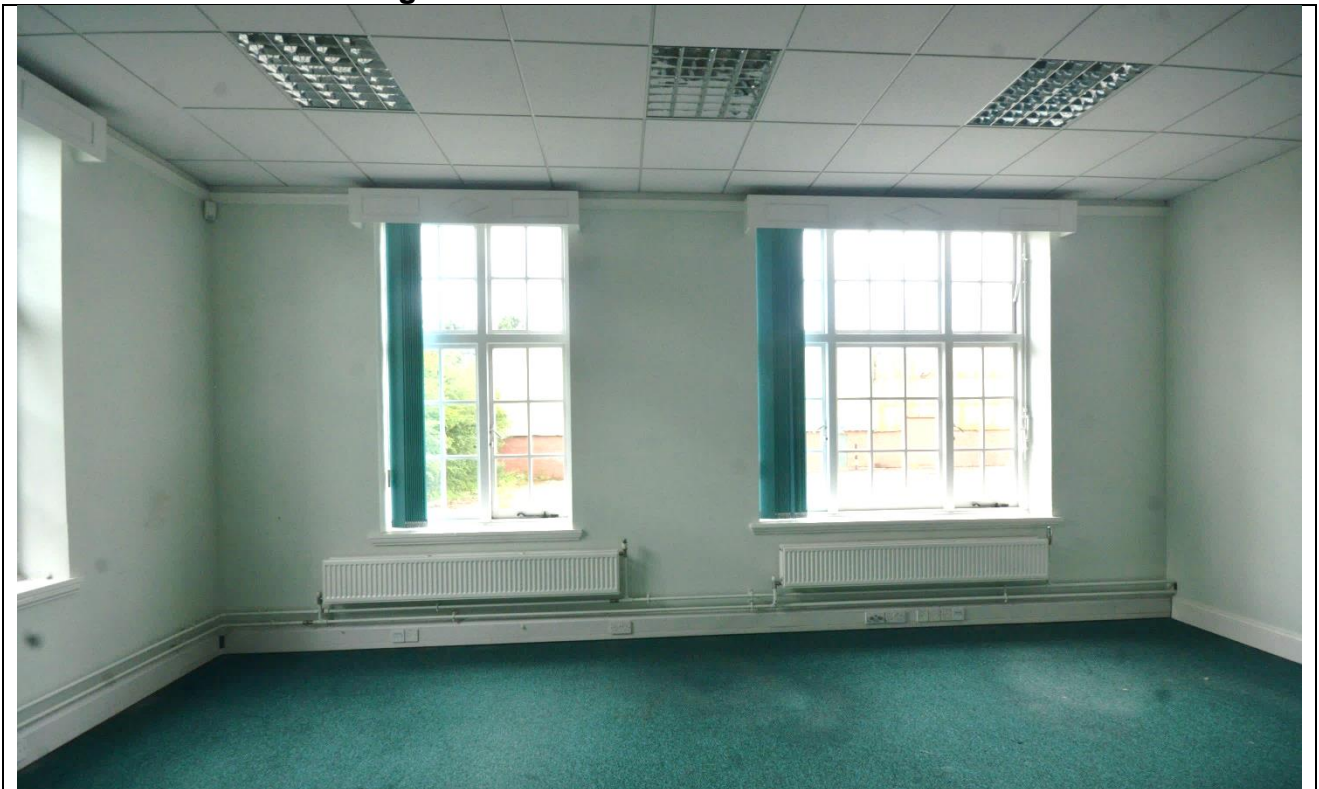
| Comments/Description | Located at the corner of the building, the room features internal windows to the axial corridor. A recent suspended ceiling obscures the original. |

Plate 36: Room 4 Looking Northeast

Plate 37: Room 4 Looking Southeast

Plate 38: Room 4 Looking Southwest

Plate 39: Room 4 Looking Northwest

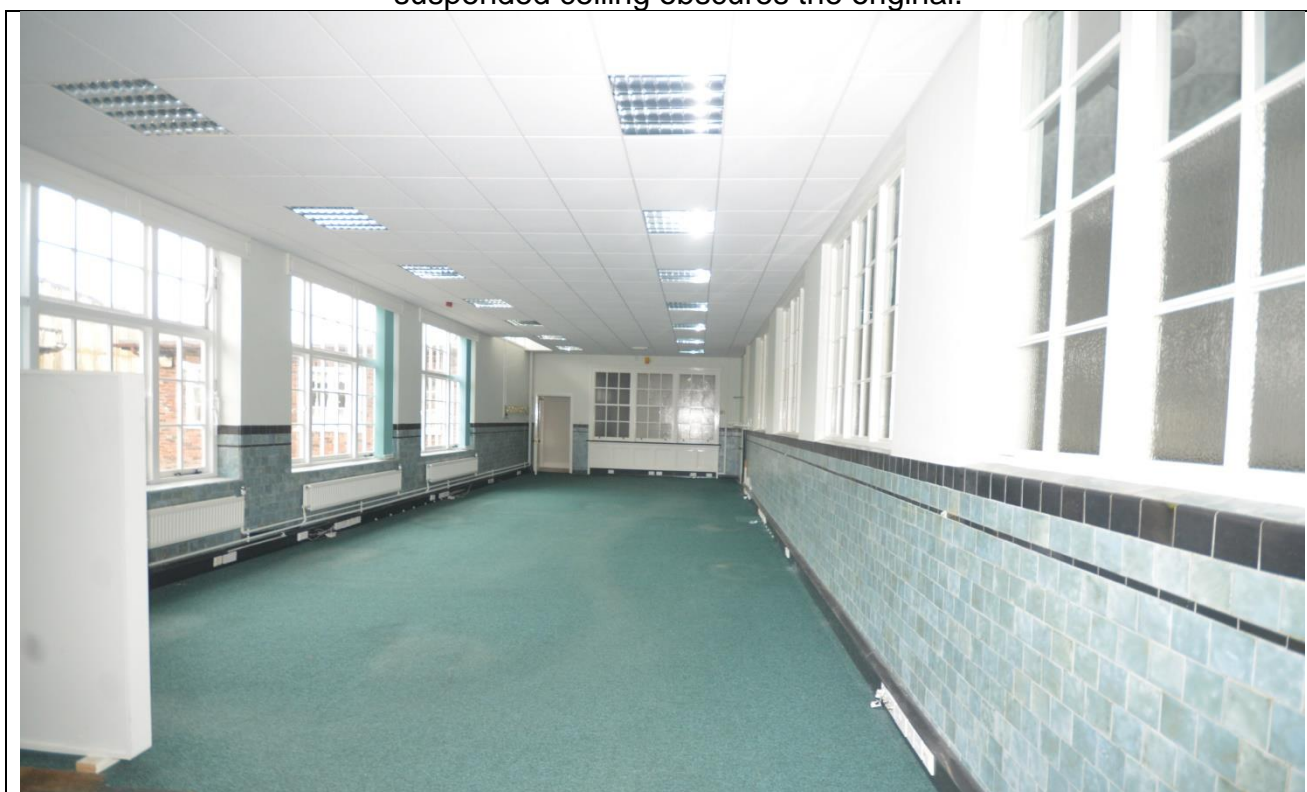
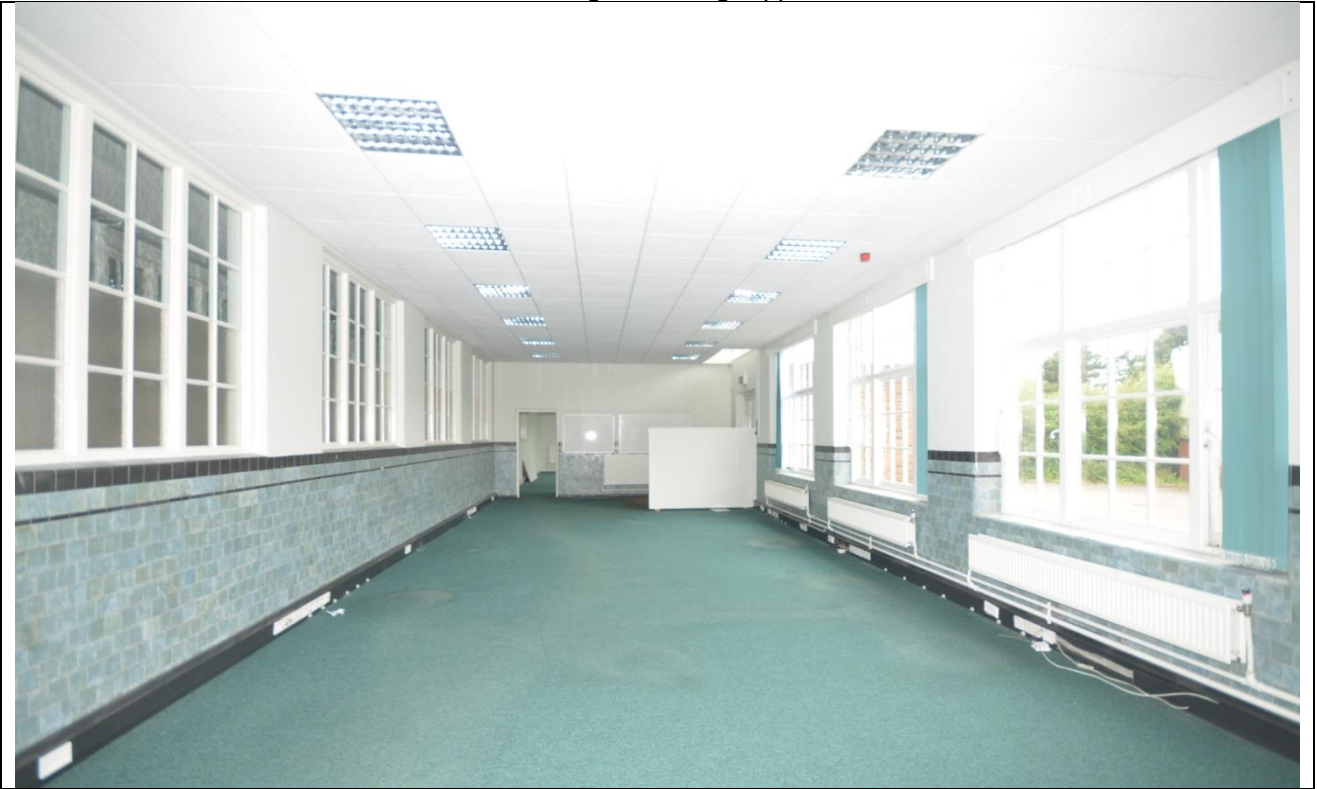
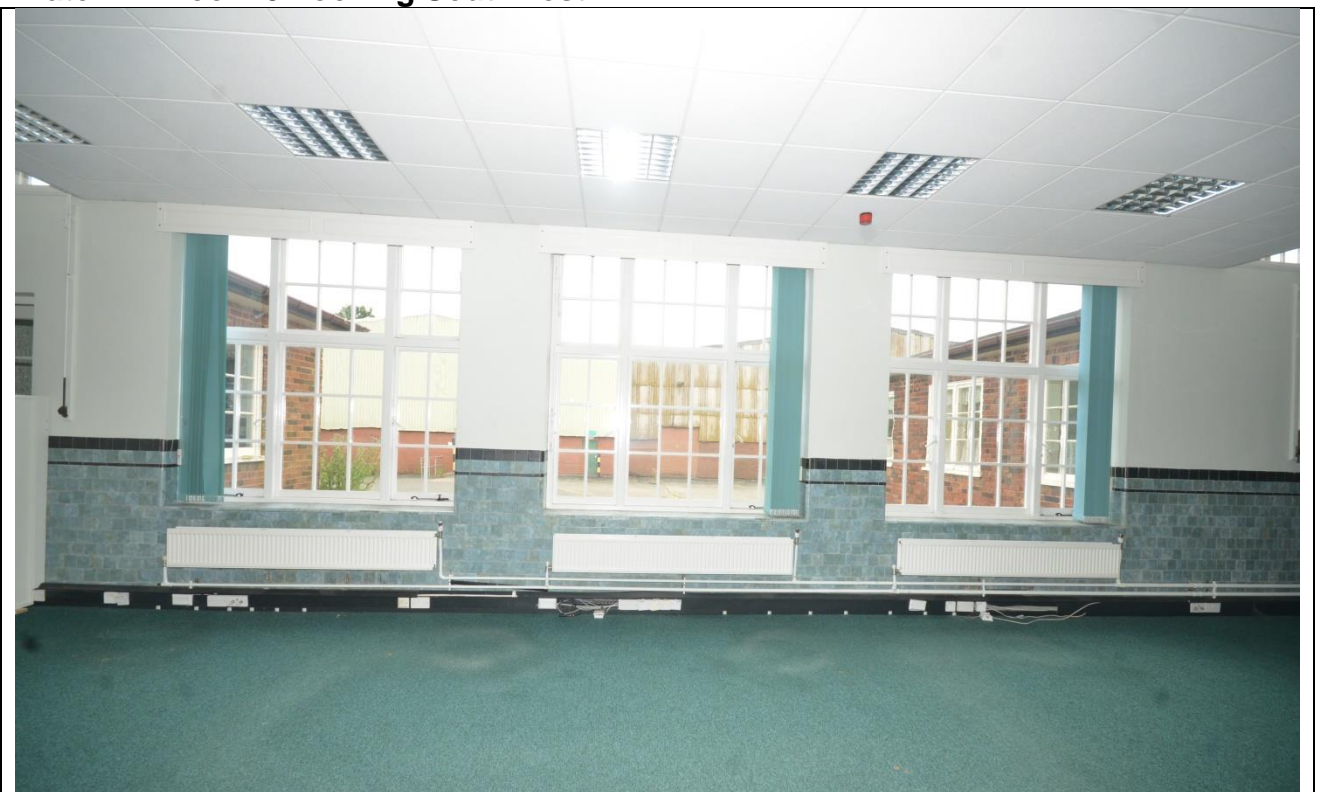
| Comments/Description | The dining room is a large open space with external windows to the northwest and internal windows to the southeast. A low partition is located inside the door to the porch, presumably to help prevent draught from the door when opened. A recent suspended ceiling obscures the original. |

Plate 40: Room 5 Looking Northeast

Plate 41: Room 5 Looking Southwest

Plate 42: Room 5 Looking Northwest

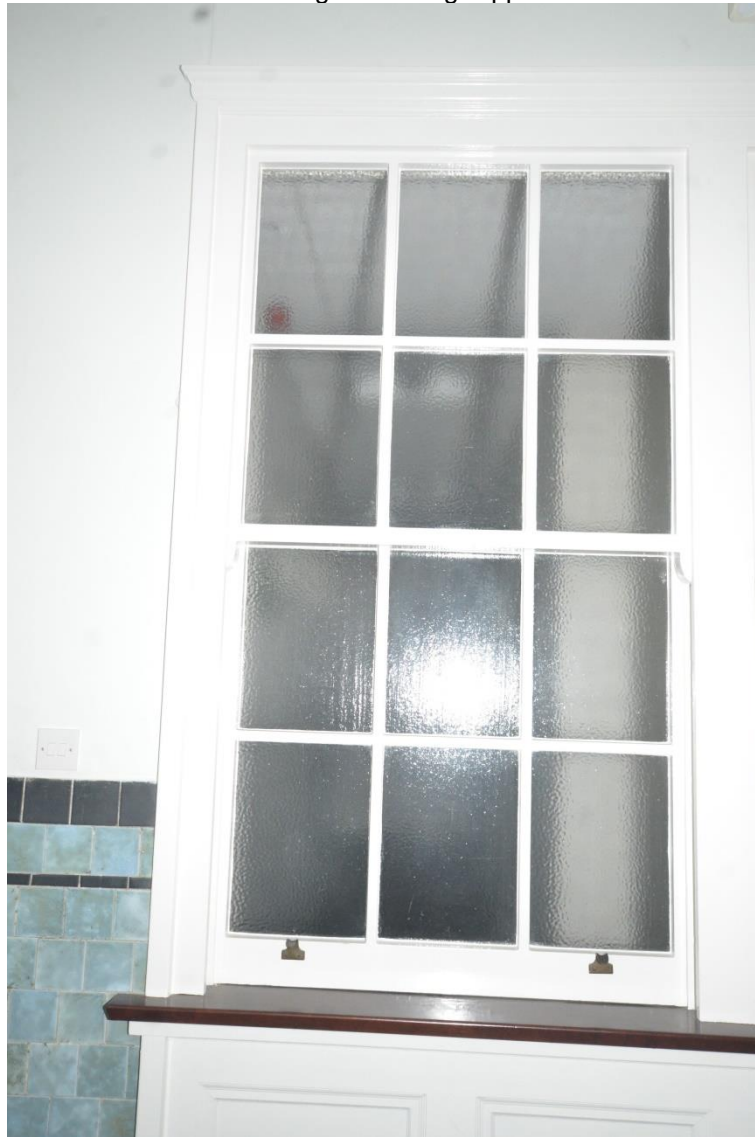
Plate 45: Obscure-glazed serving sash window

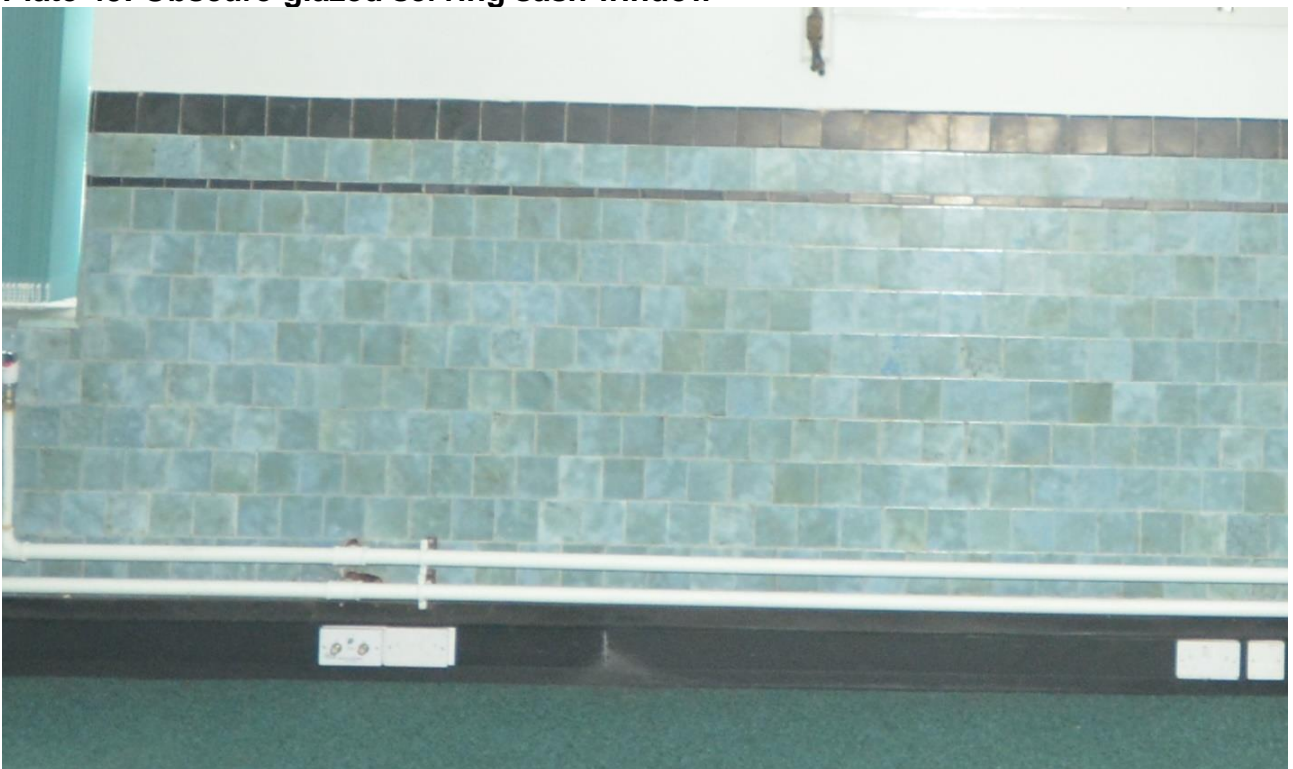
Plate 46: Detail of tiles

| Historic Features | Lower part of walls tiled |

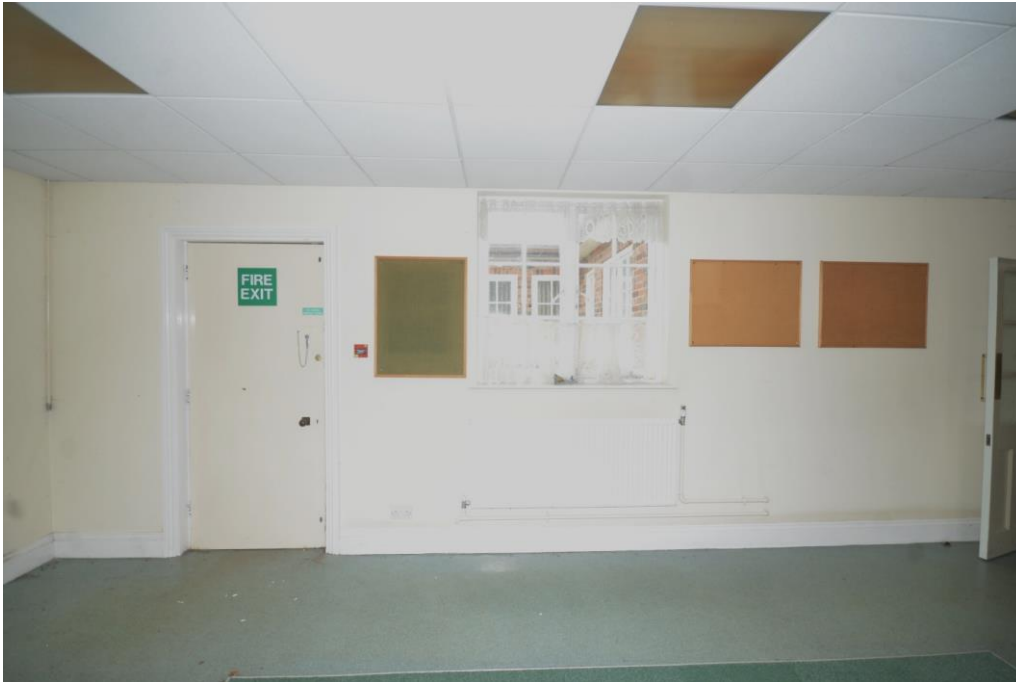
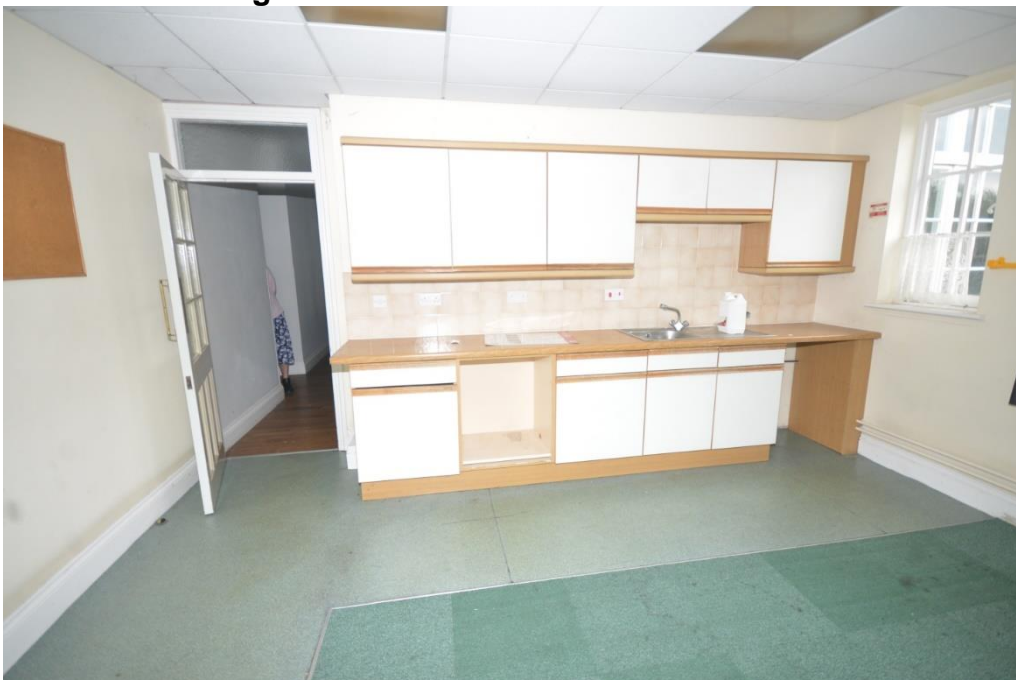
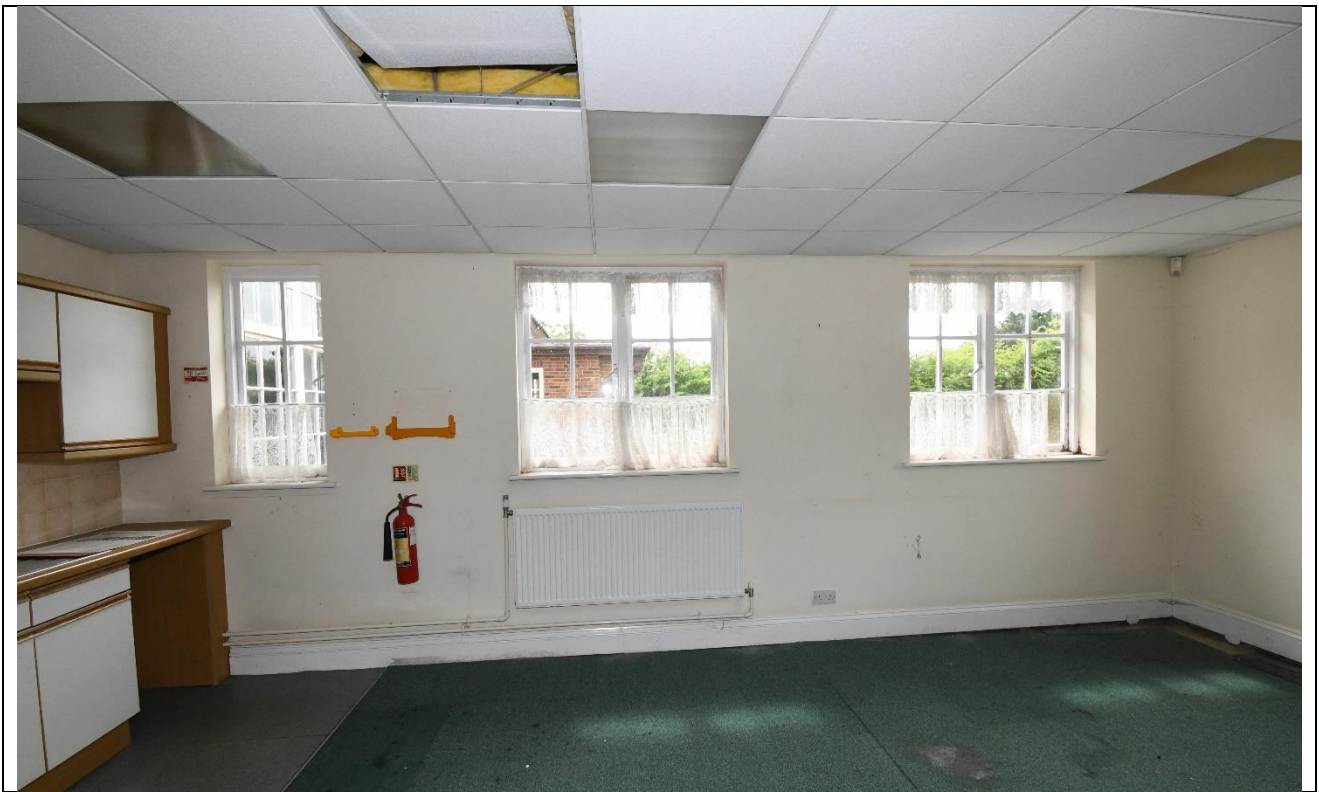
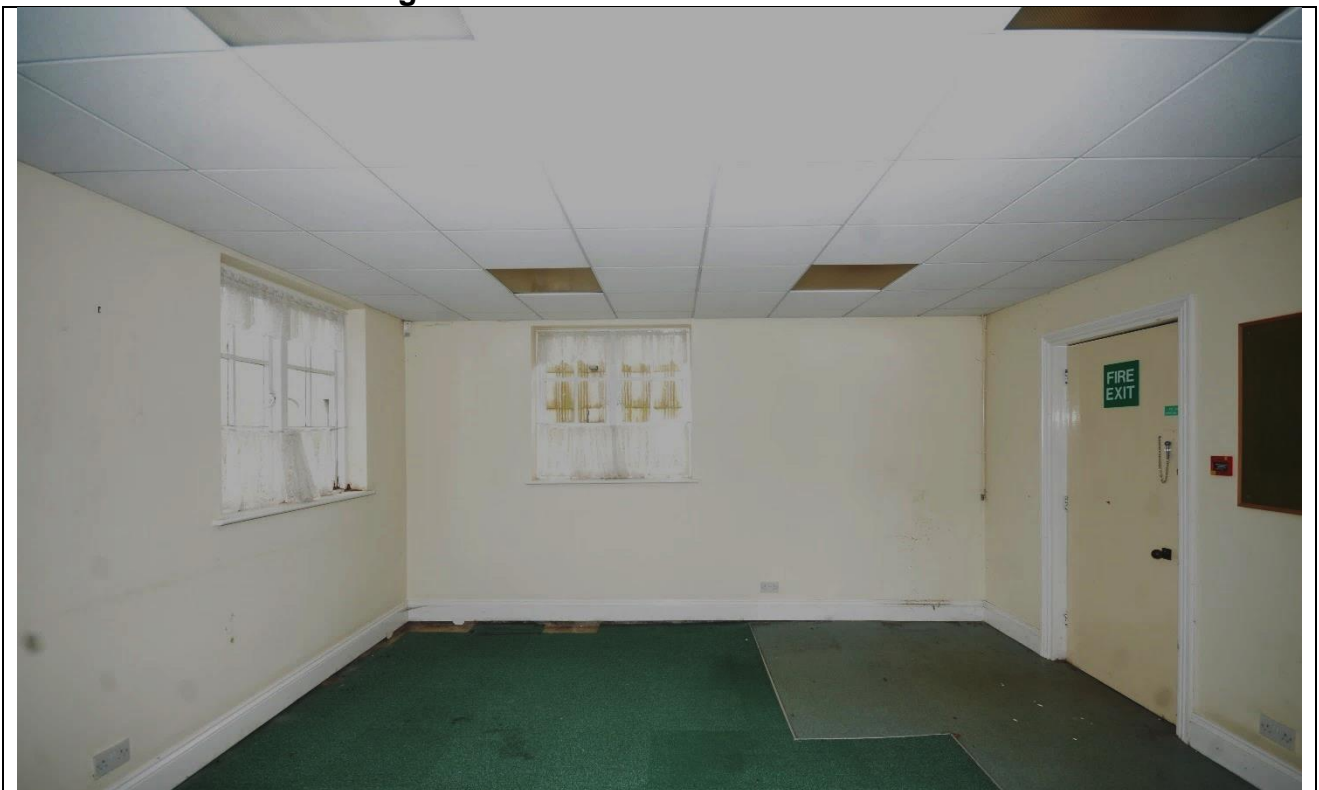
| Comments/Description | A recent suspended ceiling obscures the original. Historic England suggests this part of the building is a later addition. |

Plate 47: Room 6 Looking Northeast

Plate 48: Room 6 Looking Southeast

Plate 49: Room 6 Looking Southwest

Plate 50: Room 6 Looking Northwest

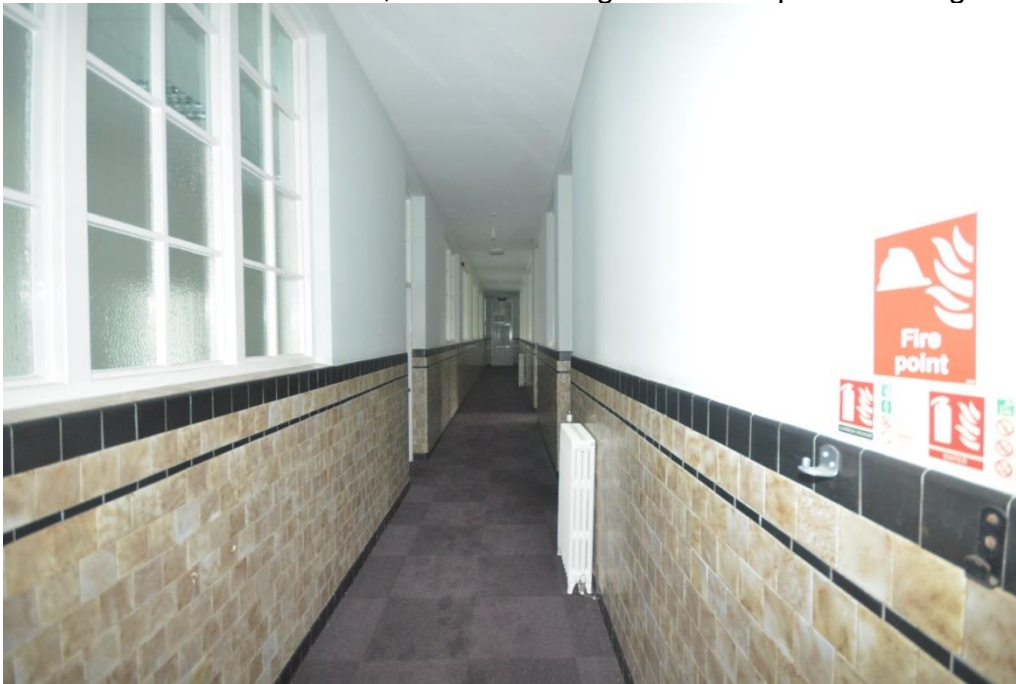
Plate 51: Room 7 Looking Northeast

| Comments/Description | Long axial corridor lit with borrowed light from rooms to northwest, via obscure—glazed multi-pane fixed lights. |

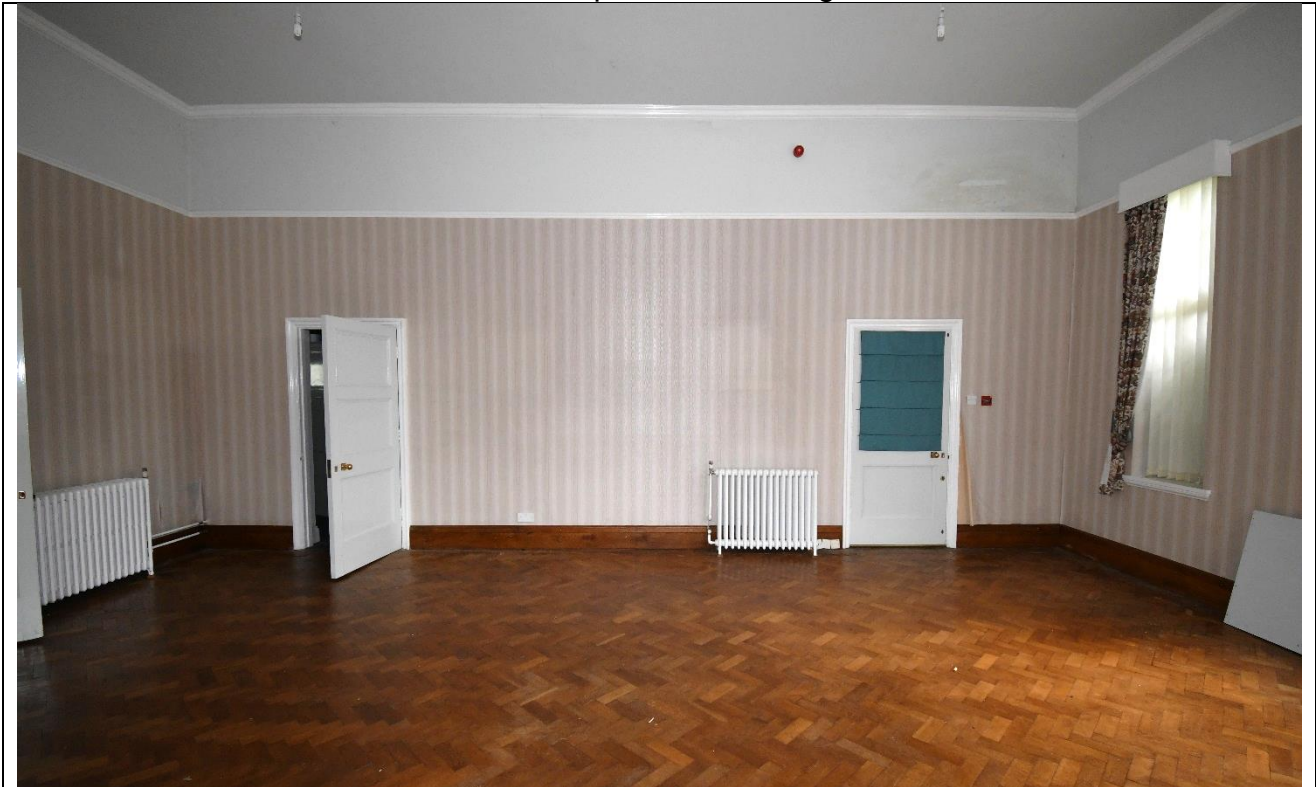
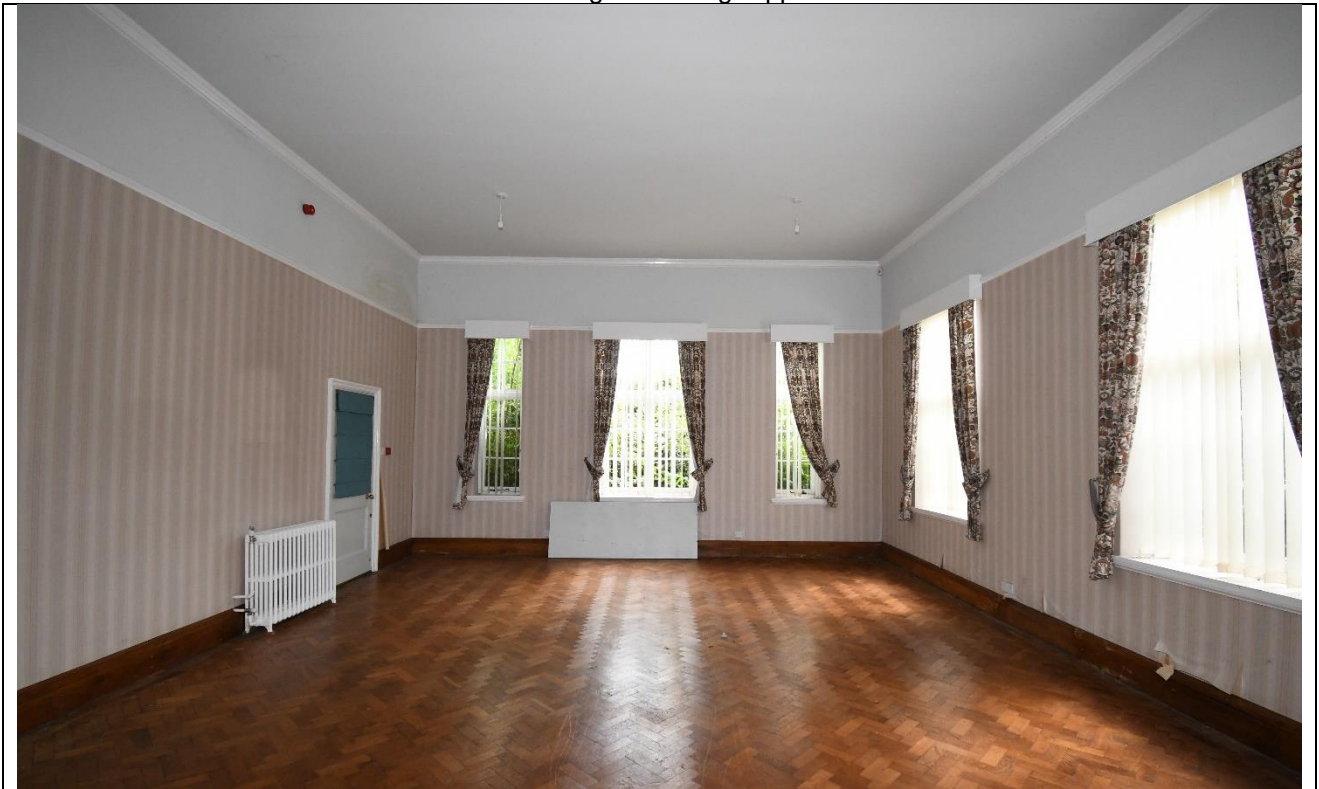
| Historic Features | Parquet floor, skirting |

Plate 53: Room 8 Looking Northeast

Plate 54: Room 8 Looking Southeast

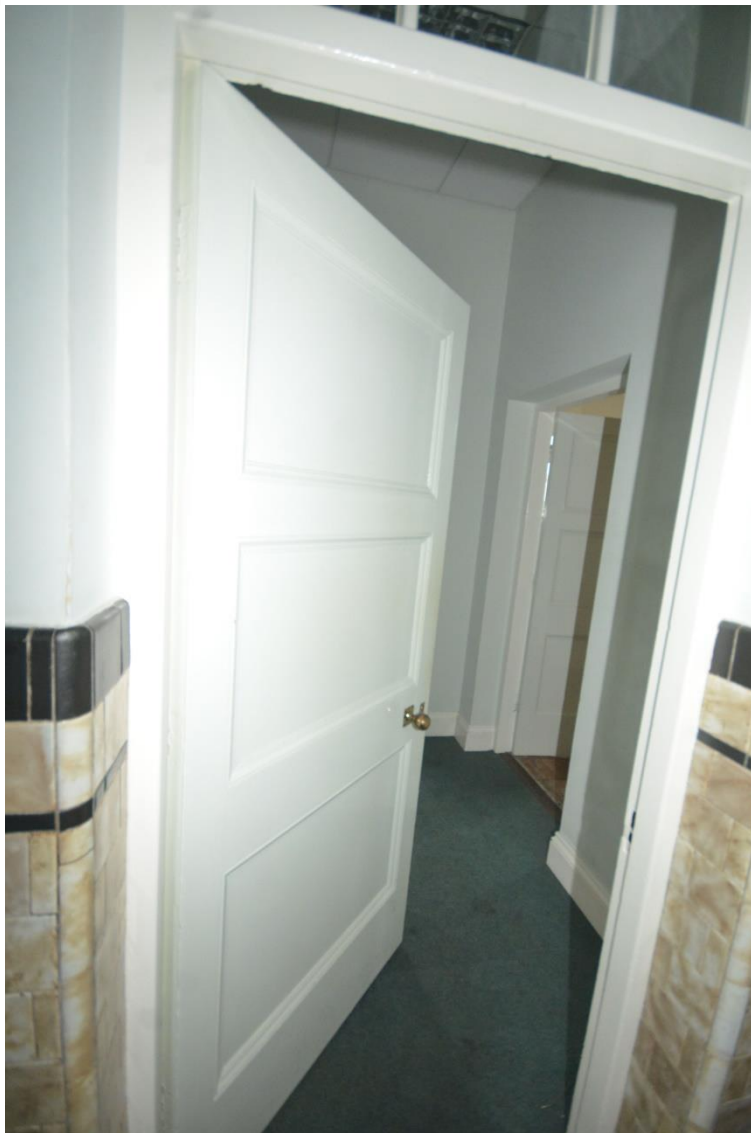
Plate 59: Room 9 Looking Southeast

| Door | Three panelled doors. Contemporary with building. |
| Historic Features | Skirting |

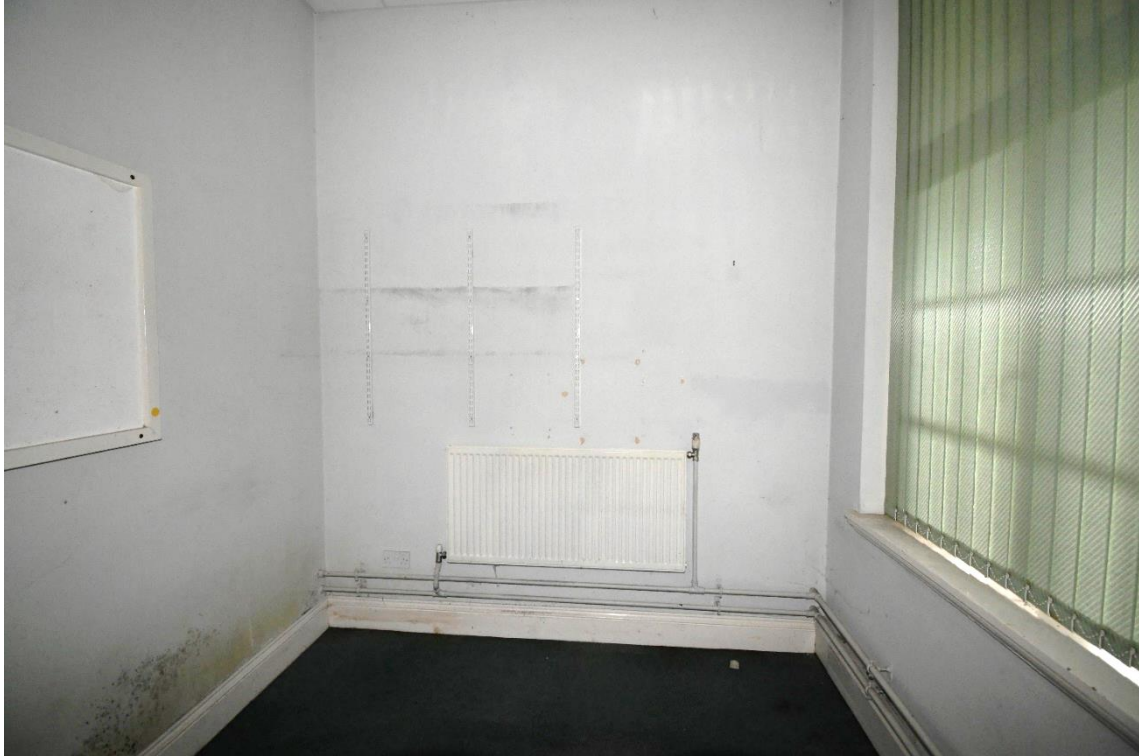
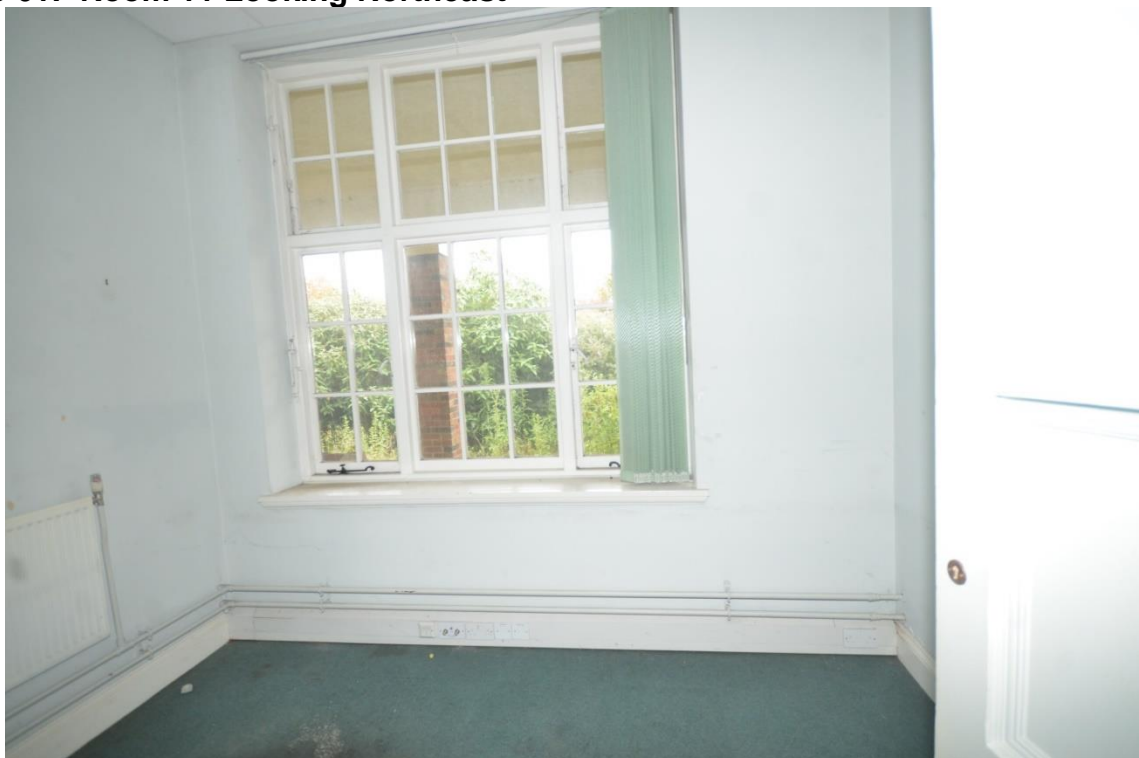
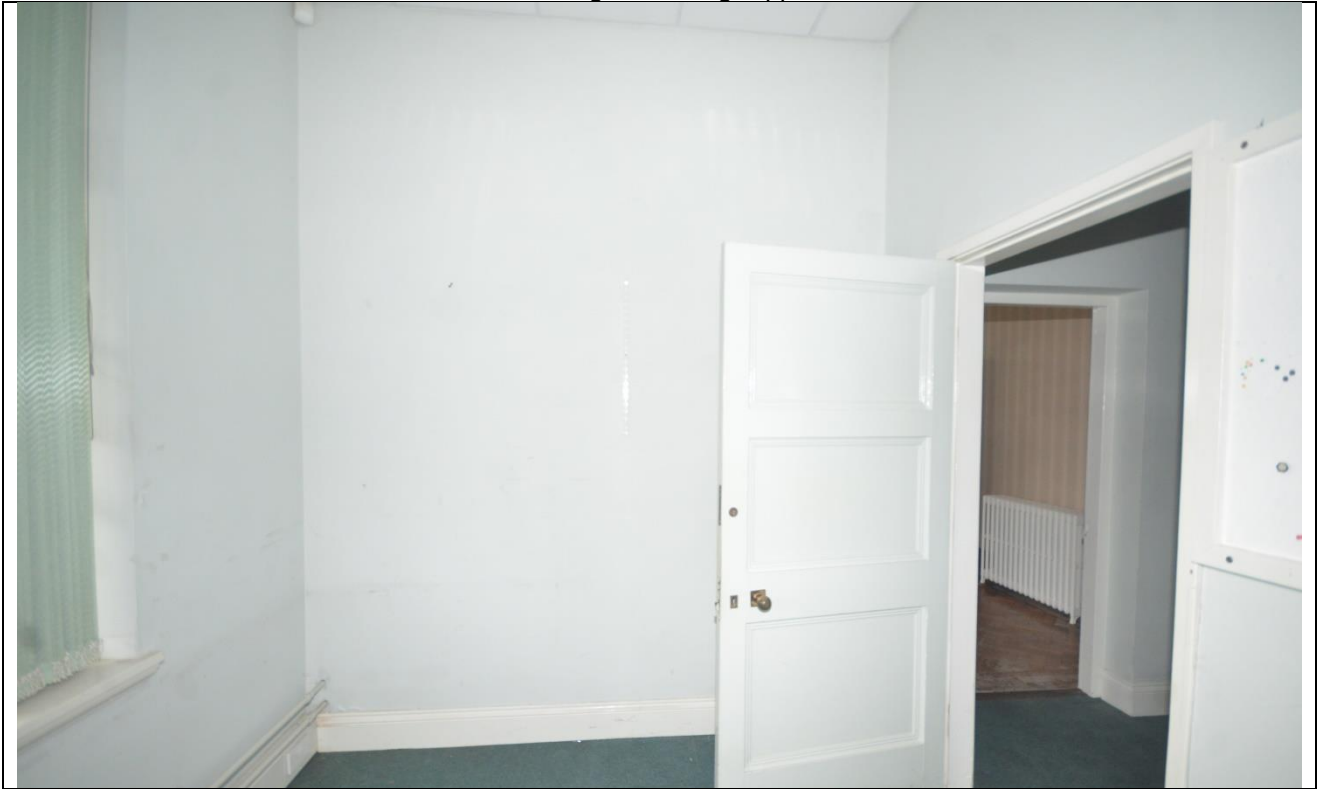
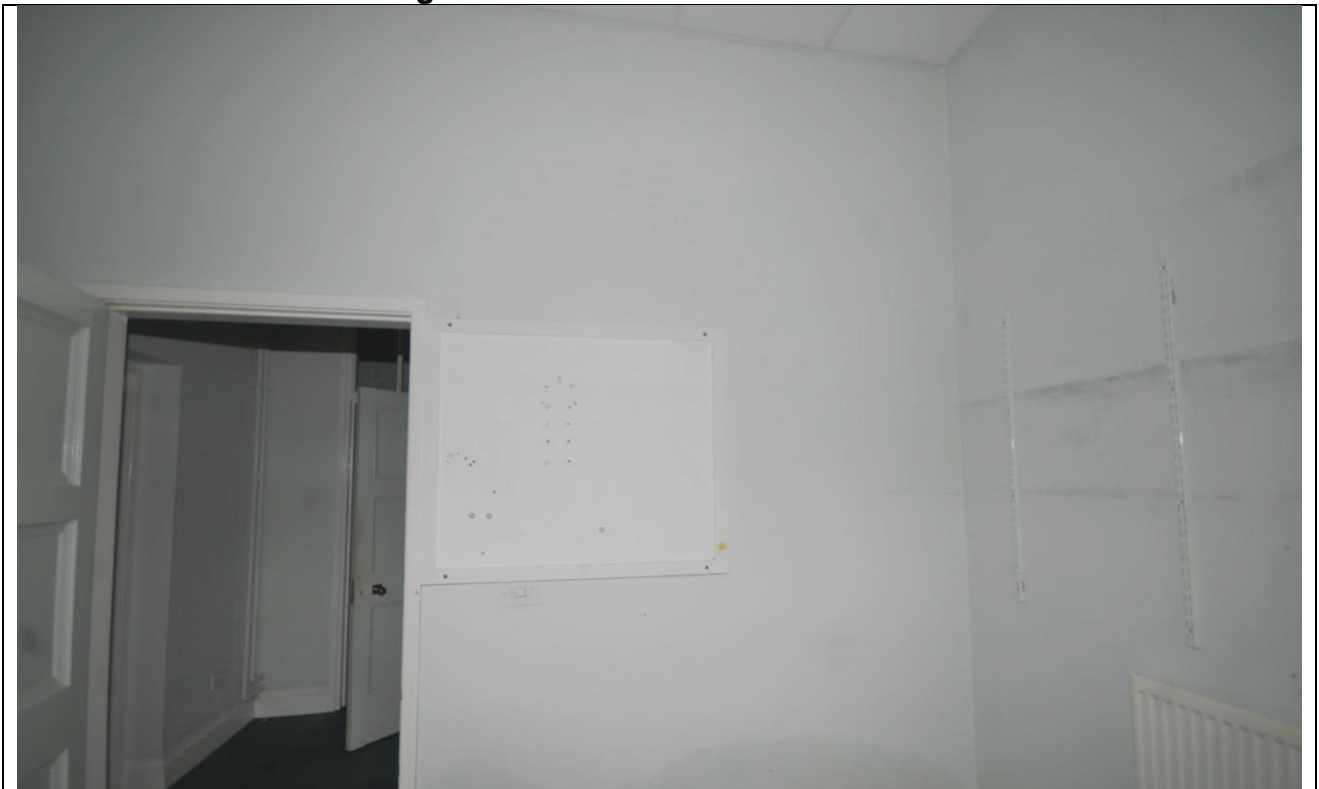
| Door | Three-panelled door. Contemporary with building. |
| Windows | Wooden framed multi-light casements and fixed lights contemporary with building |
| Comments/Description | A small plain room with large window to the southeast |
