Appendix 2 Level 3 Building Recording of
The Canteen Building

Blue Bird Park
Bromsgrove Road
Hunnington
Worcestershire
B62 0JW

Document Reference Number 2023/1681

Dr Peter Wardle & Colin Lacey

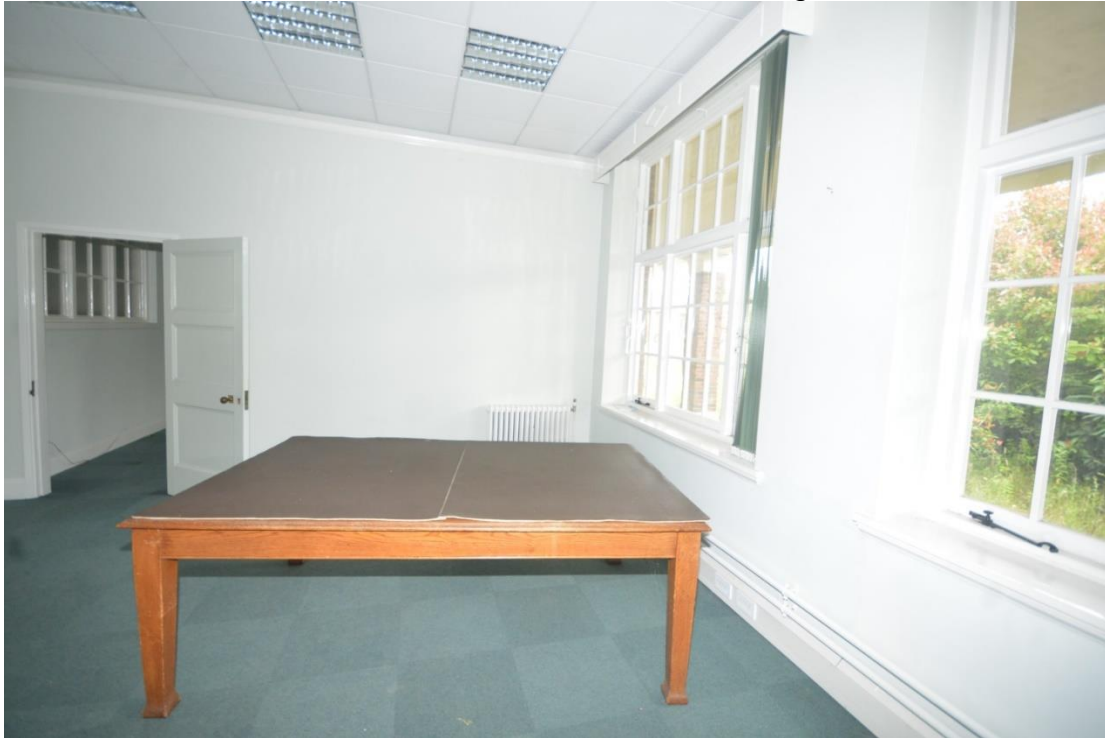
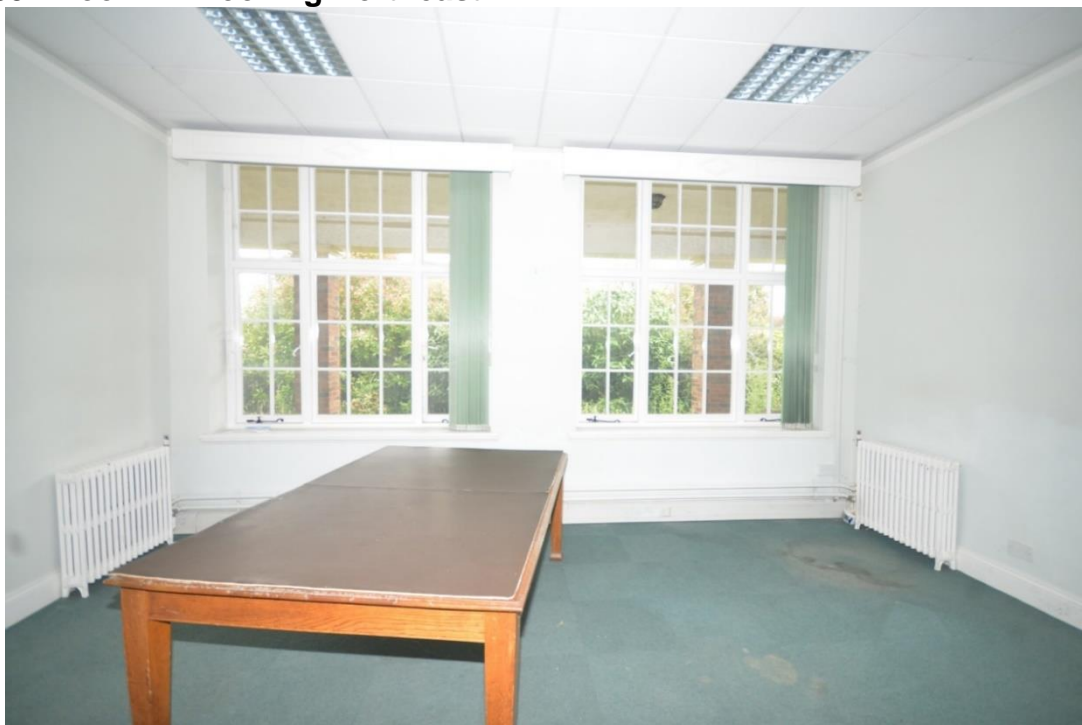
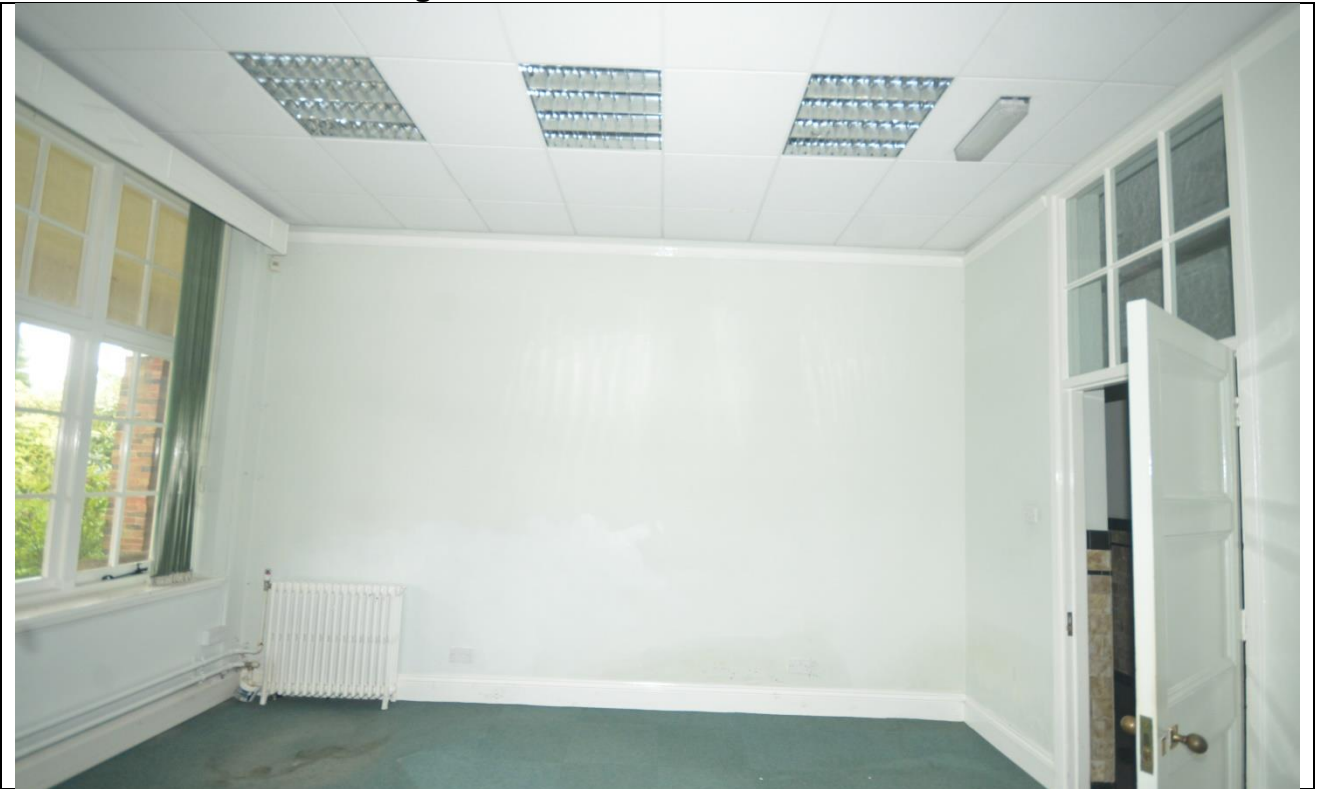
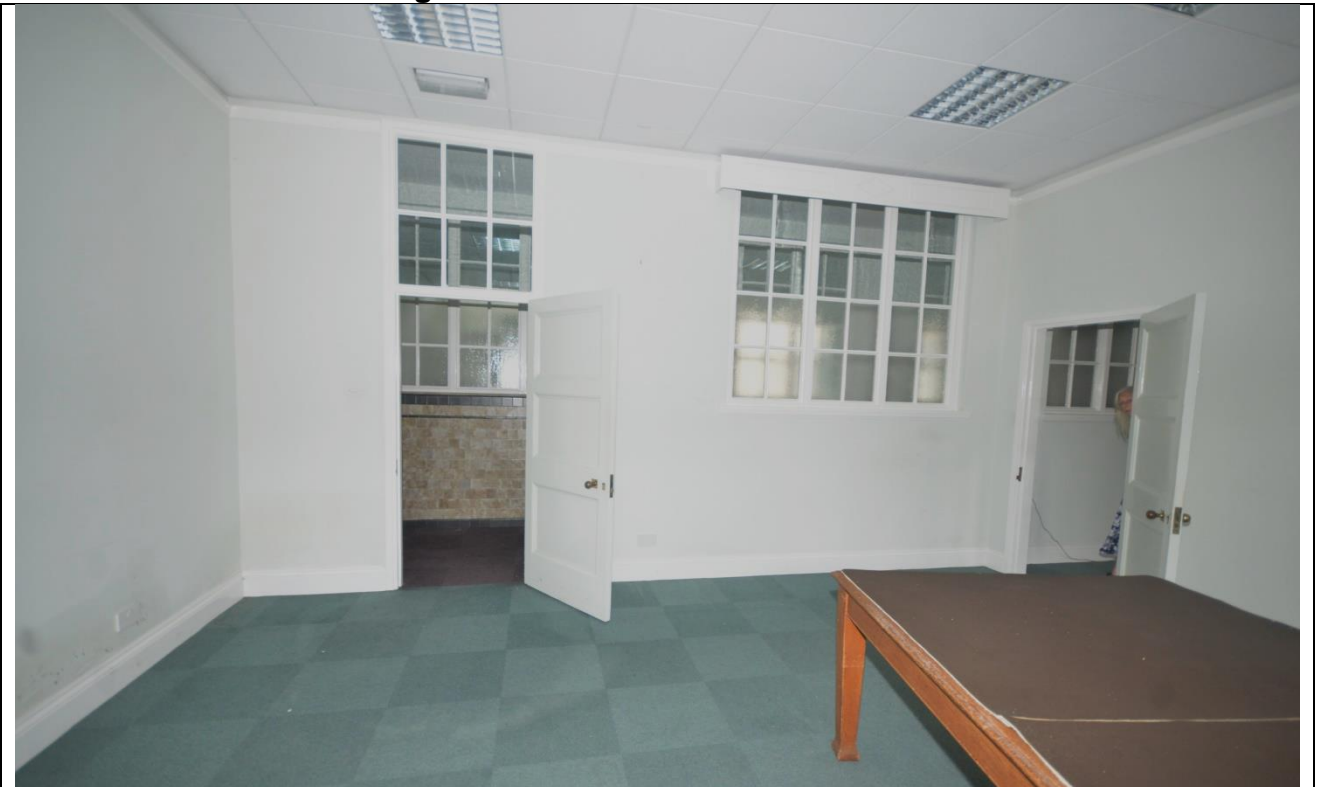
| Plan Form | Altered |
| Comments/Description | A recent suspended ceiling obscures the original. Rooms 12-16 have been subdivided from a single room. |

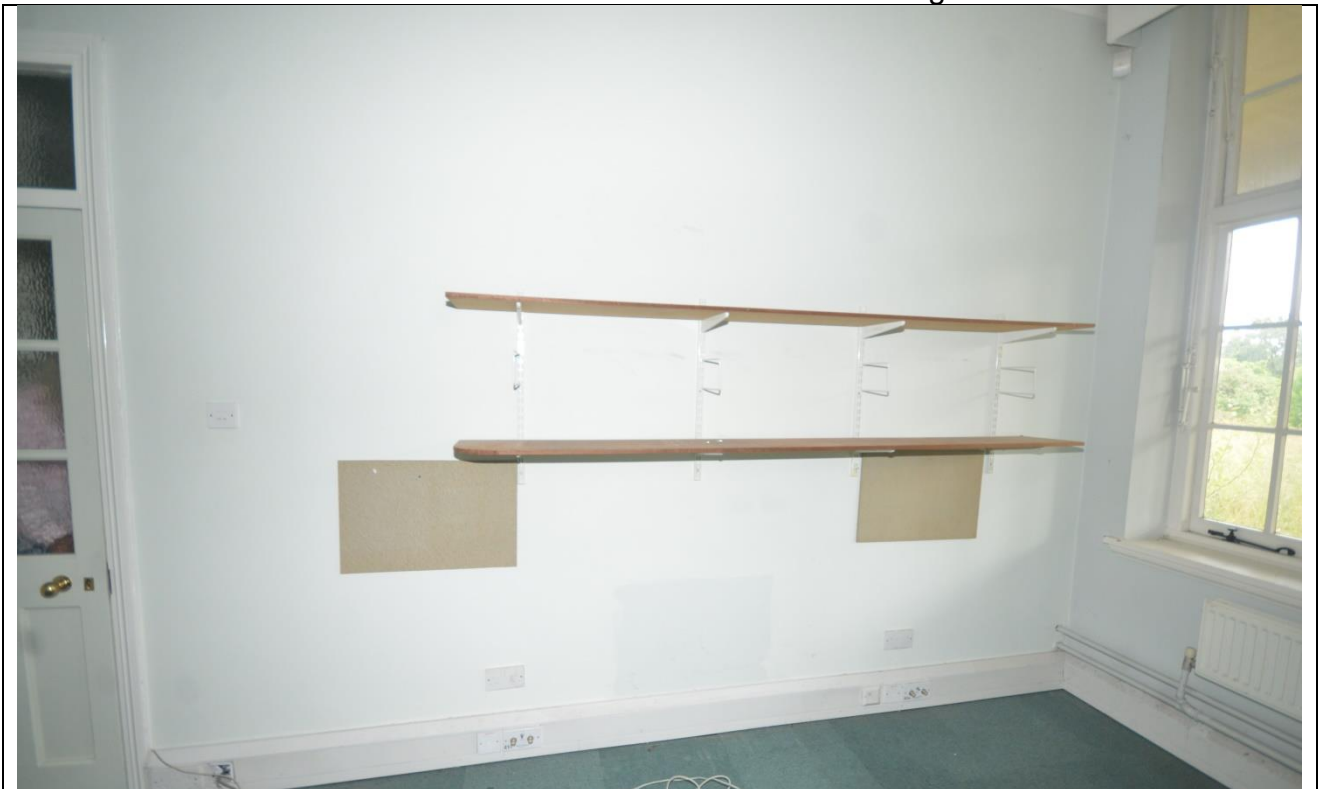
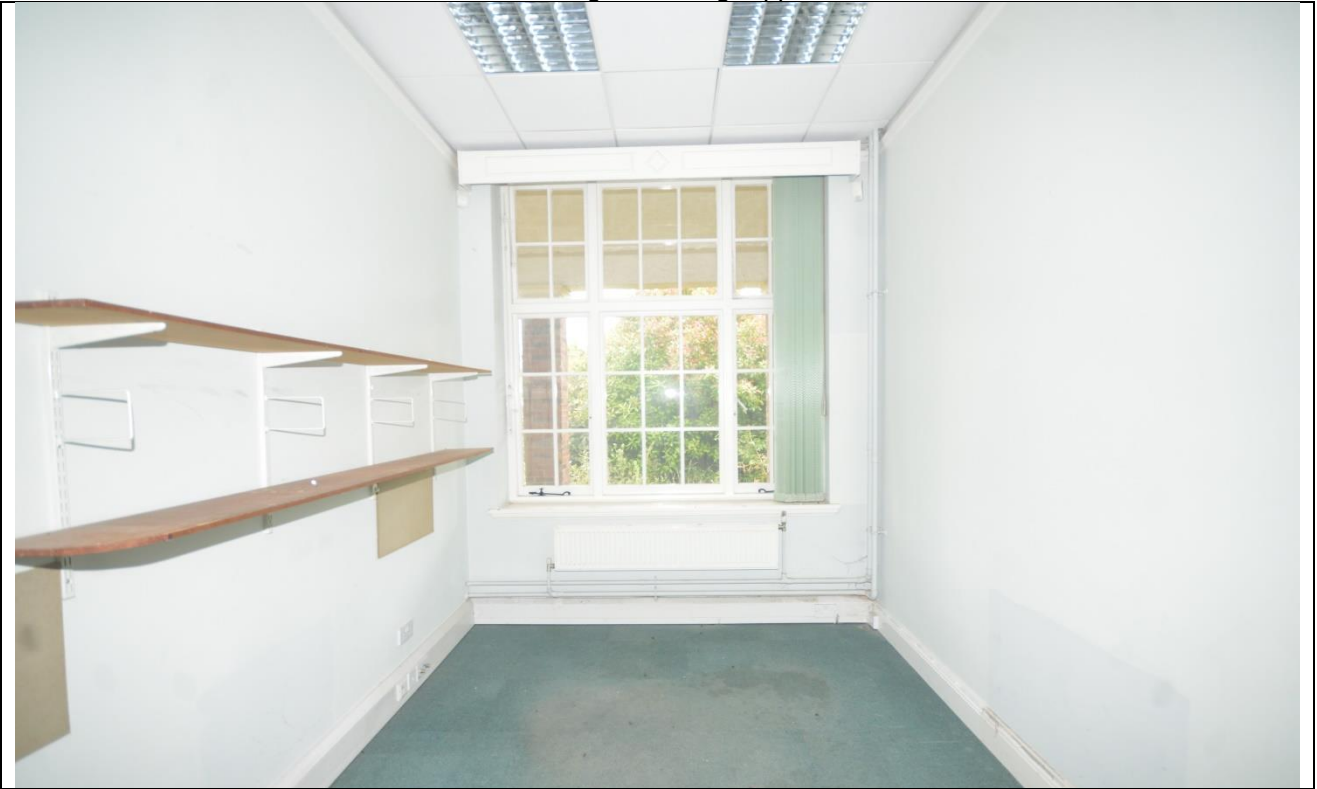
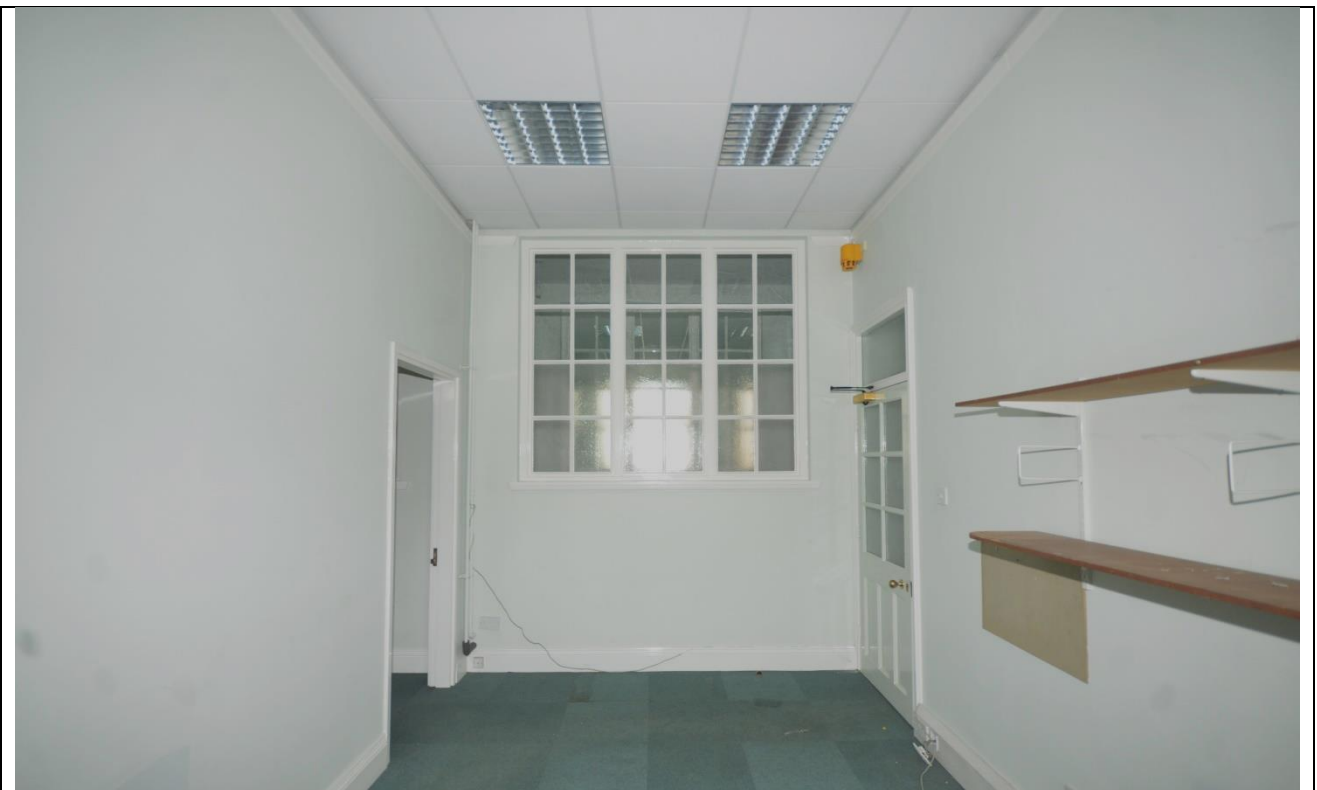
| Door | To room 12: Three-panelled door. Contemporary with building. To room 14: three vertical panels with 2x3 glazing over, uncertain date |
| Comments/Description | A recent suspended ceiling obscures the original. Rooms 12-16 are subdivisions of a larger room. |

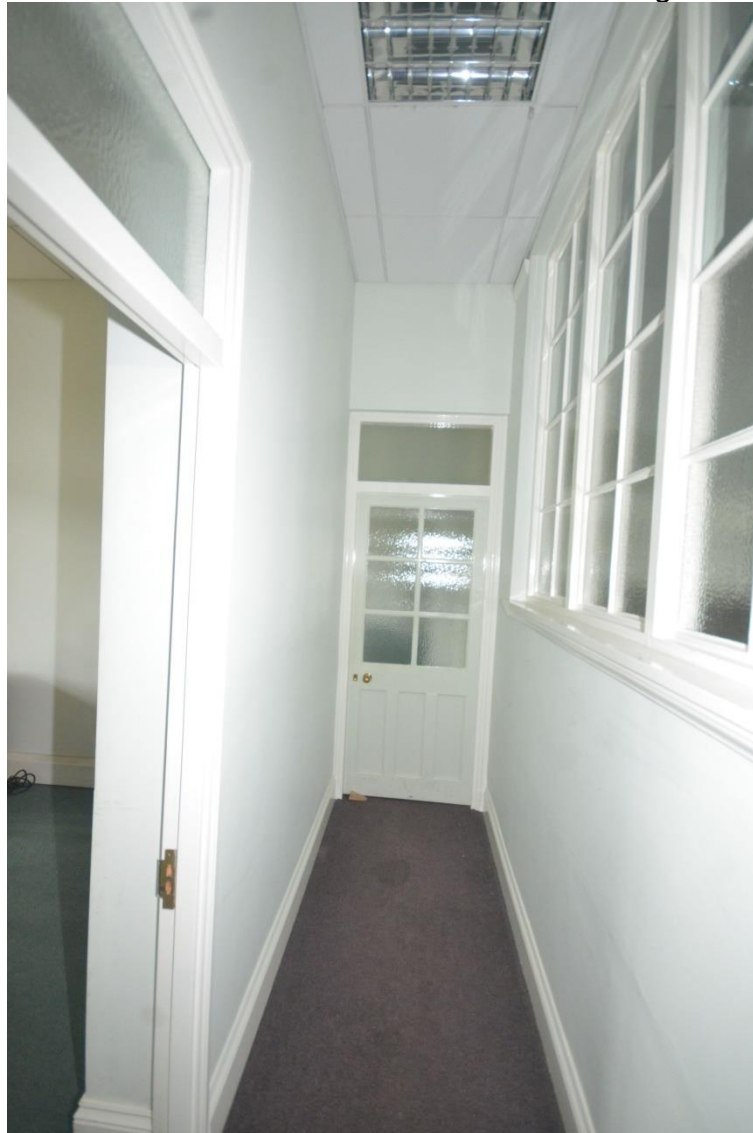
Plate 72: Room 14 Looking Southwest

| Comments/Description | A recent suspended ceiling obscures the original. Rooms 12-16 are subdivisions of a larger room. |

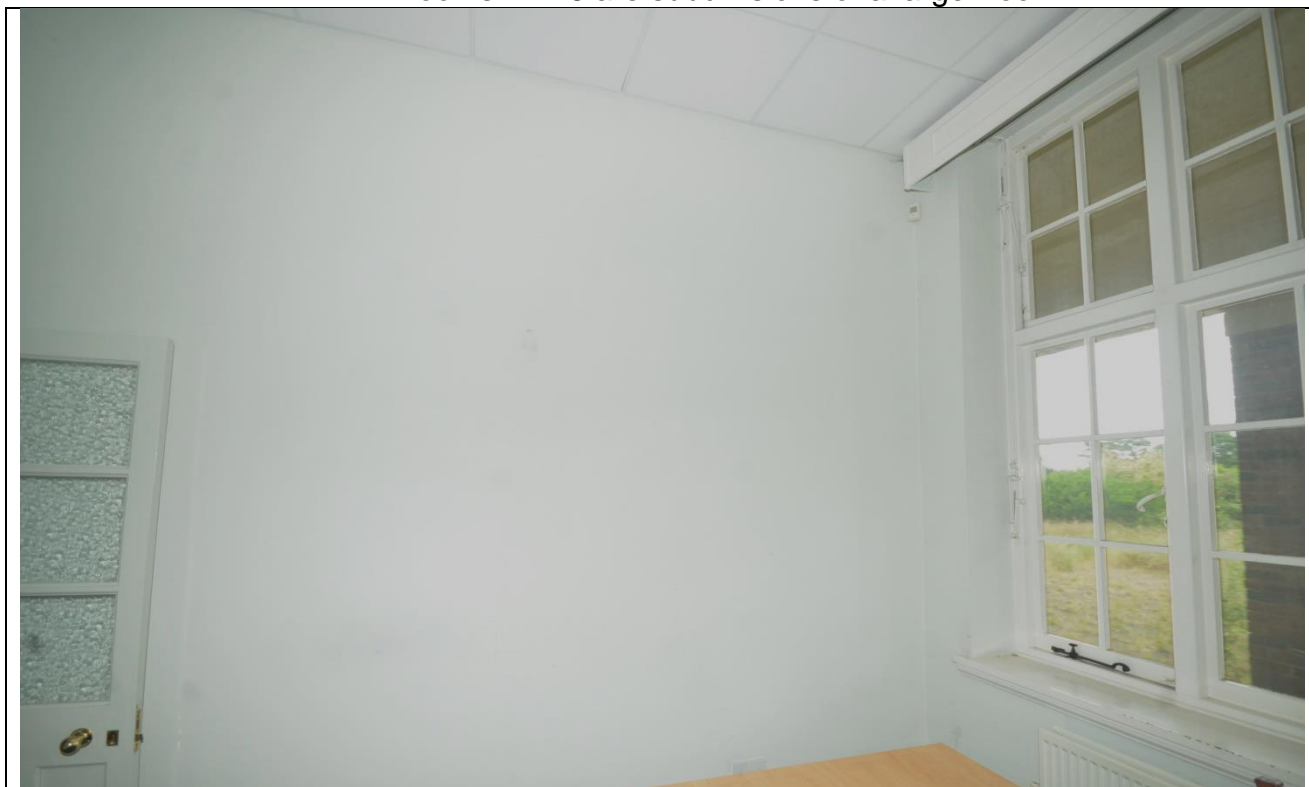
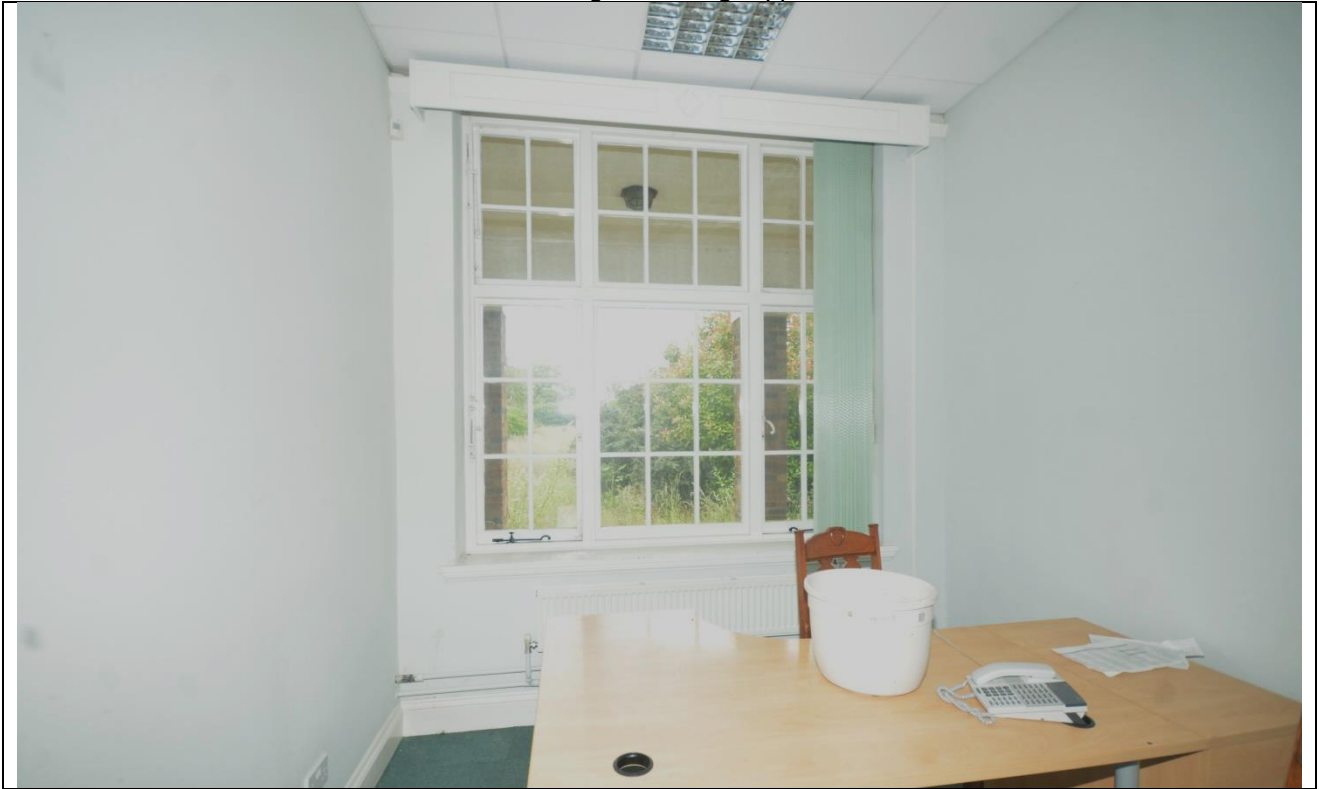
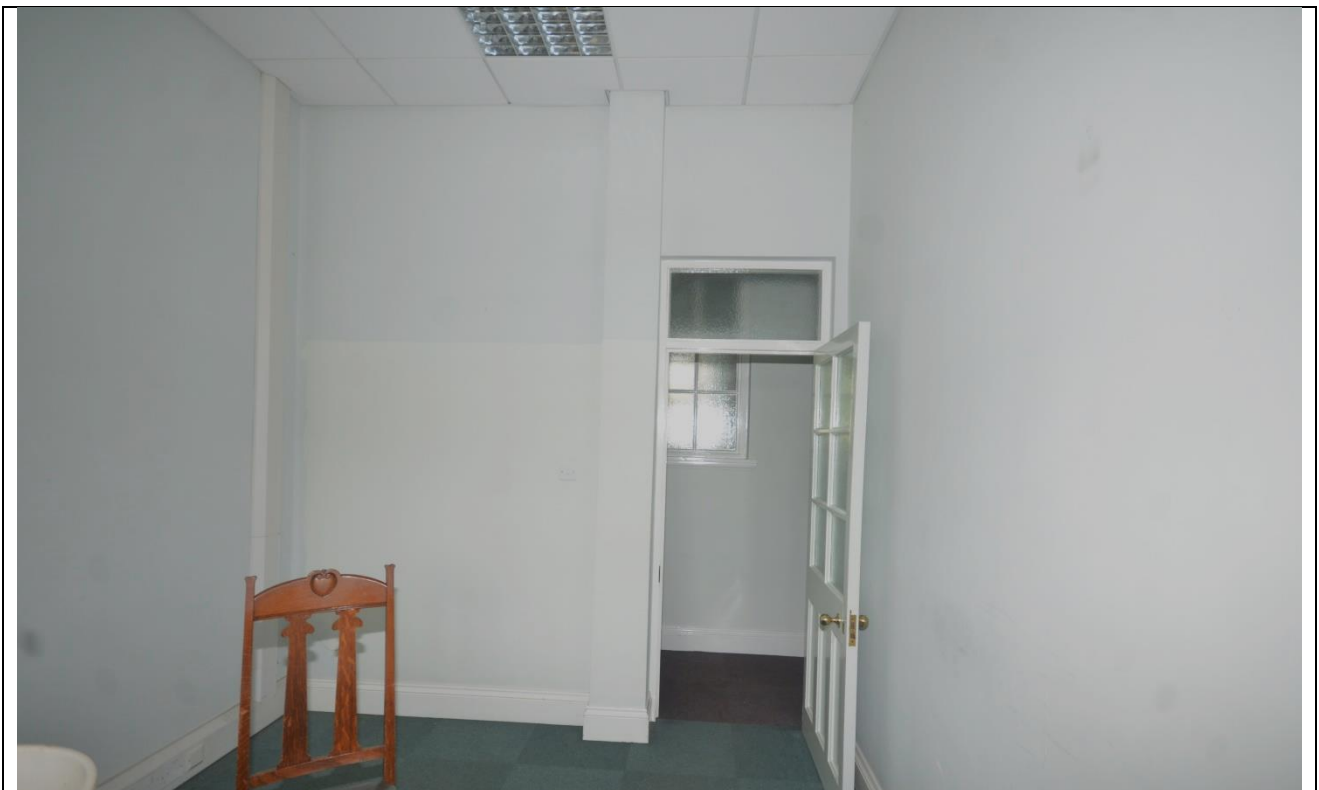
| Door | Three vertical panels with 2x3 obscure glazing over |
| Comments/Description | A recent suspended ceiling obscures the original. Rooms 12-16 are subdivisions of a larger room. |

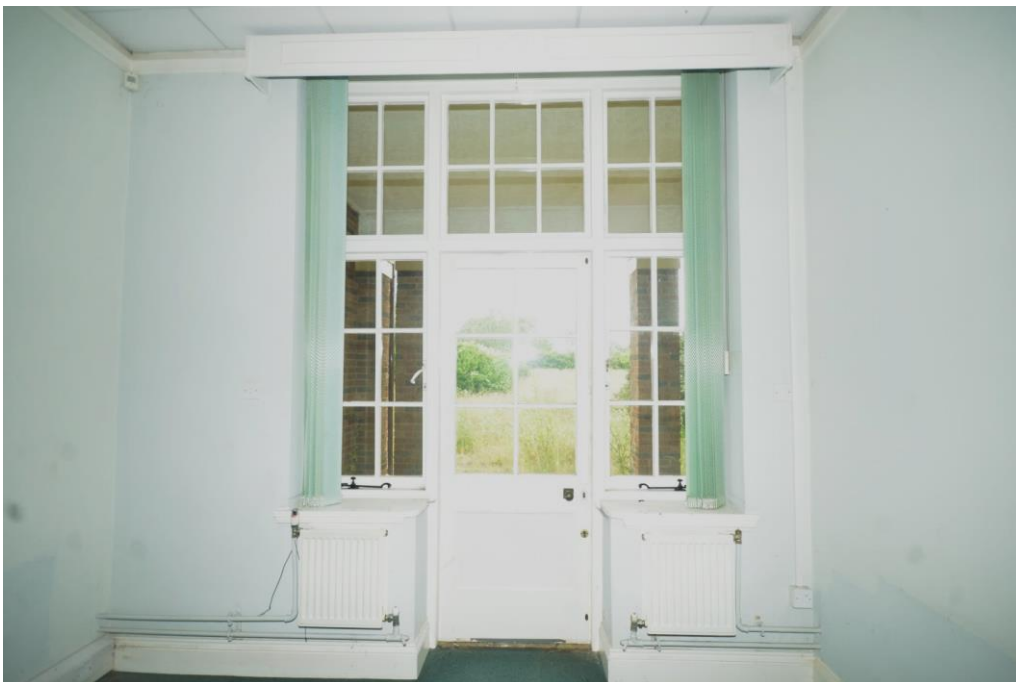
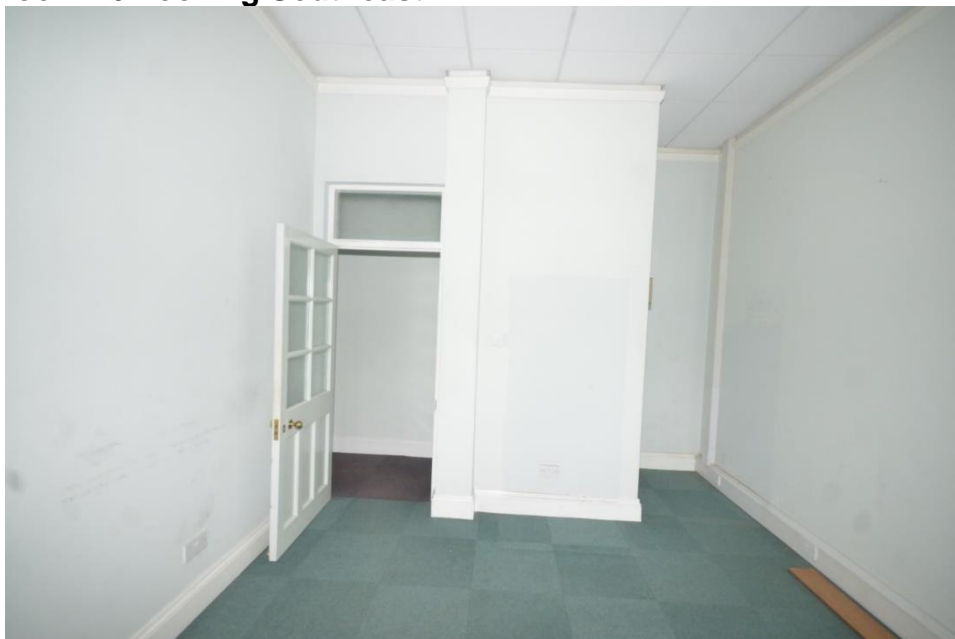
| Comments/Description | This room has a door to the southeast veranda. It is considered likely the division to the northwest forming corridor 14 is an addition. A recent suspended ceiling obscures the original. |

Rooms 12-16 are subdivisions of a larger room.

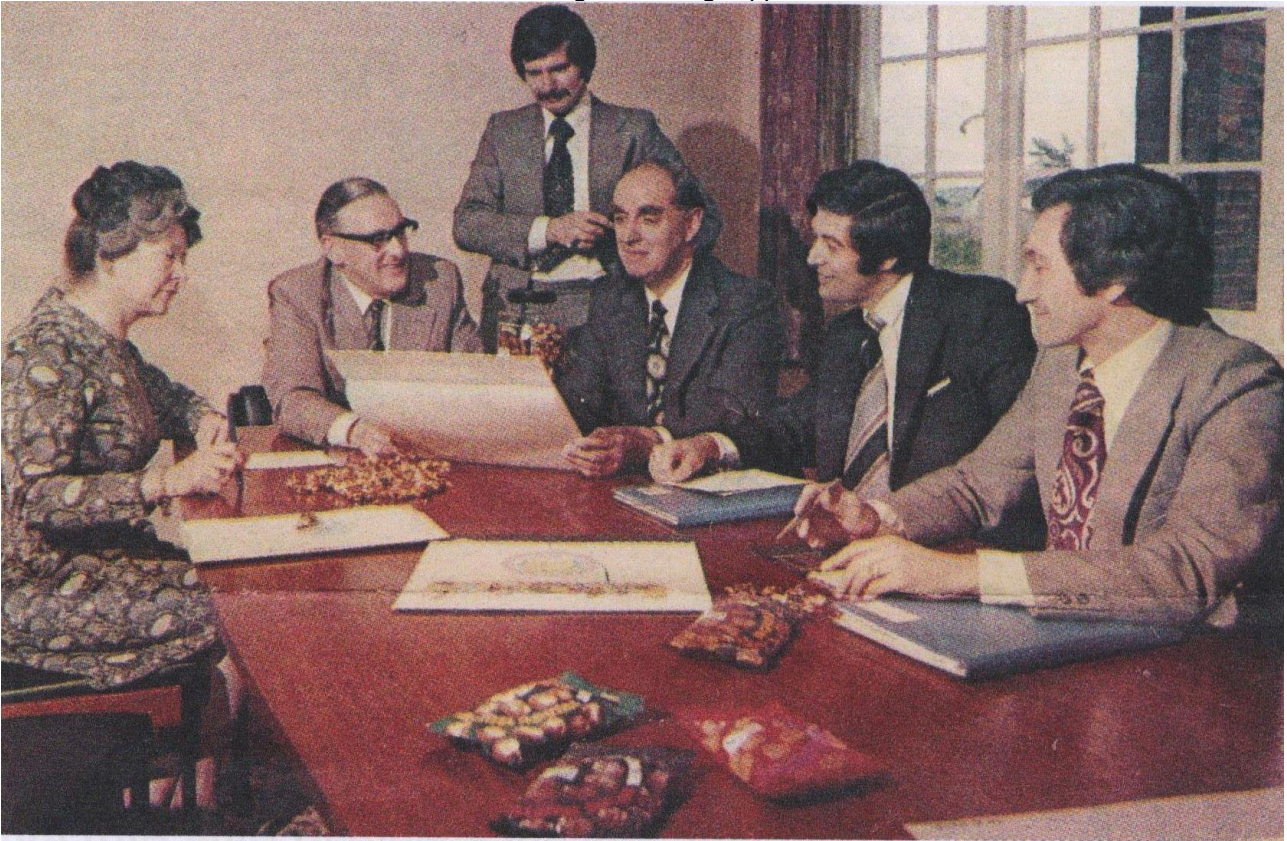
Plate 78: Historic view to northeast, prior to division of room 16, c. 1970s (Blue Bird Album, Romsley & Hunnington History Society)

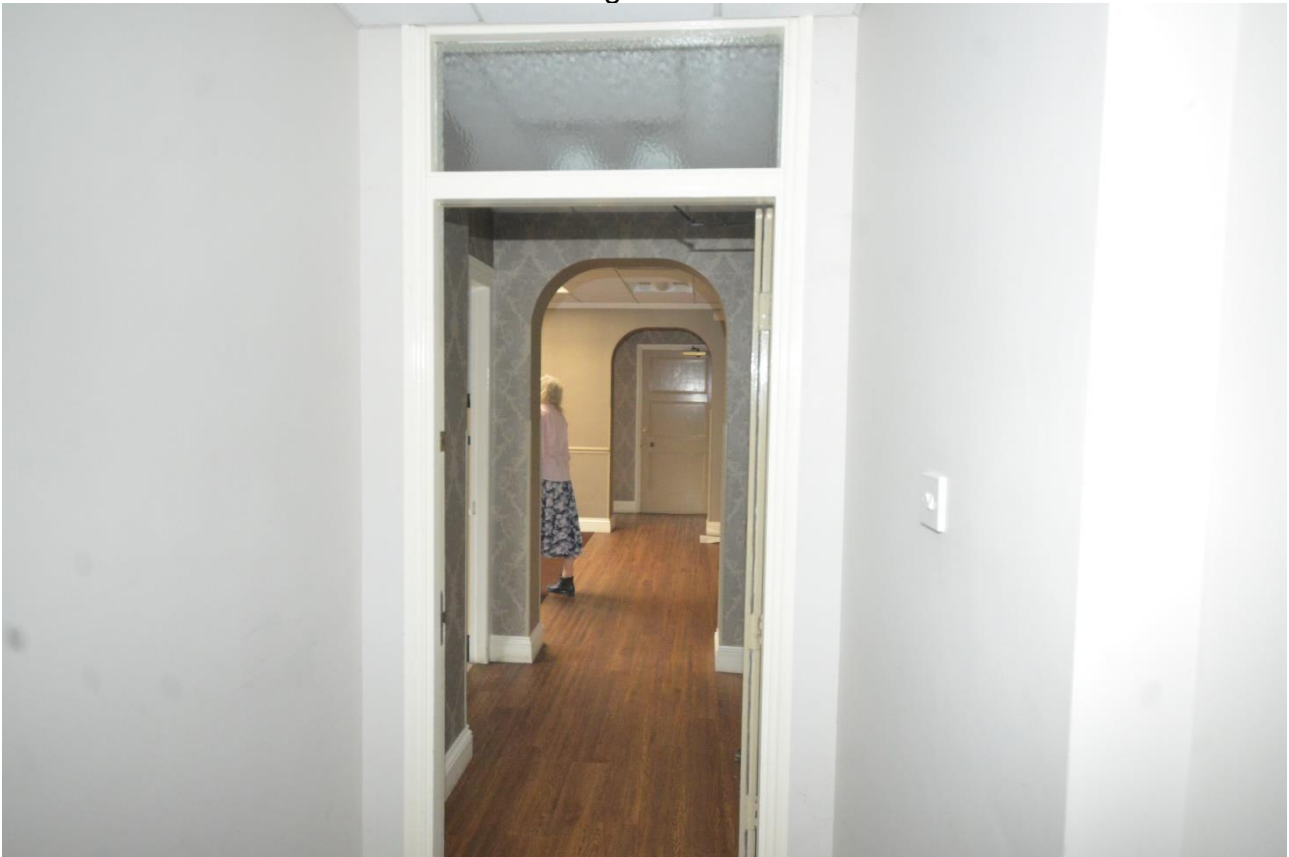
| Comments/Description | The room is an 'L'-shaped corridor. The use of this room as a servery is as yet unexplained, but the presence of servery sash windows suggests it had this purpose. The room is one of the small number of areas of the building with an exposed wooden floor. A recent suspended ceiling obscures the original. |

Plate 79: Room 17 Looking Northeast

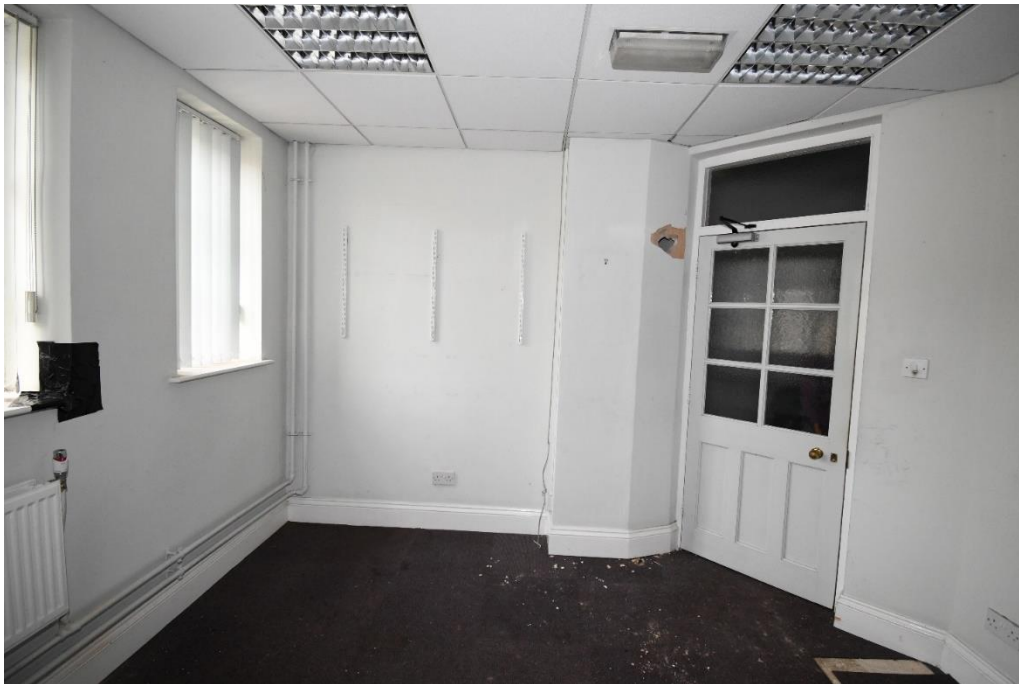
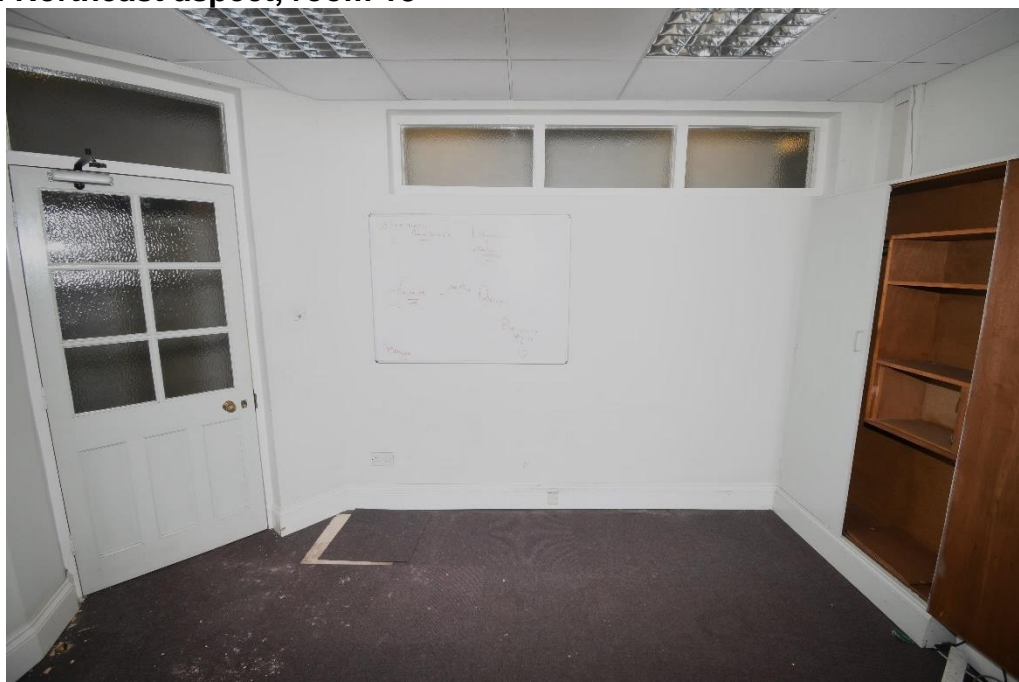
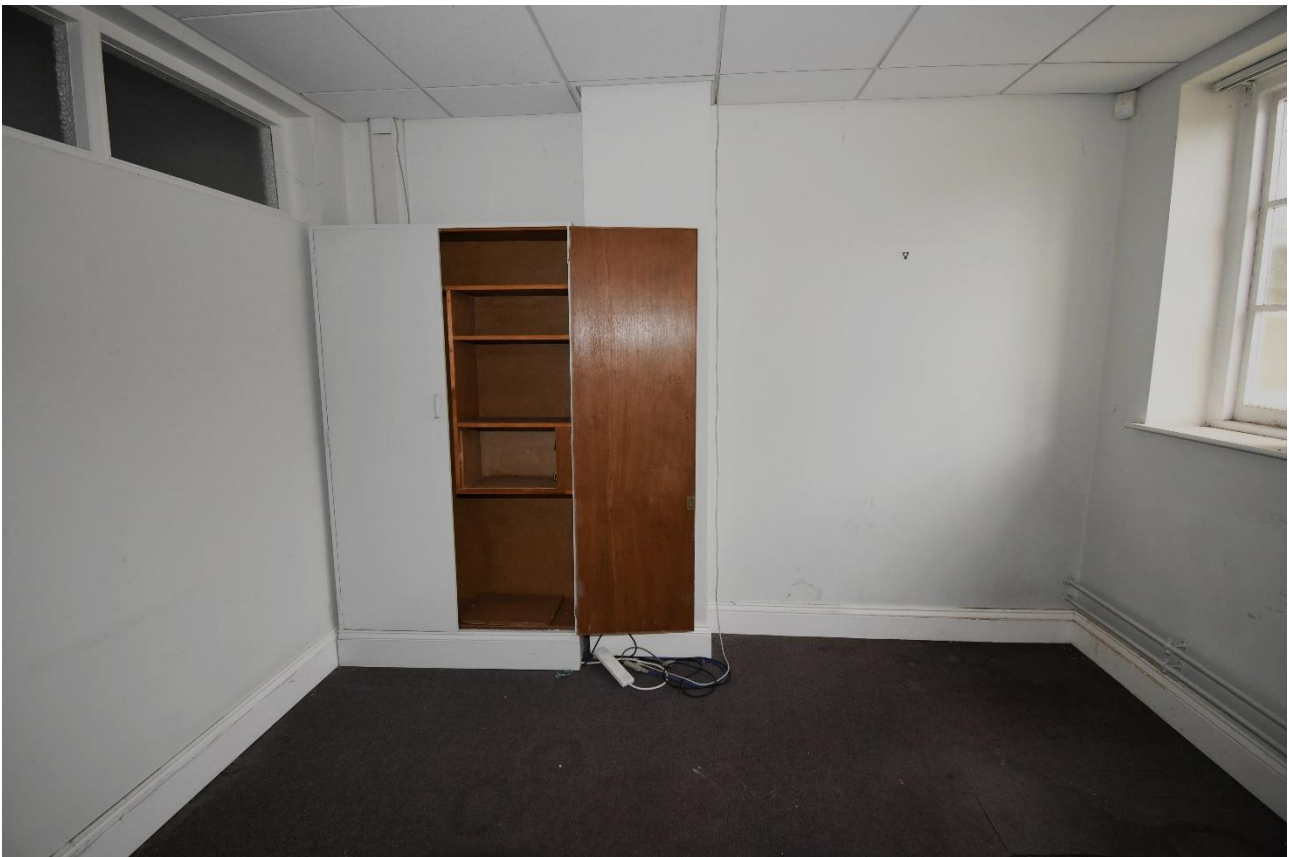
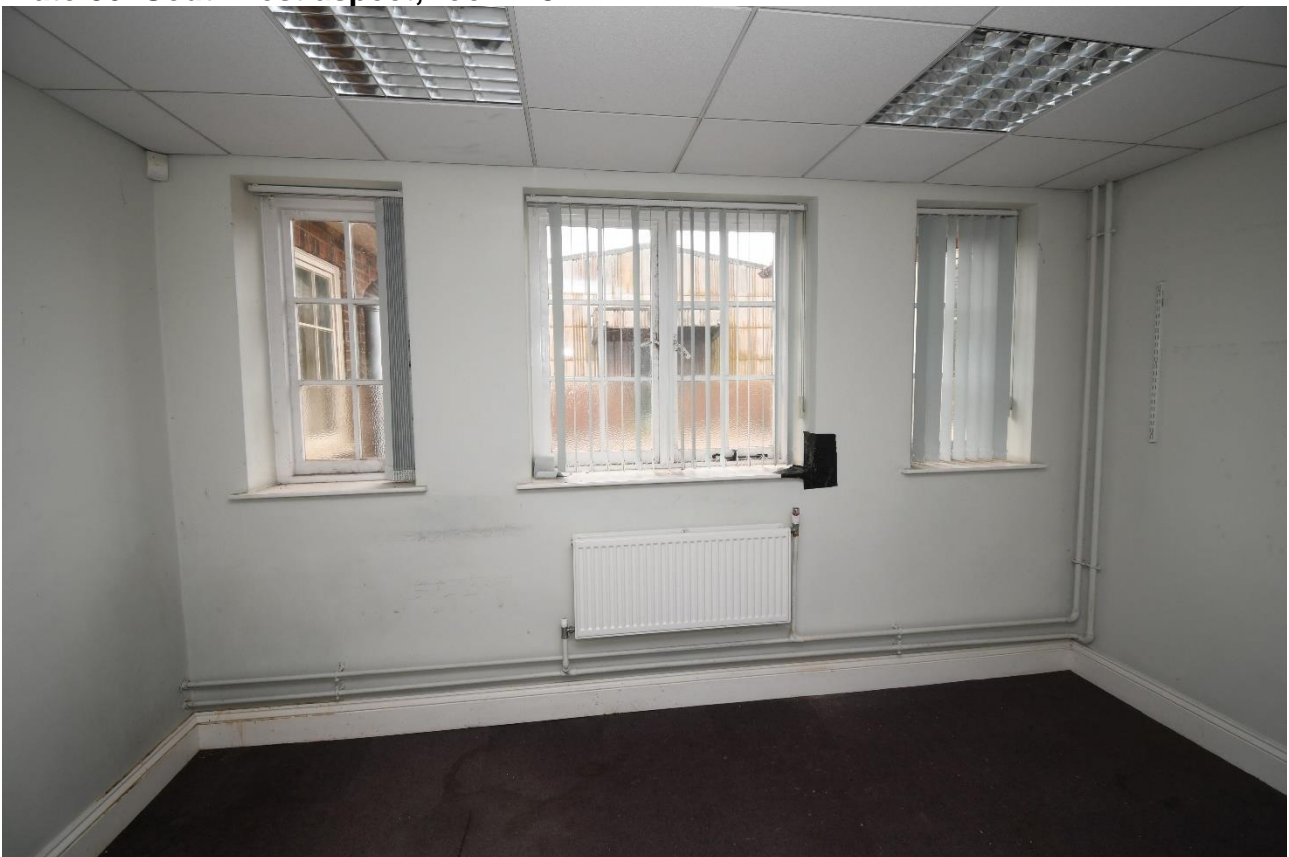
The eastern corner of this room is truncated, facilitating ease of passage in the corridor. The door to the room is located in this eastern wall.

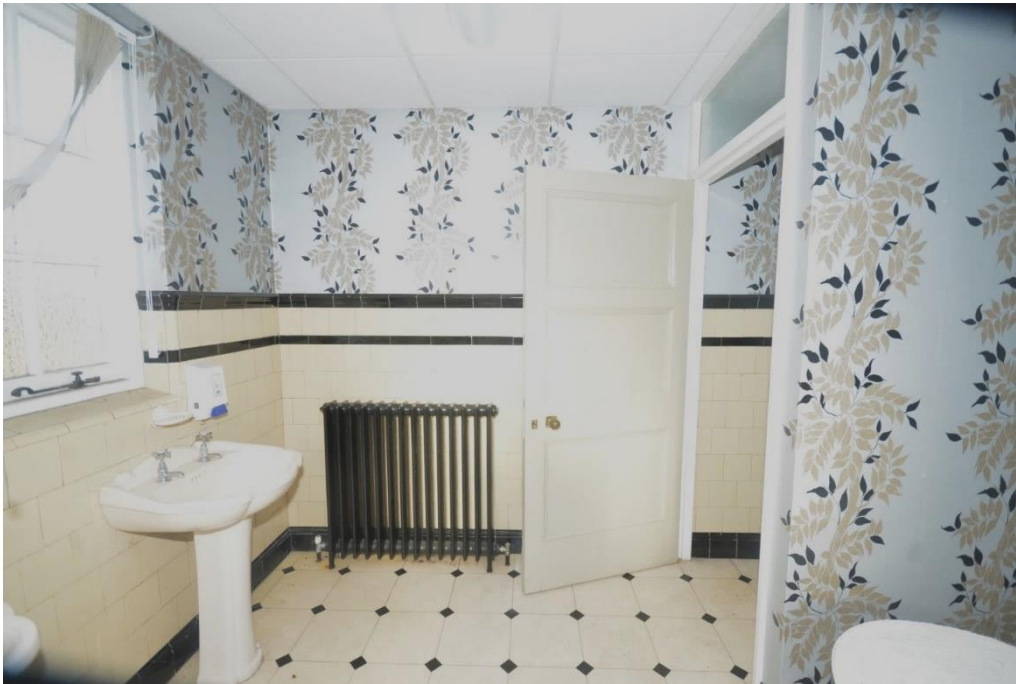
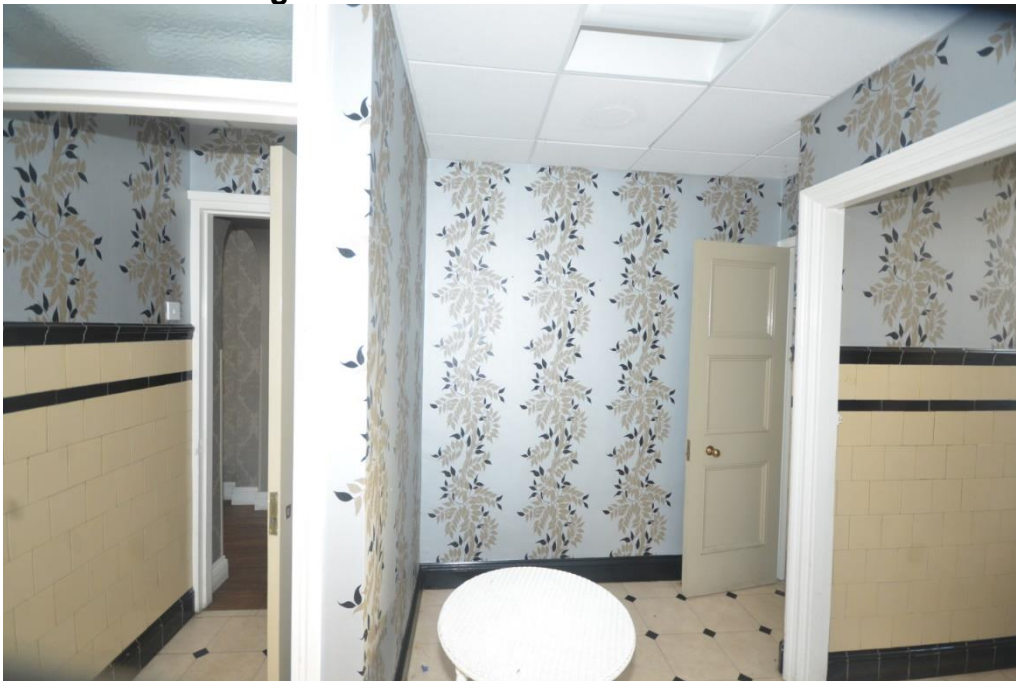
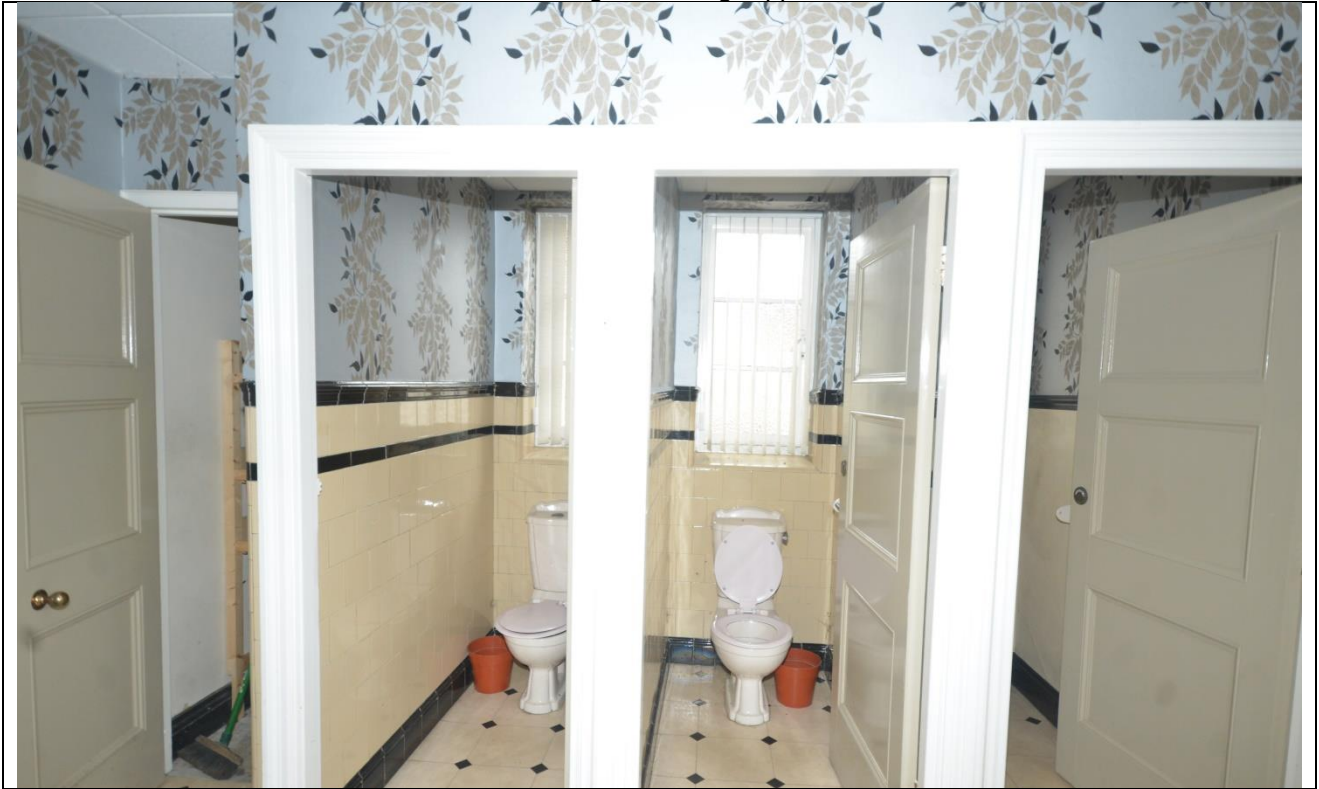
| Historic Features | Original partitions, tiles, radiator |
| Comments/Description | A recent suspended ceiling obscures the original. Historic England suggests this part of the building is a later addition however this cannot be confirmed. |

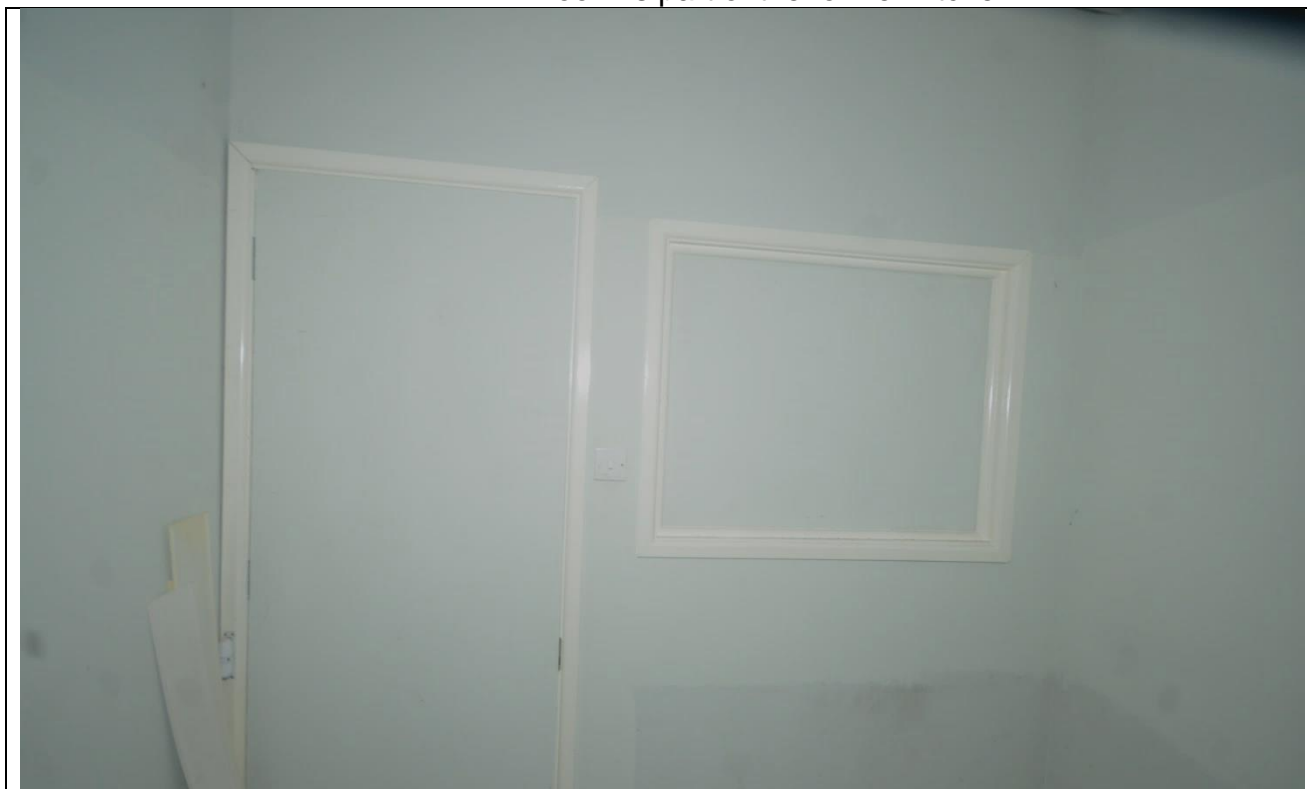
| Comments/Description | Room 20 is a small area partitioned from the larger room 22. The room is accessed via room 21. This room is part of the former kitchen. |

Plate 92: Room 20 Looking Southeast, showing blocked door and window
