Appendix 2 Level 3 Building Recording of
The Canteen Building

Blue Bird Park
Bromsgrove Road
Hunnington
Worcestershire
B62 0JW

Document Reference Number 2023/1681

Dr Peter Wardle & Colin Lacey

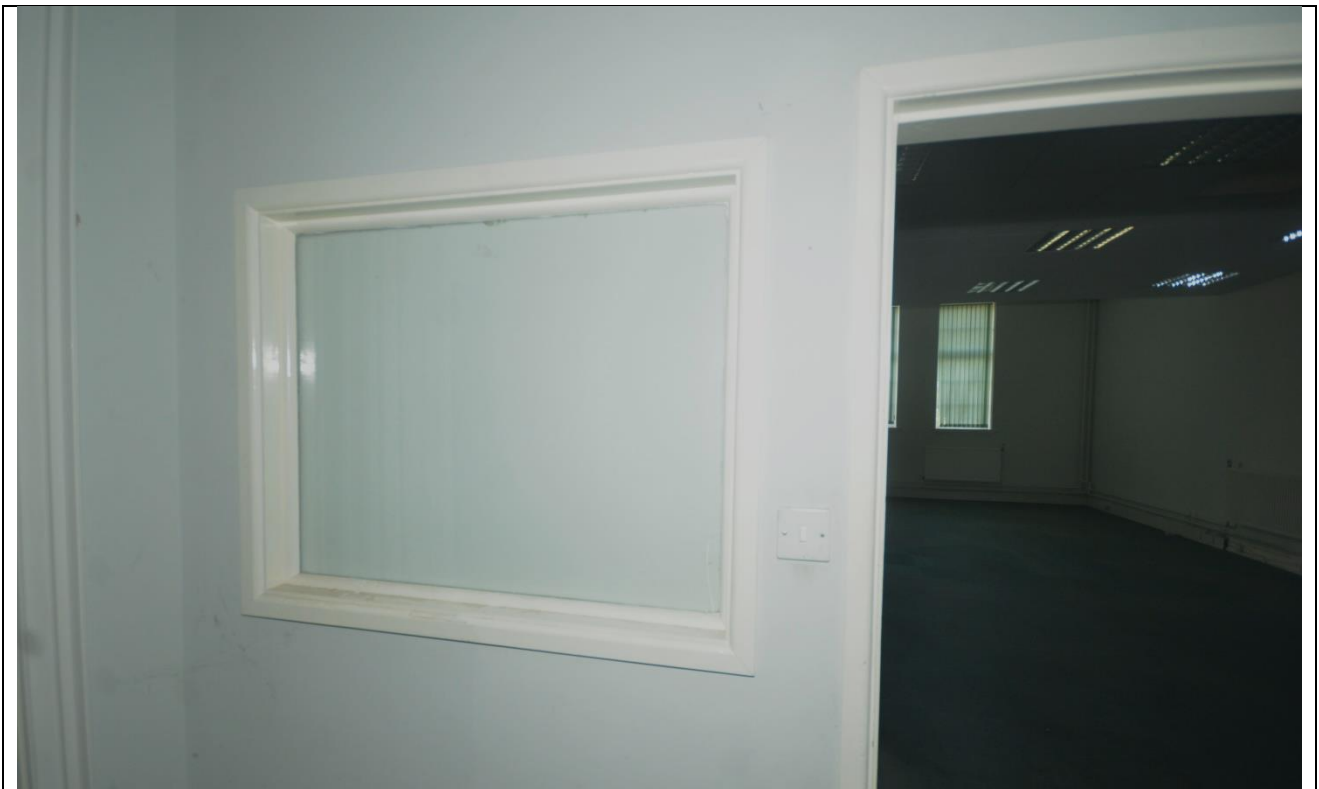
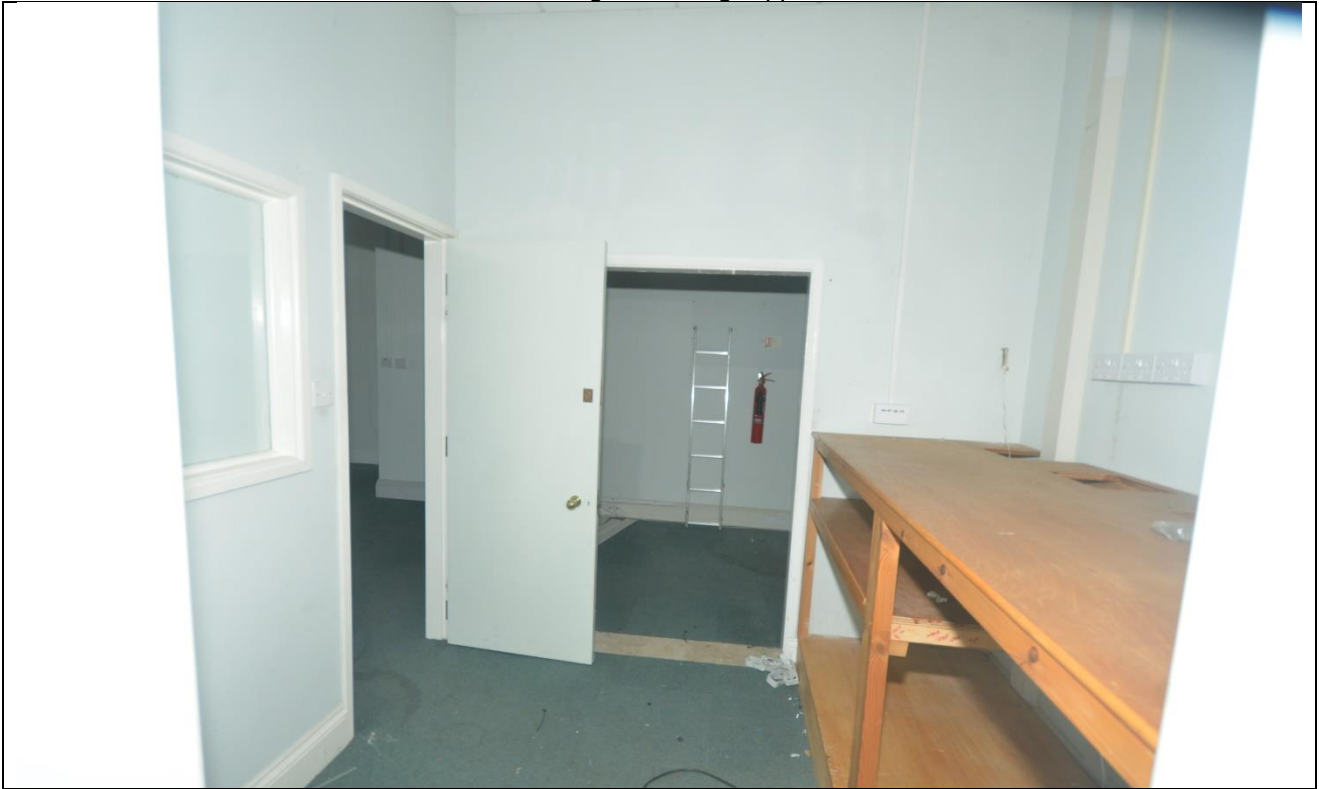
| Comments/Description | Room 21 is entered via a small antechamber which features a ladder to the roof space above this part of the building. The room is partitioned from room 22 and gives access to room 20. This room is part of the former kitchen. |

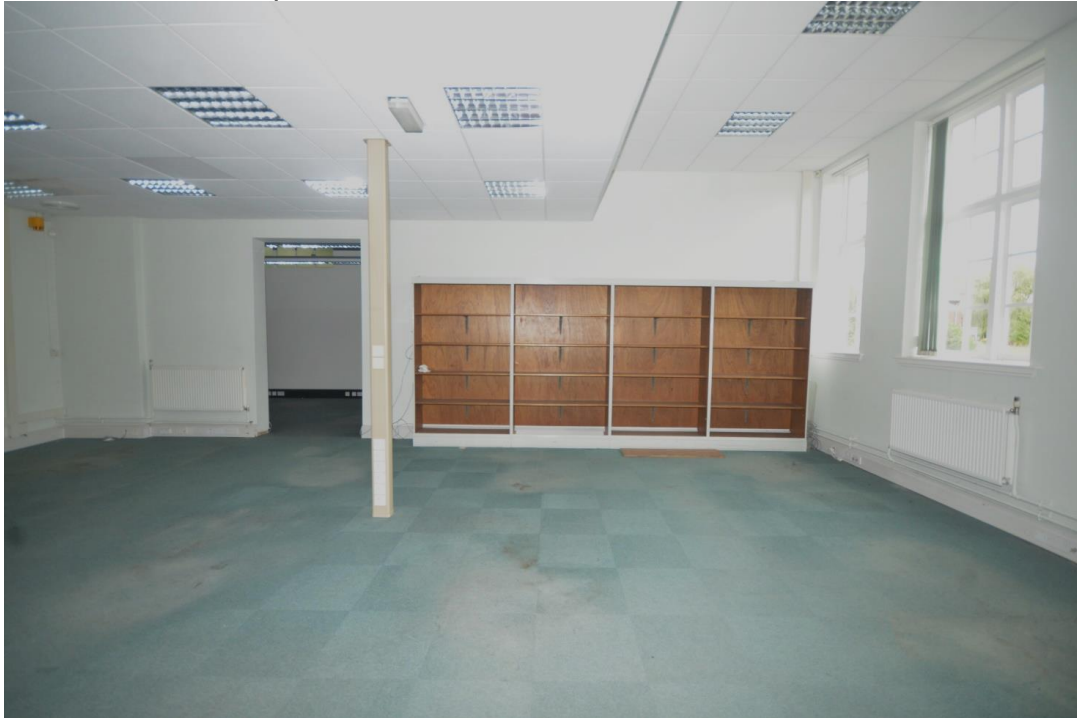
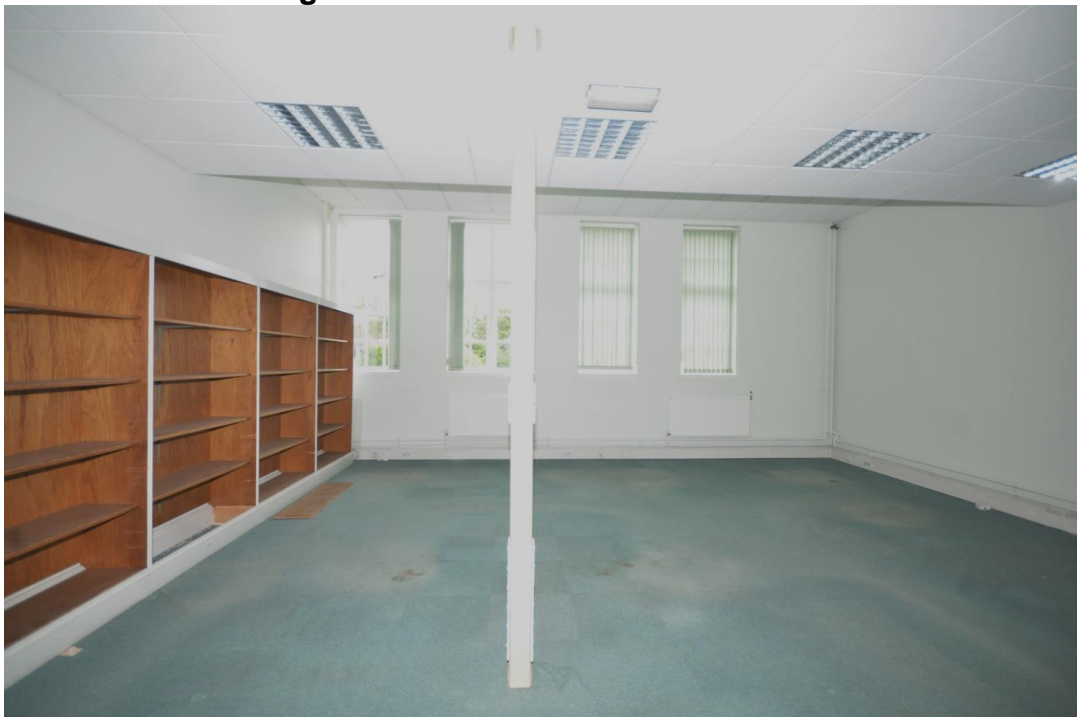
| Comments/Description | A recent suspended ceiling obscures the original. This room is part of the former kitchen. |

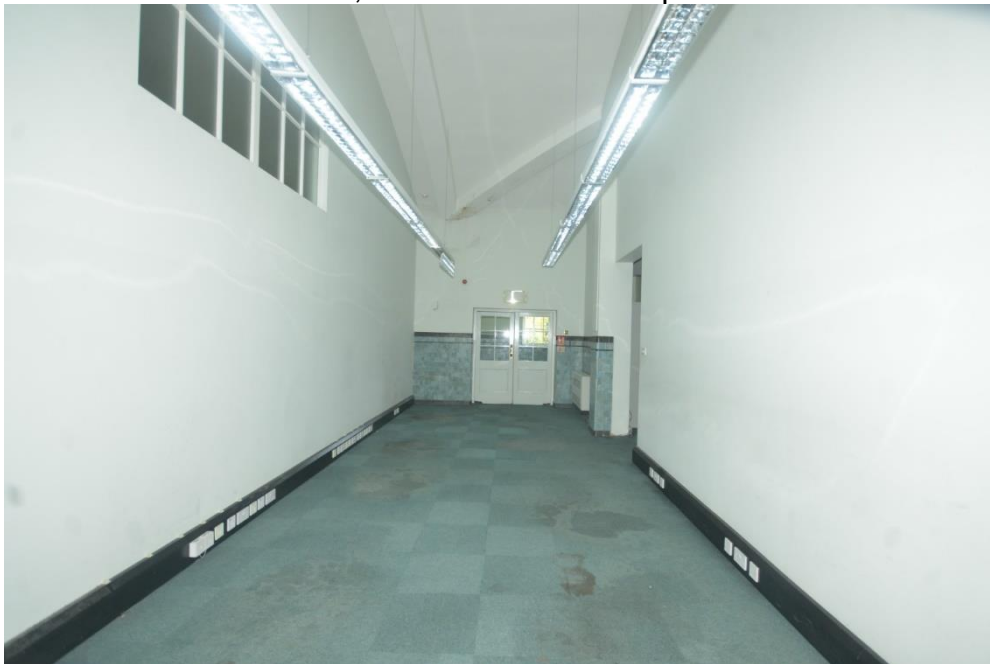
Plate 102: Room 23 Looking Southeast

| Comments/Description | This room has been partitioned from the main auditorium. This is considered likely to have happened when the factory was still in operation, owing to the nature of the window in the partition. The blue tiled walls of the auditorium continue into this area, but do not cross the partition wall. |

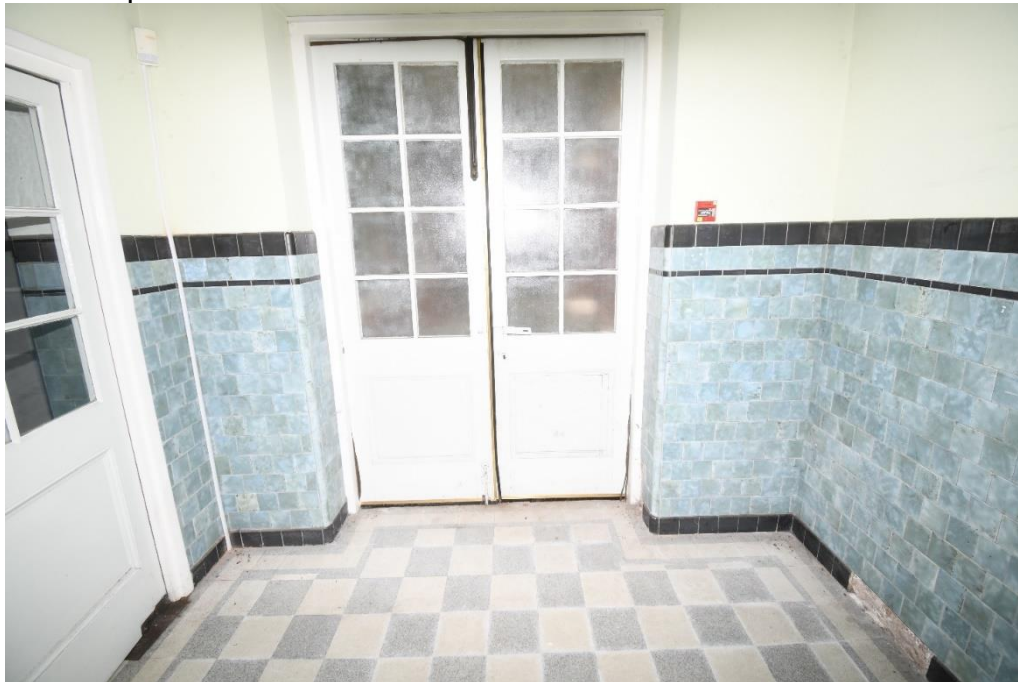
Plate 104: Northeast aspect, room 24

Door Double doors (single panel with 2x4 lights over) to northeast,
double doors (single panel with 2x3 lights over) to northwest

Windows Wooden framed multi-light casement and fixed light,
contemporary with building

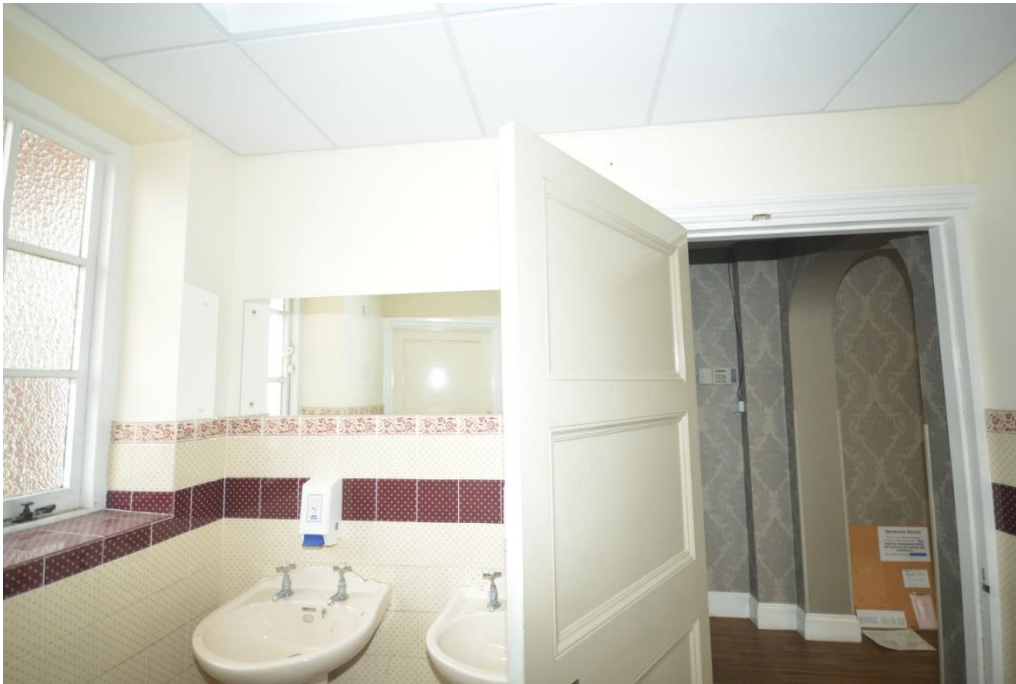
Plate 108: Room 25 Looking Southeast

| Historic Features | Original partitions, tiles, radiator |
| Comments/Description | A recent suspended ceiling obscures the original. Historic England suggests this part of the building is a later addition. |

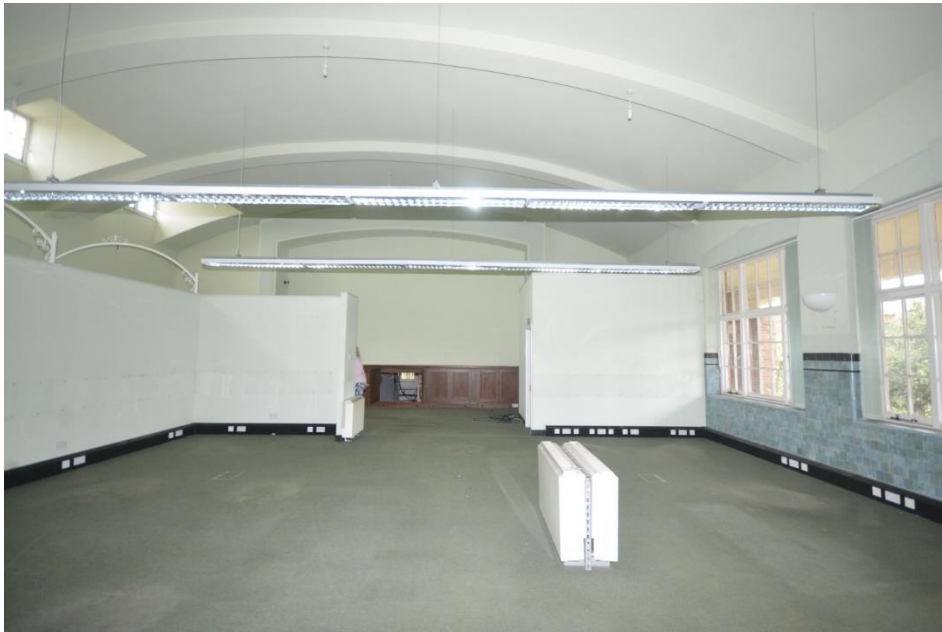
Plate 111: Room 27 Looking Northeast

Arched ceiling, lower part of walls tiled

The room has been subdivided with recent partitions to form open-plan office space, with an entrance lobby in the eastern corner.

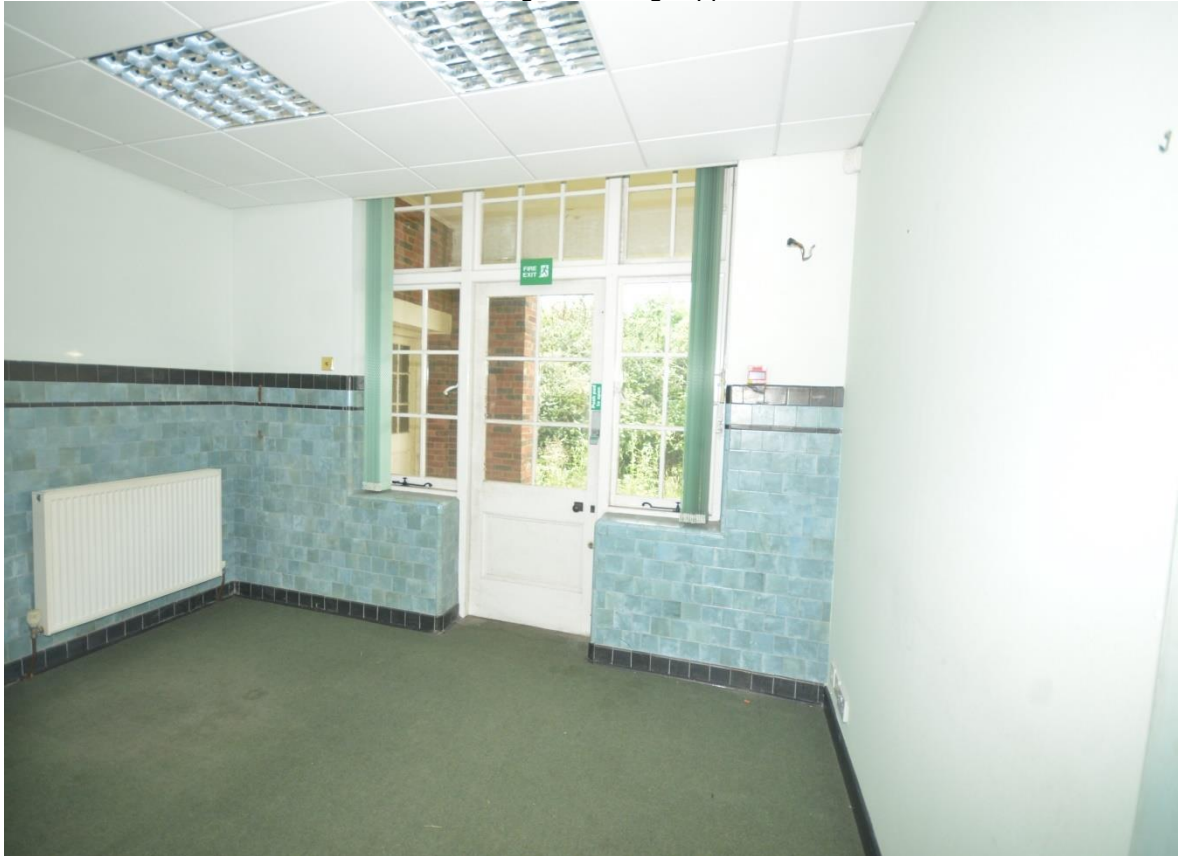
Plate 120: Small partitioned entrance lobby, eastern corner of room 27

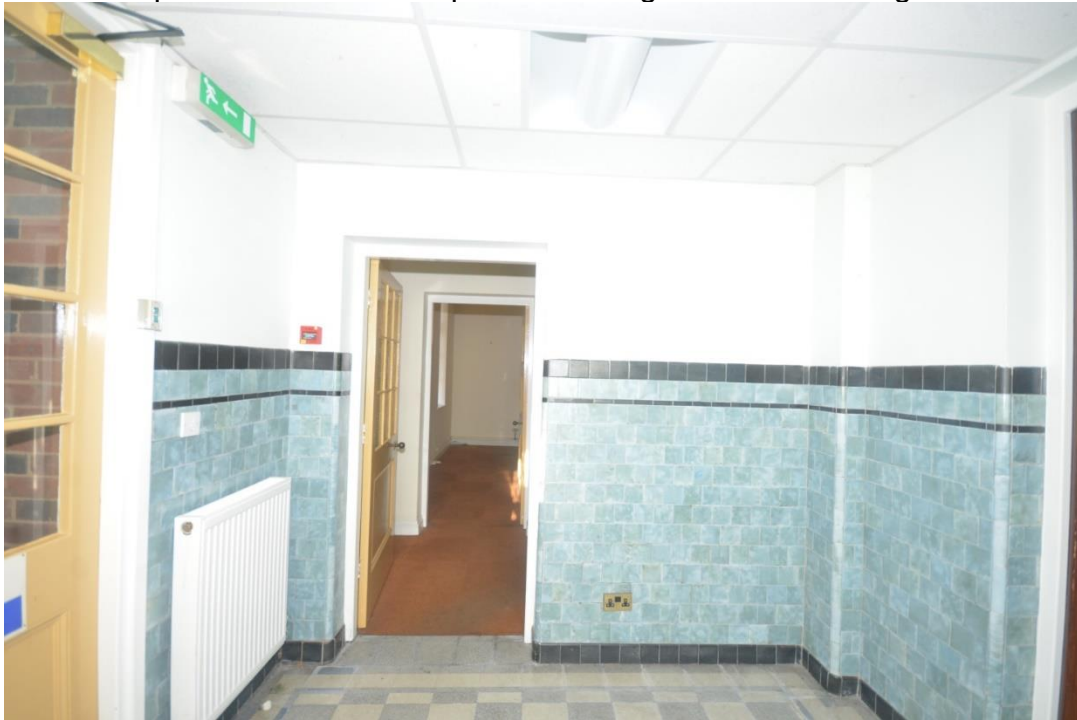
Plate 121: Room 28 Looking Northeast

| Historic Features | Tiled floor, lower part of walls tiled |
| Comments/Description | A recent suspended ceiling obscures the original. |

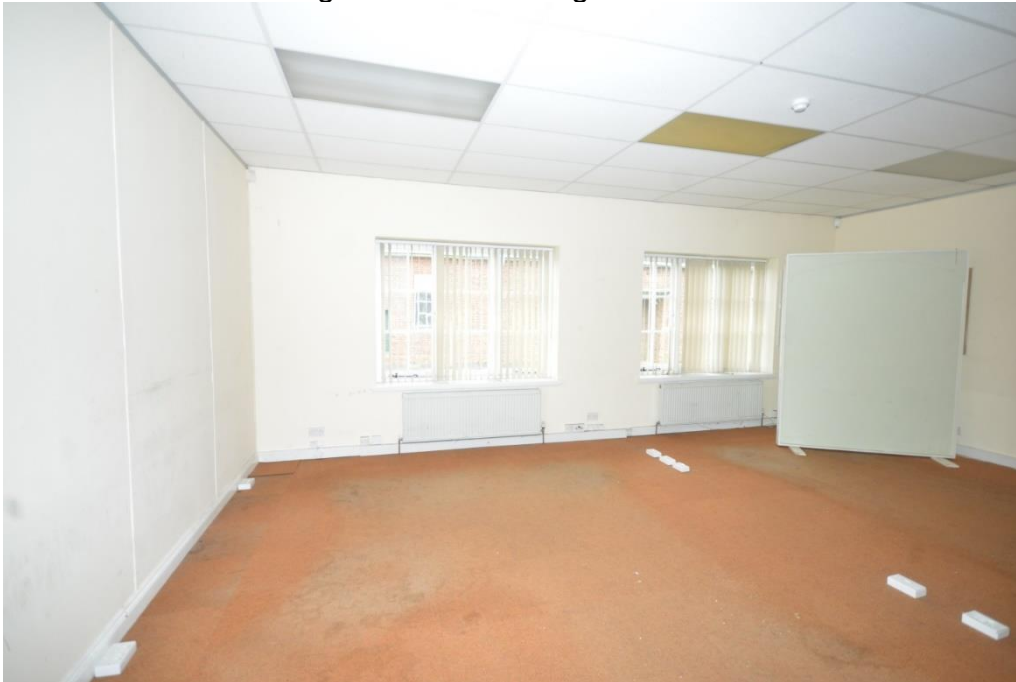
Plate 131: Room 32 Looking Northeast

| Comments/Description | The room has most recently been used as an open-plan office, evidenced by the rows of power sockets across the floor, indicating the location of desks. A recent suspended ceiling obscures the original. |

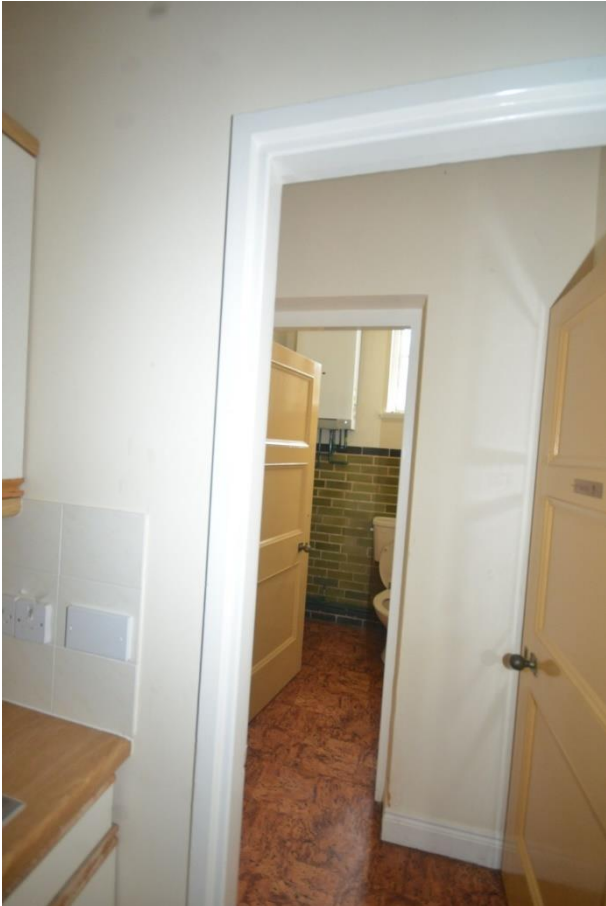
Plate 136: Room 34 Looking Northeast

| Historic Features | Lower part of walls tiled with brick-sized tiles |
| Comments/Description | A recent suspended ceiling obscures the original. |

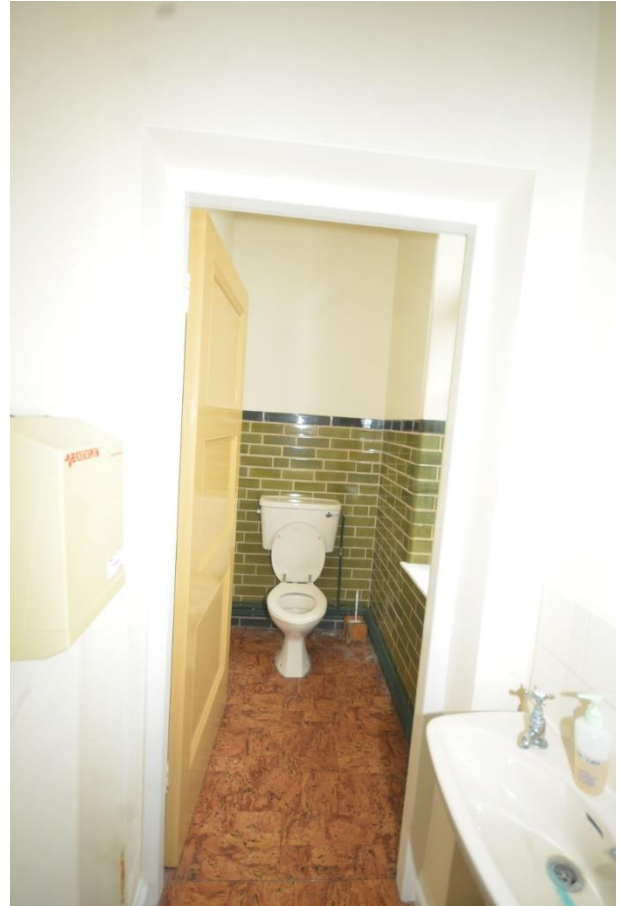
Plate 137: Detail of lavatory

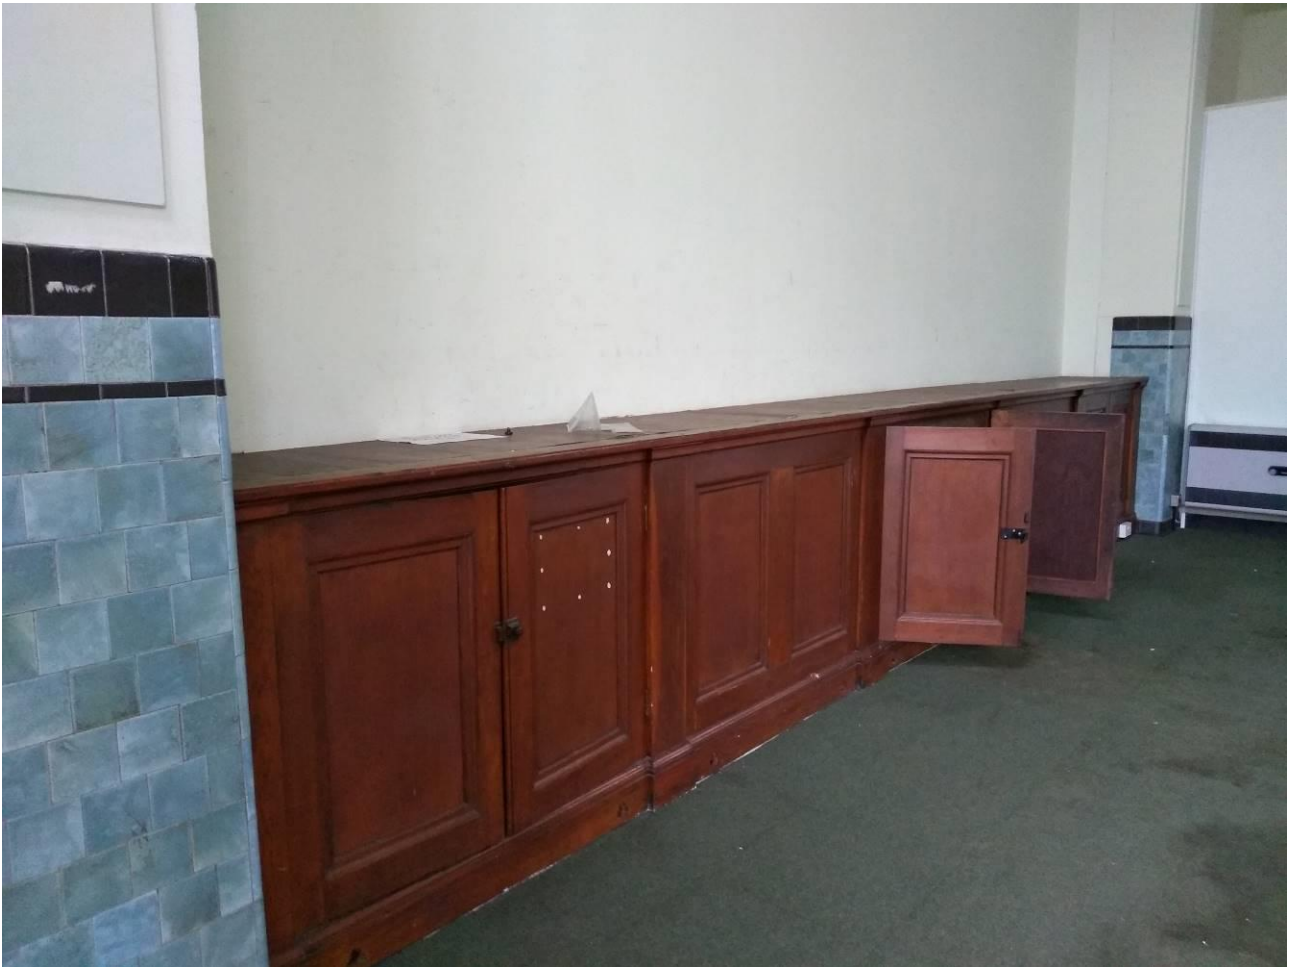
| Comments/Description | The space beneath the stage is divided into five bays and is accessed via three sets of double doors from room 27. Internally, steps give access to the lower level. |

Plate 140: Entrance from room 27

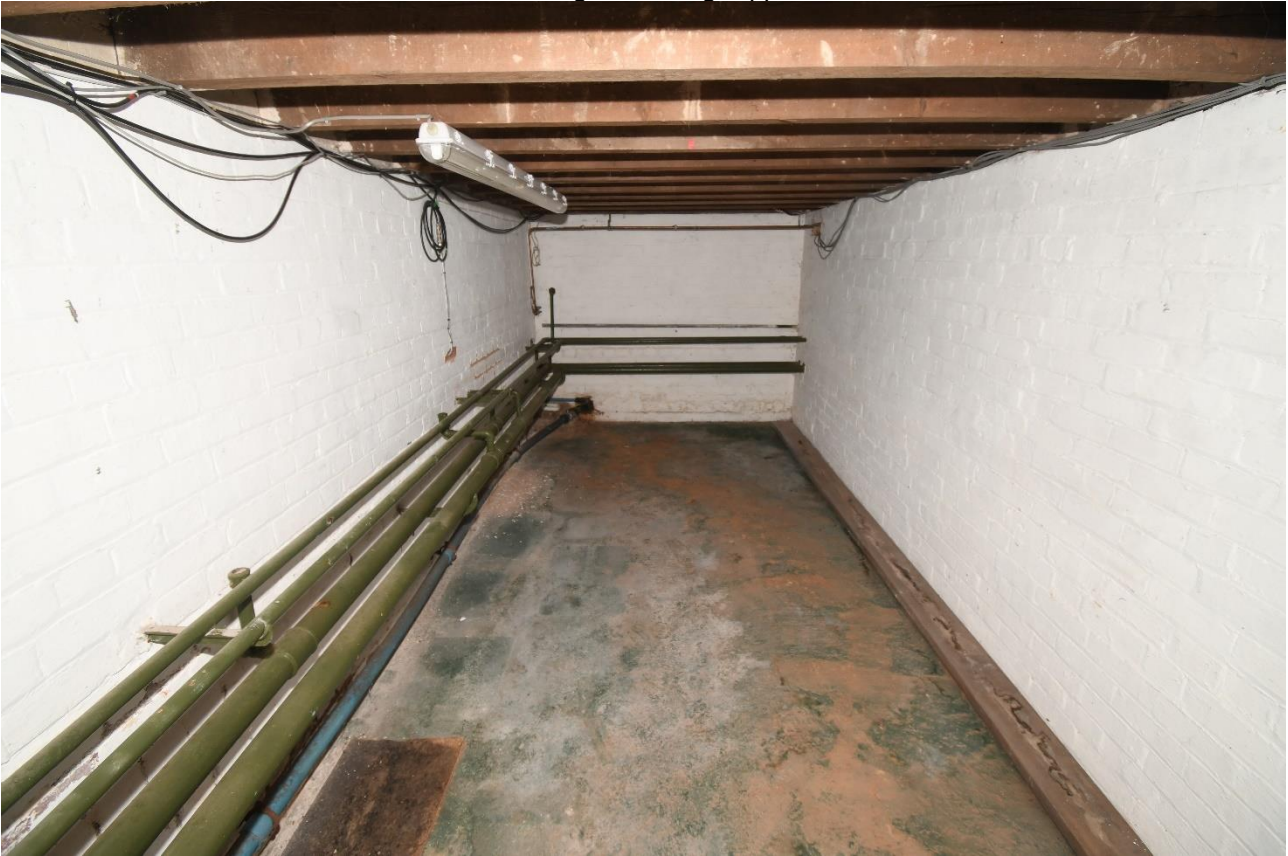
Plate 141: Bay 1 looking northeast

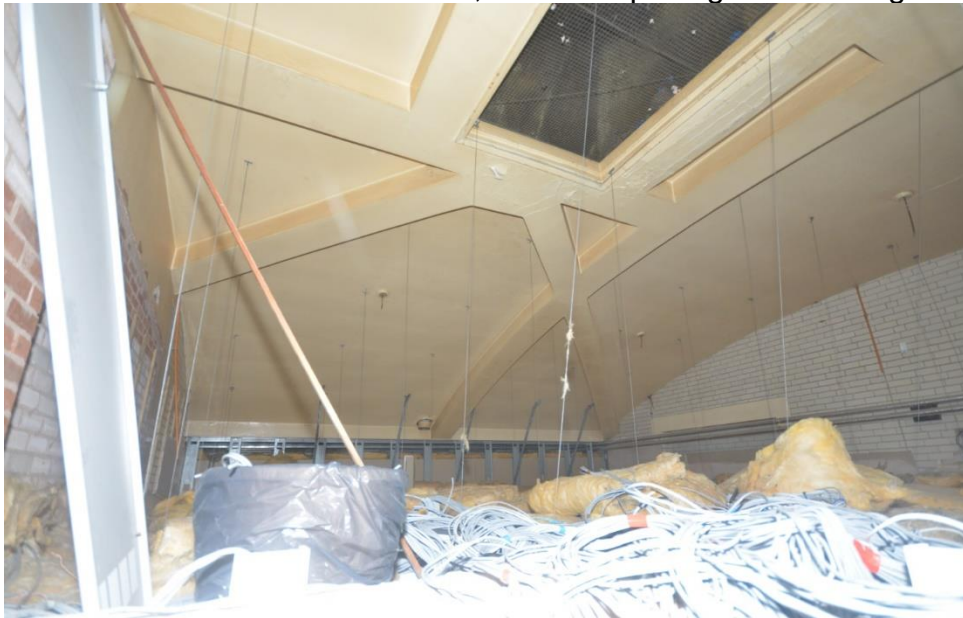
Access to the roof space above room 23 is via the ladder fixed to the wall of room 21. The original roof structure can be seen, with rendered beams forming the structure of the arched roof. A square-mesh grille is present leading into the void at the apex of the roof above the bow of the arched roof. This is considered likely to have been constructed as an air vent.

Plate 147: Northwest aspect, roof space, showing rendered beams

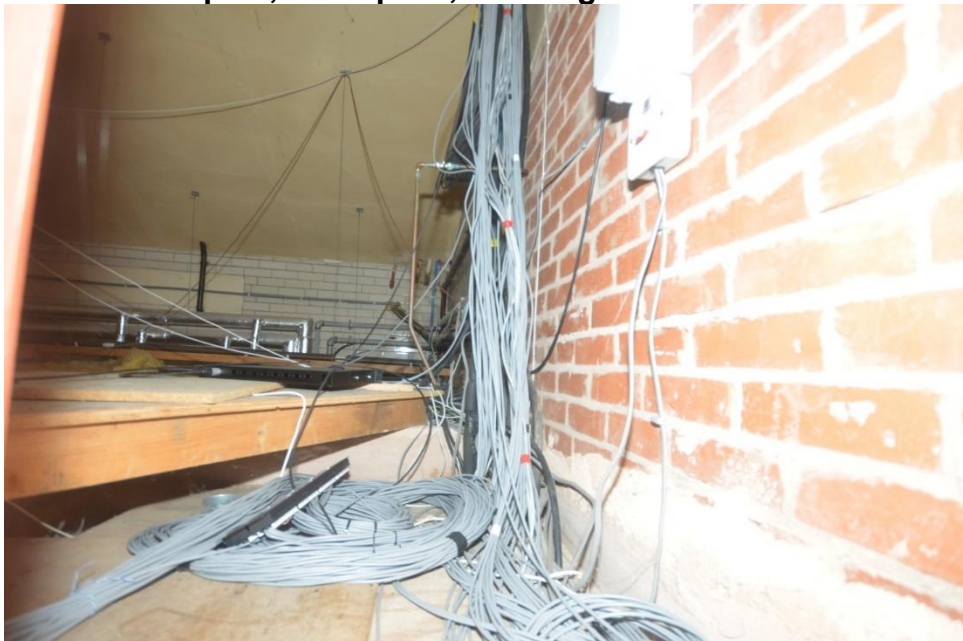
The northwest, northeast and southeast walls are seen to be constructed of white glazed brick. The southwest wall is of plain brick. All brickwork is in stretcher bond.

Plate 148: Southeast aspect, roof space showing brick wall

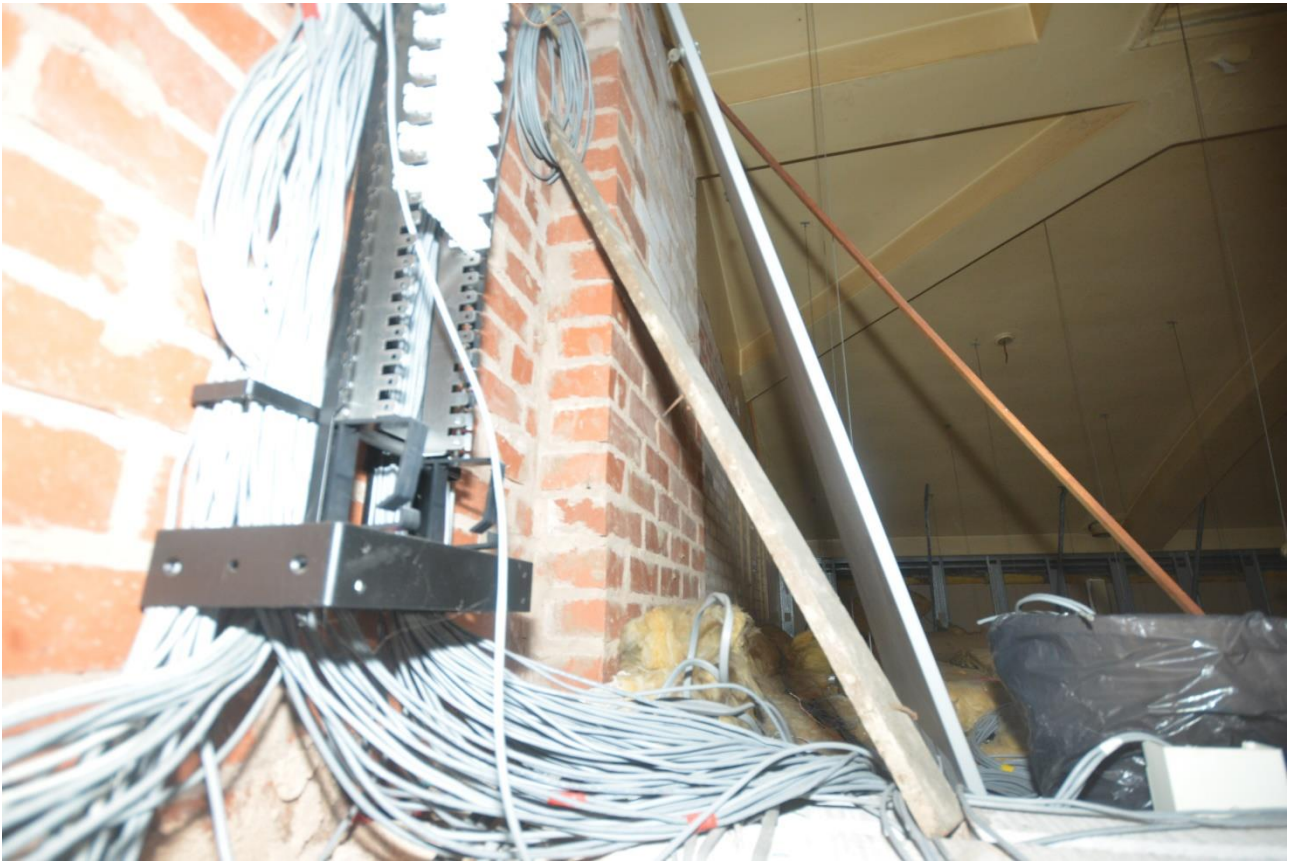
Plate 149: Cable distribution

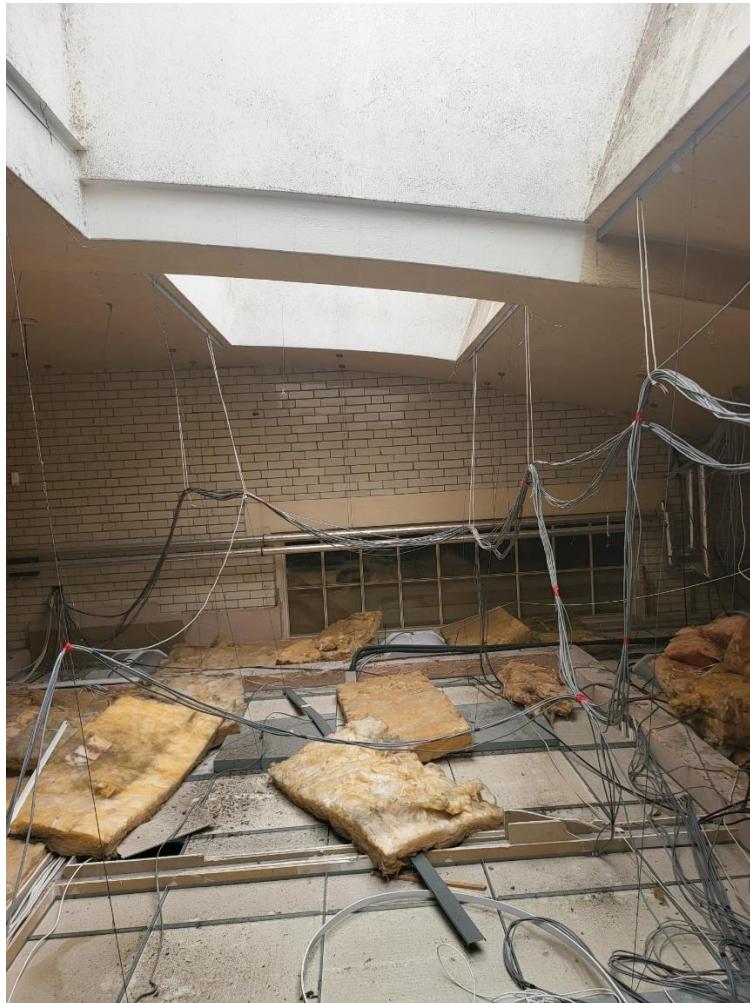
The roof has a number of recessed windows, each comprising four fixed lights.

Plate 150: Roof space showing window openings

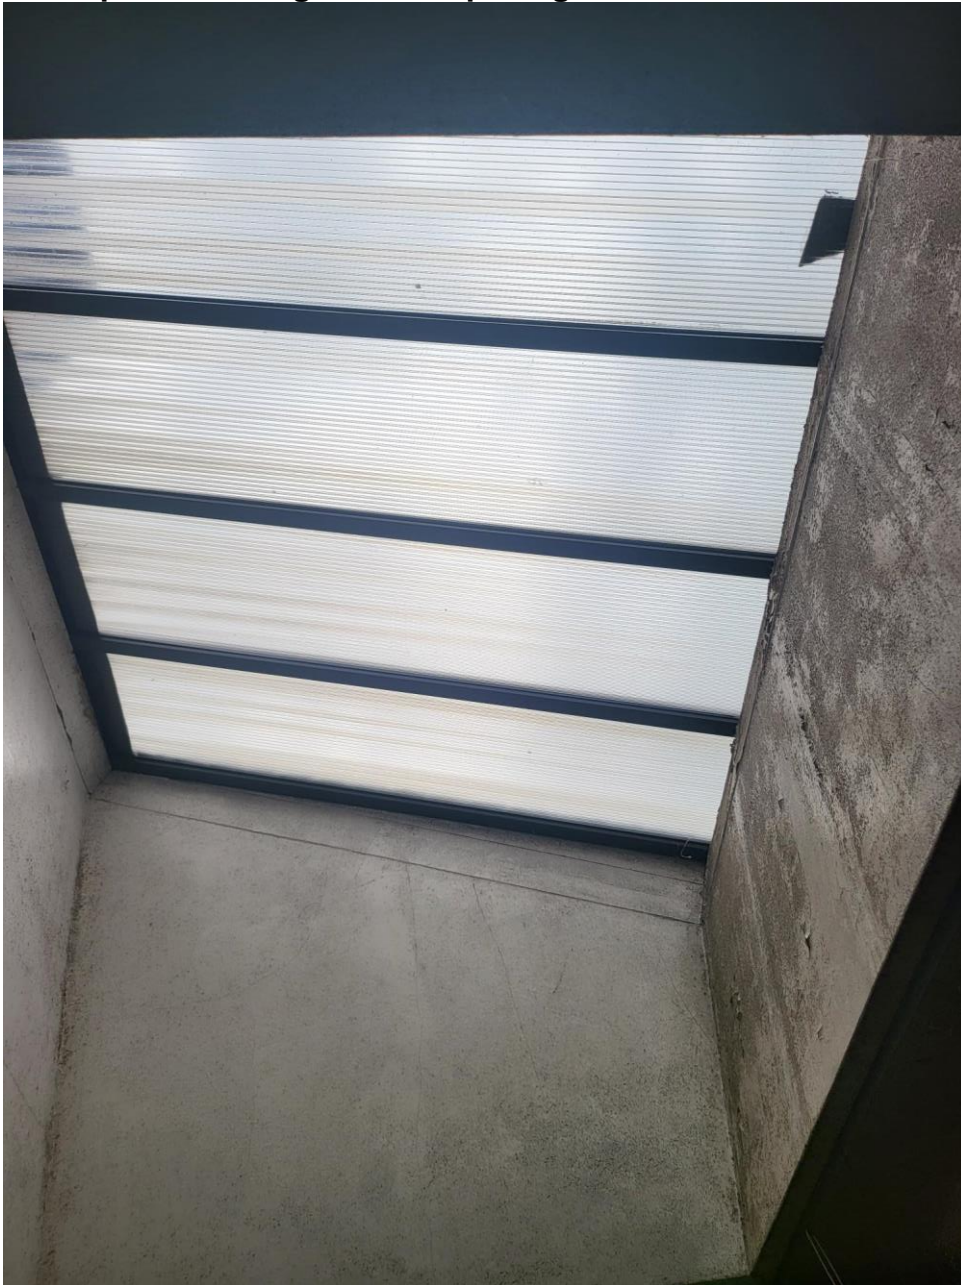
Plate 151: Detail of window

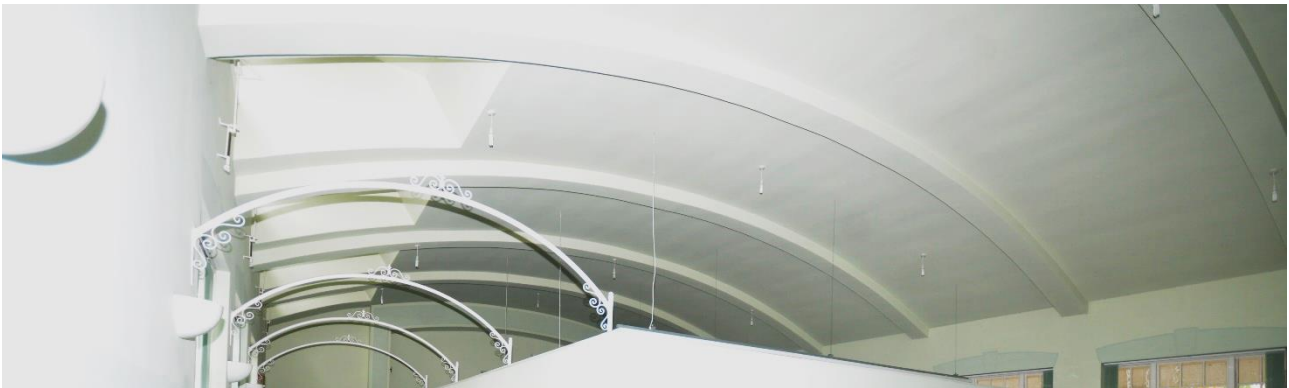
The roof over the former auditorium is formed from arched concrete beams. These beams are rendered / plastered, then painted, concealing any details of their construction.

The roof structure is described in the Listing Description as *“the concrete-ribbed roof structure above the former concert hall proved an effective and unusual technological achievement for this period”*

Plate 152: Detail of straight concrete arched beams over main auditorium

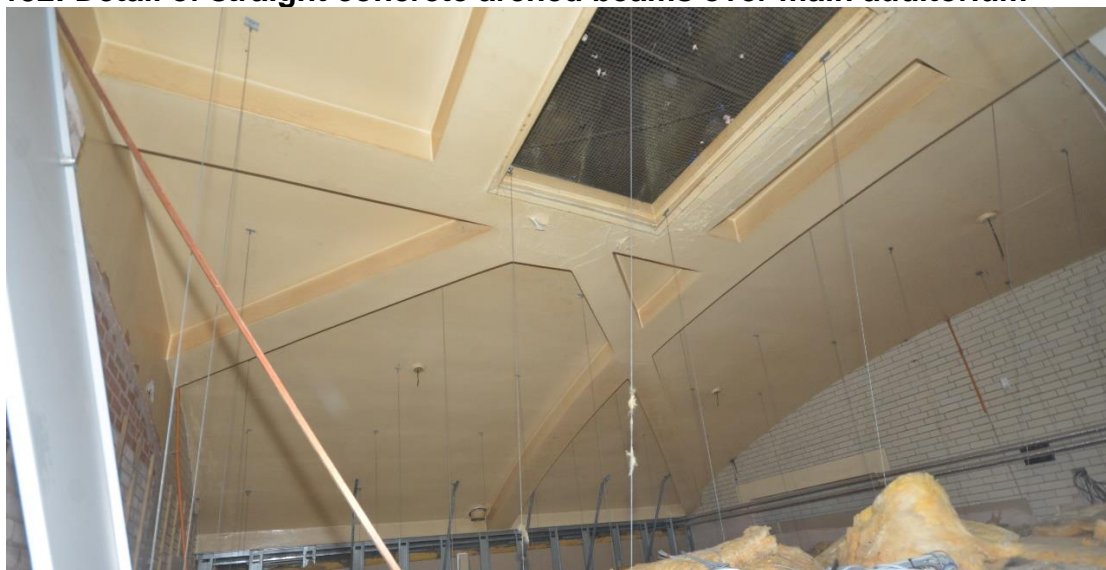
It is noted that the structure over the auditorium comprises beams running perpendicular to the auditorium itself, whereas those recorded in the roof space above are angled. It is clear that the roof structure at its southwest end features angled bracing against the end wall and around openings, to maintain structural integrity. A similar arrangement is anticipated above the suspended ceilings in the rooms at the northeast end of the building, above the former stage and adjacent rooms.

Plate 153: Detail of bracing formed by arched concrete beams, southwest of main auditorium

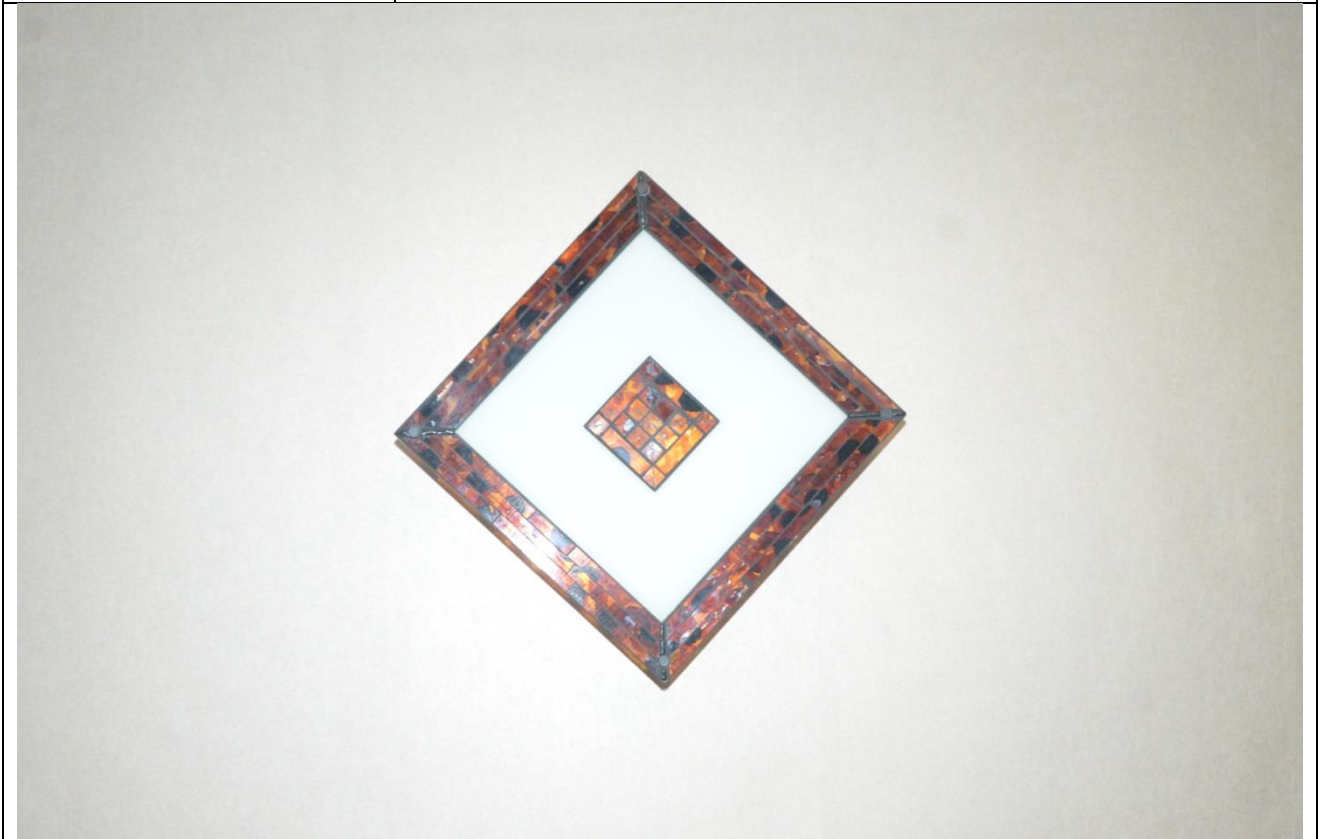
| Feature | Ornamental diamond-shaped lights on the northeast and southwest walls. |
| Location | Room 1 |

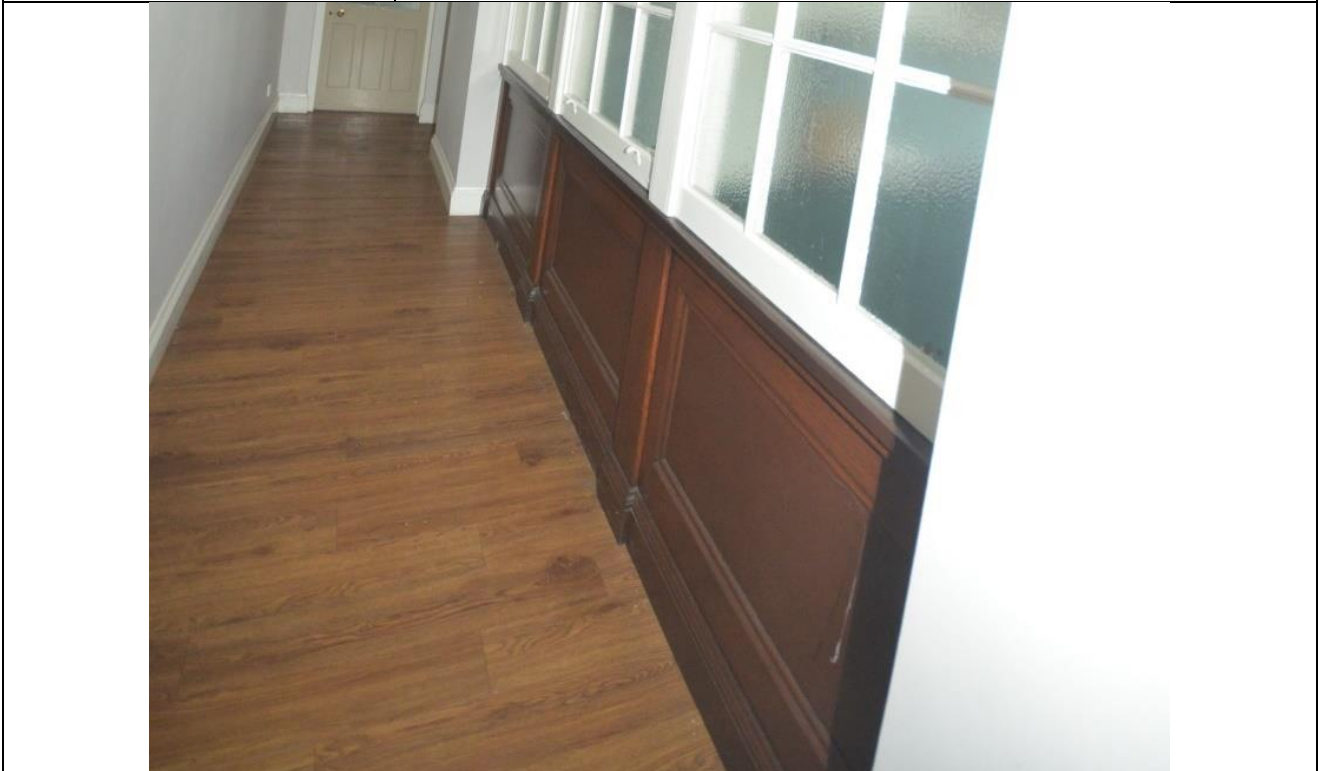
| Feature | Wood panelling |
| Location | Room 17 |
