## Appendix 3: Level 3 Building Recording of **Boundary Walls, Railings and Gates**

Blue Bird Park  
Bromsgrove Road  
Hunnington  
Worcestershire  
B62 0JW

Document Reference Number 2023/1681

**Building Recording of: Boundary Walls, Railings and Gates**  
**Dr Peter Wardle & Colin Lacey**

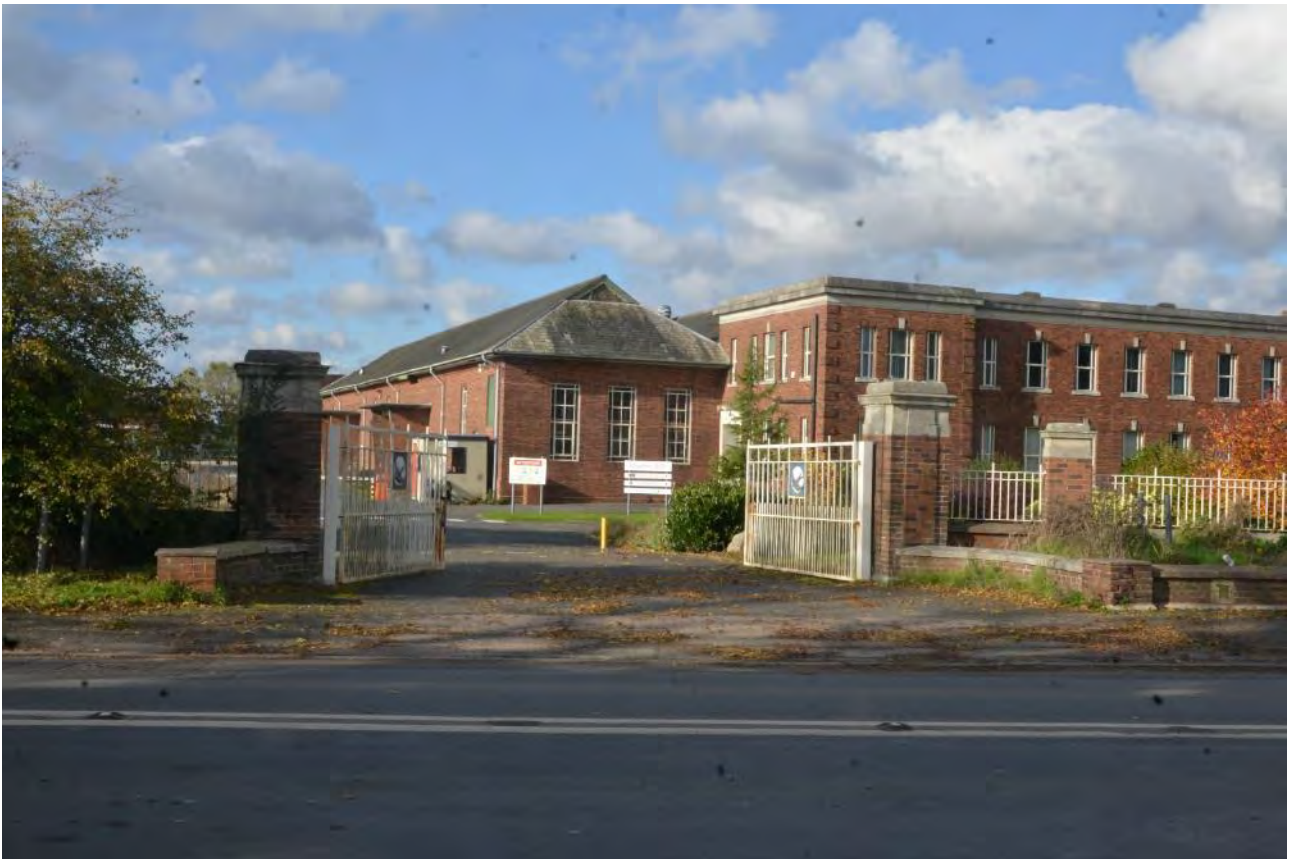
**Plate 10 Southwest gates (vehicle), open**

The southwest gates are set between two brick piers with ashlar heads. At the foot of each pillar, a low curved wall with ashlar cap runs to the pavement. To the northeast of the gateway, this wall continues along the edge of the pavement, creating a flower bed / planter between this low wall and the main front wall.

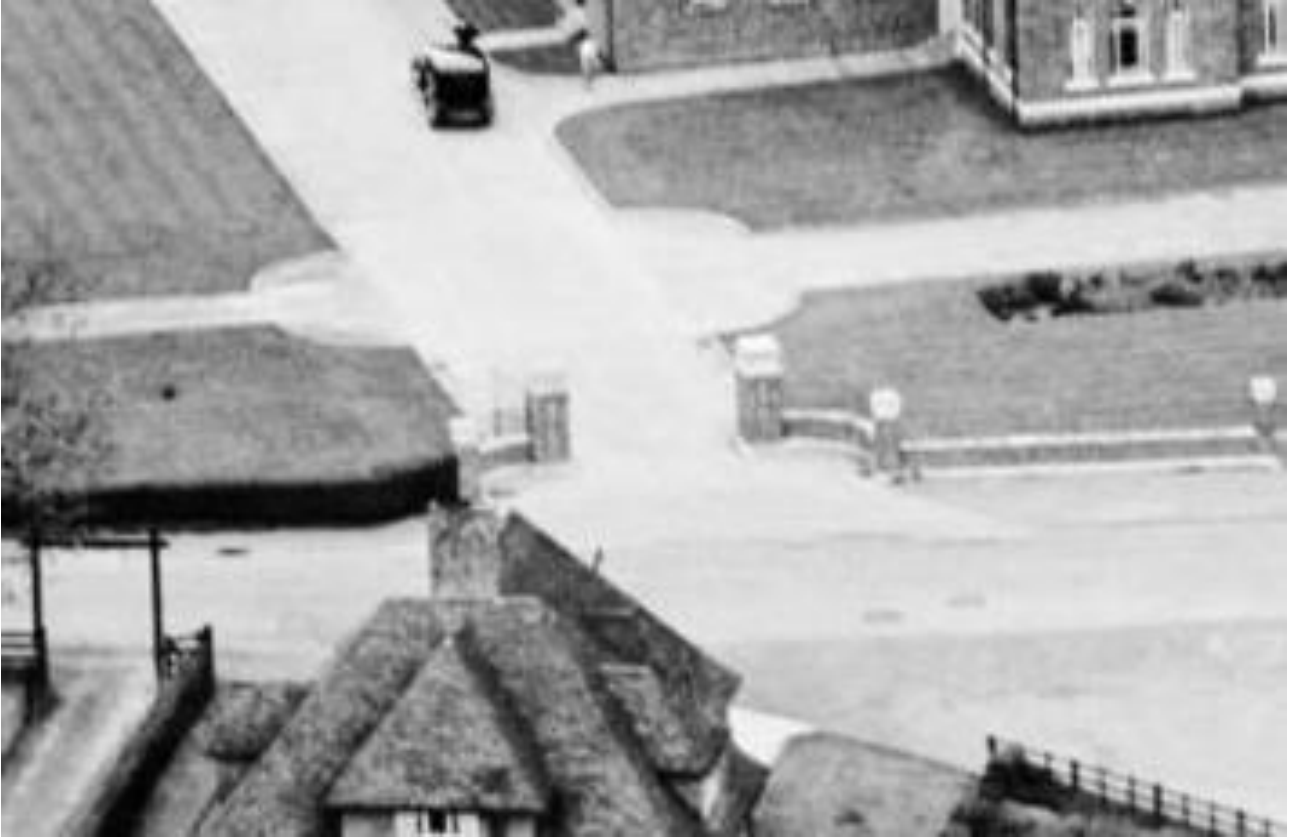
Comparison of historic photographs with modern photographs indicates that the wall, gates and railings have been altered. The gate opening has been widened slightly and the wall and railings to the northeast of the gateway have been moved away from the edge of the pavement, leaving the planter / flower bed in the intervening space. Owing to the wider gateway, the gates themselves must post-date this work. The date of the work is unknown.

**Plate 11: View of southwest entrance in 1936 showing original layout**

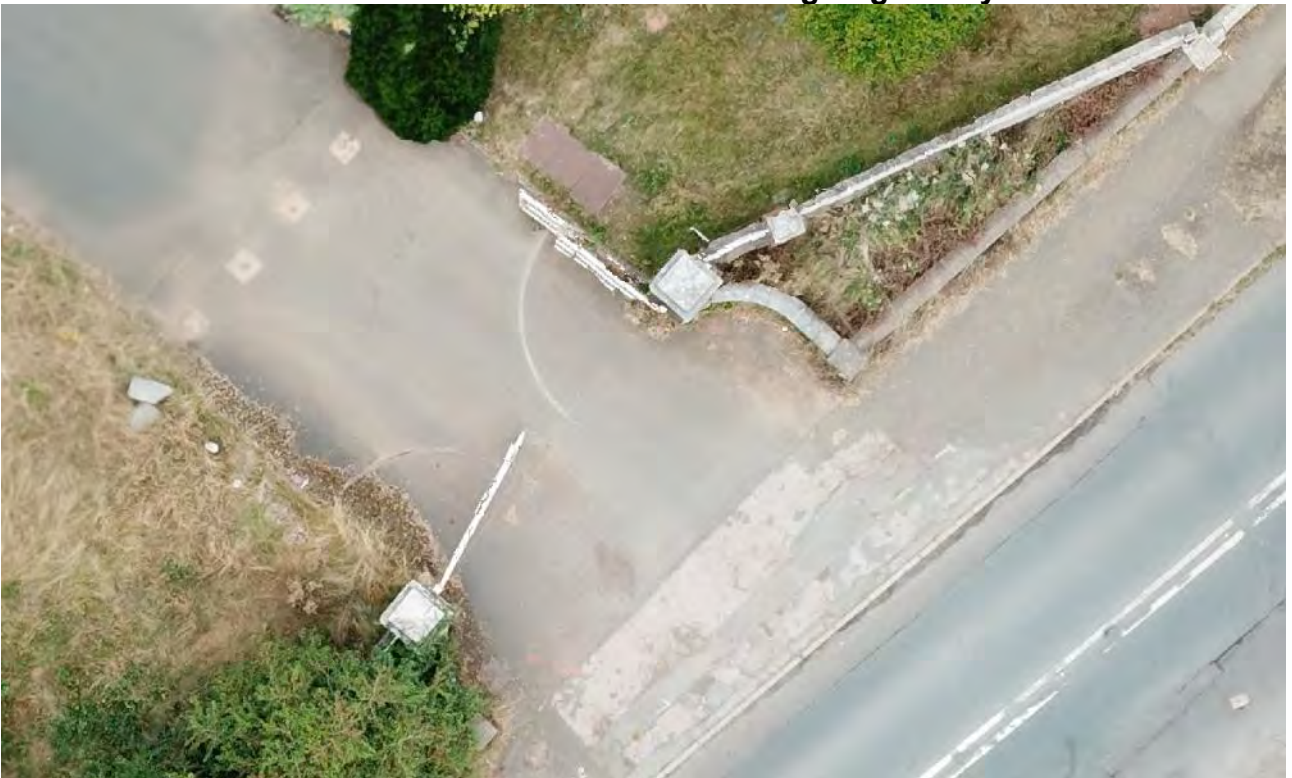
**Plate 12: 2022 Aerial Photograph showing current layout**

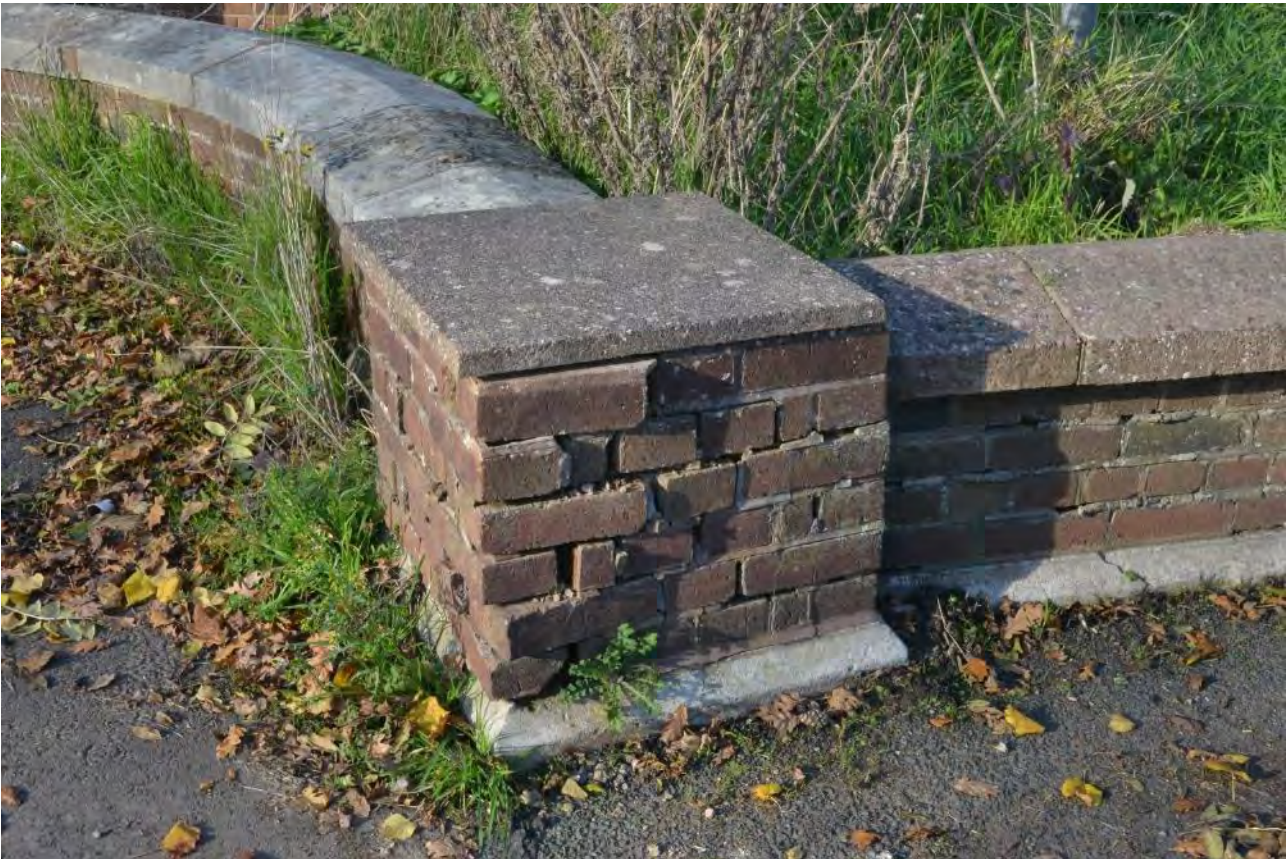
It is likely that numerous collisions occurred with vehicles turning off of the road, so the wall was moved away from the path of swinging vehicles. There is collision damage to the current lower wall since the main wall and railings were moved. This reinforces this suggestion.

**Plate 13: Corner of low wall to northeast of gate, showing collision damage**

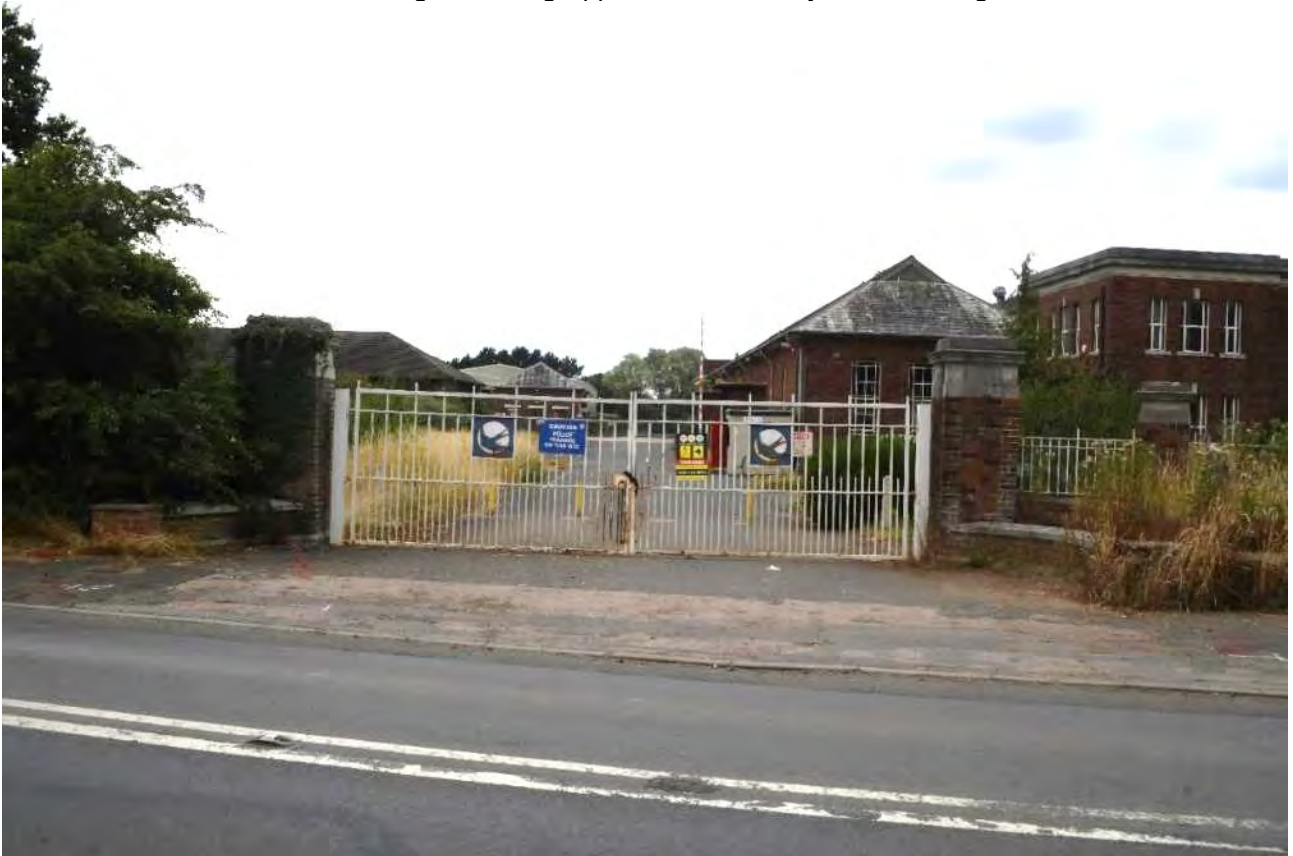
The gates themselves are hinged from the substantial brick piers with ashlar capping. Each gate features a square panel bearing the Blue Bird insignia.

**Plate 14: Southwest gates (vehicle), closed, viewed from outside**

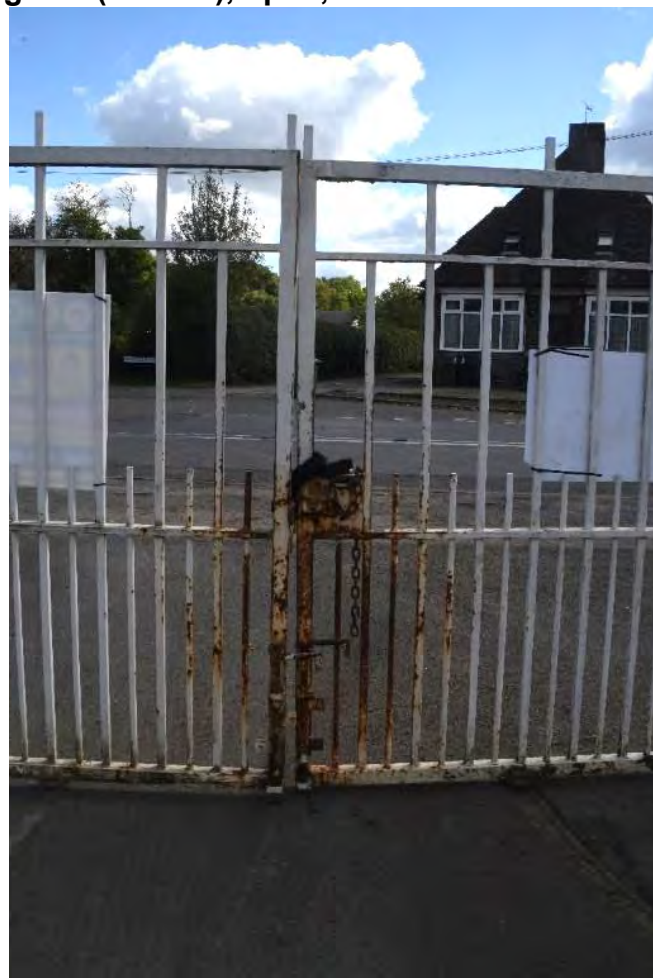
**Plate 17: Detail of gate closure**

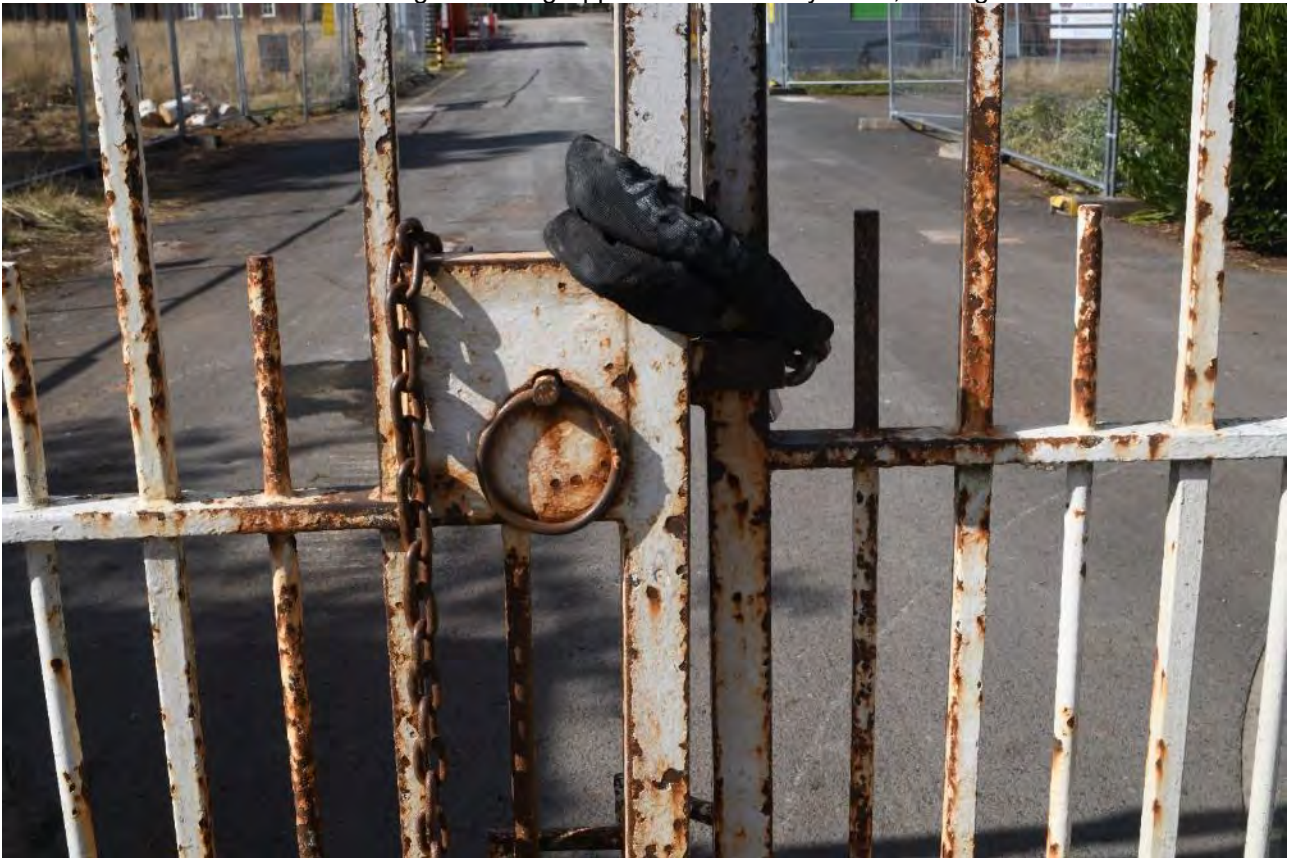
**Plate 18: Detail of gate latch (exterior)**

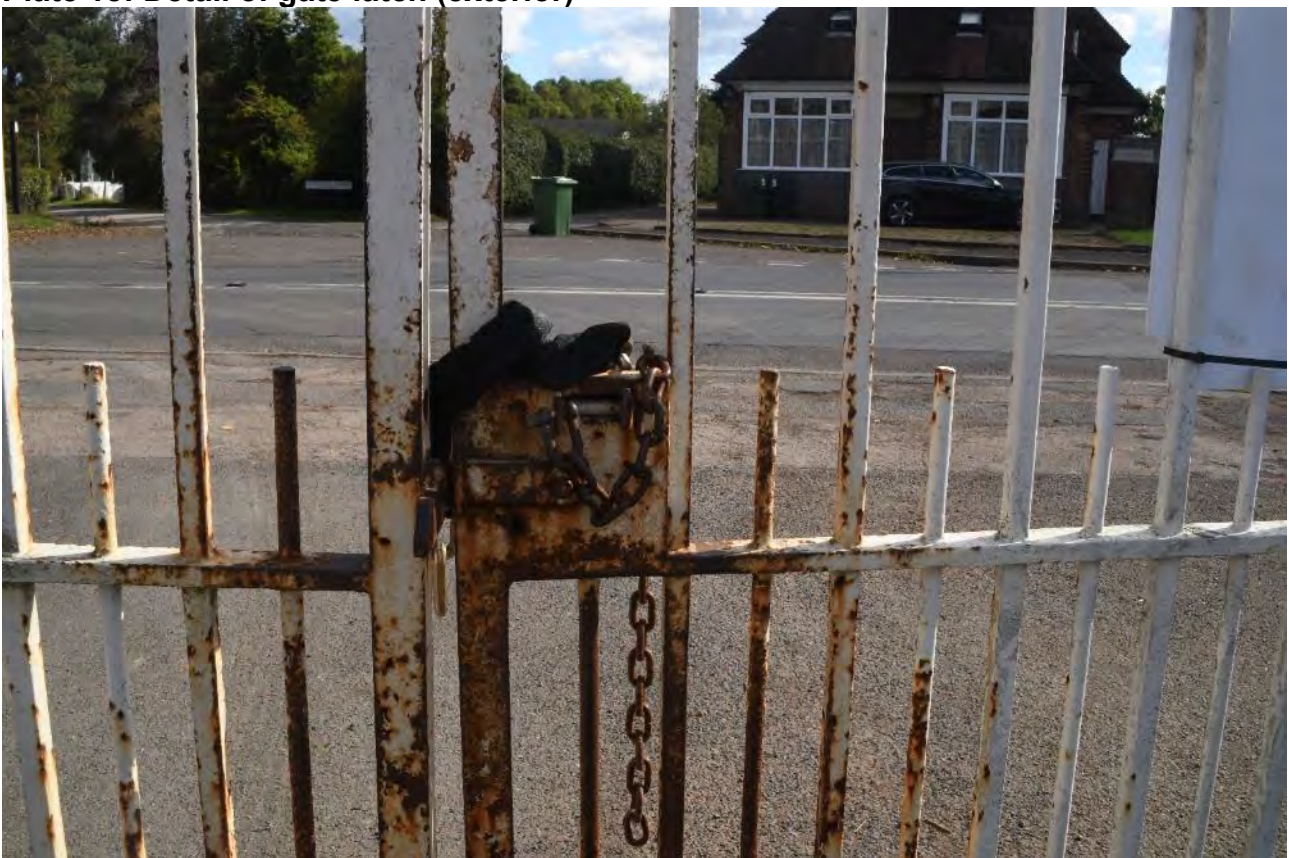
**Plate 19: Detail of gate latch (interior)**

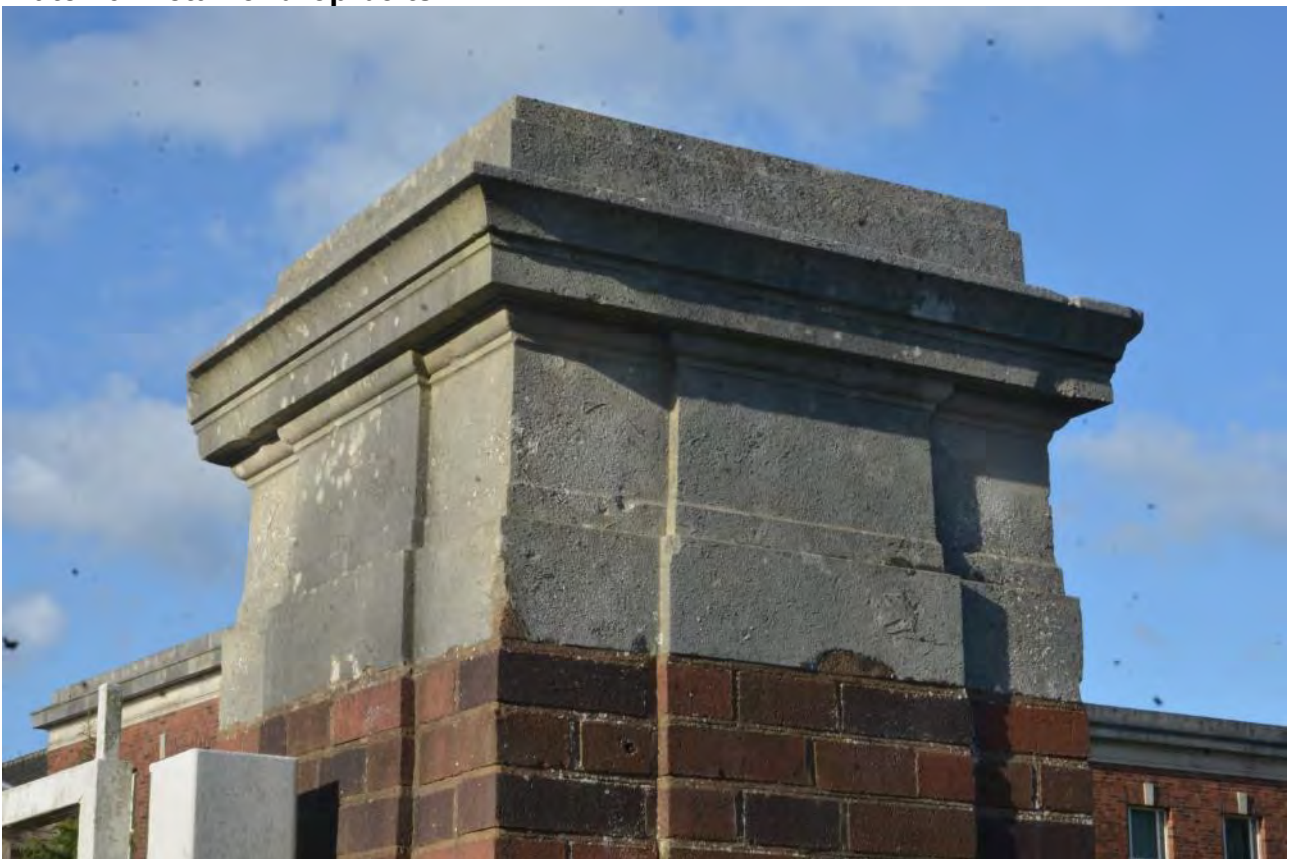
**Plate 21: Detail of head of gate pier**

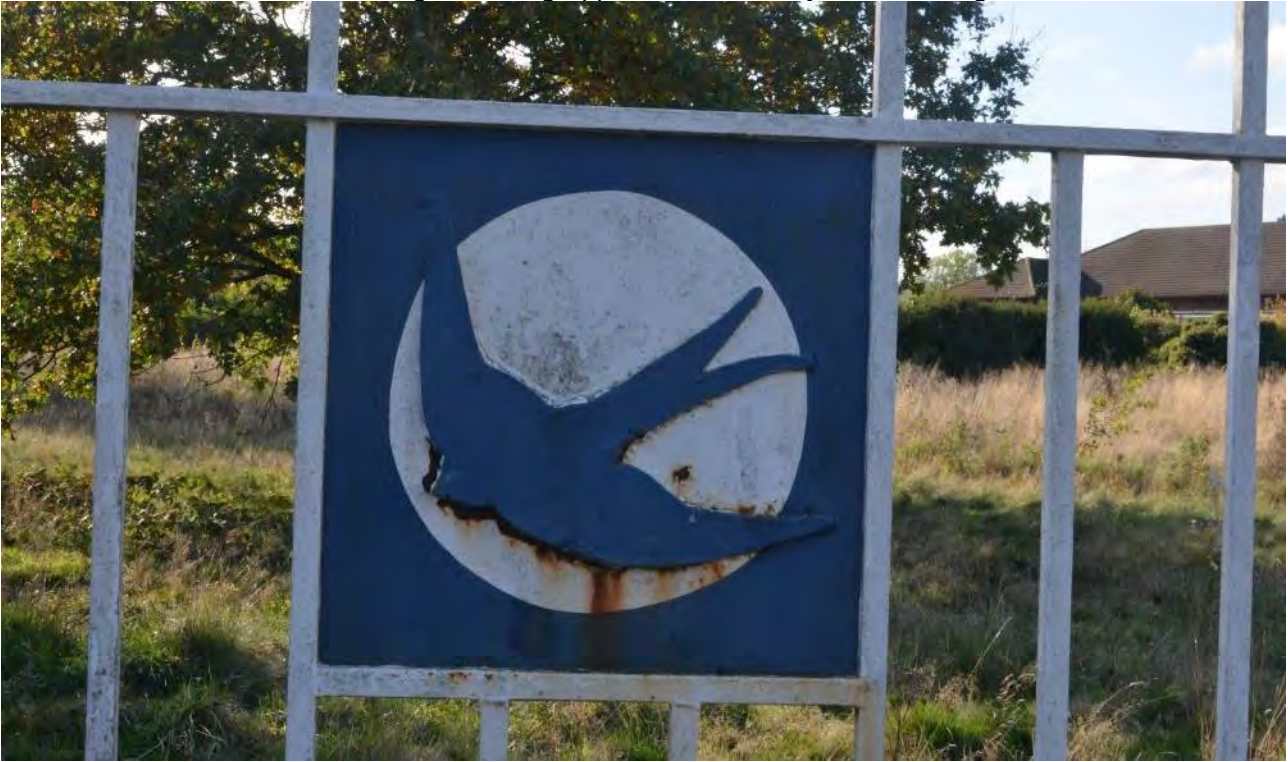
**Plate 22: Detail of Blue Bird insignia fitted to gate**

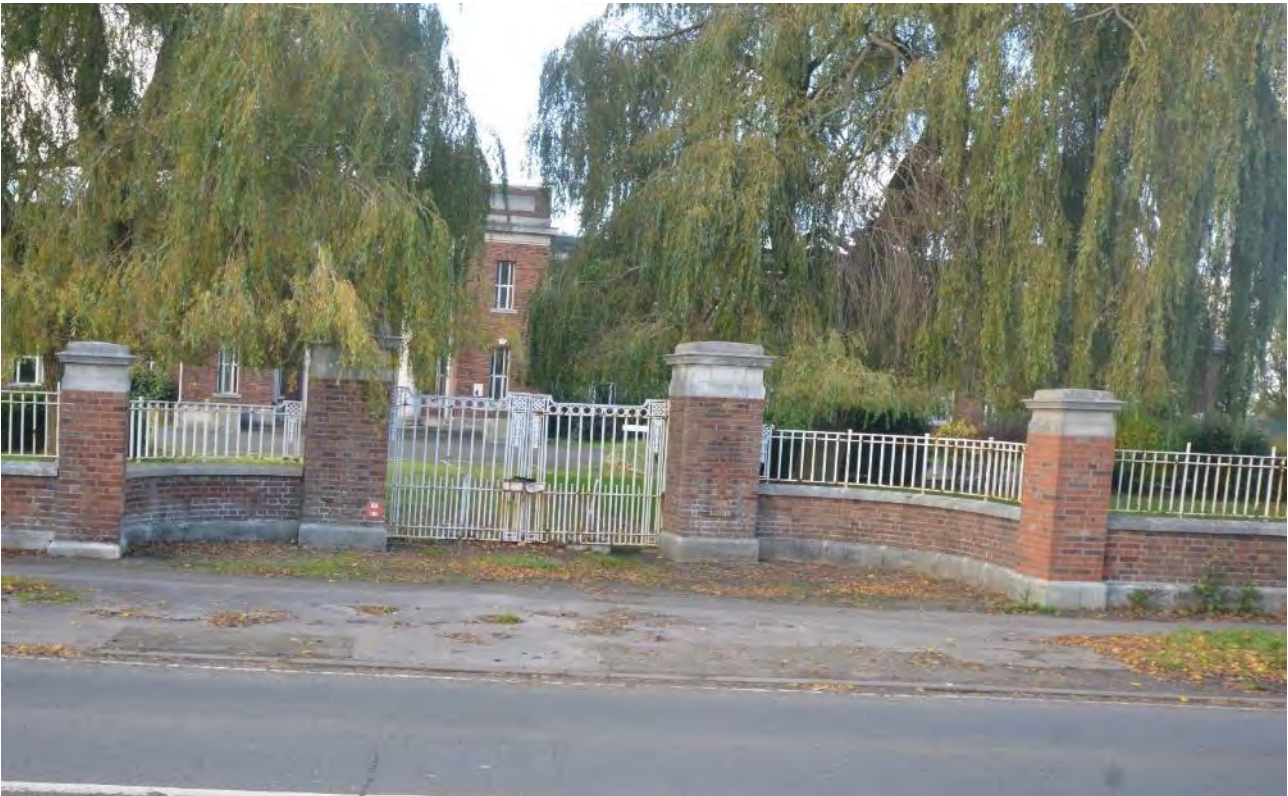
The central double gates are thought to have been intended for pedestrian use. The gates are set back from the line of the pavement with a curved wall at each side. These walls have brick piers at each end and are fitted with ashlar caps and railings following the shape of the curve. There is no brand insignia on these gates.

**Plate 23: Central gates (pedestrian), outside**

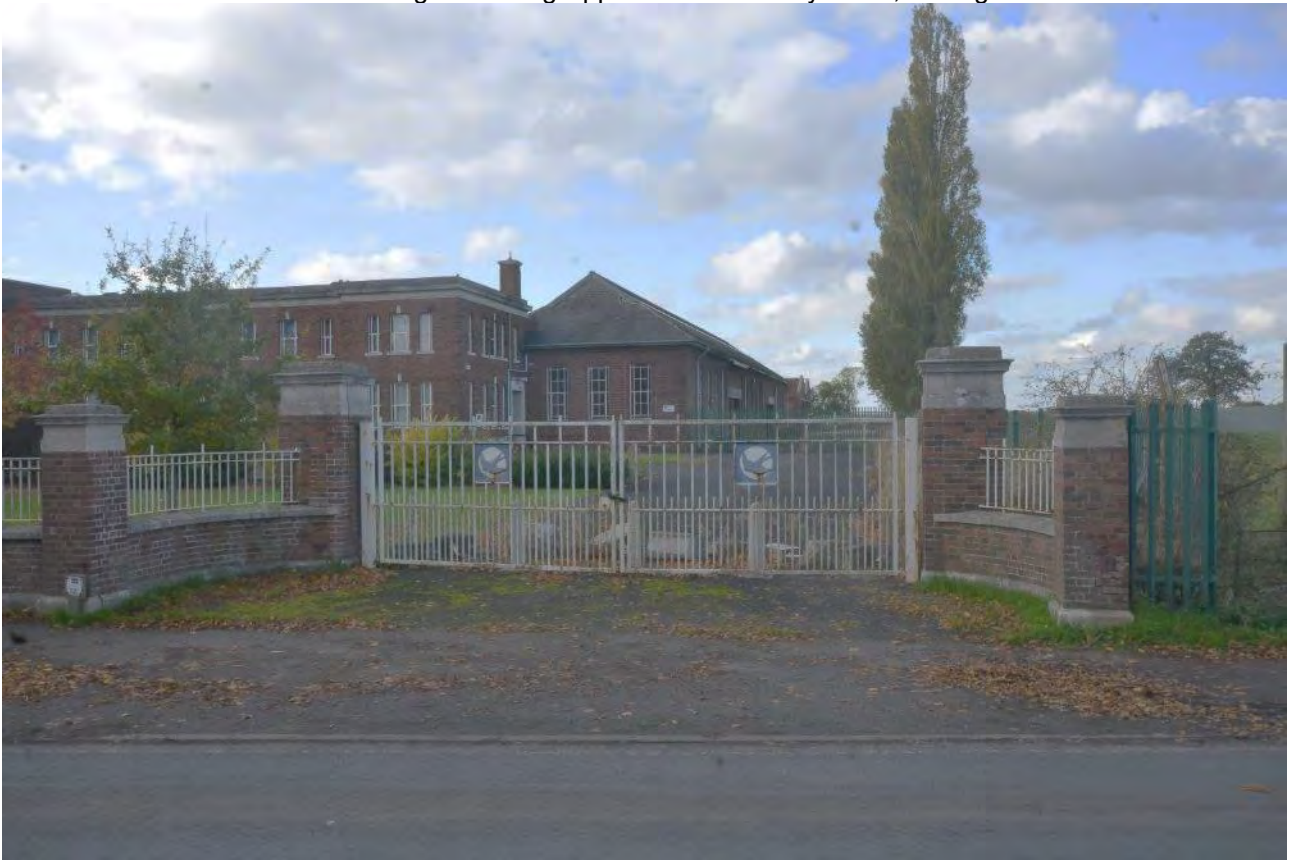
**Plate 26: Northeast gates (vehicle), outside**

The northeast gates are vehicle gates, opening on to the northeast side of the administration and factory buildings. The gates follow the same pattern as the vehicle gates to the southwest, with a square panel bearing the Blue Bird insignia.

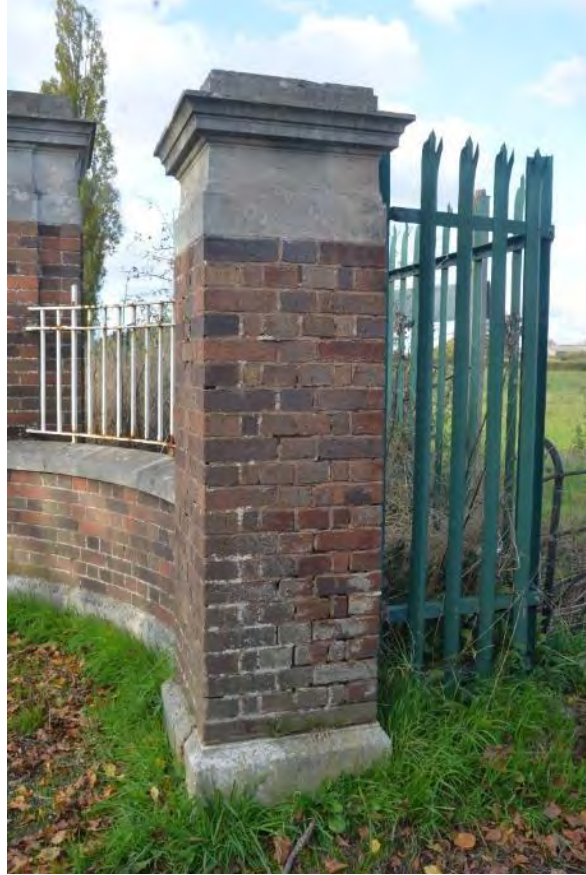
**Plate 28: Detail of brick pier adjacent to northeast gate**

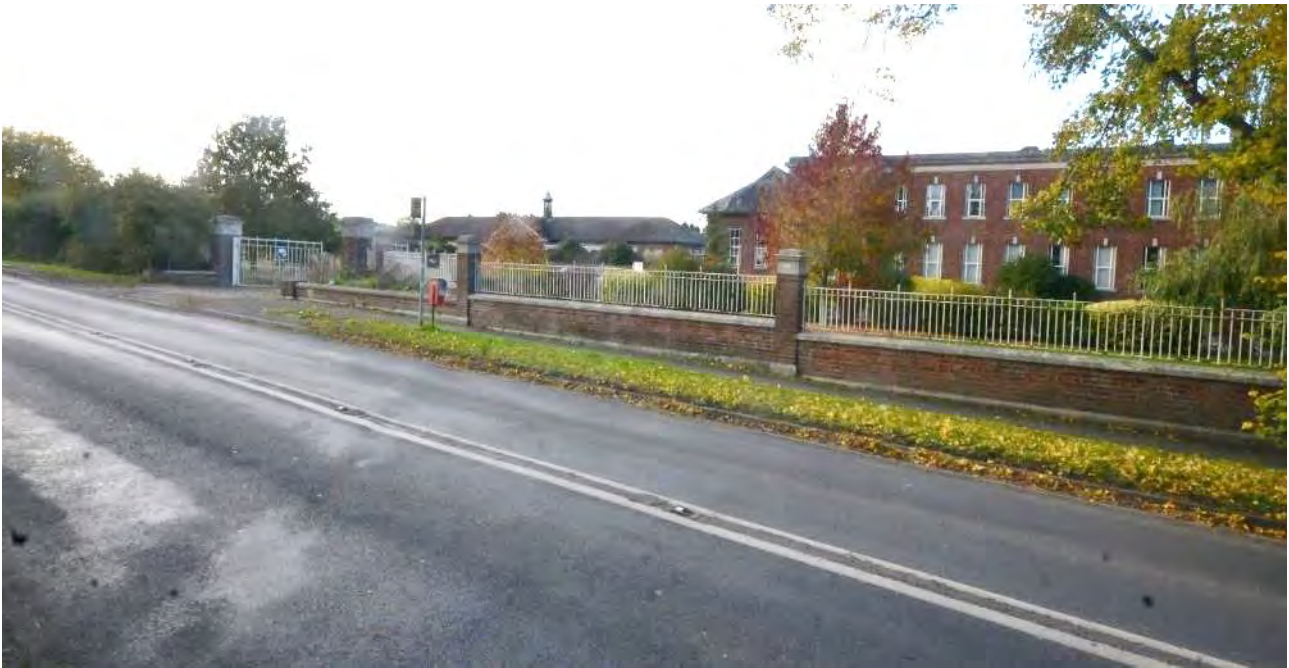
**Plate 30: Boundary wall, external**

Views of the outer face of the boundary wall follow, taken from southwest to northeast (left to right). Along the length of the wall, railings supported by brick piers can be seen.

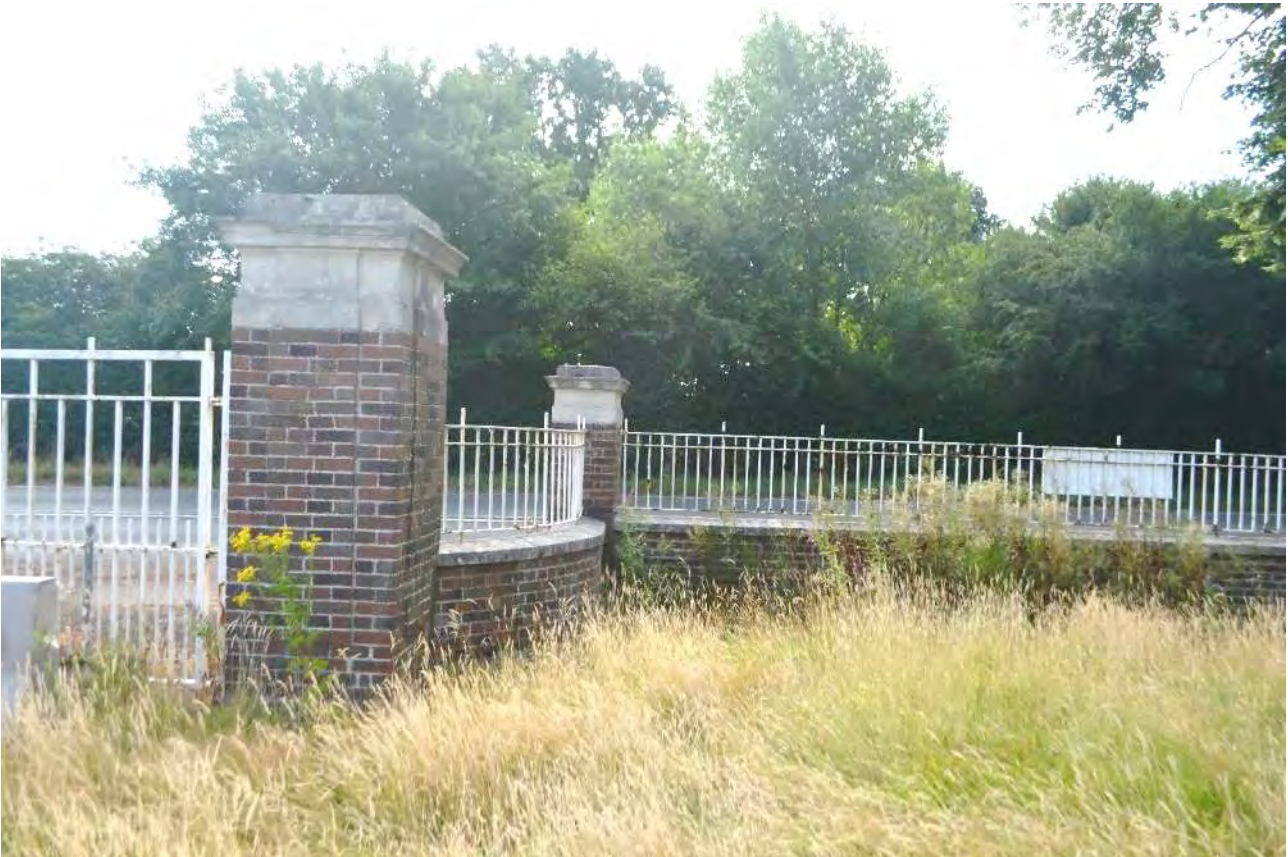
**Plate 35: Boundary wall, internal**

The internal face of the wall is depicted from northeast to southwest (left to right):
