Level 3
Building Recording of
Manufactory
Blue Bird Park
Bromsgrove Road
Hunnington
Worcestershire
B62 0JW

Planning Reference Number: 19/00592/FUL
OASIS ID: thearcha1-516388
HER Event No. WSM80084

Document Reference Number 2023/1681

Dr Peter Wardle & Colin Lacey

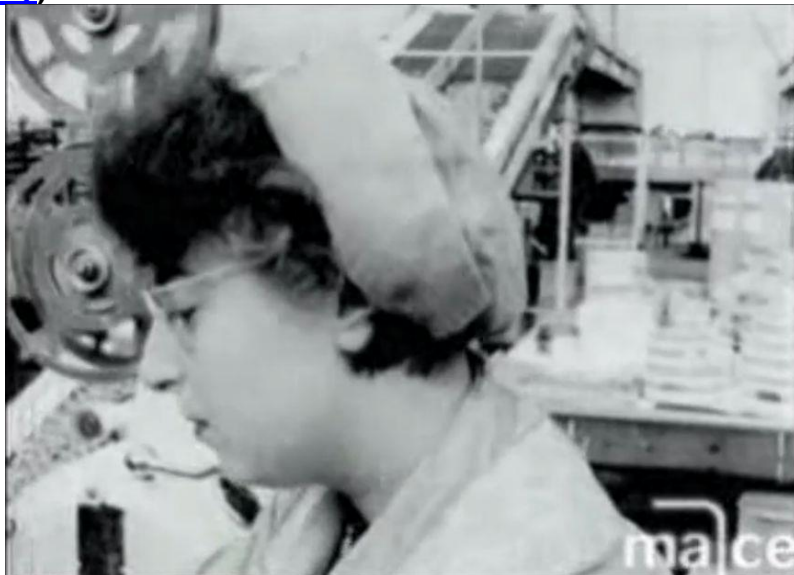
Plate 9: Machinery between two mezzanine floors / platforms, 1958 (still from Midlands News, <https://www.macearchive.org/films/midlands-news-02061958-donald-campbell-blue-bird-toffee-factory>)

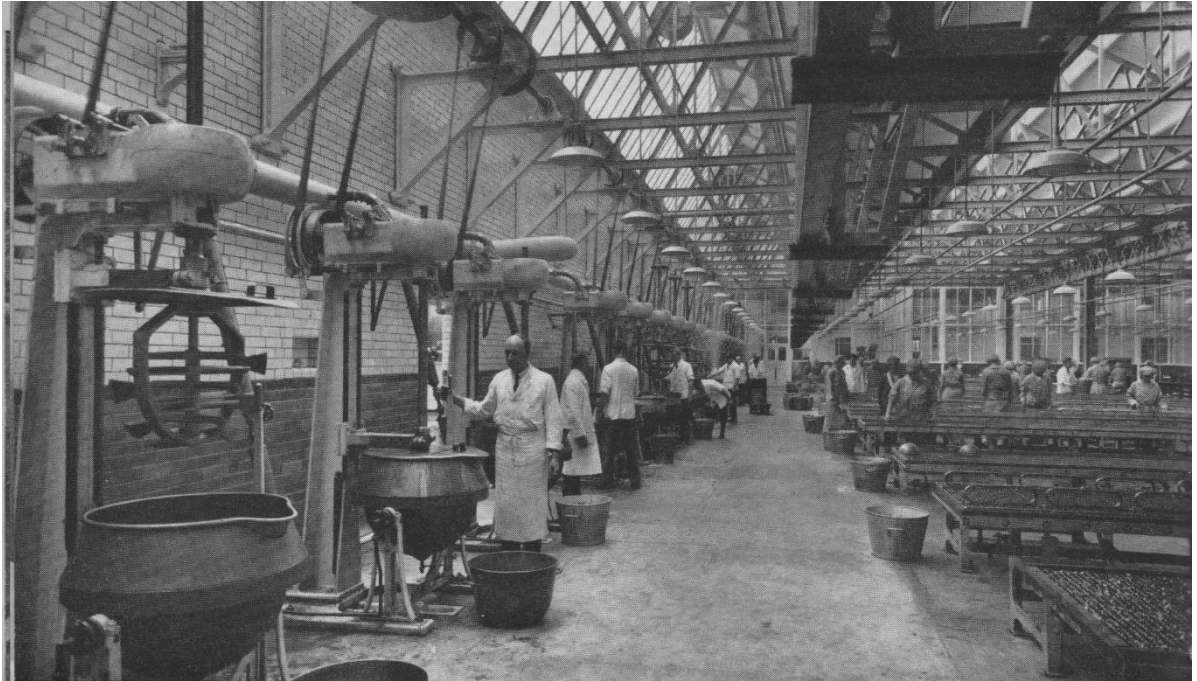
Plate 15: Manufactory boiling pans, 1930s (Mid Pastures Green)

It is noted from historic images that cooling tables were located in the southern part of the boiling room and further machinery positioned to the northwest outside the door of Room 10.

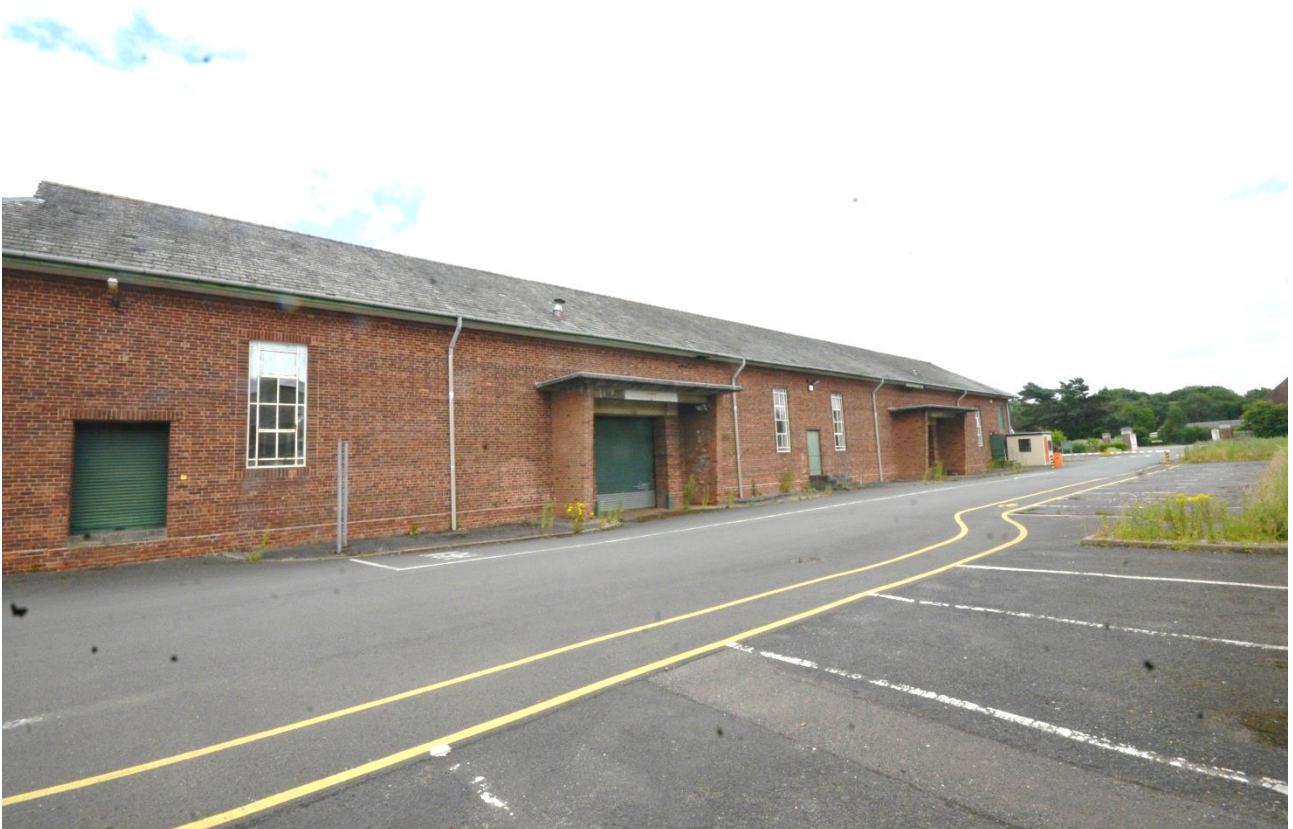
Plate 28: Southwest elevation

Loading doors on the southwest elevation have canopies over, whereas those to the northeast do not. This may be an indicator of the prevailing wind direction.

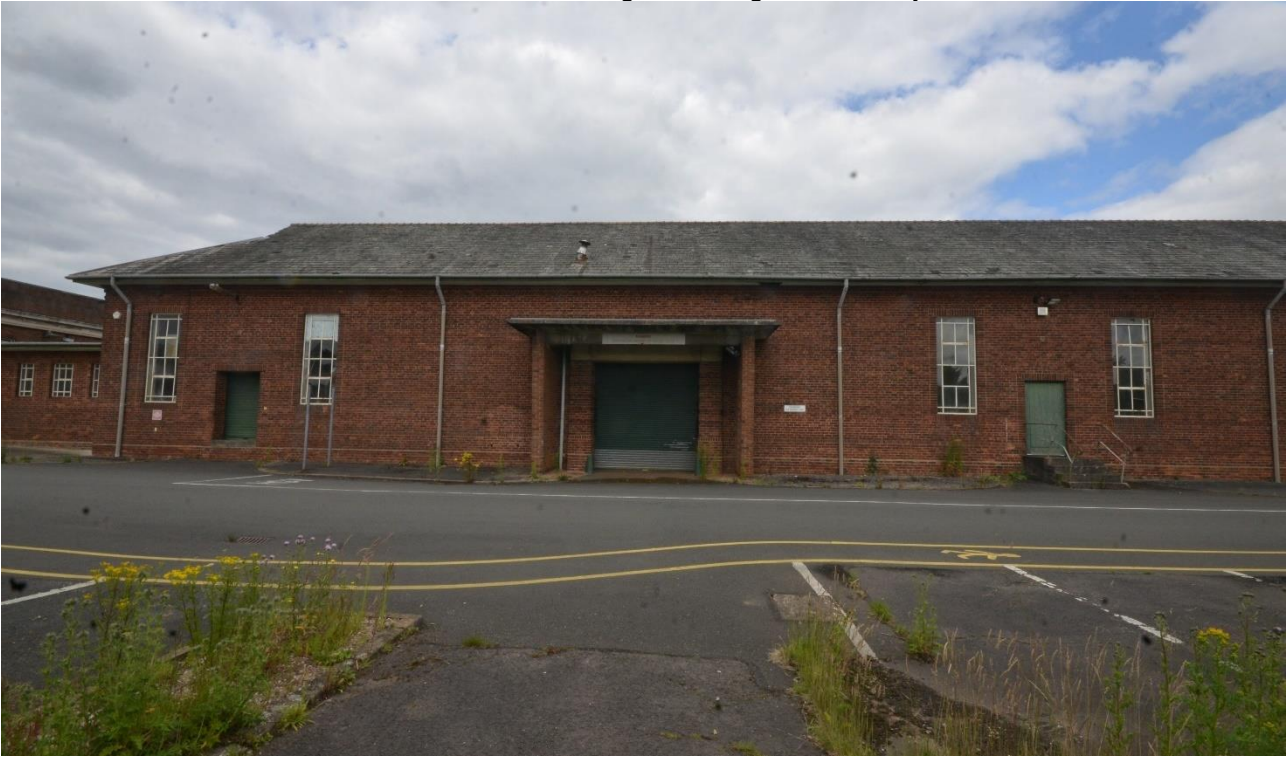
Plate 29: Northwest part of southwest elevation

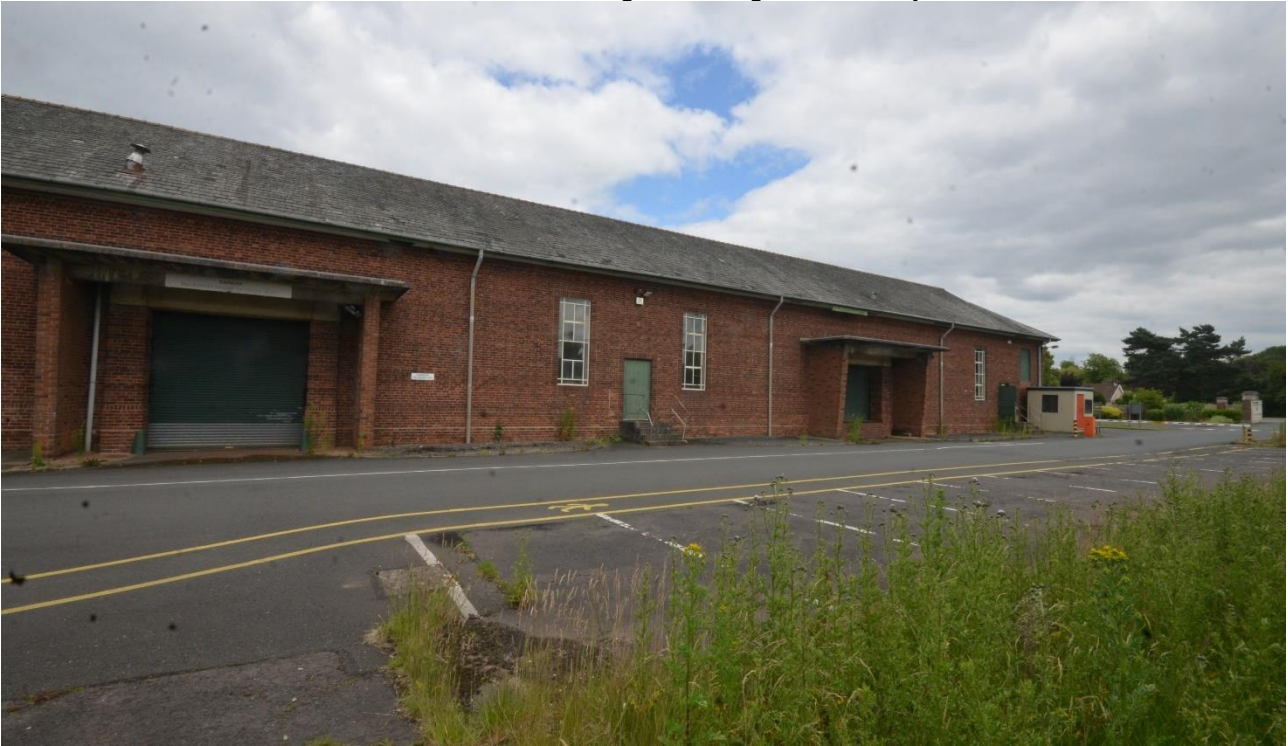
Plate 31: Southeast part of southwest elevation

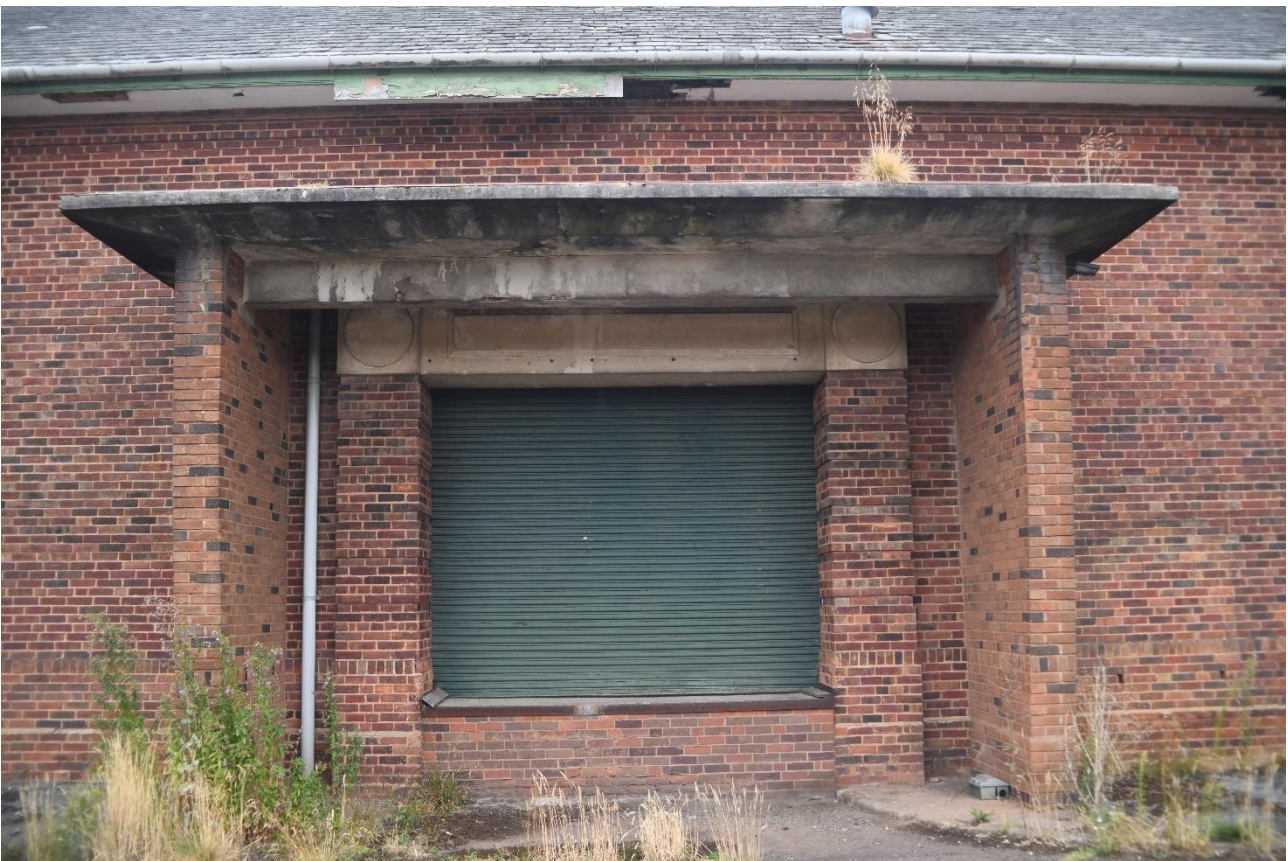
Plate 32: Detail of loading bay

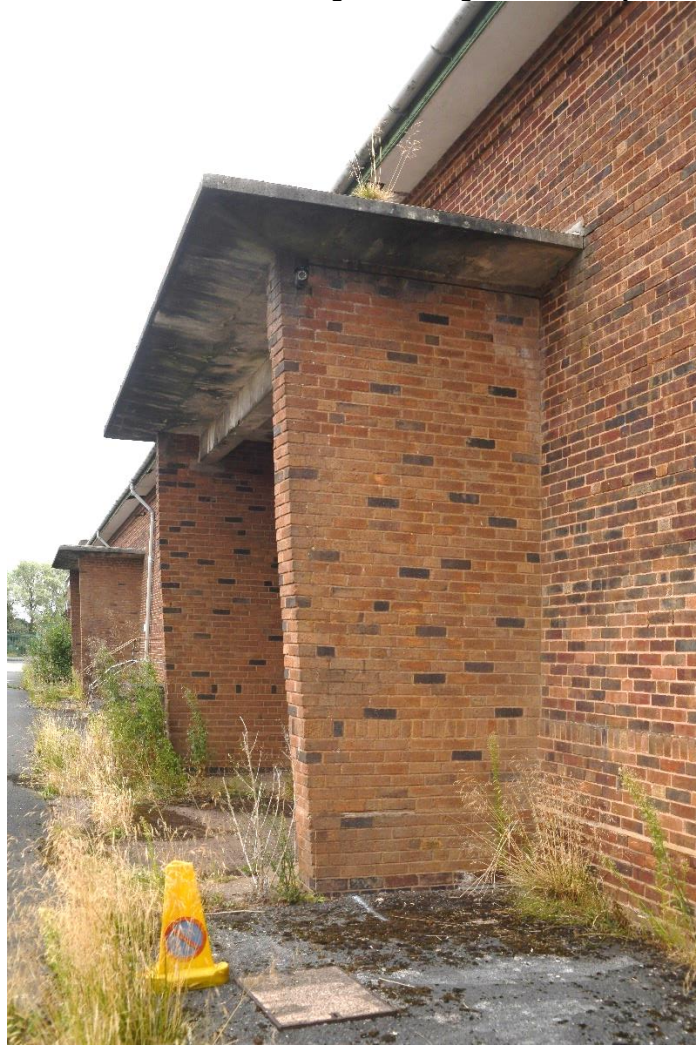
The canopies have flat roofs and are supported on angled brick walls either side of the door opening.

Plate 33: Profile of loading bay canopy

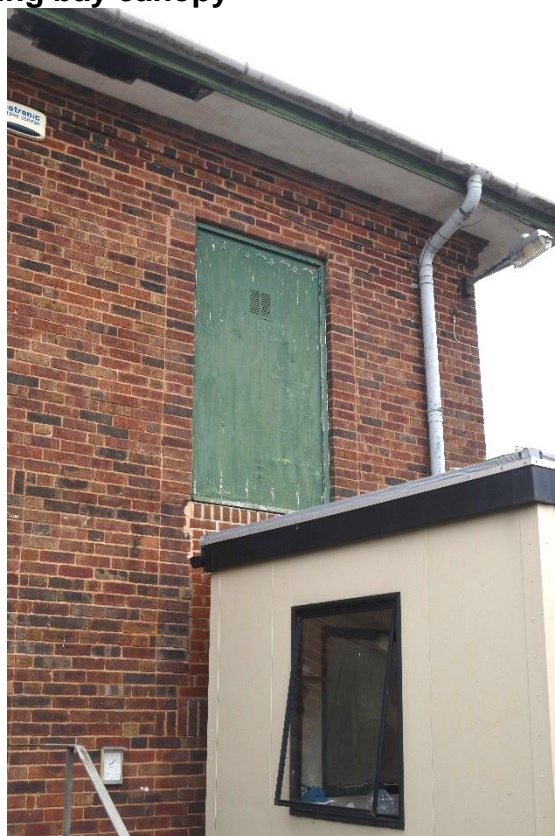
Plate 34: Detail of former first floor fire exit

At the head of the southwest elevation, at its southeast end, a planked door is present. This door is a former fire exit, with the external staircase having been removed prior to the installation of the temporary building located below the door. Scarring on the wall below the door may relate to this staircase.

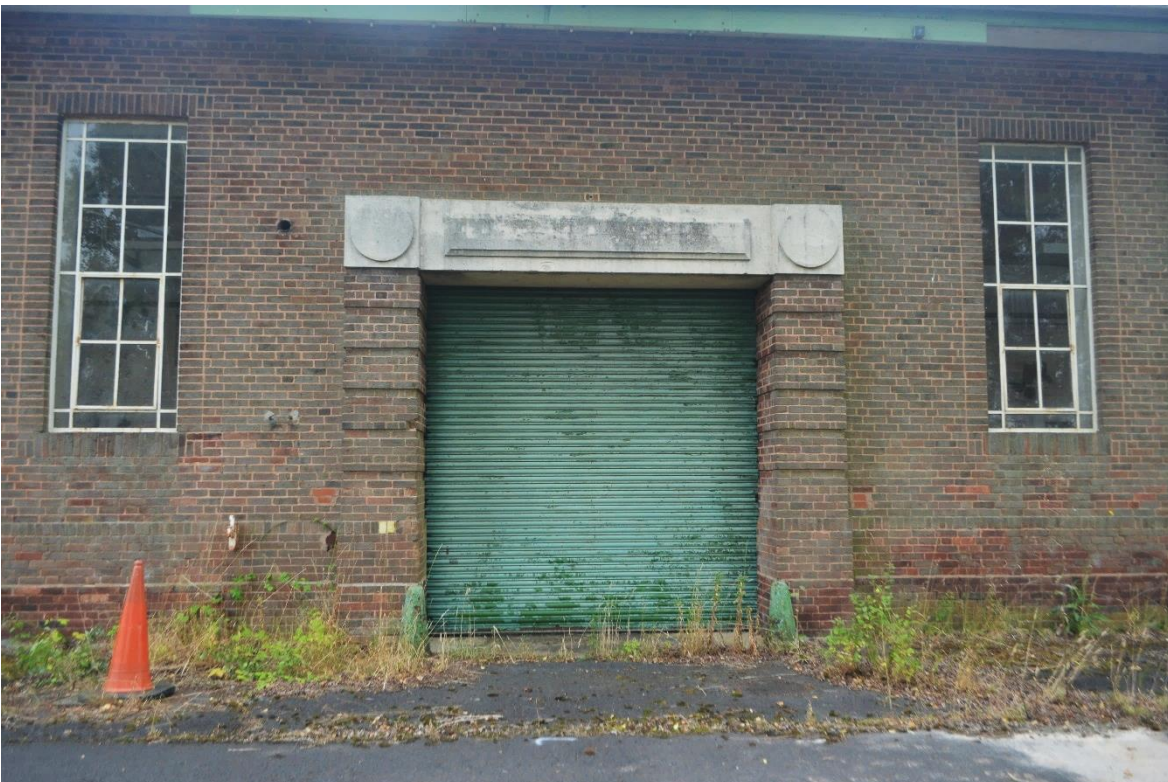
Plate 38: Detail of loading bay, northeast wall

Each of the large loading bay shutter doors on the northeast and southwest walls has brick pilasters on each side and a stucco lintel with raised circle and rectangle decoration.

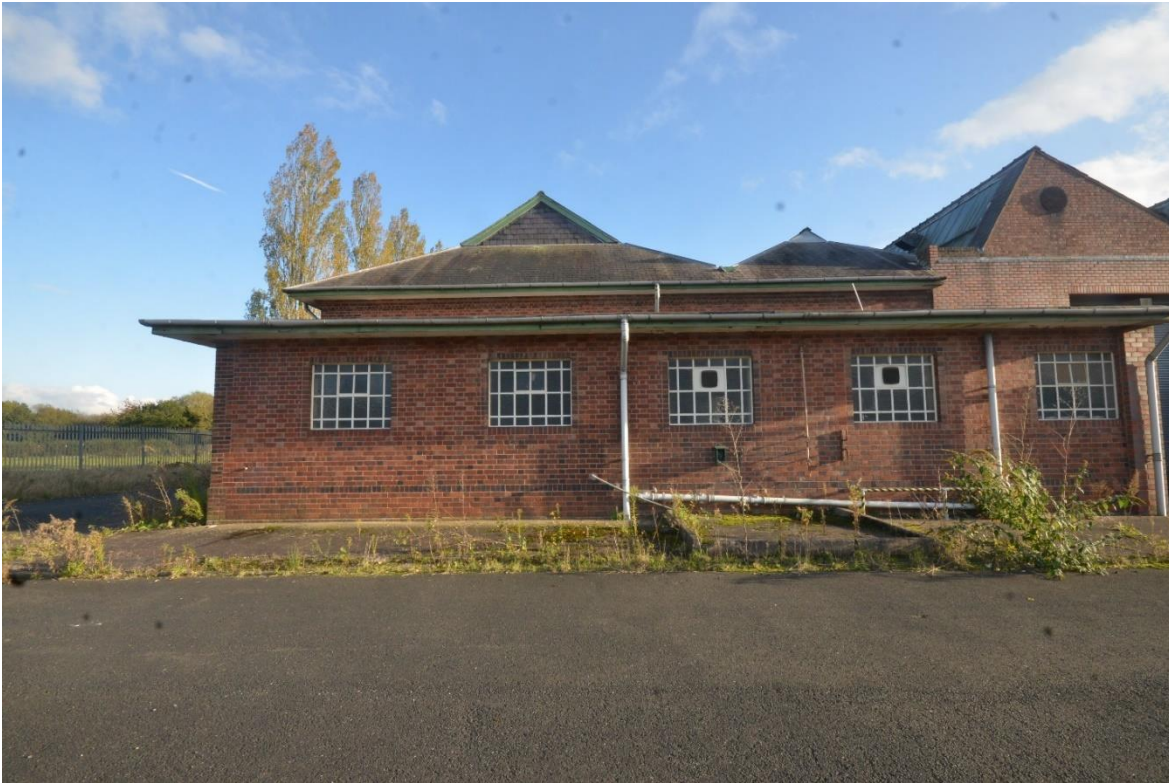
The northwest part of the building, the rear, comprises part of the structure lower in height than the main part of the building. This is considered to be contemporary with the rest of the structure, rather than being a later addition. It features glazed lanterns fitted to the roof to admit light to the areas inside.

Plate 39: Northwest elevation

The outermost bays of the rear elevation have tiled roofs with suppressed gables.

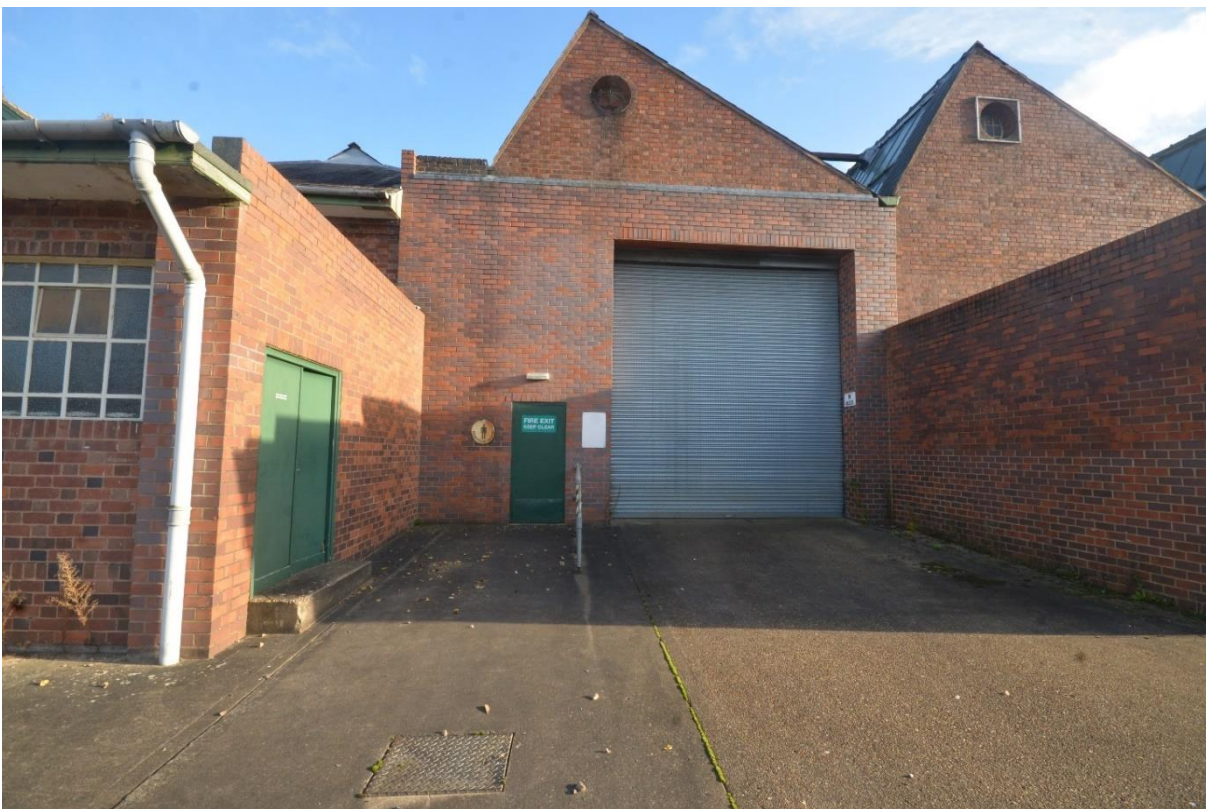
Plate 40: Northwest elevation

The double door to the left of the above photograph opens into room 13, gents' locker room and lavatory. The roller shutter and adjacent pedestrian door open into the main

Blue Bird Park Building Recording: Manufactory
manufactory area. The roller shutter is not painted. It features a ramp for vehicle access.
Variations in brickwork and mortar around this door, both internal and external, suggest this
door is not original.

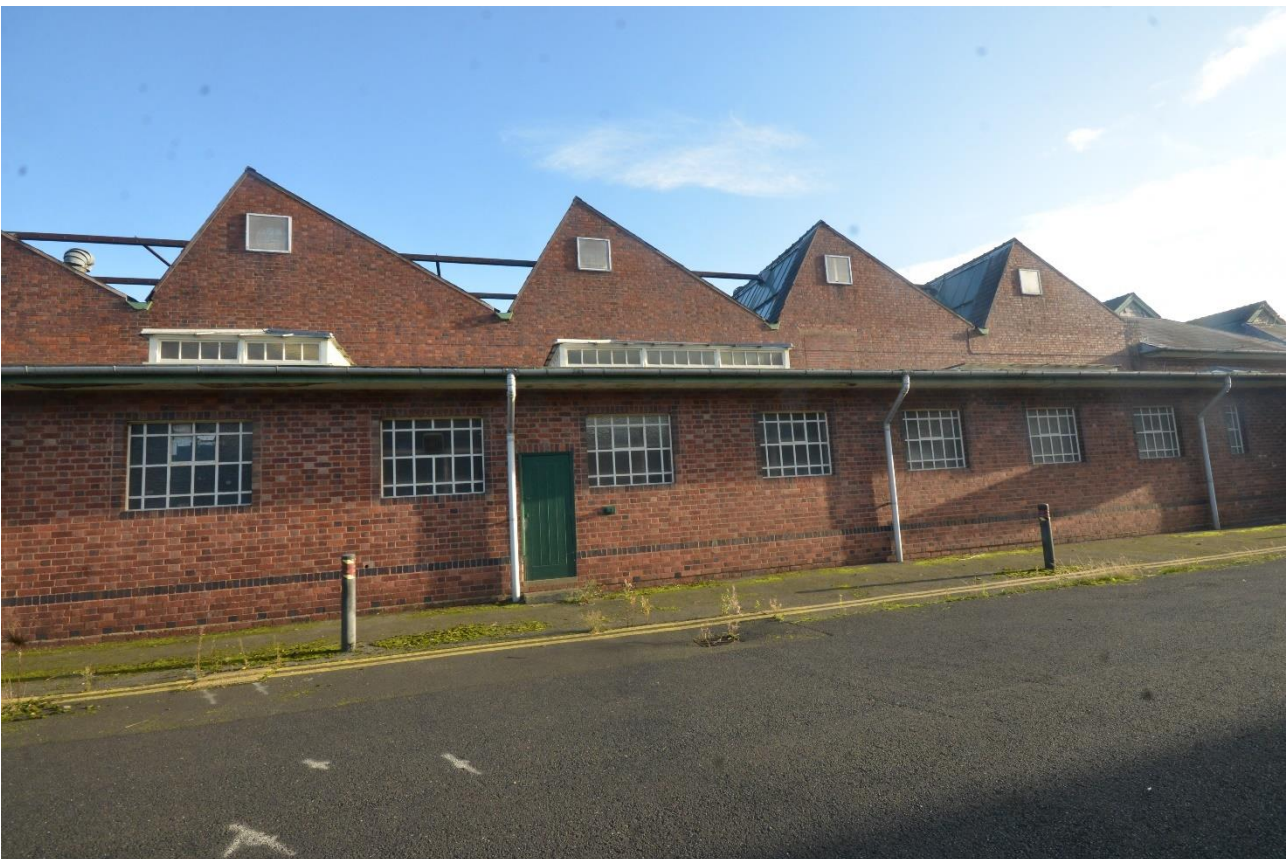
Plate 42: Northwest elevation

The pedestrian door in the above photograph opens into room 9.

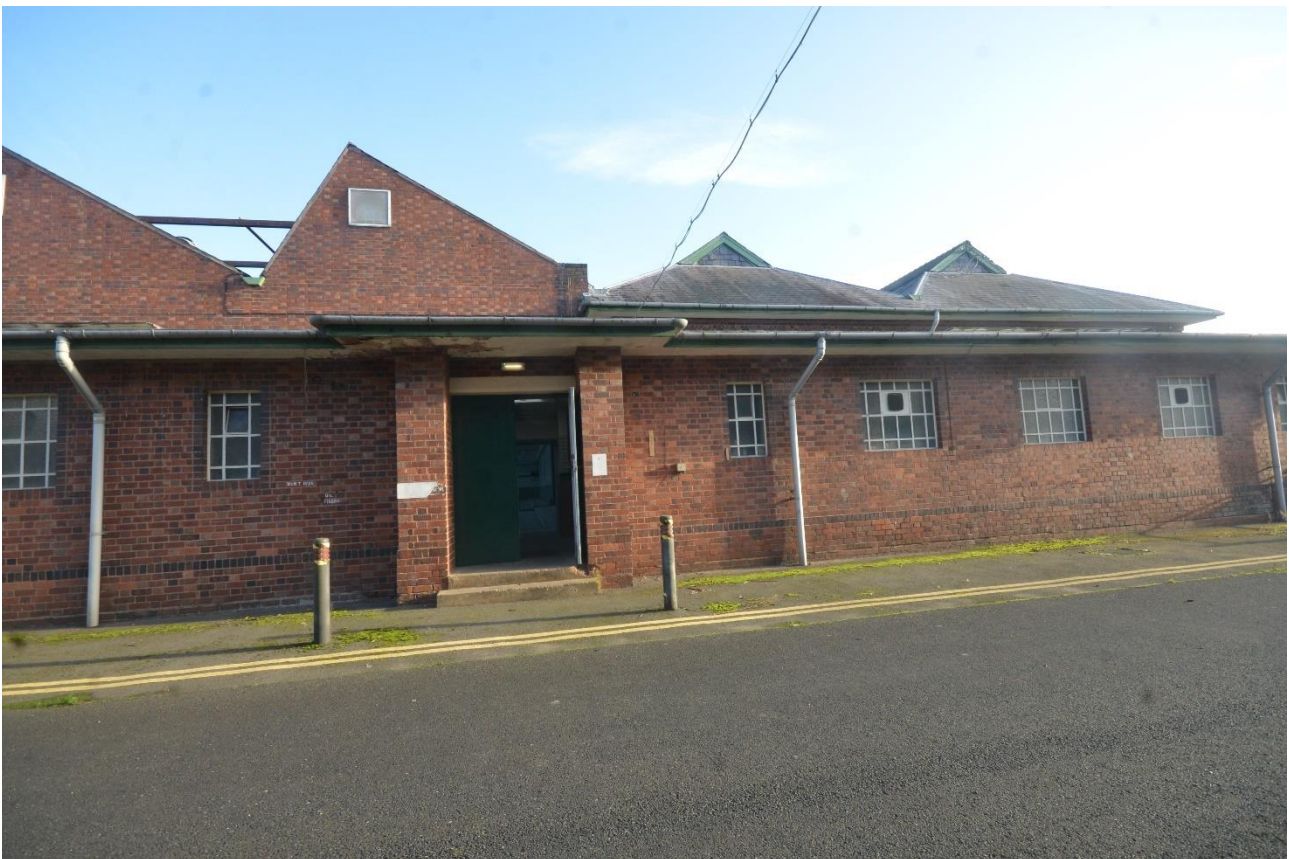
Plate 44: Northwest elevation

The double pedestrian doors are considered to be the main staff entrance to the manufactory.

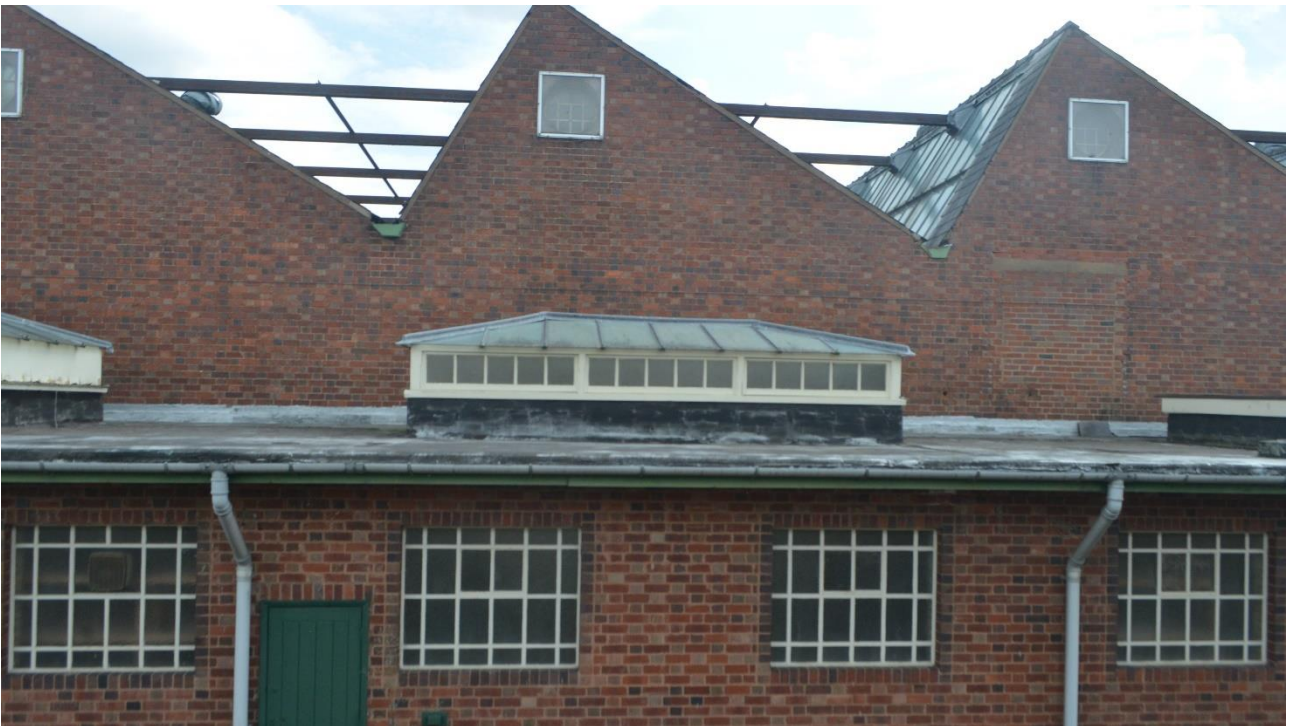
Plate 46: Detail of lantern over room 9

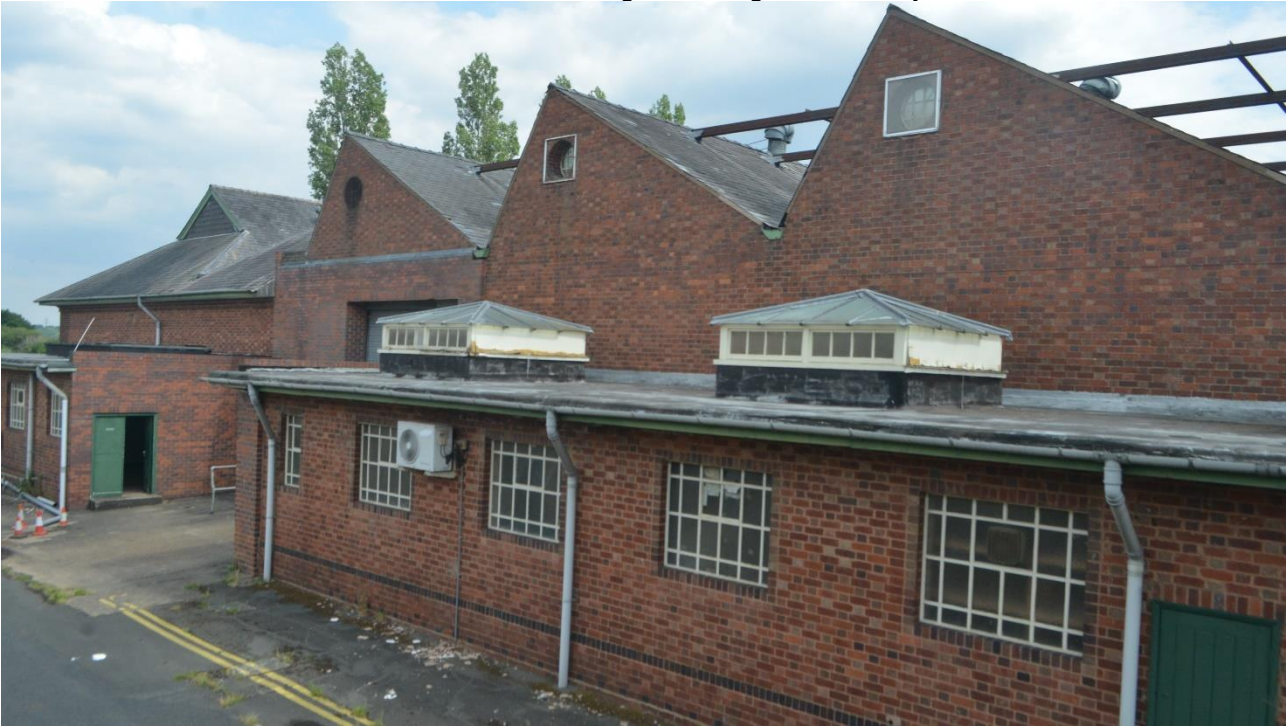
Plate 47: Detail of lanterns over rooms 10 and 12

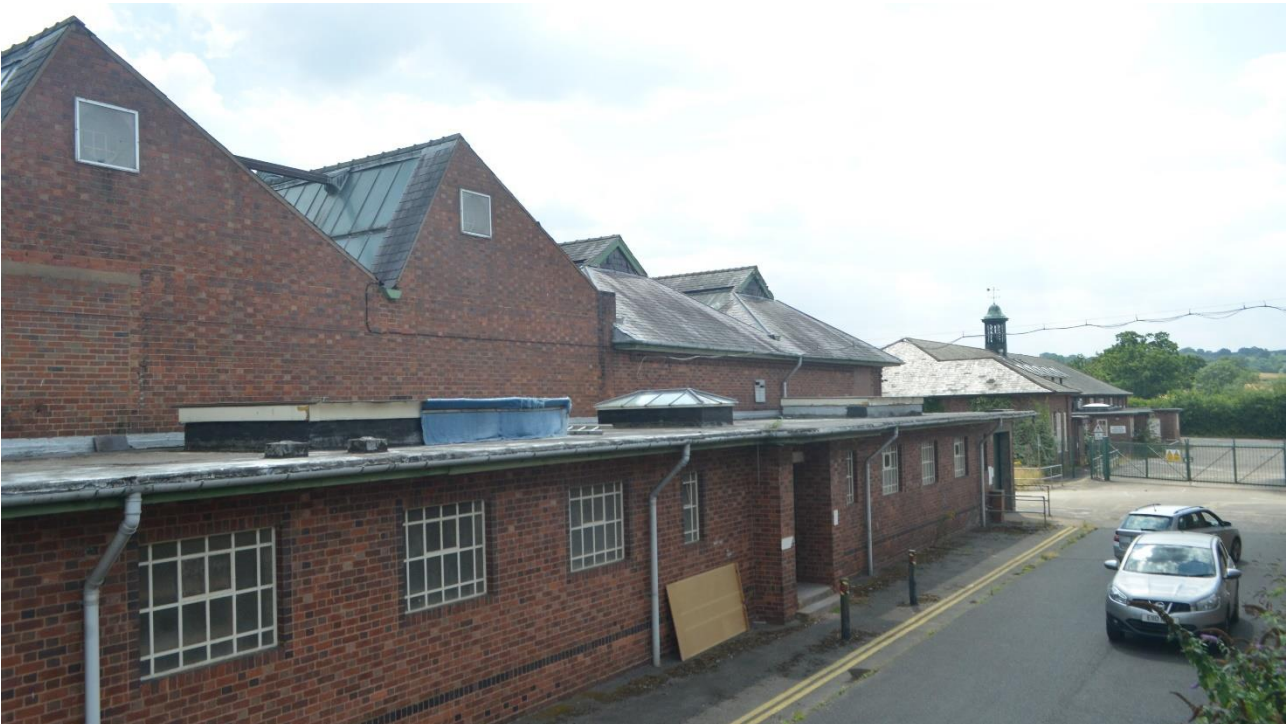
Plate 48: Detail of lanterns over rooms 7, 8 and 9

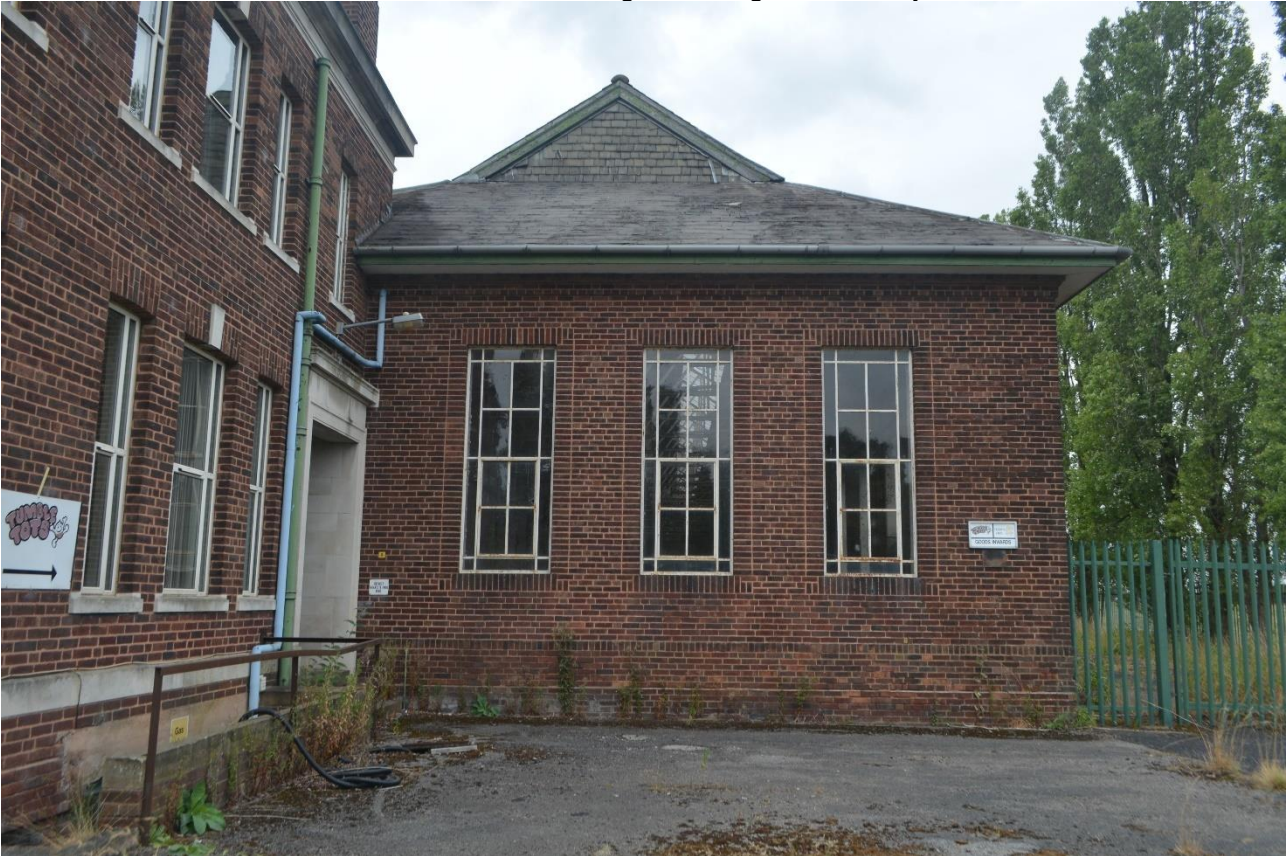
Plate 49: Southeast elevation, northeast bay

Either side of the Administration building, the southeast wall of one bay of the manufactory can be seen, facing on to the road. The roof profile of these outer bays can be seen, taking the form of a hipped roof with suppressed gable.

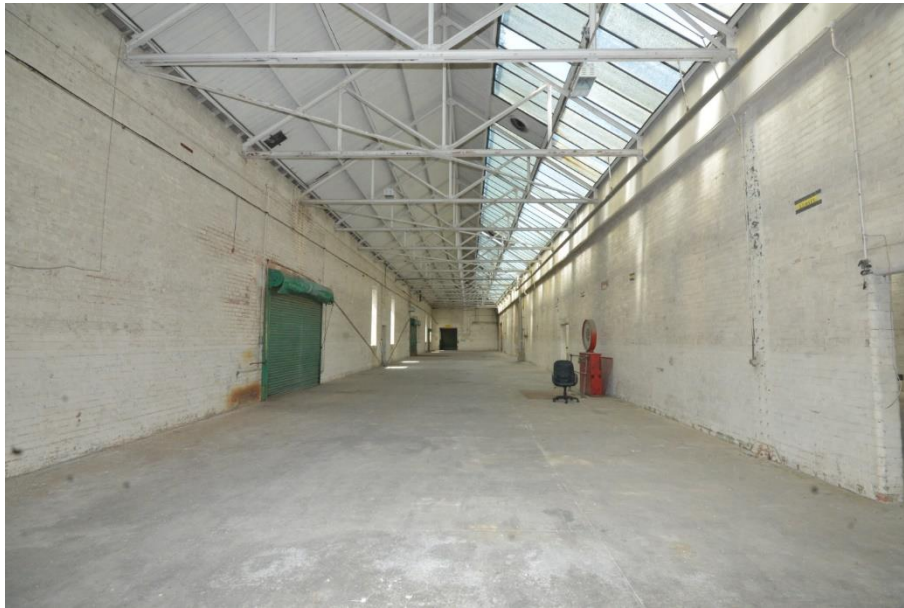
Plate 52: Room 1, northwest aspect

Internally, the walls and roof trusses (of the Howe variety) are painted white. The floor is of poured concrete. Windows and roller shutter doors are present in the southwest wall.

One remnant of the historic use of the building is an industrial weighing scale, left approximately halfway along this room, when the building was abandoned.

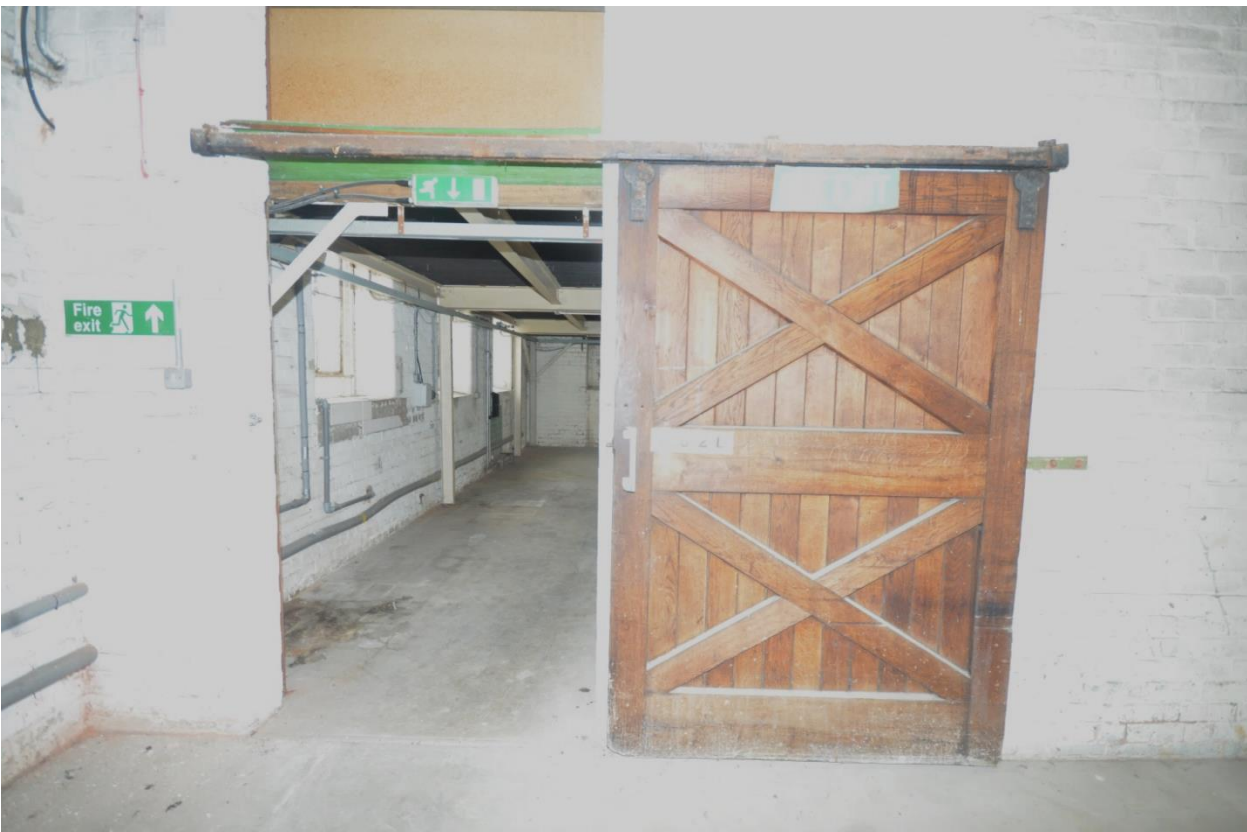
Plate 57: Detail of sliding door, room 1

Doors between the rooms of the building are largely substantial ledged and braced timber sliding doors in the style of that depicted below. This door opens from room 3 to room 1, beneath the mezzanine which is found at the southeast end of the room.

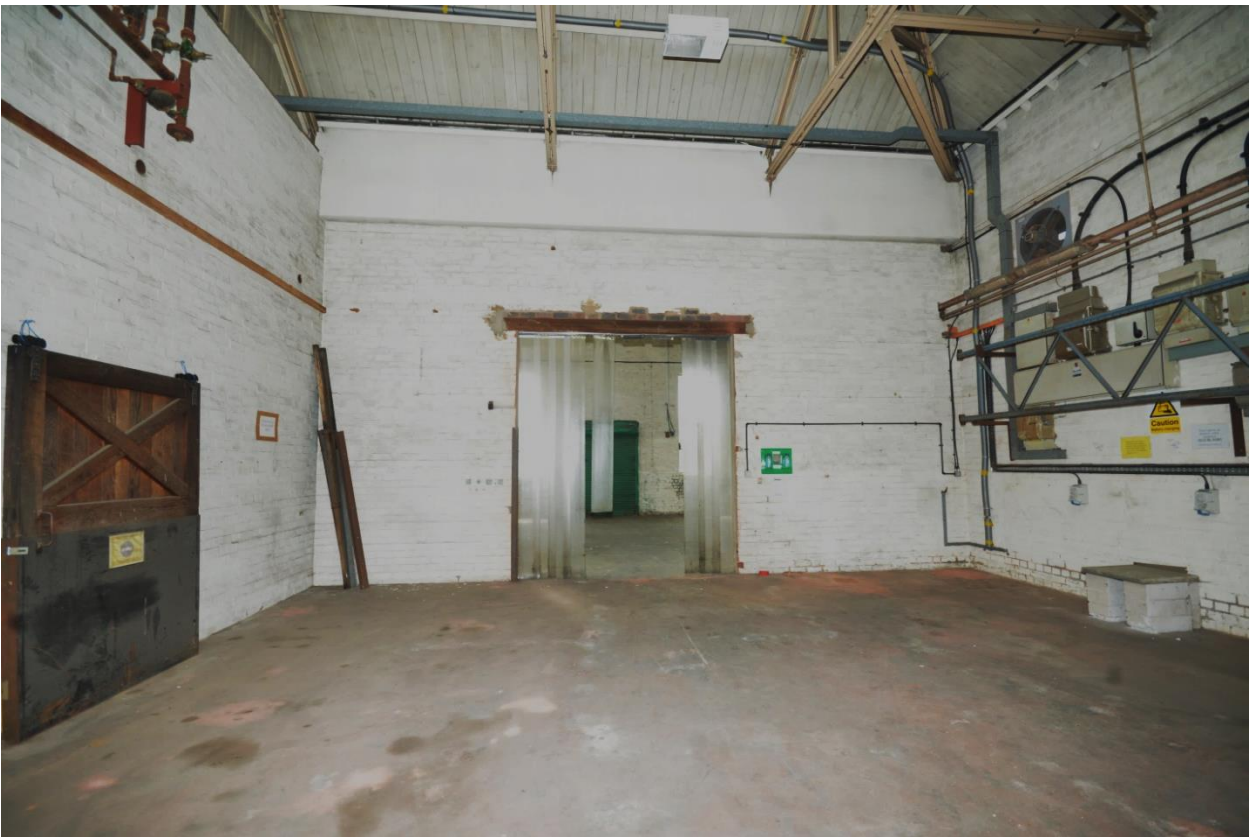
Plate 58: Southwest aspect, room 2

Room 2 is a small room at the northwest end of the second bay. Again, the walls and roof trusses are painted white. Electrical distribution equipment and piping can be seen to the northwest and southeast of the room.

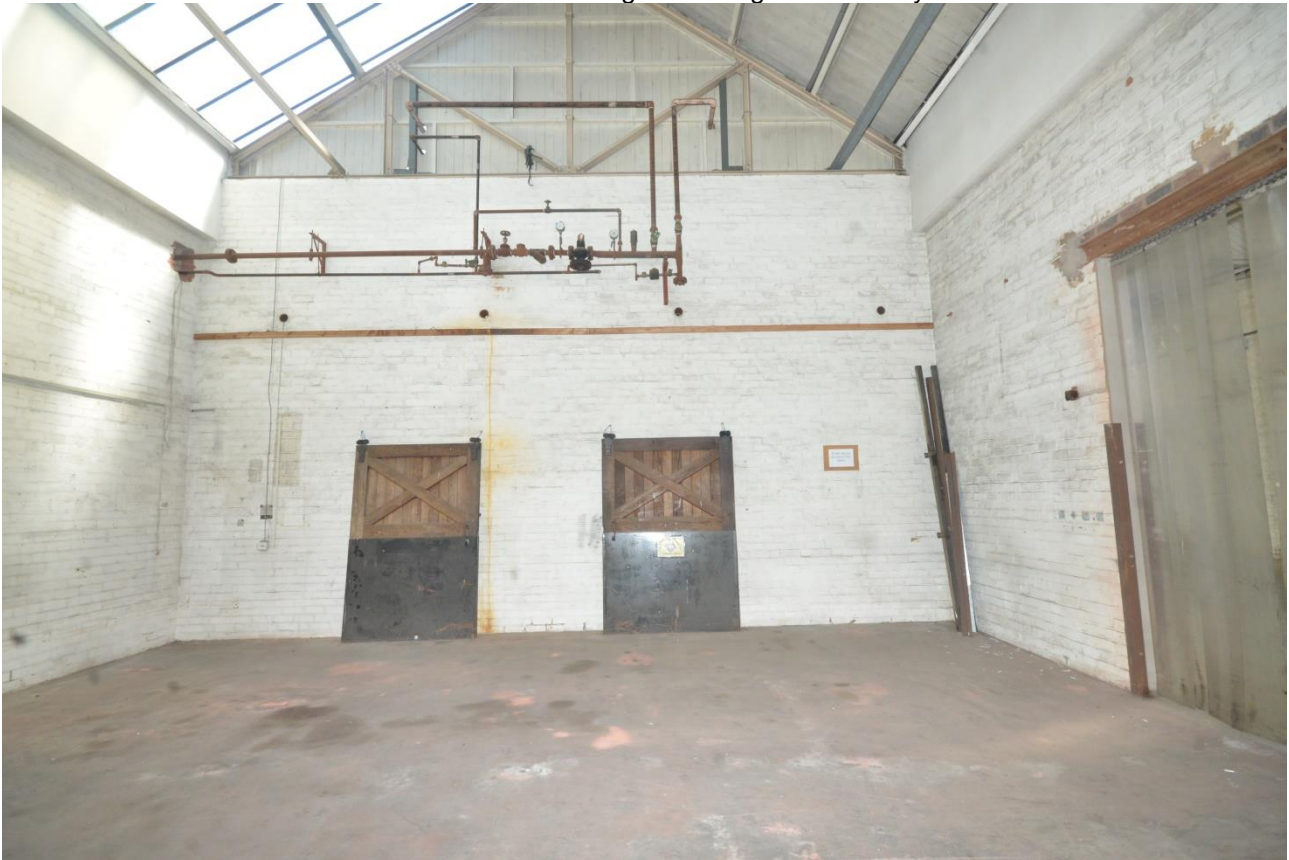
Plate 60: Southeast aspect, room 2

Pipework at the head of the southeast wall features a number of valves and pressure gauges. This pipework is likely to have been used for distribution of a pressurised gas, however the lack of insulation to the pipes suggests this was not steam. Some pipework on the northwest wall, however, is insulated, suggesting it is likely to have carried steam.

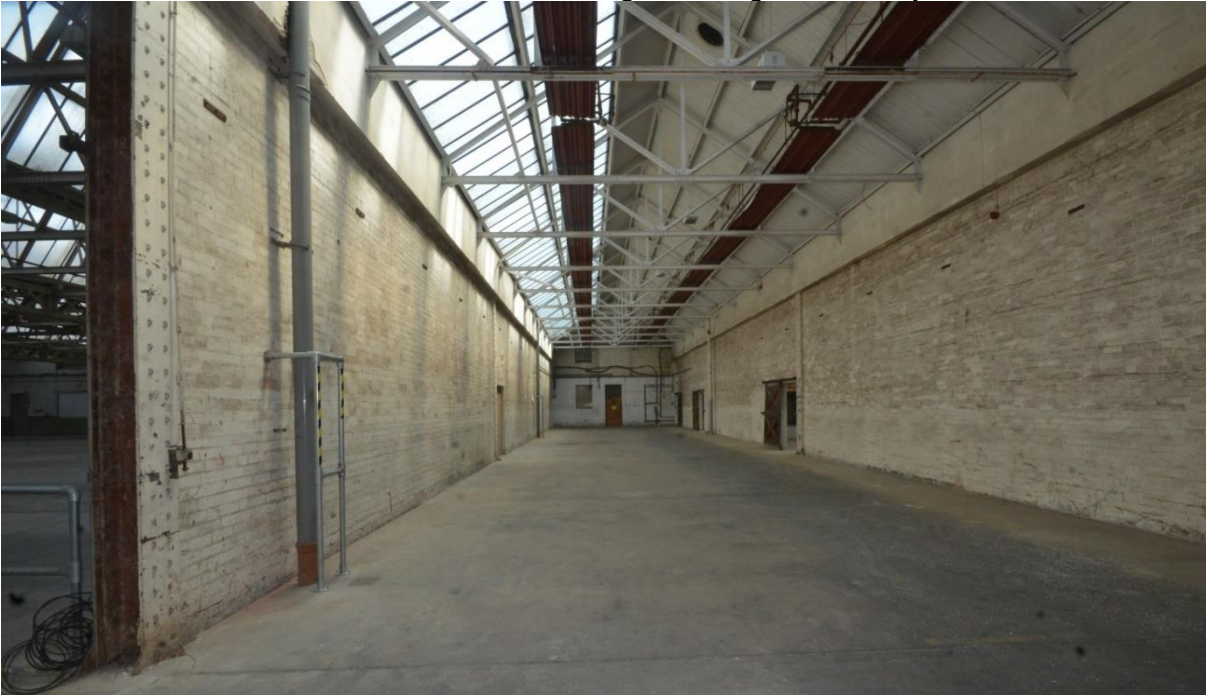
Plate 61: Southwest aspect, room 3

The walls of room 3 are painted white. The roof is supported on steel Howe trusses through which pipework is routed, running the length of the building from northwest to southeast.

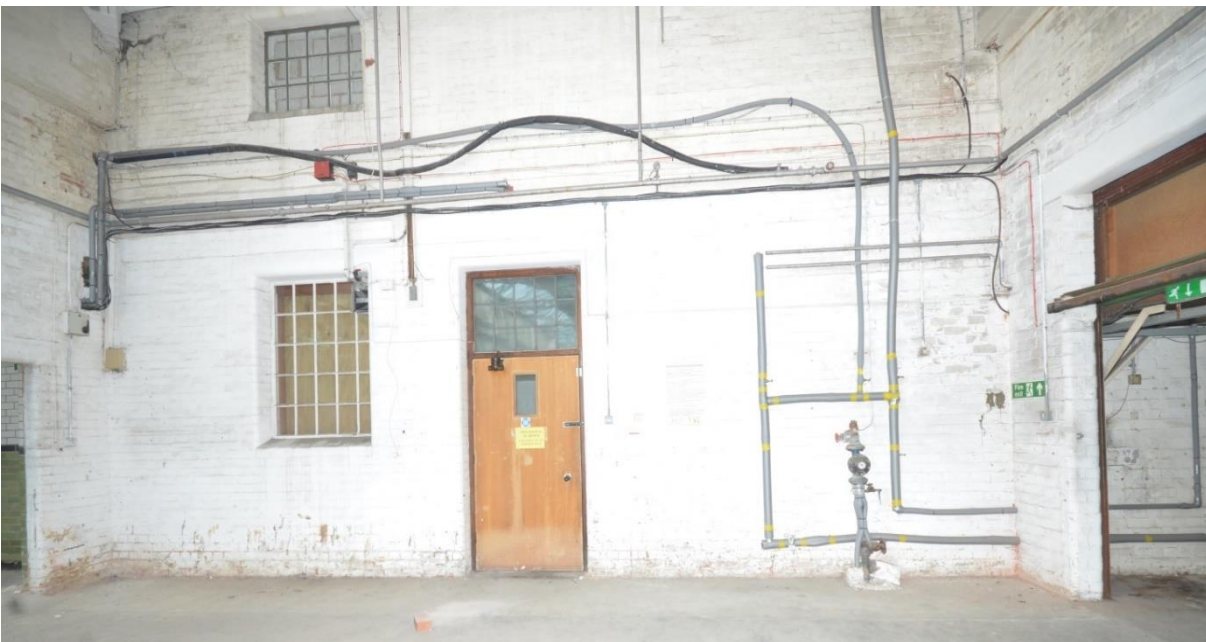
Plate 62: Detail of southwest wall, room 3

At the southeast end of room 3, iron-framed fixed windows are present allowing the manufactory to be observed from the administration building. Further pipework and cabling is present on this wall.

The lack of glazed bricks on the walls of room 3 suggests the room was used for the storage and / or processing of foodstuffs that have already been packaged.
