Level 3
Building Recording of
Manufactory
Blue Bird Park
Bromsgrove Road
Hunnington
Worcestershire
B62 0JW

Planning Reference Number: 19/00592/FUL
OASIS ID: thearcha1-516388
HER Event No. WSM80084

Document Reference Number 2023/1681

Dr Peter Wardle & Colin Lacey

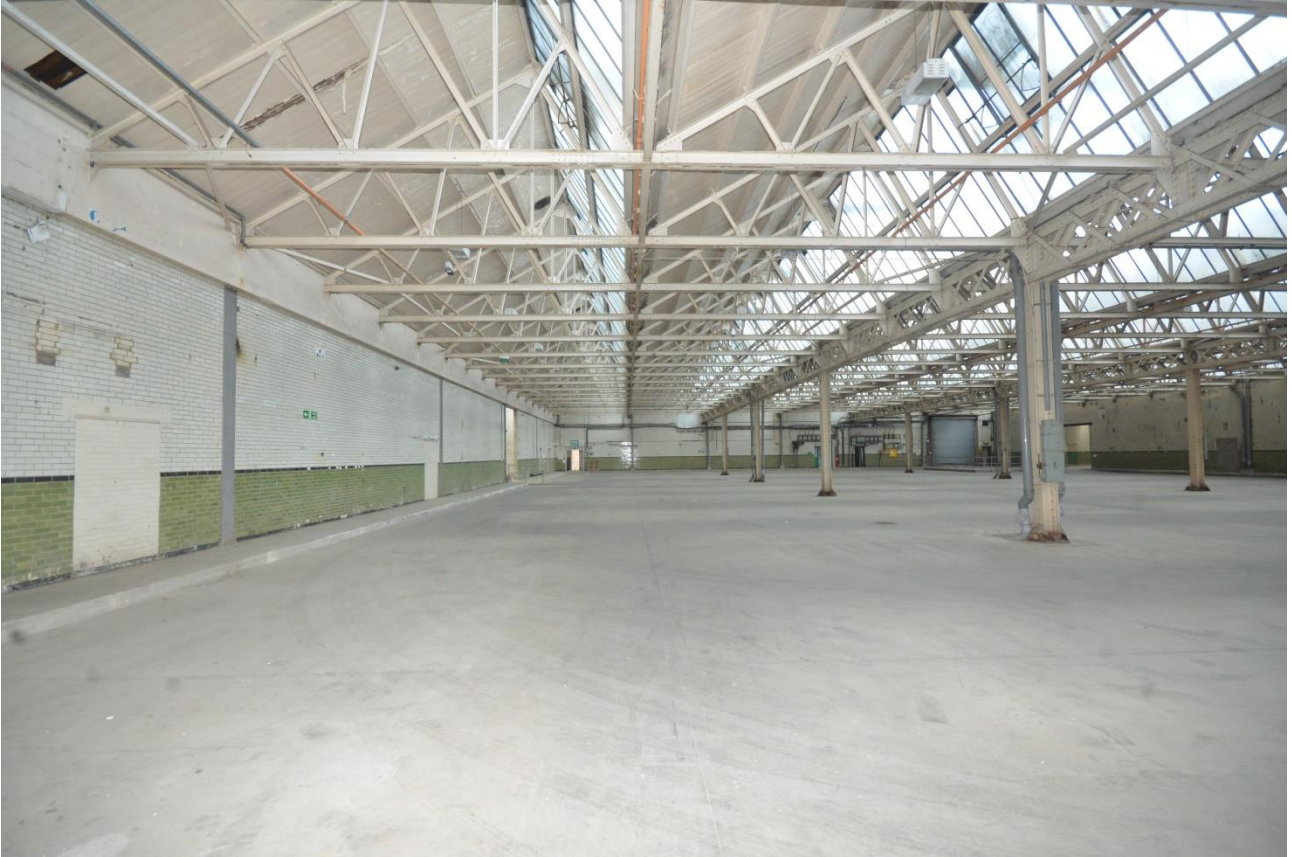
Plate 63: Northwest aspect, room 4

The main manufactory area is a large open space taking up the majority of the floor plan of the building. The roof structure is supported on eight steel pillars around the centre of the building. There are minimal overhead services present.

Significant electrical distribution equipment is present on the northwest wall.

The walls are constructed with glazed brick over their entire height. The lower parts of the walls have green glaze, with a black band separating white upper parts. The roof structure is painted white.

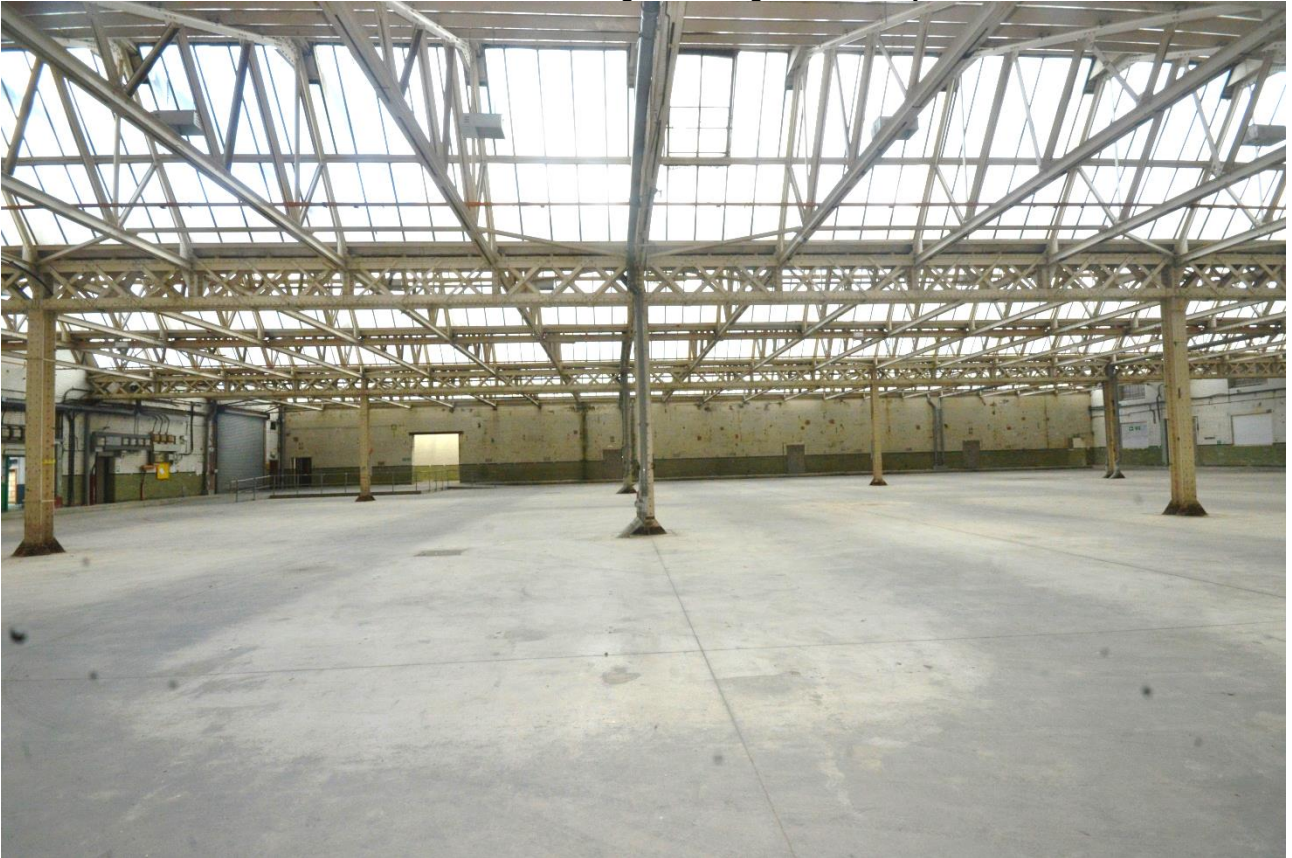
Plate 64: Northeast aspect, room 4

Windows and doors between room 4 and the administration building have been blocked.

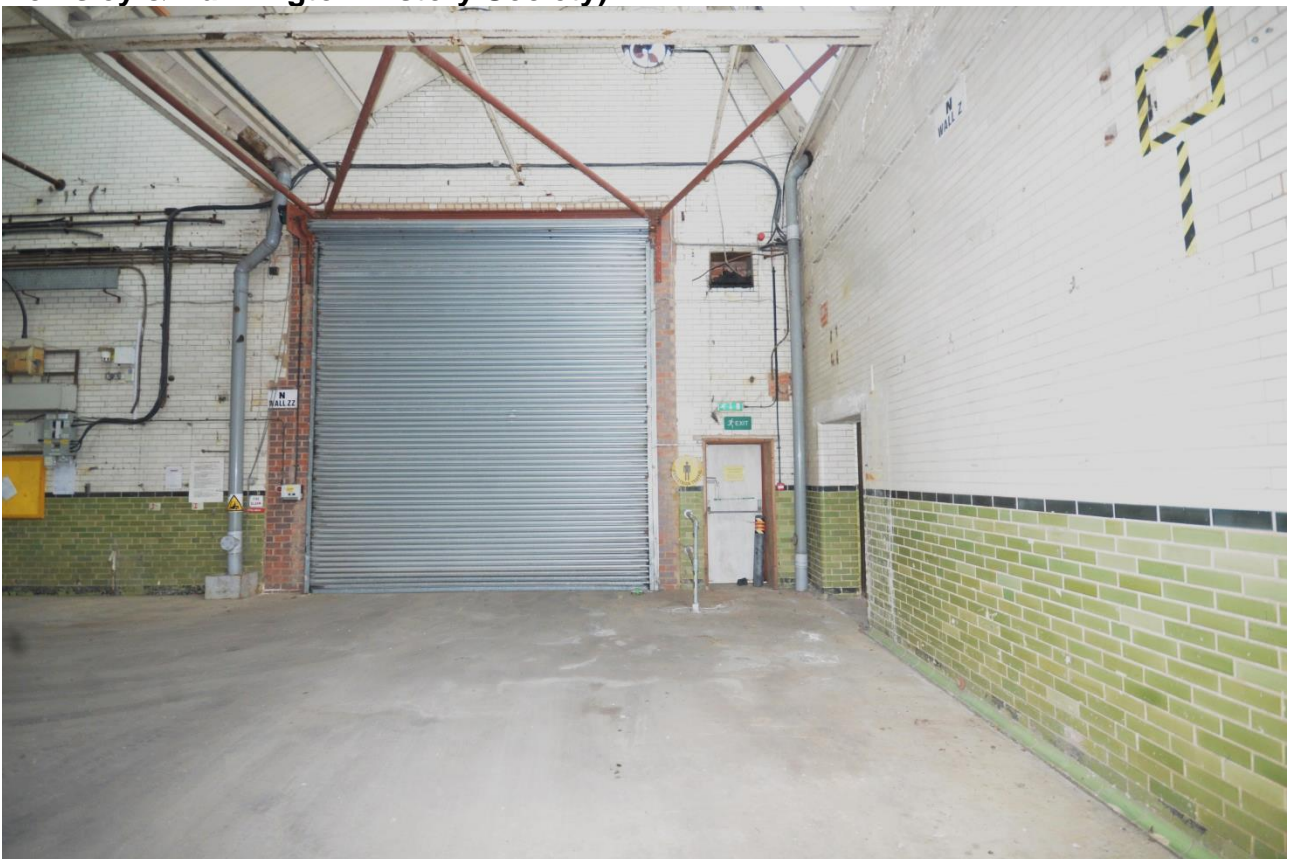
Plate 73: Detail of roller shutter

Brickwork around the roller shutter is not painted and there are no glazed bricks present. This suggests the shutter is a recent insertion.

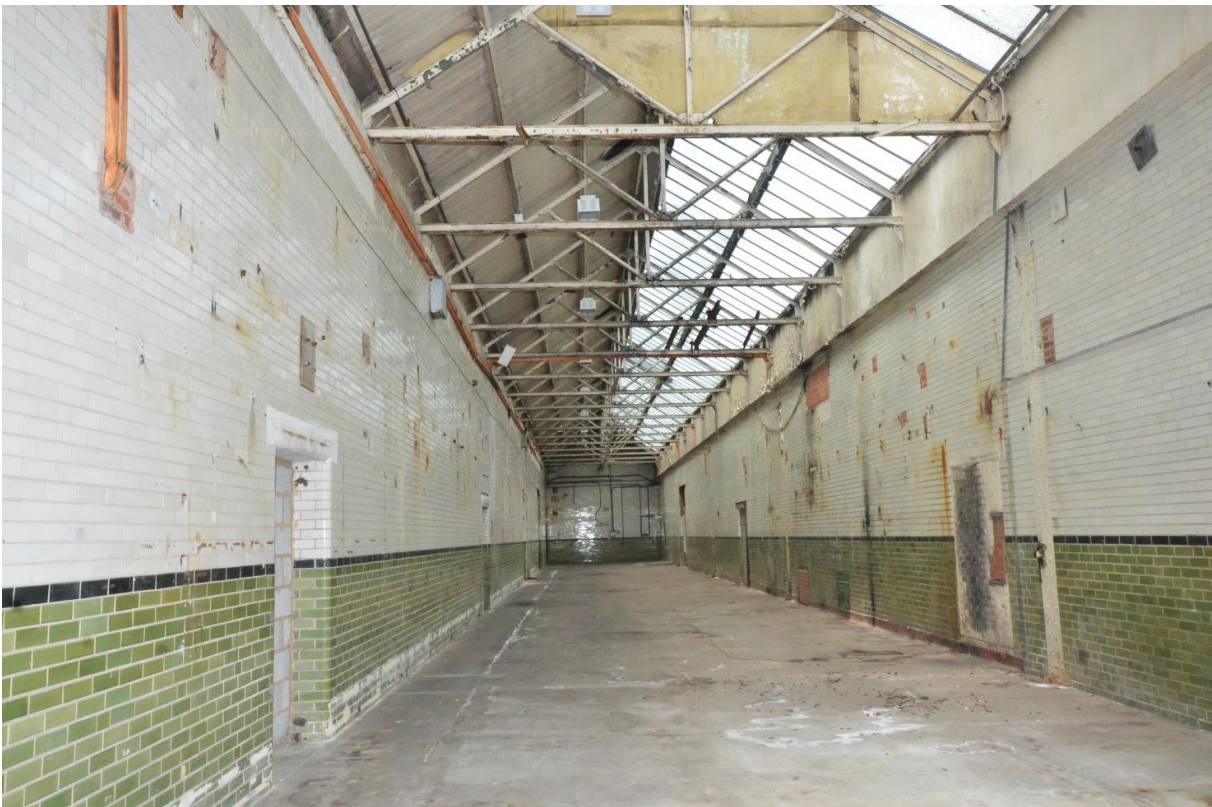
Plate 77: Northwest aspect, room 5

Again, minimal overhead services are present, however some wiring is present, the majority being fixed to the northwest and southeast walls.

Historic photographs show this room used for storage of raw ingredients.

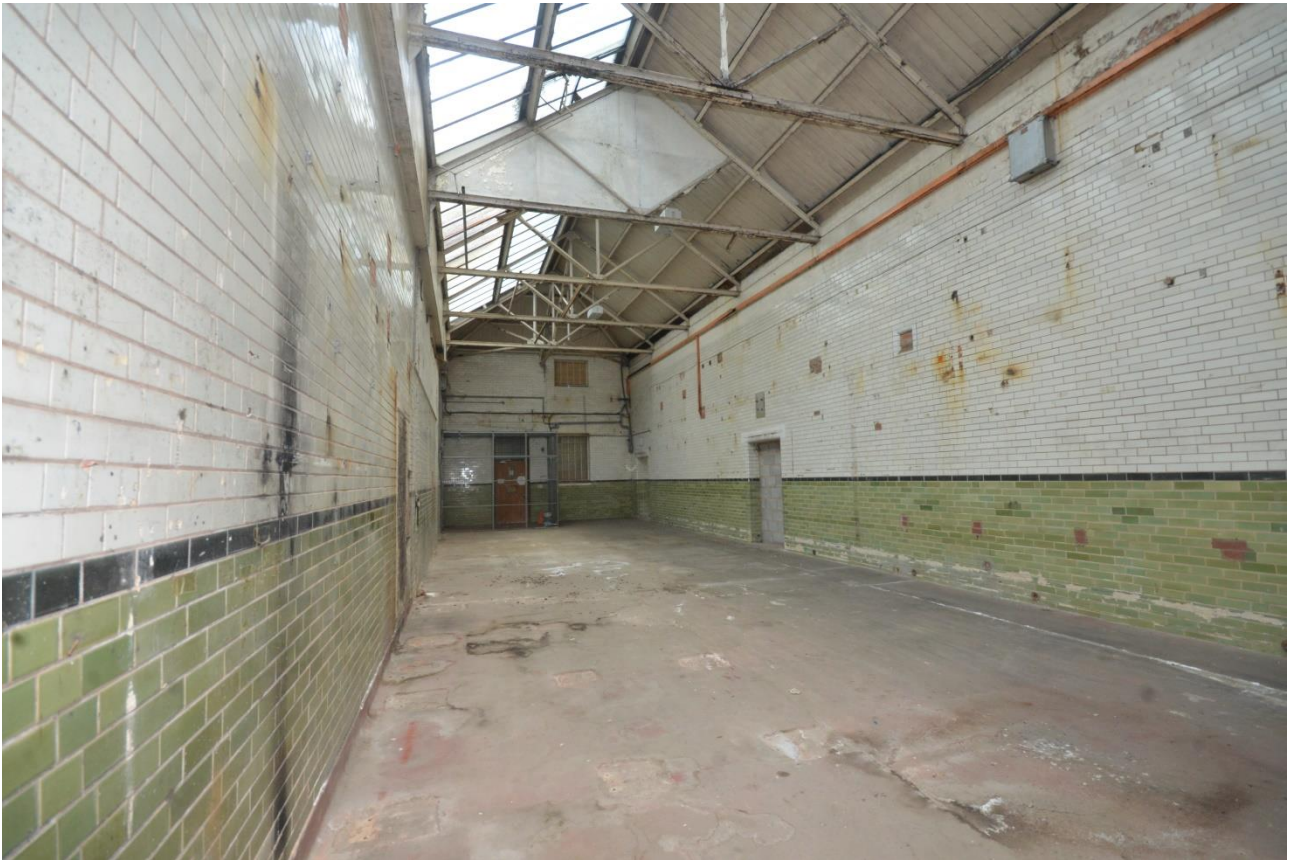
Plate 78: Southeast aspect, room 5

At the southeast end of the room, a wire mesh partition is located. A door in the southeast wall leads into the administration building and the mesh partition restricts access through this room into room 6. There is no direct access from the administration building into room 5.

Scars on the walls of room 5 suggest the former locations of industrial equipment. Blocked openings in the lower part of the wall show where equipment once passed through the wall separating room 5 from room 6.

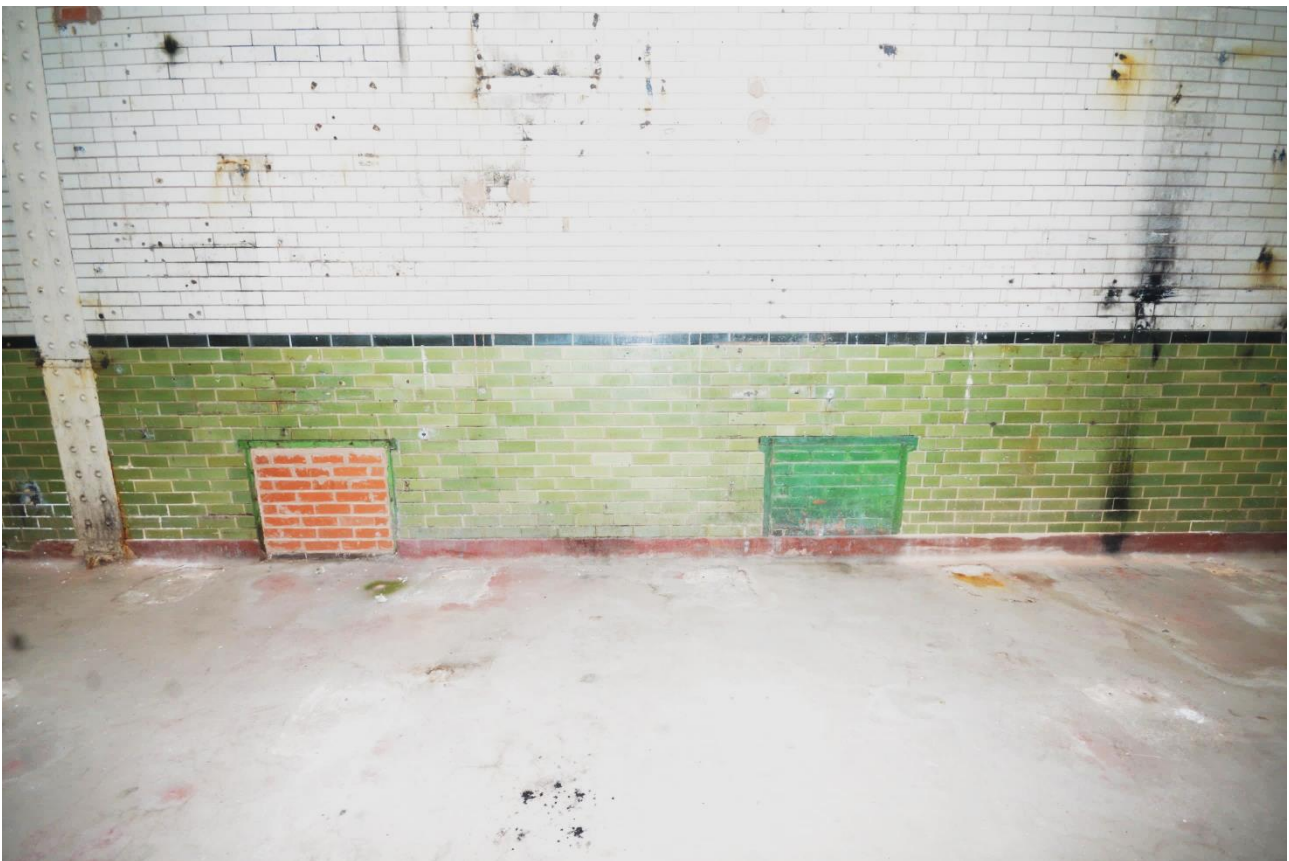
Plate 80:Detail of blocked openings in northeast wall

Scars on the walls of room 5 suggest the former locations of industrial equipment. A number of blocked openings are present in the northeast and southwest walls. These blocked openings varying in size from pedestrian doorways to small openings show where former access for personnel and equipment through the walls separating room 5 from rooms 4 and 6.

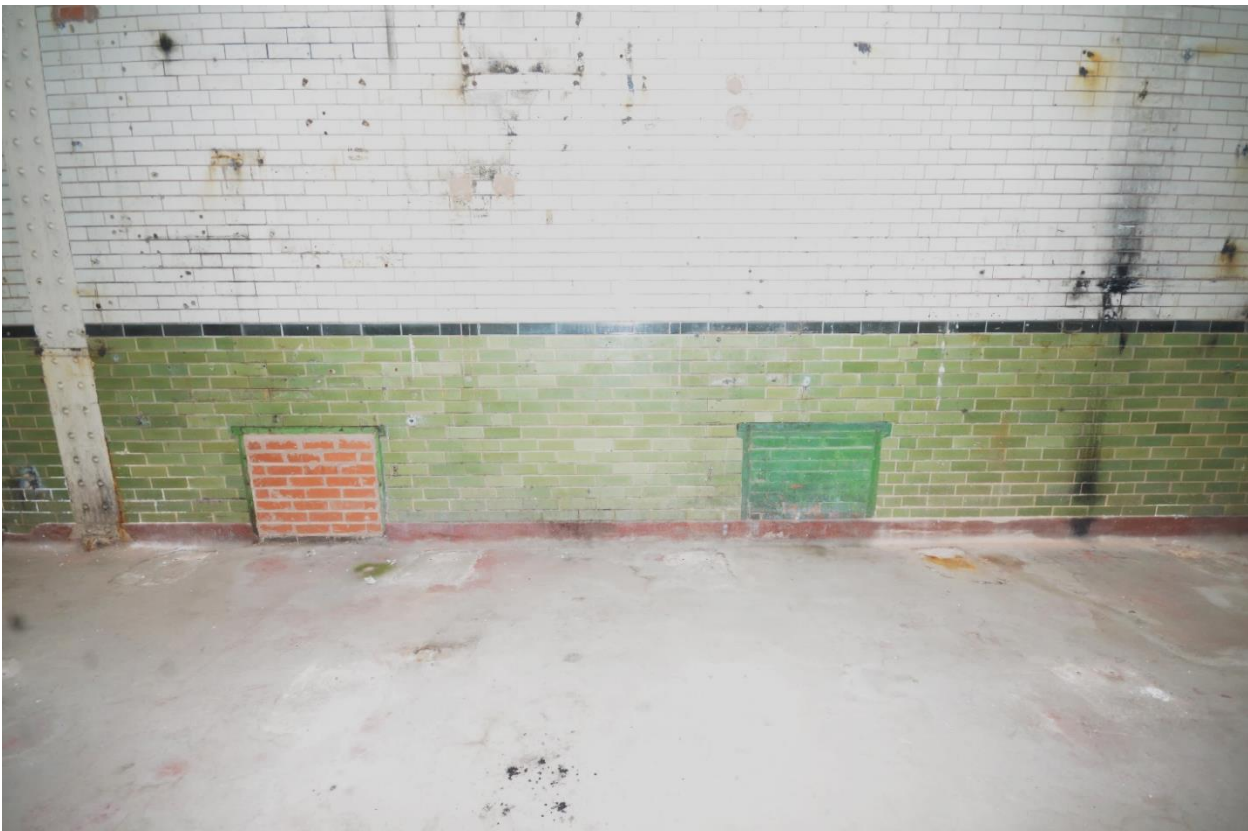
Plate 82: Detail of blocked openings in northeast wall

Openings are blocked with a variety of materials, with red brick commonly used. More recent blockings have been made with concrete blocks and early blockings have glazed bricks / tiles used in an attempt to match the surrounding walls.

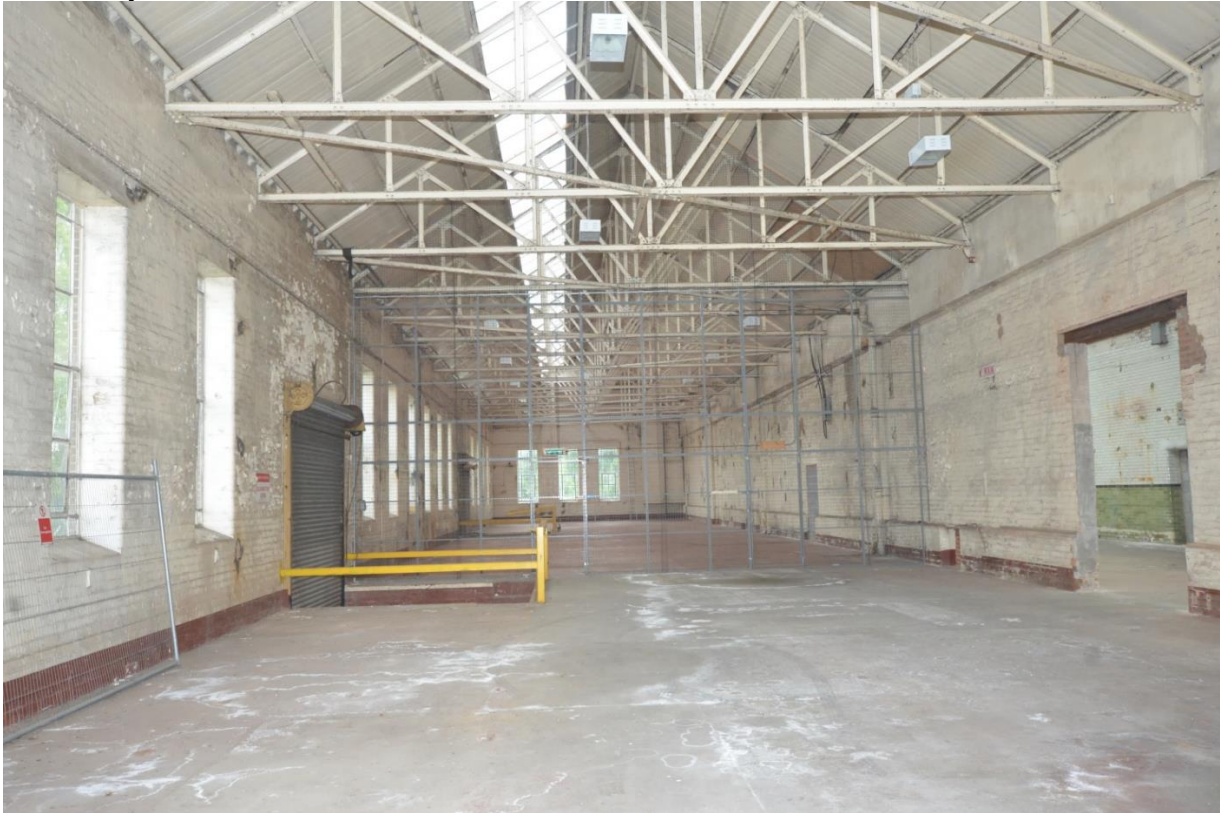
Plate 85: Southeast aspect, room 6

Room 6 is the northeast bay of the manufactory building. The walls are not tiled or built with glazed brick, but are painted, as per those of rooms 1-3, suggesting less cleanliness was

required in this part of the building. It is considered that this area was used for the loading of raw ingredients into the factory.

Loading bays are present along the northeast wall. These are internal loading bays, in that the lorry would back inside the building in order to be loaded or unloaded. This contrasts the loading bays in room 1 in which the lorry remains outside the building and reverses up to the doorway.

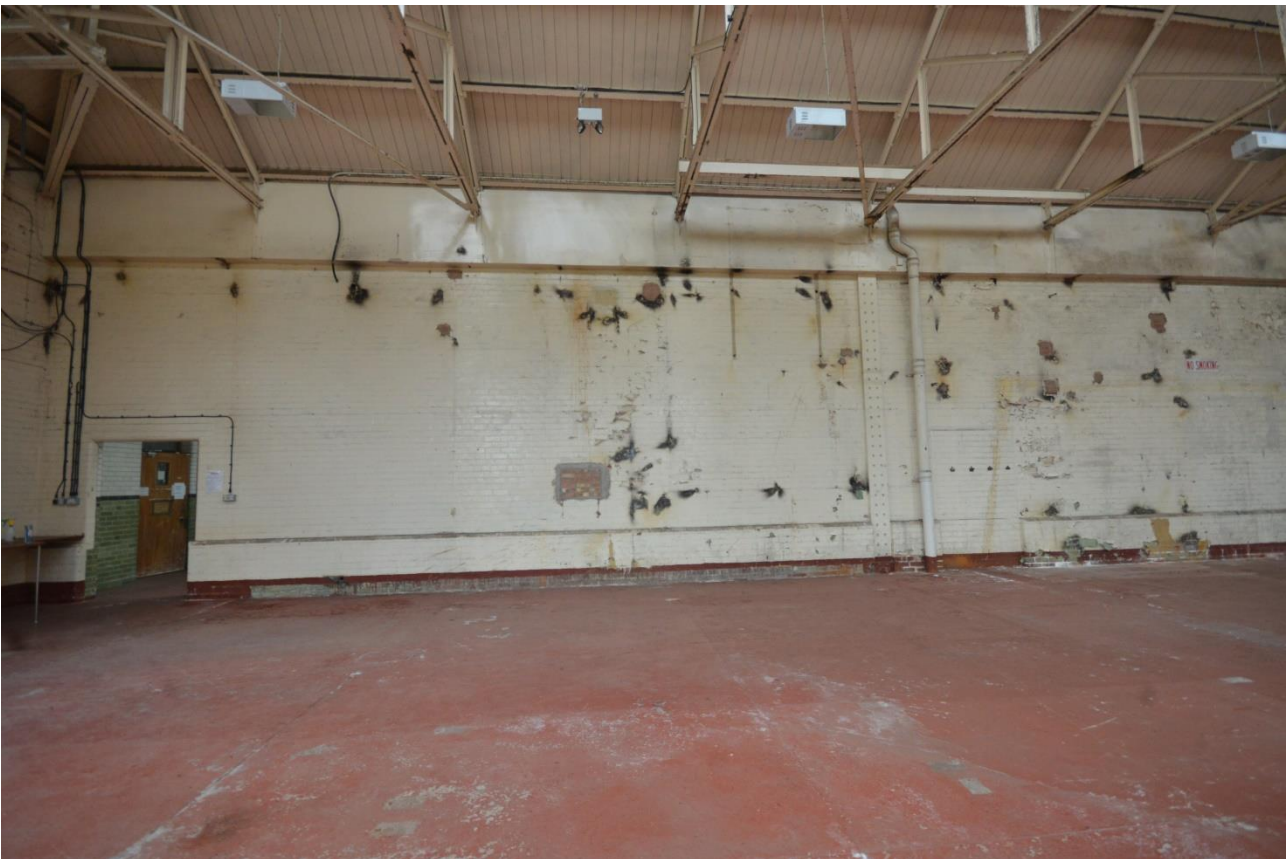
Plate 87: Southwest aspect, room 6

Scars on the northeast and southwest walls of room 6 suggest the former locations of equipment now since removed.

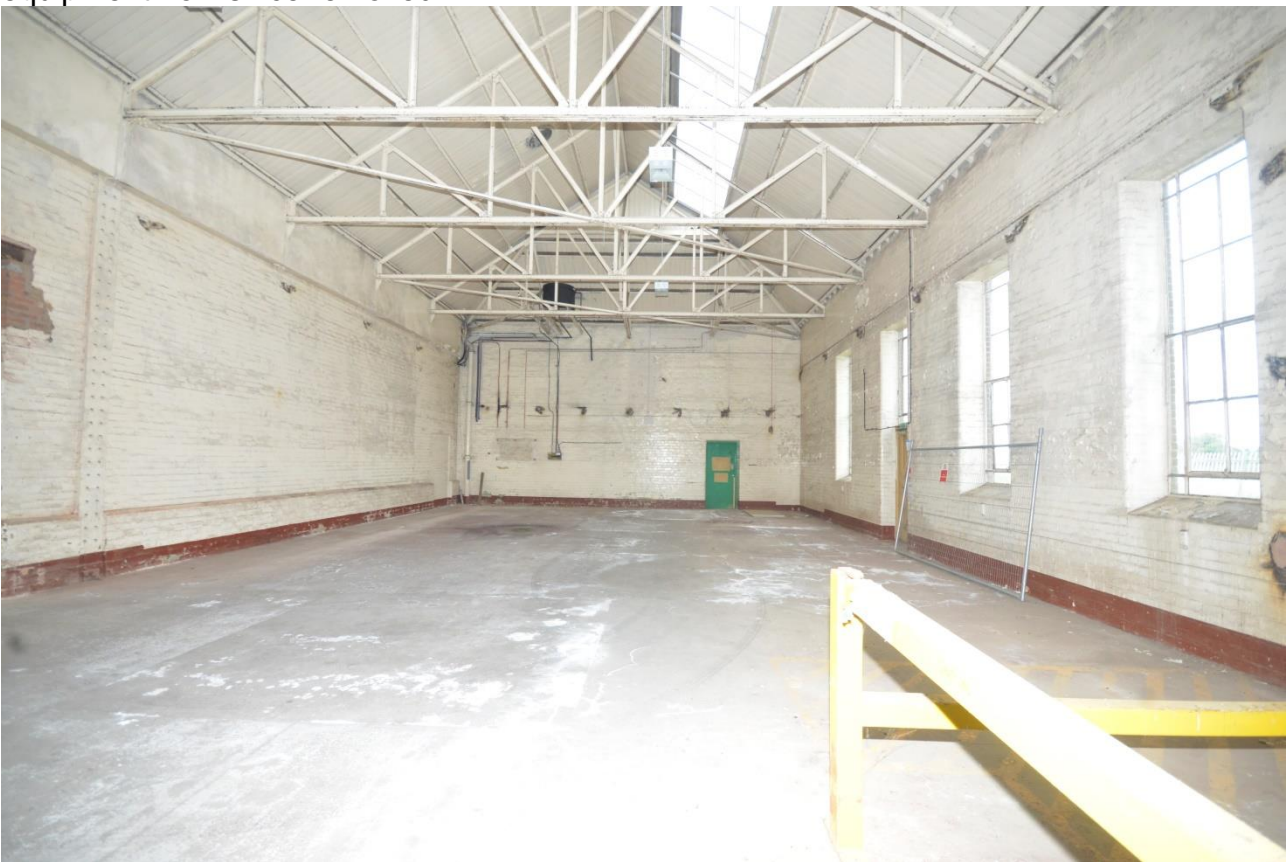
Plate 88: Northwest aspect, room 6

The northwest end of room 6 is divided from the remainder by means of a steel mesh partition. Signs indicate that this is a quarantine area. The need for quarantining goods reinforces the suggestion that room 6 was used for incoming ingredients as it is considered unlikely quarantine would be required for outgoing products.

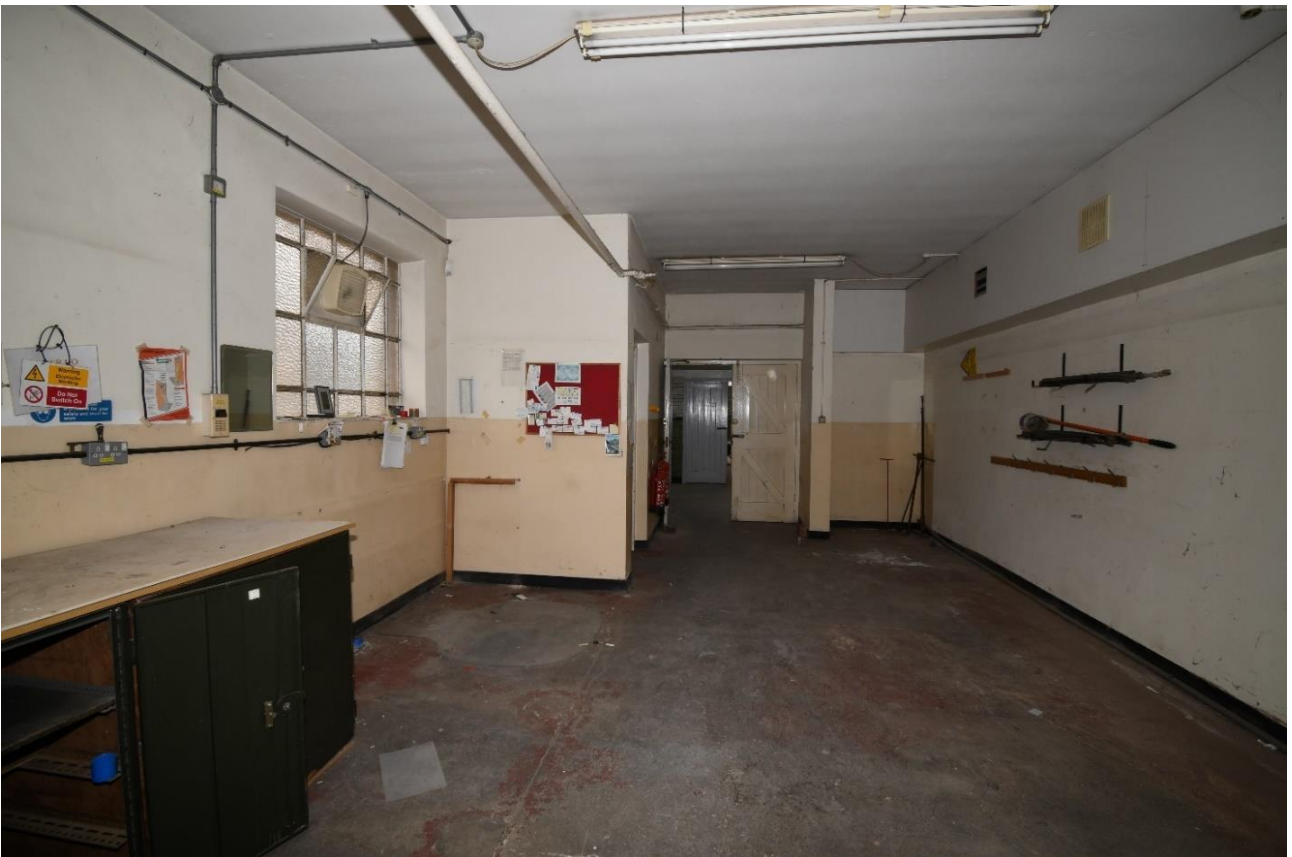
Plate 91: Northeast aspect, Room 7

Room 7 is an ancillary room to the rear of the manufactory building. Doors in this room lead to a lavatory (7a) and a small store room (7b). The room may have been a staff locker room. A lantern in the ceiling admits natural light to the room.

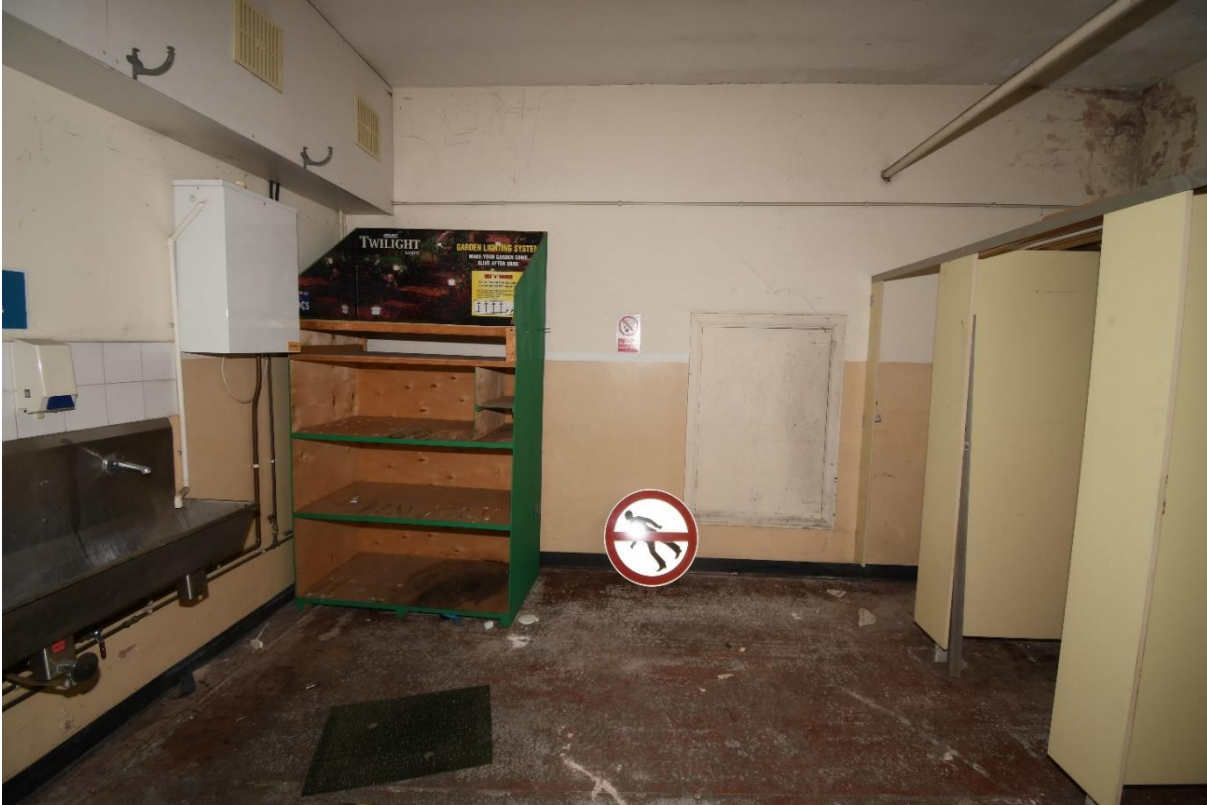
Plate 94: Southwest aspect, room 7a

Room 7a is a staff lavatory (female) with three cubicles. A door in the northeast wall leads into room 7 and a small loading door is located in the southwest wall. This door leads to the southwest loading bay of the main manufactory space.

This lavatory is considered to have been used by production staff. One indicator of this is the knee-operated taps, so as to minimise contamination by touch.

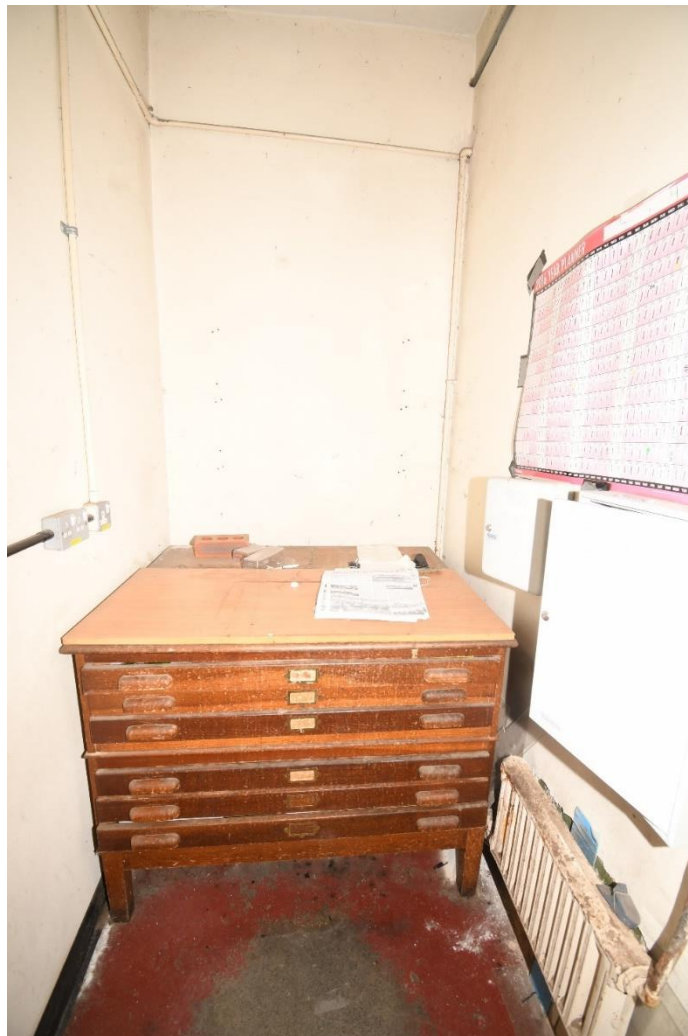
Plate 97: Northeast aspect, room 7b

Room 7b is a narrow room located in the northern corner of room 7. Access is via a single door in the southeast wall.

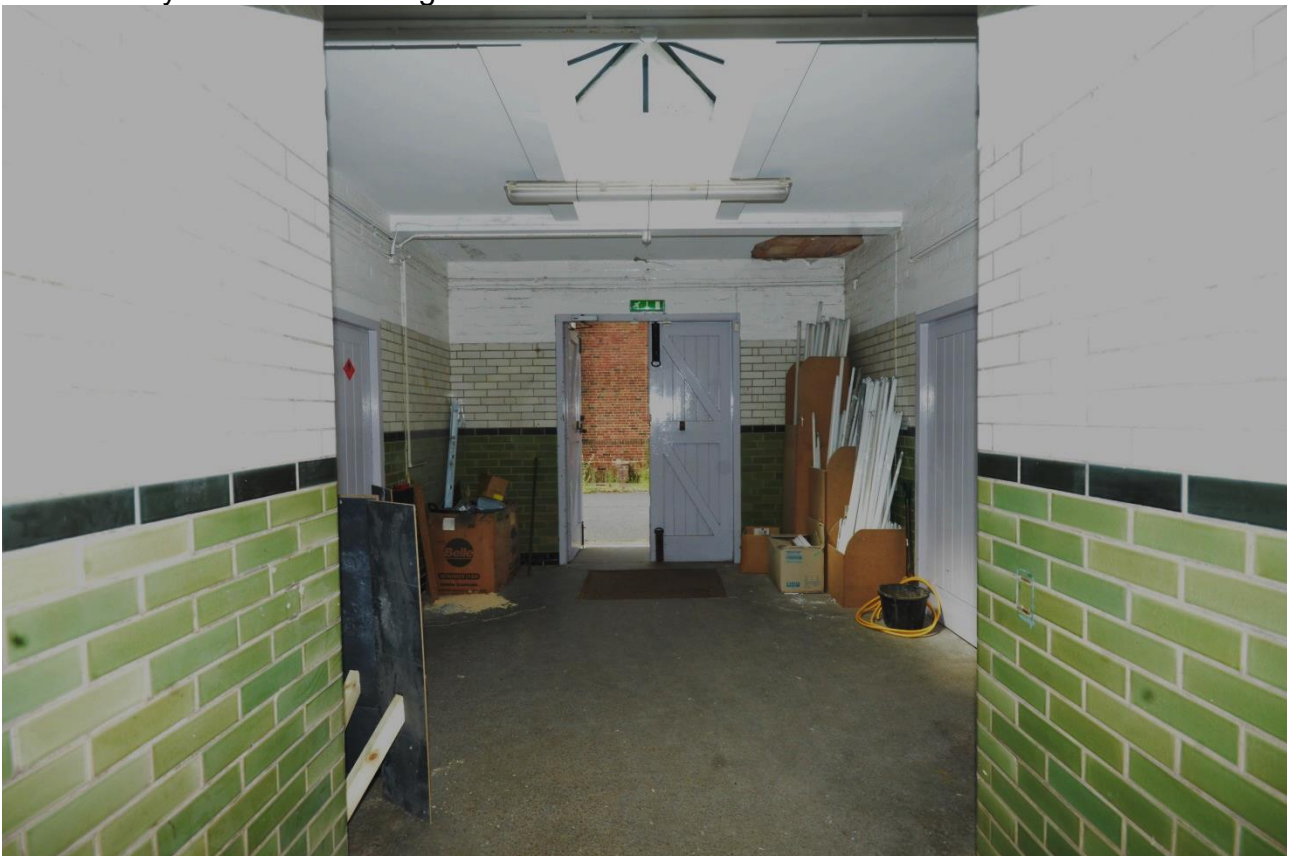
Plate 99: Northwest aspect, room 8

The rear entrance is considered to have been the main entrance for the staff of the manufactory. The walls have glazed bricks in the same form as rooms 4 and 5.

The room has double external doors in its northwest wall and to rooms to the northeast and southwest. A passage leads directly into the western corner of room 4.

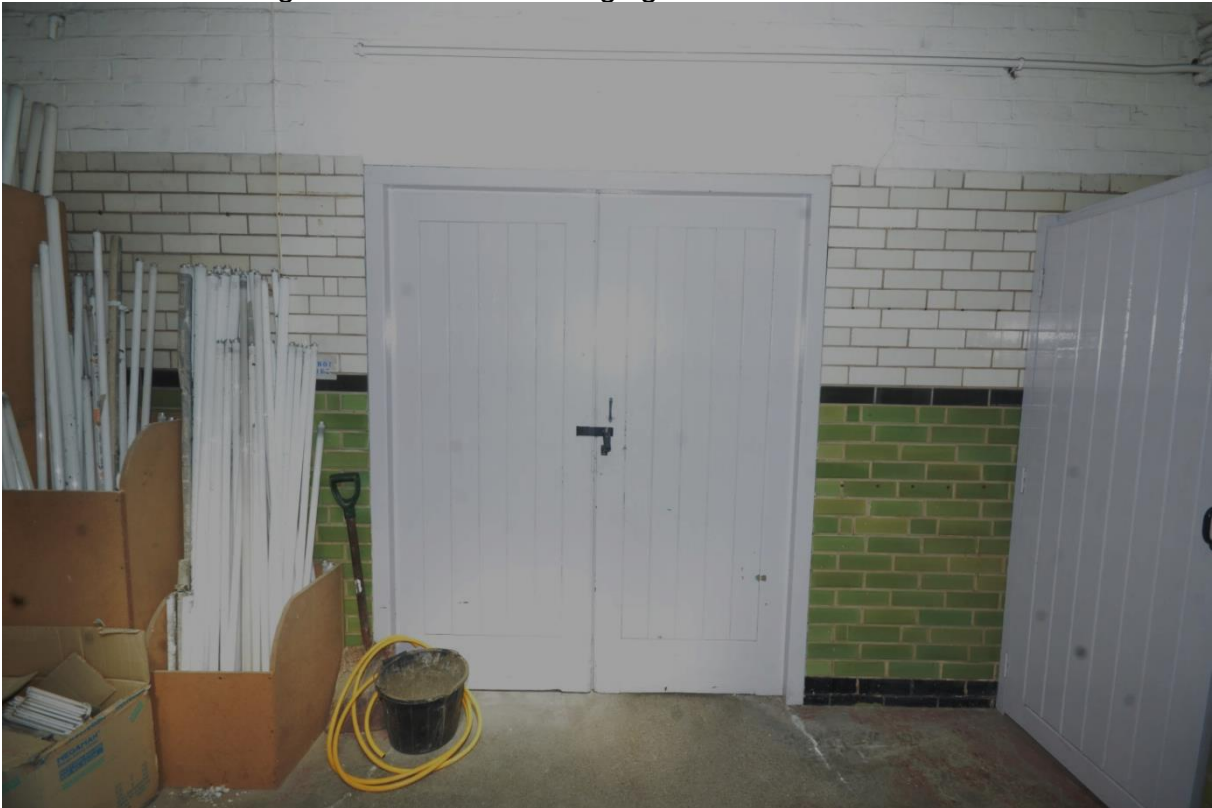
Plate 100: Northeast aspect, room 8

Room 8 has a central glazed lantern admitting light to this otherwise windowless area.

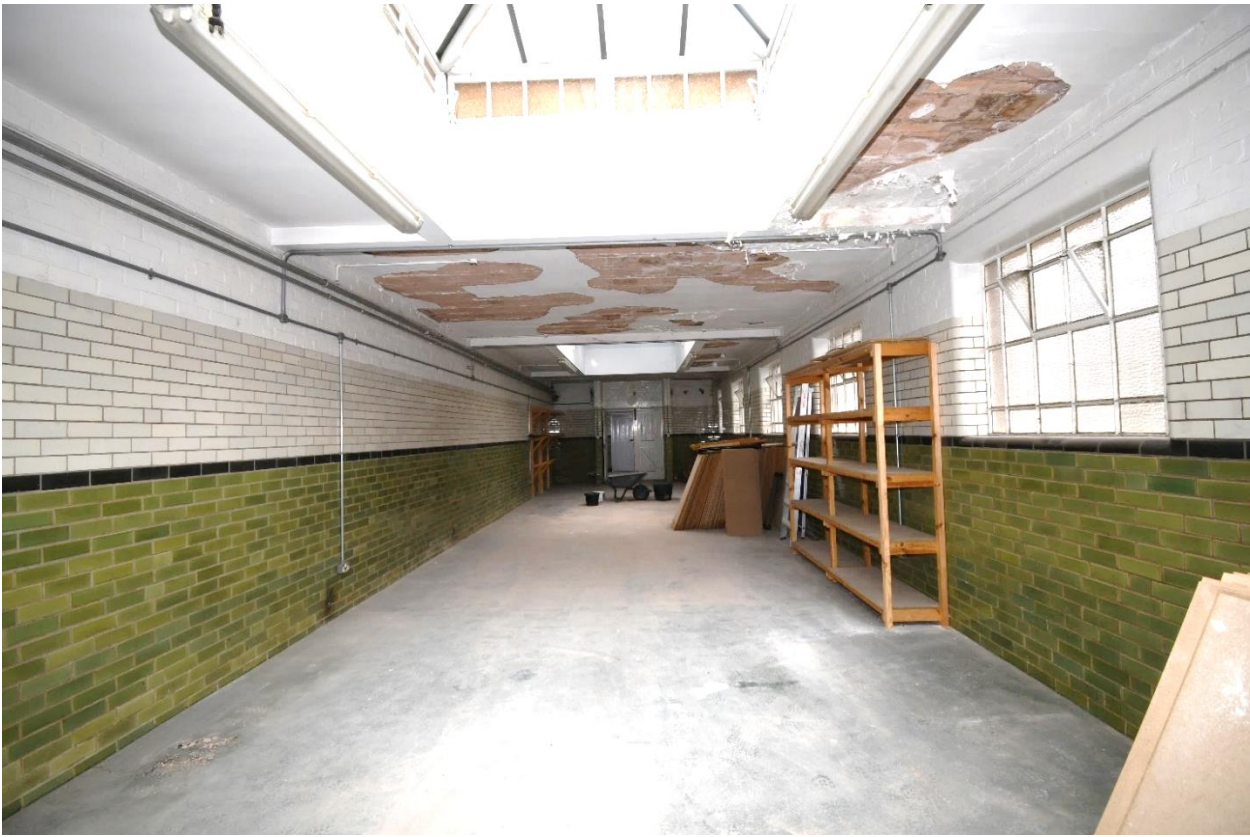
Plate 102: Southwest aspect, room 9

Room 9 is a long room at the rear of the building. The walls are formed from glazed bricks / are tiled, indicating this room was used for wet or dirty processes. Lanterns are present in the flat roof, admitting natural light to the internal space. Windows are also present in the northwest wall.

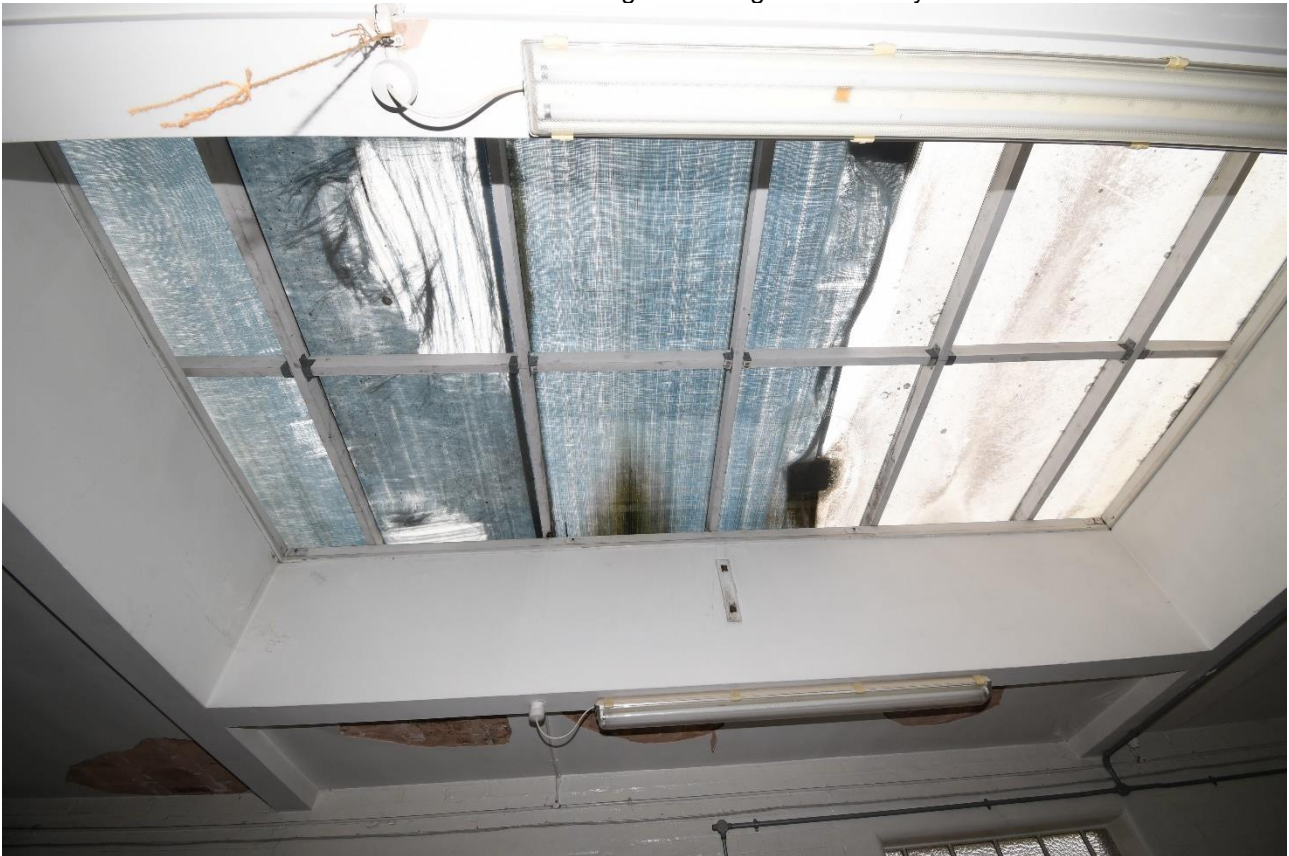
Plate 104: Detail of flat lantern over room 9

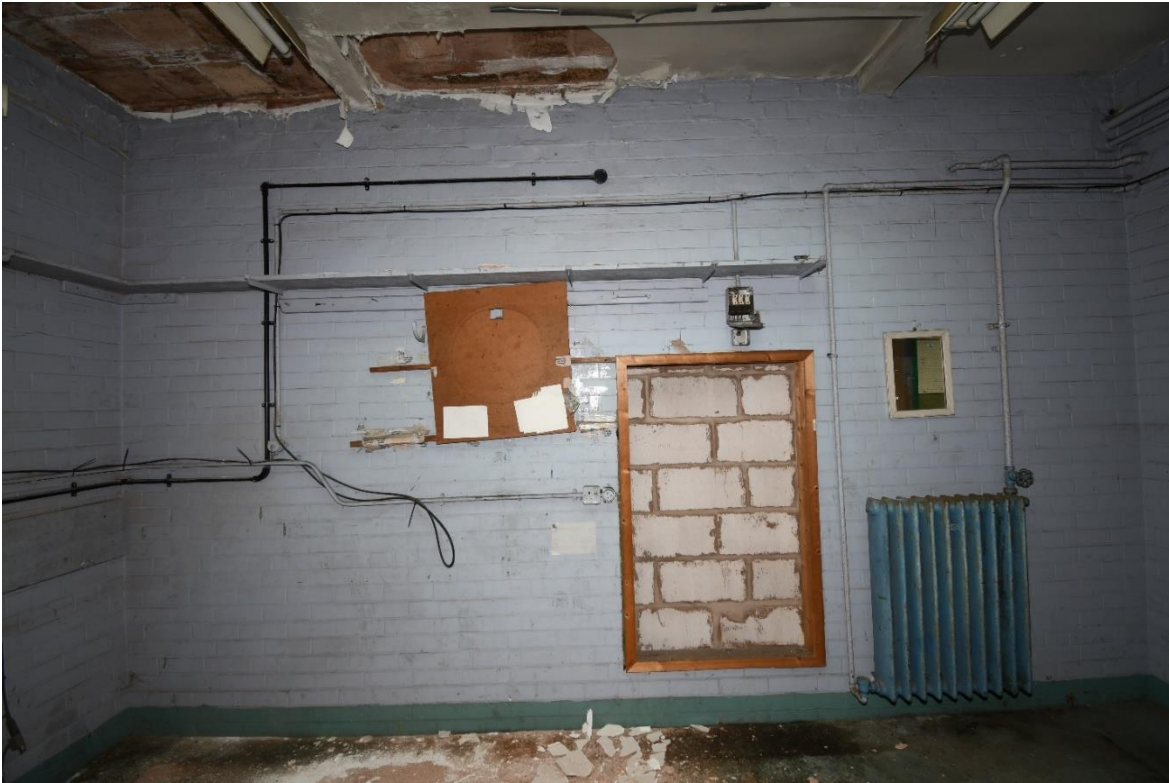
The room does not have glazed brick or tile, suggesting a 'clean' purpose – possibly the office of a supervisor. A blocked opening is present in the northeast wall which divides room 10 from room 11. The opening is not full-height and was not a pedestrian door.

Plate 106: Northeast aspect, room 10 showing opening

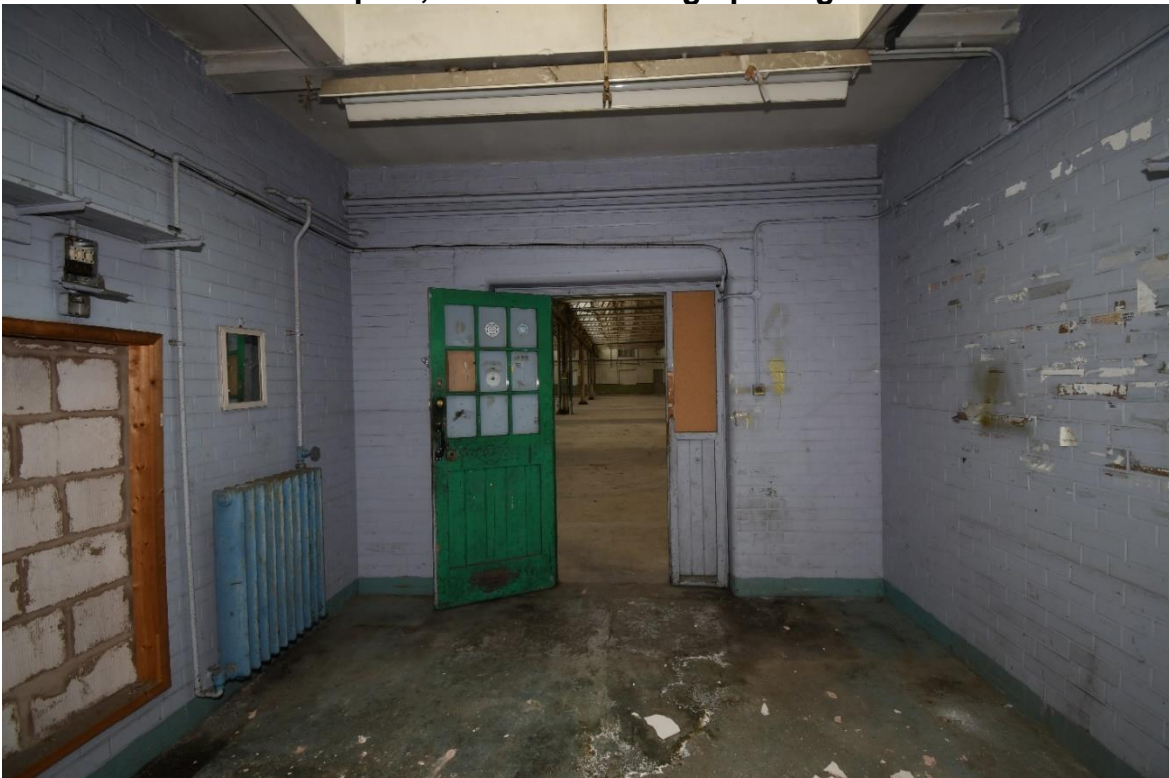
Plate 107: Southeast aspect, room 10 showing opening

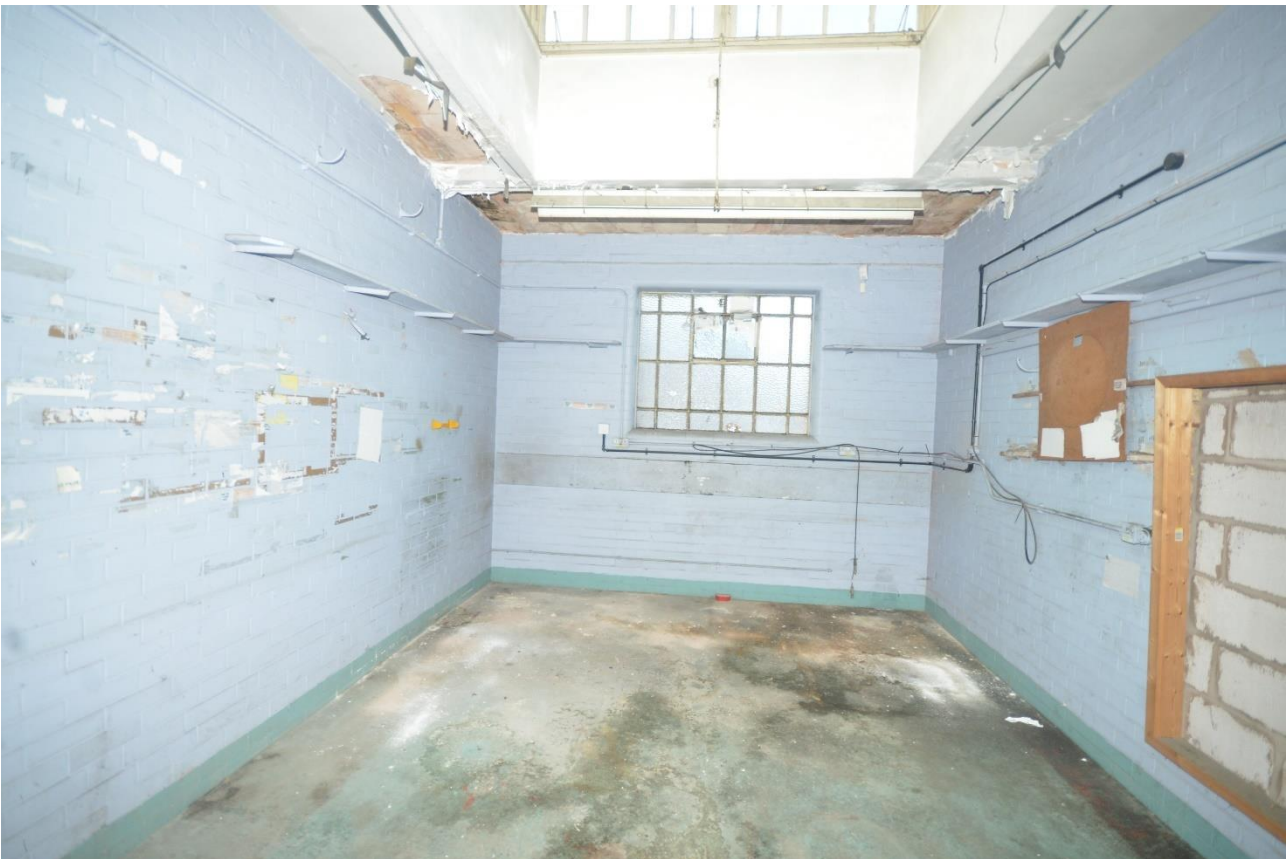
Plate 108: Northwest aspect, room 10

A gabled lantern is present over the centre of the room.

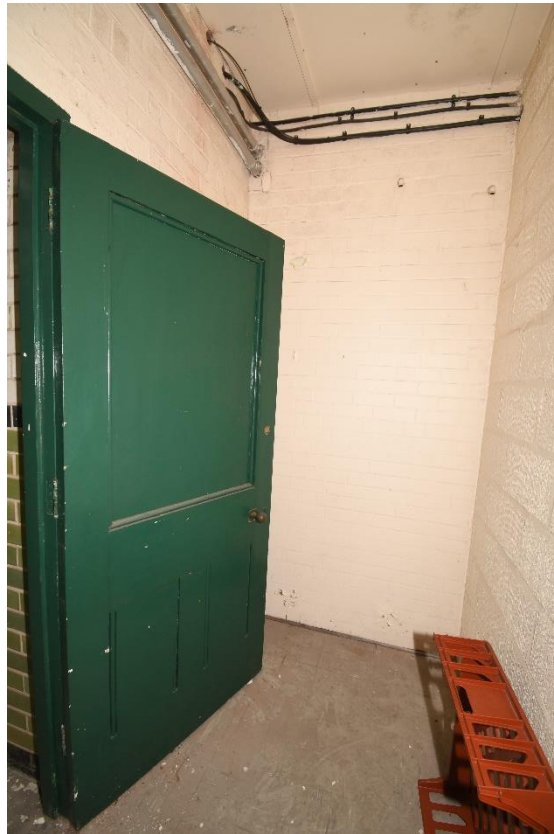
Plate 110: Southwest aspect, room 11a

Room 11a is a small lobby between the manufactory area, room 11 and room 12. The door is panelled, with a single upper panel and two vertical lower panels.
