Level 3
Building Recording of
Manufactory
Blue Bird Park
Bromsgrove Road
Hunnington
Worcestershire
B62 0JW

Planning Reference Number: 19/00592/FUL
OASIS ID: thearcha1-516388
HER Event No. WSM80084

Document Reference Number 2023/1681

Dr Peter Wardle & Colin Lacey

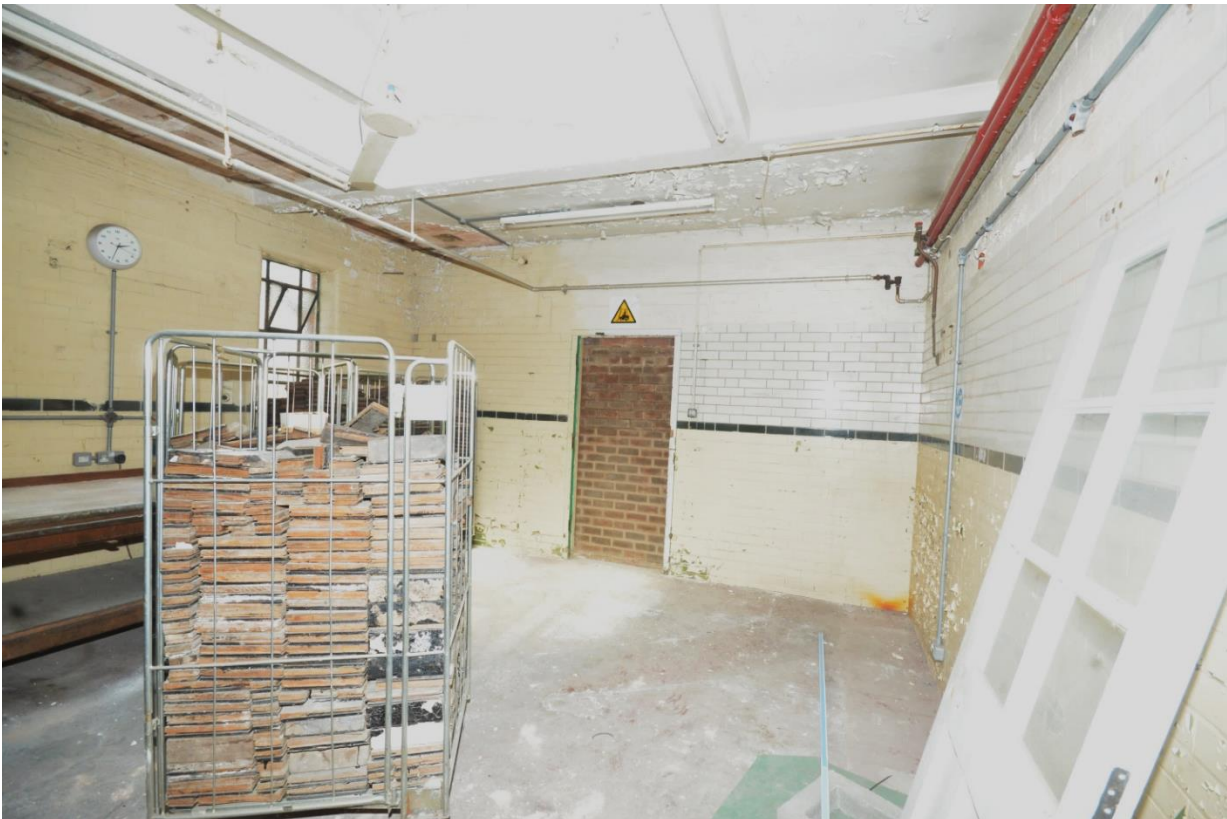
Plate 111: Northeast aspect, room 12

Room 12 has glazed brick walls with cream lower parts. The black band and white upper parts are shared with other areas of the building. A blocked door is present in the northeast wall and iron-framed obscure-glazed windows are present to the northwest. A glazed lantern is present in the ceiling of the room. The obscure glazing suggests this may have been a changing room or similar.

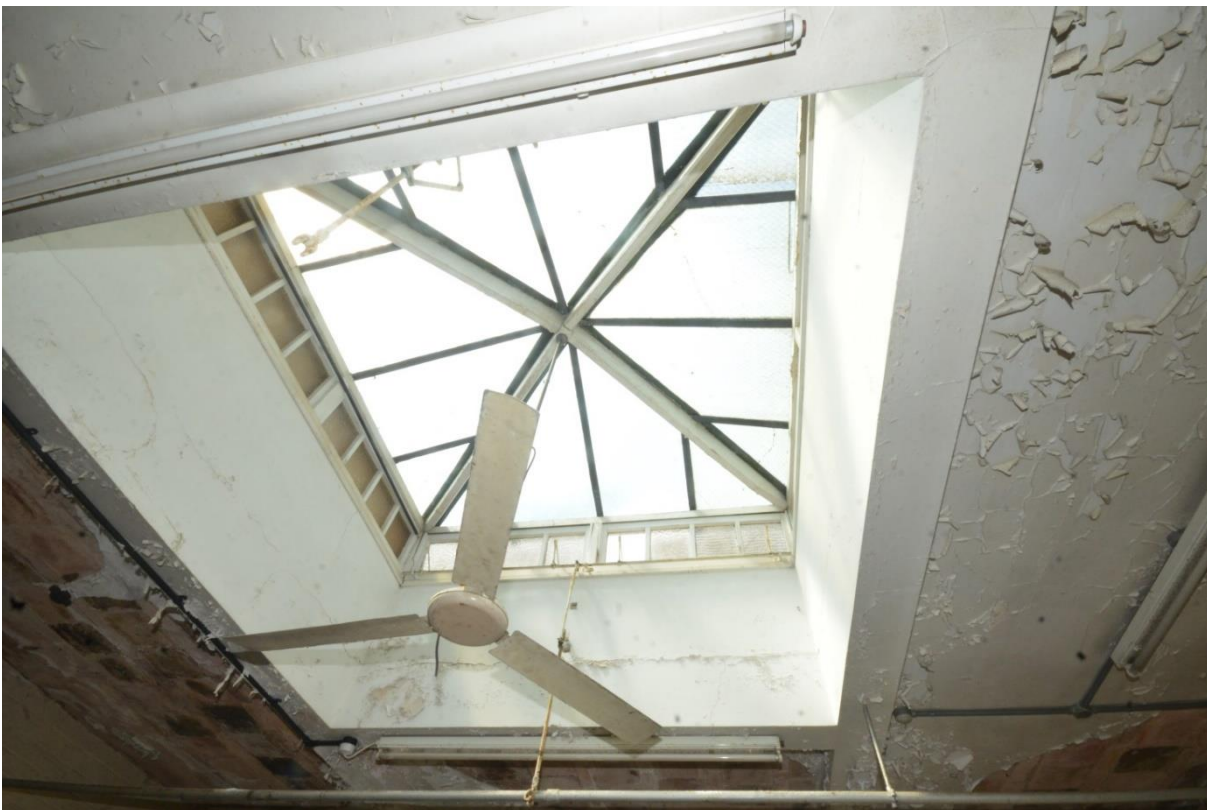
Plate 113: Lantern above room 12

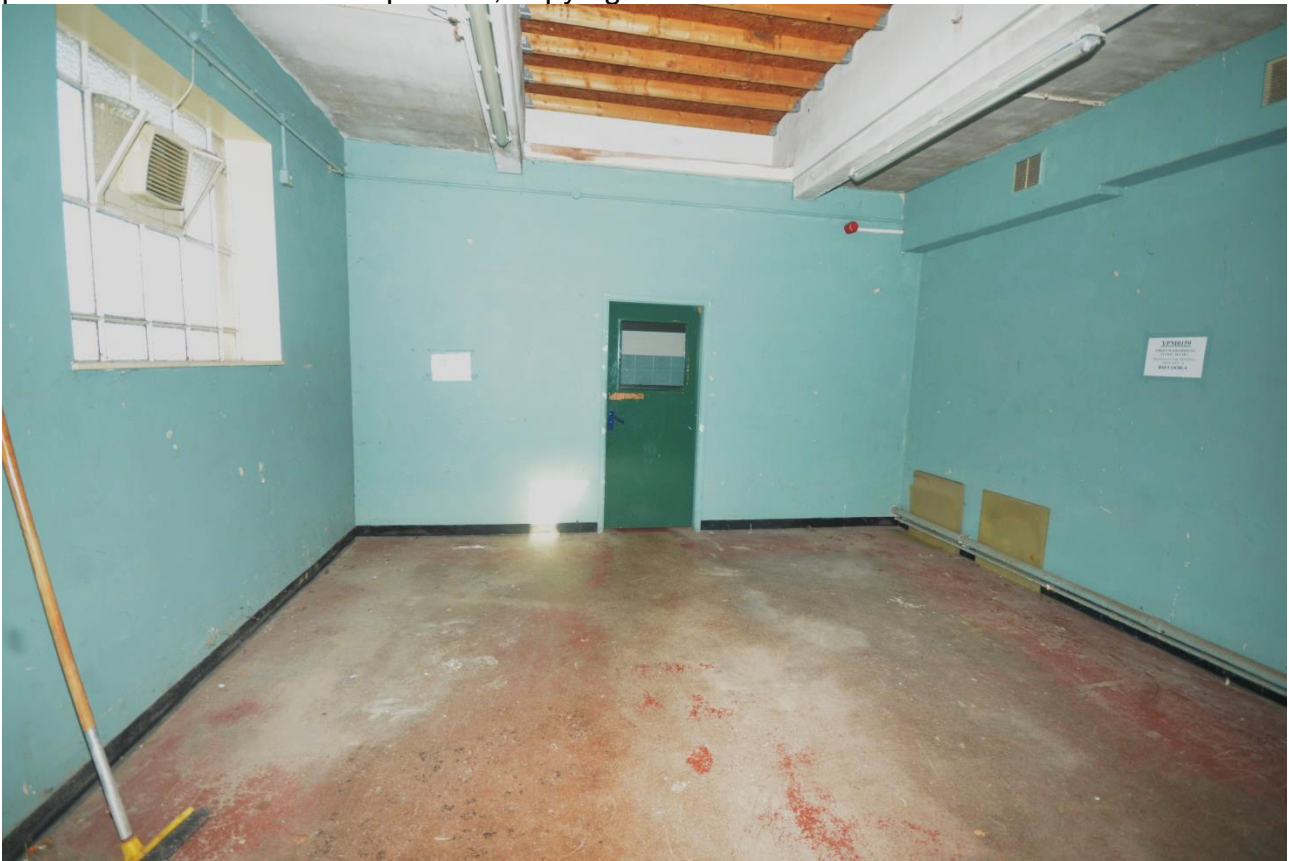
Plate 114: Northeast aspect, room 13

Room 13 is accessed via a double door to the northwest loading bay. It is considered likely to have previously been used as a locker room. The windows are obscure-glazed and a possible blocked lantern is present, copying the form of room 12.

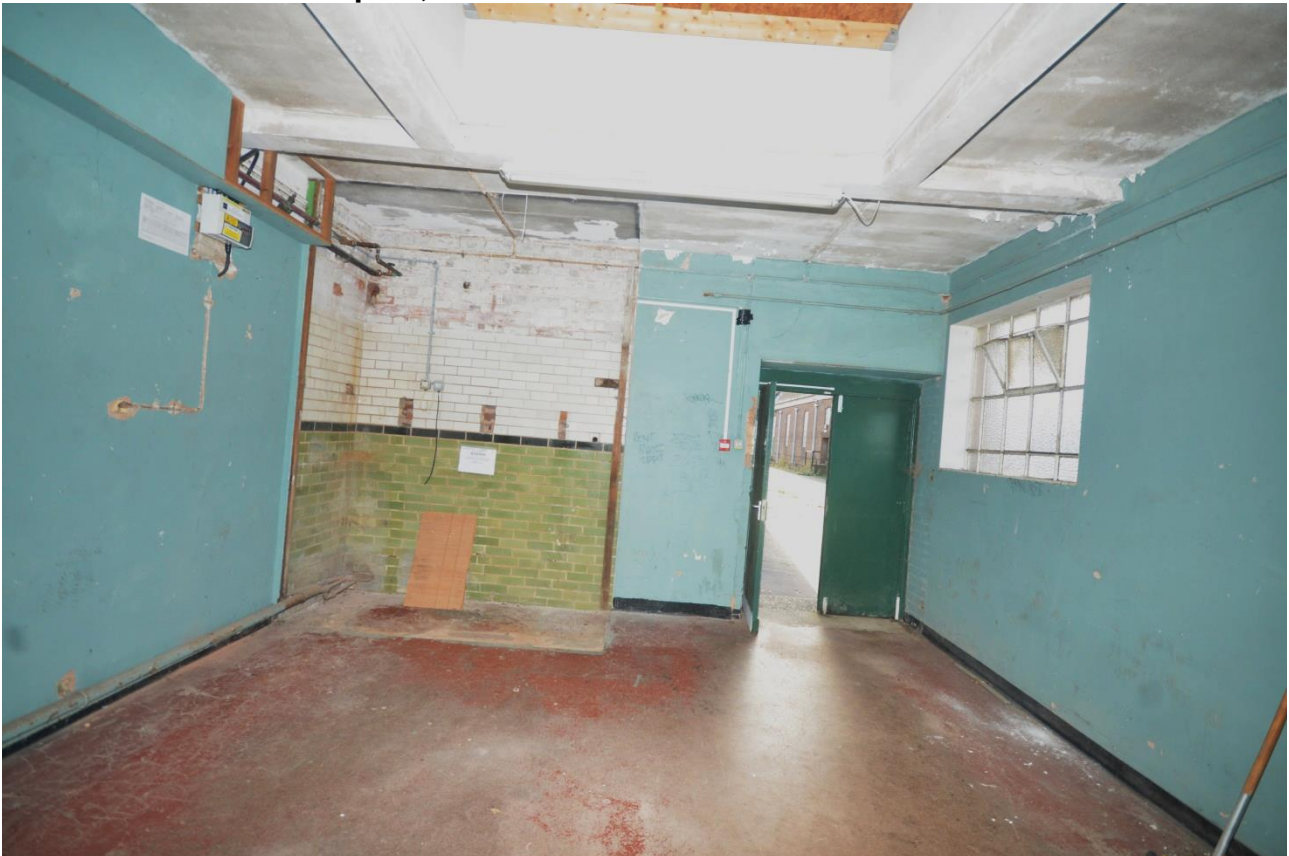
Plate 115: Southwest aspect, room 13

The southern corner of the room is constructed with the same green / black / white arrangement of glazed brick as other rooms. The remainder of the walls are painted blue. The floor in this corner of the room is of bare concrete whereas that of the remainder of the room is painted red. It is suggested that this corner was once partitioned off from the rest of the room. The original purpose of this partitioned area cannot be determined from the physical remains present, and it is unclear if glazed brick was used.

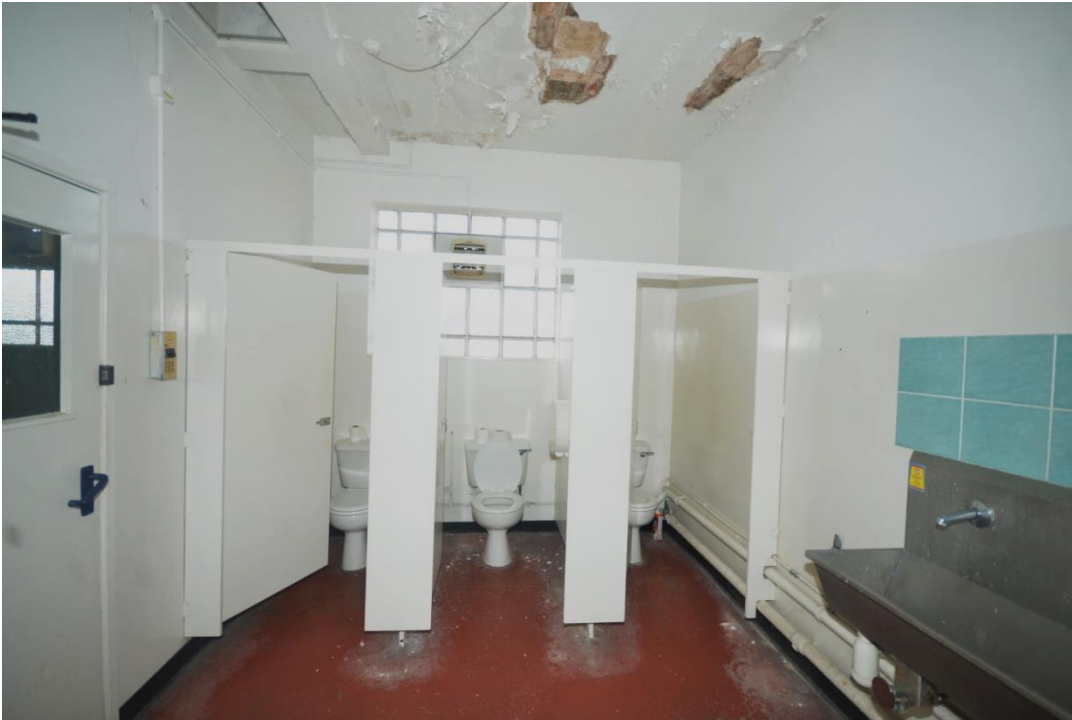
Plate 116: Northwest aspect, room 14

Room 14 is a gents' lavatory located at the northeast end of room 14. Fixtures and fittings are considered to be late 20thC in origin. This room also features knee-operated taps as found in room 7a.

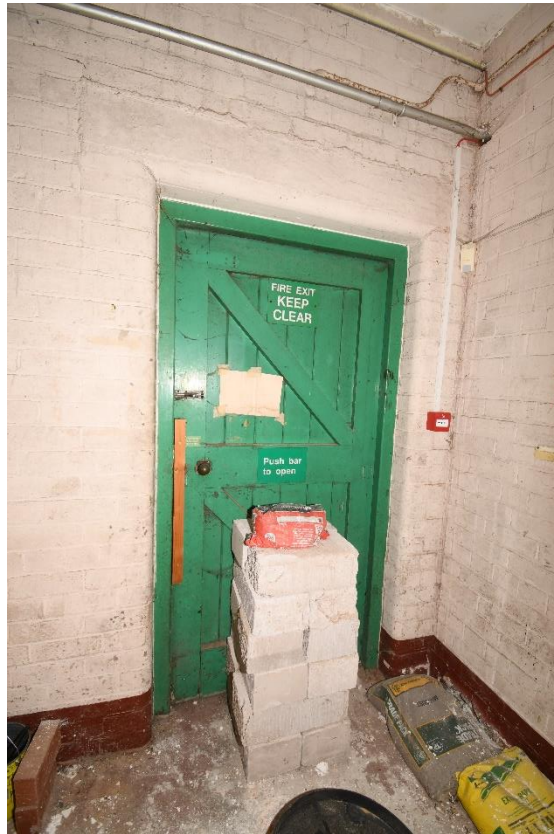
The room is entered from a doorway to room 6 and features a plank-and-ledge external door in its northeast wall. There are no other features of interest in this room.

Plate 120: Northeast door

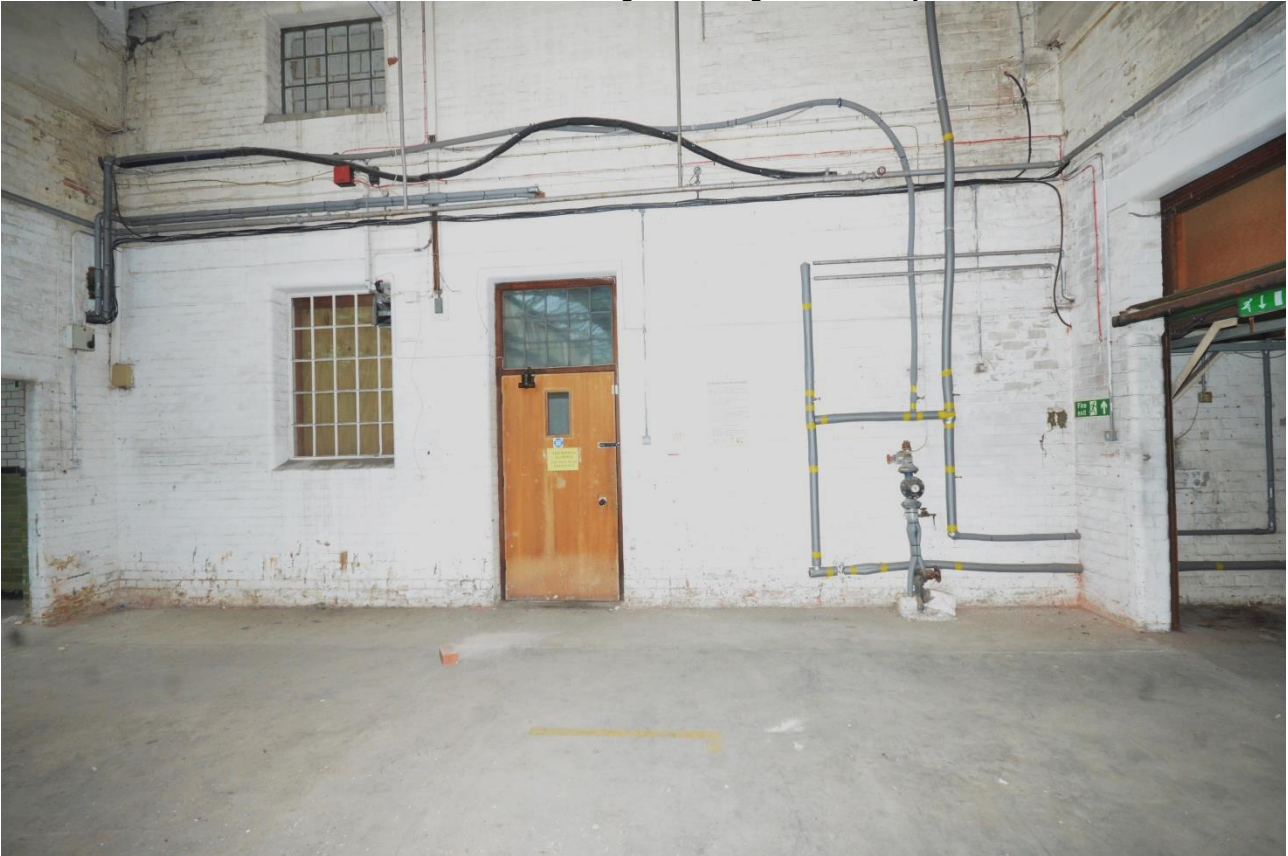
A number of doorways also ran between the ground floor of the administration building and the manufactory. Of these, room 3 had a single door (which is still operational), room 4 had three (which are blocked), room 5 had one (still operational).

In rooms 4 and 5, the wall is clad with the green and white glazed bricks of the manufactory whereas in room 3, the wall is of painted brick.

Plate 121: Door and windows to administration building in southeast wall of room 3

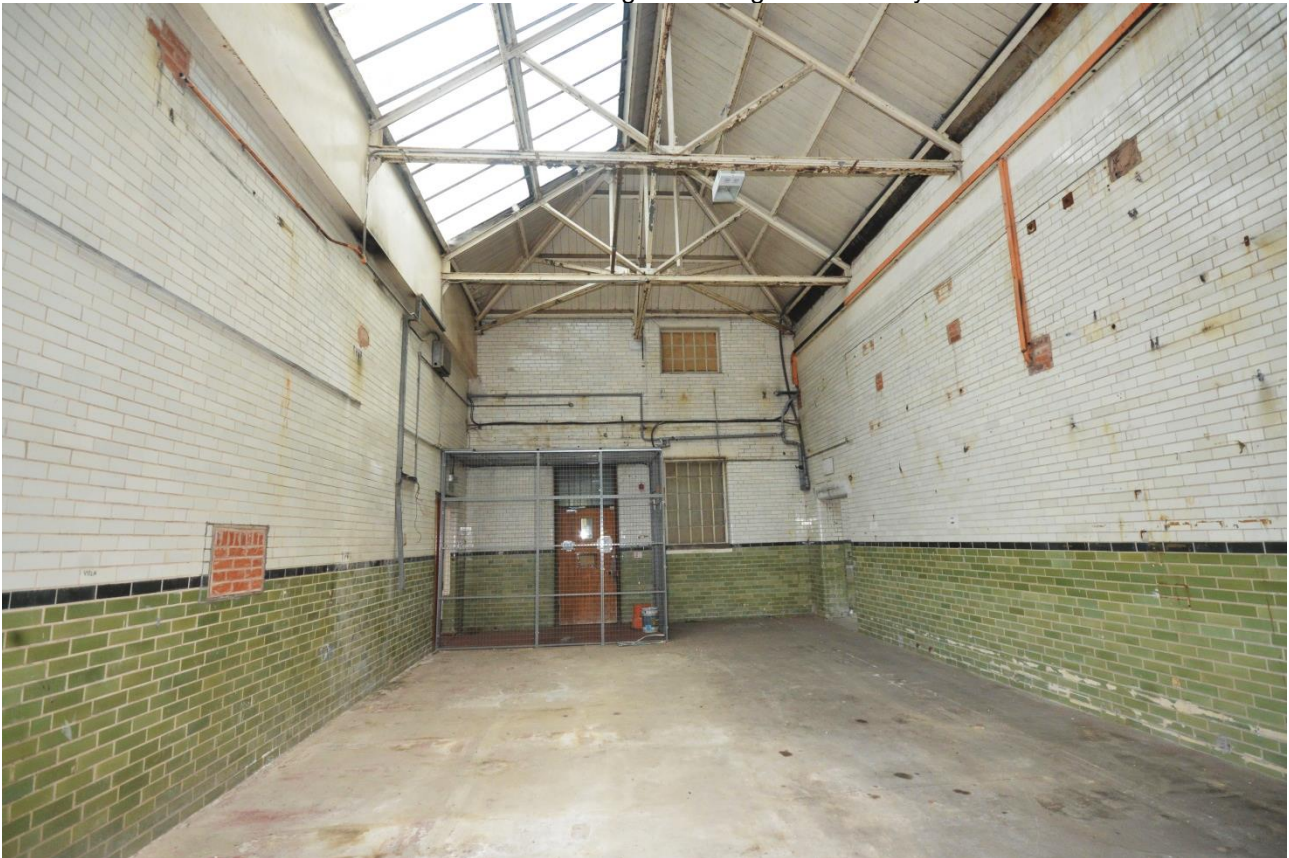
Plate 123: Door and windows to administration building in southeast wall of room 5

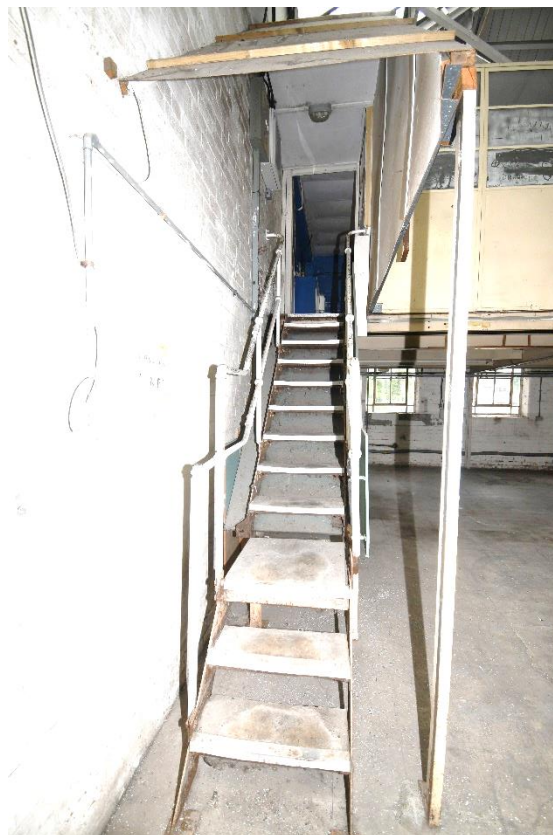
Plate 124: Staircase to mezzanine

Access is via a steel staircase which leads to a single room with no features of interest. A door in the southwest wall of this room leads to the second room

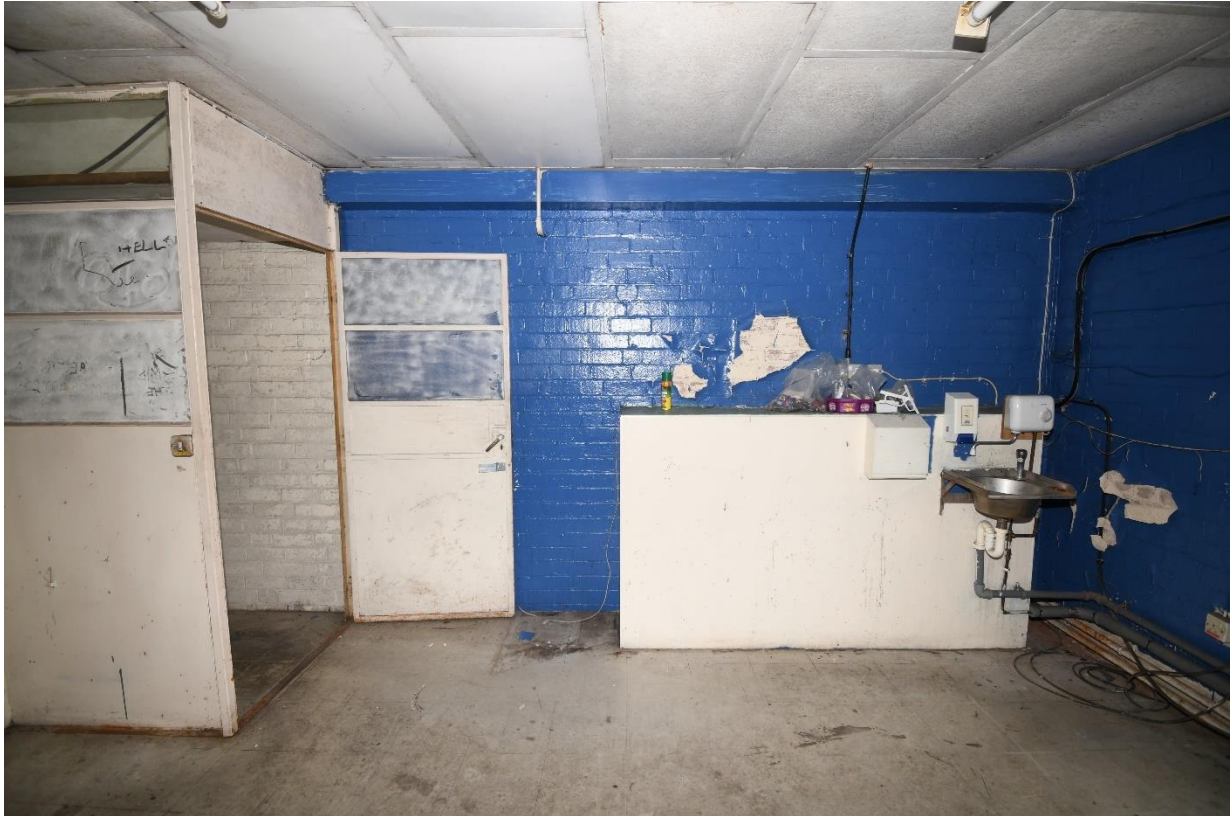
Plate 125: Northeast aspect, mezzanine room 1

The mezzanine floor at the southeast end of room 1 contains two rooms. The mezzanine is considered to be a later addition to the building and is not an original feature.

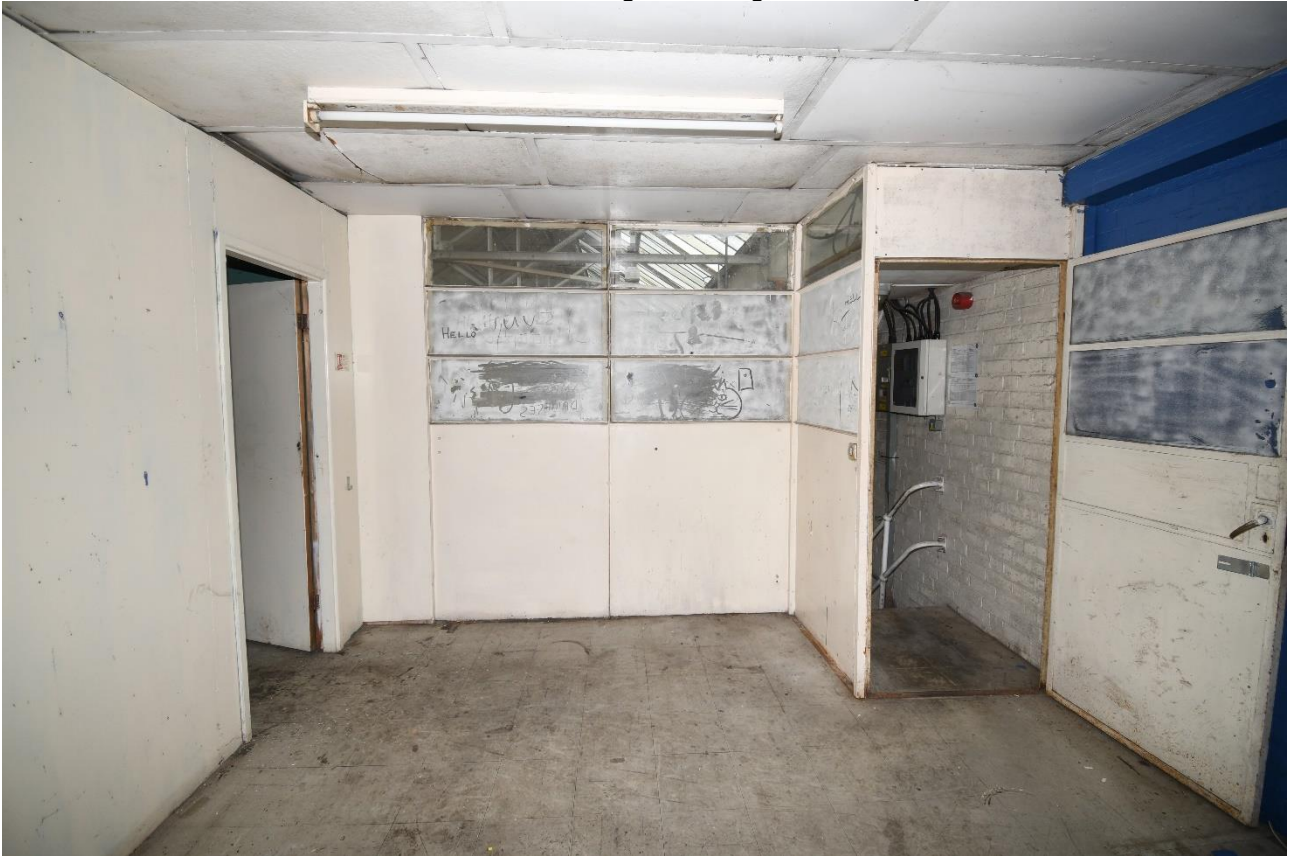
Plate 127: Northwest aspect, mezzanine room 1

In the northwest wall of the mezzanine, windows overlook the space below.

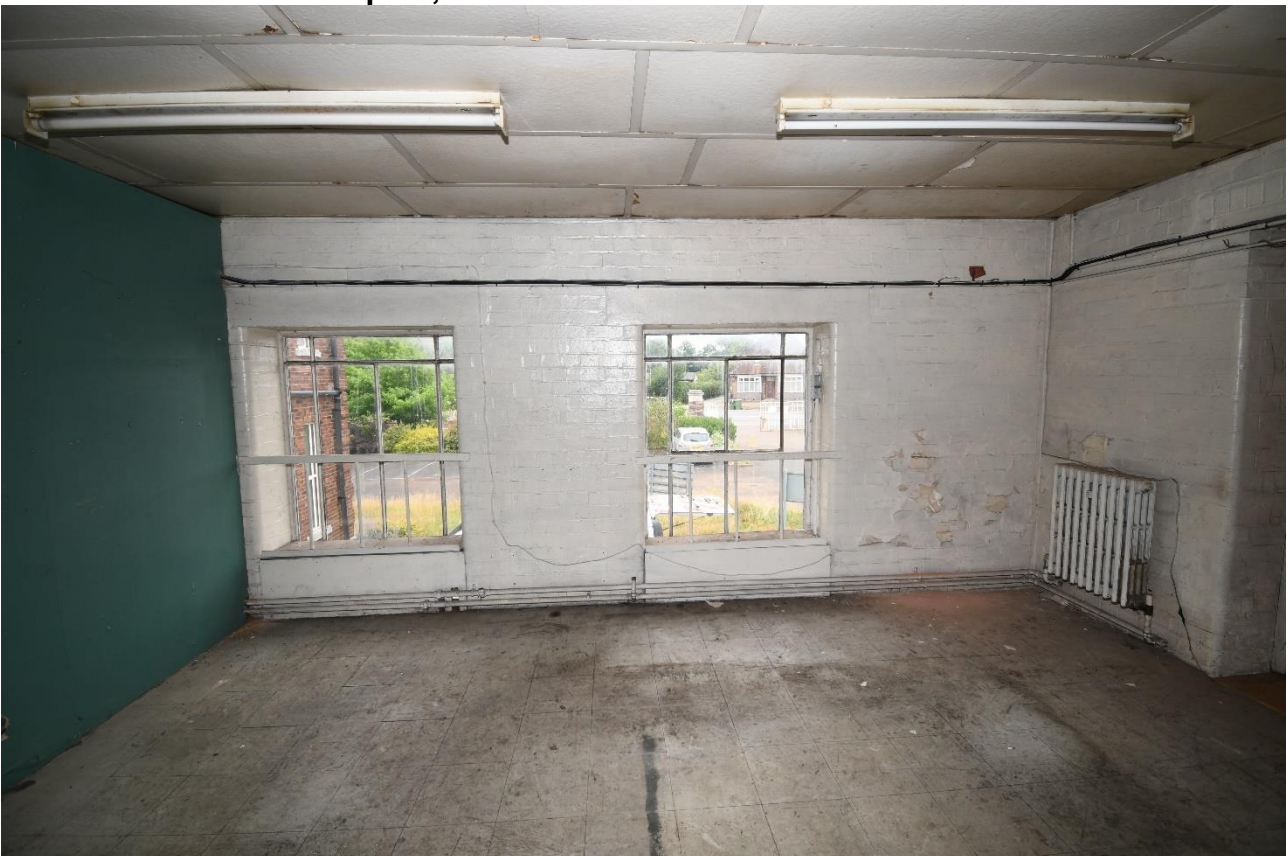
Plate 130: Details of windows, mezzanine room 2
