Appendix 6: Level 3 Building Recording of Power House & Boiler House

Blue Bird Park
Bromsgrove Road
Hunnington
Worcestershire
B62 0JW

Document Reference Number 2023/1681

# Building Recording of: Power House Dr Peter Wardle & Colin Lacey

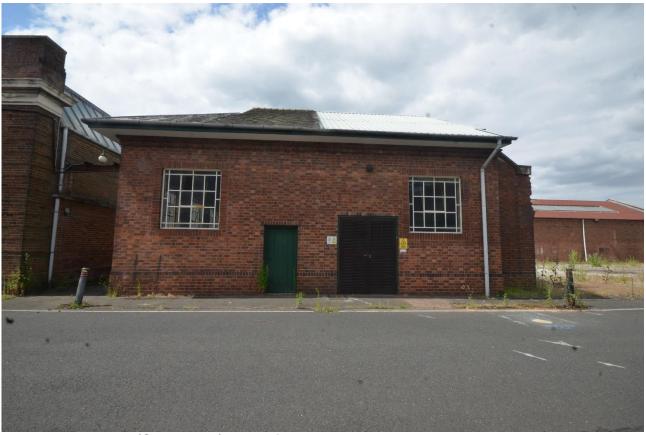
Plate 3 The Front (Southeast) Elevation

Building 5 is constructed of red brick in Flemish bond, with decorative courses of vertical-header engineering bricks. The roof, hipped to the southwest, is of slate to the southwest and of corrugated sheet to the northeast.

Two windows are present in the southeast wall. These are steel-framed multi-pane windows. Between, two doors are present. To the left, a planked personnel door, to the right, tall double louvered doors. Warning signs either side of the double doors suggest the interior of the building at this may have been used for power distribution.

The southwest part of the roof is of tile in a suppressed gable form, however following the demolition of the adjacent boiler house at some point around August 2007, the northeast part of the roof is of corrugated metal sheet.

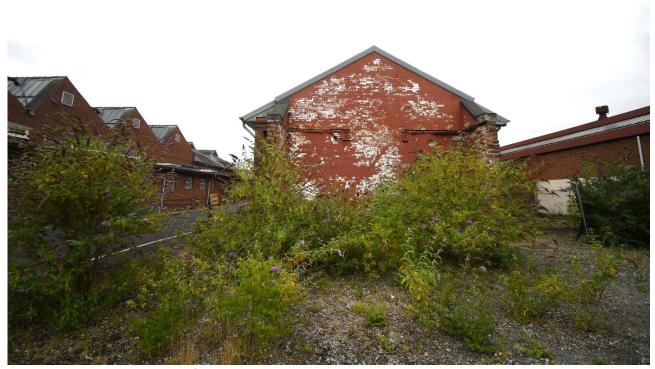
Plate 4: Northeast elevation

The northeast wall was once the southwest wall of the adjacent former boiler house, now demolished. The stubs of the walls of the former boiler house are present on the northeast wall of the building, which still bears paint from the interior of the boiler house.

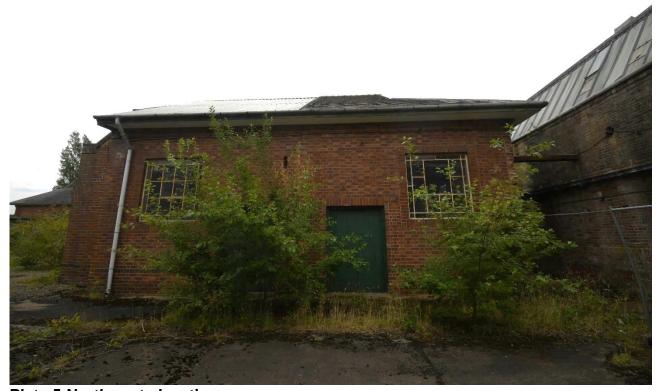
Plate 5:Northwest elevation

The northwest elevation, like the southeast, features two steel-framed windows and two pairs of planked double doors.

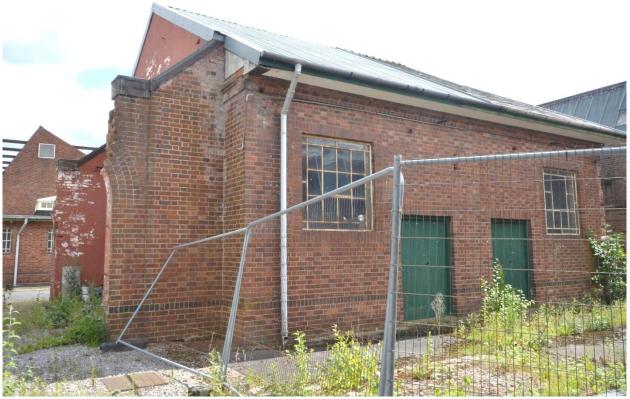
Plate 6: North aspect

The southwest of the building is located a short distance from the northeast of building 4. A narrow passageway is present between the buildings. The southwest wall of building 5 has three steel-framed windows and no doors. A duct carries cables from building 5 to building 4.

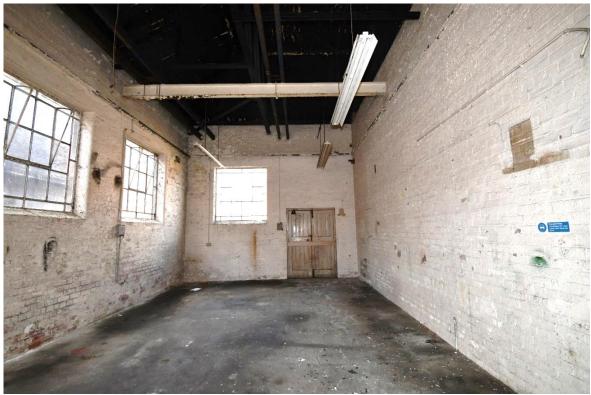
Plate 15: Northwest aspect, southwest room

The southwest room is empty. The walls are painted white and the floor is of poured concrete.

Spanning the width of this room, a duct at eaves-height takes cables from the northeast room to the alley between this building and building 4.

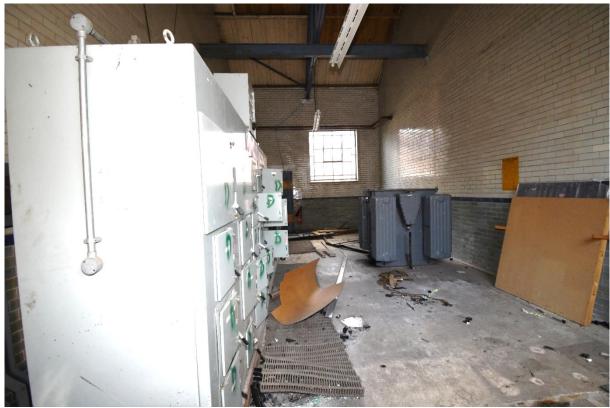
Plate 19: Northwest aspect, northeast room

The room occupying the remaining (northeast) part of the building was most recently used for electrical distribution. A substantial transformer is fitted, along with banks of switchgear.

The former boiler house, joined to the northeast side of the building, is considered to have contained electricity generation equipment, this room distributing the power around the Blue Bird site.

Equipment is raised above floor level on low brick plinths, and sunken areas of the floor are present, possibly for cable distribution.

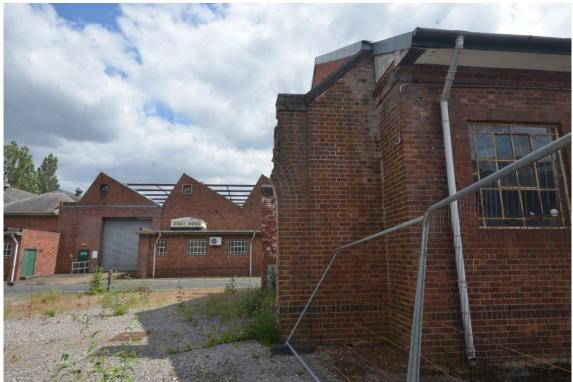
Plate 24: Stub of northwest wall of boiler house, showing start of arch

At its northeast end, the adjacent power house has the stubs of the northwest and southeast walls of the boiler house. Each shows the end of an arch of bricks, presumably to support the weight of the water in the water tower above. Following demolition of the boiler house, these walls were capped, to prevent water ingress.

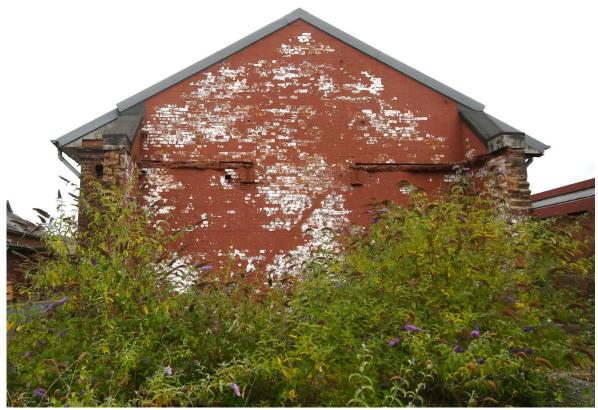
Plate 26: Interior of southwest wall (northeast wall of power house)

There is evidence for a former first floor or ground floor ceiling just below eaves level of the southwest wall. A large concrete slab is present in the location of the former boiler house. This is thought to be partly comprised of the floor of the original building and of surrounding hardstanding.
