Appendix 7: Level 3 Building Recording of
The Transport Building

Blue Bird Park
Bromsgrove Road
Hunnington
Worcestershire
B62 0JW

Dr Peter Wardle & Colin Lacey

Document Reference Number 2023/1681
Version 1

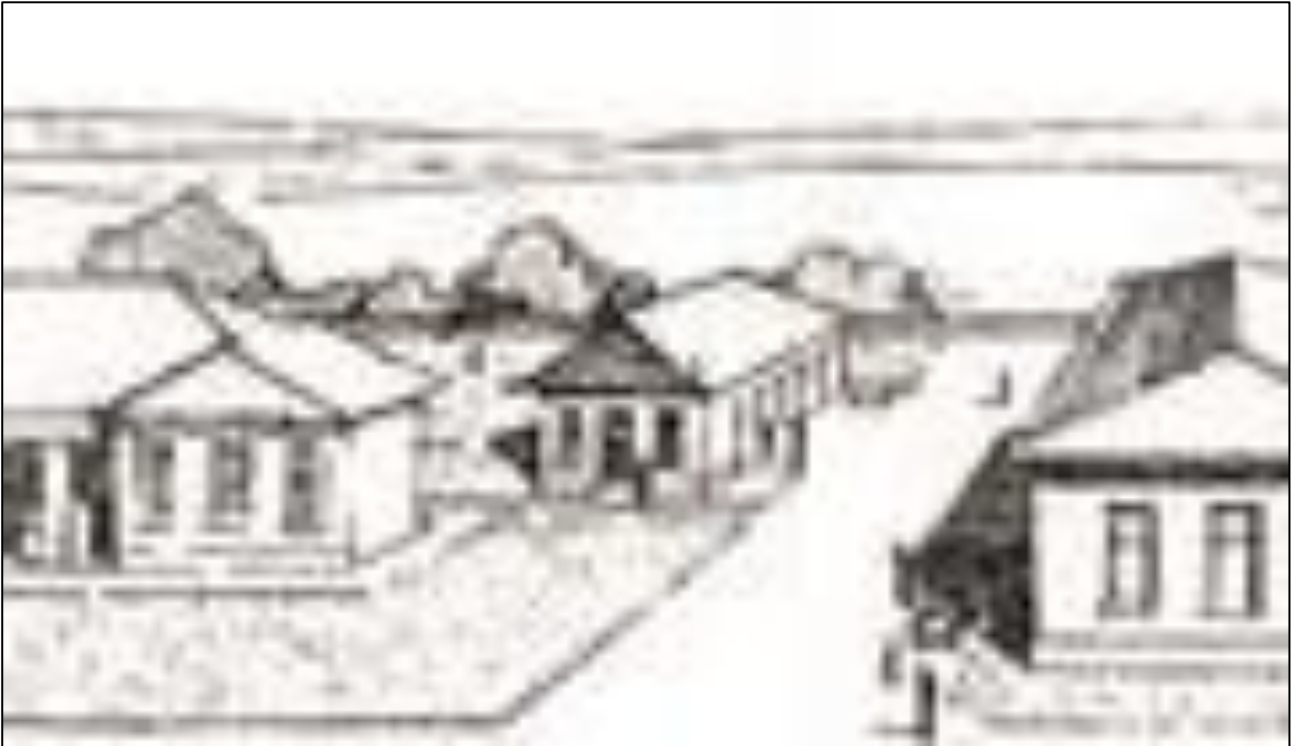
Figure 3: Detail of transport building from 1927 Midlander article

Whilst this article does not mention the transport building, it has a sketch of the factory complex from the road. This shows the transport building. An excerpt of the drawing is shown below.

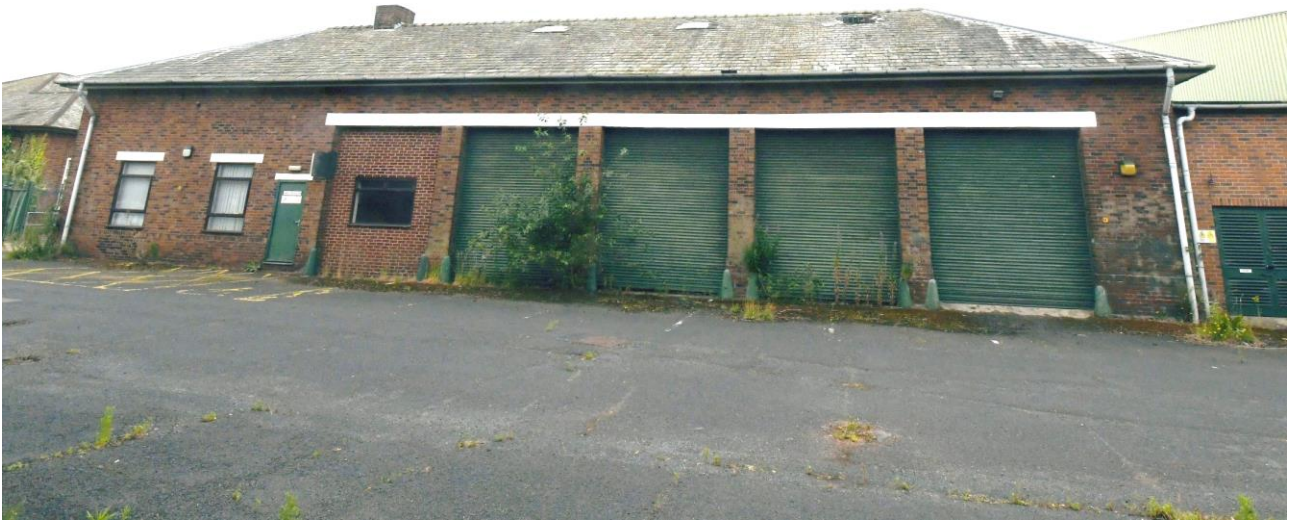
Plate 8: Northeast elevation

The transport building is a northwest-southeast oriented building of red brick in the same bond based on stretcher, Flemish and English Garden Wall bonds as is found in the main manufactory building, with the addition of a course of vertical headers low to the wall.

The roof is a low hipped structure with a small chimney towards the southeast end of the building. Small roof lights / vents are present to the northwest.

To the left, a single pedestrian door is present, followed by two windows. The door has a sign for the 'vehicle reception', relating to the former use of the building. To the right, four roller shutter doors are present. A recessed brick wall with window shows where a fifth roller shutter was once located.

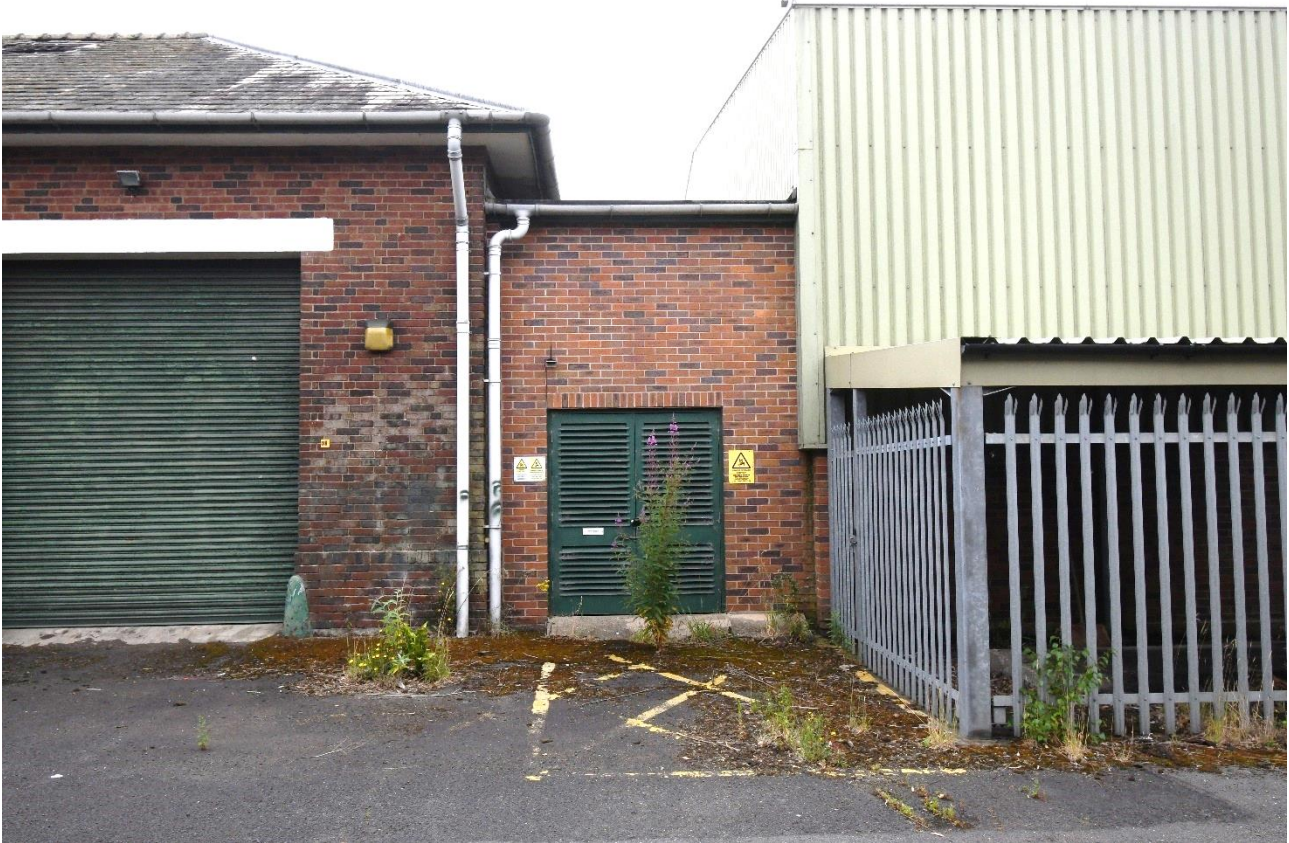
Plate 11: Link between transport building and building 11

A flat-roofed single-storey structure connects the transport building with building 11. The presence of louvred doors and warning signs suggests the building contained electrical distribution equipment.

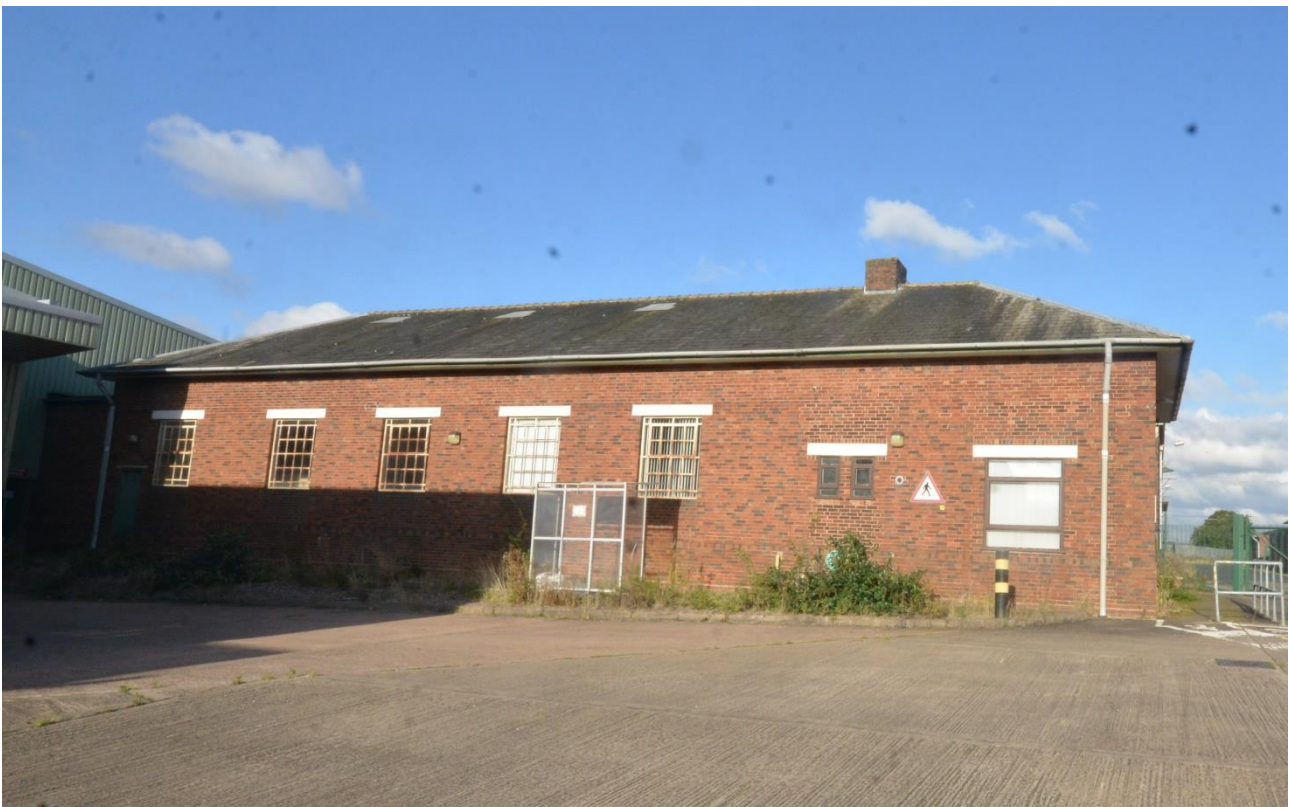
Plate 18: Southwest elevation

A single timber door is present to the left of the southwest elevation, followed by five steel-framed multi-pane fixed windows. A pair of smaller steel-framed single windows and a larger three-pane window (both at a lower level to the multi-pane windows), are present to the right. All windows have concrete lintels.

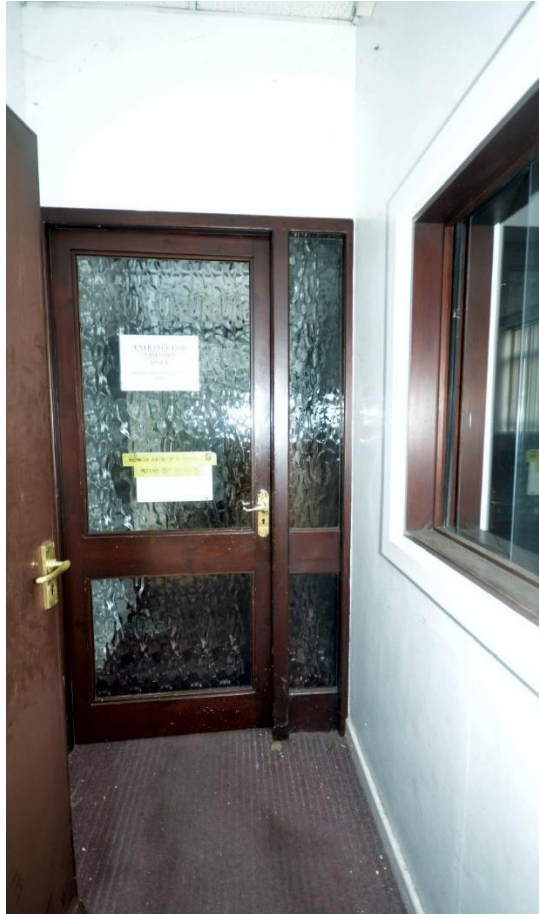
Plate 25: Northwest aspect, room 1

The entrance lobby is accessed via the southeast door. A glazed timber door opens into the reception. A window is present also opening into the reception.

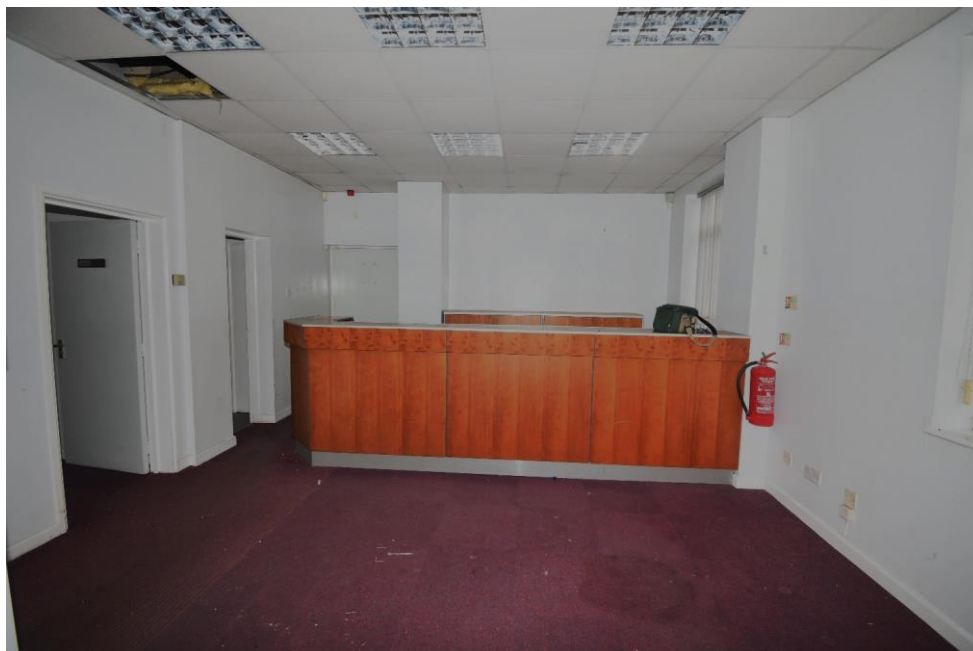
Plate 26: Northwest aspect, reception

The reception features a wooden reception desk / counter in front of the entrance door. Doorways lead off to the northwest and southwest.

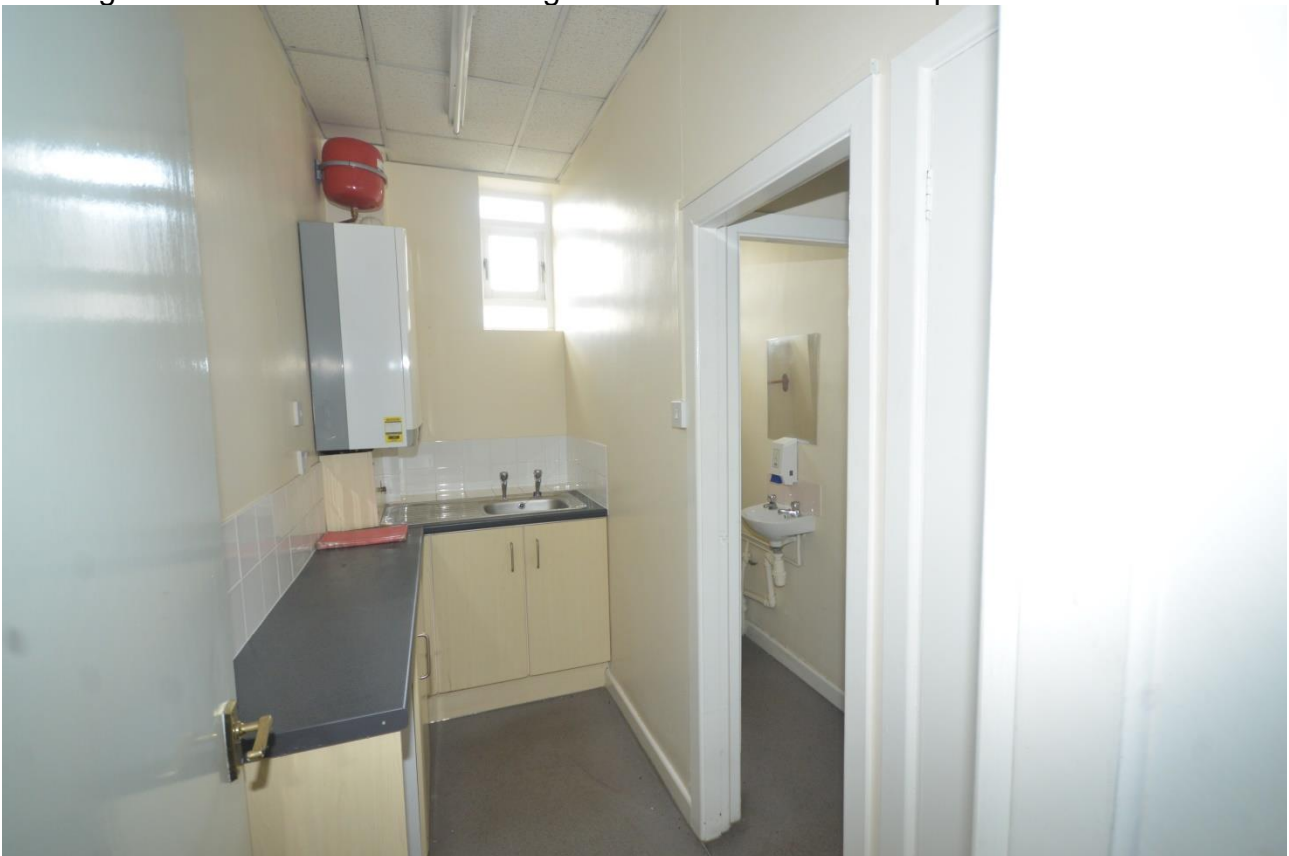
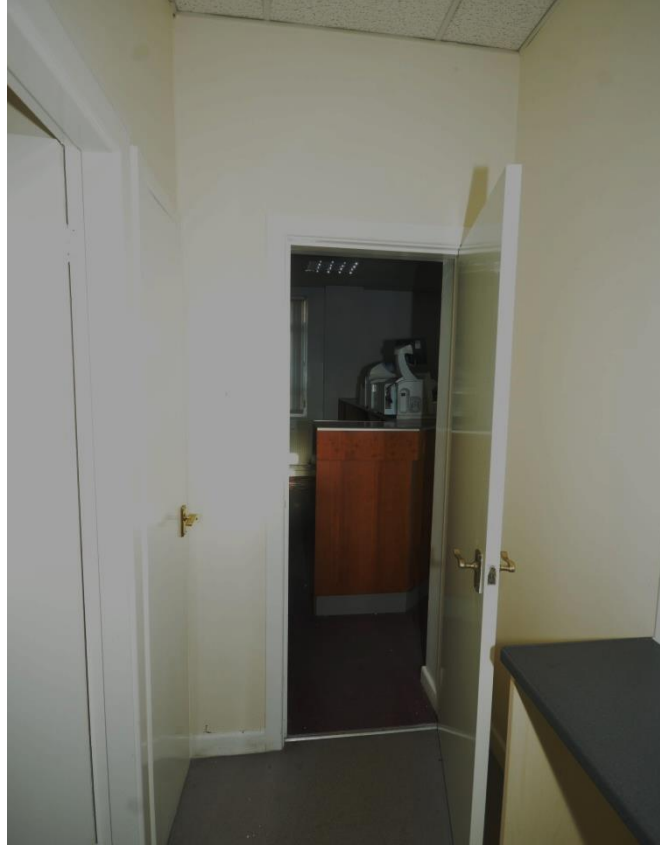
A small works kitchen is present in room 4. The kitchen is considered to have been converted / partitioned from a lavatory once the canteen building had ceased to provide catering facilities. Modern kitchen fittings and a modern boiler are present.

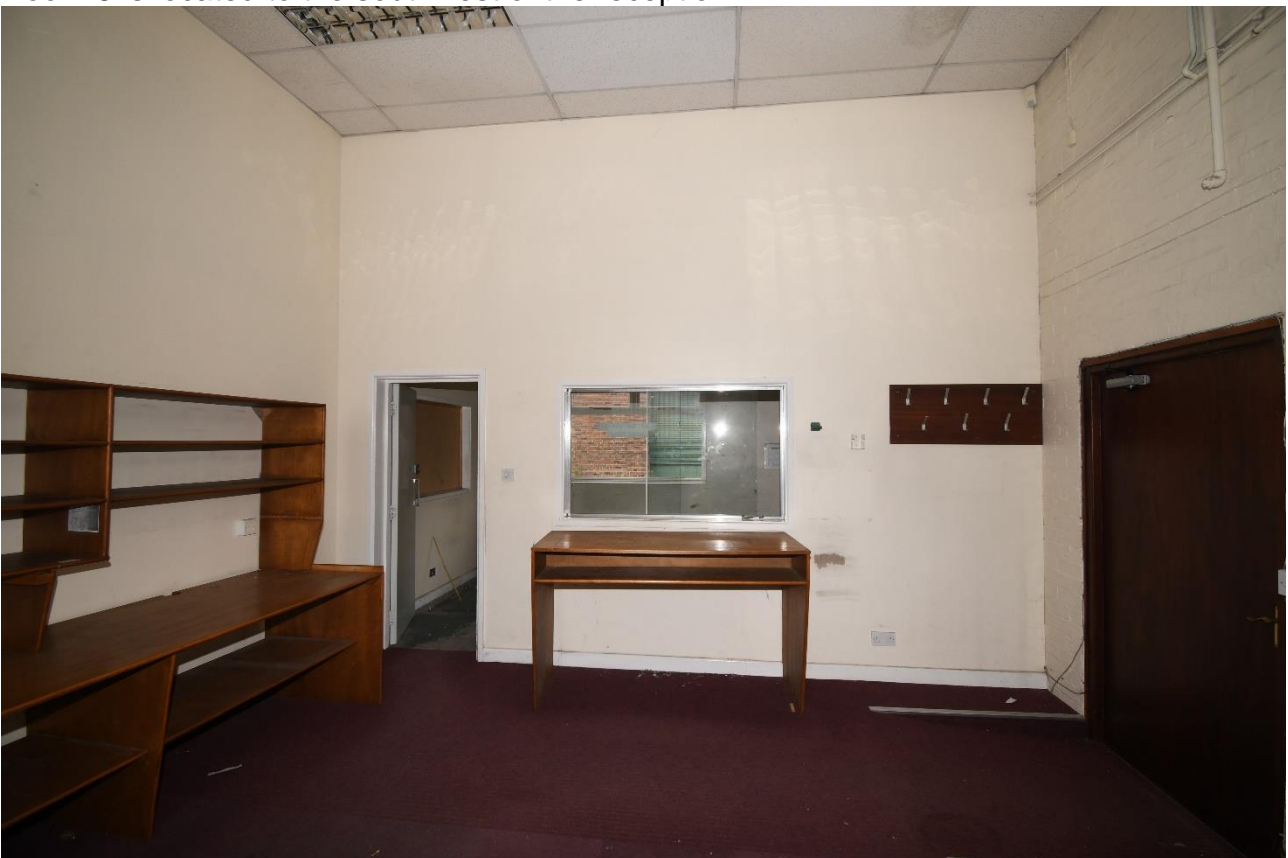
Plate 36: Northeast aspect, room 6

The room has an internal door and window to room 7, and it is considered that the room was used as an office supervising deliveries and other transport activities with drivers arriving at the internal window from room 7 to communicate with office staff.

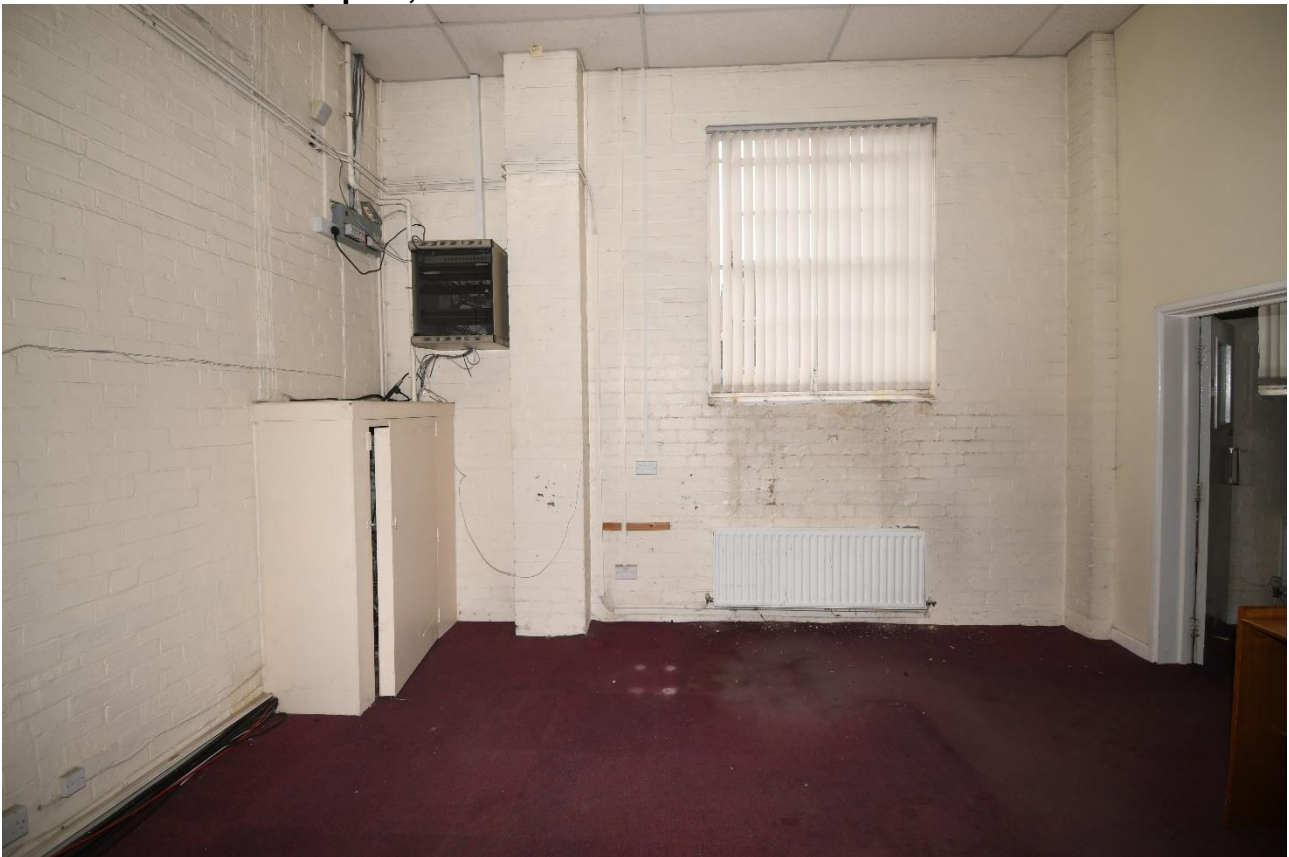
Plate 38: Southwest aspect, room 6

A small cupboard built into the western corner of the room. This is comparatively recent in construction and cables internally suggest it has been used to house electrical / data equipment.

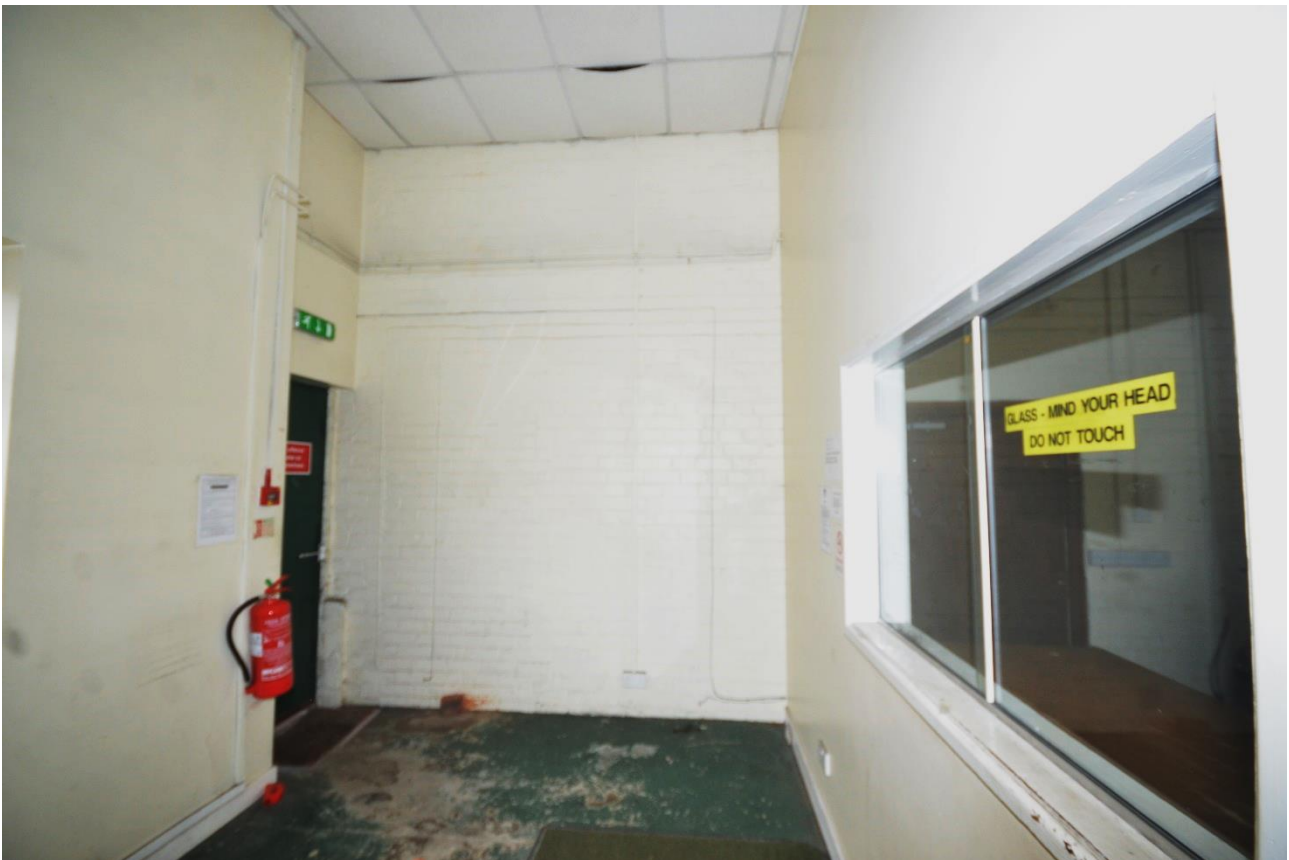
Plate 40: Southeast aspect, room 7

Room 7 has an external door in its northeast wall and an internal door to room 6 in its southwest wall. This was previously used as a reception area where drivers would receive their instructions for the day via the window to room 6.

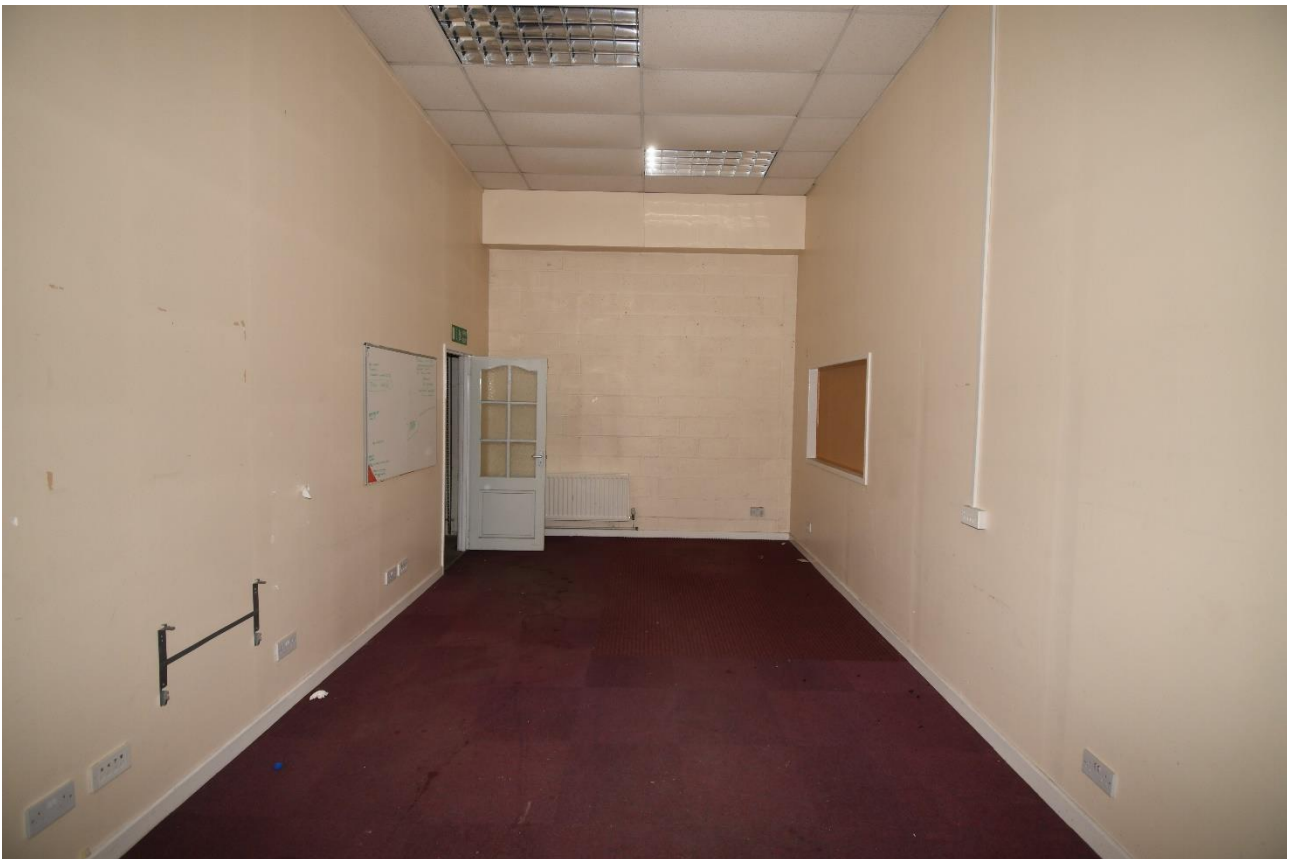
This room is located in a former vehicle bay of the transport building. The former opening to the northeast is filled with brick and a window. Externally, a concrete lintel is present showing its original form.

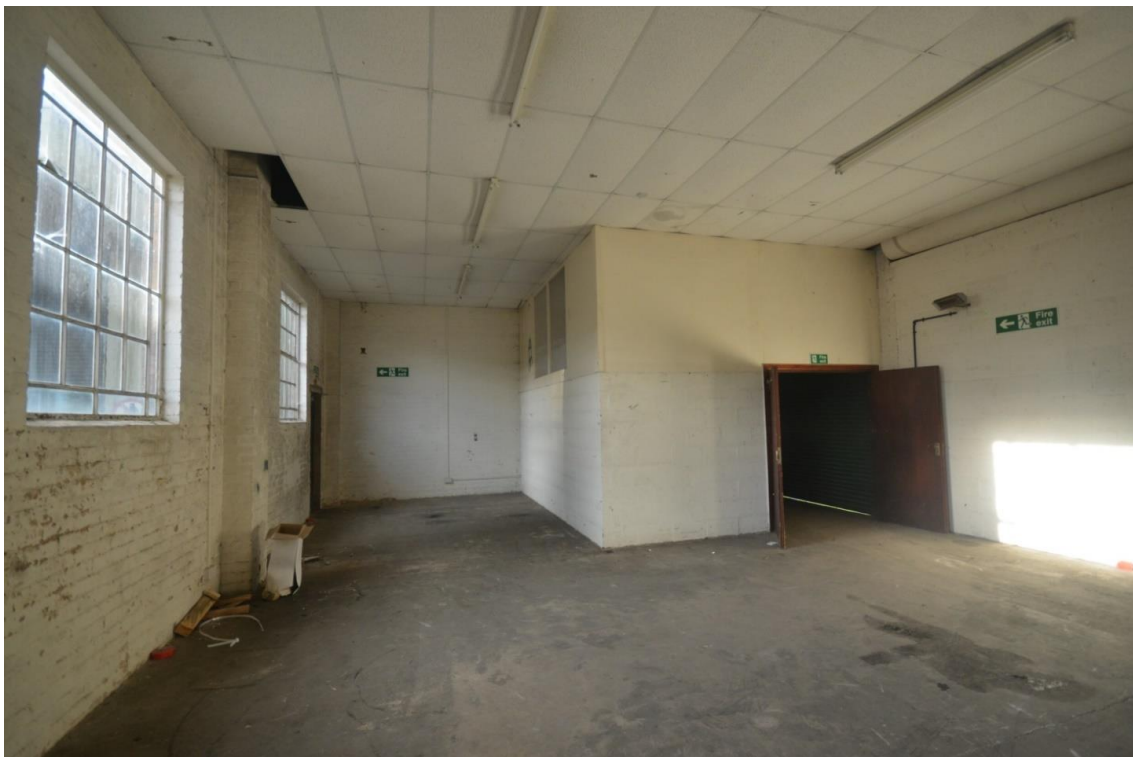
Plate 44: Northwest aspect, room 9

Room 9 has minimal decoration. A suspended ceiling is present, however the walls are of bare brick, painted white. The floor is of concrete with no carpet. A modern stud wall divides this area from room 8.

Room 9 comprises two former vehicle bays. A block wall has been constructed internally over the two roller shutters, which are still fitted and visible externally. The roller mechanism has been panelled off internally although the chains for raising and lowering the shutters are still fitted.

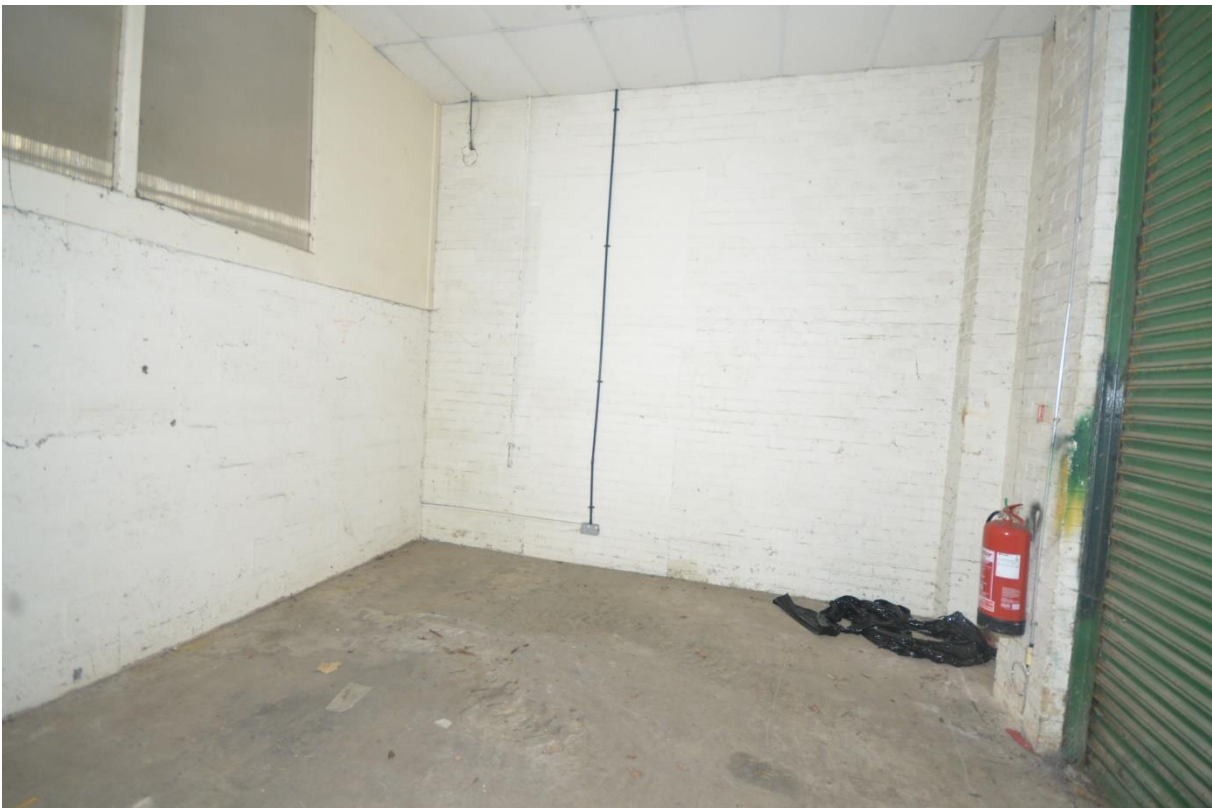
Plate 48: Northwest aspect, room 10

Room 10 is an area partitioned from room 9. This room houses a steel roller shutter door to the northeast. A modern double door is present leading into room 9. The lower part of the wall partitioning room 9 from room 10 is of painted concrete block. The upper part is of sheet material, with a high level internal window to the southwest wall.
