## BUILDING RECORDING

Mac's Café  
Bath Road  
Padworth  
Berkshire

*Colin Lacey BA MSc PIFA*  
24/07/2008

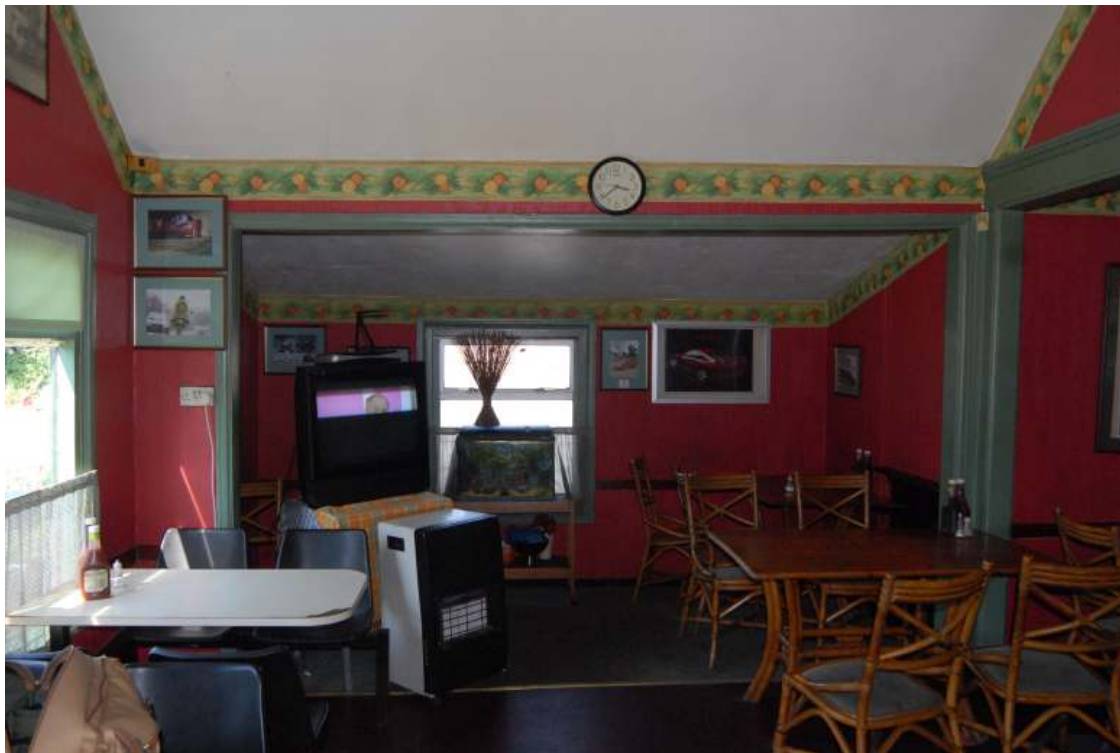
**Plate 13: View into northeast extension**

The northeast wall of the original building has been removed for almost the entirety of the northeast extension, excepting a short section at the northwest end. The extension features a cast iron fireplace corresponding with the chimneybreast on the outside of the building. Around the resultant opening,

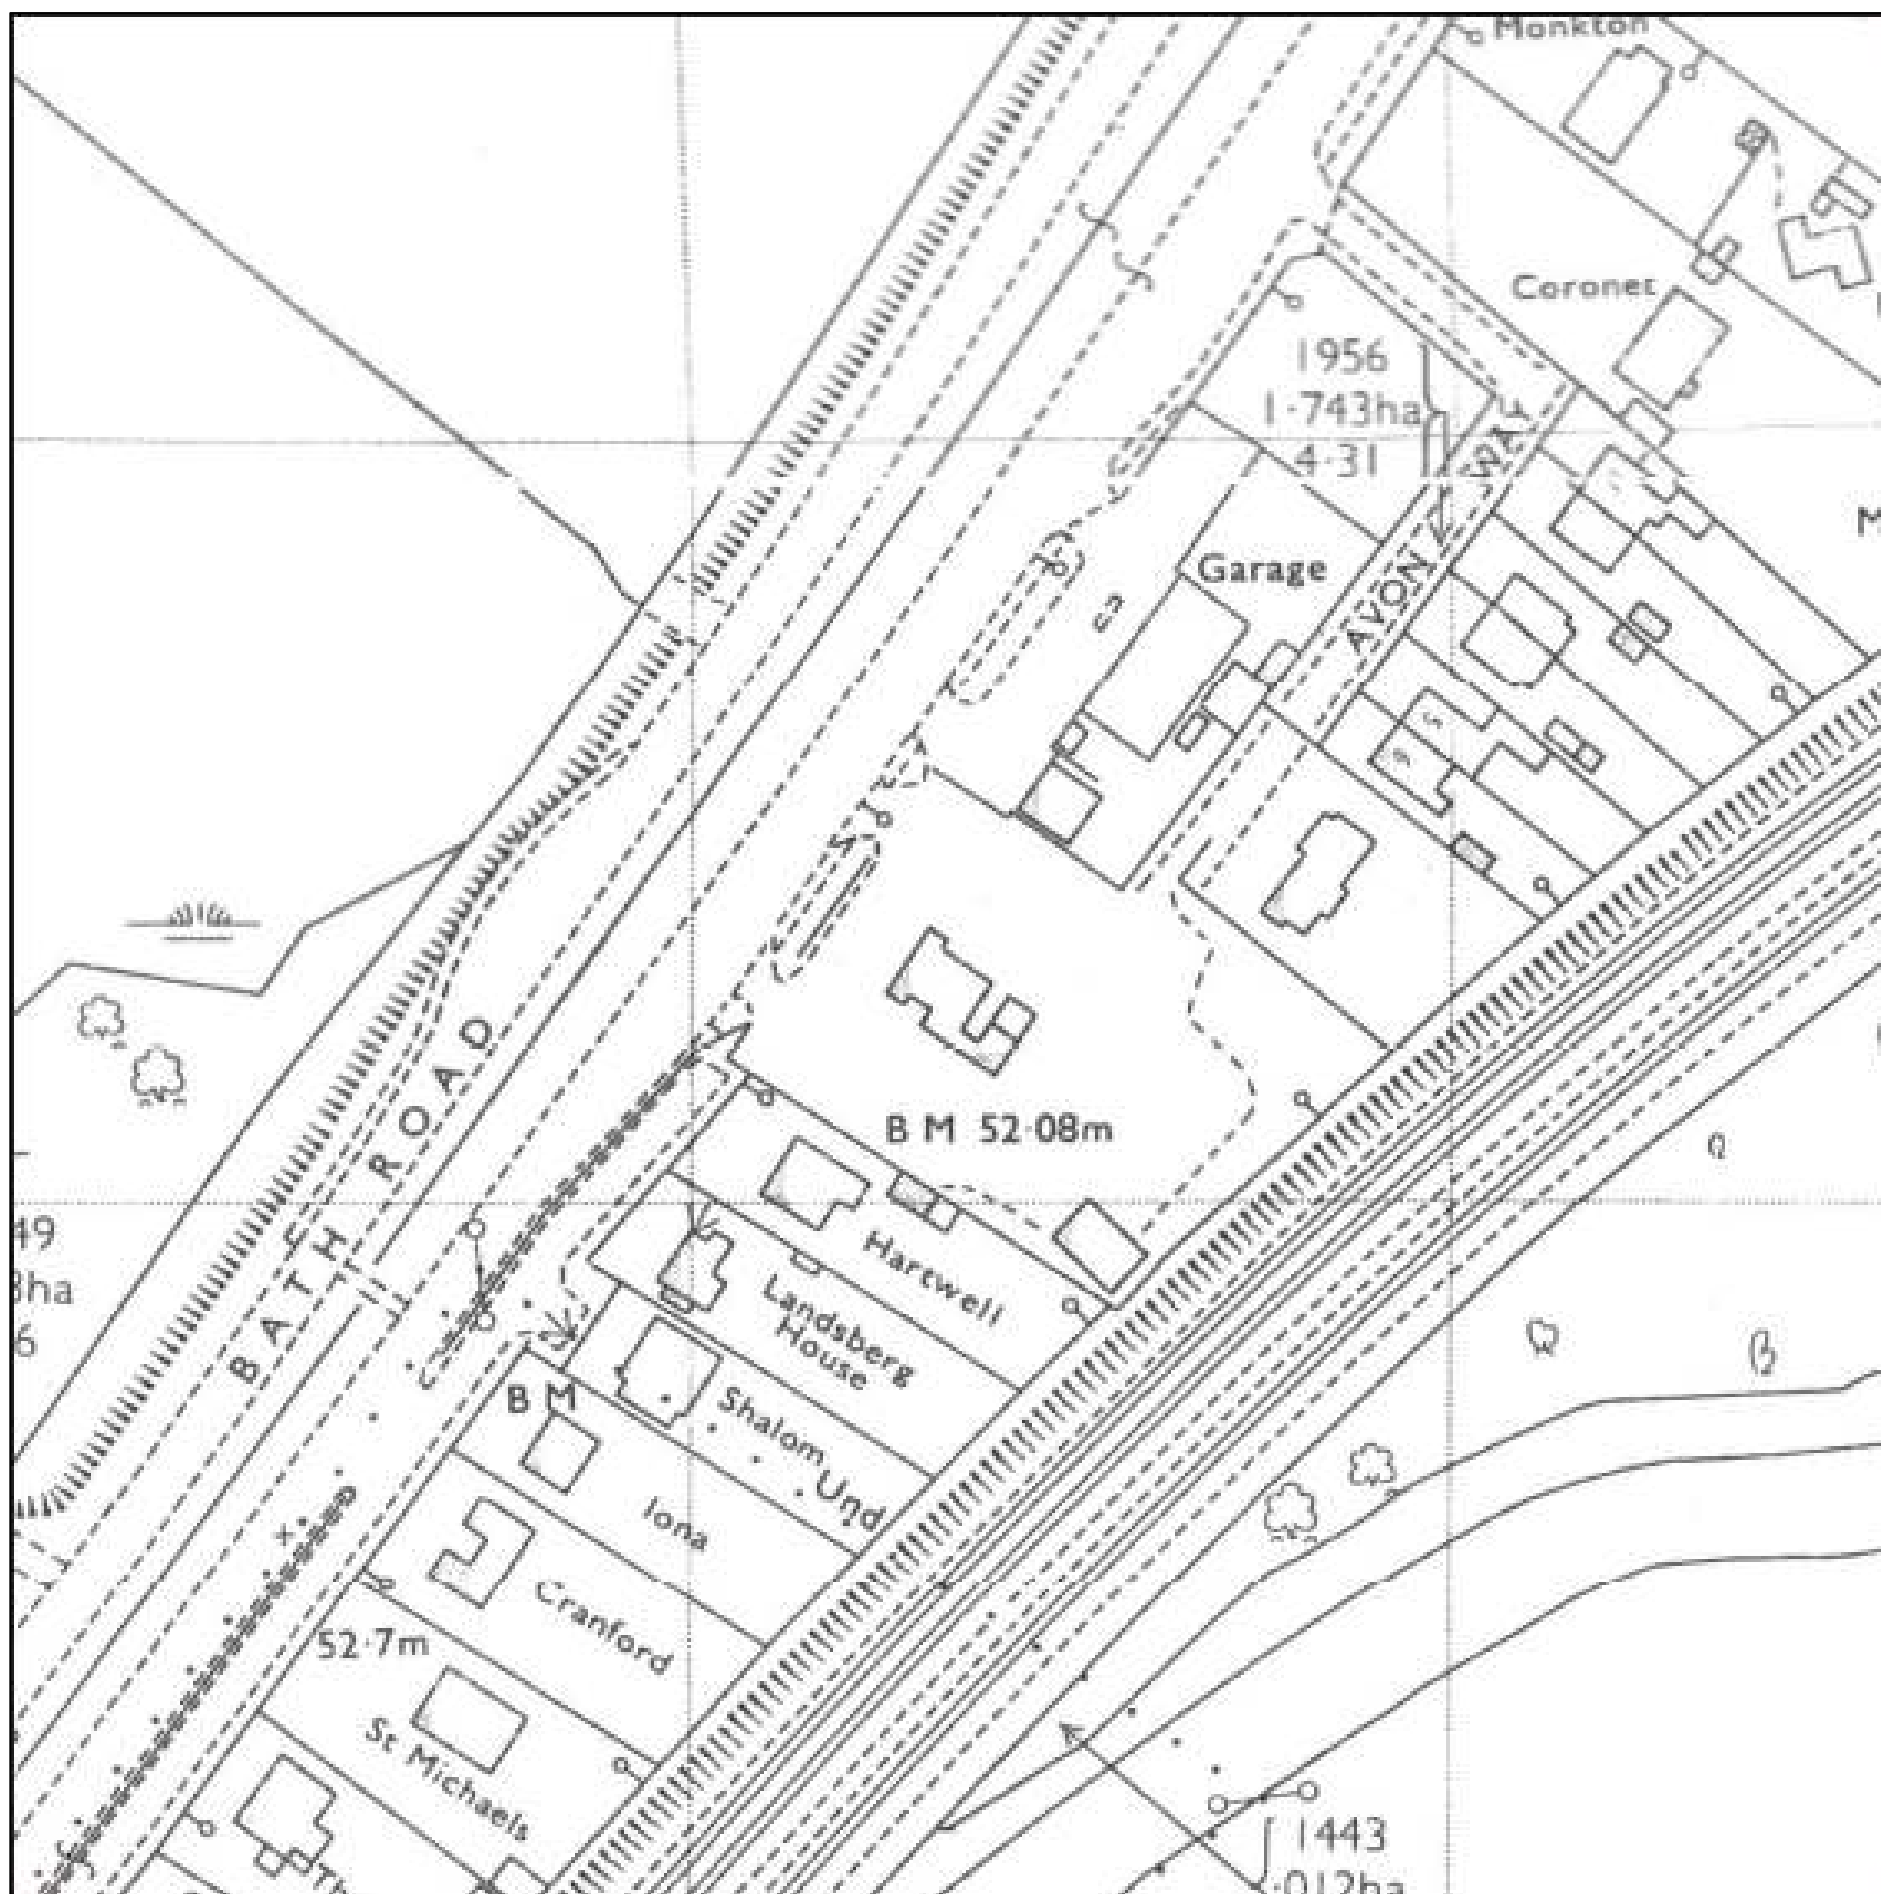
Figure 4: Ordnance Survey map, 1970, 1:1000 @ A3

A large building is present in the southern corner of the yard.

Substantial development of the railway has been carried out and the widening of Bath Road is apparent.

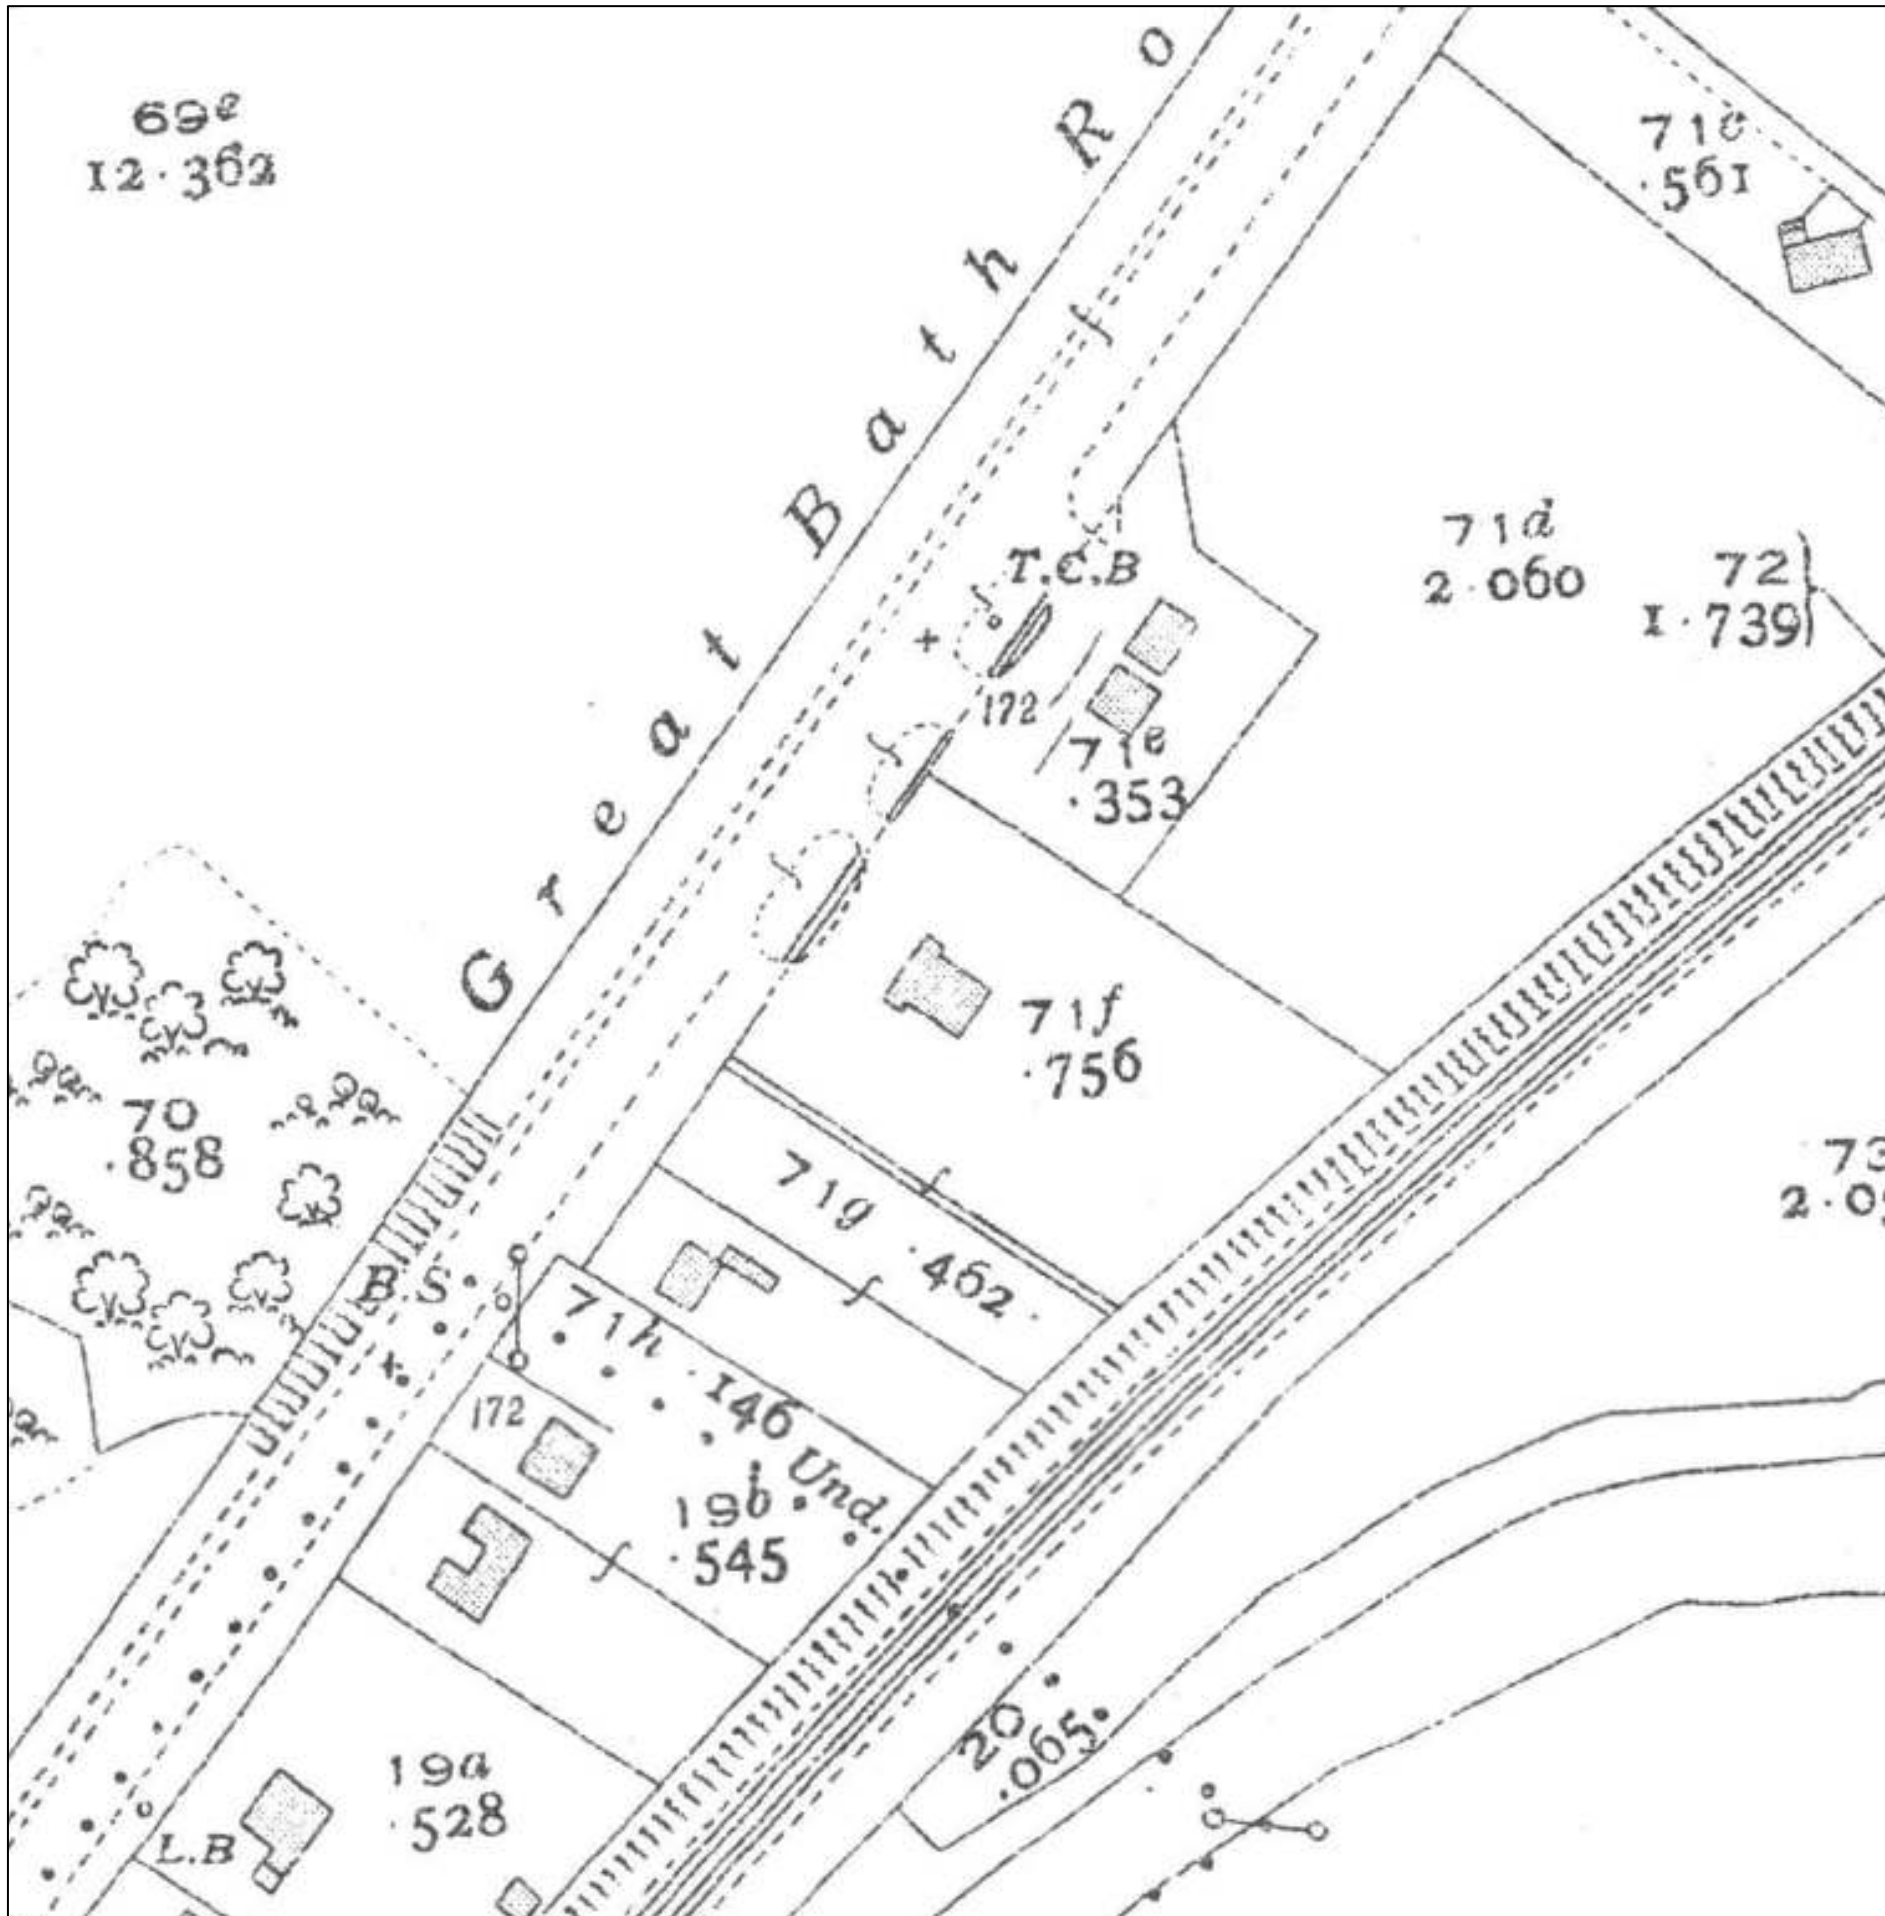
**Figure 5: Ordnance Survey map, 1936, 1:1000 @ A3**

Mac's Café is present in its present location with only the front extensions intact.

The exact date of construction of the café is unknown, although anecdotal evidence suggests it was built within six years of the survey for this map.

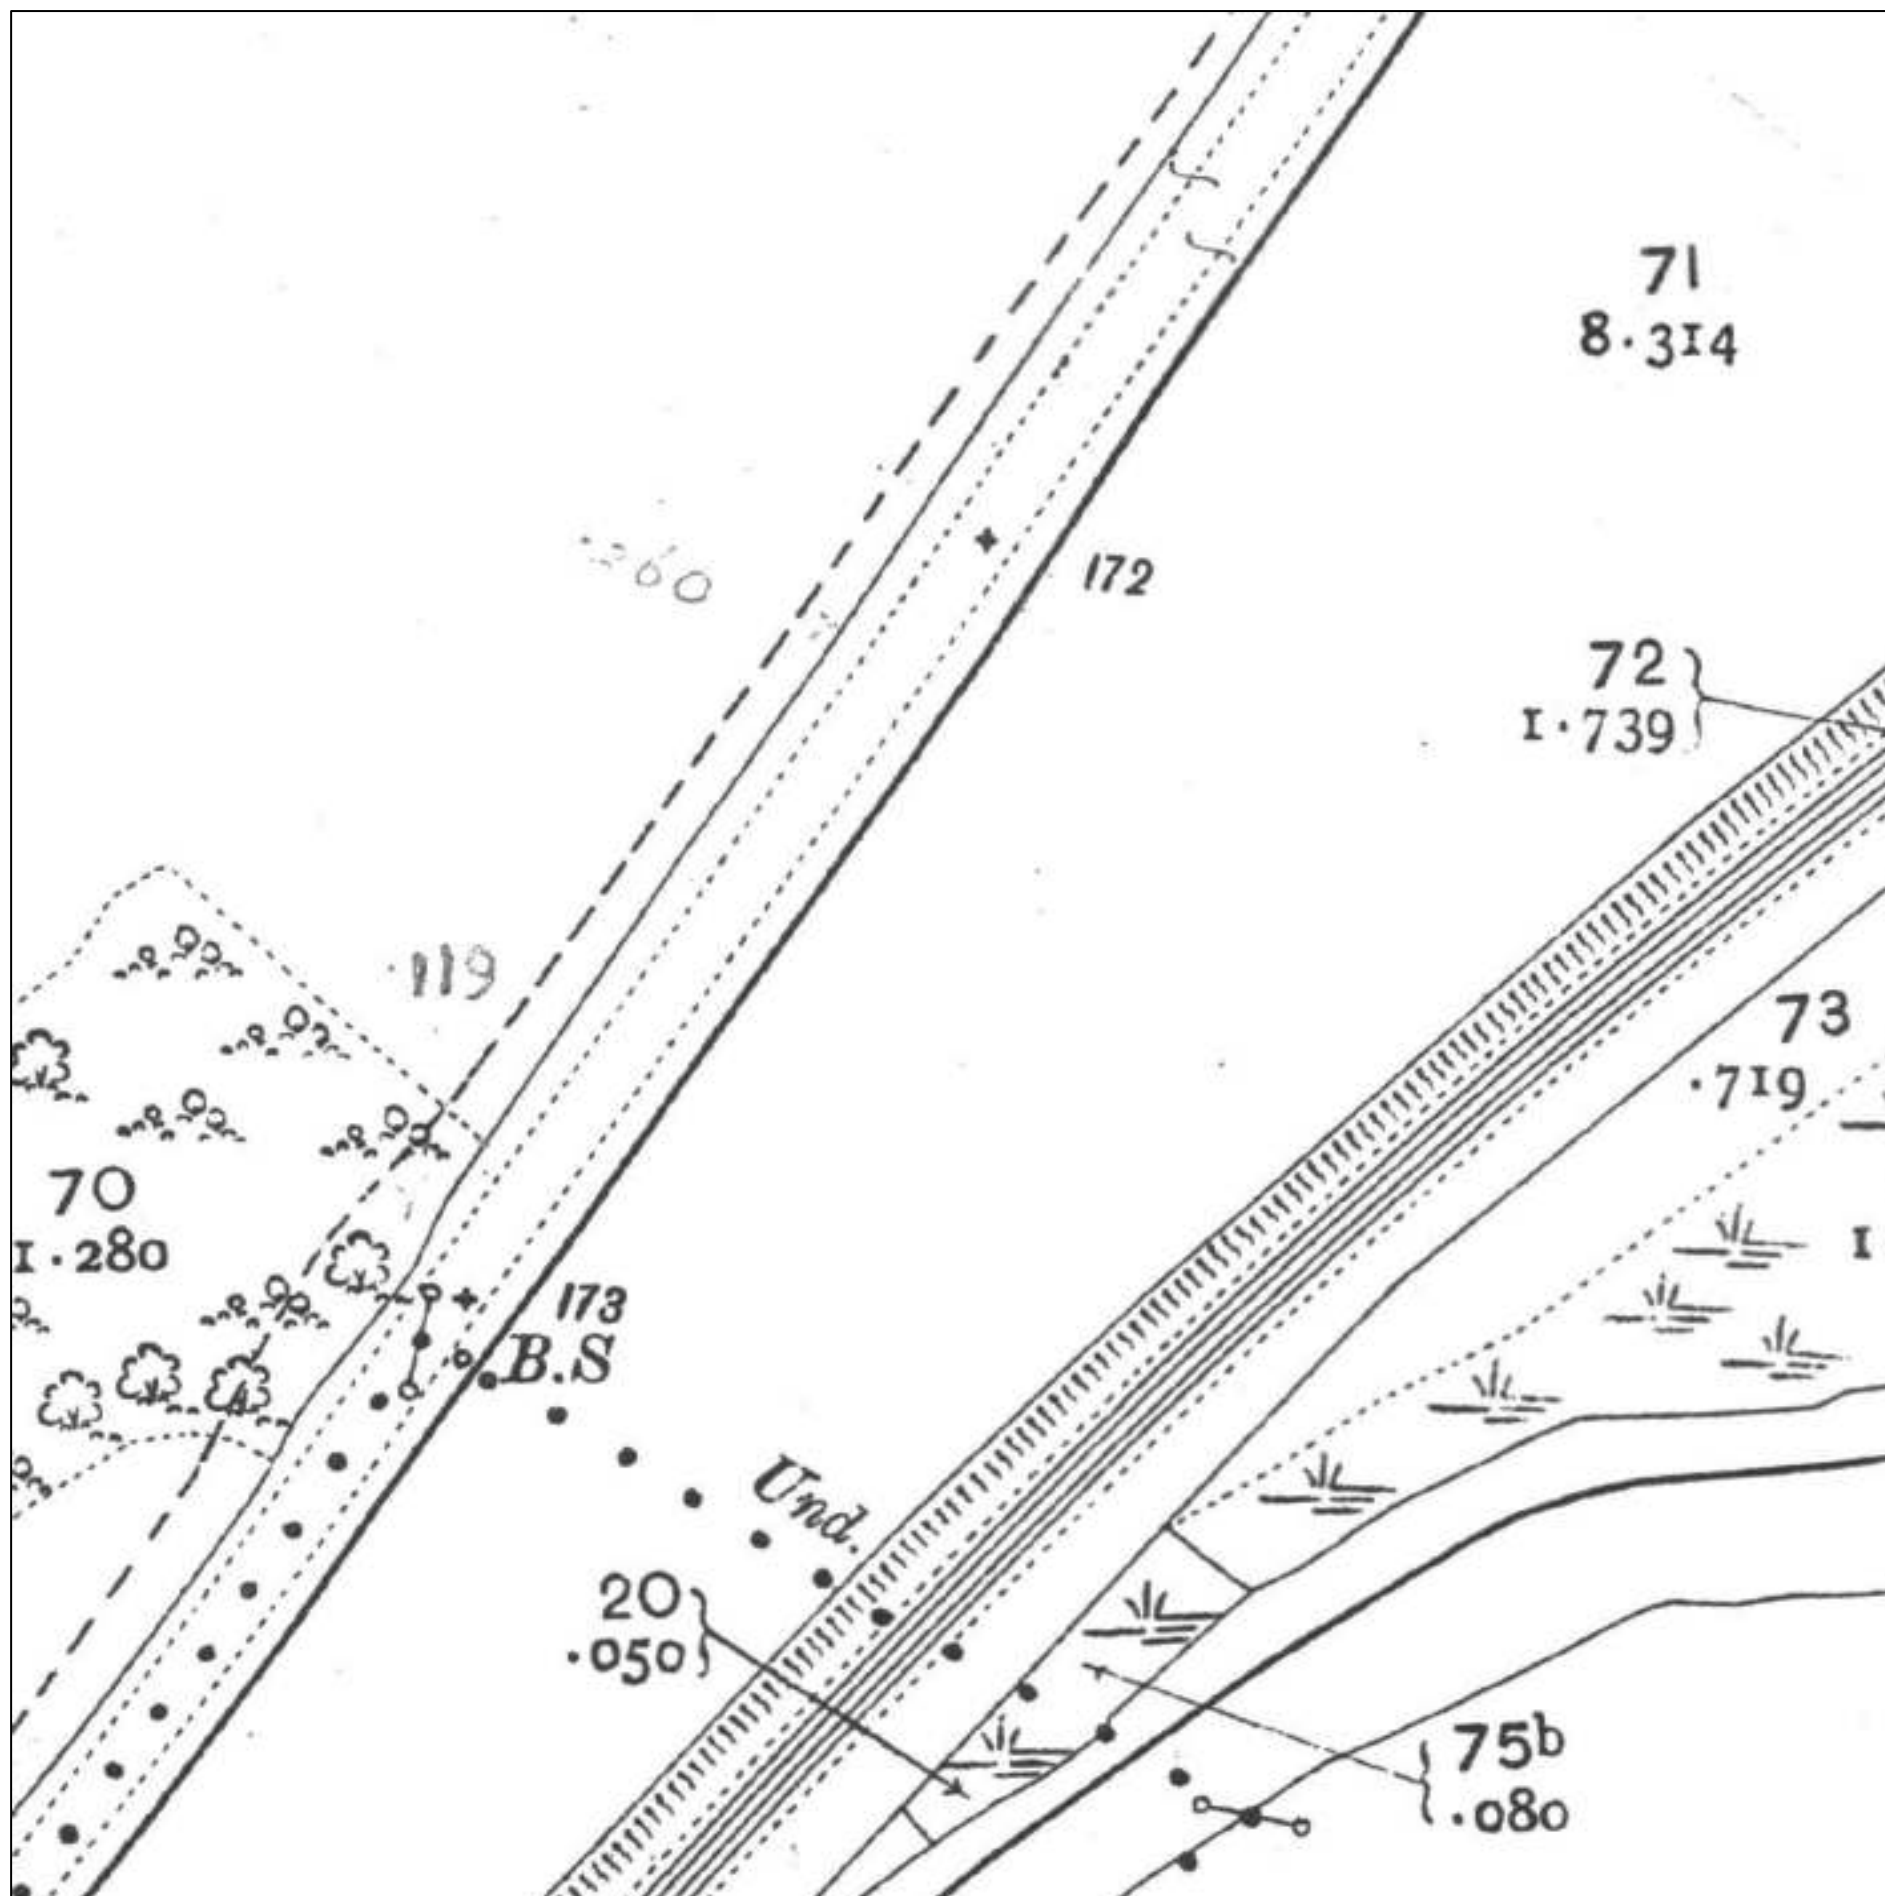
**Figure 6: Ordnance Survey map, 1911, 1:1000 @ A3**

The site of Mac's Café prior to any development in the area.  
The railway exists as a pair of tracks.
