Building Recording of
61-63 Great Eastern Street
Shoreditch
London
EC2A 3HS
National Grid Reference: TQ 331 823
Planning Reference Number: 2012/0506

Document Reference Number 2014/1146
Version 1

Building Recording of: 61-63 Great Eastern Street
Dr Peter Wardle and Colin Lacey
14/05/2014

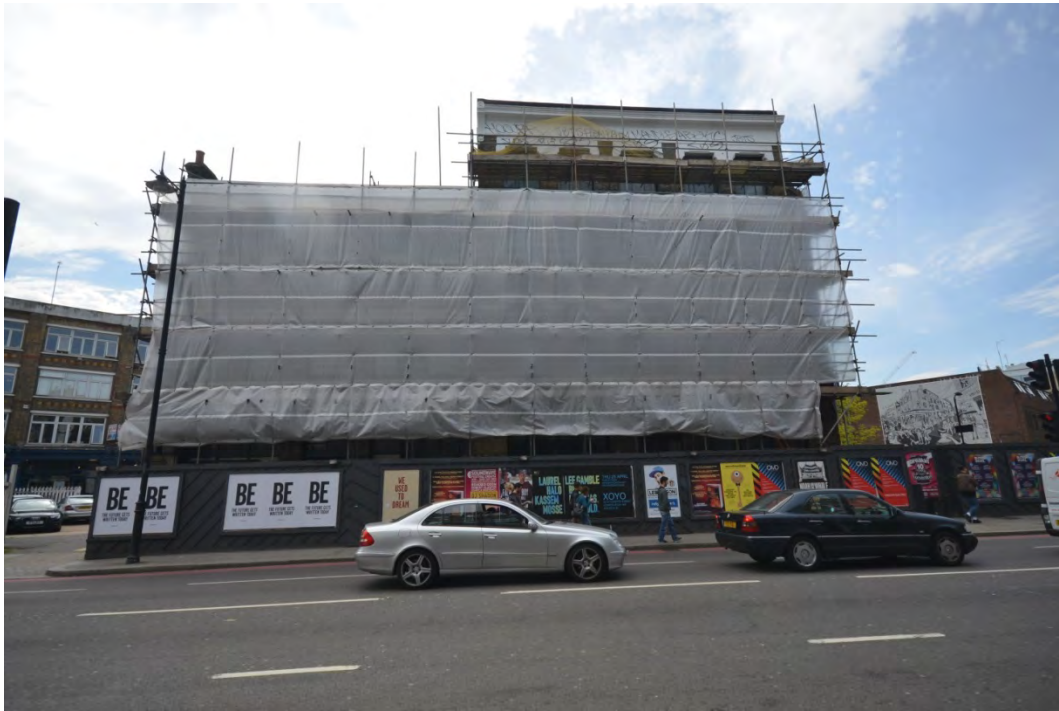
Plate 1: The facade of the building, concealed by scaffolding and hoarding

The building has been empty for some years and has fallen into a state of dereliction. A structural appraisal carried out in 2000 notes that the condition of the buildings is critical and that they are well beyond repair. It states 'The properties are now shells with the external walls unstable and having moved and the floors failed. The only possible recommendation is total demolition and rebuilding' (Shaya 2000).

It is noted that the structural report was compiled in 2000, and 14 more years of weathering and degradation have occurred since then. The building is dangerous to enter and was, therefore, only examined from the exterior during the course of this exercise.

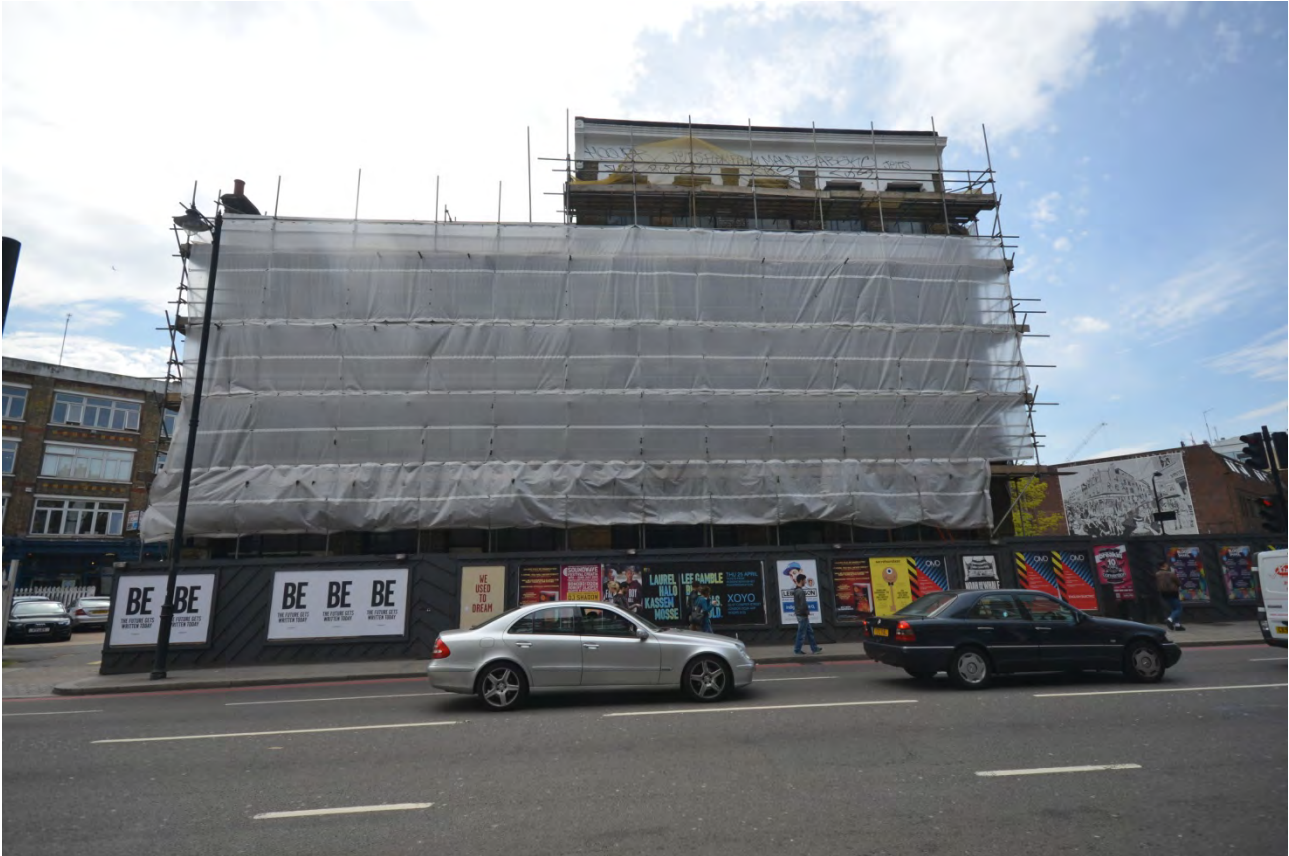
Plate 6: The northeast façade as surveyed - currently obscured from view

The street frontage of 61-63 Great Eastern Street is currently concealed behind timber hoardings at ground floor level and sheeted off scaffolding over the upper floors. Only the parapet at the head of the upper floor of 63 is visible.

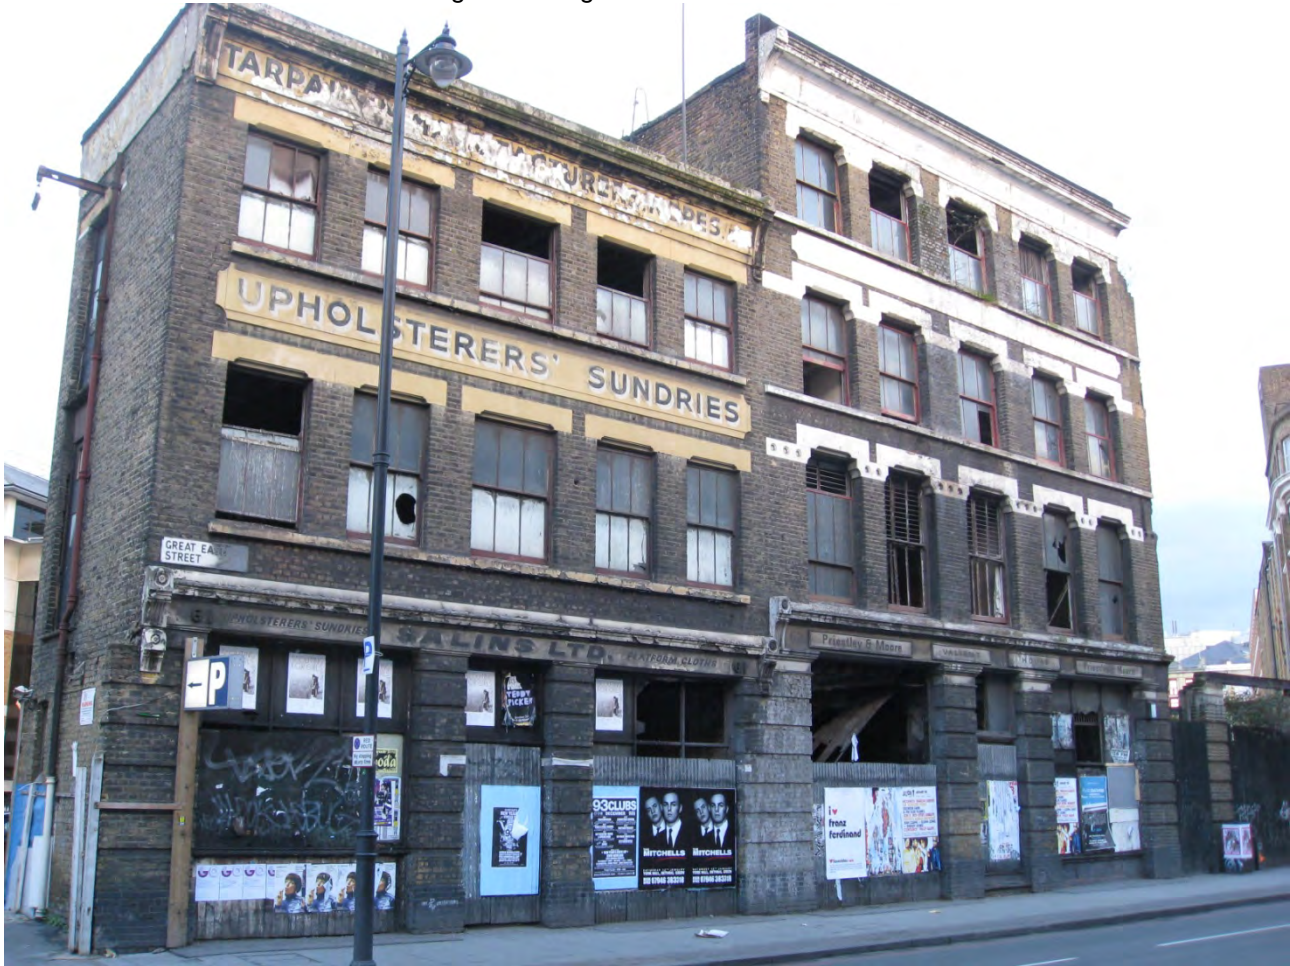
Plate 7: The northeast façade in 2009 prior to the installation of scaffolding
61 is a building of three floors with a parapet with corbels at either end.

The parapet wall to 63 has a moulded cornice which was in poor condition at the time of the structural appraisal.

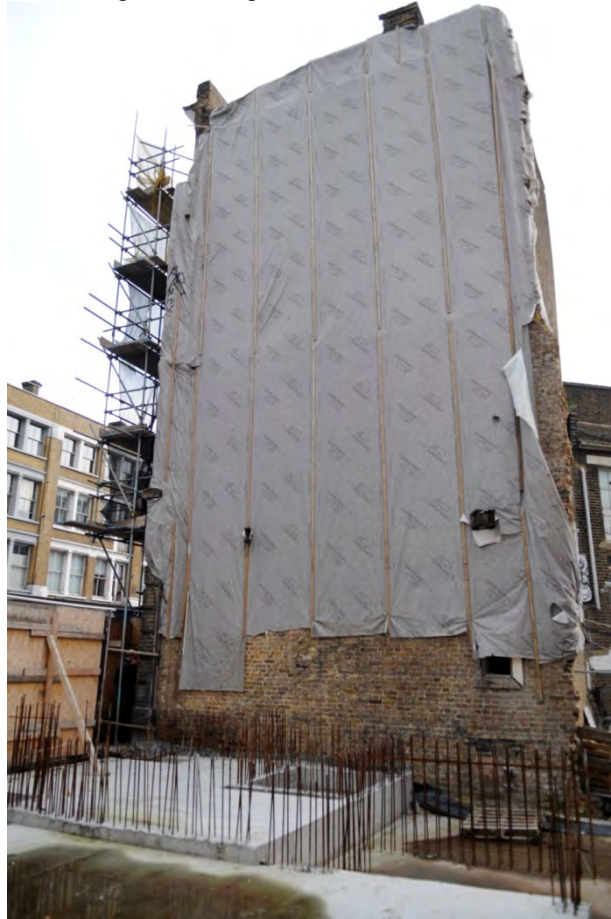
Plate 10: Northwest elevation, frontage

The northwest elevation is largely obscured by sheeting. Exposed brickwork to the rear shows where another building was joined onto the existing structure.

The profile of the parapet is visible, as is a brick chimneystack to the rear of the building.

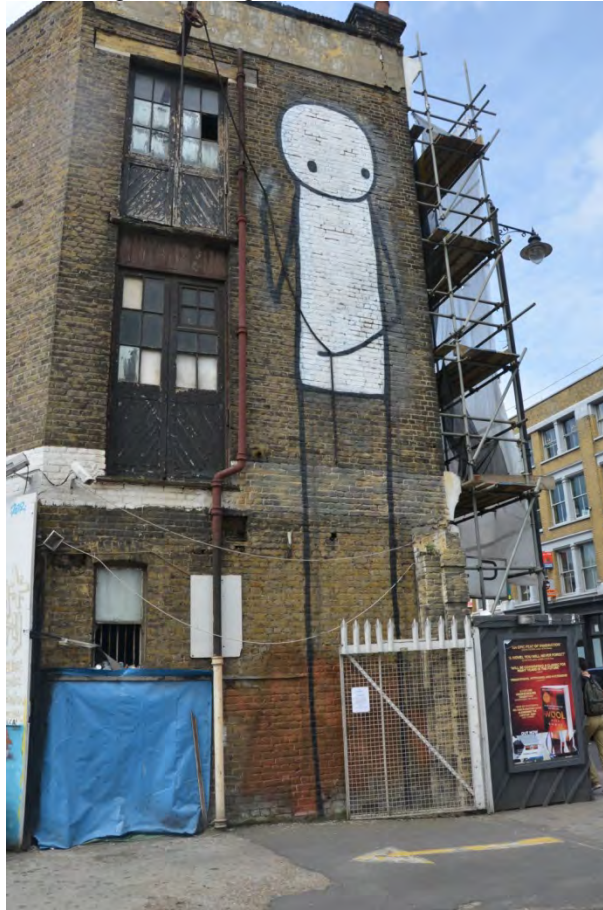
Plate 12: Southeast elevation, frontage

At the head of the southeast wall, a band of render is located. At the front of the building, a chimneystack with ceramic pot is present. To the rear, a pulley is located on a protruding steel beam. Below, a set of taking-in doors is present at first and second floor level. These are timber with glazed uppers. At ground floor level, a single barred window is present, below which sheeting conceals any detail.

The pulley and chain have been utilised in a piece of street art dominating this face of the building.

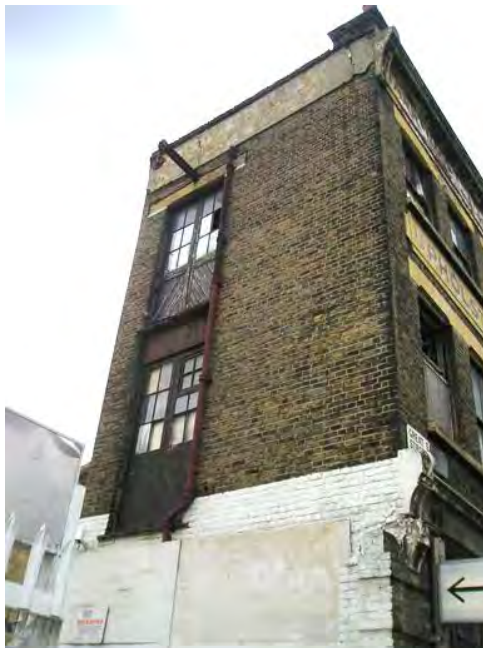
Plate 13: Southeast elevation, 2010 (Tweedie 2012)

The ground floor was painted white in 2010, with boarding covering window openings.

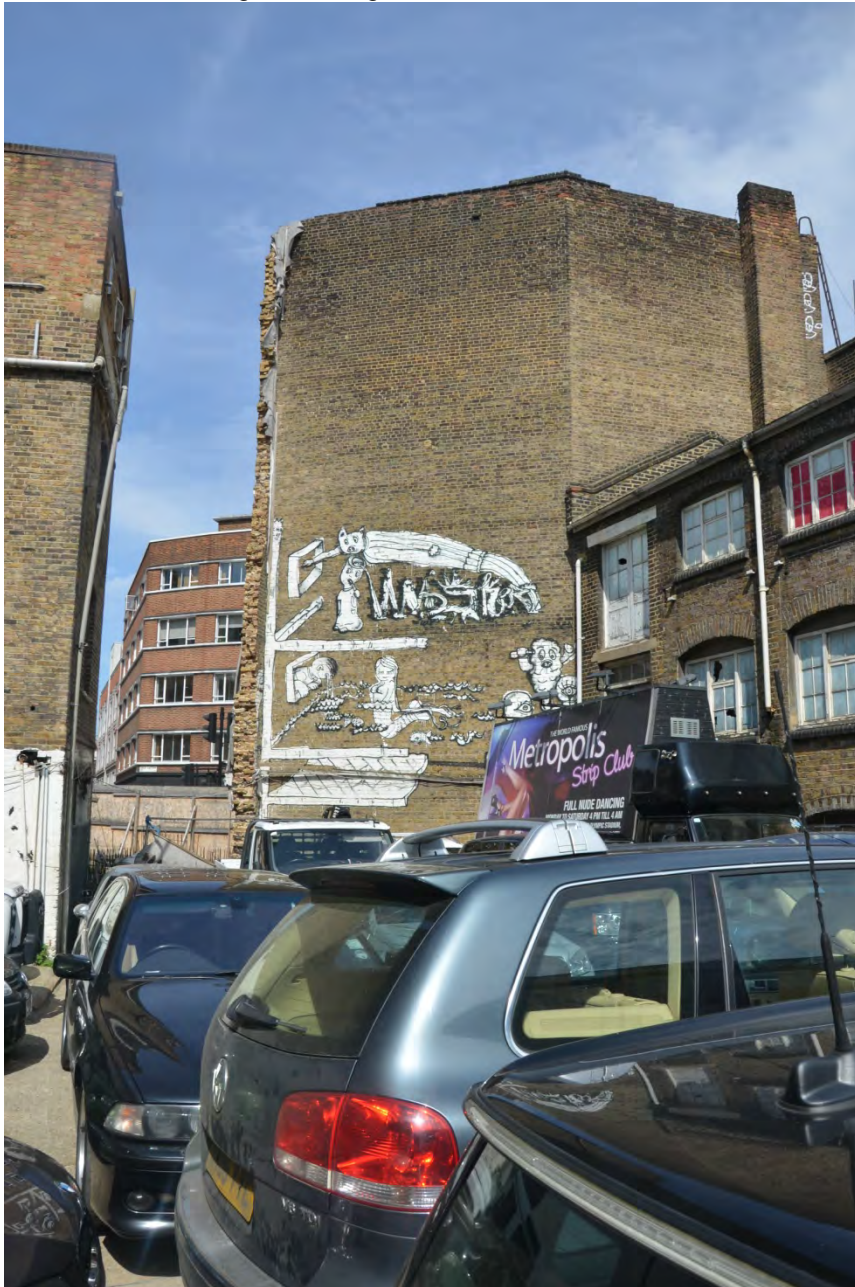
Plate 14: Rear of 63

The rear of 63 is plain, with no openings or decoration. A chimney is located to the southern end of the building adjacent to which, a fire escape ladder is fitted.

The rear wing butts against this wall, visible to the right of the above image.

The lower part of the wall has also been used for street art.

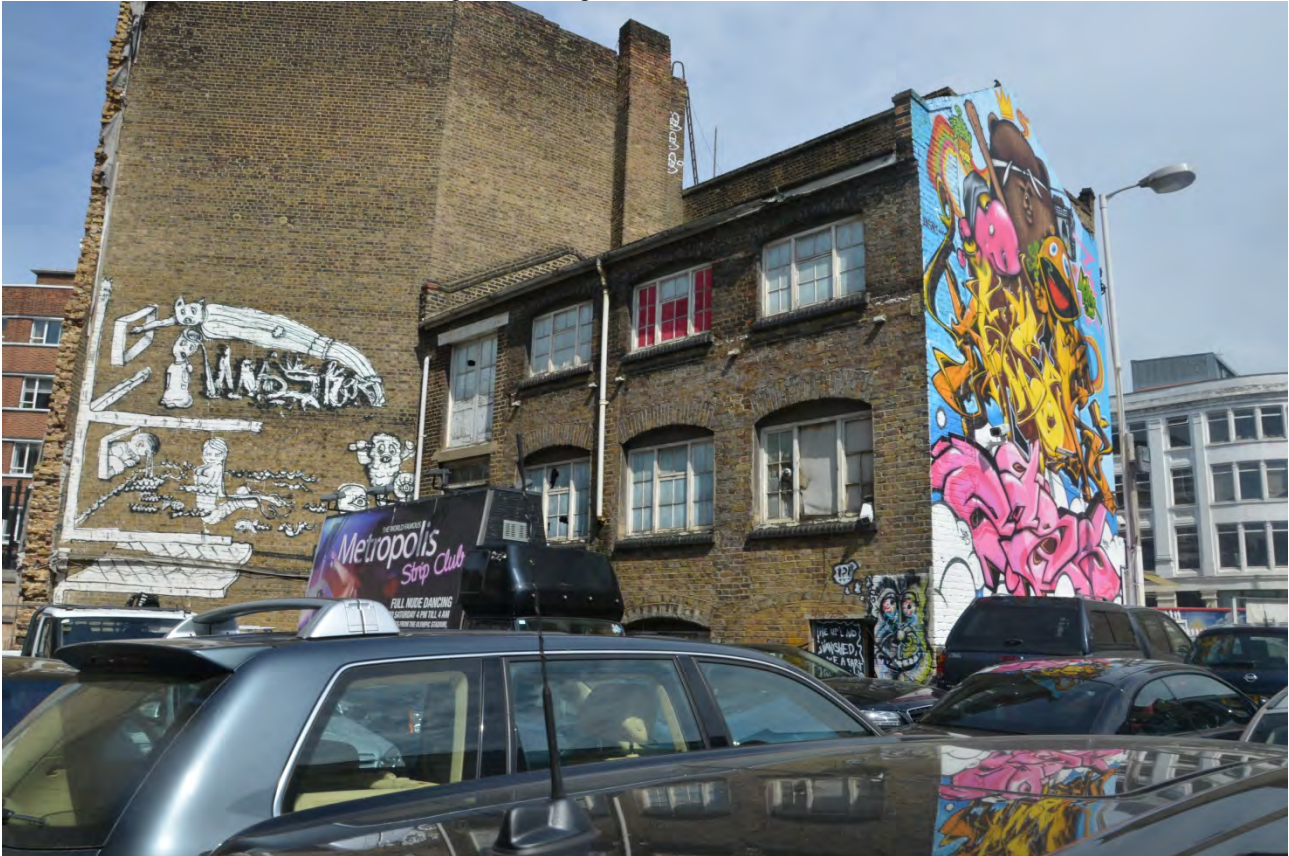
Plate 15: Western elevation, rear part of building

The section of the building depicted in Plate 15 has three storeys. It is a north-south gabled structure with steps to the ends of its raised gable walls. It is constructed of similar brick to the frontage.

The upper floors have iron framed windows consisting of a fixed central light with opening casements either side. There are three such windows per floor, with projecting sills and cambered brick lintels. At the northern end of this part of the building, taking-in doors are present however there is no crane or beam visible above from which a pulley would have been suspended.

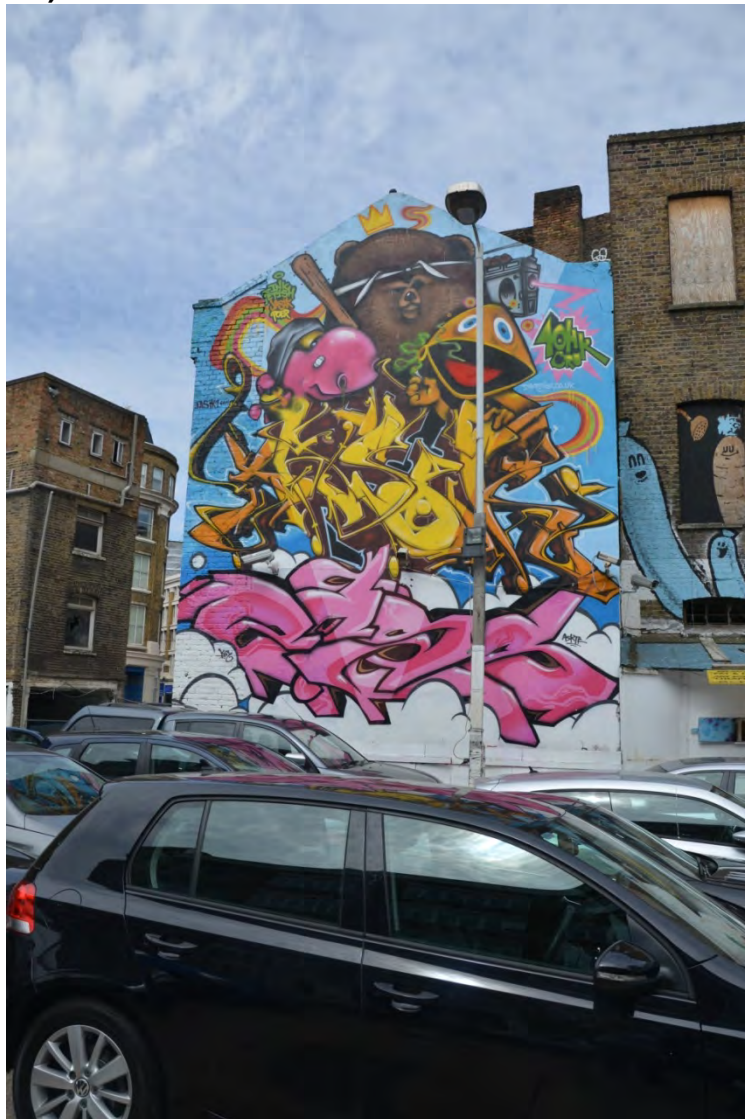
Plate 17: Southern wall, gabled section

The southern wall of the rear section is covered by a mural concealing any historic detail.

A pair of windows is present at second and first floor level, however these are boarded, obscuring any surviving historic frames. The windows have cambered brick lintels and projecting sills.

At ground floor level, a small lean-to structure is present to the west, with a cambered lintel light above, whilst to the east, a hoarding is present obscuring any detail of the structure.

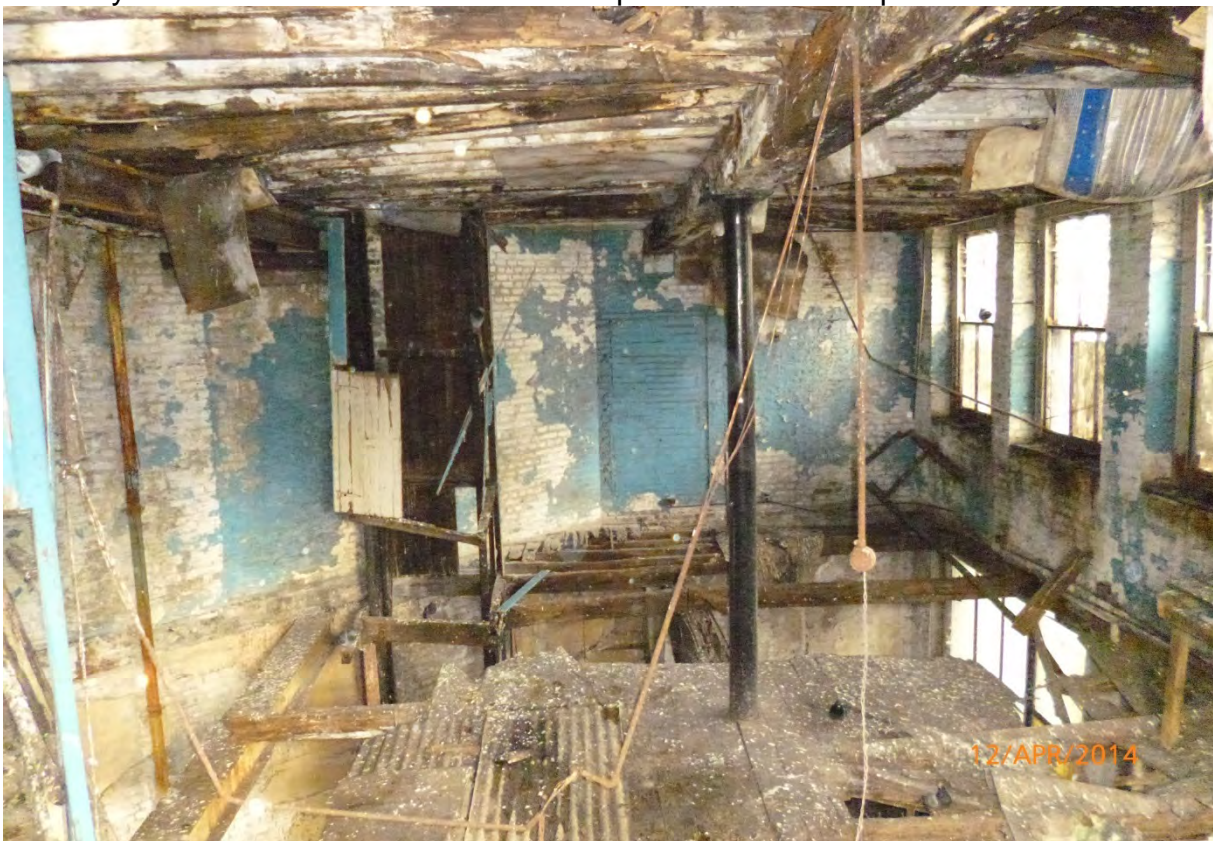
Plate 34: West view, first floor

The dark section to the left of the image is a pulley-driven hoist for raising and lowering items between floors.

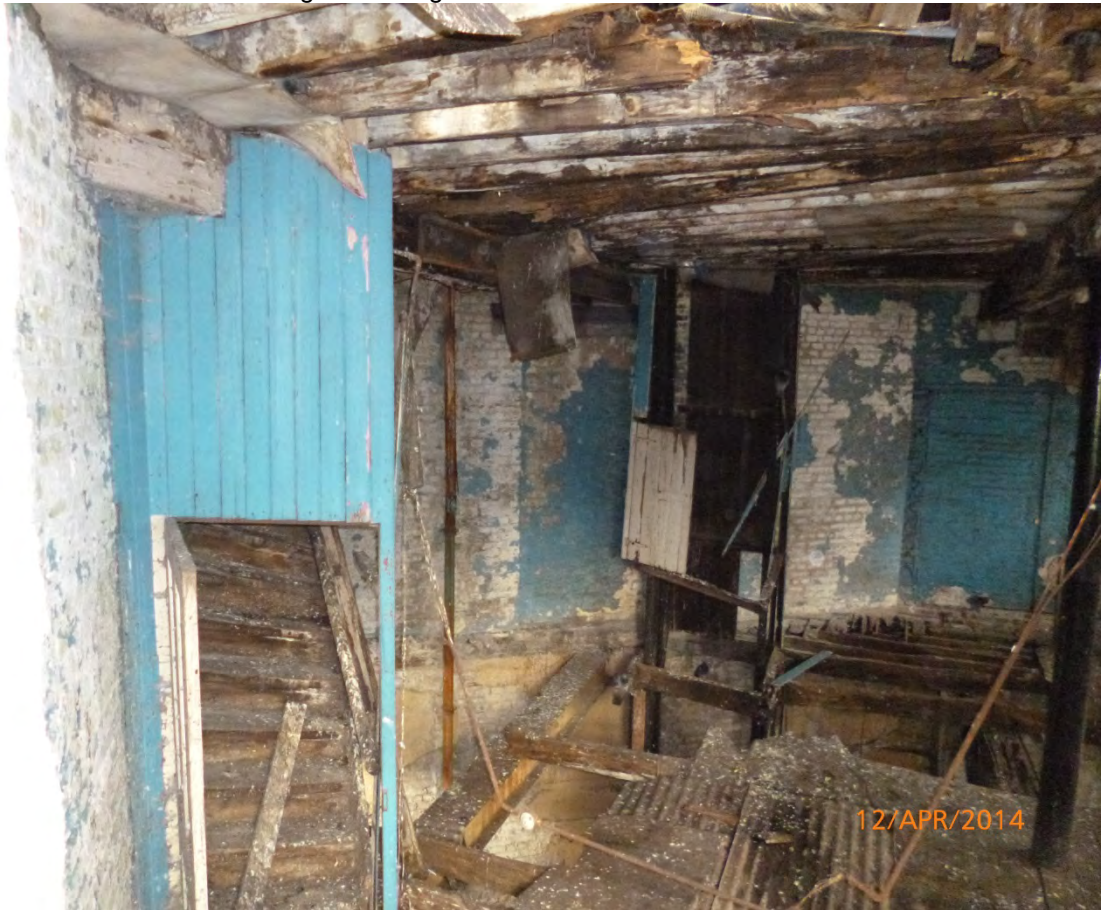
Plate 35: First floor, showing staircase

A staircase to the second floor is present. This is enclosed within a tongue and groove partition with a door at its lower end.

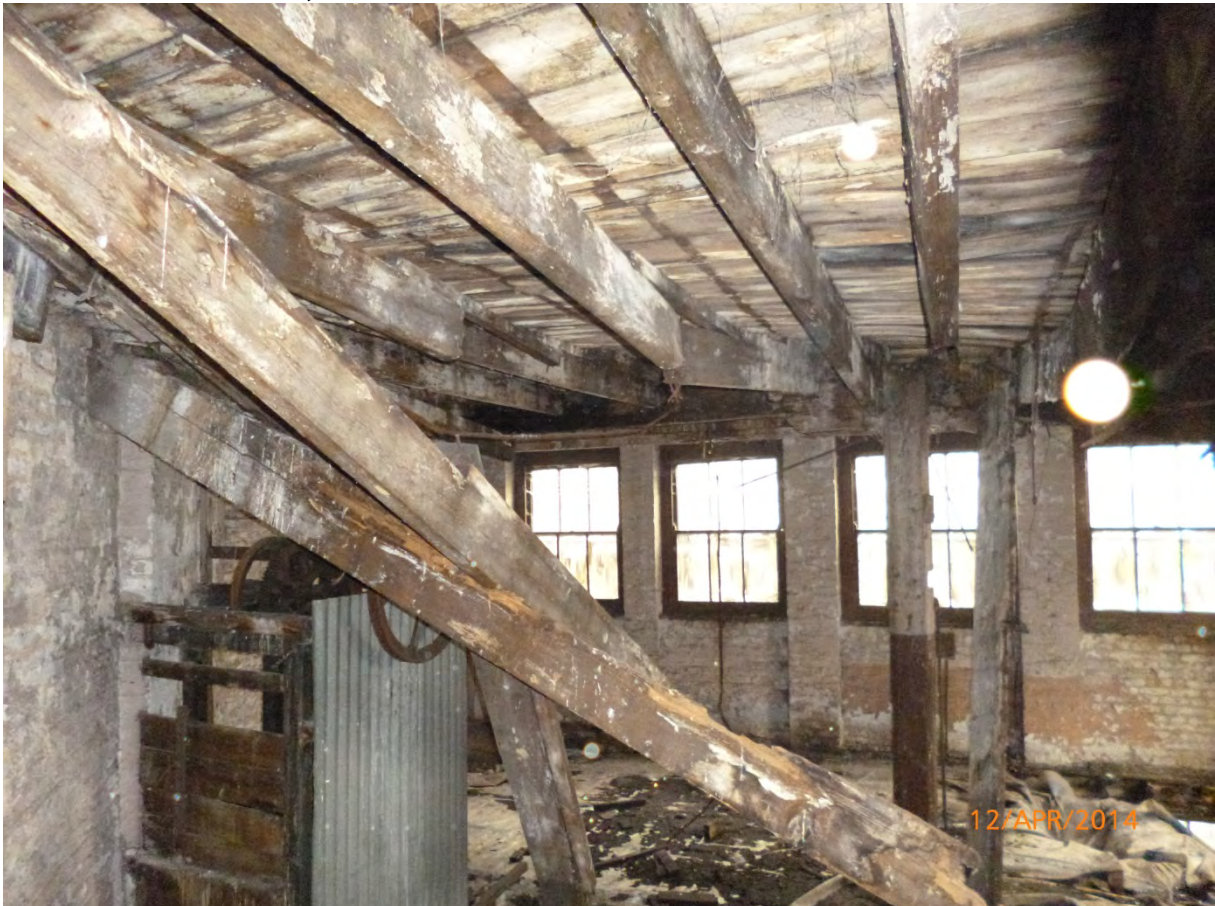
Plate 39: General view, second floor

The hoist mechanism can be seen to the left of the above image.

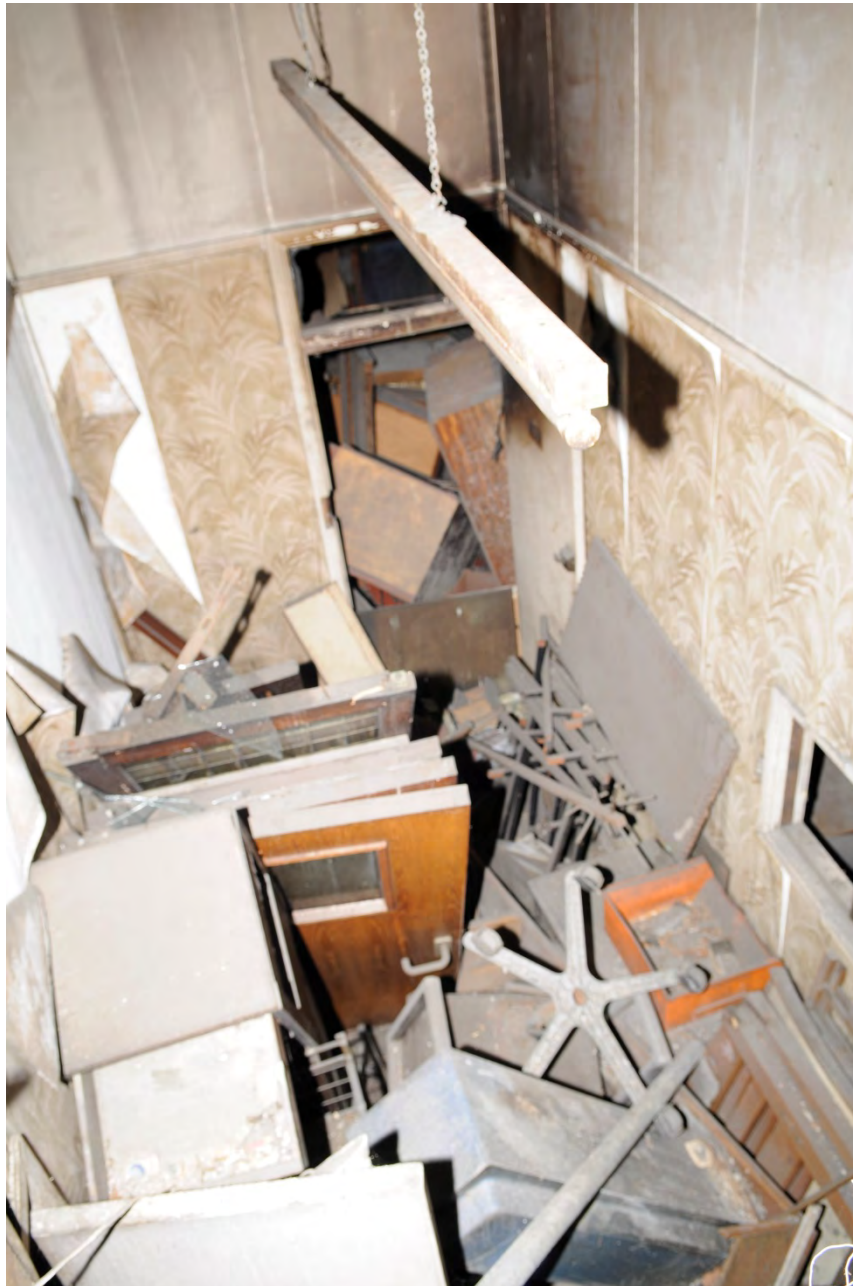
Plate 42: View into entrance hall

The entrance vestibule to the building is located immediately inside the double doors. The room is considered to have been formed from 20th century stud walls. A door leads southwest into the remainder of the ground floor whilst a window opens to the northwest.

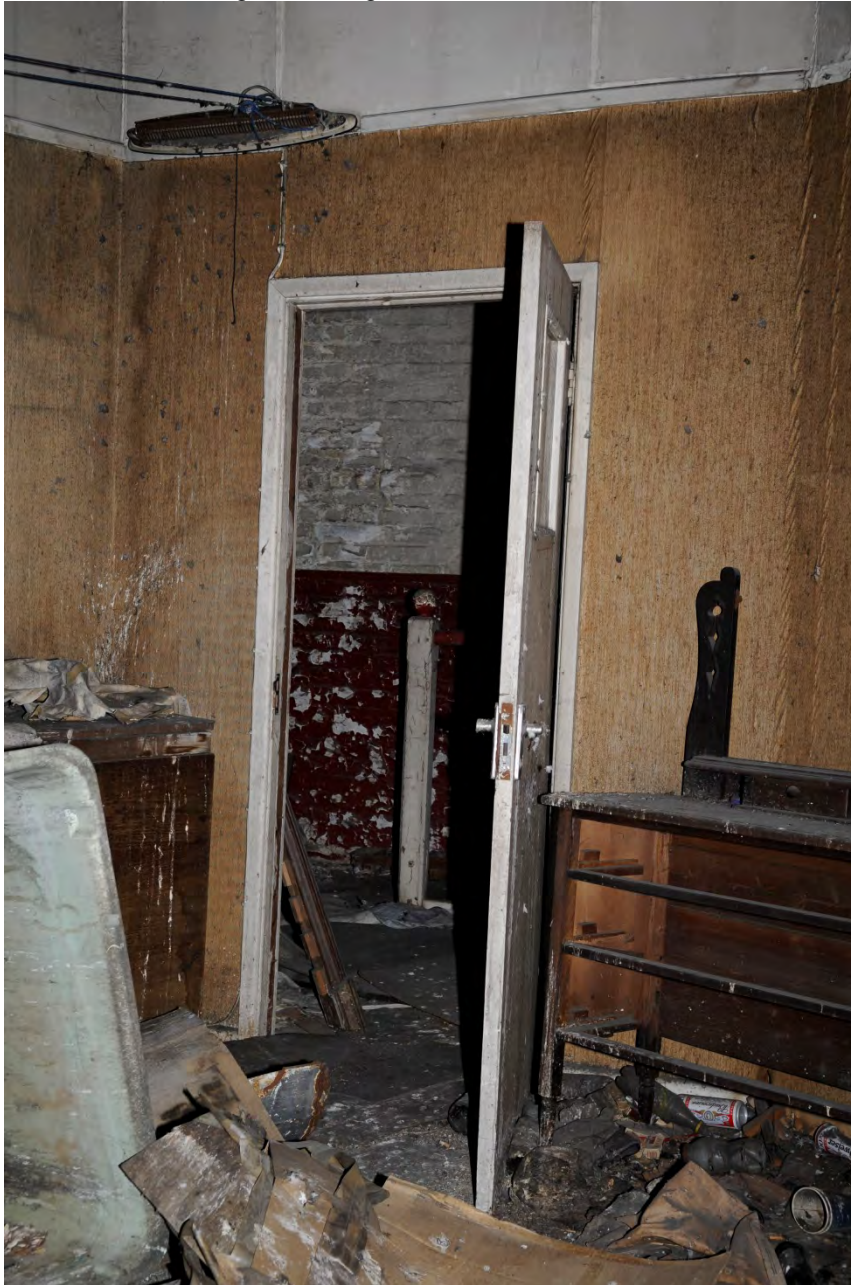
Plate 43: Southeast room

The angles of the corners either side of the door suggest this room is situated in the tapering southeast corner of the building.

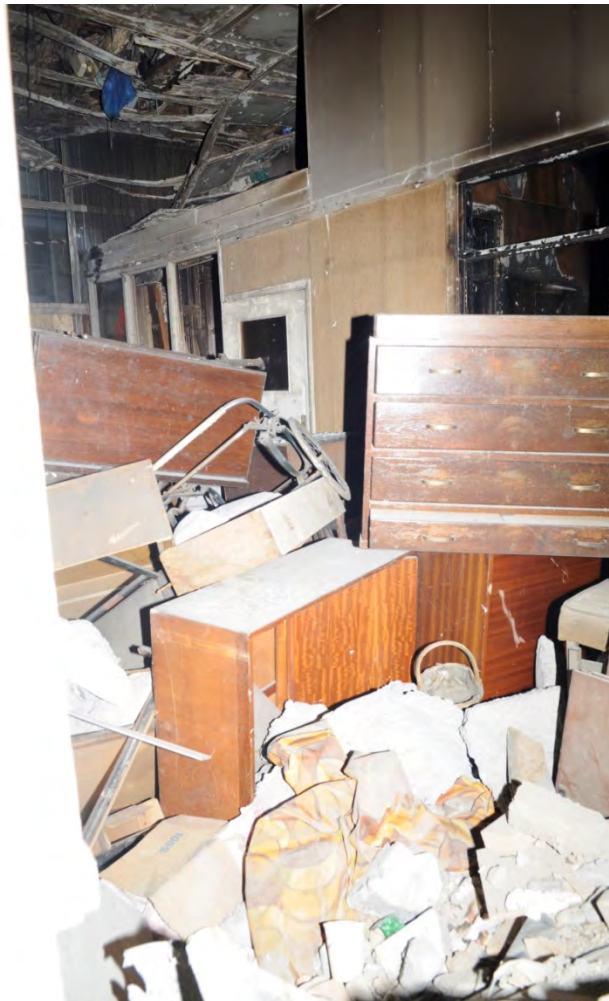
Plate 45: View of northwest room

The above photograph is considered to depict a store room towards the southern end of the building. It has been extensively damaged by fire. Fire / smoke damage is also apparent in the northwest room, illustrated in photographs below.

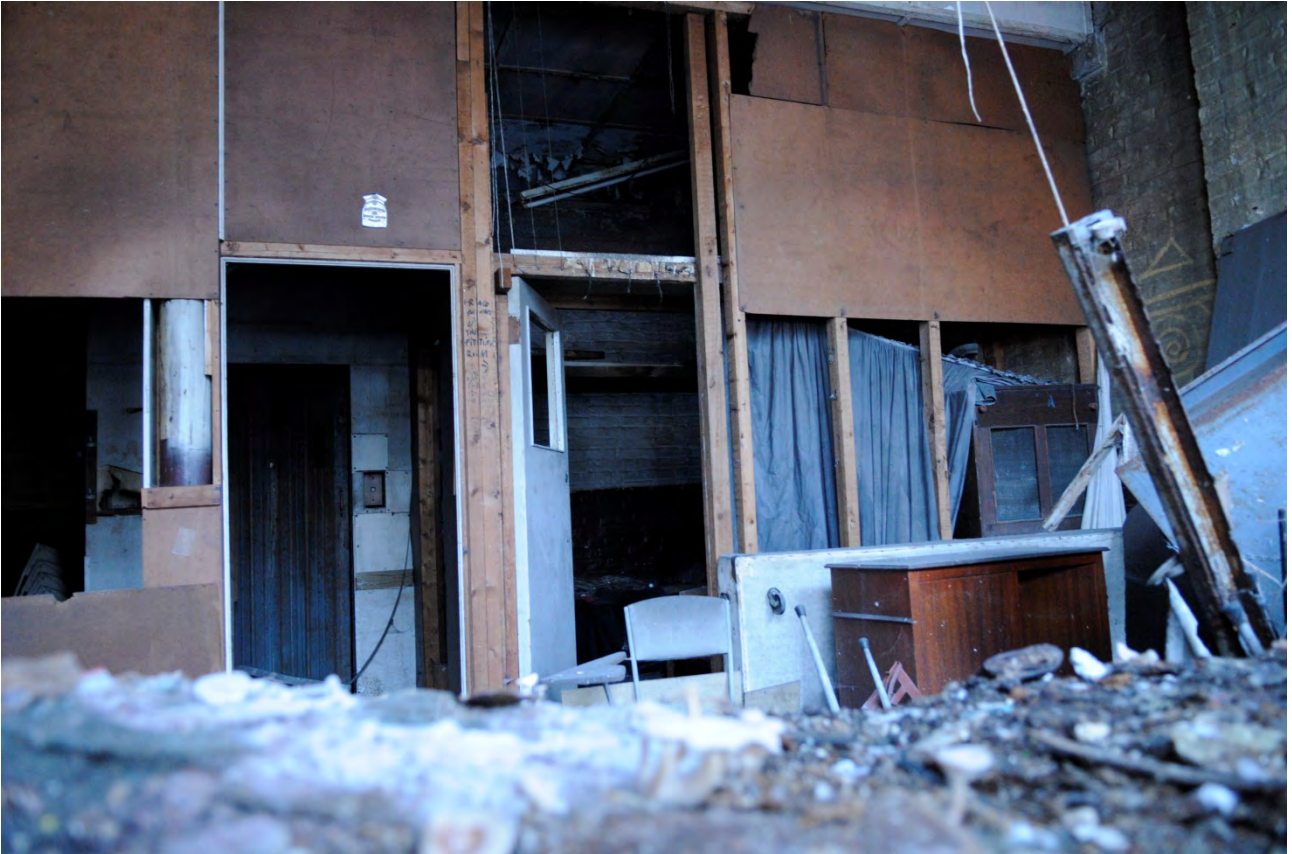
Plate 48: View into first floor northern room

There was no access to the area beyond the modern partition walls. The layout of this area is hereto unknown. Through the left door opening, the door of a lift can be seen.

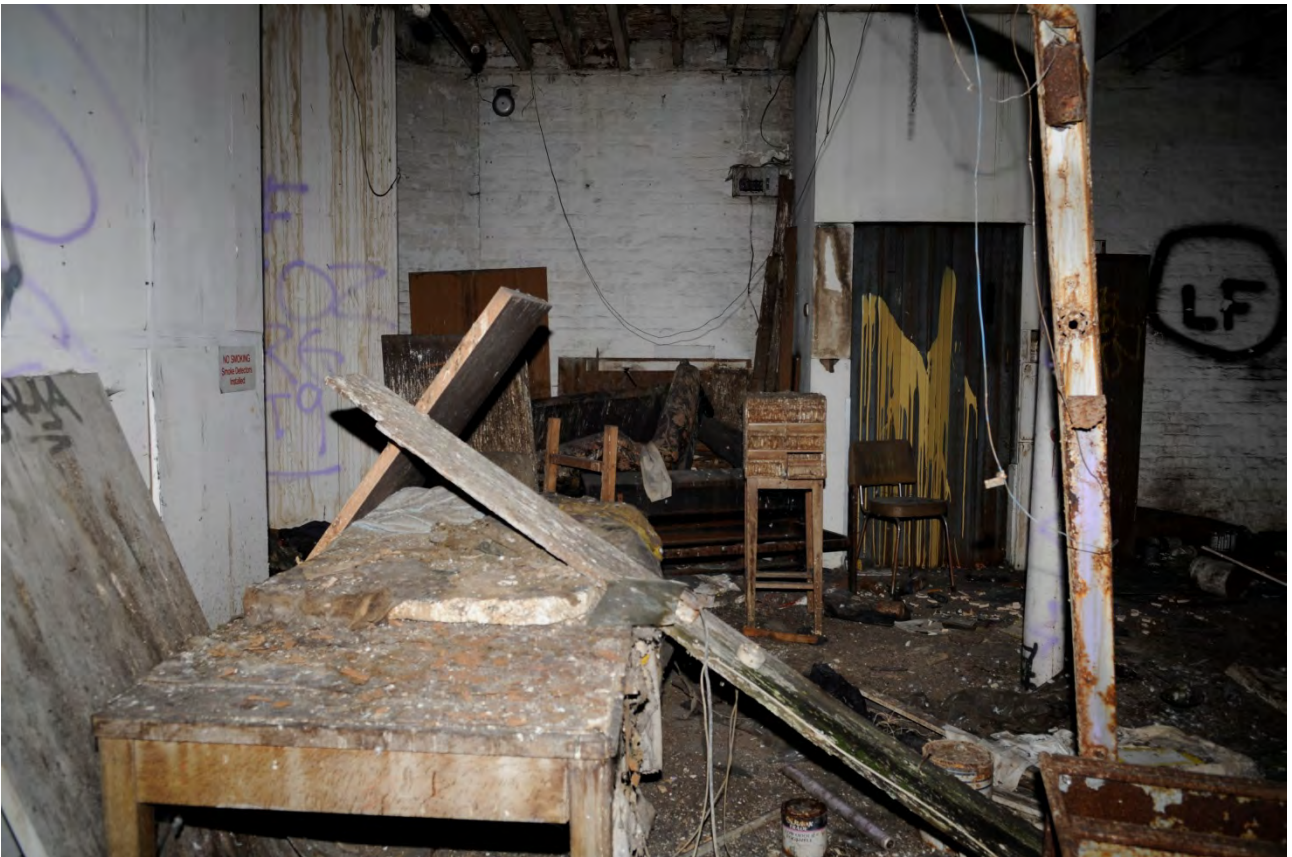
Plate 50: General view, second floor

The lift is visible towards the right of the image, the door daubed in yellow paint. An iron post supports the ceiling above.

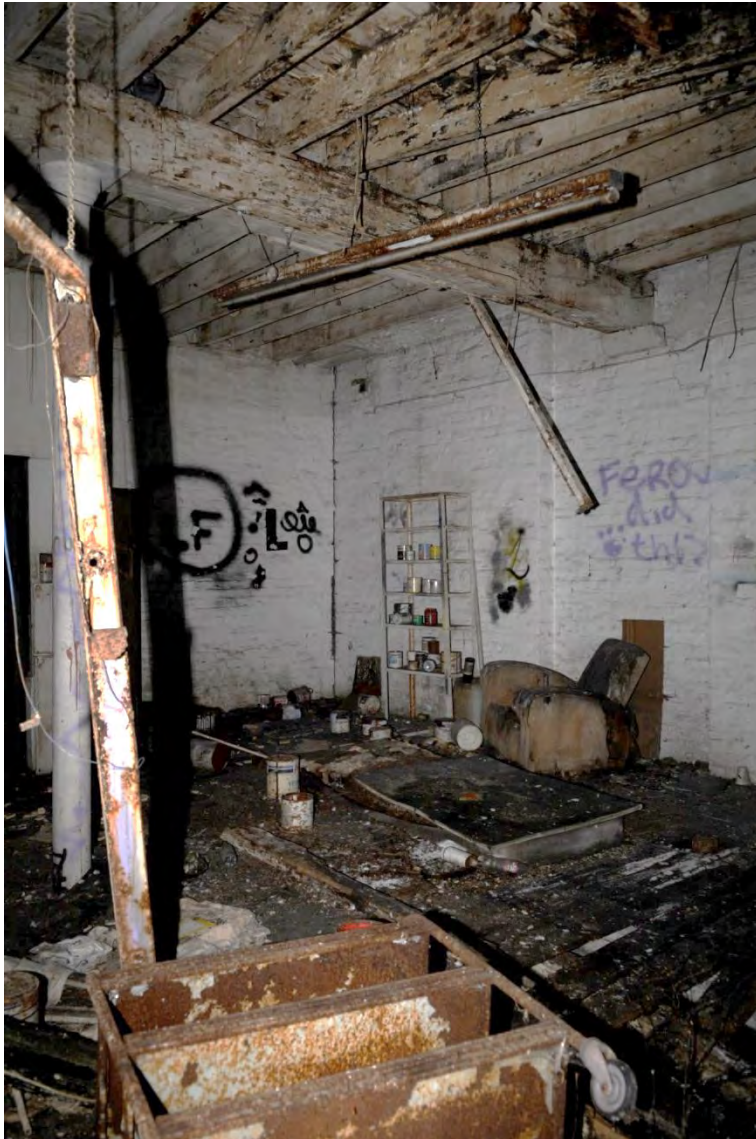
Plate 52: Northwest corner

A chimneybreast can be discerned to the right of the shelving unit towards the back of the room.

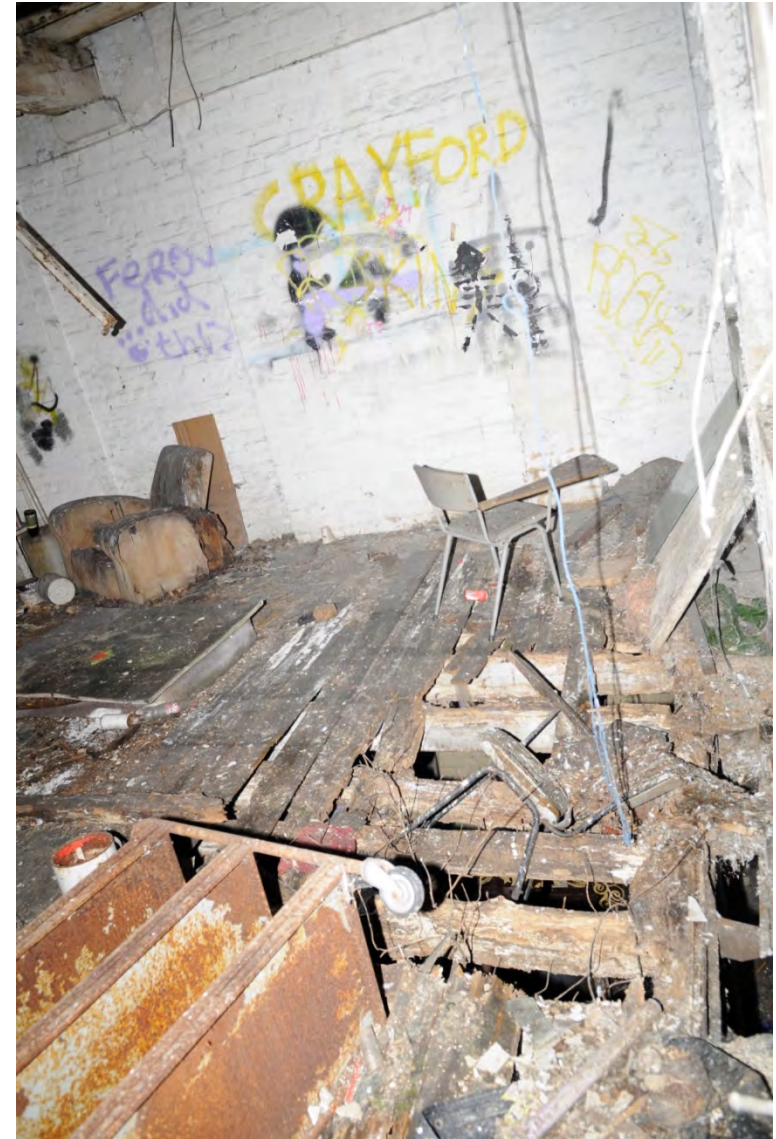
Plate 53: Detail of floor

The timbers making up the floor have rotted extensively owing to rain ingress. This makes them appear older than they are.

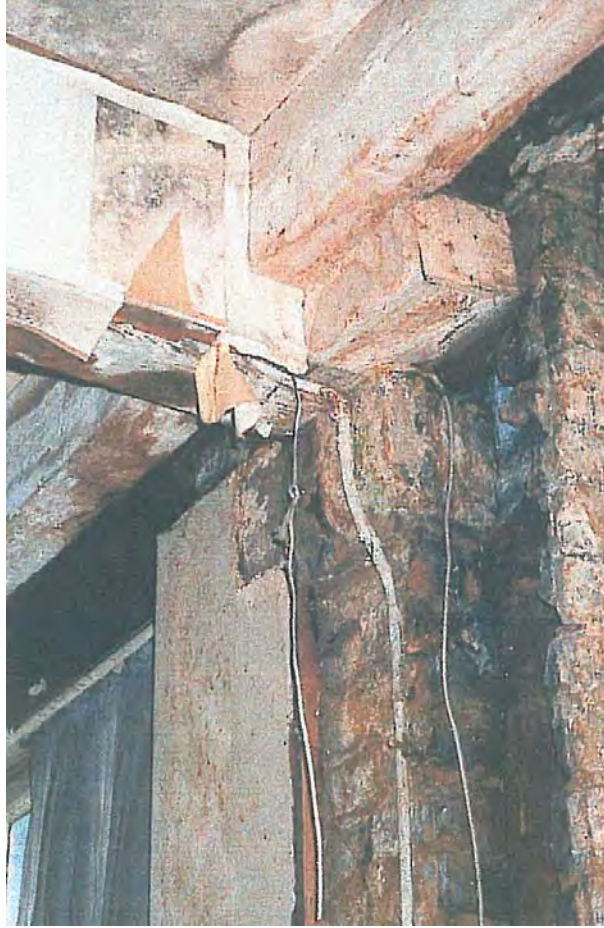
Plate 57: Detail of main and secondary beams at corbel junction, 3rd floor (Shaya 2000)

The lift is visible to the centre of the image. A substantial post is noted in front of the lift, supporting a north-south ceiling beam mentioned in the structural appraisal. The structural appraisal mentions two main beams spanning the east and west walls, supported centrally by a wooden post. The ends of these beams are supported on stone corbels projecting from the walls. The walls are noted as moving outwards at this time, resulting in the beams being out of alignment with the corbels. The timber posts were also cracked. Above these, three secondary timber beams were noted, running north-south. These were supported on stone corbels and again, the movement of the walls had resulted in 'less than minimum bearing for the secondary beams'. It is noted that this movement of walls is a consequence of there being no bond between the brickwork of the walls at the corners.

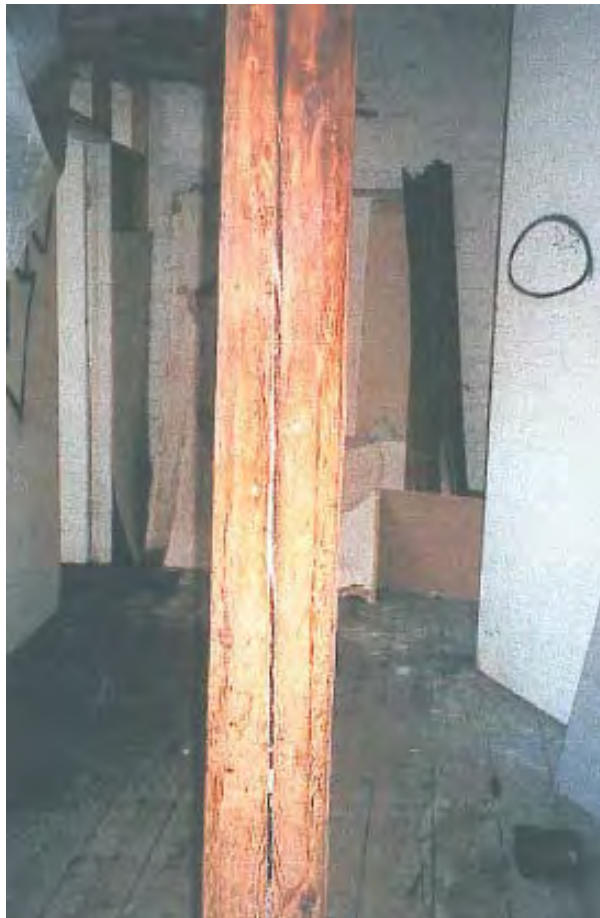
Plate 58: Split in timber post, 3rd Floor (Shaya 2000)

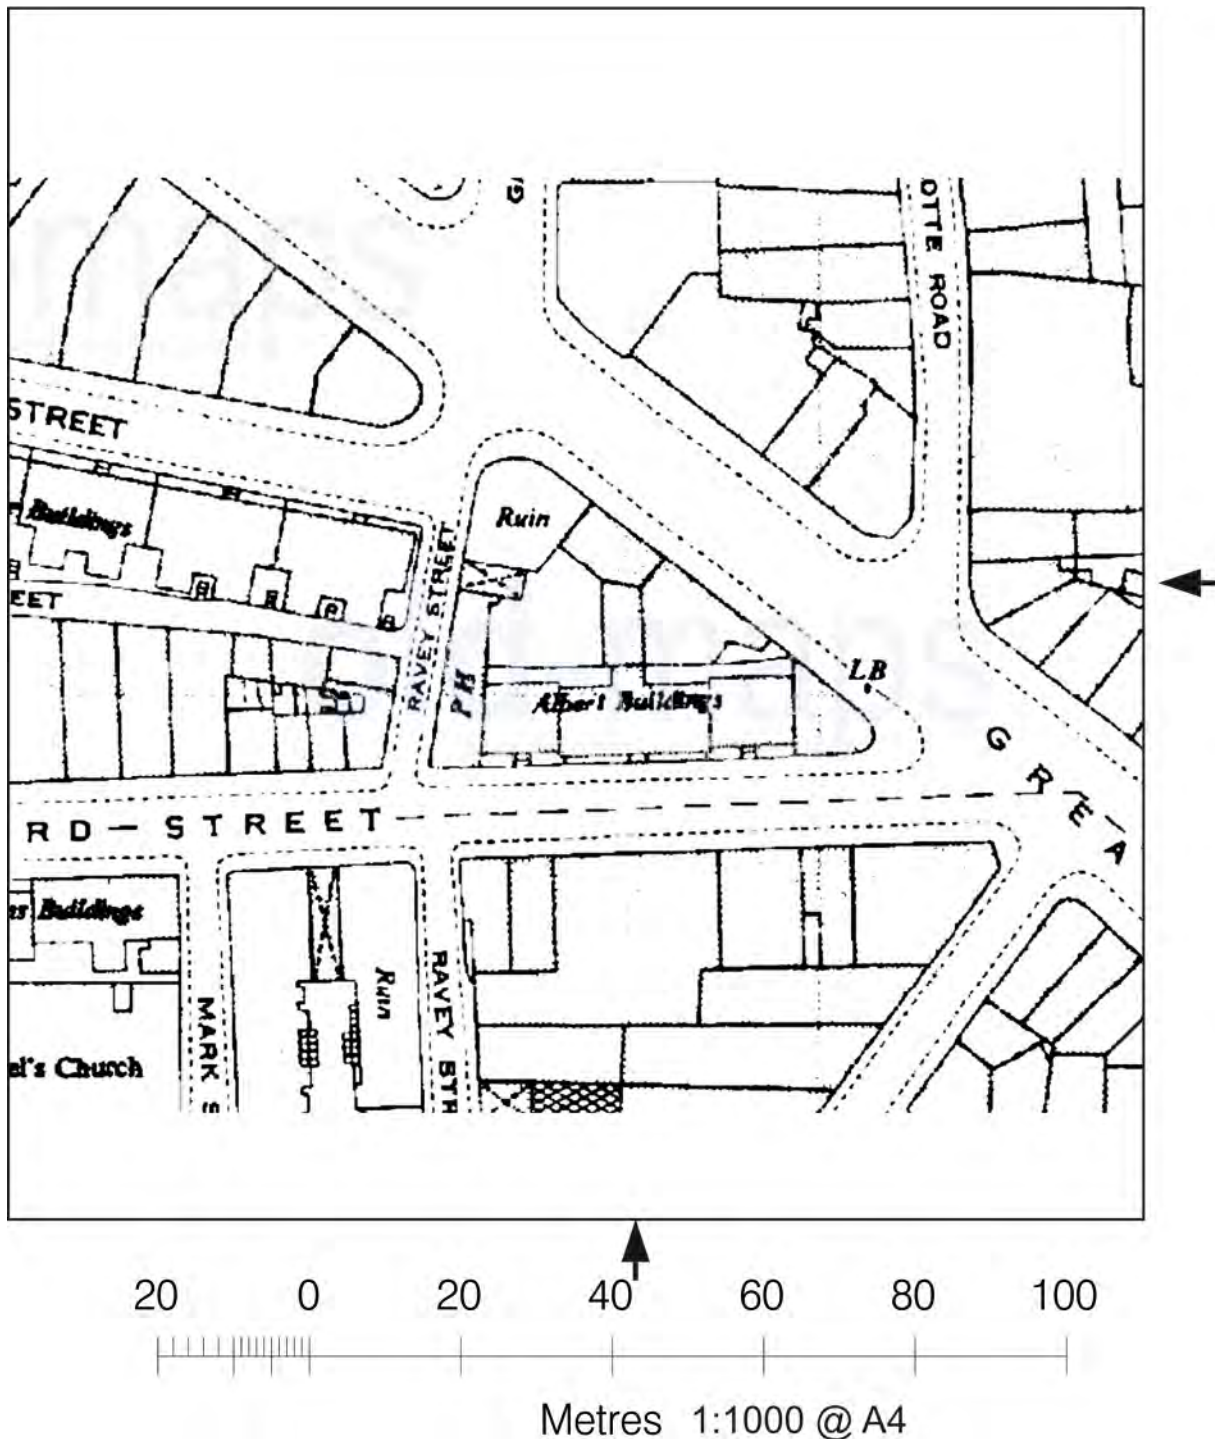
Figure 17: 1954 Ordnance Survey

63 appears to have the same layout, whereas 61 is different to the southeast. It appears to extend along Great Eastern Street to the southeast, which may be a remnant of the former adjacent building which may have been affected by bombing during the Second World War. Similarly, the property to the northwest of 63 is now marked as a ruin, owing to wartime bomb damage.

The two-storey structure appears shorter than the present building as it extends only as far as the rear of 61. This is thought to reflect a now absent extension / lean-to to the rear of 61, taking the southern extent of 61 to the same as that of the two storey building, which is considered to be in its current form. It joins at its southern end onto the rear of the central structure of Albert Buildings.
