Building Recording of
61-63 Great Eastern Street
Shoreditch
London
EC2A 3HS
National Grid Reference: TQ 331 823
Planning Reference Number: 2012/0506

Document Reference Number 2014/1146
Version 1

Building Recording of: 61-63 Great Eastern Street
Dr Peter Wardle and Colin Lacey
14/05/2014

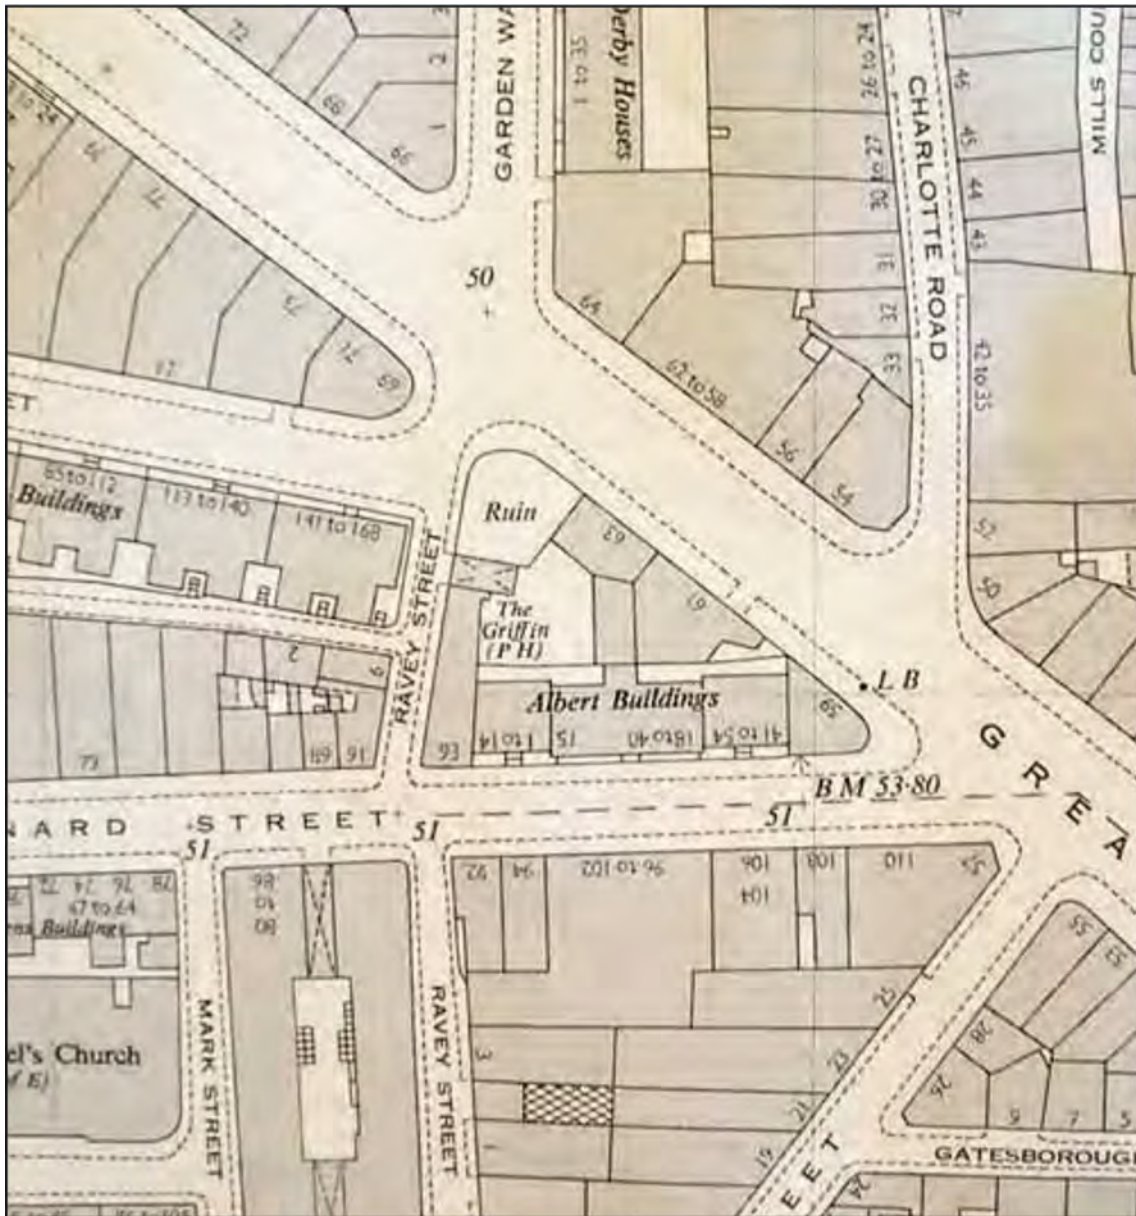
Figure 18: 1957 Ordnance Survey

There is no change in the layout of the buildings.

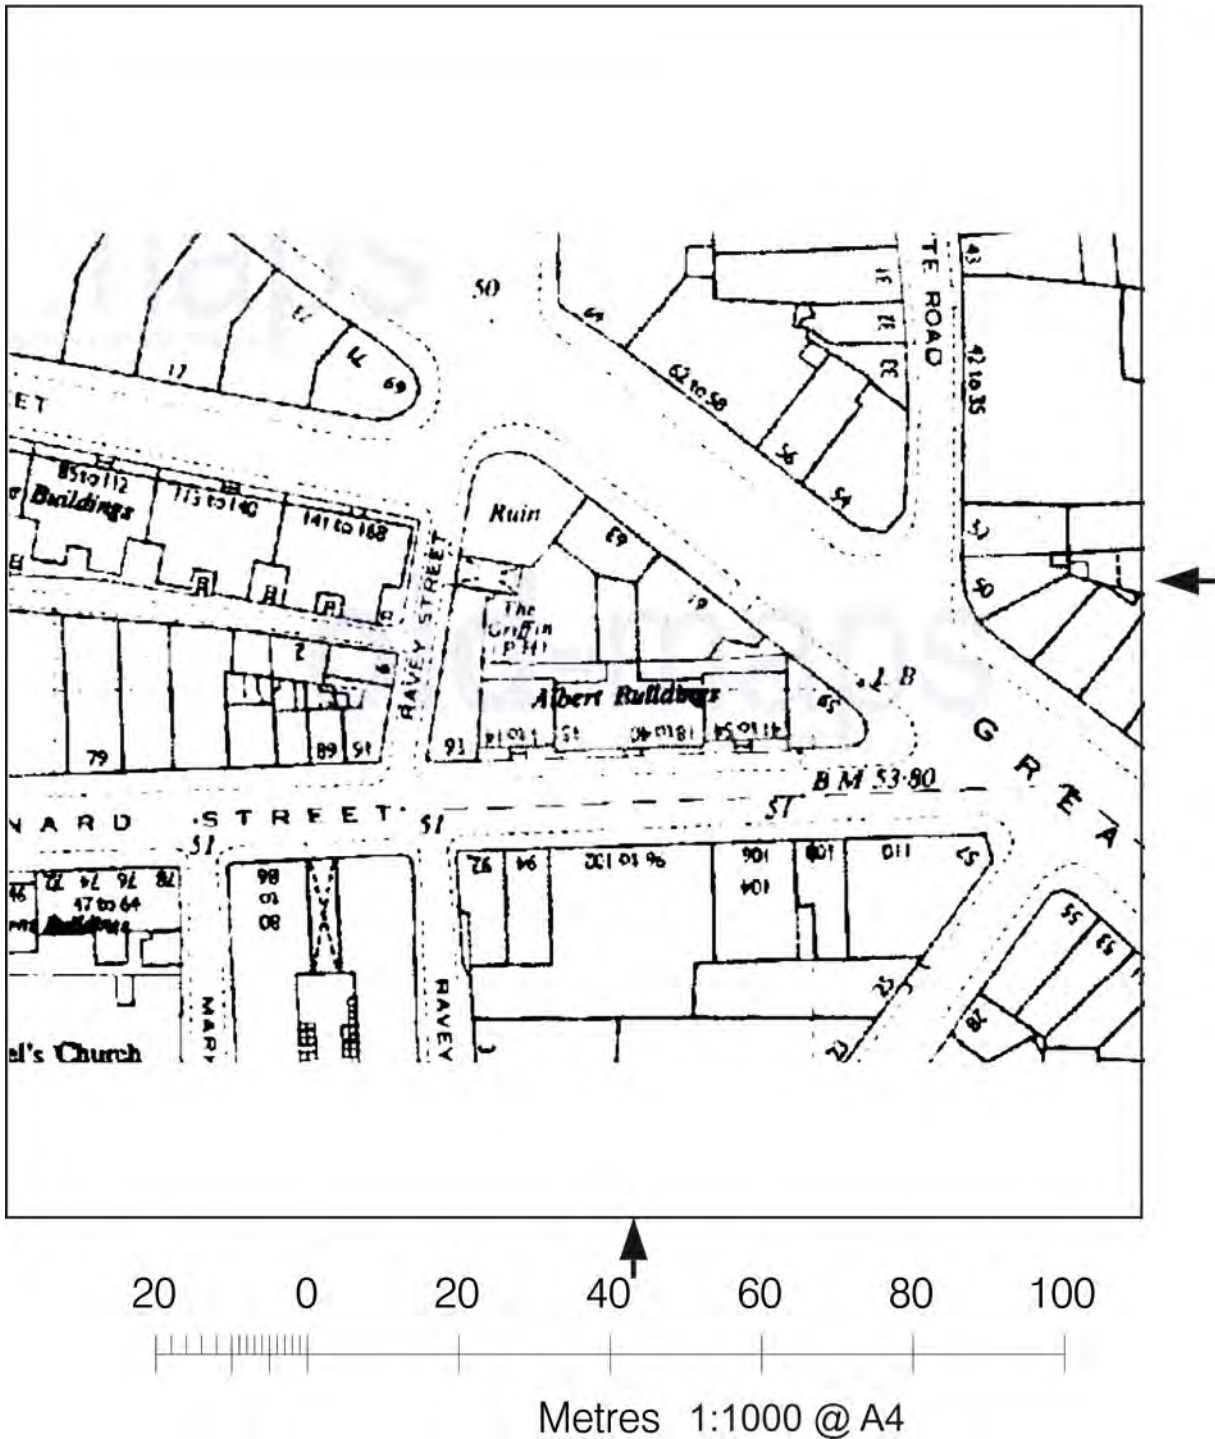
Figure 19: 1964 Ordnance Survey
There is no change in the layout of the buildings.
