## **HERITAGE STATEMENT**

Gilsons Engineering Works  
NEWTOWN ROAD  
NEWBURY, WEST BERKSHIRE

Dr Peter Wardle  
With Contributions by Colin Lacey  
Feb 2012  
Document Reference Number 2011/1067

**HERITAGE STATEMENT**  
**for**  
**Sandleford Farm, Newbury, West Berkshire,**  
**National Grid reference: SU475645**  
**by**  
**Dr Peter Wardle BA MSc PhD**  
**With Contributions by Colin Lacey**  
**15/2/2012**

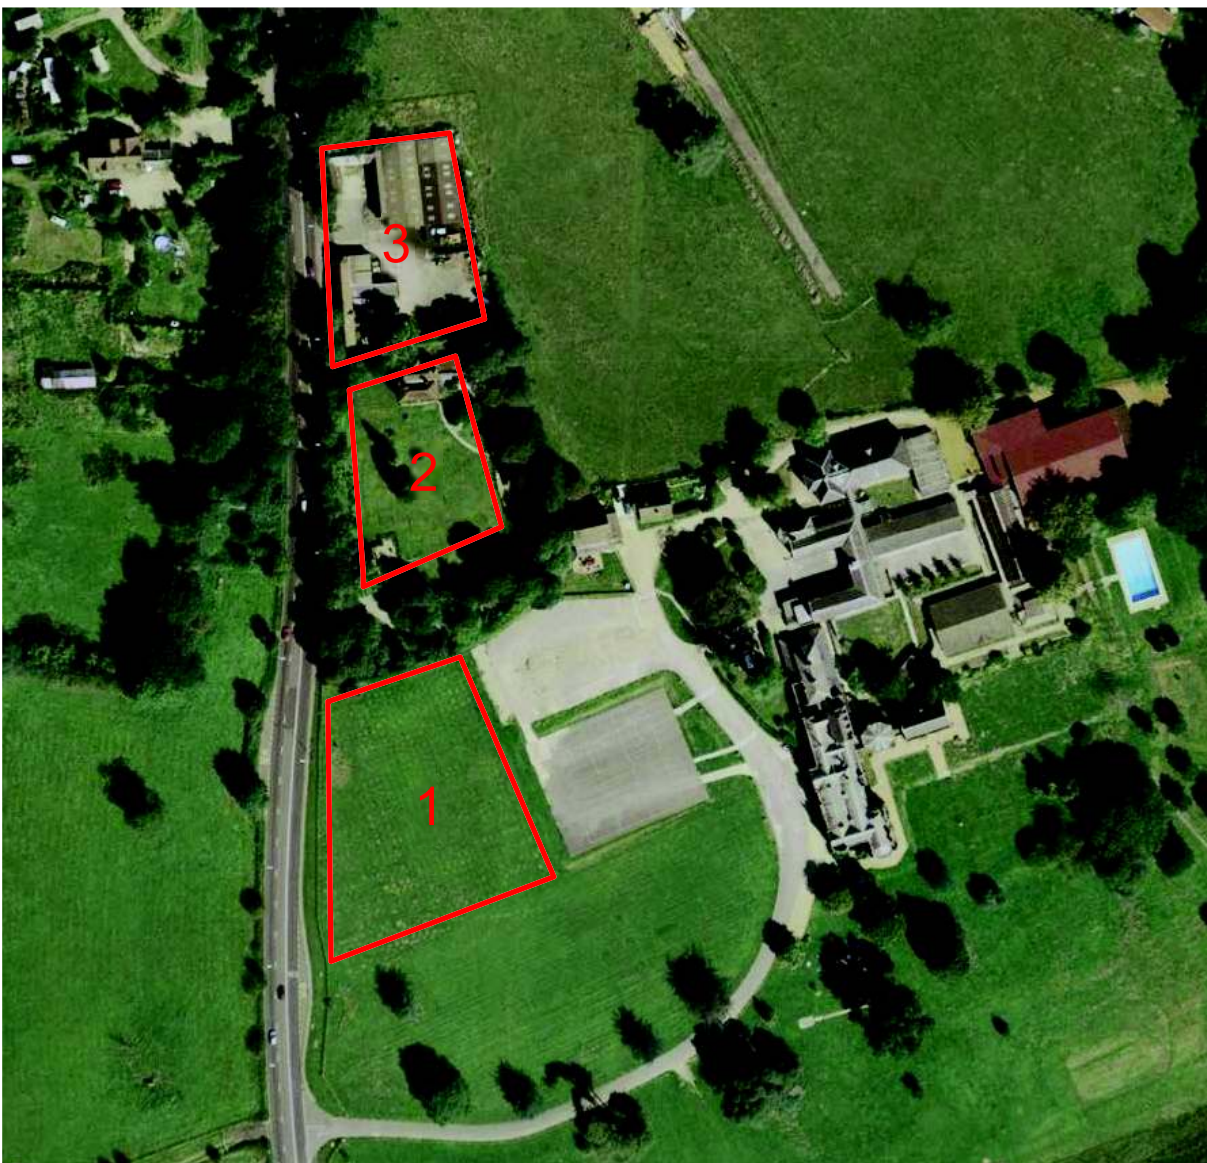
**Figure 6: Three locations of Sandleford Farm**

In Figure 6, the three locations of Sandleford Farm can be seen. Area 1, now the school hockey pitch, was the initial location of the farm, adjacent to the priory. Area 2 was the farmyard until the

There is evidence that the farmyard has been moved northwards away from the house twice in its history, presumably to lessen the impact of farmyard noise and smell on the residents of the house. The final such move took place between the years of 1835 and 1873. Originally there were far more buildings present on the site, many of which have been demolished to leave the site as it is today. These are shown in the map regression analysis.

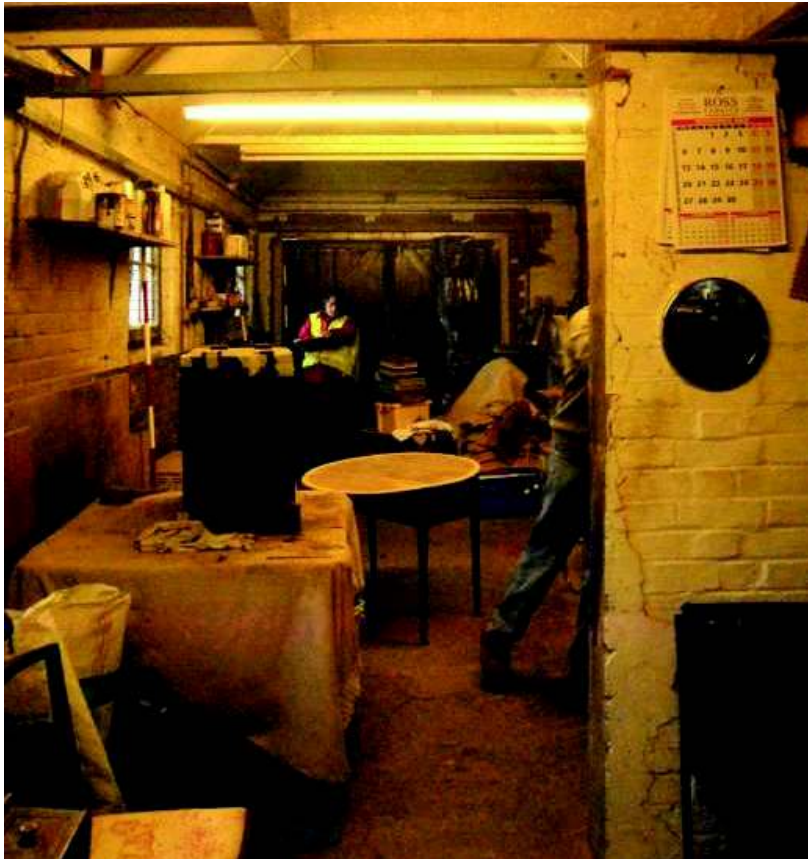
**Plate 7: Unit 1 from north, viewed through partially demolished wall**

The tenant uses the boarded-out roof space of the unit 1 extension for storage. Access is via a hatch at the southern limit of the extension (see Plate 7).

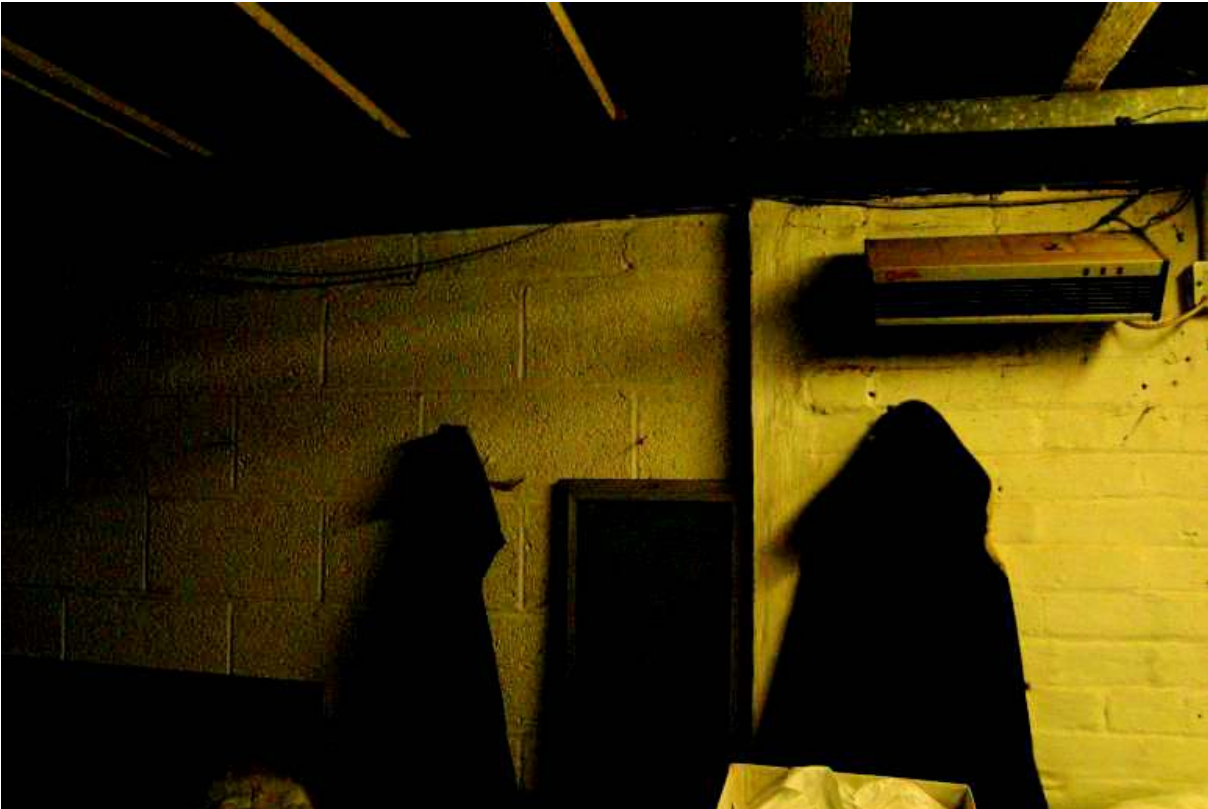
**Plate 8: Unit 1, modern partition wall to unit 2 (left), original wall (right)**

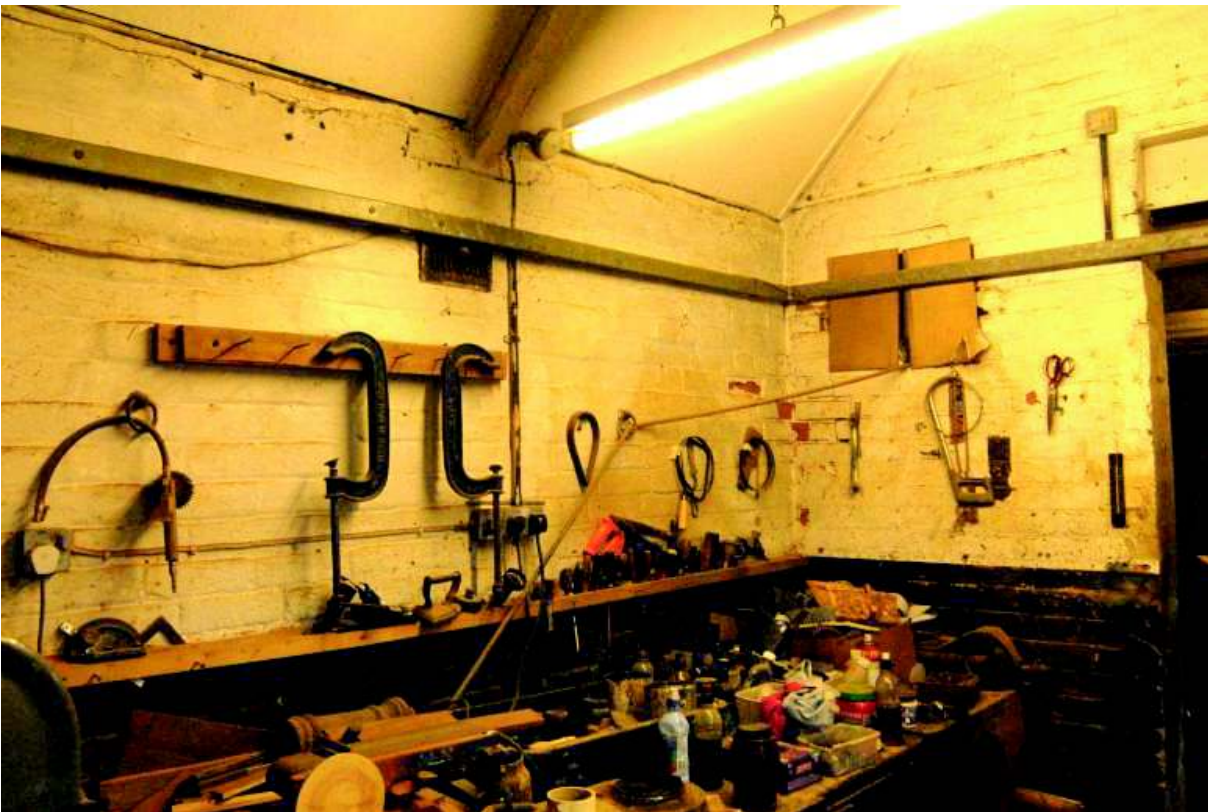
**Plate 9: Historic features of unit 1 - air vent and rings**

Further original features can be located on the inside of the western wall (see Plate 9). Beneath modern galvanised ducting, a cast iron air vent can be found, and below, two iron rings can be found, originally for tethering horses and hanging feed. It is thought that any interior partitions between stables would have been of timber, of which no trace remains.

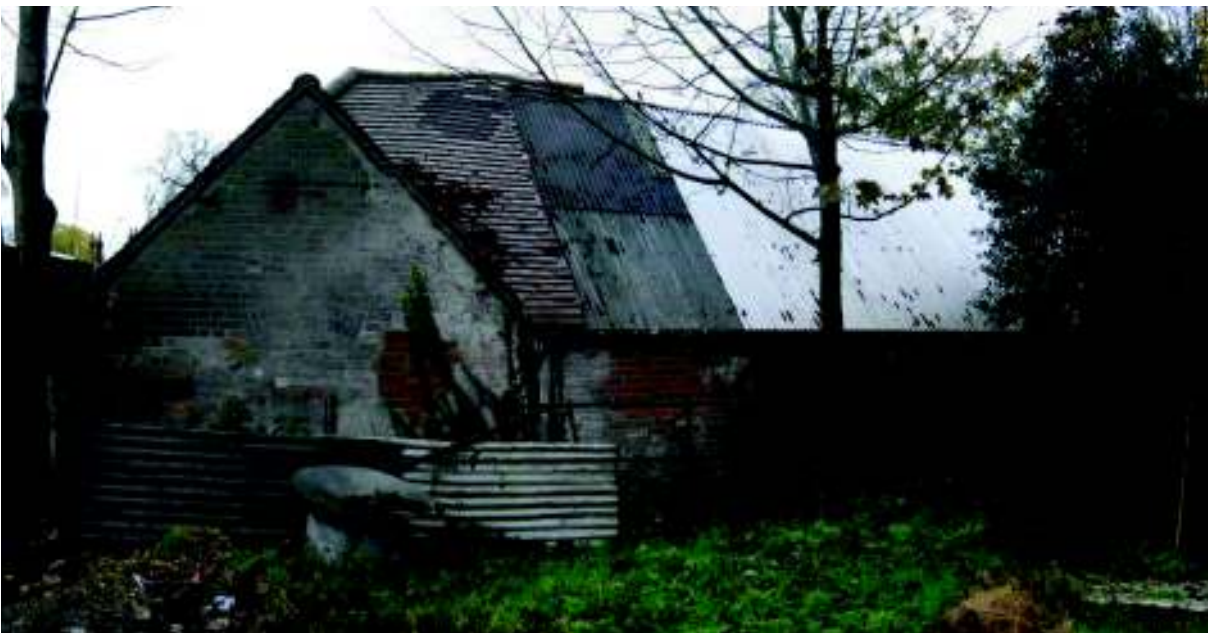
**Plate 10: North elevation unit 2**

The north elevation of unit 2 gives an insight into the original layout of buildings. To the east can be found the gable end of a building or range of buildings that would have stood in the location of the western part of the current unit 3; buildings which have now largely been demolished. A bricked-up arched window can be found in the centre of this wall, alongside a more modern bricked up opening.

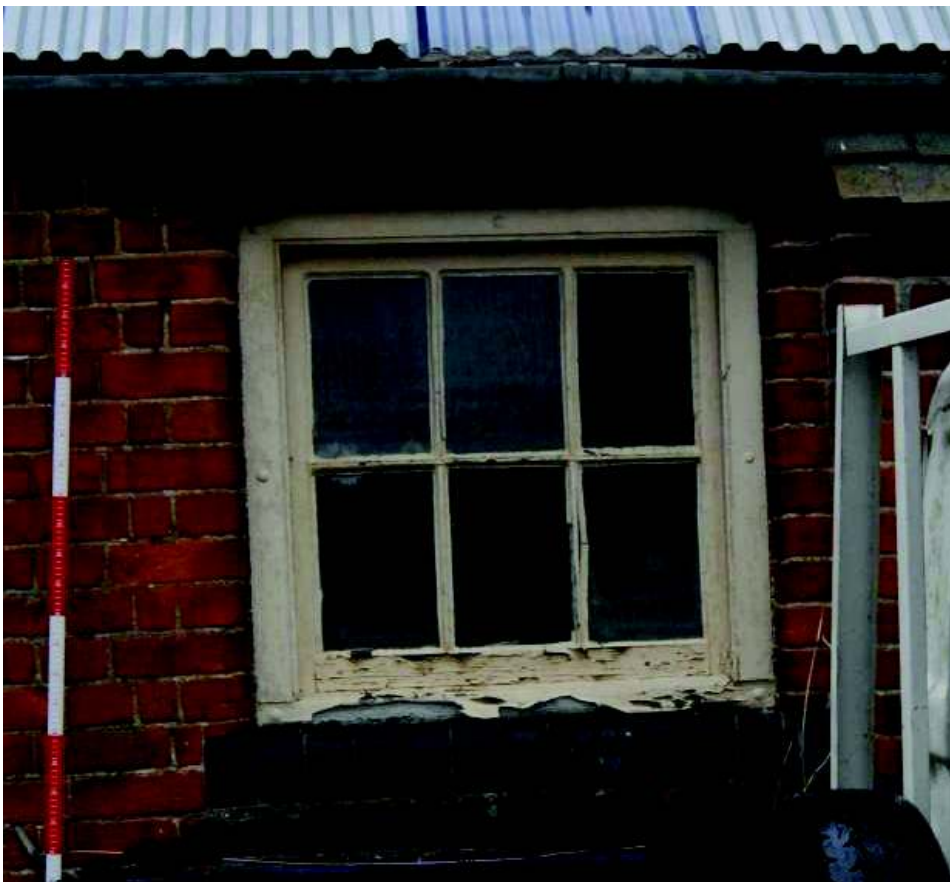
**Plate 13: Window, unit 2, showing lintel**

The west elevation is a modern block-built party wall with unit 1, which can be seen in the photograph below. The door to unit 2 appears to be contemporary with the door fitted to unit 1 and to unit 3. This suggests the doorway is not original, although may well be in the position of an original door, owing to the lack of evidence for another door in this elevation. Six windows exist to the east of the door. The windows appear to be identical to those in unit 1, although these have different lintels. All lintels are moulded like that in Plate 13 except that furthest to the east which has no moulding.

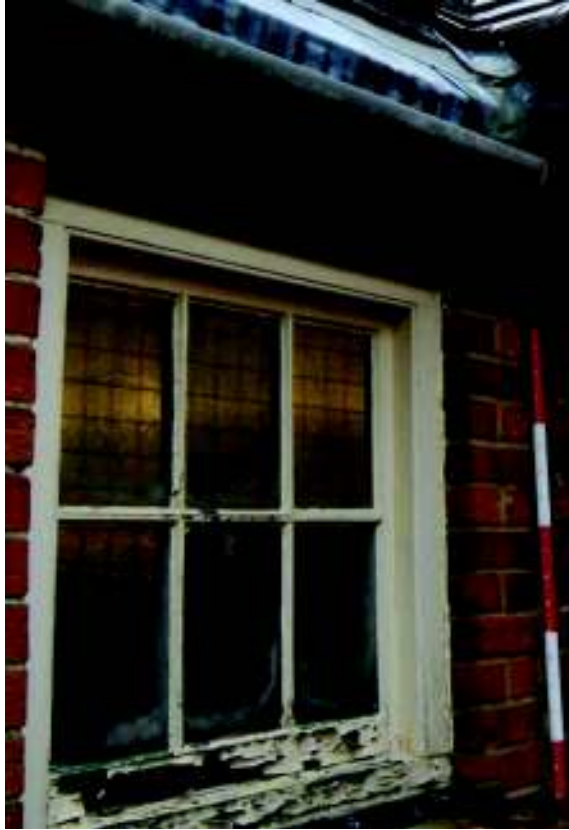
**Plate 14: Eastern window, unit 2, south elevation, showing different lintel**

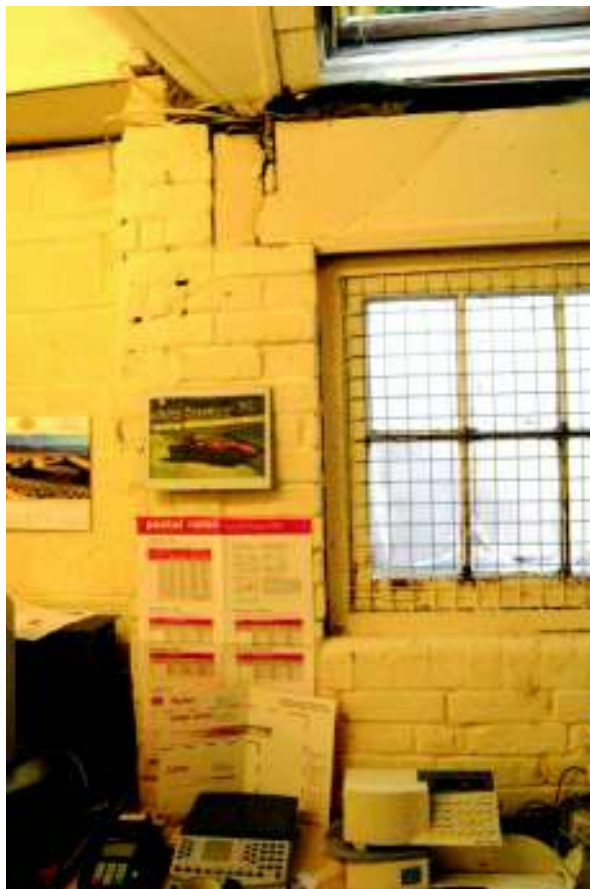
**Plate 15: Unit 2 internal, showing original wall of north-south range**

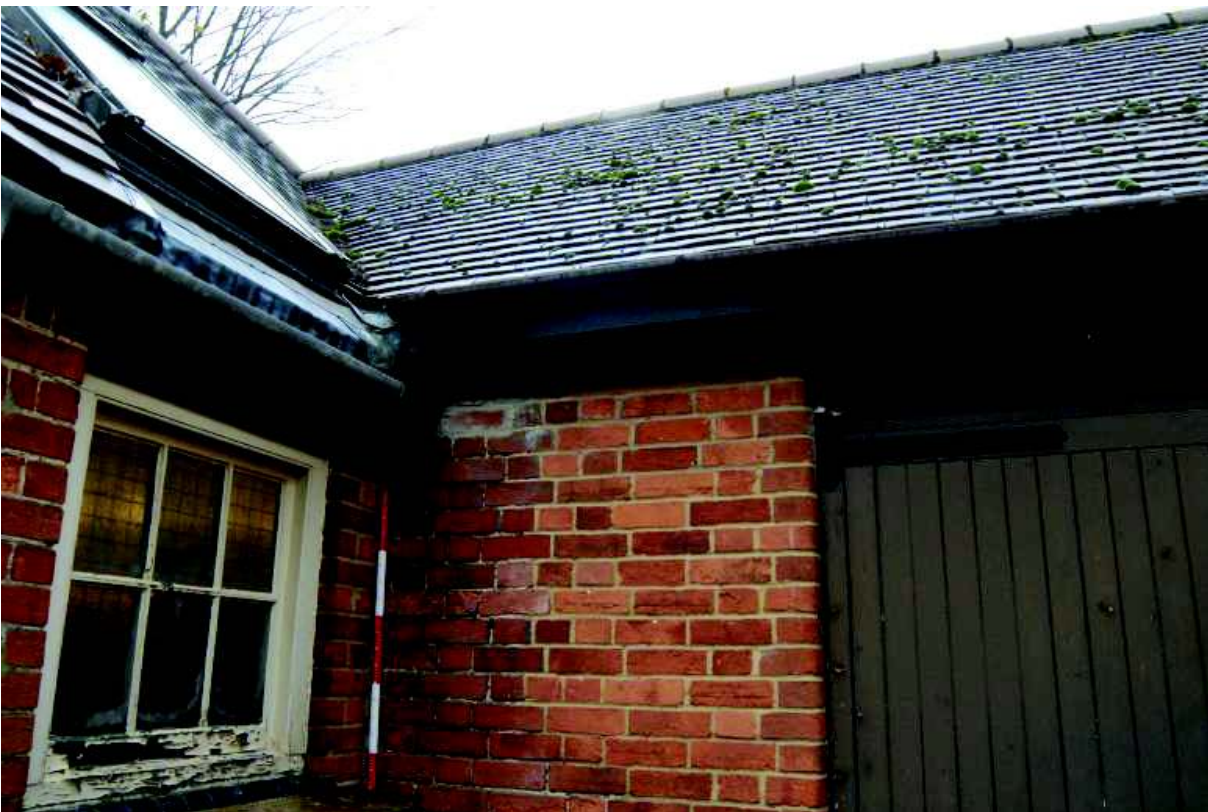
**Figure 10: Corner of units 2 and 3, showing original brickwork in wall of unit 3**

*UNIT 3 is a late C20 industrial unit built after 1990. There are two parallel sheds with shallow pitched roofs to the east and an office range with a steeper pitched roof to the west, all in red brick. There is a small area of older fabric to the north-west comprising a section of brick walling which is probably of late C19 date, and there are other reused historic*

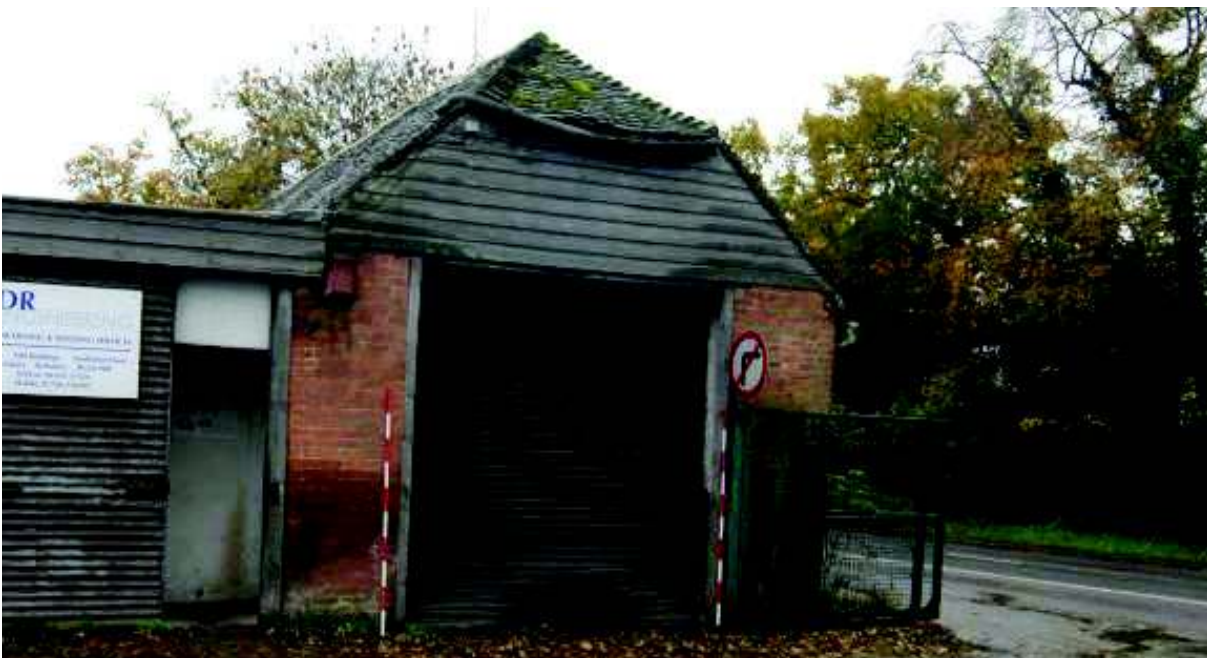
**Plate 18: Unit 4 north elevation**

A roller shutter stretches over the central part of the north face of the building. Either side, red brick walls can be found, in mainly Flemish with some stretcher bond. Above the door, the wall is clad in timber weatherboarding. The roof is half-hipped and is dressed in slate.

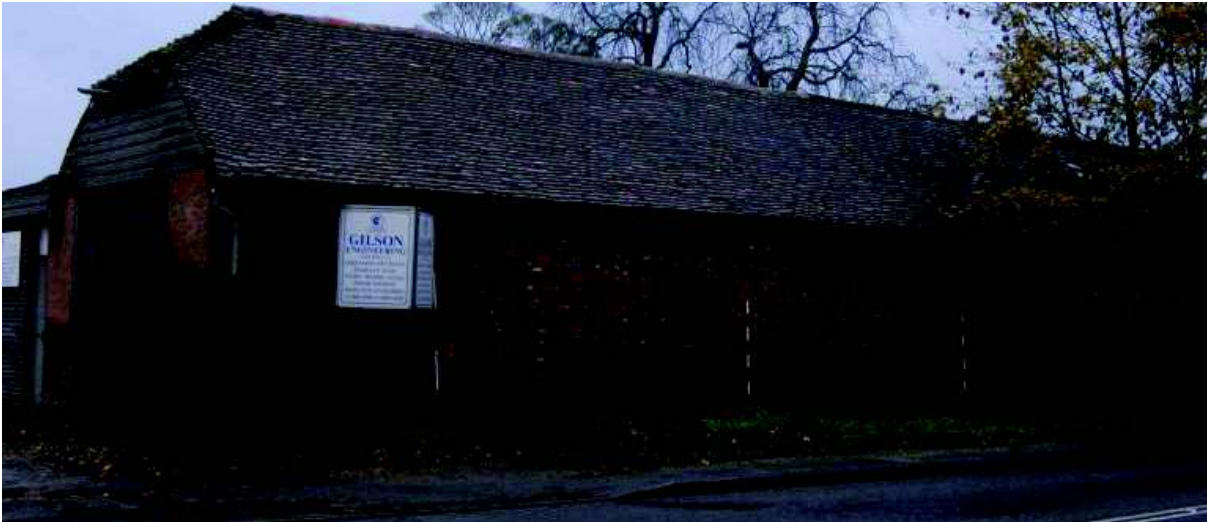
**Plate 19: Western elevation, unit 4**

Plate 19 shows at least two phases to the construction of unit 4. The area to the left of the photograph behind the 'Gilson Engineering' sign is of older brickwork than any other part of the barn

The abrupt termination of the darker section of the wall may indicate the extent of an earlier structure. It is common when repairing or joining walls for the brickwork in existing structure to be tied into new brickwork. This has clearly not occurred, ruling out this possibility.

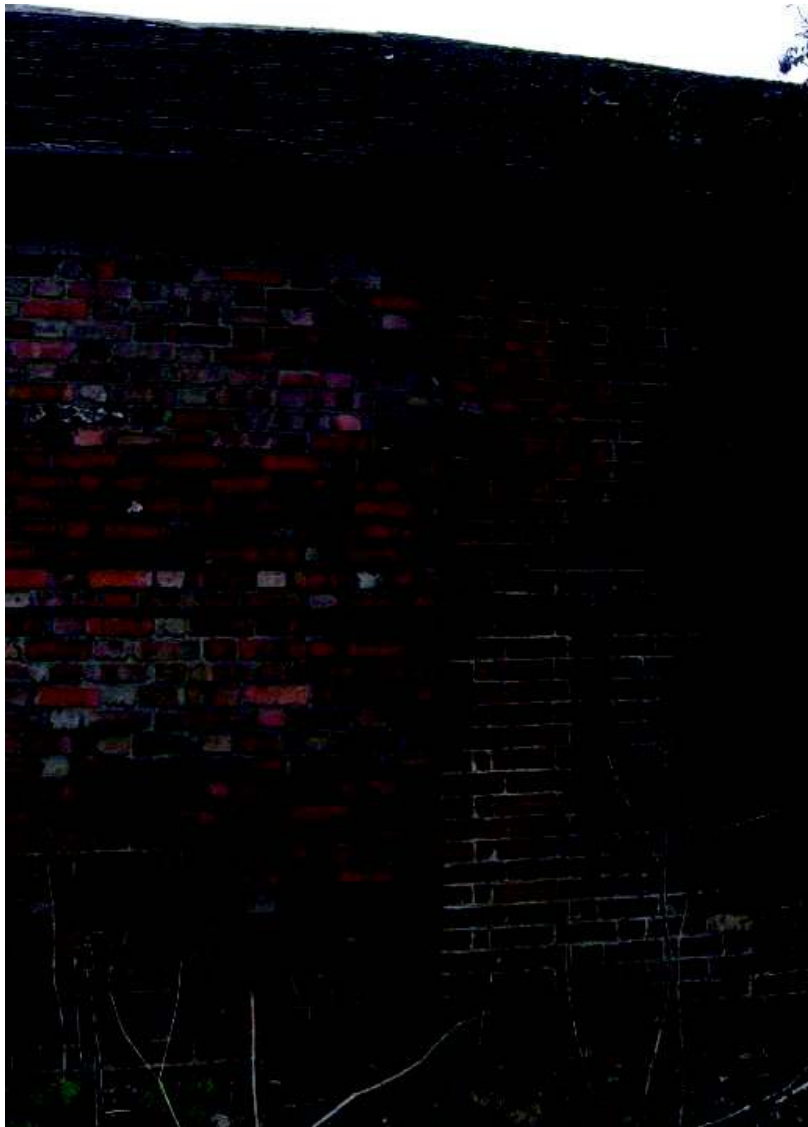
**Plate 20: Join between unit 4 (left) and unit 7 (right) is clear from the western elevation**

It can be seen in Plate 20 that the wall of unit 4 is not interlocked with that of unit 7. This suggests that unit 7 was a separate entity prior to the construction of unit 4.

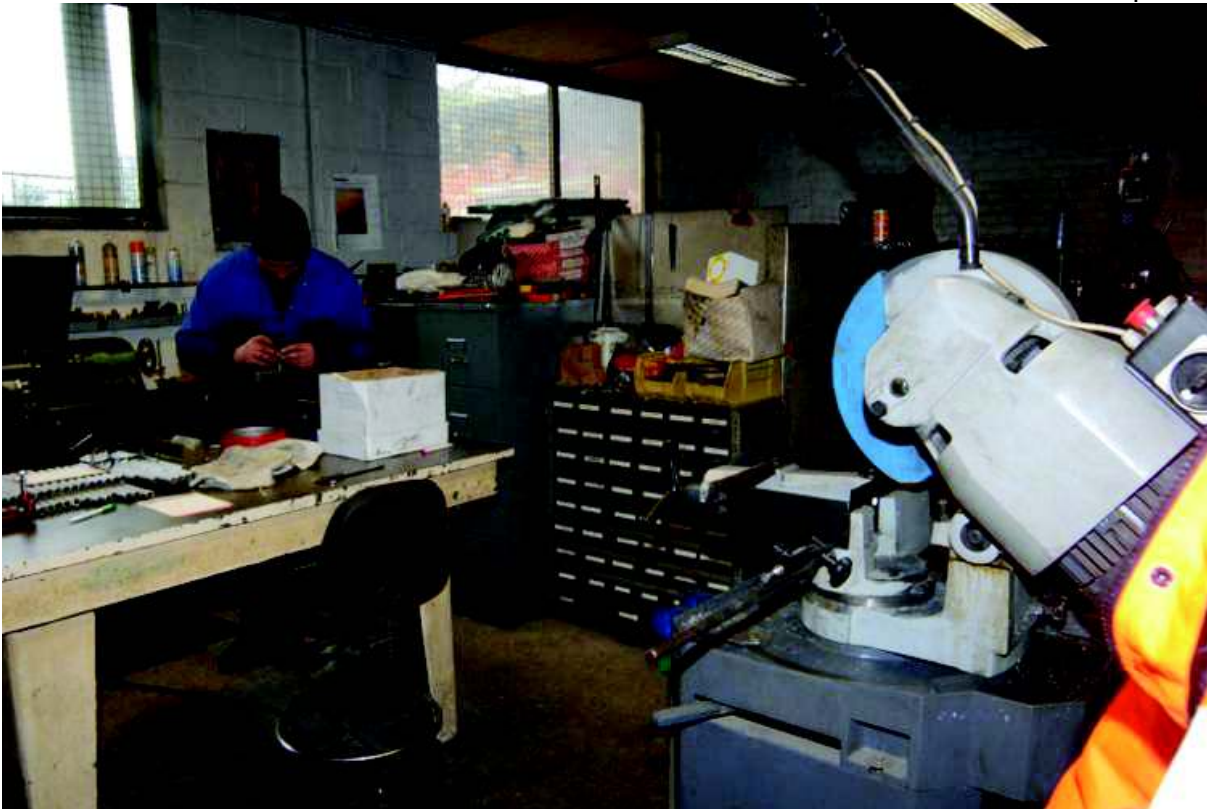
Unit 5 is a modern engineering workshop built of pre-cast concrete blocks with a flat corrugated metal roof. The structure utilises the walls of units 4 and 6, the area between which it occupies.

Plate 21: Unit 5 interior

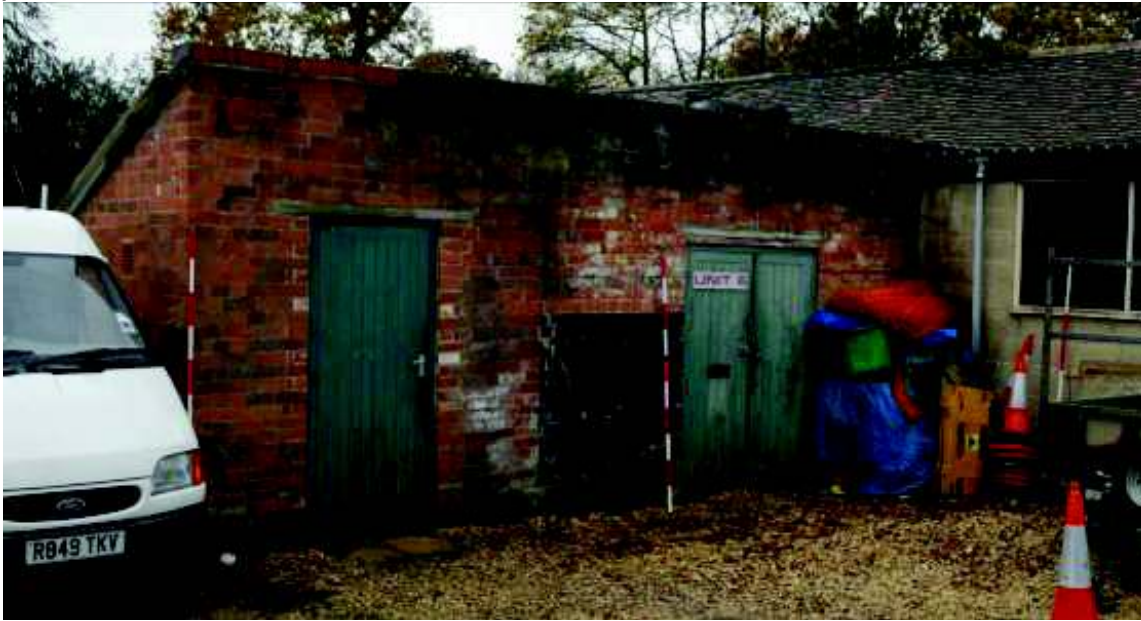
**Plate 22: North elevation, unit 6**

The north elevation of unit 6 appears to be of newer brick than that of the southern face. Repairs to the top left corner of the wall are evident, and a large patch of black painted brickwork between the two doors and to the west is evidence that there is likely to have been a structure located to the north of this part of the building and consequentially, the part of the wall bearing black paint was once an internal face. This suggestion is perpetuated by the presence of black paint over the lower part of the interior of unit 1.

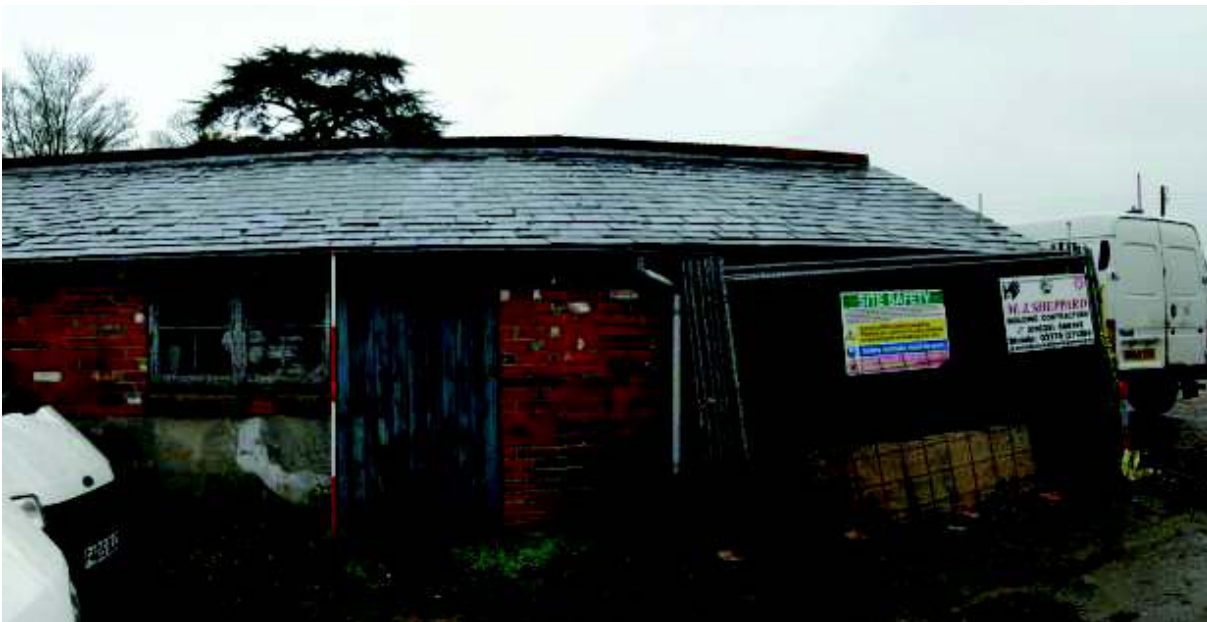
**Plate 23: South elevation, unit 6 (manipulated image)**

The southern elevation contains a second access door to unit 6, with a window alongside. Beneath the window, the wall is rendered in cement to the west. Examining the brickwork, the lower ten courses are constructed of bricks considerably smaller than those above. This has two possible causes – either that the wall was constructed in two phases, existing originally as a low wall for a pigsty or similar, before being extended vertically upon construction of the building as it now stands, or alternatively that the lower portion of the wall was built using recycled bricks from a previous structure, whilst the upper part used newer bricks.

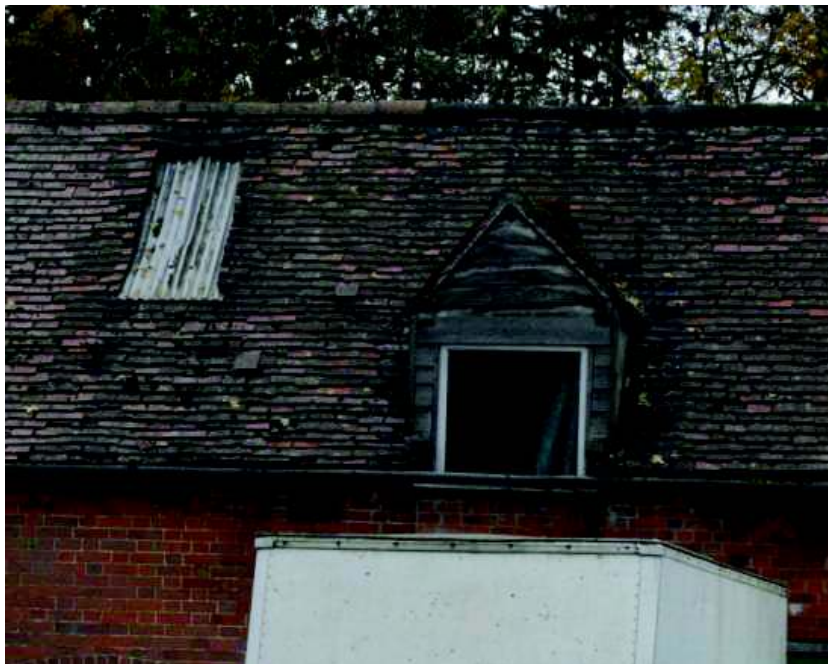
**Plate 28: Detail of roof, east side, showing dormer and roof window**

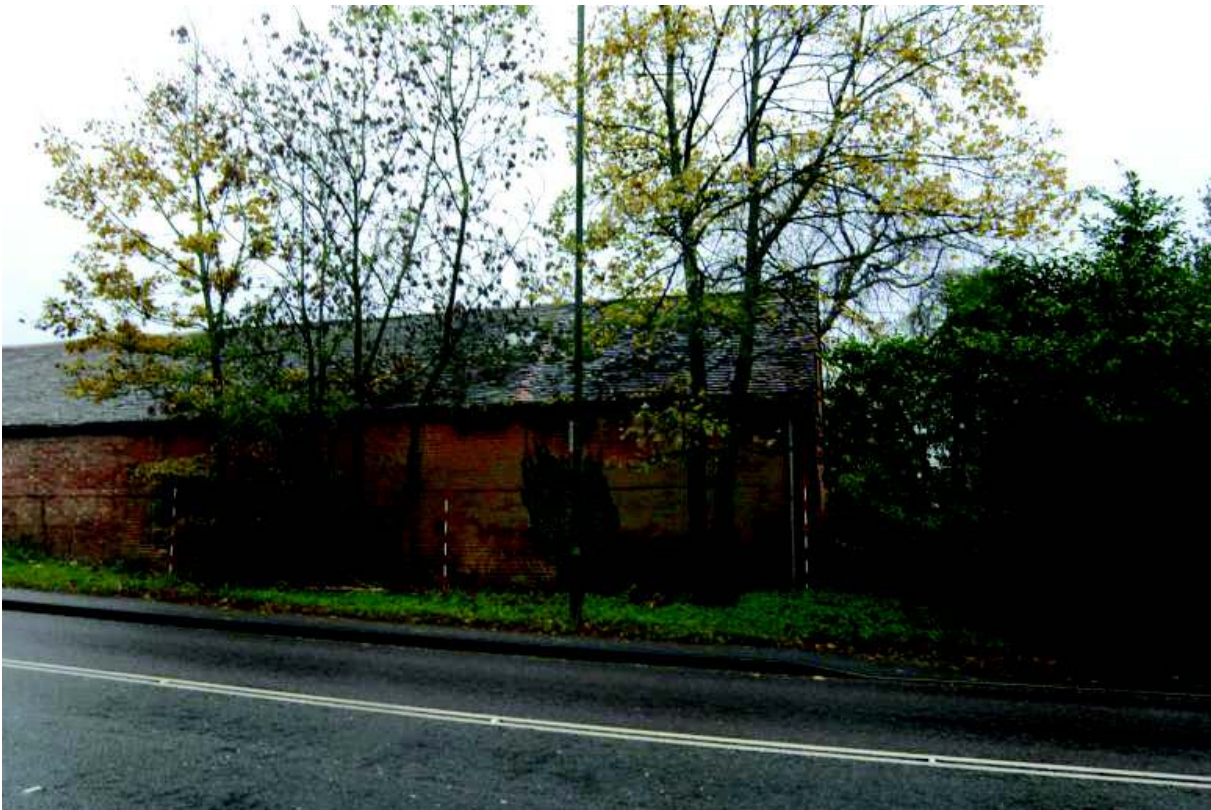
**Plate 30: West elevation, unit 7**

The west wall of unit 7 joins with that of unit 4 and makes up the farmyard boundary to Newtown Road. In Plate 30, the extent of unit 7 can be seen slightly to the left of the leftmost ranging pole. Another modern roof window can be seen on this side of the building.

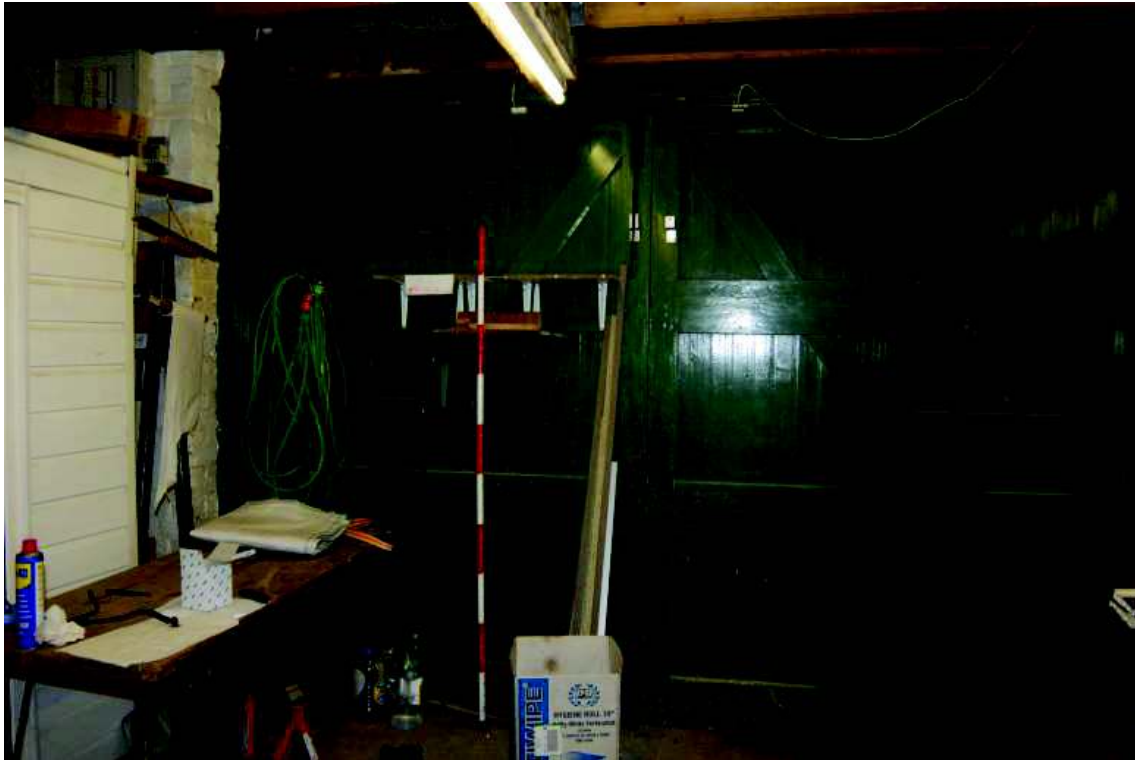
**Plate 31: Internal face of large doors, unit 7, showing RSJ lintel**

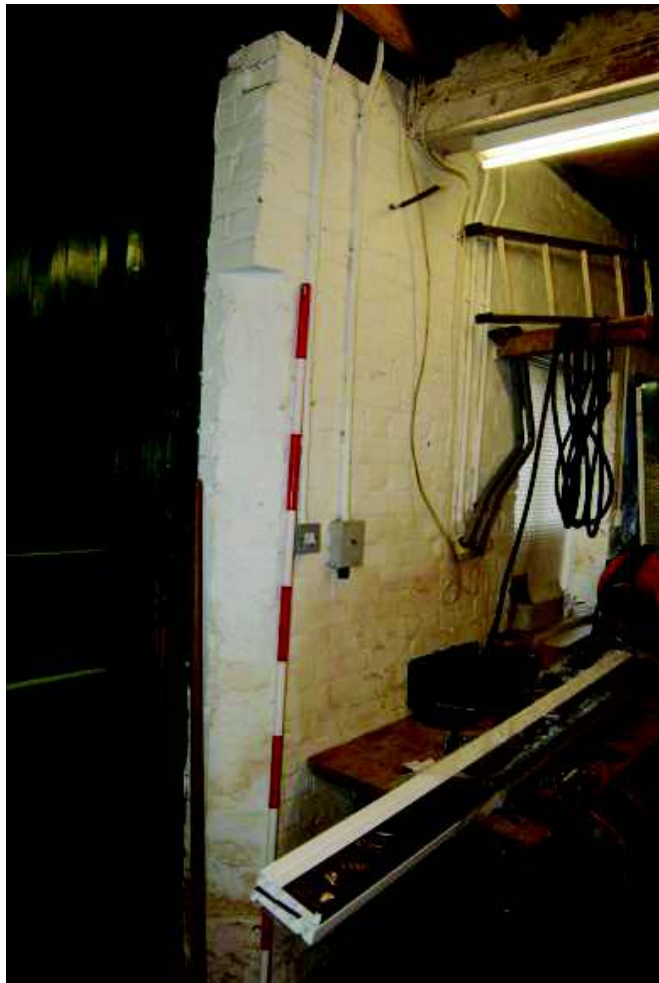
**Plate 32: Detail of door frame, unit 7, showing chamfered wall**

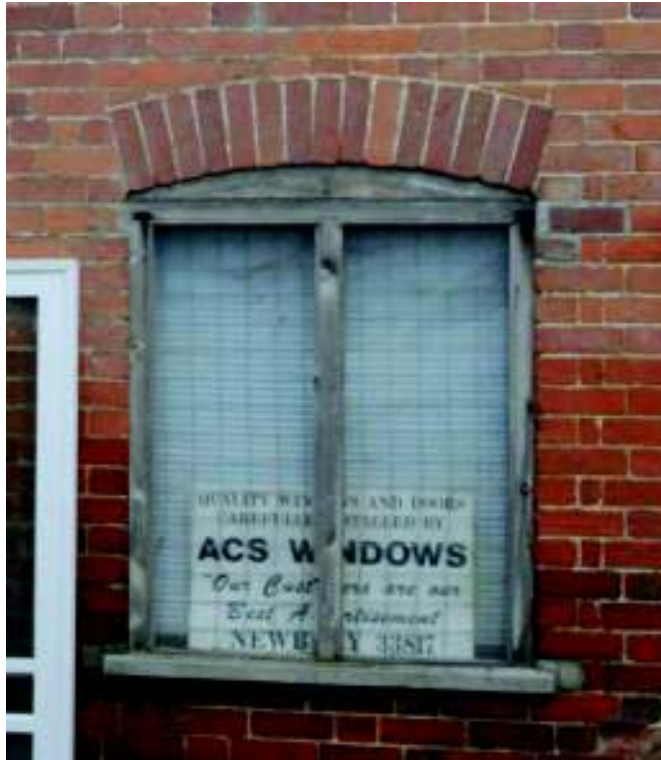
**Plate 33: Unit 7 window**

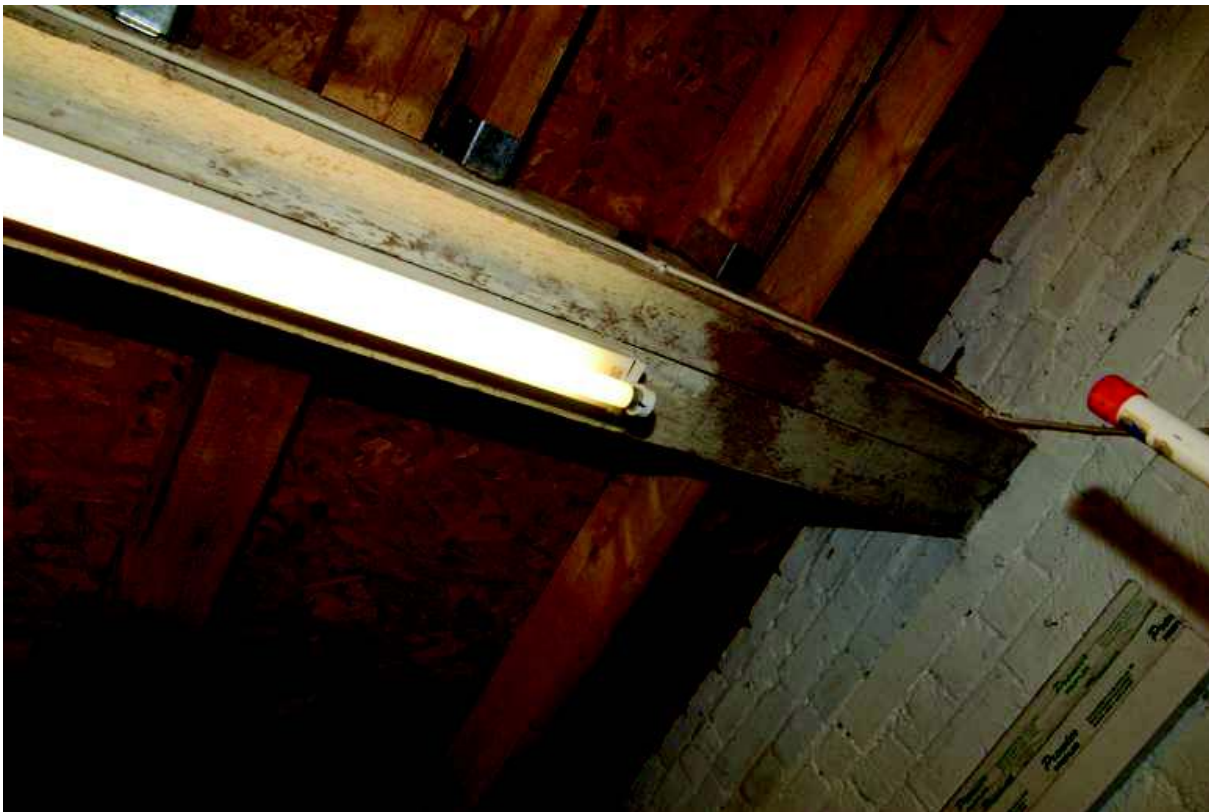
**Plate 34: Modern north-south timbers and original east-west timbers supporting upper floor**

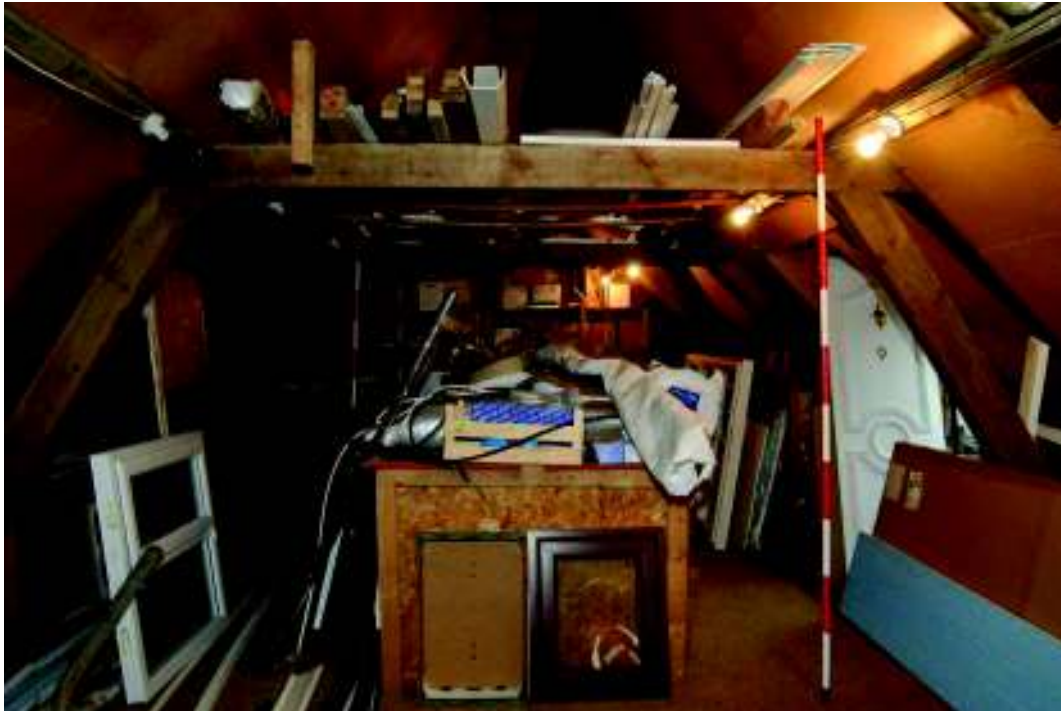
**Plate 35: Roofing timbers of unit 7**

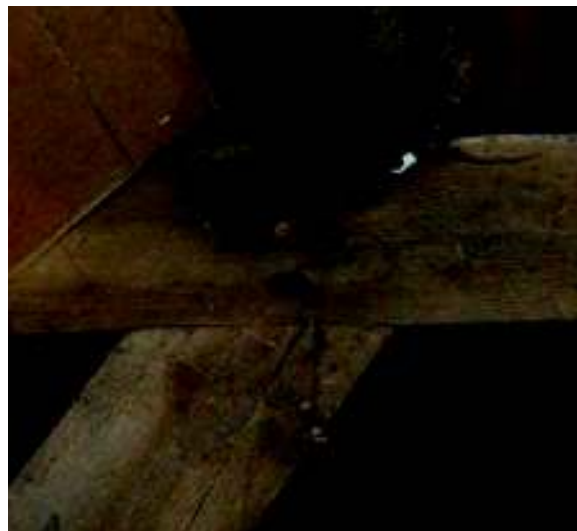
**Plate 36: Detail of roofing timber joint**

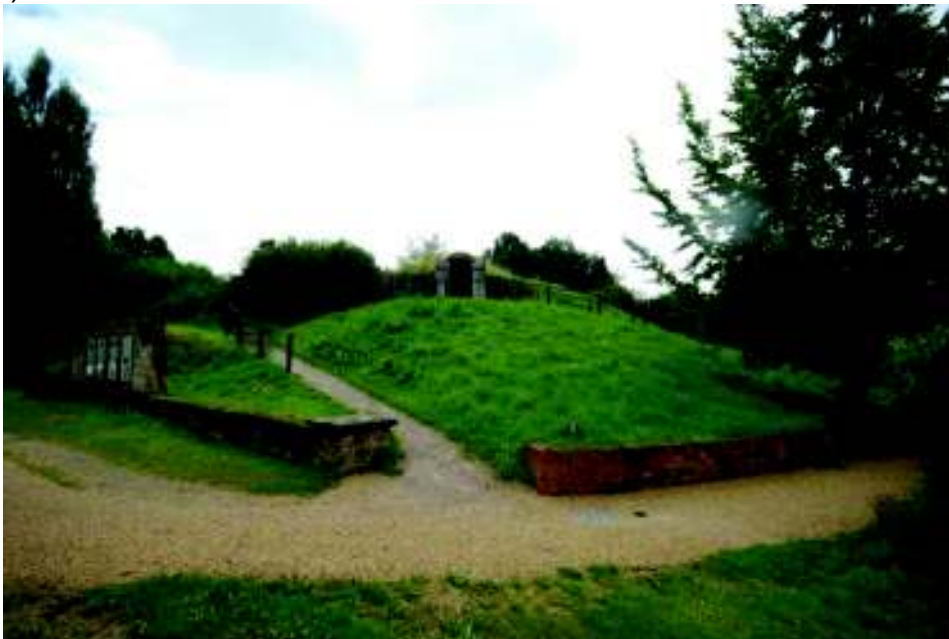
Plate 37: The ice house at Avoncroft Museum of Buildings

An ice house is a structure located partially underground, used to store ice collected during winter for use in cooling and preserving food during the year. Ice houses were first introduced into Britain at around 1660 although the majority were built between 1750 and 1875<sup>4</sup>. By the end of the Victorian era most large houses were equipped with one. Generally they are large deep structures with a mound on top. An entrance door into the mound often faces north or southeast.

The chamber was usually constructed from brick (although examples constructed from stone or timber are known) with double walls separated by a cavity to provide extra insulation and keep the ice dry. A drain at the bottom of the ice chamber was considered to be a vital feature because the presence of water increased the rate at which the ice melted. The chamber was topped with a brick vaulted or domed roof, again with cavity. This was either covered with earth or by a thatched roof. Brick ice house walls often reach 2 feet (0.6m) in thickness.

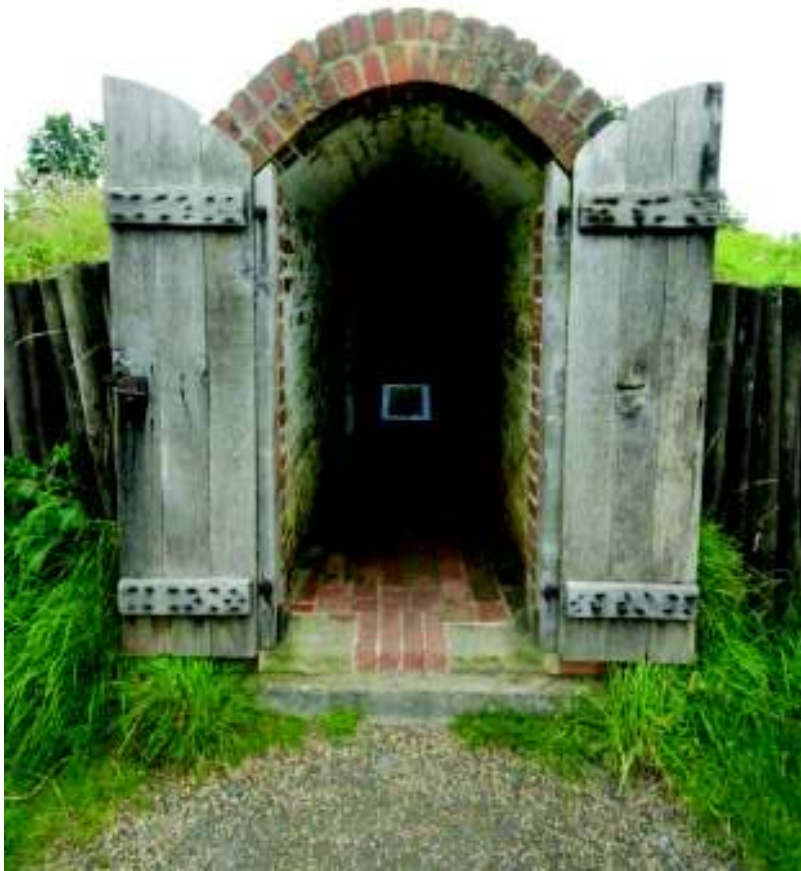
**Plate 38: The entrance to the ice house at the Avoncroft Museum of Buildings**

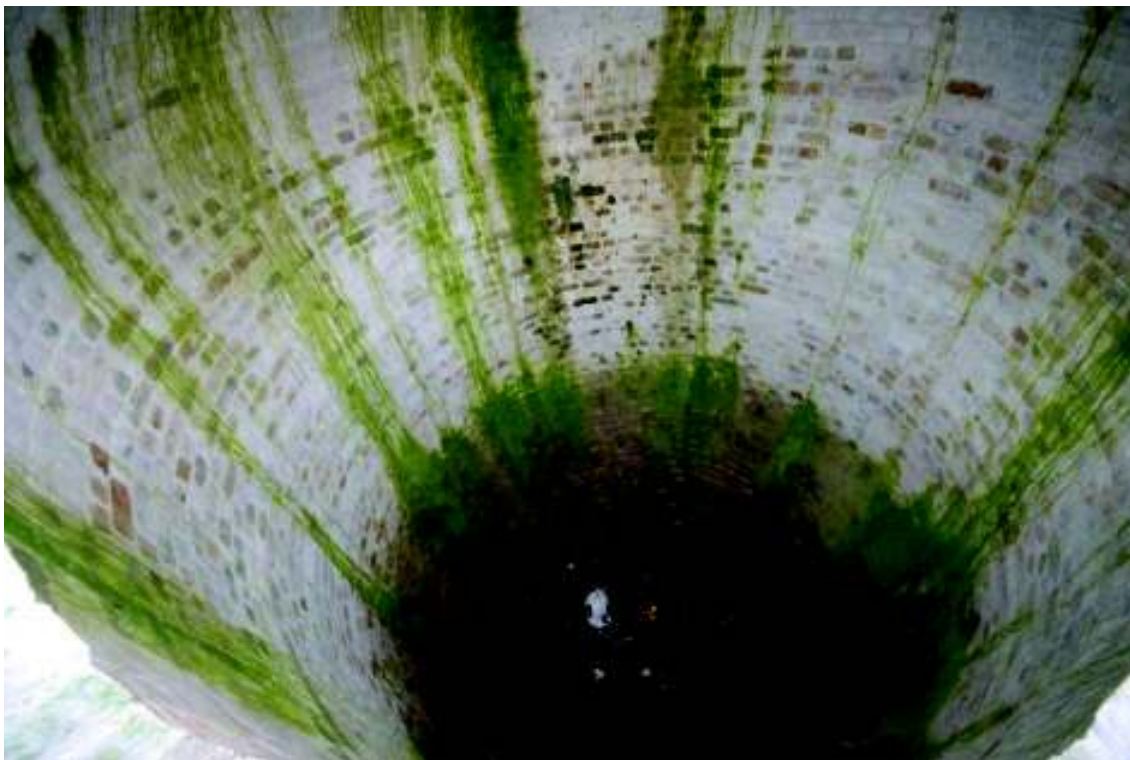
**Plate 39: The internal structure of the ice house (Avoncroft Museum of Buildings)**
