## **HERITAGE STATEMENT**

Gilsons Engineering Works  
NEWTOWN ROAD  
NEWBURY, WEST BERKSHIRE

Dr Peter Wardle  
With Contributions by Colin Lacey  
Feb 2012  
Document Reference Number 2011/1067

**HERITAGE STATEMENT**  
**for**  
**Sandleford Farm, Newbury, West Berkshire,**  
**National Grid reference: SU475645**  
**by**  
**Dr Peter Wardle BA MSc PhD**  
**With Contributions by Colin Lacey**  
**15/2/2012**

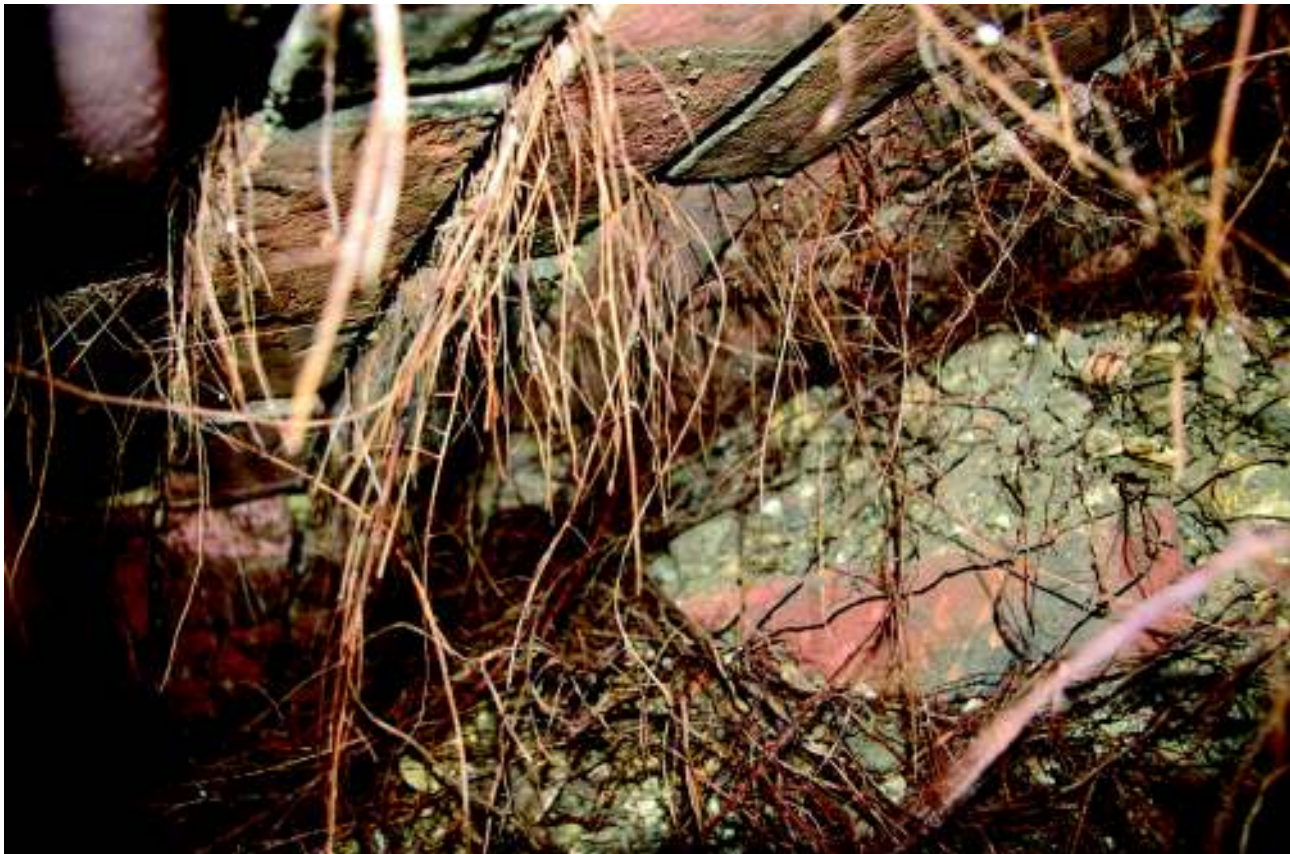
An extension pole with attached camera was inserted into the opening and 'blind' photos taken, It can clearly be seen that the structure has a domed roof and measurements reveal it stretches beyond the boundary of the farmhouse.

#### **Plate 41 Hale Photograph of Subterranean Structure**

While it is difficult to identify and date the bricks with certainty is clear that they are not Georgian in date. The bricks appear to be Victorian in date and likely to date towards the end of the Victorian period.

I have now carried out further limited excavations and the results are very interesting. It appears as though there is an entrance/opening just below the surface, which at sometime in the past has had excavated material banked up in front of and inside it. Beyond the opening it appears to extend into another chamber, unfortunately this could not be excavated as it on the application site.

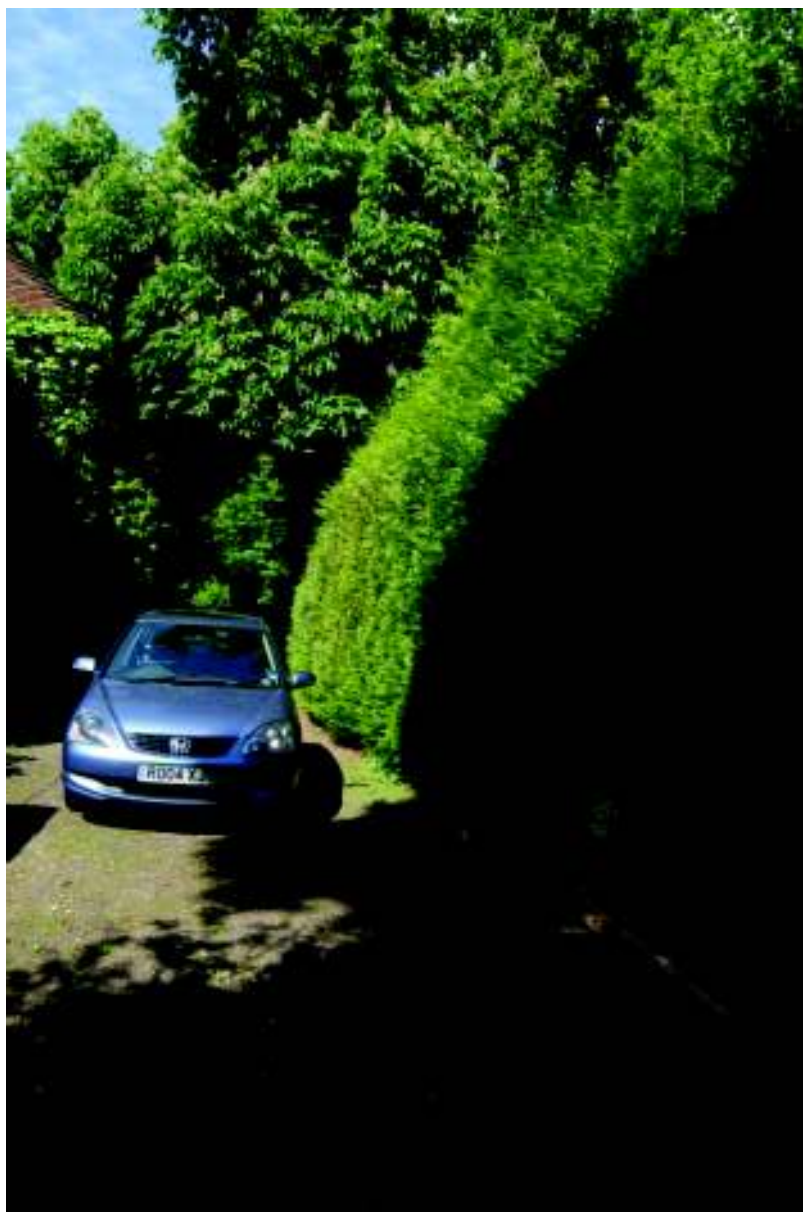
#### **Plate 42: The location where the wall was found**

There are no visual signs of a structure here. An ice house would have a definite mound, no trace of which was visible above the ground (see Plate 42).

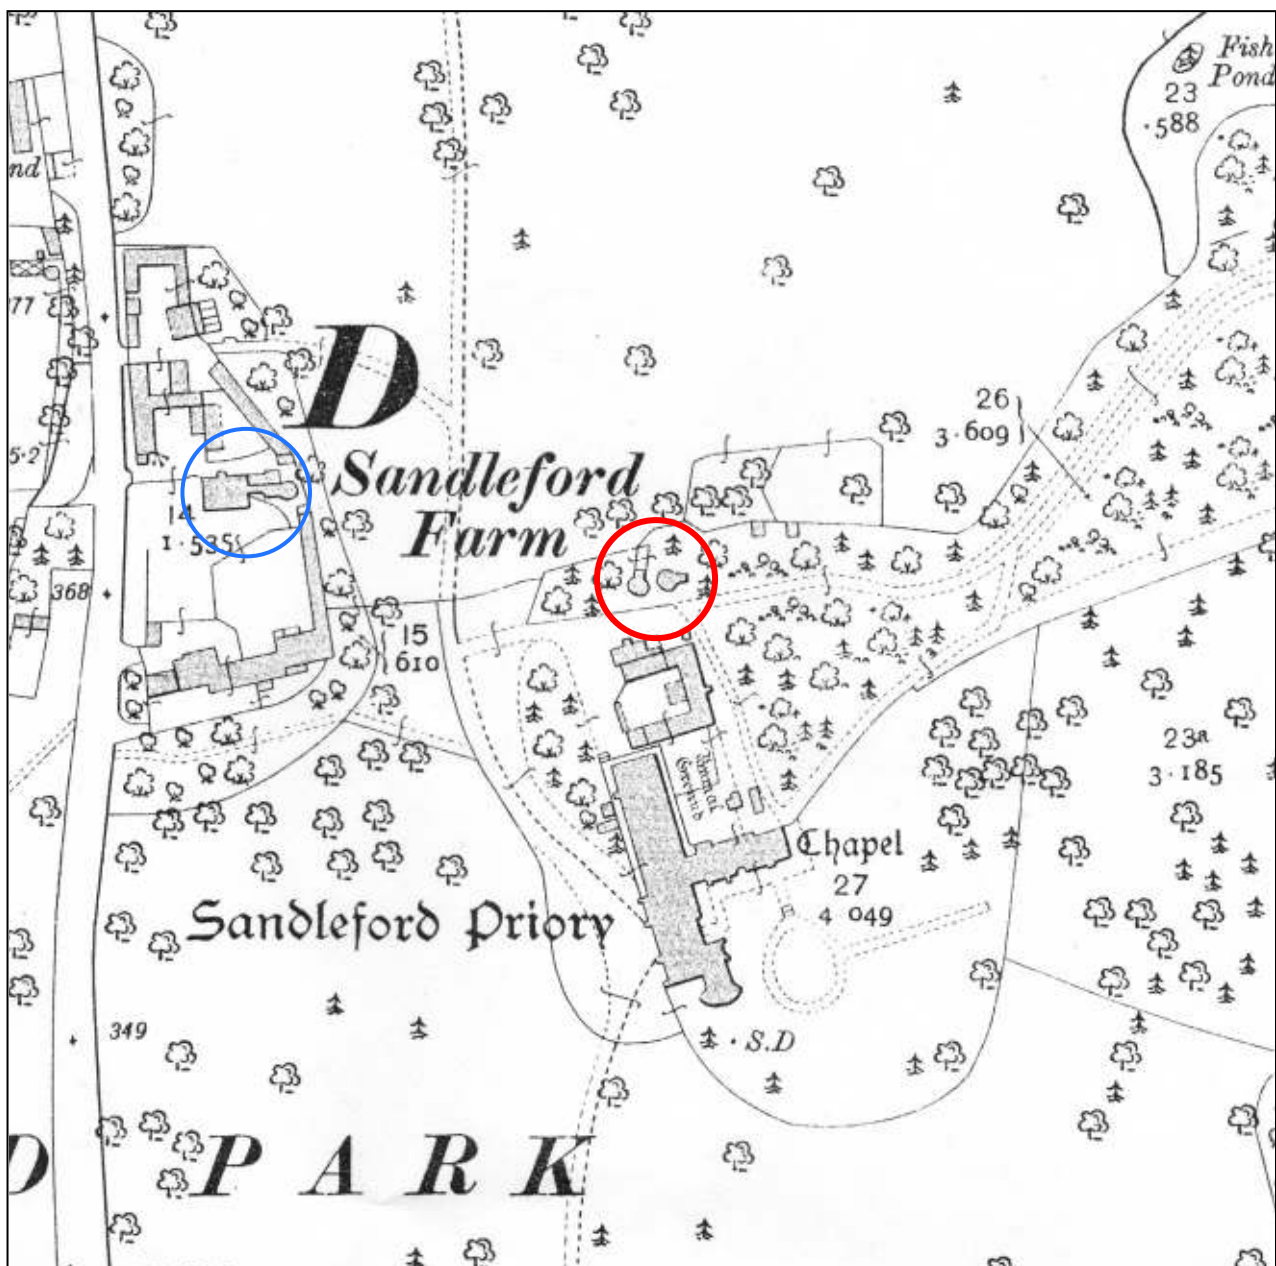
Figure 11: 1911 Ordnance Survey plan (not to scale)

Farmhouse highlighted in blue, ice houses in red.

No ice house is shown near the farmyard on the historic mapping. However on the 1877, 1911 and 1934 Ordnance Survey plan there are structures which are the right size (c. 7m across) and shape for ice houses, located adjacent to Sandleford Priory.

Two ice houses in close proximity is very rare, making it more unlikely the structures depicted are ice houses. The shape indicates that if they are ice houses, they were not covered, either by earth or thatch, at the time they were recorded by the Ordnance Survey, and presumably were disused or recently completed at this point. They are adjacent to a track which leads to the fish pond - a source of ice in the winter - however as stated above, proximity to an ice source is not a necessity.

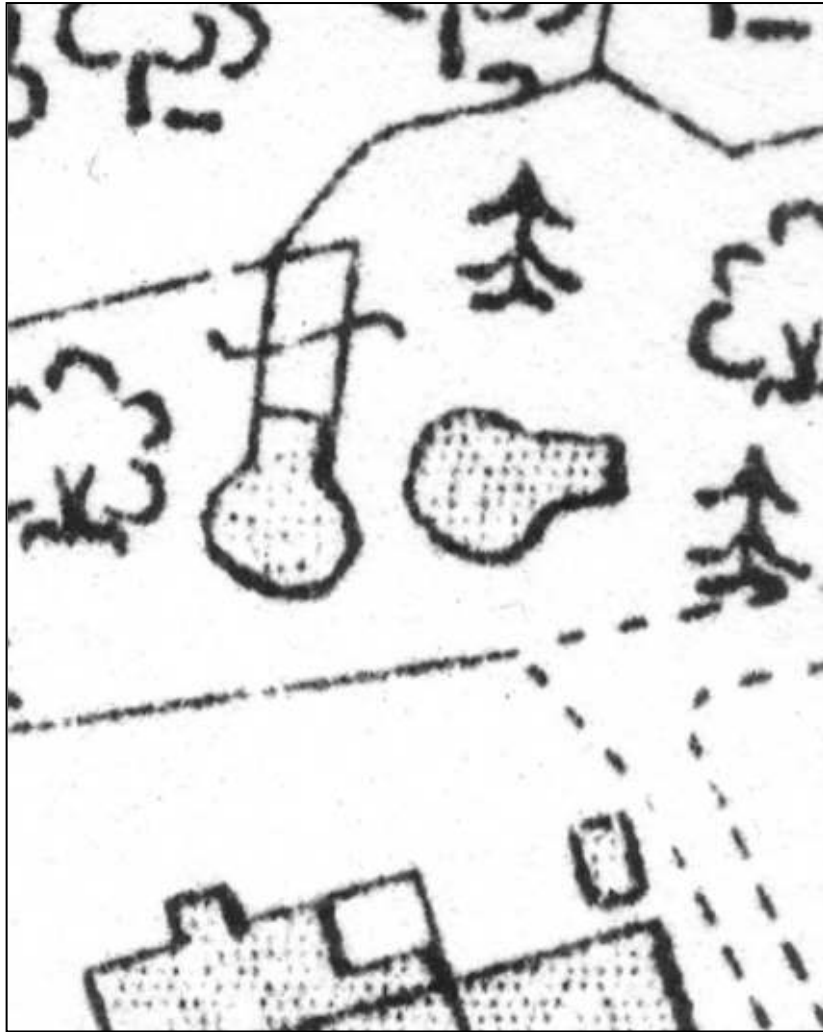
Figure 12: Detail of 1911 OS Plan

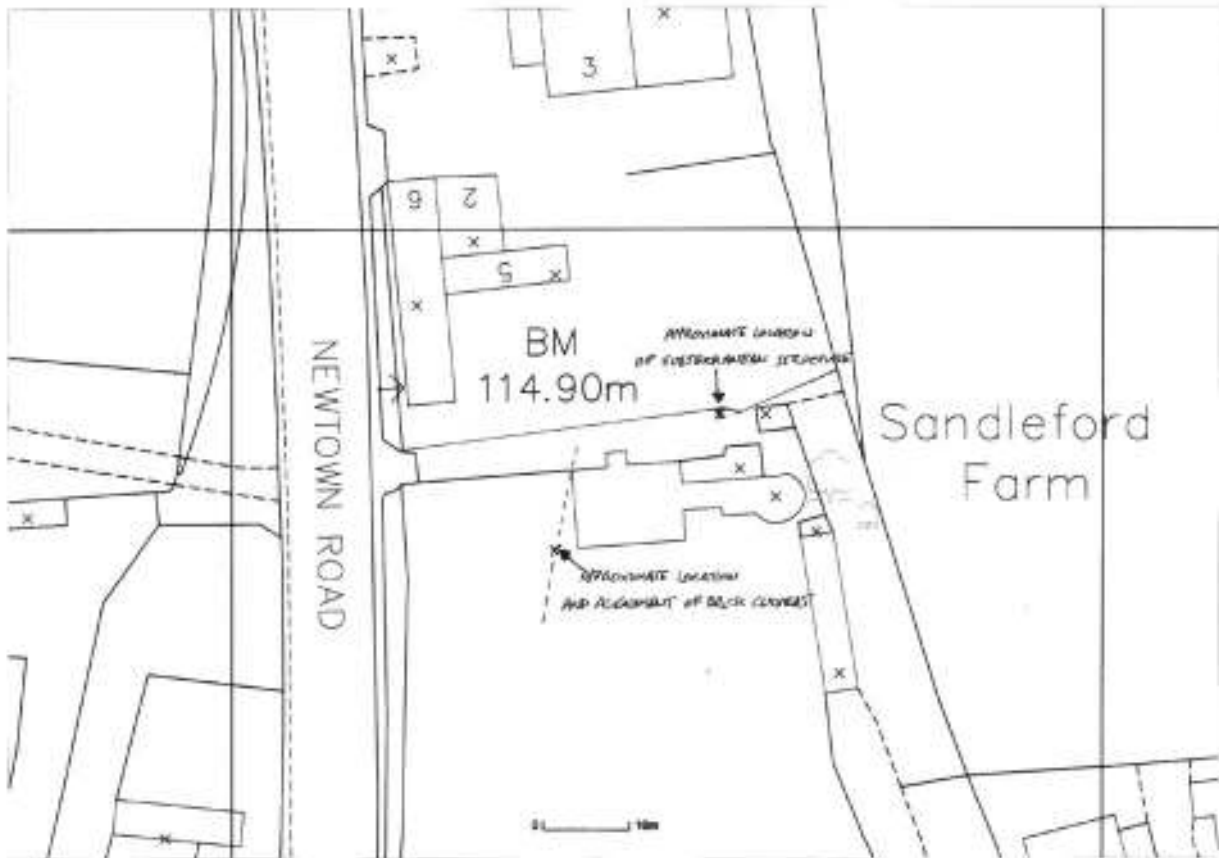
Figure 14 Plan with annotations made by West Berkshire Council's Archaeologist.

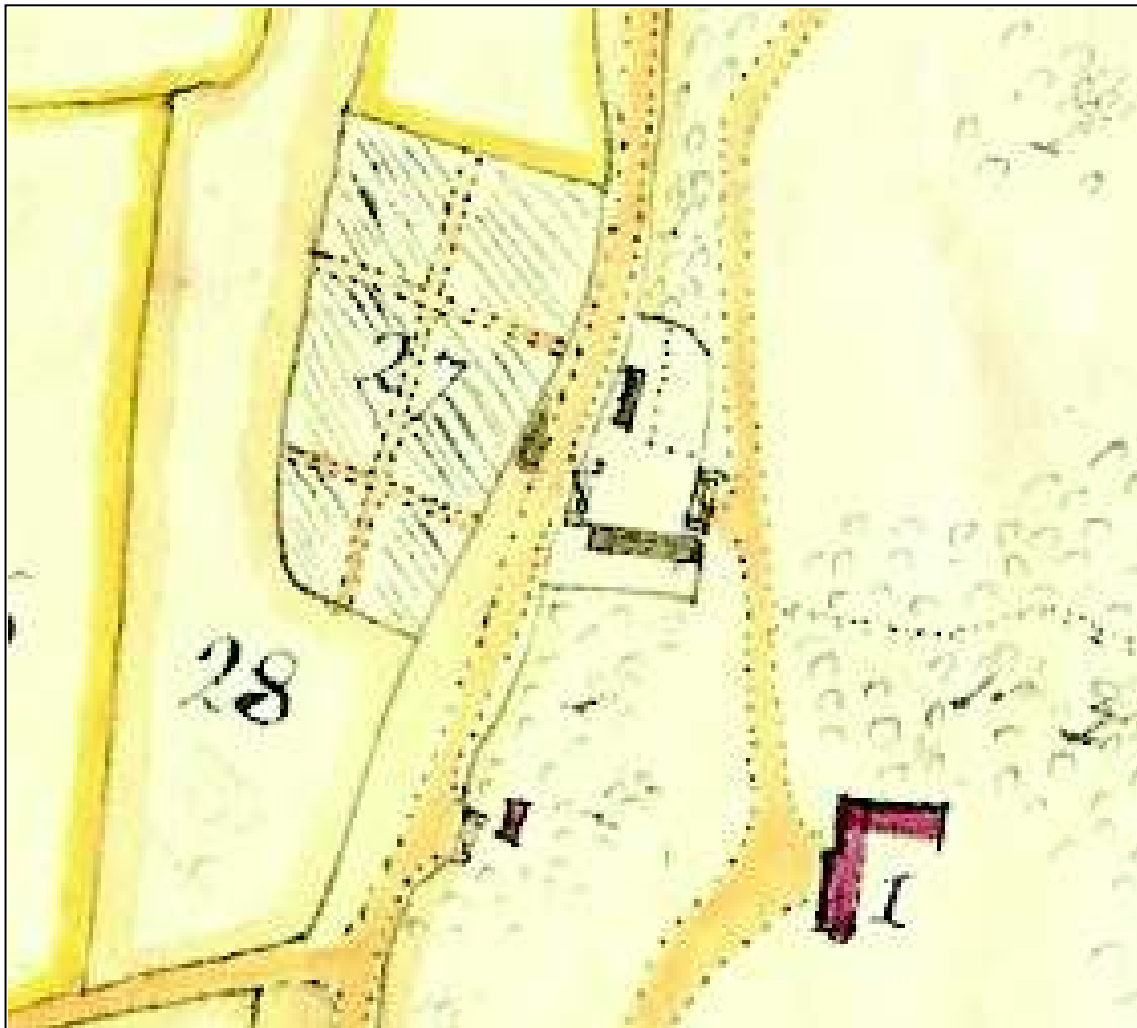
**Figure 25: Detail of 1805 Estate Map (not to scale)**

Sandleford Priory is shown as being 2.7 chains long or 59.9 yards or 55.2m whereas in fact it is 41m long. Similarly the distance of the Priory to the Road is again in error by about 20%.

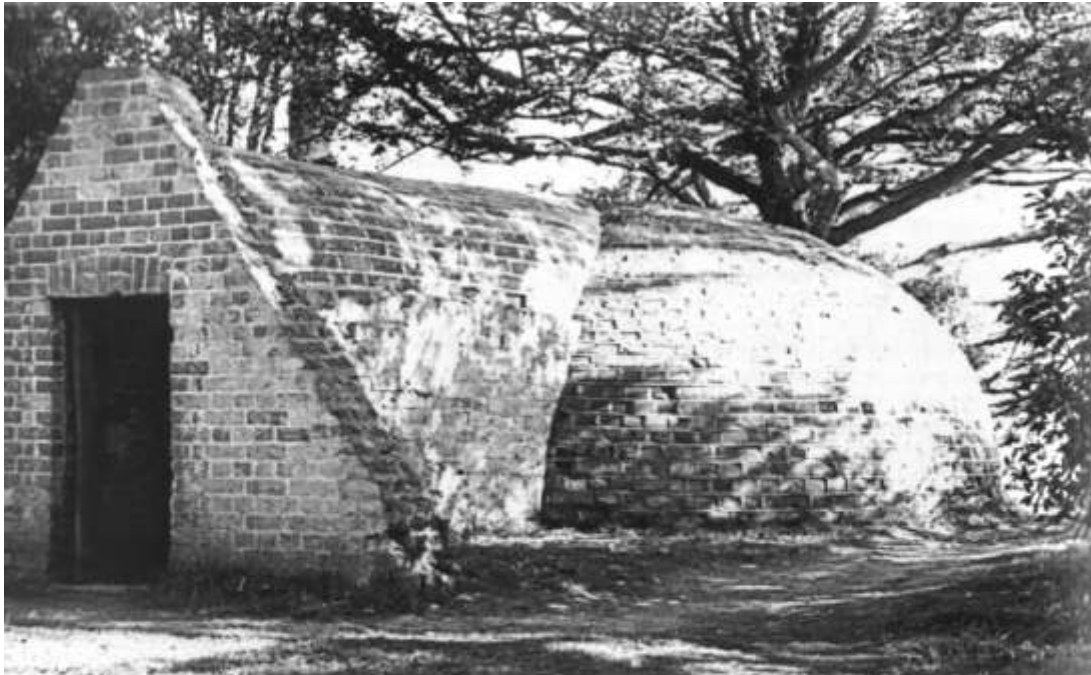
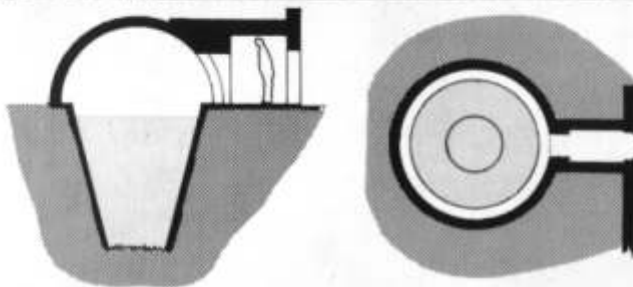
Above and left: *Tapeley icehouse in Devon may have been built in two phases: a conical brick well followed by a set-back hemispherical vault. The capacity of the ice chamber is shown as 12½ tons. (Far left: section; left: plan.)*

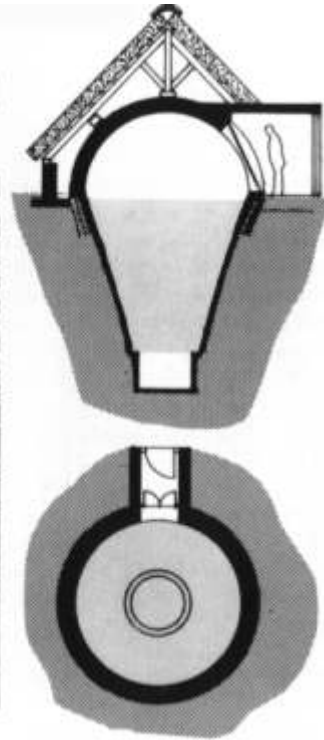
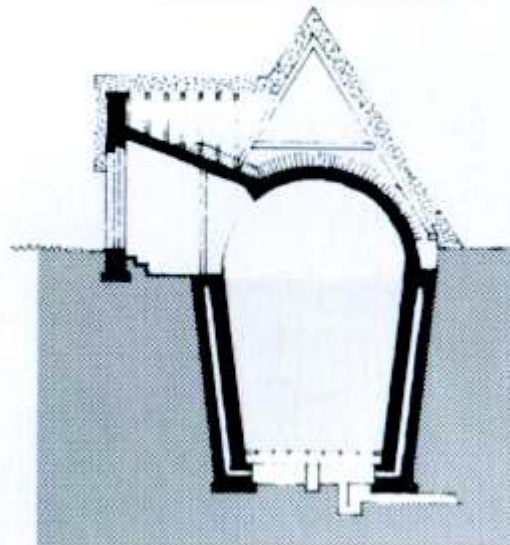
Above: Drawings by Sir John Soane, 1798, for a thatched icehouse proposed to be built at Betchworth Castle, Surrey, for Henry Peters (elevation and section). The capacity of the ice chamber is shown as 21 1/2 tons.

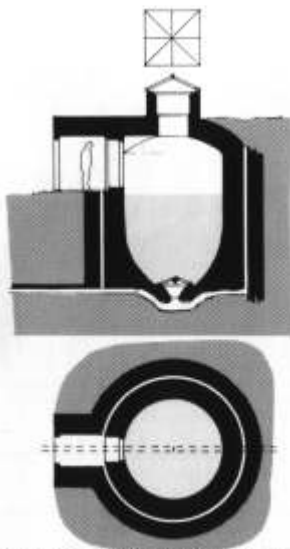
Above: A design for an icehouse at Luffness, Lothian, dated 1847 and entitled 'No 8'. The capacity of the ice chamber is shown as 24 tons.

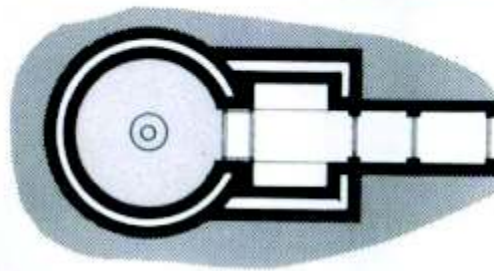
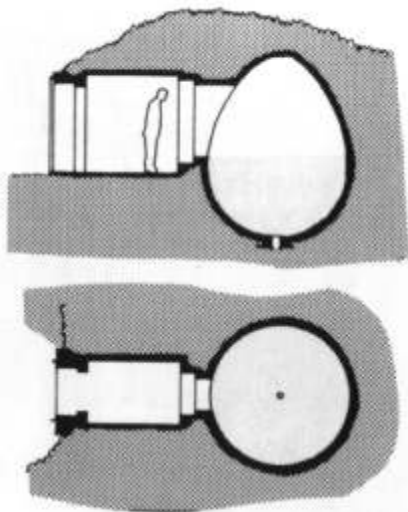
Above: The icehouse chamber at Whim, Borders, is impressive, having been built throughout of finely wrought ashlar, probably around 1740 when Lord Milton laid out the surrounding pleasure grounds. The capacity of the ice chamber is 7 tons. (Section and plan.)

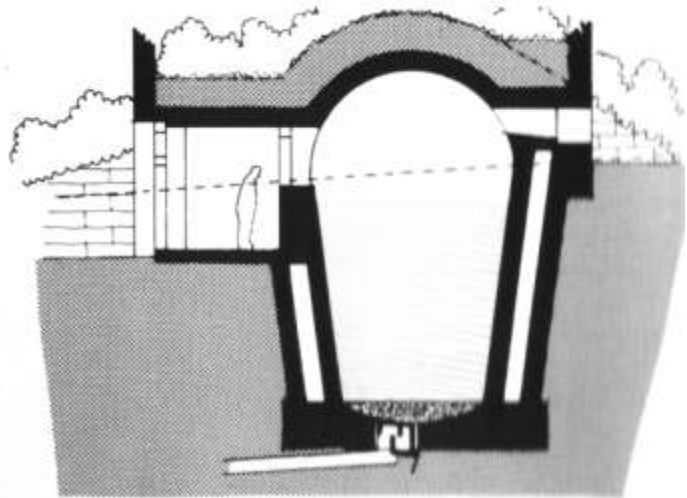
Right: A design of about 1850 by Bailey, the gardener at Nuneham Park, Oxfordshire, for an icehouse with cavity walls (the inner of brick, the outer of rough stone or puddled clay). The lobby doors were to be opened at night and closed in the morning. The capacity of the ice chamber is shown as 33 tons. (Above: section; below: plan — from Charles MacIntosh's 'Book of the Garden'.)

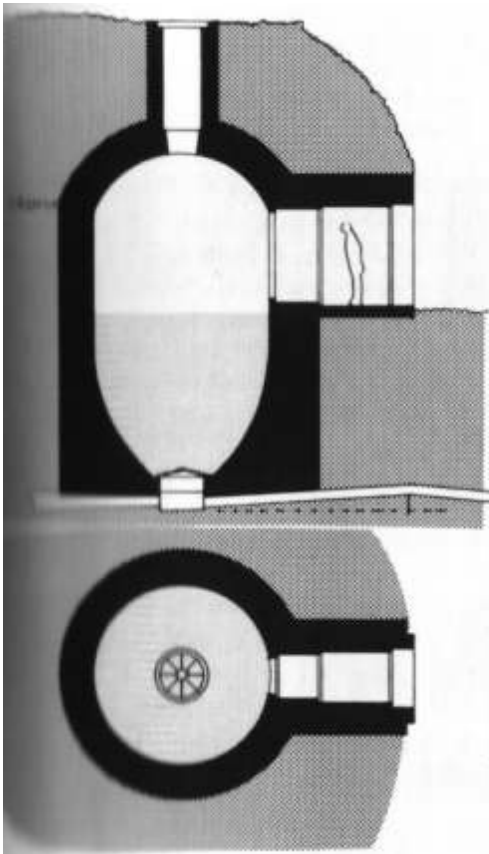
Left: *Proposals for a top-loaded icehouse at Meadowbank, Lothian, dated 1819. Drawings show the entry door set back behind 'rustick rybatts' of dressed freestone for protection against the weather. In the chamber 'every second brick was to be built with the end towards the inside of the icehouse leaving one half built solid into the rubble wall'. The capacity of the ice chamber is shown as 20½ tons. (Section and plan.)*

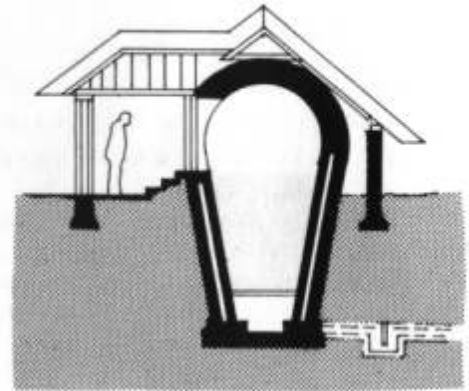
Right: *A design dated 1815 for an icehouse to be built at the Military College. Note the thatched roof and 'perforated stone' over the sump. The capacity of the ice chamber is shown as 5 tons. (Section and plan.)*

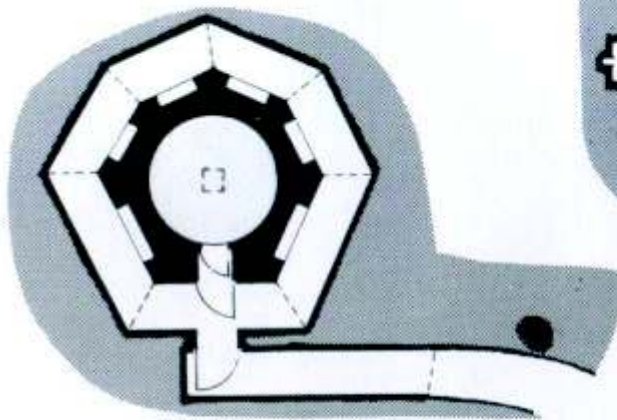
Above: The seven-sided passage at Alva, Central Region, is floored with stone slabs, its brick-vaulted ceiling supported on rubble walls with niches carrying shelves of dressed stone. Two doors give access from passage to chamber.

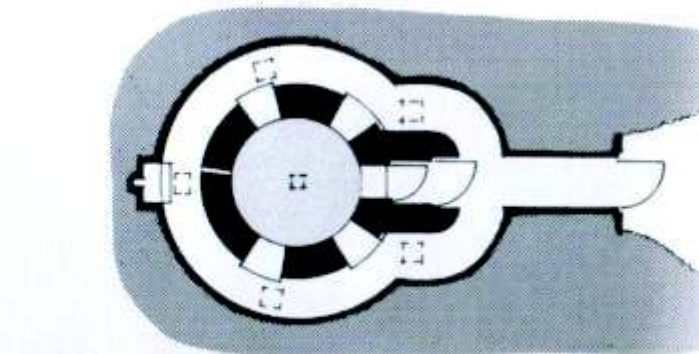
Above: At Moreton Hall, Lothian, the brick-lined icehouse chamber has been altered to install a floor, now gone, and openings have been cut in the walls. That work was probably part of a Second World War conversion into an air-raid shelter.

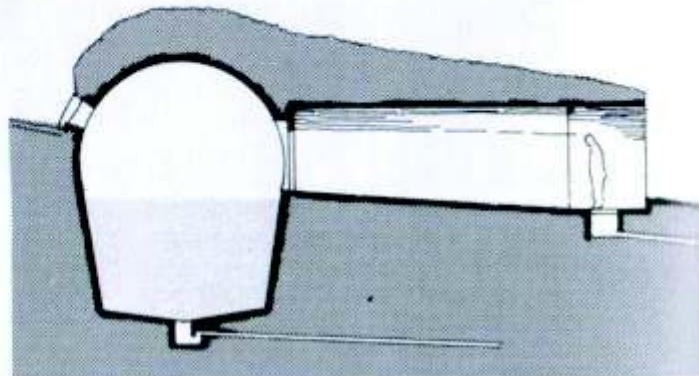
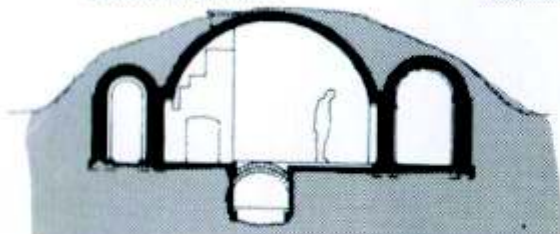
Left: A barrel-vaulted chamber with surrounding insulating corridor at Attingham, Shropshire (section and plan). In 1856 it was converted to a pumphouse supplying the mansion, and a waterwheel and attendant machinery were installed. (Drawing based on a survey by the National Trust.)

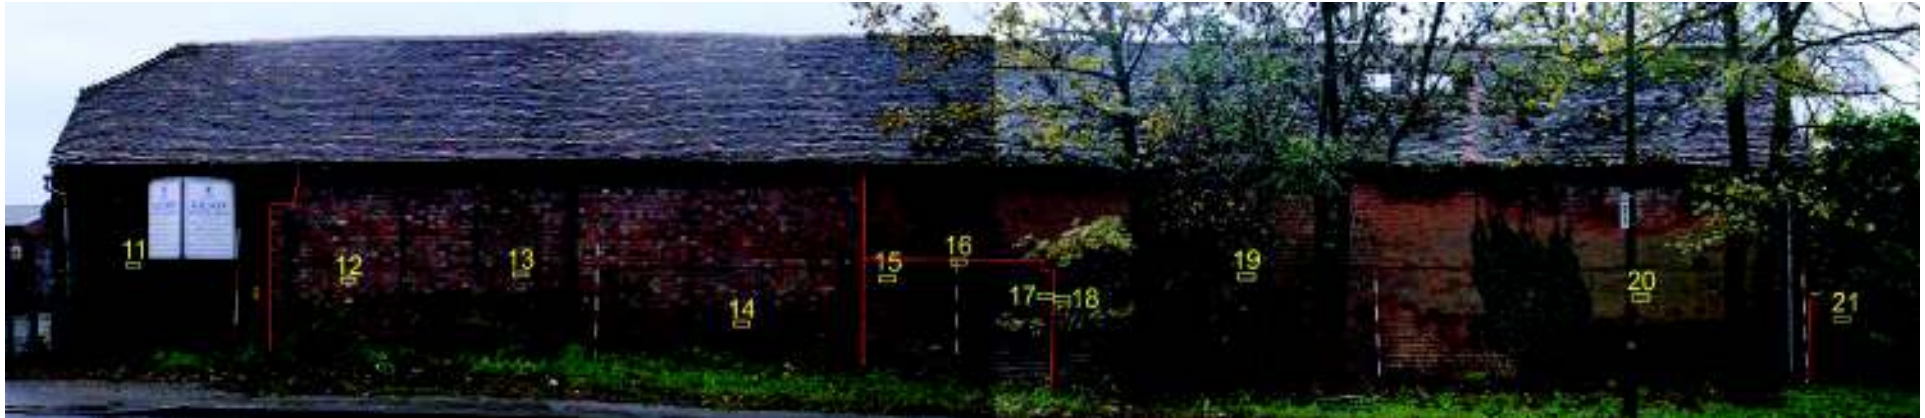
Figure 28: Detail of west wall, units 4 and 7 (not to scale)

Brick locations are marked in yellow, with joins in brickwork marked in red.

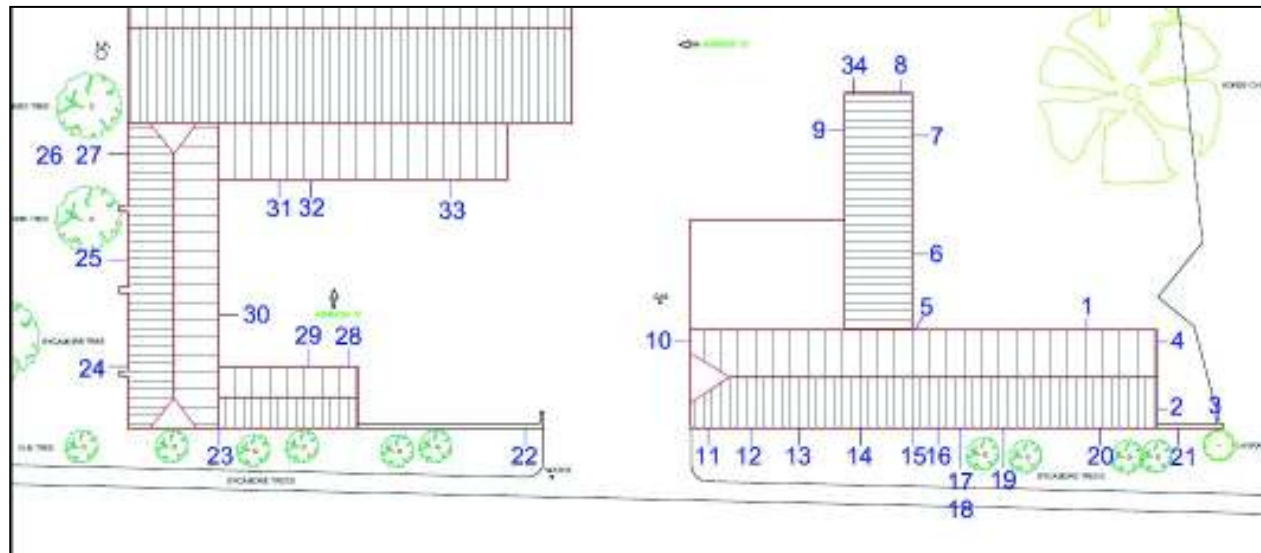
Figure 29: Location of bricks (not to scale)

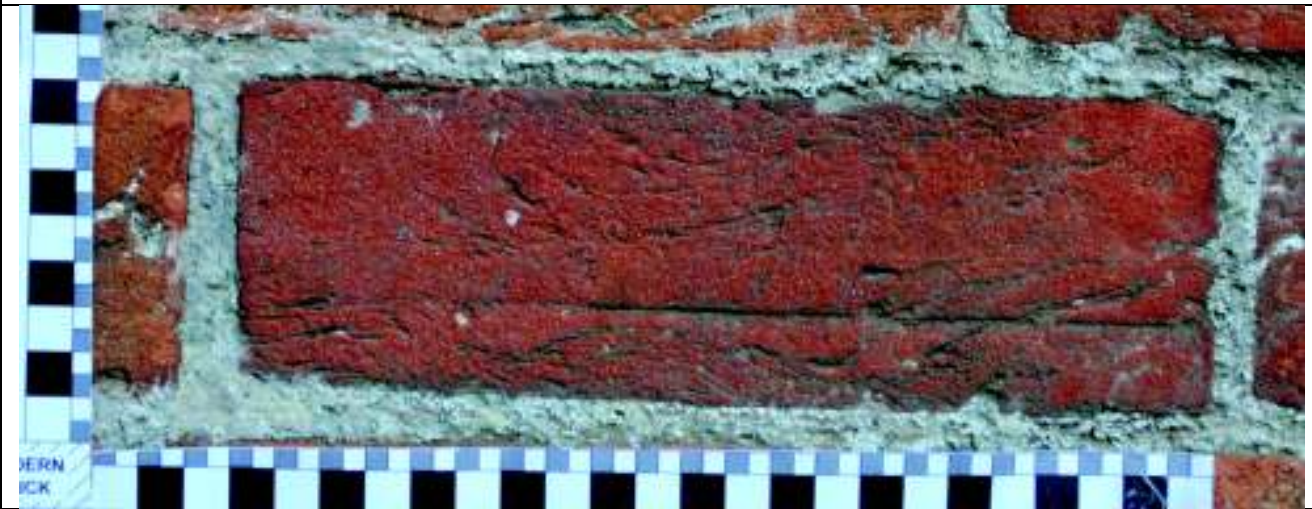
**BRICK 1**

<b>Location</b>	Eastern face, unit 7		
<b>Description</b>	Handmade / wirecut red brick		
<b>Length</b>	215mm	<b>Depth</b>	70mm
<b>Bond</b>	Variation on Flemish	<b>Mortar</b>	Lime
<b>Date</b>	Mid-late 19th

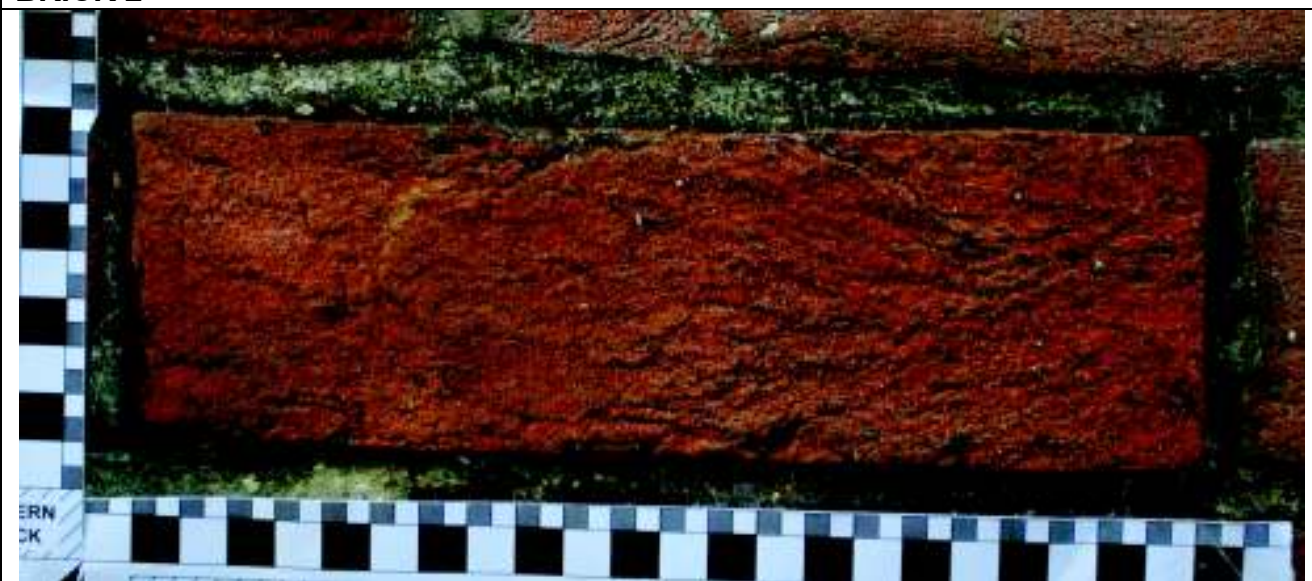
**BRICK 2**

<b>Location</b>	Western end, southern wall, unit 7		
<b>Description</b>	Regular red brick, few inclusions, handmade / wirecut		
<b>Length</b>	220mm	<b>Depth</b>	65mm
<b>Bond</b>	Variation on Flemish	<b>Mortar</b>	Lime
<b>Date</b>	Late 19 <sup>th</sup> – early 20 <sup>th</sup>

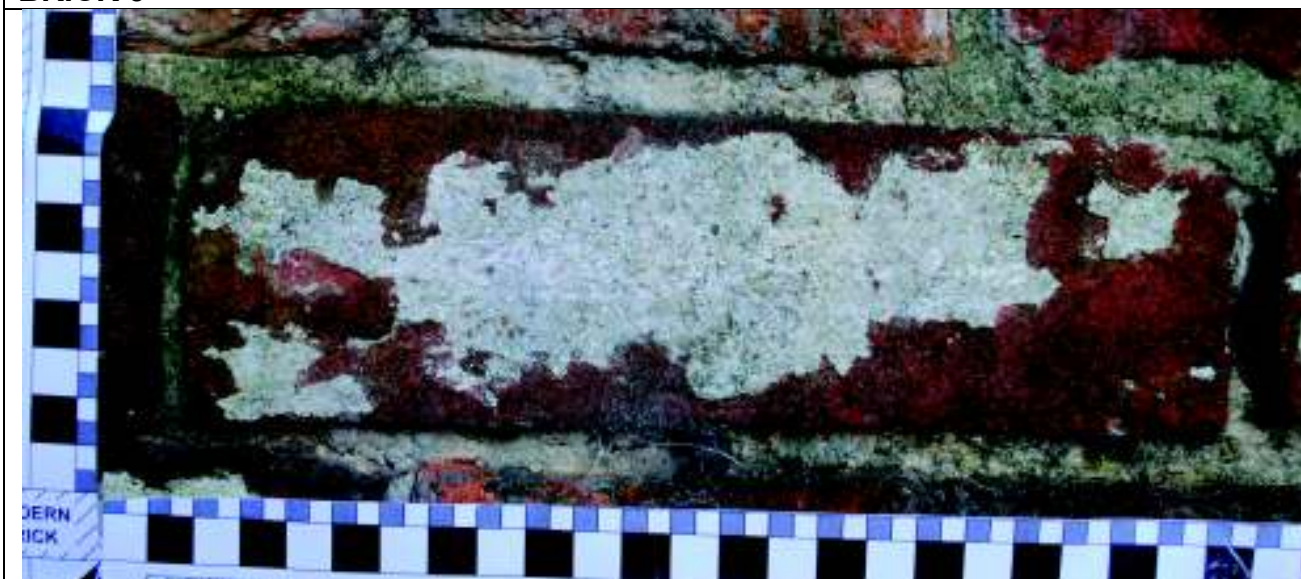
**BRICK 3**

<b>Location</b>	East side of boundary wall to south of unit 7		
<b>Description</b>	Handmade red brick, some traces of render, possibly reused		
<b>Length</b>	220mm	<b>Depth</b>	65mm
<b>Bond</b>	Flemish	<b>Mortar</b>	Lime
<b>Date</b>	19th

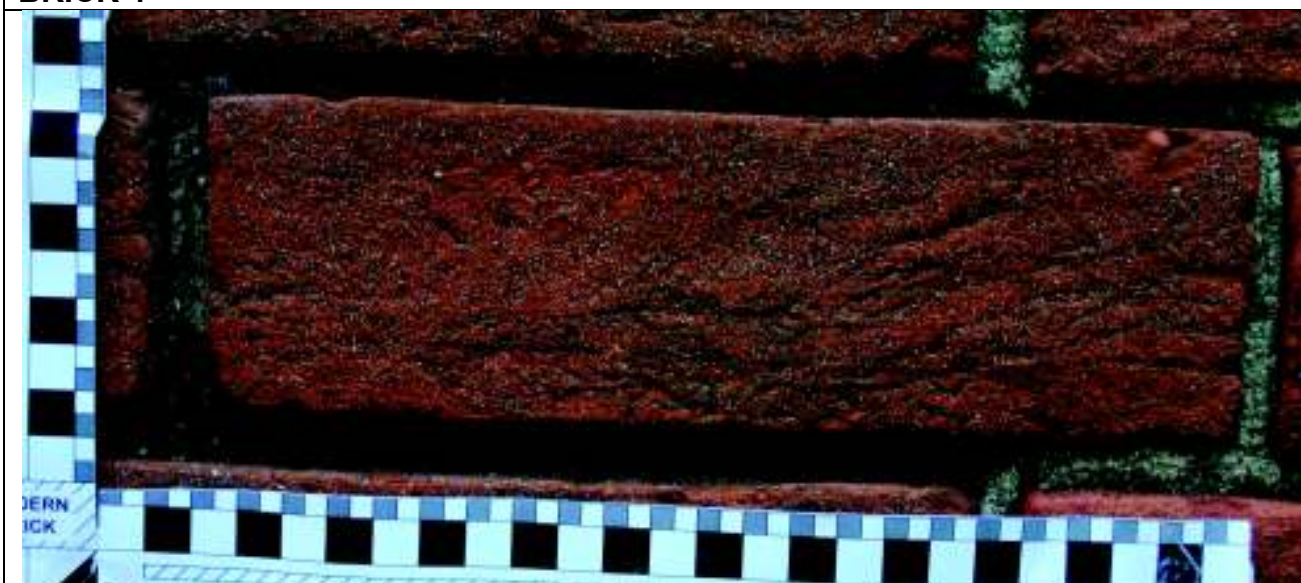
**BRICK 4**

<b>Location</b>	Eastern end, southern wall, unit 7		
<b>Description</b>	Regular handmade / wirecut red brick		
<b>Length</b>	225mm	<b>Depth</b>	65
<b>Bond</b>	Flemish	<b>Mortar</b>	Lime, degraded
<b>Date</b>	19th

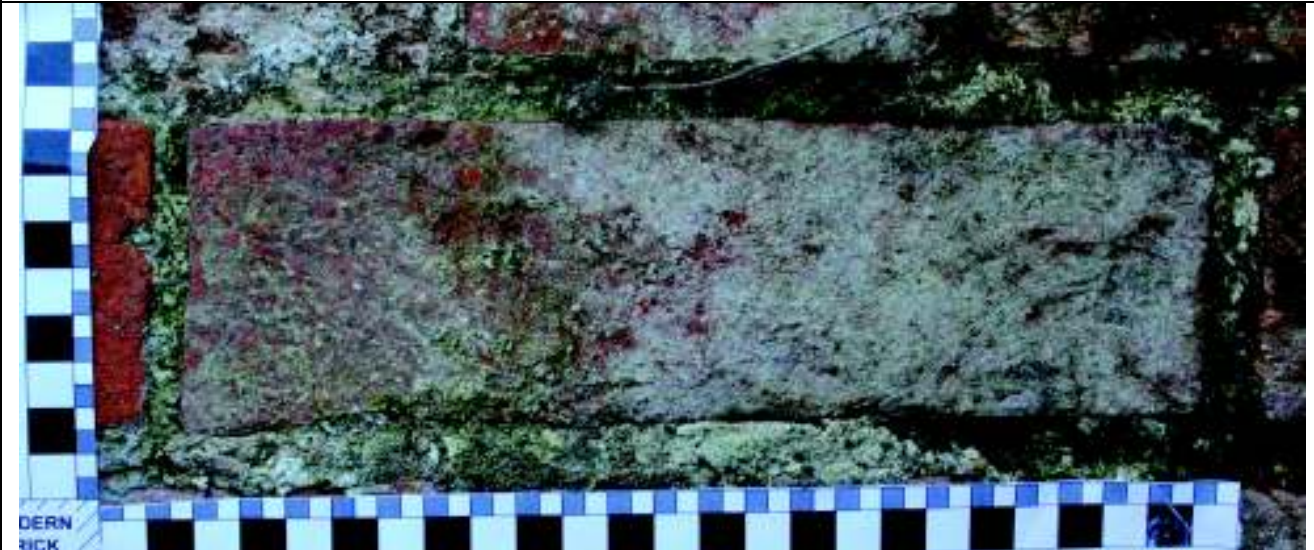
**BRICK 5**

<b>Location</b>	Eastern wall, unit 7, at junction between units 6 and 7		
<b>Description</b>	Regular machine-made red brick, some white staining (possible efflorescence caused by leaking gutter above)		
<b>Length</b>	225	<b>Depth</b>	65
<b>Bond</b>	Flemish	<b>Mortar</b>	Lime
<b>Date</b>	Late 19 <sup>th</sup> -mid 20 <sup>th</sup>

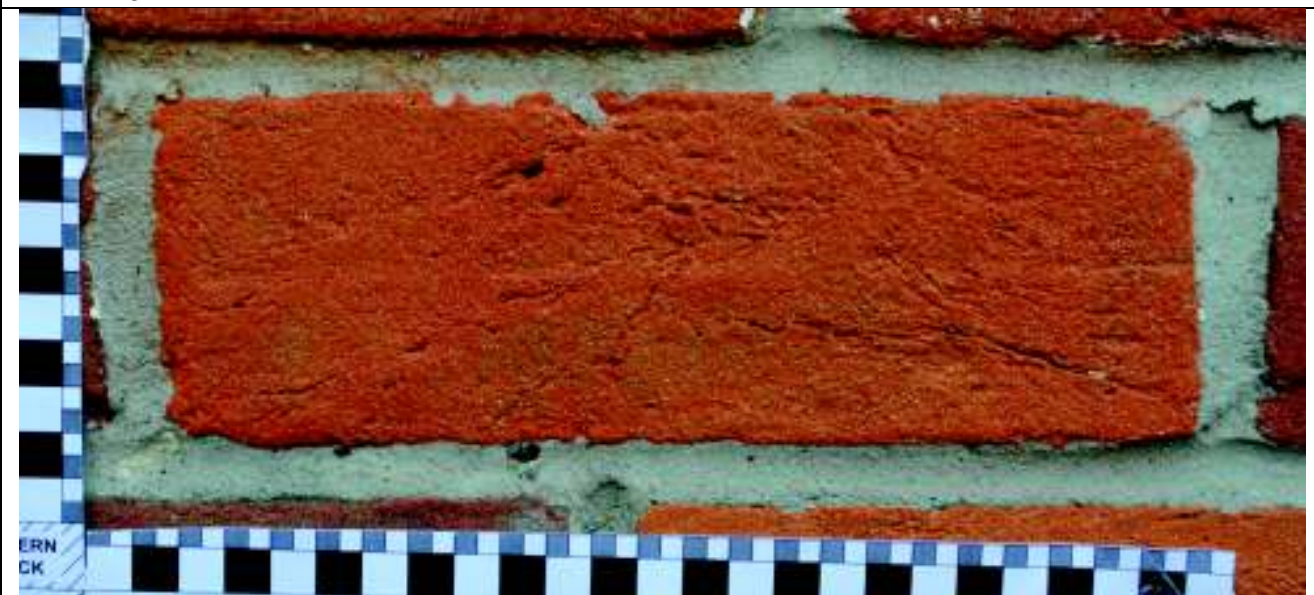
**BRICK 6**

<b>Location</b>	Southern wall, unit 6, west of centre		
<b>Description</b>	Regular machine-made red brick		
<b>Length</b>	225mm	<b>Depth</b>	75mm
<b>Bond</b>	Stretcher	<b>Mortar</b>	Cement
<b>Date</b>	20th

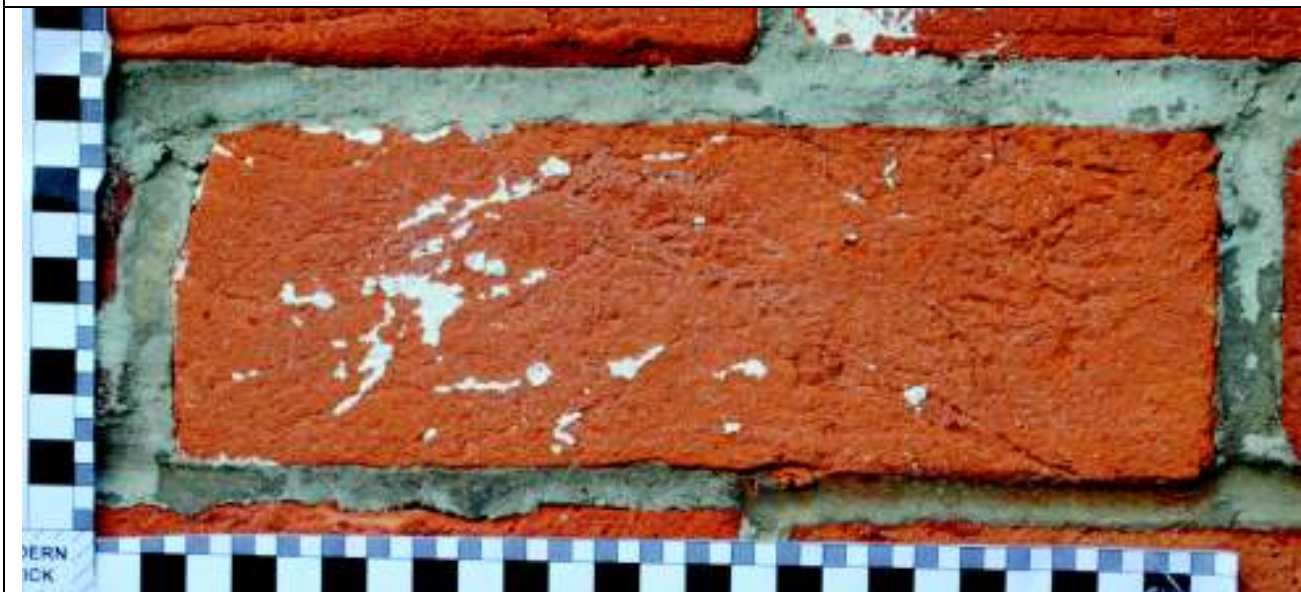
**BRICK 7**

<b>Location</b>	Southern wall, unit 6, east of centre		
<b>Description</b>	Regular machine-made red brick		
<b>Length</b>	225mm	<b>Depth</b>	75mm
<b>Bond</b>	Stretcher	<b>Mortar</b>	Cement
<b>Date</b>	20 <sup>th</sup>

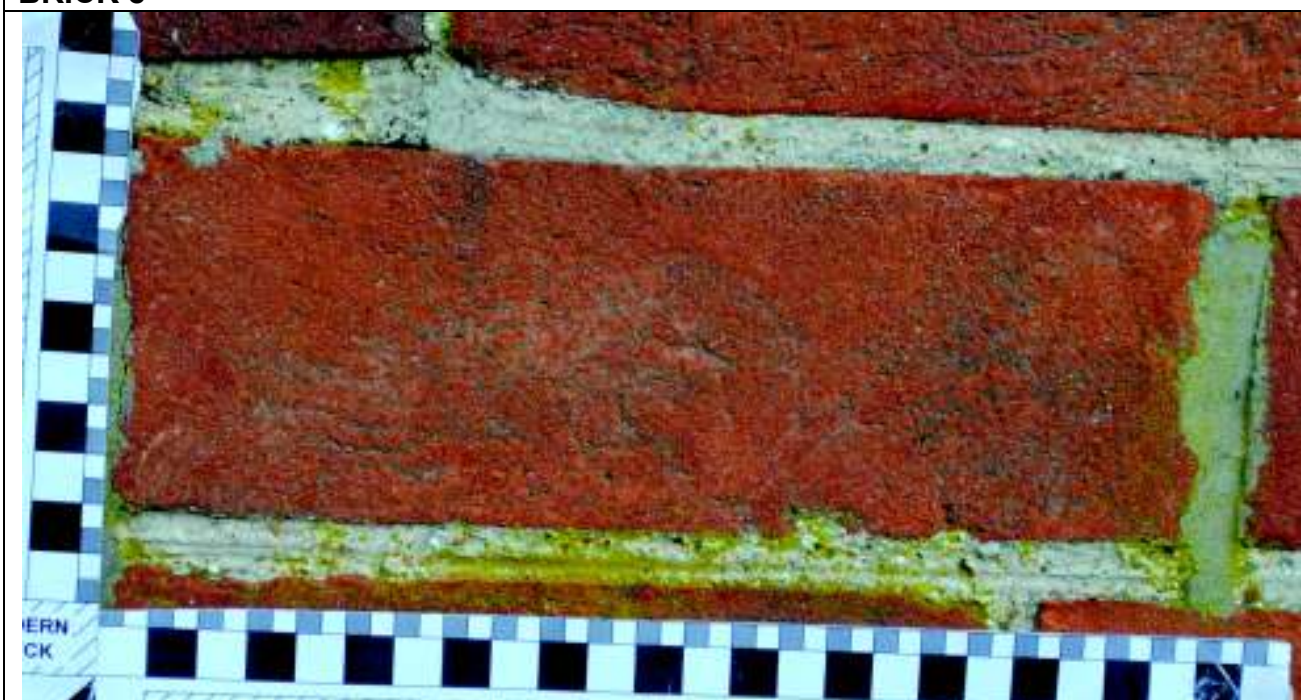
**BRICK 8**

<b>Location</b>	Eastern wall, unit 6, southern end		
<b>Description</b>	Regular machine-made red brick, some cement repointing		
<b>Length</b>	225mm	<b>Depth</b>	75mm
<b>Bond</b>	Variation on Flemish	<b>Mortar</b>	Lime / cement
<b>Date</b>	Early – mid 20th

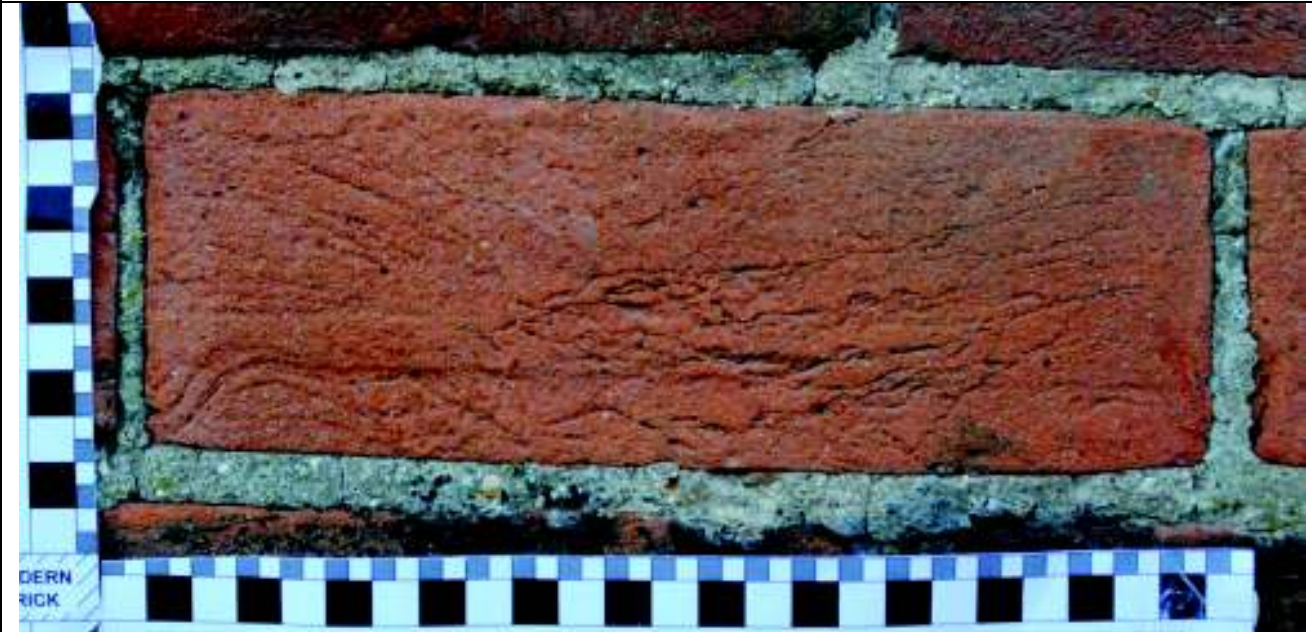
**BRICK 9**

<b>Location</b>	Northern wall, unit 6		
<b>Description</b>	Uniform red brick, possibly wirecut		
<b>Length</b>	230mm	<b>Depth</b>	75mm
<b>Bond</b>	English	<b>Mortar</b>	Lime
<b>Date</b>	Late 19 <sup>th</sup> – mid 20 <sup>th</sup>

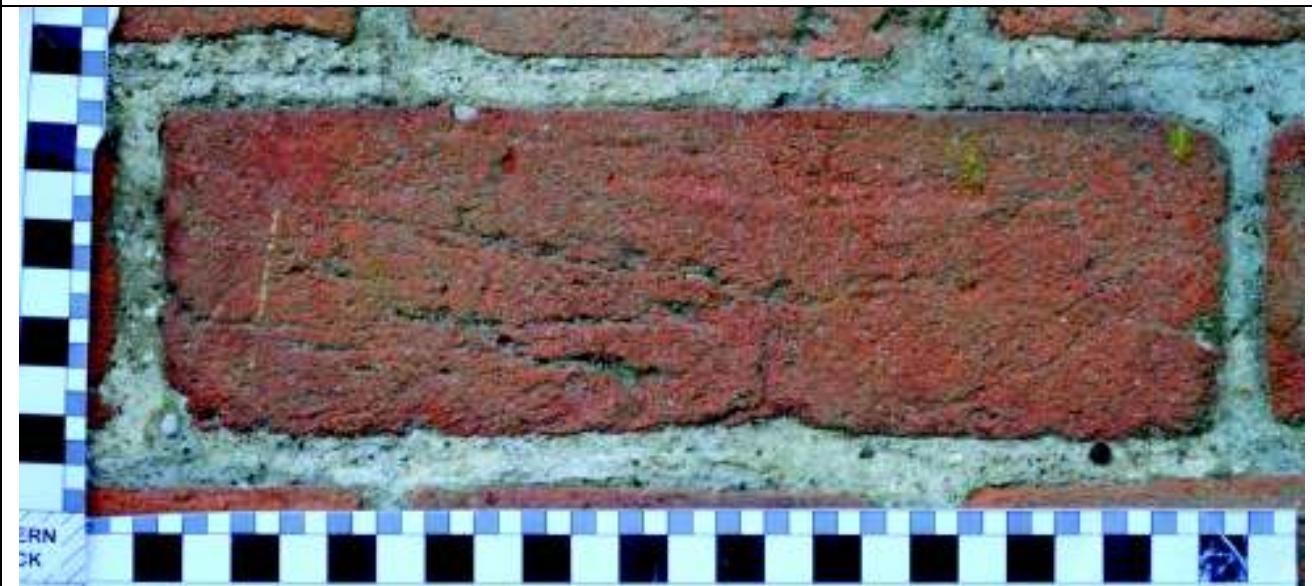
**BRICK 10**

<b>Location</b>	East of northern door, unit 4		
<b>Description</b>	Red brick, possibly handmade / wirecut		
<b>Length</b>	215mm	<b>Depth</b>	65mm
<b>Bond</b>	Flemish	<b>Mortar</b>	Lime
<b>Date</b>	19 <sup>th</sup> - 20 <sup>th</sup>

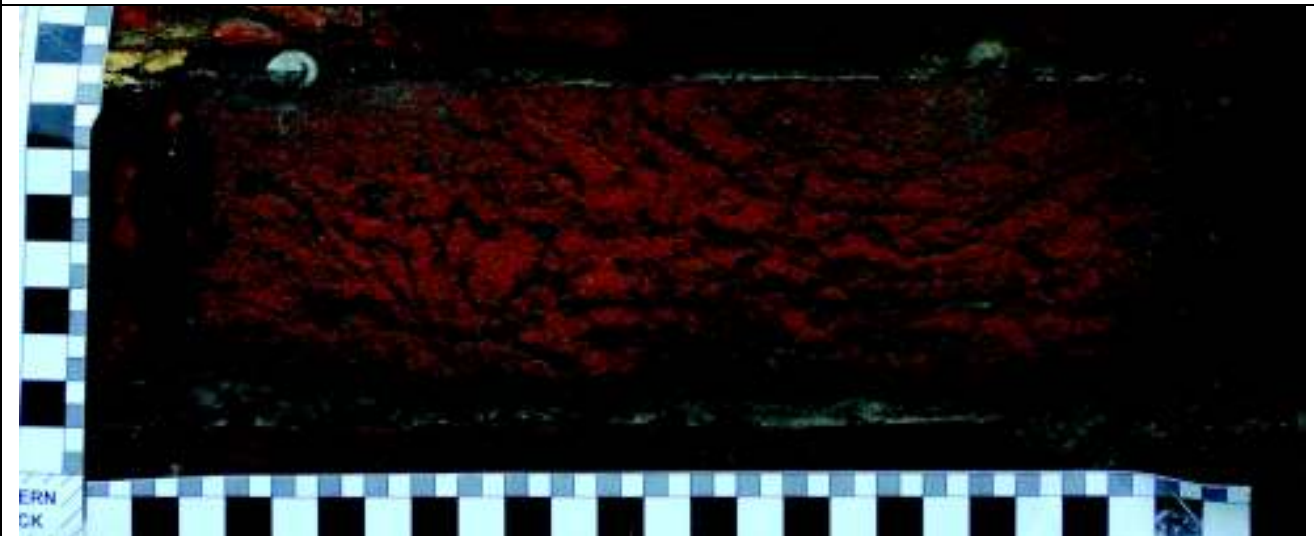
**BRICK 11**

<b>Location</b>	Western wall, unit 4, northern end		
<b>Description</b>	Hand-made red brick, black staining (?traffic fumes)		
<b>Length</b>	220mm	<b>Depth</b>	65mm
<b>Bond</b>	Mixed	<b>Mortar</b>	Lime, degraded
<b>Date</b>	Late 19 <sup>th</sup> – mid 20 <sup>th</sup>
