## **HERITAGE STATEMENT**

Gilsons Engineering Works  
NEWTOWN ROAD  
NEWBURY, WEST BERKSHIRE

Dr Peter Wardle  
With Contributions by Colin Lacey  
Feb 2012  
Document Reference Number 2011/1067

**HERITAGE STATEMENT**  
**for**  
**Sandleford Farm, Newbury, West Berkshire,**  
**National Grid reference: SU475645**  
**by**  
**Dr Peter Wardle BA MSc PhD**  
**With Contributions by Colin Lacey**  
**15/2/2012**

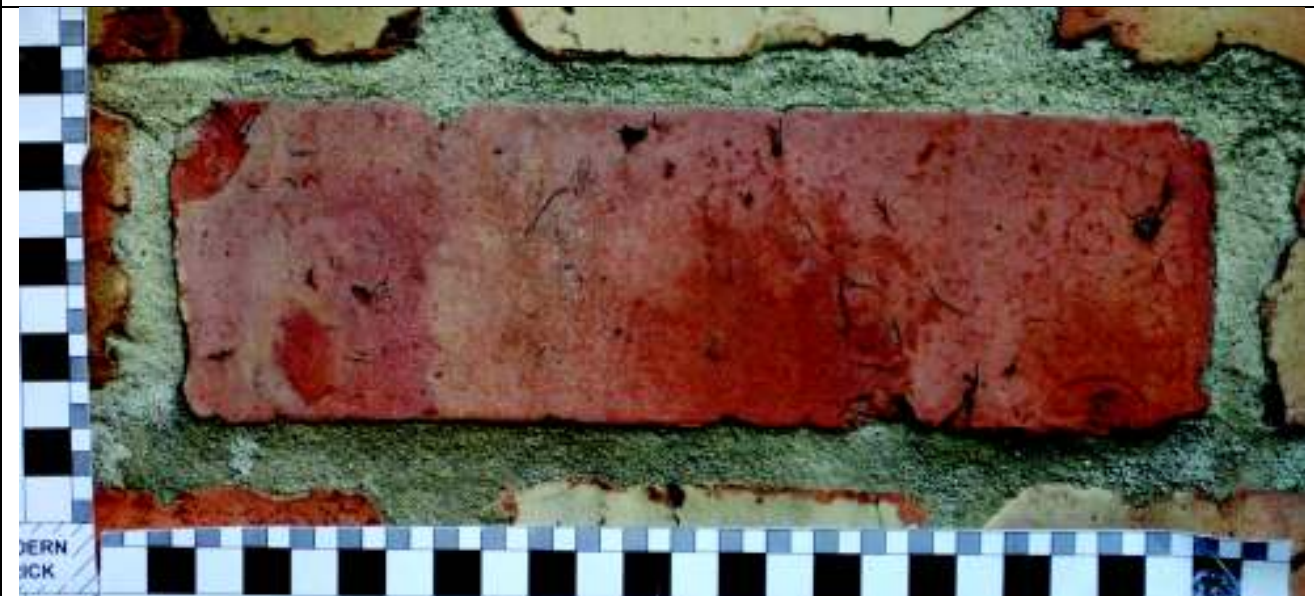
**BRICK 12**

<b>Location</b>	Mid western wall, unit 4		
<b>Description</b>	Modern machine-made brick, somewhat uneven, possibly reused		
<b>Length</b>	220mm	<b>Depth</b>	67mm
<b>Bond</b>	Flemish	<b>Mortar</b>	Cement
<b>Date</b>	20 <sup>th</sup>

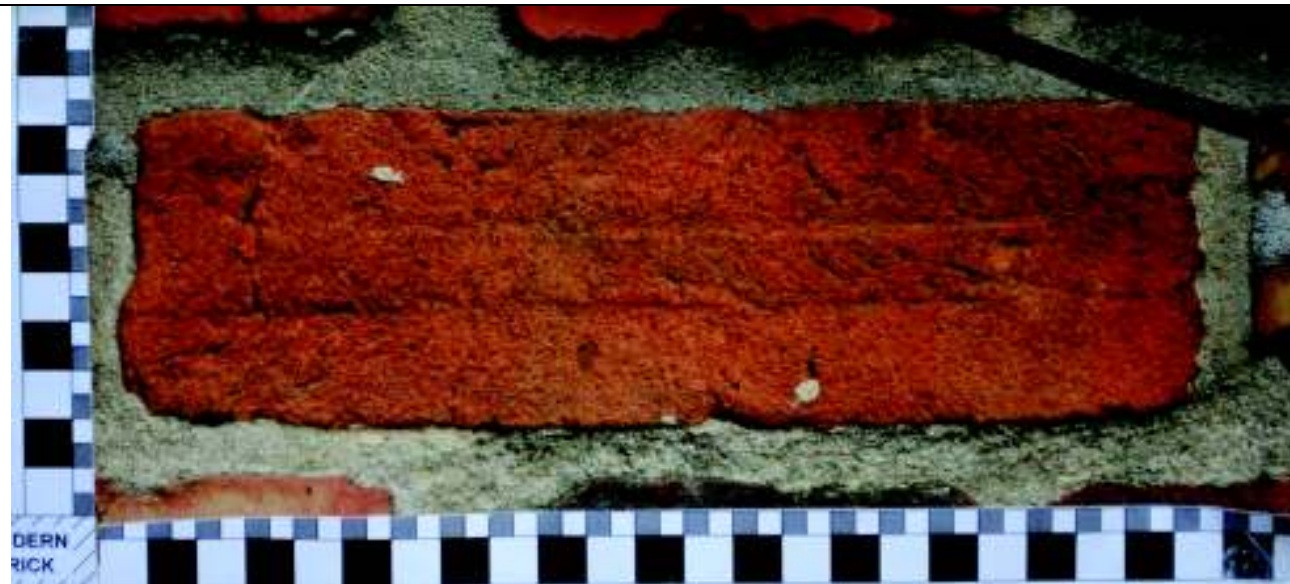
**BRICK 13**

<b>Location</b>	Mid western wall, unit 4		
<b>Description</b>	Red wirecut / machine-made brick, possibly reused as located within other bricks as brick 12 above		
<b>Length</b>	220mm	<b>Depth</b>	65mm
<b>Bond</b>	Flemish	<b>Mortar</b>	Cement
<b>Date</b>	Late 19 <sup>th</sup> – 20 <sup>th</sup> , laid in 20 <sup>th</sup>

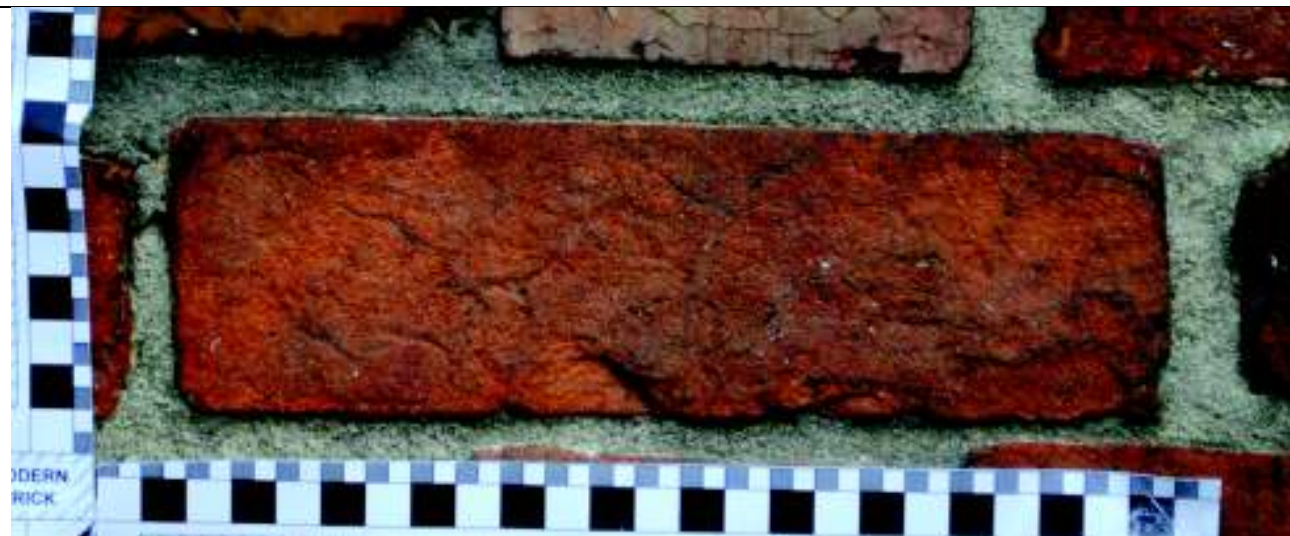
**BRICK 14**

<b>Location</b>	Southern end, western wall, unit 4		
<b>Description</b>	Handmade / wirecut red brick, missing area to lower face may indicate reuse		
<b>Length</b>	225mm	<b>Depth</b>	65mm
<b>Bond</b>	Flemish	<b>Mortar</b>	Cement
<b>Date</b>	Early 20 <sup>th</sup>

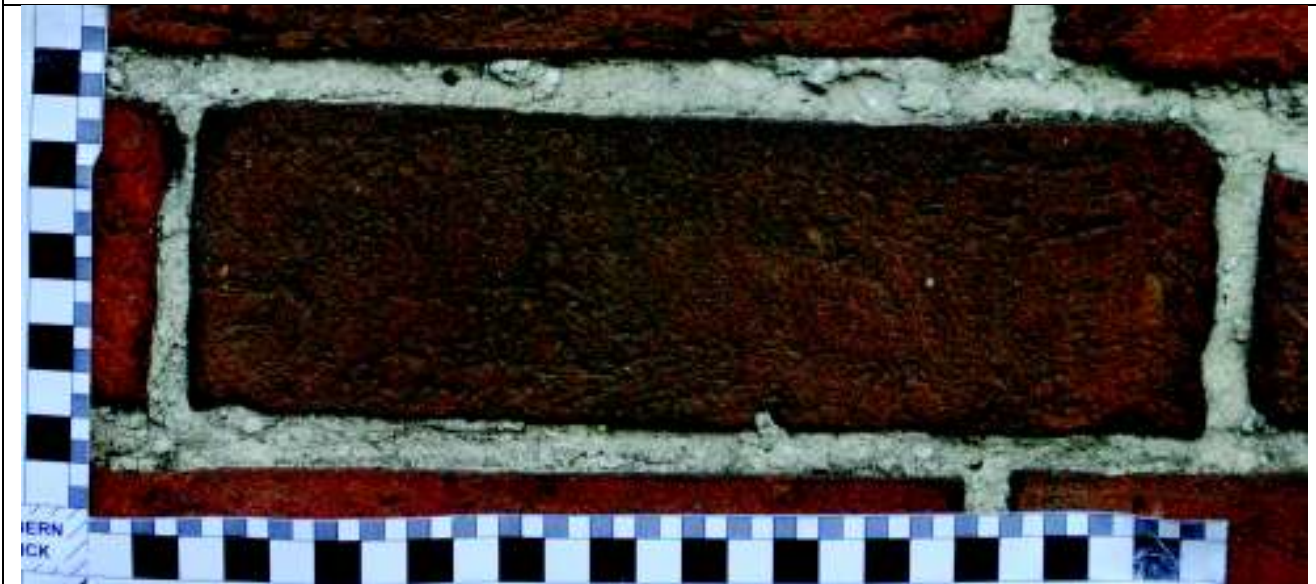
**BRICK 15**

<b>Location</b>	Northern end of western wall, unit 7		
<b>Description</b>	Regular ?wirecut red brick		
<b>Length</b>	220mm	<b>Depth</b>	70mm
<b>Bond</b>	Flemish	<b>Mortar</b>	Lime
<b>Date</b>	Late 19 <sup>th</sup> – early 20 <sup>th</sup>

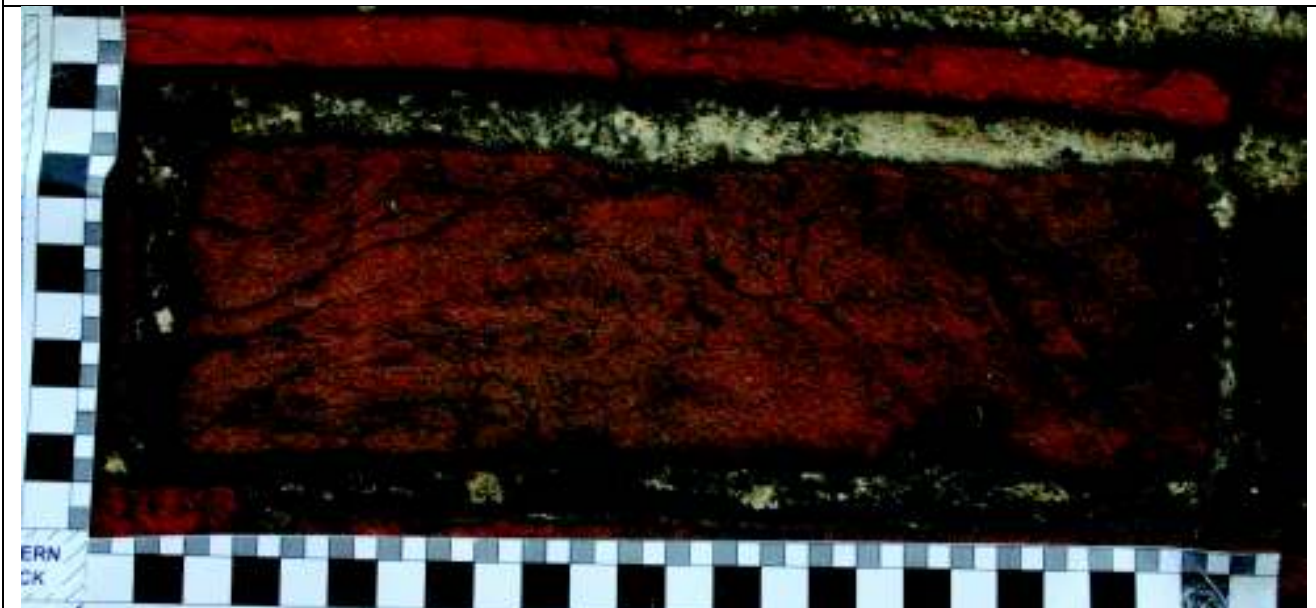
**BRICK 16**

<b>Location</b>	Northern part, western wall of unit 7		
<b>Description</b>	Hand-made red brick, some blackening (traffic)		
<b>Length</b>	215mm	<b>Depth</b>	65mm
<b>Bond</b>	Flemish	<b>Mortar</b>	Lime
<b>Date</b>	Late 19 <sup>th</sup>

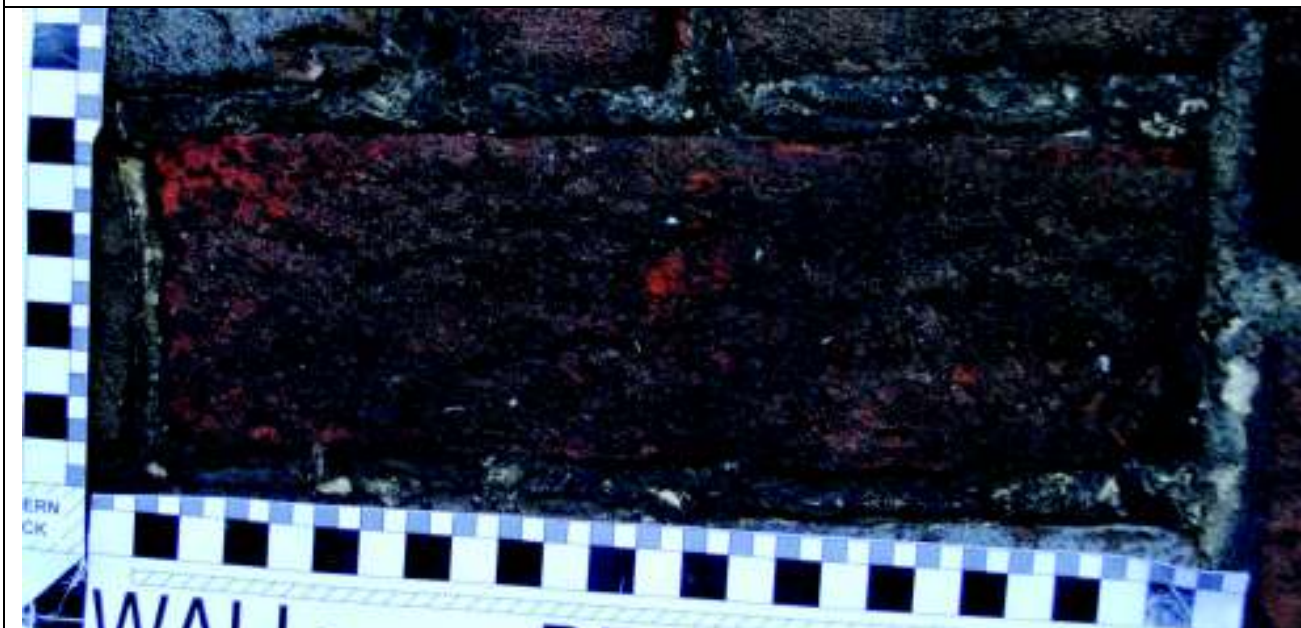
**BRICK 17**

<b>Location</b>	Mid west wall, unit 7, north of join in brickwork		
<b>Description</b>	Handmade / wirecut red brick, heavily blackened (traffic)		
<b>Length</b>	225mm	<b>Depth</b>	70mm
<b>Bond</b>	Flemish	<b>Mortar</b>	Lime
<b>Date</b>	Late 19 <sup>th</sup> - early 20 <sup>th</sup> century

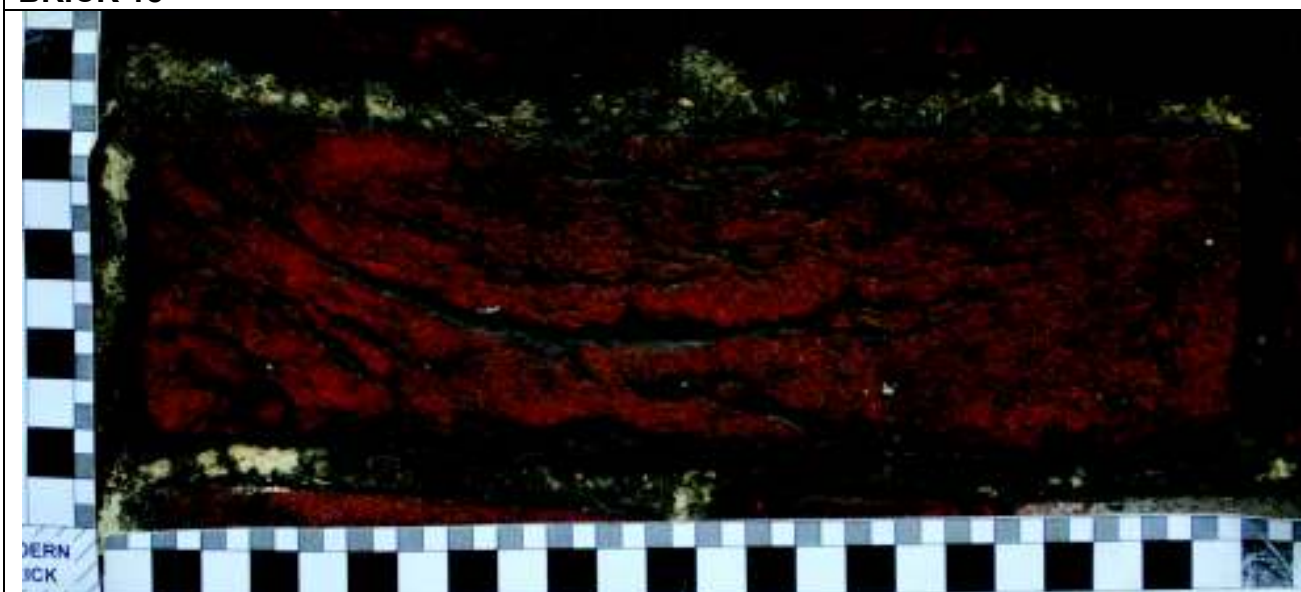
**BRICK 18**

<b>Location</b>	Mid west wall, unit 7, south of join in brickwork		
<b>Description</b>	Handmade red brick with some blackening (traffic)		
<b>Length</b>	225mm	<b>Depth</b>	65mm
<b>Bond</b>	English	<b>Mortar</b>	Lime
<b>Date</b>	19 <sup>th</sup>

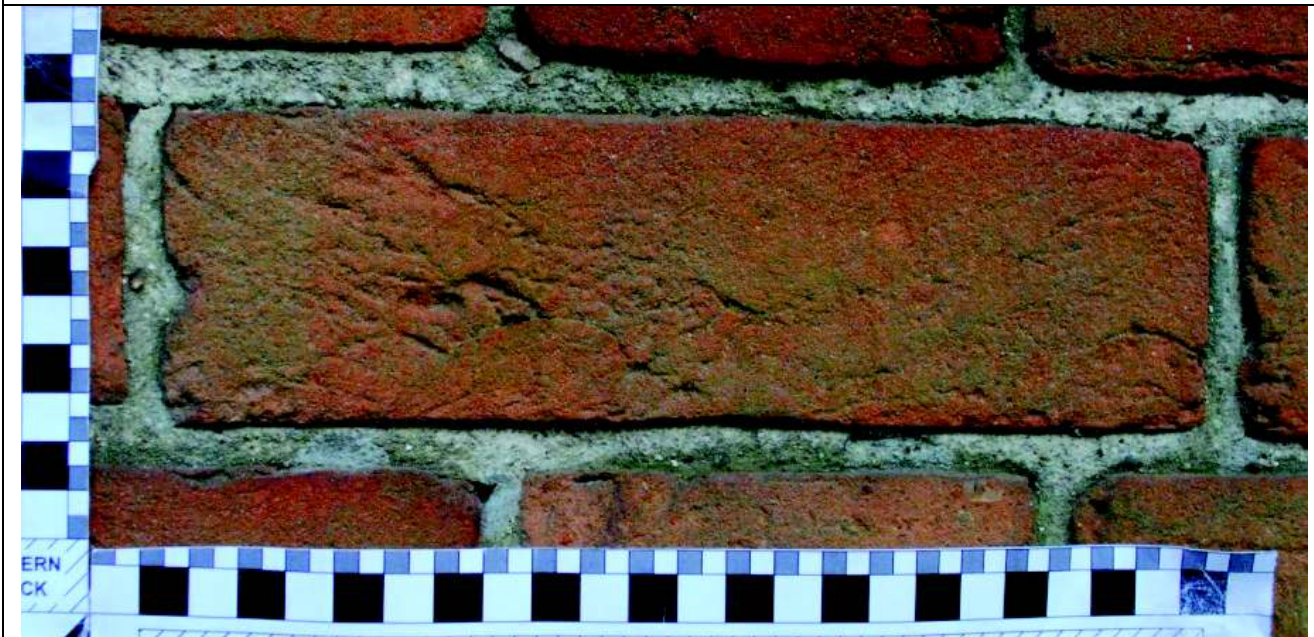
**BRICK 19**

<b>Location</b>	Mid western wall, unit 7		
<b>Description</b>	Regular ?wirecut red brick		
<b>Length</b>	220mm	<b>Depth</b>	68mm
<b>Bond</b>	English	<b>Mortar</b>	Lime
<b>Date</b>	Late 19 <sup>th</sup> – early 20 <sup>th</sup>

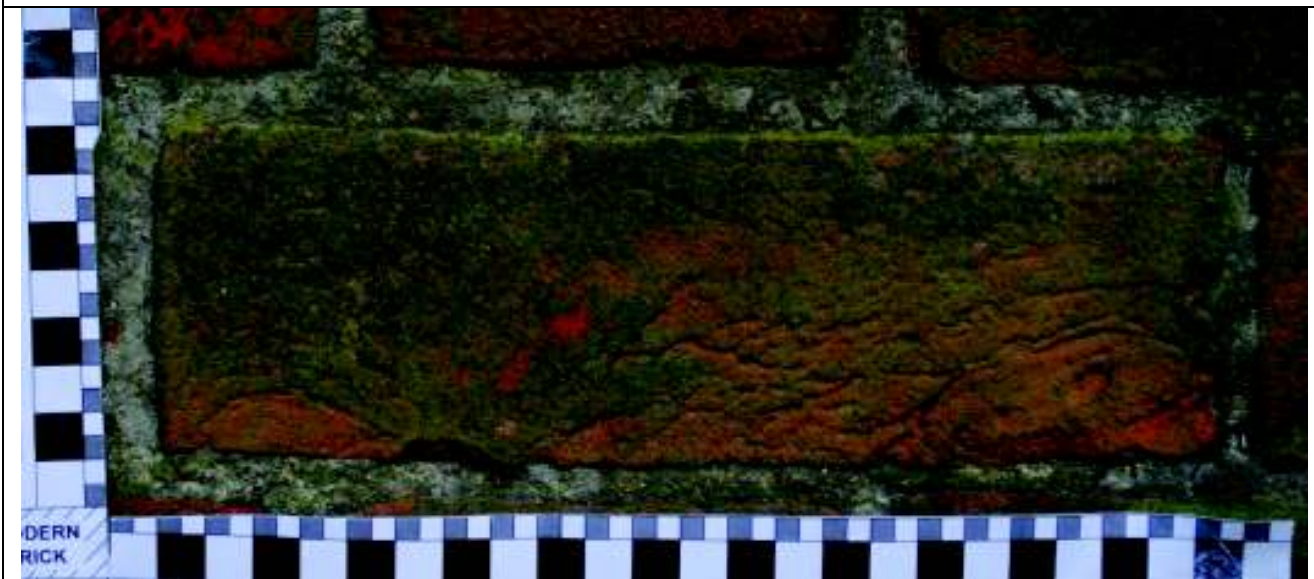
**BRICK 20**

<b>Location</b>	Southern end, western wall, unit 7		
<b>Description</b>	Regular machine-made / wirecut red brick		
<b>Length</b>	225mm	<b>Depth</b>	70mm
<b>Bond</b>	English	<b>Mortar</b>	Cement
<b>Date</b>	Early 20 <sup>th</sup>

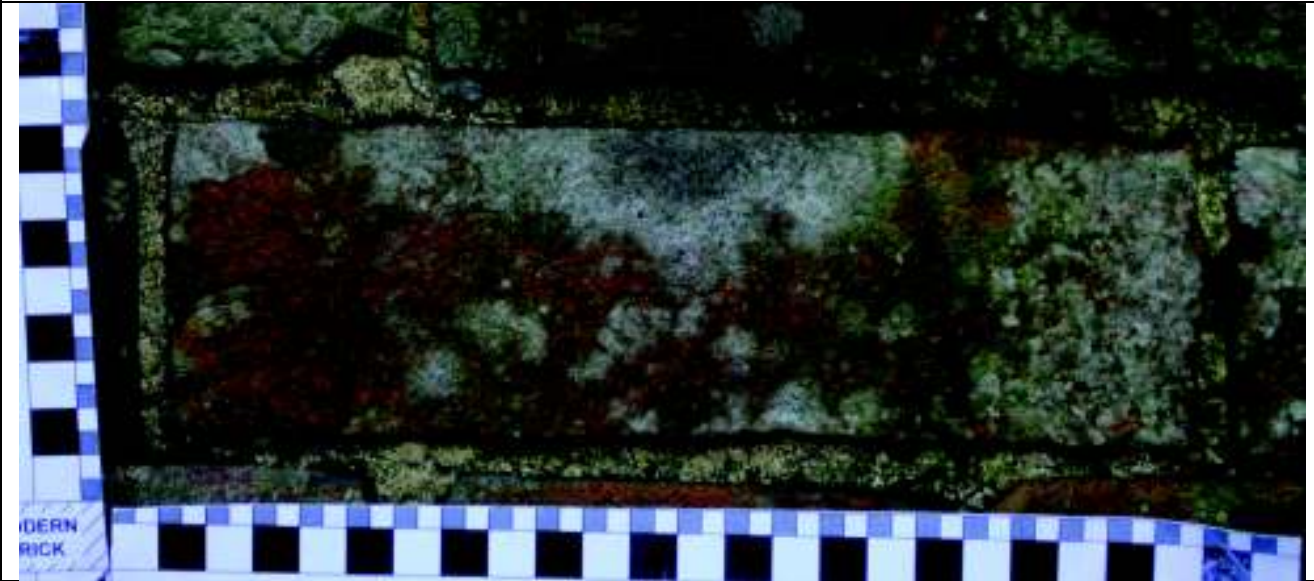
**BRICK 21**

<b>Location</b>	Western face, boundary wall to south of unit 7		
<b>Description</b>	Regular ?wirecut red brick		
<b>Length</b>	215mm	<b>Depth</b>	67mm
<b>Bond</b>	Flemish	<b>Mortar</b>	Lime
<b>Date</b>	Late 19 <sup>th</sup> – early 20 <sup>th</sup>

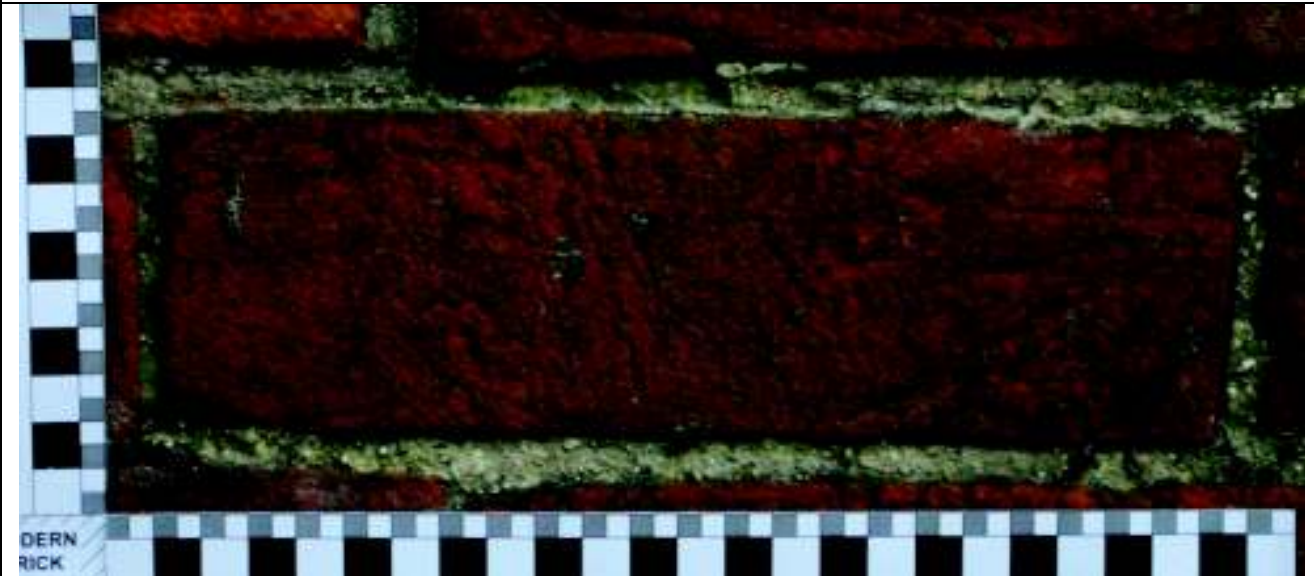
**BRICK 22**

<b>Location</b>	Boundary wall south of unit 1		
<b>Description</b>	Regular machine-made / wirecut red brick		
<b>Length</b>	220mm	<b>Depth</b>	65mm
<b>Bond</b>	Flemish Garden Wall	<b>Mortar</b>	Lime
<b>Date</b>	Late 19 <sup>th</sup> – 20 <sup>th</sup>

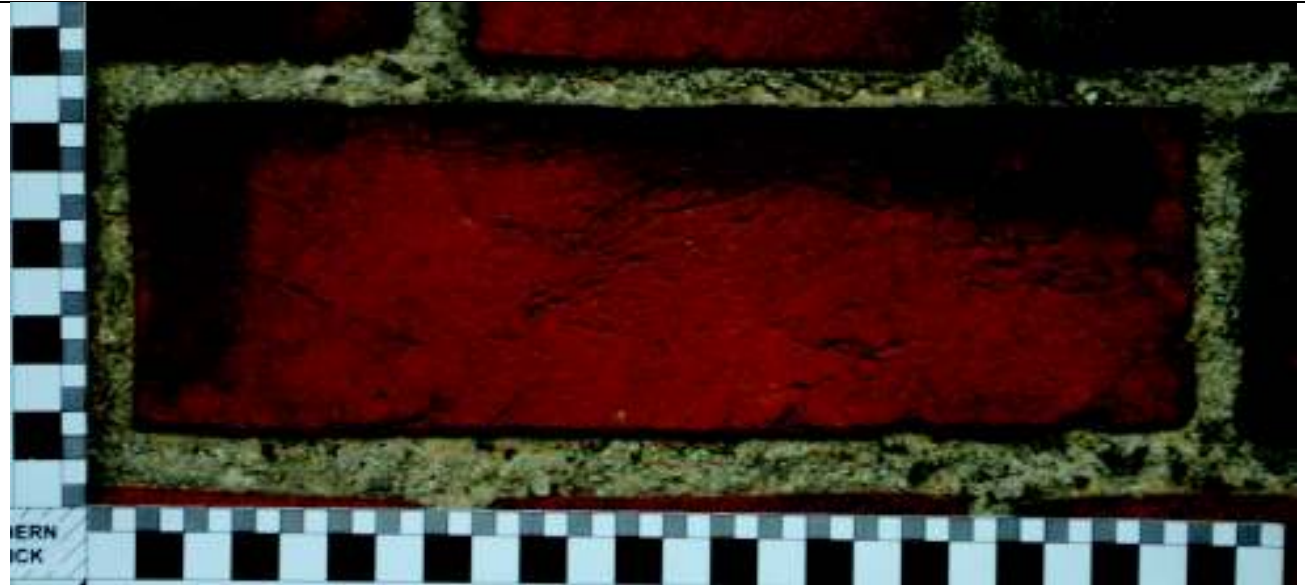
**BRICK 23**

<b>Location</b>	Western wall, unit 1		
<b>Description</b>	Uniform red brick, wirecut / machine made		
<b>Length</b>	223mm	<b>Depth</b>	67mm
<b>Bond</b>	Flemish Garden Wall	<b>Mortar</b>	Lime
<b>Date</b>	Late 19 <sup>th</sup> – 20 <sup>th</sup>

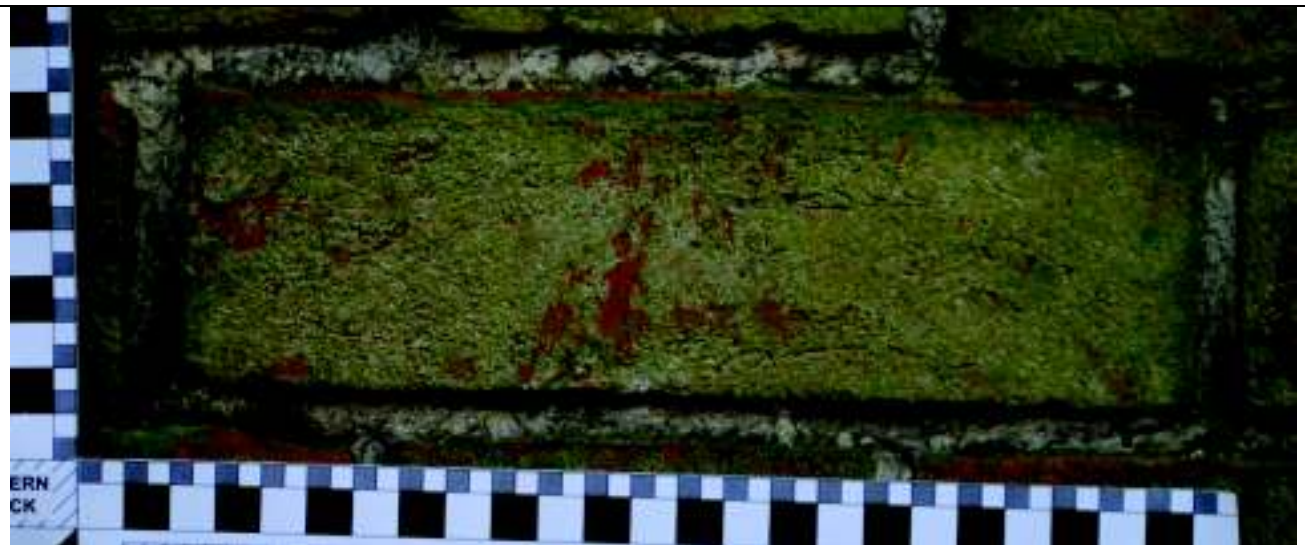
**BRICK 24**

<b>Location</b>	North wall of unit 1		
<b>Description</b>	Regular machine-made / wirecut red brick		
<b>Length</b>	220mm	<b>Depth</b>	65mm
<b>Bond</b>	Flemish Garden Wall	<b>Mortar</b>	Lime
<b>Date</b>	Late 19 <sup>th</sup> – 20 <sup>th</sup>

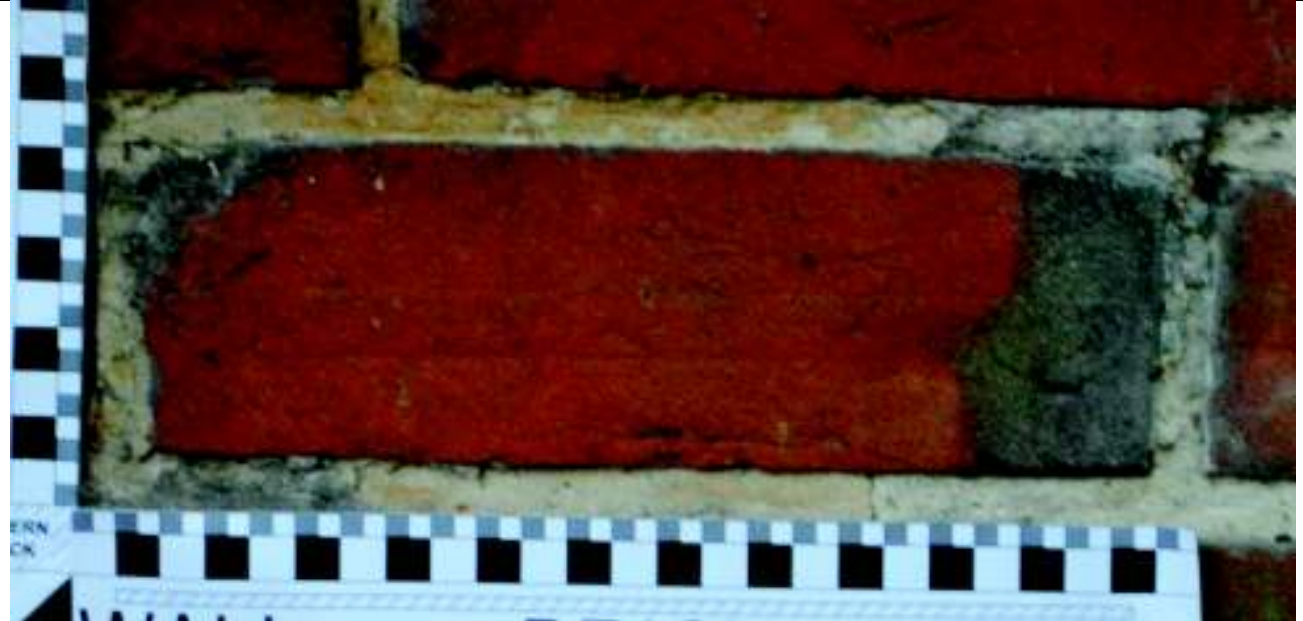
**BRICK 25**

<b>Location</b>	Northern wall, unit 2		
<b>Description</b>	Even red brick with some vitrification, ?wirecut		
<b>Length</b>	225mm	<b>Depth</b>	70mm
<b>Bond</b>	Flemish Garden Wall	<b>Mortar</b>	Lime
<b>Date</b>	19 <sup>th</sup> – early 20 <sup>th</sup>

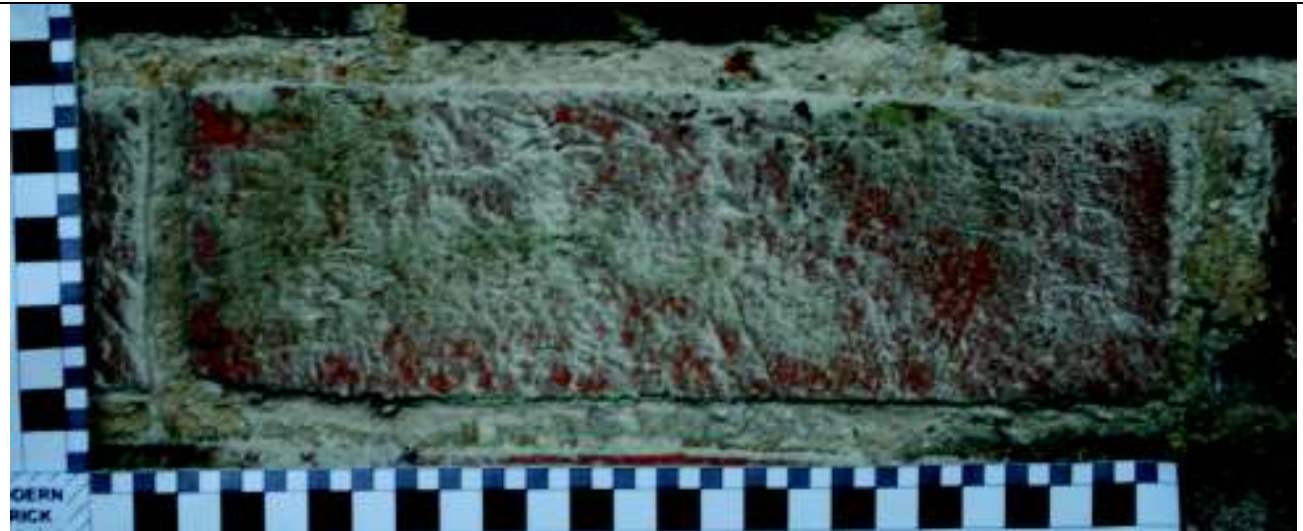
**BRICK 26**

<b>Location</b>	North elevation, historic section of unit 2		
<b>Description</b>	Uniform red brick, wirecut / machine-made		
<b>Length</b>	225mm	<b>Depth</b>	70mm
<b>Bond</b>	Flemish Garden Wall	<b>Mortar</b>	Lime
<b>Date</b>	19 <sup>th</sup> – early 20 <sup>th</sup>

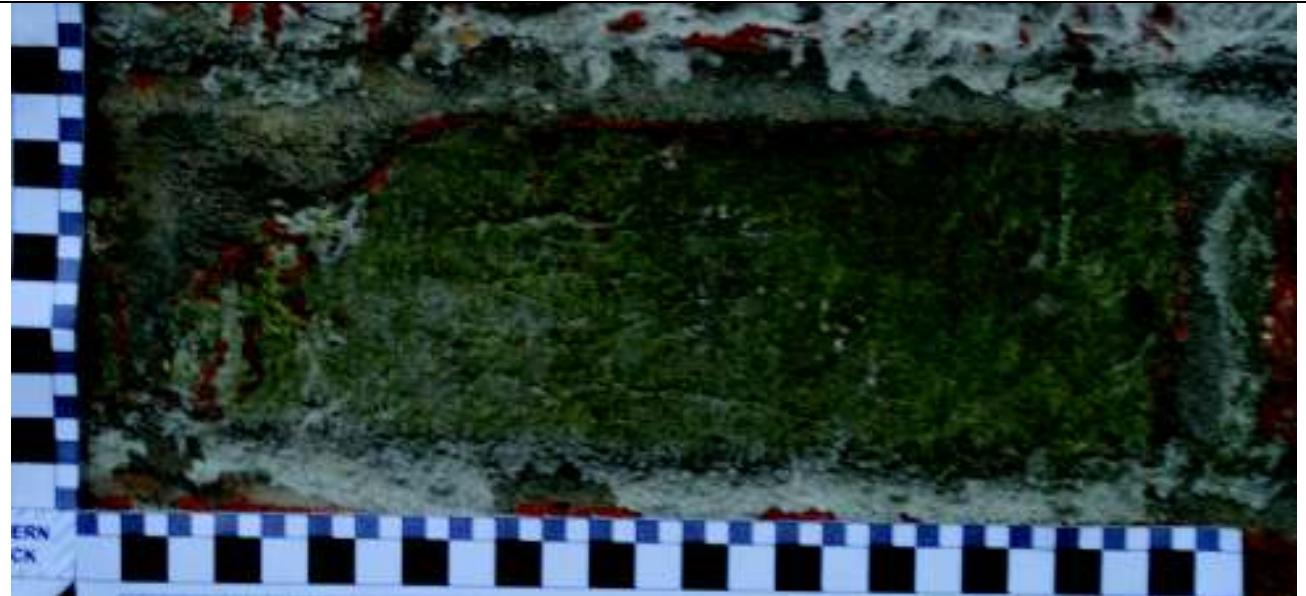
**BRICK 27**

<b>Location</b>	North elevation, historic section of unit 2, blocked window		
<b>Description</b>	Uniform red brick, possibly reused in blocking window		
<b>Length</b>	220mm	<b>Depth</b>	75mm
<b>Bond</b>	Various	<b>Mortar</b>	Cement
<b>Date</b>	Late 19 <sup>th</sup> - 20 <sup>th</sup>

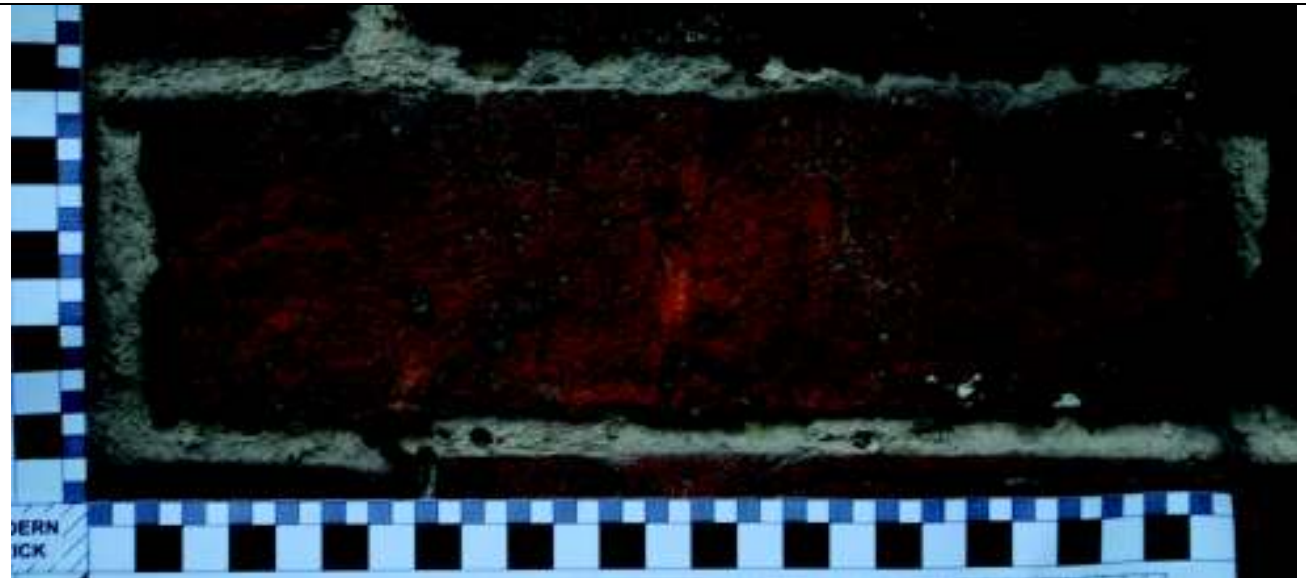
**BRICK 28**

<b>Location</b>	East face, unit 1		
<b>Description</b>	Uniform red brick, wirecut / machine made		
<b>Length</b>	230mm	<b>Depth</b>	70mm
<b>Bond</b>	Flemish Garden Wall	<b>Mortar</b>	Lime, degraded
<b>Date</b>	19th

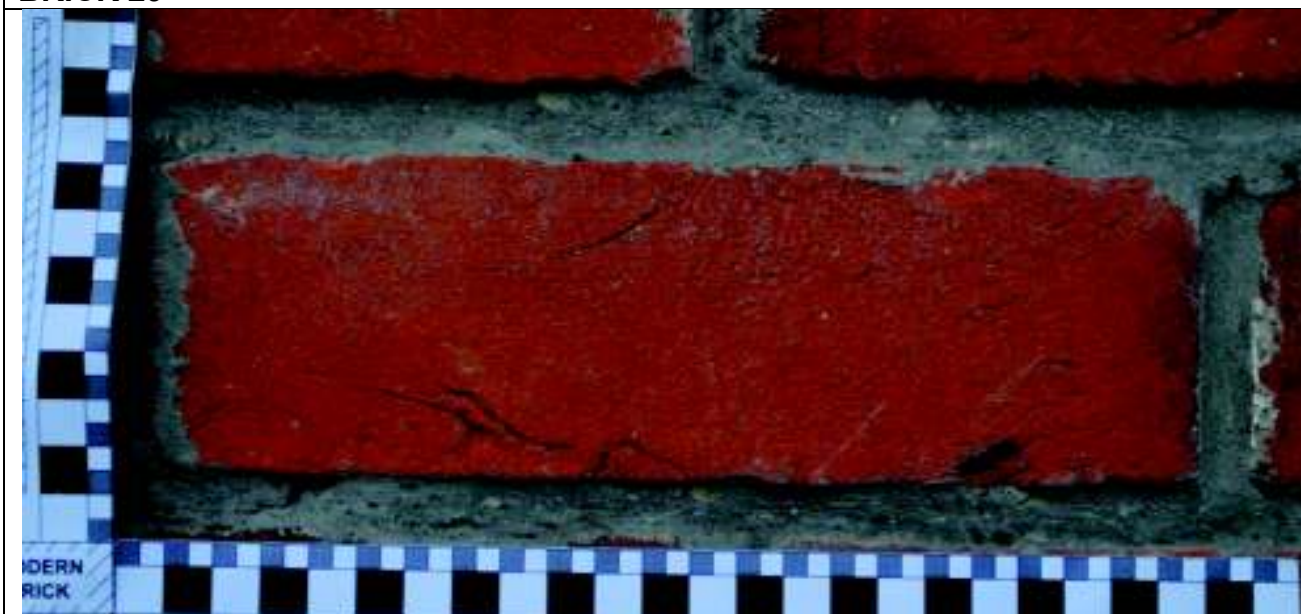
**BRICK 29**

<b>Location</b>	Blocked doorway, east wall, unit 1		
<b>Description</b>	Modern machine-made red brick		
<b>Length</b>	220mm	<b>Depth</b>	65mm
<b>Bond</b>	Stretcher	<b>Mortar</b>	Cement
<b>Date</b>	20 <sup>th</sup> - Modern

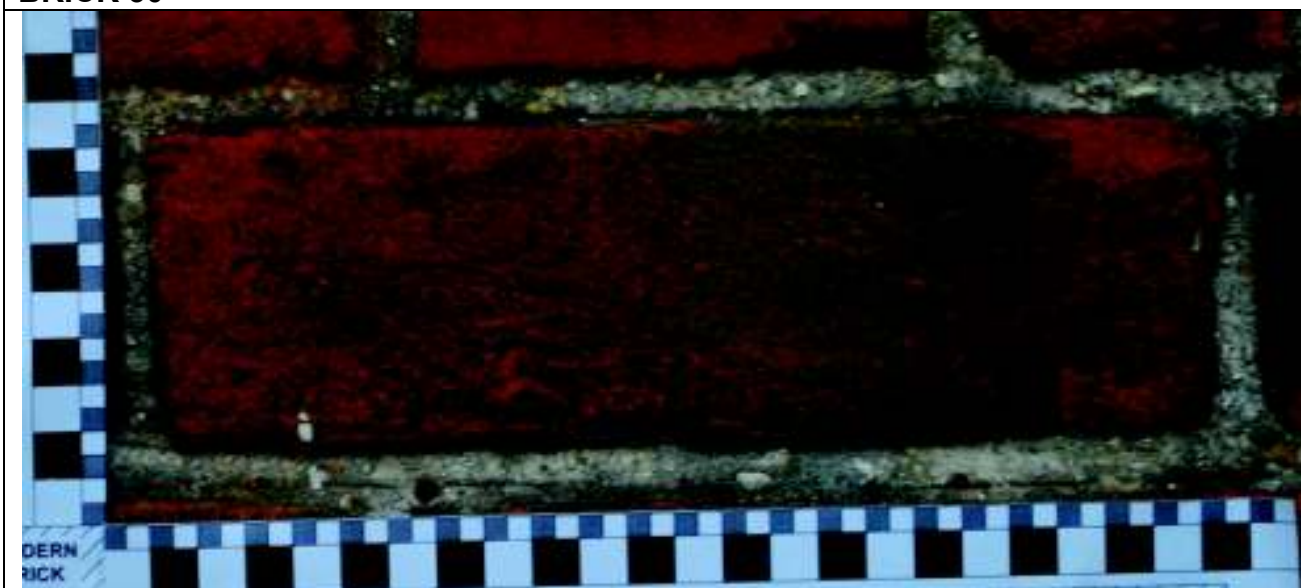
**BRICK 30**

<b>Location</b>	South wall, unit 2		
<b>Description</b>	Uniform red brick, wirecut / machine-made		
<b>Length</b>	220mm	<b>Depth</b>	65mm
<b>Bond</b>	Flemish Garden Wall	<b>Mortar</b>	Lime
<b>Date</b>	Late 19 <sup>th</sup> – 20 <sup>th</sup>

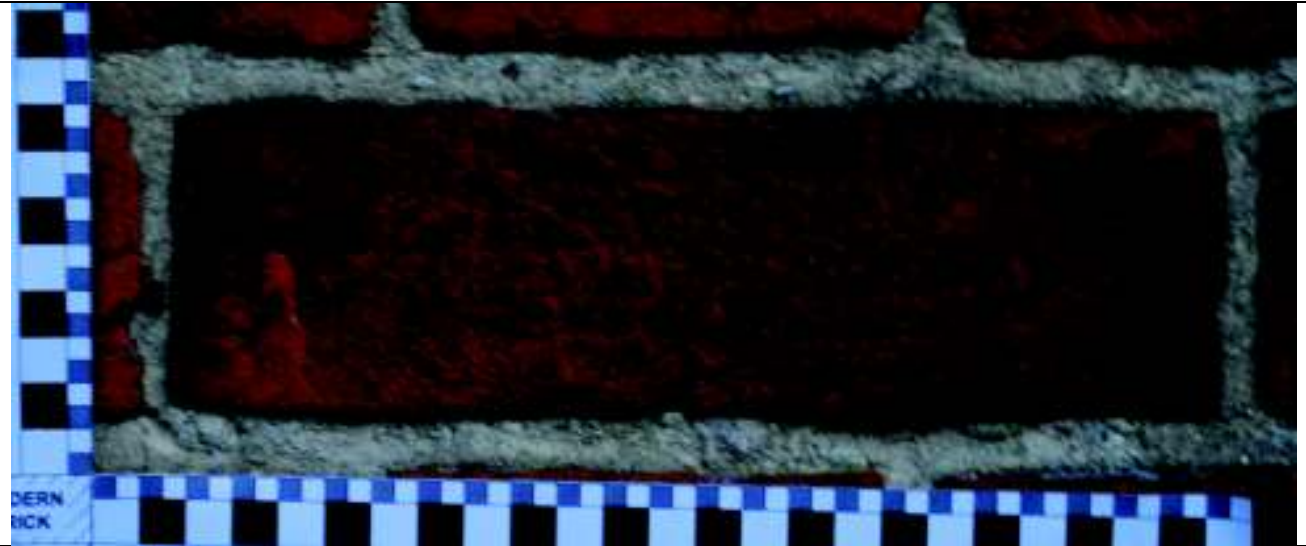
**BRICK 31**

<b>Location</b>	Western wall, unit 3		
<b>Description</b>	Uniform wirecut / machine-made red brick		
<b>Length</b>	225mm	<b>Depth</b>	65mm
<b>Bond</b>	Flemish Garden Wall	<b>Mortar</b>	Lime
<b>Date</b>	Late 19 <sup>th</sup> – 20 <sup>th</sup>

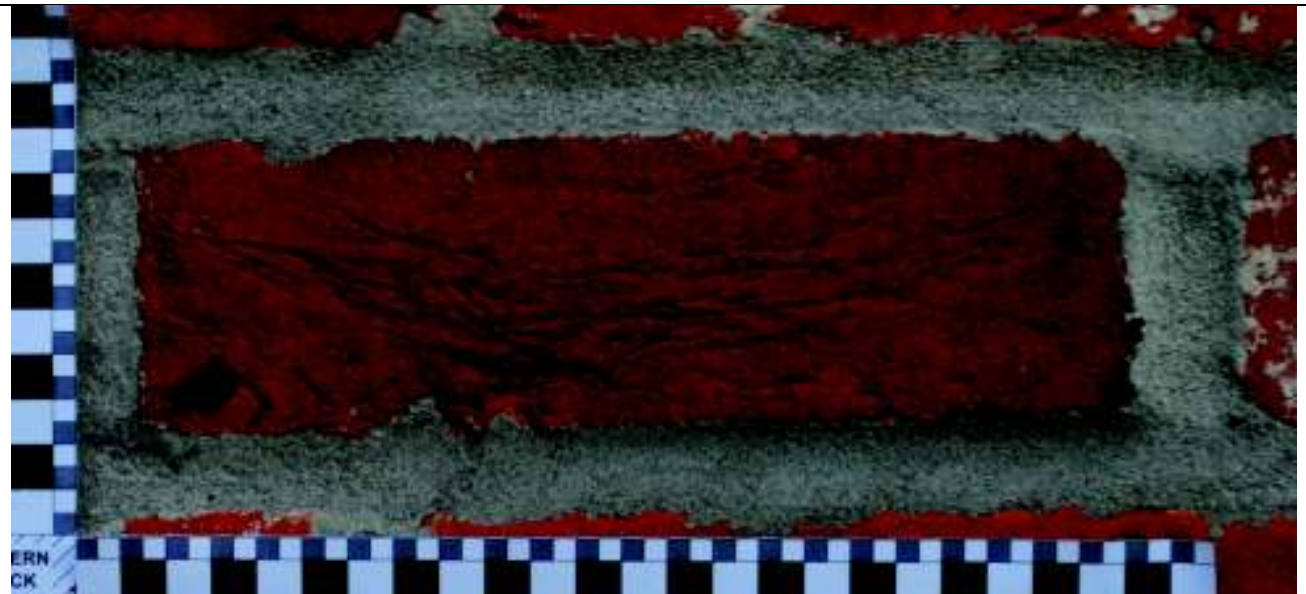
**BRICK 32**

<b>Location</b>	West wall, unit 3		
<b>Description</b>	Modern machine-made red brick		
<b>Length</b>	220mm	<b>Depth</b>	65mm
<b>Bond</b>	Various	<b>Mortar</b>	Cement
<b>Date</b>	Modern

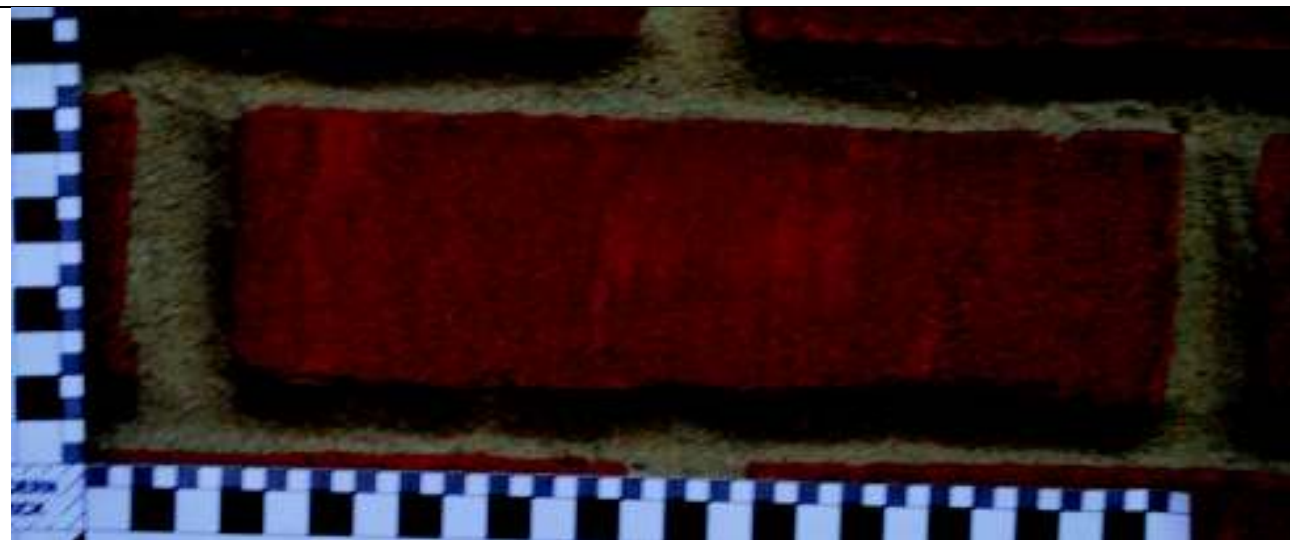
**BRICK 33**

<b>Location</b>	Western wall, building 3 south		
<b>Description</b>	Modern machine-made brick		
<b>Length</b>	210mm	<b>Depth</b>	60mm
<b>Bond</b>	Stretcher	<b>Mortar</b>	Cement
<b>Date</b>	Modern

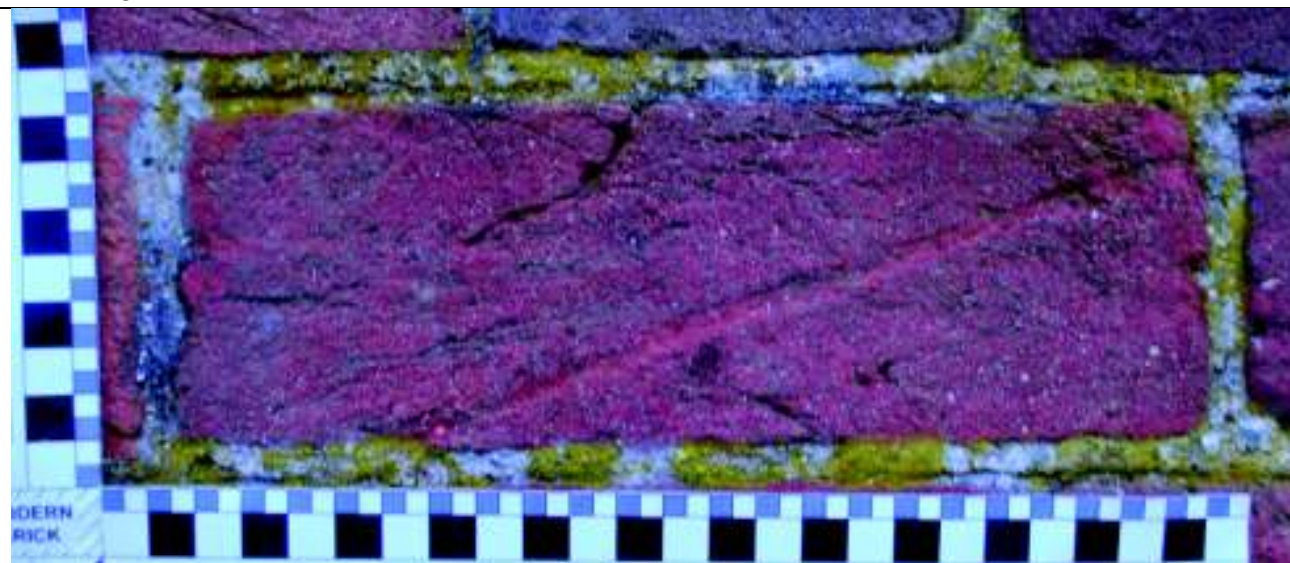
**BRICK 34**

<b>Location</b>	Eastern wall, unit 6, northern end		
<b>Description</b>	Uniform handmade / wirecut red brick		
<b>Length</b>	225mm	<b>Depth</b>	70mm
<b>Bond</b>	Various	<b>Mortar</b>	Lime
<b>Date</b>	19 <sup>th</sup> – 20 <sup>th</sup>

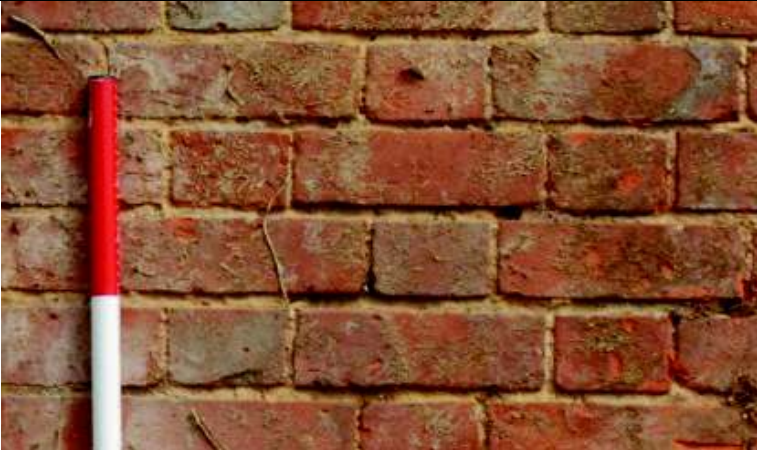
<p><b>15<sup>th</sup>-17<sup>th</sup> century brick</b> from College Farmhouse, South Stoke, South Oxfordshire</p> <p>230mm x 45mm</p> <p>Hand made thin red brick, dated via listing description to 17<sup>th</sup> century, although size suggests 15<sup>th</sup> century.</p>
	<p><b>16<sup>th</sup> century brick</b> from Old House Farmhouse, Shinfield, Berkshire</p> <p>240mm x 50mm</p> <p>Hand made red brick, uneven, with inclusions, dated via building phasing and size of brick</p>
	<p><b>Late 16<sup>th</sup> century brick</b>, Shaw House, Newbury, Berkshire</p> <p>Very uneven soft red hand made brick, dated to 1581 – the construction date of the building</p>
	<p><b>17<sup>th</sup>-18<sup>th</sup> century brick</b> from Jasmine Cottage, Purley, Berkshire</p> <p>220mm x 60mm</p> <p>Hand made red brick with uneven vitrification, suggesting clamp firing, dated via brick size</p>

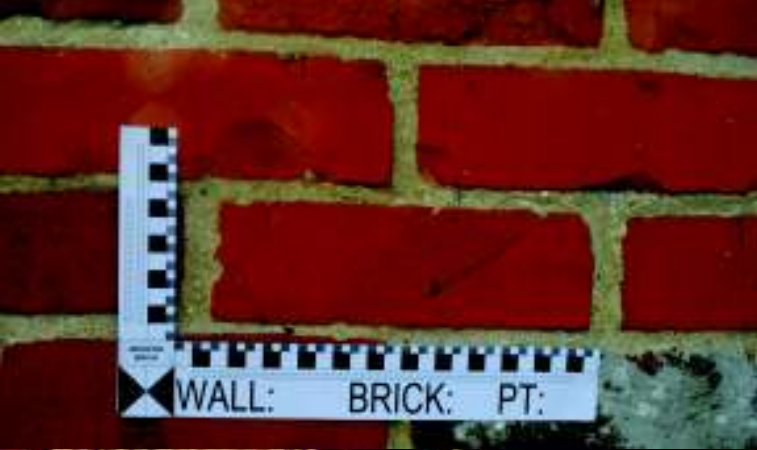
<p><b>1840-1881 brick</b> from <i>Gidley Farm, Peasemore, Berkshire</i></p> <p>215mm x 70mm</p> <p><i>Regular ?machine made soft red brick, building dated via map evidence</i></p>

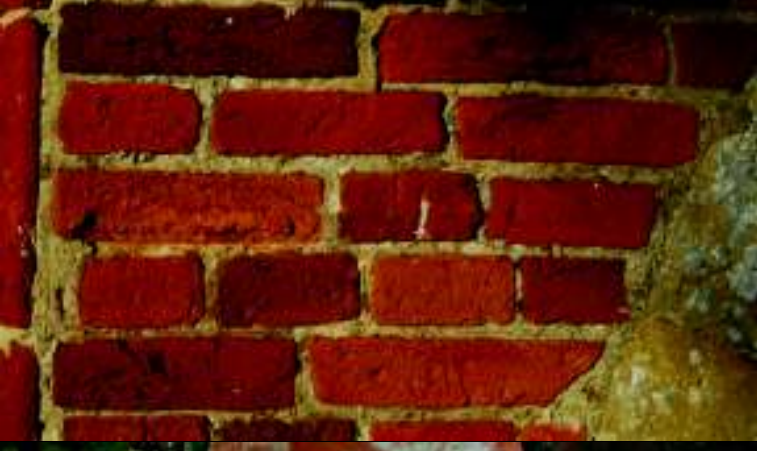
<p><b>Victorian brick</b> from <i>Old House Farmhouse, Shinfield, Berkshire</i></p> <p>230mm x 70mm</p> <p><i>Medium-soft red wirecut brick, few inclusions, dated via building phasing</i></p>

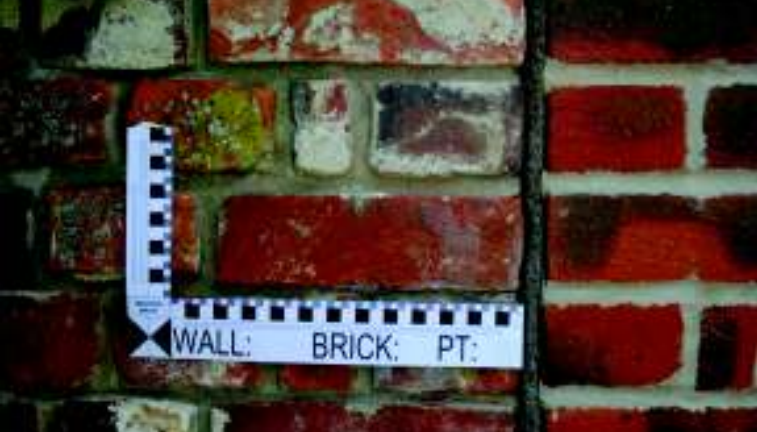
<p><b>19<sup>th</sup> century brick</b>, <i>Church of St Michael, Enborne, Berkshire</i></p> <p><i>Hand-made soft, uneven red brick, dated via listing description of church</i></p>
