## HERITAGE STATEMENT

Little Faringdon House (Langford House)  
Little Faringdon  
Lechlade  
Oxfordshire GL7 3QN

**Heritage Statement:  
Little Faringdon House (Langford House)  
Little Faringdon, Lechlade, Oxfordshire GL7 3QN  
SP2237201563  
by  
Dr Peter Wardle & Colin Lacey  
20/07/2011**

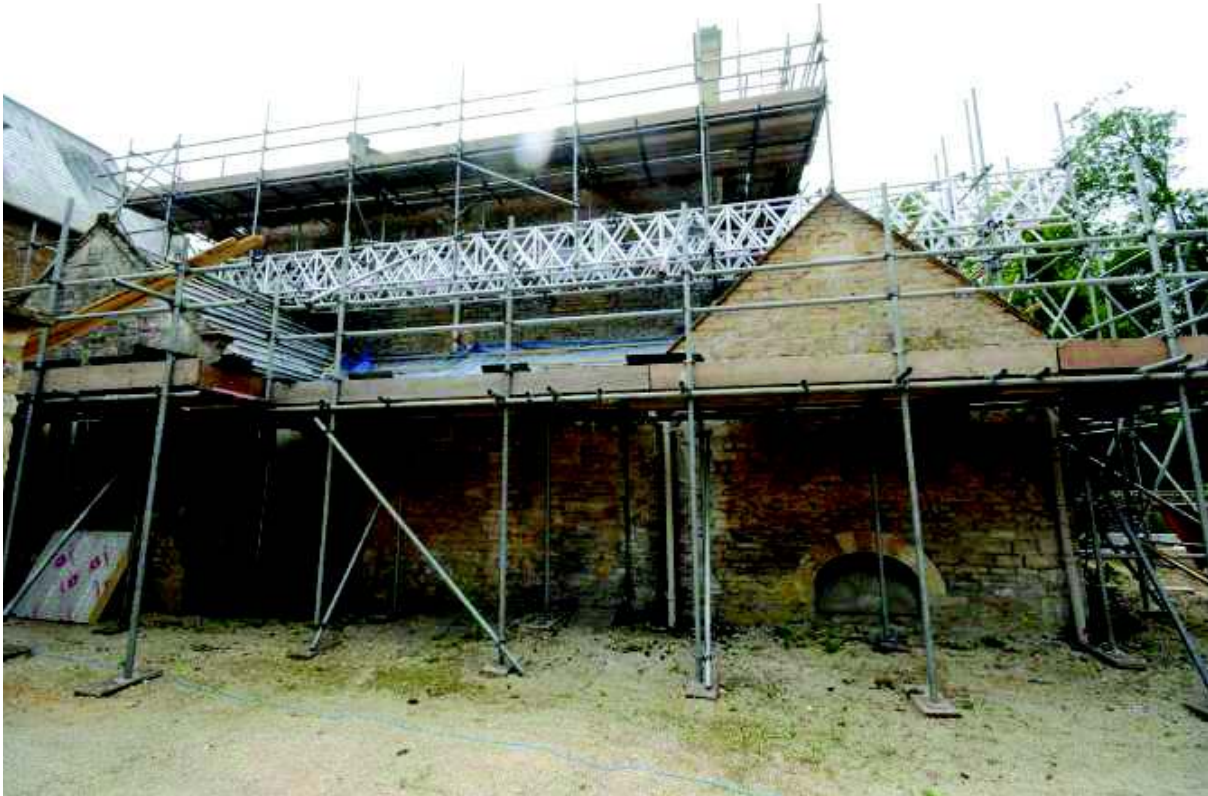
**Plate 1: Northwest part of northeast elevation, northwest wing**

Several phases of construction are apparent, stemming from the main northwest-southeast gabled roof of the earliest part of this wing. To the far northwest, a gabled section extends to the northeast. This has a pair of blocked arched openings - one at the apex of the northeast gable, with a second, much larger example at ground floor level below.

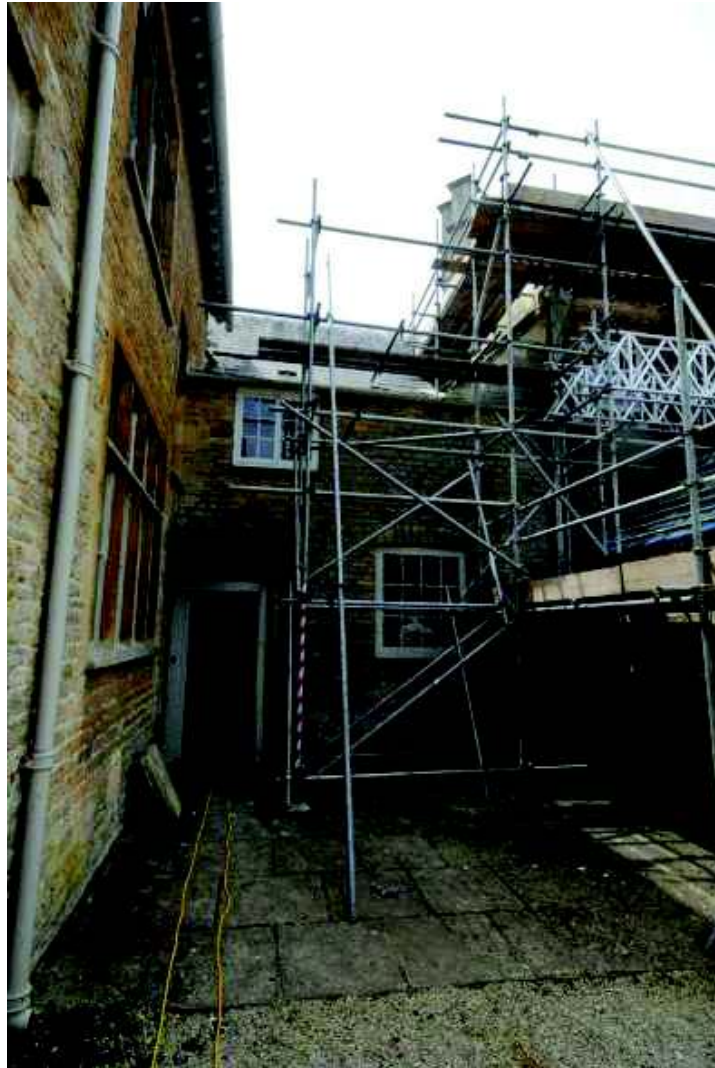
Southeast of this section a recess marks the return to the original wall line of the northwest wing. This section of the wall has a ground floor window with cambered brick

lintel, a door into the building and a first floor casement window. These windows are all multi-paned and have wooden frames.

**Plate 2: Recessed area to southeast of northeast elevation, northwest wing**

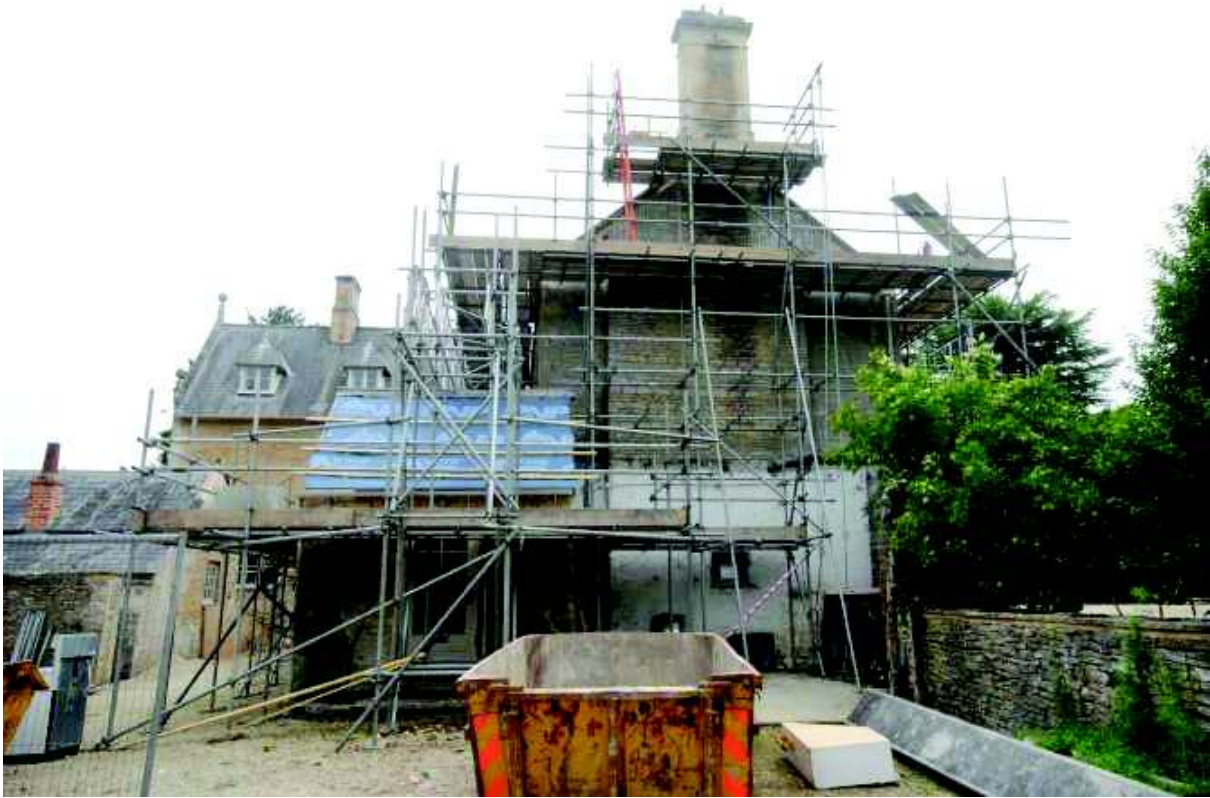
Until recently before the recording exercise was completed, a further structure was attached to the northwest end of the wing. The extent of this structure is clearly visible in the paint remaining on the northwest wall. A substantial chimneybreast dominates this wall, with a recess present to the southwest.

The northwestern gabled extension projects further than the earlier part of the northwest wing. Its northwest wall features a glazed door with steps compensating for the change of level.

**Plate 3: Northwest aspect, northwest wing**

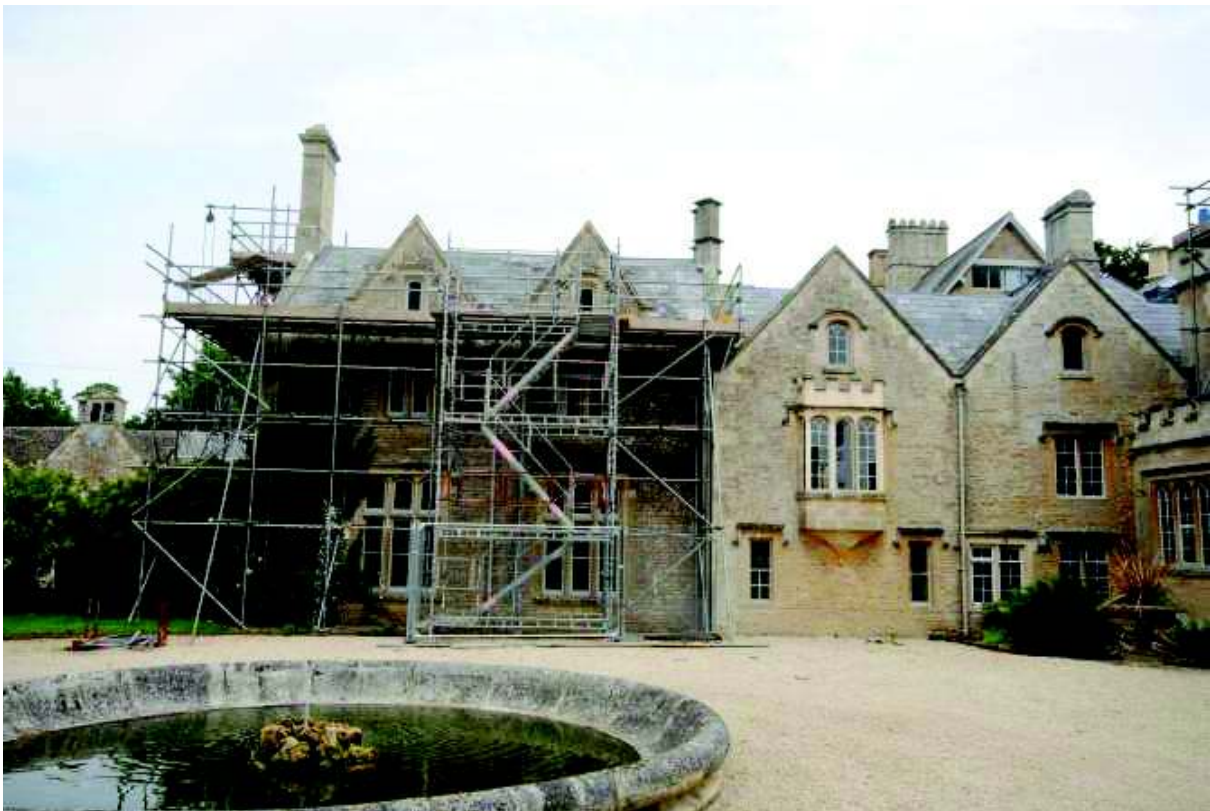
**Plate 4: Southwest elevation, northwest wing**

The southwest side of the wing comprises two distinct sections. To the northwest, the stonework is distinctly greyer than that to the southeast. The greyer section is considered older and has a different architectural style.

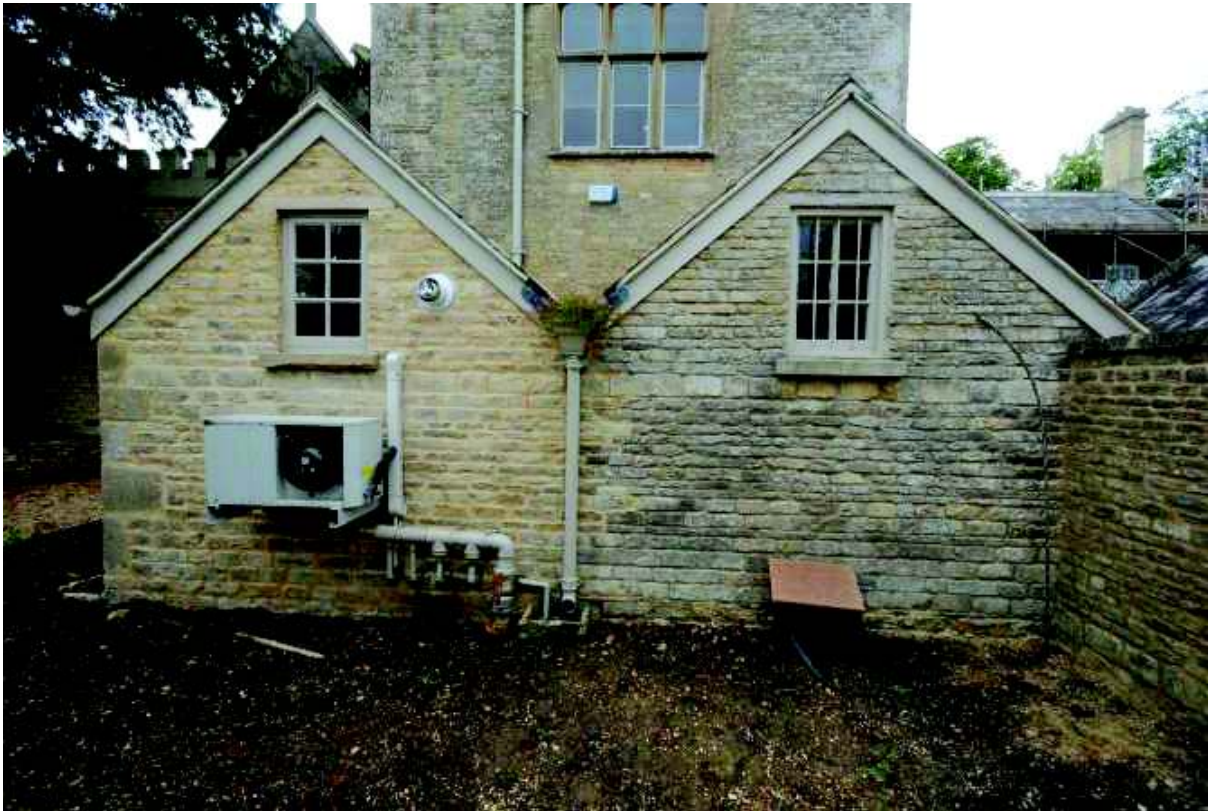
At the northeast end of the northeast wing, a pair of ground floor extensions are present. These have gabled roofs, pitched southwest - northeast and each has a window in the northeast wall, located central to the apex of the roofs.

The stone and mortar forming these extensions differs in appearance and weathering. This suggests the southeast extension is more recent than the northwest example.

**Plate 5: Northeast elevation, northeast extensions**

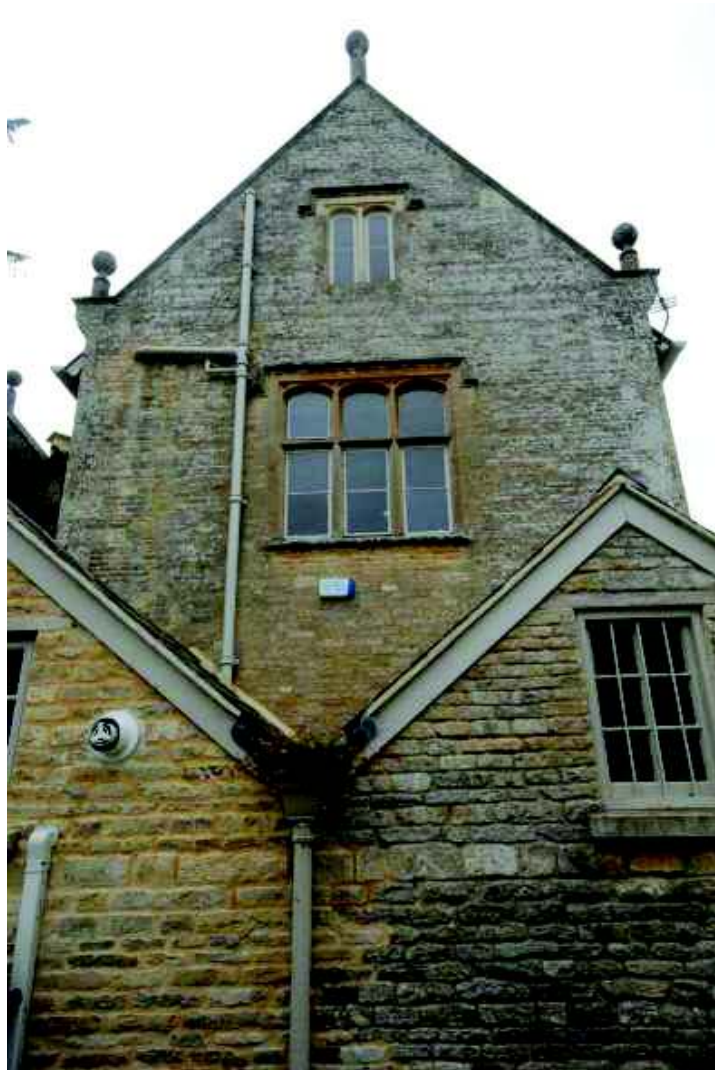
Above the extensions, a first and a second floor window are present. Both have arched tops and are outlined by hood mouldings.

The gable end of the building features a low parapet with platforms on either side of the roof slope. Ball finials are present on these platforms and on the apex of the roof.

**Plate 6: Northeast elevation, northeast wing**

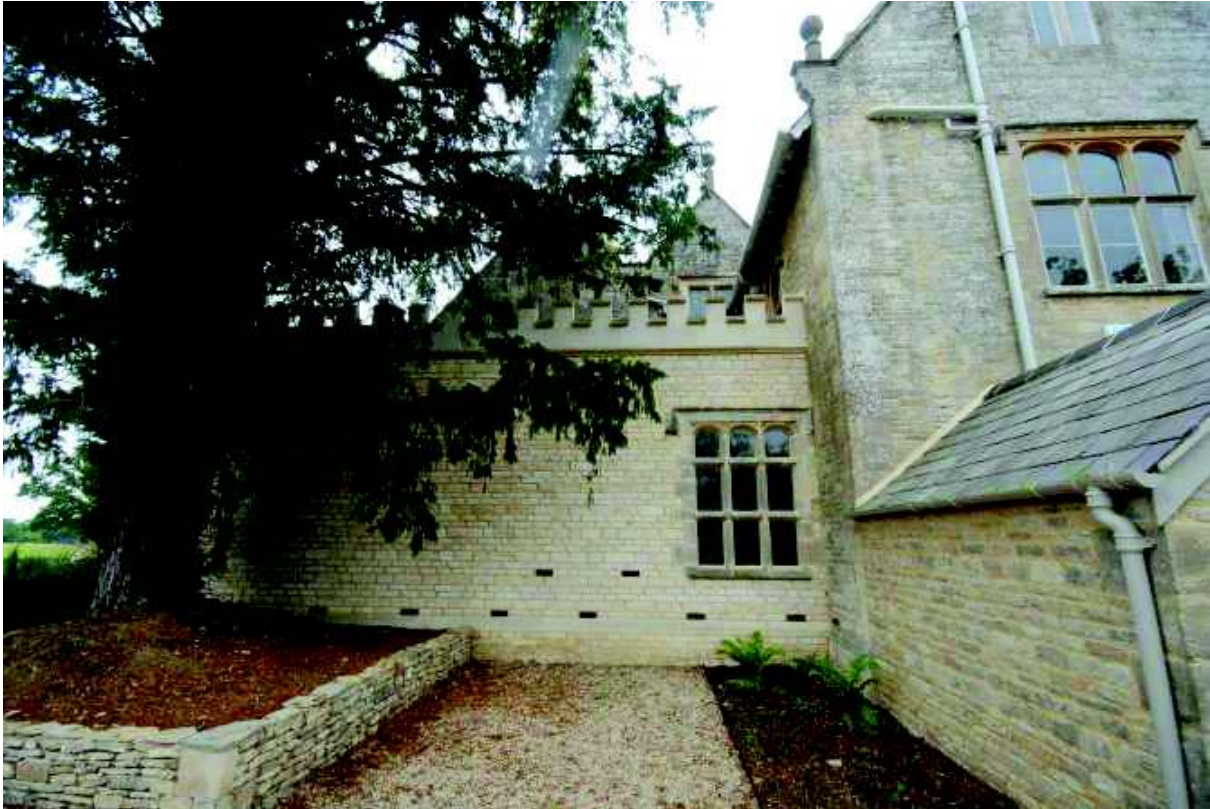
To the southeast of this part of the building, a single storey section is located housing the kitchen. This is again a new addition to the property and has been fitted with a castellated parapet to help it blend in with the historic parts of the building. A stone framed window with arched upper lights is present in the northeast wall of the kitchen.

Southwest of the kitchen, two gables are present at the northeast end of an earlier phase of the building. These are fitted with ball finials similar to those noted above.

Plate 7: Northeast aspect, kitchen extension

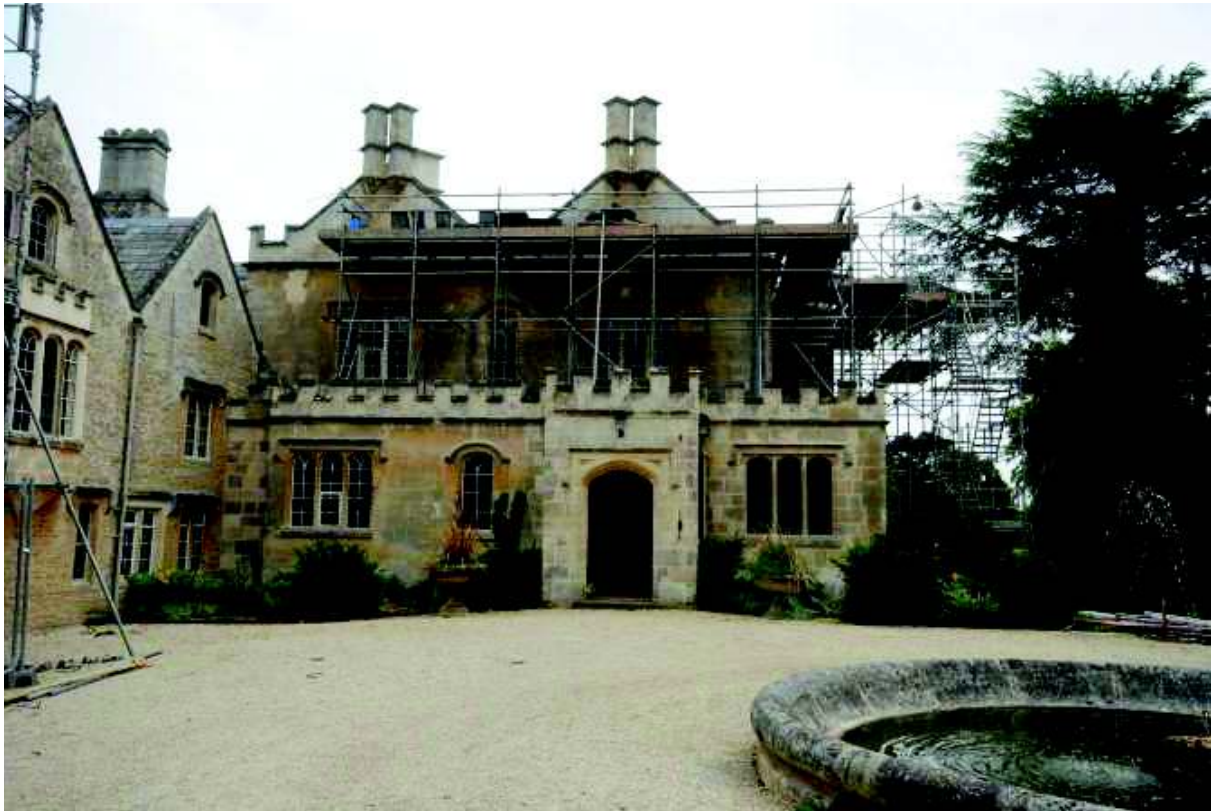
**Plate 8: Northwest elevation, southwest wing**

Both the ground and first floors of the northwest elevation of the southwest wing have castellated parapets. The form of the windows echoes that previously encountered, with arched tops and stone mullions. Hood mouldings are present across all windows.

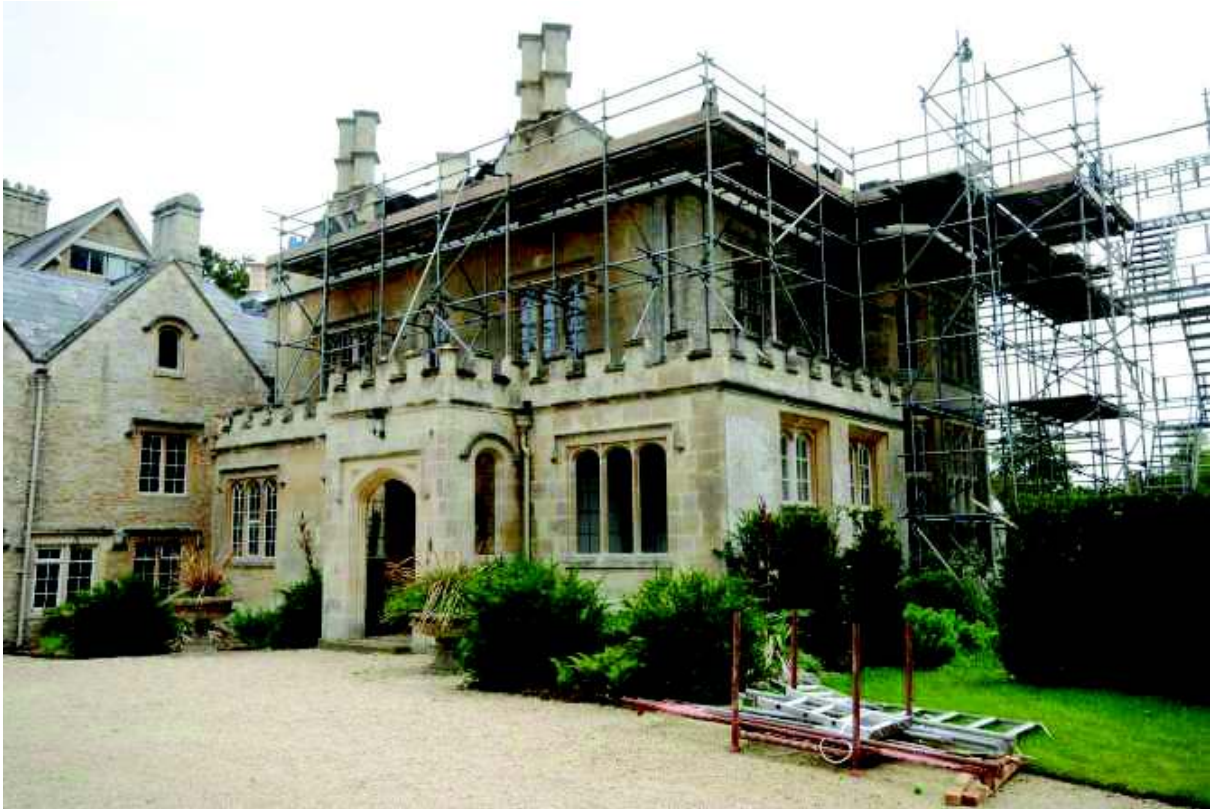
The ground floor is extended slightly to the northwest, staggering the castellated parapet away from the first floor wall and enhancing the grandeur of the appearance.

The main entrance to the building is via a portico again castellated, projecting further from the northwest wall. The portico is offset to the southwest and features a three-centred arched opening with triangular mouldings beneath a further hood moulding.

**Plate 9: Southwest wing viewed from west**

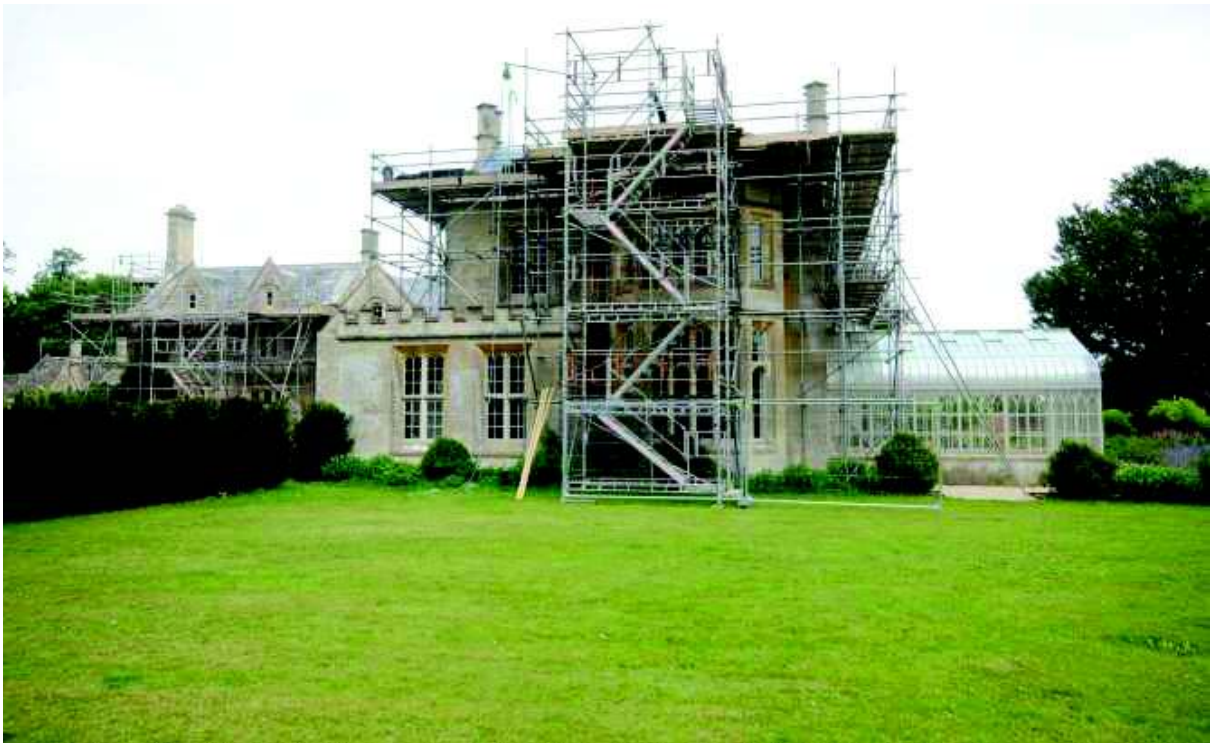
Two large two-storey bay windows are present on the southwest face. These are fitted with stone framed windows. The parapets are obscured by scaffolding but appear plain.

**Plate 10: Southwest aspect, southwest wing**

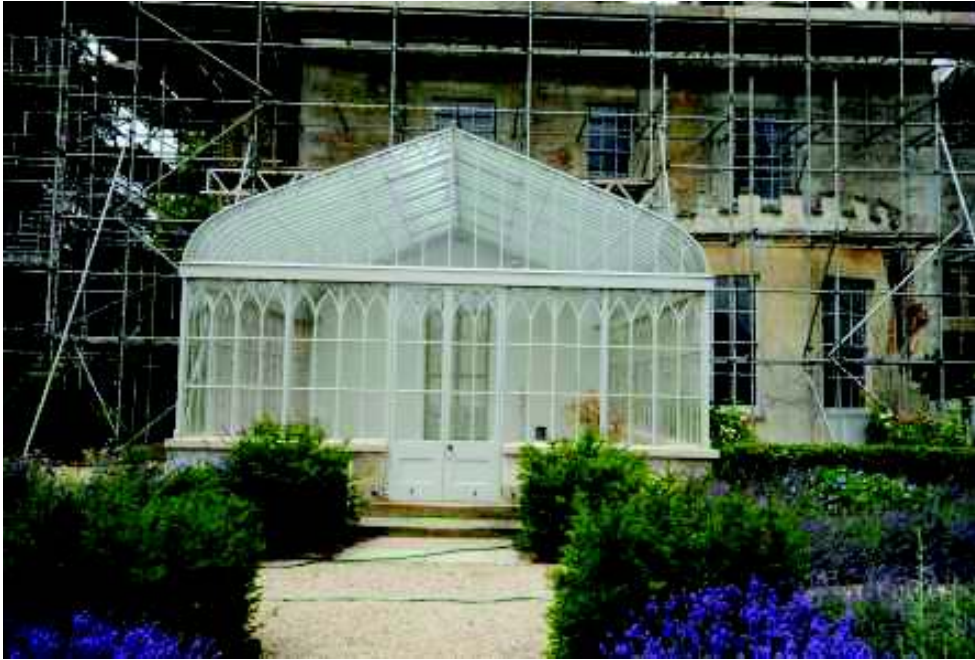
The rear (southeast elevation) of the southwest wing is largely taken up by a conservatory of Victorian date. The lower part of the conservatory walls are constructed of dressed stone blocks, above which the glazed portion is located. Double doors in the southeast end give access to the garden.

**Plate 11: Southeast aspect, conservatory and rounded bay**

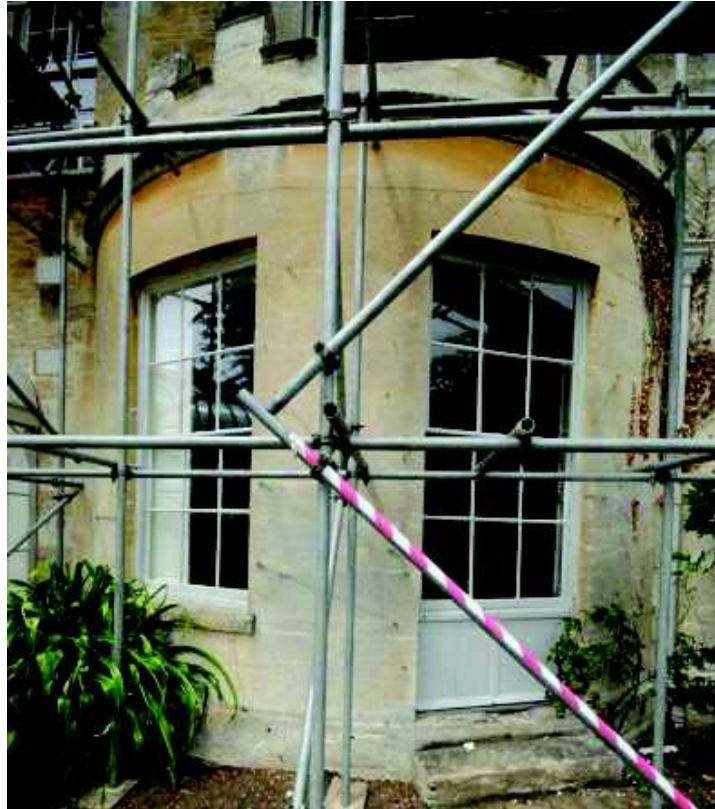
Northeast of the conservatory, a rounded bay is present. This extends over the ground floor only and features a castellated parapet. The bay has two sash windows, the northeastern of which has wooden doors below, suggesting the sash can be raised and the doors opened providing pedestrian access to the garden from the house.

**Plate 12: Detail of rounded bay**

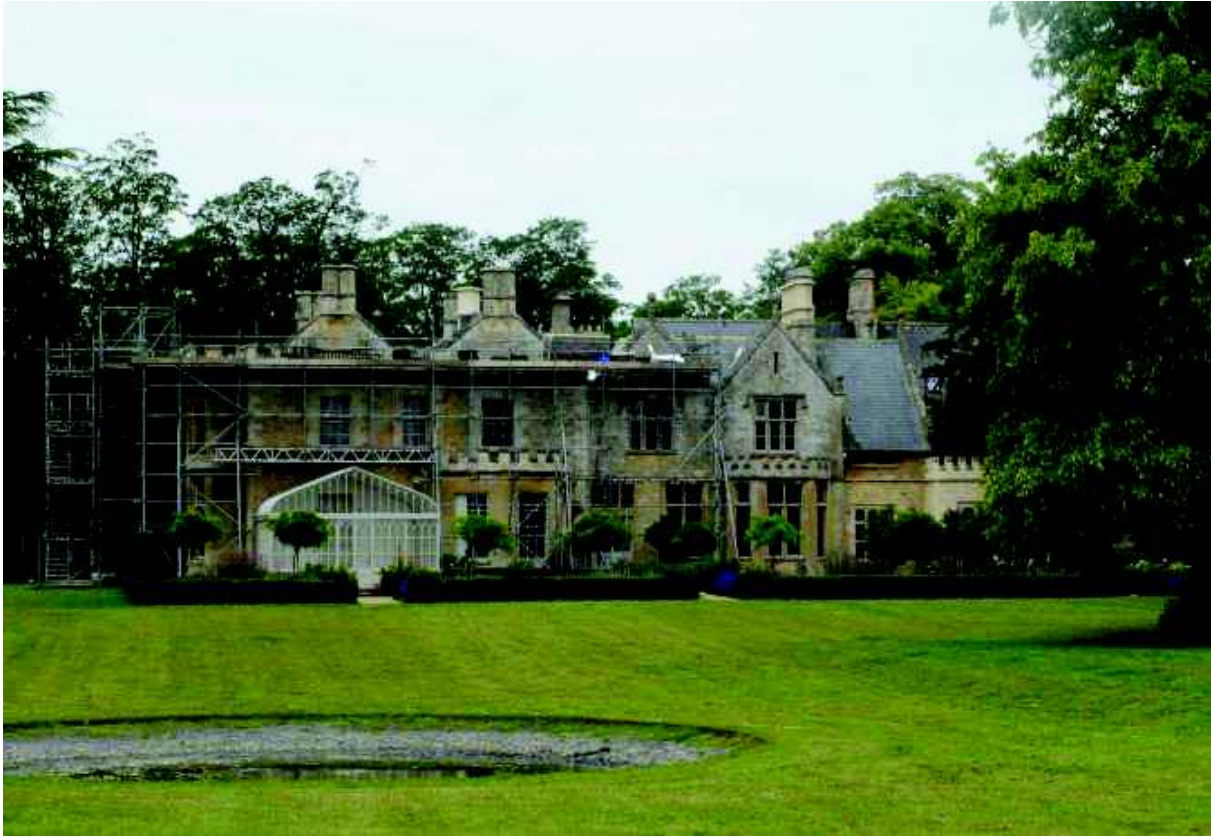
**Plate 14: Southeast elevation**

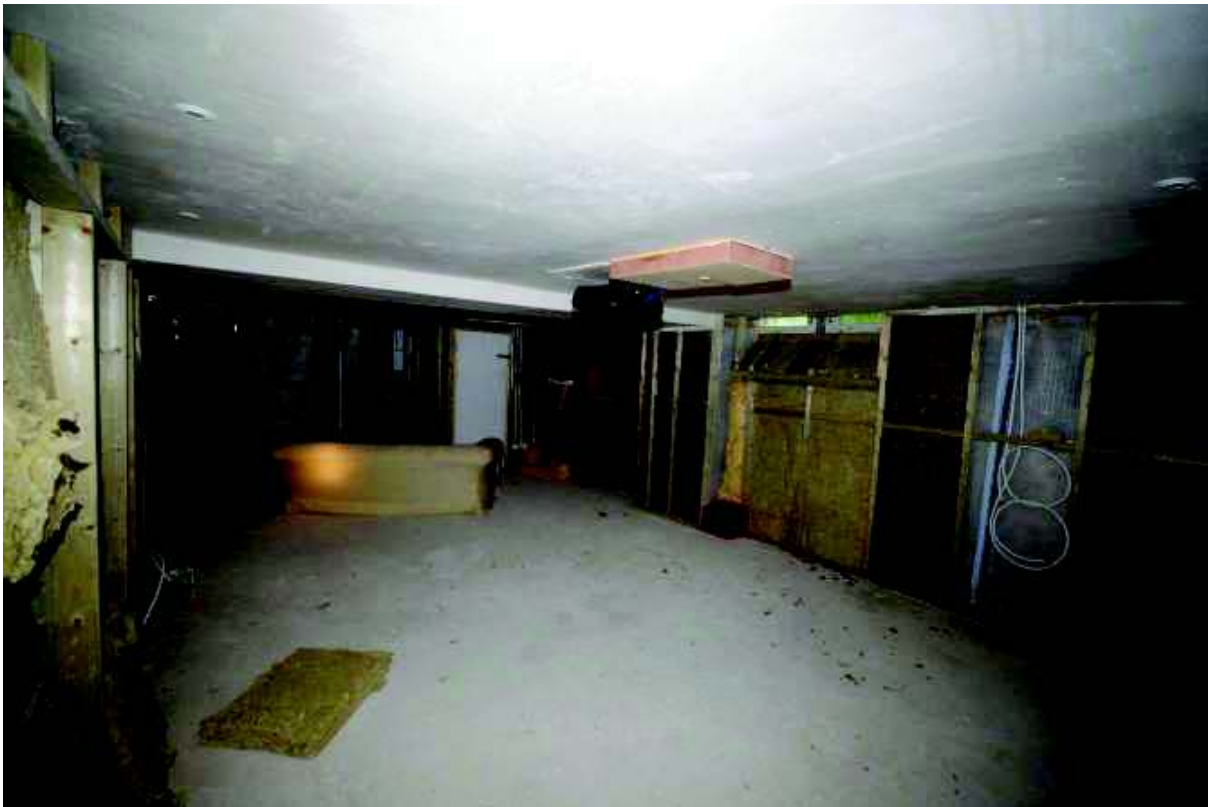
The cellar comprises two rooms - a larger room to the southeast and a smaller room to its northwest. The larger room is lined with modern timber and insulation except for a small area of exposed stone to the northeast. The room follows the shape of the bay window above at this end, and a pair of windows in this structure admit light to the cellar area. A further light is present further to the southwest of this window. The ceiling is flat and modern finishes obscure any constructional details.

Plate 15: Eastern aspect, southeast cellar room

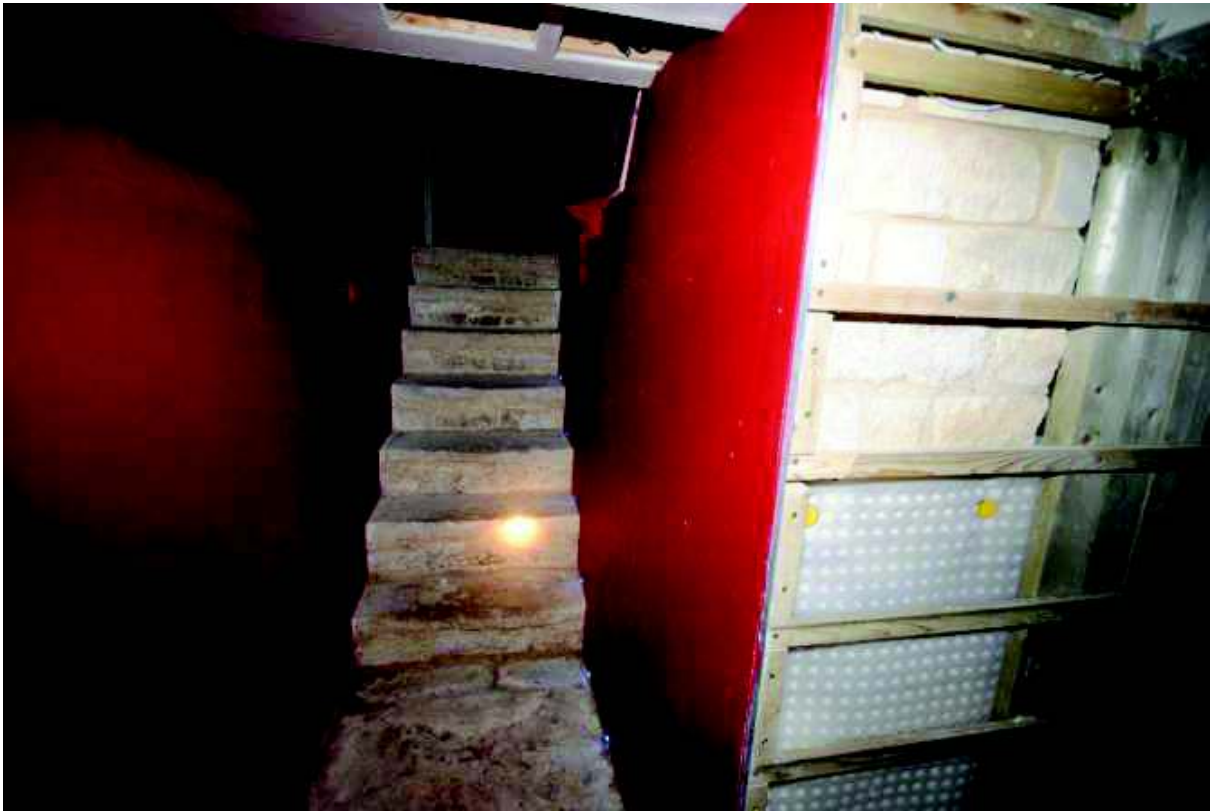
The internal staircase has worn stone steps. Modern finishes obscure any historic detail in the walls and ceiling.

Plate 16: Internal staircase from ground floor

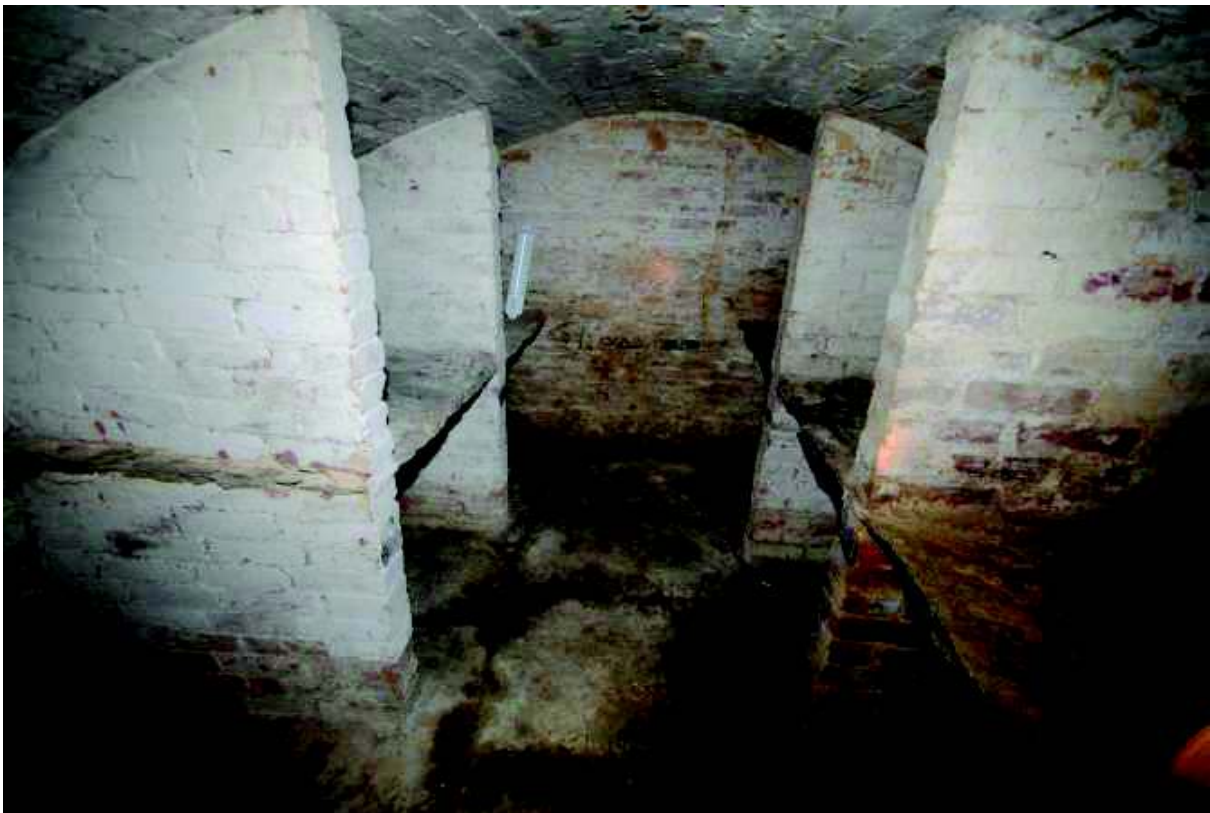
The second room in the cellar, accessed via a short angled passageway, has a vaulted brick ceiling. Brick walls divide this part of the structure into eight bays. These are fitted with stone slab shelves, although one is missing. The floor is of flagstones, whereas in the southeast room, it is of poured concrete.

Figure 7: Northwest room viewed from northeast

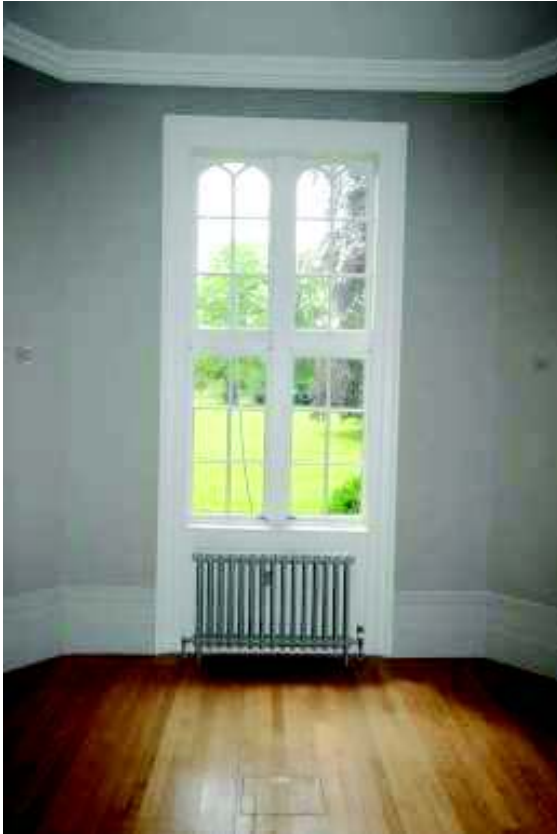
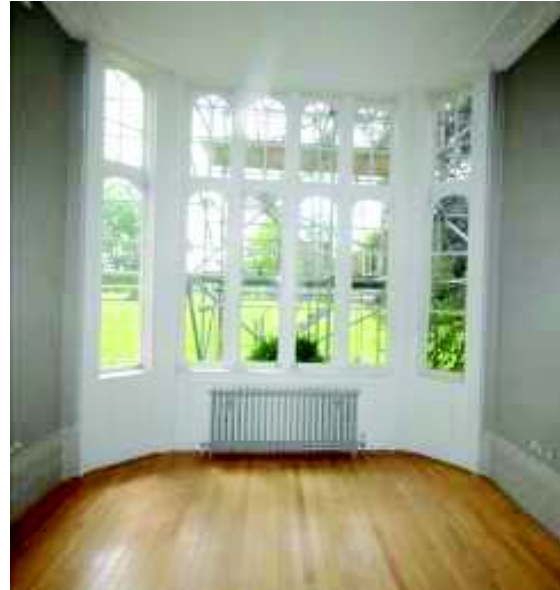
**Plate 21: Detail of windows in bays**

Two bays with moulded window surrounds  
18<sup>th</sup> - 19<sup>th</sup> century neo-classical carved marble fireplace with thistle and rose motif  
Brass fireplace insert of early 19<sup>th</sup> century date, with stylised thistle mouldings  
Service bell pull to left of fireplace  
Moulded cornice with floral motif  
Deep skirting  
Parquet floor

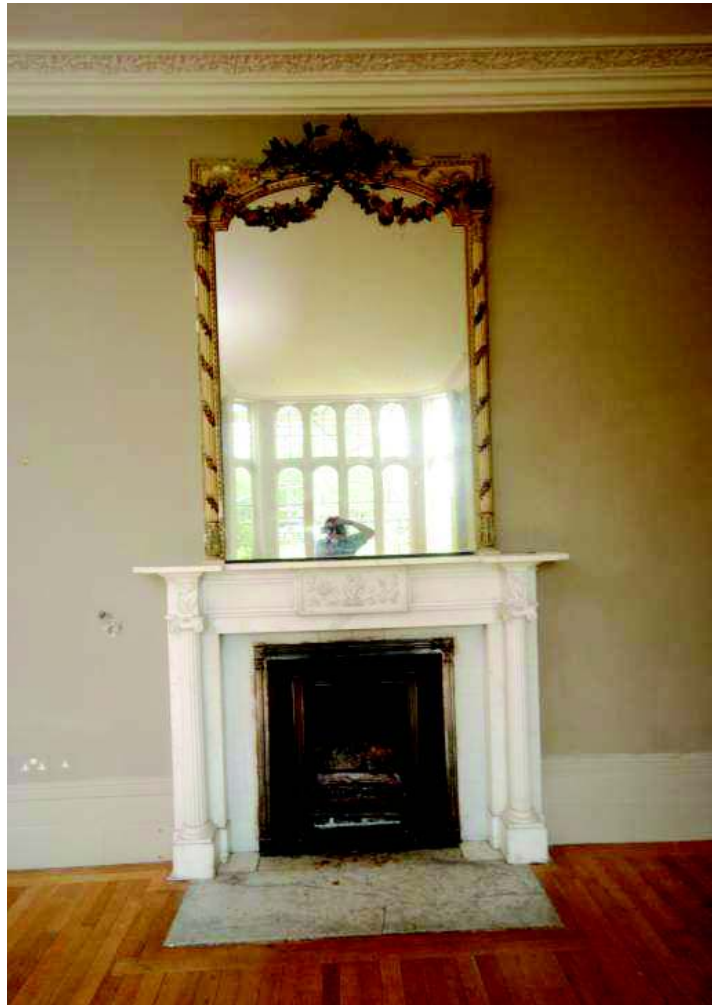
**Plate 22: Fireplace**

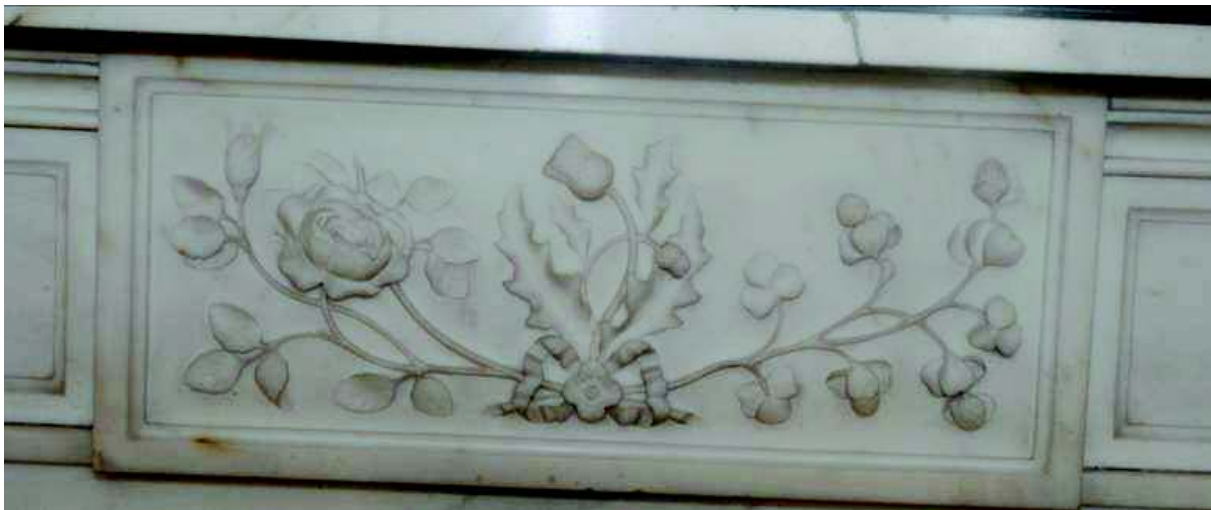
**Plate 23: Detail of rose and thistle motif, fireplace**

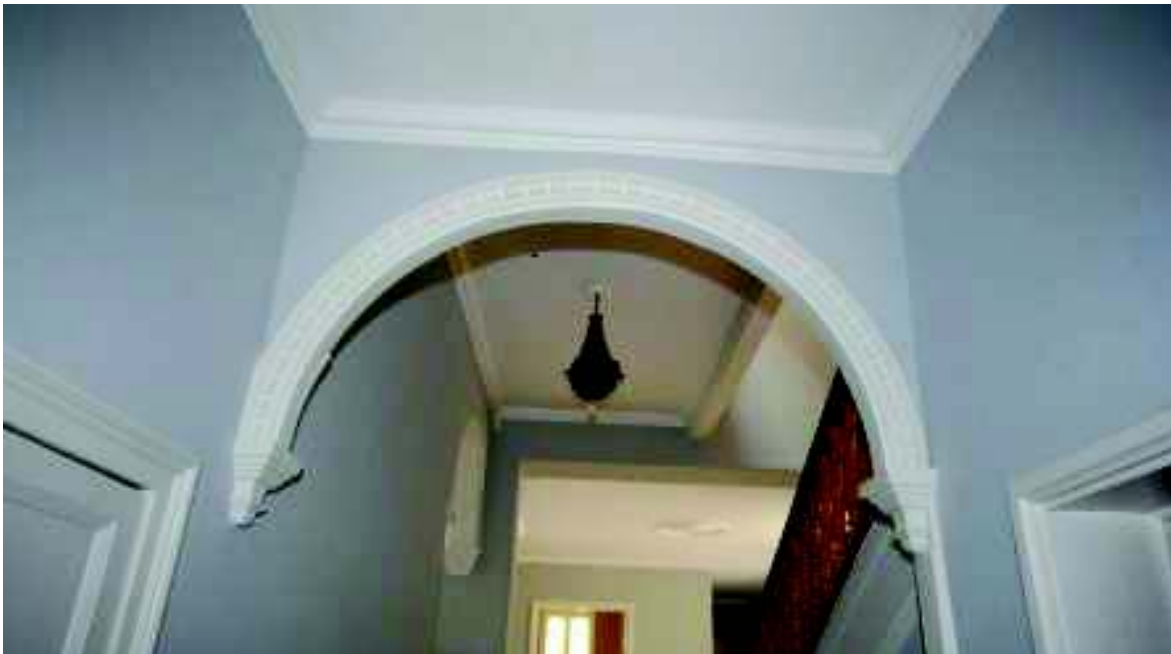
Plate 33: Detail of arch moulding

Arch to southwest with dentil moulding

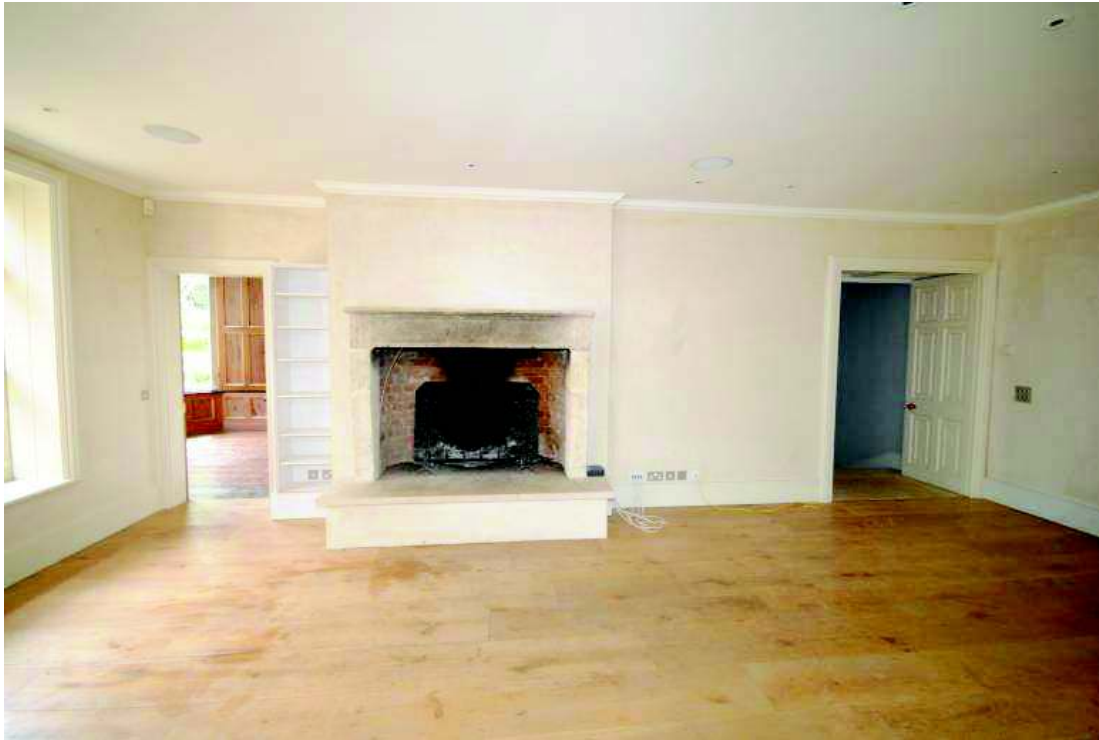
**Plate 36: Southwest aspect**

19<sup>th</sup> century stone mullioned and transomed windows to southwest

19<sup>th</sup> century fireplace to southwest, raised on plinth

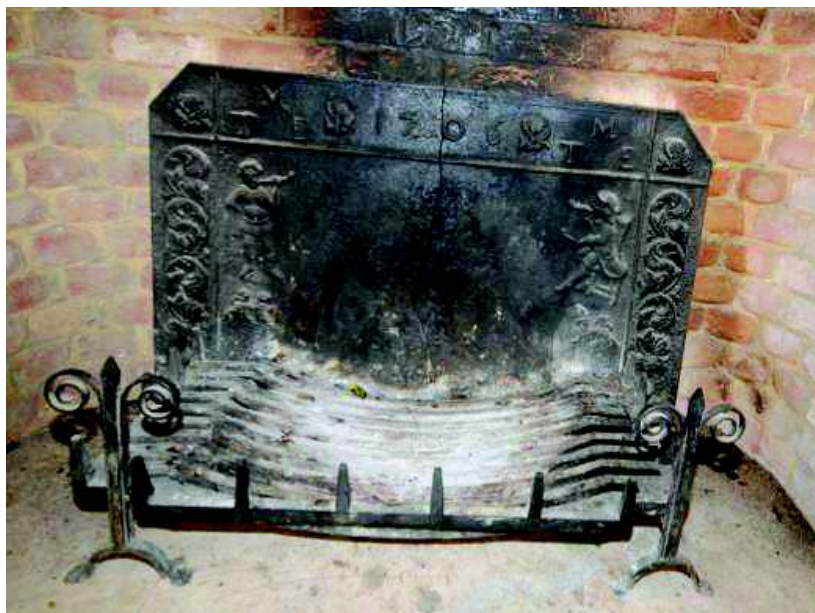
**Plate 37: Detail of fireback**

Cast iron fireback dated 1706 with floral motif and the initials 'M T E', images of a person in contemporary western dress seated and a standing individual wearing a loincloth, both smoking clay tobacco pipes, not in-situ as this is a 19<sup>th</sup> century part of the building

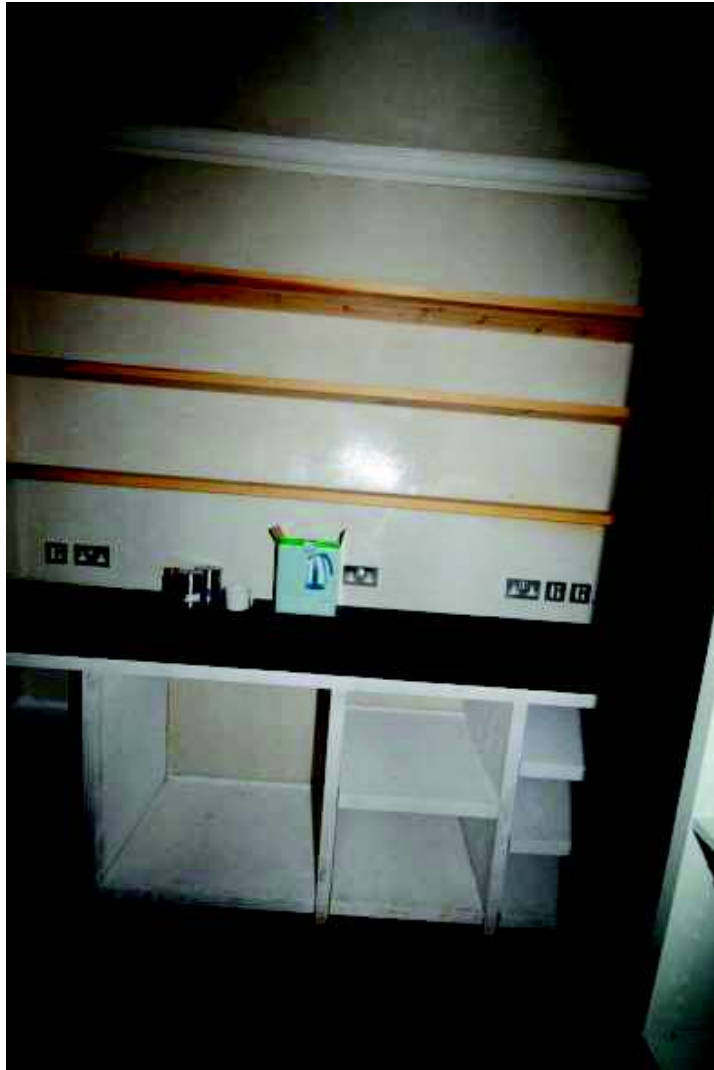
**Plate 38:** Northwest aspect, room 8

Late 19<sup>th</sup> century cornice

Late 19<sup>th</sup> century quarry tile floor
