## HERITAGE STATEMENT

Little Faringdon House (Langford House)  
Little Faringdon  
Lechlade  
Oxfordshire GL7 3QN

**Heritage Statement:  
Little Faringdon House (Langford House)  
Little Faringdon, Lechlade, Oxfordshire GL7 3QN  
SP2237201563  
by  
Dr Peter Wardle & Colin Lacey  
20/07/2011**

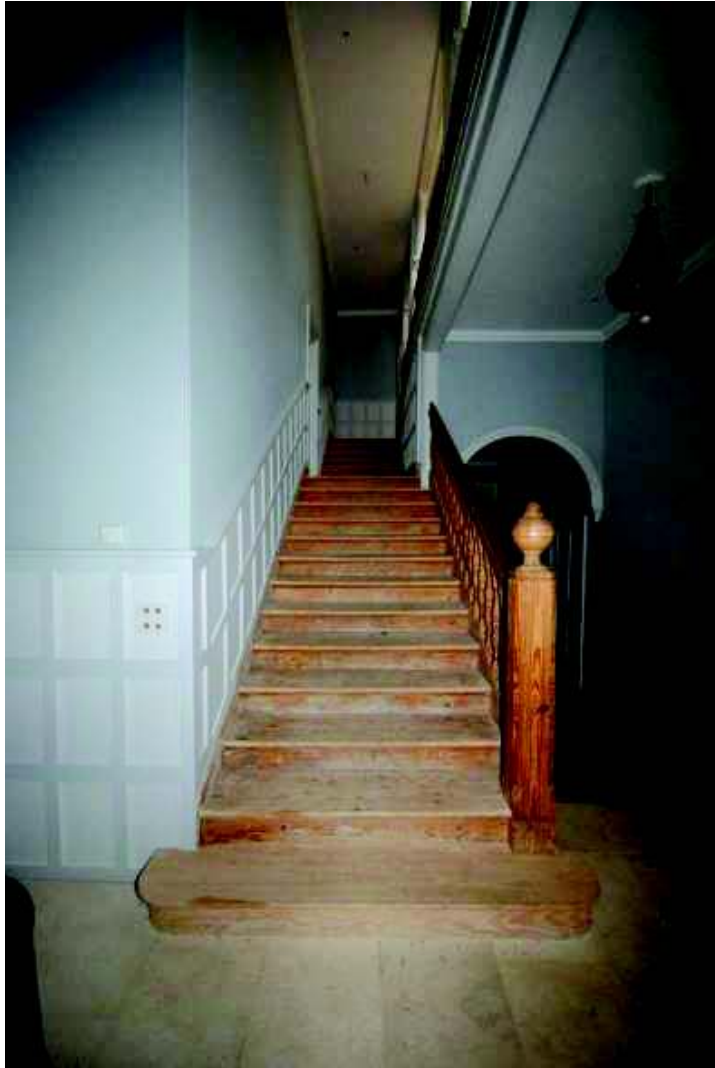
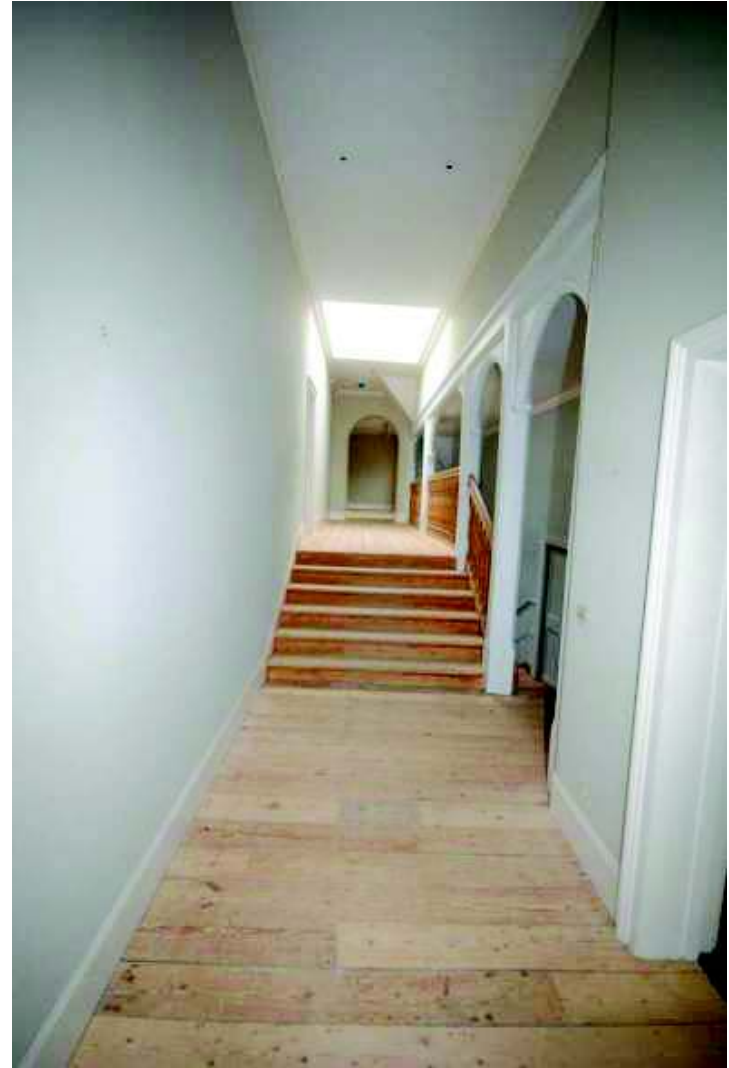
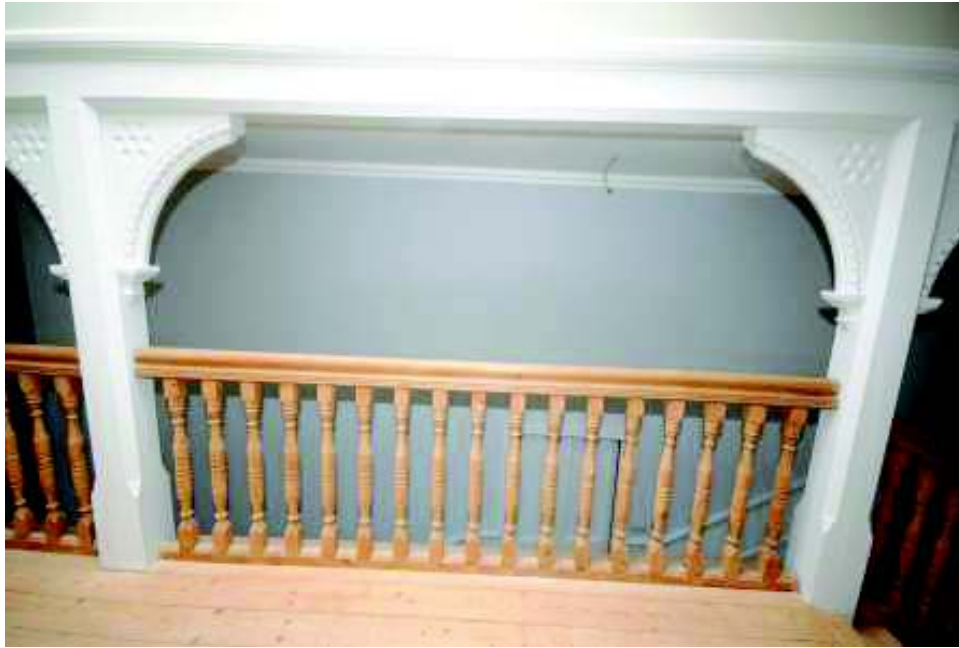
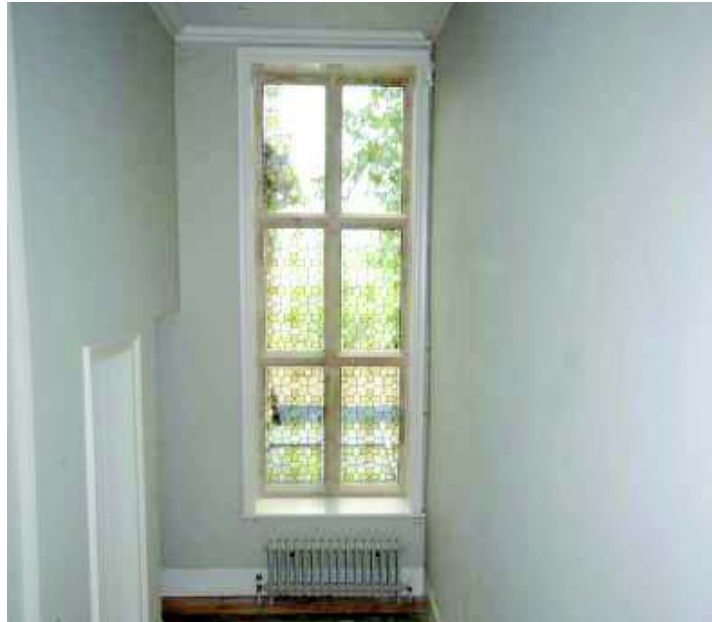
Plate 73: Staircase viewed from ground to first floor

Plate 74: View southwest along landing area

**Plate 75: Detail of brackets and balusters**

**Plate 76: Detail of stained glass window**

Closed string staircase from ground floor, apparently softwood although 17<sup>th</sup> - 18<sup>th</sup> century styled balusters

Small-square panelling in a 17<sup>th</sup> - 18<sup>th</sup> century style, historic detail concealed by paint

Chamfered posts with dentil moulded arch-brackets forming arched openings over staircase

Stone mullioned and transomed window with stained leaded lights to northeast

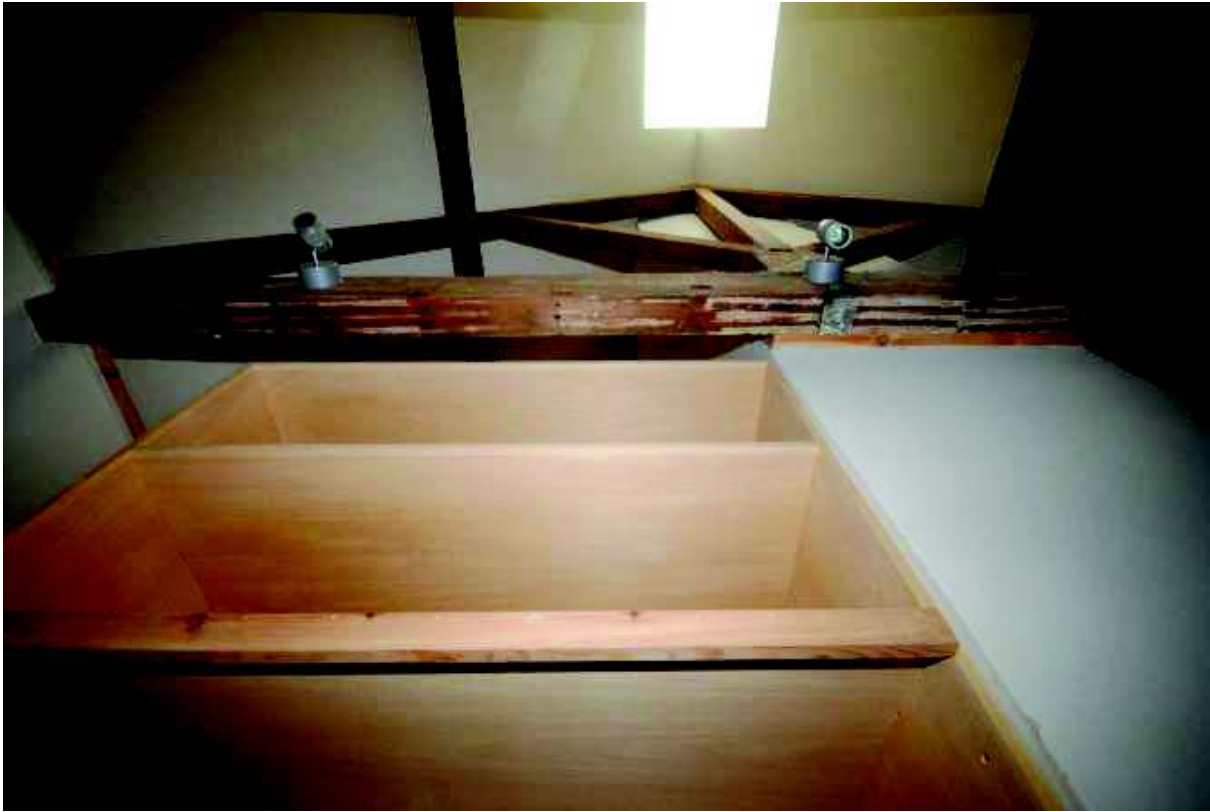
Plate 79: Roof structure over storage area

Narrow storage area leads from western corner of room, featuring machine-sawn timber king post / raking strut truss and machine-sawn purlins (post 1790) with roof light over Stone mullioned and transomed window with four opening lights  
Slope of roof visible in southern corner of room  
Wide floorboards  
Moulded stone fireplace with tiled insert, 19<sup>th</sup> century

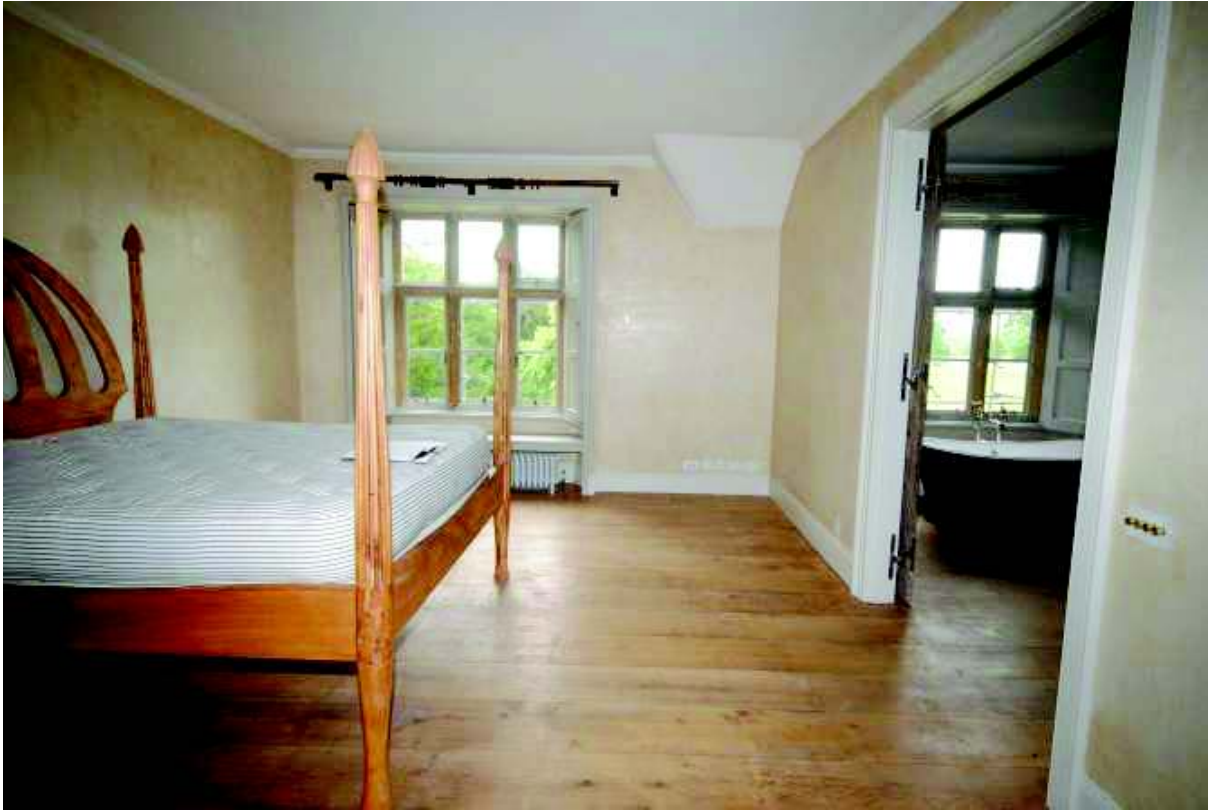
**Plate 81: Southeast aspect**

Stone mullioned and transomed window with four opening lights  
Window seat  
Panelled shutters  
Wide floorboards  
Slope of roof visible in southern corner of room

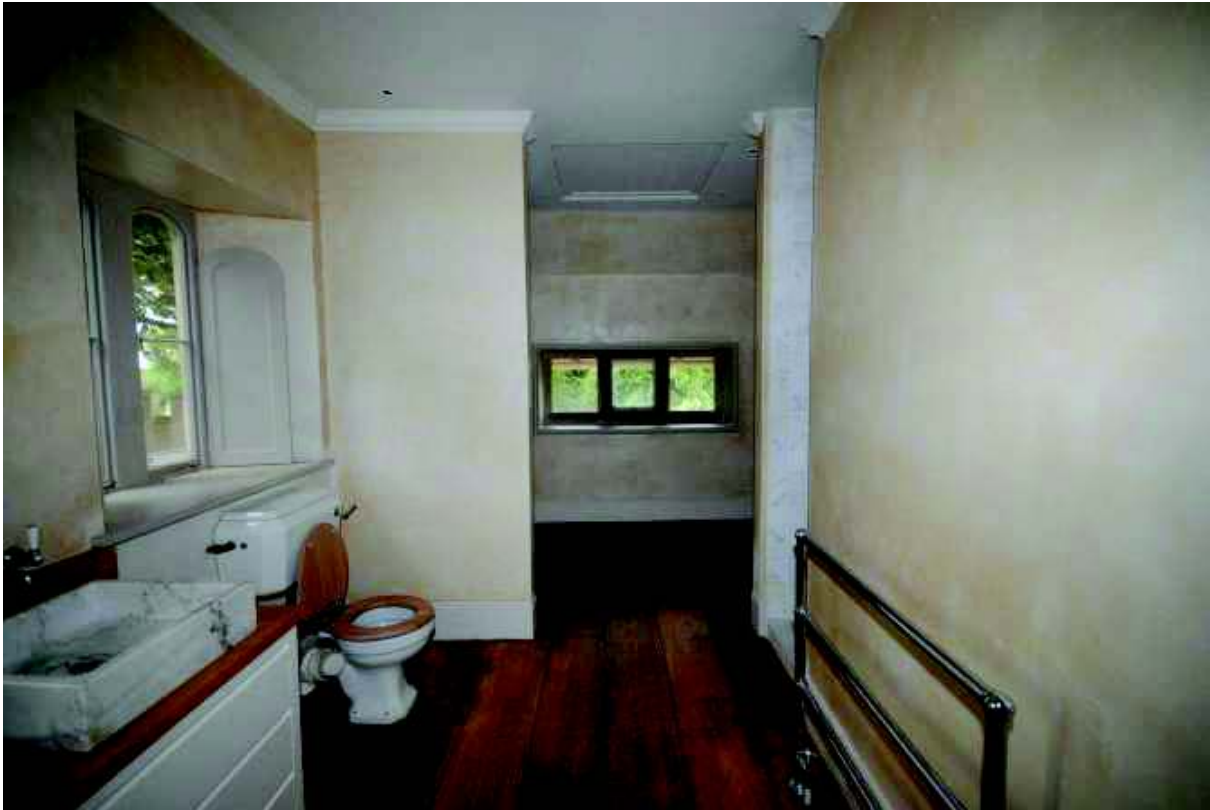
Plate 82: Southeast aspect

Closed string staircase

Low stone mullioned window to southeast with central opening casement and panelled window surround

Pair of mullioned windows each with two opening casements, arched heads and panelled arched shutters which may be modern

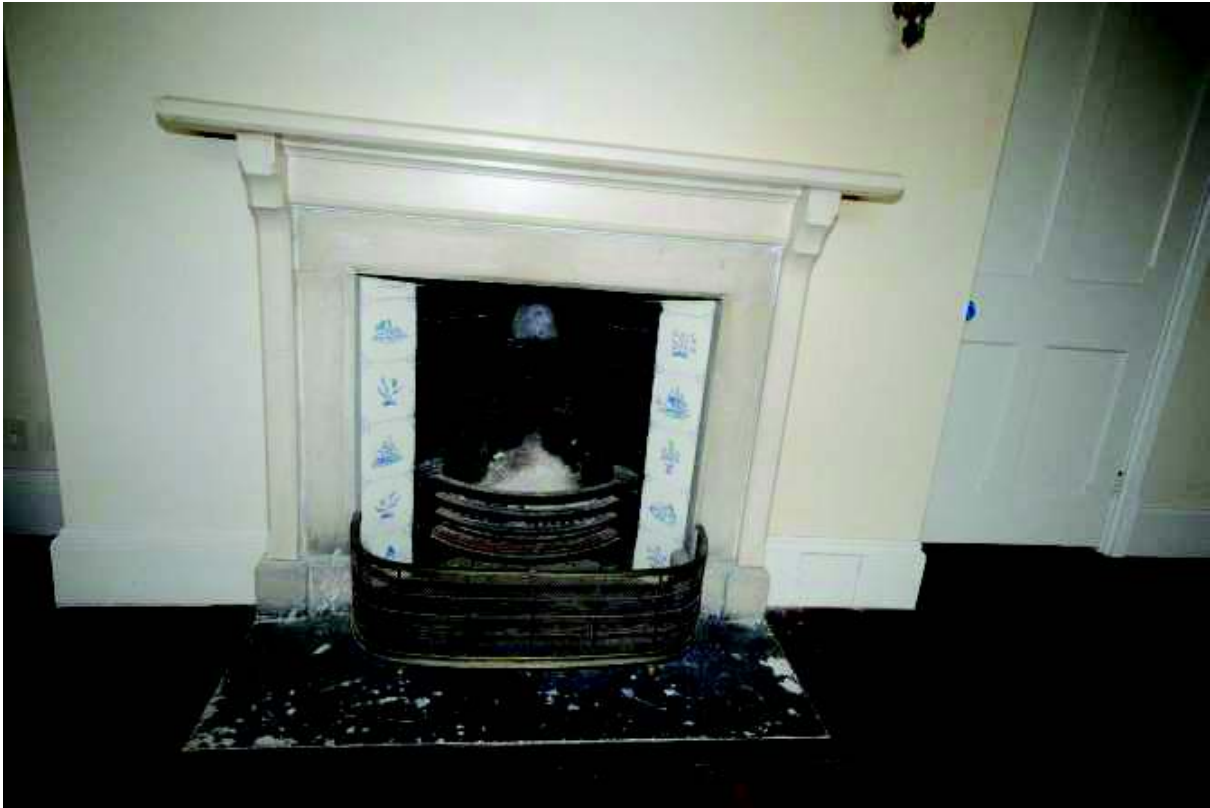
Plate 83: Detail of tiled fireplace

Chimneybreast with 19<sup>th</sup> century stone and tiled fireplace with blue-on-white tiles similar to those produced by Minton in the late 19<sup>th</sup> century

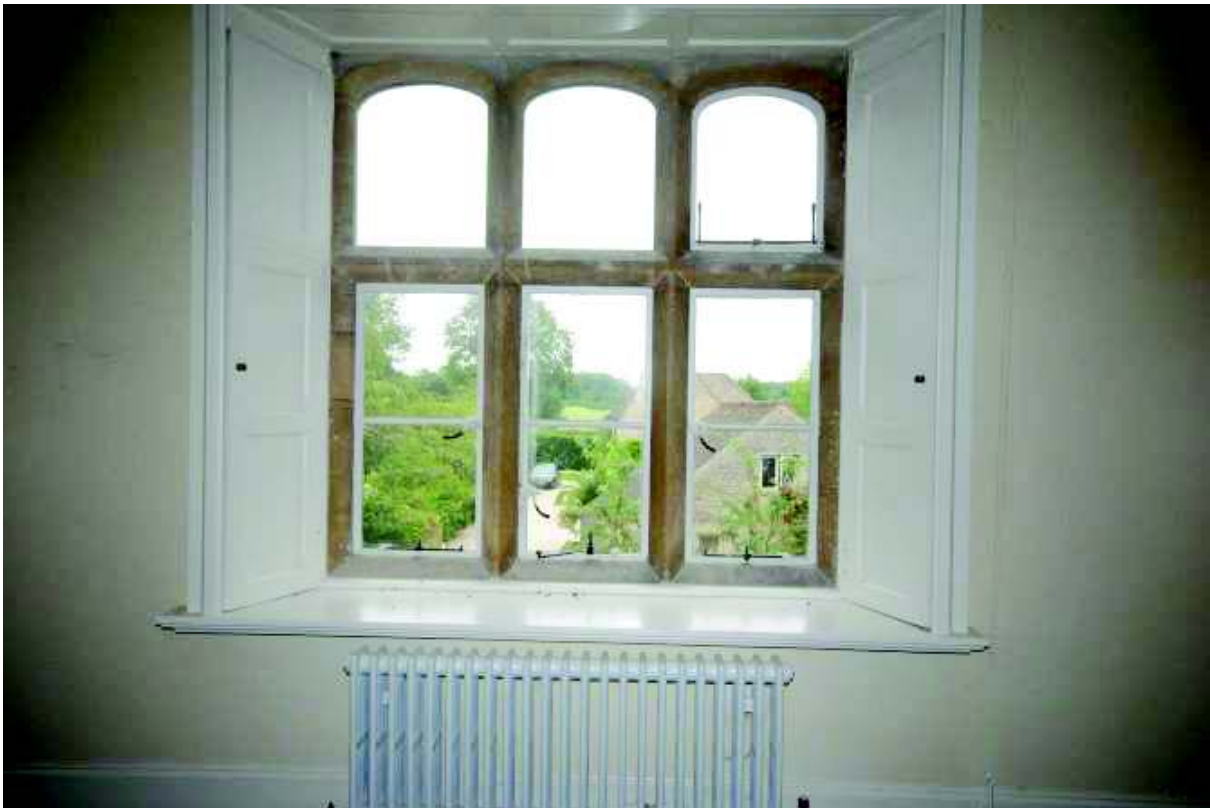
Plate 84: Detail of window

Stone mullioned and transomed northeast window with arched upper lights, four of which open

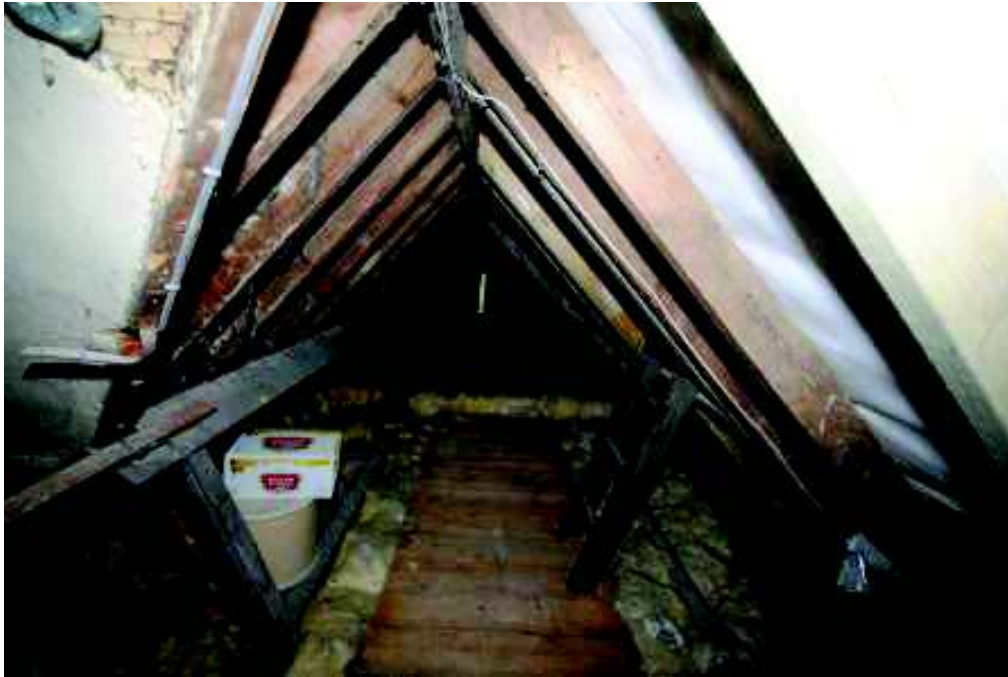
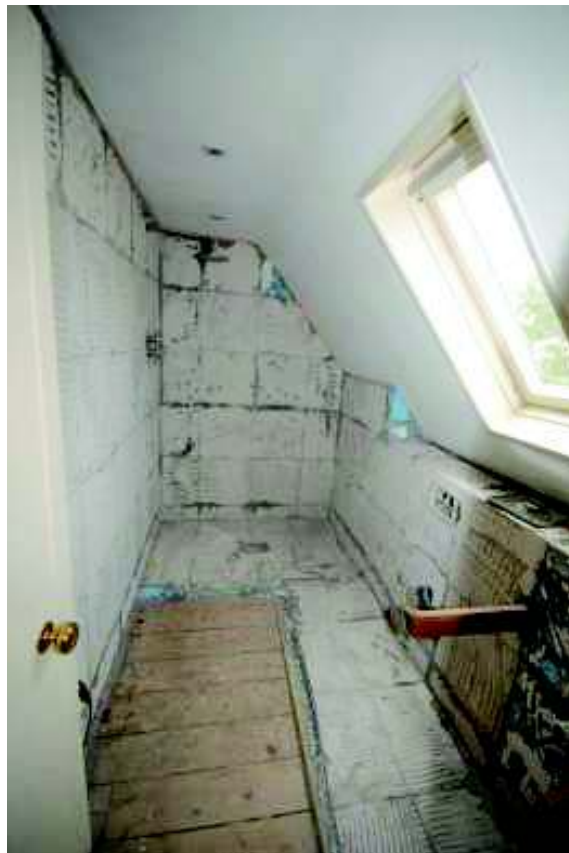
Plate 98: Roof Space

Plate 99: Rendered part of roof space

Common rafter roof constructed from machine-sawn (post 1790) timbers, partially rendered suggesting occupation at some point in the past

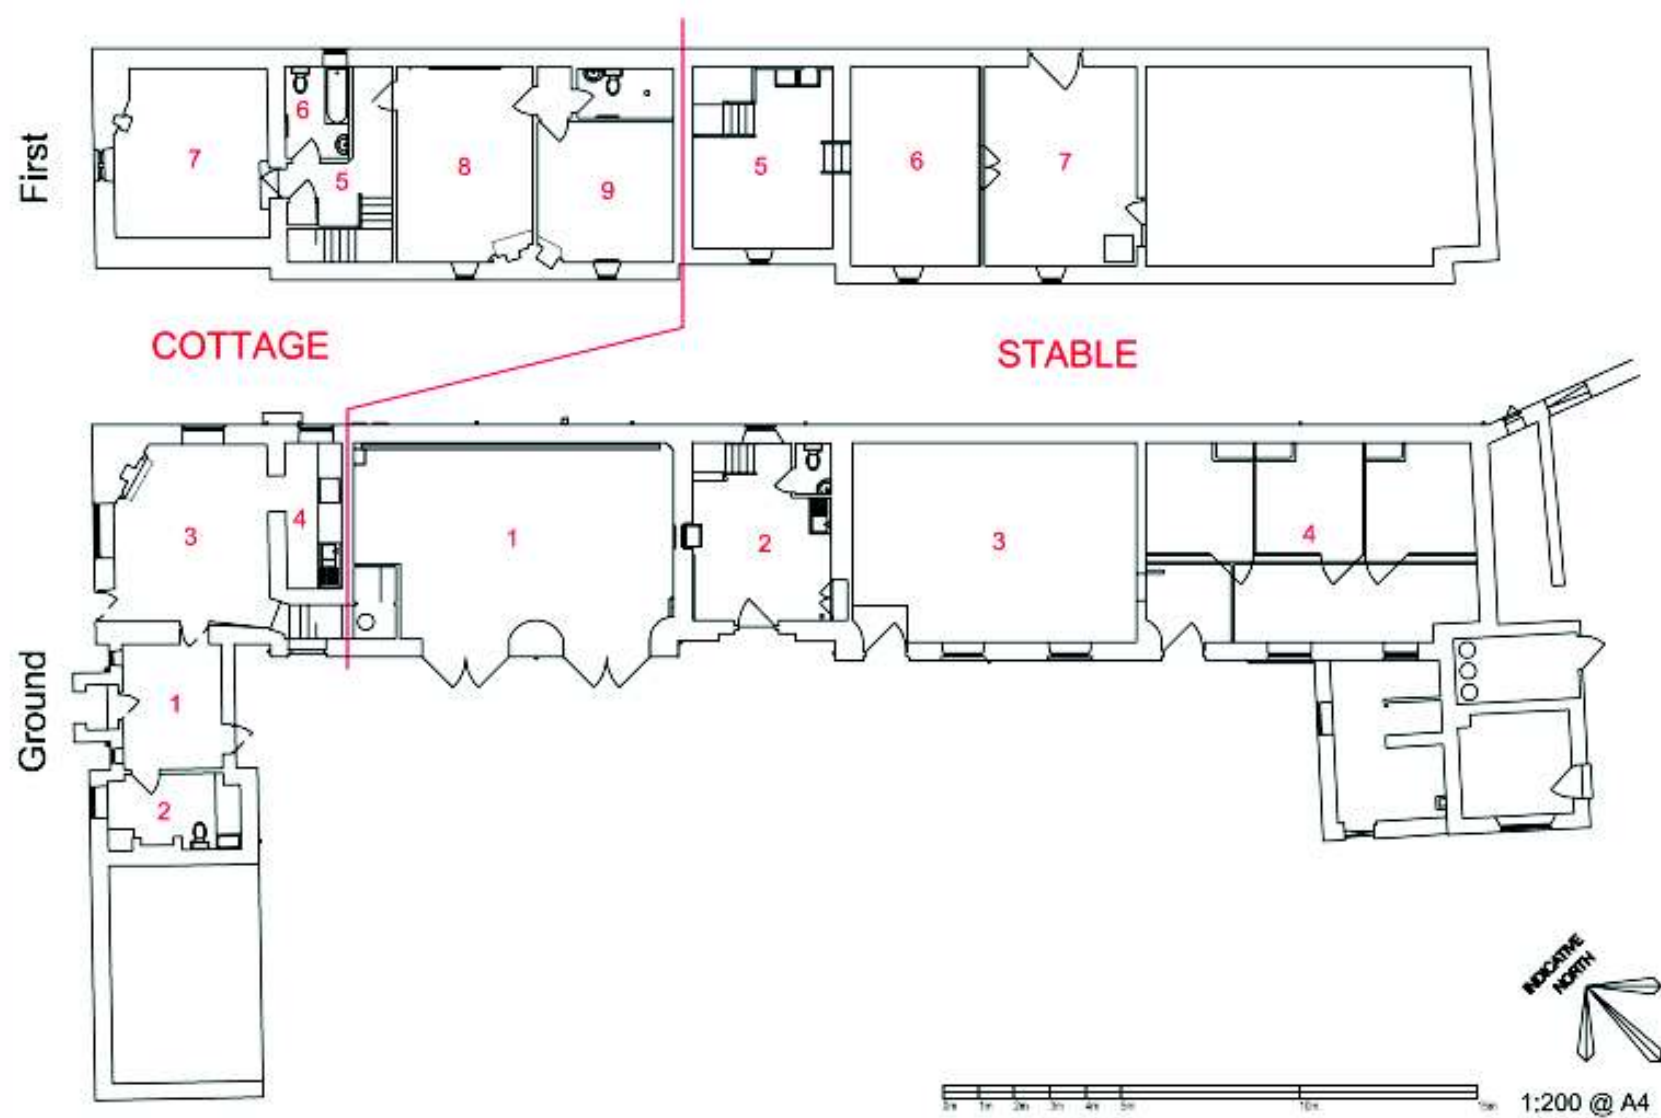
Figure 8: Cottage & stable floor plans

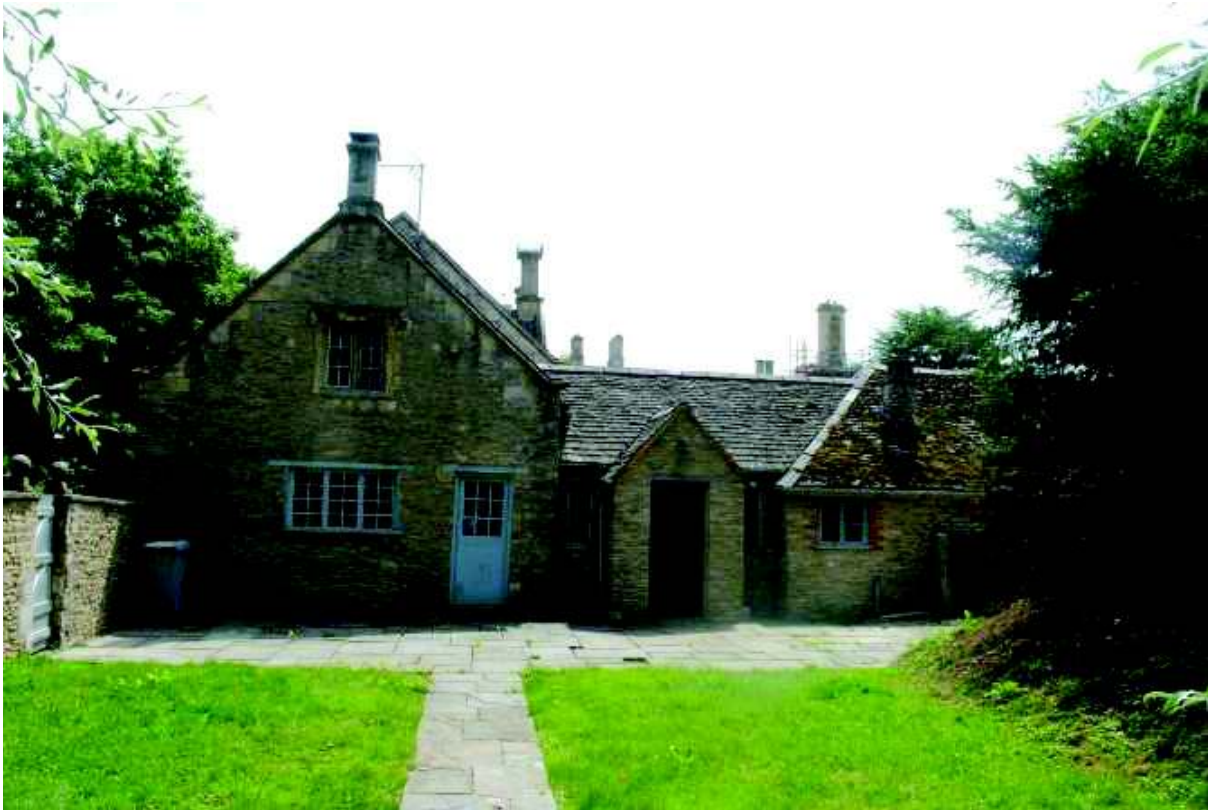
**Plate 100: Northwest elevation**

The cottage is located at the northwest end of the building. The northwest part of the cottage is slightly lower than the main northwest - southeast wing. This is likely to indicate a different phase of construction.

The northwest part of the cottage is a one-and-a-half storey building with the first floor partially located in the roof space. A window is present in the gable wall with stone mullioned surround. The ground floor features a larger timber framed window and timber framed door.

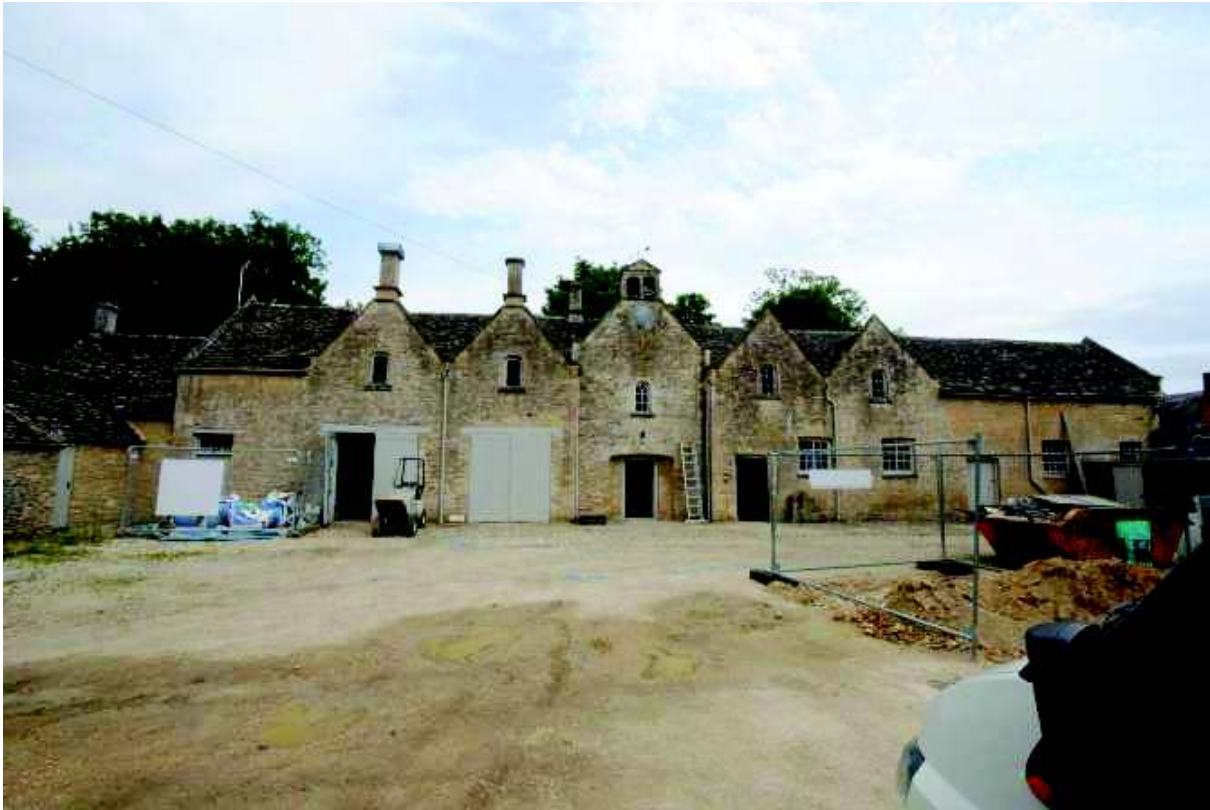
**Plate 101: Southwest aspect**

The southwest aspect of the stable block contains a range of five gables, located slightly off-centre to the northwest.

Each gable has an arch topped stone-framed window with six panes. The central window is slightly lower than the others.

At ground floor level, a single window is present at the northwest end. Moving to the southeast, two large plank and ledge doors are located in the first two bays. Centrally, a pedestrian sized door is located within a three-centred arch which may be a blocking of a wider opening. A stable door and window are located below the next dormer. Beneath the window, a mounting block is built into the wall. The final dormer contains a timber framed window. Further to the southeast, a stable door and two windows are located.

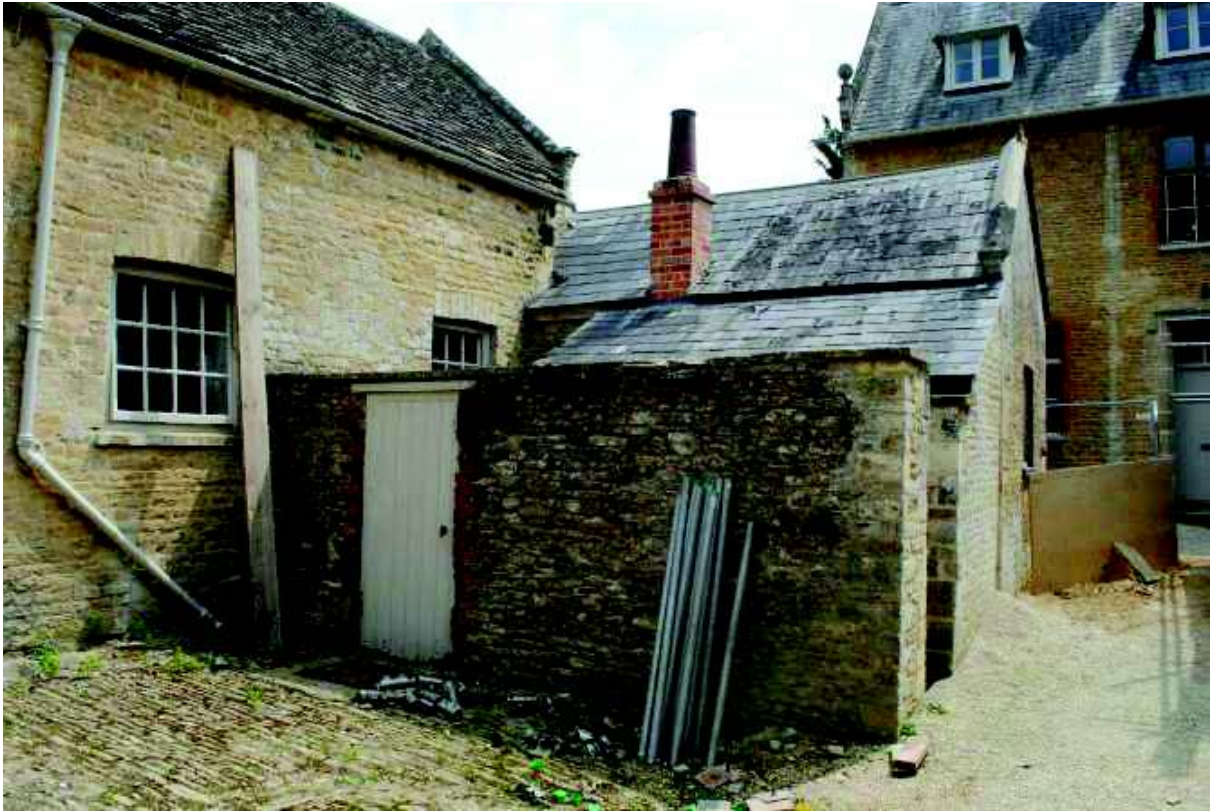
**Figure 11: Southeast part of stable block viewed from west**

At the southeast end of the stable building, a wing projects into the yard. This wing comprises an outbuilding with a lean-to housing a coal / wood store to the northwest. Along the southeast wall of the main range, a further lean-to is located, with its northeast wall formed from the boundary wall and the southeast wall formed by the outbuilding.

The outbuilding features a similarly ornamented gable wall to other buildings on site. The roof is again of slate and on its northwest side, a red brick chimney is present with ceramic chimneypot.

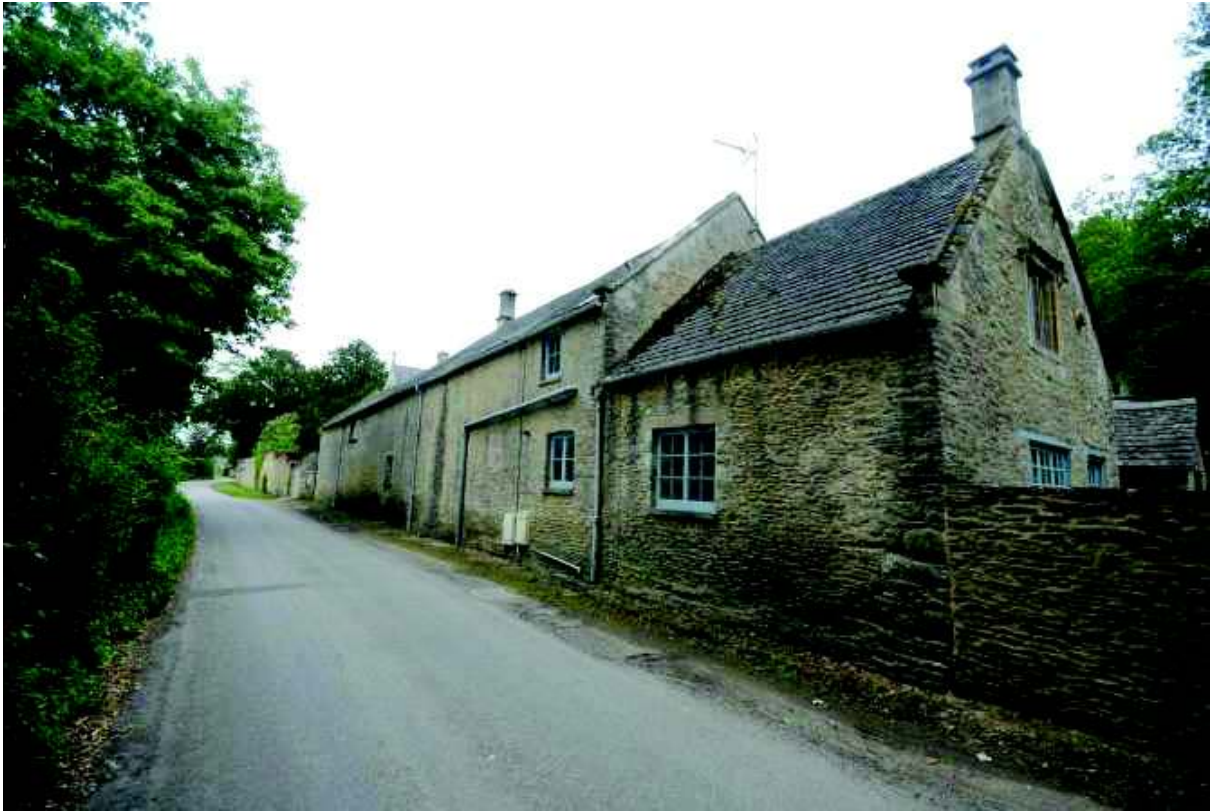
**Plate 104: Northeast elevation viewed from north**

The northeast aspect of the building is largely plain. The difference in roof apex heights is clearly visible.

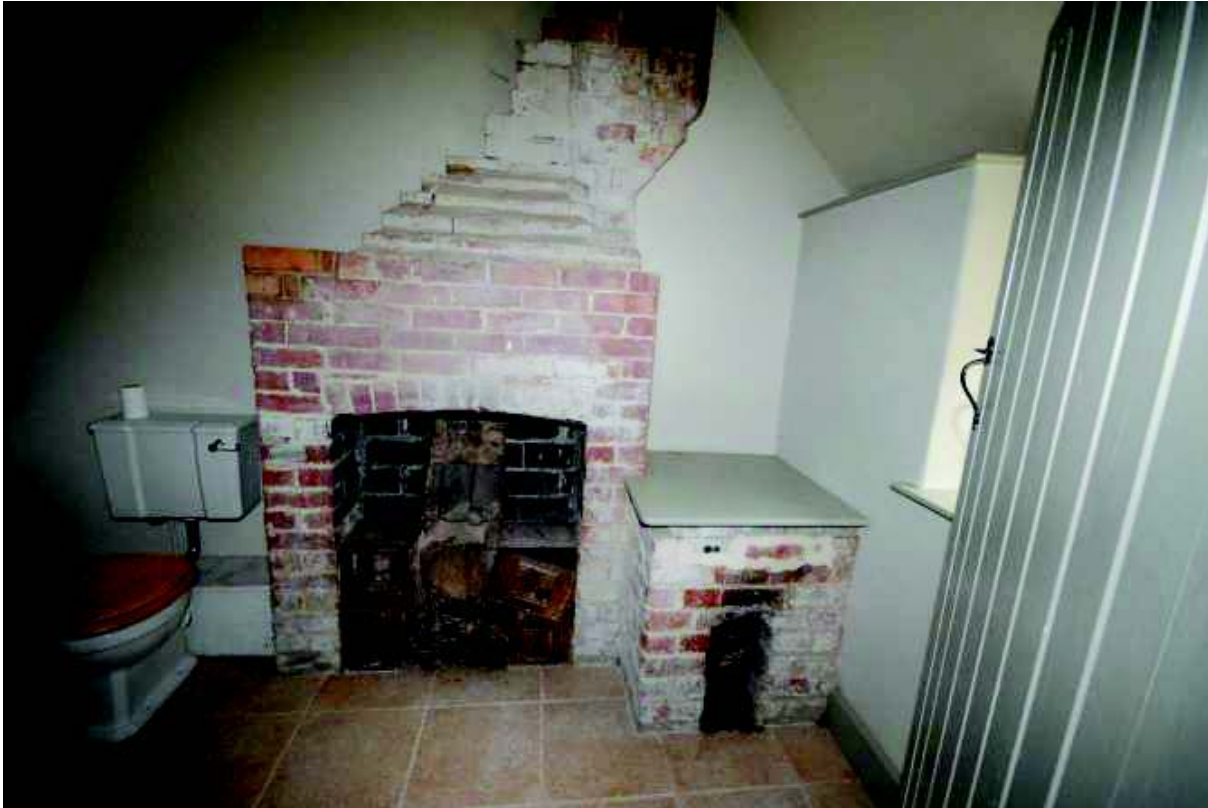
**Plate 106: Detail of fireplace and copper, room 2**

Brick fireplace with chimneybreast over

Remains of cast iron range cooker - smoke blackening suggests this was not an original feature and an open fire was present previously

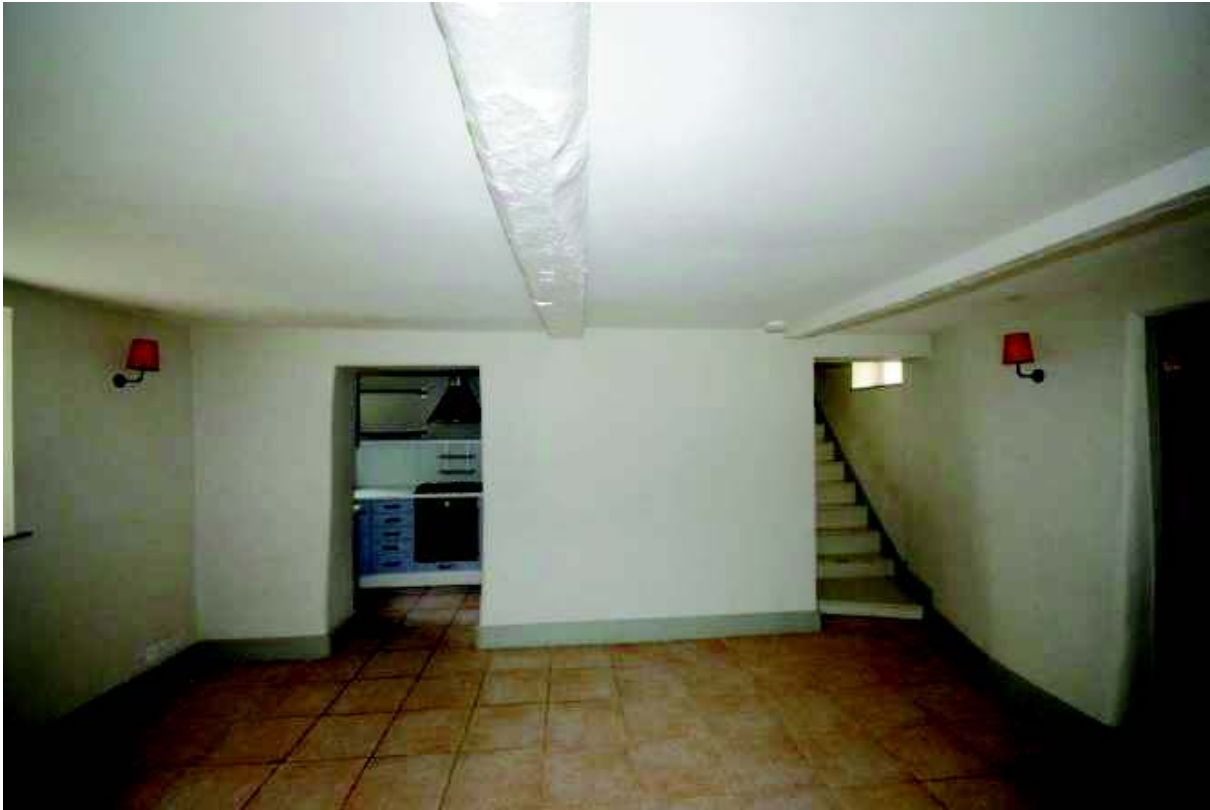
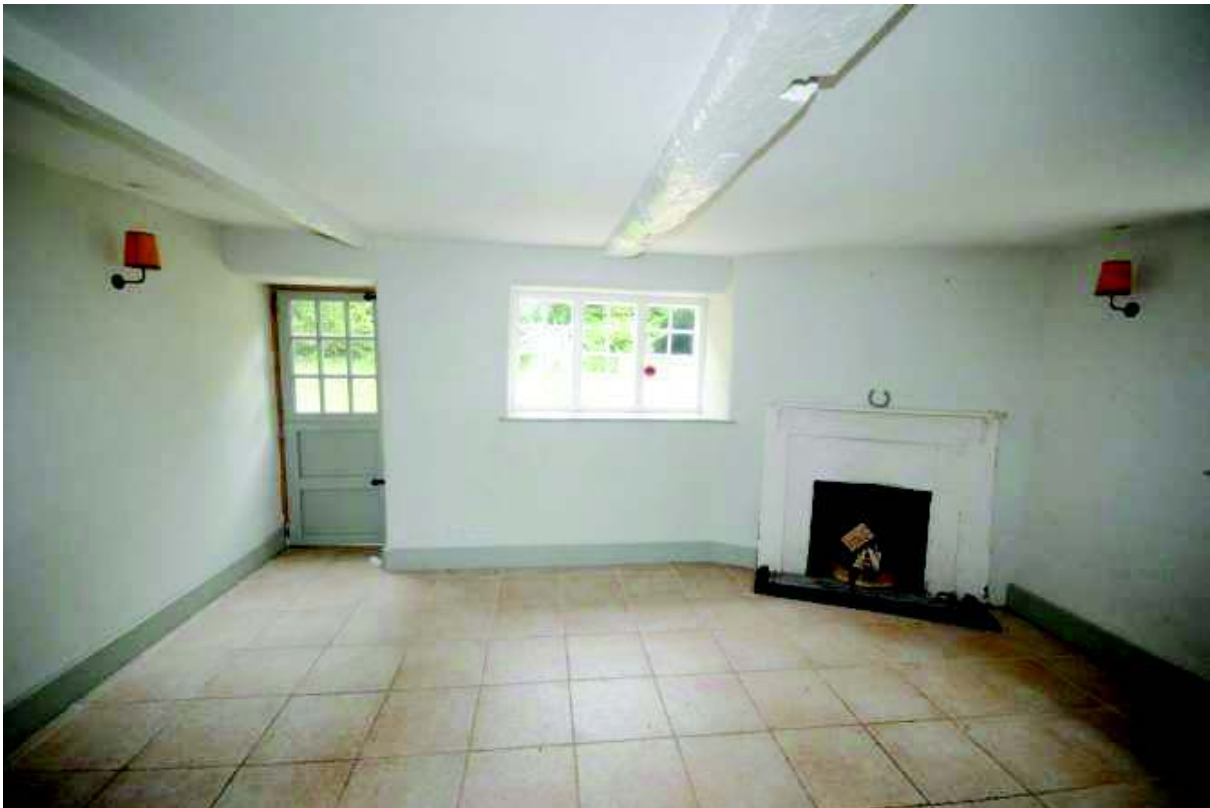
Plate 107: Southeast aspect

Plate 108: Northwest aspect

Two hand-sawn timber beams running northwest - southeast, with empty mortices  
Angled corner with 19<sup>th</sup> century plain timber fire surround and 20<sup>th</sup> century firebasket  
Southeast wall has openings to kitchen and modern winder staircase to first floor

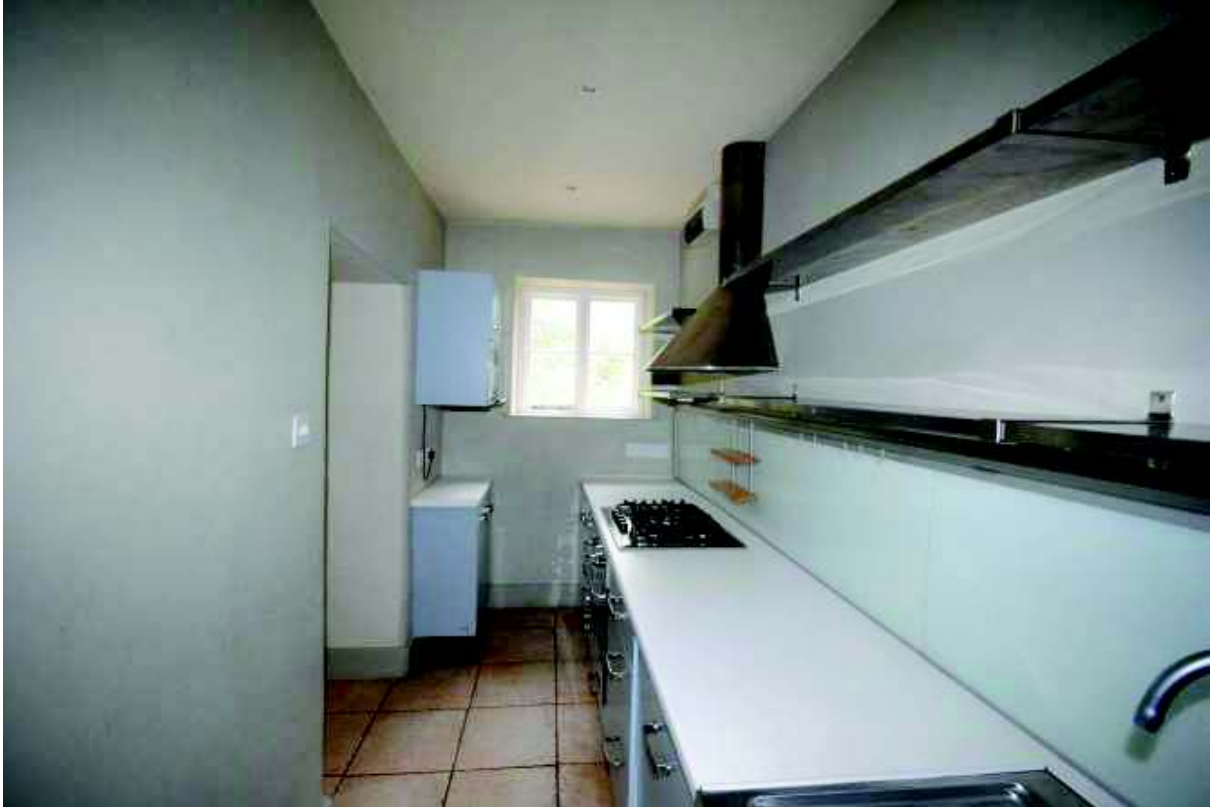
**Plate 109: Northeast aspect**

Opening through wall to room 3

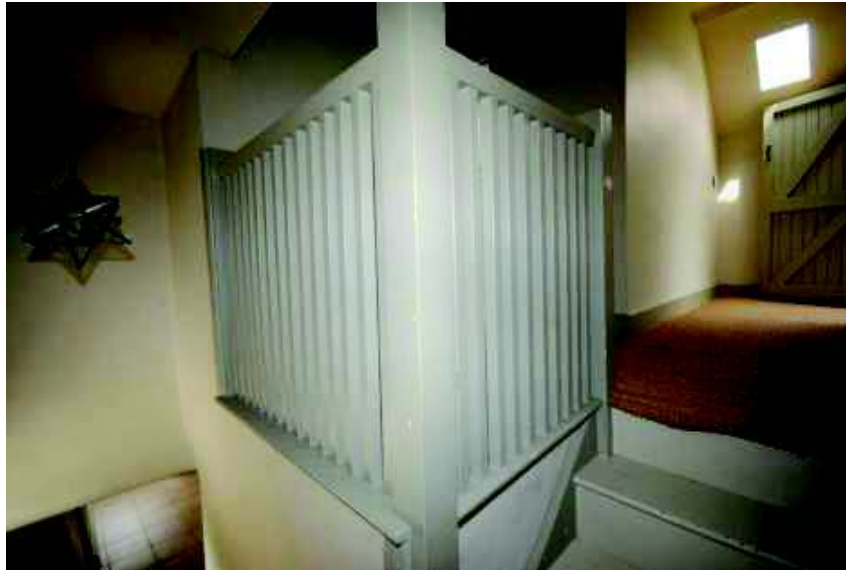
Plate 110: Stairs and landing, room 5

No historic features

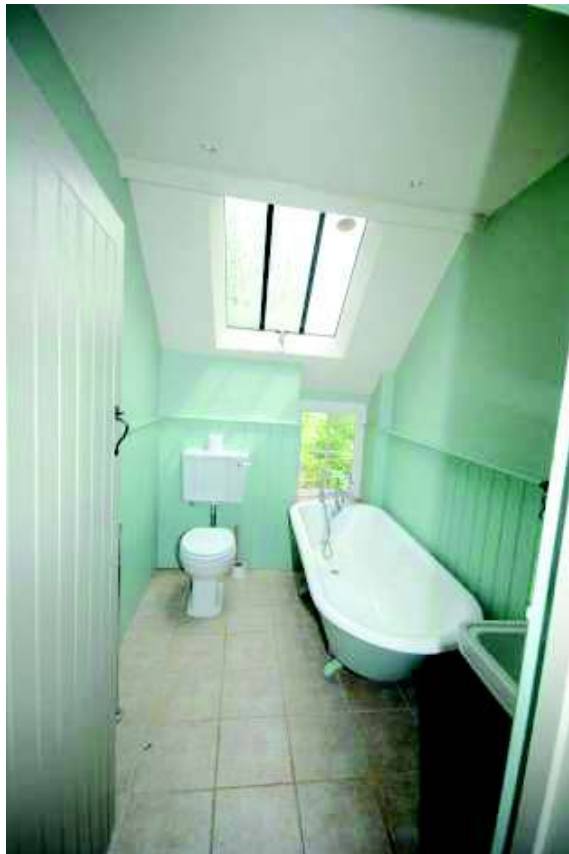
Plate 111: Bathroom

Small window at eaves height

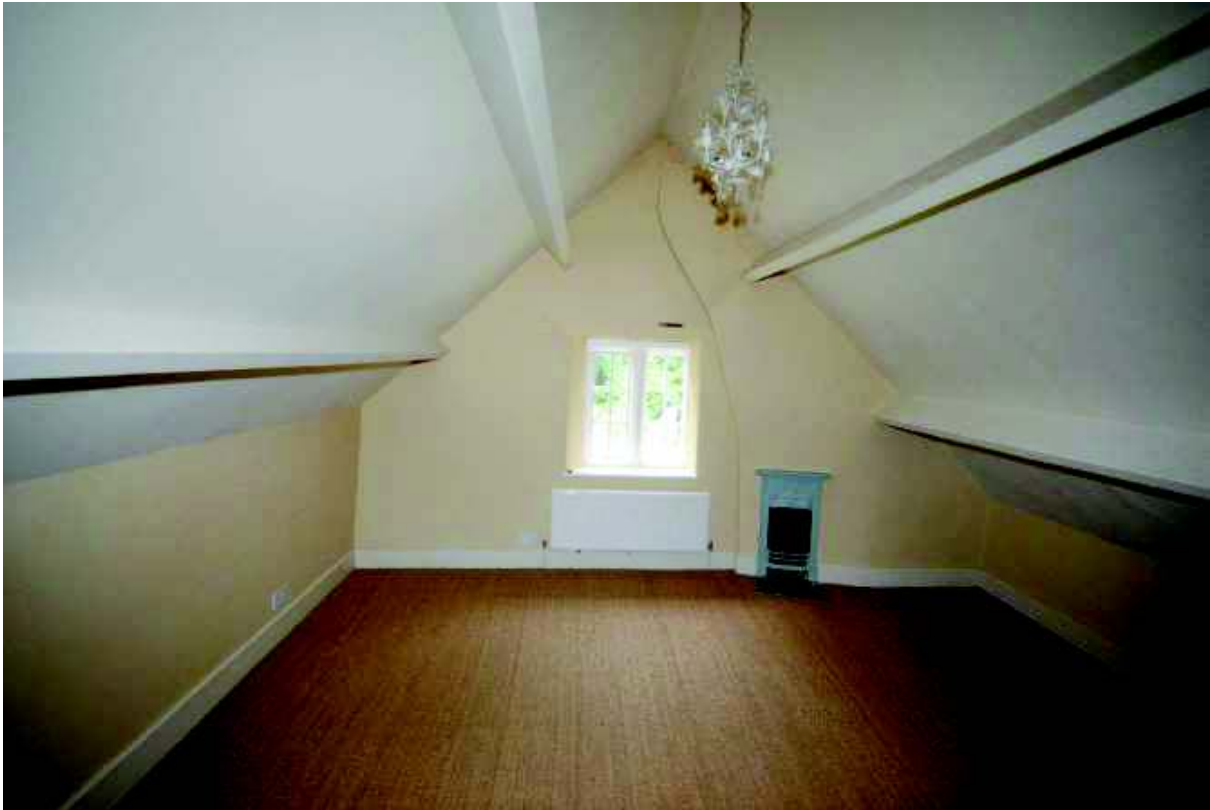
#### Plate 112: Northwest aspect

Machine-sawn (post 1790) purlins

Protruding chimneybreast in northern corner

Cast iron bedroom fireplace (mid - late 19<sup>th</sup> century)

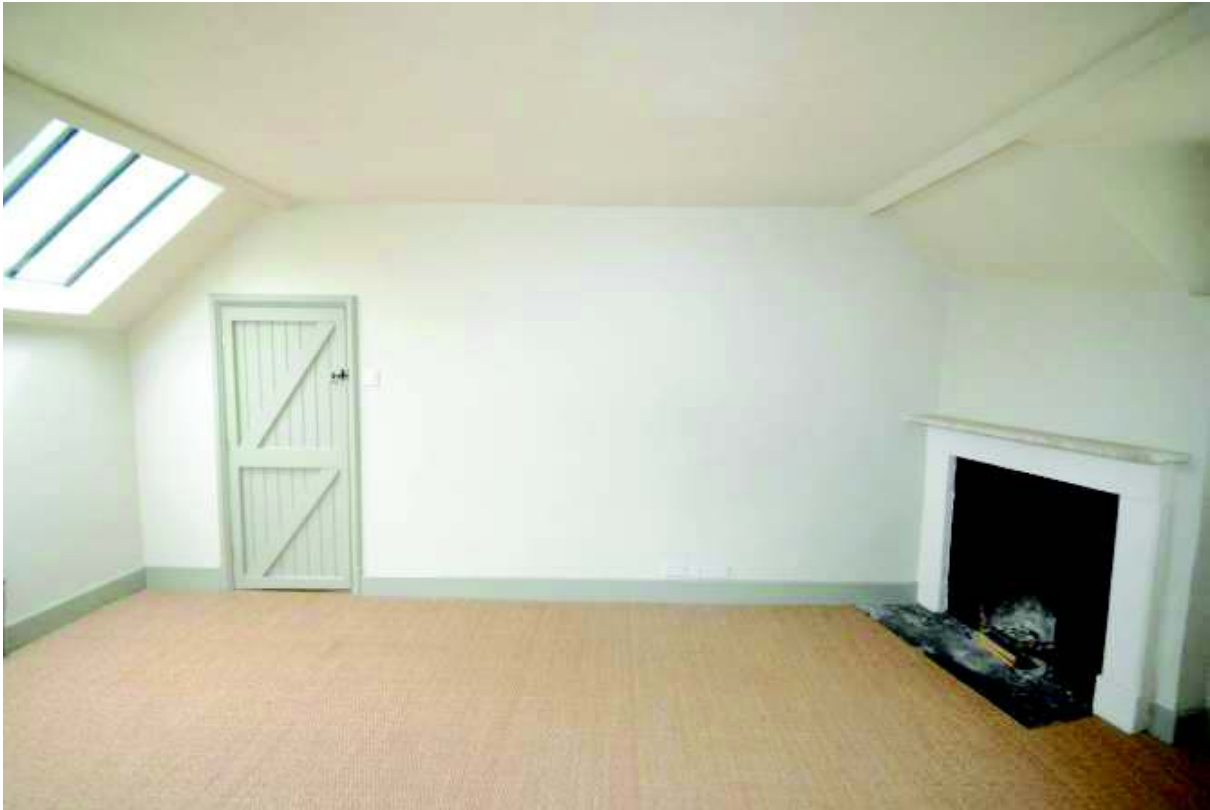
**Plate 113: Southeast aspect**

Plain 19<sup>th</sup> century fire surround with marble top  
19<sup>th</sup> - 20<sup>th</sup> century firebasket
