## HERITAGE STATEMENT

Little Faringdon House (Langford House)  
Little Faringdon  
Lechlade  
Oxfordshire GL7 3QN

**Heritage Statement:  
Little Faringdon House (Langford House)  
Little Faringdon, Lechlade, Oxfordshire GL7 3QN  
SP2237201563  
by  
Dr Peter Wardle & Colin Lacey  
20/07/2011**

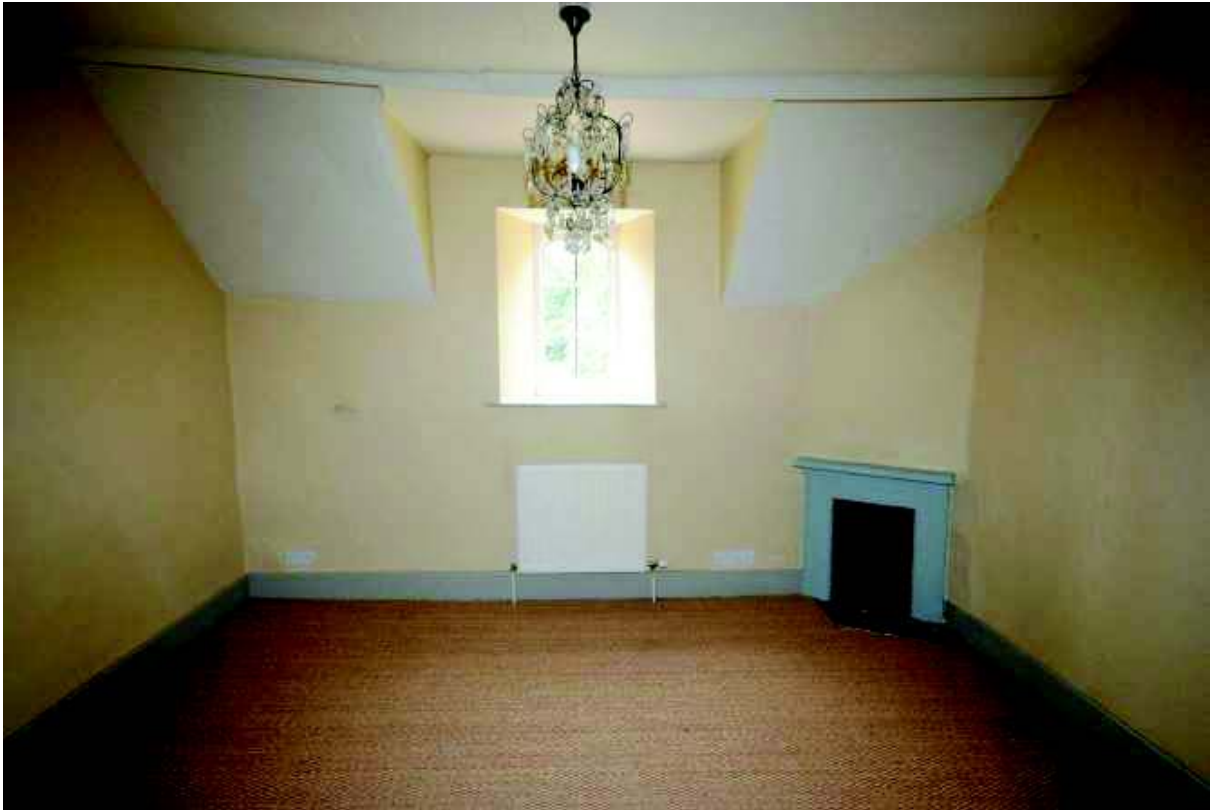
**Plate 114: Southwest aspect**

Slope of roof either side of gable window  
Purlin with iron repair / joining plate over window  
Angled corner with plain 19<sup>th</sup> century fire surround  
Cast iron Victorian bedroom hobgrate fireplace insert

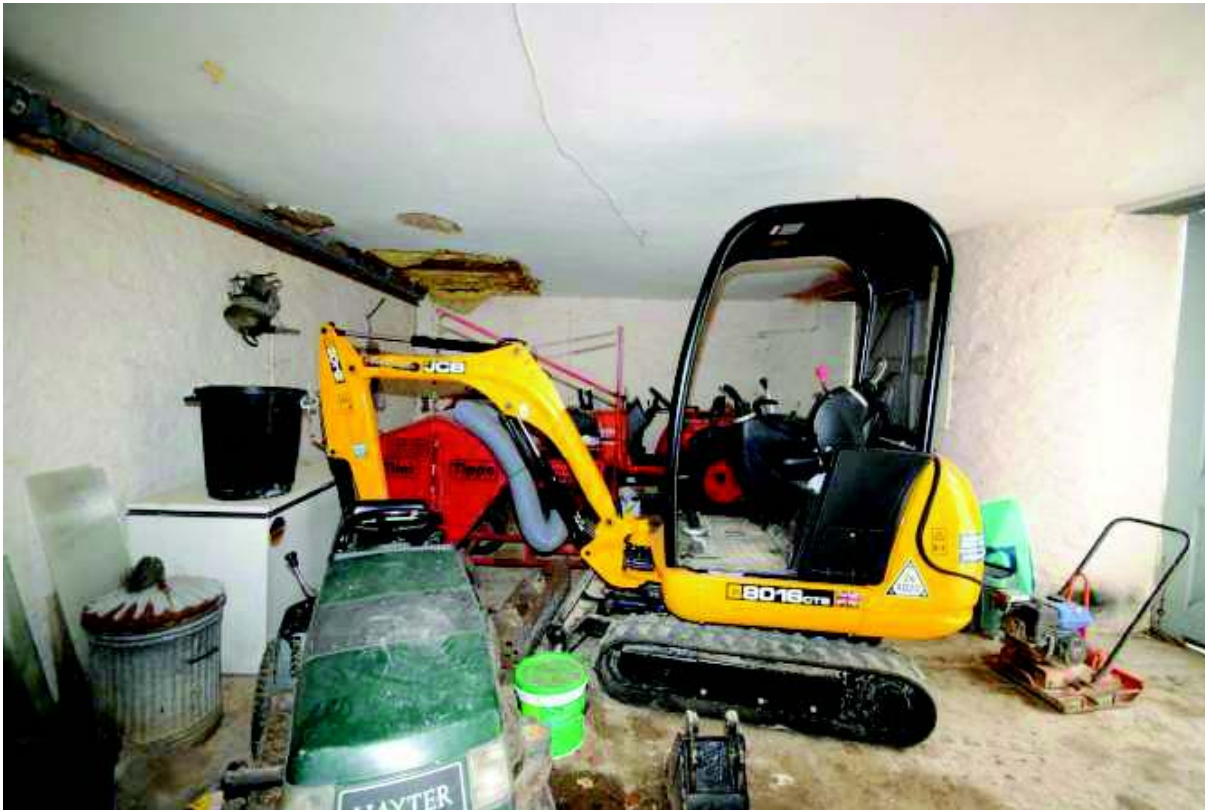
**Plate 115: Southeast aspect, carriage store**

The size of the doors into this part of the building suggest it was used as a carriage store.

There are no features of interest visible excepting two areas of damaged ceiling in the eastern corner of the room revealing its construction of lath and plaster. The presence of modern fibrous insulation suggests the first floor has been lifted at some point, then replaced with a layer of insulation beneath.

The stone pier between the carriage doors (which are considered to be 19<sup>th</sup> - 20<sup>th</sup> century in date) is substantial, rounded on its northeast face, in order to support two fireplaces and a chimneybreast on the first floor above.

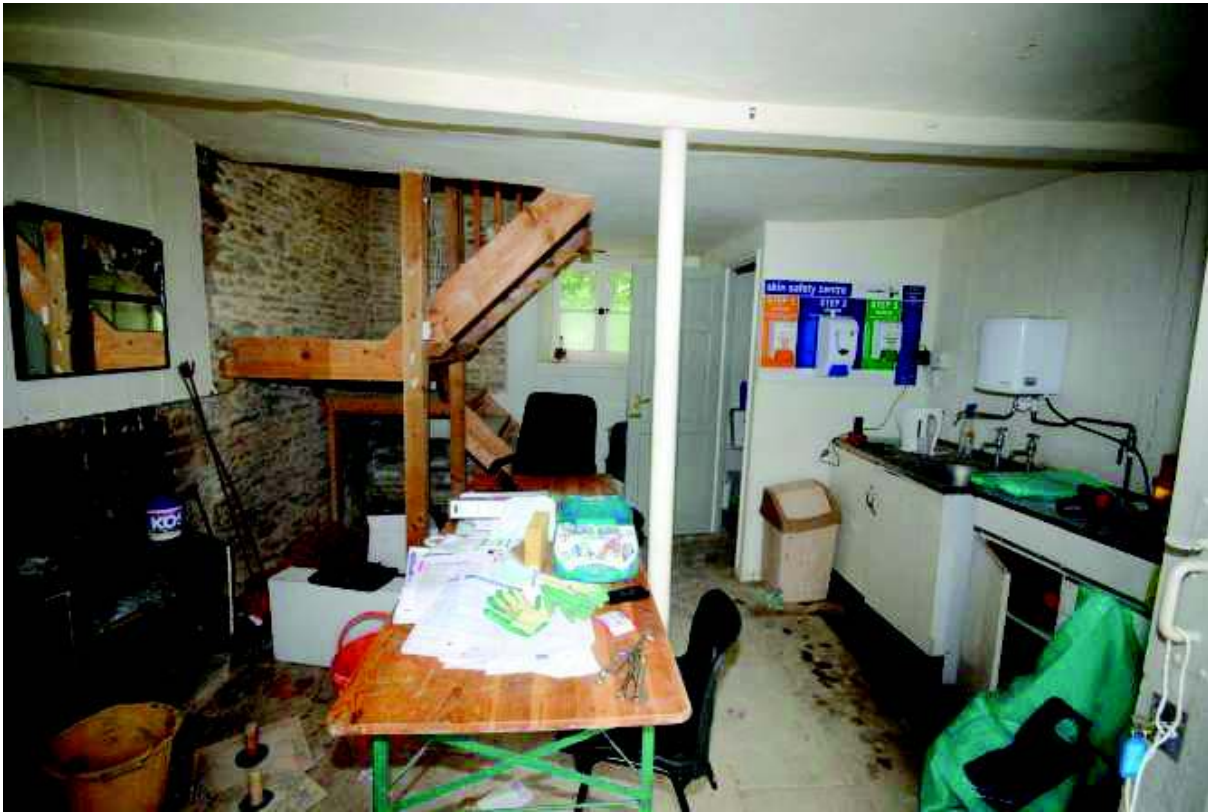
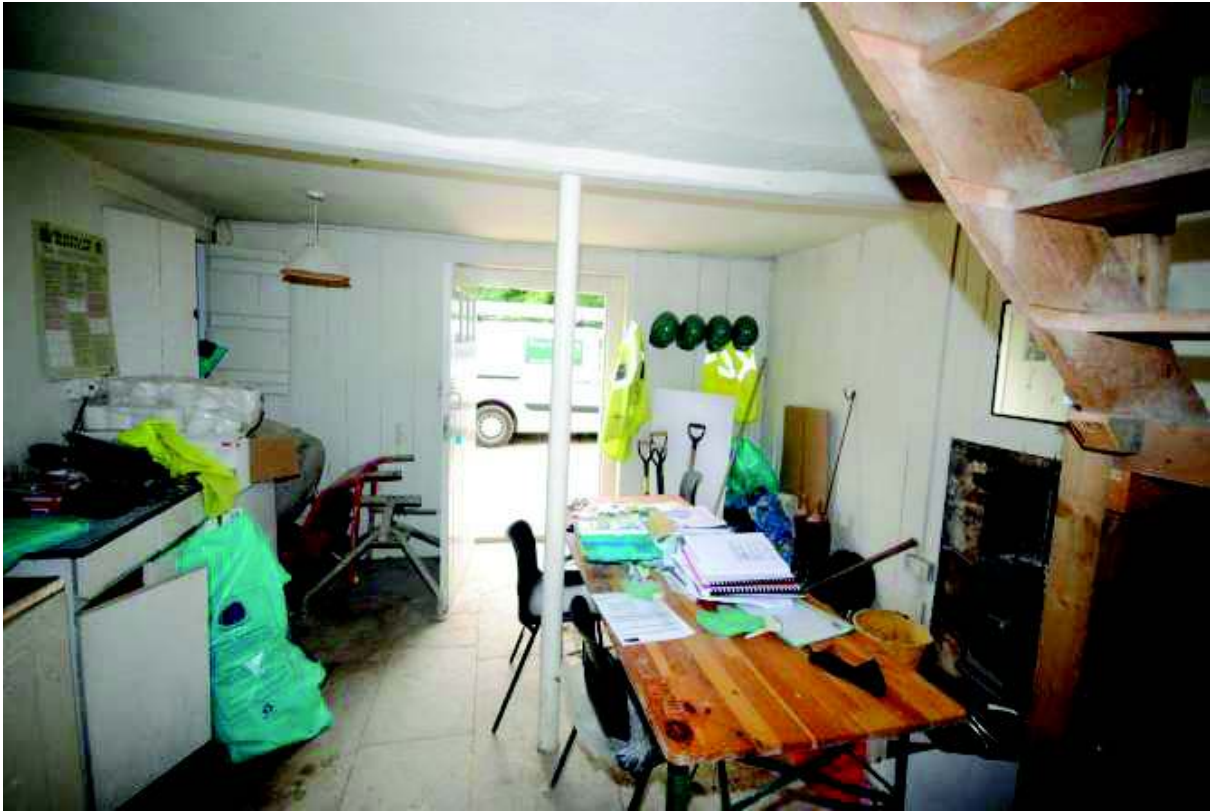
The fireplace has an iron lintel and is lined in brick. A modern woodburning stove is present.

Exposed stonework in the northern corner, a hand-sawn lateral beam supported on a central metal post, timber panelling to the southwest half of the room and a wooden casement window in the northeast wall total the historic features visible.

Plate 116: Northeast aspect

Plate 117: Southwest aspect

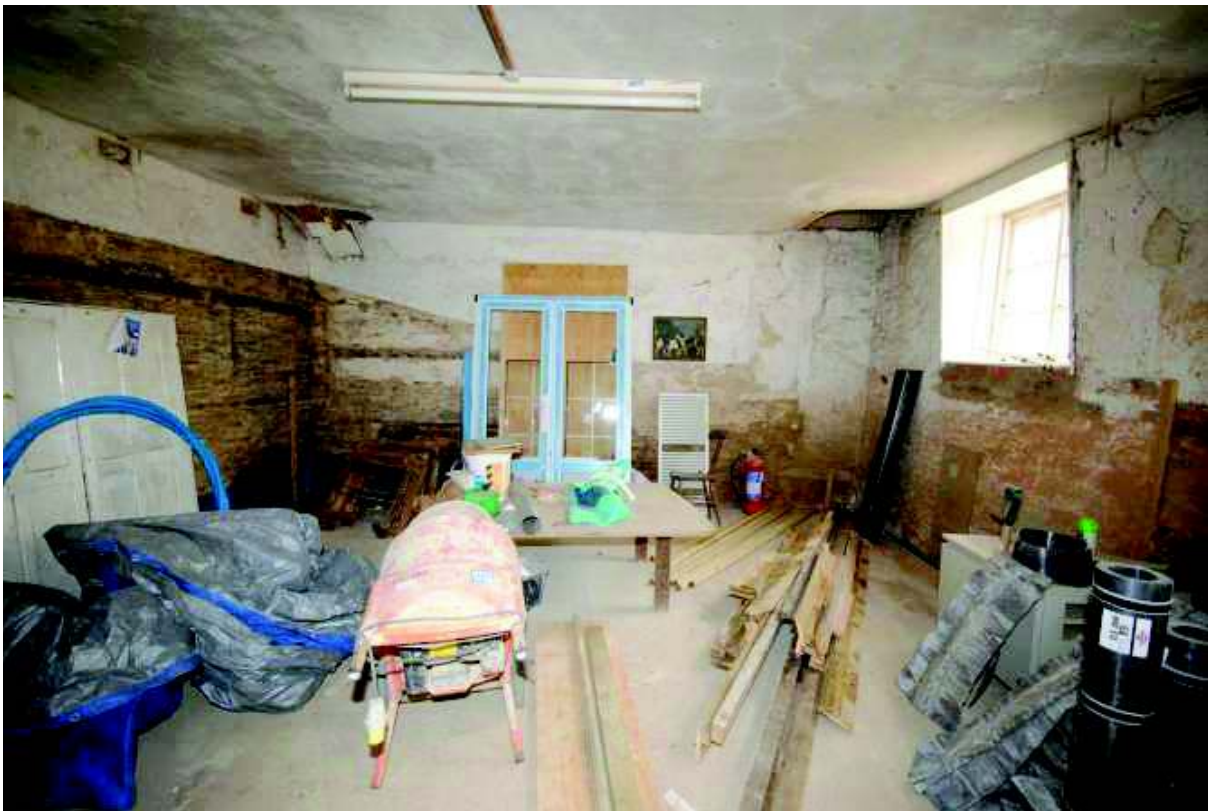
Plate 118: Southeast aspect

The room is considered to have been a stable although is now used for storage. The floor has been tanked and concreted obscuring any cobbled drainage surface that would be expected in a stable although the northwest, northeast and southeast walls were rendered around now absent panelling, the shape of which suggests stalls with sloping dividers were located along the northeast wall running northeast-southwest. The panelling was attached to battens set in the stonework of the wall.

There is ample room to manoeuvre horses in the remaining space to the southwest and the slightly wider and taller doorway would facilitate their passage. Air vents located at the head of the northeast wall also suggest this part of the building was a stable.

Damage to the ceiling indicates its lath and plaster construction. A hatch to the first floor is present in the southern corner of the room.

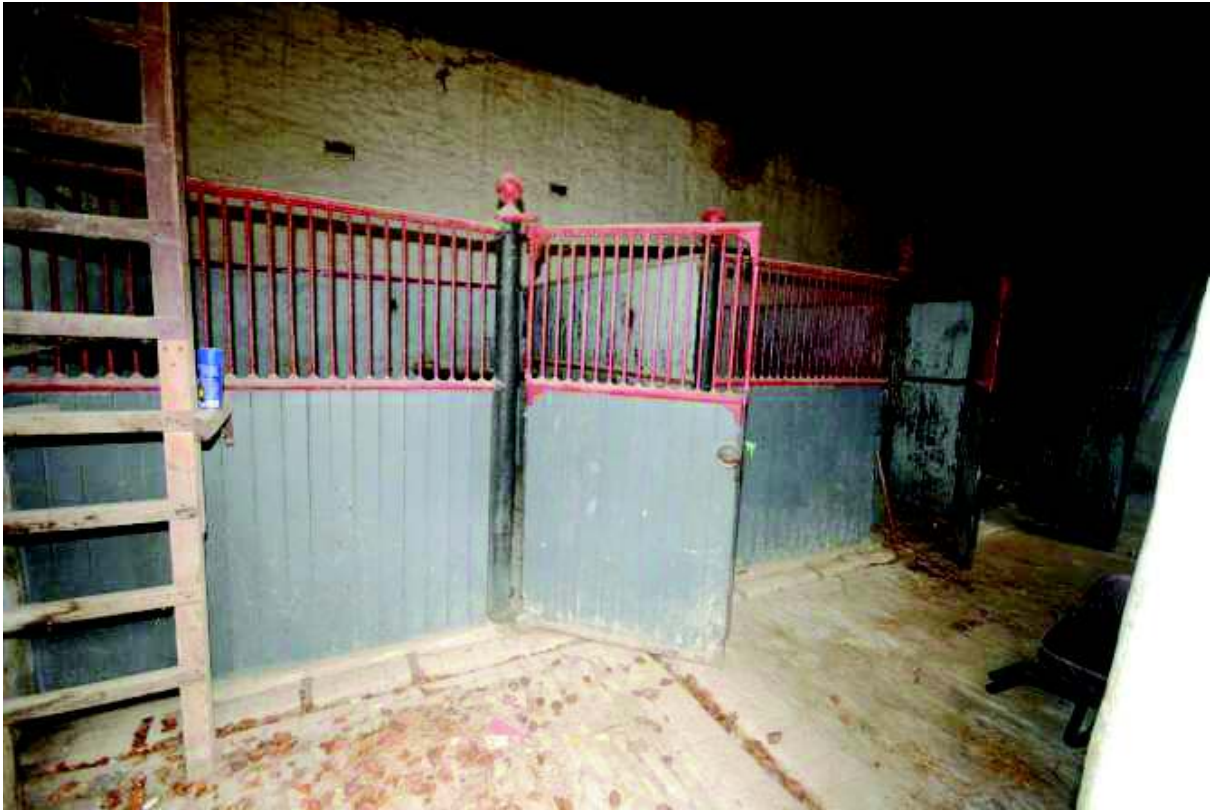
Plate 119: Eastern aspect

Room 4 is a stable with three looseboxes of 19<sup>th</sup> - 20<sup>th</sup> century date, each with a manger / feed trough and iron rings for tethering horses and hanging hay nets. The presence of render on the walls and lath and plaster scarring on collar beams suggests a ceiling was once present at a similar height to that in room 3. Air vents are again present along the northeast wall.

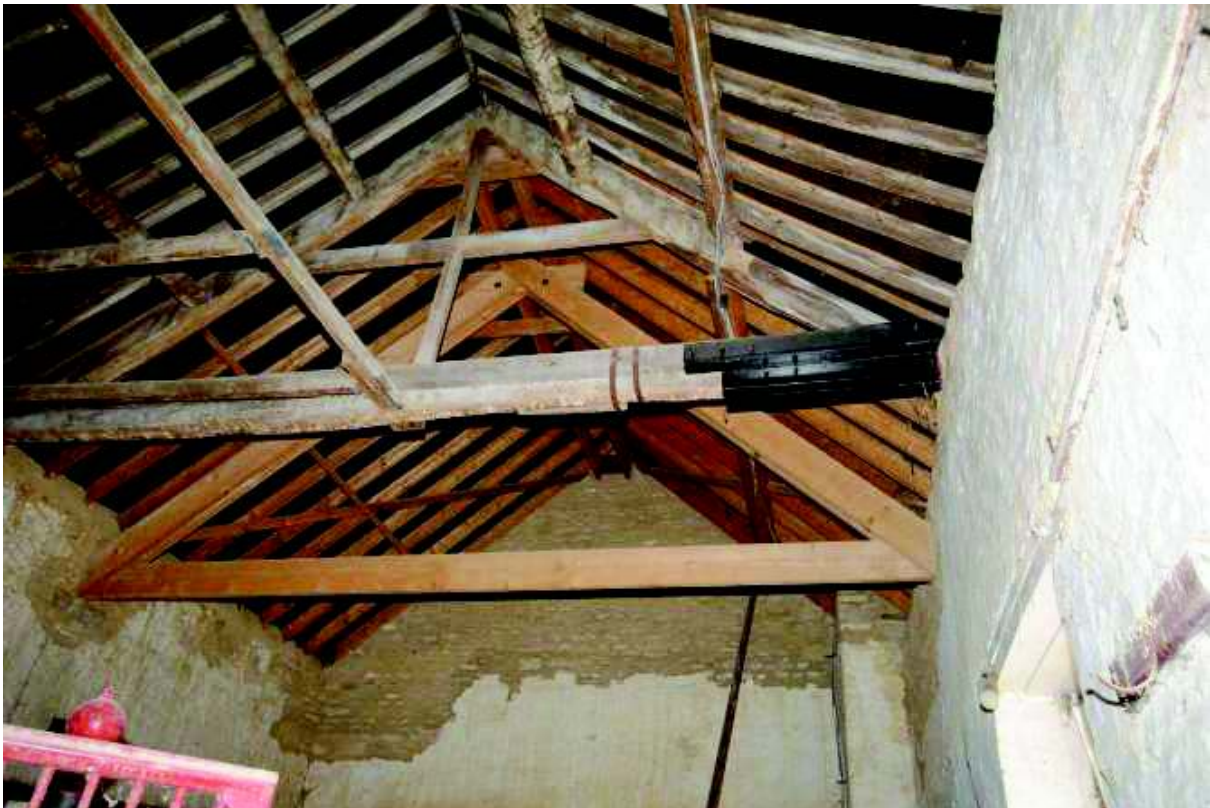
Plate 120: Detail of roof structure

The roof structure is visible, being primarily constructed of machine-sawn timber although a hand-sawn collar is present, reinforced significantly with iron strapping and brackets.

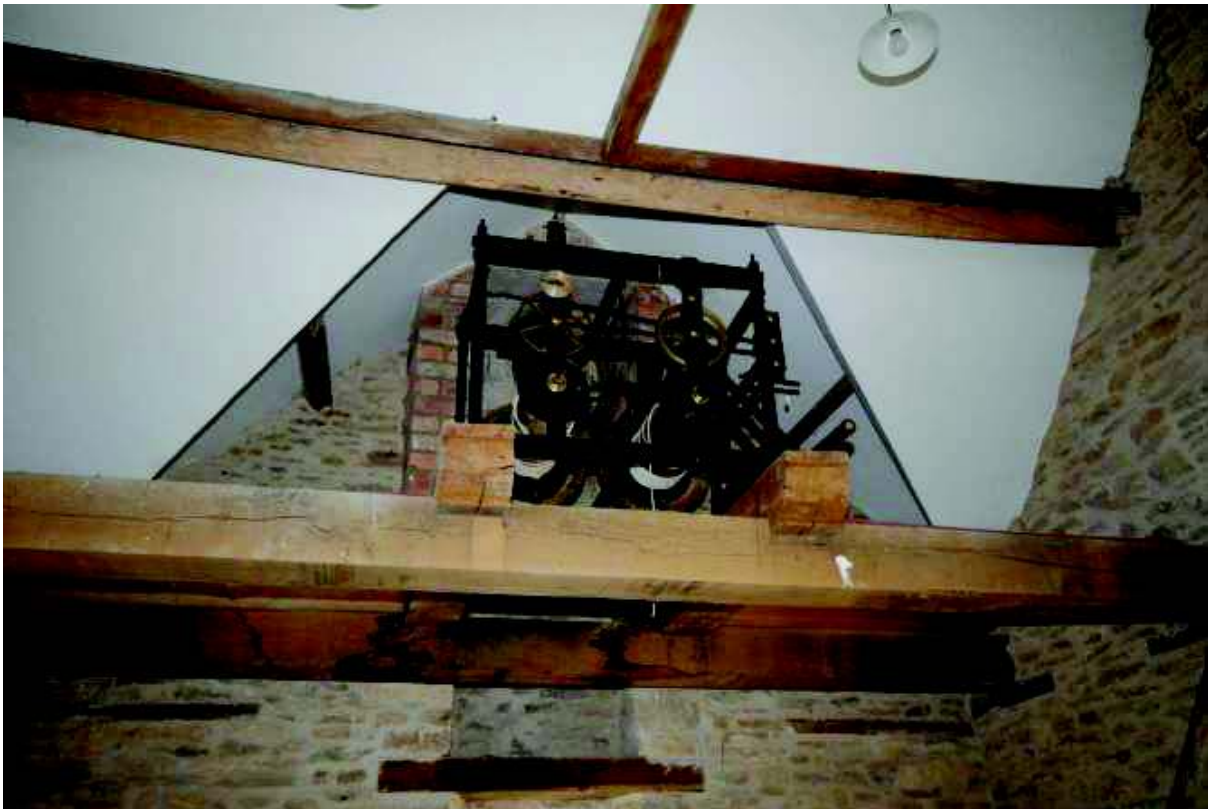
Plate 121: Clock mechanism

Room 5 is accessed via a modern staircase in room 2. It is located in the central gable of the building and as such houses the clock mechanism. This is in good condition and may have been recently refurbished. The mechanism is supported on modern machine-sawn timbers in the apex of the gable. Hand-sawn purlins are present to the northeast.

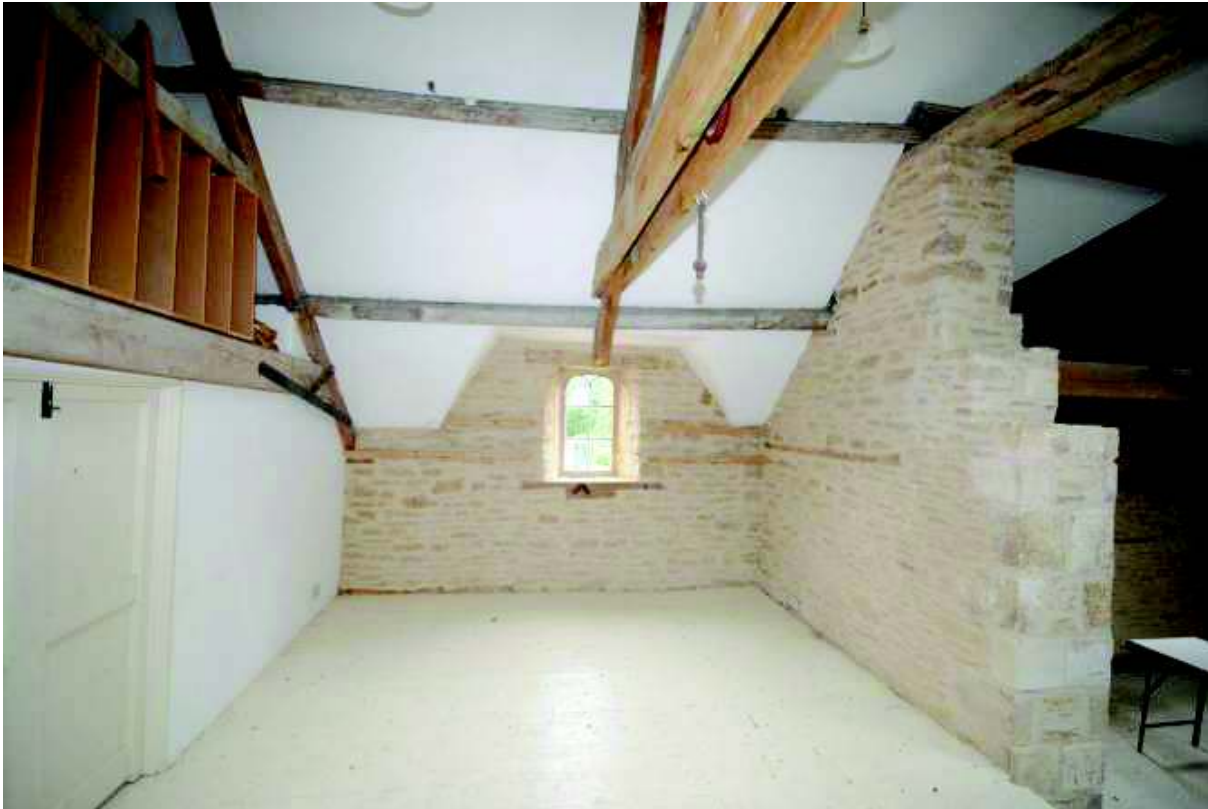
Plate 122: Southwest aspect

The room is entered via a stepped opening from room 5. The roof structure where visible is a mixture of hand and machine-sawn timbers suggesting 19<sup>th</sup>-20<sup>th</sup> century repairs to an earlier structure. The roof structure is rendered however the stonework of the walls is visible.

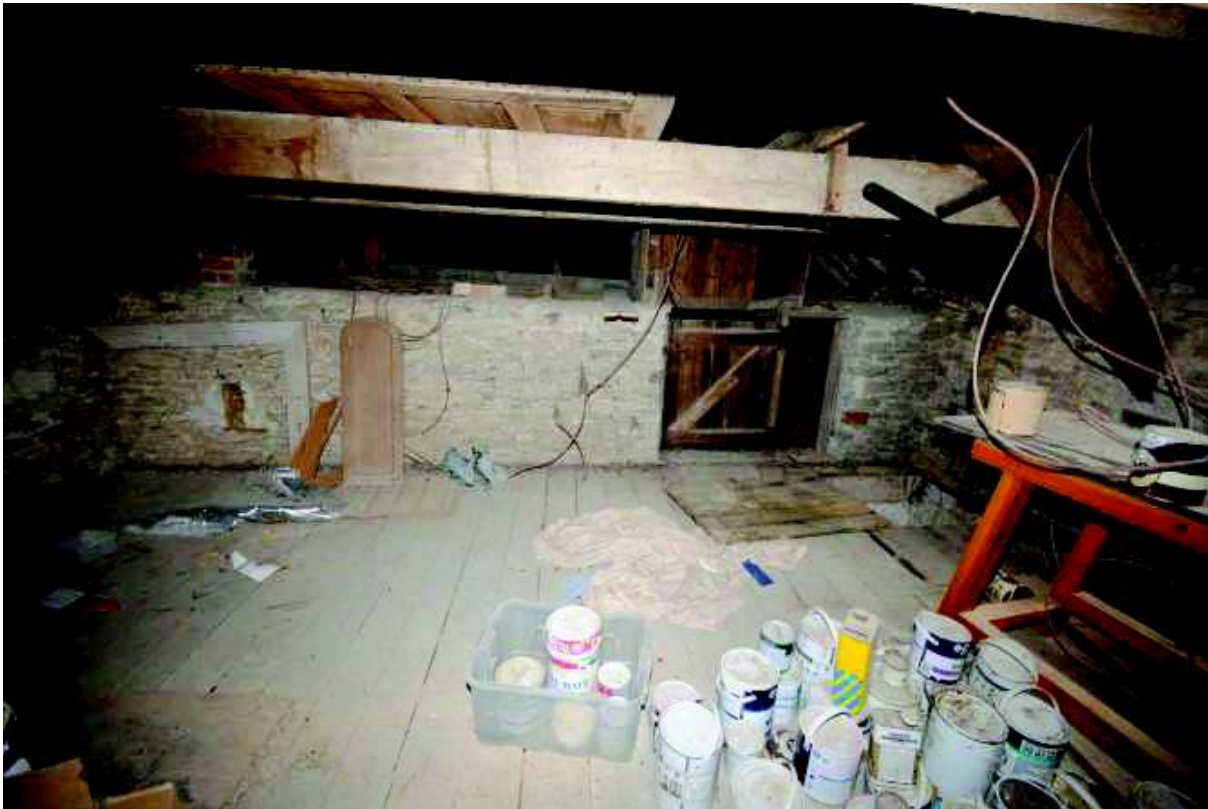
Plate 123: Southeast aspect showing chain

The roof structure over room 7 is entirely of machine-sawn timber with iron strapping.

Along the southeast wall of room 7, a chain at floor level is considered to have been installed to act as a tie between the front and back walls of the building and stop any lateral spread.

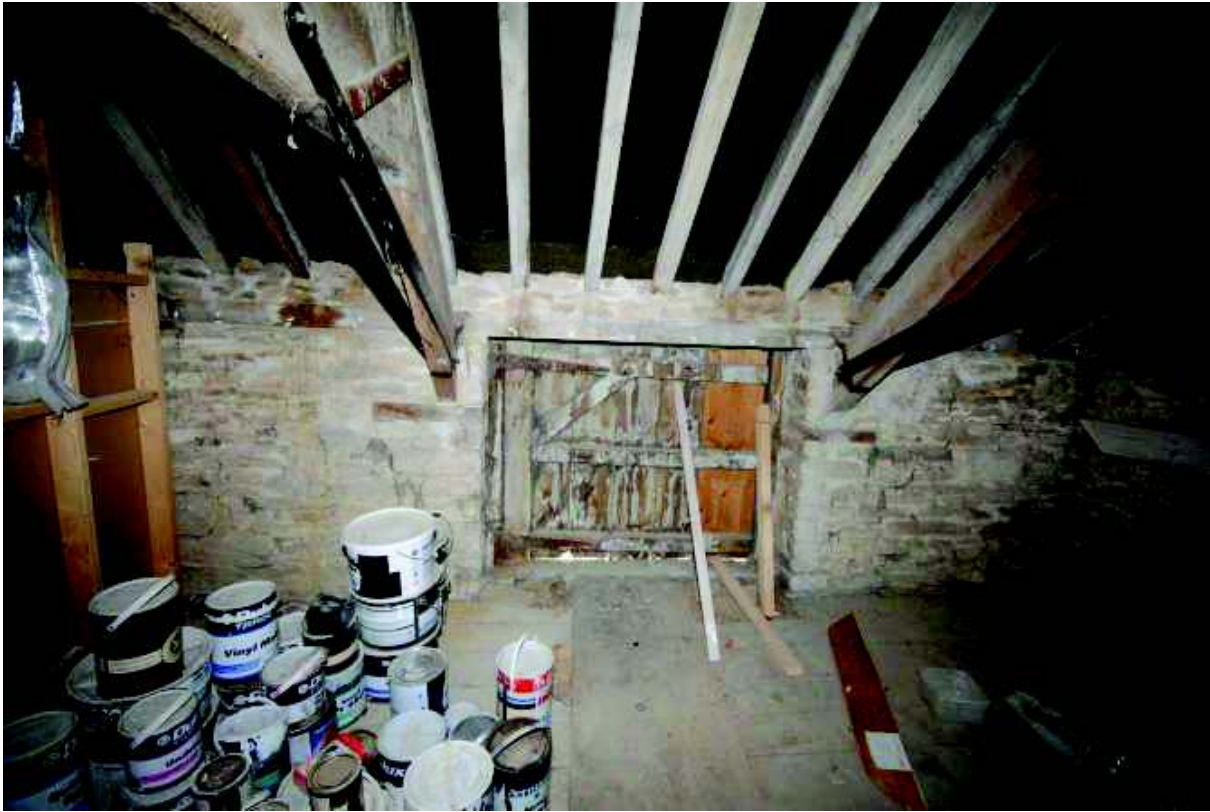
Plate 124: Hayloft door

A low door in the northeast wall for loading purposes confirms this area was once a hayloft.

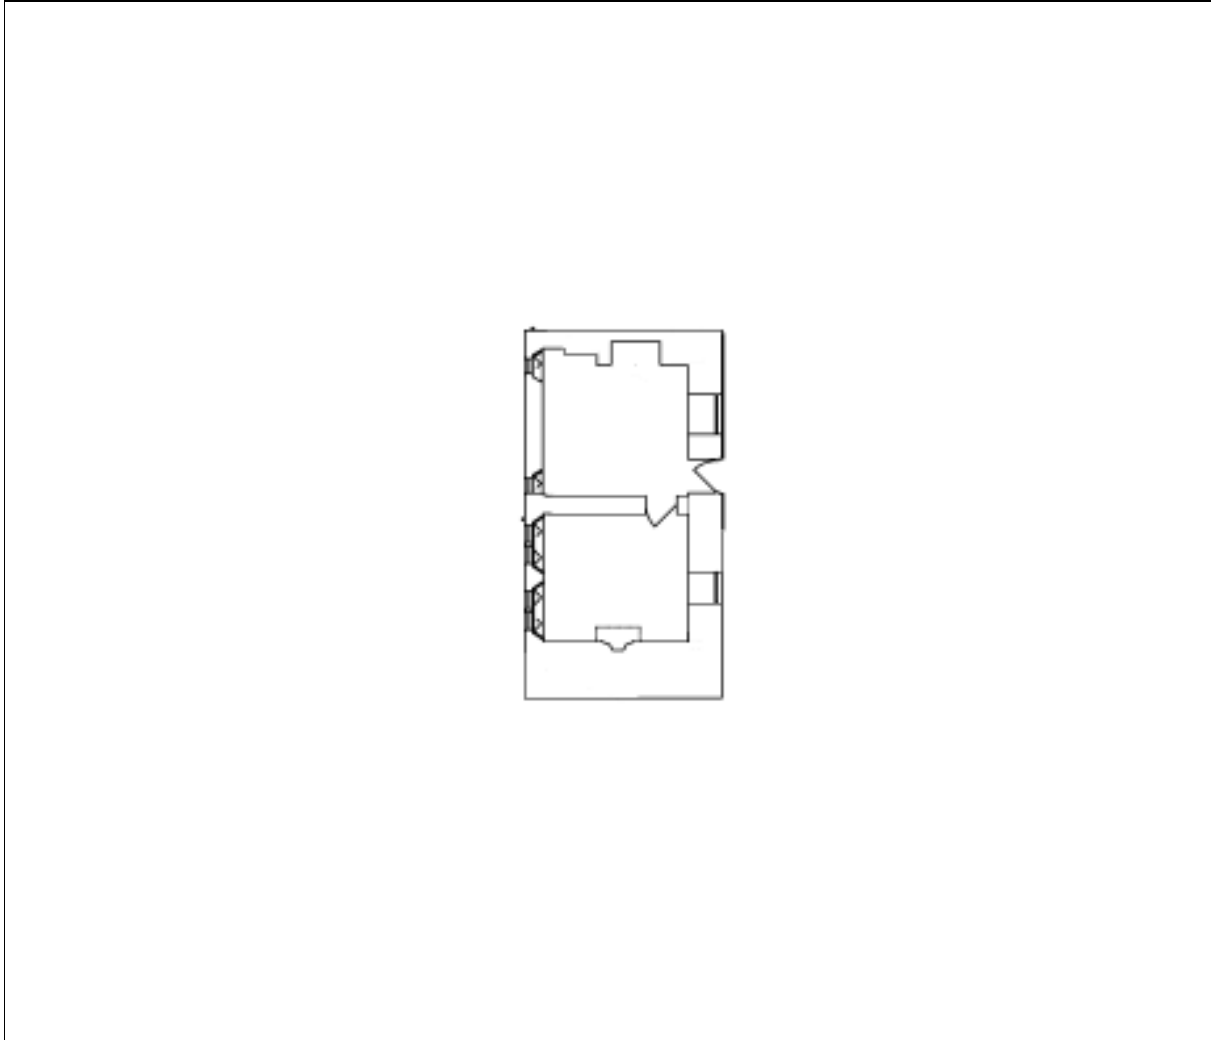
**Figure 12: Phase 1 plan**

The initial phase of the building is the area containing ground floor room 14 and first floor rooms 12 and 13. This is dated by the listing description as being of 16<sup>th</sup> century construction, although the Victoria County History dates this phase of the building to the 17<sup>th</sup> century. There is no physical evidence that can refine this date beyond the period of 16<sup>th</sup>-17<sup>th</sup> century. The extent of this phase is visible externally in the limits of the double gable over this section of the building.

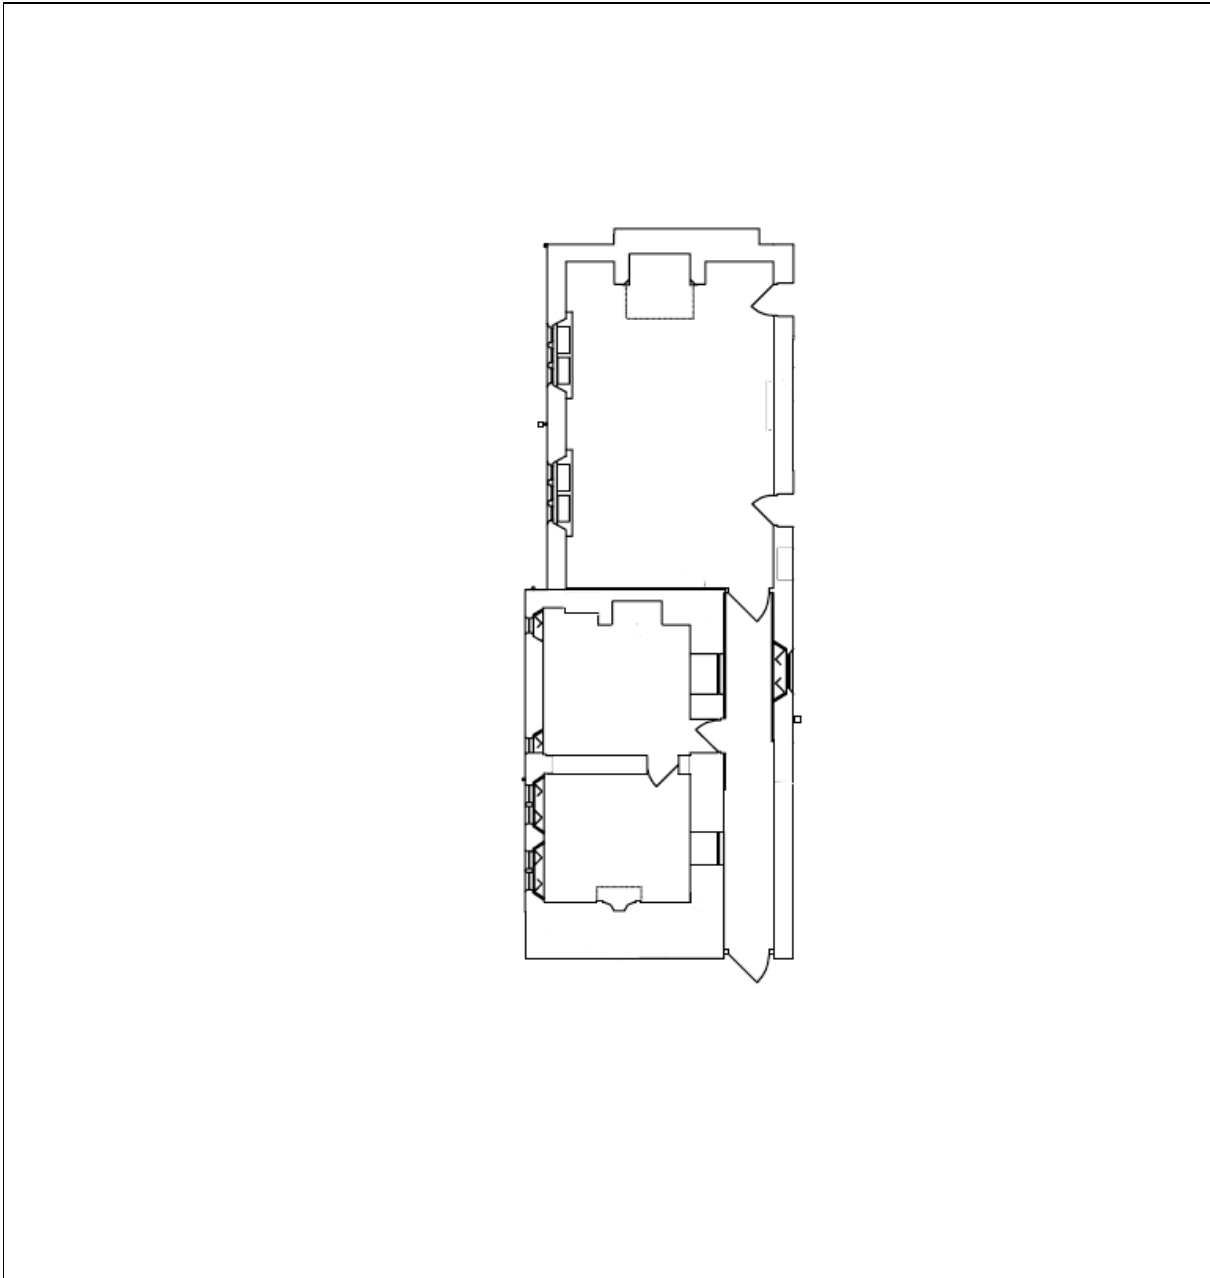
**Figure 13: Phase 2**

The part of the building containing ground floor rooms 15 and 16 is dated by the listing description as being constructed around 1830, as a service range. It is, however, considered more likely to predate this. Its external appearance suggests its age is greater than is suggested by the listing description. It is also considered likely that the part of the building housing the corridor running alongside phase 1 also dates from this period.

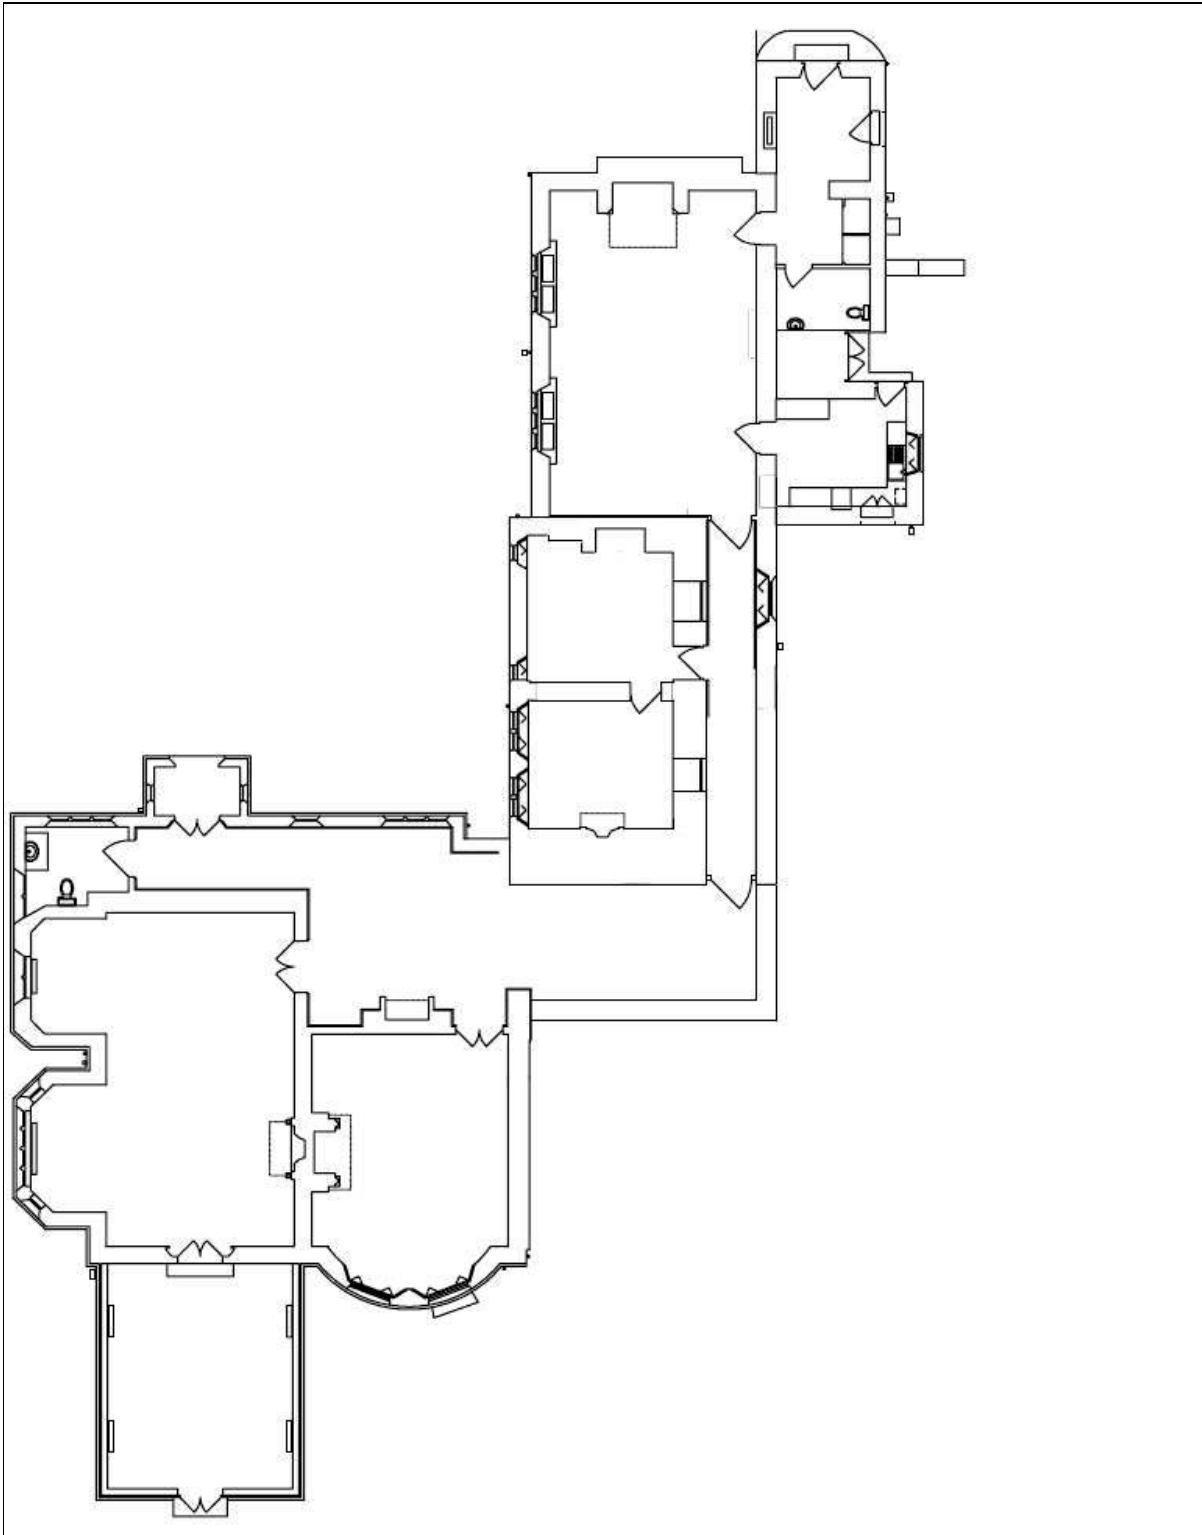
**Figure 14: Phase 3**

The southwest part of the building, housing ground floor rooms 1-3 and the conservatory is dated by the listing description as being constructed around 1820. It is considered to have joined on to the phase 1 and 2 structure in a way similar to that illustrated.

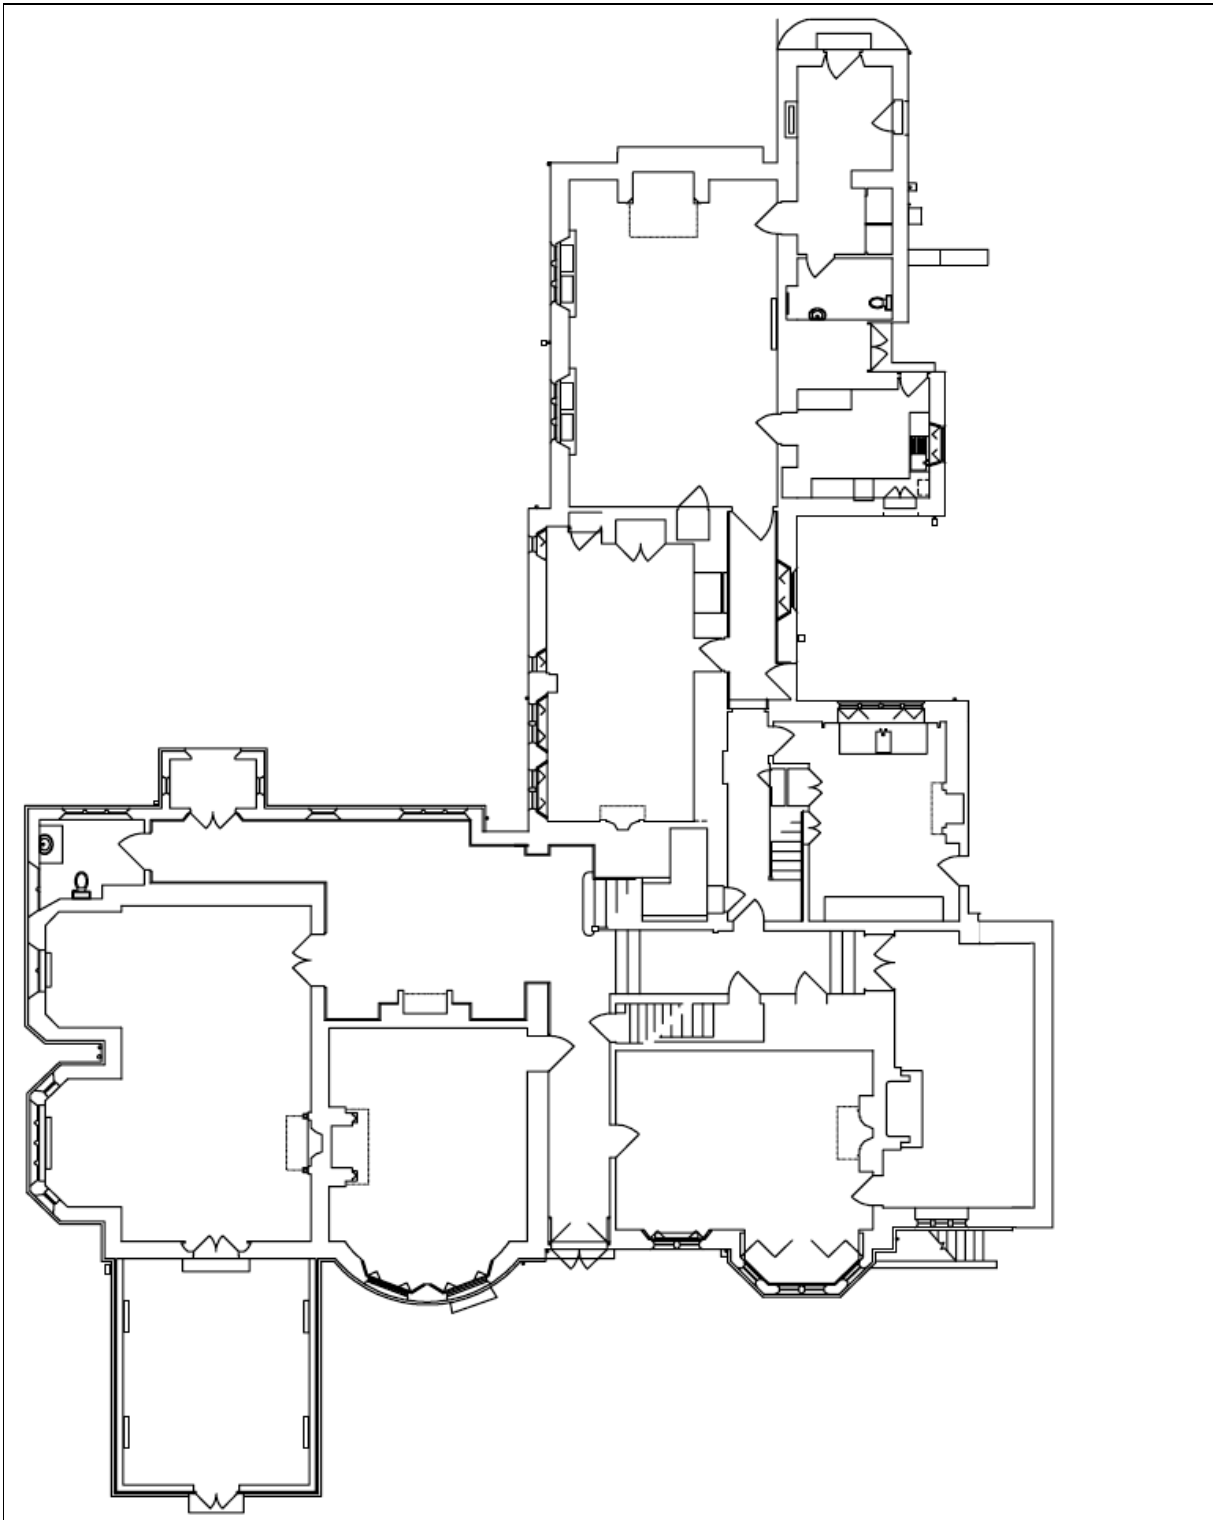
**Figure 15: Phase 4**

A further redevelopment occurred in 1876 in which the area containing ground floor rooms 4, 5, 12, 13 and parts of 6 and 7 was constructed. The listing description dates this as 1876, also the year of the first edition Ordnance Survey map, on which the building is depicted following the 1876 building work. The outbuildings adjacent to phase 2 are also depicted. Their exact date of construction is unknown however they are present on the first edition map.

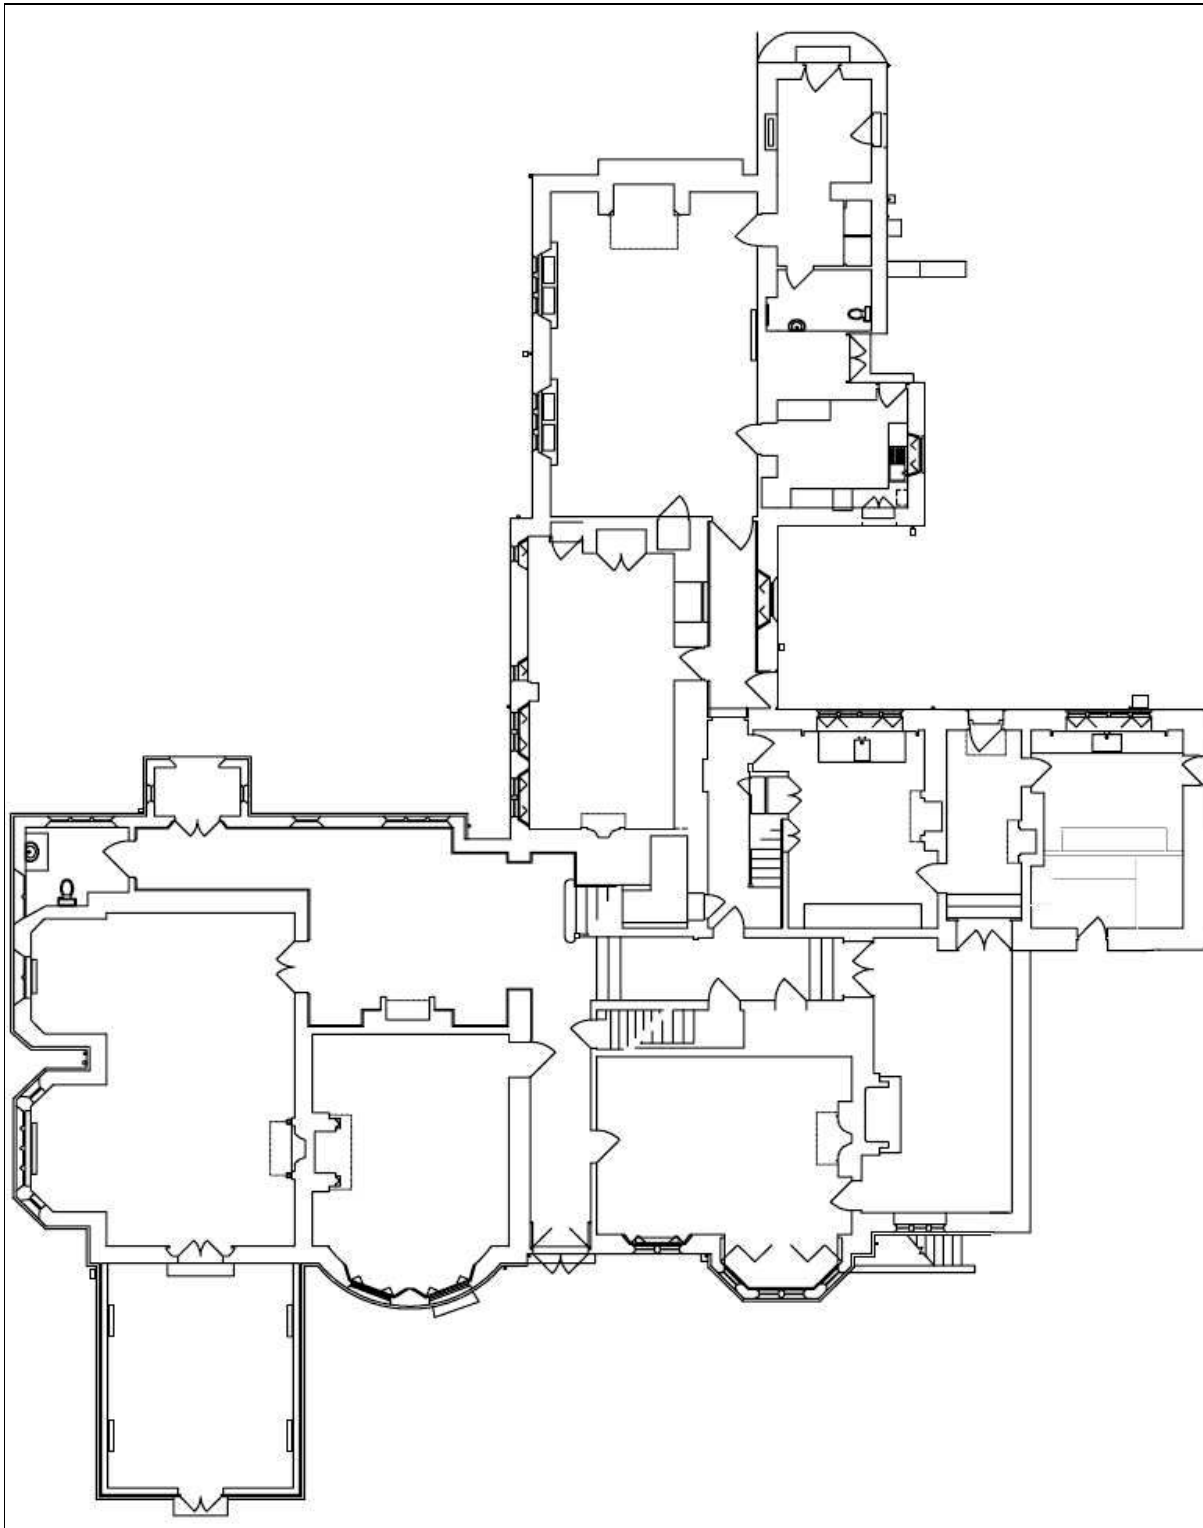
**Figure 16: Phase 5**

This phase is dated from map evidence. The section containing ground floor rooms 8-10 is not present on the 1876 map, however has been constructed prior to the production of the 1899 map.

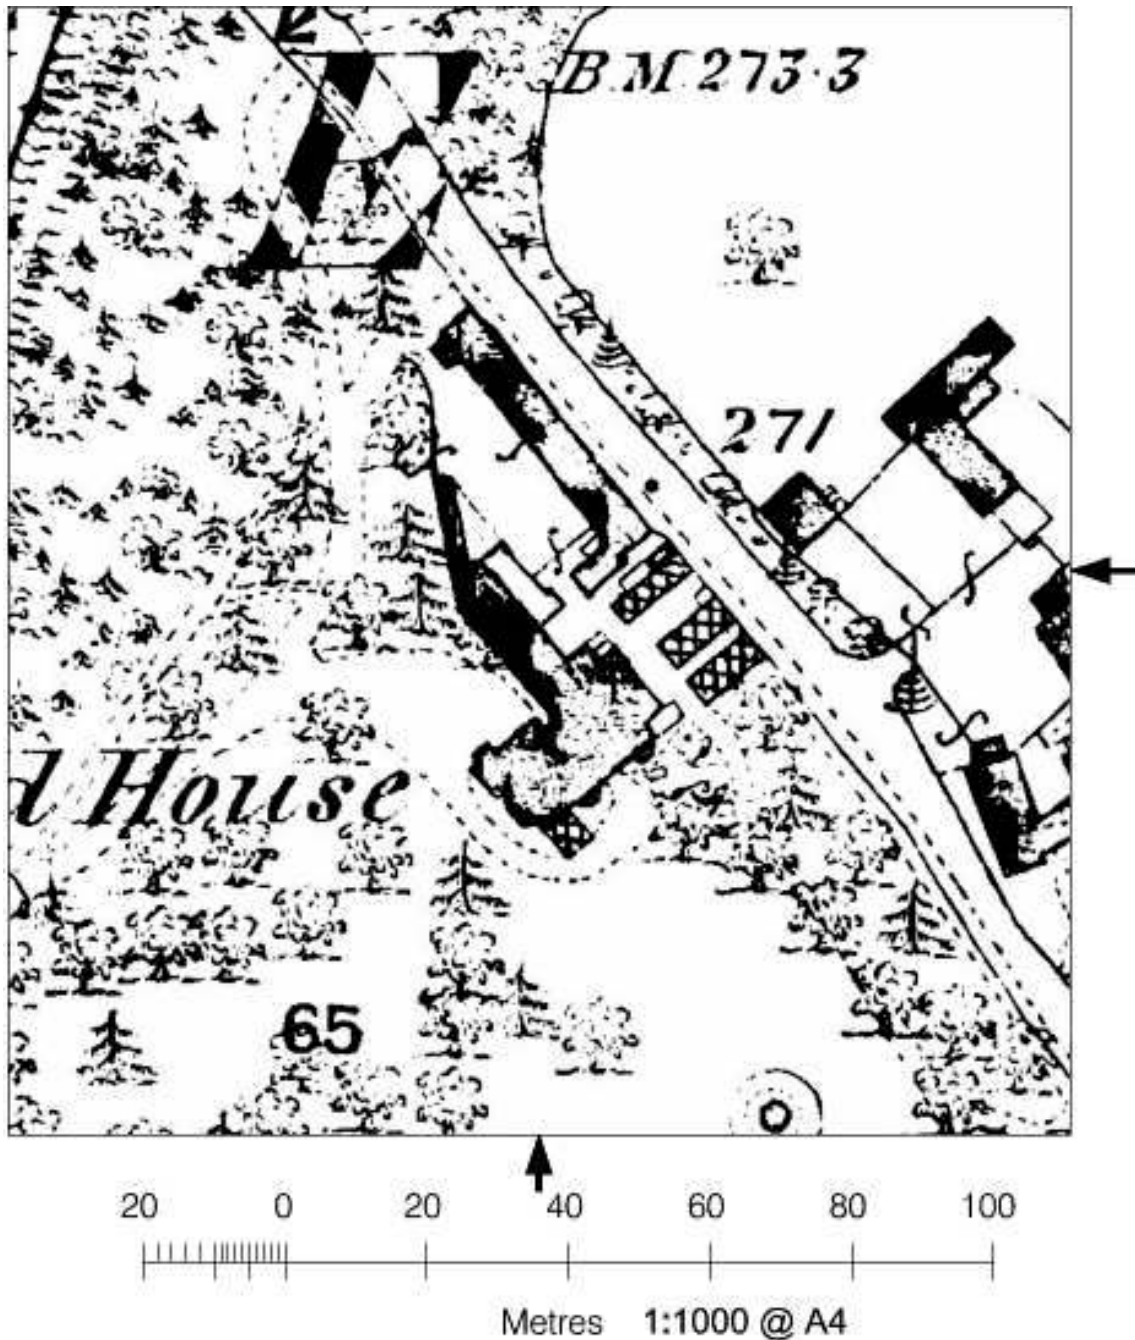
Figure 20: First edition Ordnance Survey plan, 1876

The house is depicted as an inverted 'T' shape, minus the more recent extensions to the northeast. A long thin building is attached at the northwestern end of the 'T'.

Three glasshouses are present to the northeast of the house.

The cottage has a small extension to the southwest.
