## HERITAGE STATEMENT

Little Faringdon House (Langford House)  
Little Faringdon  
Lechlade  
Oxfordshire GL7 3QN

**Heritage Statement:  
Little Faringdon House (Langford House)  
Little Faringdon, Lechlade, Oxfordshire GL7 3QN  
SP2237201563  
by  
Dr Peter Wardle & Colin Lacey  
20/07/2011**

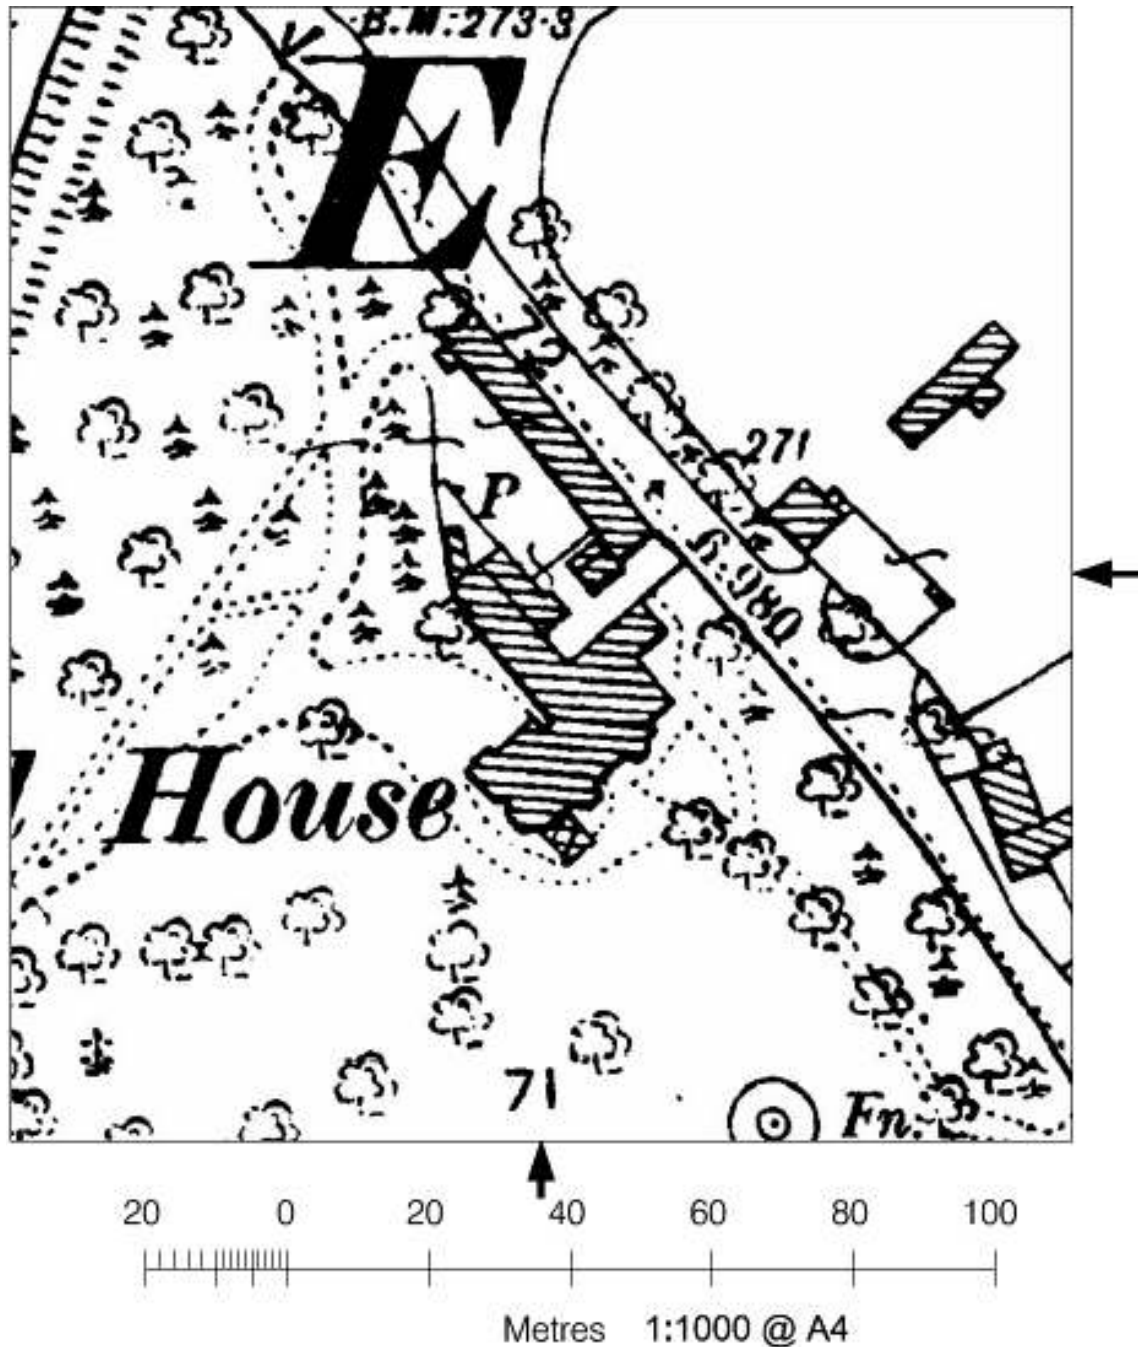
Figure 21: 1899 Ordnance Survey plan

The long thin extension at the northwest end of the main house has been reduced in length by approximately half.

The glasshouses to the northeast have been removed and the first extension has been constructed at the northeast end of the house.

The open lean-to structure attached to the outbuilding at the southern end of the stable block has been constructed.
